# National Park Service Cultural Landscapes Inventory 2022

**Bluffs Lodge**  
**Blue Ridge Parkway**

Bluffs Lodge, previously listed in good condition, is currently in poor condition but still retains all major features from the period of significance. The property possesses historic integrity in six of seven criteria as defined by National Register standards.

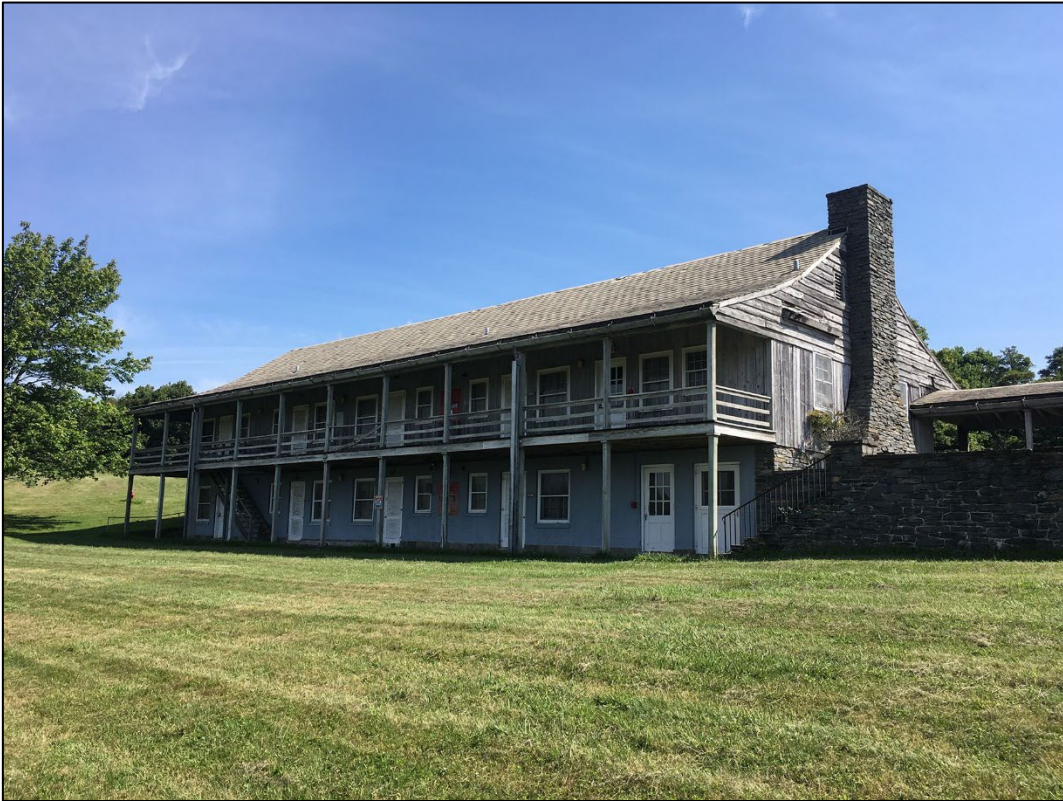
*Fig 8-1. View of Bluffs Lodge, south façade, illustrating interplay with surrounding topography, facing north (2021)*

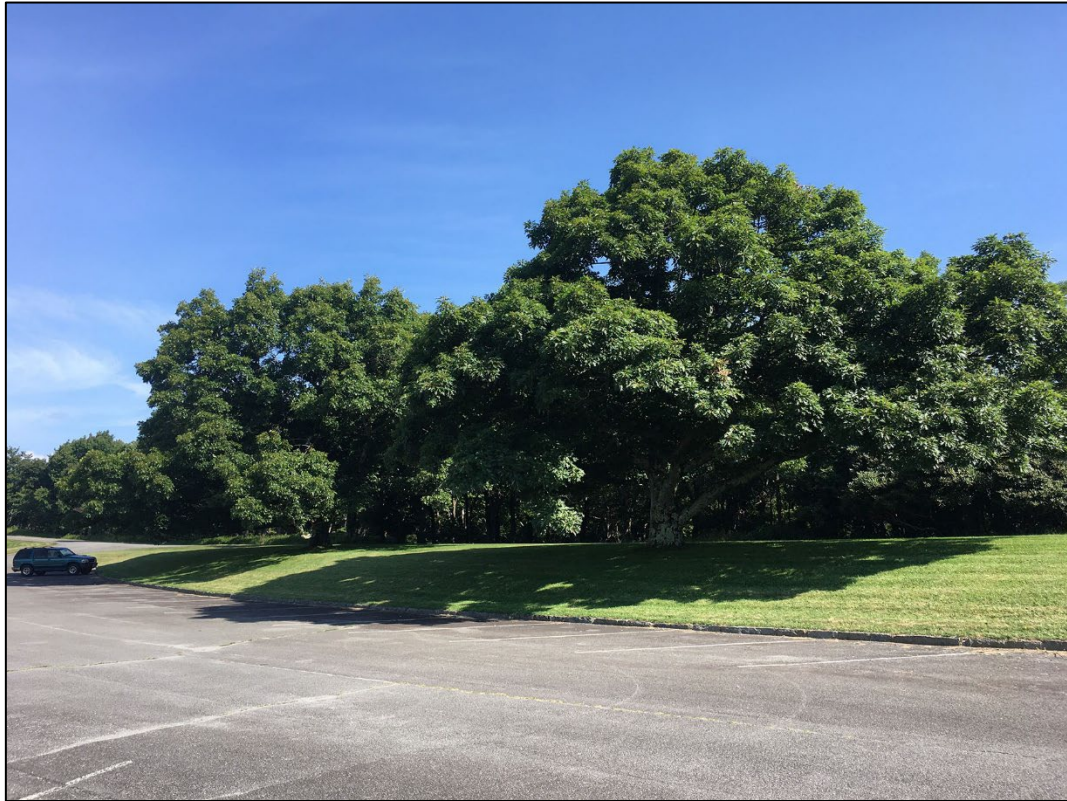
*Fig 8-4. Mature northern red oaks shading Bluffs Lodge parking lot. Historic remnants of 1940s planting plan (2021)*

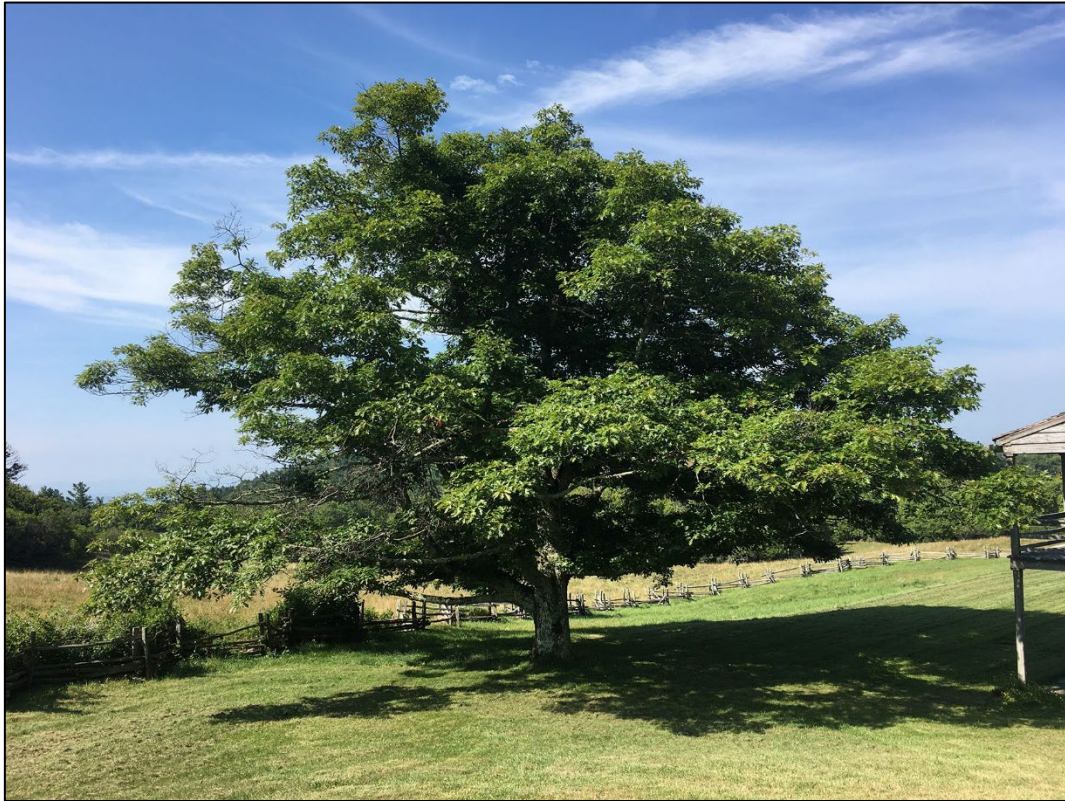
*Fig 8-5. Mature white oak near southeast corner of Bluffs Lodge. Historic remnant of 1940s planting plan (2021)*

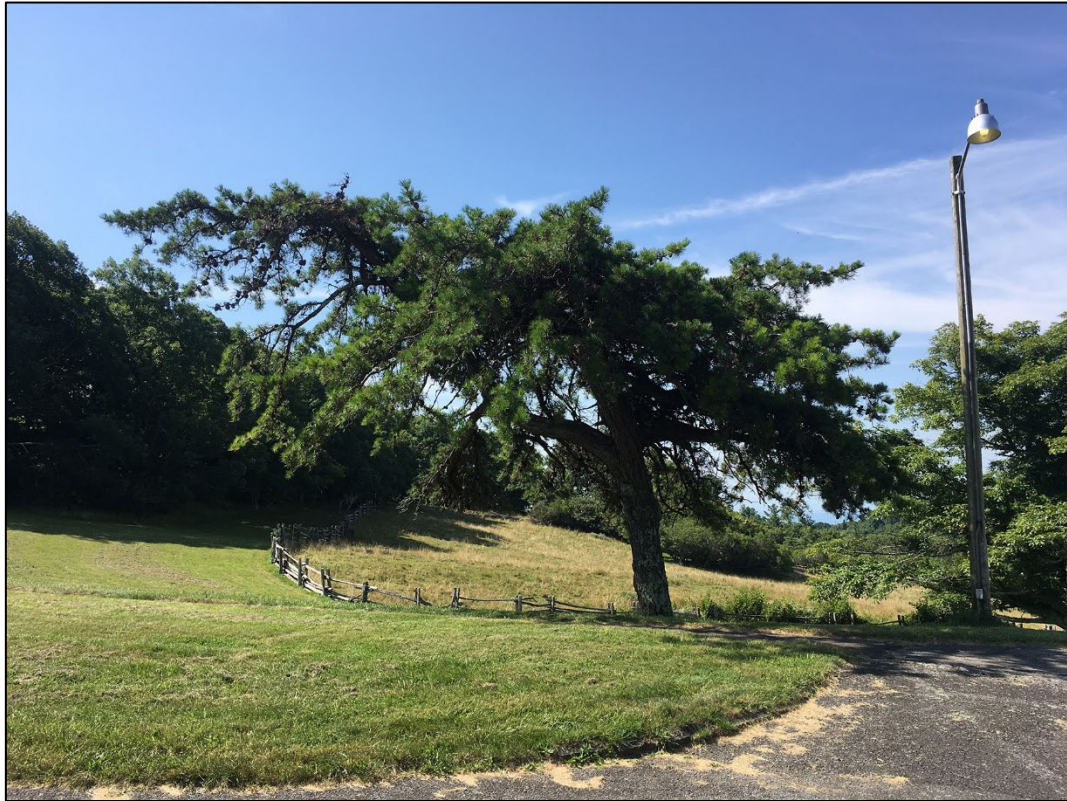
*Fig 8-6. Table mountain pine near northeast corner of Bluffs Lodge. Historic remnant of 1940s planting plan (2021)*

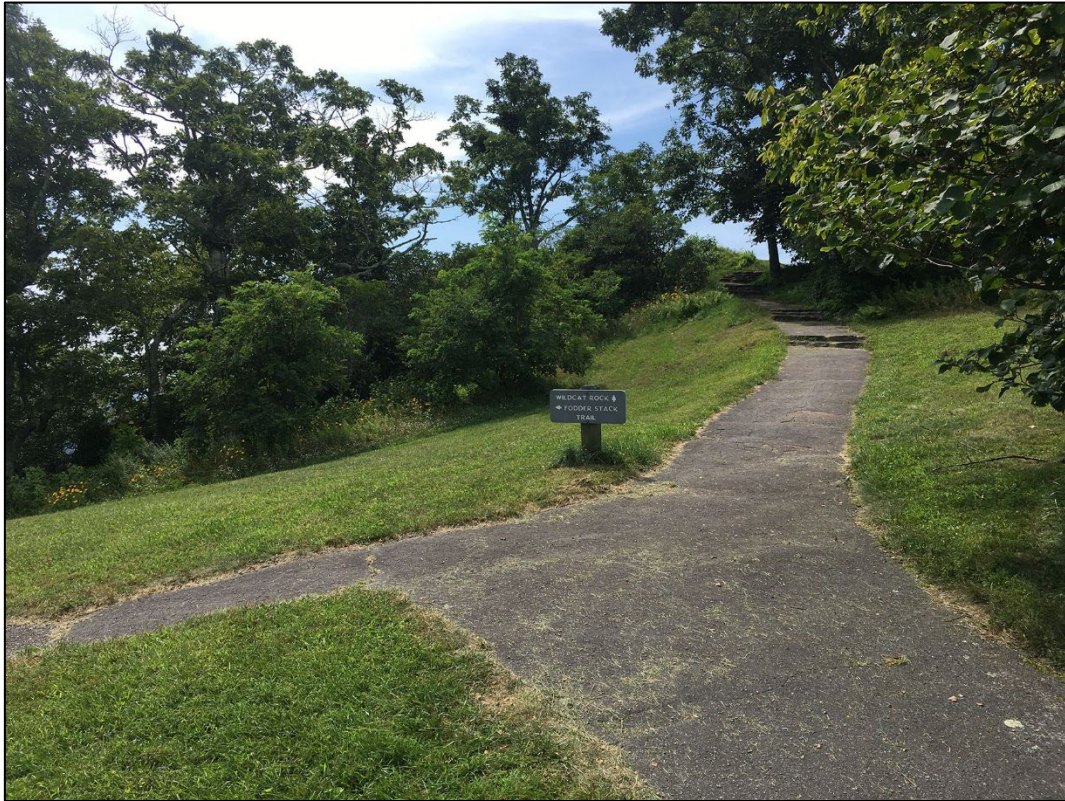
area. This path is divided by an 85 feet long linear path which connects the center of the Lodge to the center of the Lodge Parking area. The asphalt paths immediately in front of the Lodge are approximately 6 feet wide and are also used as a vehicular lane for luggage drop-off. Most of the paths are worn. Some areas of path are excessively worn with the worst portions missing areas of asphalt and overgrown with turf. The overall condition of the asphalt on these pedestrian paths is fair.

*Fig 8-10. Asphalt paths leading to Wildcat Rock Overlook and Fodder Stack trailhead (2021)*

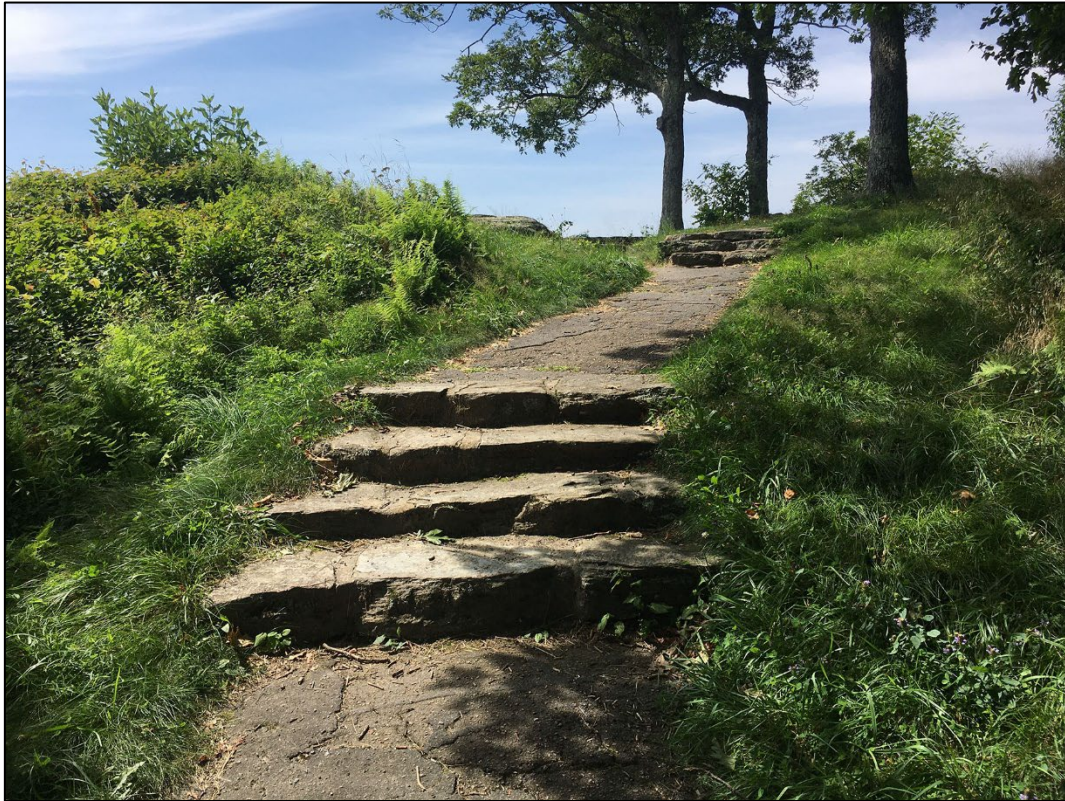
*Fig 8-12. Asphalt walkway and stone steps leading to Wildcat Rocks Overlook, facing south (2021)*

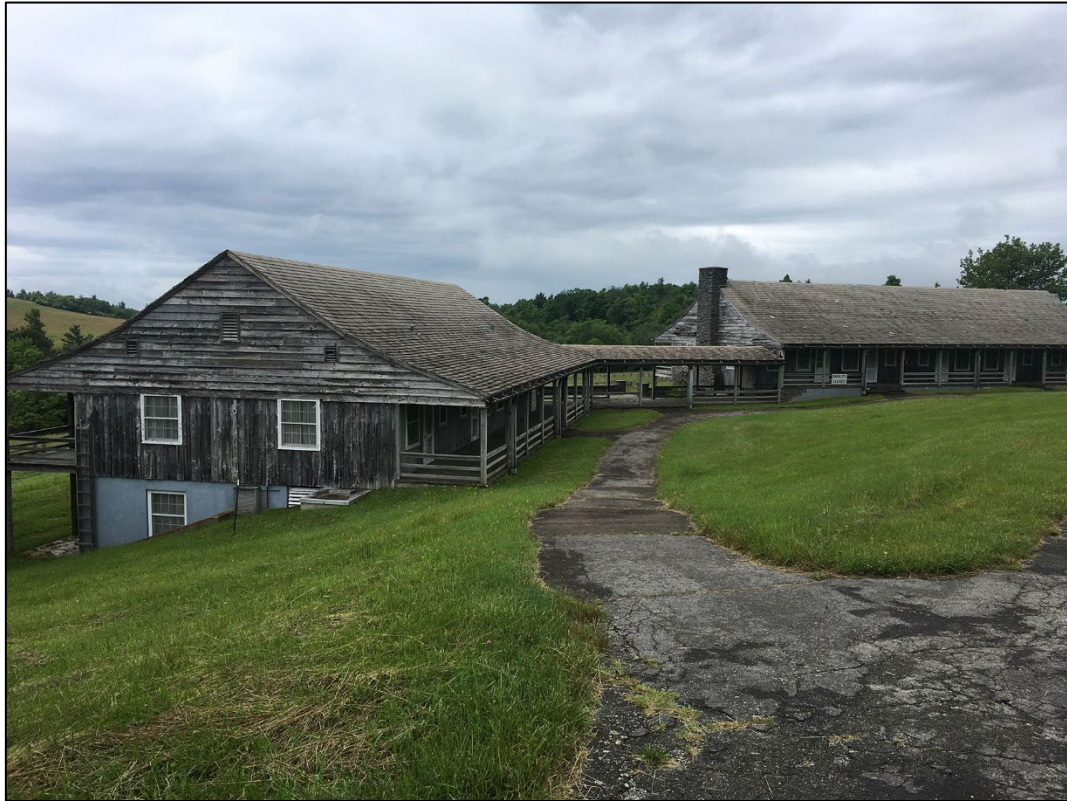
The overall condition of Bluffs Lodge is poor. The exterior of the Lodge complex is visibly deteriorated. Several screen doors have fallen off their hinges, and many window screens are broken or have fallen from their frames. The glass panes of many windows are also shattered, with several appearing to be the result of past break-in attempts. These broken windows have exposed the interior of the building to the elements, exacerbating the spread of black mold and other moisture and weather-related damage. Further, there is visible mold on the exterior of the screen doors.

The stone veranda, steps, and outdoor fireplace are also visibly deteriorated. Stones have broken loose, mortar has failed, and weeds have proliferated in the spaces between the flagstones. The stone planting bed adjacent to the outdoor fireplace has been similarly overtaken with weeds. Despite bearing these visible signs of neglect and weather exposure, as well as its extensive interior damage, the building appears to be structurally sound., the building appears to be structurally sound.

*Fig 8-19. Oblique view of Bluffs Lodge, north facade, facing southwest (2021)*

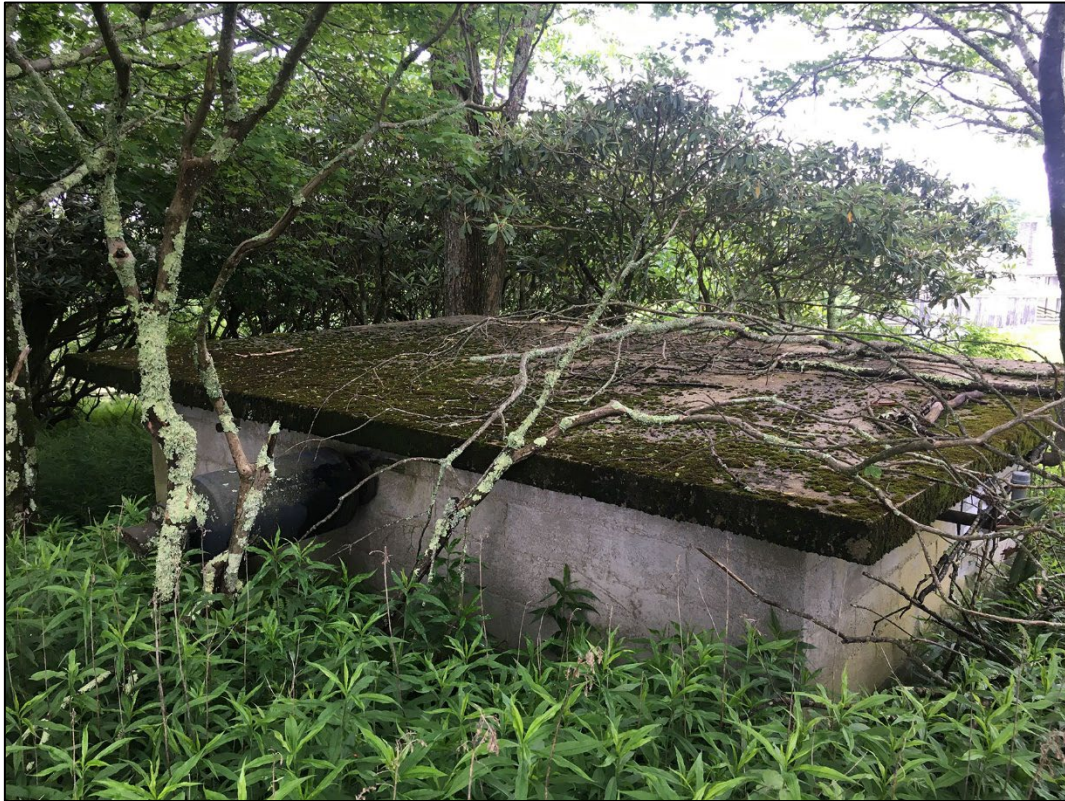
**Pump House:** The Pump House is located approximately 200 feet west of Bluff Lodge in a mown-turf clearing and is surrounded by a wood post-and-rail fence. It is a small one-story wood-framed structure with concrete foundation, board and batten siding, and a wood-framed wood shingle gable roof with exposed eaves. The slope on either side of the gable roof is slightly different, giving the structure an asymmetrical appearance. The main entrance is centered on the front elevation and has a steel door. The Pump House is a non-contributing resource due to its age, which is outside the period of significance for the Blue Ridge Parkway (WJE 2016, A-234).

*Fig 8-20. Fallen branches littering Pump House roof, facing southwest (2021)*

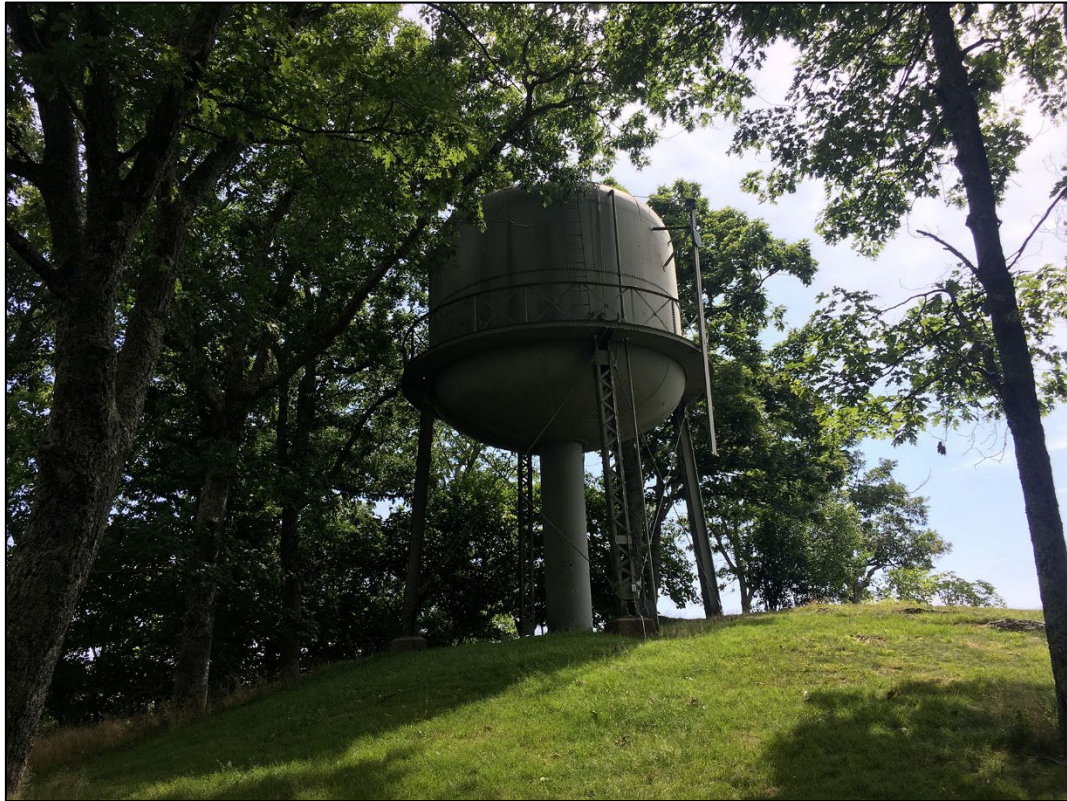
Water Tank: Built in 1939, the water tank is one of the oldest structures in Doughton Park. The tower is located on top of a knoll, just behind Wildcat Rocks Overlook and consists of a steel water tank set atop an approximately 25' tall steel tower. The structure is painted olive green, appears structurally sound, and remains in good condition, albeit with some graffiti and other

*Fig 8-21. Zoomed-in view of Wildcat Rocks Water Tank, hardwood canopy in background, facing south (2021)*

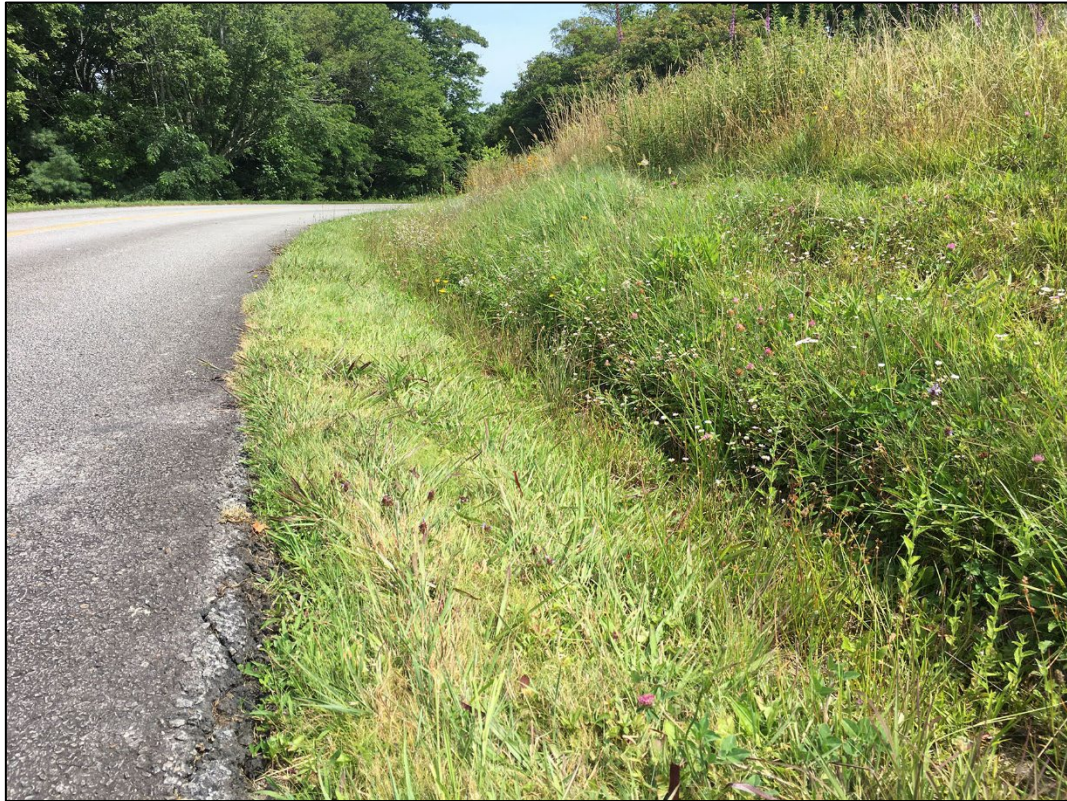
Area. The craftsmanship and construction methods utilized for this gutter are consistent with other Parkway construction along Sections 2A, B, and C. This gutter remains in good condition.

*Fig 8-25. Close-up of stone gutter along Bluffs Lodge entrance road. Heavily obscured by overgrown vegetation and accumulated debris. Facing northwest (2021)*

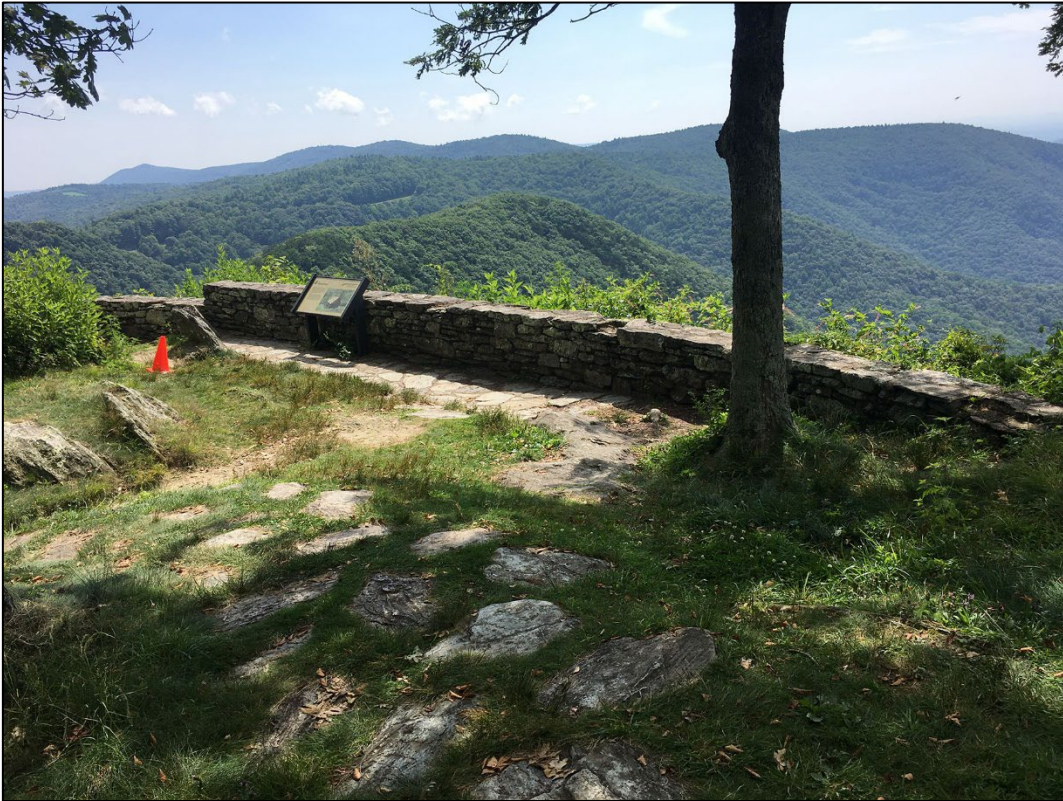
*Fig 8-26. Partially obscured flagstones at Wildcat Rock Overlook (2021)*

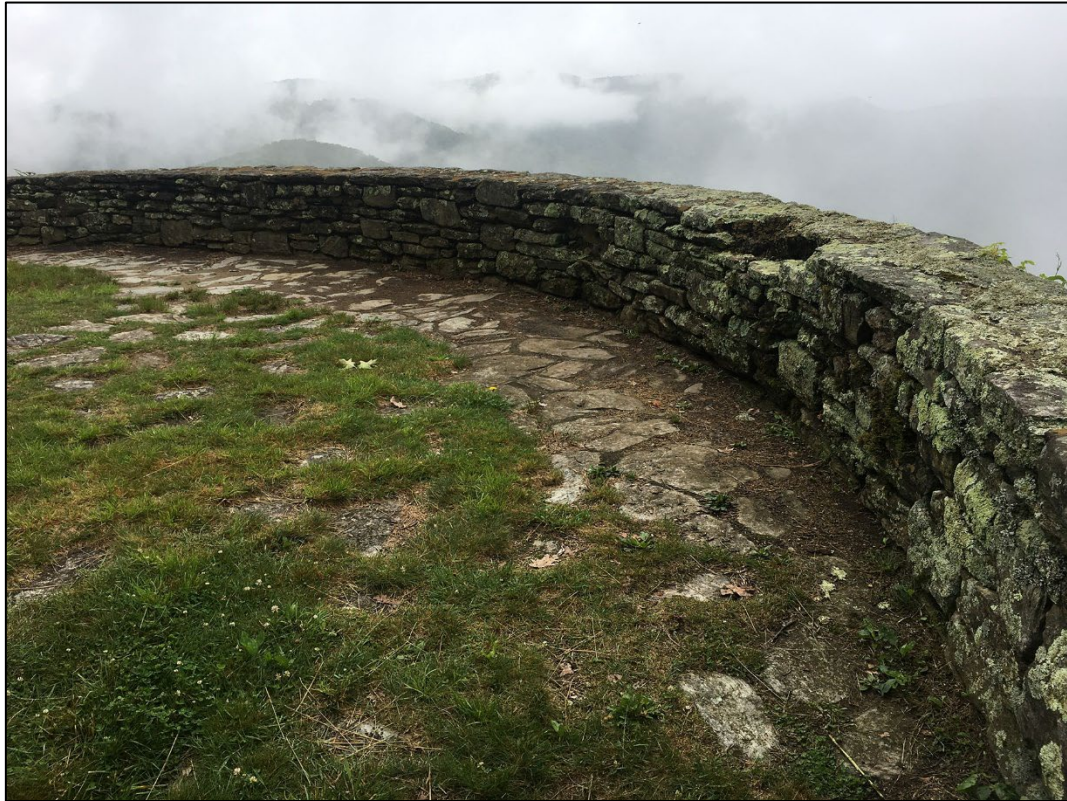
*Fig 8-27. Stone wall at Wildcat Rocks Overlook with view over Basin Creek watershed, facing south (2021)*

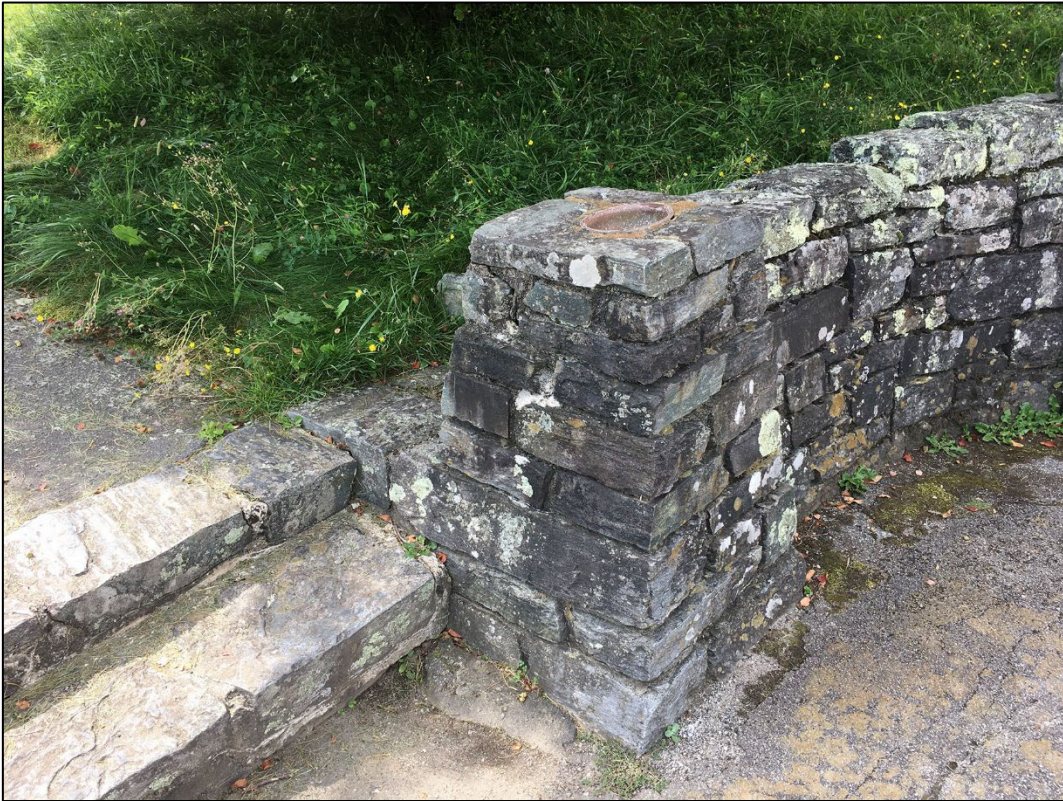
*Fig 8-30. Rustic-style stone drinking fountain incorporated into Robert L. Doughton Memorial wall (2021)*

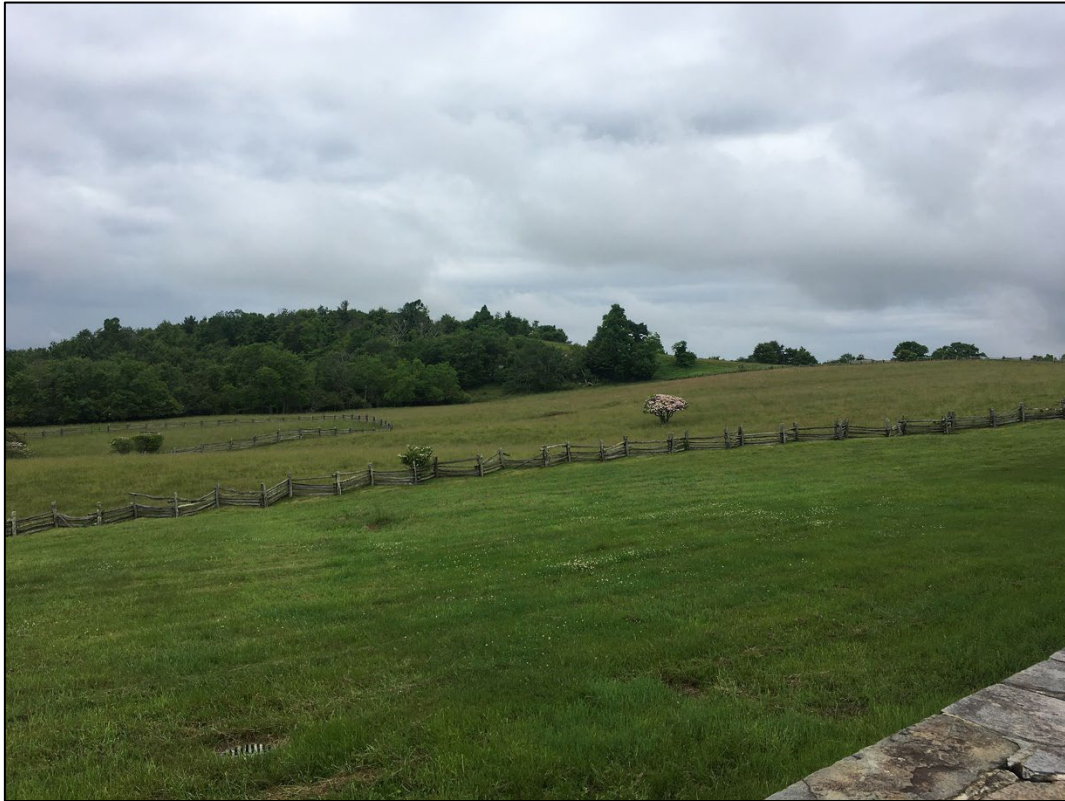
During the Resumption of Construction Era (1946-1955), NPS constructed additional small-scale features at the Bluffs Lodge site. Split rail fences surrounding the rolling pasture adjacent to the Lodge buildings were reconfigured to accommodate Lodge construction. These fences remain in good condition.

*Fig 8-32. Wood worm fencing south of Bluffs Lodge (2021)*
