# Blue Ridge Parkway

## *Cultural Landscape Report for Guardrails*

Final Report  
November 2003

THE  
JAEGER  
COMPANY

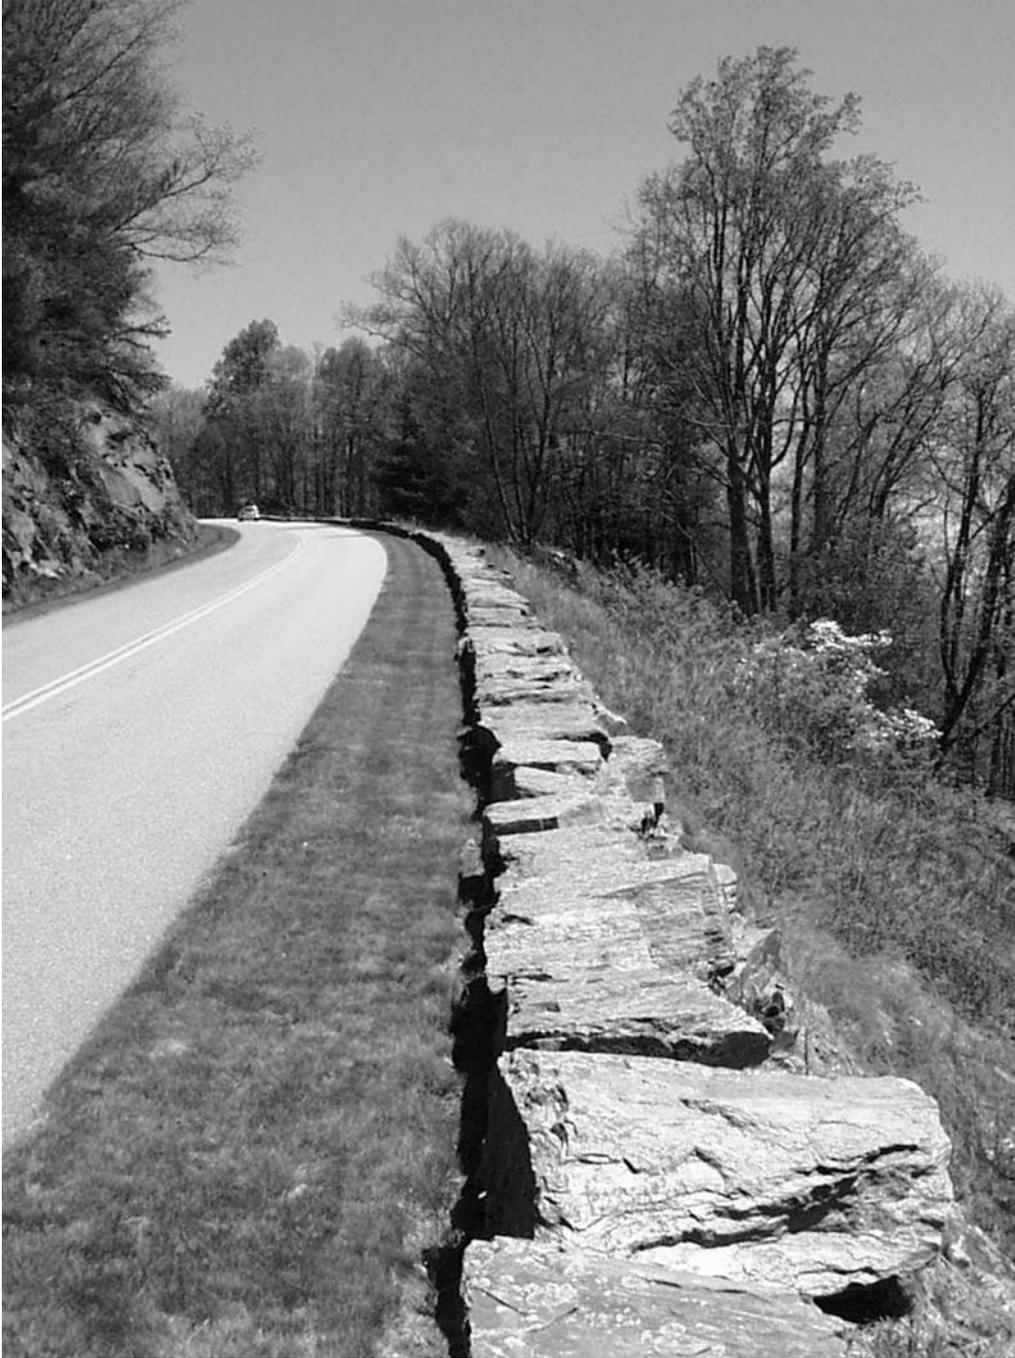
**Figure 1: Stone Guide Wall, National Park Service.**

Rustic dry-laid stone walls were the first safety devices implemented on the parkway to protect motorists from steep slopes. Guide walls were constructed of heavy fieldstone salvaged from dynamite blasts (for tunnel excavation and road construction). Later, granite from a local quarry at Grandfather Mountain (now closed) was used to construct many of the walls. The smoothest side of the stone was placed to face the roadway and the irregular side faced away from the road. Over the years, park maintenance staff has cemented some of the stones in place.<sup>31</sup>

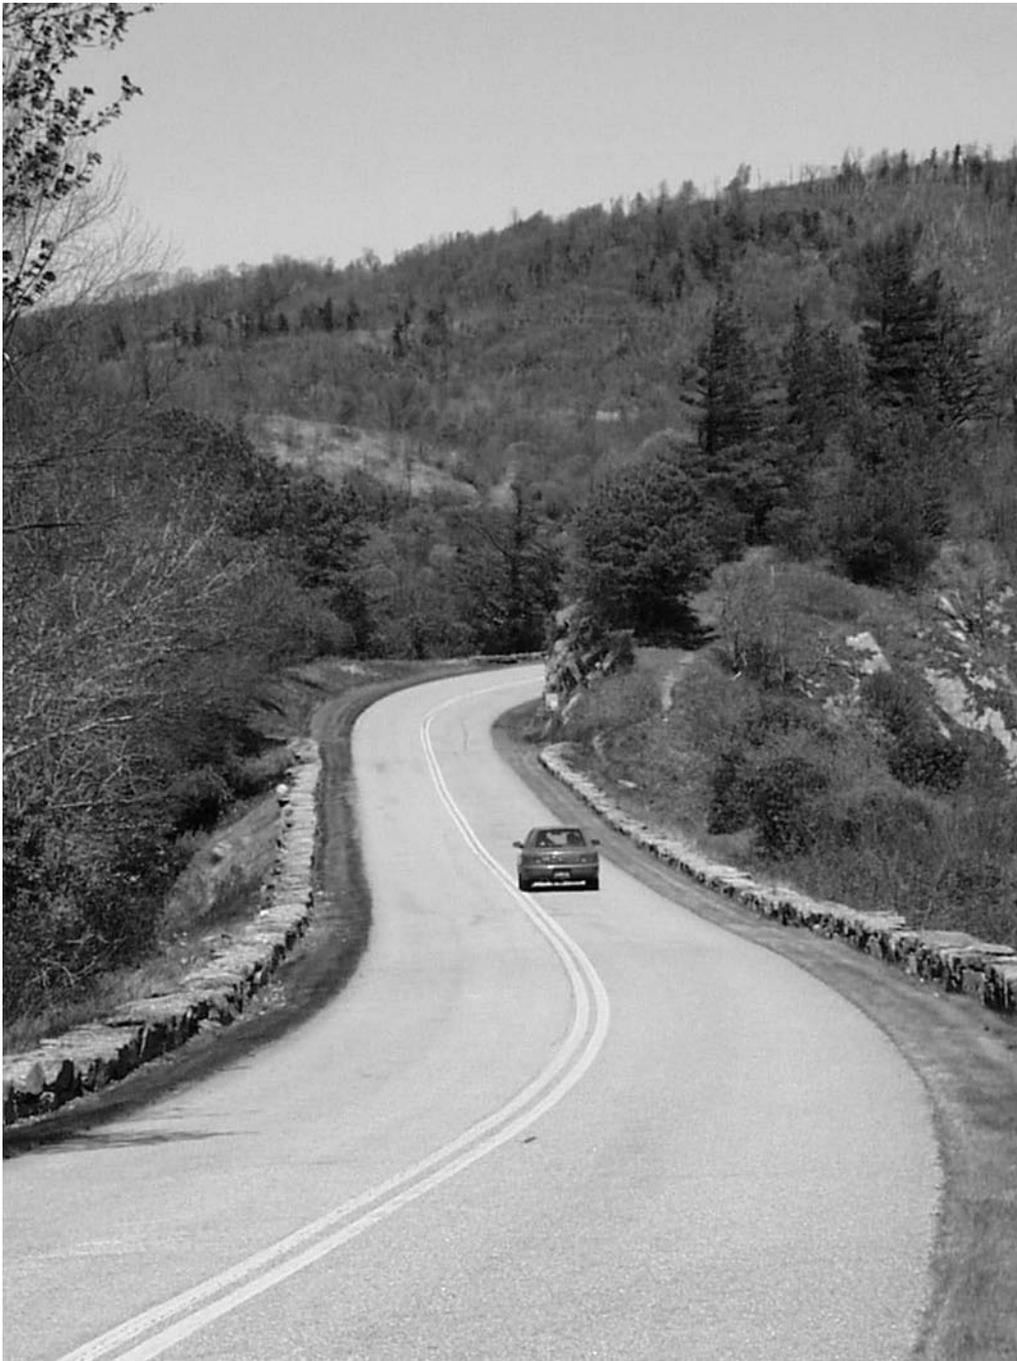
**Figure 2: Stone Guard Walls, National Park Service.**

Stone guard walls are often present at the ends of metal bridge rails and steel and concrete bridge constructions. Stone was also used in the wing walls, abutments and piers, helping to create a transition from engineered forms back into the rustic landscape.

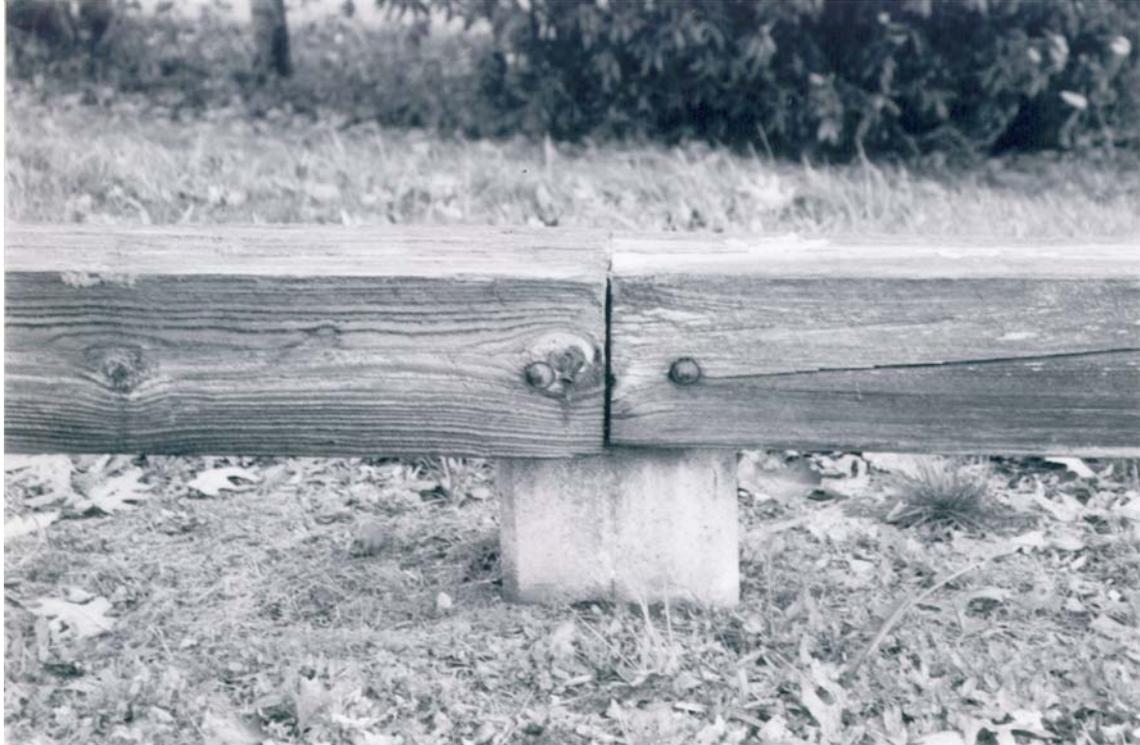
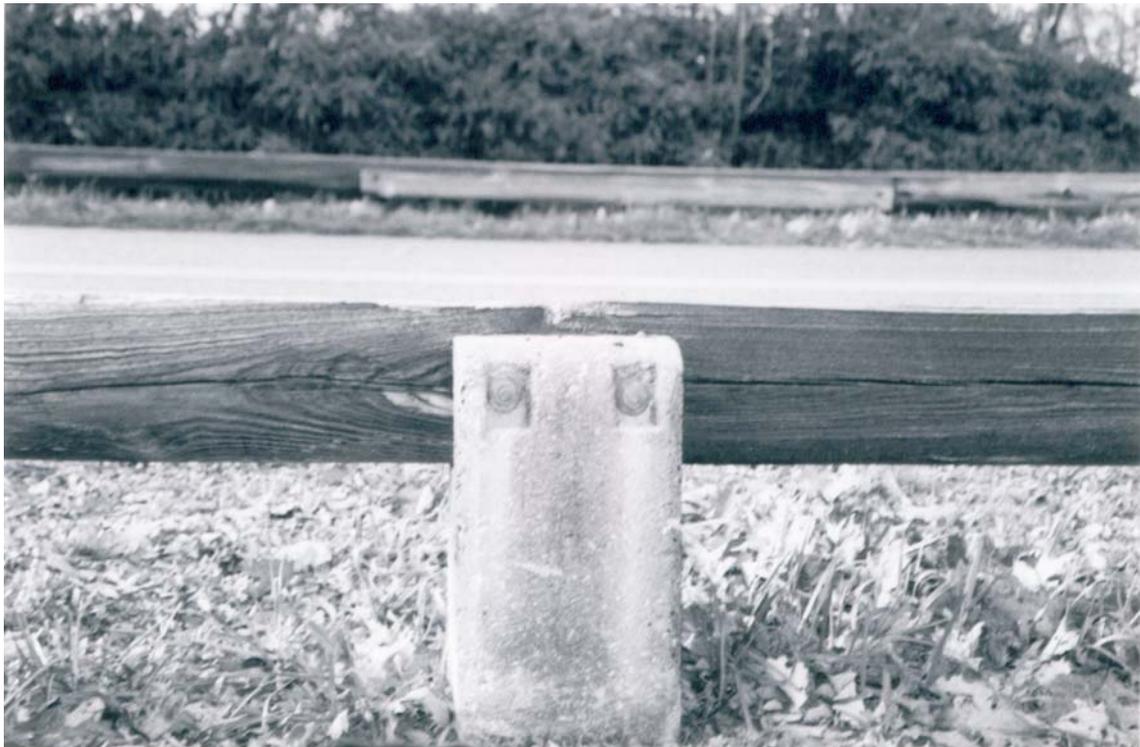
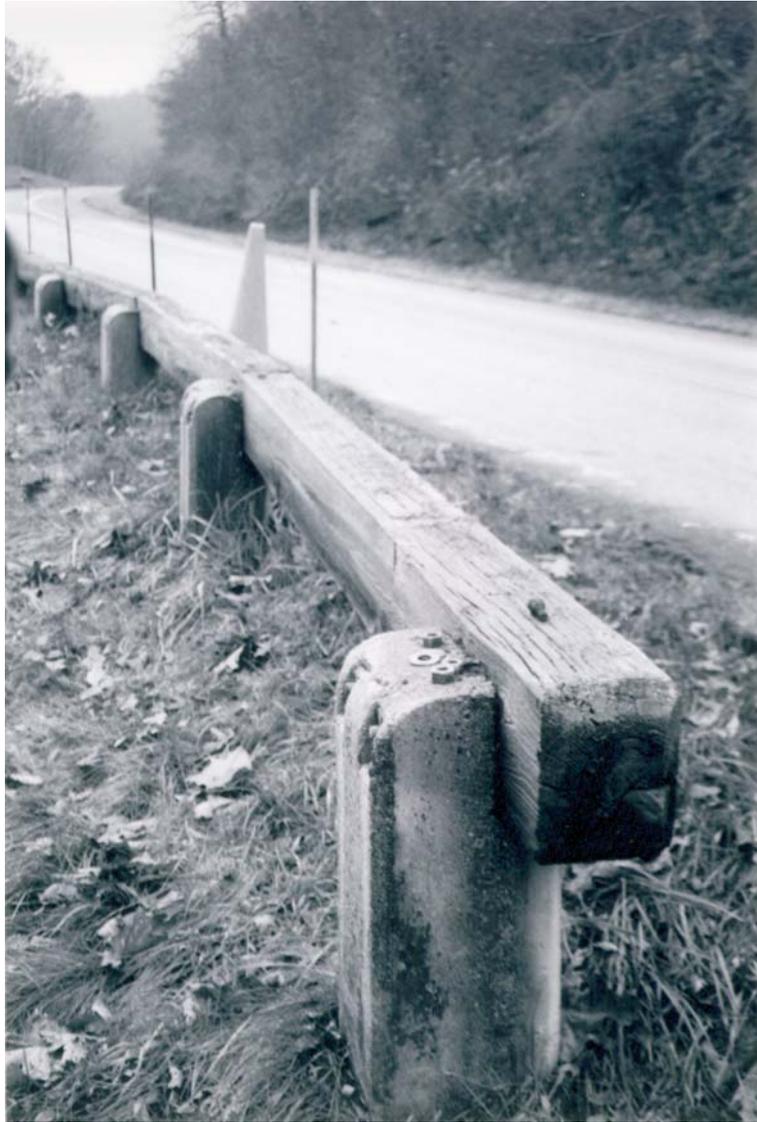
**Figure 5: Type One Guardrail, Front View.**

This type is the oldest guardrail found on the parkway (documented in construction drawings dated from 1953). The concrete posts are a standard grey reinforced concrete, with a rounded back and a notched front for supporting the timber rail. The average top of rail height is 20" above grade and is double bolted to the post. Typical placement for the posts and rails is 5'-0" offset parallel with the edge of road pavement. This type of guardrail is also found abutting stone parapet walls at bridge crossing points. Type One occurs in the southernmost portion of the study area only, beginning at milepost 411.9 and ending at milepost 435. This twenty-three mile long stretch comprises approximately twenty-two percent of the study area. Overall, these structures have withstood the test of time and are in relatively good shape. The Guardrail Inventory recommended roll down flared end extensions for most of the existing sections (*Figures 4-7*). However, during the May 2003 field survey, all Type One post and rails had been removed and were observed in large piles. Type Four guardrails had been installed in the exact locations where Type One had been removed.

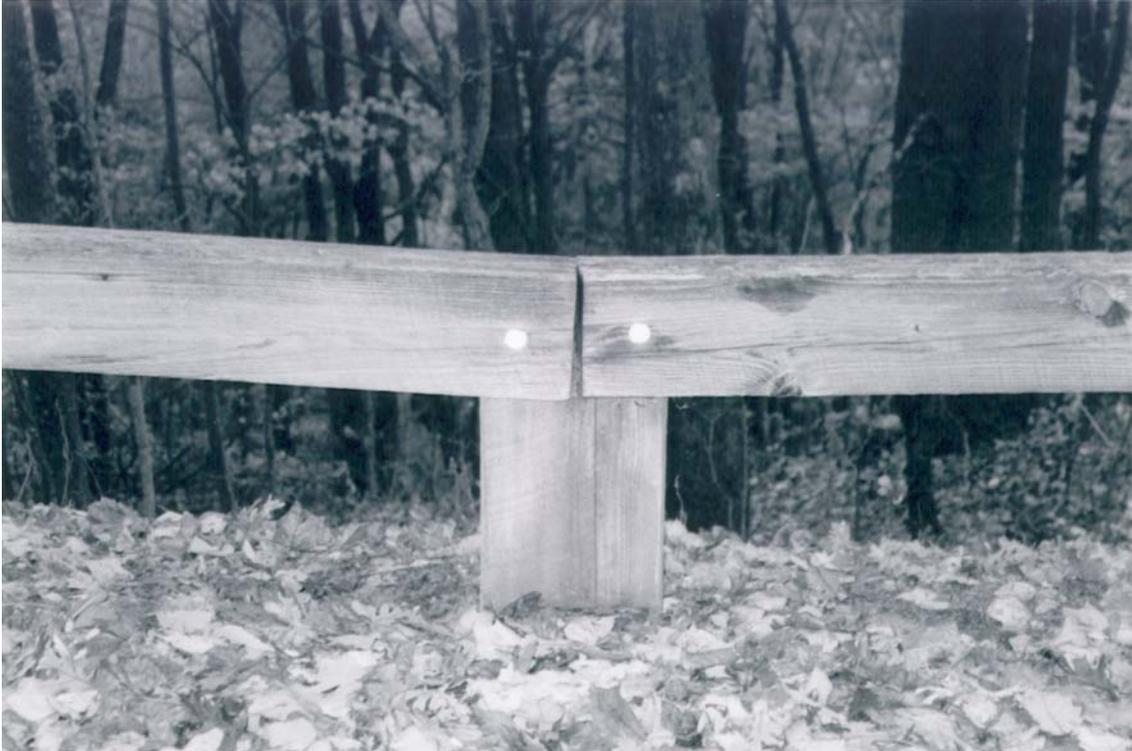
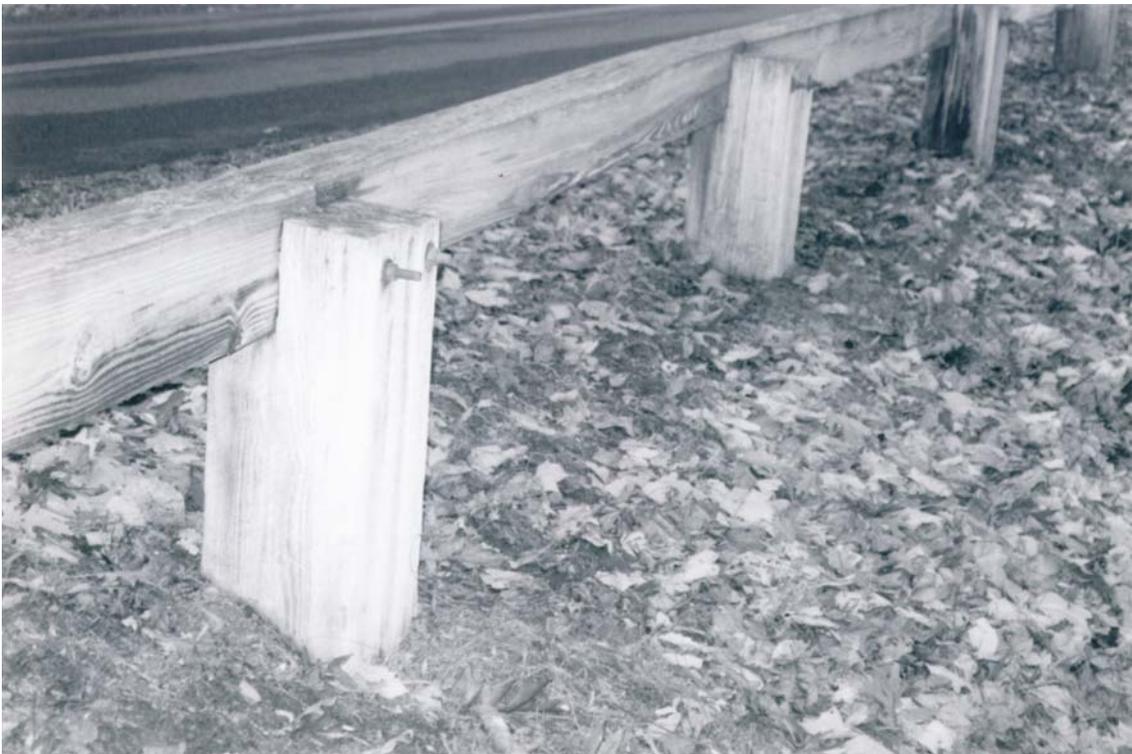
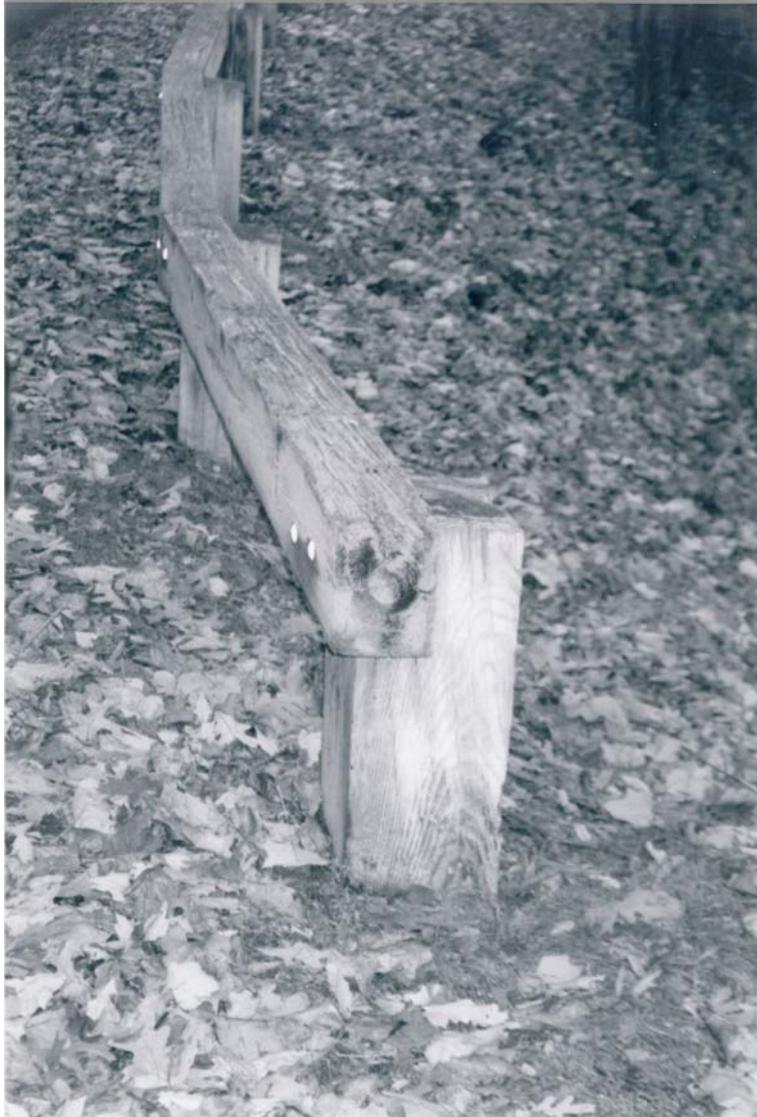
**Figure 8: Type Two Guardrail, Front View.**

to Craven Gap at milepost 375.1. This type has suffered the most damage of all the types, with many sections bent or broken from vehicle impact and general decline due to apparent underground instability. Like Type One, this type was designed to a standard height of 20" above grade, but has sunk substantially and in most places is considerably lower than that today. The Guardrail Inventory recommended the addition of roll down extensions for some of the ends of sections of this type that are still maintaining an adequate profile elevation, and that portions of or entire sections are to be removed completely (*Figures 8-10*). However, during the May 2003 field survey, Type Two post and rails were in the process of being removed and replaced with Type Four guardrails.

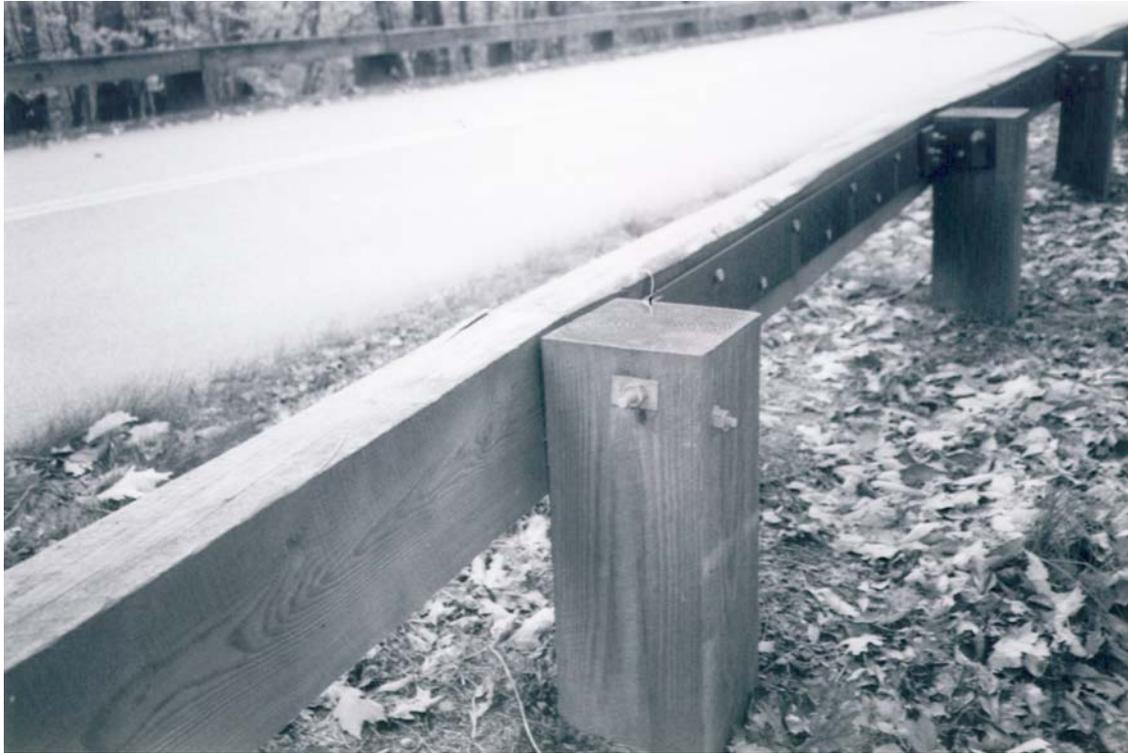
**Figure 13: Type Three Guardrail, Side View.**  
**Note: no steel backing on end sections in foreground.**

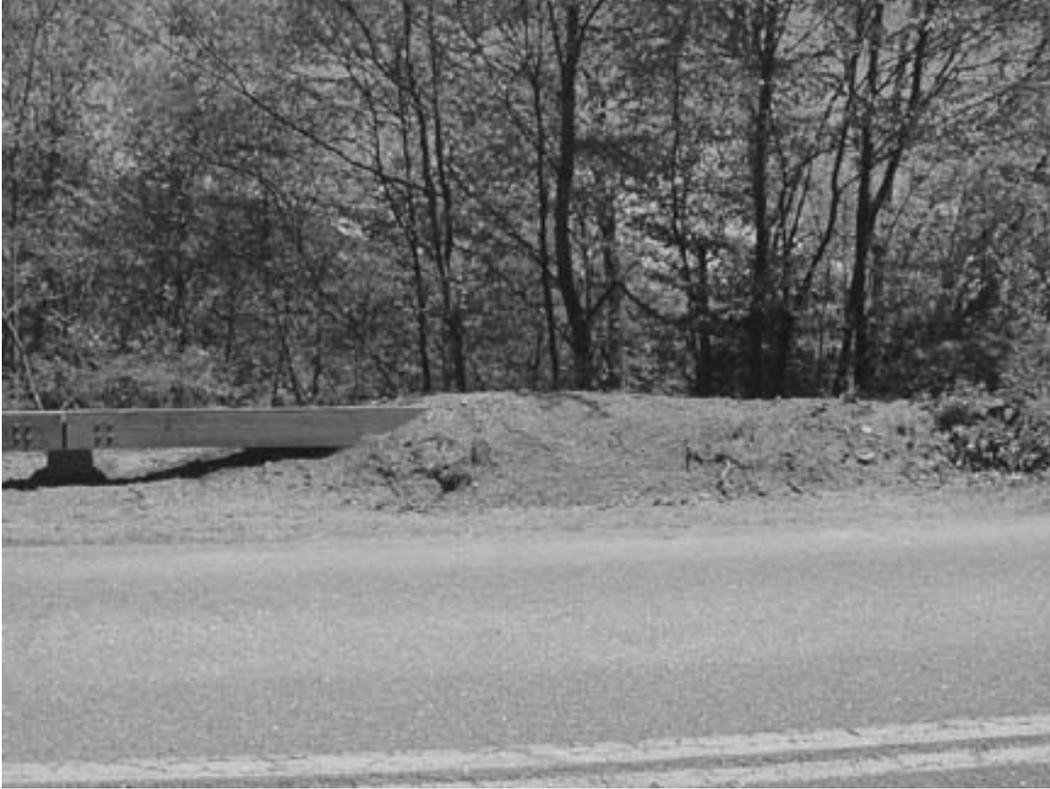
**Illustration 19: Type Four Guardrail with taper into new embankment.**

Recent Type Four installations involve earthwork to create mounds for terminal taper sections to transition back into the ground (*Figure 19*). Also observed during the May 2003 field survey is a new six-bolt timber post and rail connection adjacent to bridge abutments (*Figure 20*).

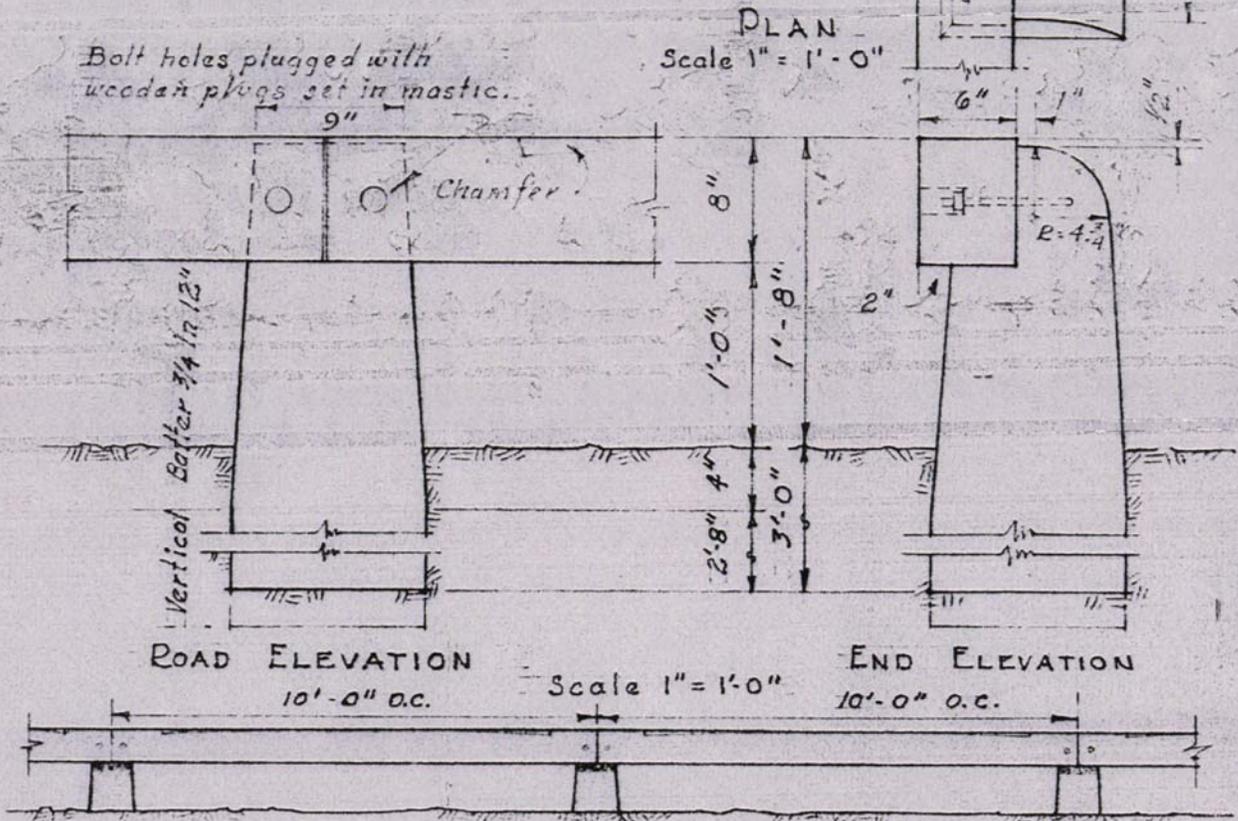
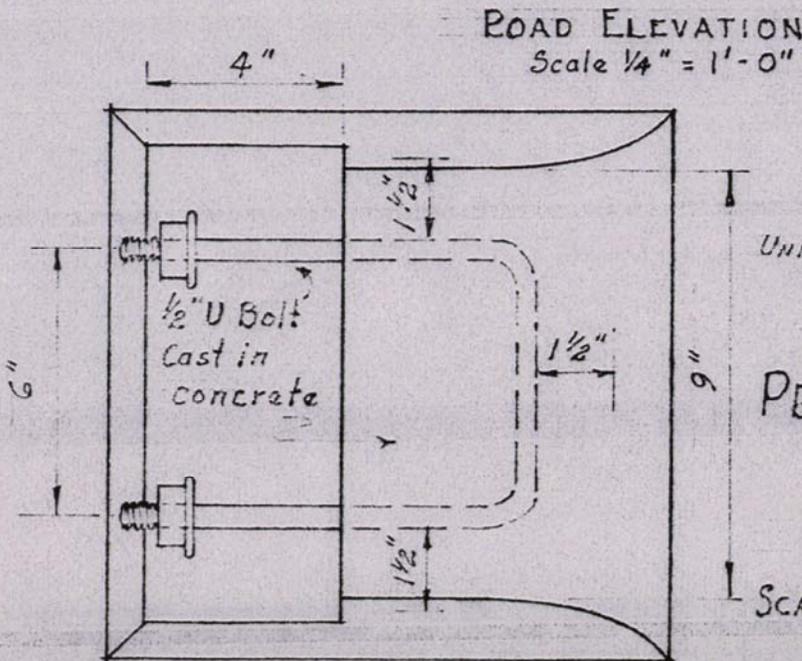
Illustration 3: 1938 NPS Drawing of Proposed Guardrail Construction

Precast concrete posts to have the anchor U bolts cast in the post. Lamp block to be mixed in concrete to color the post gray. The 6x8 wood rail (Shortleaf Pine) stained gray. Post to be reinforced with  $\frac{1}{2}$ "  $\phi$  in corners.

Bolt holes plugged with wooden plugs set in mastic.

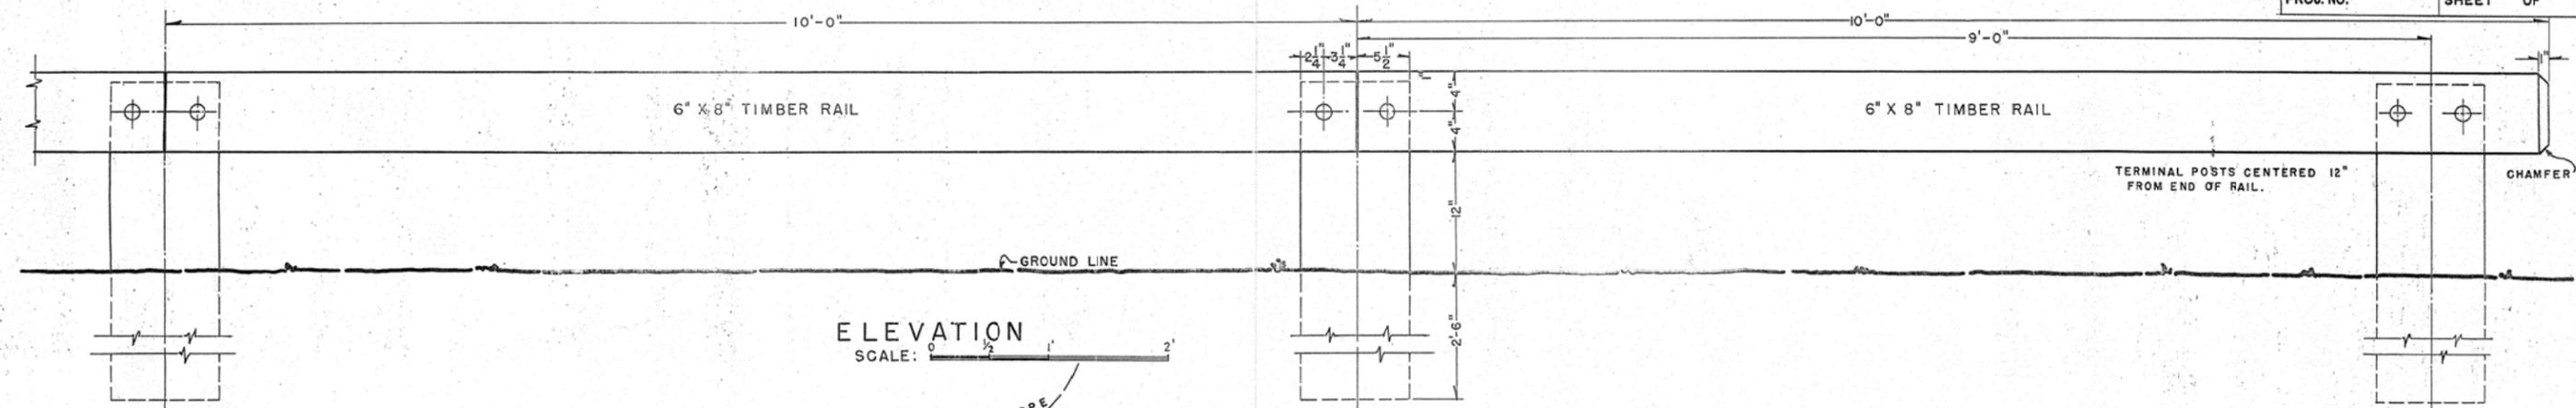
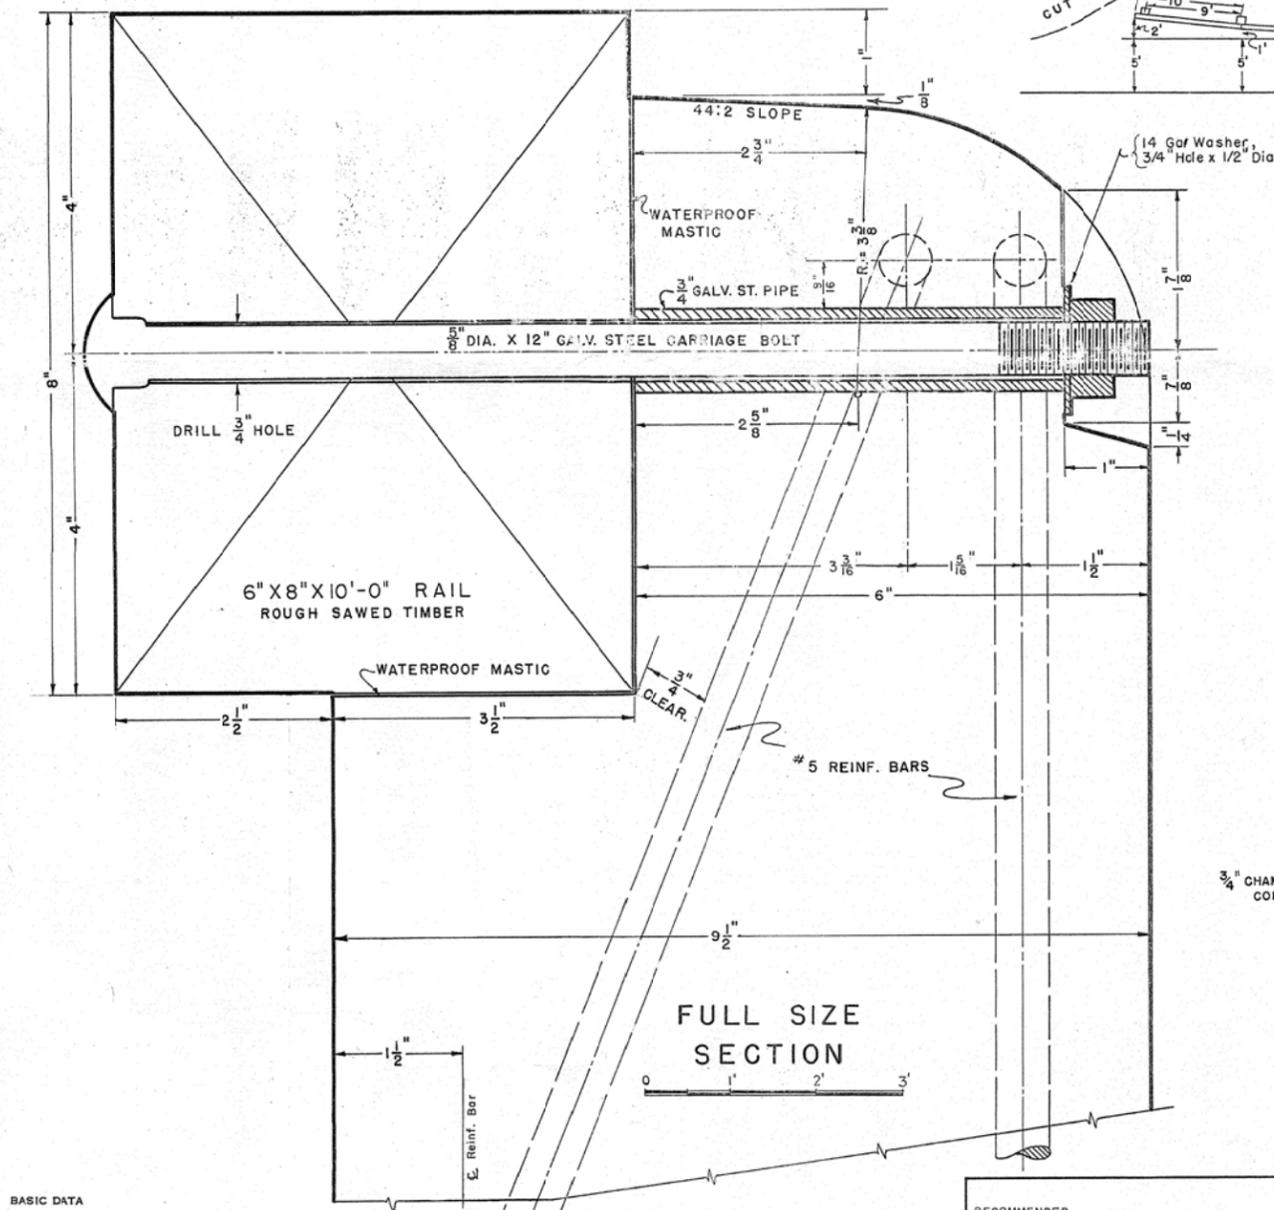
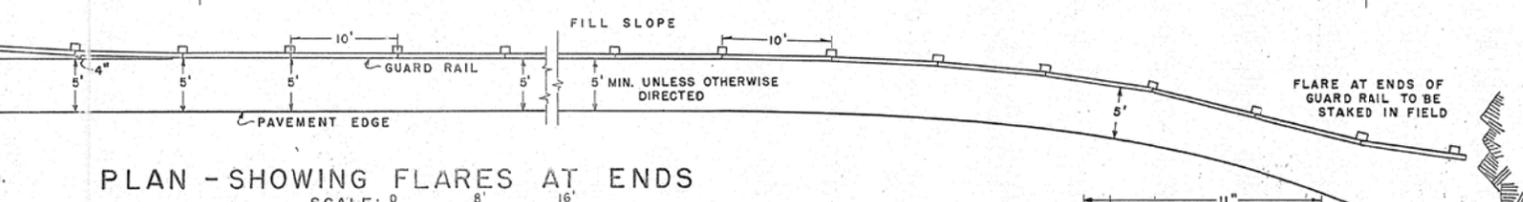
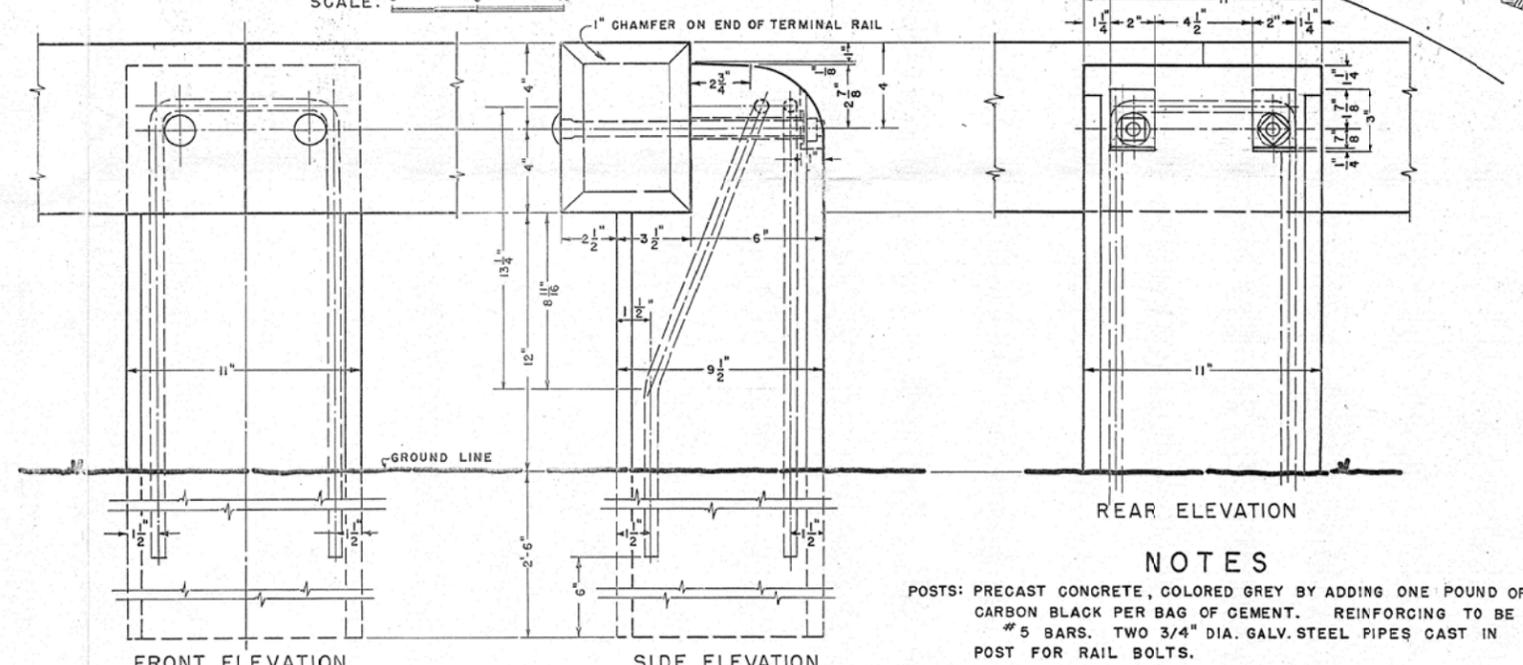
Illustration 4: 1953 NPS Drawing of Type One Guardrail.

Signed construction drawings, (dated November 1953), document the Type One guardrail design that was observed in the field at the beginning of this study. Similar to the 1938 drawing, the concrete posts have rounded backs and notched fronts to support "rough sawed timber" rails, which are double bolted to the post. Unlike the earlier u-bolt connection, this drawing shows a rail to post connection detail with a bolt penetrating through the entire thickness of the post and the rail. The posts appear to be a standard grey concrete and are straight-sided. Posts dimensions are 9.5" x 11" with an overall length of 49", leaving a 2'-6" footer below ground and the exposed post 19" above ground. The posts are spaced 10'-0" on center, except terminal posts which are centered 12" from the end of rail. The timber rails are pressure treated Southern Yellow Pine and measure 10'-0" long, with 1" chamfered ends. The top of rail elevation is dimensioned to a height of 20" above grade. In plan, post and rails are specified to be located 5'-0" out from the edge of pavement with a 20'-0" long flared terminus extending an additional 2'-0" out from the roadway for "cut slopes" and a note that appears to apply to all other conditions stating, "Flare at ends of guard rail to be staked in field." Approximately five years later, drawings (dated January 1958) illustrate an improved concrete reinforcement design for these same guardrail posts. This is how they appeared during the initial field survey. It is likely that since reinforced concrete components added to the cost and labor intensiveness for implementation, that this method for post construction was later abandoned with the use of wooden posts (*Illustrations 4-6*).

POSTS: PRECAST CONCRETE, COLORED GREY BY ADDING ONE POUND OF CARBON BLACK PER BAG OF CEMENT. REINFORCING TO BE #5 BARS. TWO 3/4" DIA. GALV. STEEL PIPES CAST IN POST FOR RAIL BOLTS.

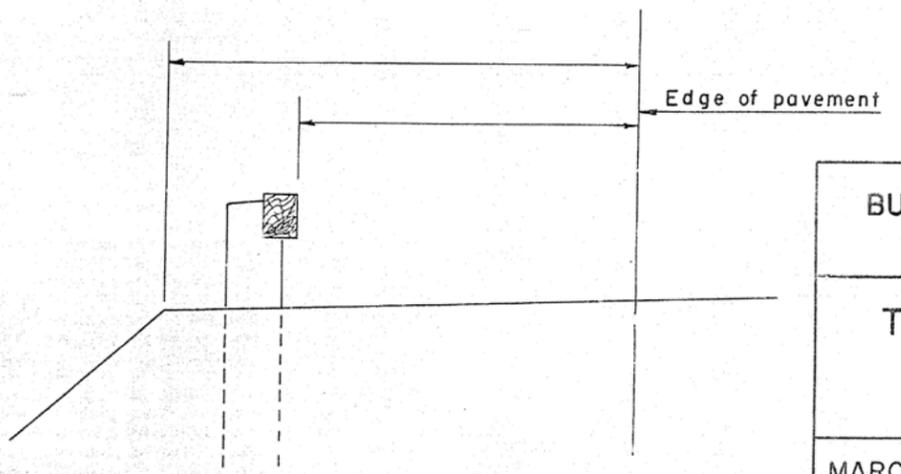
Illustration 7: 1965 NPS Drawing of Type Two Guardrail, Sheet 1 of 2

Type One, with a notched post and double bolted rail. Post spacing, flared ends, and 5'-0" setback distance from the edge of pavement are also the same. The major difference is a timber instead of a reinforced concrete post. Additionally, the absence of a concrete footer to anchor the post is apparently what has caused these guardrails to sink into the ground, making them considerably lower than the intended top of rail elevation of 20" above grade (as shown on plans). The lower height and lack of steel reinforcement make this type the least effective of all four types as a roadside barrier. These structures are not tall enough, nor strong enough to meet safety standards (*Illustrations 7-8*).

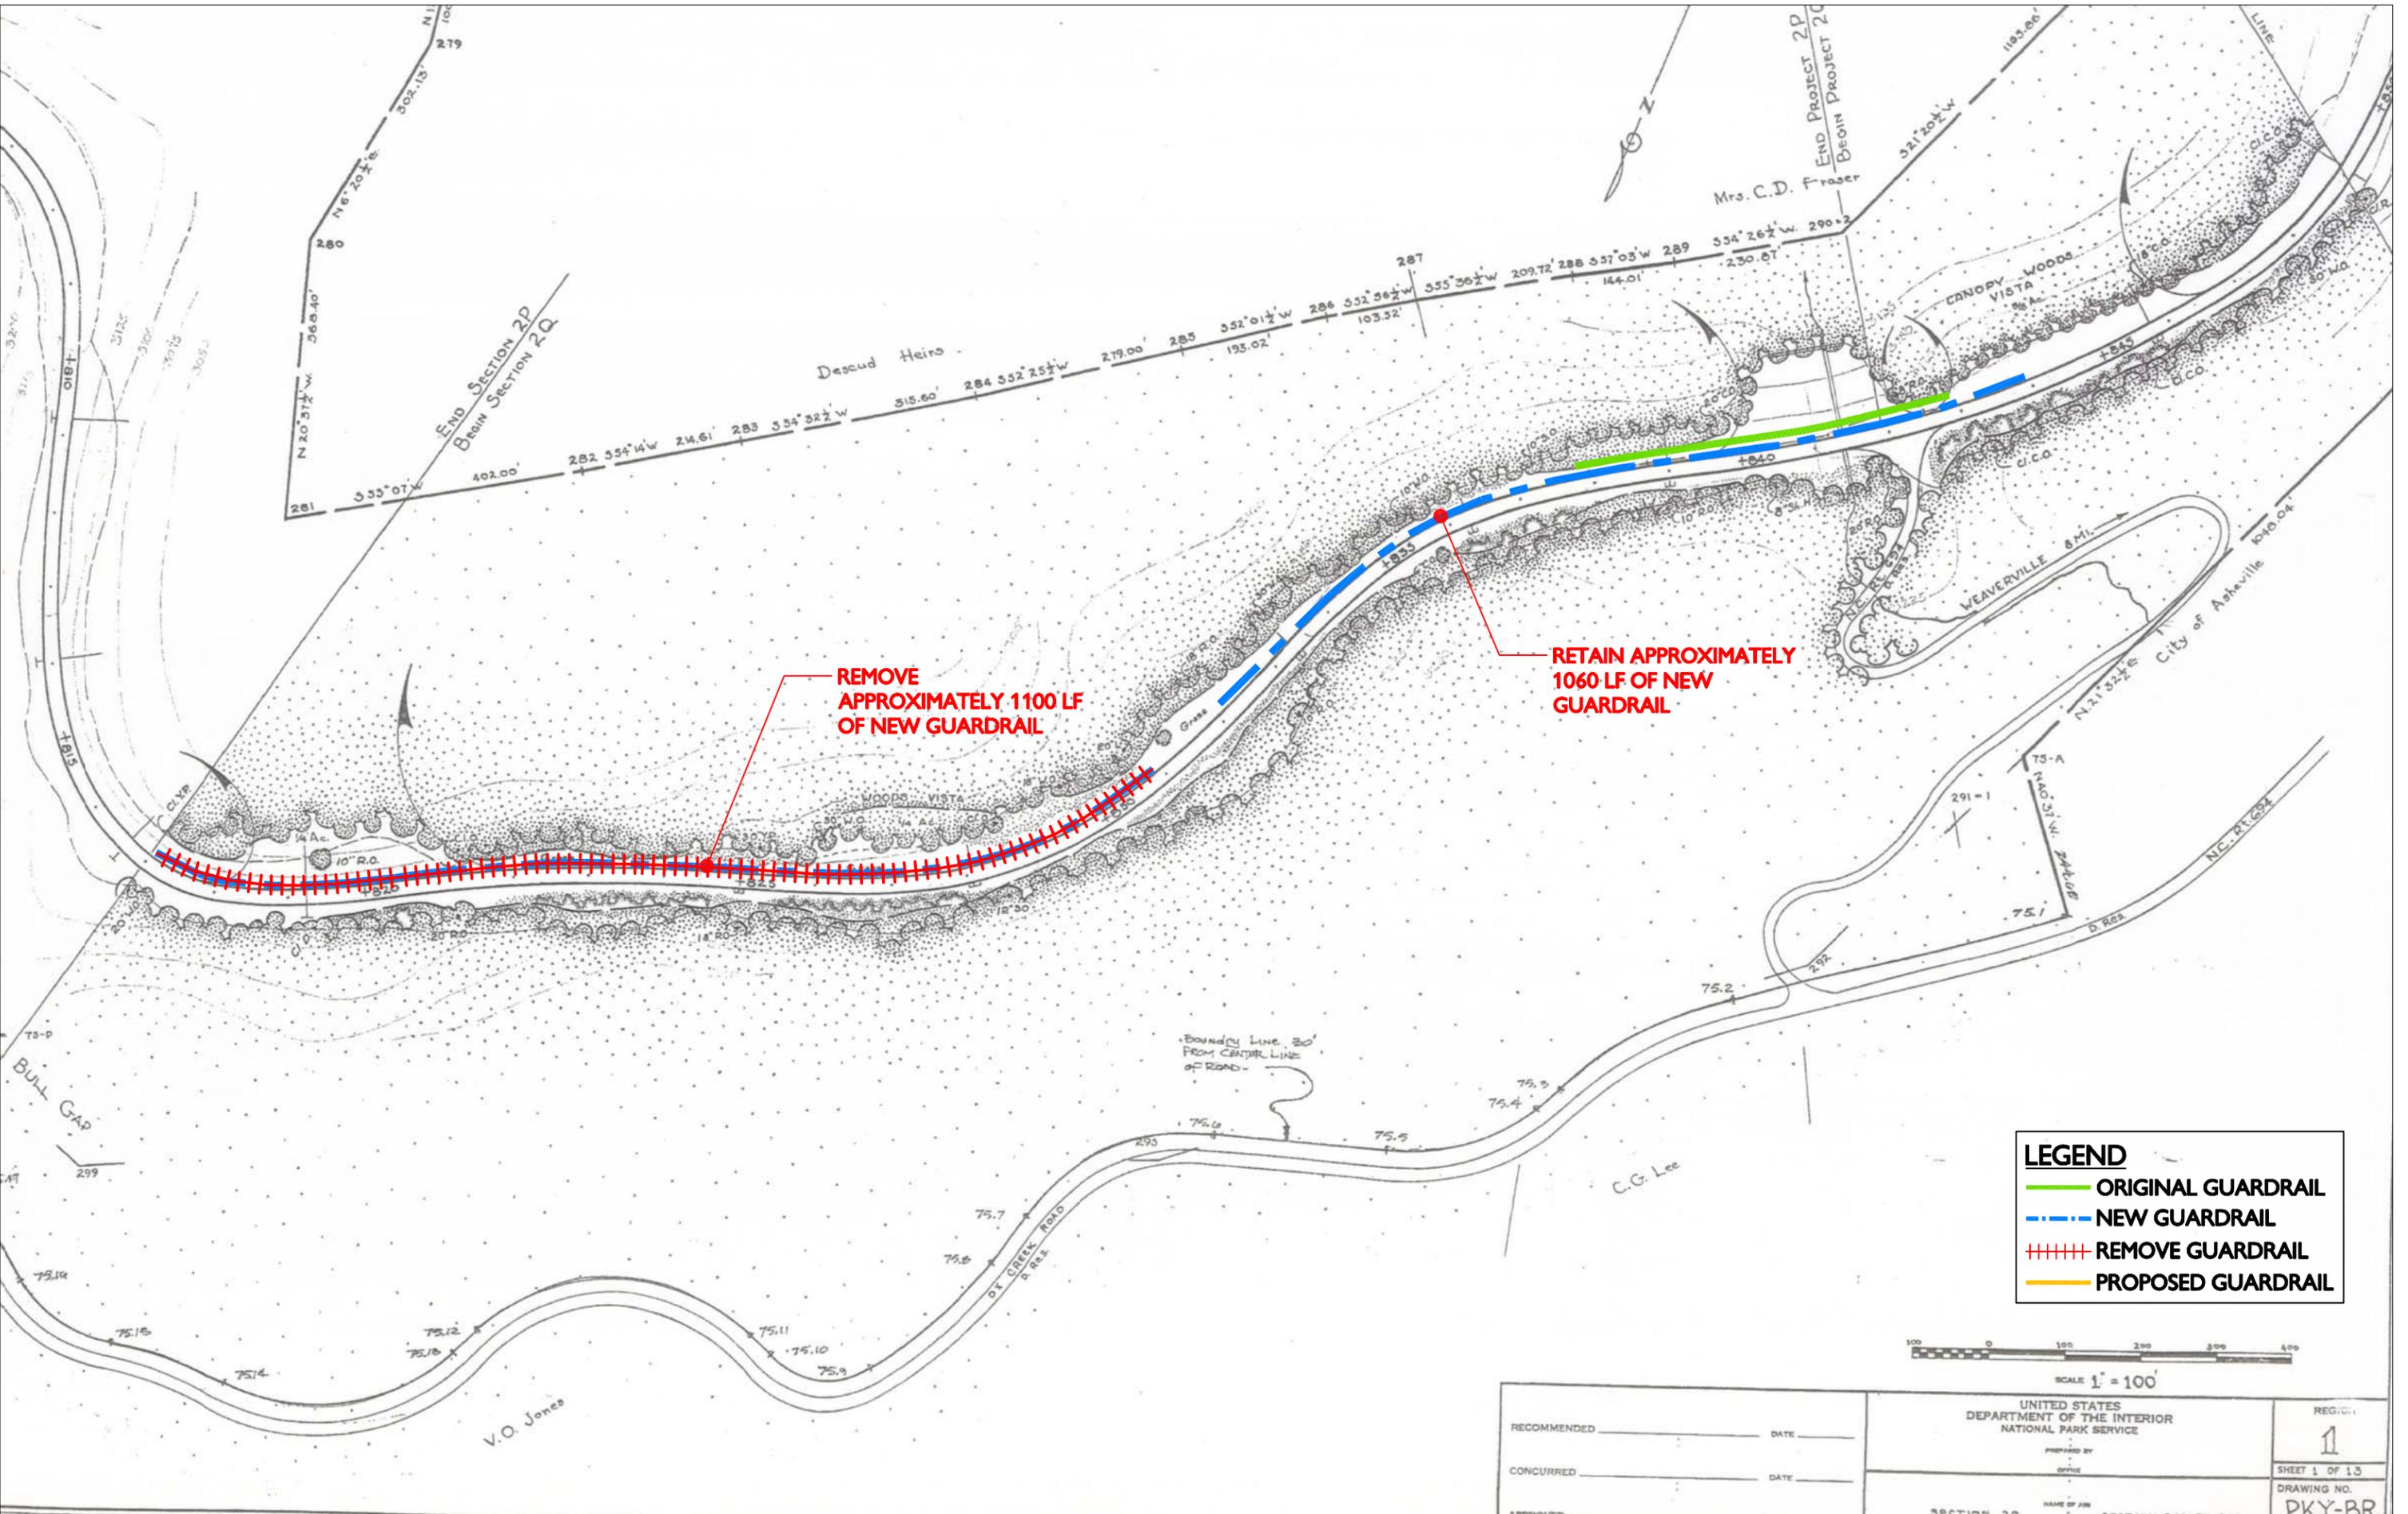
Illustration 15: NPS PLUM Map 2Q-1

REMOVE  
APPROXIMATELY 1100 LF  
OF NEW GUARDRAIL

RETAIN APPROXIMATELY  
1060 LF OF NEW  
GUARDRAIL
