# Blue Ridge Parkway

## *Cultural Landscape Report for Guardrails*

Final Report  
November 2003

THE  
JAEGER  
COMPANY

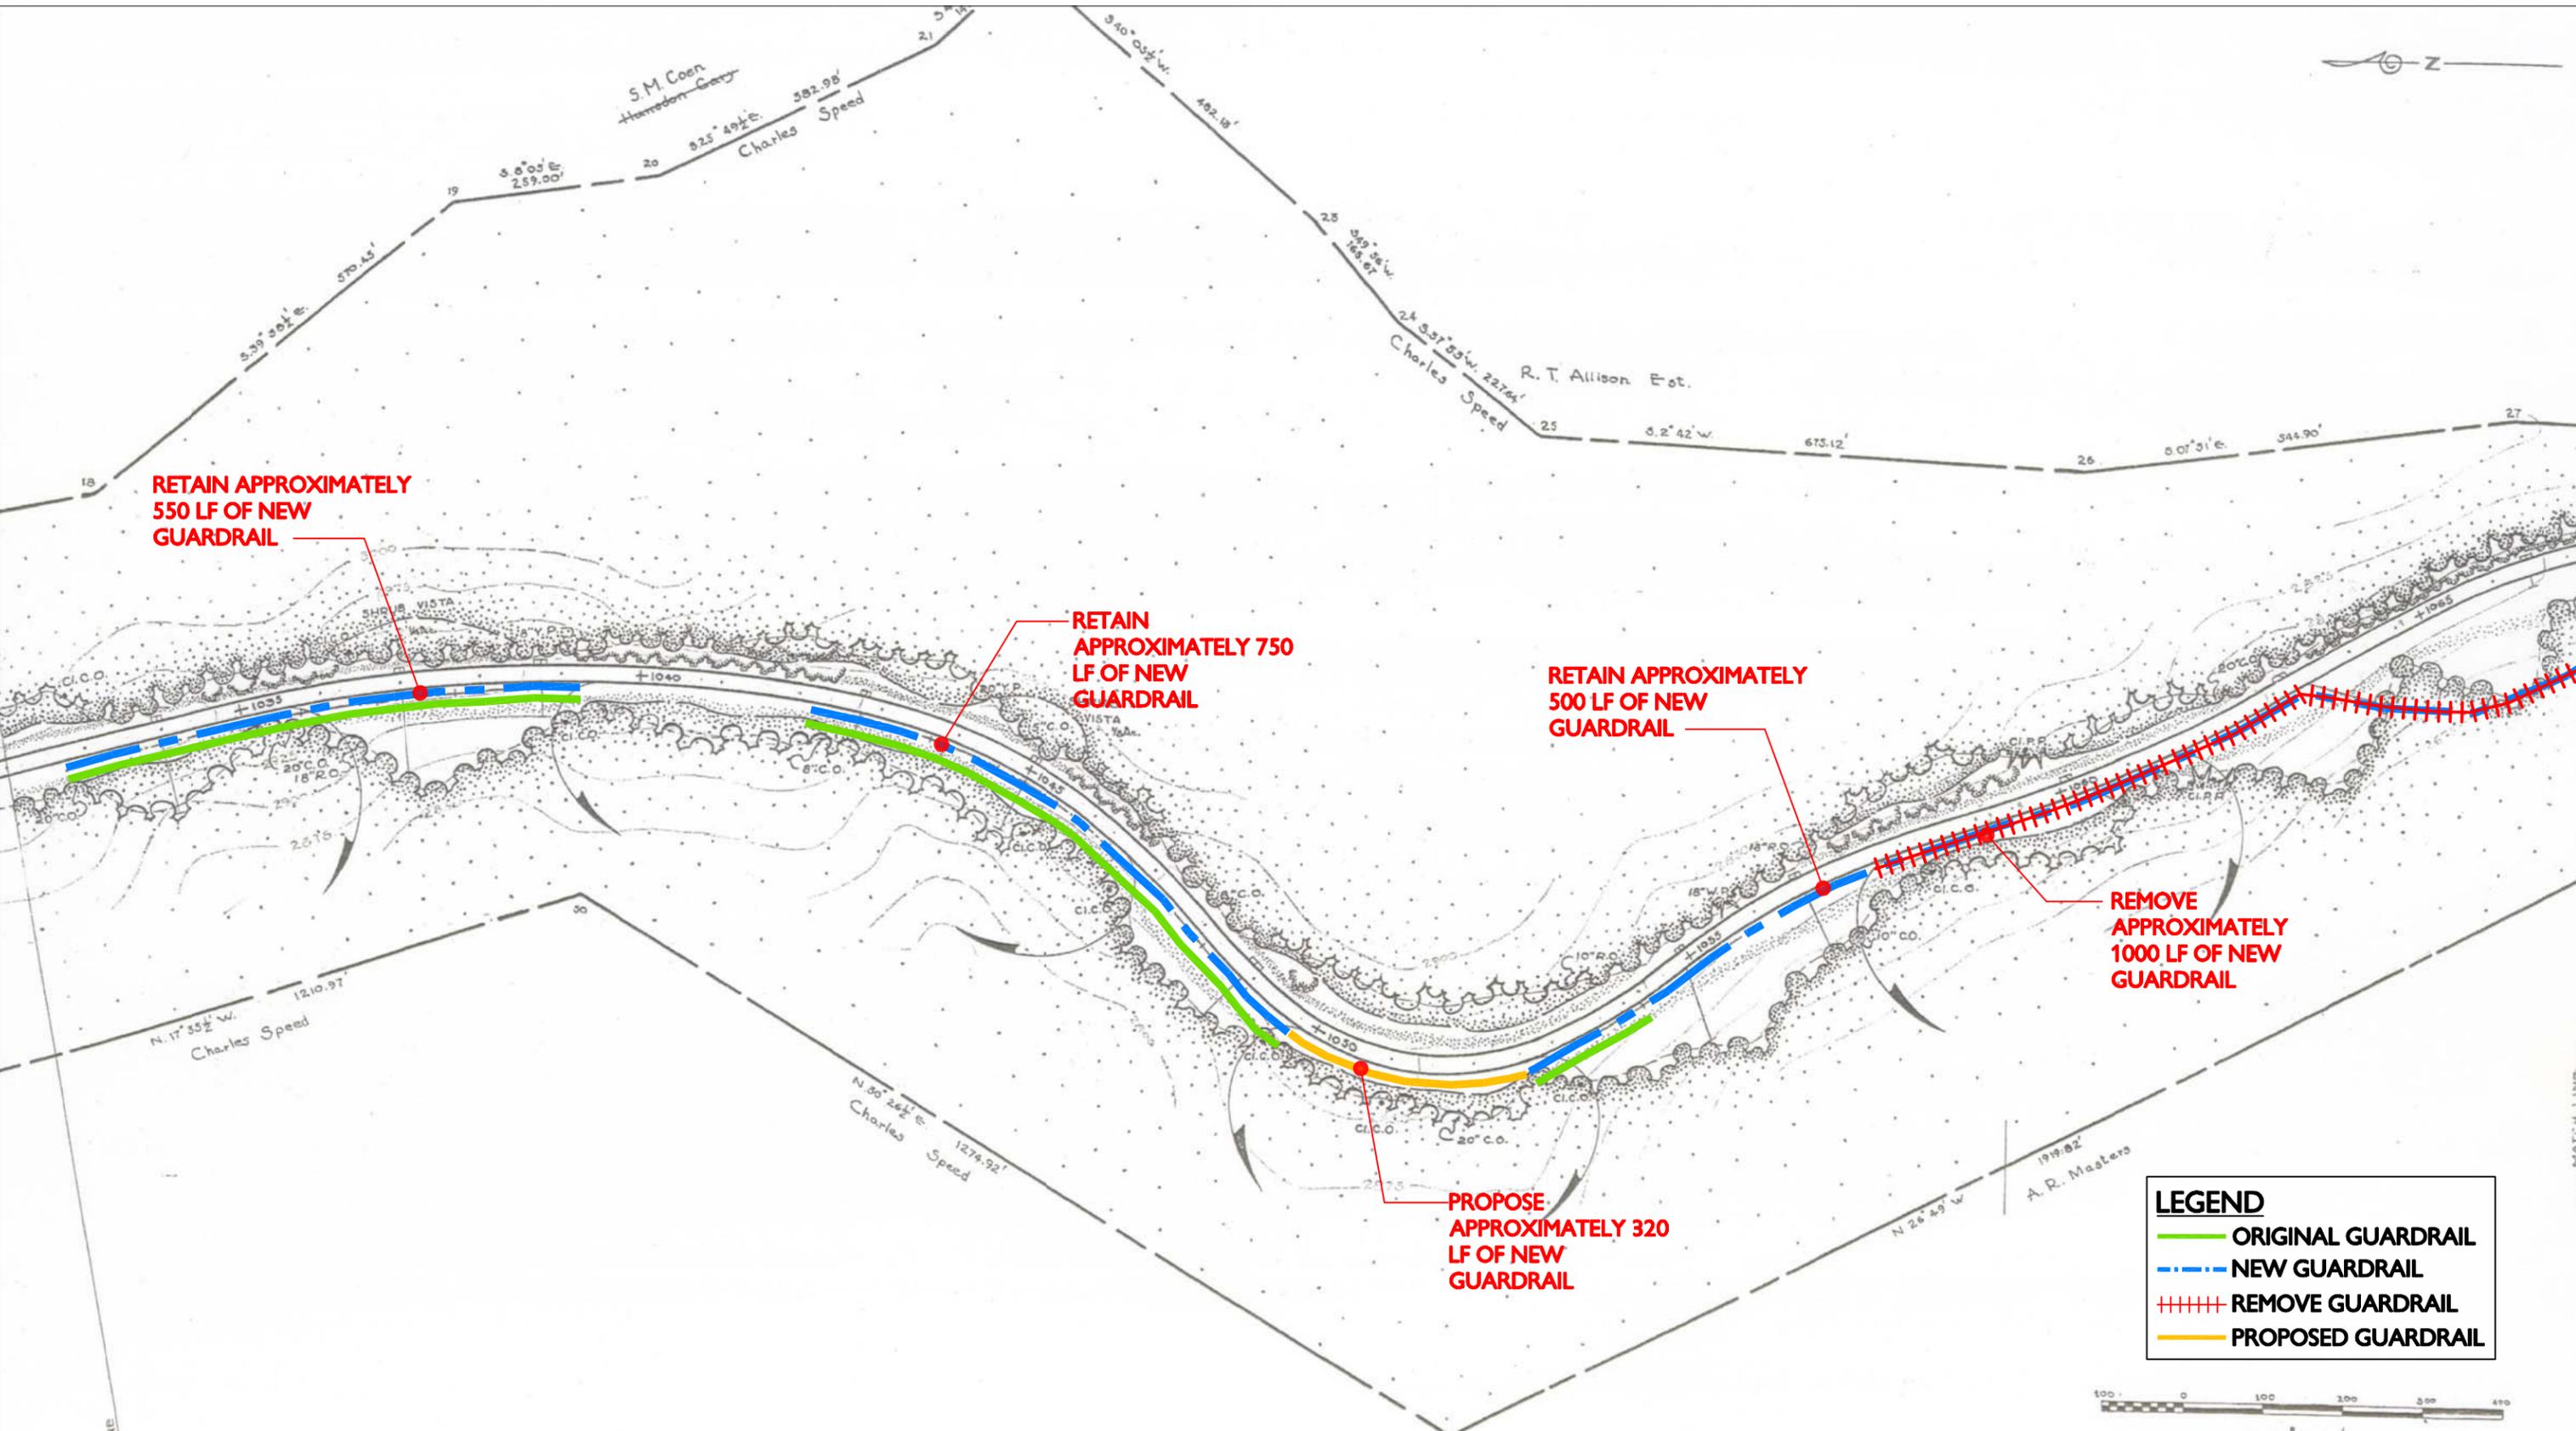
RETAIN APPROXIMATELY  
550 LF OF NEW  
GUARDRAIL

RETAIN APPROXIMATELY 750  
LF OF NEW  
GUARDRAIL

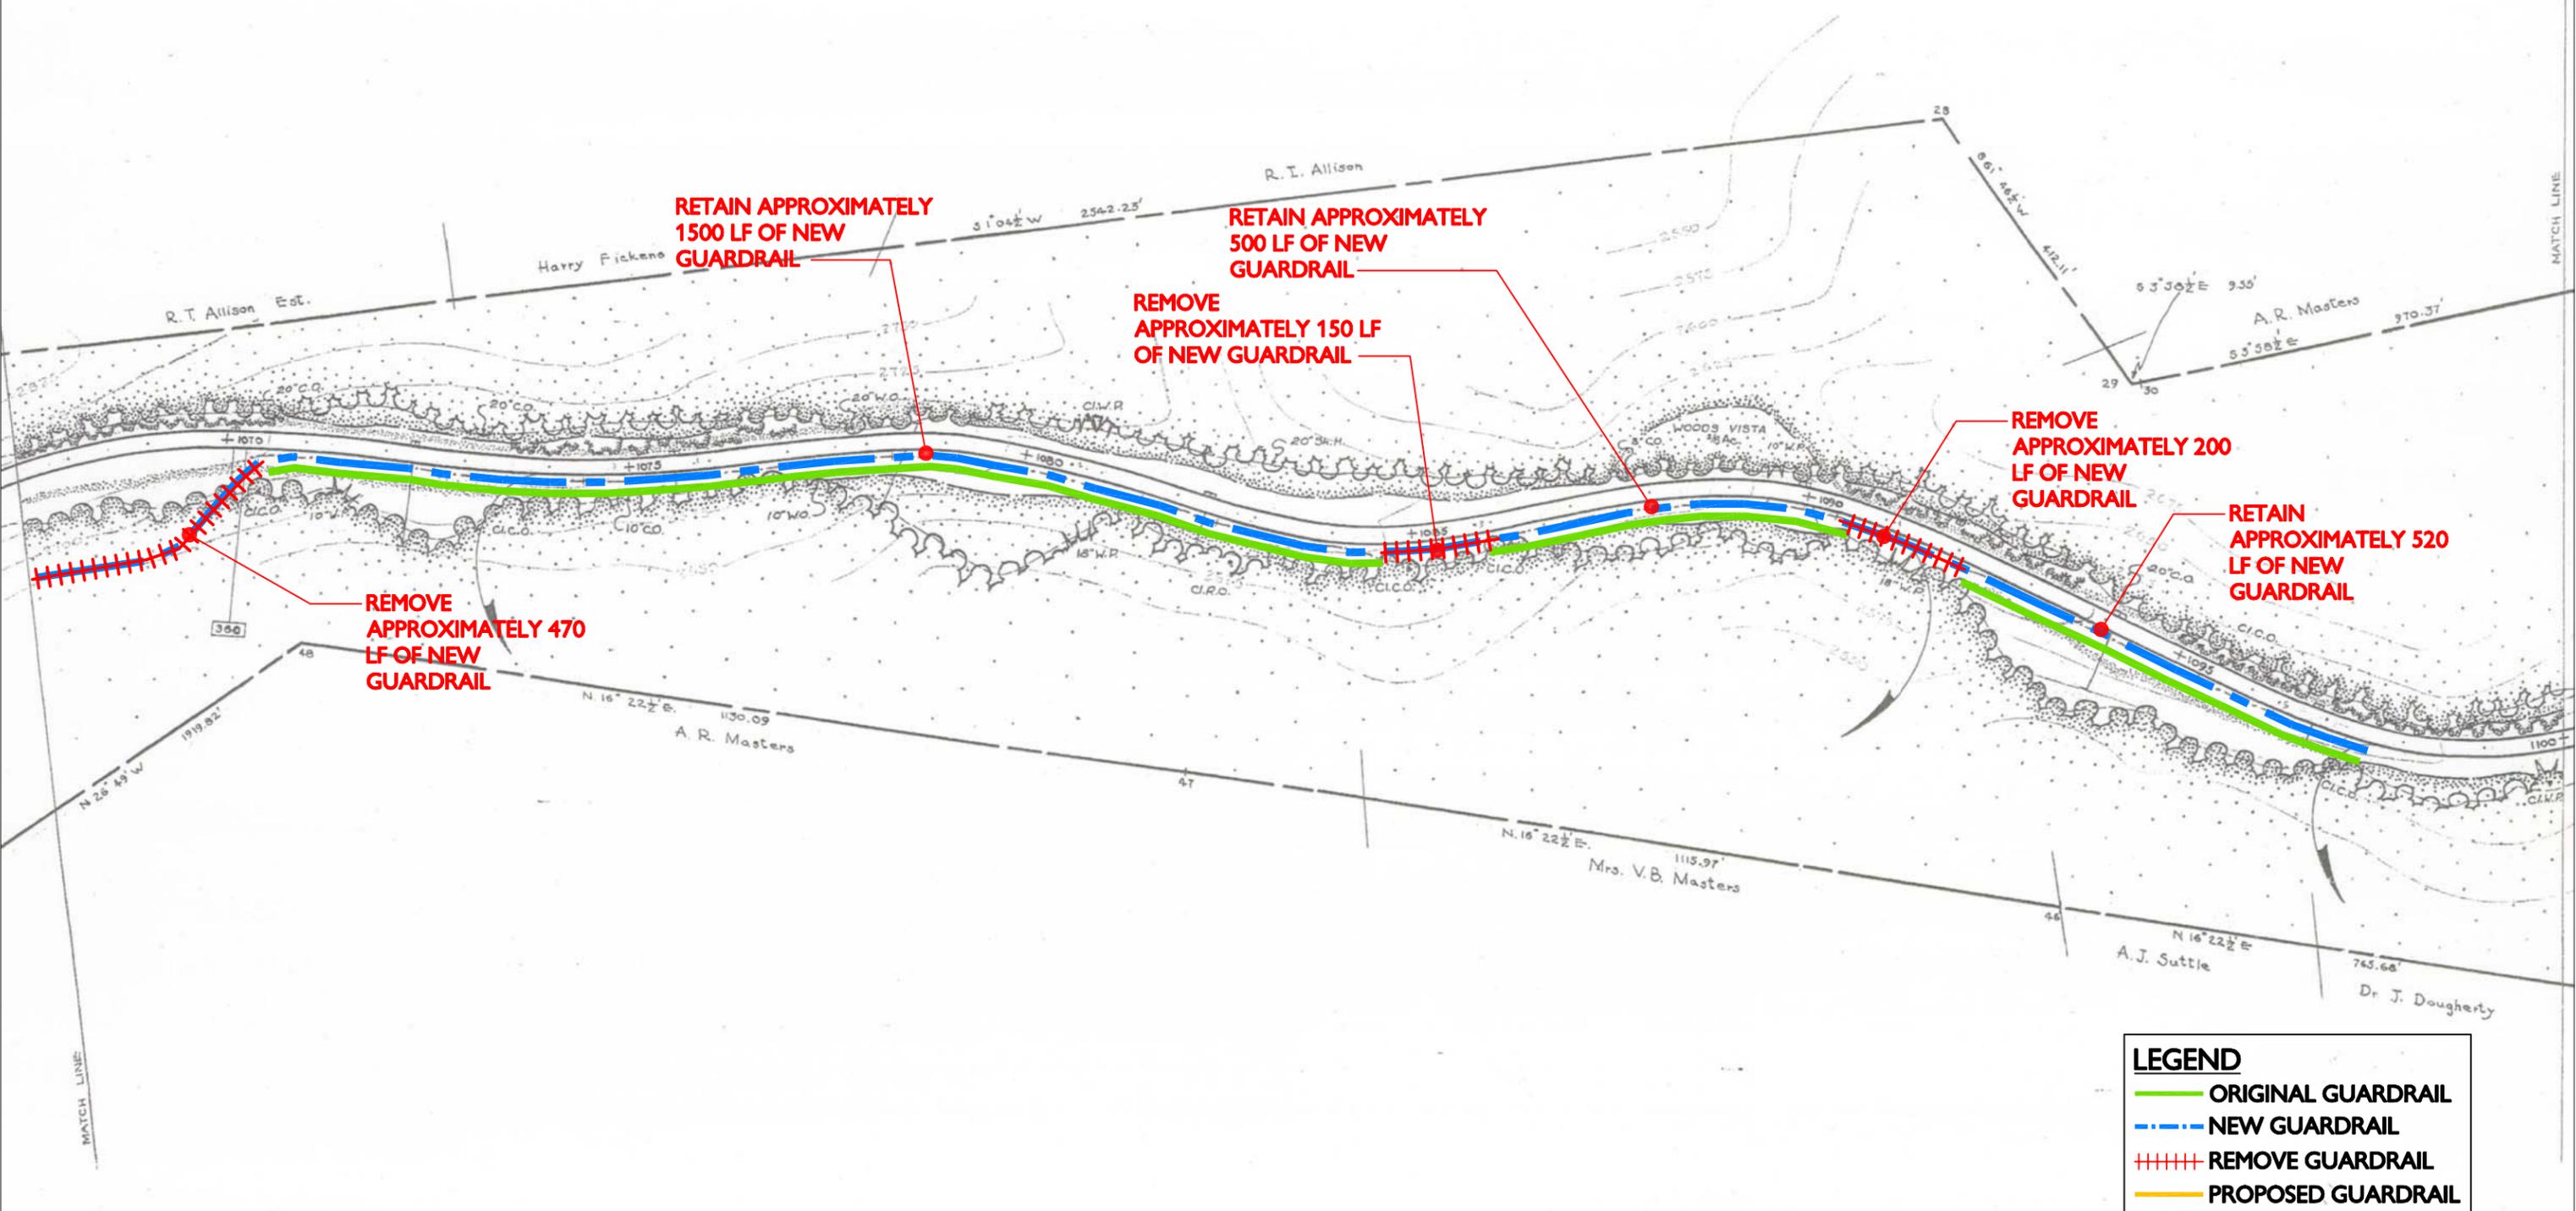
RETAIN APPROXIMATELY 1500 LF OF NEW GUARDRAIL

RETAIN APPROXIMATELY 500 LF OF NEW GUARDRAIL
