National Park Service
Cultural Landscapes Inventory
2010

Dorchester Heights National Historic Site
Boston NHP - Dorchester Heights

Site Plan

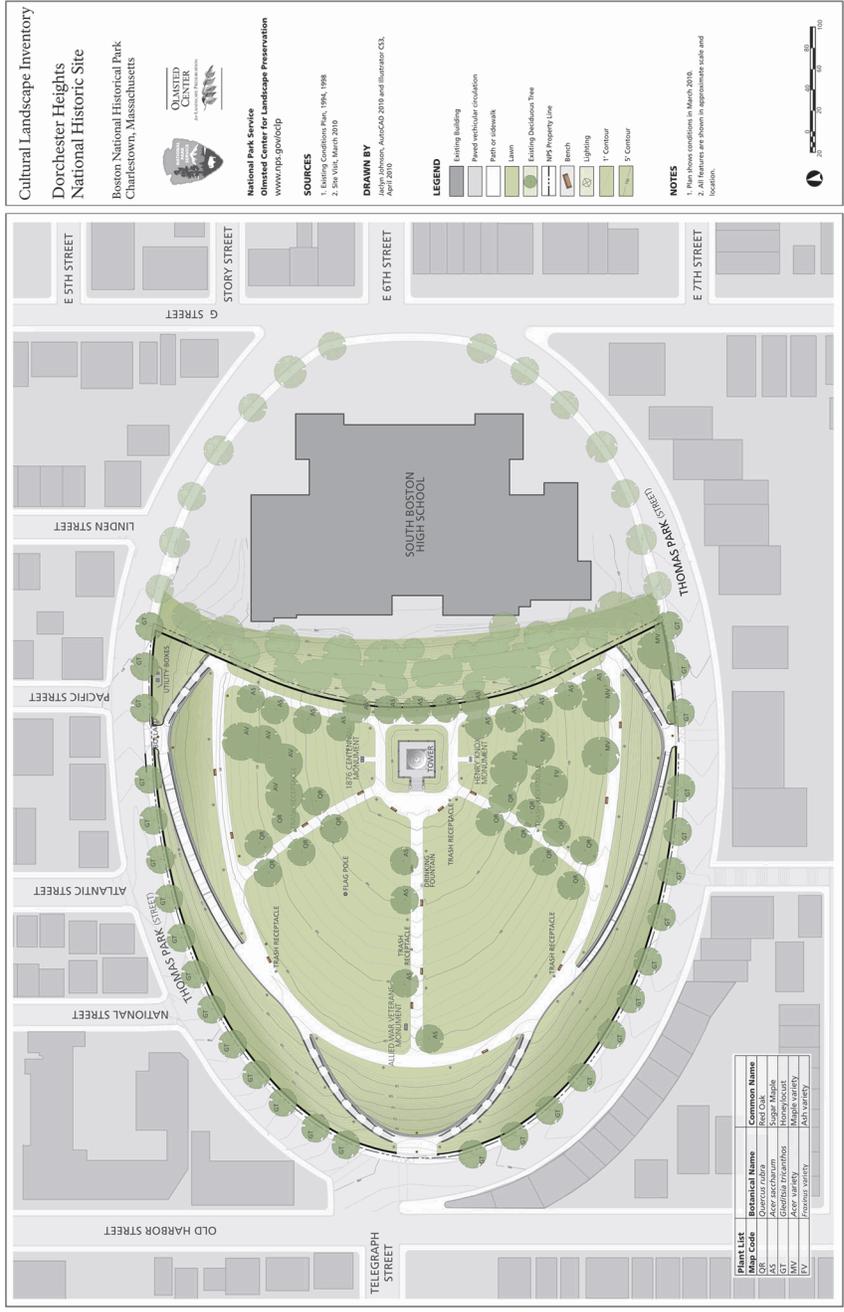
Site plan for Dorchester Heights National Historic Site (Olmsted Center for Landscape Preservation, 2010).

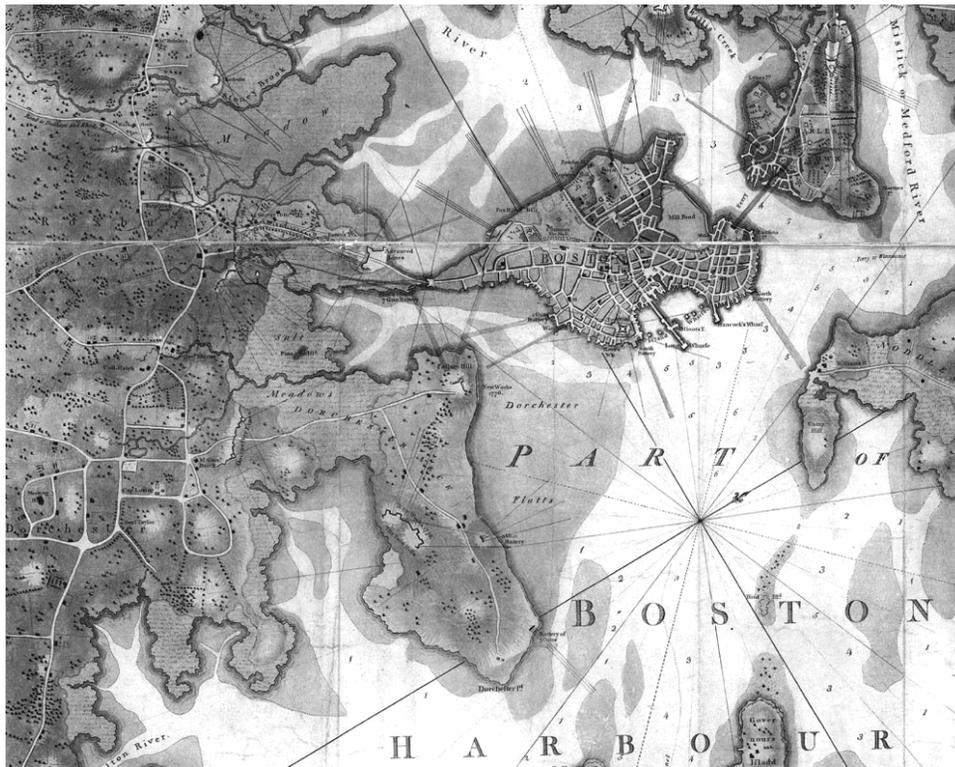
Figure 1. A 1777 Map of Boston drawn by Henry Pelham, which shows the Dorchester Heights fortifications and has them labeled as “New Works-1776.” The works are located on the Dorchester Peninsula, southwest of Boston (Library of Congress, Map Division).

One of the earliest maps to show the March 1776 fortifications on Dorchester Heights was “Plan of Boston” drawn by Henry Pelham, a Loyalist who published the map in England in 1777 (Figure 1). On the map, the fortifications appear as a solid line crowning the two hills of Dorchester featuring four rectangular, bastion-like projections, and are labeled as “New Works 1776. The Twin Hills.” The map is roughly consistent with a frontal, but distant, sketch showing a continuous line of fortifications along the northern mid-slope of Dorchester Heights (ARCH 1998:20).

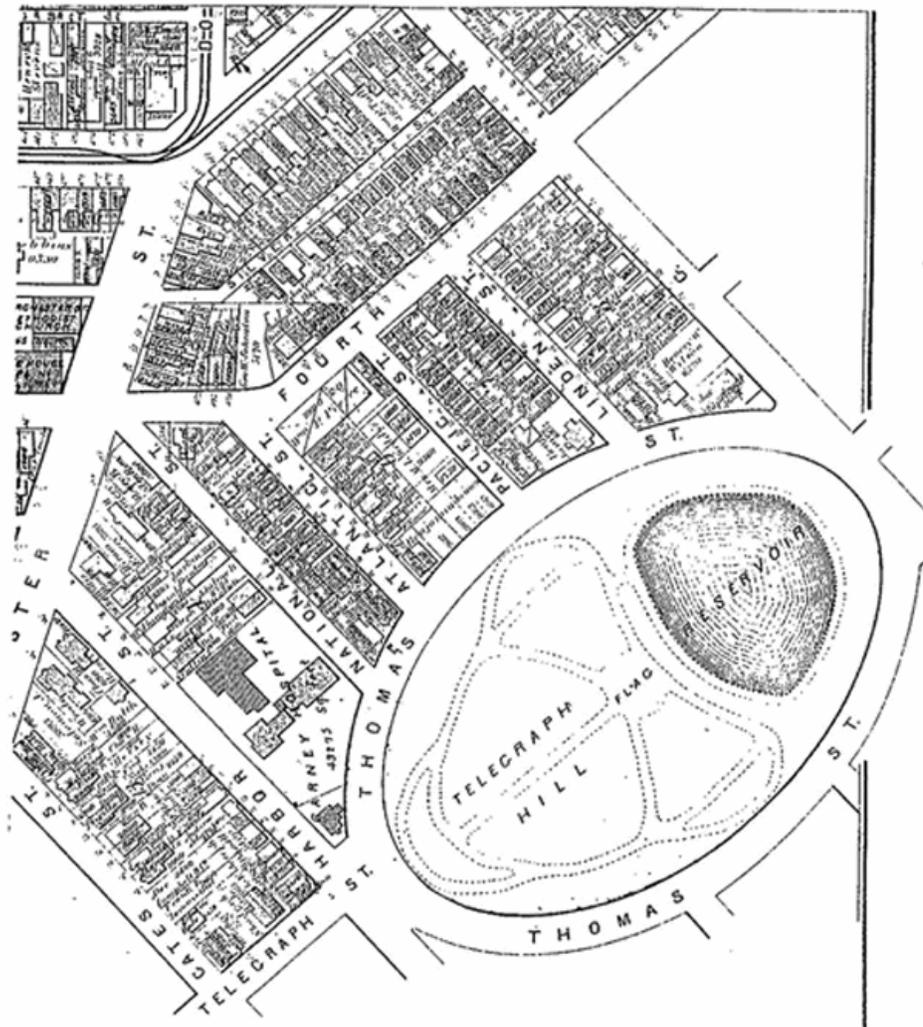
Figure 4. 1874 map from the “Atlas of the County of Suffolk” by G.M. Hopkins, showing the siting of Thomas Park within the grid pattern of South Boston, park circulation and the reservoir (Society for the Preservation of New England Antiquities).

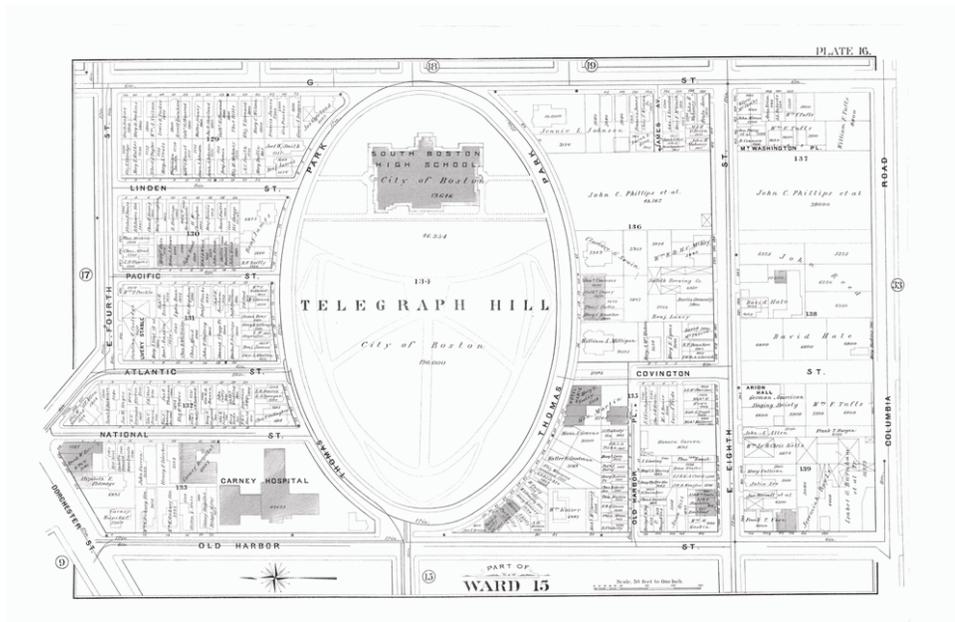
Figure 5. Plan of Dorchester Heights from 1899, showing a configuration of paths similar to current conditions, as well as the newly constructed South Boston High School. The Dorchester Heights Monument has yet to be constructed (Suffolk County of Deeds).

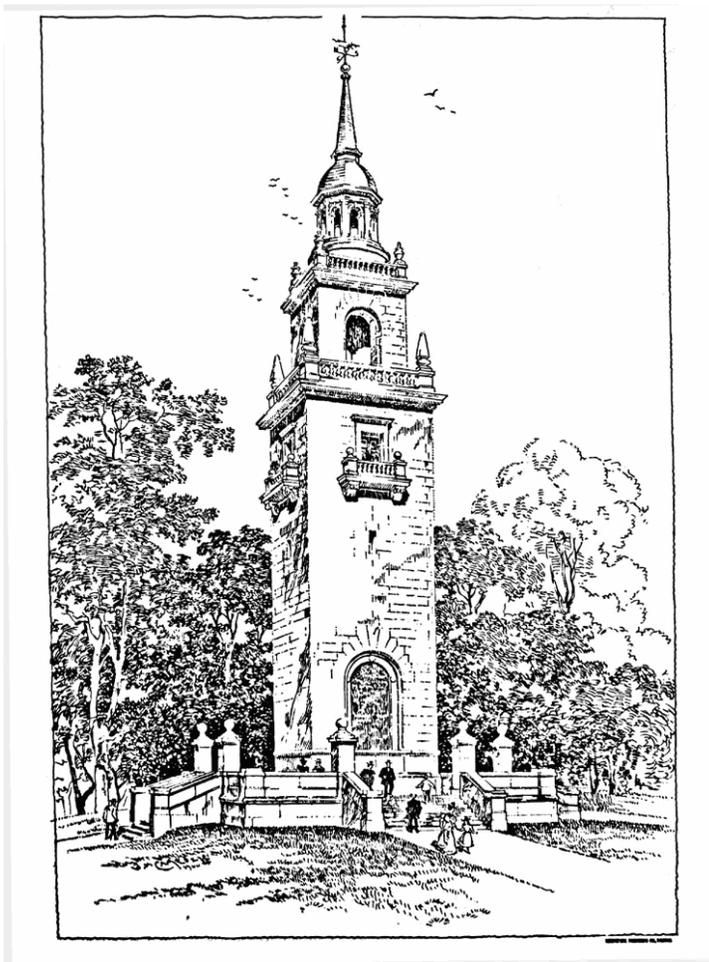
Figure 6. 1900 drawing of the Dorchester Heights Monument done by the firm of Peabody and Stearns, published in American Architect and Building News (Boston Public Library, Fine Arts Division).

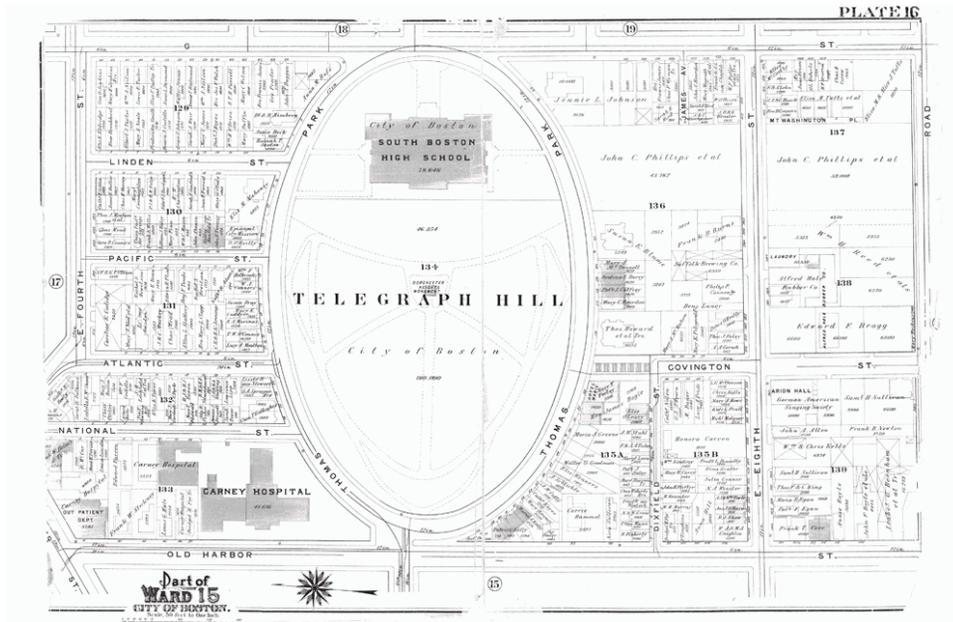
Figure 8. Plan of Dorchester Heights from 1910, showing the recently constructed monument, the South Boston High School, and the path configuration (Suffolk County of Deeds).

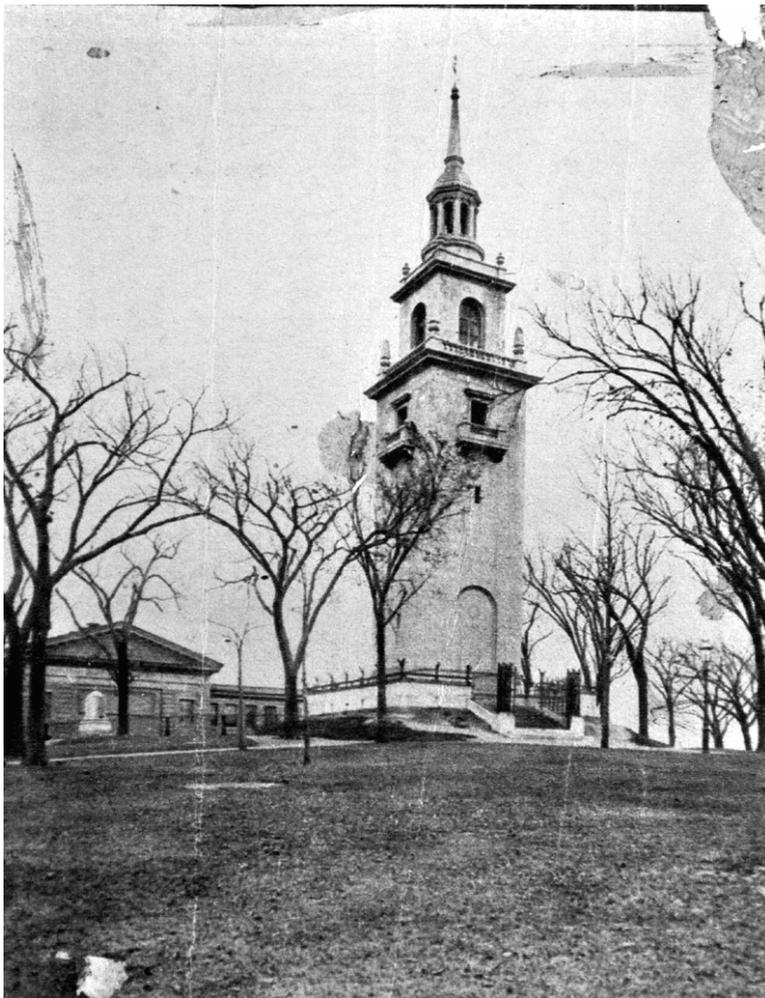
Figure 10. A post-1905 newspaper clipping of the Dorchester Heights Monument showing allees of trees along the walkways and grassy slopes surrounding the monument as well as the fence around the monument base (Boston Public Library, Fine Arts Division).

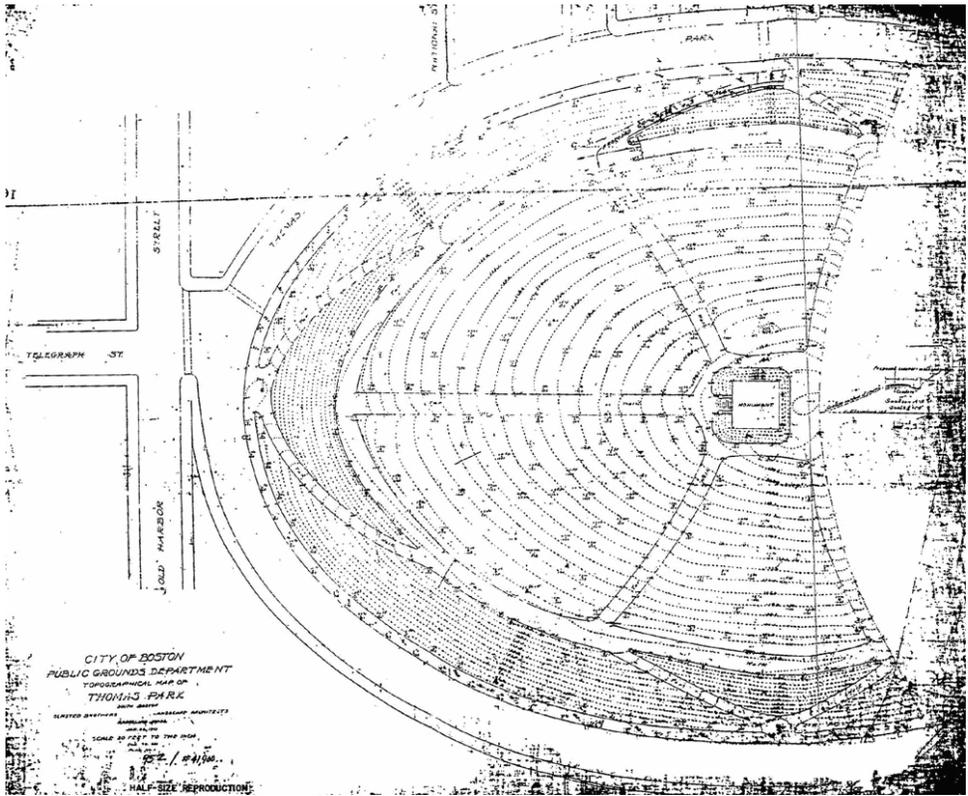
Figure 11. Topographical map from the 1913 survey of Dorchester Heights done by the Olmsted Brothers (National Park Service, Denver Service Center).

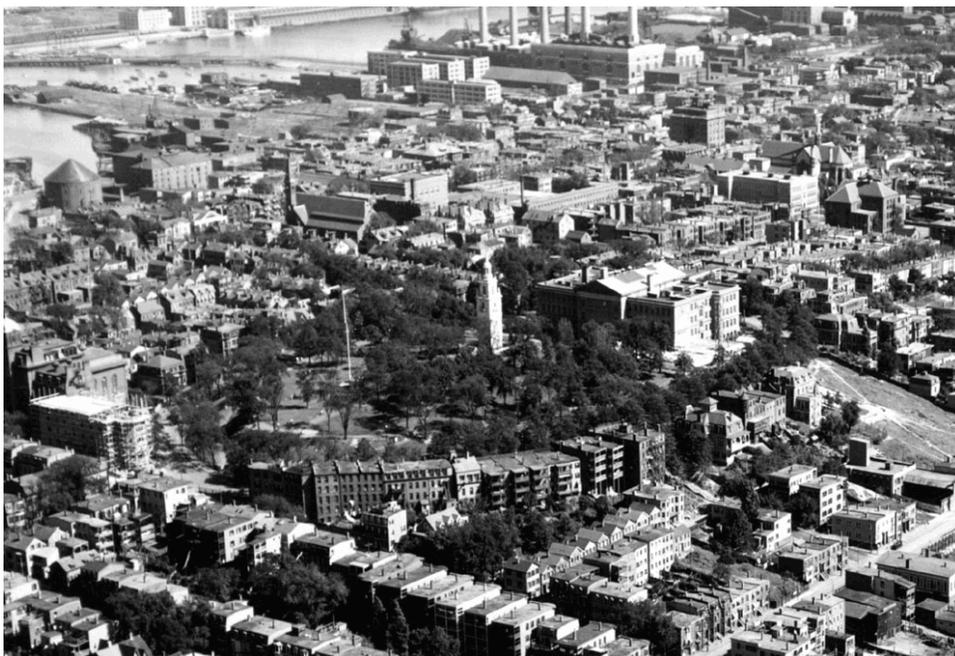
Figure 12. A 1925 aerial photograph of Dorchester Heights that shows spatial organization of the site within the surrounding neighborhood (Boston Public Library, Prints Division).

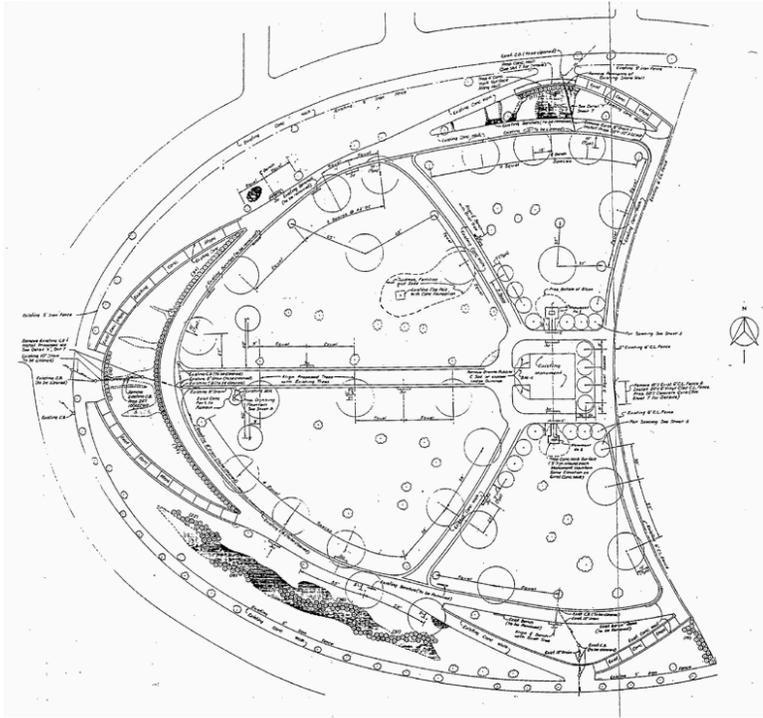
Figure 14. The 1968 plan for Dorchester Heights done by Vollmer Associates. Note the large number of non-historic plantings, particularly on the southern slope (National Park Service, Denver Service Center).

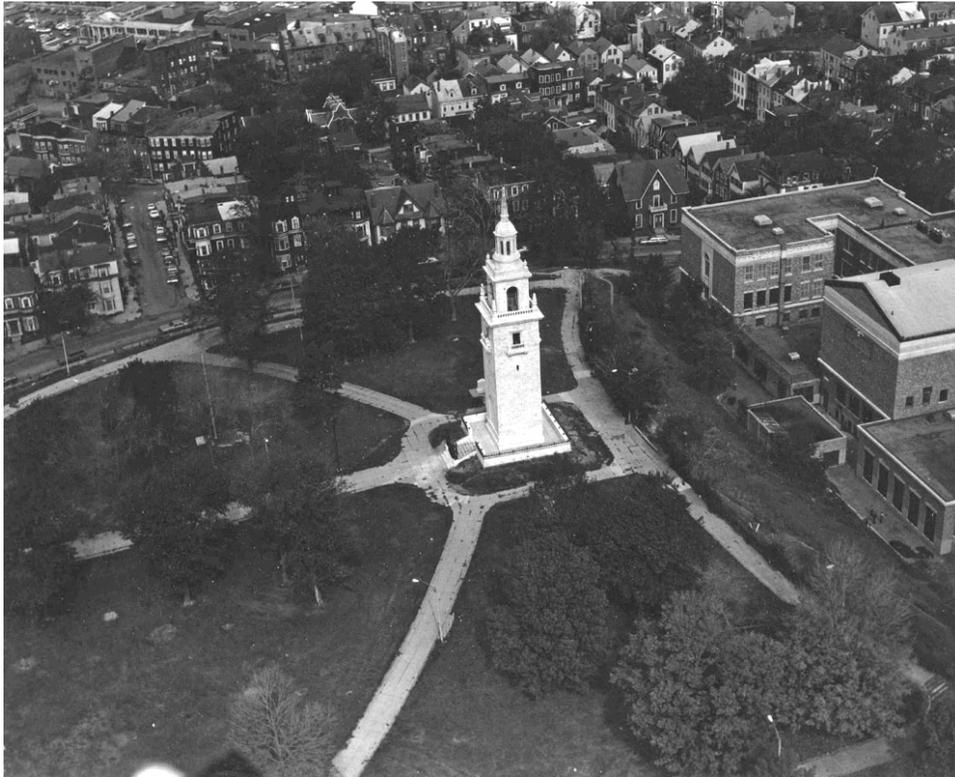
In the mid-1970s, at the time studies were underway to add the site to Boston National Historical Park, Dorchester Heights National Historic Site was in a state of disrepair and suffered from vandalism and misuse (Figure 15). The site had become a hodge-podge of collapsing retaining walls, broken sidewalks, litter, and overgrown grass. It was not used for recreation purposes by the people of the neighborhood due to fears about safety and rowdy teenagers (Ian Menzies 1978).

Figure 15. A 1977 aerial photograph of Dorchester Heights. Cobra-style lighting and vegetation in sidewalk cracks can both be seen (Boston National Historical Park).

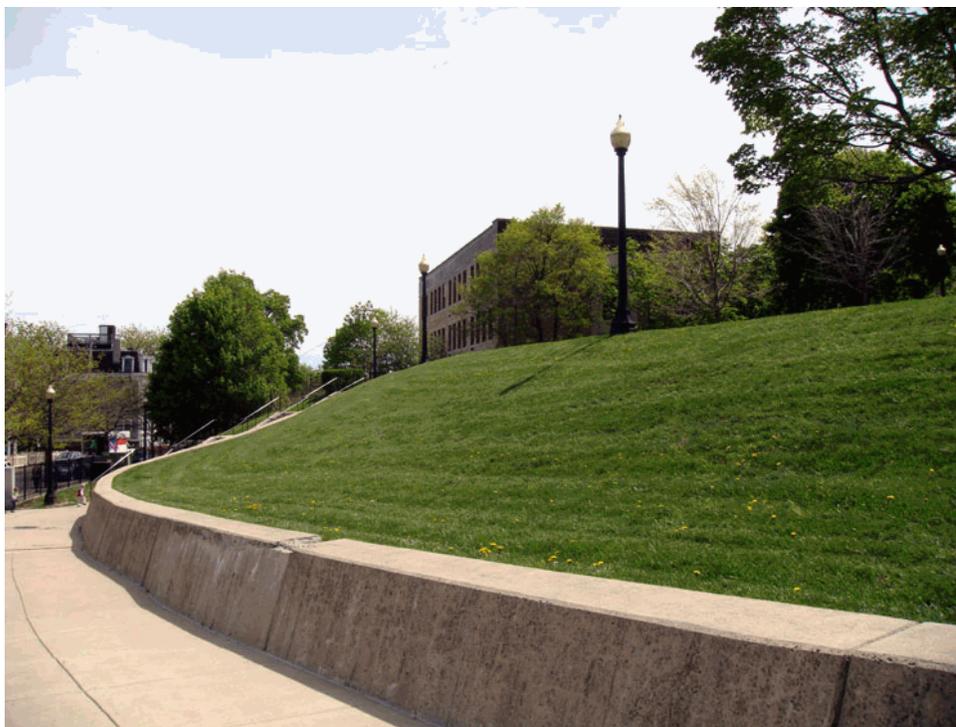
Figure 16. View looking southeast at some of the steep slopes, with South Boston High School in the background (OCLP 2010).

Additional survey work in 1992 revealed that the site's fill areas, especially on the east and west sides of the hill, were showing signs of slumping (CLR 1993:120). Site renovations undertaken between 1995 and 1997 attempted to remedy the continuing slope creep. Special consideration was paid to the relationship between the altered topography and the installation of new retaining walls to avoid past problems (Figure 16). Topography was also changed to improve accessibility through the construction of ramps with more gradual slopes, and to allow for easier maintenance access (Interview, Ruth Raphael, 2010).

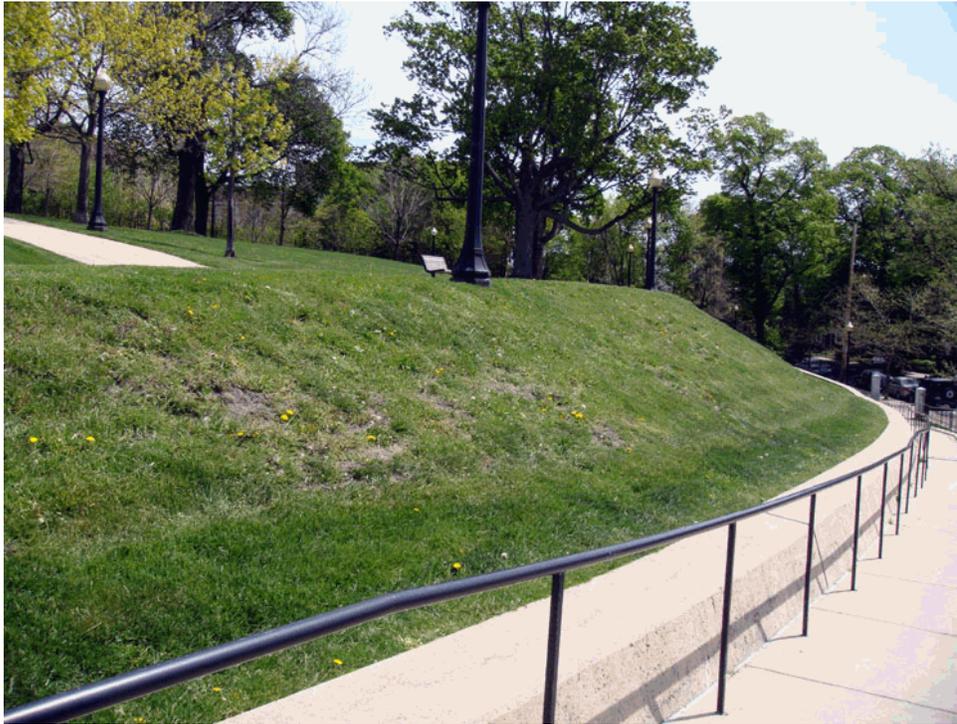
Figure 17. Slope on the southern side of the site showing signs of erosion (OCLP 2010).

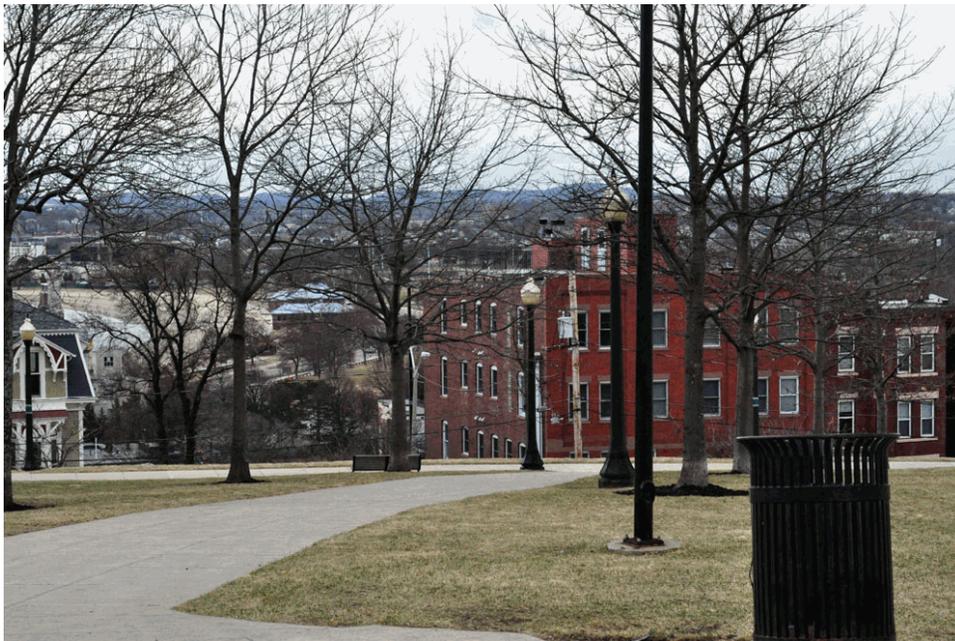
Figure 20. View of allee along sidewalk on the upper lawn of the southern side (OCLP 2010).

Anticipated for the year 2011, the National Park Service has planned a series of projects for Dorchester Heights National Historic Site. The trees in the main allée, planted in the 1997 renovations, were incorrectly installed, leading to stunted growth. One of the major plans for 2011 is to remedy the situation by trenching the area to add drip irrigation and proper drainage for the trees. Also planned is installation of additional benches and trash receptacles around the site and replacement of the Monument up-lighting. For the Monument itself, interior re-pointing is scheduled. Finally, the National Park Service intends to install gates into the fence that currently runs between the site and South Boston High School, connecting the site with the landscape of “No Man’s Land” (Interview, Ruth Raphael, 2010).

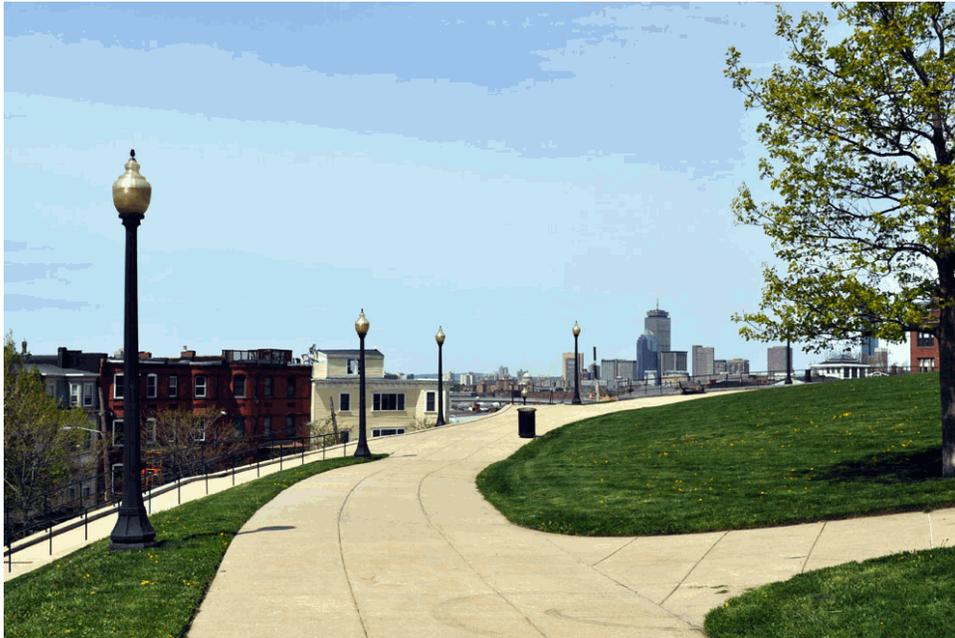
Figure 22. View of main loop walk on the southern side of the site, and the view to the Back Bay area (OCLP 2010).

another and separating the upper terrace area from the steep side slopes (Figure 22). This path is typically in good condition. It is approximately twelve feet wide, though it widens in the places where it meets the ramps. In one place on the southern side, the sidewalk has settled, presumably due to the freeze-thaw cycle, creating a small valley. There are eight benches and two trash receptacles located directly on the main loop walk (CLR 1993:125).

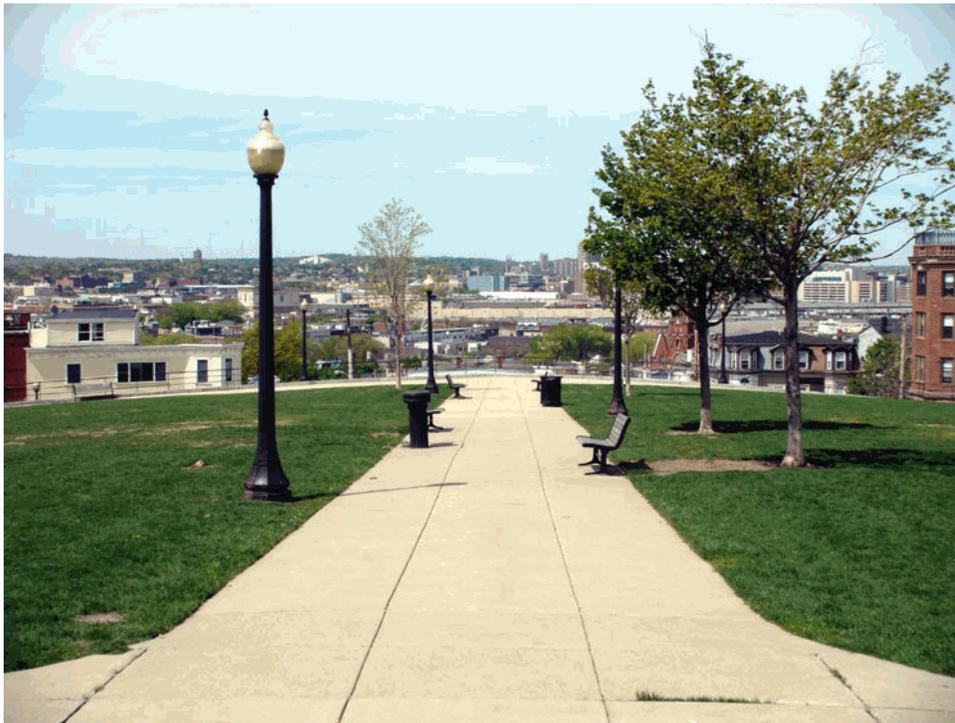
Figure 23. View of the main allee leading to the monument, looking to the west (OCLP 2010).

The main walk extends from the Dorchester Heights Monument to the main loop walk, going directly along the east to west axis (Figure 23). This walk is about twelve feet wide and has four benches, one trash receptacle and a drinking fountain located directly on the path. The walk is not currently showing signs of advanced concrete spall, or joint separation and has little damage other than ordinary wear (CLR 1993:129).

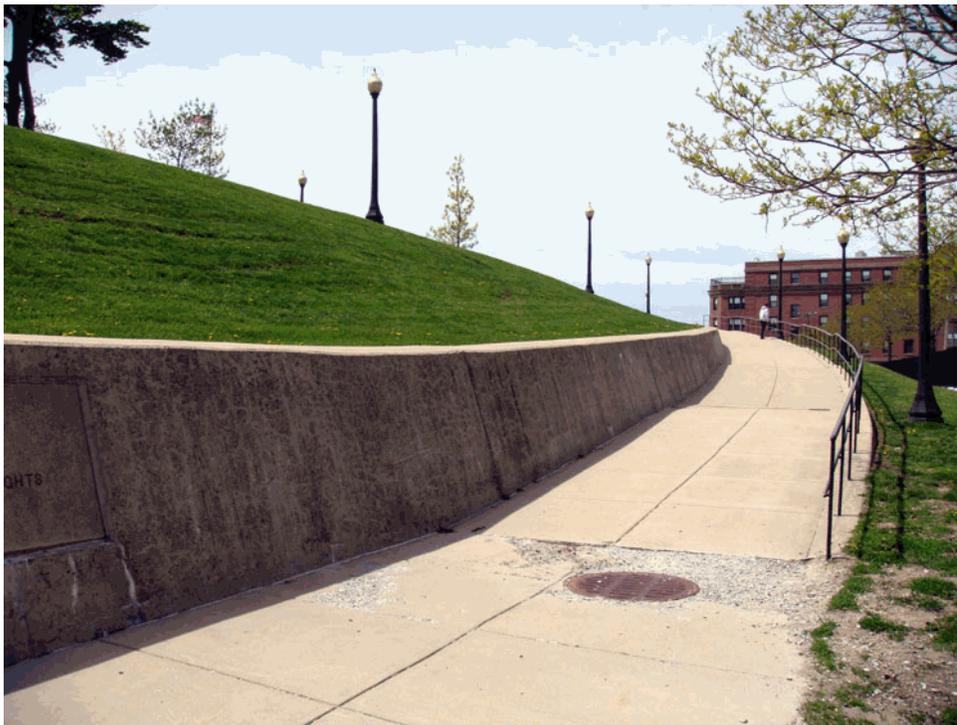
Figure 24. View looking west at of ramp on the northern side of the site. Note the concrete spall at the base of the ramp (OCLP 2010).

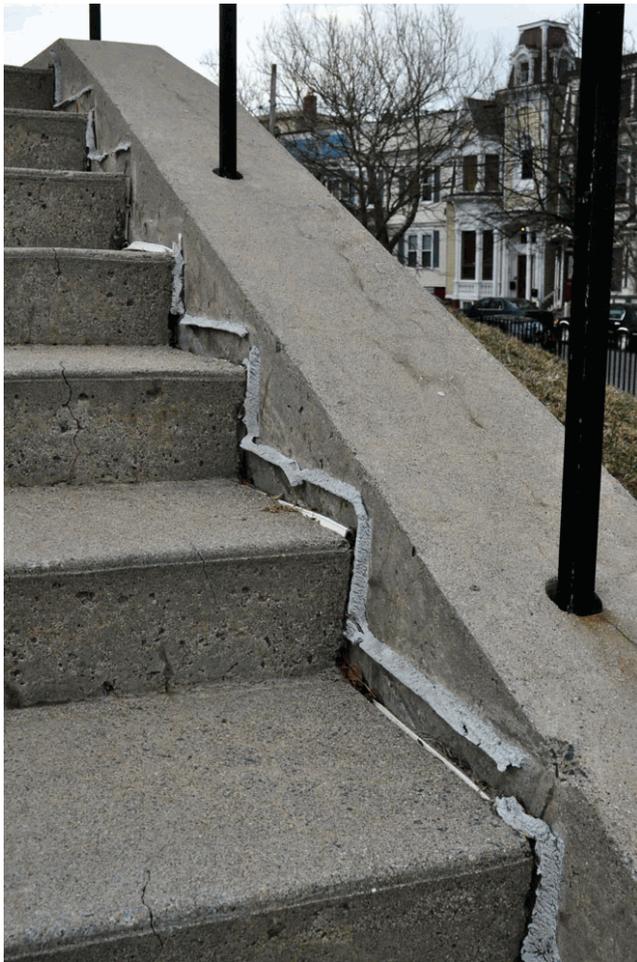
Figure 25. Stairs on the southern side of the western park entrance showing the effects of slope creep on the stairs and retaining walls (OCLP 2010).

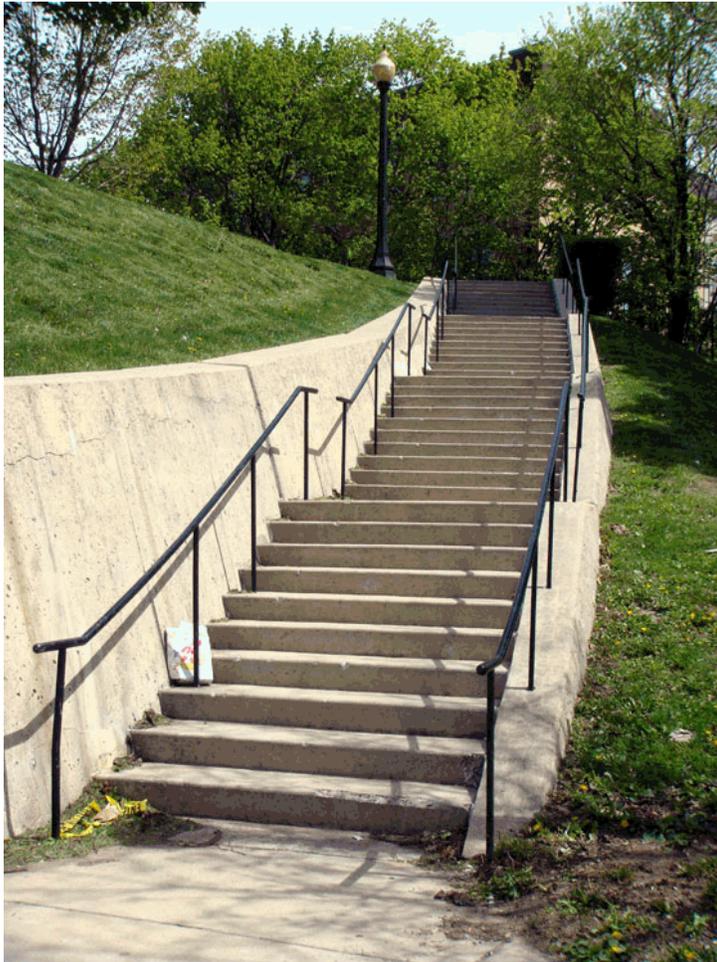
Figure 26. View of stairs on the southern side of the site, looking east(OCLP 2010).

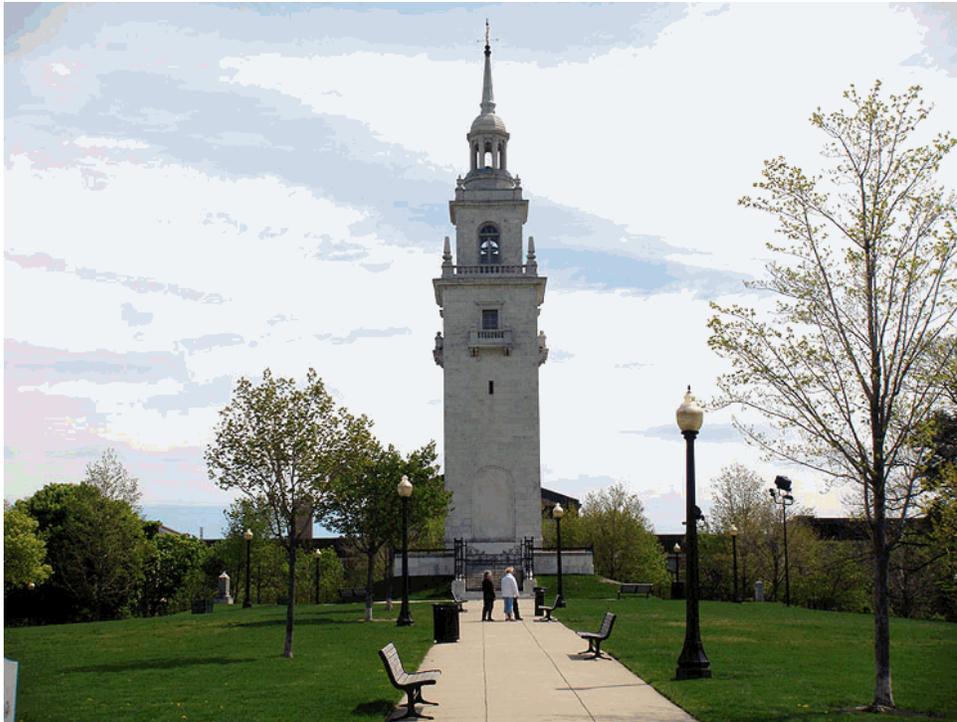
Figure 27. View of the Dorchester Heights Monument, built in 1901 (OCLP 2010).

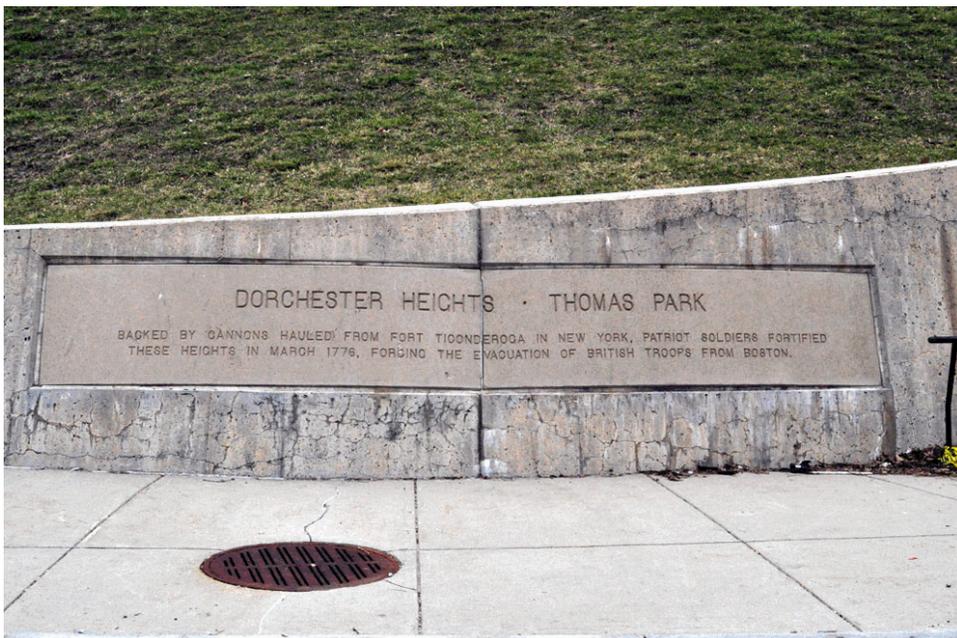
Figure 28. View of the southern retaining wall which contains an informational panel about Dorchester Heights and Thomas Park (OCLP 2010).

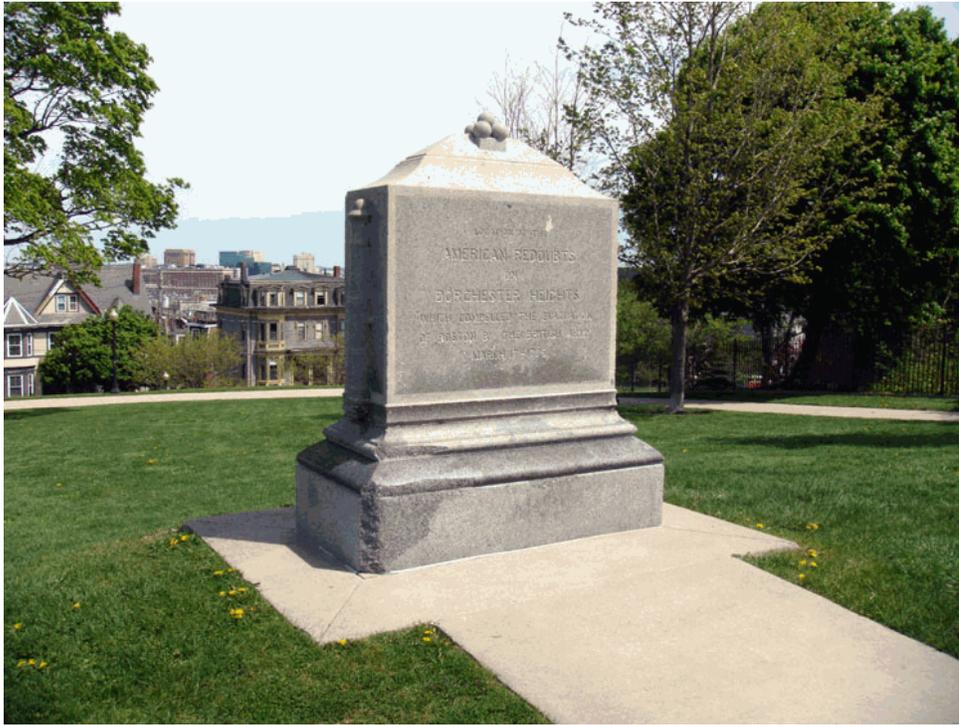
Figure 29. The 1876 Centennial Monument, located north of the tower (OCLP 2010).

The 1876 Centennial Monument, a granite piece, is located approximately 32' north of the main monument, and is approximately 6 feet tall, in a rectangular shape with a concave-curved pyramidal top, with three cannonballs placed at the peak (Figure 29). It was originally installed in 1877, in the western portion of the site, and then later moved north of the tower (CLR 1993:130,135). In 1927, the Henry Knox Monument was installed just south of the Dorchester Heights Monument Tower (Figure 30). This monument was a 4'-tall, tombstone-shaped marker, approximately 1'-deep with rough carved edges. A smooth face of the marker faces the monument and bears an inscription describing Henry Knox's role in bringing the cannons from the Fort Ticonderoga, which led to the evacuation of the British from Boston (CLR 1993:130,135).

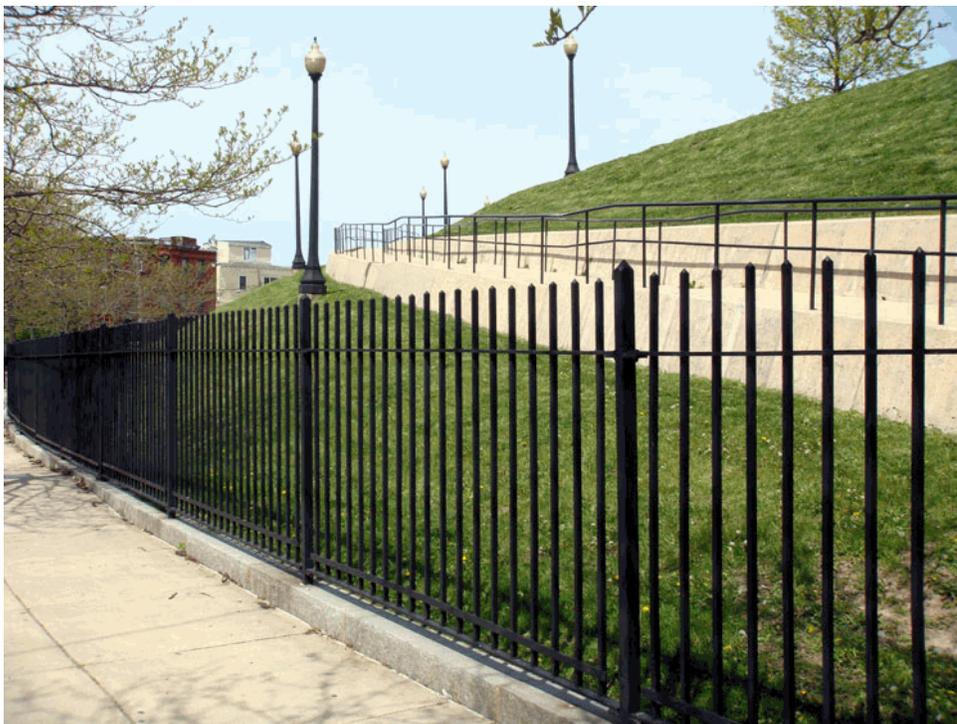
Figure 32. A view of the historic fence that surrounds the perimeter of the site (OCLP 2010).

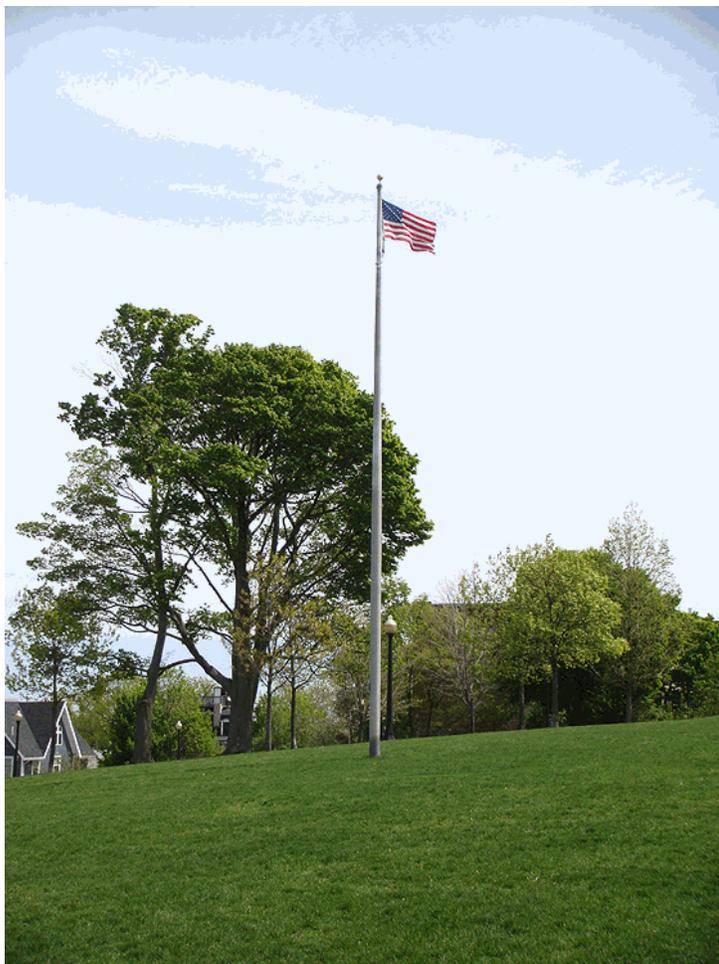
Figure 33. View of flagpole located on the northwestern portion of the upper terrace (OCLP 2010).

The flagpole features a 50-foot aluminum pole set into a concrete footing and is in good condition (Figure 33). It has been located in the same place since the 1913 Olmsted Brothers survey. Both the 1941 Parks and Recreation Department Plan and the 1968 Vollmer plan indicate the flagpole in its present location (CLR 1993:135).

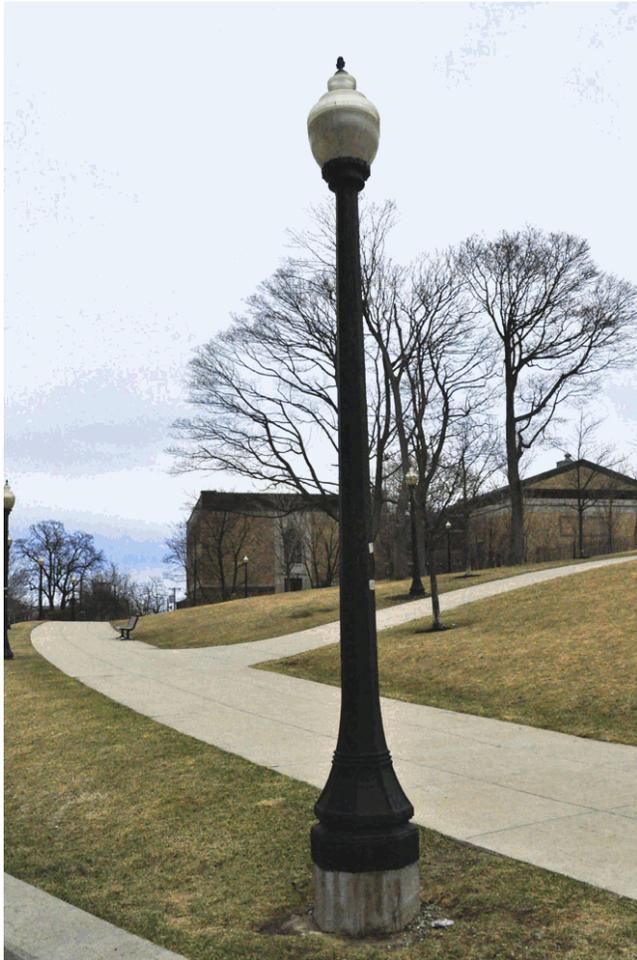
Figure 34. View of acorn-style lighting seen around the site (OCLP 2010).

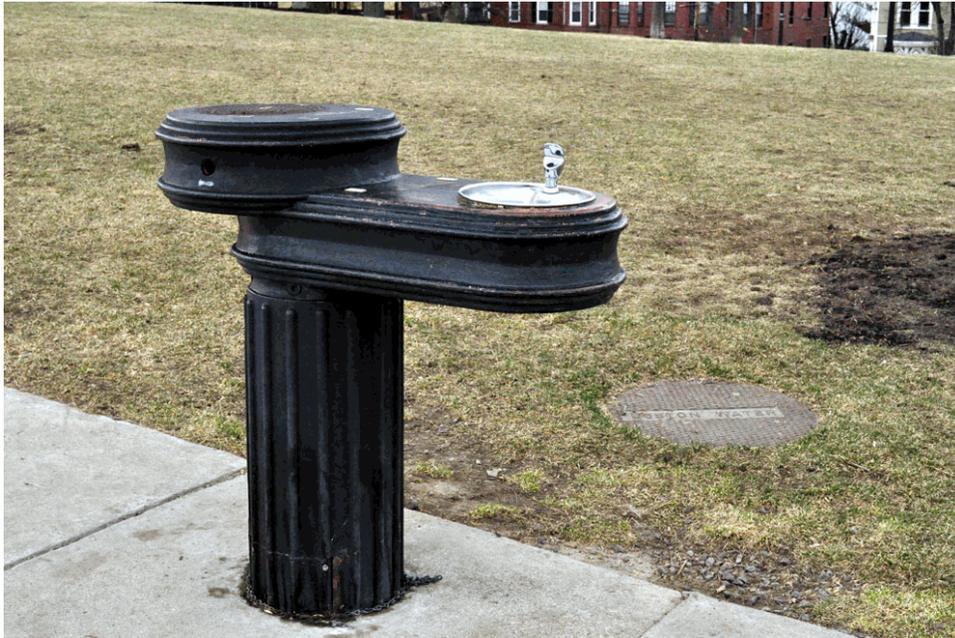
Figure 35. View of the drinking fountain found on the southern side of the main walkway (OCLP 2010).

The drinking fountain that was noted on the 1913 Olmsted Brothers survey was removed at an unknown date. It was replaced during the 1995-1997 renovations with a new fountain approximately halfway down the central walk, on the western side of the site (Figure 35).
