CULTURAL LANDSCAPE REPORT  
DORCHESTER HEIGHTS/THOMAS PARK  
AT BOSTON NATIONAL HISTORICAL PARK

# CULTURAL LANDSCAPE REPORT

## DORCHESTER HEIGHTS/ THOMAS PARK

### AT BOSTON NATIONAL HISTORICAL PARK

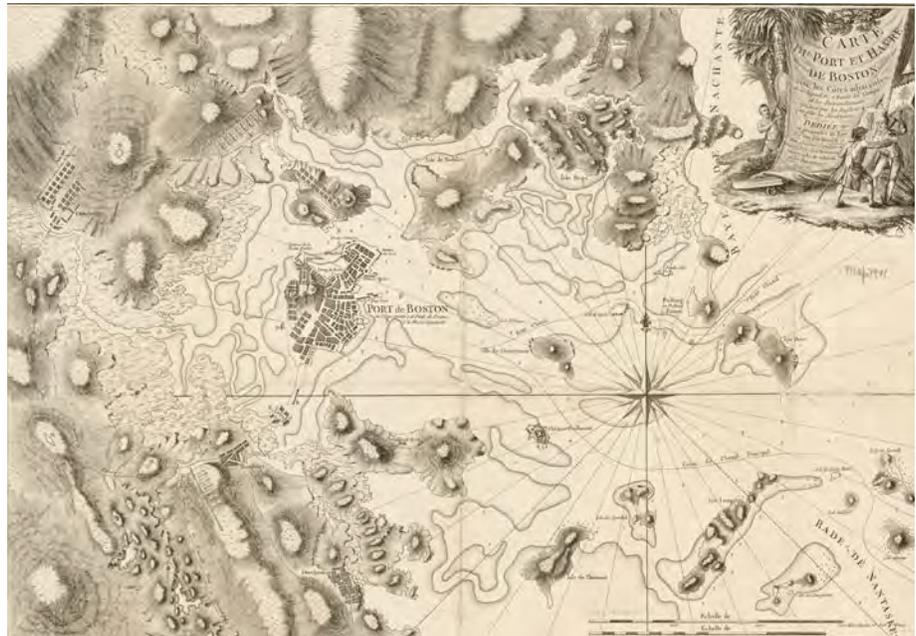
A 1776 map drawn by French cartographer Jean de Beaurain graphically illustrates, through exaggeration, the relationship of drumlins and lowlands that were characteristic of the Boston Basin. The unhatched areas were lowlands or flats and are often under water at high tide. (Figure 2-2)

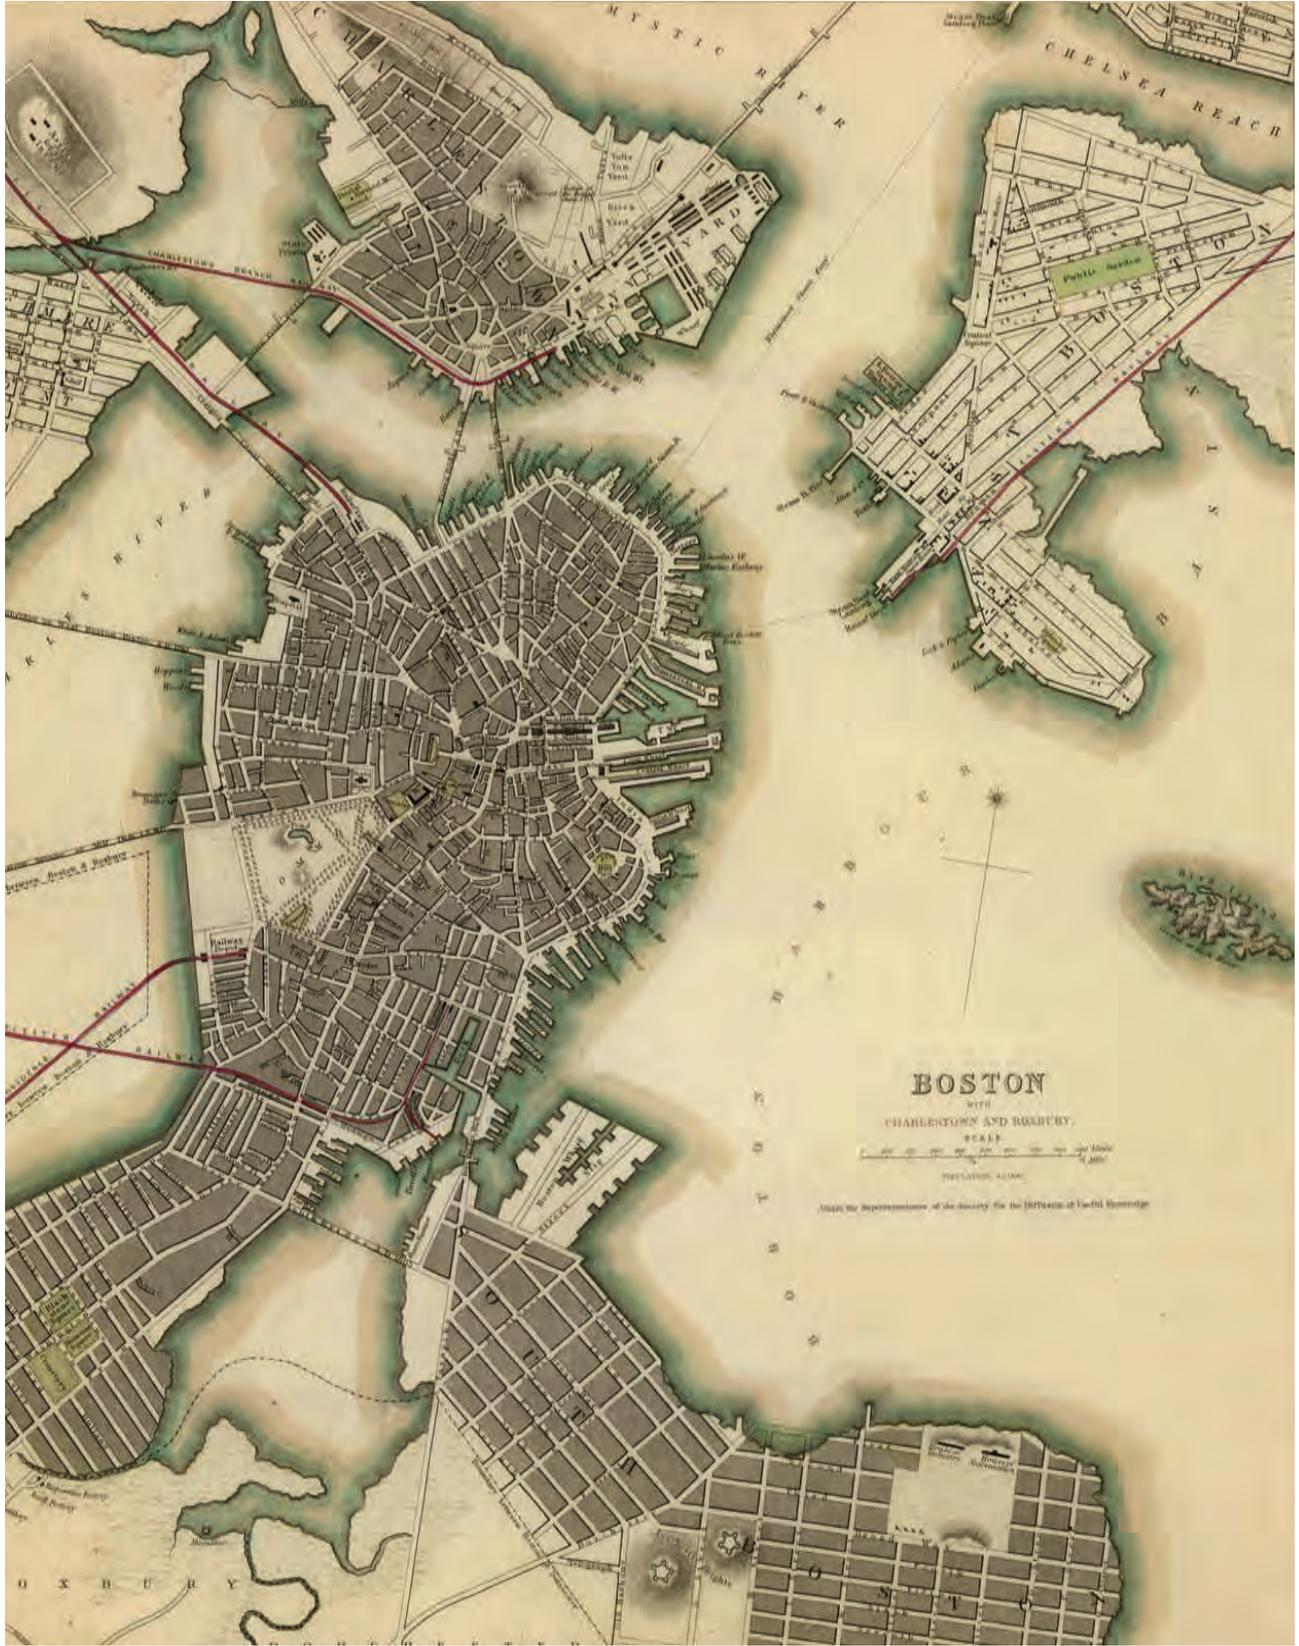
Figure 2-11: "Boston with Charlestown and Roxbury," 1842. Map purchased from the David Rumsey Historical Map Collection.

The map illustrated in Figure 2-II, published in England in 1844 by the *Society for the Diffusion of Useful Knowledge*, shows a five-point fort on each of the two hills of Dorchester Heights, as do many other maps of the same period.

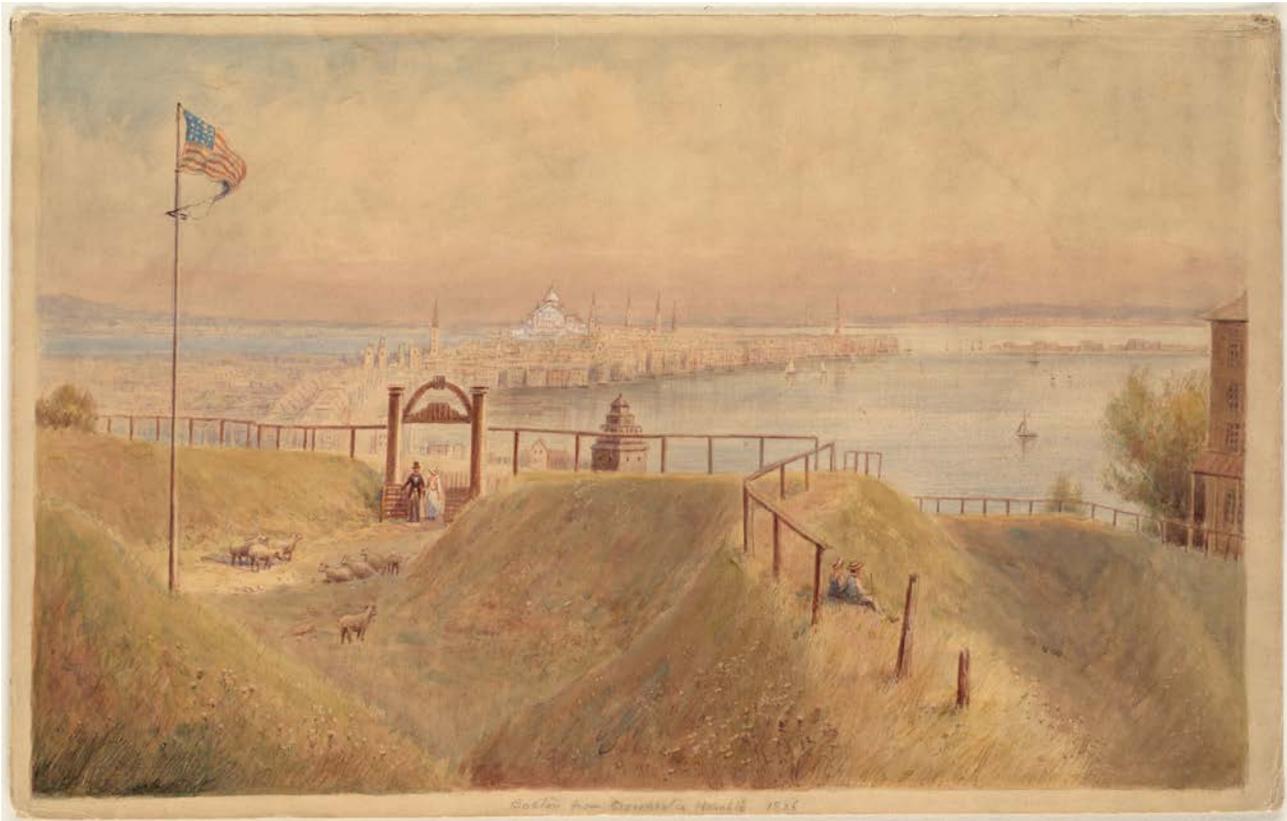
Another early depiction of the declining fortifications is a print entitled "Boston from Dorchester Heights" which was published in London in 1838 (Figure 2-13). In the foreground, one bastion of one of the fortifications is clearly visible. It shows a partially eroded earthwork with dirt paths and a safety handrail. Which fort is depicted is impossible to tell.<sup>104</sup> This is a romantic view and probably takes considerable liberties in depicting the scene. Bostonians in fine dress are strolling leisurely, and grazing sheep among the ruins are also illustrated.

(top) Figure 2-13: "Boston from Dorchester Heights," 1838. Print reproduction courtesy of the Boston Public Library, Print Department.  
(bottom) Figure 2-14: "View of the City of Boston from Dorchester Heights," 1841. Print reproduction courtesy of the Boston Public Library, Print Department.

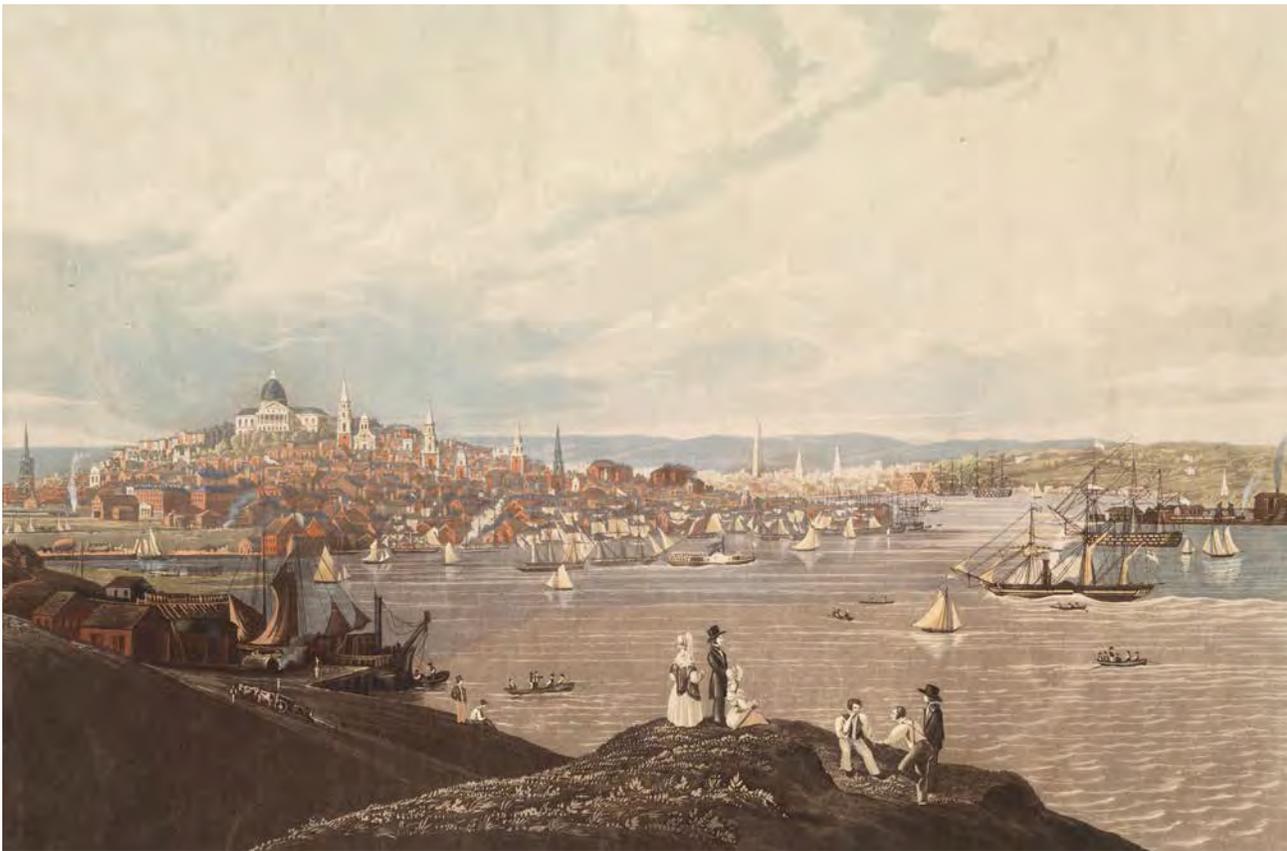
An 1841 lithograph entitled “View of the City of Boston from Dorchester Heights” (Figure 2-14) again shows an idealistic view. It shows the hill as a rugged landscape but informs little else about the development of the landscape of Dorchester Heights except to reiterate the desire for residents to stand on the heights and enjoy the air and views of Boston Harbor and Charlestown beyond. The Bunker Hill monument is visible towards the center of the image.

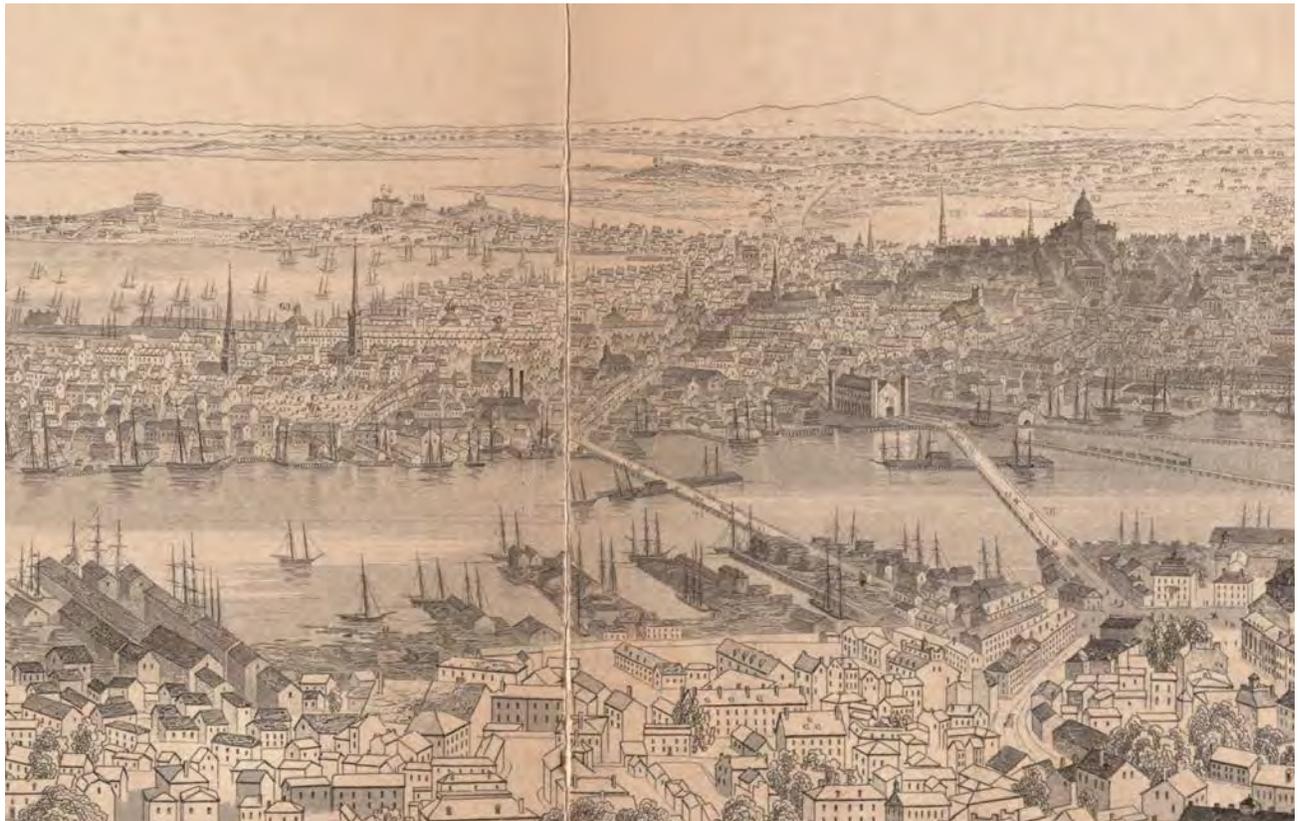
**Figure 2-15: Crop of “Panoramic view from Bunker Hill Monument,” 1848. Print reproduction courtesy of the Norman B. Leventhal Map & Education at the Boston Public Library.**

A distant view of Dorchester Heights appears in Figure 2-15, a panorama from the Bunker Hill Monument dated 1848. The forts on the Heights are numbered “64.” Unfortunately, the rendering of the forts and the Heights is extremely schematic. Immediately to their left (“62”) is the Perkins School for the Blind (formerly Mount Washington House), built in 1834 at the base of the second hill. The State House can be seen to the right of the image as cropped herein.

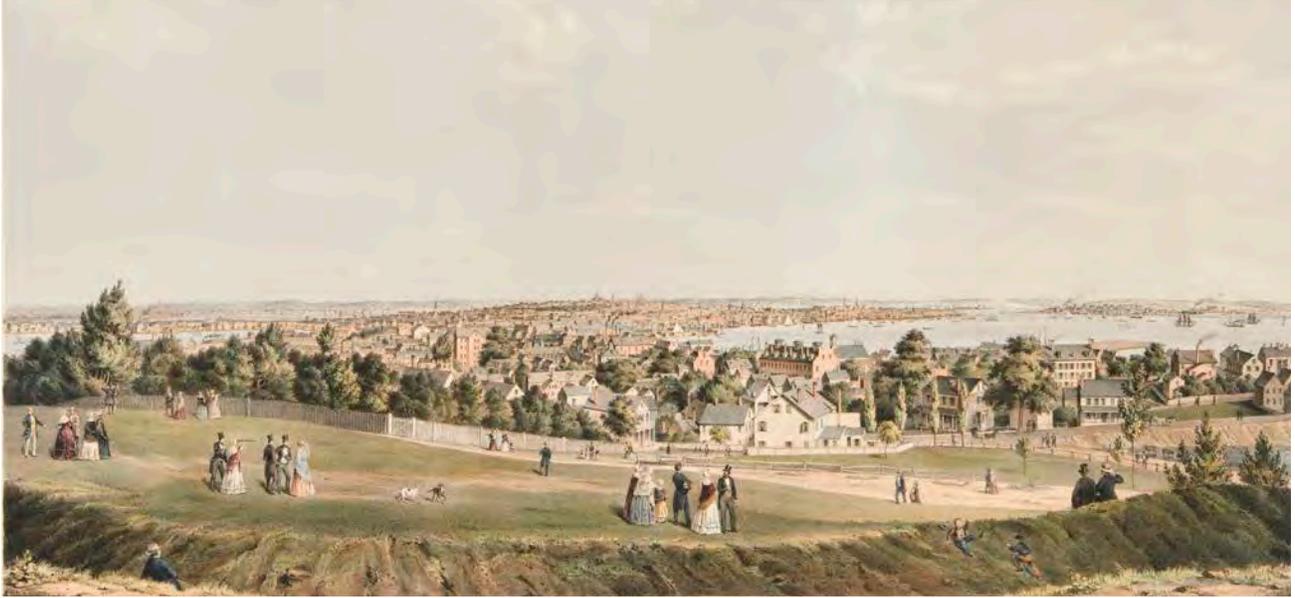
(top) Figure 2-16: "View of Boston from Telegraph Hill," 1850. Print reproduction courtesy of the Yale University Art Center.

Perhaps the most striking view of Dorchester Heights is the lithograph, “View of Boston from Telegraph Hill, South Boston,” drawn by Bernard Spindler (Figure 2-16). In this view remnants of the fort’s embankments are clearly shown in the foreground; no bastions are visible. People, some of them holding telescopes, are shown walking on top of the embankments and on a wide dirt track (running diagonally just to the right of the center of the view) that may be the remnants of the parade ground of the 1776 fortification. To the far right is another embankment that may be part of the reservoir. At least four fences appear in this view: a long

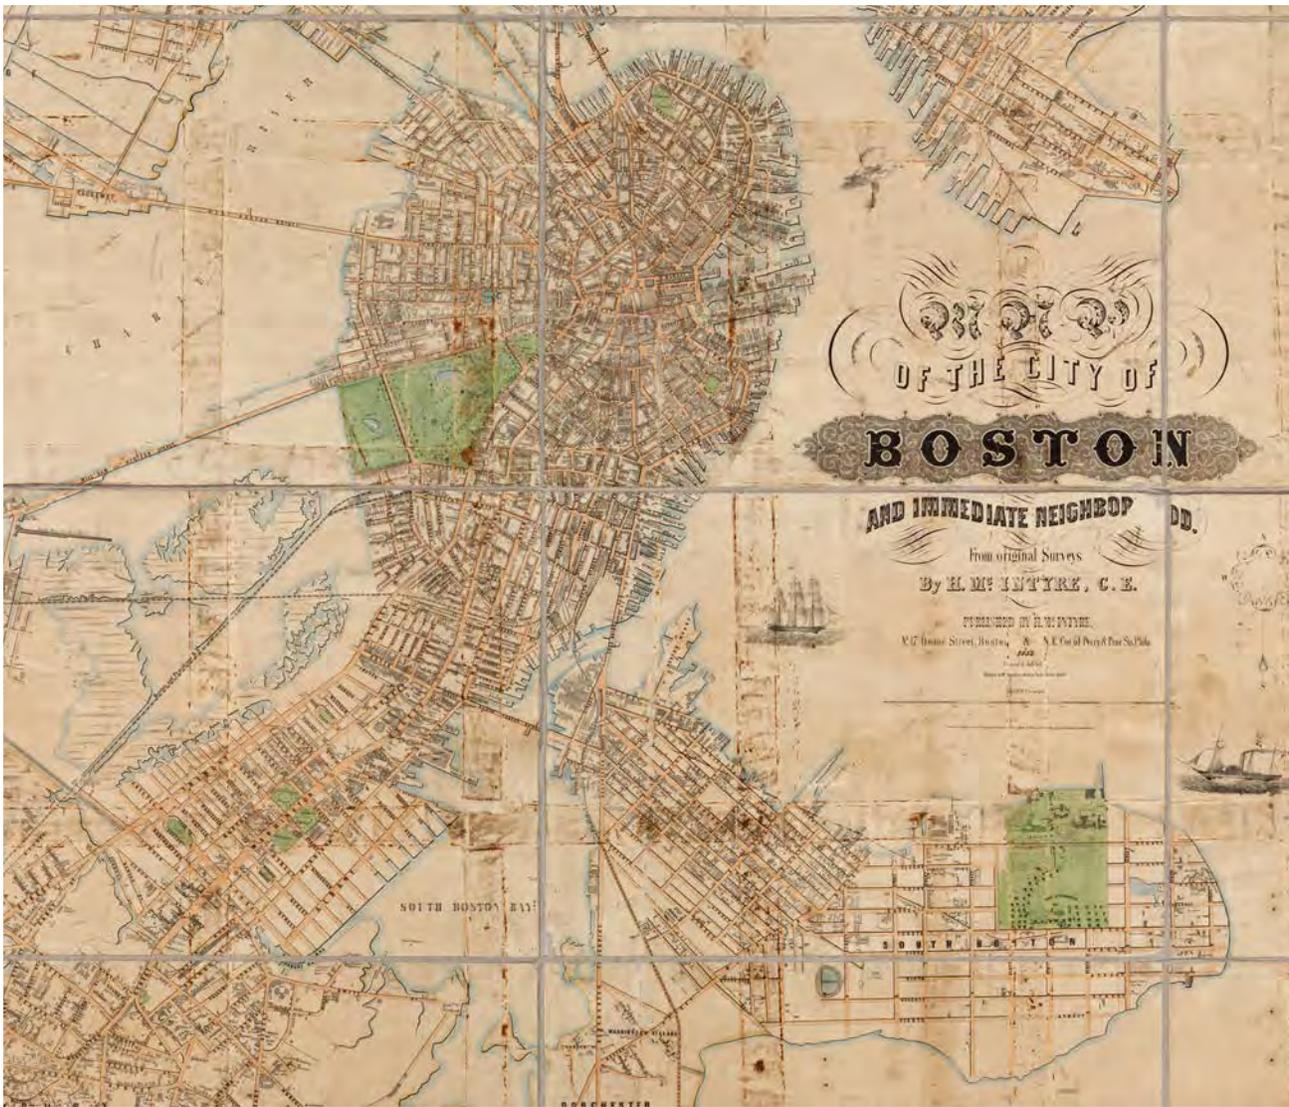
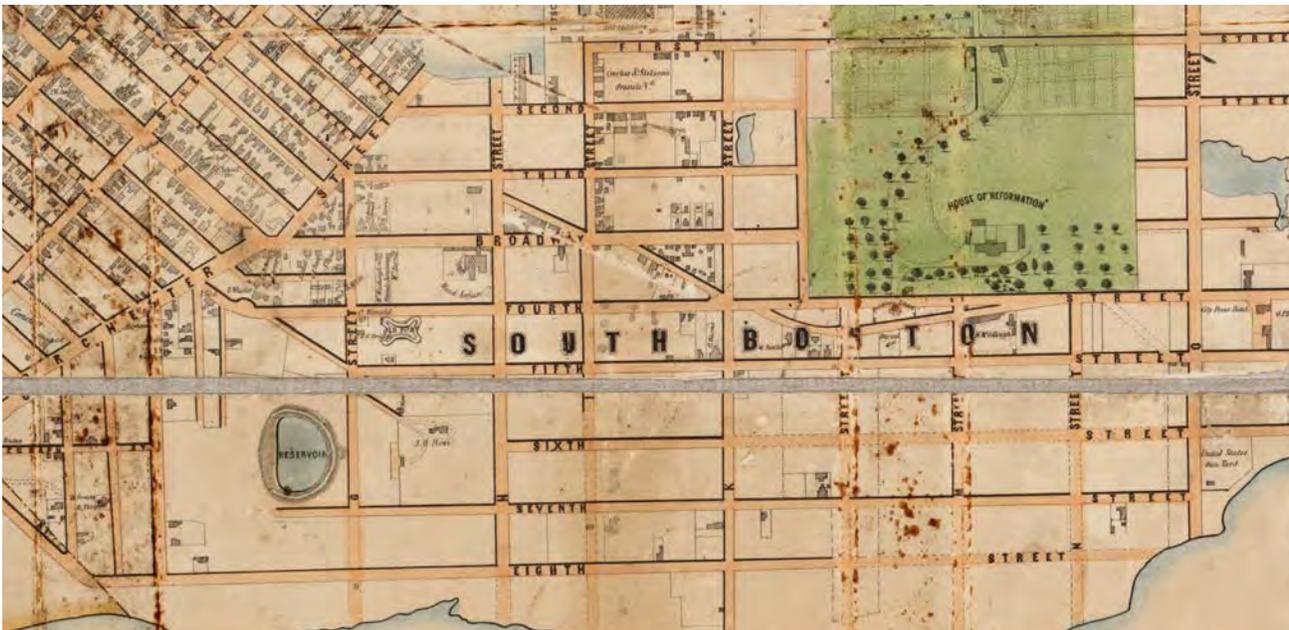
Two maps conclude the sequence of visual documents for the fortifications after 1814. The first, entitled “Map of Boston and Immediate Neighborhood,” was surveyed by H. McIntyre and published in 1852. It is probably the most detailed Boston map of its period. The McIntyre map in its entirety is illustrated in Figure 2-18 and a detail is shown in Figure 2-19. The detail shows Dorchester Heights and its surroundings in a state of transition. The easternmost of the two forts, the one on Bird Hill, appears as a roughly bastioned rectangular fortification; it will shortly be completely leveled. On Telegraph Hill, the half-oval reservoir has been completed on the eastern side. There are no fortifications depicted on Telegraph Hill, although, as seen in the Spindler lithograph, the embankments must still have been there. Thomas Street has not yet been constructed and there is as yet no park laid out. Figure 2-20, the 1855 Colton Map of Boston, shows the process complete. Both forts have vanished.

(top) Figure 2-18: Crop of “Map of the city of Boston and immediate neighborhood: from original survey,” 1852. Map reproduction courtesy of the Norman B. Leventhal Map & Education at the Boston Public Library.

(bottom) Figure 2-19: Crop of the same image.

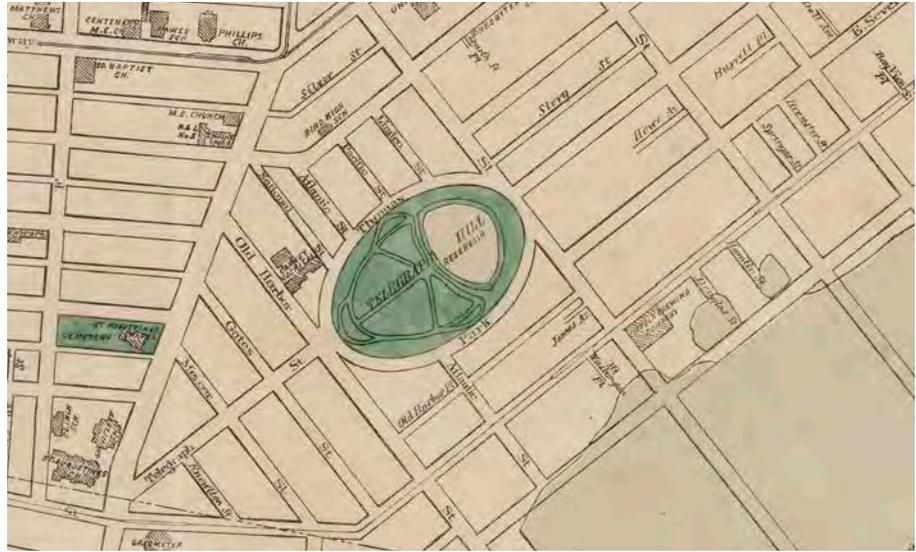
Figure 2-25: Crop of “Plan of South Boston”, 1880. Map reproduction courtesy of the Norman B. Leventhal Map & Education at the Boston Public Library.

The third early plan from this era (Figure 2-25) is a South Boston street map dated 1880 that includes a plan for the reservoir and park. The area within the oval shows the outline of the reservoir as constructed and a plan for the park close but not identical to that which appears in the South Boston Volume of the 1874-1876 Hopkins *Atlas* (Figure 2-26). The configuration of the path system shown in the Hopkins *Atlas* is nearly identical to what is there today. (See Section 3: Existing Conditions of this report). Since the differences between Figure 2-25 and the Hopkins, shown in Figure 2-26—the earliest plan that can be unequivocally identified as a survey and that clearly delineates the internal layout of Thomas Park—are very minor (consisting of the curvature of the paths closest to the reservoir).

A large oval space occupied by a flagpole in 1874 was changed to a rectangle by 1901 and accommodated the monument, but without any significant increase in the size of the space. (The flagpole was moved northwest of the Dorchester Heights Monument after it was built.) Since it is unlikely that the park would have been redesigned only twenty years after it was completed, it is probable that the path system of today has not been altered since the mid-1850s. Below, it will be demonstrated, by citing the City financial reports between 1857 and 1874, that, although some improvements were made to the park during these years, no significantly large sums of money were spent on it. Therefore, a total redesign and reconstruction of the site is very unlikely to have occurred.

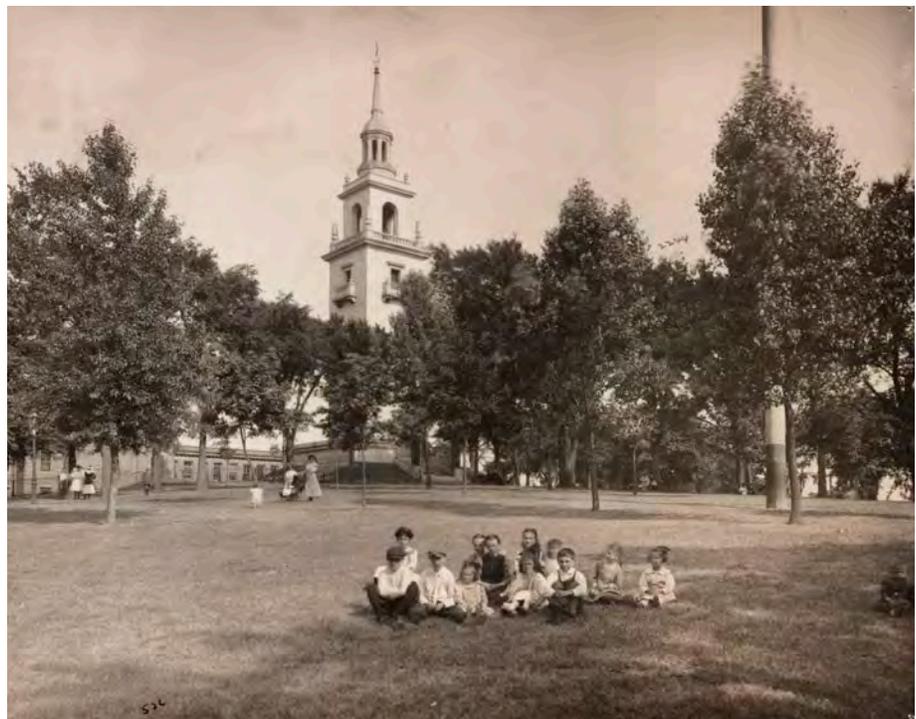
(top) Figure 2-38: "View from the Monument toward Boston Harbor," circa 1910. Postcard reproduction courtesy of Historic New England.

An undated photograph of a group of children and one woman in Thomas Park was, to judge from clothing styles, probably taken about 1915 (Figure 2-37). The same simple treatment of grass and trees appears. A postcard of about the same period (Figure 2-38) offers a rare glimpse of a view from the monument to the harbor and demonstrates that, at this time, there were heavy shrub plantings among the street trees on Thomas Park Street. Another view by Boston photographer Leon Abdalian dated November 20, 1920 (Figure 2-39) focuses primarily on the monument but also shows the iron fence separating South Boston High School from the monument, as well as lights, a bench, and the Centennial monument on a raised mound of grass. Of note is a mature elm seen at the base of the monument's slope on the north side, visible in the 1920 photograph. The caliper of this tree, noted on the 1913 survey (twenty inches), indicates it was carefully kept through the monument construction. The walk around the Peabody and Stearns monument passes between the elm and the monument's berm.

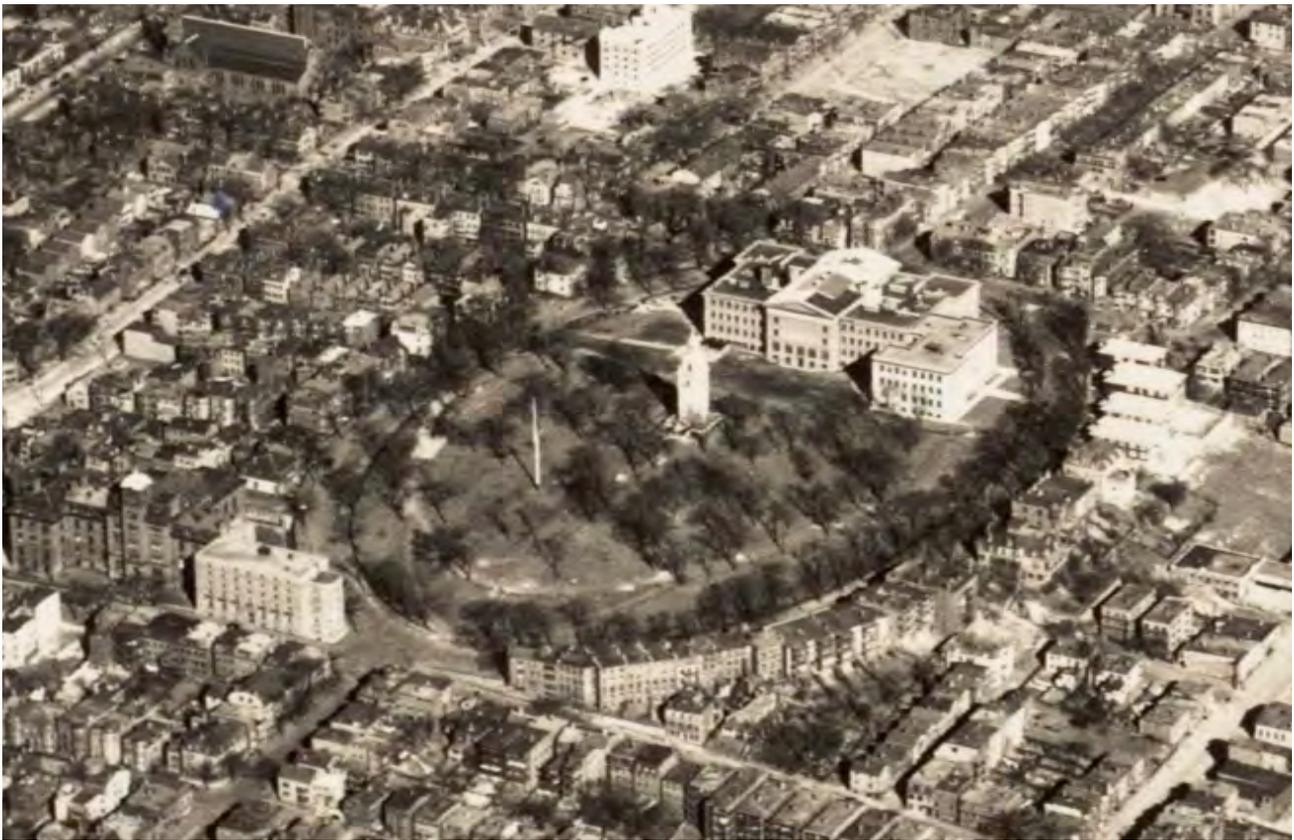
(bottom) Figure 2-41: Detail of "South Boston," 1930. Photograph reproduction courtesy of Boston Public Library, Print Department.

Spectacular photographs by the Fairchild Aerial Survey Company in 1925 and 1930 shows large canopied trees in the park. It is a very clear aerial, and, on the enlarged detail (Figures 2-40 and 2-41), individual trees can be made out.

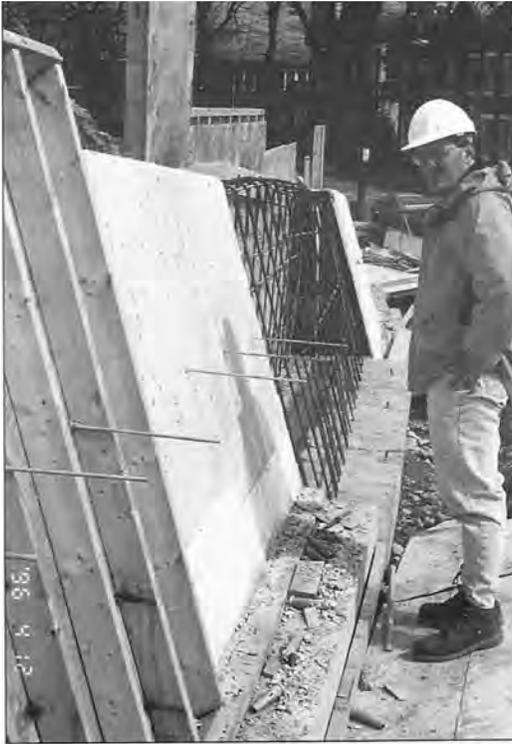
(top left) Figure 2-51: April 1996, after installation of the retaining walls on the south side of the park.

In the Park’s Archives there is a set of plans dated January 7, 1997 entitled “Boston National Historical Park: As-Constructed Drawings.” (The original construction drawing plans are from November 1994; see Figures 2-49 and 2-50.) Sheets SU-1 and SU-2 are labeled “Existing Site Survey North” and “South” respectively. What is most exciting about these plans is the overlay of the star fortification’s ditch labeled “Outline of May, 1776 Fortification Ditch (+/- 20” Below Grade)” on the survey of the 1994 conditions based on the archaeological investigations.<sup>337</sup> This rehabilitation focused on the issues of slope movement, accessibility, and restoring historic vegetation patterns.

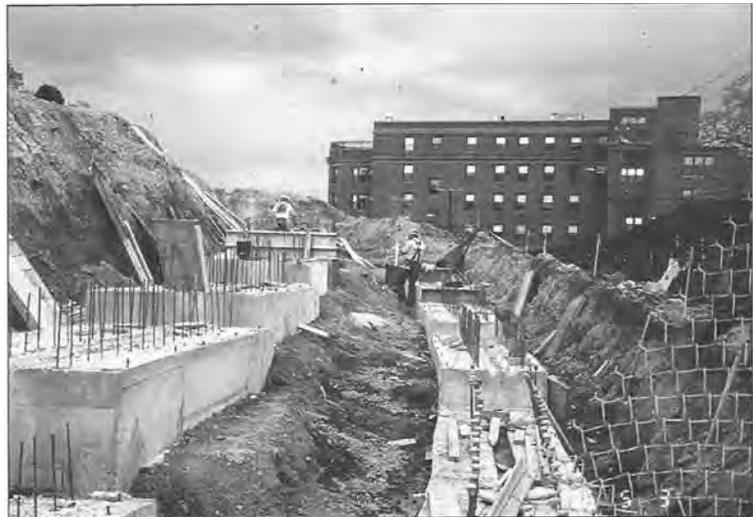
(top right) Figure 2-52: May 1996 image of the installation of stairs and ramp on the northwest corner of the site.

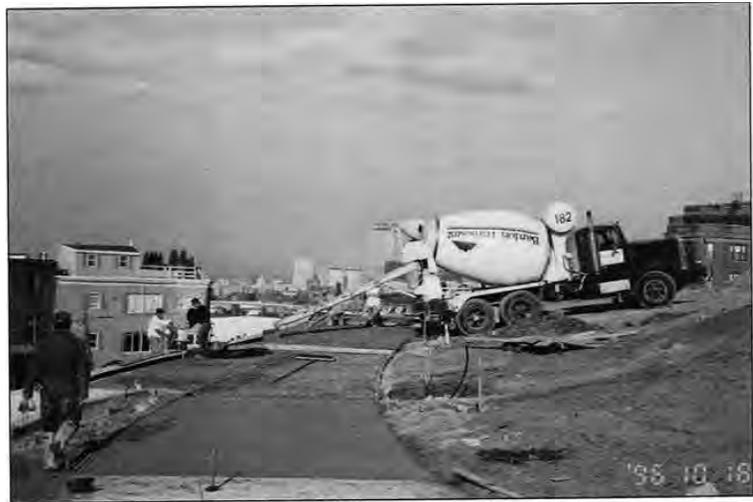
(middle right) Figure 2-53: October 1996, placing concrete walkways on the southwest corner of the site.

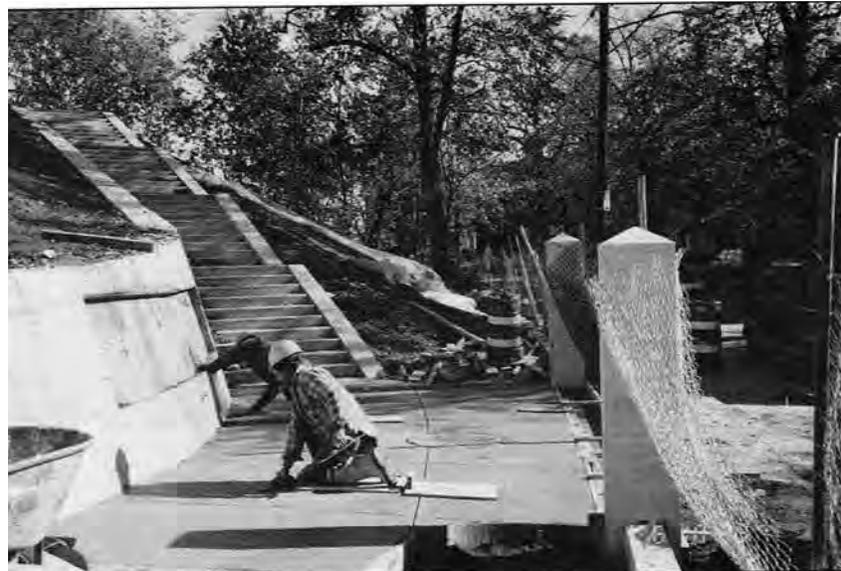
(bottom right) Figure 2-54: Fall 1996, completed stairs, retaining wall and new granite pillars on the southeast entrance of the park at Thomas Park Street. Note the hollow in the retaining wall for the precast park identification signs.

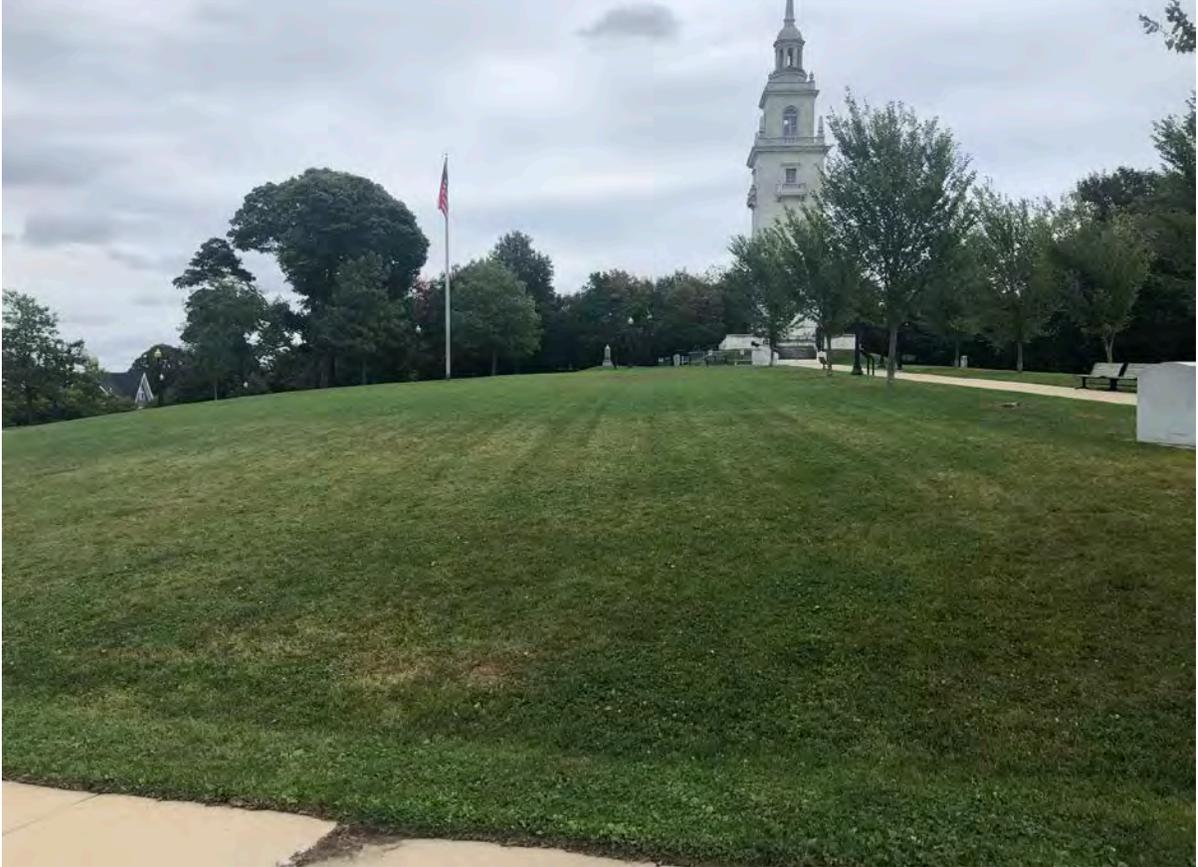
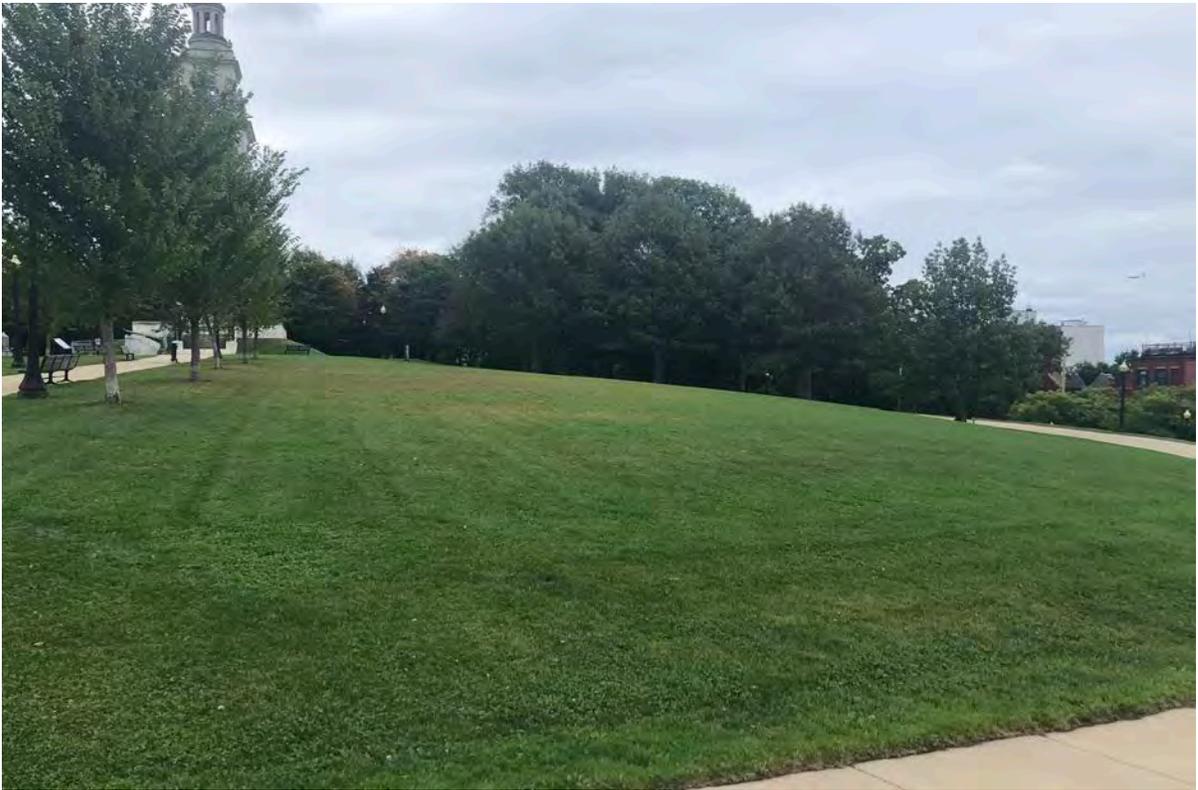
(top) Figure 3-13: Upper lawn panel on the north of the park

(bottom) Figure 3-14: Upper lawn panel on the south of the park

The turf areas of the park fall into two main areas: the upper lawn and the steep sloped areas. As part of the 1995-1997 park rehabilitation project, the entire site was irrigated. (The irrigation was then upgraded in 2013.) All the turf is in good condition save for small wear spots likely from canine urine and some erosion areas on the steep slopes adjacent to the north-south walkway behind the Monument under the dense canopy of the sugar maples; especially on the south side: the soil is bare and roots are exposed. (Figure 3-13 through 3-17)

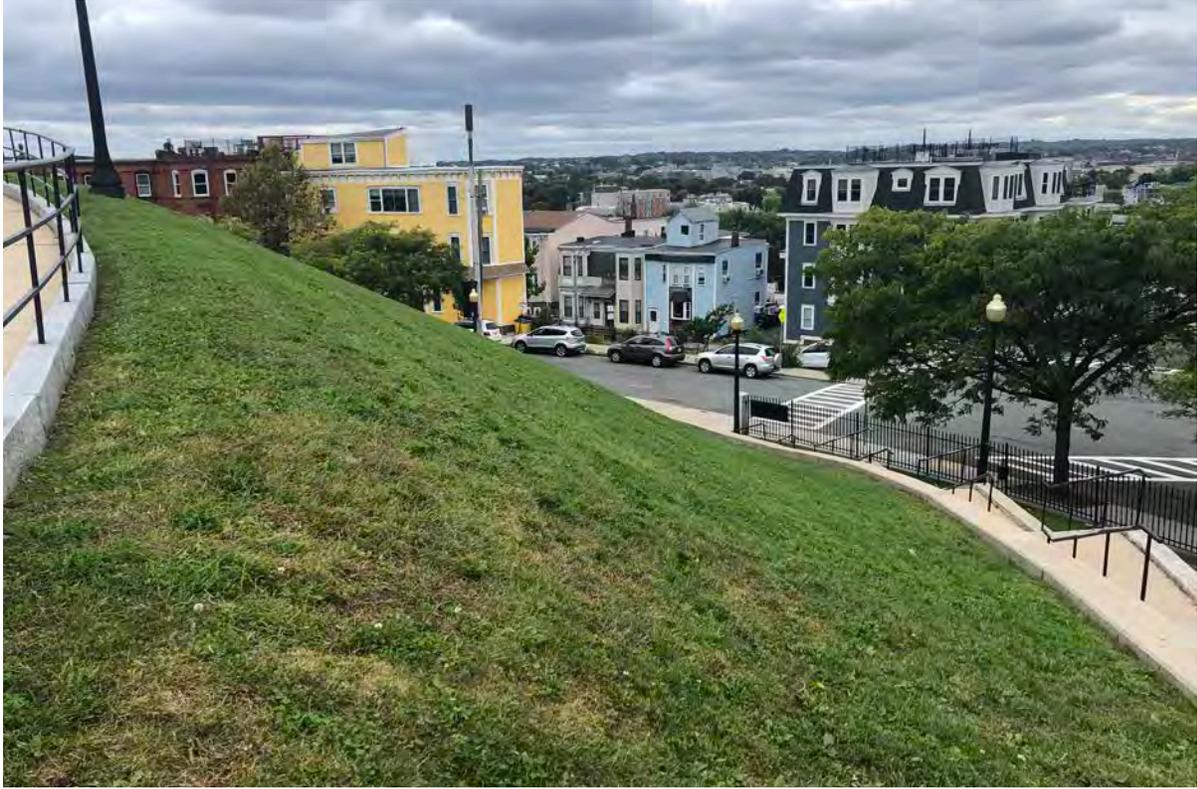
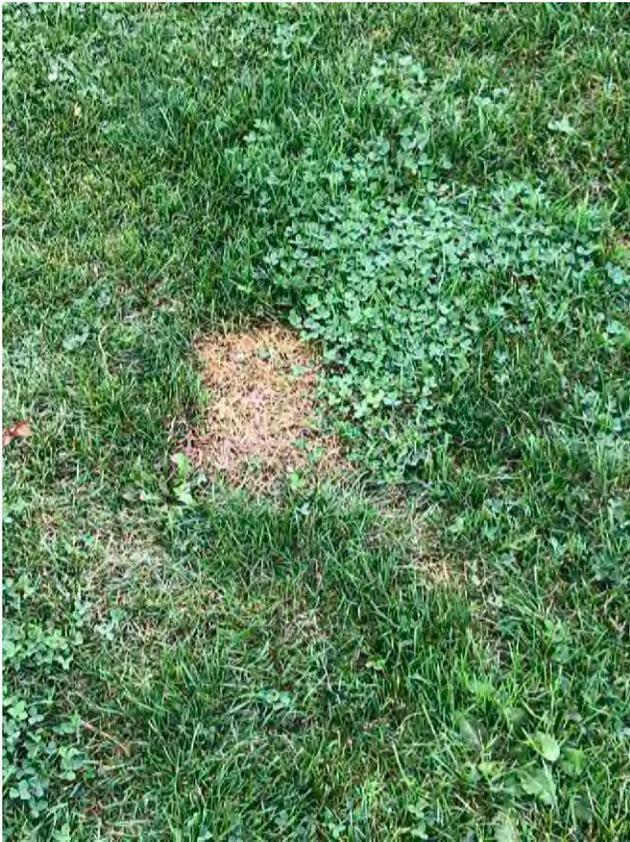
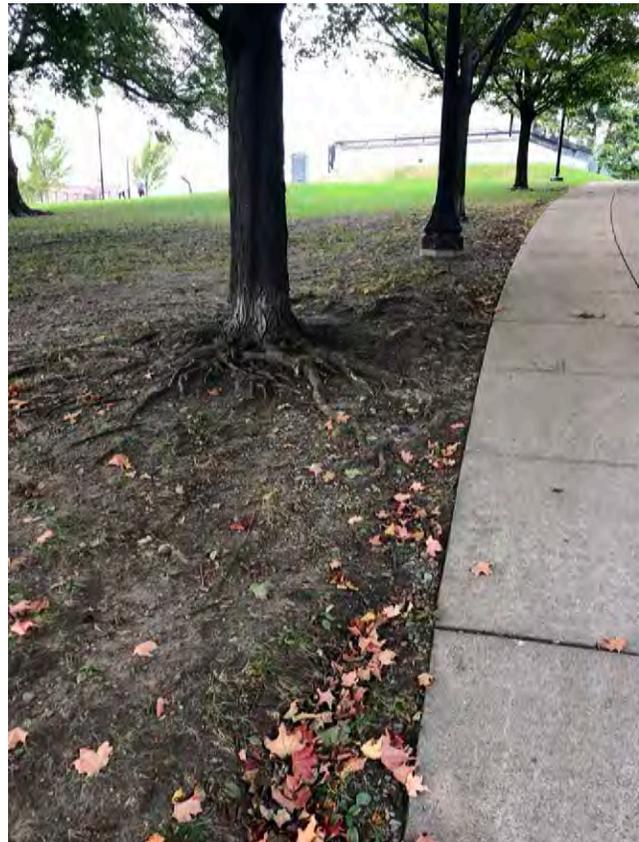
(top) Figure 3-15: The steeply sloping lawn panel towards the west end of the park

(bottom left and right) Figure 3-16 and 3-17: Yellowing of turf; and erosion under sugar maples has eliminated the turf entirely so that the roots are exposed

The slope and soil issues identified in 1994 have been addressed and have held up well except in two relatively minor locations: to the extreme southeast of the park beyond the stairs and to the northwest adjacent to the stairs. In the southeast corner there is evidence of the turf and soils sliding down the steep embankment. In the northwest there is evidence of the soil subsiding at the top set of stair runs. (It is likely no coincidence that the areas where the soil movement is evident is also where the hardscape is in the worst condition.)

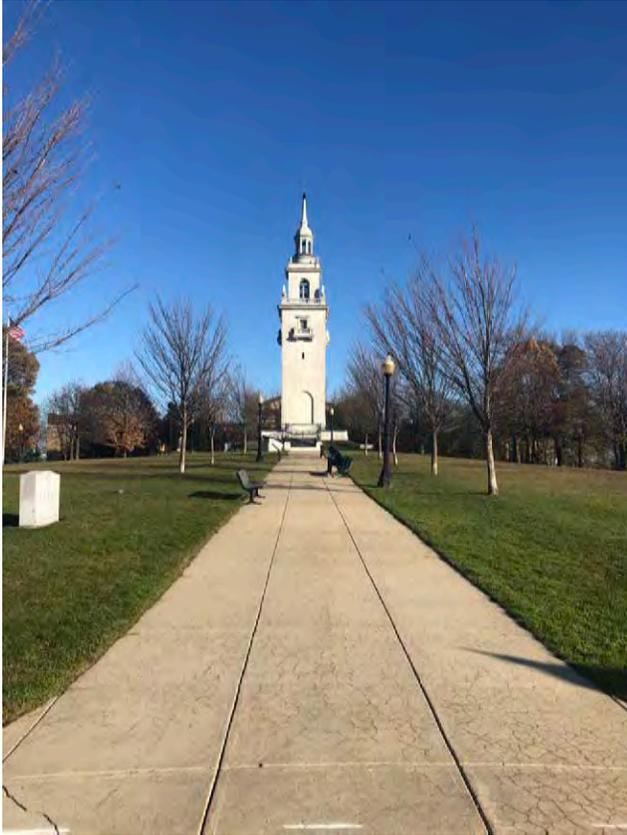
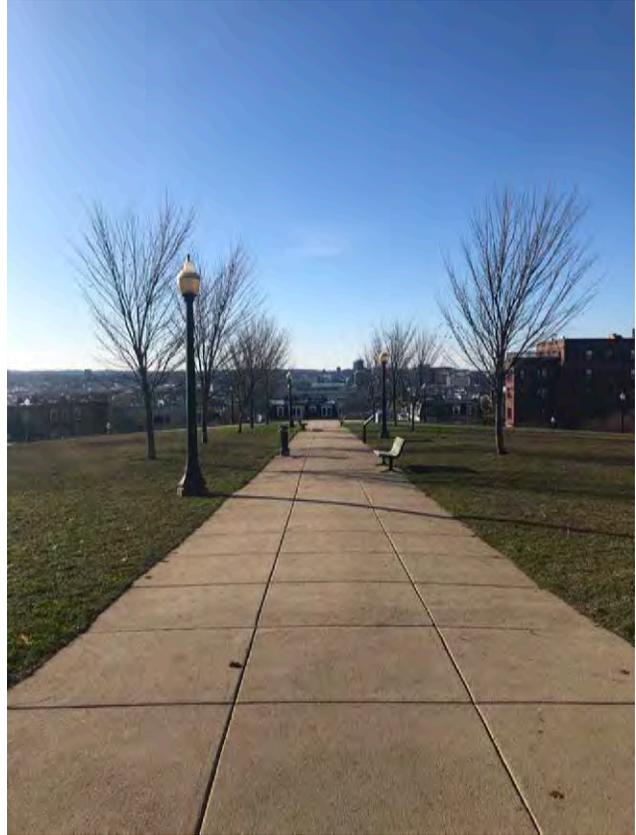
(top left and right) Figures 3-18 and 3-19: Main walkway at east-west axis, looking west toward the Monument and looking east beyond the park landscape

The eastern terminus of the walkway widens out to create a small plaza in front of the Dorchester Heights Monument. The concrete plaza varies from 11 feet at the corners to 24 feet where it meets the axial walk. In this space, the replica cannon and granite mount, a bench, and two interpretive wayside panels have been placed. The wayside to the north is no longer level due to the significant differential settlement that has occurred. (Figure 3-18 and 3-19.)

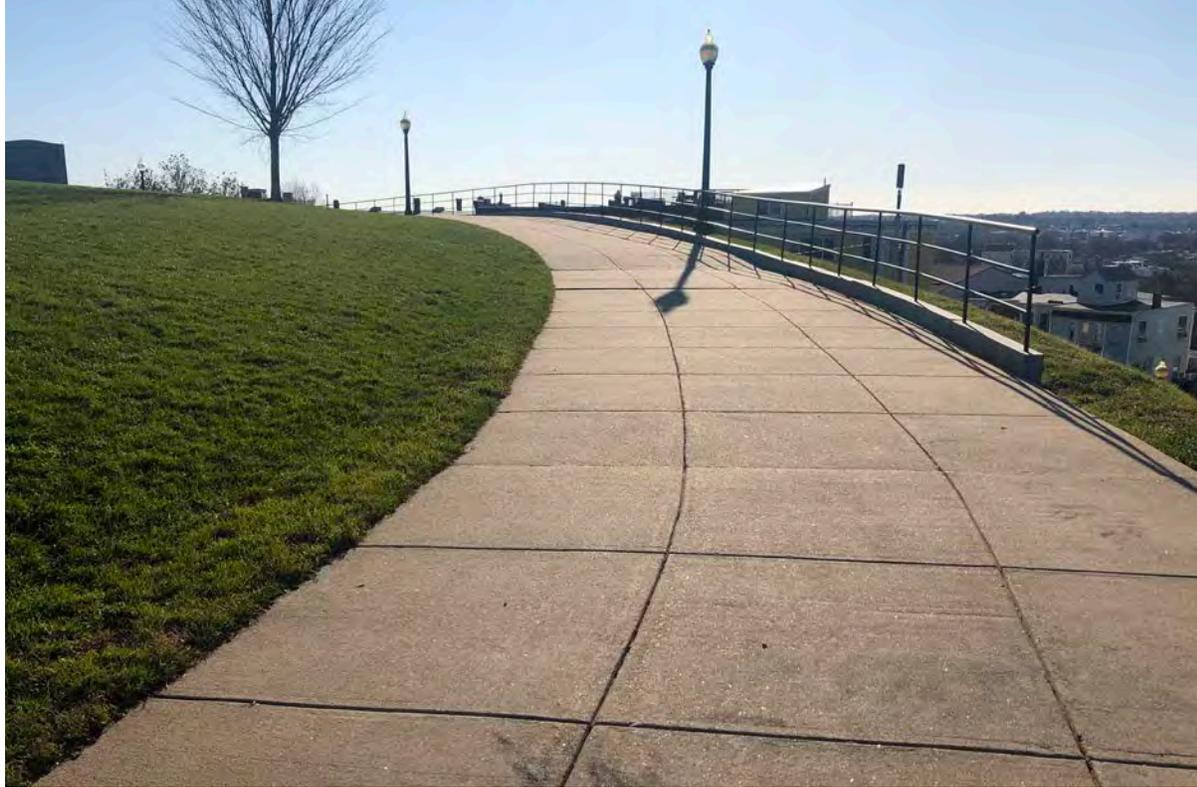
(bottom) Figure 3-20: Main elliptical loop walkway looking southwest

What is apparent is that the intersections of walkways are in the worst condition, likely due to differential settlement. These are the areas where the most spalling and cracking occurs. It is also evident that expansion joints are areas of failure as moisture has gotten into the joints, and the freeze/thaw cycle cracked and damaged the concrete more extensively in these locations. (Figure 3-20.)
