CULTURAL LANDSCAPE REPORT  
DORCHESTER HEIGHTS/THOMAS PARK  
AT BOSTON NATIONAL HISTORICAL PARK

# CULTURAL LANDSCAPE REPORT

## DORCHESTER HEIGHTS/ THOMAS PARK

### AT BOSTON NATIONAL HISTORICAL PARK

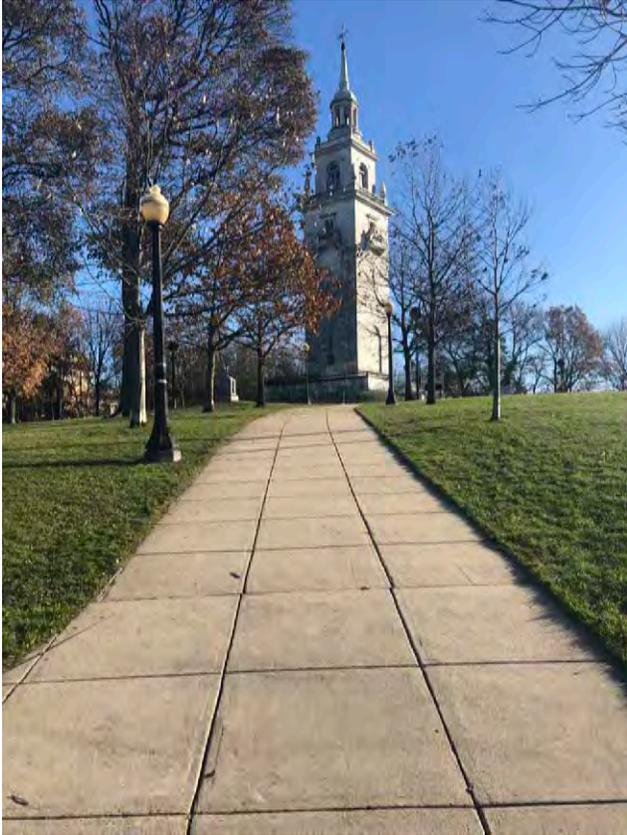
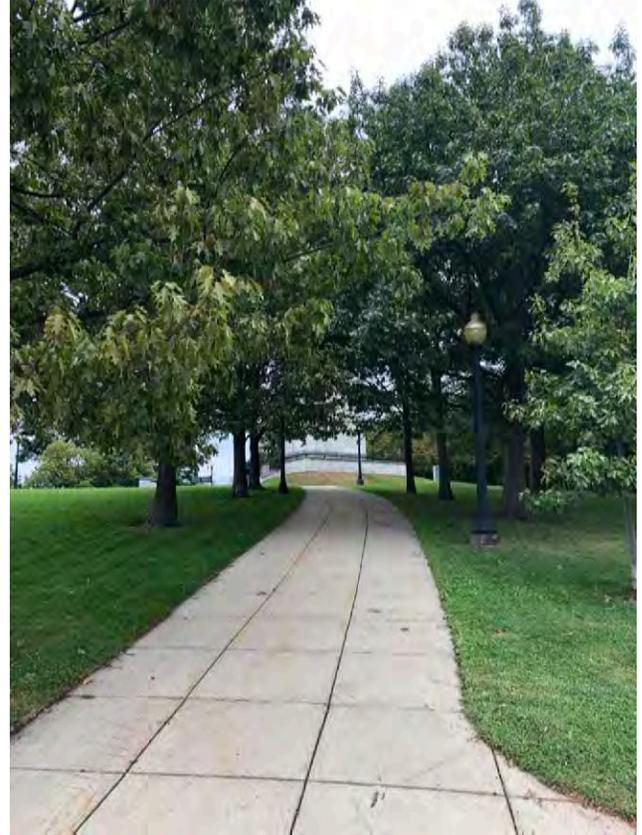
(top left and right) Figures 3-21 and 3-22: Northwest-southeast radial walkway and the northeast-southwest radial walkway  
(bottom left and right) Figure 3-23 and 3-24: North-south walkway along high school fence

These walkways radiate from the Dorchester Heights Monument to the main loop walkway. They consist of a 10-foot wide concrete walk and pitch with a slope of 10 percent (approximate). These walks are in fair condition with minor cracking. (Figure 3-21 and 3-22.)

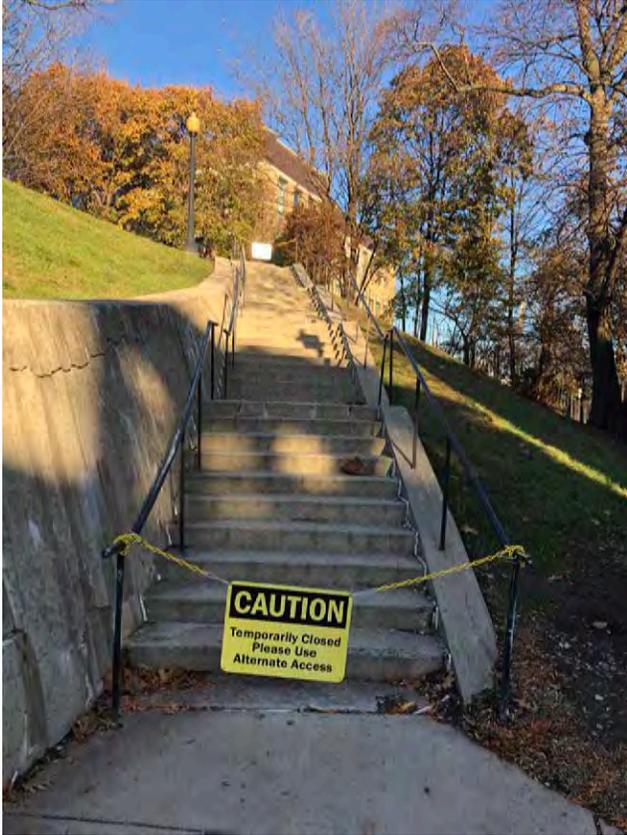
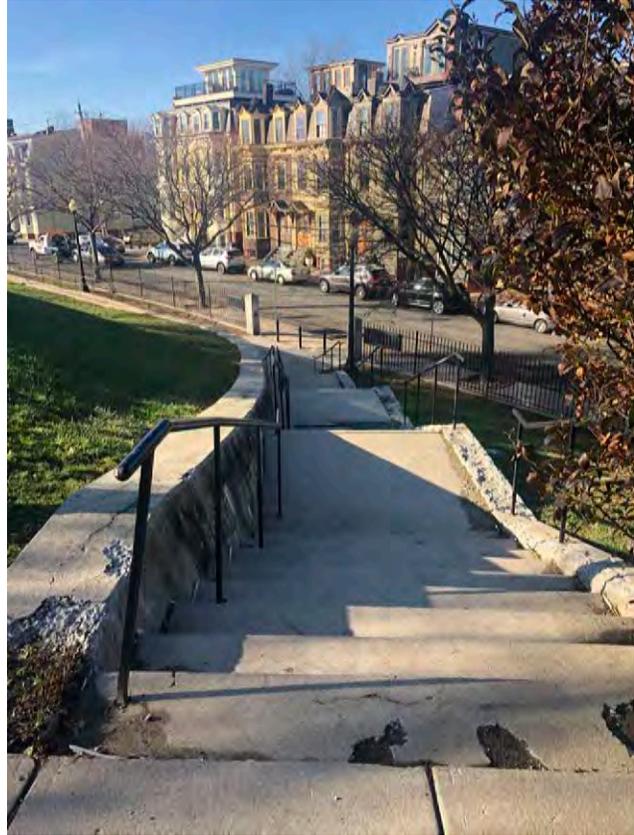
(top left and right) Figures 3-30 and 3-31: Closed stairway to the southwest and open stairway at the northwest  
(bottom) Figure 3-32: Western stairs showing cracking and spalling on the steps and walls

The northeast and southeast stairs consist of four sets of stairs with a battered retaining wall on each side. The interior wall connects west along the interior side of the ramped walkway. At the top of the stairs, the top landing has separated from the wall return 1 to 2 inches in several locations and has settled differentially. The stairs have separated from the retaining wall substantially and efforts to fill joints have repeatedly failed. Each landing between stair run shows varying degrees of differential setting. (Figures 3-30 and 3-31)

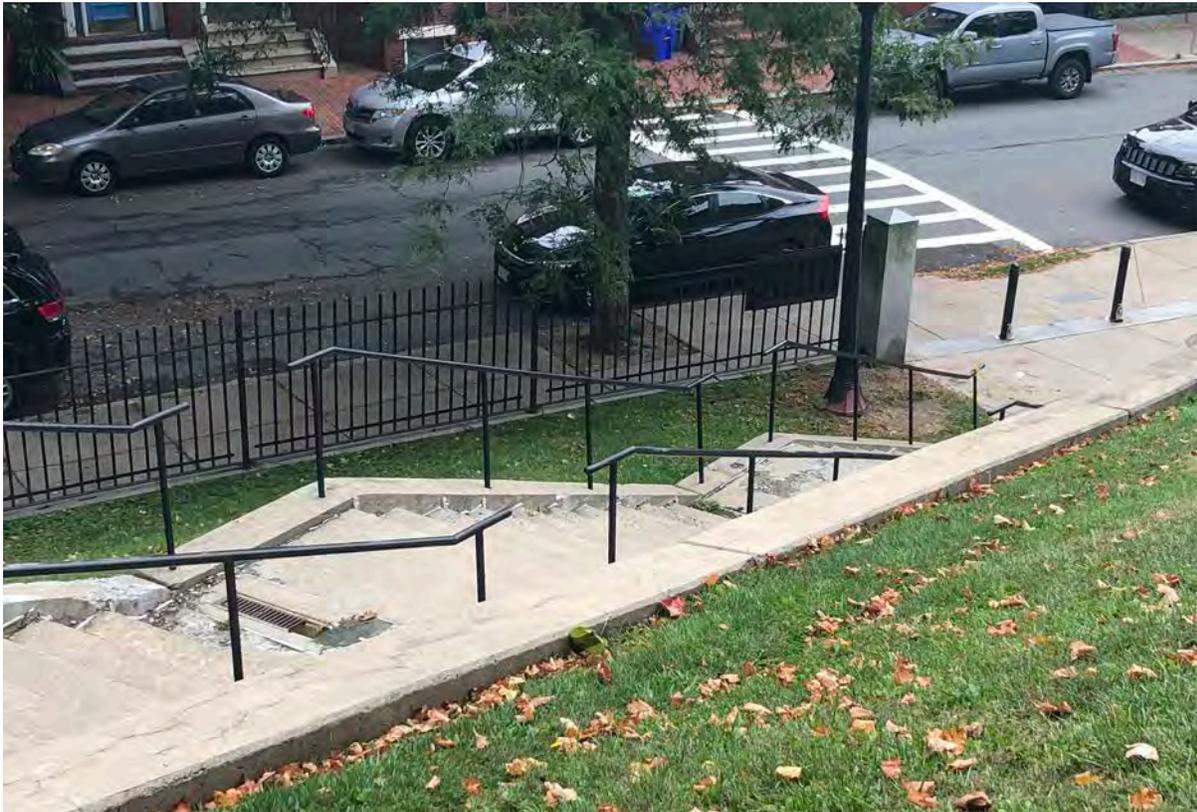
(bottom) Figure 3-41: Sample stair handrail

The ramp handrails have a gripping surface of 1-3/4-inch diameter and are at 32 inches to 34 inches above the finished grade. The posts are 1-inch square and on the inside of the ramps are set in the ramp concrete pavement. On the outside of the ramp, the handrail is set in the retaining wall and has an intermediate rail at around 22 inches above the finish grade of the ramp. The mid-rail is a one-inch round rail apparently intended to serve as a guardrail though it does not meet International Building Code.

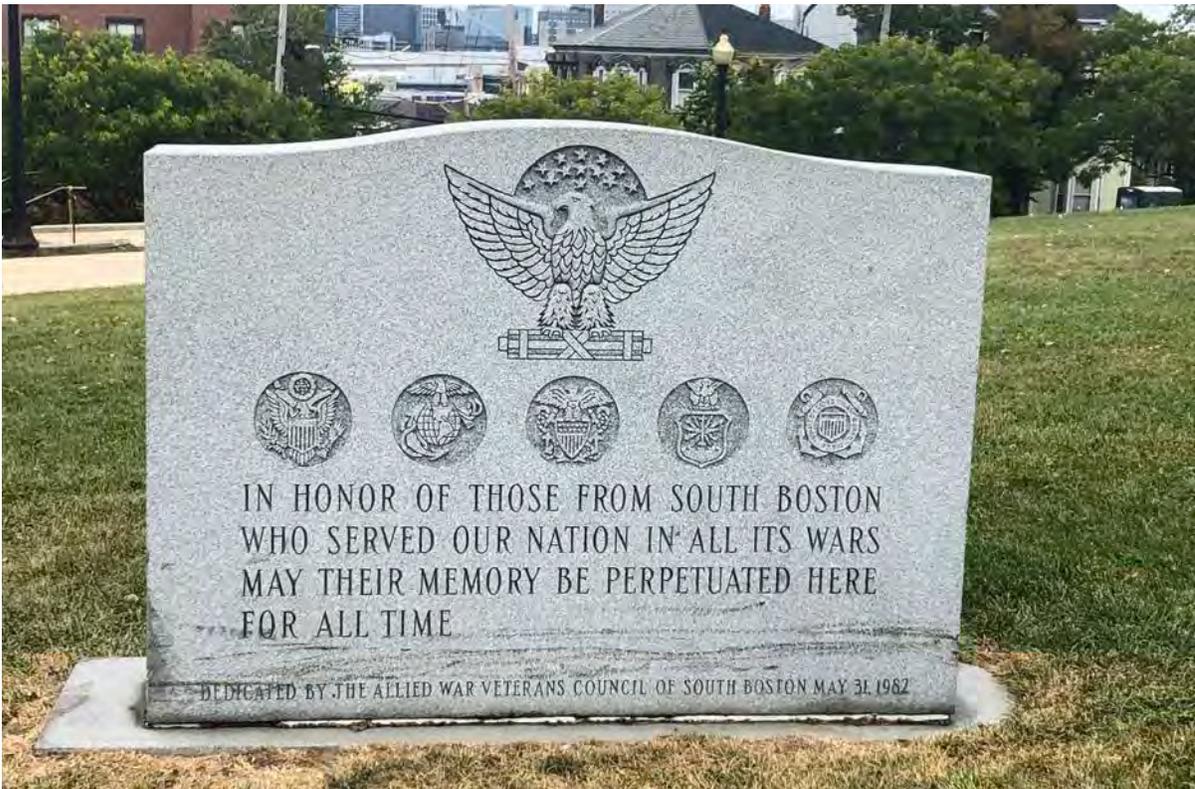
(bottom) Figure 3-46: Allied War Veterans Monument erected in 1982. Shows damage likely from maintenance equipment.

As this monument is relatively new, it is in good condition, though it has a series of dark markings at its base which is likely from lawn mowing equipment.

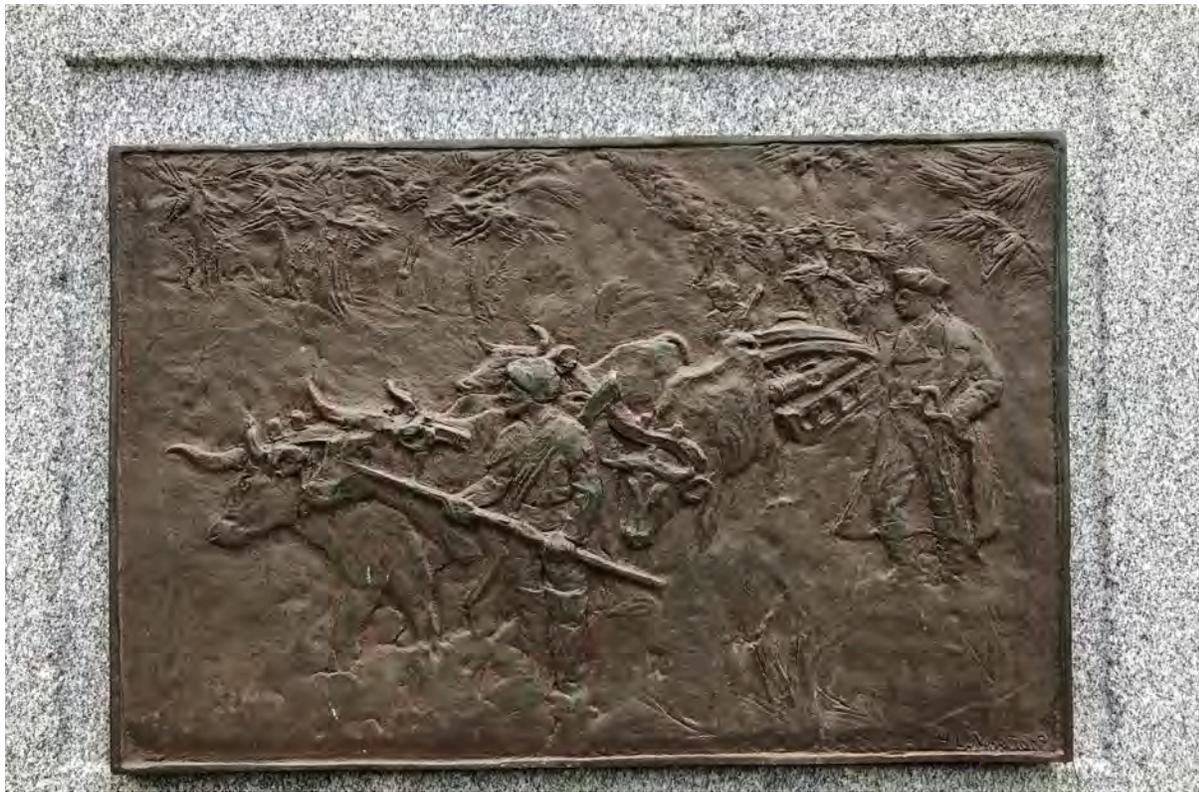
(bottom) Figure 3-49: Close-up of the bronze bas relief plaque depicting Knox's efforts to bring the cannon from Fort Ticonderoga.

The monument is a three-foot high by ten-inch wide slab of pale granite, polished on the face and rough-hewn on three sides. Above the text is set a bronze bas relief plaque. The plaque was designed by sculptor Henry L. Norton (1873-1932), an American sculptor who ran a bronze tablet factory in Boston. It features oxen pulling cannons on sleds, with soldiers behind them. A similar but larger bas relief which included the text within the bronze plaque was designed by Henry James Albright for the New York monuments. An additional marker was placed on Cambridge Common, site of Washington's camp headquarters. In 2009, a marker was added to the Roxbury Heritage State Park, adjacent to Major General John Thomas's house. Thomas oversaw the delivery of the weapons to Dorchester Heights.

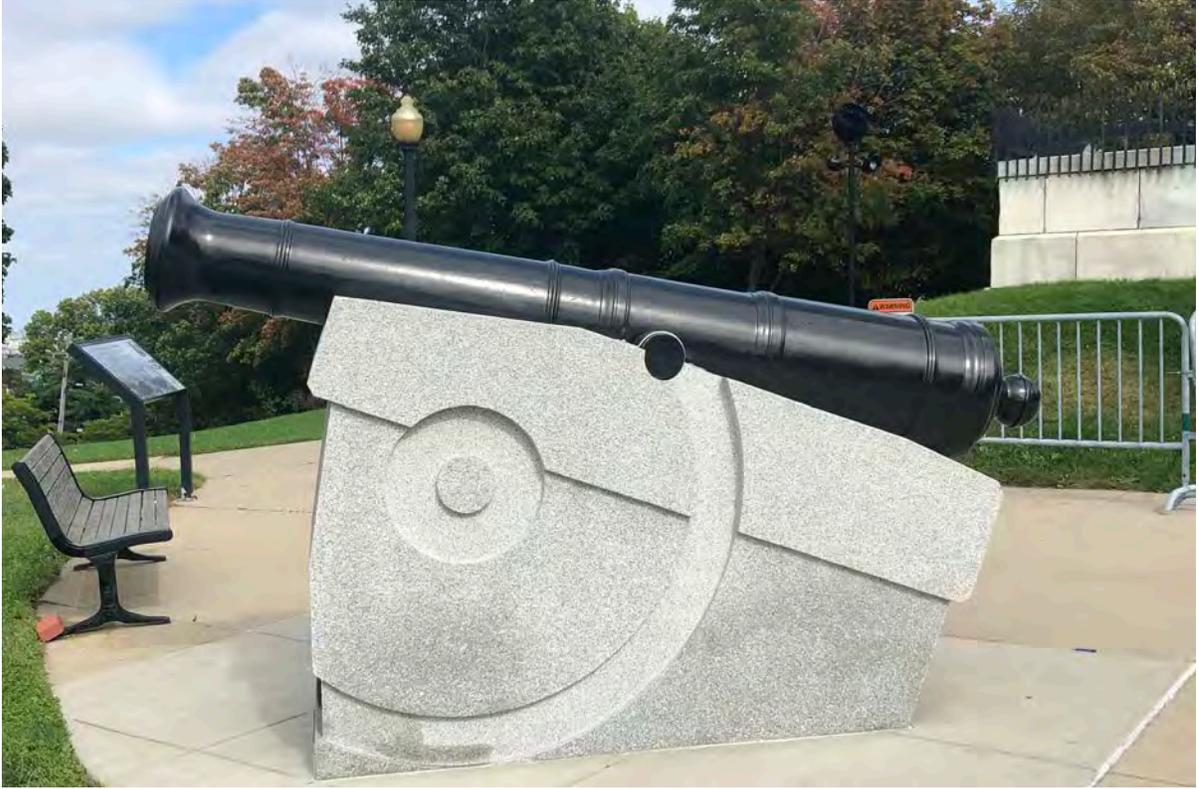
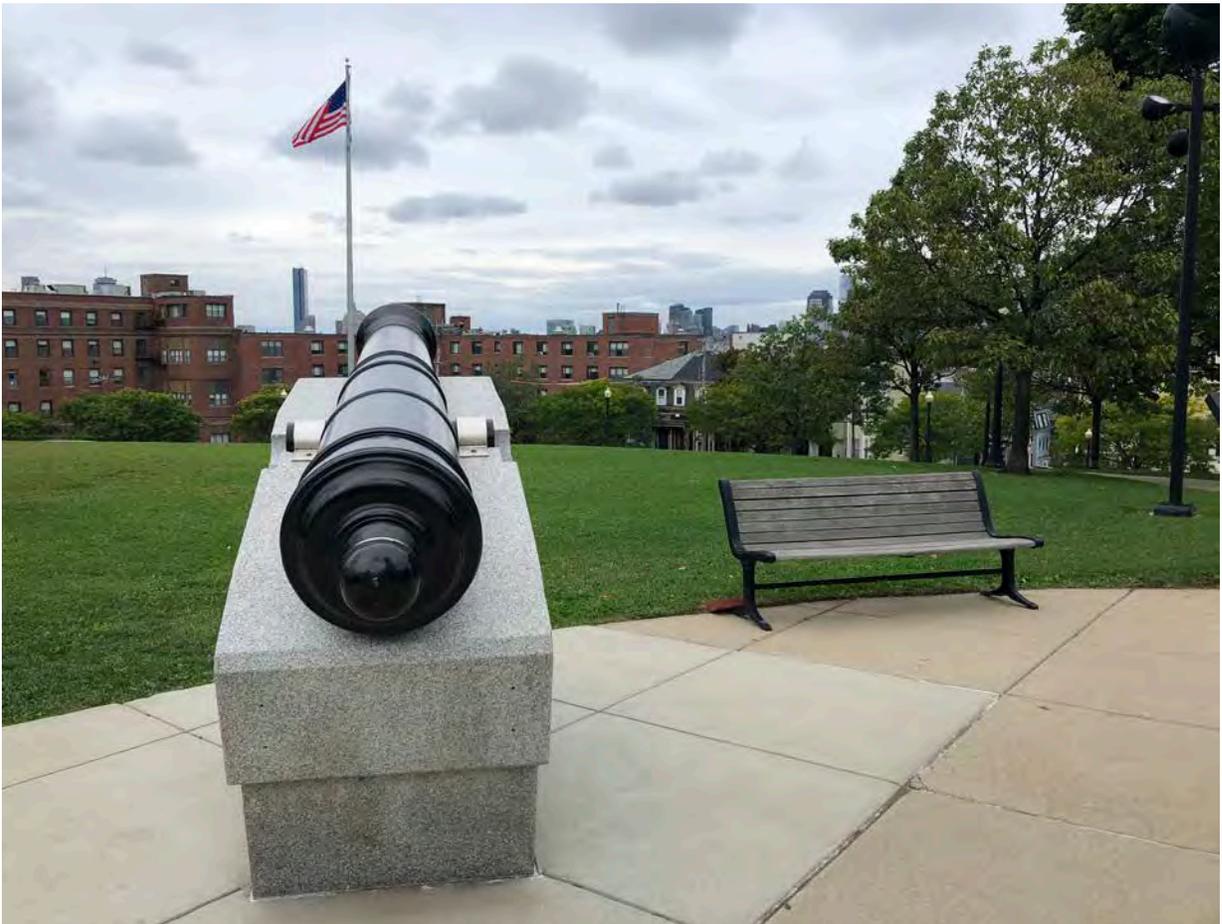
(top and bottom) Figures 3-50 and 3-51: Replica cannon and granite mount aimed towards Boston

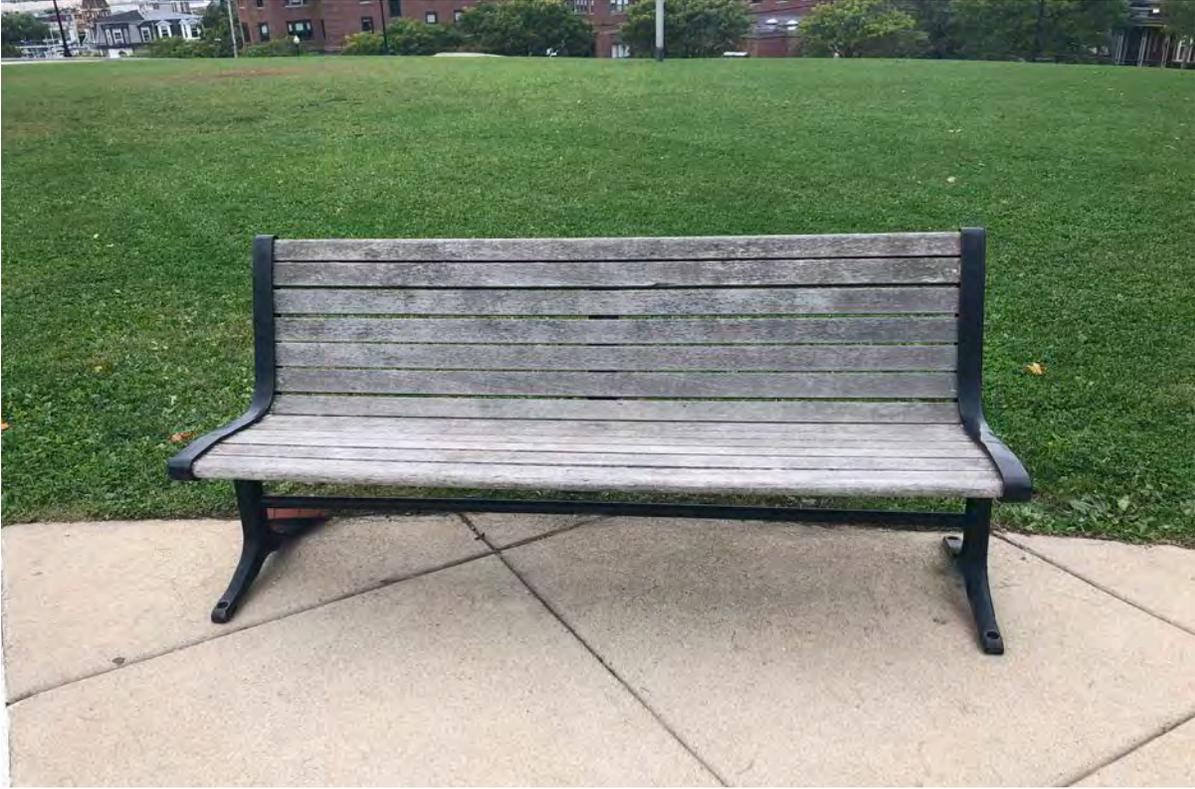
(top) Figure 3-52: Victor Stanley bench installed in 1990s

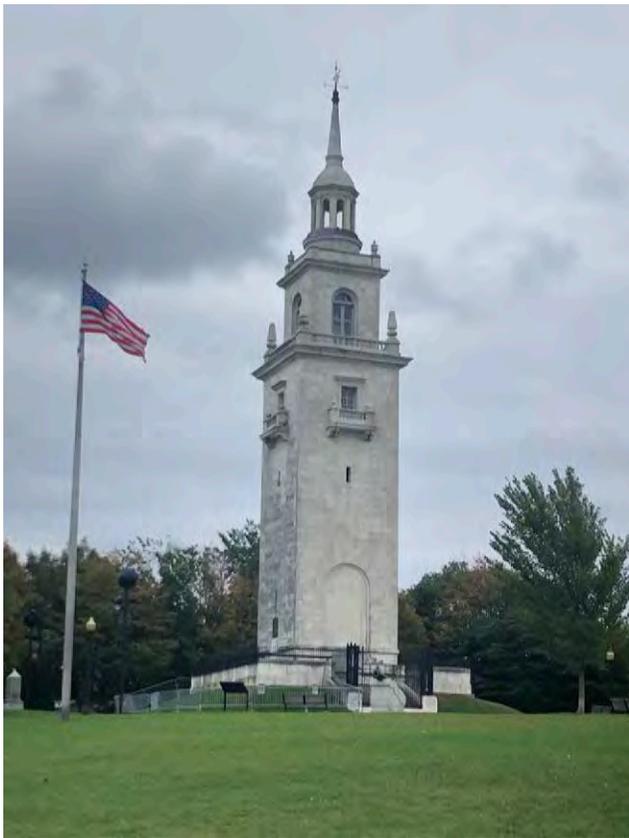
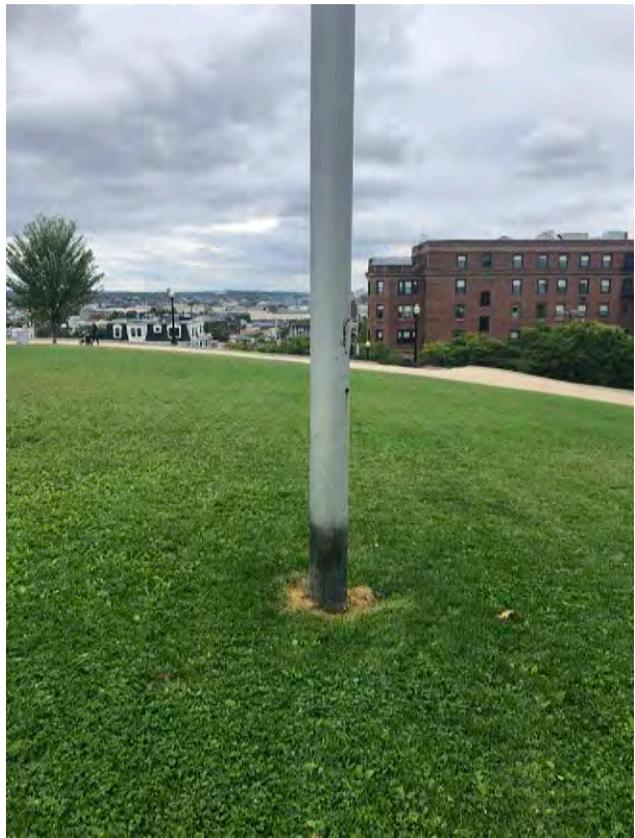
(bottom left and right) Figures 3-53 and 3-54: Flagpole installed to the northeast of the Monument; close-up of the base of the flagpole

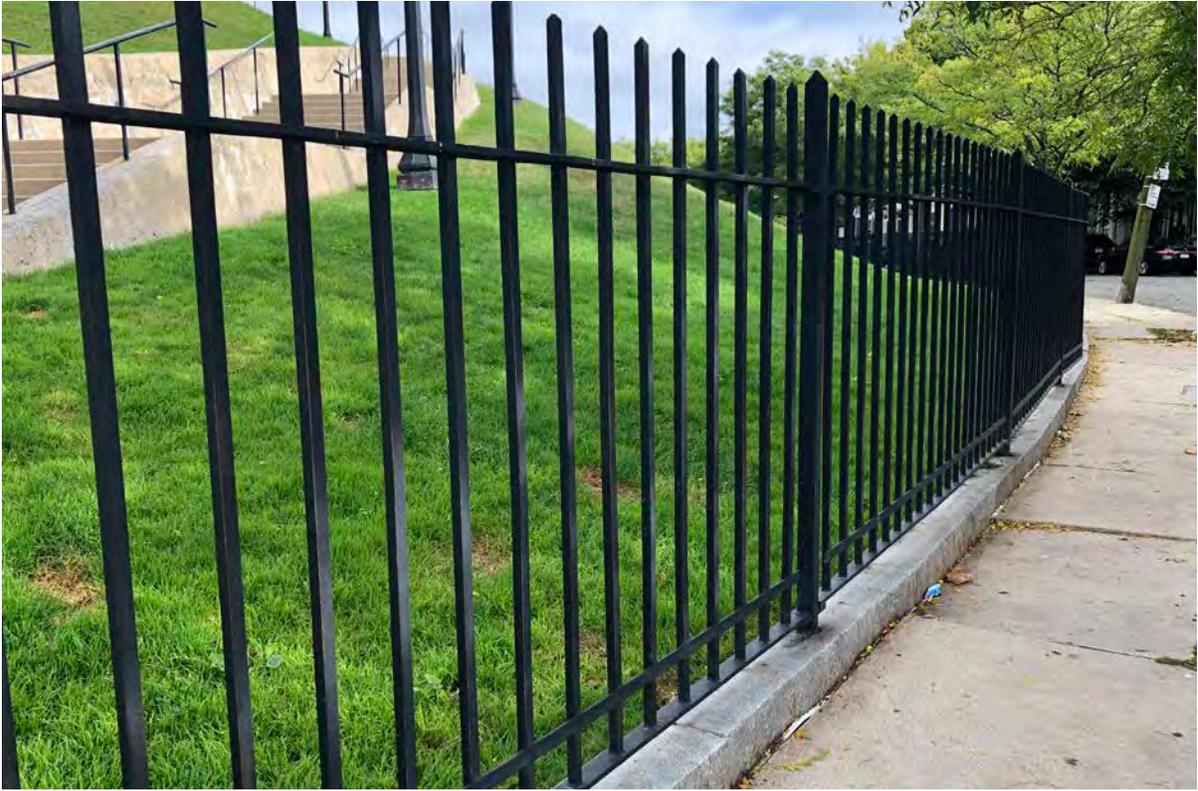
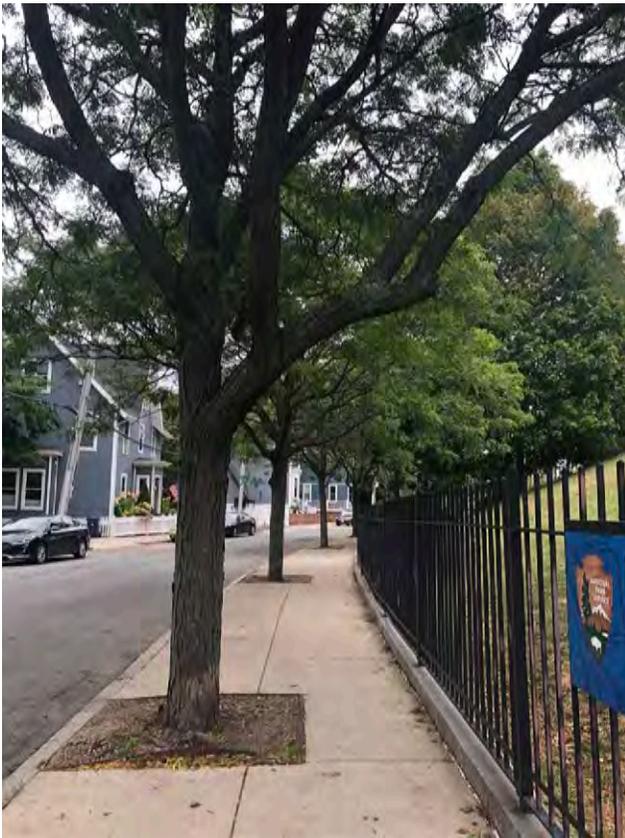
A black wrought iron fence runs around the perimeter of the park at the sidewalk at Thomas Park Street on a vertical granite curb that is 8 inches wide and has a 6-inch reveal above the finished sidewalk grade. The fence consists of 2-inch square posts at 10 feet on center; the post extends to a height of 63 inches above the vertical granite curb in which it is set. The pickets are 7/8-inch square and occur between the posts at six inches on center. Horizontal rails 1/2-inch by 2 inches occur 2-1/2 inches and 50-1/2 inches above the granite curb. A third vertically-oriented rail, located 7-1/2 inches above the bottom rail and is 3/8-inch by 1-1/4-inch. The fence line breaks at the three main entrances and at each of these entrances, the fence terminates in a granite column that is 16 inches square 6 feet tall with a 6-1/2-inch pyramidal top (inclusive of the 6 feet). (See Figures 3-55 through 3-57.)

The fence is generally in good condition after having been refurbished in the late 1990s, but this fence is difficult to date. In the physical history section of this report (Section 2) it is noted that the fence was removed in 1881. The 1901 view from Carney Hospital (Figure 2-31) shows an iron picket fence similar in style to the one which exists today though much shorter. However, neither the 1913 survey nor 1941 plan indicate a fence at all. Not until the NPS master plan of 1951 is an iron picket fence indicated.

(top) Figure 3-55: Historical wrought iron picket fence on granite base

(bottom left and right) Figures 3-56 and 3-57: wrought iron fence at Thomas Park Street sidewalk and terminal granite pillar at park entries

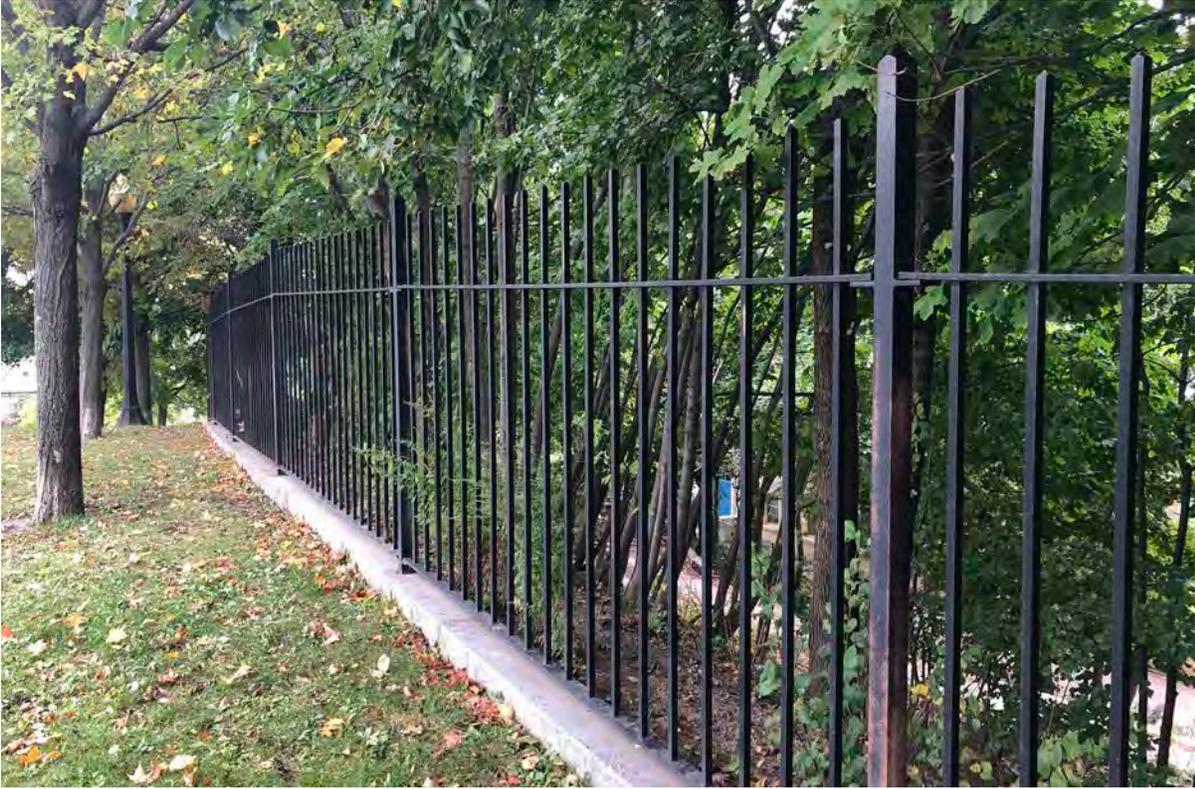
(top) Figure 3-58: Steel picket fence at South Boston High School property division

What was once a chain link fence at the rear of the site along the east side of the north-south walkway has been replaced by a steel fence, Figure 3-58. Despite being steel, this fence is stylistically coordinated with the fence which encircles the landscape on Thomas Park Street, including the granite curb. The fence is set 9 feet off the concrete walkway. (This fence was installed as part of the 1995-1997 rehabilitation.)

The fence is comprised of 2-inch square posts which are set 10 feet on center and stands 66 inches above the vertical granite curb. The two rails are located 2-1/4 inches and 49-1/4 inches above the vertical granite curb which is 8 inches wide with a 4-1/2-inch reveal above finished grade. The pickets are 3/4-of-an-inch square, are spaced at 6 inches on center, and are 4 inches shorter than the posts. This fence is in fair condition without much damage; though the finish is wearing off and needs to be refurbished.

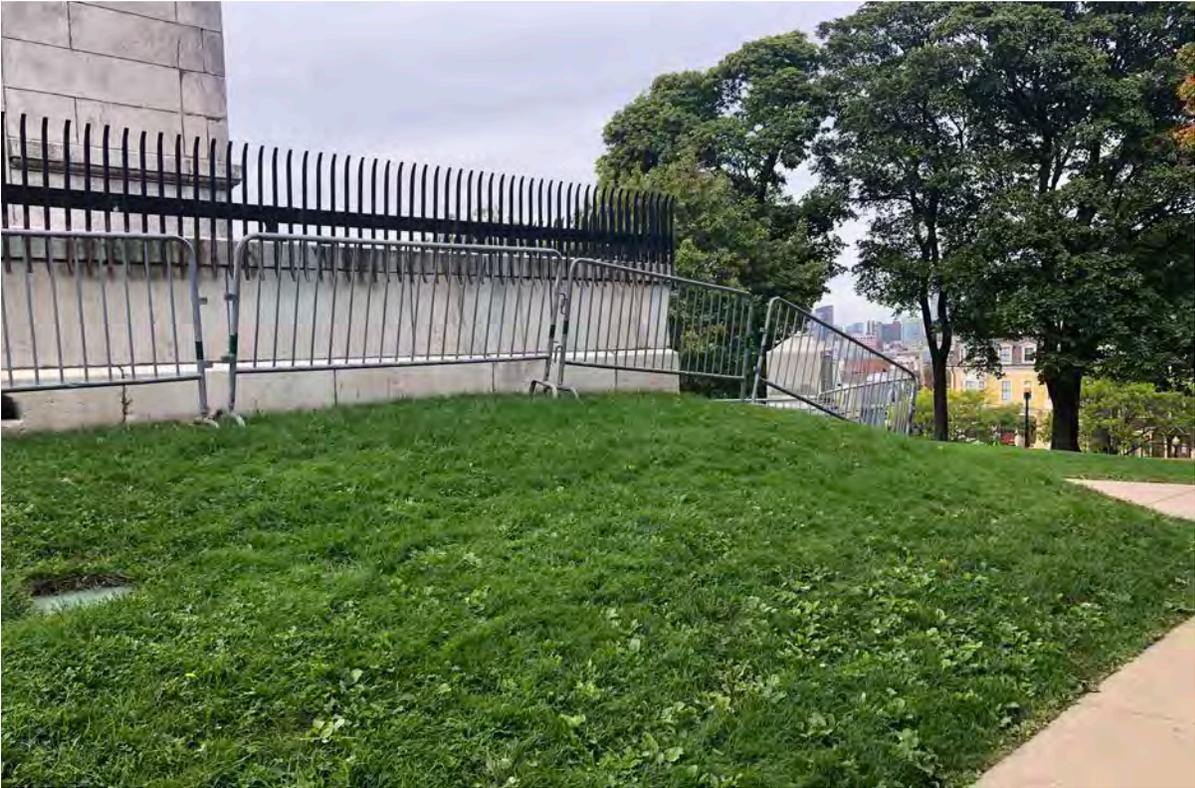
(bottom) Figure 3-59: Temporary protection fencing at the base of the Monument's north side

On the north side of the Dorchester Heights Monument a temporary security fence has been placed. It is movable and has been combined with signs that read "WARNING: Hard hat area". The fencing runs from the left side of the Monument's marble stairs and wraps around to the back side. It is assumed that these have been placed due to the potential hazard of falling debris. (Figure 3-59)

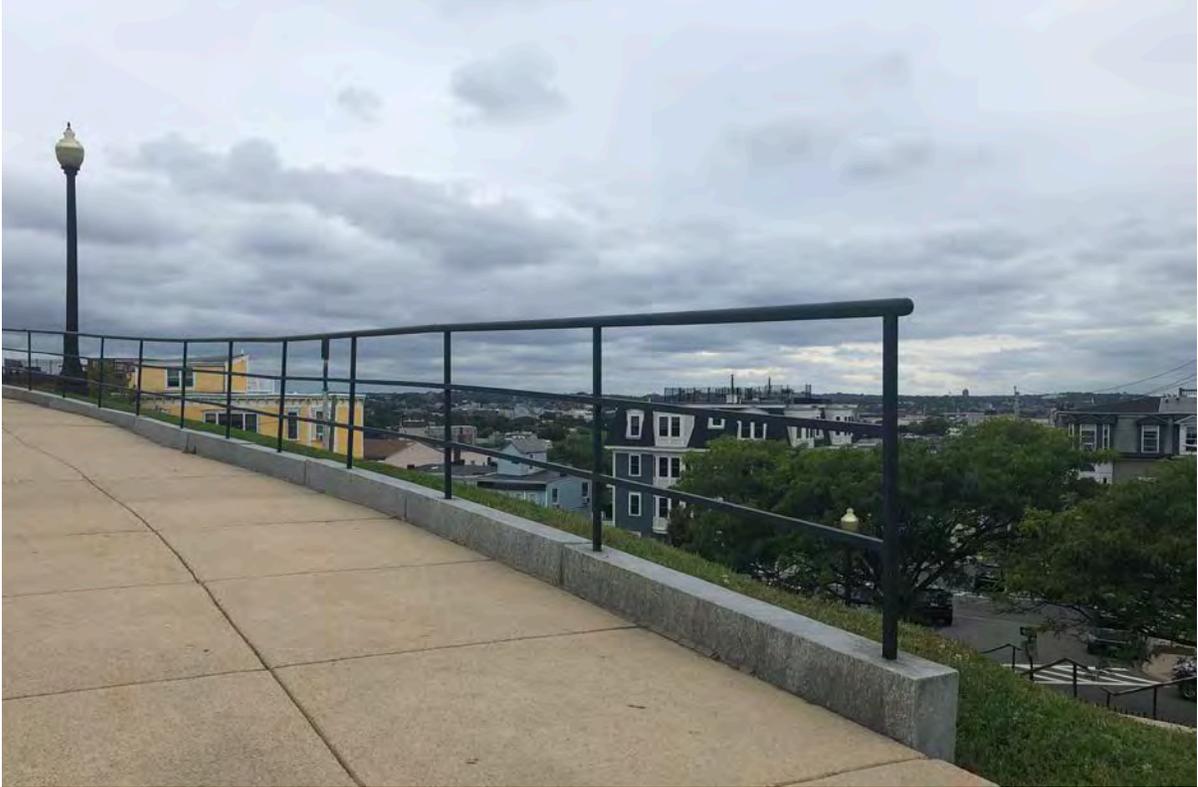
(top) Figure 3-60: Steel guardrail on granite base at the loop walkway overlooking Old Harbor Street

At the apex of the park, on the western end, a guardrail on a granite curb was installed at some time after the rehabilitation that occurred in the late 1990s. (Figure 3-60) The guardrail has three horizontal rails at 33-1/2 inches, 21-1/2 inches, and 10-1/2 inches above the vertical granite curb in which it is secured. The top rail is round with a 1-3/4-inch diameter and the lower rails are 1-inch square. The granite curb is 6 inches wide with a 7-1/2-inch to 8-inch reveal and runs for approximately 186 linear feet. While the guardrail is not technically required by International Building Code, it separates the walkway from the steeply sloped (2 to 1) lawn that drops 22 feet down to the road, making the walkway feel more comfortable with the addition of the guardrail. It appears that this guardrail was added in 1999 or shortly thereafter; a plan dated April 10, 1999 entitled "Sign Type 1 and 4 Location Plan" labeled as sheet number GR-8 is marked up with a label location of rail.<sup>9</sup> The mark-up, though, shows the guardrail extending fully from stair to stair, which is longer than was actually installed.

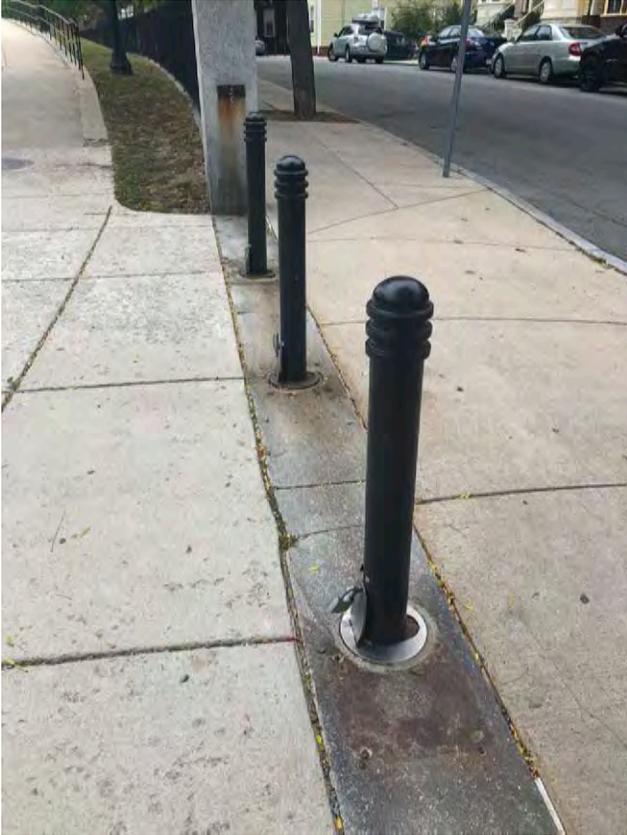
(top left) Figure 3-62: Removable bollards set in historical granite band at north and south entrances (top right) Figure 3-63: Plaque commemorating Congressman Moakley dedication to the park

At each of the three entrances, between the granite pillars, is a granite band which continues the line of the cast iron fence. The granite band is 16 inches wide and in fair condition with little cracking save where old bolt holes from previous bollards are visible.

In the granite band at both of the two side entrances is a set of three steel removable bollards (see BO-# on Figure 3-I for locations), centered on the gate opening. The bollards are powder-coated black and are padlocked in place in a steel sleeve. They are 5-1/2 inches in diameter by 3 feet high with segmented rings and a rounded top. (Figure 3-62). Each group consists of three bollards approximately 6 feet apart with no chain. The bollards are in good condition. These bollards were installed in 2013.

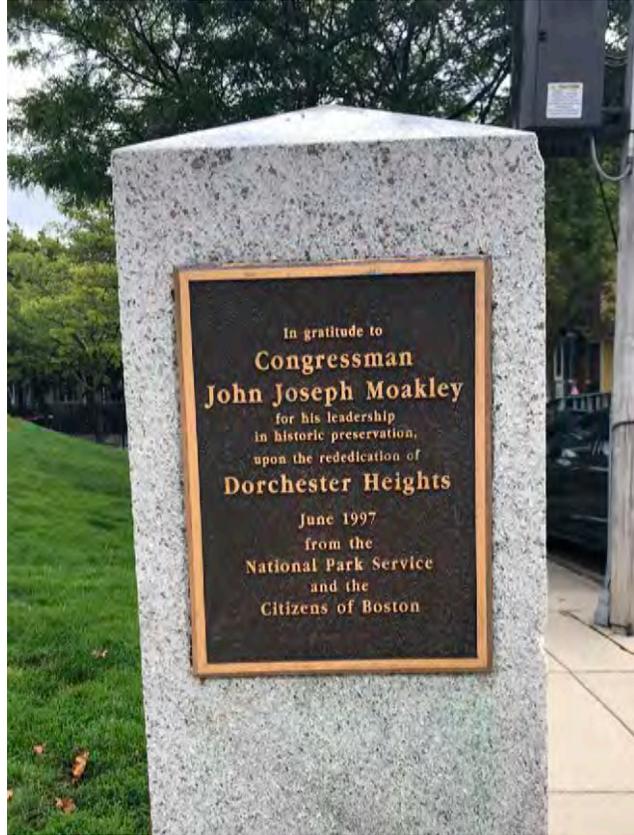
4. At the main entrance off Old Harbor Road is a bronze plaque which is mounted on the right column facing the entrance. (Figure 3-63) It reads:

In gratitude to  
Congressman John Joseph Moakley  
for his leadership  
in historic preservation/upon the rededication of  
Dorchester Heights  
June 1997  
from the National Park Service  
and the Citizens of Boston

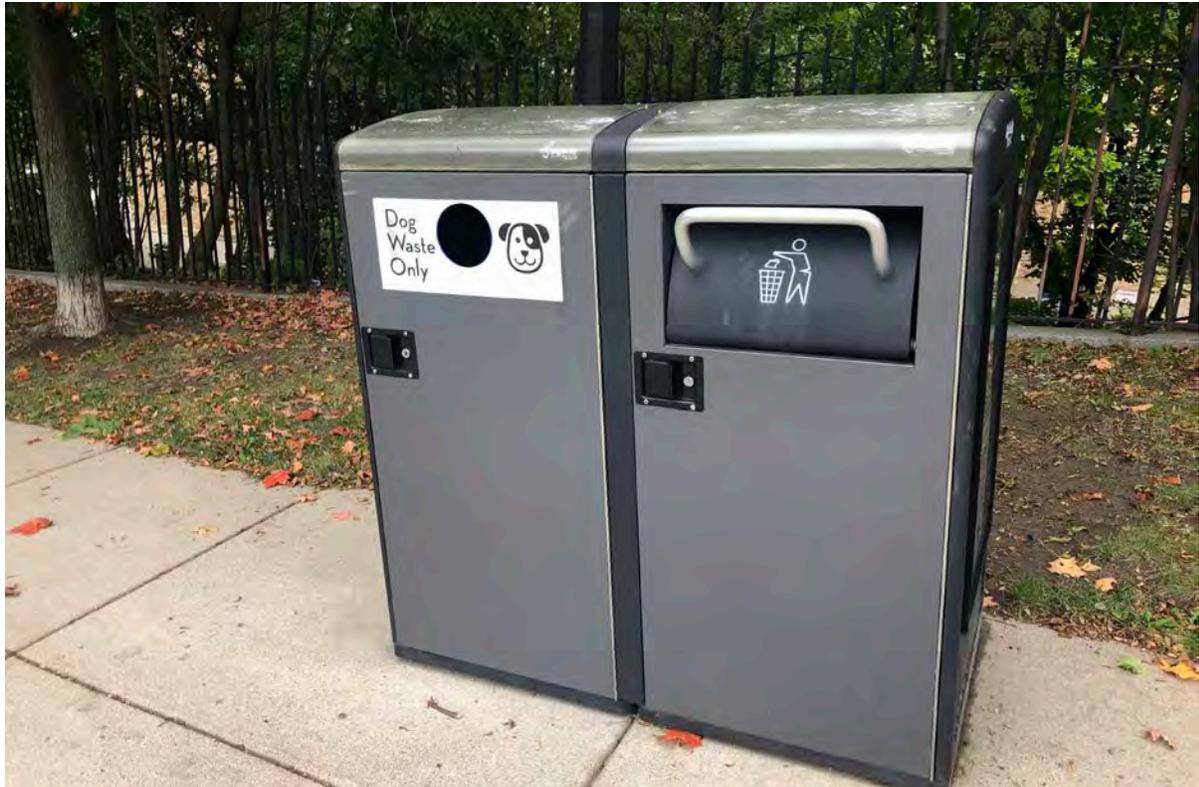
(bottom) Figure 3-64: Waste and dog waste bins

Three sets of waste bins have been located around the site. All are Big Belly bins and are paired: one solar composting trash bin with a dog waste bin accompanying it. No recycling bins have been included on site. (See T-# on Figure 3-I and Figure 3-64). These bins were installed in either late 2014 or early 2015 and replaced other trash receptacles.

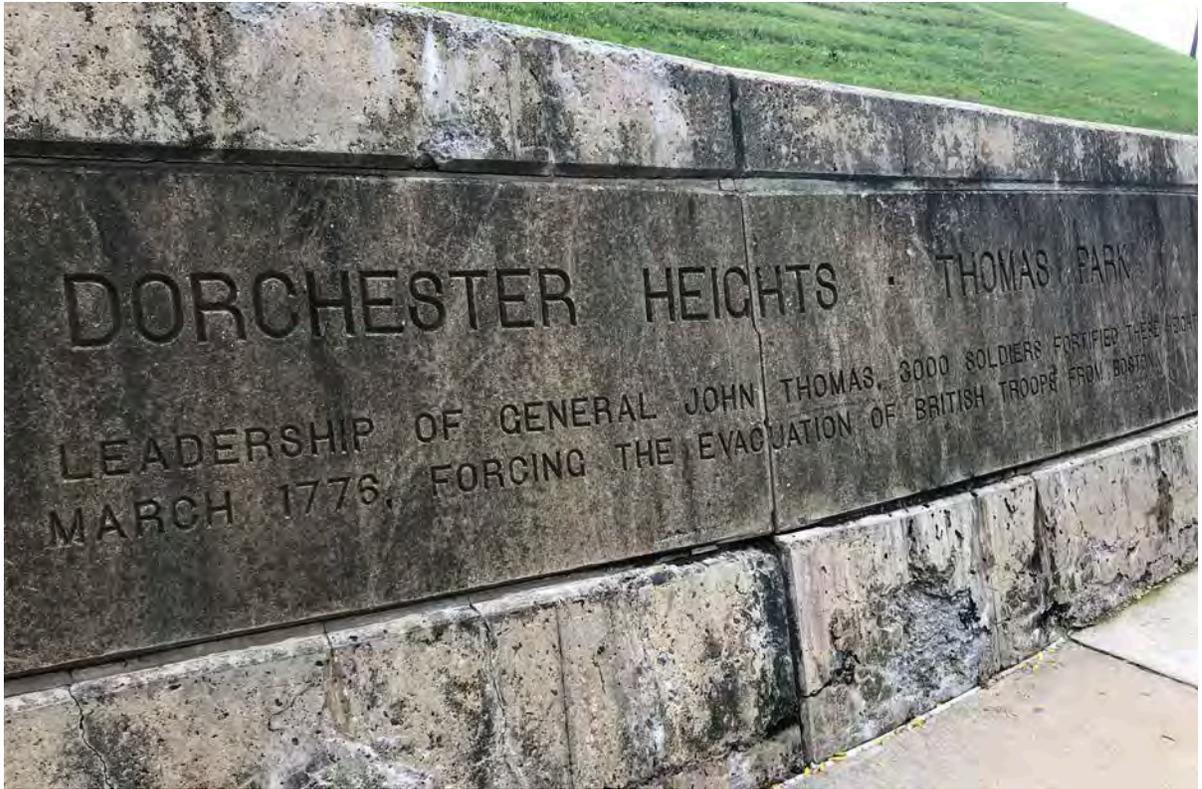
(top) Figure 3-65: Precast concrete park identification signs

1. The first type is the precast concrete park identification signs which date to the site rehabilitation completed between 1995 and 1997. The panels are in fair condition but the walls in which they are placed are in very poor condition. The panels on the north side have become very dark since their installation. (Figure 3-65)

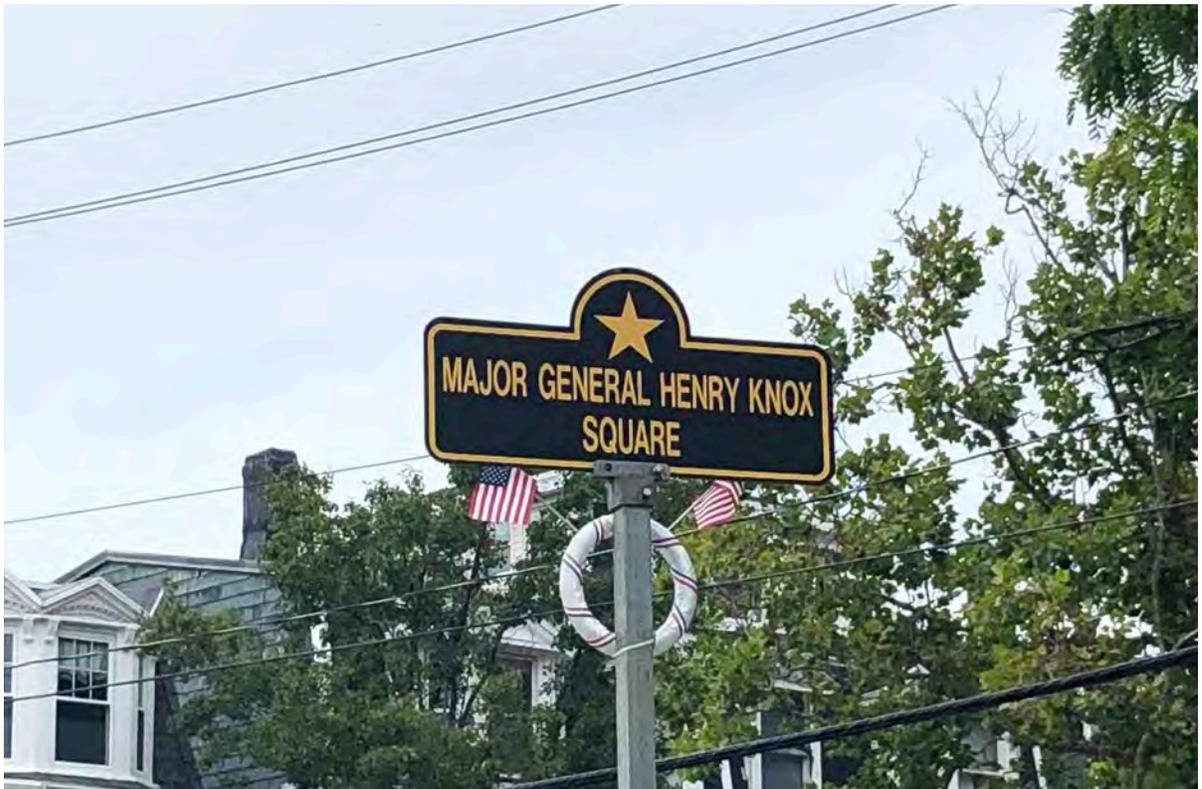
(bottom) Figure 3-66: Major General Henry Knox Square identification sign at Old Harbor Street entrance

- 
5. Three interpretive waysides were installed in 2013, as described in Section 2. Two are located in front of the Dorchester Heights Monument on the plaza and one is located on the north side of the axial walkway. (Figures 3-69 through 3-71) Two of the three the graphics are in good condition, but the third had damage to the graphic panel. The panel holder on the north side of the plaza is no longer level due to the differential settlement of the soils and concrete pavement.
  6. Street Sign-style Memorial Marker: On the sidewalk of Thomas Park Street near the intersection with Old Harbor Street is a street sign-style of sign which reads “Major General Henry Knox Square”. (Figure 3-66.)

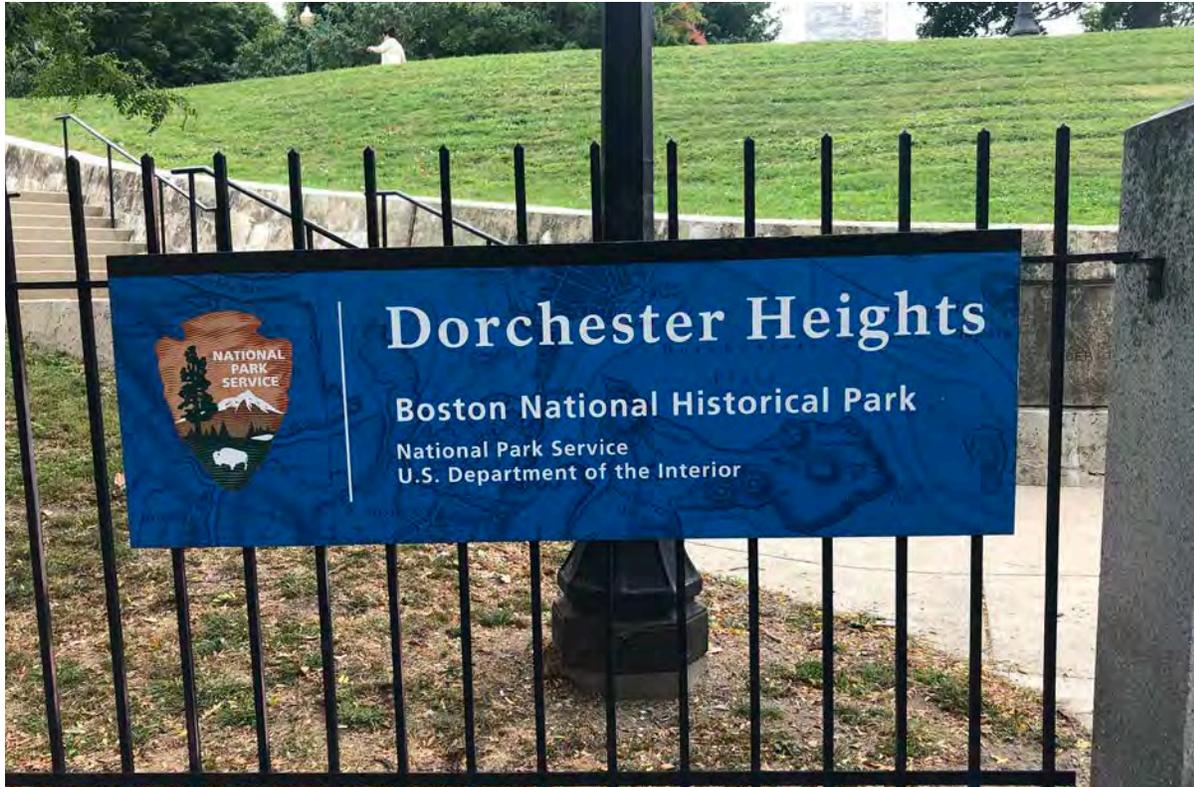
(top) Figure 3-67: Park identification signs

2. At each of the entrances are National Park Service Park identification signs reading: “Dorchester Heights/Boston National Historical Park/National Park Service/U.S. Department of the Interior”. These are located on the left side of each of the three entrances and are secured to the cast iron fence. These are poly laminate signs 2 feet by 6 feet. (Figure 3-67). These are in good condition.

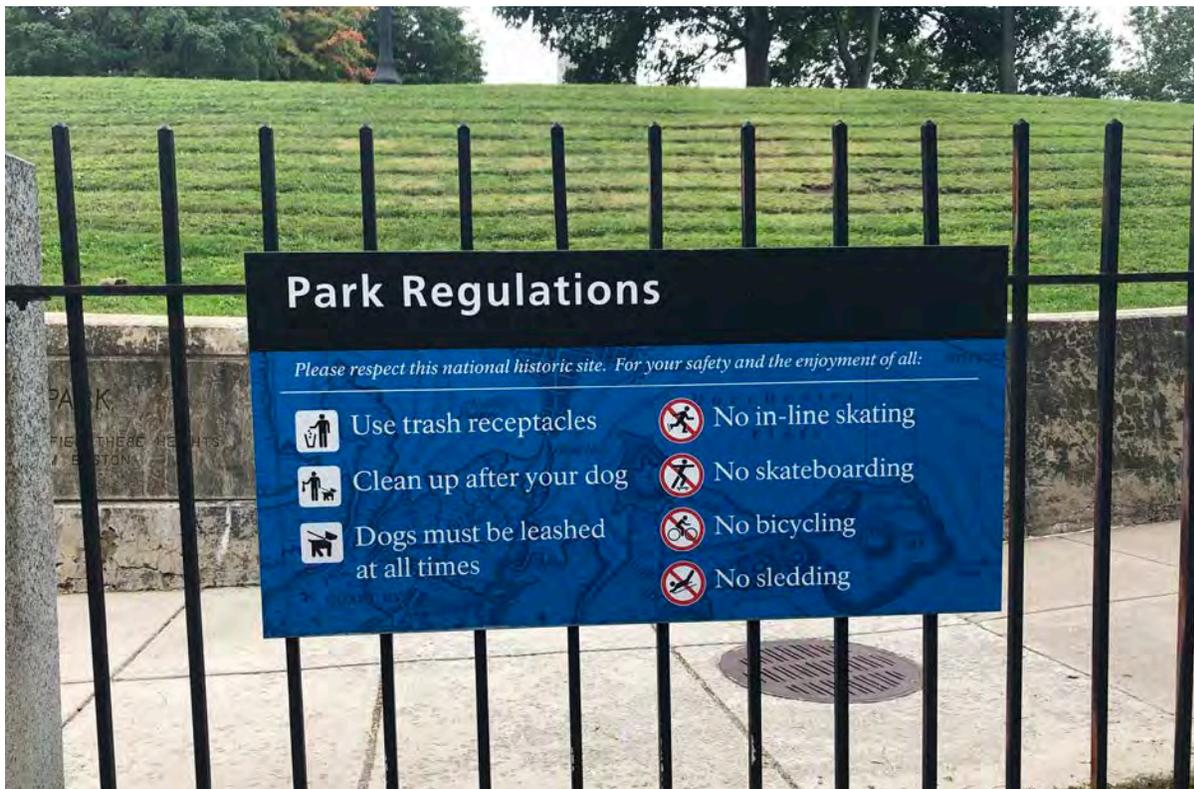
(bottom) Figure 3-68: Park rules signs

3. On the right side of each park entrance is a National Park Service Rules sign (Figure 3-68), which reads: “Park Regulations/Please respect this national historic site. For your safety and the enjoyment of all:
