CULTURAL LANDSCAPE REPORT  
DORCHESTER HEIGHTS/THOMAS PARK  
AT BOSTON NATIONAL HISTORICAL PARK

# CULTURAL LANDSCAPE REPORT

## DORCHESTER HEIGHTS/ THOMAS PARK

### AT BOSTON NATIONAL HISTORICAL PARK

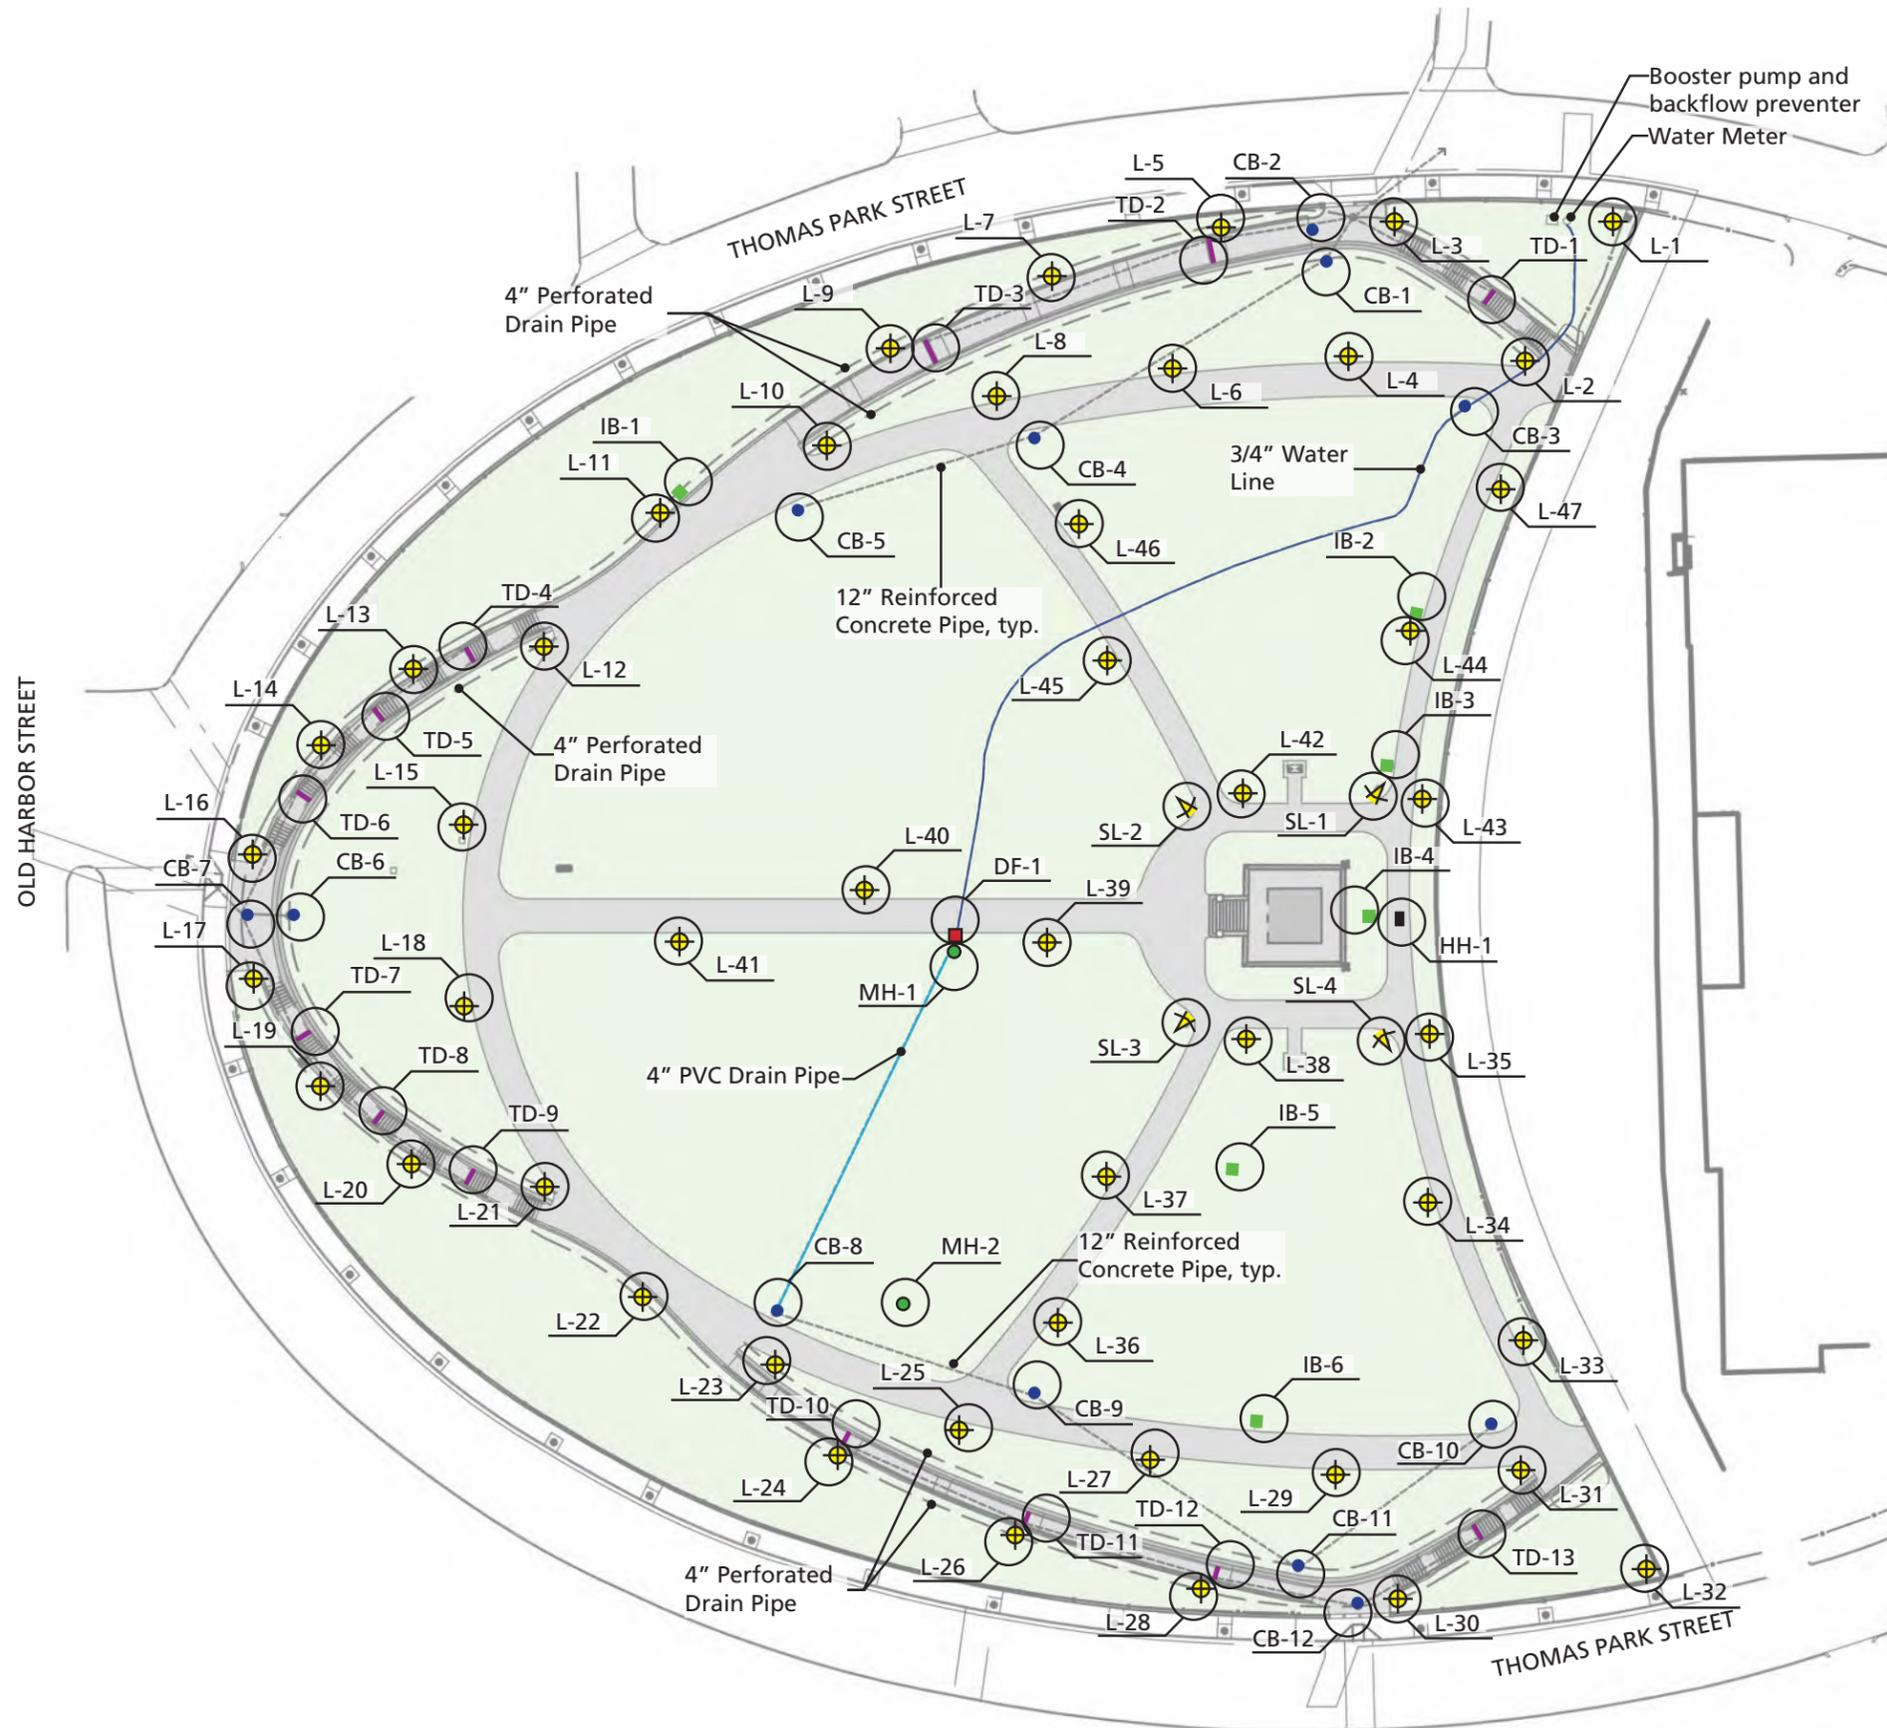
**Existing Conditions  
Site Lighting and Utilities**

See Figure 3-J: Existing Conditions: Site Lighting and Utilities.

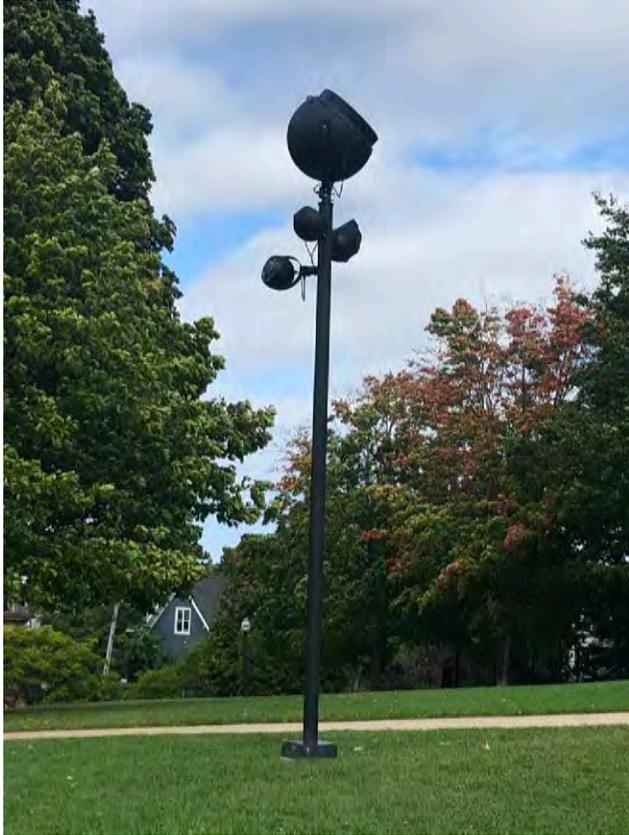
The monument spotlights (Figure 3-72) are located at the four angles of the Dorchester Heights Monument at approximately 30 feet away from its base. The spotlights are substantial fixtures on the top of a 16-foot steel pole with two smaller fixtures each and are all black with a marine-grade powder-coated finish. These fixtures were installed on the existing poles as part of the small 2013 rehabilitation project. One of these poles—the one in the northwest and closest to the flagpole—has an additional fixture to light the American flag. The large fixtures are 100-watt, 3000 Kelvin metal halide, very narrow spots, as specified in the project manual (possibly the Series 3700 as manufactured by B-K Lighting of Medera, California).

(top left) Figure 3-72: Monument spot light (here, with spot light for flagpole)

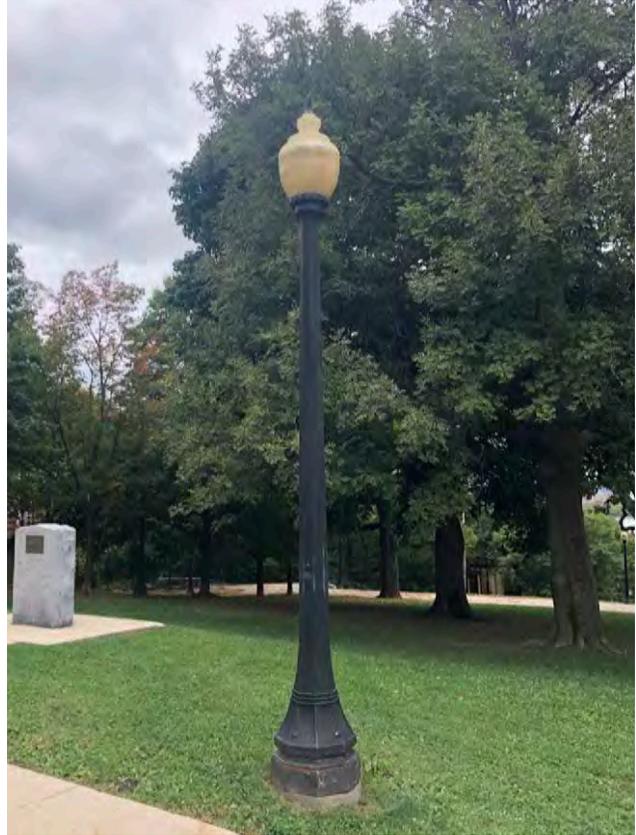
Site lighting consists of two types of fixtures: pedestrian-scale park lighting (Figure 3-73) and spot lighting for the Monument. The park lighting is an acorn-style fixture that sits on 12-foot poles. All but two or three of the acorns have oxidized to an opaque gold tinge. The poles show wear, mainly at the bases where the finish has worn away. All the light poles have chipping and peeling paint. (Figure 3-74)

(top right) Figure 3-73: Typical site light fixture and pole

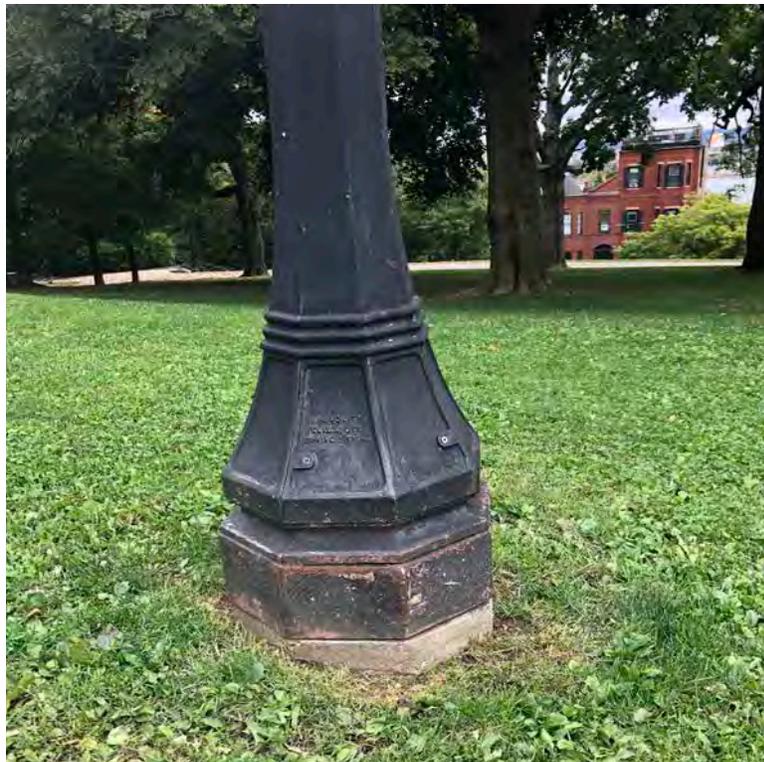
(bottom) Figure 3-74: Wear on base of the light pole
