### NATIONAL REGISTER OF HISTORIC PLACES REGISTRATION FORM

historic name: Bryce Inn

other name/site number: General Store, Head House, HS-118

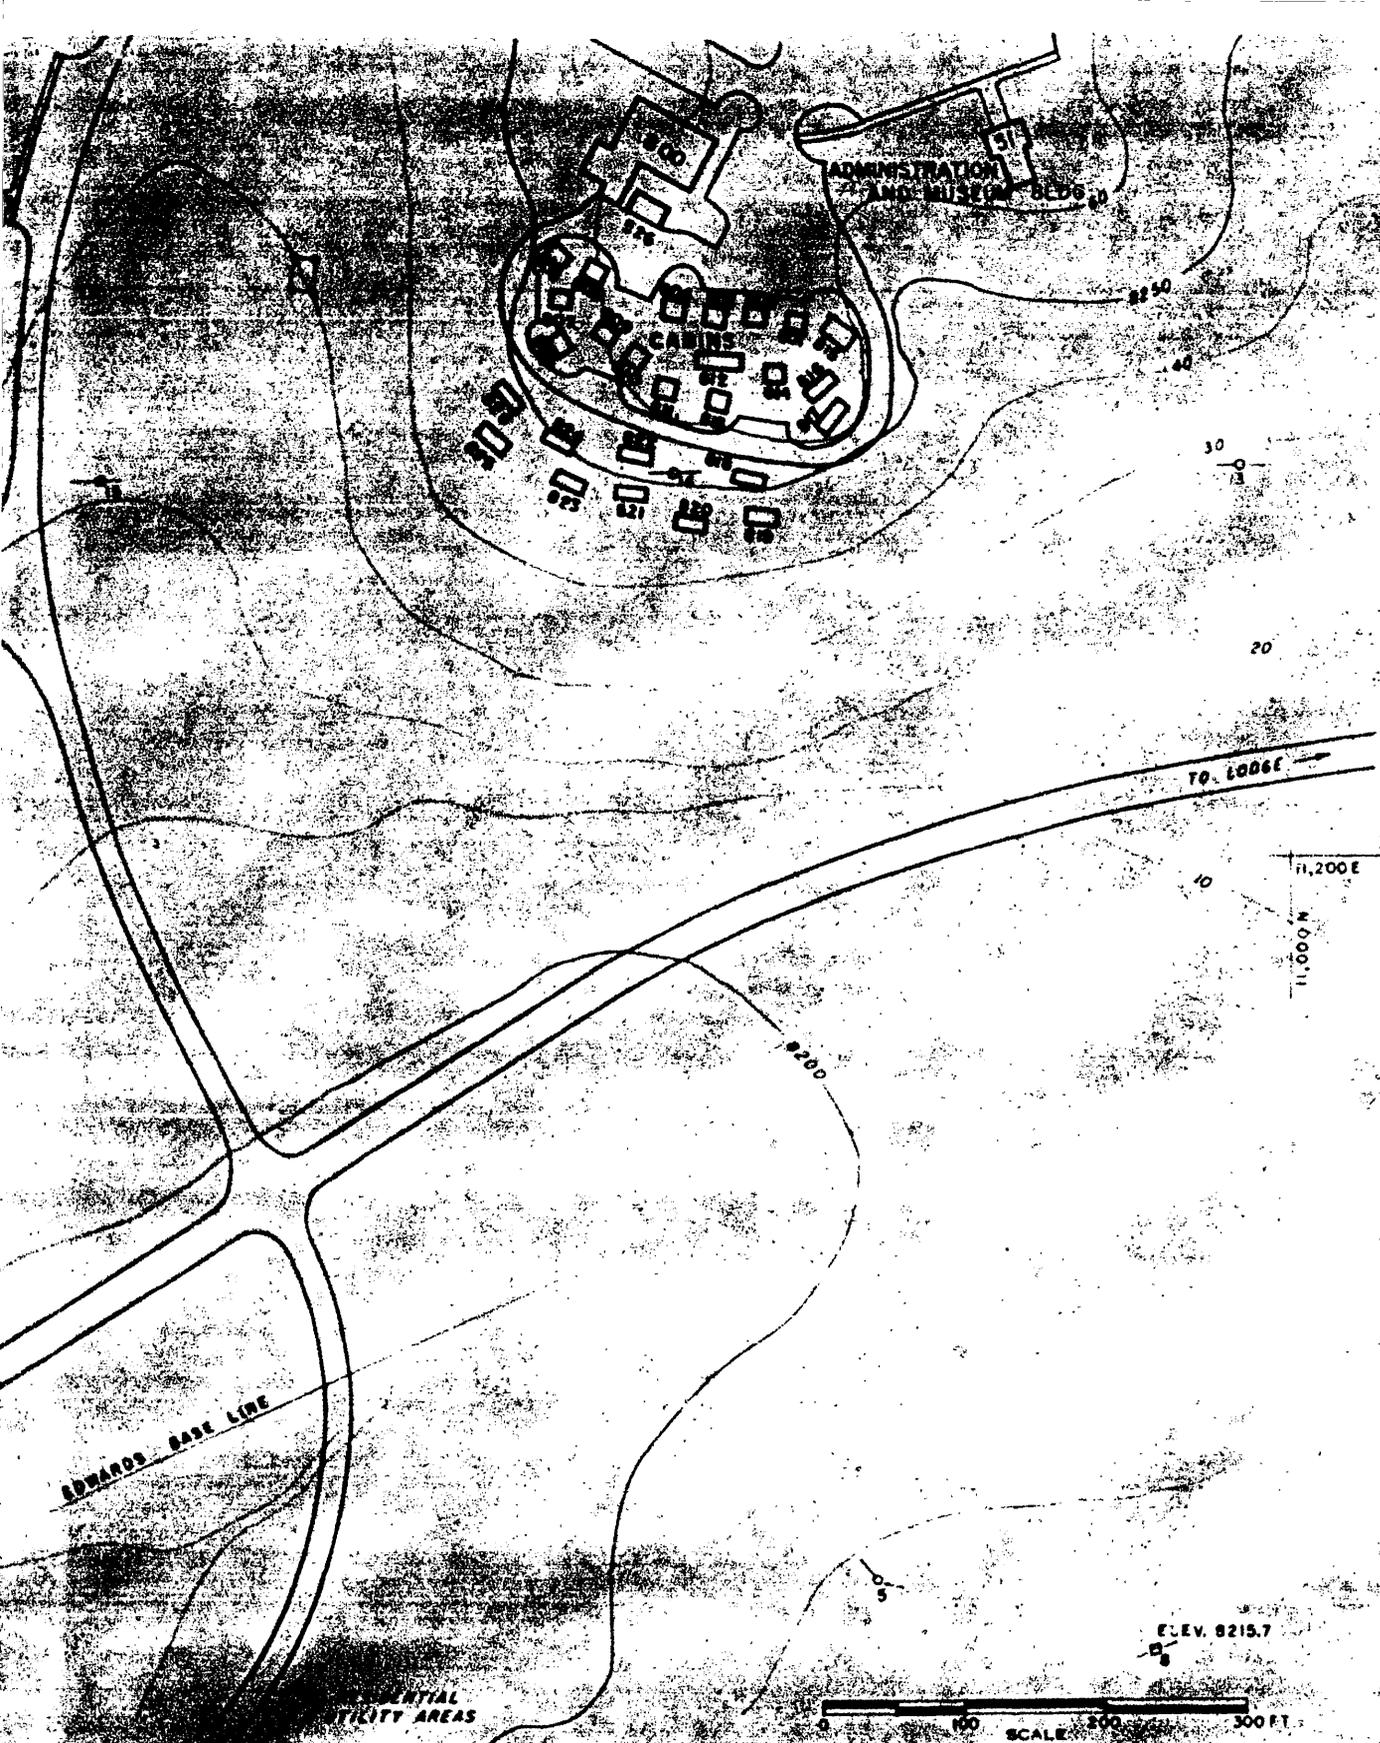
NP-BC  
 2111-A  
 12-1947

**CAMPGROUND & INN**  
 PART OF THE MASTER PLAN  
**BRUCE CANYON NATIONAL PARK**

OLD ADMINISTRATION BUILDING AND BRYCE INN  
BRYCE CANYON NATIONAL PARK

The boundary of the Bryce Inn is shown on the accompanying site plan.

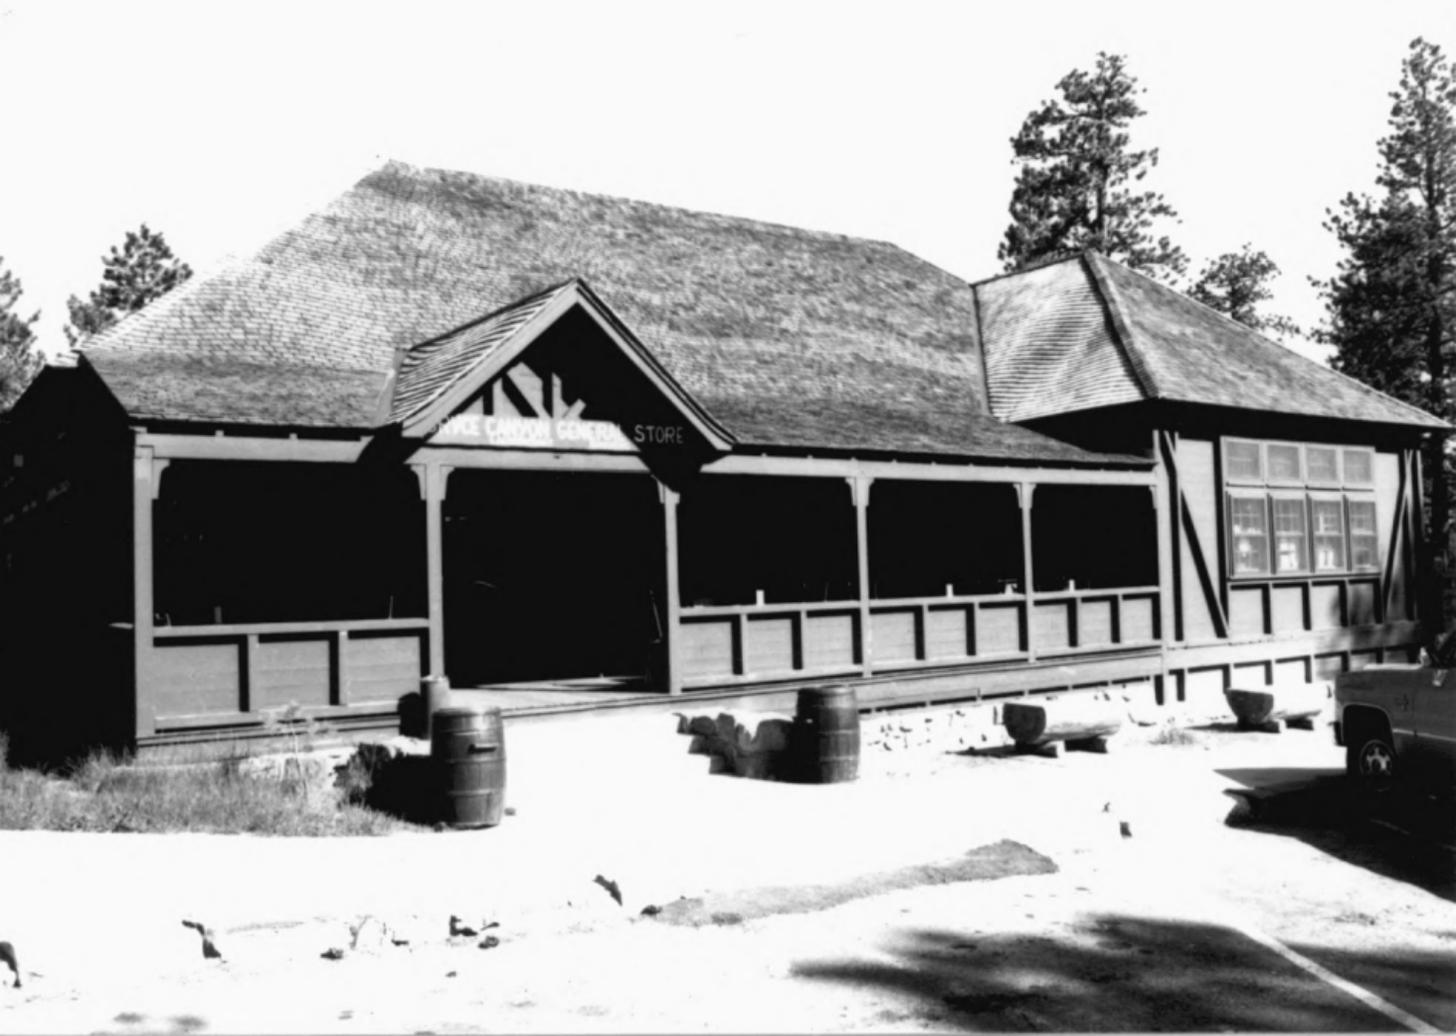
#### Photo #1

Looking northwest to southwest elevation.

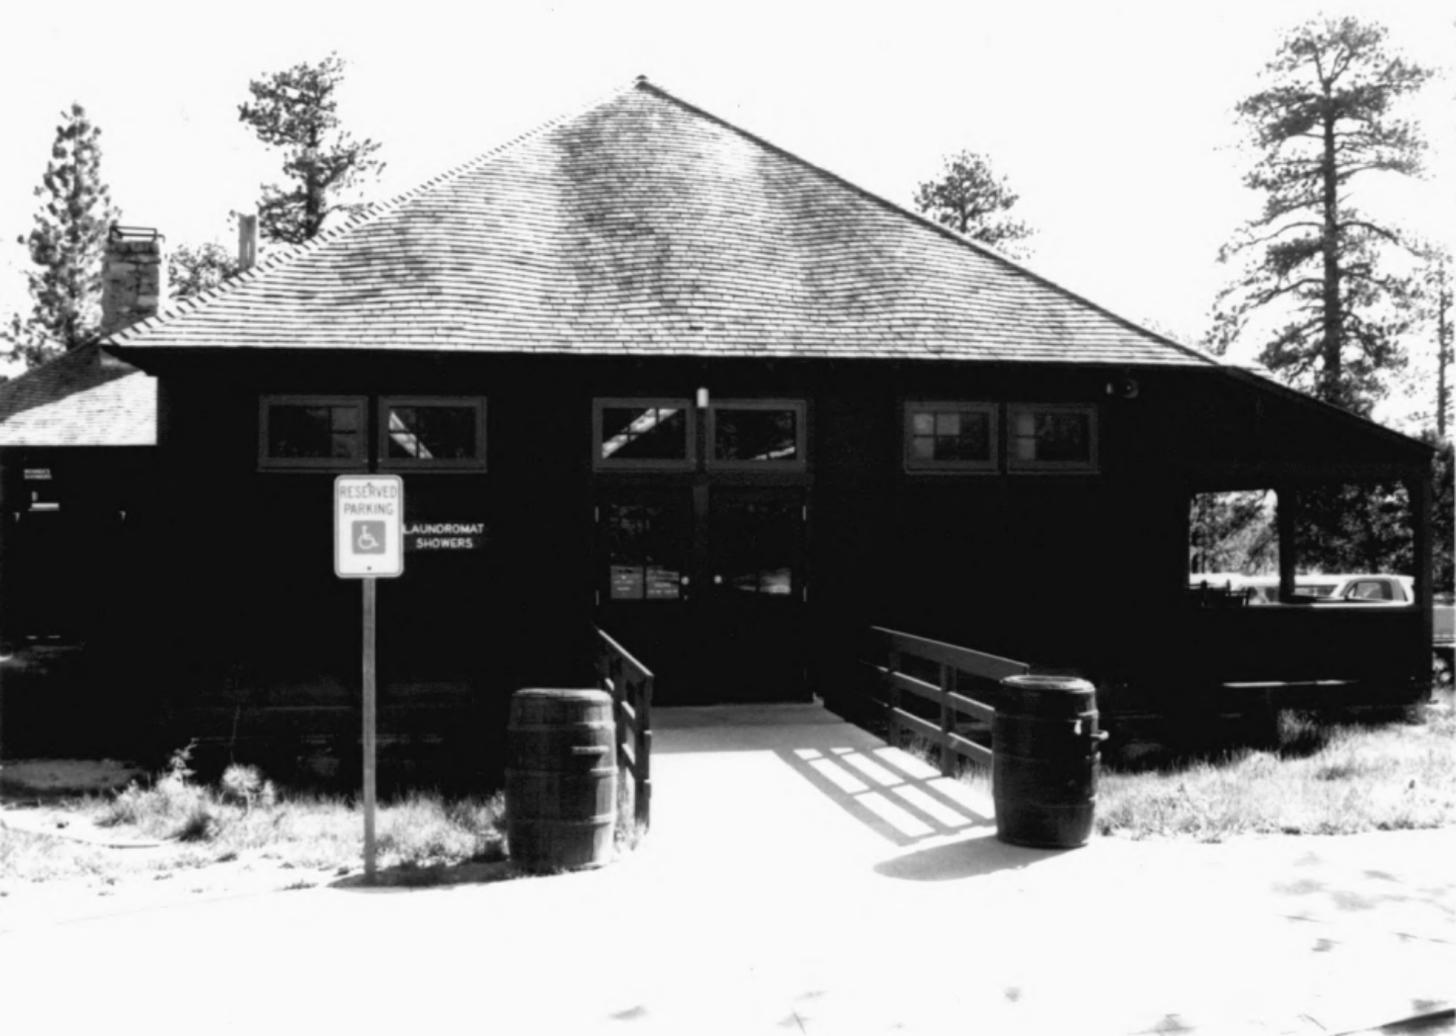
#### Photo #2

Looking northeast to southeast elevation (new handicapped accessible entrance).

The main entry into the general store is via the southeast porch described above. This is a double entry with swinging doors, each with two panels topped by four lights. A new (1973) entry into the building is located on the southwest elevation. This entry is centered in the wall of the building, and contains doors that are identical to those in the east side entry. A handicapped-accessible ramp leads to the southwest doorway.

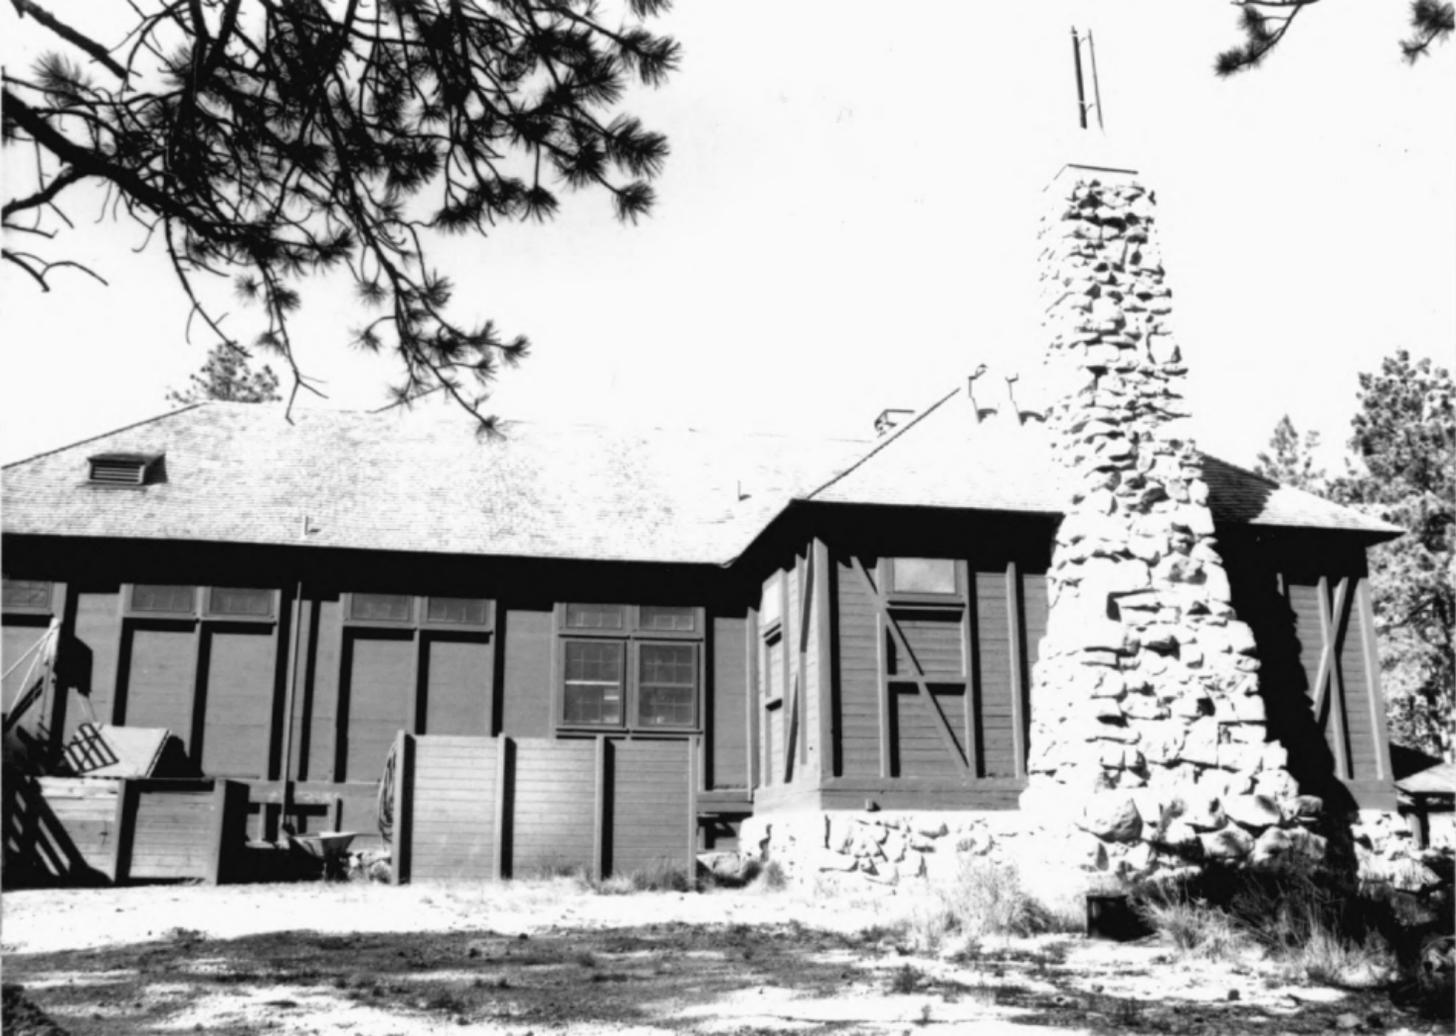
#### Photo #3

Looking southwest to northeast elevation of building.

A loading dock is located on the east end of the northeast elevation. A set of exterior stairs with wooden railings leads to this dock. The west end of the northeast elevation contains an addition that dates to the 1937 expansion. This 25'8" X 12' addition contains an exterior stone chimney on the north elevation. This addition contained a store room and also stairs leading to the partial basement.

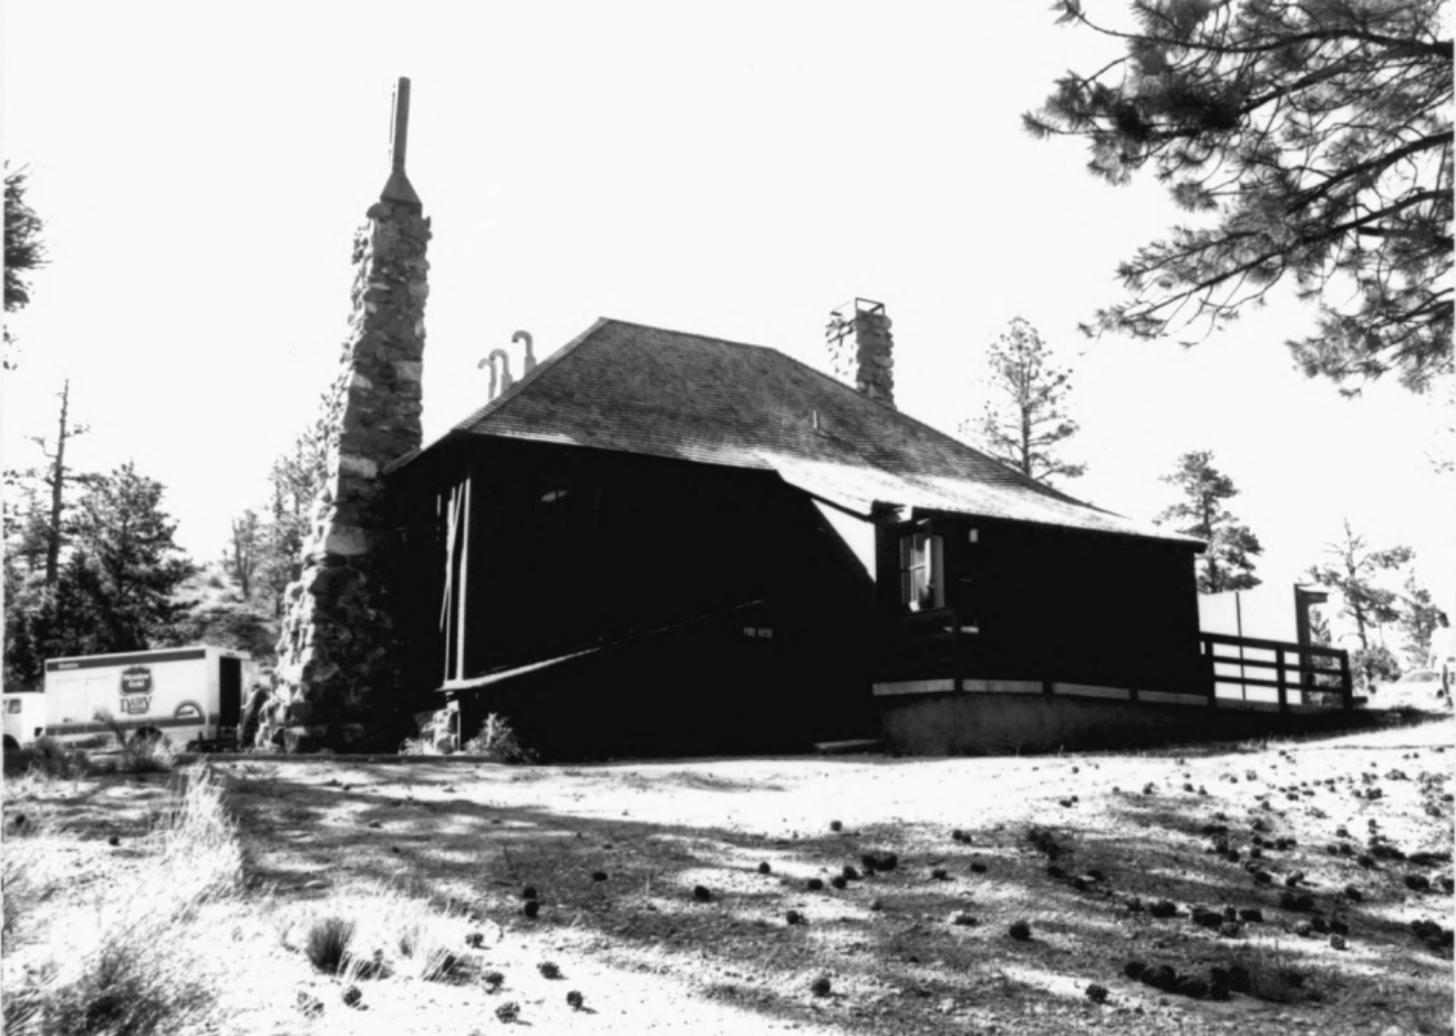
#### Photo #4

Looking southeast to northwest elevation.

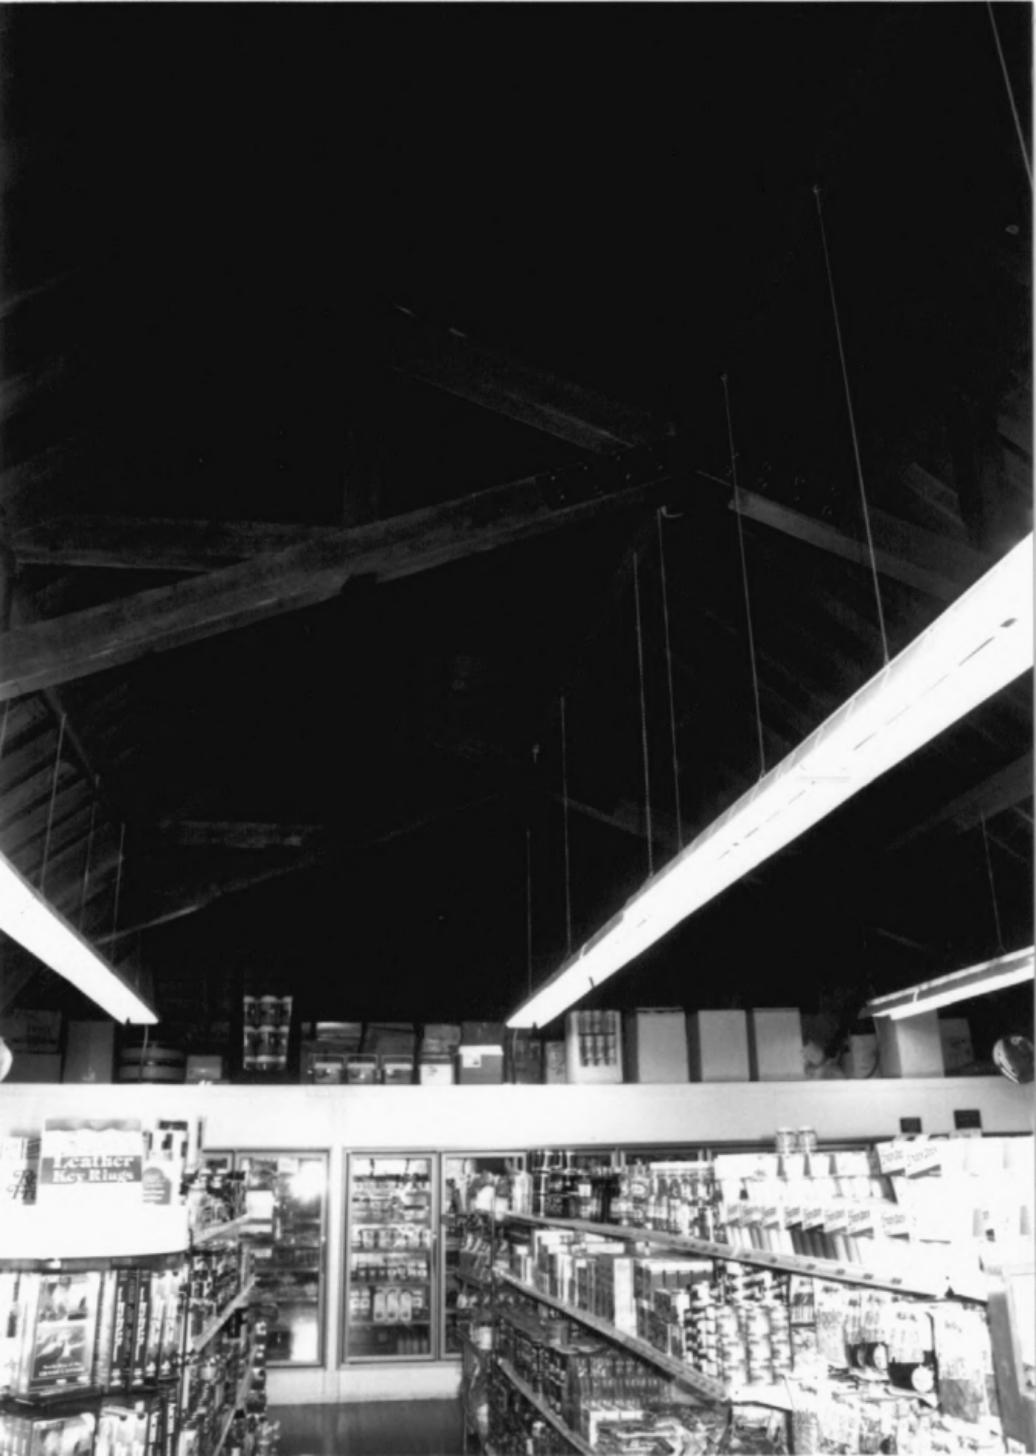
#### Photo #5

Looking southeast towards doors in southeast elevation--interior now used for general store.
