NATIONAL REGISTER OF HISTORIC PLACES REGISTRATION FORM

historic name: Old Administration Building

other name/site number: Nature Center; Museum; HS-31

street & number: Bryce Canyon National Park

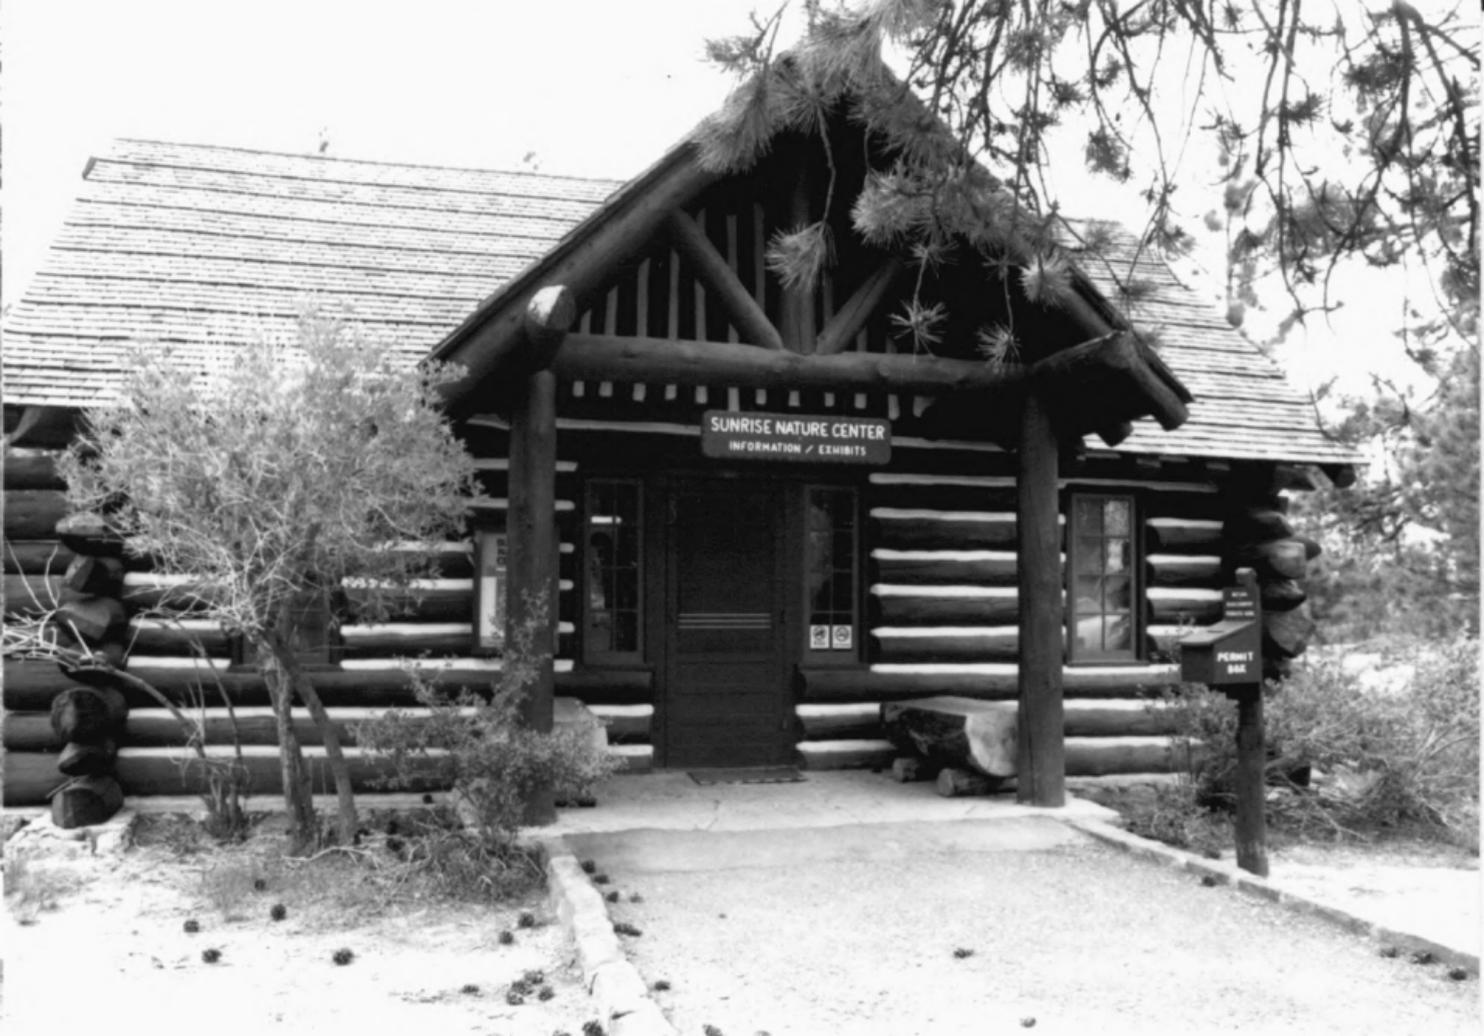
Photo #1

The east elevation contains a central open porch with a cross gable roof, which shelters the entry into the public room of the building. The roof is supported by log columns, and the king post truss is exposed in the pediment. The entry has a modern flush wood door with three staggered lights, paired with a wooden, three-panel screen door.

Narrow, eight-light casement windows are located directly adjacent to each side of this entry and are also protected by the porch overhang. The east elevation contains two additional eight-light casement windows, one on either side of the porch.

Looking west to east elevation (main entry).

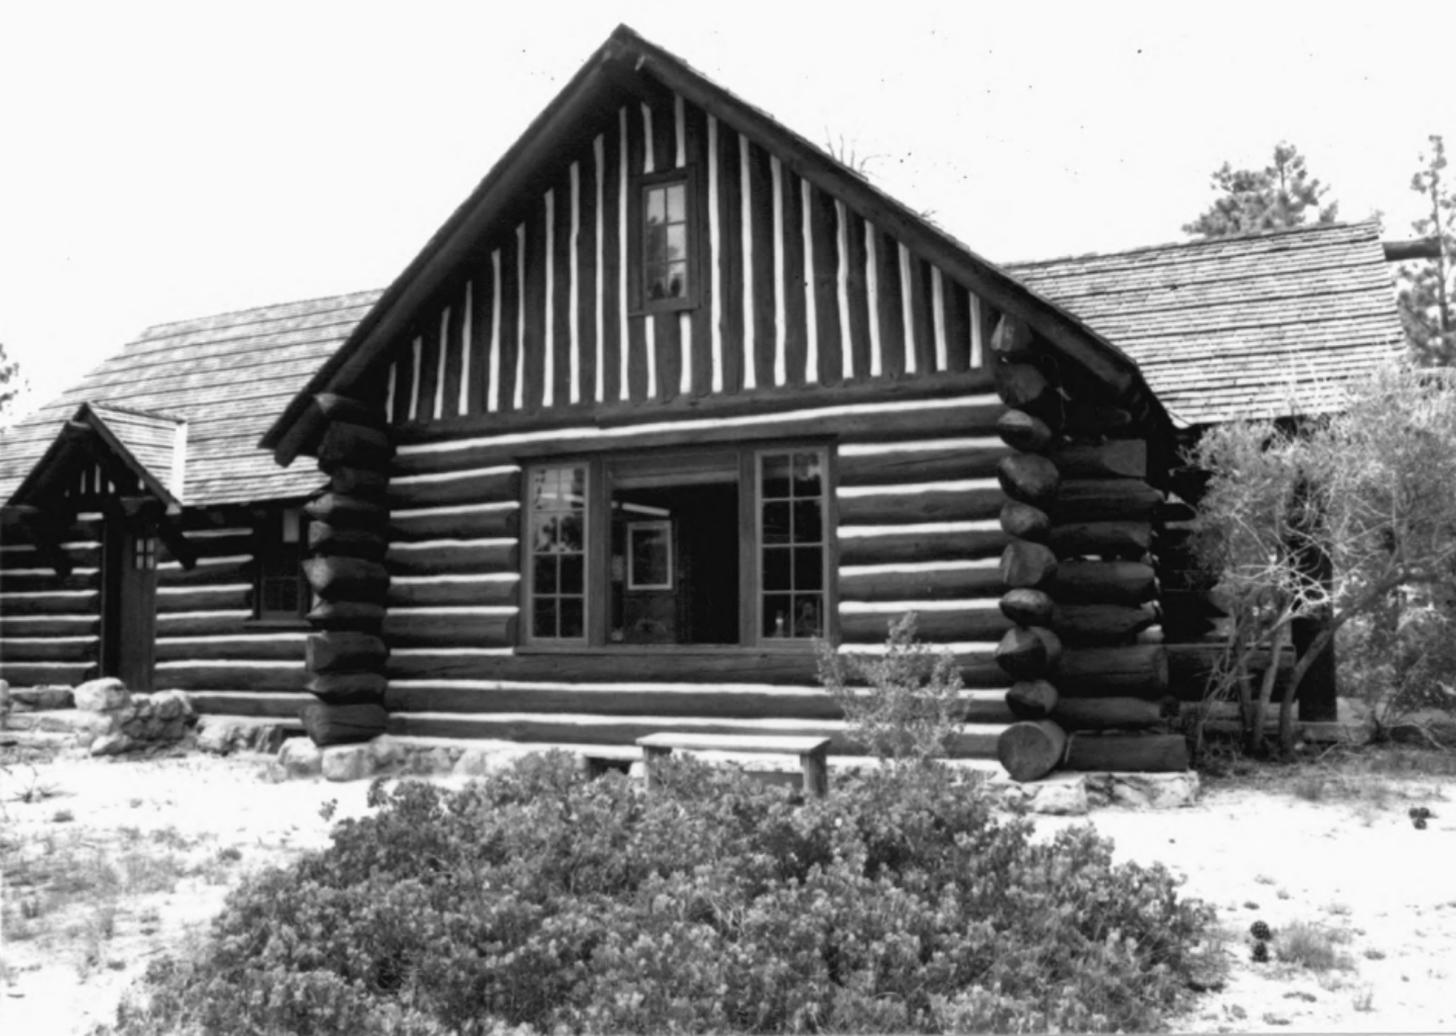
Photo #2

The south elevation contains an entry that accesses the interior office space. This entry is located towards the east end of the 1934 component and is protected by a small gable-roof overhang supported by log brackets. Two stone steps lead to the entry which has a vertical tongue and groove door with four fixed lights. A pair of six-light casement windows is located in the wall to the east of the entry. Fenestration in the south elevation of the original (1932) component is identical to the north elevation, namely a fixed, six-light window in the gable end and a picture window flanked by two eight-light casement windows in the ground level wall.

Looking northwest to south elevation.

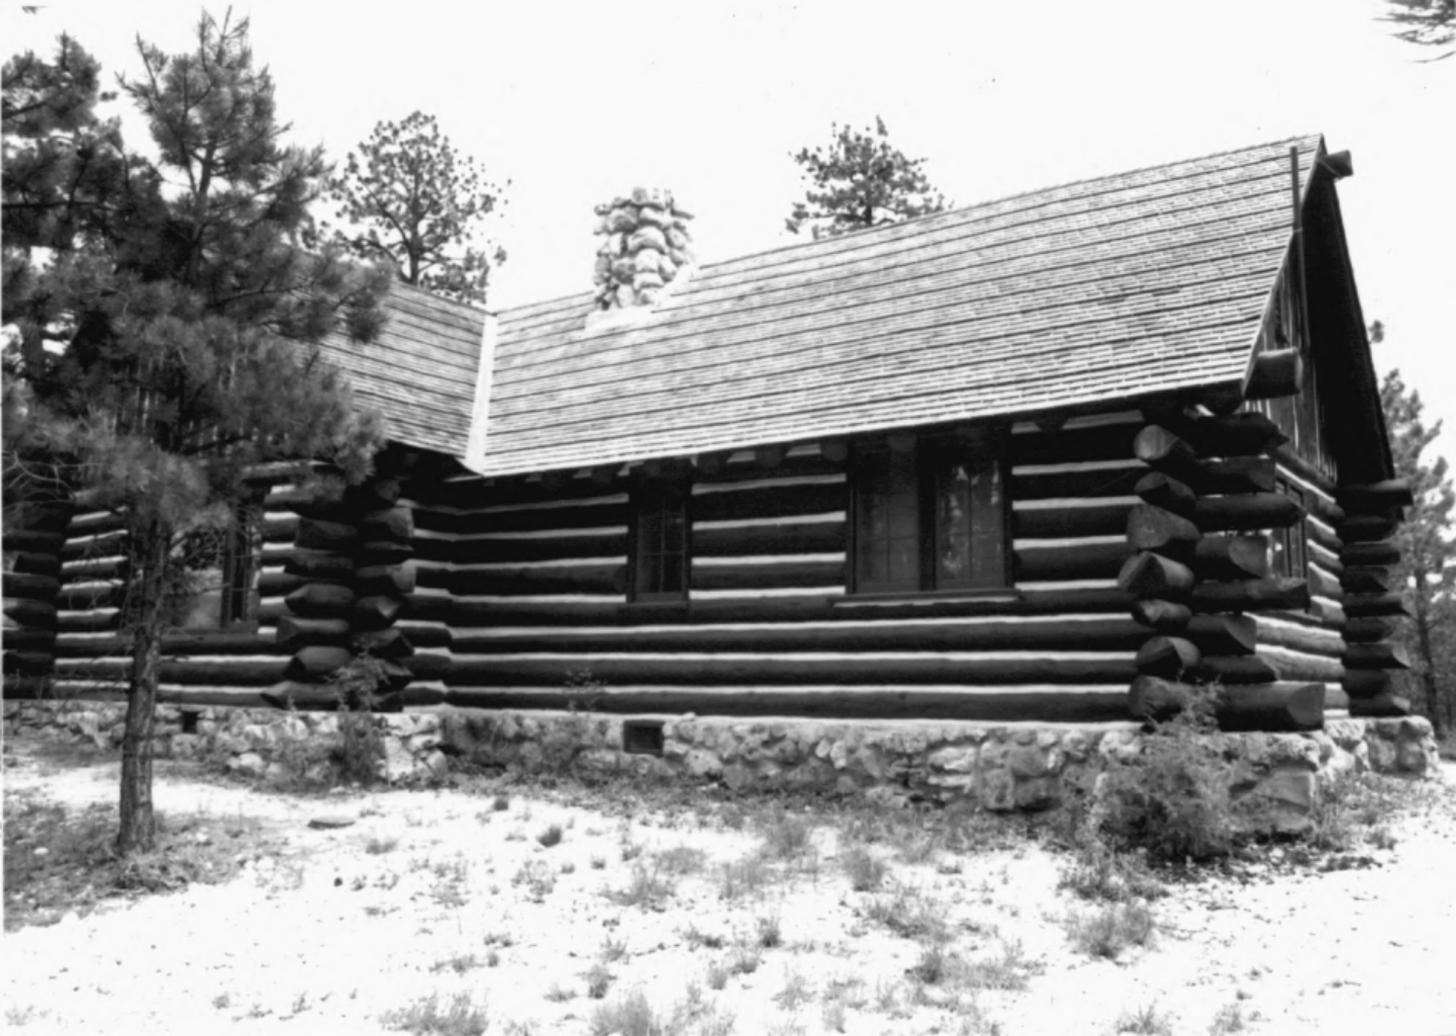
Photo #3

The north elevation of the building incorporates a variety of windows. A narrow, fixed, six-light, wood frame window is located high in the gable end of the original component. The wall below the gable contains a large picture window flanked on either side by one eight-light casement windows. The north wall of the addition has three six-light casement window, one occurs singly and the other two in a pair towards the west end of the elevation.

The west elevation of the building contains a large picture window flanked on either side by a six-light casement windows, all of which are centered in the wall beneath the gable end. A louvered vent is centered high in the gable end.

Looking southeast to north and west elevations.
