NATIONAL REGISTER OF HISTORIC PLACES REGISTRATION FORM

historic name: Rainbow Point Comfort Station and Overlook Shelter

other name/site number: HS-58 and HS-59

street & number: Bryce Canyon National Park

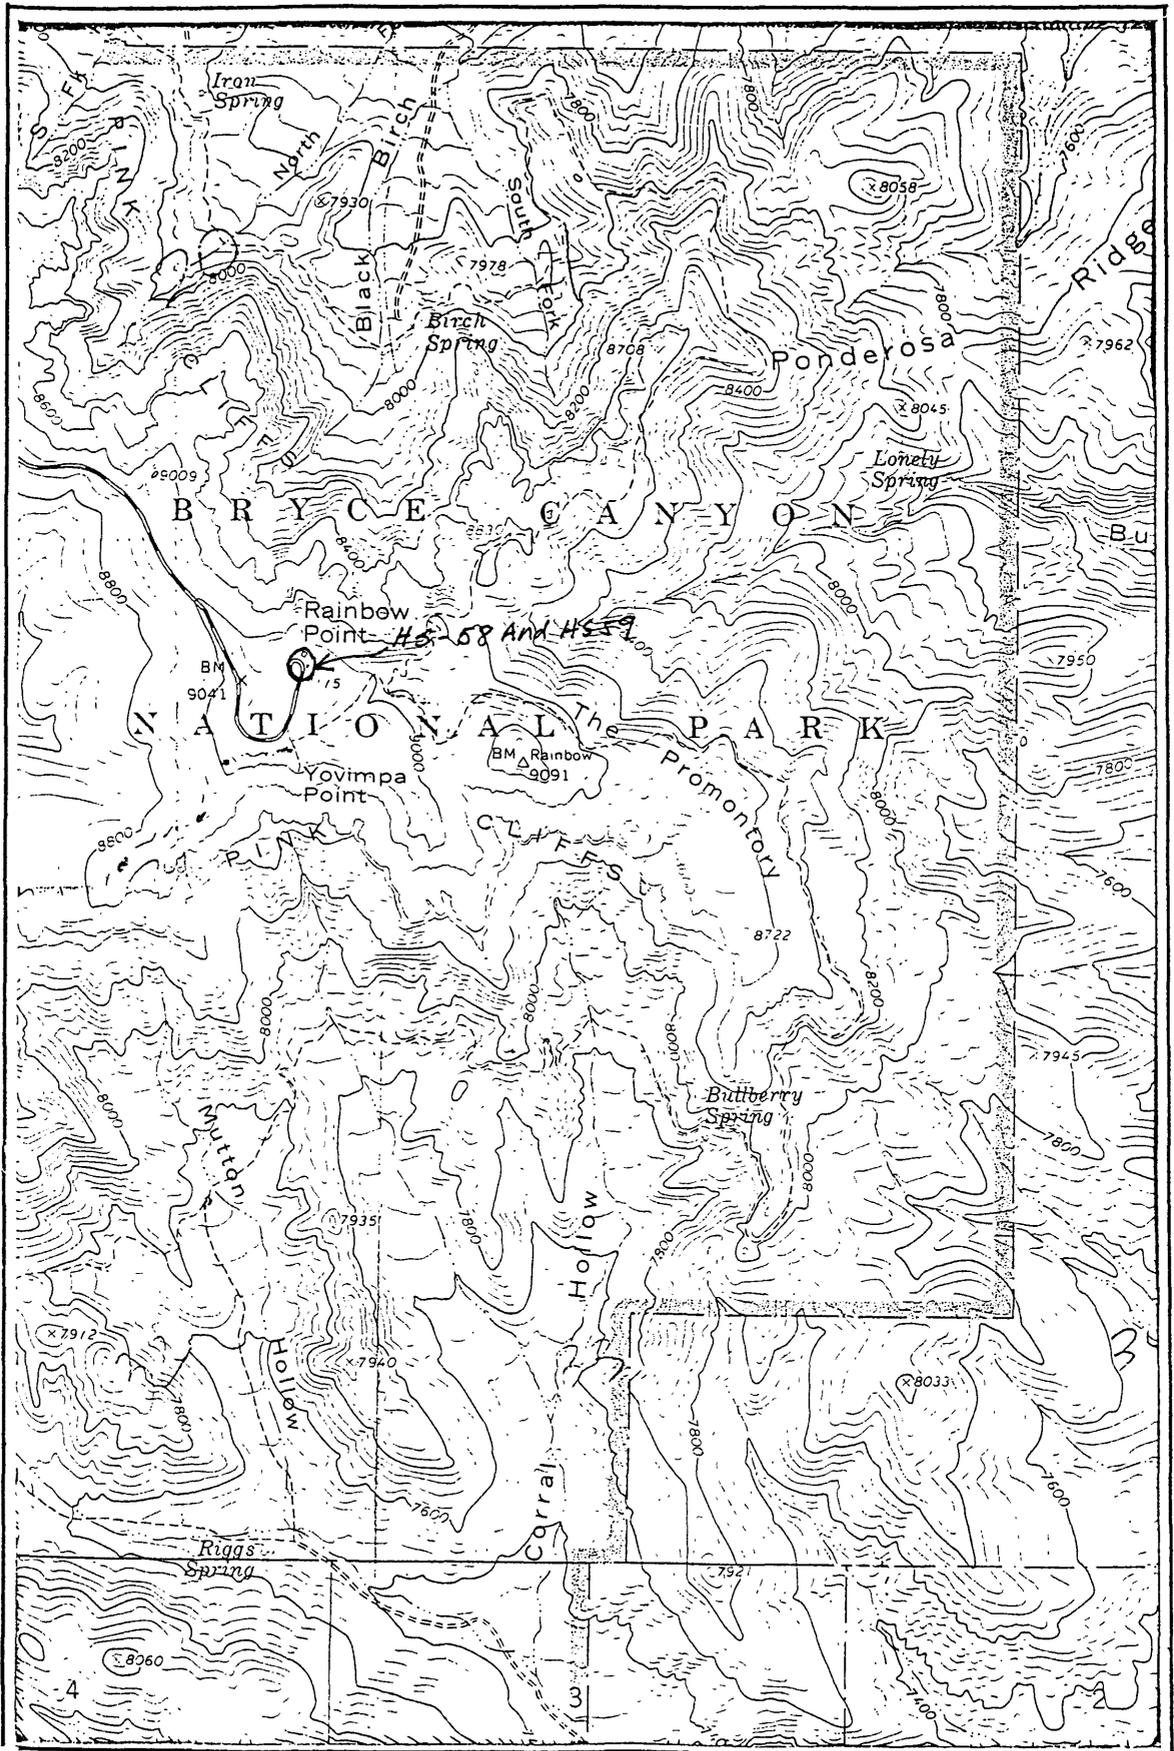
RAINBOW POINT
BRYCE CANYON NATIONAL PARK

HS-59:
Overlook
Shelter

HS-58:
Comfort
Station

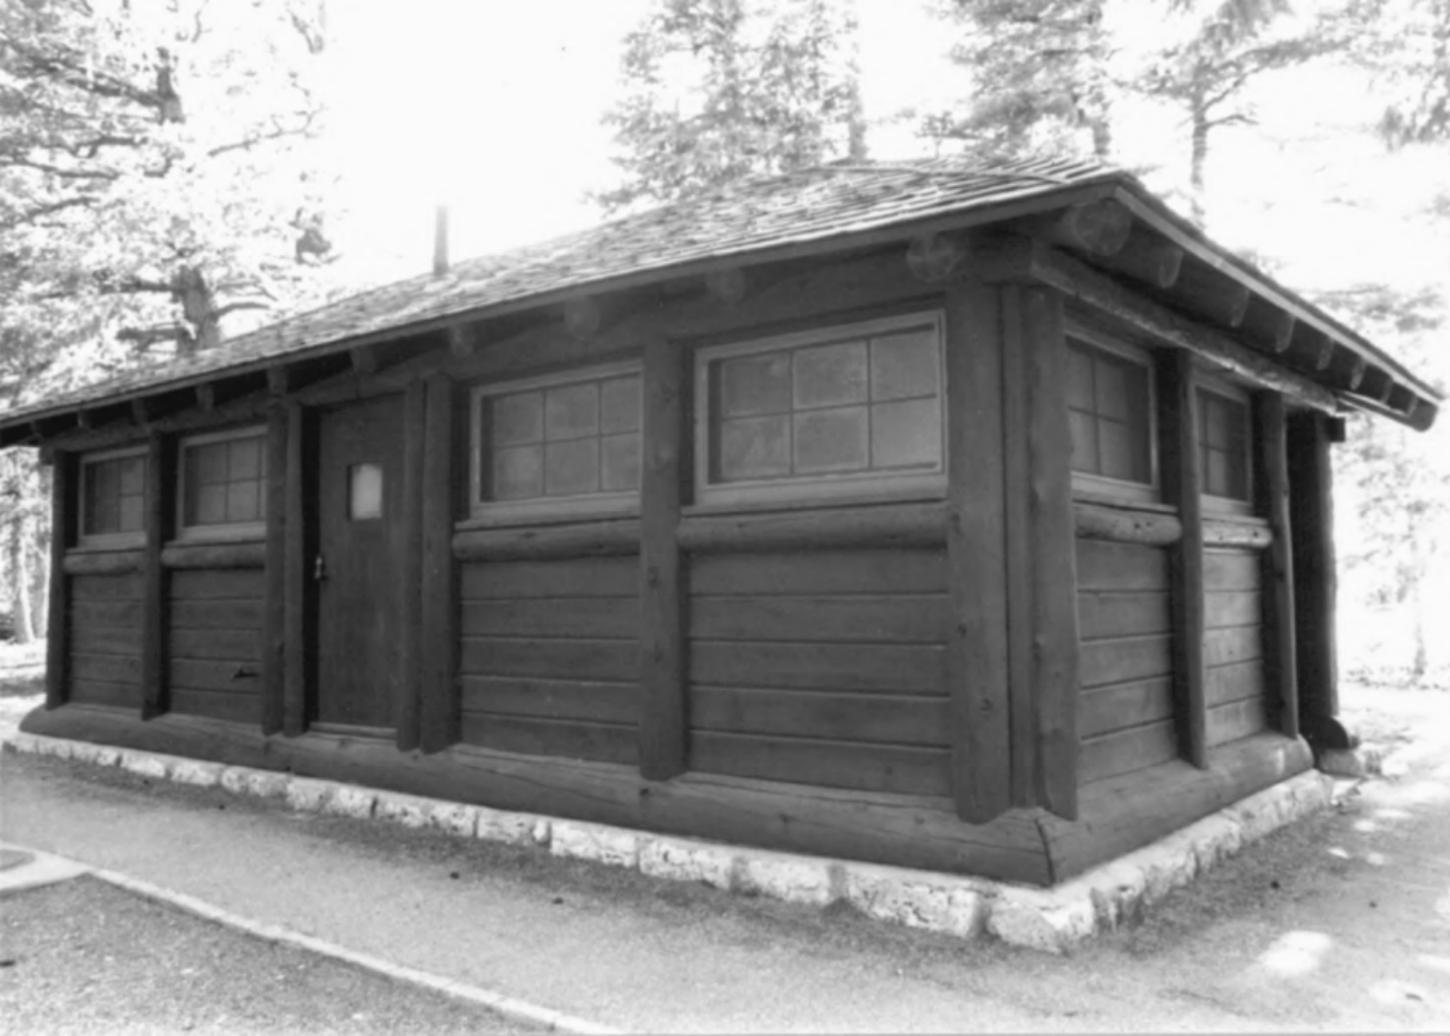
Photo #1

HS-58 Comfort Station. Looking southwest to east and north elevations of building.

Comfort Station (HS-58): This one-story, rectangular, wood frame building rests on footings of native stone. The exterior walls are finished with horizontally placed "V-joint" shiplap siding, with vertical half logs used to cover the joints in the shiplap. The hip roof is covered with unpainted wood shingles and has a metal vent extending from the interior storage area. The log rafters have exposed ends. Windows throughout the building are wooden, six-light hopper, which open inward in order to accommodate the fixed exterior screens.

The north elevation contains an entry (with a tongue and groove plank door), flanked on the east side by two windows. The east elevation contains a central entry flanked on either side by two windows. This entry has a tongue and groove plank door with one small light. It provides access to a storage area that runs the width of the building. The south elevation has another entry (with a solid tongue and groove door) that is flanked on the west side by three windows.

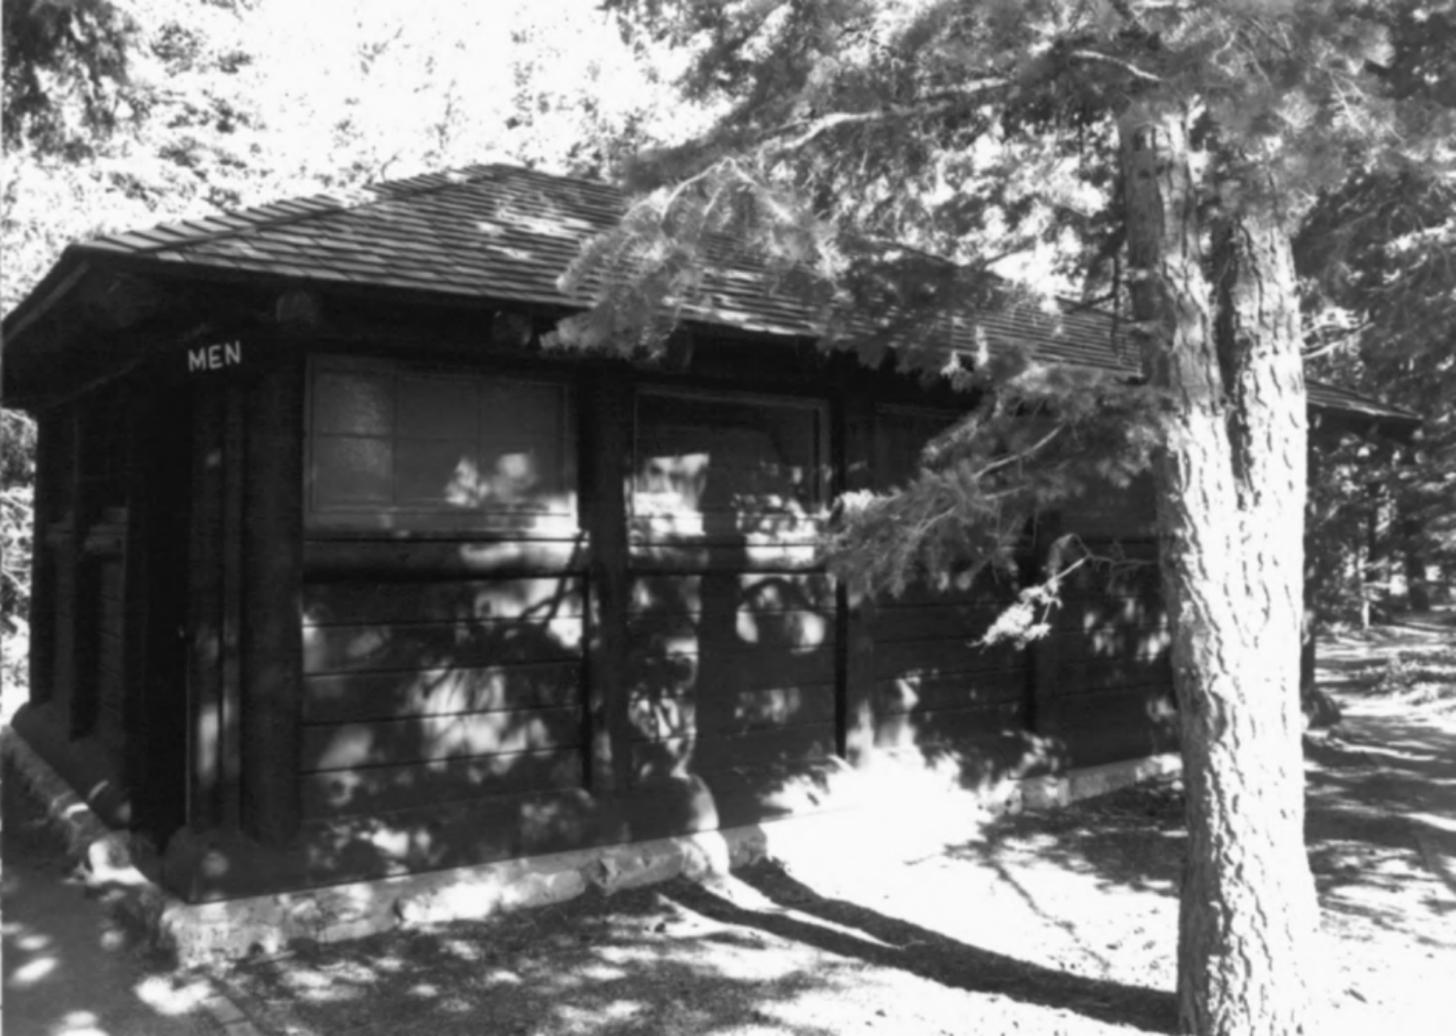
Photo #2

HS-58 Comfort Station. Looking southeast to north and west elevations of building.

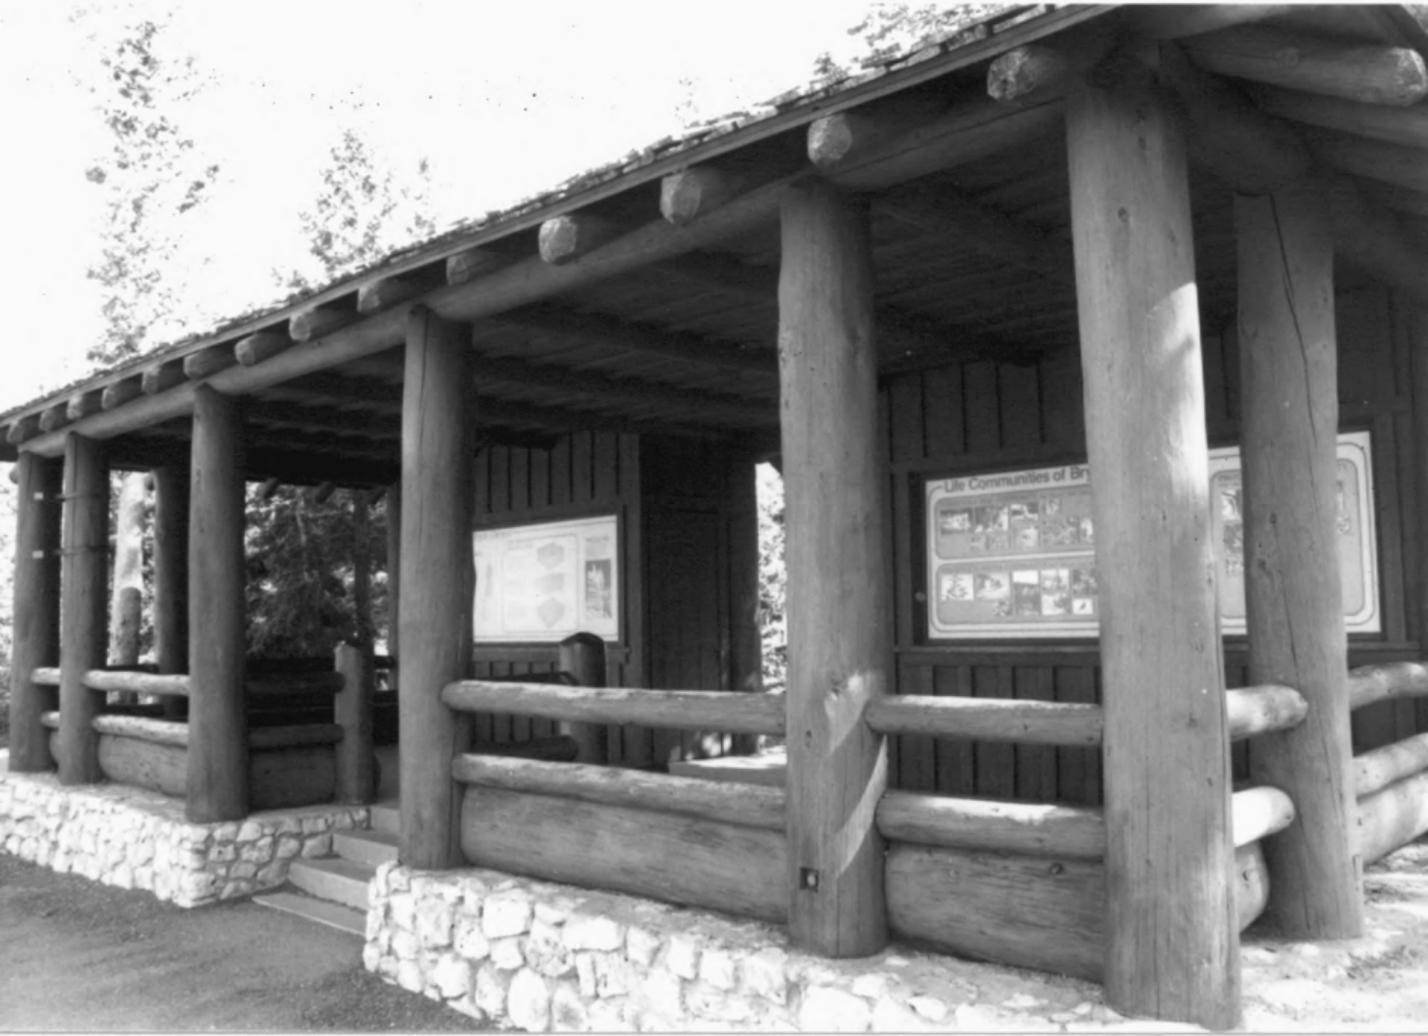
Photo #3

HS-59 Overlook Shelter. Looking southeast to northeast elevation of building.

Overlook Shelter (HS-59): This rectangular, one-story building is constructed on a concrete and stone foundation. The open structure has a hip roof covered with wooden shakes. The structural system for the roof, including the truss work, rafters, and vertical columns, are formed with peeled logs. Rafter ends are exposed. A board and batten ceiling currently obscures the underside of the roof system. The northwest, northeast, and southeast elevations are enclosed only with a horizontal log railing. Built-in seats, made from a large (21"-diameter) log line these sides of the building, with the exception of a centrally placed opening in the northeast elevation, which provides direct access to the plateau rim.

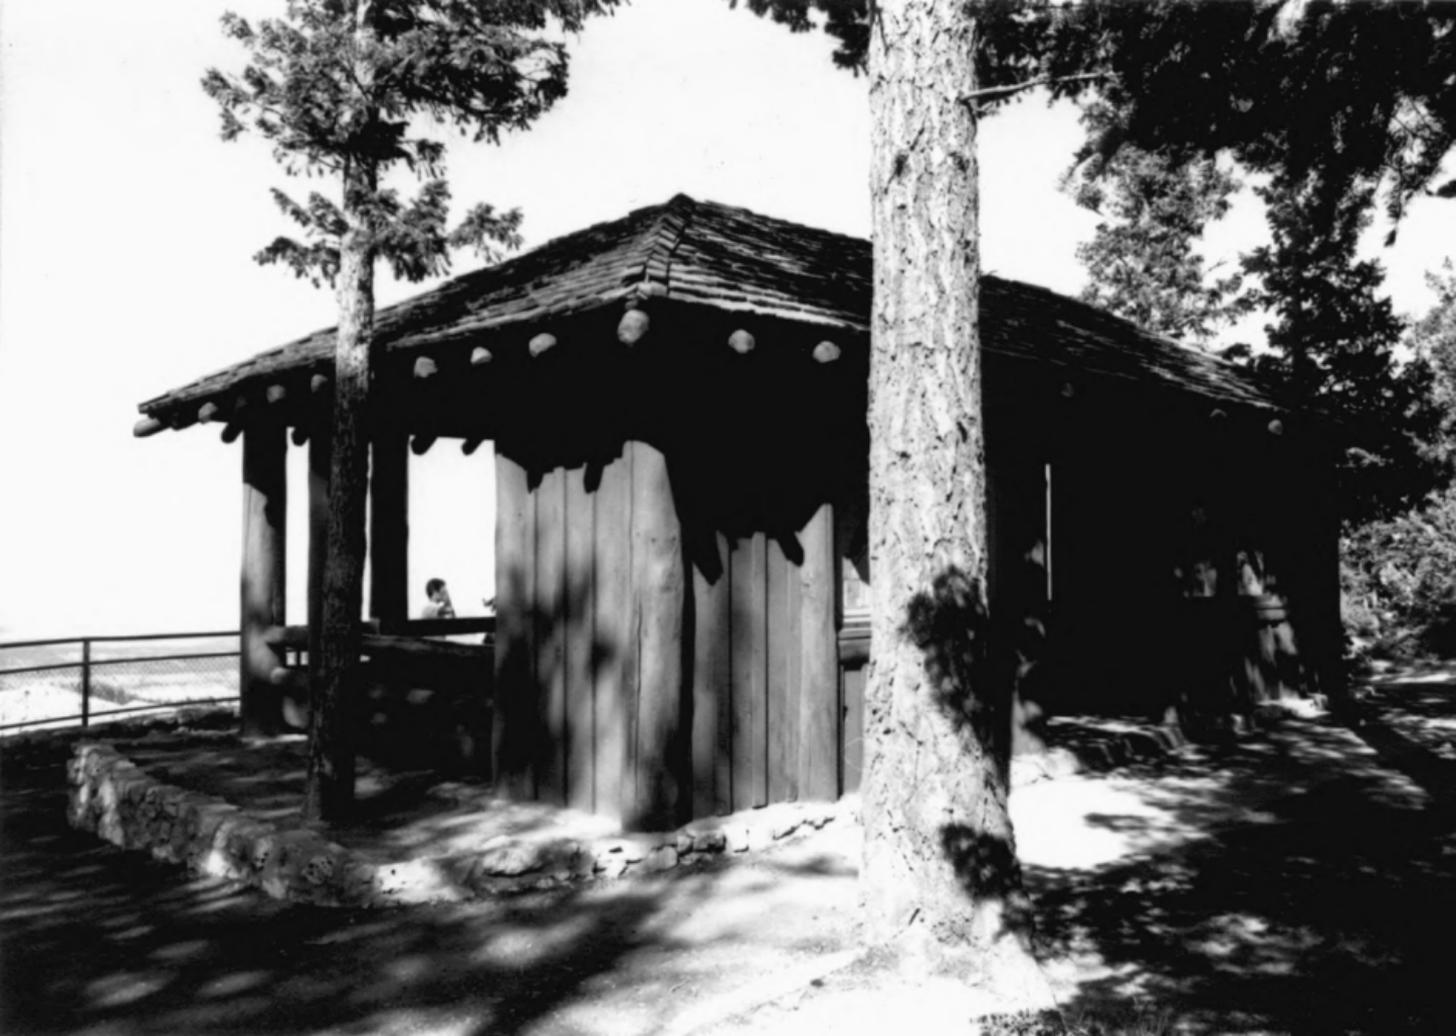
Photo #4

HS-59 Overlook Shelter. Looking east to northwest and southwest elevations of building.

The southwest elevation contains two display bulkheads, one on each side of a central opening into the shelter. The bulkhead walls are constructed with 8" vertical boards and 1X4" battens. The interiors of the bulkheads are accessed via separate entries located on the interior of the building. Both entries have tongue and groove plank doors. There are two recessed display areas in each bulkhead, which are meant to be viewed from the exterior of the building. The north display area is enclosed behind plate glass set in a 1X2" wood frame. The interior of the storage areas are unfinished.

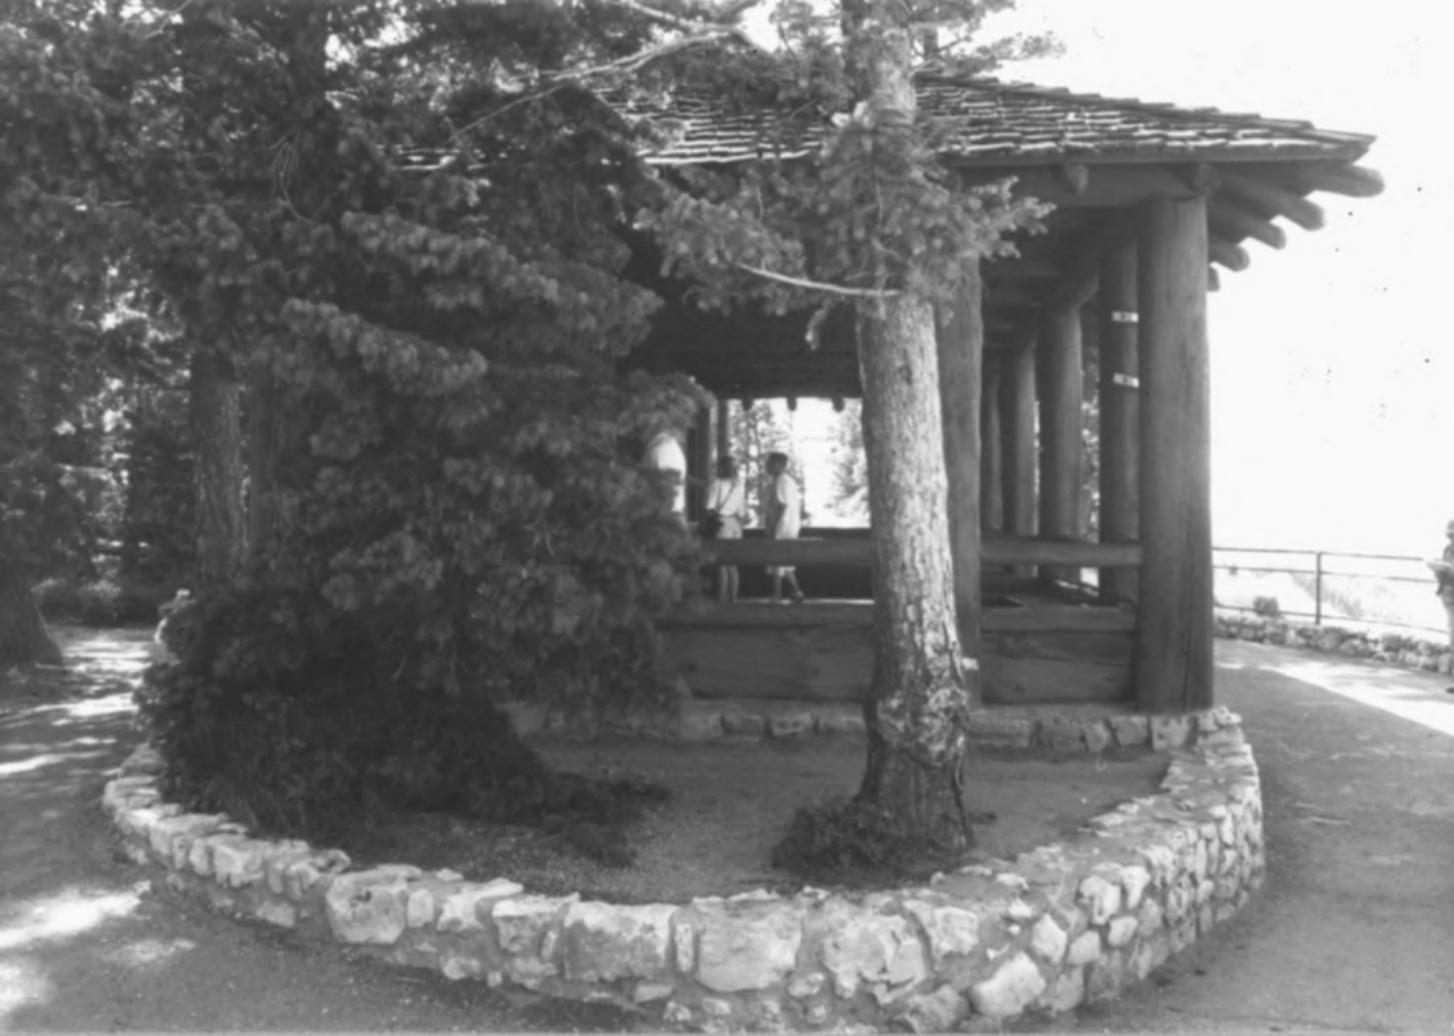
Photo #5

HS-59 Overlook Shelter. Looking northwest to southeast elevation of building.
