ARCHEOLOGICAL SURVEY OF THE PROPOSED TYLER BEND ACCESS ROAD,
BUFFALO NATIONAL RIVER,
SEARCY COUNTY, ARKANSAS

ROGER E. COLEMAN

1987

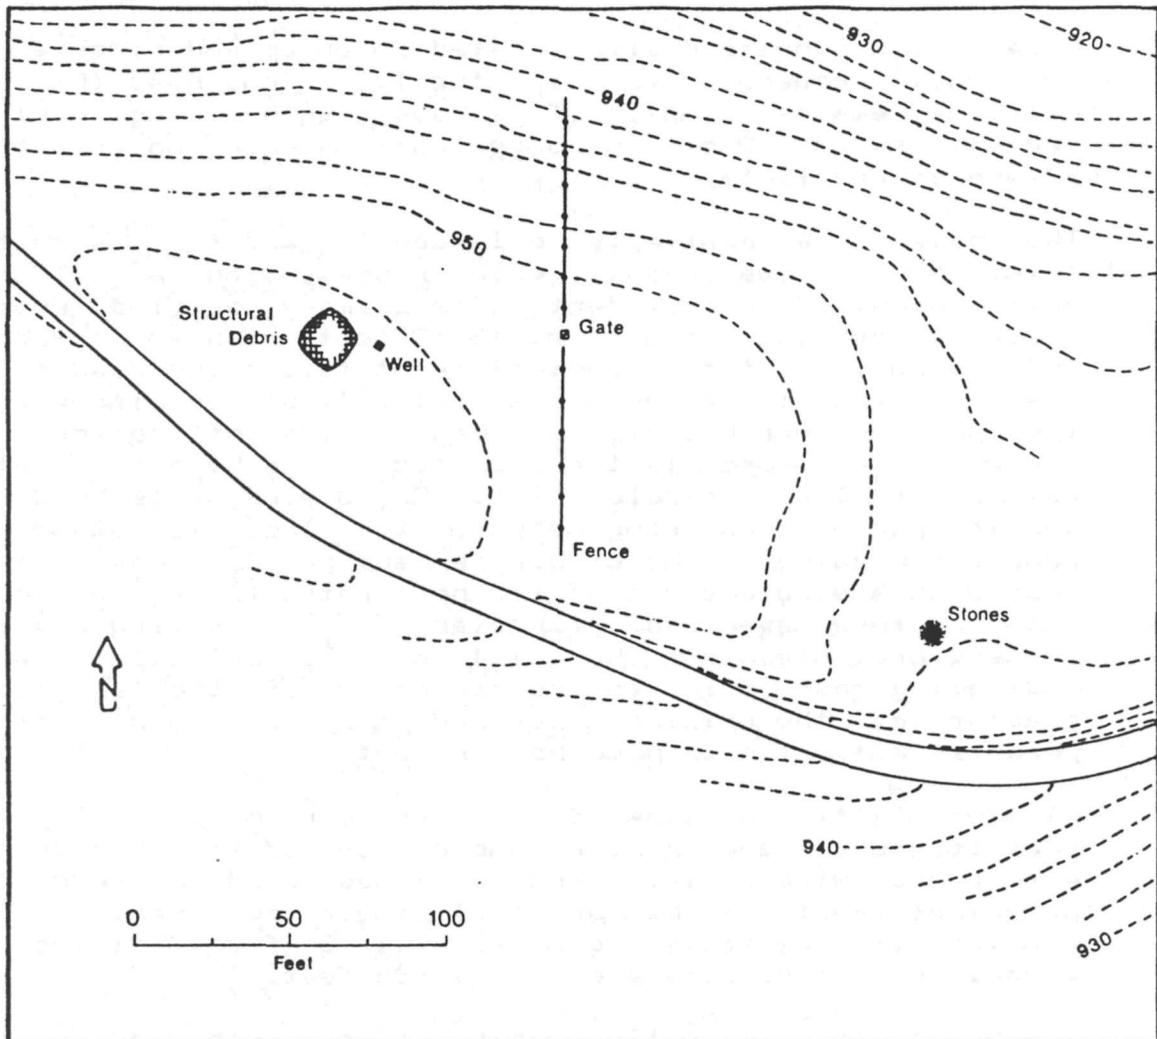
Figure 3. Area 3/4.

Area 3/4 is a homestead site adjacent to the Tyler Bend road on an upland ridgetop at 950 feet ASL. Cultural remains include a collapsed structure, cistern, fallen wooden gate and fence line, and a rock concentration (Fig. 3).

Intensive examination of the site surface did not reveal artifacts. Likewise, shovel tests excavated to delimit site boundaries were sterile. Based on other surface indications, however, the house site and possible garden area encloses approximately 33,000 square feet.

Area 3/4 is a relatively late dating site with little structural integrity, and does not meet minimum standards for inclusion in the National Register of Historic Places. Clearance is recommended.

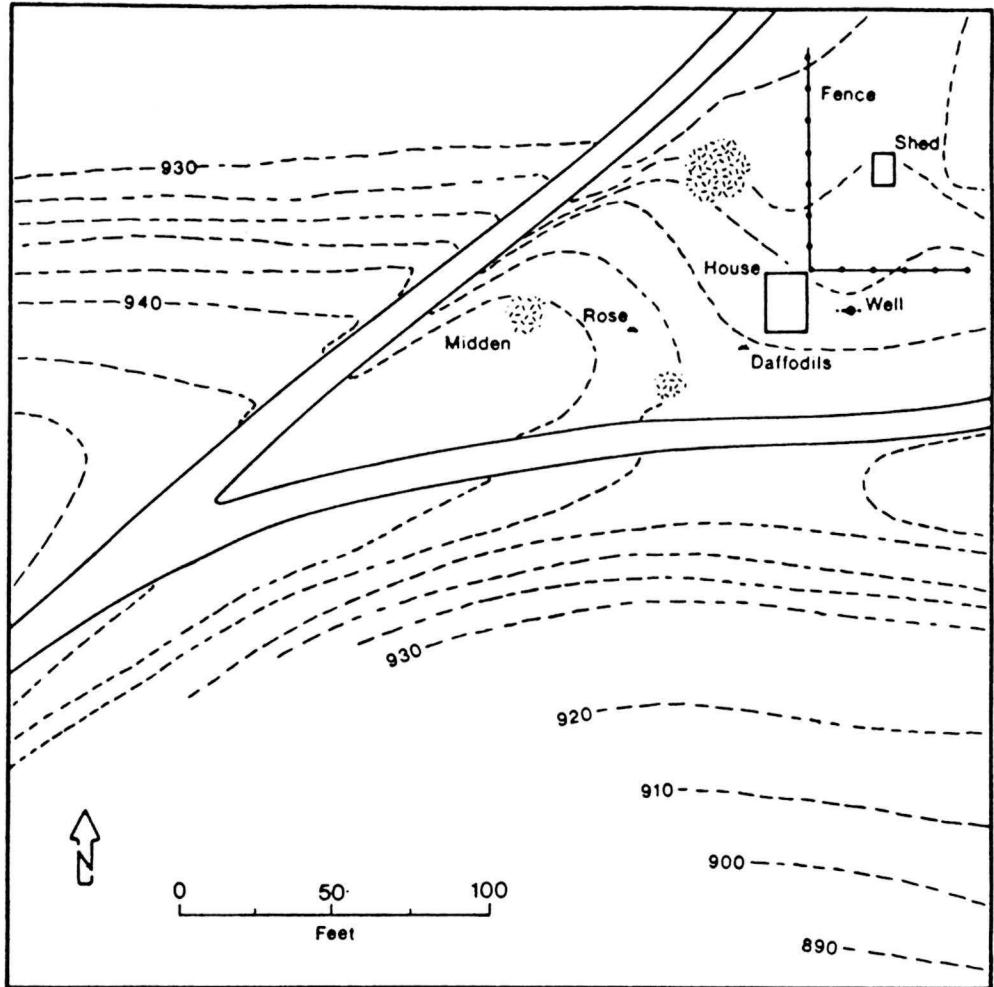
Figure 4. Area 5.

Area 5 is a homestead site located on an upland ridge at 930 feet ASL, between a fork in the Tyler Bend Road (Fig. 5). Cultural remains consist of a house, outbuilding, cistern, fencelines, and 3 midden concentrations covering an area of 20,306 square feet.

Domestic plants and midden concentrations define distinct use areas. Daffodils and a domestic rose are situated immediately south and east of the house and probably indicate yard areas. Midden concentrations occur a greater distance from the house to the south, southeast, and southwest. These garbage dumps contain numerous bottles, tin cans, enamel tinware, car oil filters, oil cans, battery poles, and plastic hair curlers.

Area 5 is relatively recent and possesses little architectural integrity. It fails to meet the minimum requirements for inclusion in the National Register of Historic Places. Clearance is recommended.

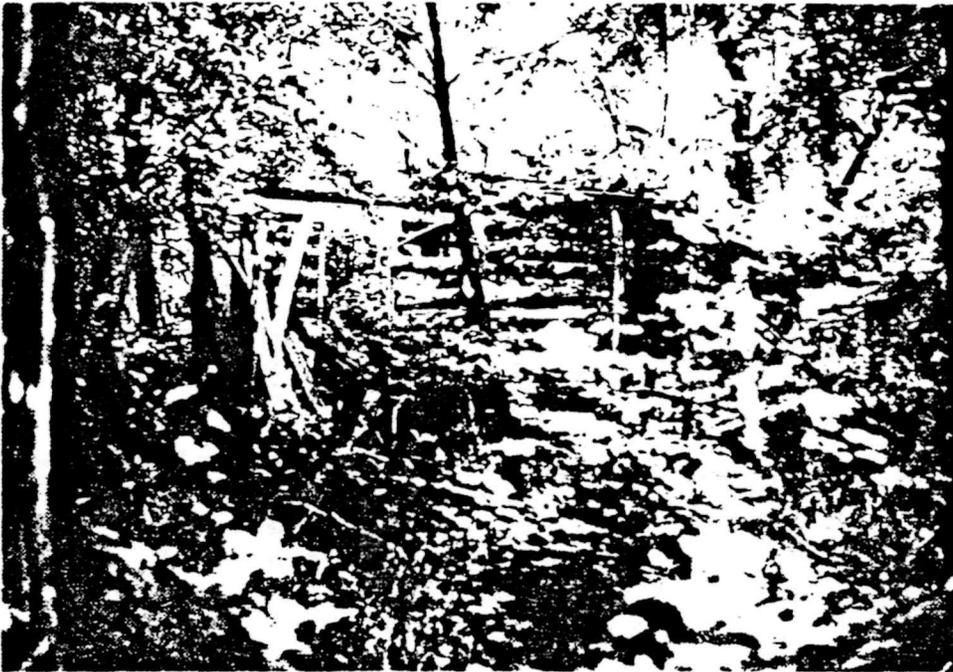
B

The house is a partially collapsed log and frame structure (Fig. 4b). Two rooms, each representing a different building episode are evident. The primary, original room is a single pen log structure, 13x13 feet, with an off-center left doorway on the principal front facing the road to the east. The south facade has a centrally placed window while the opposing north gable end has another off-center left doorway. Logs are left round and joined by a combination half-dovetail and saddle notch. Round wire nails hold each log in place. Chinking between the logs is stone and concrete nogging. The single pen supported a shake shingle roof with a single sheet of tin perforated for a stove pipe. The structure never had a fireplace. Two surviving 2x4 inch rafters protrude from the sill on the principal facade indicating that prior to construction of the additional frame room, the original pen had a porch. Width of the porch is estimated to have been 6 feet.

Although little remains of the second room, it is apparent that it is a frame or board and batten addition constructed with round wire nails. The room was added to the east or principal front of the original single pen cabin. Dimensions of the frame room are 11x13 feet, giving the overall structure dimensions of 13x24 feet.

The house rests directly on piers of concrete and sandstone construction. Each pier is composed of 4 courses of stone and is roughly 1 foot square. 10 piers support the building. Concrete and stone nogging fills the gaps between piers creating the illusion of a full length foundation.

Figure 5. Structural Remains in Areas 3/4 and 5.
A) Collapsed house in area 3/4. B) Partially standing house in area 5.

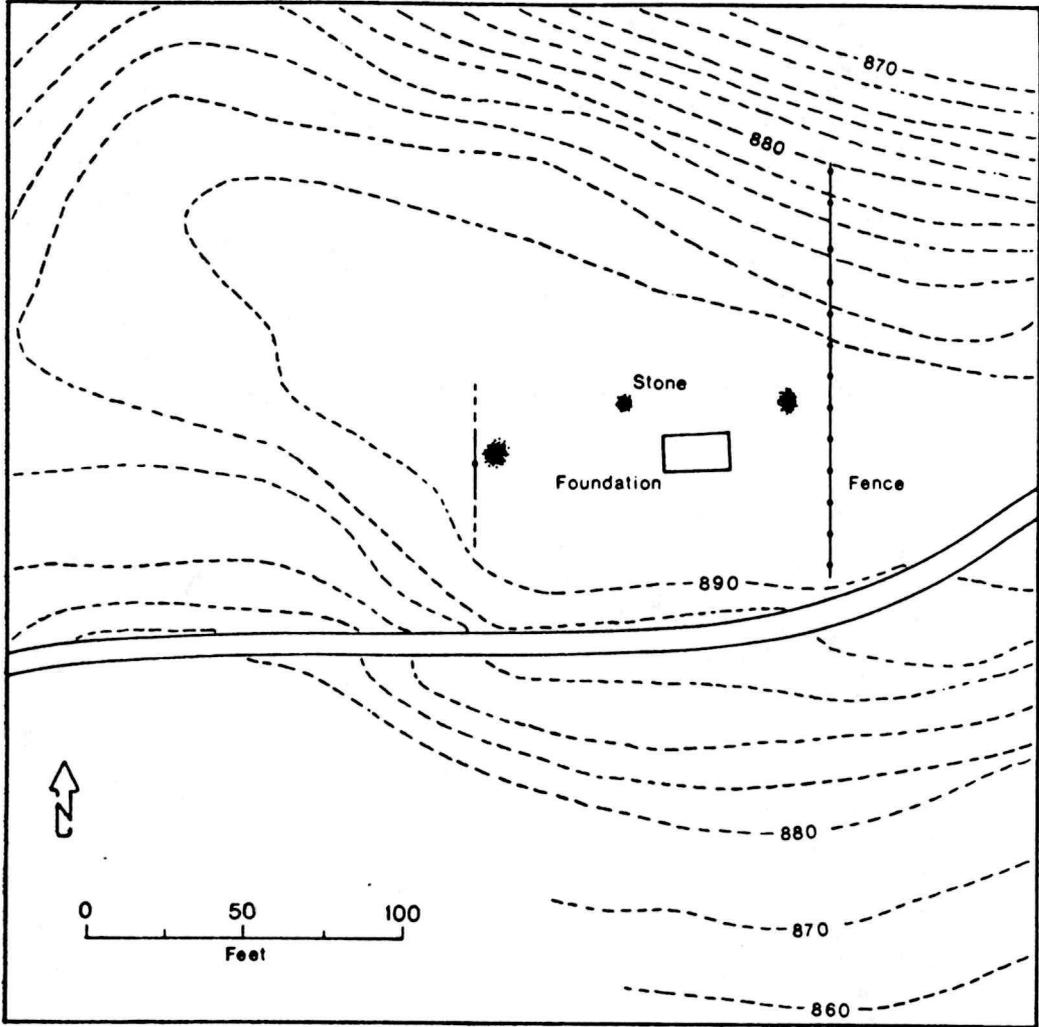
Figure 6. Area 6.

Area 6 is a homestead site adjacent to the Tyler Bend road on an upland ridgetop at 896 feet ASL (Fig. 6). The site contains a house foundation, 3 stone concentrations, a tree scaffold, and evidence of 2 former fencelines. Artifacts were few on the site surface and shovel testing yielded little useful information regarding site size. Based on fencelines, and natural boundaries such as the road and edge of the ridgetop, however, site size is estimated to be 16,000 square feet.

Area 6 is a relatively late dating site with little structural integrity. It does not meet the minimum requirements for inclusion in the National Register of Historic Places. Clearance is recommended.

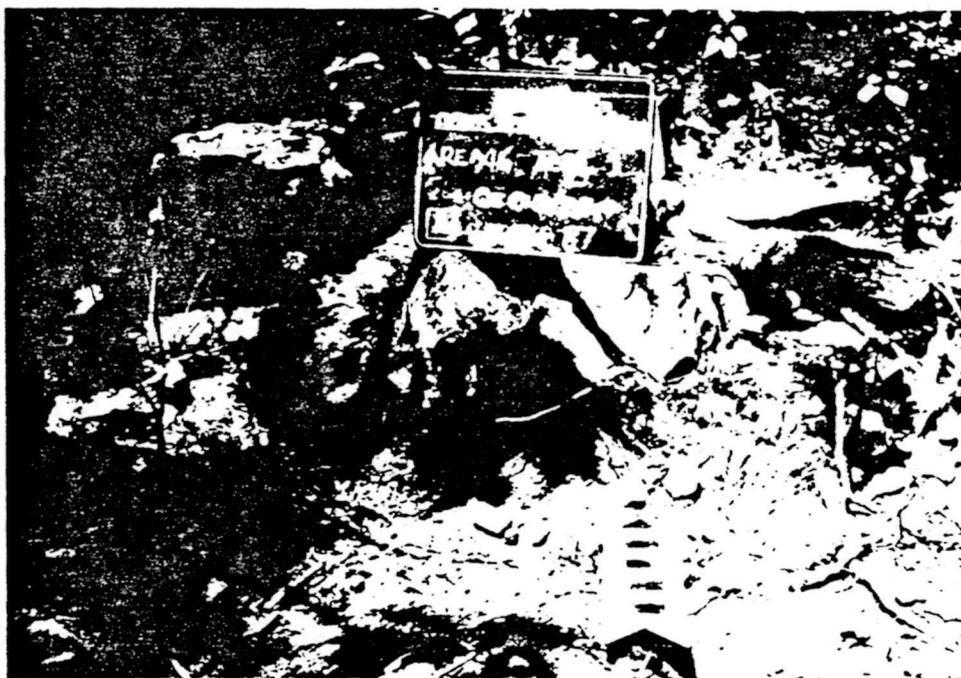
Figure 7. Structural Remains in Area 6. A) Foundation in area 6 occurs in the foreground. B) Test 1 at the northwest corner of the foundation.

The house foundation is a rectangular, 12.5x20.5 foot, continuous foundation constructed of undressed sandstone rocks cemented together with soft, orange colored, sand and lime mortar. Although the foundation is disturbed, 2 courses of stone survive in places. Stone is set directly on the ground surface without a builder's trench, and the foundation probably never supported more than 2 courses of stone. Iron stove parts from a kitchen range are abundant within the foundation. These cluster in the northwest corner and indicate that a stove once occupied this location.

The foundation is oriented to the Tyler Bend road. Presumably, the principal front of the house faced south toward the road. An improved garden site north or behind the house is indicated by 3 rock concentrations. The tree scaffold, at the northeast corner of the house, is a crude structure of plank and wire nail construction, and may have functioned as a storage cache.

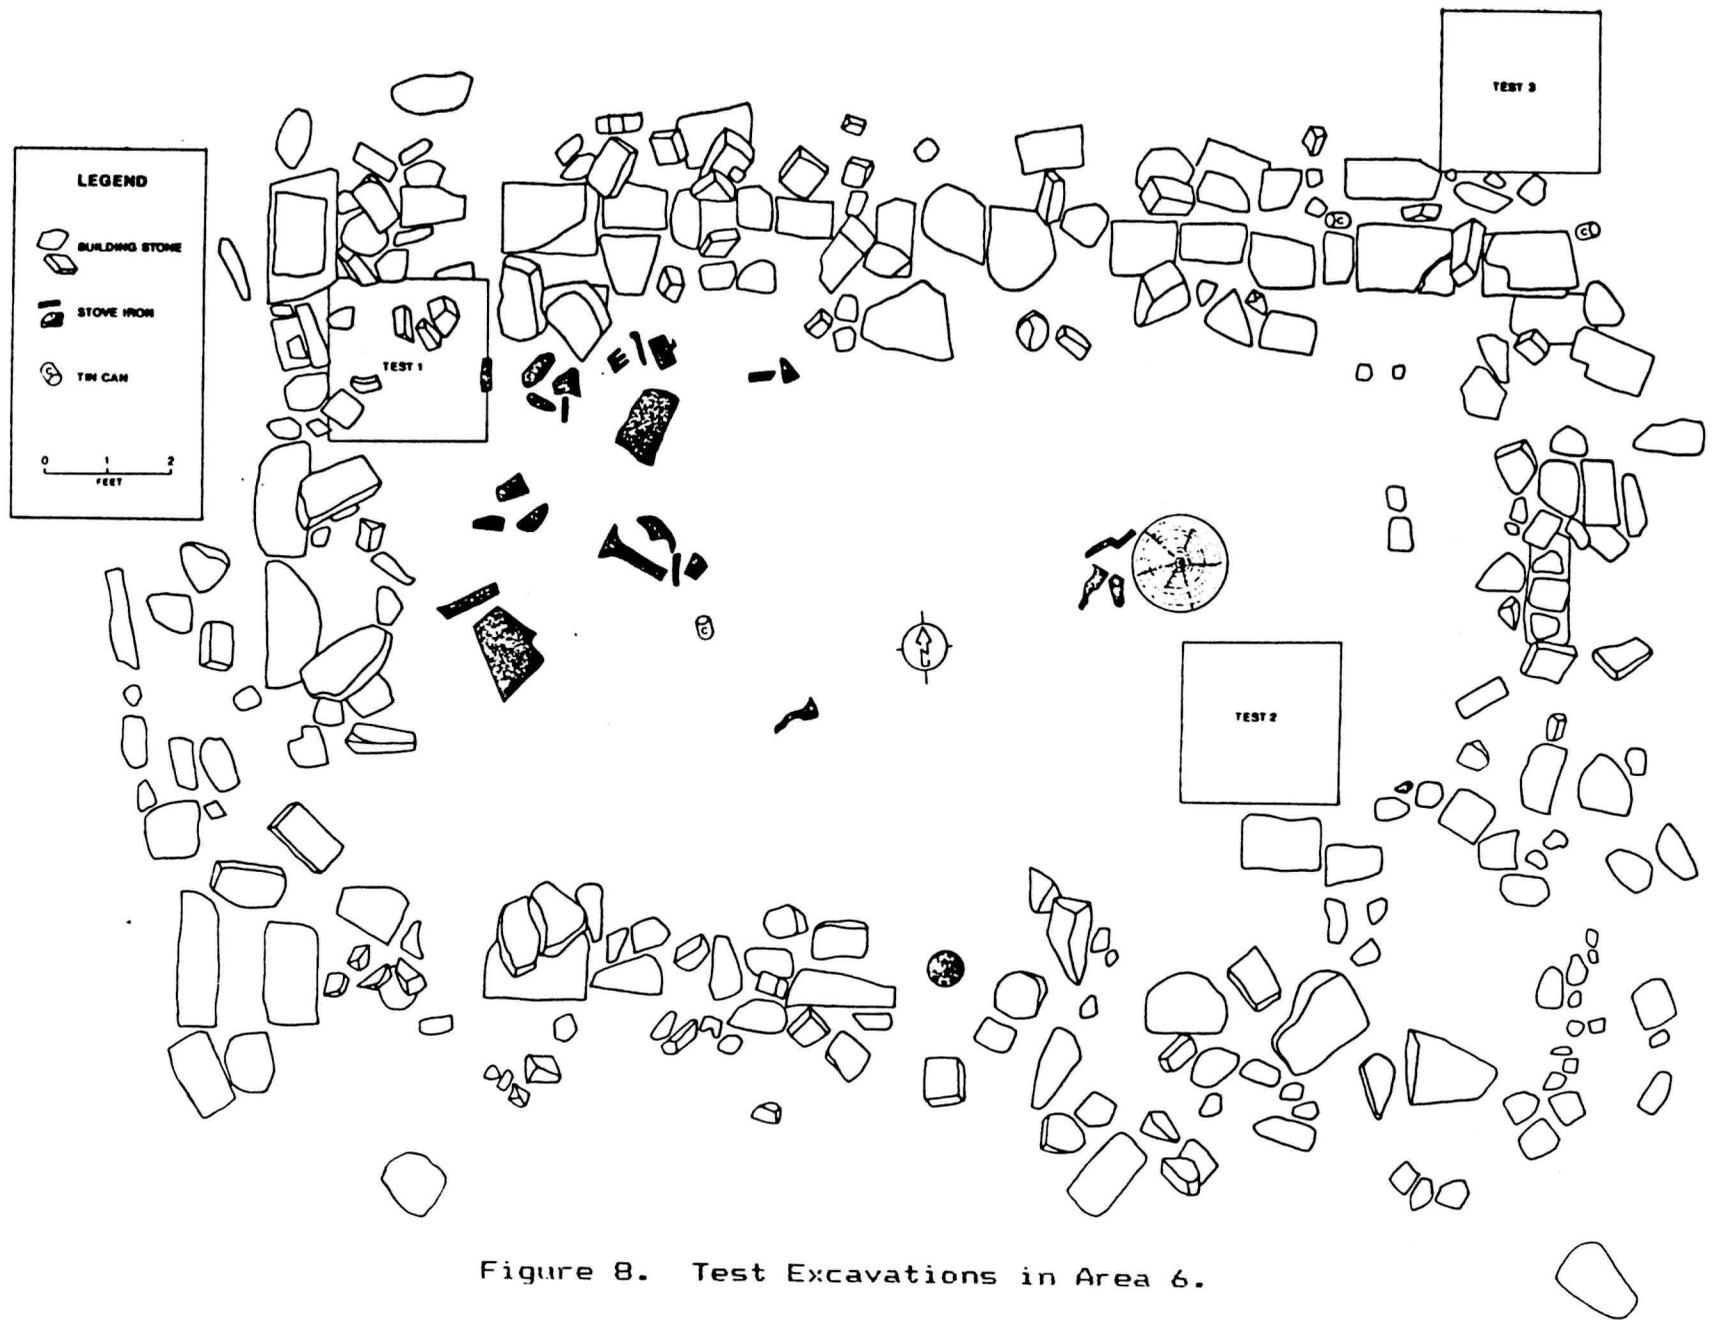
Figure 8. Test Excavations in Area 6.

3 2.5x2.5 foot-test squares were excavated at area 6 (Fig. 8). 2 tests within the foundation were placed at opposite ends of the structure. Had two rooms existed, the tests could reveal functional variation. A single test was excavated outside the foundation to sample deposits in that area.

Testing indicates that site deposits are shallow and artifacts occur sparsely within the first 0.2 feet of soil. 84 artifacts were recovered from the 3 tests (Table 2), and allow a relatively detailed assessment of the site.

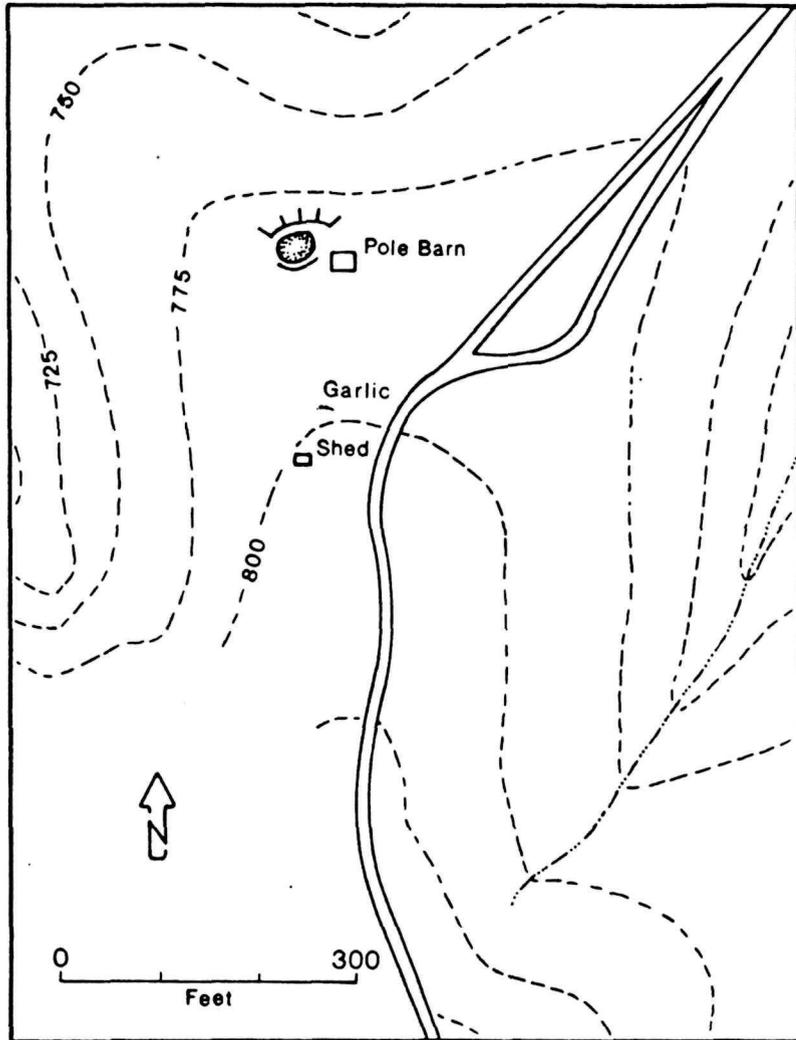
Figure 9. Area 7.

Area 7 consists of the remains of 2 outbuildings in a meadow west of the Tyler Bend road. The site occurs on an upland ridgetop at 800 feet ASL (Fig. 9). Site area is approximately 30,625 square feet.

The structures in area 7 are modern. Because of their recent age, and lack of integrity, the buildings are not considered eligible for recommendation to the National Register of Historic Places. Clearance is recommended.
