**NATIONAL REGISTER OF HISTORIC PLACES
INVENTORY -- NOMINATION FORM**
FOR FEDERAL PROPERTIES

HISTORIC
Rush Historic District
AND/OR COMMON

STREET & NUMBER
Rush Road
CITY, TOWN
Yellville
STATE
Arkansas

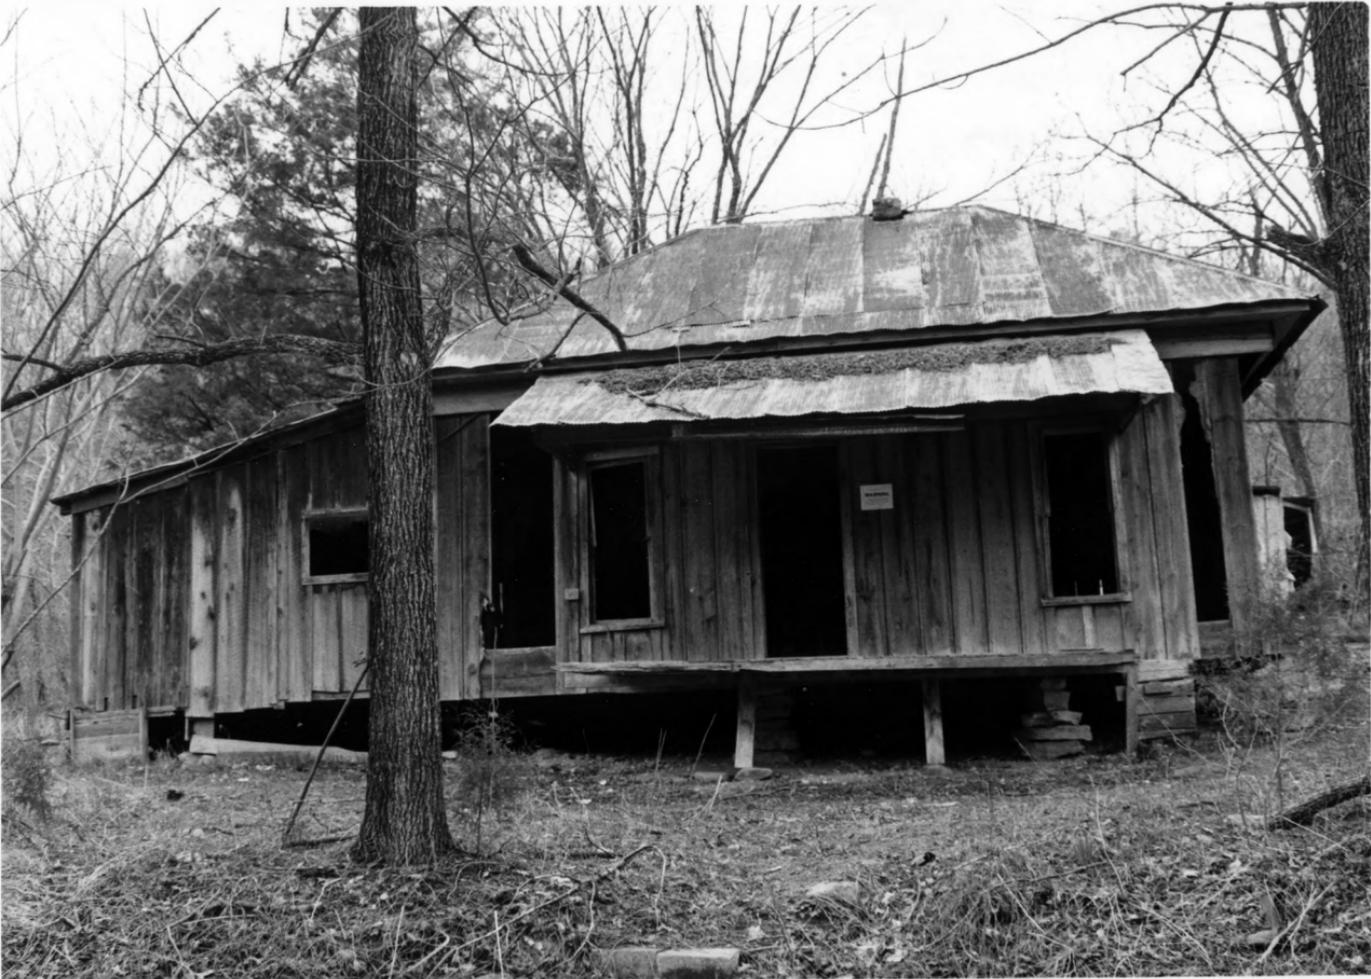
2

Bundy House, Tusk "ghost town", looking west

Bundy House. Circa. 1899. One-story, vertical board and batten dwelling, 15' X 26'. Rock pier foundation; hip roof; half-brick chimney on wooded support; porch platform and overhang across main facade. Shed addition on south (1930s) and north (1950s). Doors and window sashes missing; loss of exterior boards on east and north. Three outbuildings date from 1950s or later.

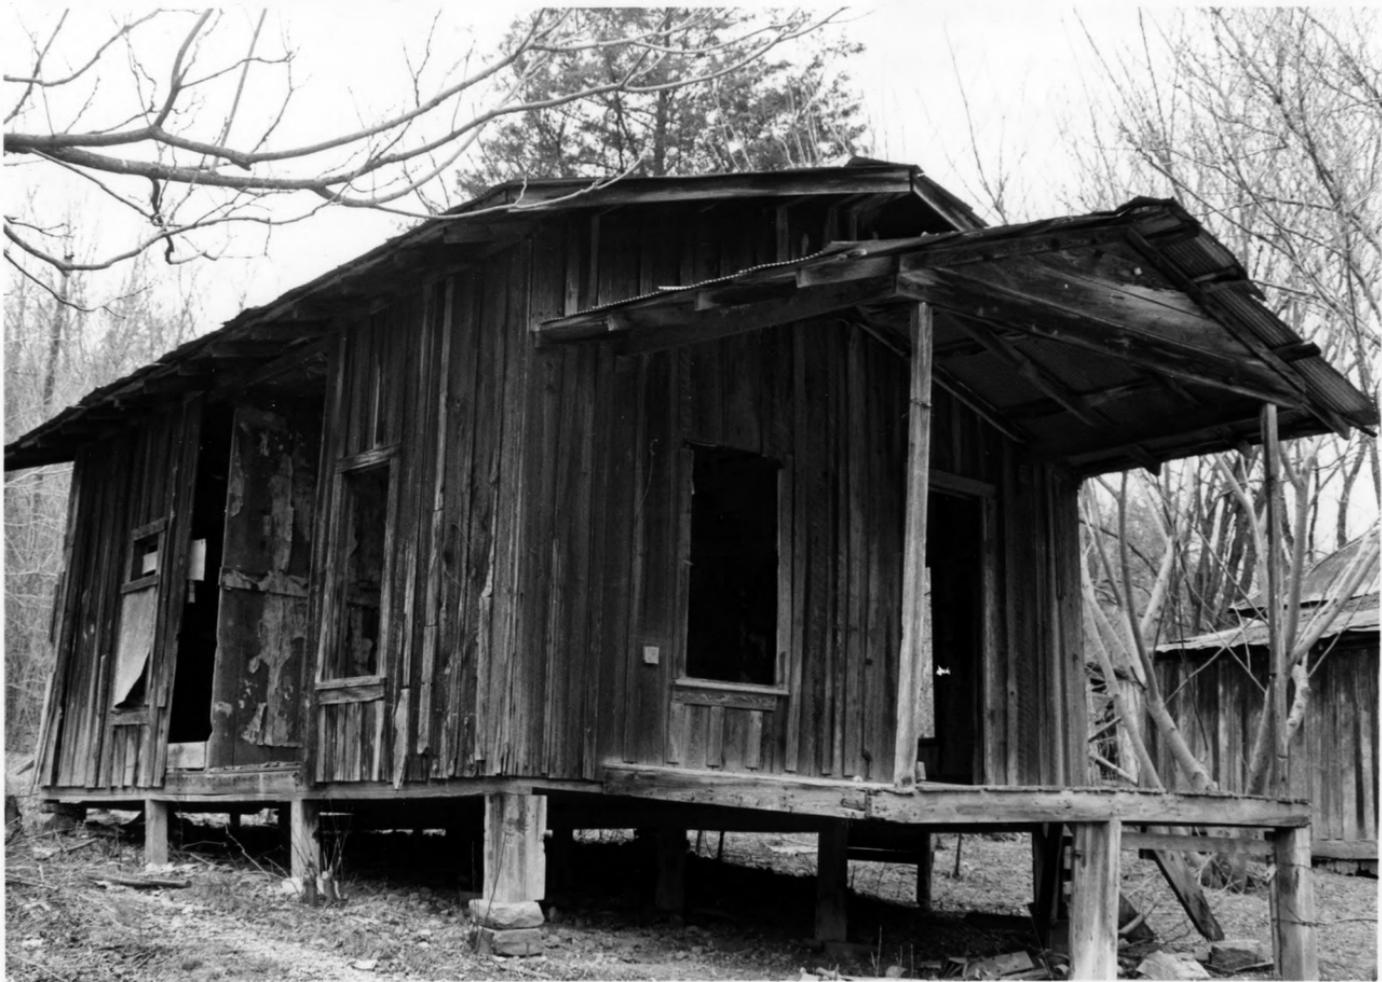
3

Wash house, Rush "ghost town" looking northwest

Washhouse. Circa 1899. One-story, vertical board and batten dwelling, 16' x 24'. Rock pier and post foundation; gable roof; porch platform and overhang across main facade, half brick chimney with masonry cover. Small horizontal board shed at rear (1960s). Doors and window sashes missing; loss of exterior boards on north.

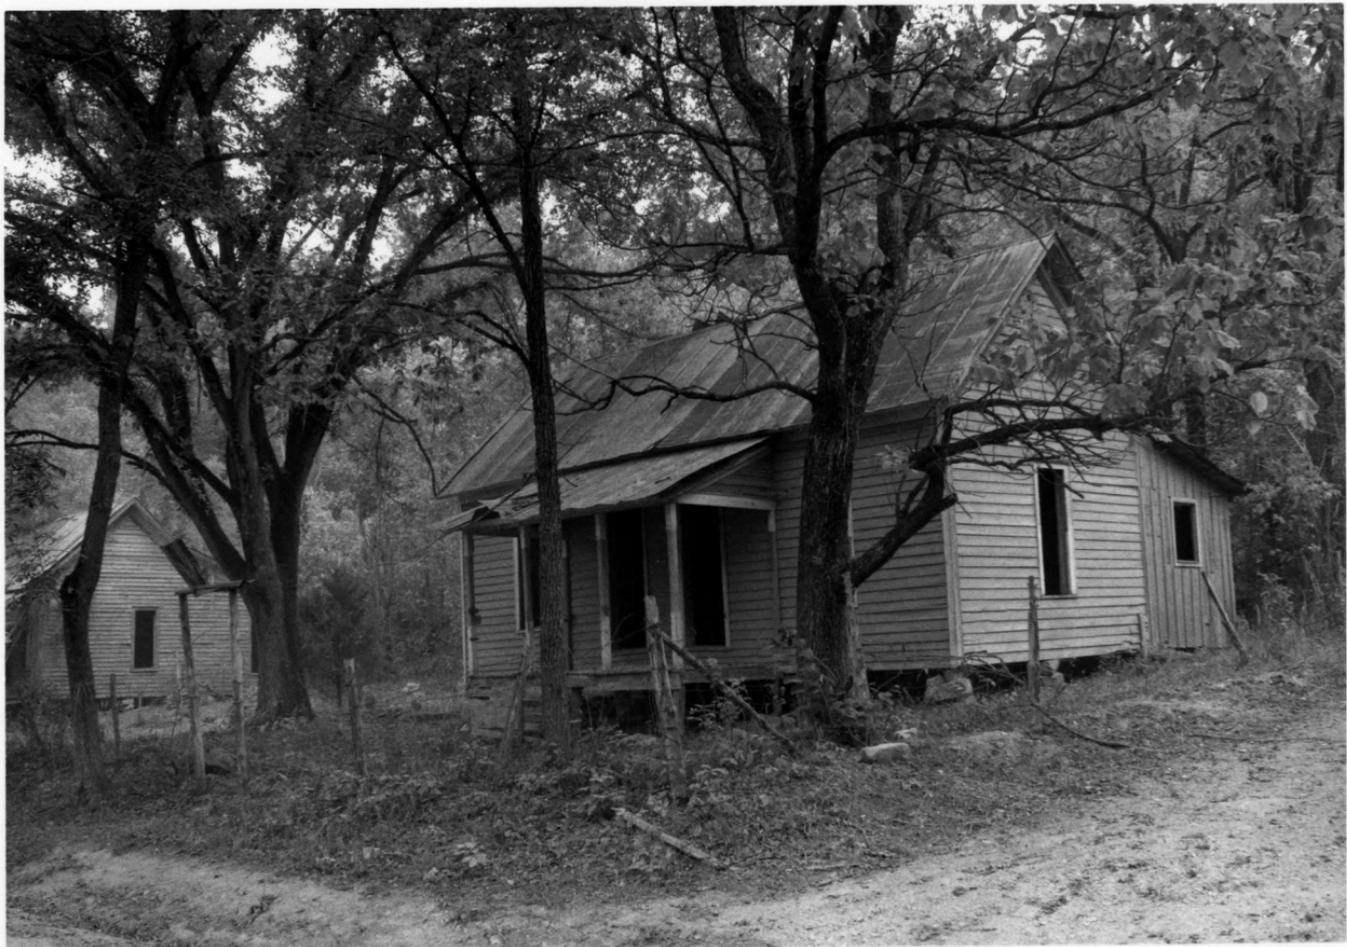
4

view of Kastning house in "ghost town," facing west

Kastning House. Circa 1899. One-story, wood frame house with overlapping siding, 21' x 31'. Design is double pen with separate entranceways, a frequent Ozark style although uncommon in Rush area. Rock pier foundation; gable roof; brick chimney on wooden support (top of chimney missing); porch platform and overhang extends across doorway entrances. Board and batten shed across length of rear (1920s or earlier). Doors and window sashes missing; some loss of interior wall boards. Wall construction is 1 x 4s and 1 x 6s over pine studding attached to 1 x 10s and 1 x 12s placed diagonally. Exterior siding painted green with white trim (1960s). Exterior construction detail more finished than other Rush buildings, including mitred corners.

Interior divided into two rooms with two additional rooms in shed. Numerous newspaper layers removed in 1950s and replaced with wallpaper, segments of which remain. Central chimney with double flue. Tongue and groove flooring over a subflooring.

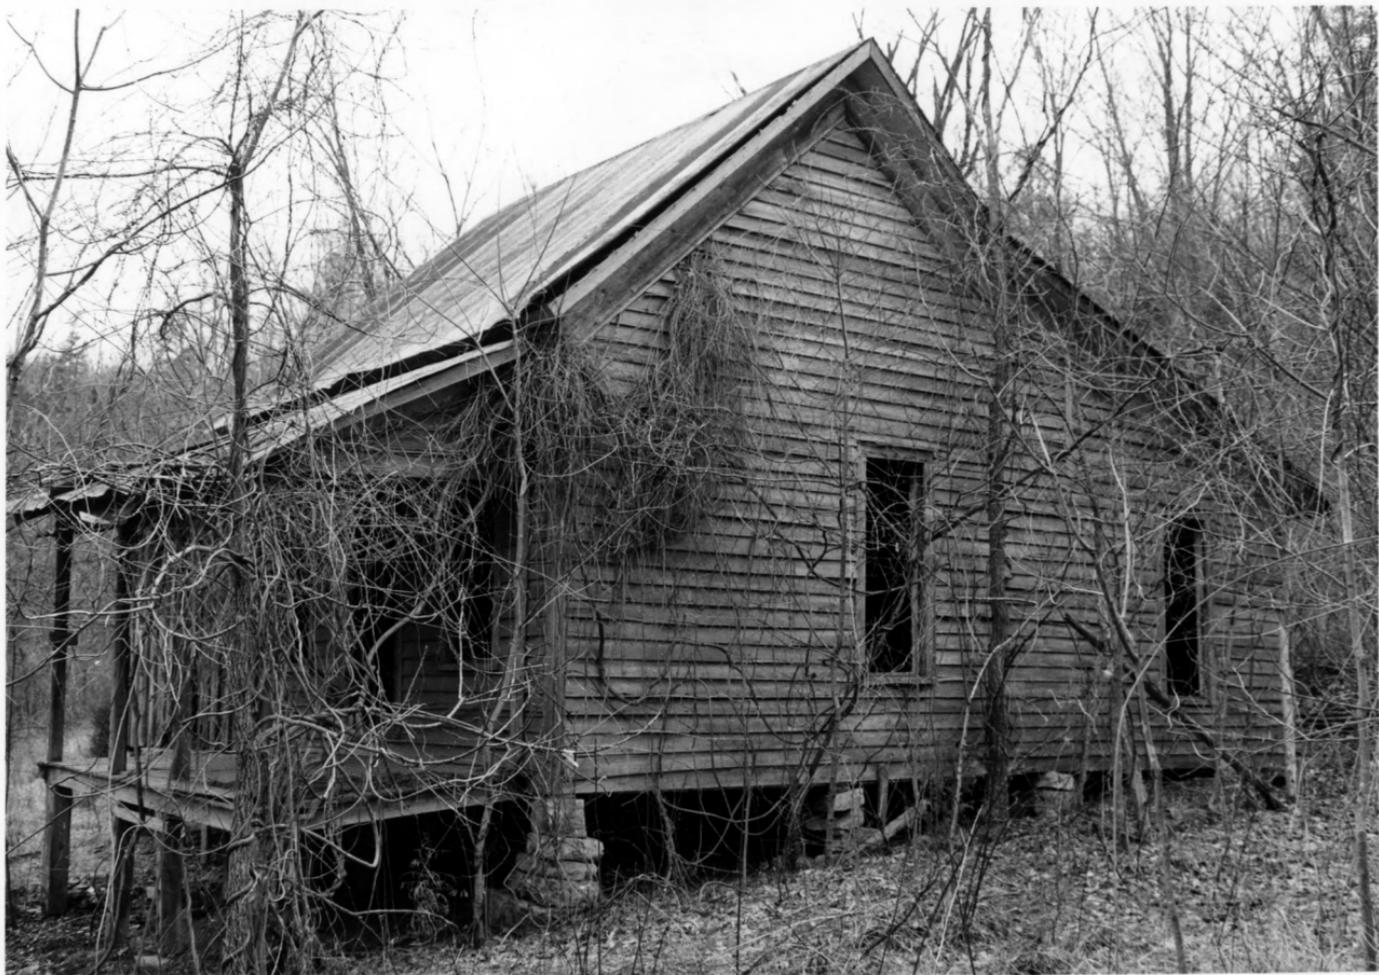
5

Brantley House, Tusk "ghost town," looking southwest

Brantley House. Circa 1899. One-story, vertical board and batten house with overlapping siding, 16' x 16'. A 10' x 16' shed addition at rear of house probably was added soon after construction. Rock pier foundation; gable roof; half brick chimney on wooden support (collapsing); porch platform and overhang across length of main structure. Board and batten lean-to on south (1960s) is deteriorating. Doors and windows missing.

One main room plus shed additions. Walls 1 x 12s. Butt-laid flooring (replacement?) and tongue and groove flooring. Newspaper and wallpaper remnants include 1910 newspaper. Two-wire electric cable runs along roof crawl space.

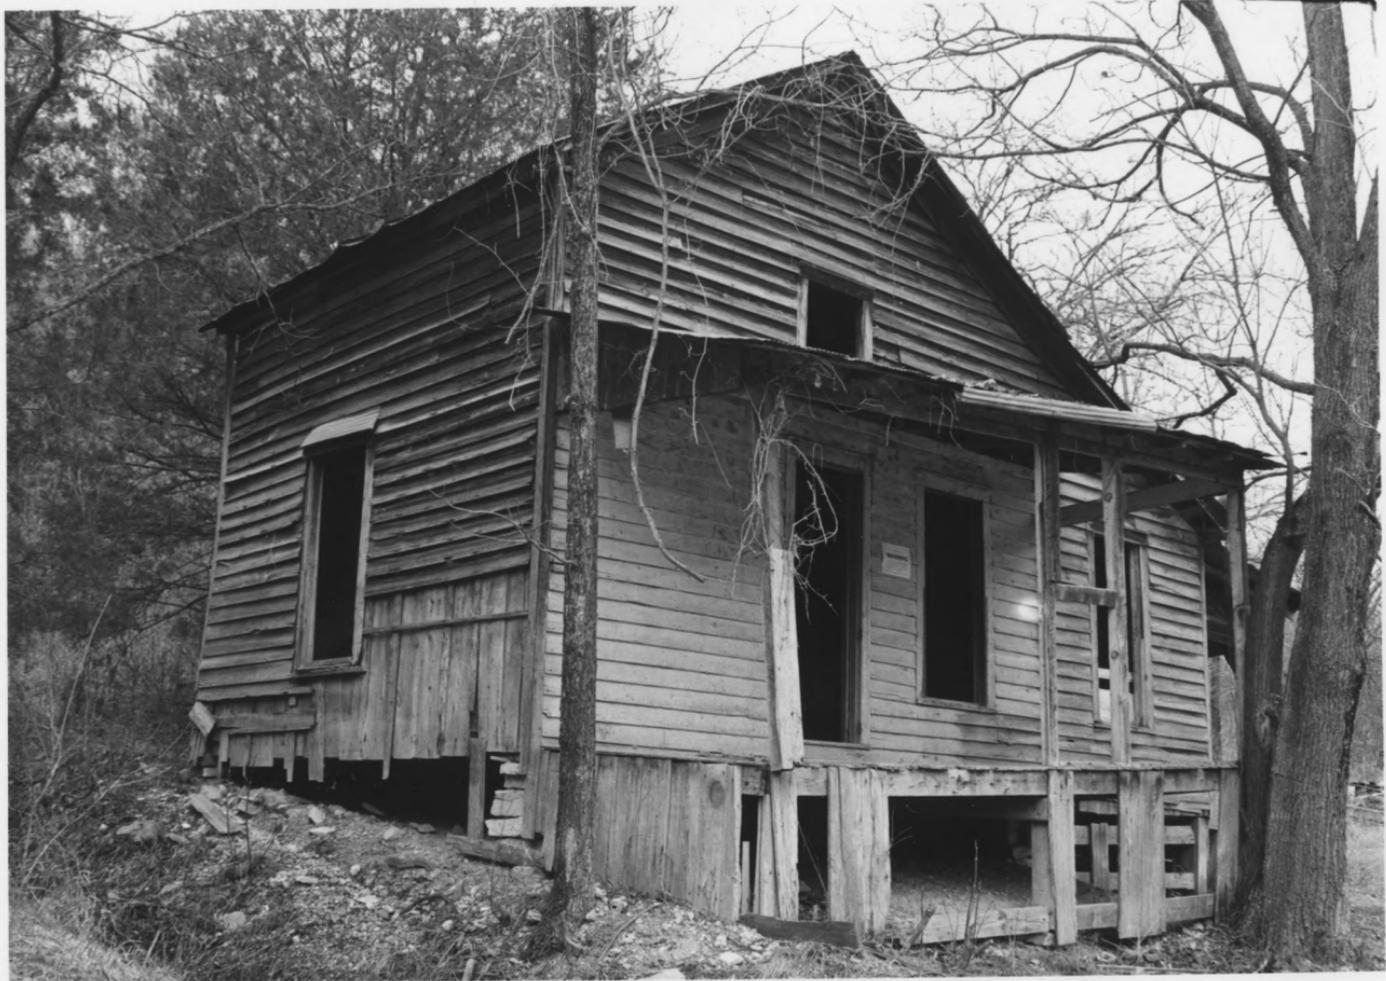
8

Storekeepers House, looking northwest

Storekeepers House. Circa. 1899. One and one-half story vertical board house with overlapping siding, 14' X 14', with 8' x 14' shed addition (1920s or earlier). Rear shed addition (1950s). Rock pier foundation; gable roof; cemented brick chimney with double flue; porch platform and overhang across main facade and along 1920s addition. Remnants of green paint on exterior siding (1960s?). Half-story room over main structure, but flooring and joists have been removed; some siding loss on exterior; doors and window sashes missing. Sills are log.

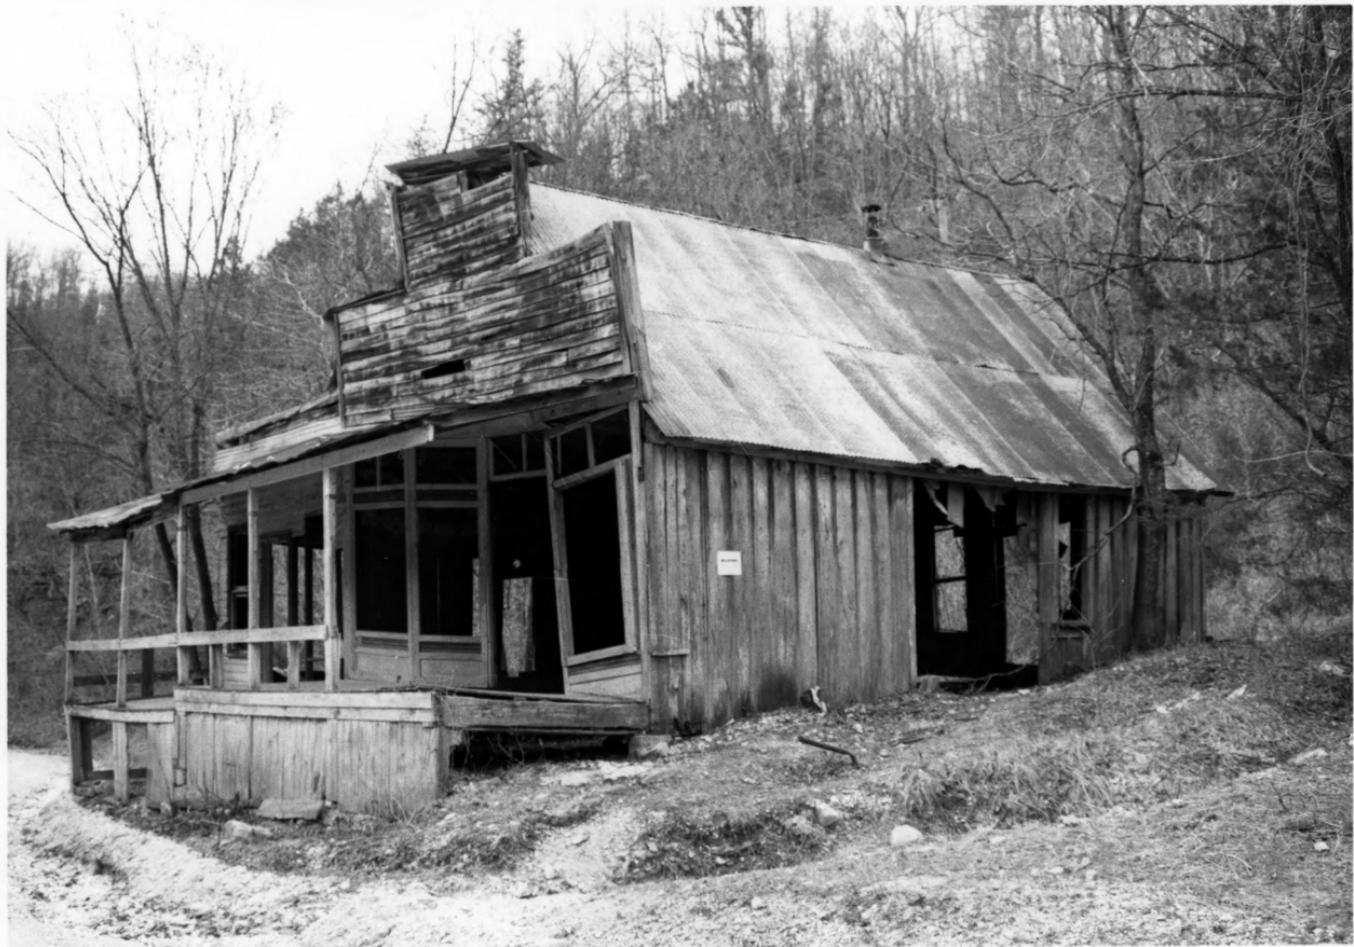
Taylor-Medley General Store. Circa 1899. One-story, vertical board and batten building, 20' x 33', with 14' x 33' vertical board shed addition. Store has gable roof with false front covering gable end; porch platform and overhang covers length of store and continues across front of shed; rock pier foundation. Doors and window sashes missing; part of the frame of a moulded bay front remains on the store showing evidence of green and yellow paint. Significant portions of the exterior boards have been removed on sides and rear.

view of deterioration of Taylor-Medley store, facing west
9

Structural loss is contributing to deterioration of the building. In 1985 a National Park Service preservation team gave emergency support to the building by adding supporting posts to the structure.

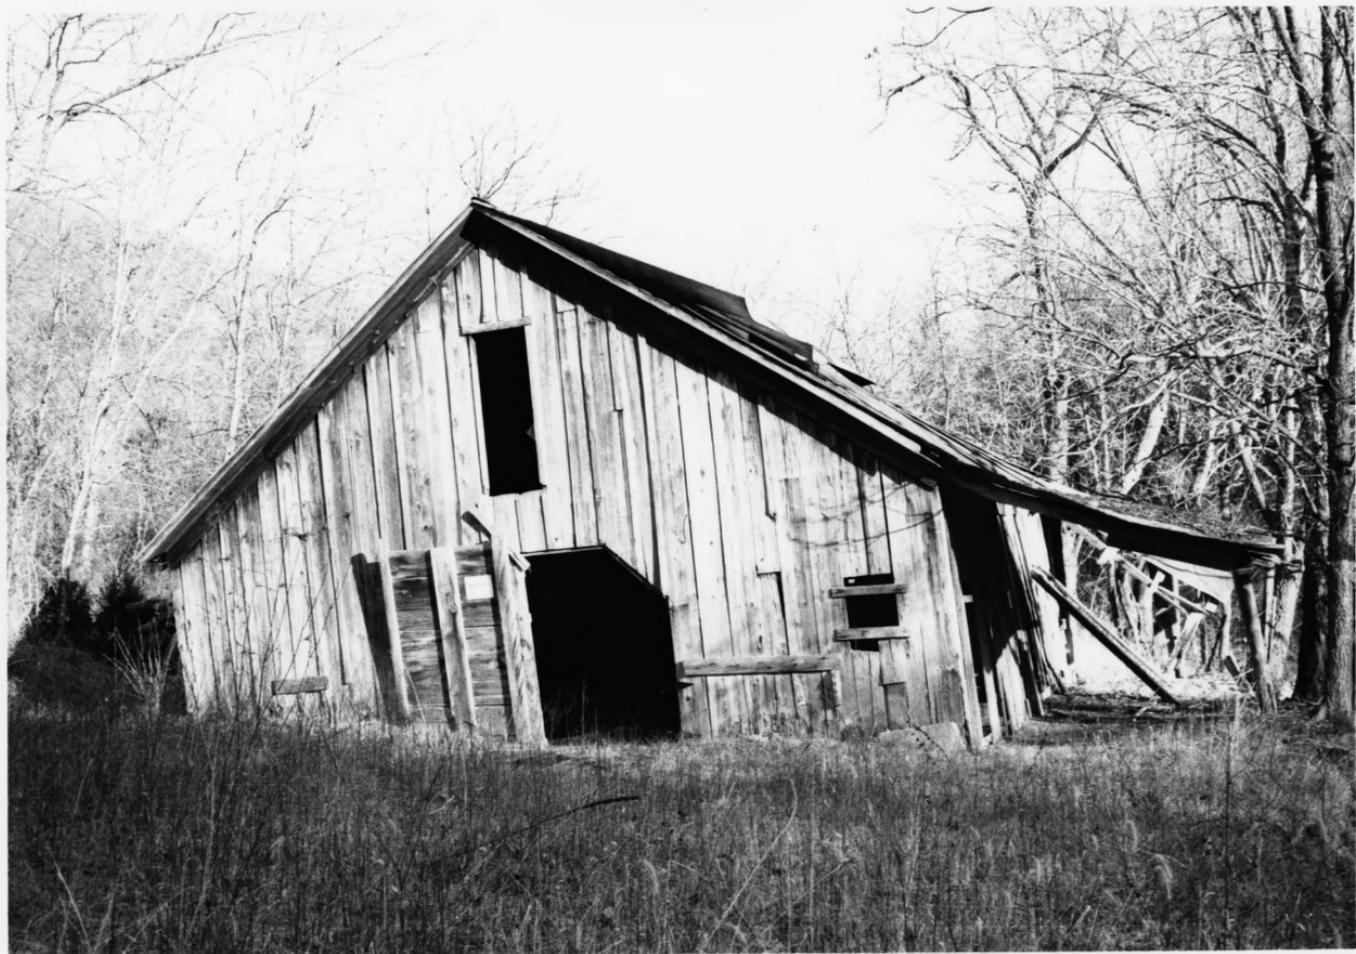
#12

Morning Star Livery Barn. Circa 1899. Vertical board and batten drive-through barn with eight stalls and a loft, 20' x 32'. Buried post foundation; gable roof, apparently originally shingled but now covered with galvanized metal. Open lean-to sheds along both lengths: early photographs show some enclosure of the lean-tos. Repaired 1920s with new boards from local sawmill; iron hardware made in 1925 blacksmith shop; board width varies but averages 1 x 12. Door intact on west gable end; window openings in loft, intact.

barn prior to stabilization, facing east

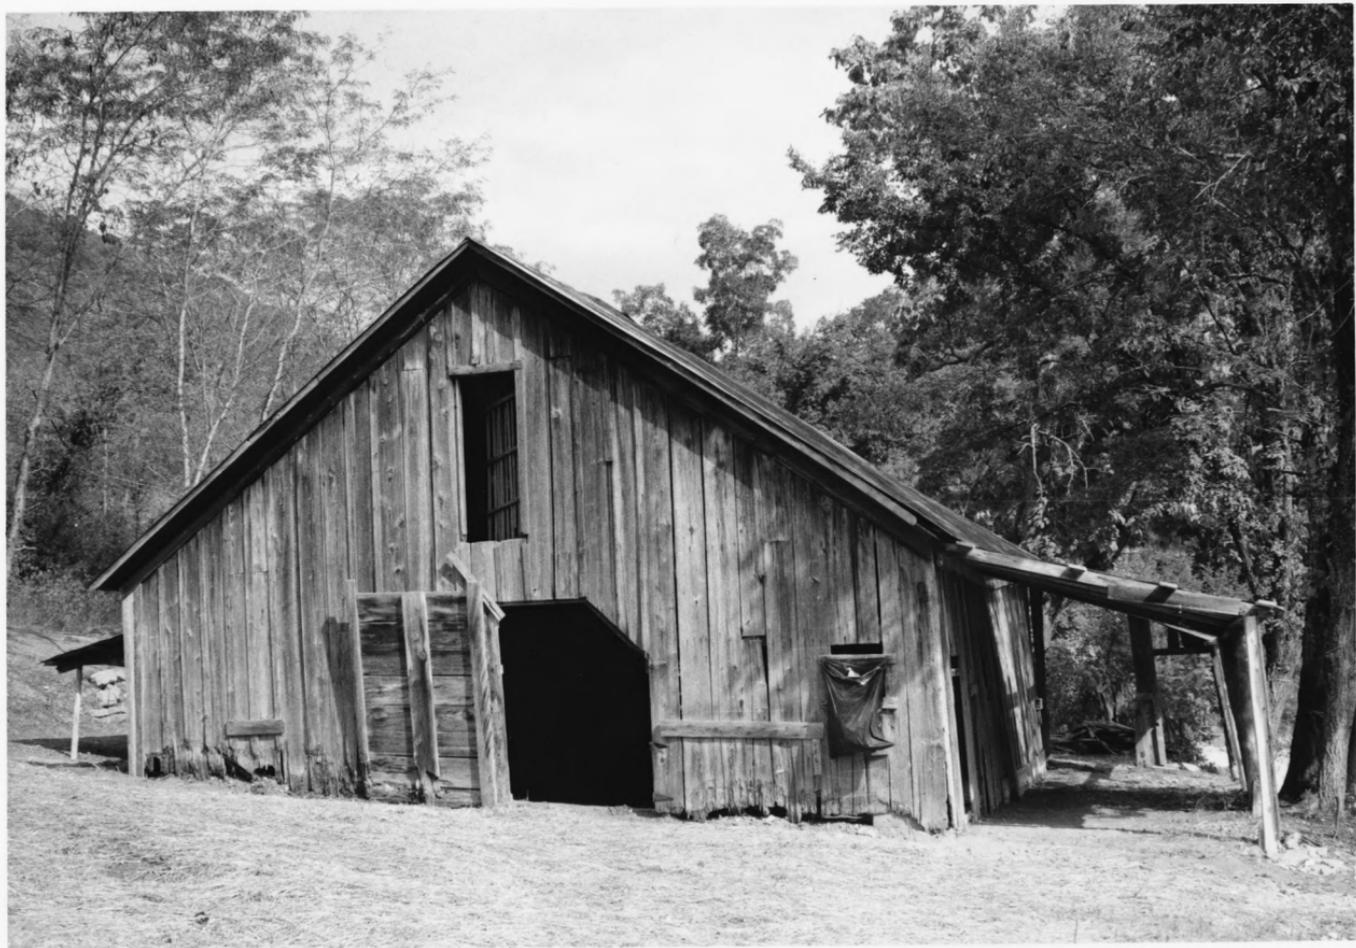
12

barn after 1985 stabilization work

This building exhibits design, workmanship, materials of the historic periods. The current physical components are either from the historic periods or are replacements added by the NPS preservation team. Despite board loss, the design and function of the barn is still evident.

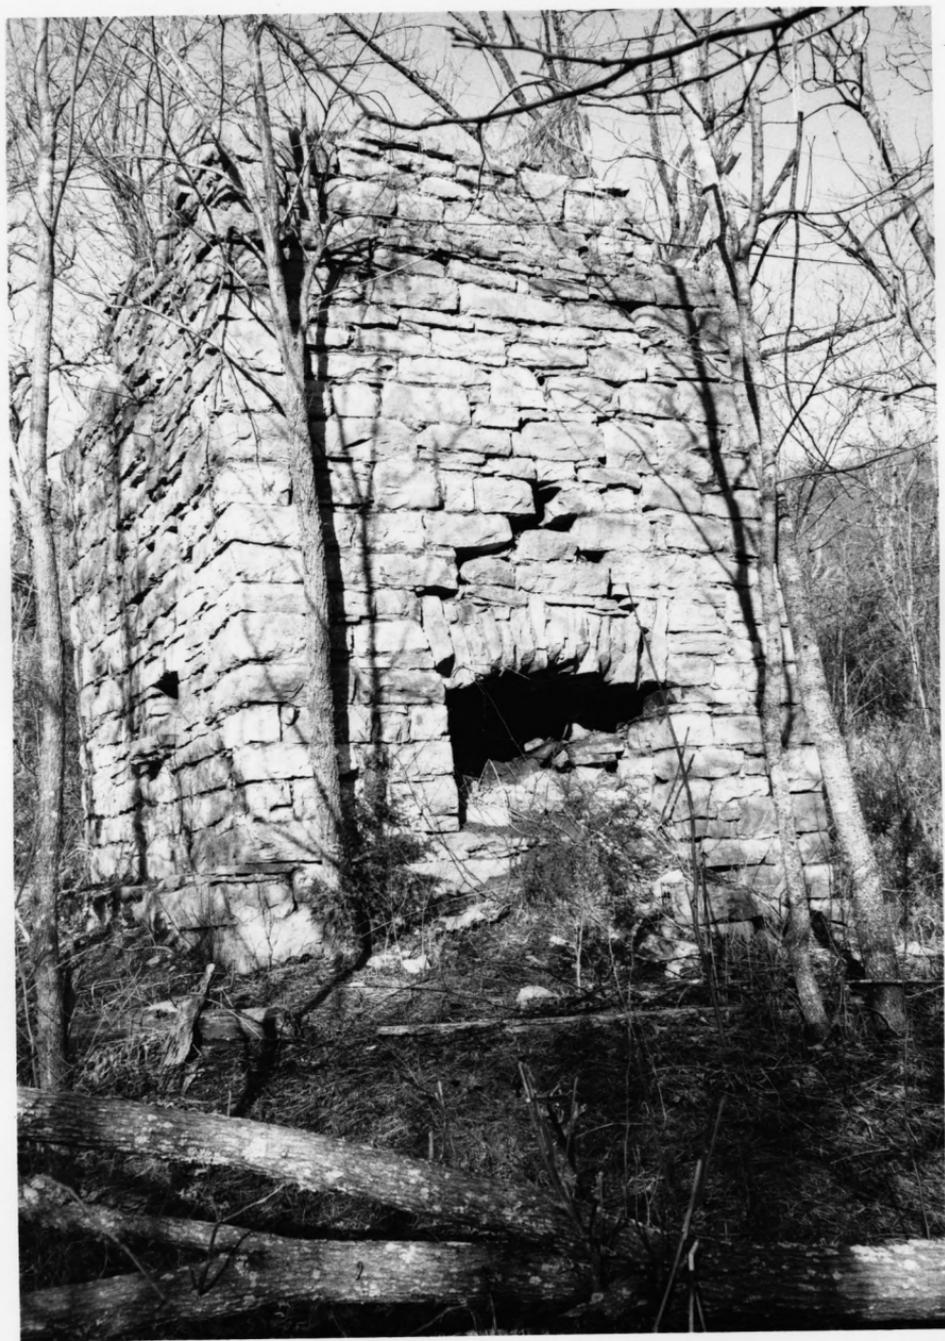
13

Smelter. 1886. Random-coursed, rough-cut, mortared limestone tower, 11' x 11' x 15'. Mortar is a clay and lime mixture. Beehived-shaped central burning chamber; arched mouth; foundation stones banked into hillside.

smelter prior to stabilization, facing northeast

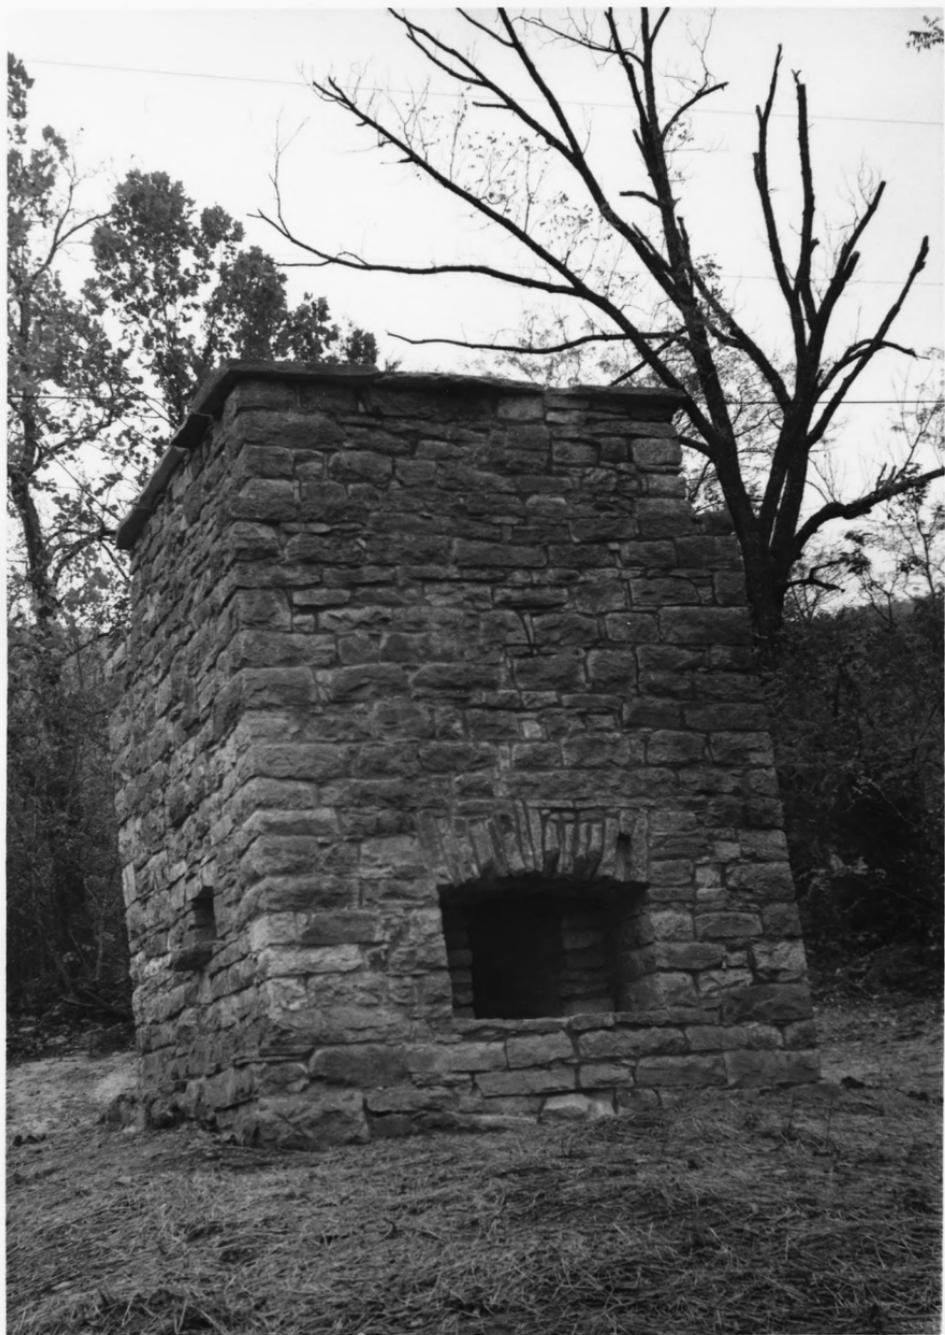
13

Smelter after 1985 stabilization work, facing northeast

In the summer of 1985 a National Park Service preservation team replaced and remortared fallen stone, including rebuilding the central chamber and repairing rock slippage in the mouth. (Historical photographs show the mouth rock slippage as early as 1911). Overgrown vegetation was removed from the area.

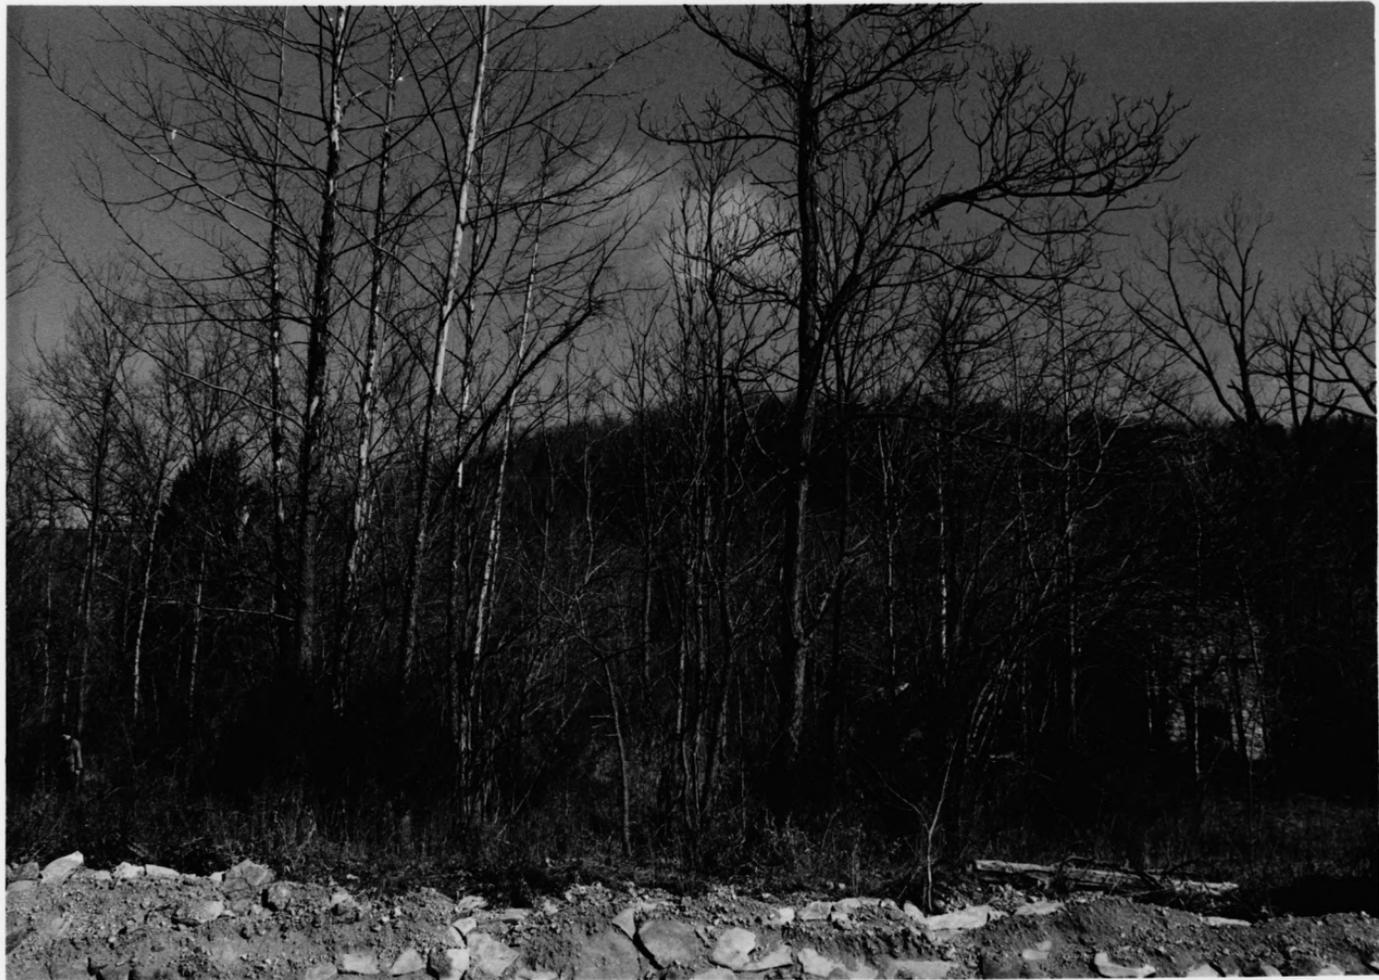
14

Morning Star Hotel ruins. Circa 1900. The two-story wooden structure which once stood here burned in 1947. Remaining is a graded area about 150' long marked by two sections of a dry-laid retaining wall. Portions of a concrete foundation and water pipe from the spring-fed water system are left. Presently covered by vegetation.

area of Morning Star Hotel, facing northeast

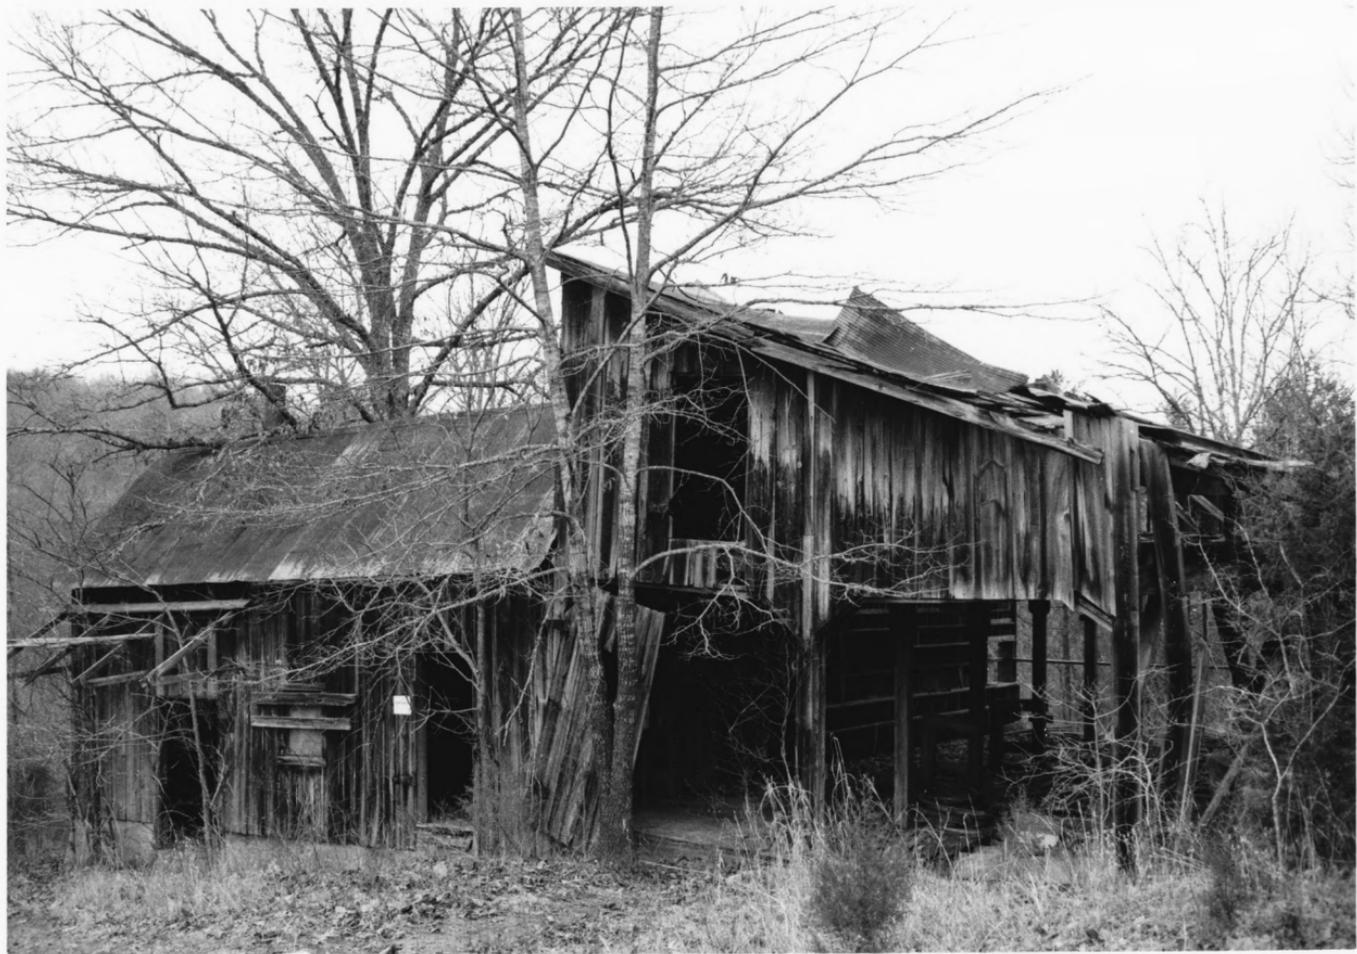
#17

Blacksmith Shop, with attached warehouse. 1925. Vertical board and batten building, 12' x 18'8", with an attached vertical board and lean-to warehouse, 30' x 42' x 25', built about 1927. Blacksmith shop rests on poured concrete foundation, 3' high above grade. Gable roof with galvanized metal covering, probably original. Shop interior divided into two rooms, one for the forge and work area, of which the forge brickwork and a portion of the stove pipe are intact as well as rude wooden work tables; and a parts room which used to have bin shelving. The floor is earthen; interior walls unfinished. Doors are missing from the entrances to each section. The frame of a porch overhang covers the forge entrance.

The warehouse towers above the blacksmith shop, and is divided into a main story and a loft, with divided storage bins along one long side and a concrete engine base 4 1/2' x 7 1/2' at the entrance to the opposite side. 2 x 4 uprights support the center. The structure is in a dangerously deteriorating condition due to removal of the protective galvanized metal roof covering and most of the interior boards on the rear and far side.

The blacksmith shop exhibits the design, materials, and workmanship of a rural blacksmith shop of the 1920s. The warehouse design provides an interesting look at auxiliary building needs of the mining companies, but the physical features are rapidly deteriorating.

Morning Star blacksmith shop and warehouse, facing north

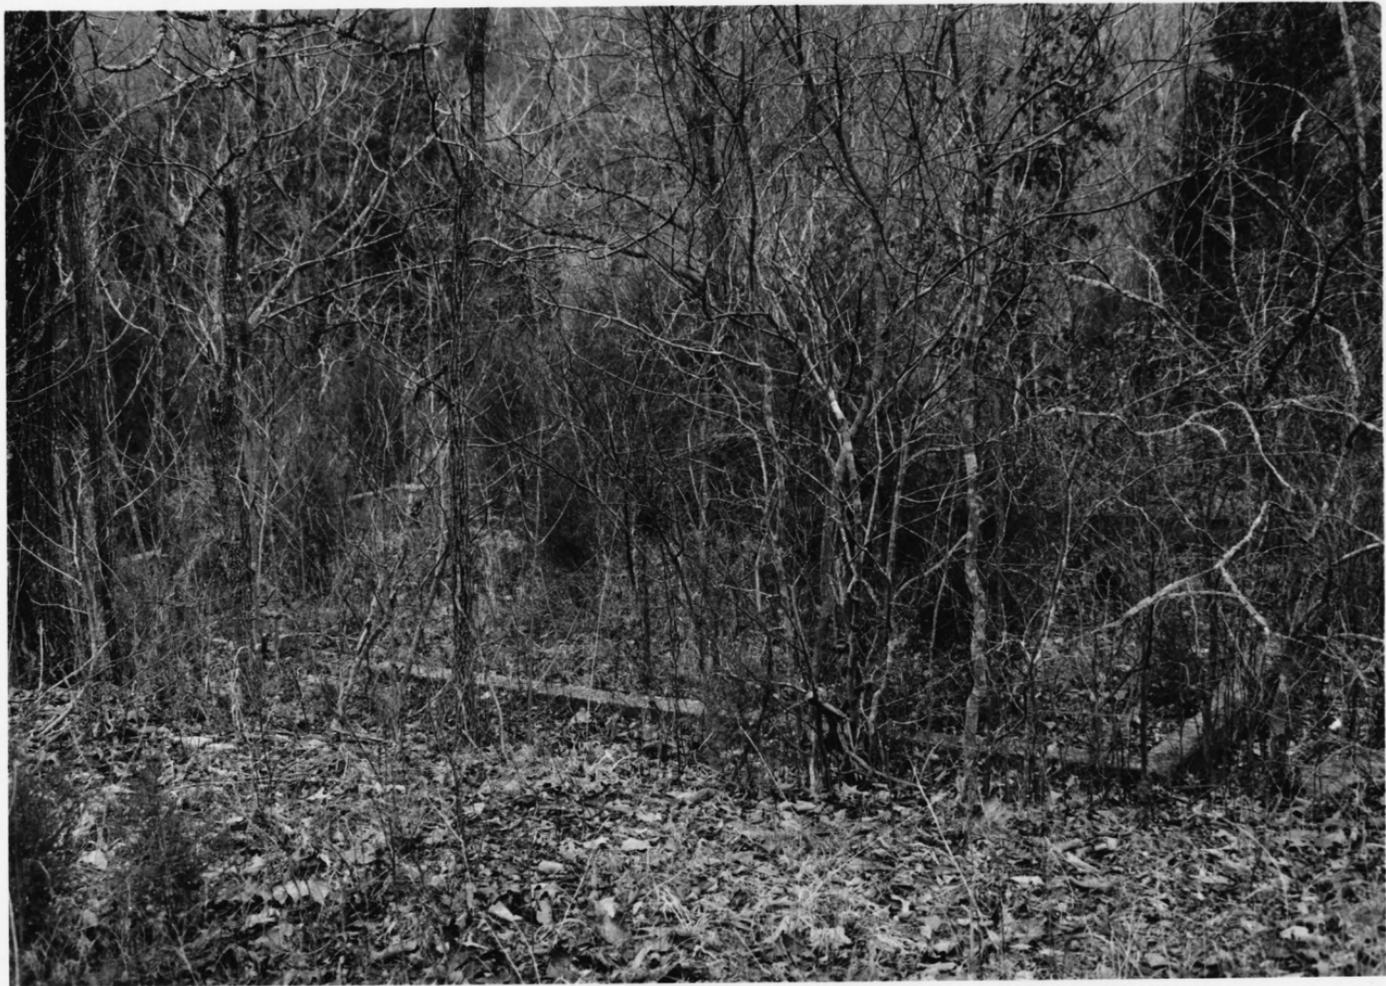
18

Morning Star Mining Company Office ruins. Circa 1911. Poured concrete foundation 14 1/2' x 31', partially buried below grade. A 20' earthen passage with a concrete pad for the drive-through of the ore platform weighing scales is still visible between the office and the company store. Originally this was a 2-story board and batten building which served as company mine office, official location of company meetings, assay office, and ore wagon weighing. The building was removed in the 1960s. The site is presently covered with vegetation.

foundation, Morning Star Mine office, looking northwest

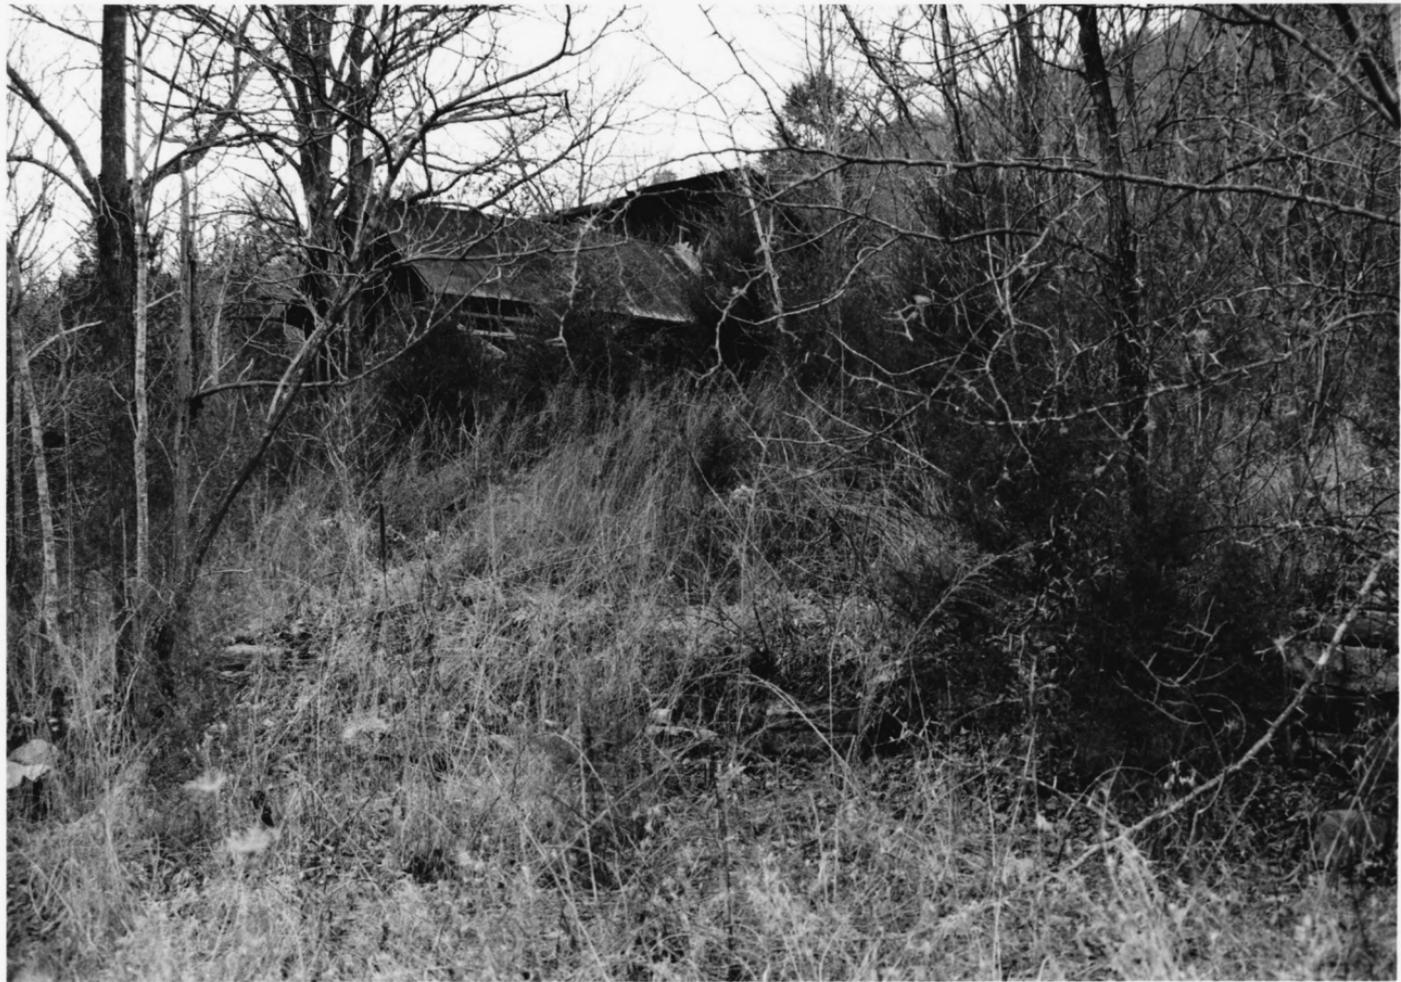
#18

Chase & Mulholland Store ruins. Circa 1899. A two-story board and batten building with later overlapping siding, removed 1960s. Current ruins are a poured concrete foundation 16' x 30' and a large earthen depression with dry-laid rock wall said to have been the storage cellar under the side room. Presently covered by vegetation.

foundation of Chase + Mulholland Store, looking northwest

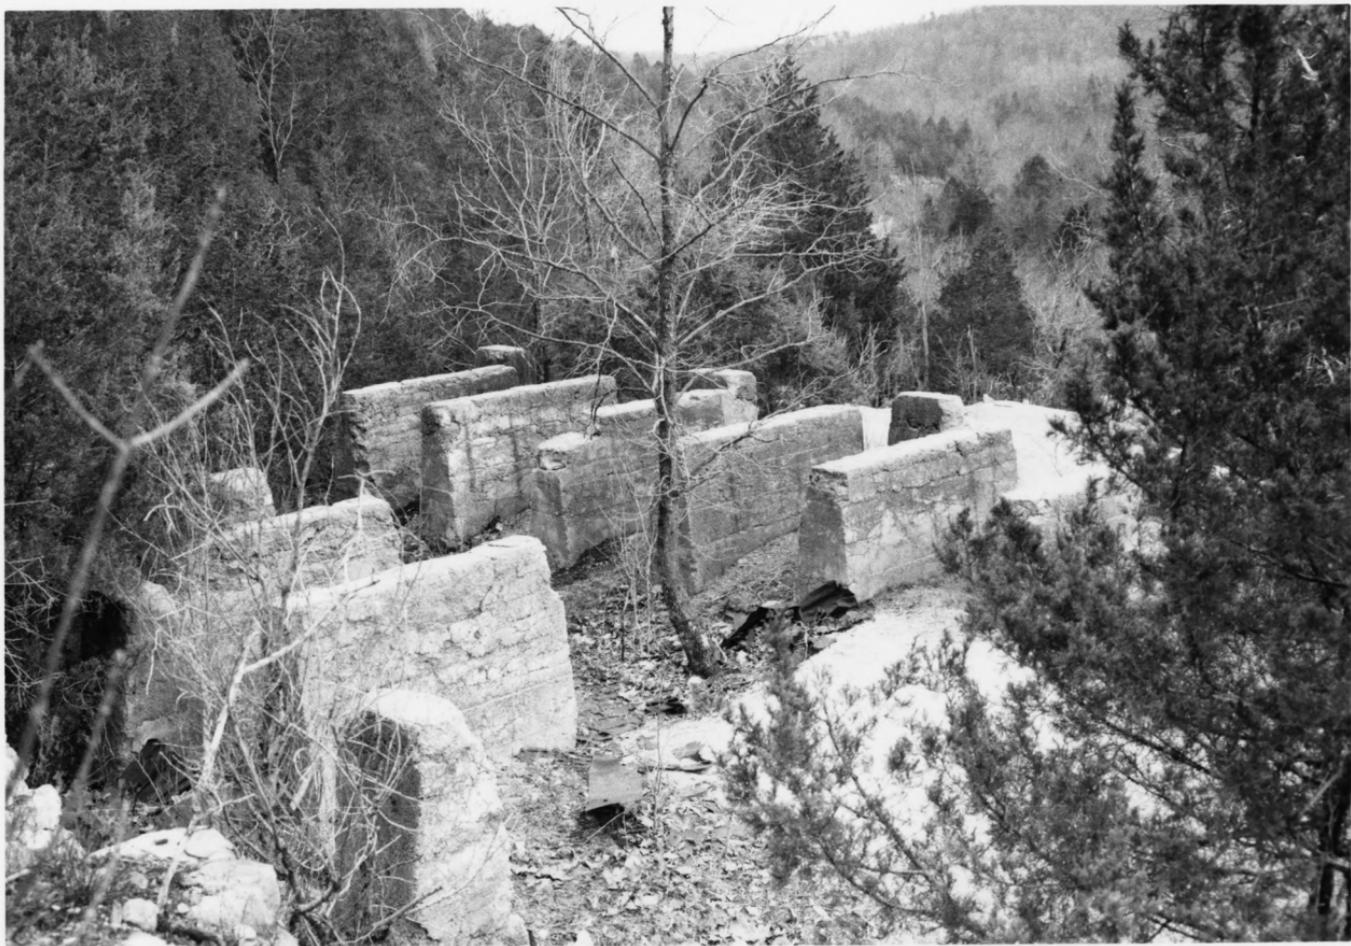
23

The most substantial ruins are those of the large concentrating mills, now represented by the four foot to twelve foot high concrete piers which once supported the large plants. Additional foundation wall outlines, concrete supports for mill machinery, and cables, anchor bolts, and other metal pieces are also present. The Buffalo River section contains the greatest number of mill ruins and sites. With the exception of the mining tunnels, the mill ruins most visibly mark the mining areas.

concrete piers of jig area, facing southwest
