**NATIONAL REGISTER OF HISTORIC PLACES
INVENTORY -- NOMINATION FORM**
FOR FEDERAL PROPERTIES

HISTORIC
Rush Historic District
AND/OR COMMON

STREET & NUMBER
Rush Road
CITY, TOWN
Yellville
STATE
Arkansas

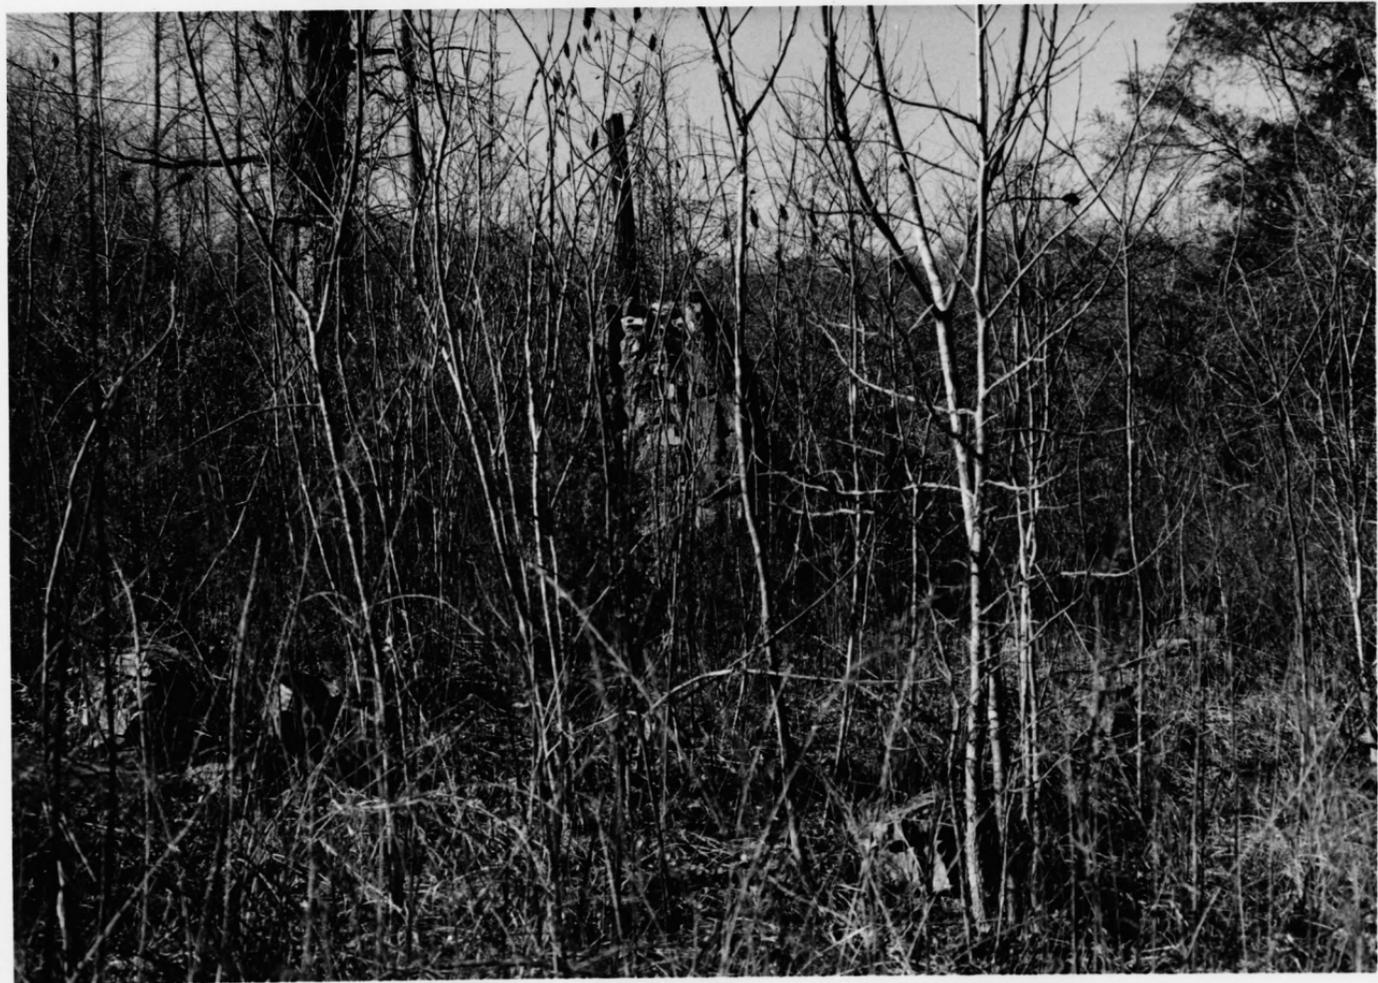
45

"Pop Campbell" house site ruins. Circa 1915. Rock piers in a area 17' x 22'; brick chimney stand; cedar posts and vertical board gates. The small vertical-board building burned in 1977. Remains represent one of the permanent houses in a small housing area near the McIntosh.

"Pop Campbell" house site, looking west
