Casa Grande Ruins Trail

CASA GRANDE NATIONAL MONUMENT
ARIZONA

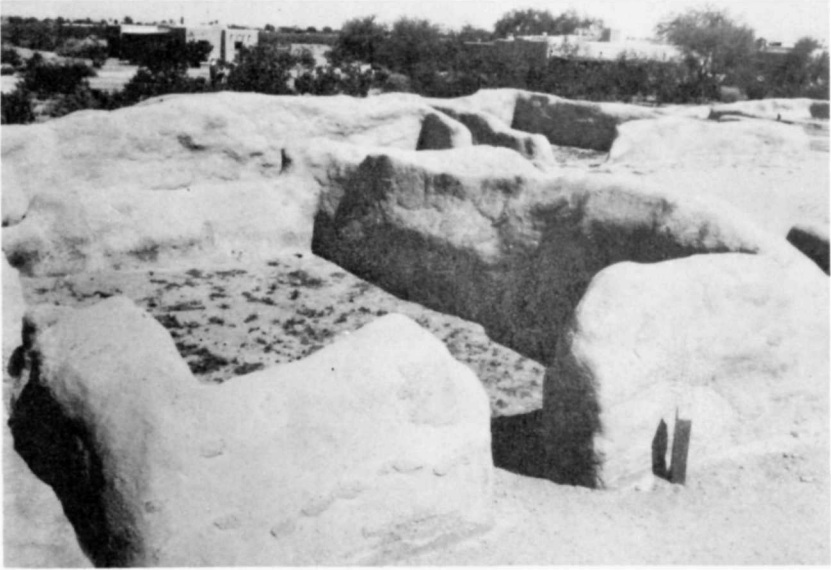
Living Room

3. Living Room. This room is one of approximately 60 rooms inside the compound wall. Walls and floors were made of caliche, and ceilings were layers of poles, saguaro ribs, and reeds capped with a covering of caliche. Some rooms, like this one, had doorways; other rooms had hatchways in the roof centers. A small clay fire pit, about 1 foot in diameter, was in the center of each room. During hot weather, cooking was done out of doors. (See next page).

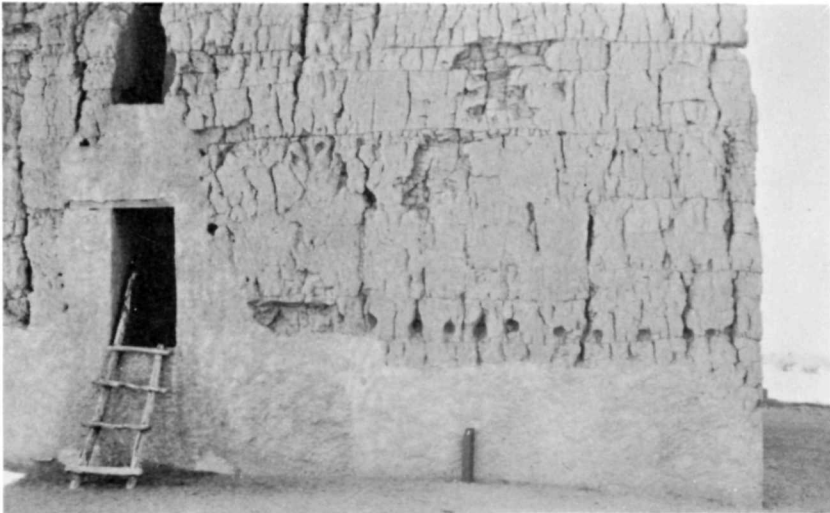
The Casa Grande. Northeast Corner

4. The Casa Grande—Northeast Corner. The Casa Grande was first seen by a European on November 27, 1694, when Father Kino, a Jesuit missionary and explorer, visited the area. He called the building the Casa Grande, or Big House, because it was the biggest structure he had seen in southern Arizona.

The large steel canopy was erected in 1932 to protect the Casa Grande from rain. This building has not been restored, but to keep it from crumbling further, the ruin was

stabilized in 1891. The undercut base of the ruin was filled with bricks and cement, two-by-fours were placed over the doorways, and two steel rods were inserted to brace the south wall.

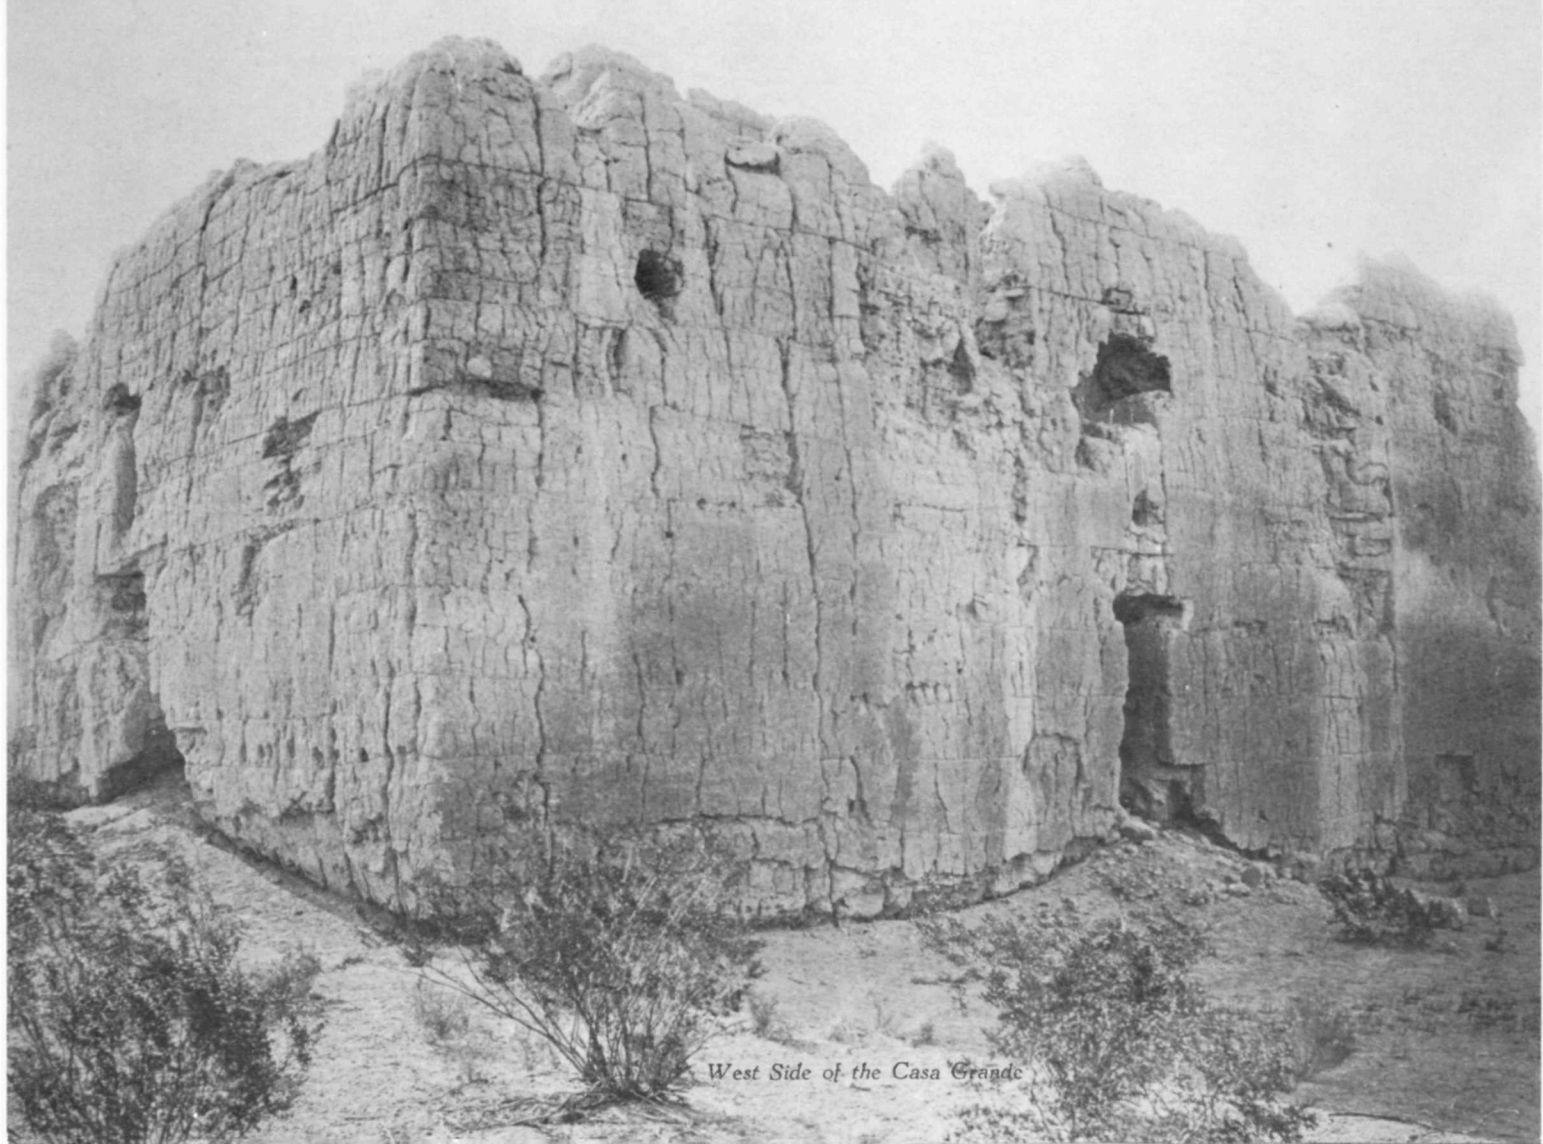
West Side of the Casa Grande

6. West Side. Notice the series of horizontal cracks along the west wall of the Casa Grande. The cracks show that the walls were built with layers of caliche mud. Each layer was about 26 inches thick. Bricks were not used. The Indians did not make adobe bricks until taught by the Spanish priests centuries later.

Above the enlarged open doorway is a blocked one. The upper doorway might have been sealed by the Indians to keep out the prevailing westerly winds, but they left a small opening for ventilation at the bottom of the block. The large hole above the blocked doorway is where the original wooden lintel poles rotted away, causing part of the wall to fall.

Both to left and right of the blocked doorway are small windows for light and ventilation for the north and south rooms. The left window is round and the right window is square.

In the 1880's, Ed Schieffelin, the founder of Tombstone, Arizona, took this photograph of the Casa Grande. In the past 80 years the structure has deteriorated little.

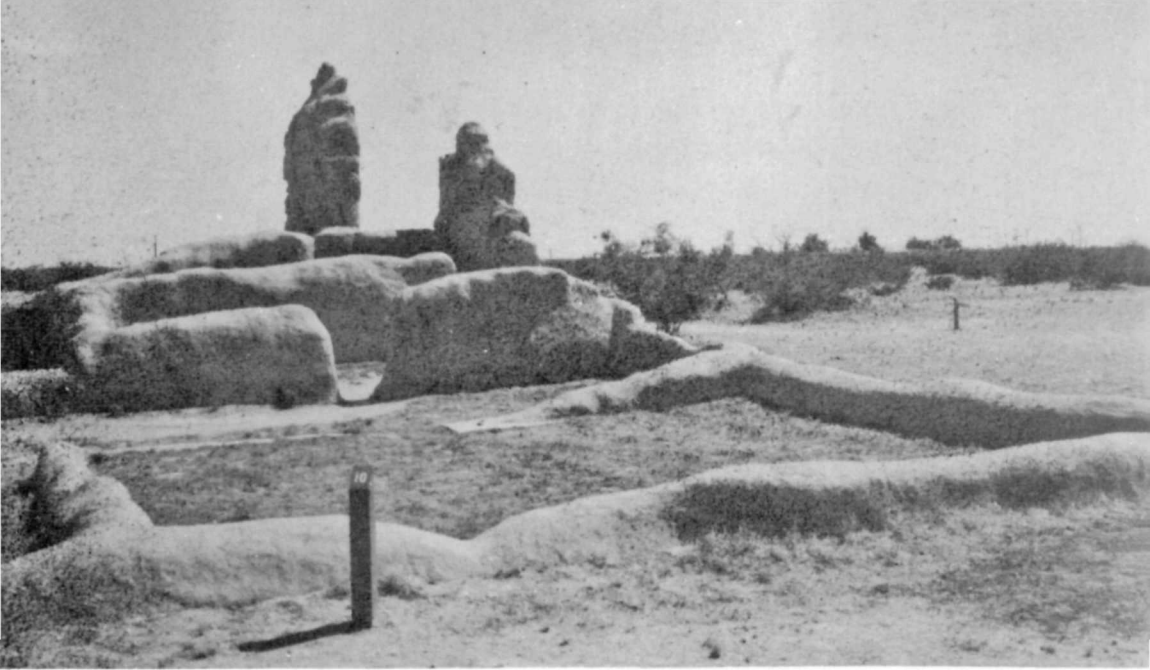
Southwest Building

The high walls shown at top of the next page are all that remain of a three-story building that stood in this southwest corner of the walled village. These rooms apparently were living rooms where several families slept, worked, and stored their food, tools, and clothing. One of the large red Hohokam jars in the Visitor Center exhibit room was recovered near here.

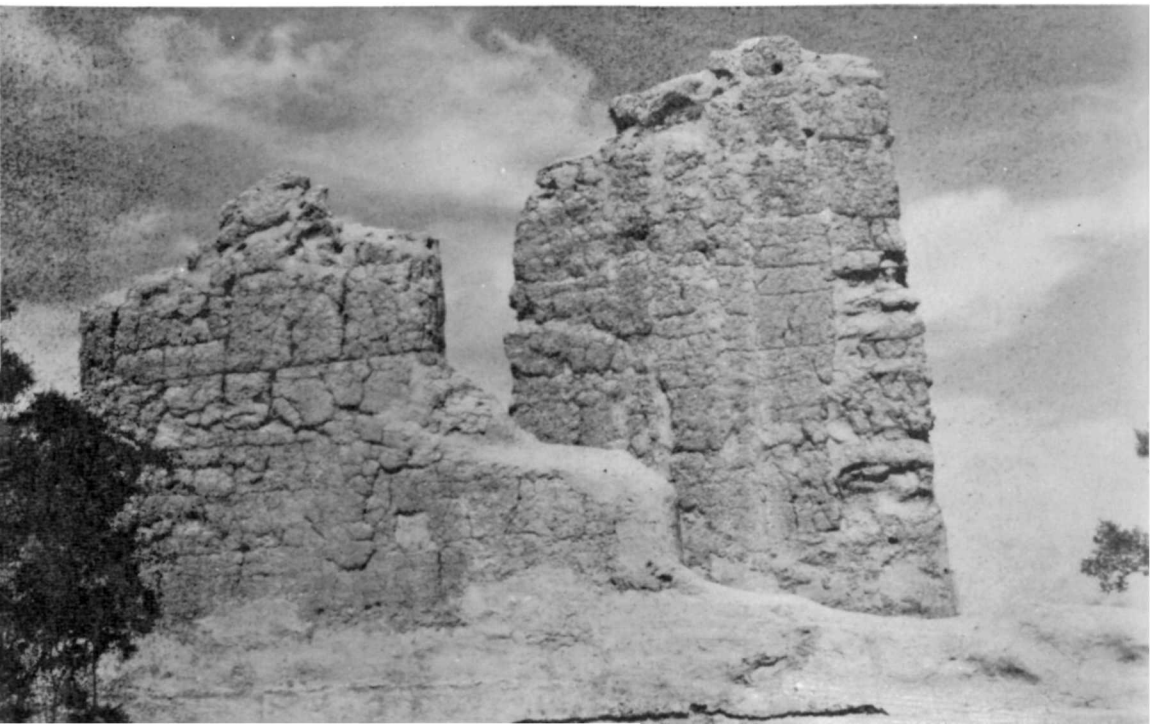
Outer Wall

11. Outer Wall. This is another part of the village wall. To save labor, the west side of the three-story building was built against the wall.

During the winter of 1906-07, Dr. J. W. Fewkes conducted excavations in this ruin for the Smithsonian Institution. He found debris along the outside of the wall indicating that it once stood 7 to 11 feet high. (Bottom, left).

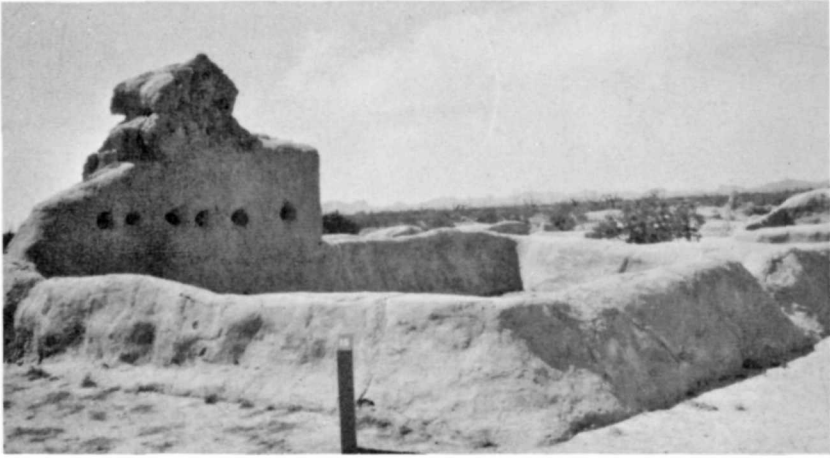
15. **Font's Room.** This building stood two stories high. Socket holes for the first-story ceiling can still be seen on the east side of the high wall. The room is called Font's

Room for Father Font, a Spanish Franciscan priest who held mass here in 1775.
