historic grounds study

CAPE HATTERAS
LITTLE KINNAKEET LIFE-SAVING
AND COAST GUARD STATION

HISTORIC GROUNDS STUDY AND REPORT FOR DEVELOPMENT

Little Kinnakeet Life Saving Station
Little Kinnakeet, N.C.

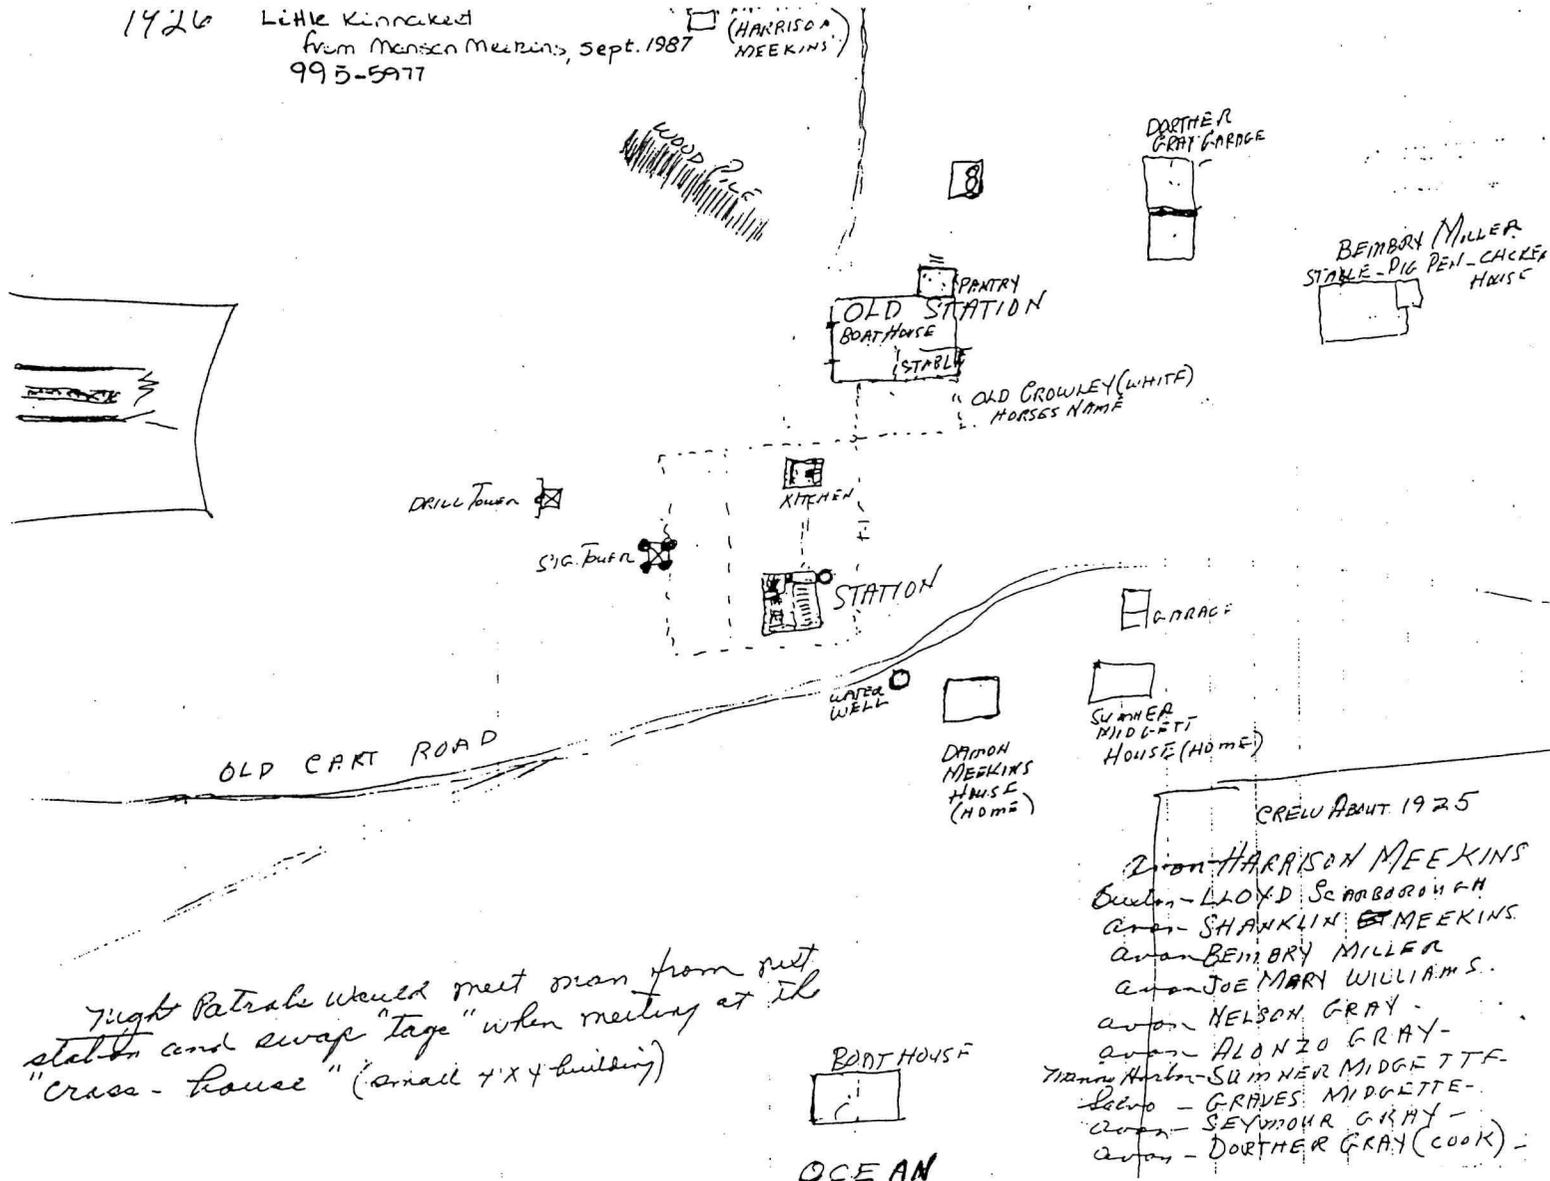
EXHIBIT 1

Exhibit 1 was drawn by Mason Meekens August, 1987, and shows the approximate locations of out-buildings north of the station. They are shown as he remembers them as a young boy when he spent the summers at the Station with his Father. Ellis Grey, during an interview, revealed that two of the homes, one owned by Demon Meekins and one owned by Sumner Midgett, were raised and relocated to the town of Avon.

Light Patrols would meet ocean from port
 station and swap "logs" when meeting at the
 "Cross-house" (small 4'x4' building)

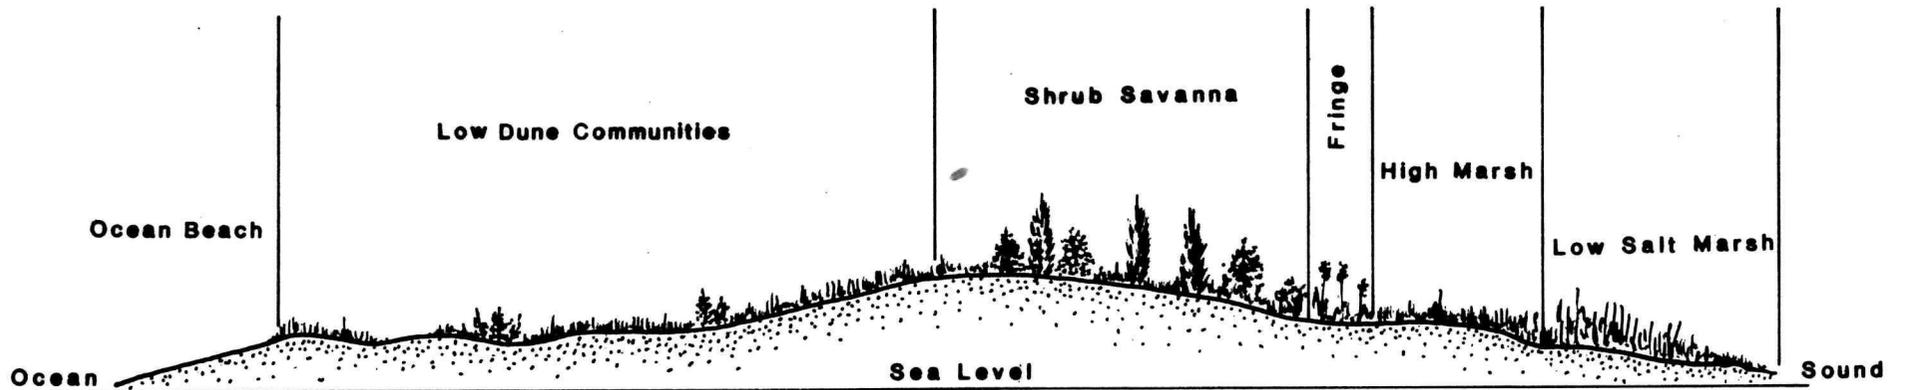
EXHIBIT 2

PRE BARRIER DUNE VEGETATION ZONES

The establishment of barrier dunes in the 1930's on the ocean side of Hatteras Island has precluded the overwash of the site during severe storms. The elimination of this phenomenon has altered conditions, mainly the periodic saturation of the soils with salt water. This has permitted the establishment of new, less salt-tolerant plant communities that were previously nonexistent. A scrub thicket vegetation zone has surrounded the complex after the build-up of the frontal barrier dunes. See exhibits 2 and 3.

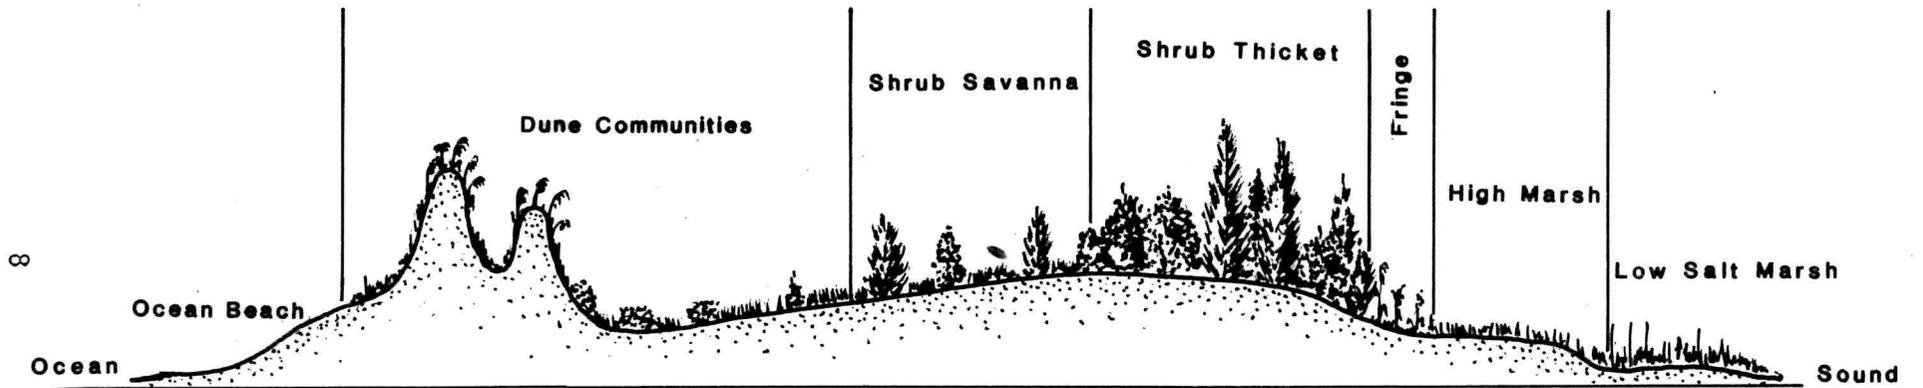
POST BARRIER DUNE VEGETATION ZONES

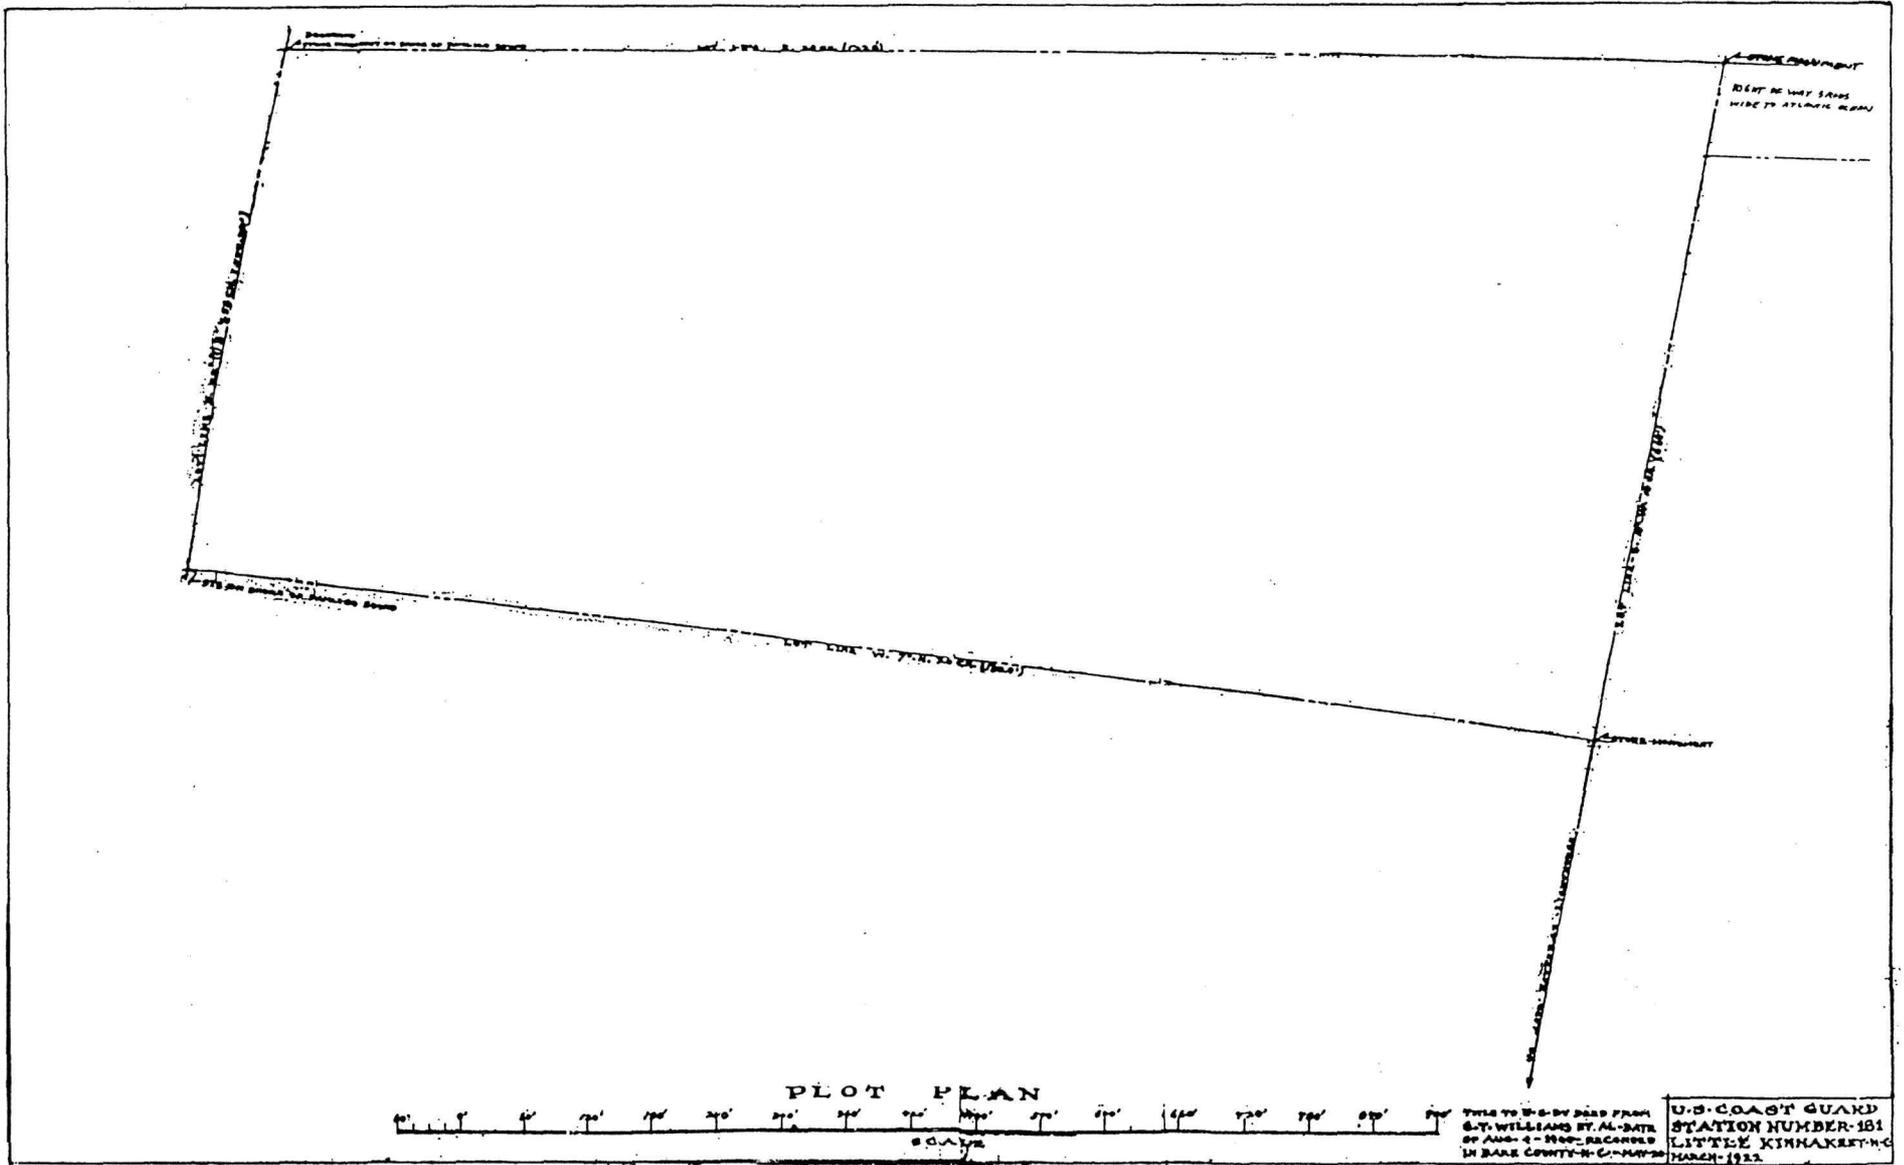
EXHIBIT 4a

I respectfully transmit herewith plat of reservation at Little Kinnakeet L.S. Station, N.C. with description of property, and a sketch of building, also the respective position of the various buildings on the reservation.

The description of property was taken by me from the records at Manteo, Dare County, N.C. but there is undoubtedly an error either in the length of the Southern line, or in the angles at S.E. and S.W. corners of reservation. As this error may also exist in the original deed, it may eventually lead to some complication unless the same is promptly rectified.

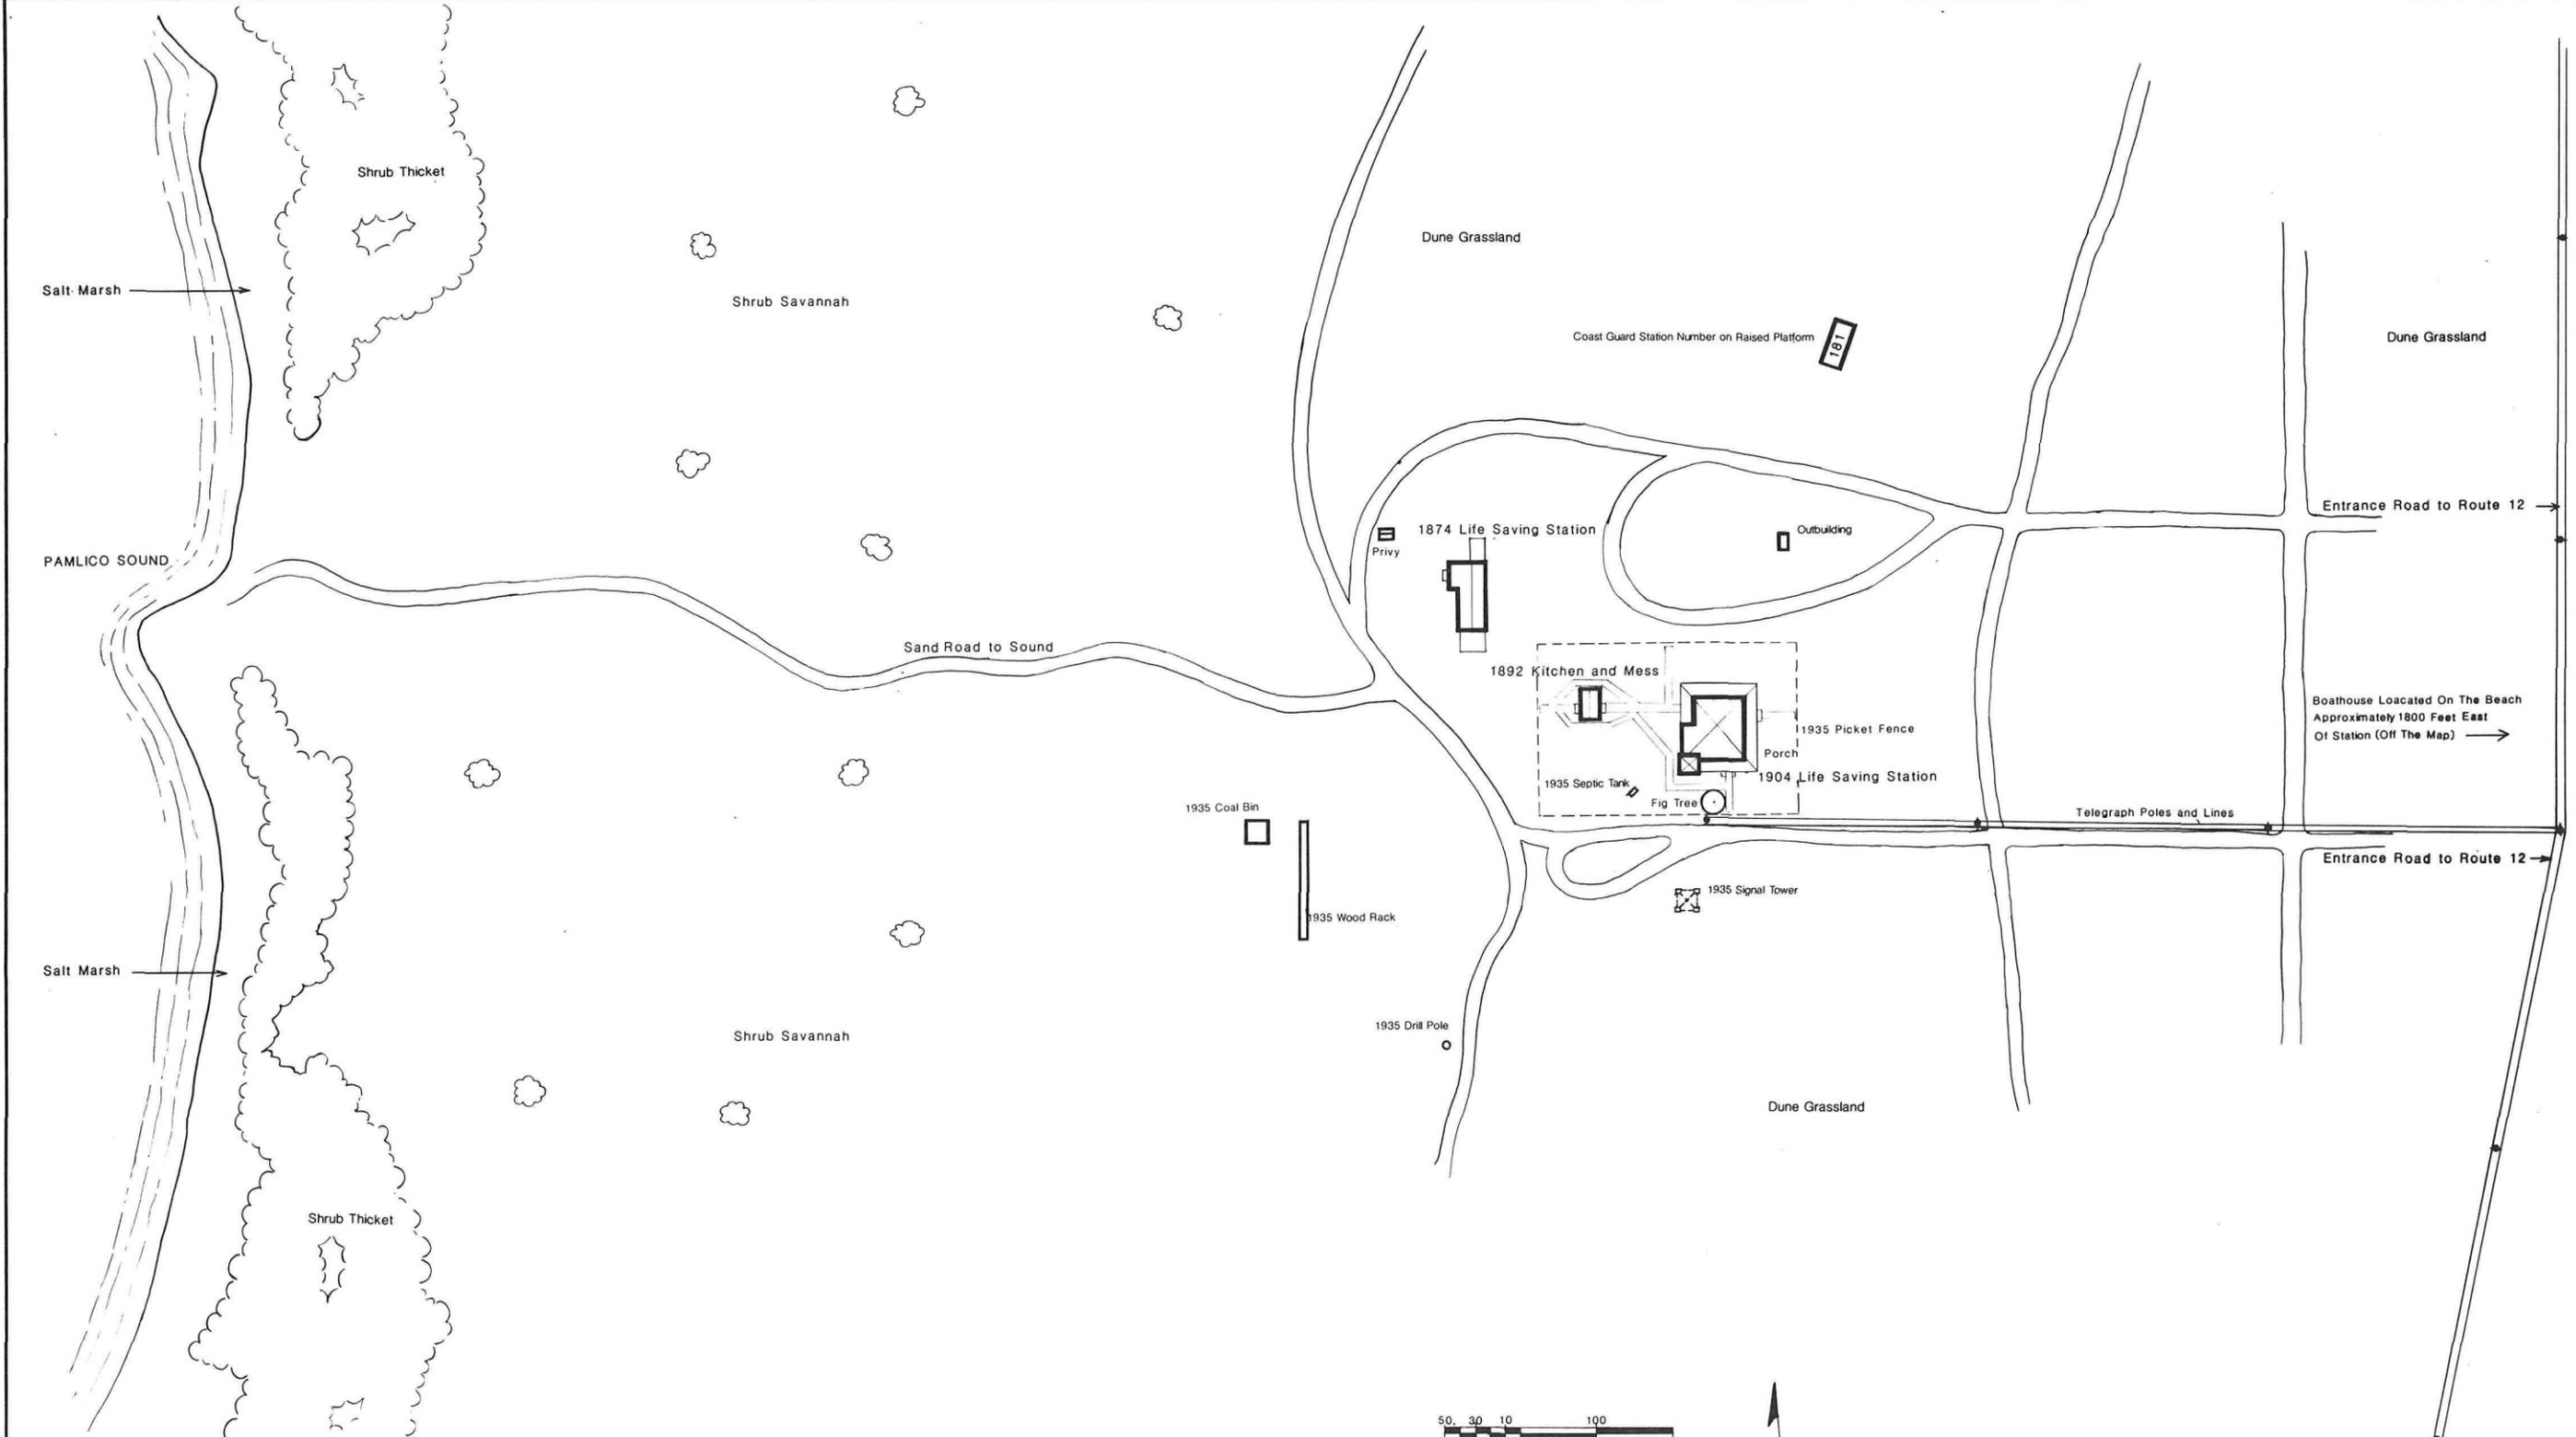
DESIGNED:	SUB SHEET NO.	TITLE OF SHEET	DRAWING NO.
DRAWN: H. Sloat		Little Kinnakeet Life Saving Station Grounds Study 1935 Conditions	603 25003
TECH. REVIEW: D.N.E.			PKG. NO. 202
DATE: / /			SHEET 3
			OF 5

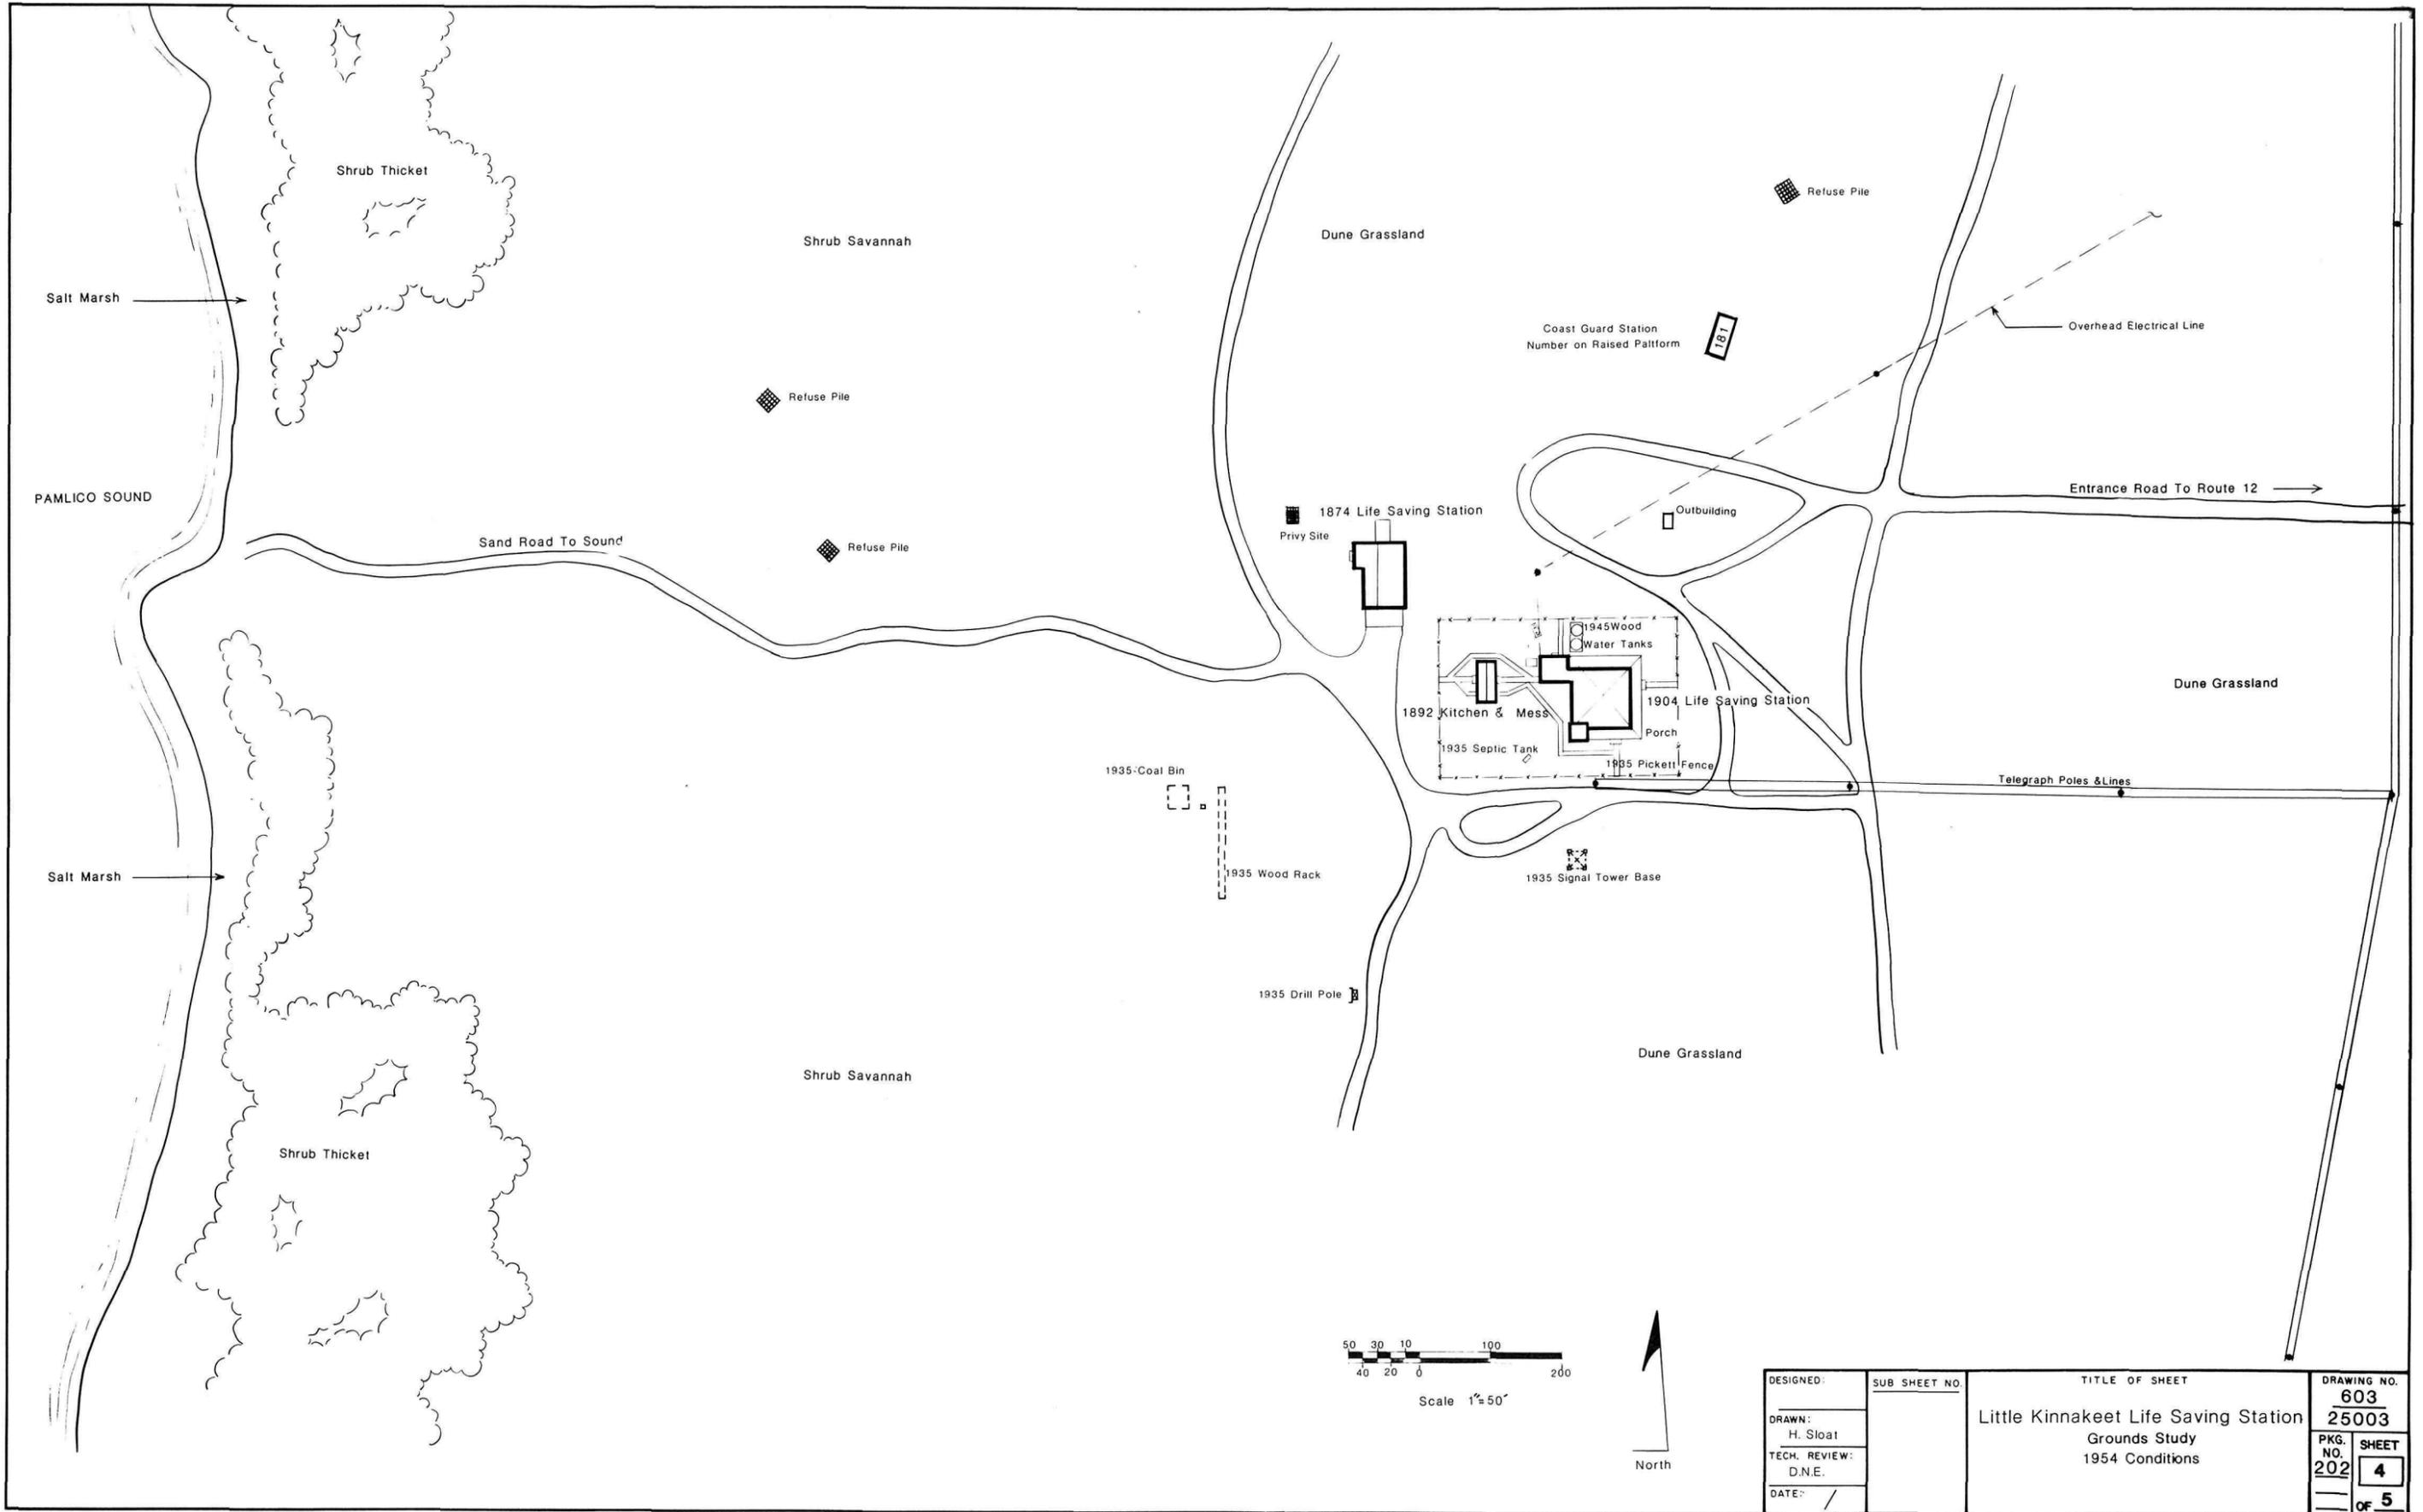
DESIGNED:	SUB SHEET NO.	TITLE OF SHEET	DRAWING NO.
DRAWN: H. Sloat		Little Kinnakeet Life Saving Station Grounds Study 1954 Conditions	603 25003
TECH. REVIEW: D.N.E.			PKG. NO. 202
DATE: / /			SHEET 4
			OF 5

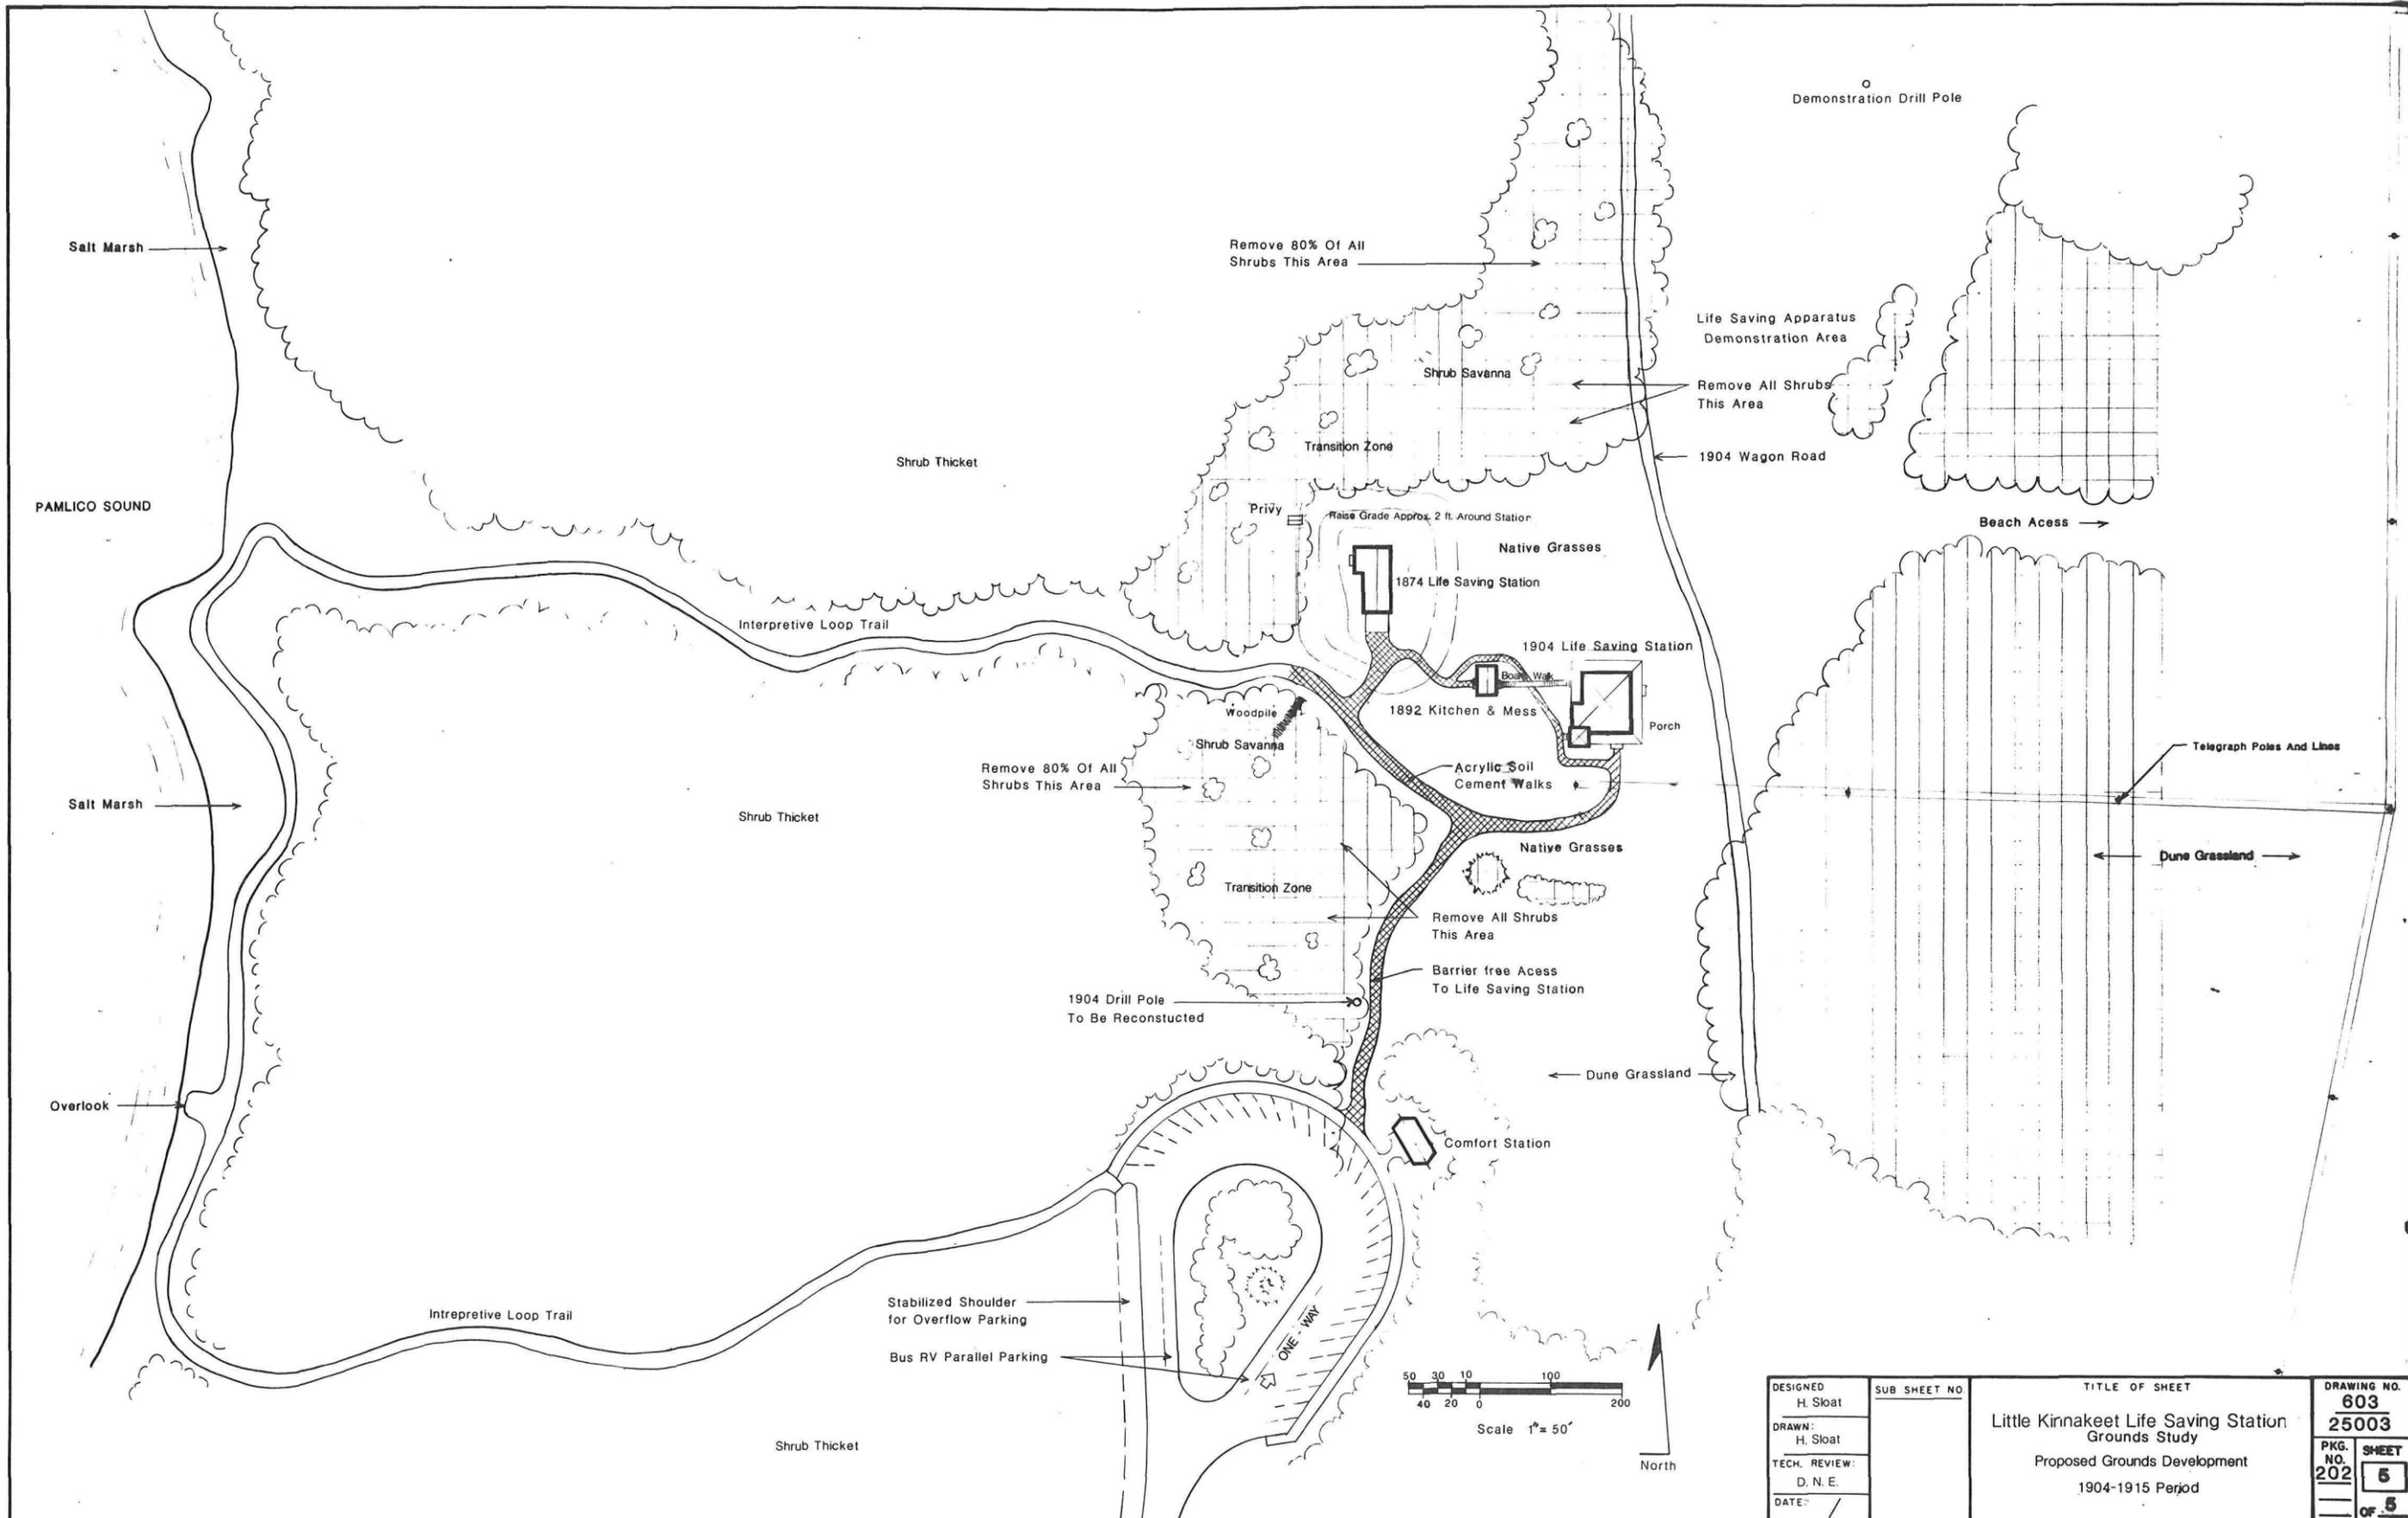
DESIGNED H. Sloat	SUB SHEET NO.	TITLE OF SHEET Little Kinnakeet Life Saving Station Grounds Study Proposed Grounds Development 1904-1915 Period	DRAWING NO. 603 25003
DRAWN: H. Sloat			PKG. NO. 202
TECH. REVIEW: D. N. E.			SHEET 5
DATE: / /			OF 5

To facilitate visitors at the site, an access road and a 35-space parking area with overflow parking for 20 cars will be required. A screened, compatible-style comfort station shall be added adjacent to the parking area. A trail head and barrier-free pedestrian loop trail will provide access to the station, structures, and proposed service amenities. In addition, the trail shall have a sufficient width of 7'-8' to accommodate small service vehicles.

Compromises on the historical development of the site are required to provide facilities such as barrier-free access, a comfort station and parking. Electrical and telephone transmission lines which currently cross the site are not a part of the historic scene and should be placed below grade. Telegraph poles and lines which no longer exist and were a part of the historic scene should be considered for reintroduction. The accompanying plans illustrate the site as it existed in 1904, 1935, 1954, and 1987; a plan for development is also included. In the implementation of this development plan, historical paths and accesses which are to be re-established shall be stabilized for barrier-free use; a recommendation is to use an Acrylic Soil Cement with a high content of local sand and shells.

If this is done, the topography surrounding the station must also be raised 2 feet. This is necessary to retain the correct perspective of the structure and to maintain the historic ramp grade at the south entrance of the station. The two feet of additional fill around the station must be tapered 40 to 50 feet away from the structure until it meets existing grades. This will minimize the visual change of the additional two feet of fill.

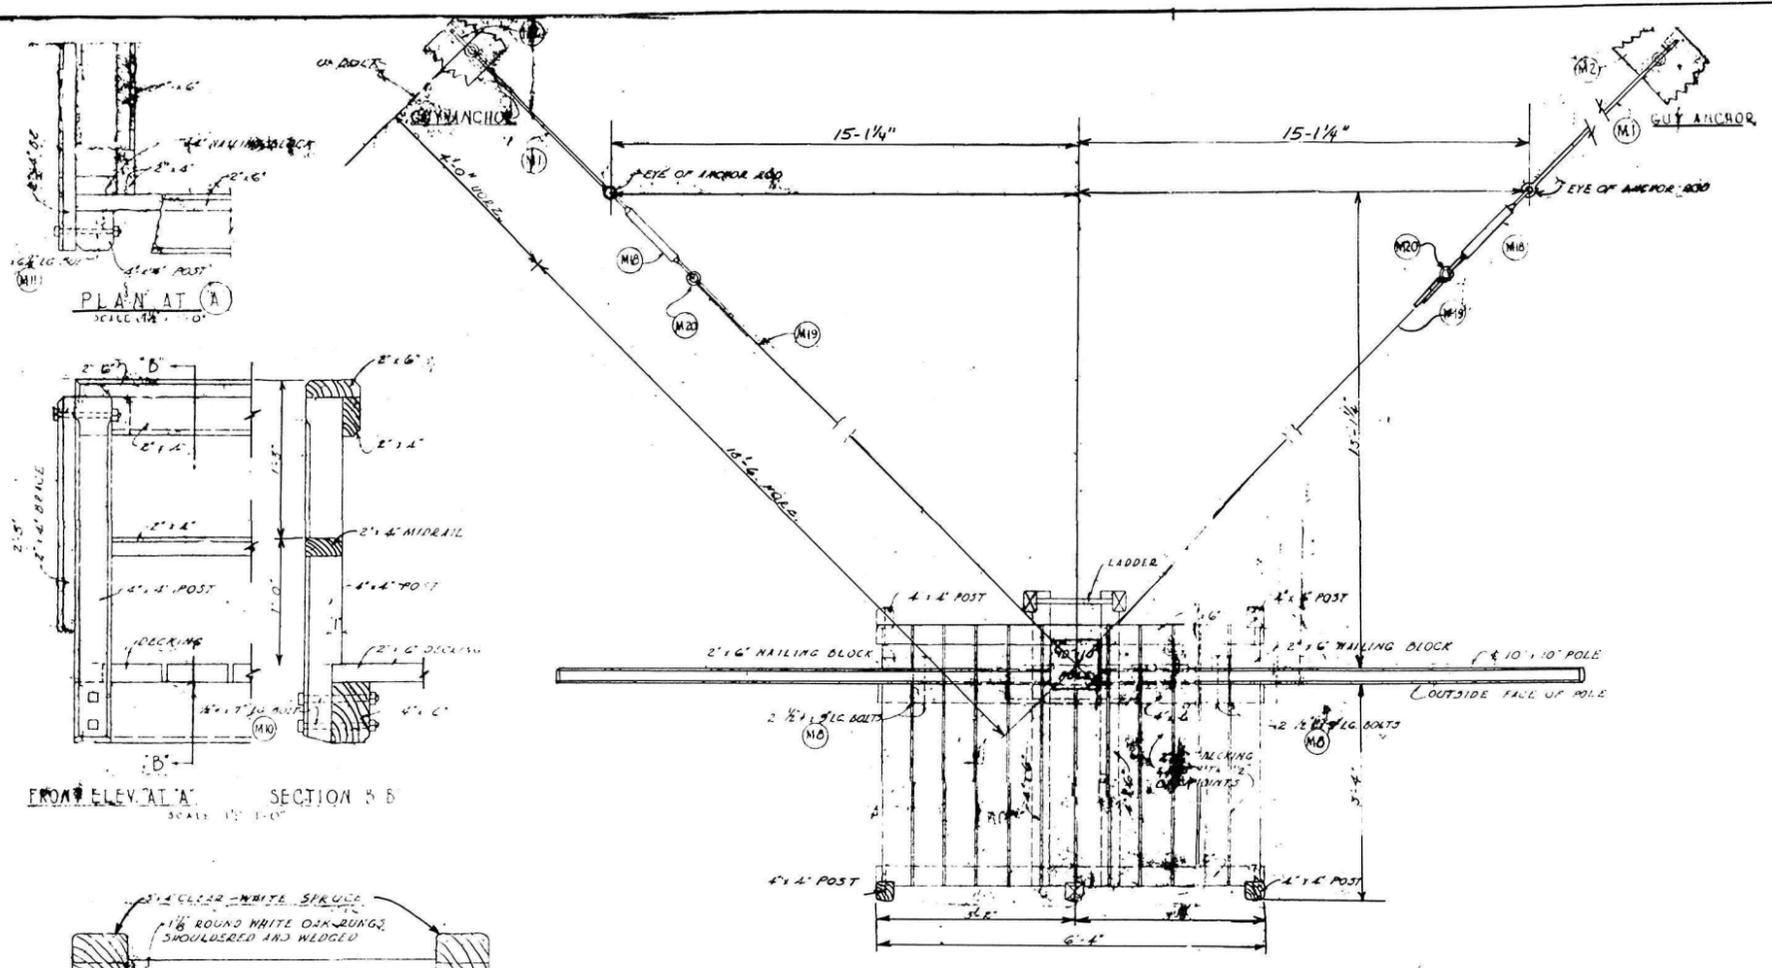
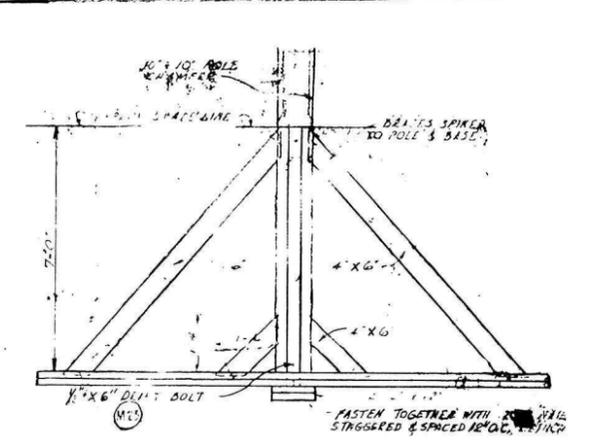
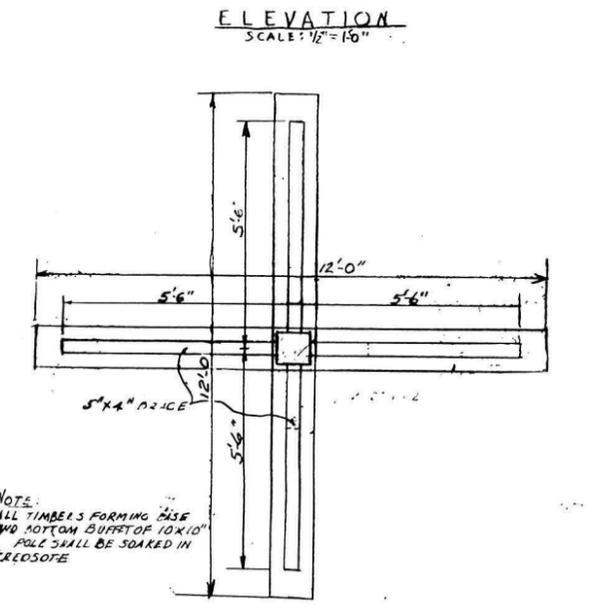
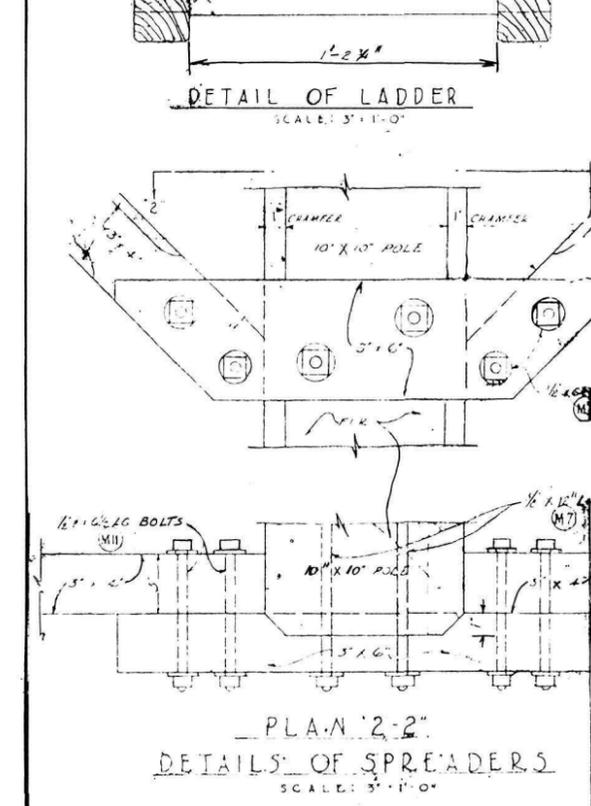
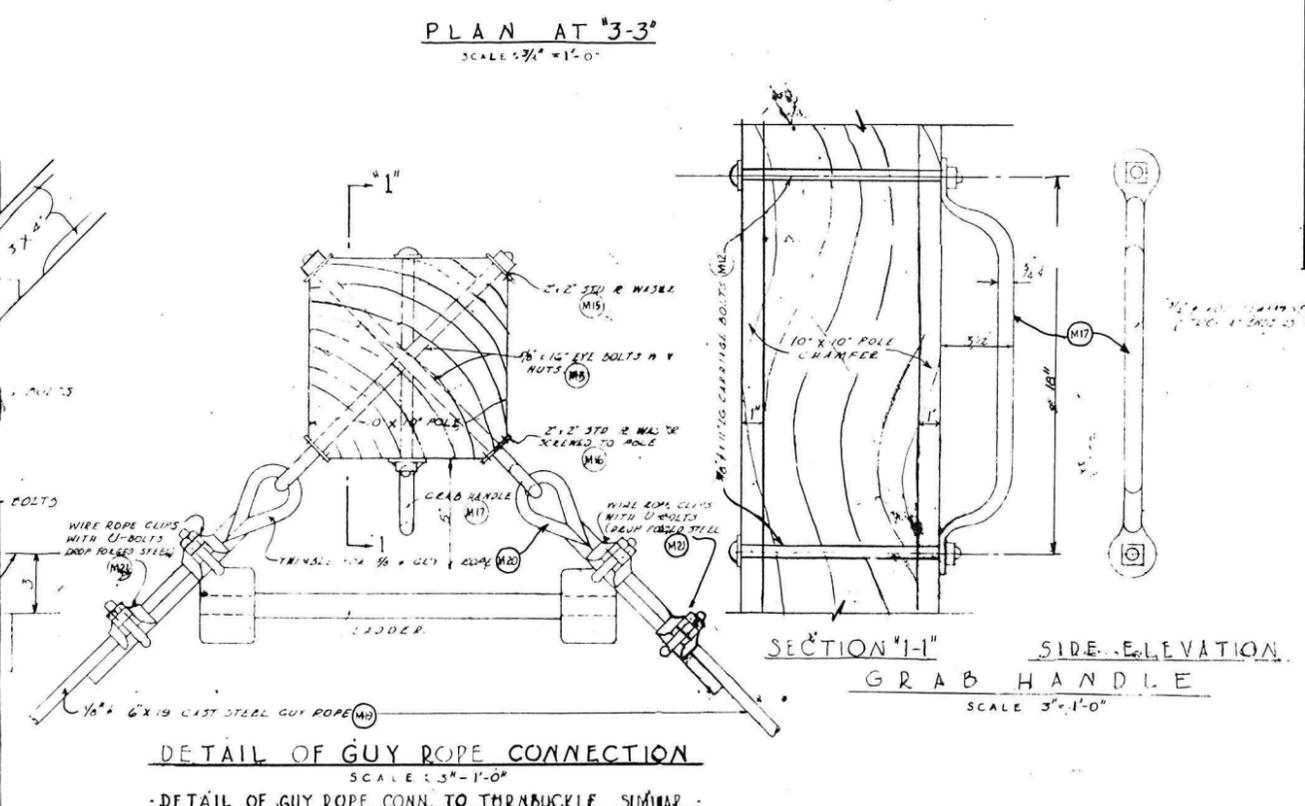
NO 107799A

U.S. COAST GUARD
STANDARD DRILL POLE
