historic grounds study

CAPE HATTERAS
LITTLE KINNAKEET LIFE-SAVING
AND COAST GUARD STATION

HISTORIC GROUNDS STUDY AND REPORT FOR DEVELOPMENT

Little Kinnakeet Life Saving Station
Little Kinnakeet, N.C.

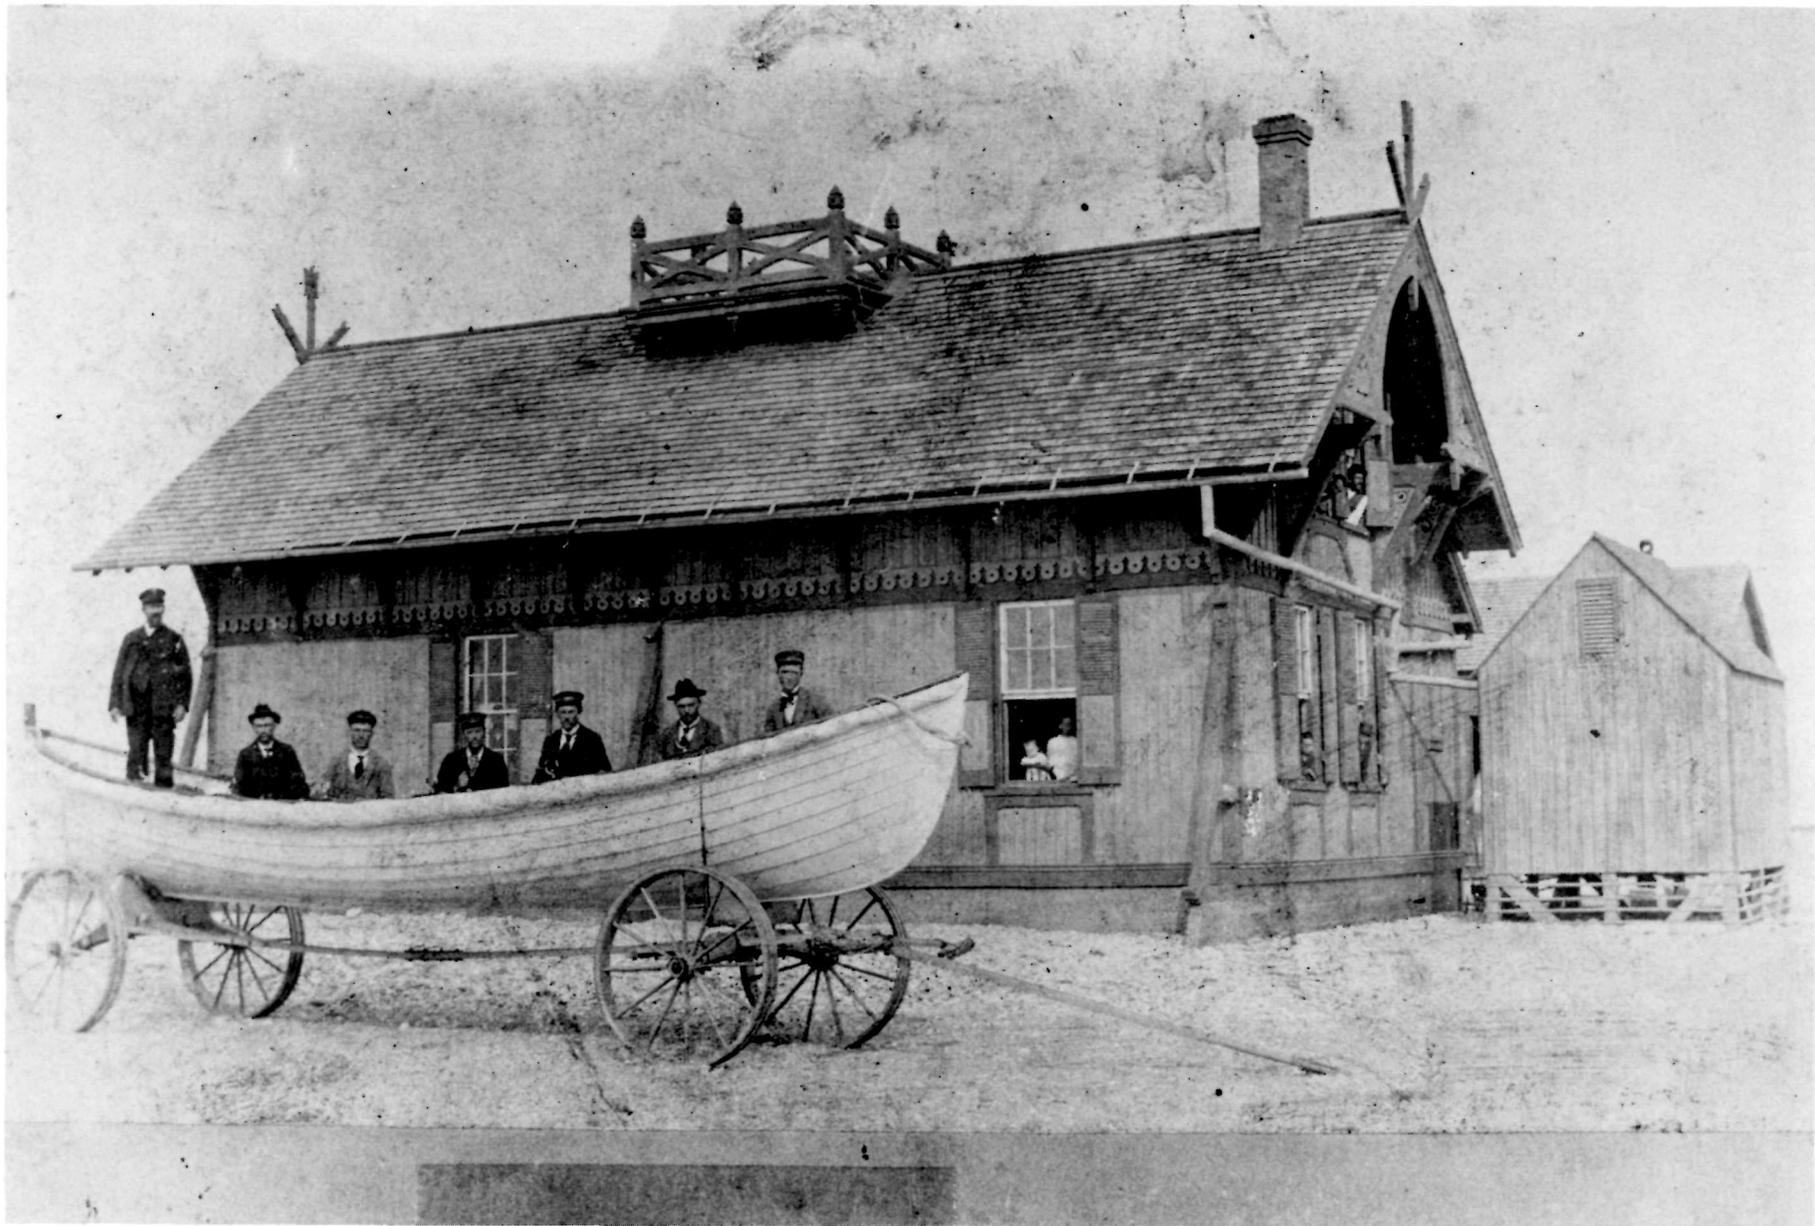
Illustration 2.

Life-saving station at Little Kinnakeet, 1890s.

15. Log entries for October 13 and 14, 1891, and October 2, 1893. NA, RG 26. Copies in CAHA folder, "Little Kinnakeet Logs, 1890-1893"; Inspection report, September 15, 1899. NA, RG 26. Copy in CAHA folder, "6th District Inspection Reports, 1890-1902." photographs of the station house taken in the 1890s clearly show the loose quality of the sand adjoining the building (Illustrations 1 and 2).

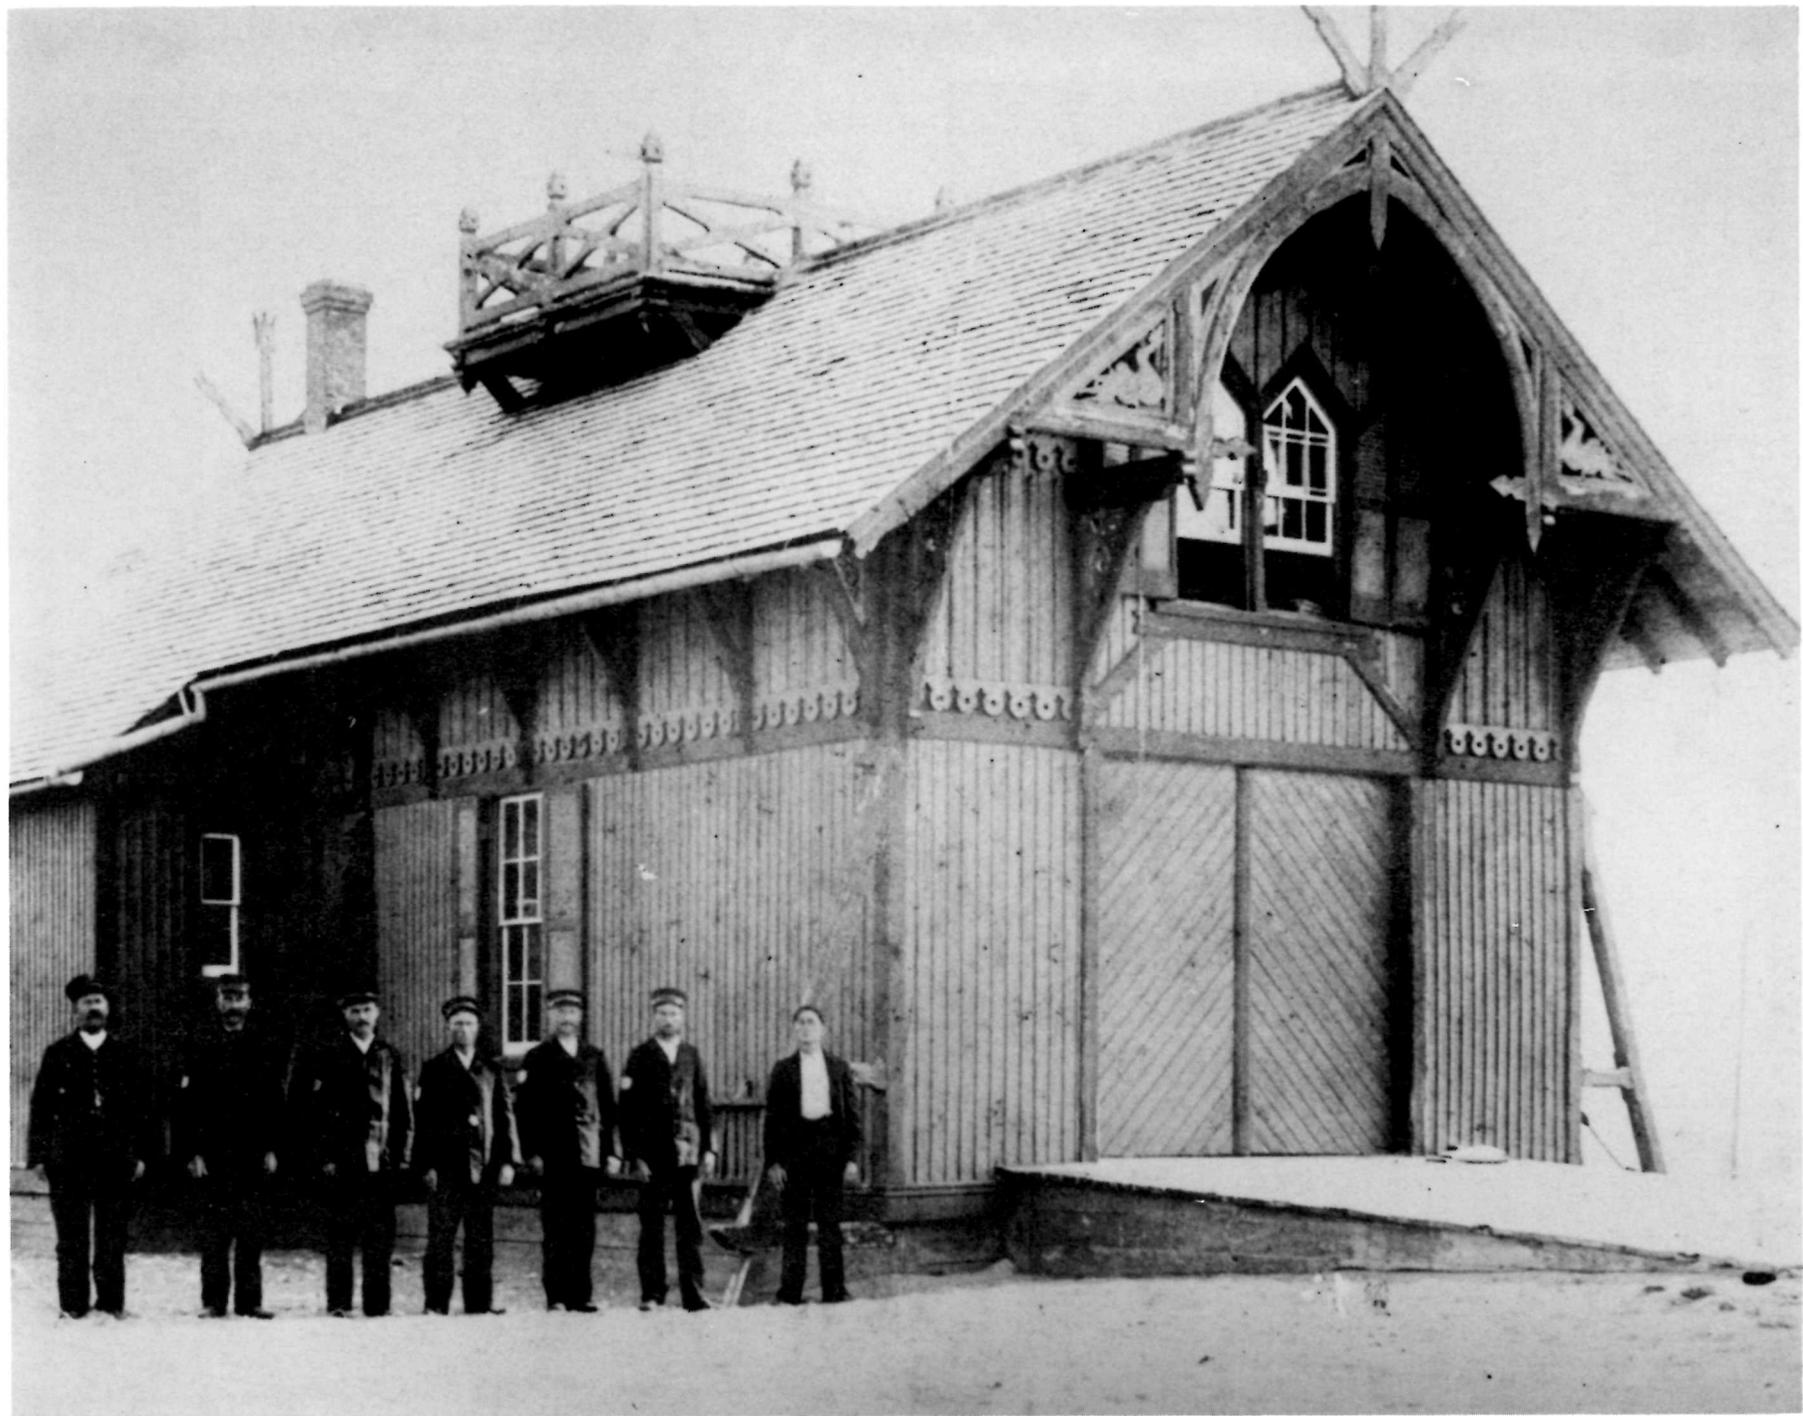
Illustration 3.

Views of 1874 station at Little Kinnakeet. Note shells around building, also grass cover.

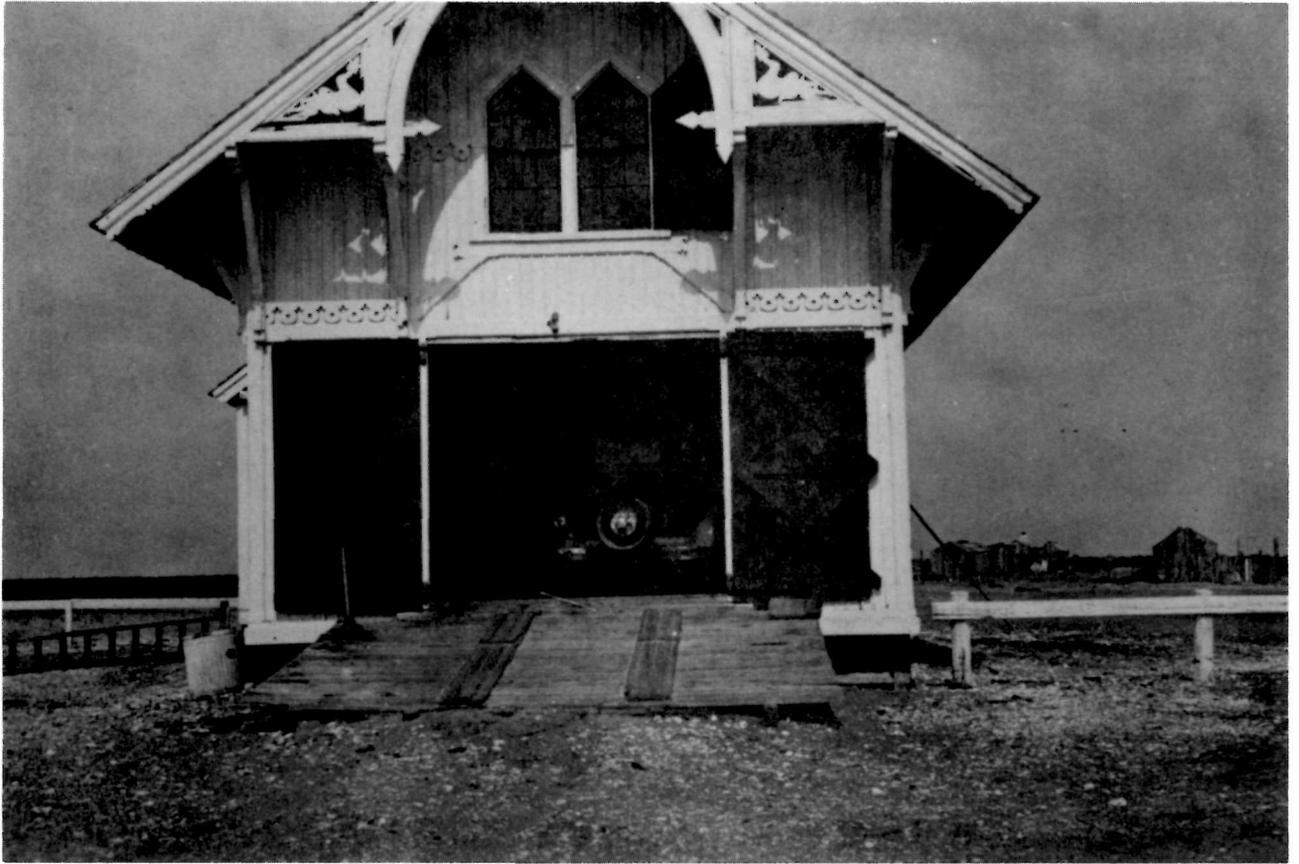
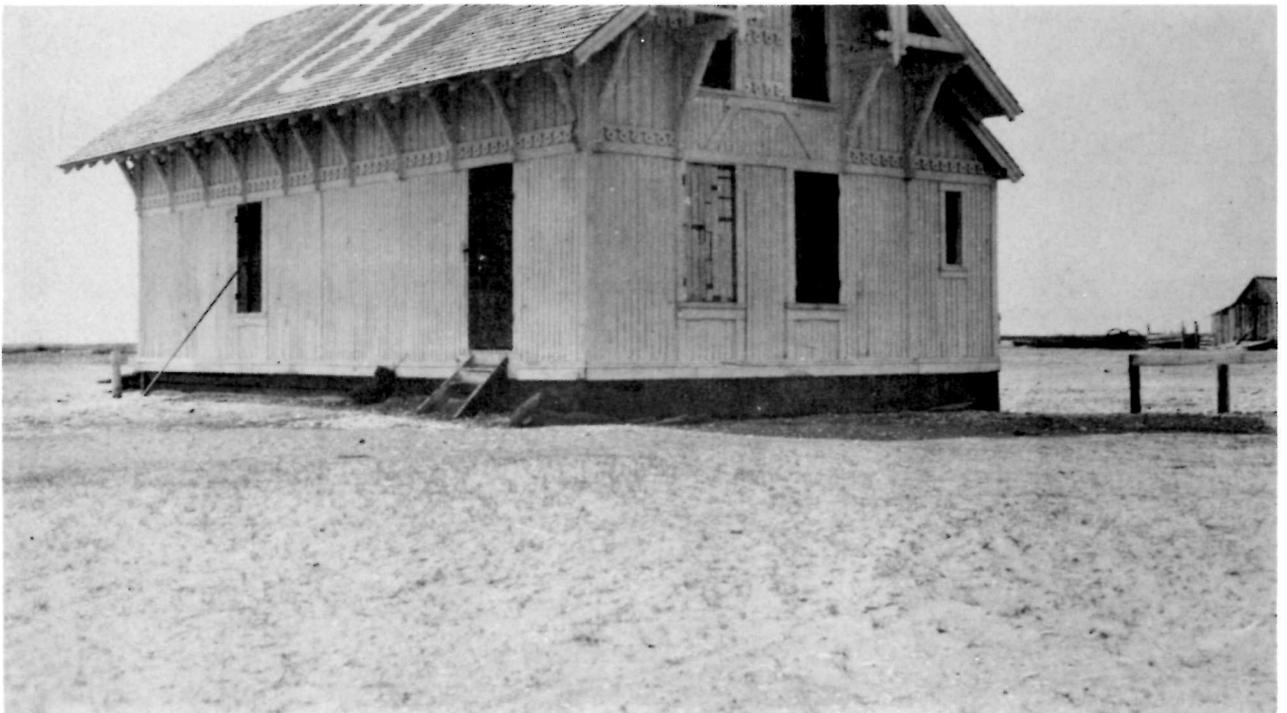
Illustration 4.

Two views of the 1904 station at Little Kinnakeet, showing ground cover.
Pictures taken March 8, 1934.

Pictures of the 1904 station taken in 1934 indicate a sparse grass cover inside the enclosed yard. A small tree stood on the south side. In a view taken in May 1935, the grass in the yard appears thicker, a condition perhaps attributed to the fact that the picture was taken in the spring almost two months later than those previously cited.(32)

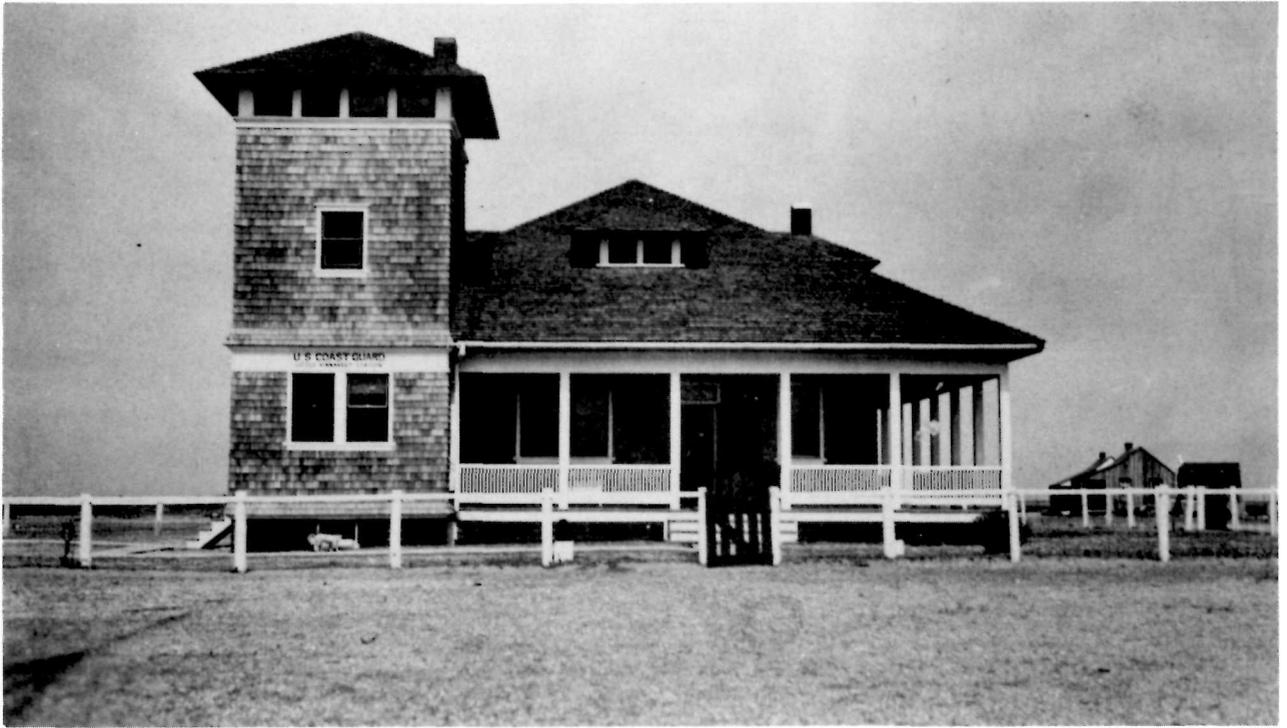
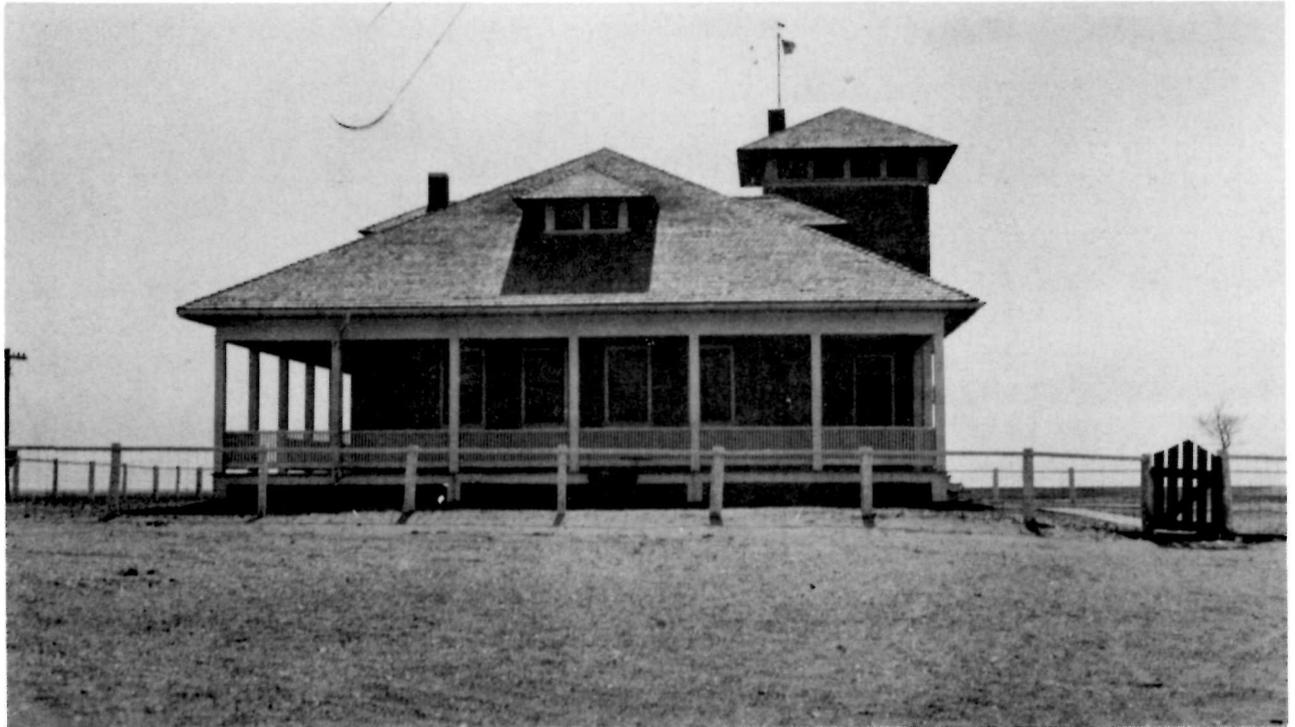
Illustration 5.

Top: View towards east of 1904 station complex, with 1892 cook house in foreground, March 8, 1934.

Bottom: View of station complex, May 2, 1935. Note picket fence and buildings to the north.

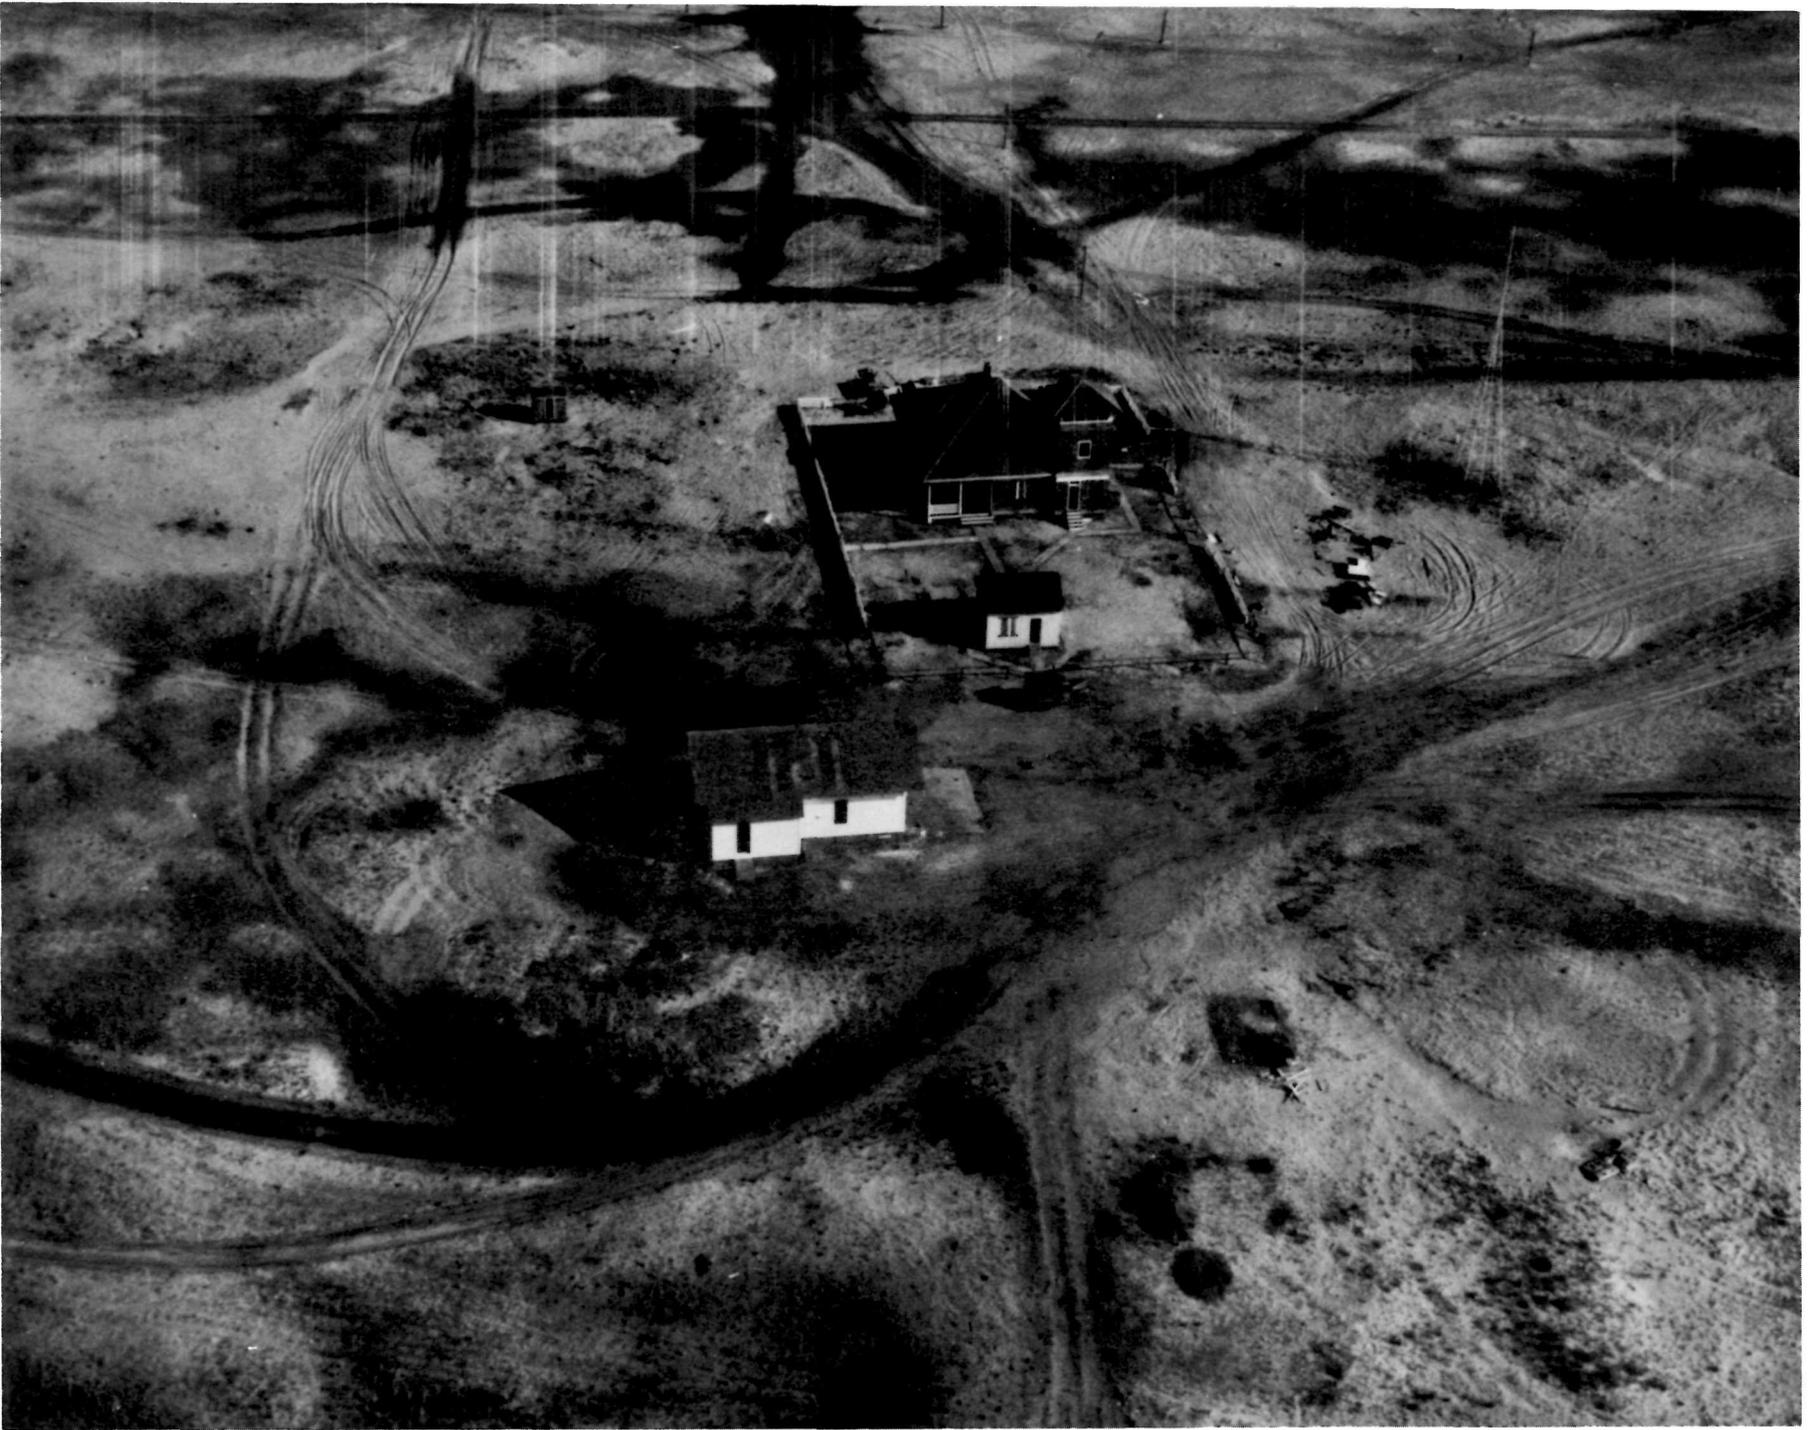
Illustration 8.

Little Kinnakeet Coast Guard Station complex, November 14, 1951. Note grass and shrubbery enveloping the site.

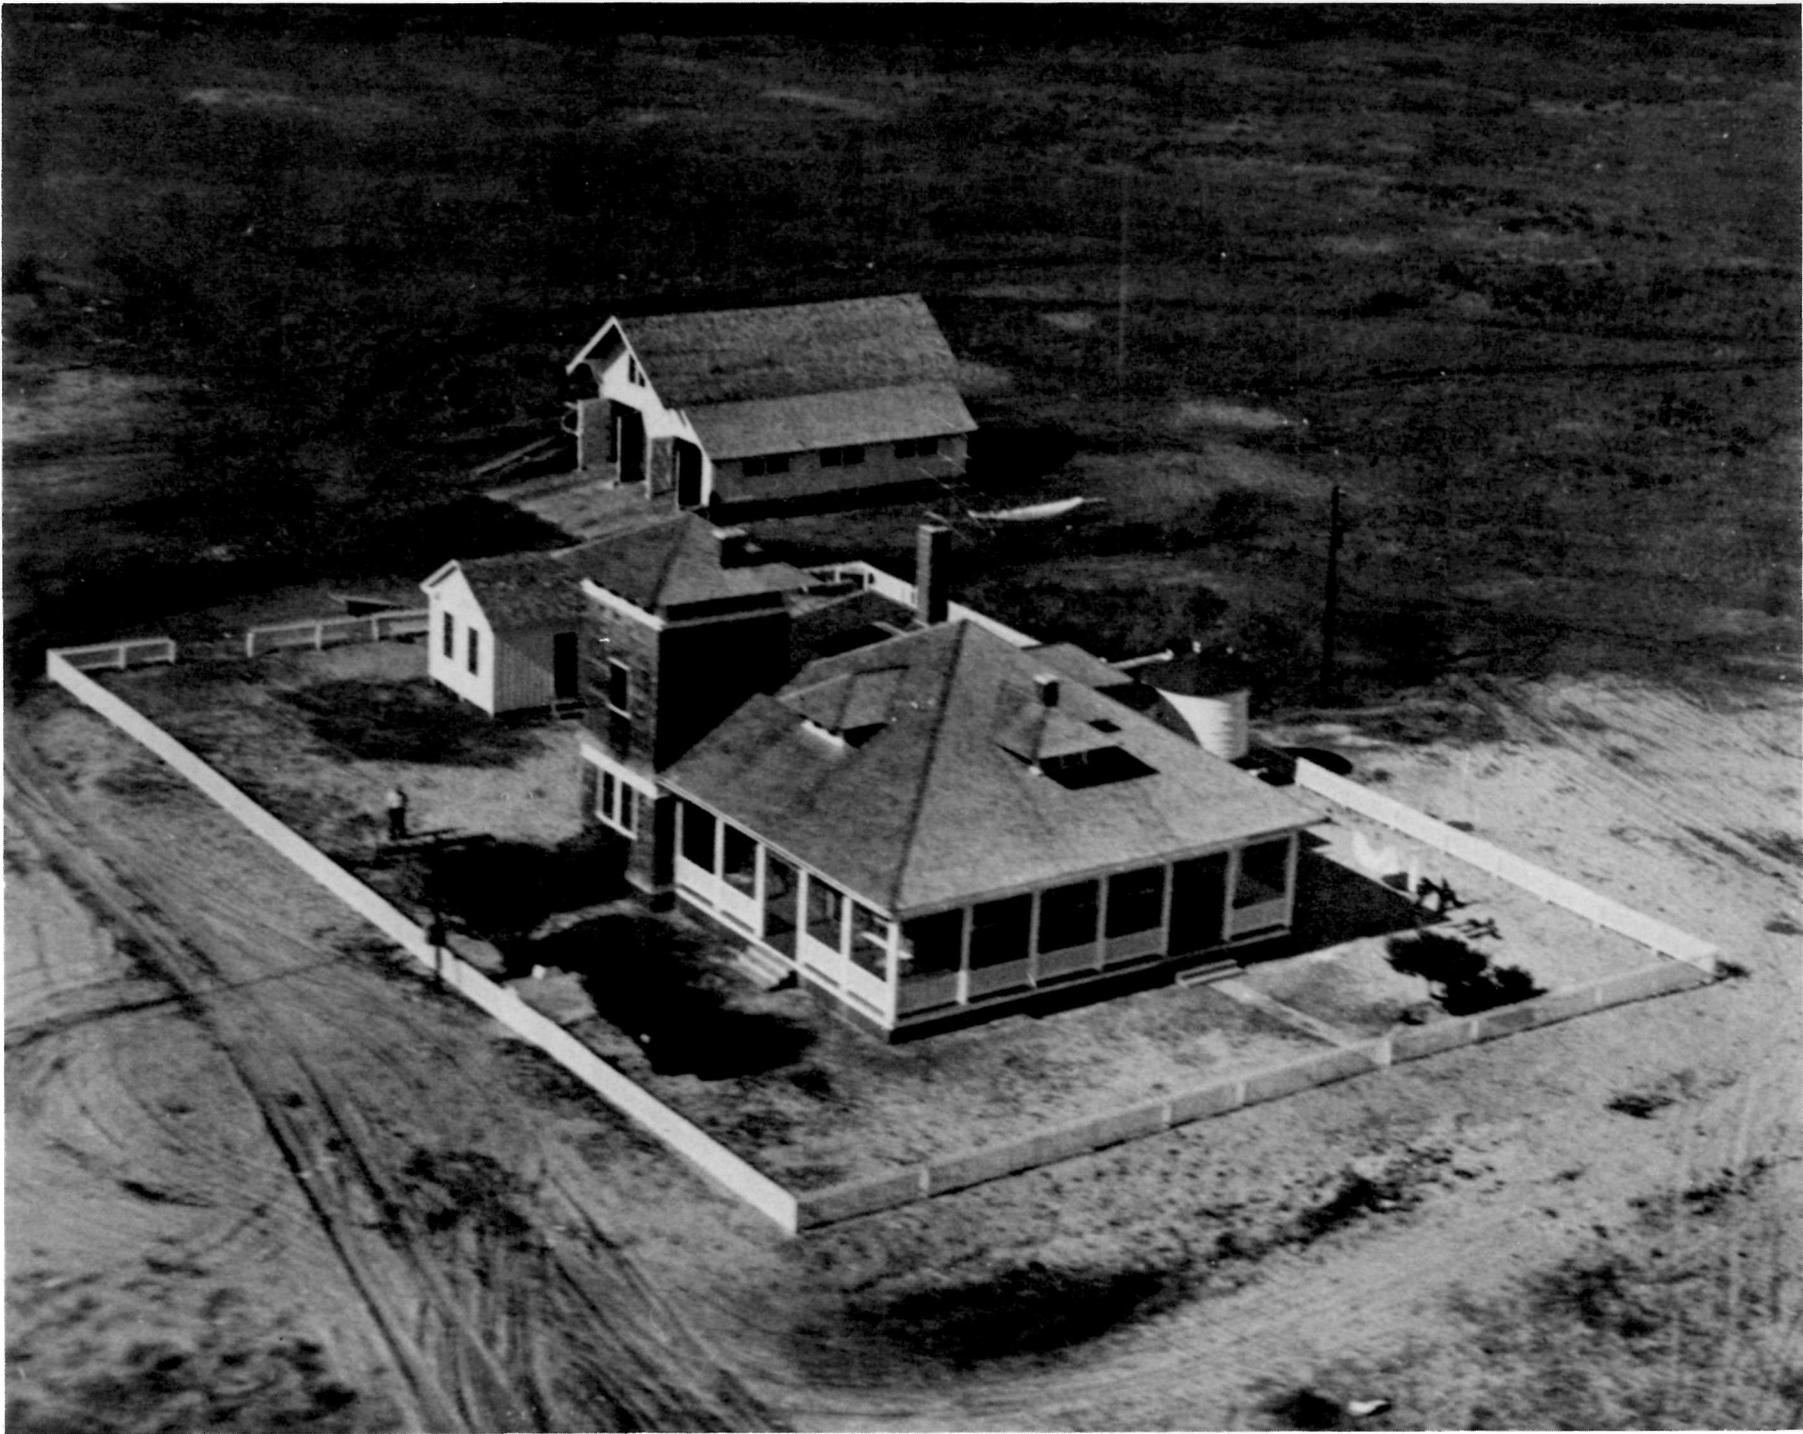
Illustration 9.

Little Kinnakeet Coast Guard Station, October 4, 1954.
