SHORELINE CHANGES ALONG THE OUTER BANKS
OF NORTH CAROLINA

Linwood Vincent and Robert Dolan

Technical Report 70-5

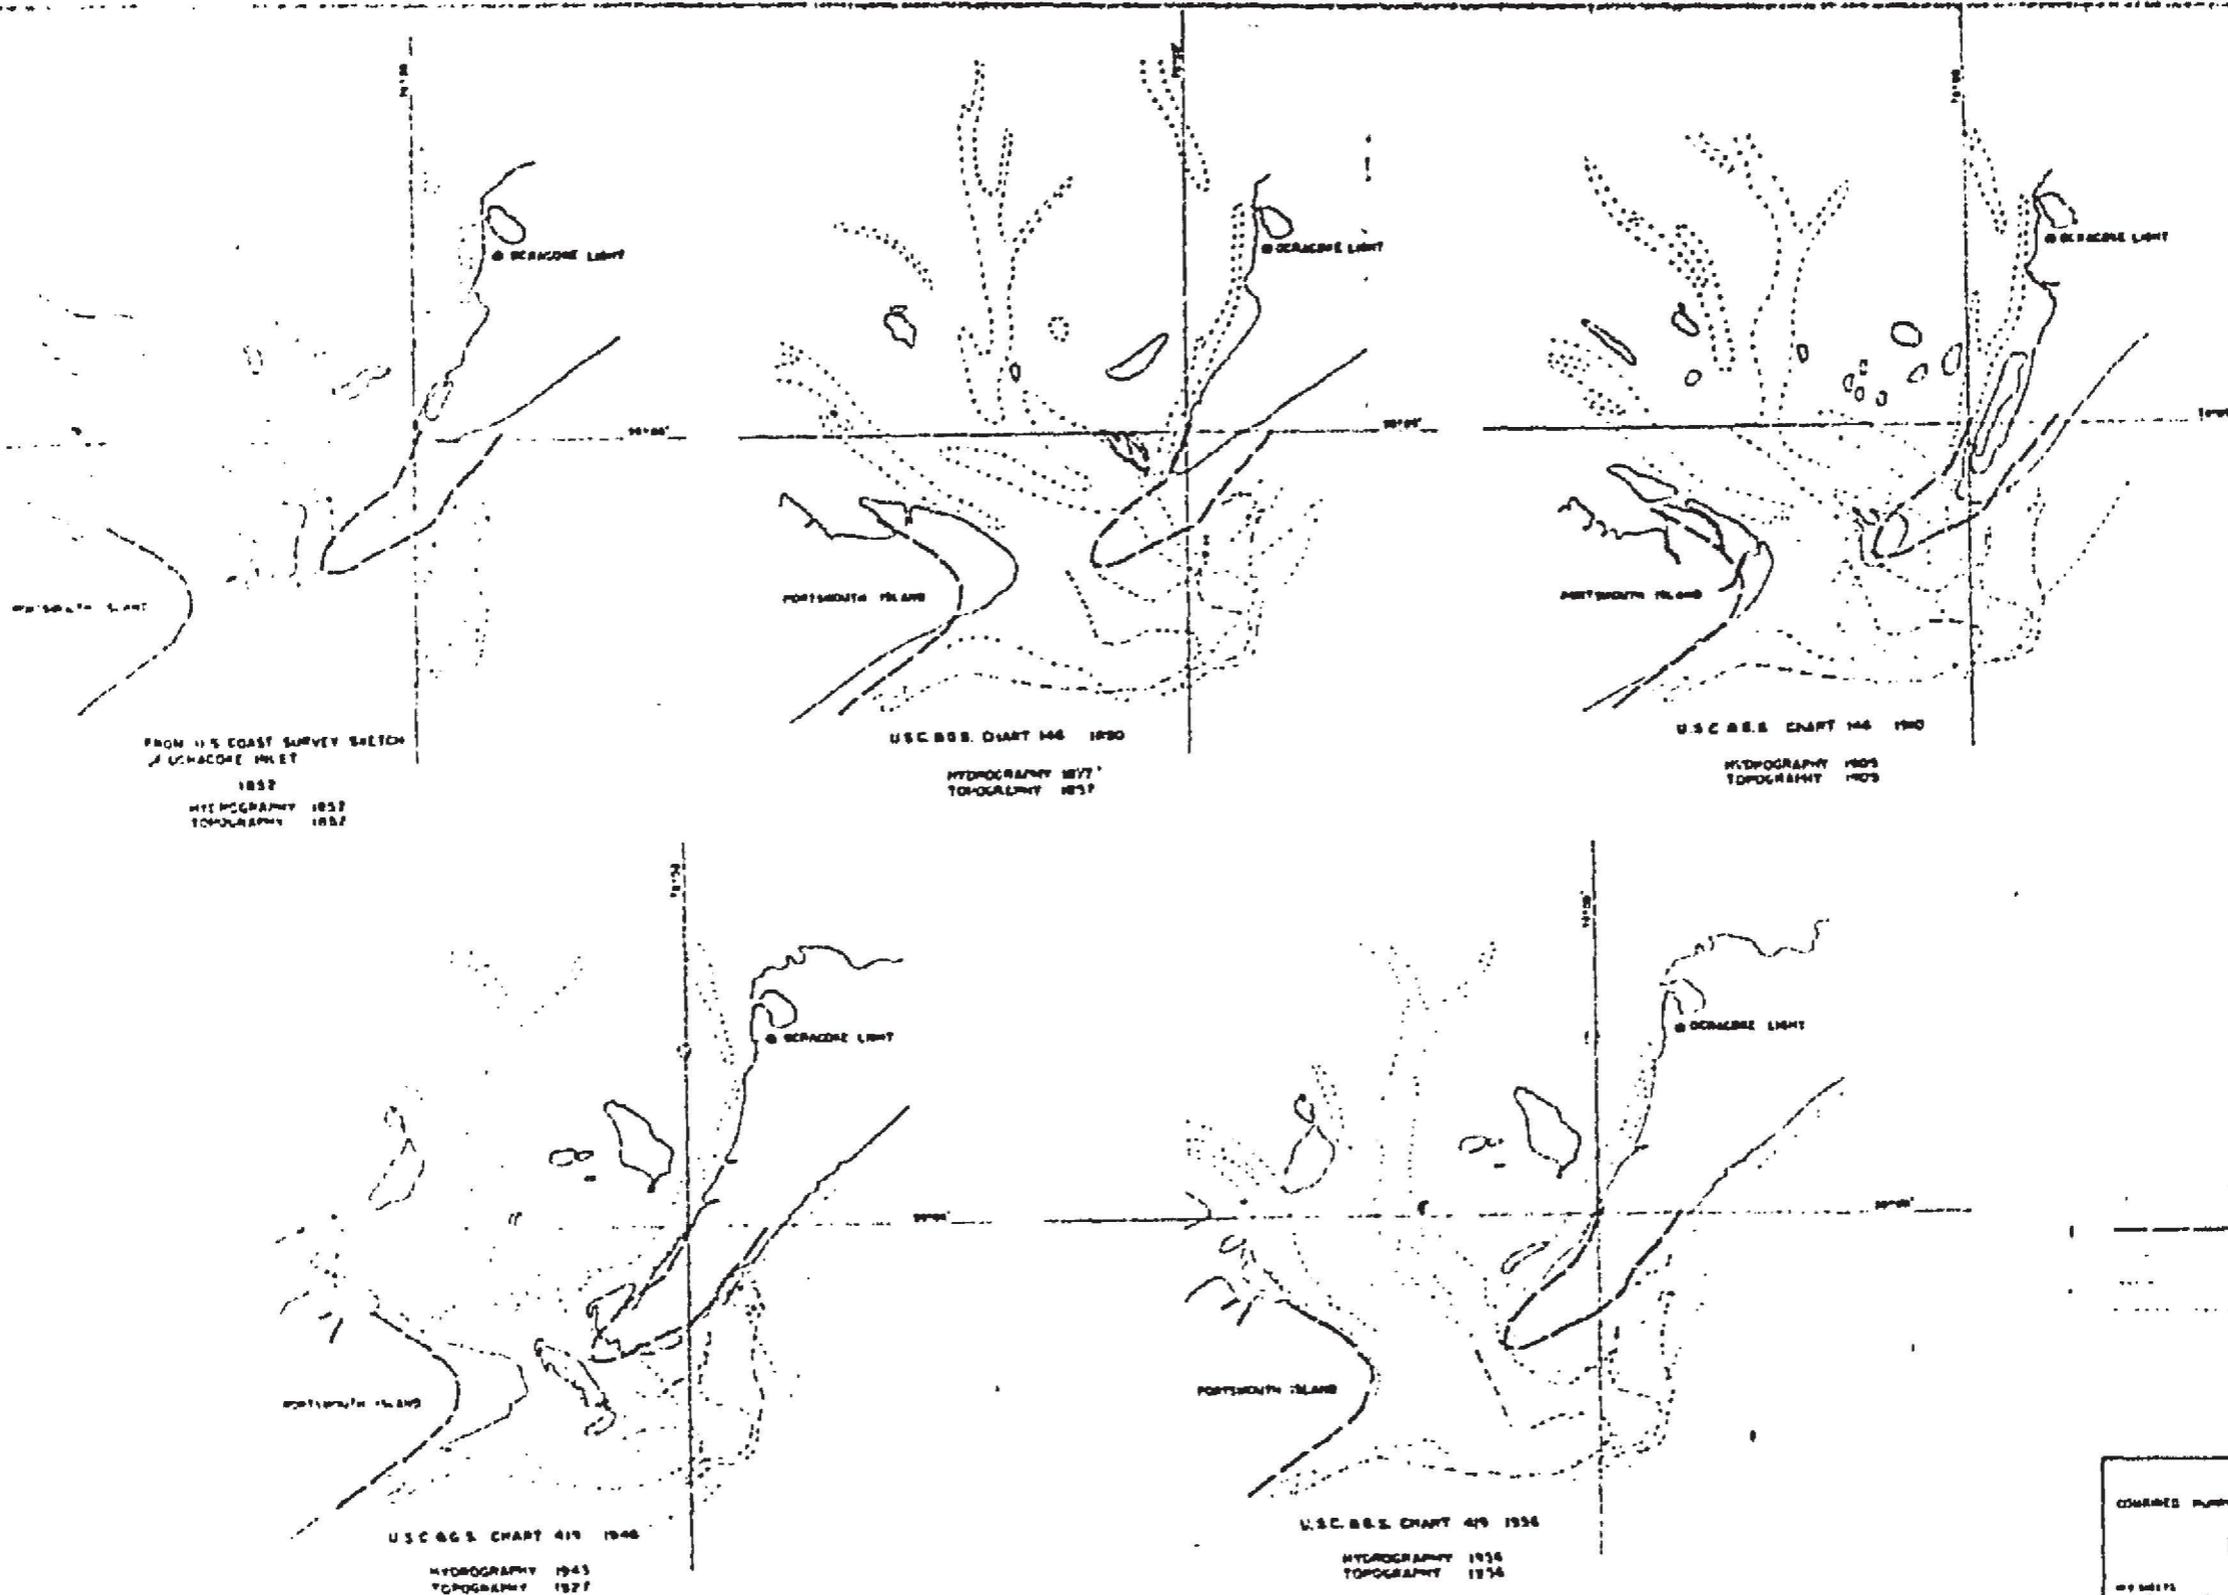
Figure 9

OCHRACOE ISLAND, N. C.
 COMBINED NARRATIVE AND COOPERATIVE BEACH EROSION REPORT

INLET CHANGES
 OCHRACOE INLET

Figure 9, from the Combined Hurricane and Cooperative Beach Erosion Report for Ocracoke Island, illustrates change in the inlet from 1852 to 1956.
