Castle Mountains National Monument Springs and Water Resources Inventory

Natural Resource Report NPS/MOJN/NRR—2016/1345

Jennifer L. Bailard

December 2016

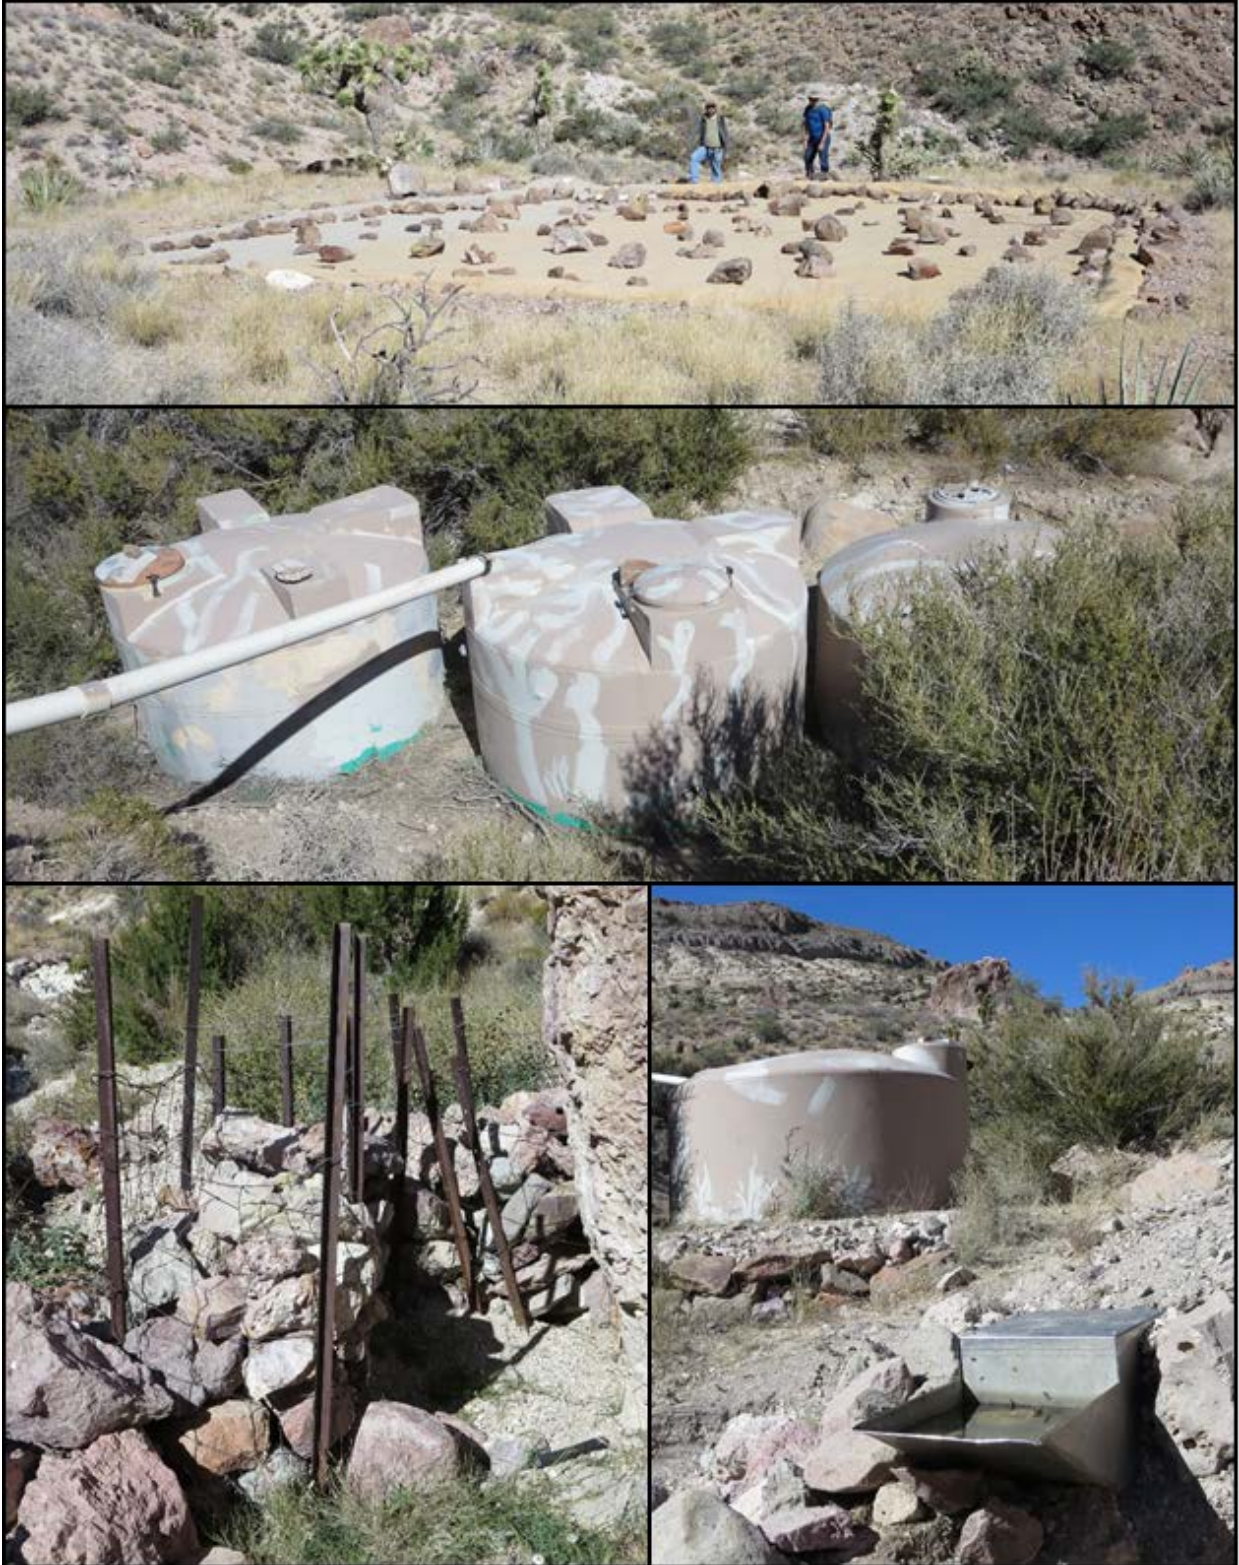
During our visit on October 19, 2016, Kidney Spring was dry. No water was found at the historical spring source near the gabion, which was still standing. We searched for another source in a dense thicket of woody vegetation (hackberry) lower down in the wash, but no riparian vegetation or obvious signs of a spring were discovered.

Between the gabion and the woody vegetation was a series of three tanks (Figure 2). One tank was fed by pipe from the dry source protected by the gabion. Another tank was fed by pipe from a large rainwater collector with dimensions of about 10 m by 10 m. This rainwater collector appeared to be active and a recent addition. The lowermost tank fed into a metal drinker that was full of water. We did not measure water quality or quantity at the drinker because that water originated from rainwater, as opposed to the natural groundwater that is of interest to the Desert Springs protocol.

Figure 2. Kidney Spring. Top: Rainwater collector above tanks. Middle: Three tanks with pipe from rainwater collector. Bottom left: Gabion enclosing dry spring source. Bottom right: Drinker full of water below tanks.

Although Kidney Spring was dry during our visit, flowing water has been observed there in the past 20 years, so it is possible that the spring is currently dry due to the ongoing drought. Because we visited the spring in early fall, it is also possible that no water was observed because the spring is only seasonally wet during the winter

Kidney Spring was dry, and there was no riparian vegetation observed near the source at the gabion or farther down the wash. However, spring discharge has been recorded there in the past 20 years as well, so this spring may also have been seasonally dry or temporarily dry due to the current drought. Previously, Kidney Spring has been called the only perennial source of water in CAMO and an important water resource for bighorn sheep. While the spring is not currently perennial, the recently-installed wildlife drinker system at the location attests to its significance.

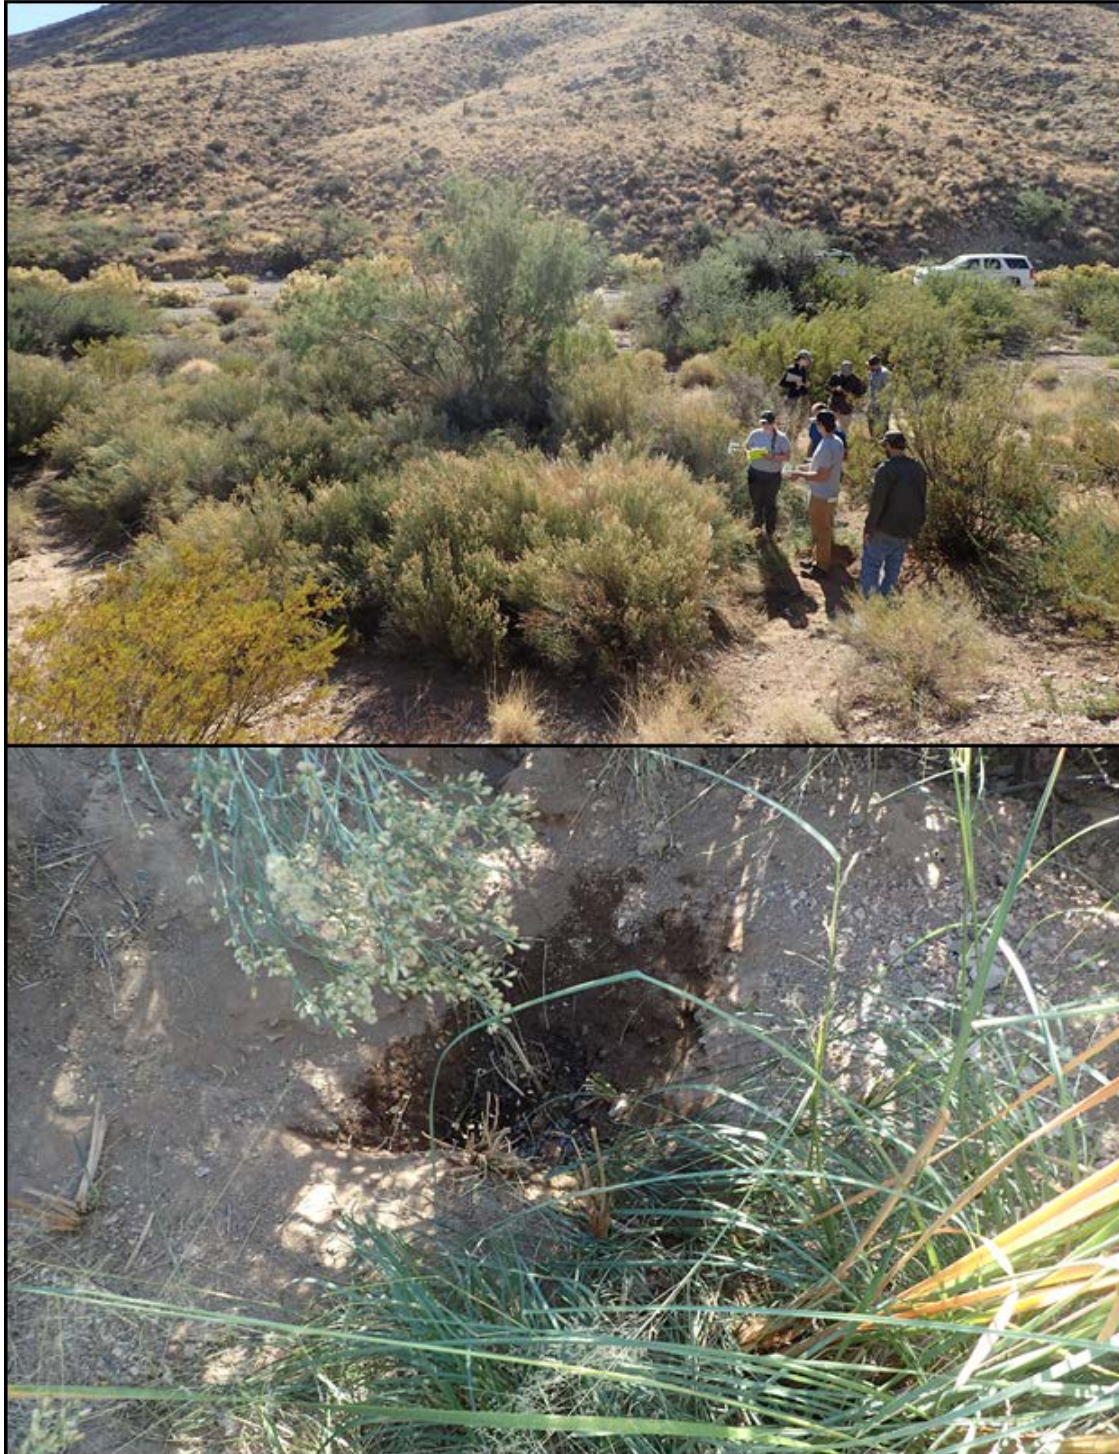
During our visit on October 19, 2016, water was again present at Lewis Holes during an ongoing period of drought. There was no surface flow, but there was a small, shaded pool with dimensions of 20 cm by 20 cm and a depth of 10 cm (Figure 3). The pool appeared to have been excavated by wildlife. There were numerous small rodent droppings and visible grazing of cattails by large mammals, possibly bighorn sheep or mule deer. We collected water quality data at the spring using an ExStik PH100 and YSI 85 (see Table 3).

Dominant vegetation around the spring included baccharis, sacaton, and cattail. The presence of riparian vegetation, like cattail, suggests that the spring has had reliable surface water in recent years. There was also a very large tamarisk >4 m tall near the spring, providing further evidence for a

significant supply of water at or near the surface. Behind the tamarisk, about 20 m southeast of the spring, was an old trough. There were additional twisted scraps of metal in the wash below Razorback Ridge where we parked. No windmill was observed.

Figure 3. Lewis Holes. Top: Looking down on Lewis Holes from the northwest. Bottom: Close-up of excavated spring source. Cattails visible in lower right corner.

Lewis Holes was the only spring visited that had surface water. There was living riparian vegetation at the spring in the form cattails, so surface water has been reliable at Lewis Holes during the current drought and possibly throughout the summer.

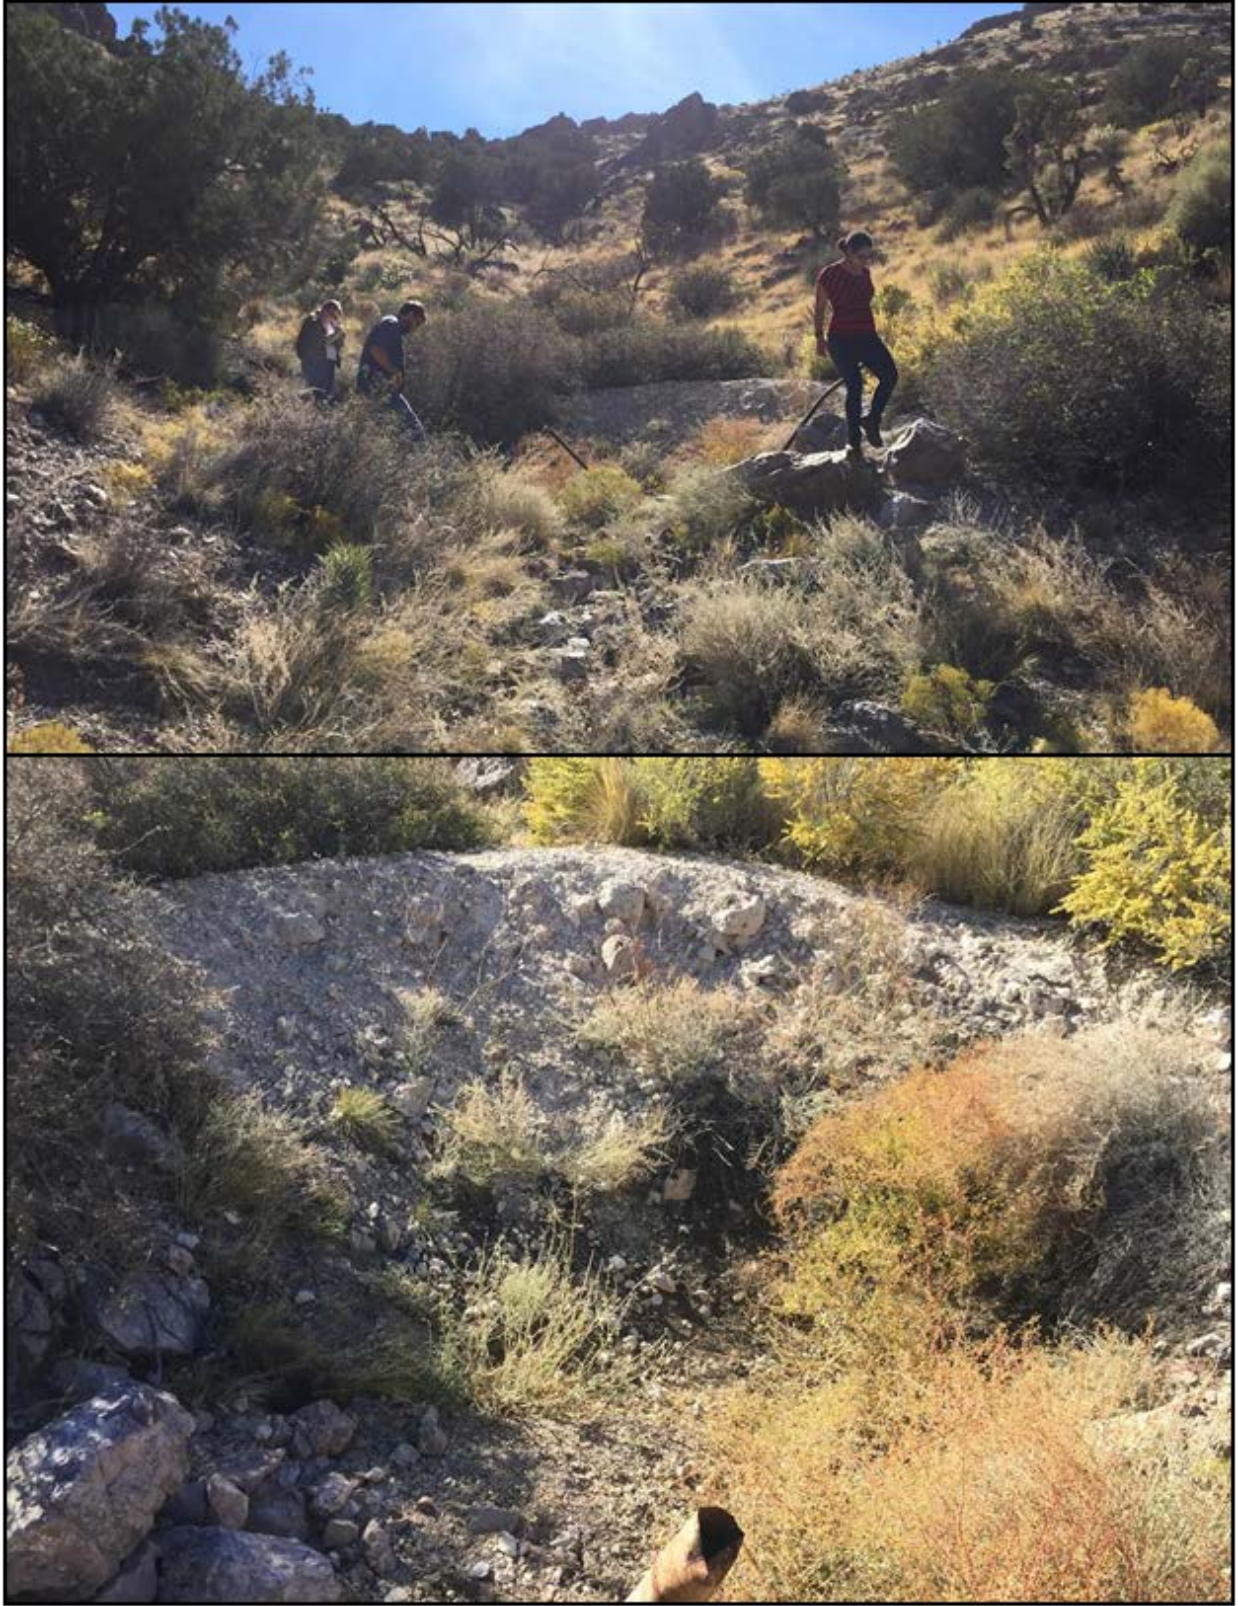
During our visit on October 20, 2016, Mouser Water was dry. There was a hand-dug or excavated source, probably the same as the small dug out pond noted by the BLM (Figure 4). There were many pipes, wooden posts, and rusted metal scraps littering the wash from the source down to the road about 150 m below. There was no riparian vegetation near the source or in the wash.

Based on our observations, we infer that Mouser Water was a manmade feature built by the Rock Spring Land & Cattle Company that fell into disrepair once ranching ended. There is no evidence suggesting that there is surface water at the location today.

Figure 4. Mouser Water. Top: Standing below the spring source, looking up the wash. Bottom: Close-up of the excavated spring source.

We found the excavated source at Mouser Water (X Spring) described by the BLM. However, there was no surface water or evidence of recent spring activity, such as riparian vegetation. Furthermore, no spring discharge has been recorded there since the 1920s. Mouser Water was likely a manmade feature built by cattle ranchers that later fell into disrepair.

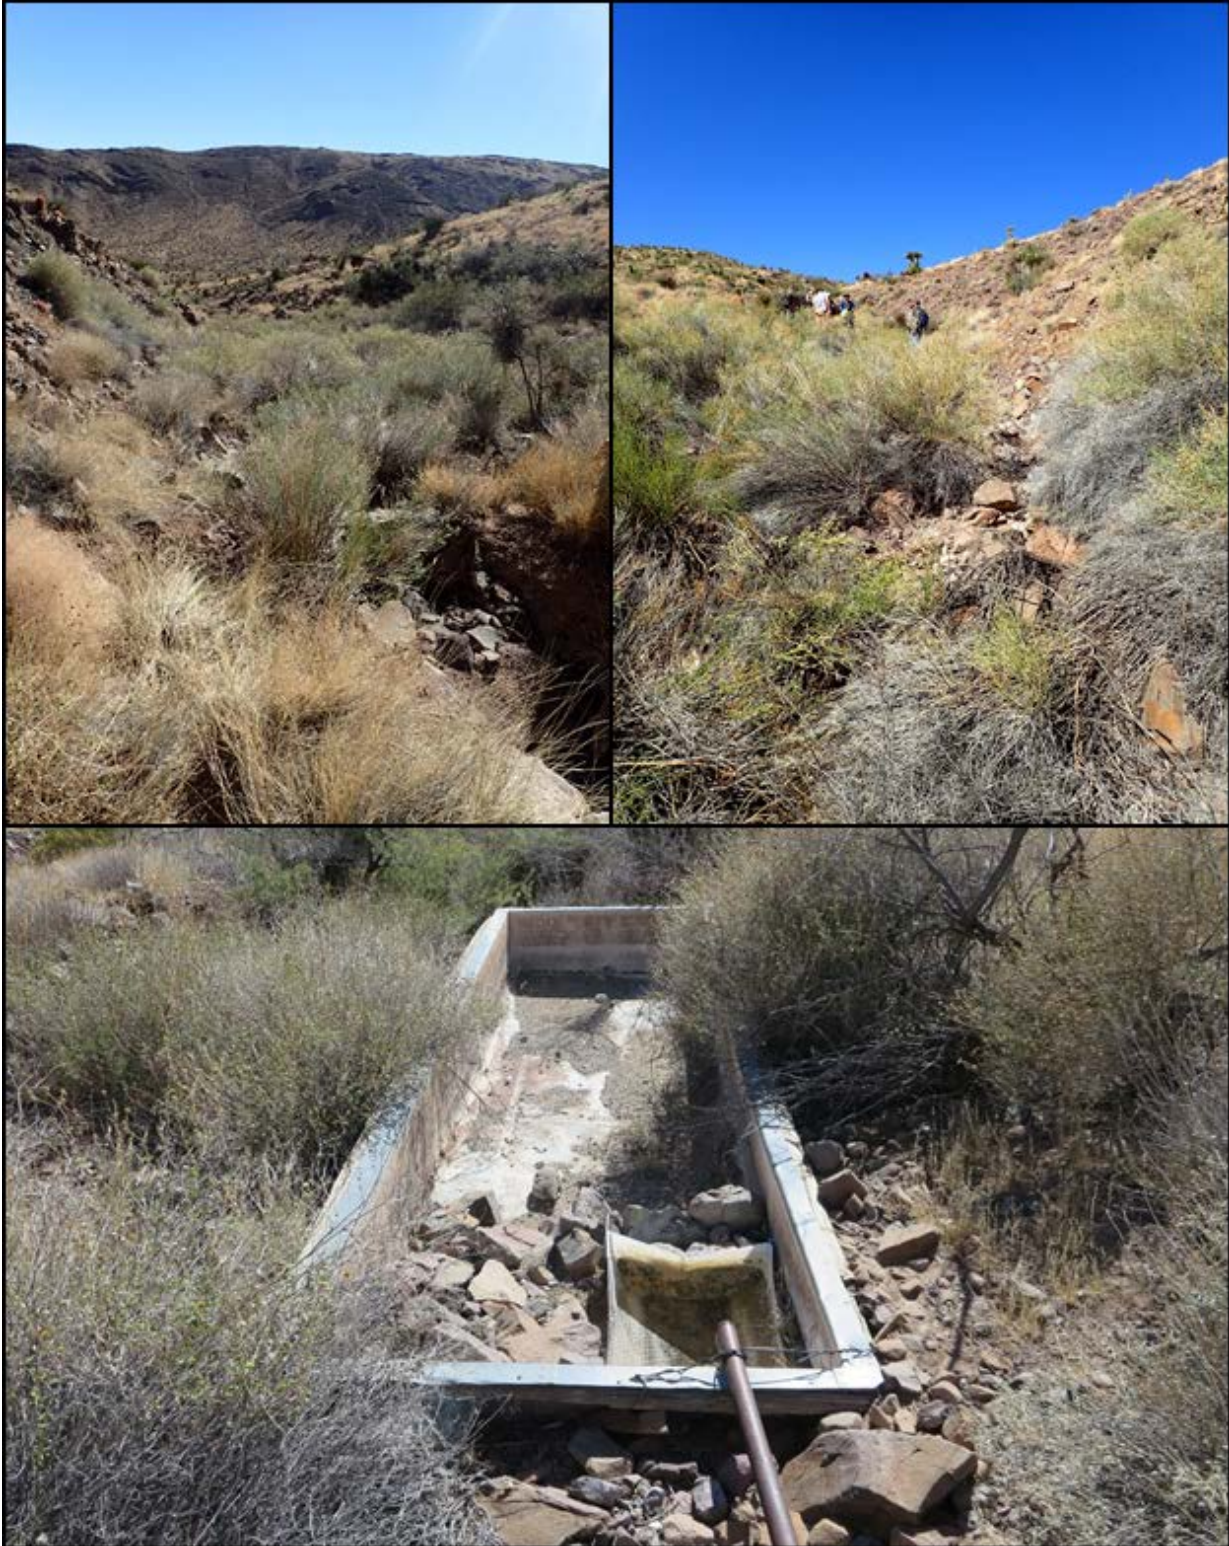
During our visit on October 19, 2016, Quail Spring was dry. We identified the approximate source using coordinates from the USGS National Hydrography Dataset. These coordinates placed the source about 65 m above the old cattle trough, which was also dry (Figure 5). The most abundant vegetation was baccharis and several species of native bunchgrass, including big galleta grass. There was also catclaw acacia hosting mistletoe within a few meters of the source. No cattails were observed at the source or in the wash above the trough. Invasive red brome was present at the source and throughout the wash. Wildlife spotted at the spring during our visit included a phainopepla and a ground squirrel.

Although Quail Spring was dry during our visit in early fall, flowing water has been observed there in the past 20 years, so the spring may be temporarily inactive due to the ongoing drought, or it may flow seasonally during the winter.

Figure 5. Quail Spring. Top left: Standing above spring source, looking down the wash. Top right: Standing below spring source, looking up the wash. Bottom: Old cattle trough and pipe. Plastic bucket visible in trough.

Quail Spring was dry, and there was no riparian vegetation observed near the source in the wash or down by the trough and pipe. However, spring discharge has been recorded there in the past 20 years, so the spring may have been seasonally dry or temporarily dry due to the current drought.

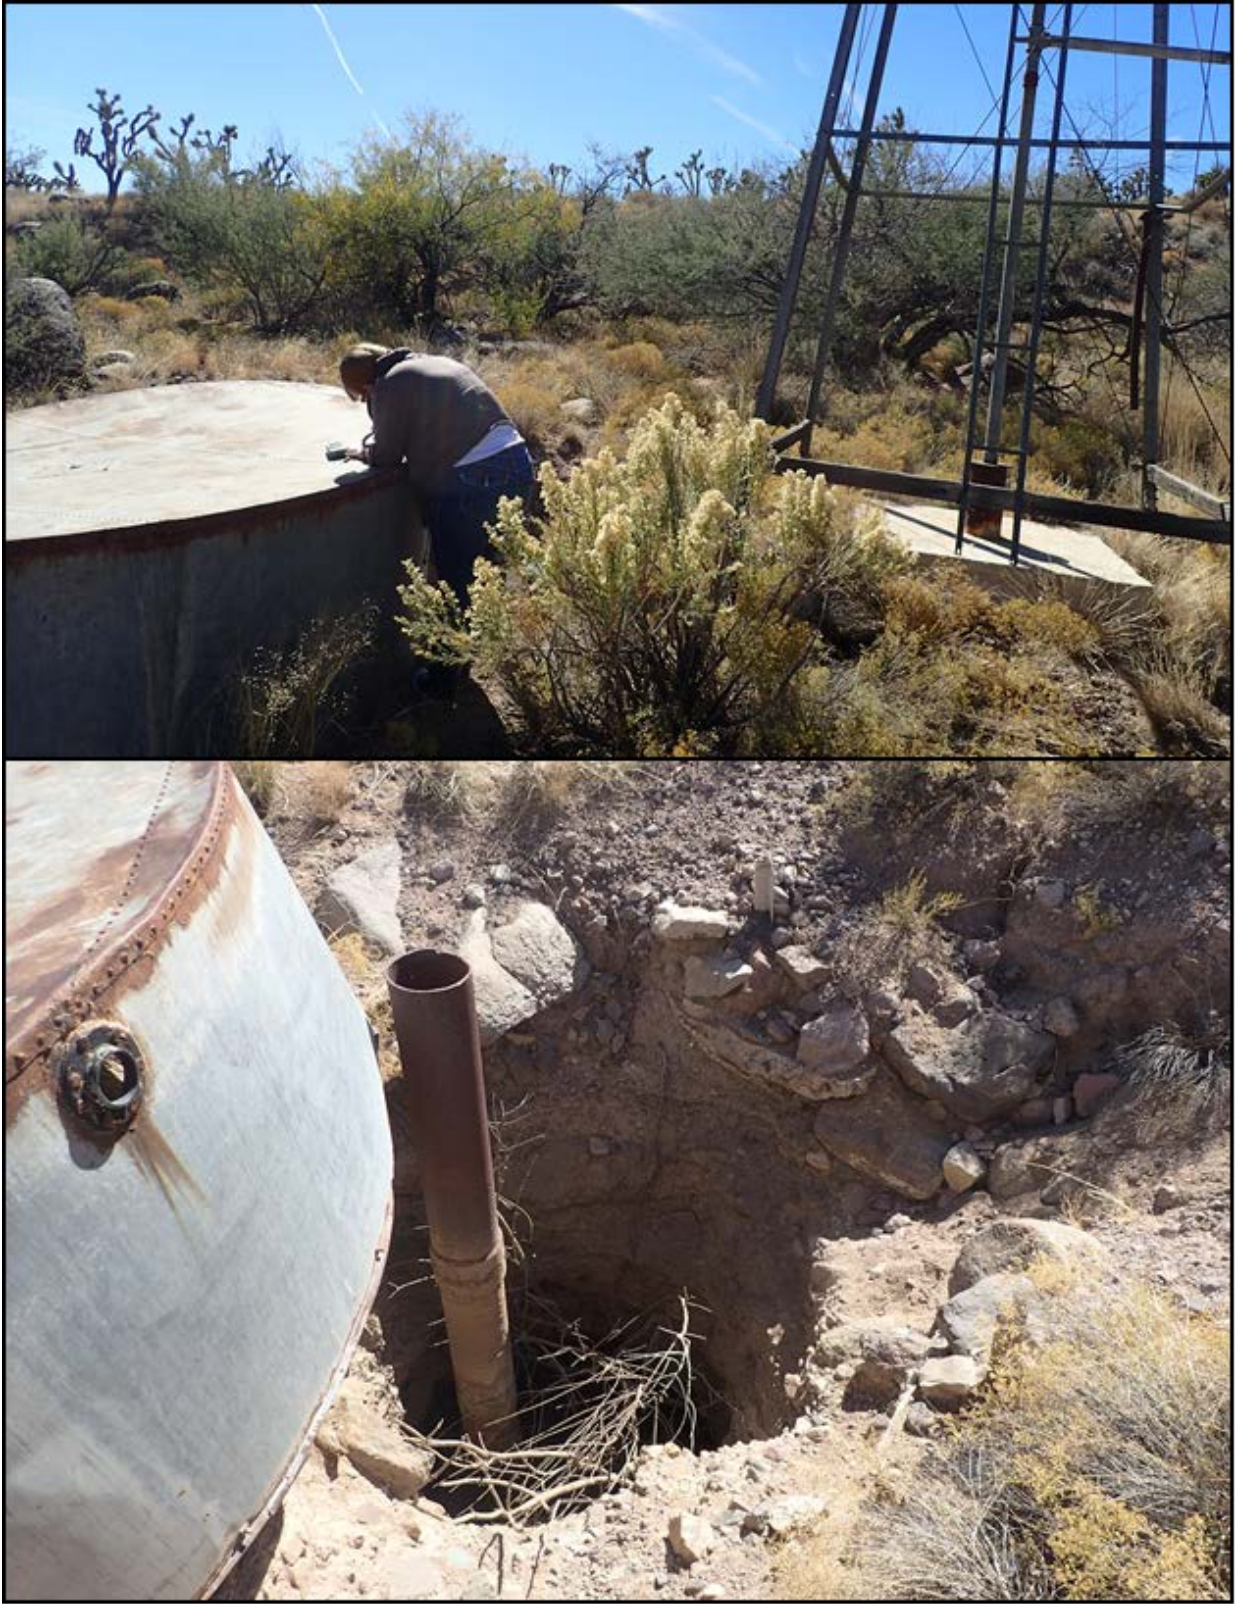
Stagecoach Spring appeared to be an entirely manmade feature, with a deteriorating windmill and tanks situated beside a deep open well (Figure 6). During our visit on October 20, 2016, there was water present in the bottom of the well. However, the surface of the water was >3 m below the surface of the ground and inaccessible to wildlife.

Figure 6. Stagecoach Spring. Top: Old tank and windmill. Bottom: Close-up of well opening.

Both Stagecoach Spring and Stray Cow Well had water present within their wells, but the water was deep below the surface (>3 m) and not accessible to wildlife. The well at Stagecoach Spring is currently uncovered and poses a potential safety hazard to wildlife and people, so we recommend covering or fencing off the opening.

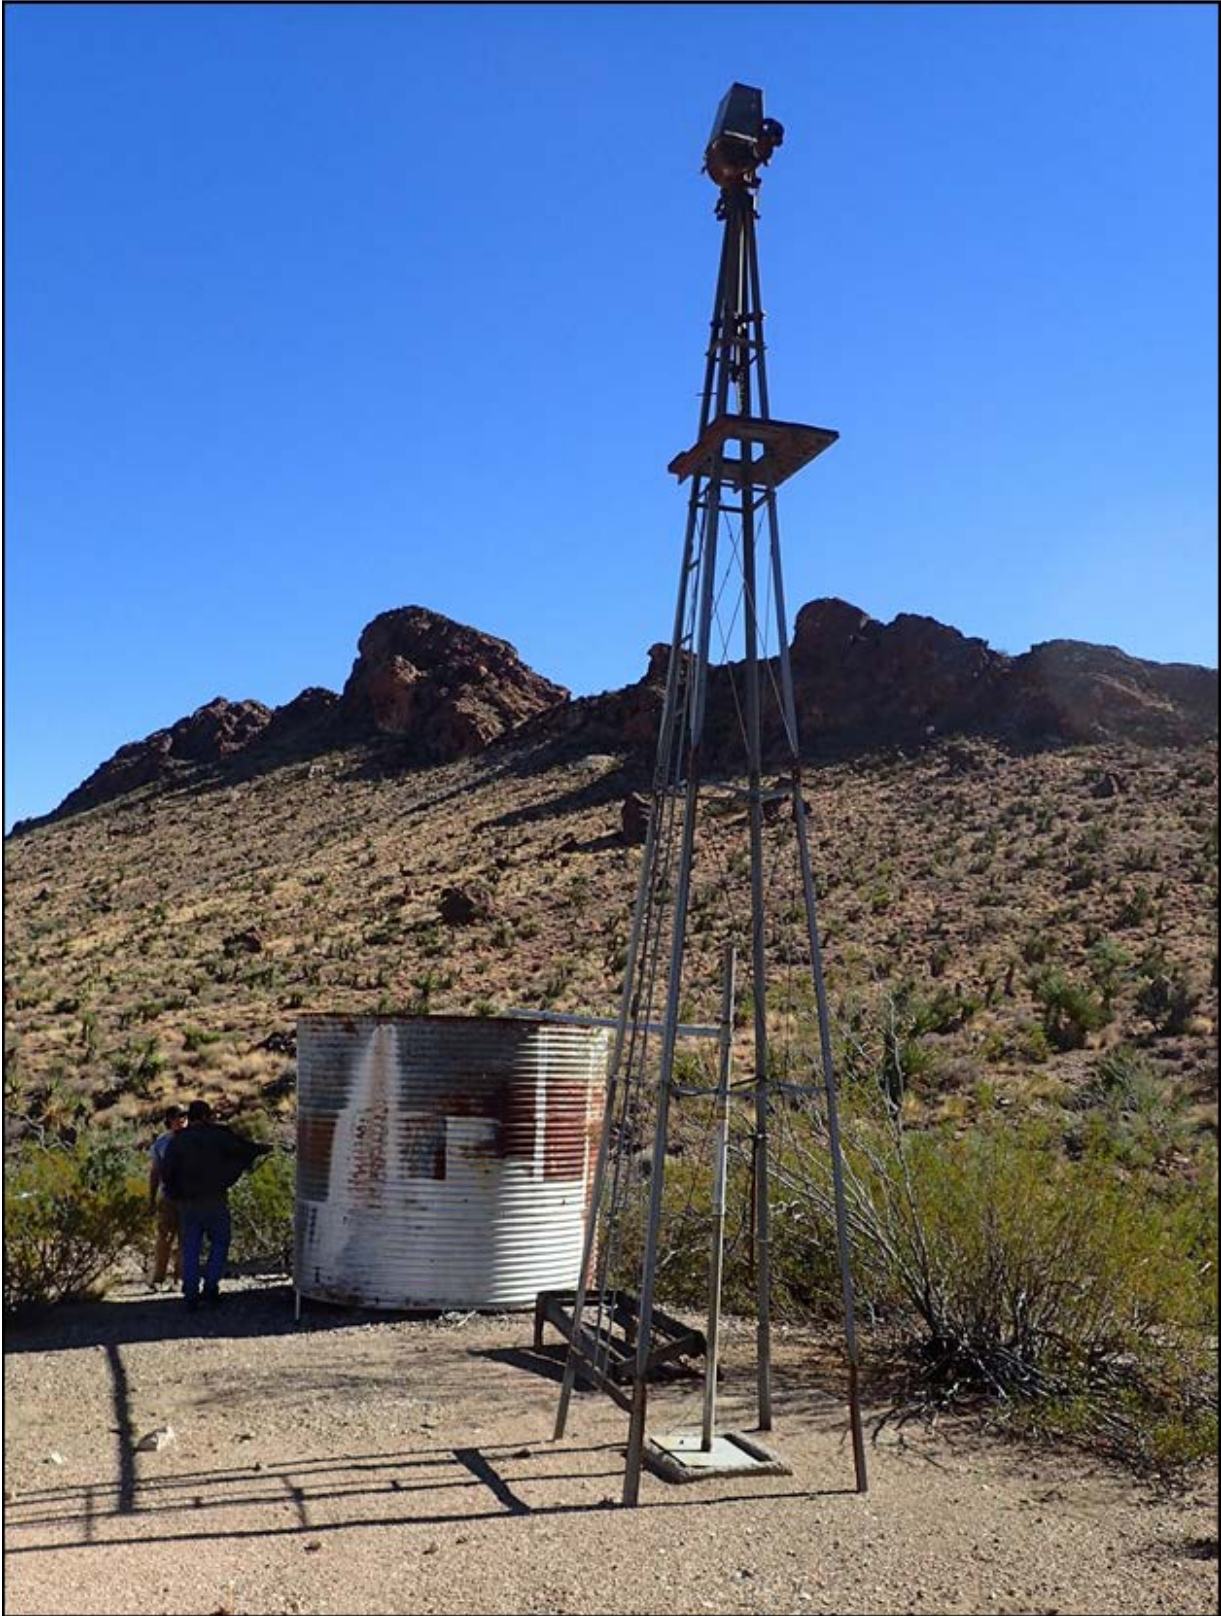
Figure 7. Stray Cow Well.

Stray Cow Well appeared to be an entirely manmade feature, with a deteriorating windmill situated over a deep well covered by a metal plate and connected to an old tank by pipes (Figure 7). During our visit on October 19, 2016, there was water present in the bottom of the well. However, the surface of the water was >3 m below the surface of the ground and inaccessible to wildlife.
