National Park Service Cultural Landscapes Inventory 2022

Magnolia Plantation

Cane River Creole National Historical Park

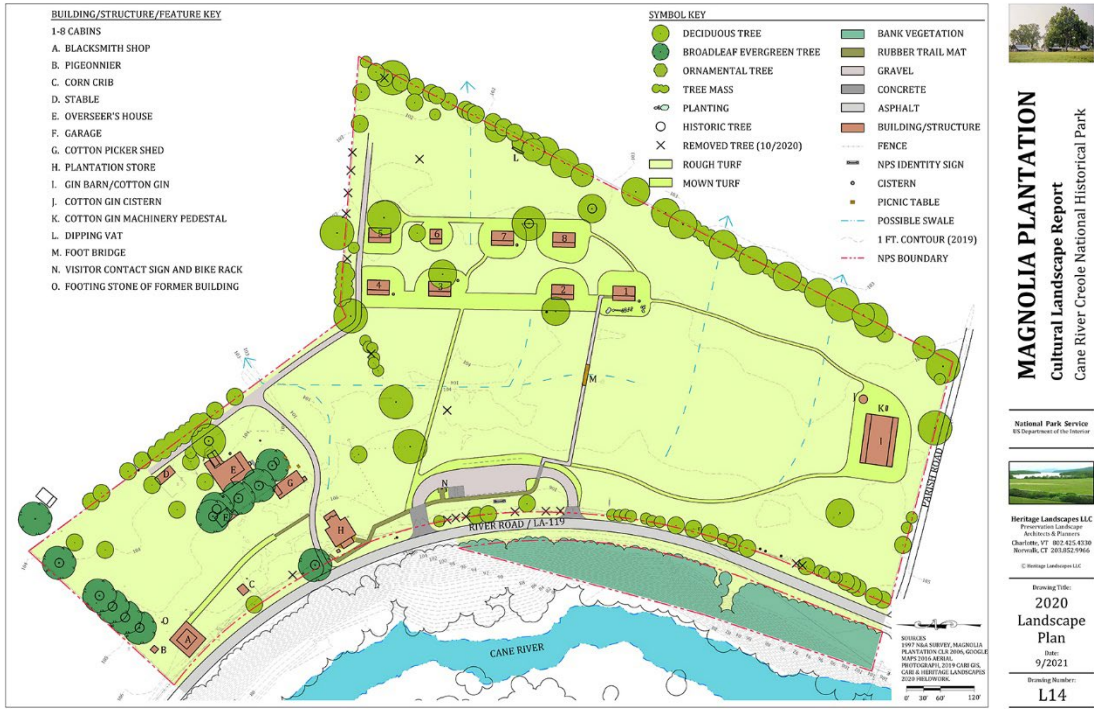
Fig 1.2. 2020 Landscape Plan (CLR Figure L14). Heritage Landscapes LLC 09/2021.

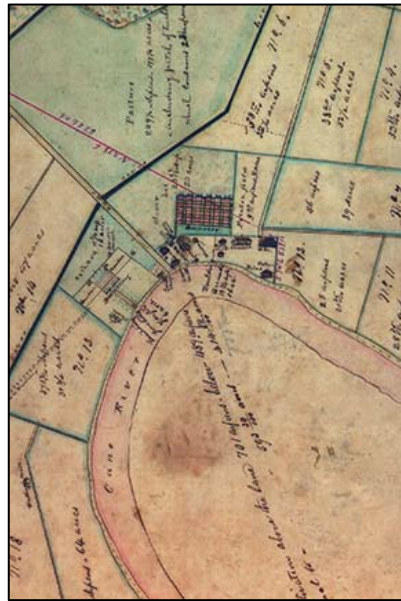
Fig 2.3. Detail from an 1858 plat map of Magnolia Plantation prepared by G.S. Walmsley illustrates the configuration of fields and roads, location and function of buildings and structures, and location of gardens and an oak allée at the Main House. Fields and pastures are shown in blue and beige. The four by six rows grid of Quarters would have housed a maximum of 48 enslaved families in 24 buildings. Wide black lines are labeled as “LEVEE” indicating a historic flood control feature. Courtesy CGHRC.

An annotated plat map of Magnolia Plantation by surveyor G. S. Walmsley, documented the overall organization and land uses of the plantation landscape in 1858 (Figure 2.3). The map remains the best illustration of the landscape prior to changes during and after the US Civil War. It illustrates the layout of fields and position of structures in relation to the Cane River and roads. The Main House, also known as the Big House, gardens, double allée of live oak (*Quercus virginiana*), and a stable lay northwest and apart from the rest of the plantation. The Plantation Yards contained several structures including a Blacksmith Shop, a sawmill, hospital, smoke house, bell tower, mill, nursery, stable, corn cribs, gin barn, and a cotton press. To the east, a field of clover (*Trifolium sp.*) and potatoes (possibly *Ipomoea batatas* and *Solanum tuberosum*) edged a gridded block of twenty-four quarters for enslaved workers. A wide lane or road passed between the blacksmith shop and Overseer's House, while two smaller lanes connected the gin to points east and south. To the east of the plantation core, a levee protected the Main House and surrounding orchard and pastures. This general organization of the plantation core persisted for many decades through to the current time. The map also shows labeled levees to the east between the core area and the fields.

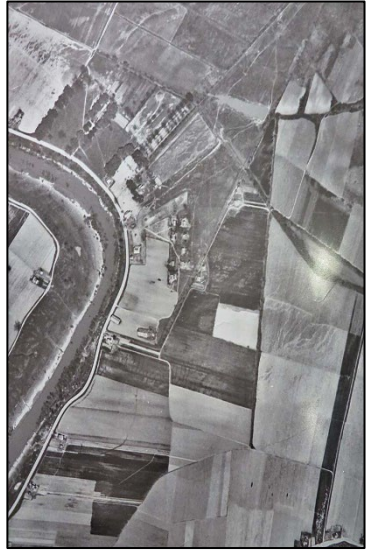
Fig 2.7. The 1941 aerial photograph of Magnolia Plantation core area shows farm roads, fences, and tree rows extending northeast from River Road (LA-119) to define fields, pastures, orchards, and residential areas. Paths formed by residents and livestock crisscross the site. The landscape of the Quarters depict pathways and vegetation of a domestic landscape. The Main House landscape appears to the north. Courtesy CARI.

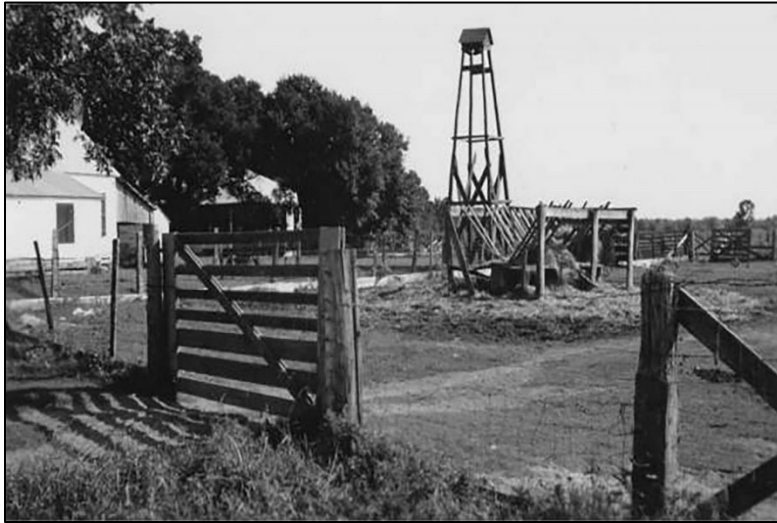
Fig 2.8. A circa 1930s photograph shows the bell tower rising above Mule Lot. Hogwire fence attached to railroad ties posts define boundaries. Live oaks are visible across the fenced fields. Courtesy LA State Library, LSU.

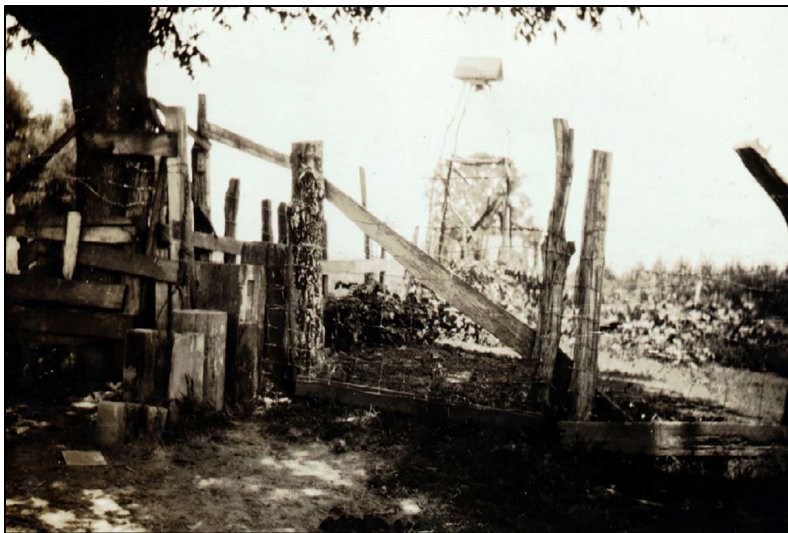
Fig 2.9. The log post steps of a stile attached to a tree enable people to cross a hogwire fence around the 1940s. The stile forms part of the primary path between the Quarters and Store. Courtesy CGHRC.

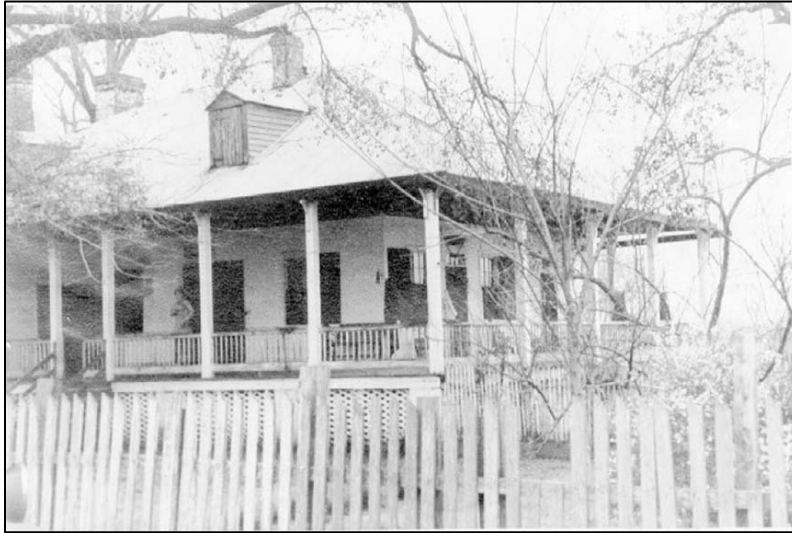
Fig 2.10. A photograph from the 1930s shows ornamental trees and shrubs growing near the Overseers House. A narrow path connects to the entry steps and goes around the building. Courtesy CARI.

Farm managers grew flowering shrubs and fruit and ornamental trees at their residence during the mid-twentieth century. The limited photographic record of the Overseer's House shows small trees, shrubs, and a narrow path inside a picket fence at the southwest side of the yard (Figure 2.9). Trees at the Overseer's House include plum (*Prunus persica*) and pear (*Pyrus communis*) though their precise location is unknown. A bed of ornamental groundcover plants, to include iris (*Iris sp.*) and cast iron plant (*Aspidistra sp.*), grow on the southeastern side. L3 1941 Aerial photograph also shows a possible garden or fenced enclosure with four internal sections, adjacent to a row of large trees north of the Overseer's House.

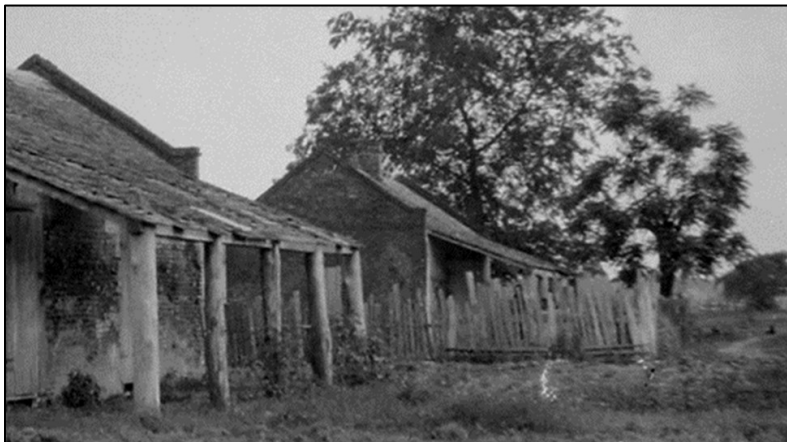
Fig 2.15. Vernacular picket fences employ irregular board lengths and low horizontal members, between Cabins 7 and 8 around the 1920s. No porch deck is present.

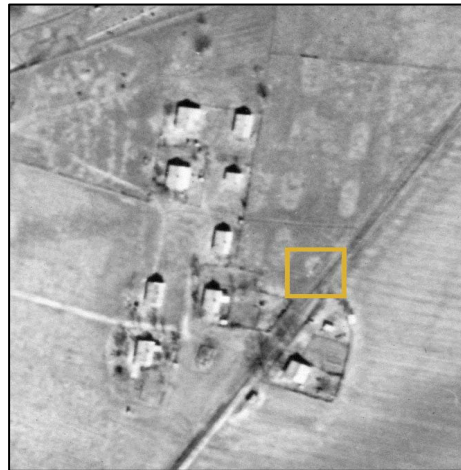
Fig 2.18. A 1955 aerial photograph provides the earliest record showing the cattle dipping vat, highlighted with an orange box. This image reveals the incomplete grid of the eight remaining cabins and the footprints of other cabins. The ruin of Cabin 9 appears as a vegetative blur south of the second row of cabins. Courtesy CARI.

The 1955 aerial photograph reveals how the unfolding process of labor mechanization and the reduction and eventual elimination of tenant farming, sharecropping, and day laborer hand work resulted in landscape change at Magnolia Plantation (Figure 2.17-2.18) (CARI 0001 Resource Management Records Collection, 1955). The fields and pastures expand with productive land use changes. With increased use of automobiles, plantation circulation patterns changed and foot traffic to the Store and elsewhere around the Plantation Yards lessened. The familiar "Y" shaped path west of the Quarters faded with decreased use and a new road appeared across the Gin

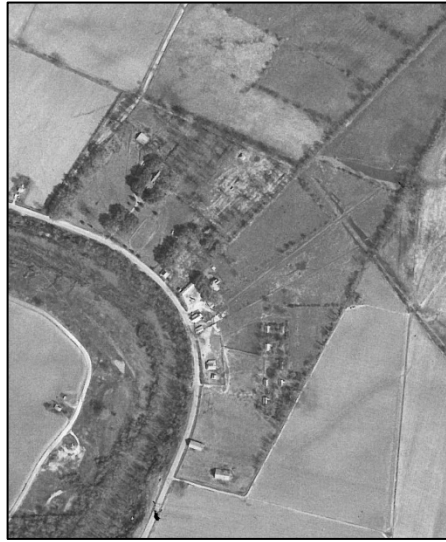
Fig 2.22. This 1972 aerial of the plantation depicts the boundaries of core from surrounding fields. The beaten earth areas documents traffic. Courtesy CARI.

L7 1972 Aerial documents evolution near the end of the period of significance (Figure 2.21-2.22) (CARI-102 Collection of Natchitoches Parish Aerial Prints, 1972). This useful photographic capture shows the landscape a few years before 1976, which signals the end of the period of significance. Changes noted on this plan include that the ruins of Cabin 9 are not highly visible as the cabin site has dense vegetative growth surrounding it. Note also that the Cotton Picker Shed, constructed at some point between after 1958, appears on this aerial view, replacing the two

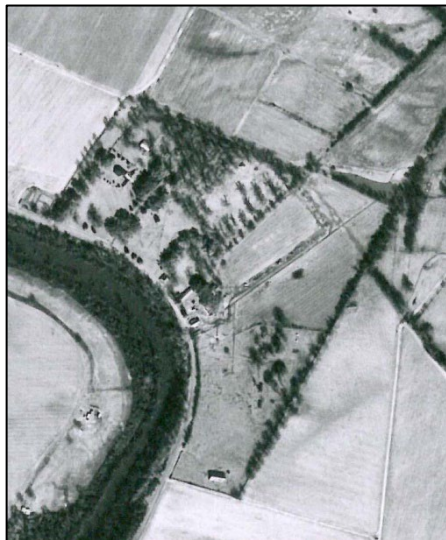
Fig 2.23. A 1990 aerial shows the core separated from fields by dense tree rows and groves along fence lines. Large trees grow within the Quarters, Overseers House, and Main House landscapes. Courtesy CARI.

A 1990 aerial photograph depicts the plantation landscape at that date (Figure 2.23) (CARI-102 Collection of Natchitoches Parish Aerial Prints 1990). Only small fields east and north of the Overseer's House are in productive use. Vegetation along fence lines within the plantation core grew freely, possibly due to dual desires to reduce maintenance and to buffer the private Main House grounds from the non-profit owned spaces of the Plantation Yards and Quarters. A row of trees also grew along the property edge along the River Road. The aerial also shows evidence of new grading with a distinct north-south swale in the center of the yards west of the Quarters. The swale does not appear in earlier documentation such as a 1982 aerial photograph.

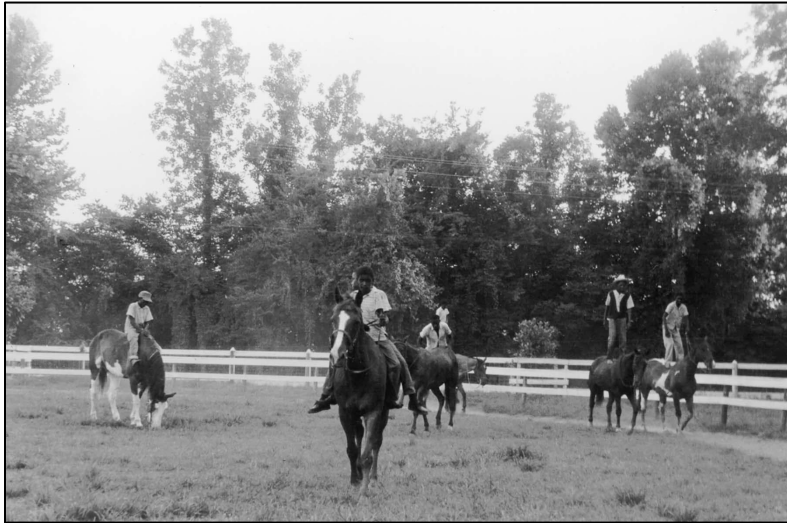
Fig 2.24. A 1960s photograph shows a tree protected by a board enclosure. The white post and plank fencing is specific to areas with horses. This view captures the dense riverbank with trees allowed to grow tall and aid erosion control. Courtesy CARI.

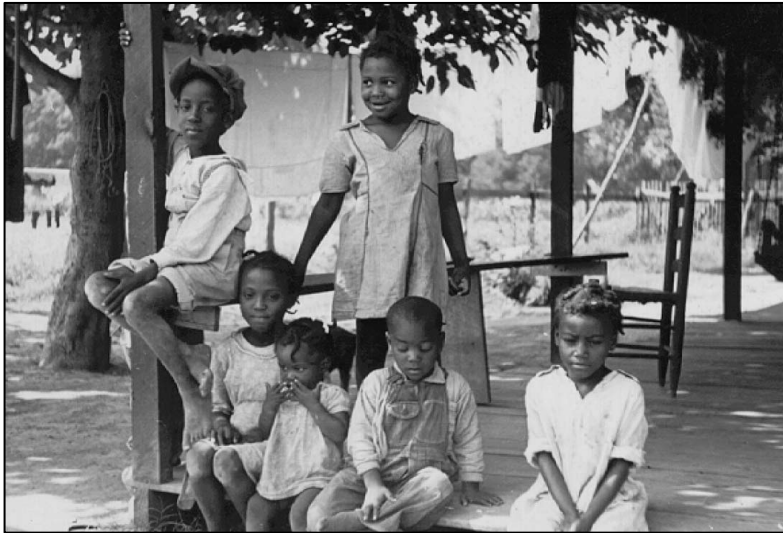
Fig 2.27. In the background of this 1960s photograph, a fence at the edge of a cabin yard depicts a board top rail between posts, and likely contains hogwire infill. The fence transitions to a picket fence. Courtesy CARI.

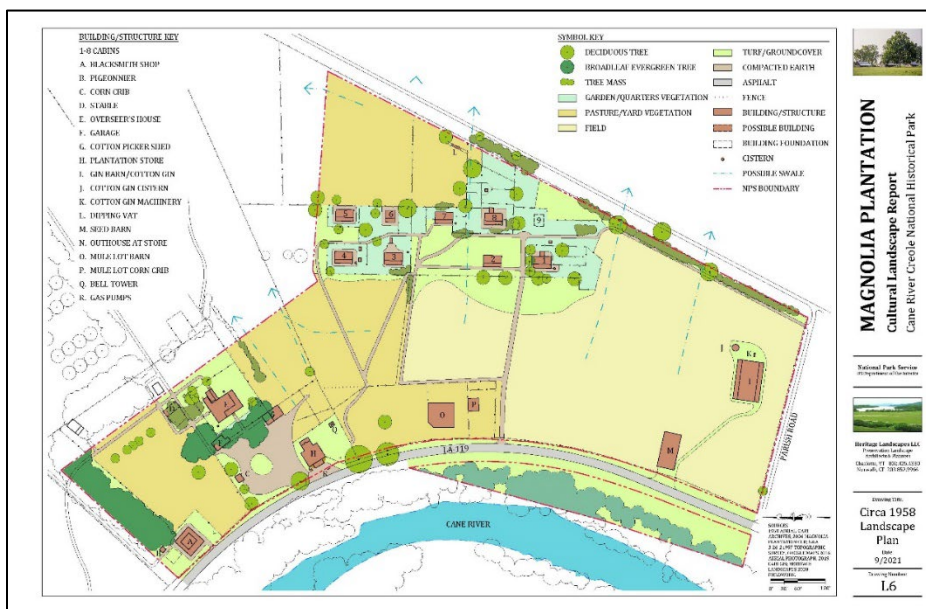
Fig 2.32. Drawing L6. Circa 1958 Landscape Plan. 1958 aerial; 2006 Magnolia Plantation CLR; N&A 3-26-21997 Topographic Survey, google maps 2016 aerial photograph; 2019 CARI GIS; Heritage Landscapes 2020 fieldwork.

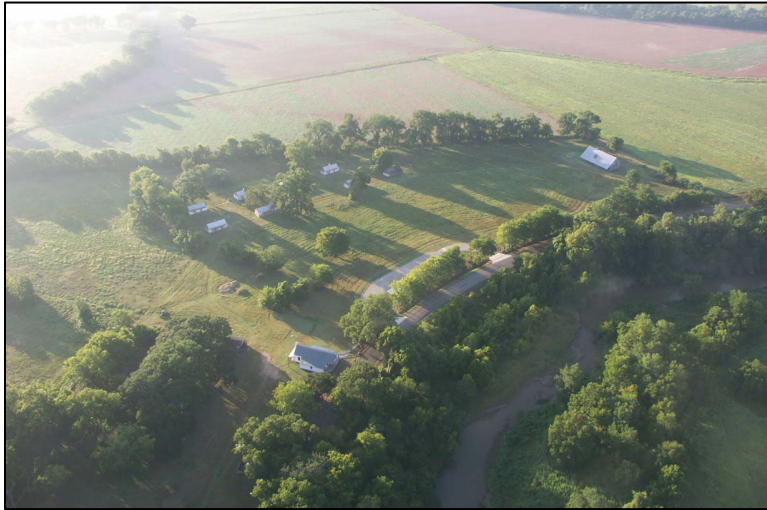
Fig 2.44. August 2005 view shows adjacent productive lands maintains agricultural setting. The steep slope to the Cane River presents challenges for stormwater management, erosion, and access issues. Courtesy CARI.

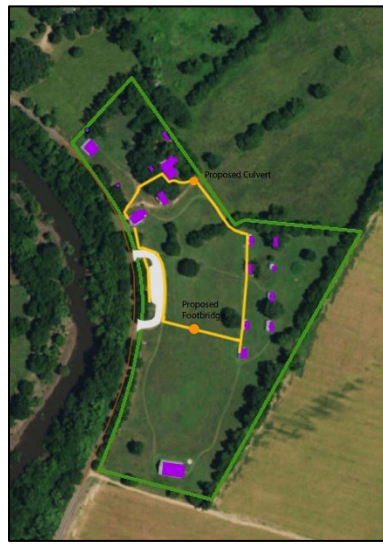
Fig 2.48. The yellow line shown on this 2017 map delineates a trail loop of new and re-laid rubber mat. The project installed a new culvert and footbridge, shown at the orange circles. This trail loop follows the recommended route described in the 2006 Cultural Landscape Report.

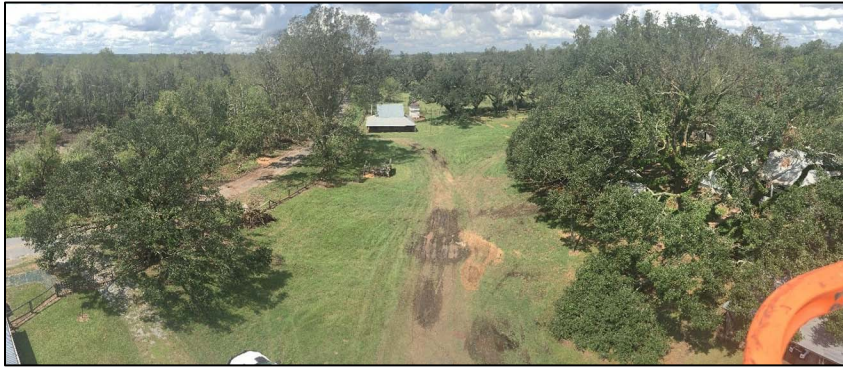
Fig 2.51. This view reveals tree canopy losses and machinery tracks after the hurricane. Courtesy CARI.

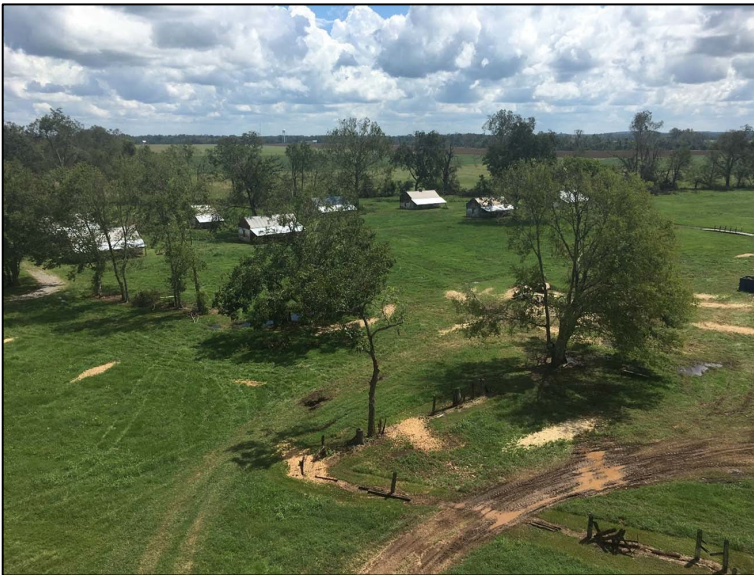
Fig 2.52. Trees with partial canopy remaining and machinery tracks from clean-up activity are visible in this image looking east southeast from the Store, from a lift. Courtesy CARI.

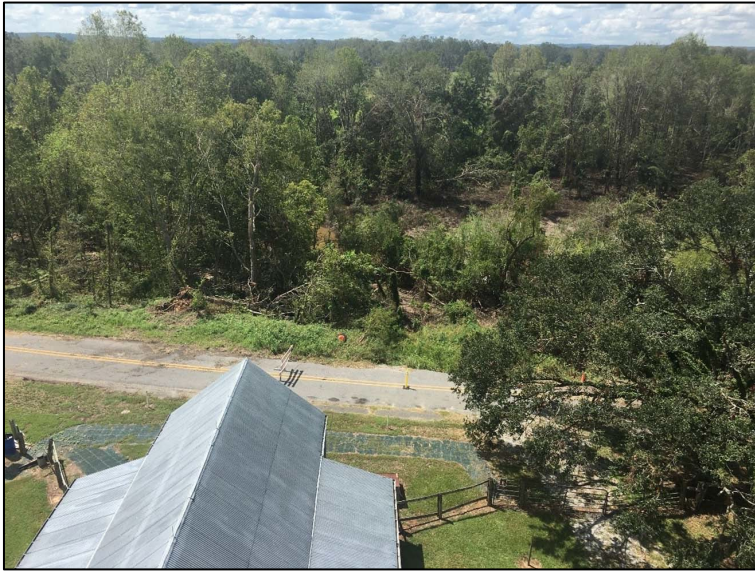
Fig 2.53. View west toward Cane River shows vegetation damage along banks. Courtesy CARI.

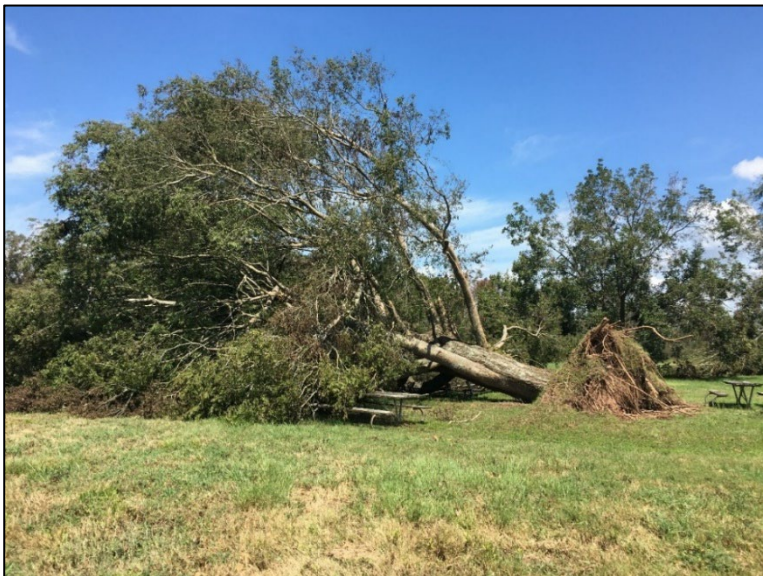
Fig 2.54. Large deciduous tree uprooted by high winds, located in the field west of the Quarters. Courtesy CARI.

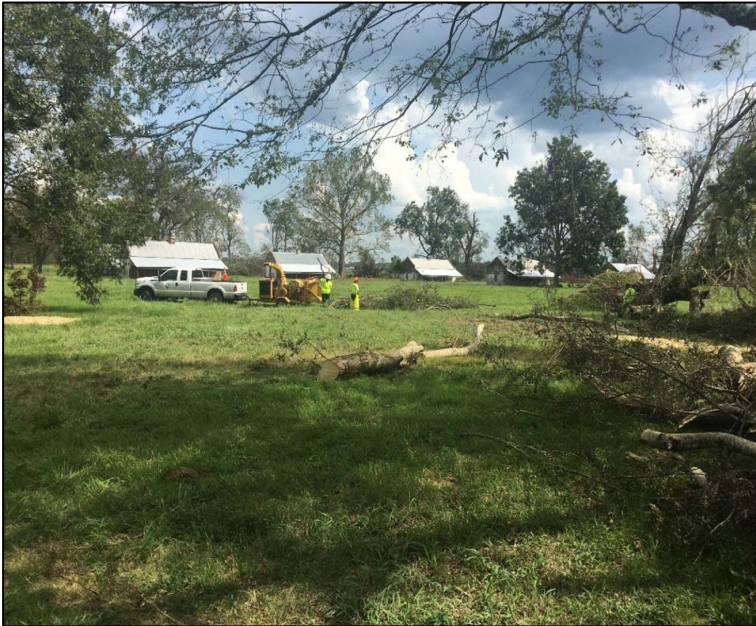
Fig 2.56. Post hurricane damage particularly to trees seen during clean-up. Courtesy CARI.

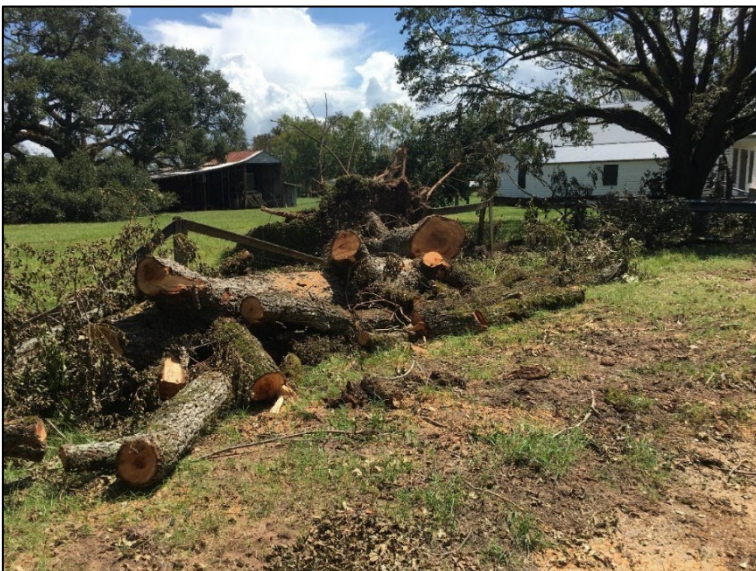
Fig 2.57. A large old tree along east property boundary fence uprooted by hurricane winds, shown after being sawn into pieces. Courtesy CARI.

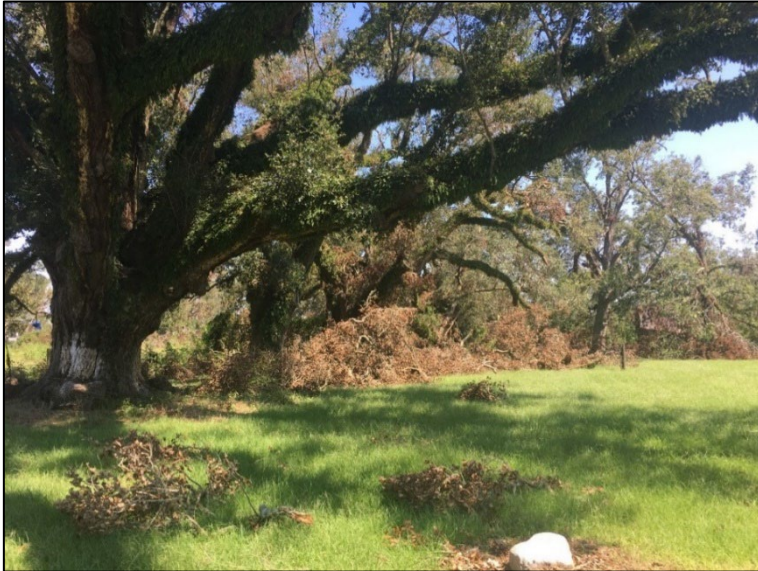
Fig 2.58. Live oak trees lost branches but were not uprooted.
Courtesy CARI.

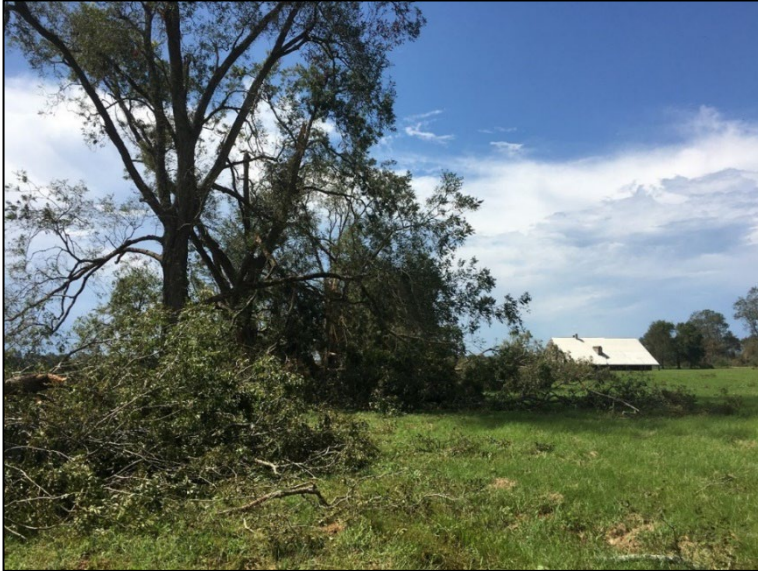
Fig 2.59. Limbs down and trees damaged along the east fence
line. Courtesy CARI.

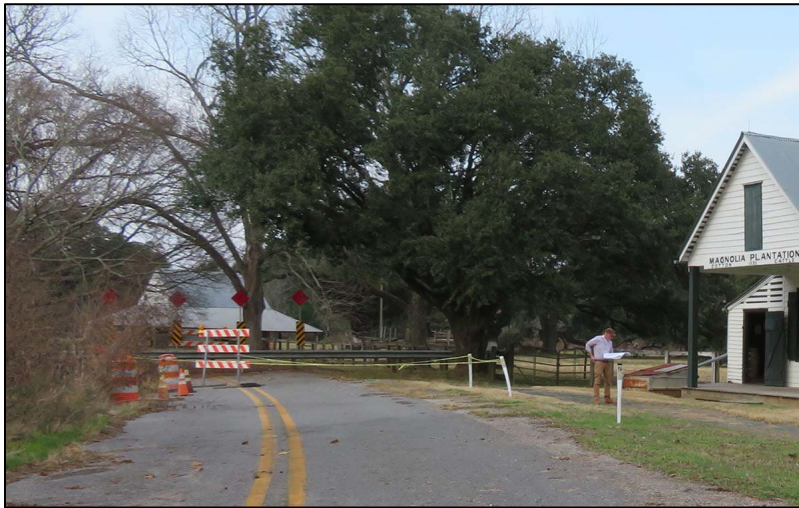
Fig 3.3. Route LA-119 is closed to traffic near the plantation Store in this December 2019 view. Barriers mark the road closure to indicate unsafe road conditions. Heritage Landscapes.

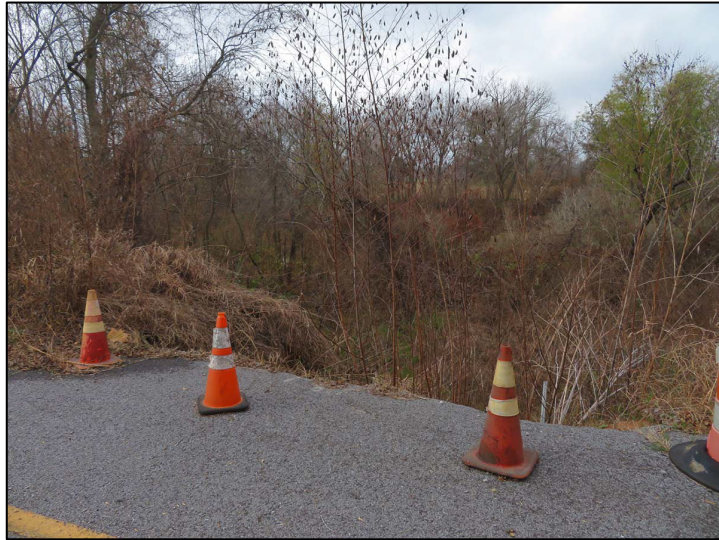
Fig 3.4. Embankment failure along the slope of Cane River west of LA-119 and west of the Store has compromised the road integrity. Heritage Landscapes.

Eroded	Issues of road collapse were first noted and reported to the Louisiana Department of Transportation and Development (DOTD) in November 2017 following increased flooding. Stabilization has taken place.	2017	CE	2019	CE
	Damaged	Hurricanes Laura and Delta damaged the site.	2020	CE	2020	CE

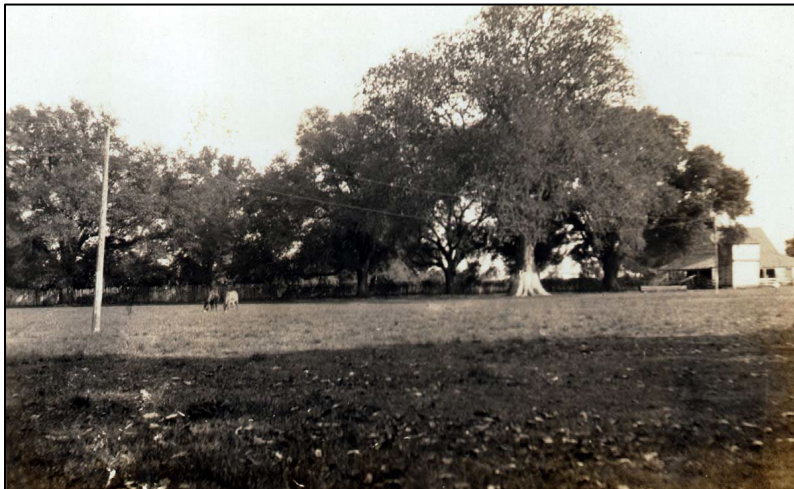
Fig 3.5. Pasture animals graze the open grass landscape with live oak trees lining the far pasture edge. Note lime wash on a tree trunk north of the current NPS property. A trough is present east of the Pigeonnier and Shop. Courtesy CARI.

Scattered trees of the Plantation Yards provide shade for people and animals. Planted pecan trees provided nut food value in addition to shade. Individual trees grew at edges of roads and yards such as near the Store, in the Mule Lot and the pasture to its north, and in a few locations along River Road. Farm managers took precautions to protect specific trees from livestock and pests with documented efforts occurring throughout the plantation. In the field directly north of the Blacksmith Shop, the limewashed trunks of some trees protect them from disease and temperature extremes (Figure 3.5). This practice also occurred by the Main House and the Quarters.

the bottom of the tree canopy and the top of the approximately four-foot-high picket fence (Figure 3.5)

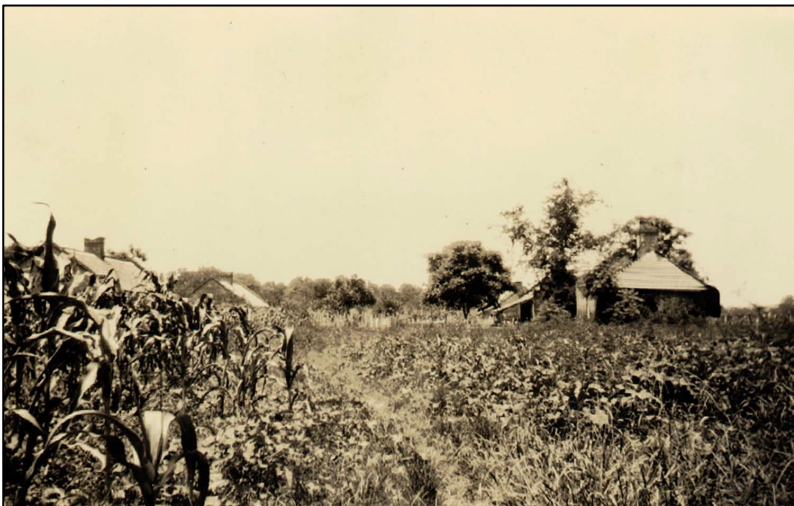
Fig 3.6. Crop vegetation, including corn as seen in this view, filled fields south of the cabin landscapes. (CARI-nd-CA-Magnolia cabin cammie henry8). Courtesy CGHRC.

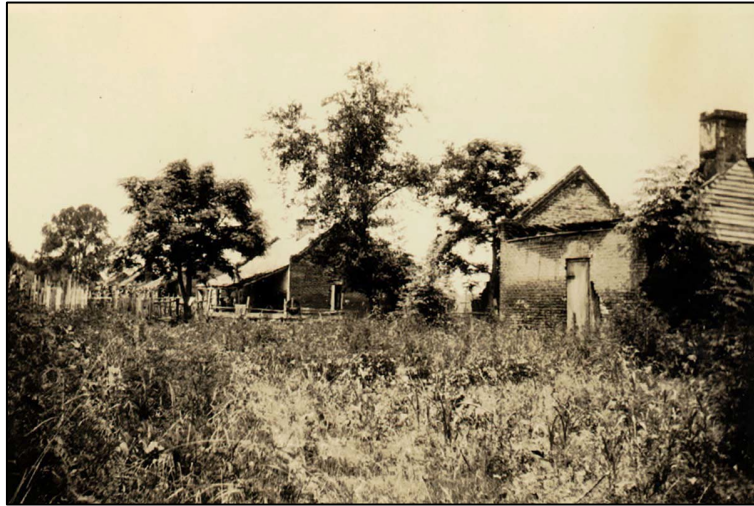
Fig 3.7. Three images taken after the 1939 tornado show Quarters landscape details. Small, scattered fruit and nut trees and rough ground plane vegetation grow in the cabin yards. Vines climb the walls of the roofless Cabin 9, south of Cabin 8. Courtesy CGHRC.

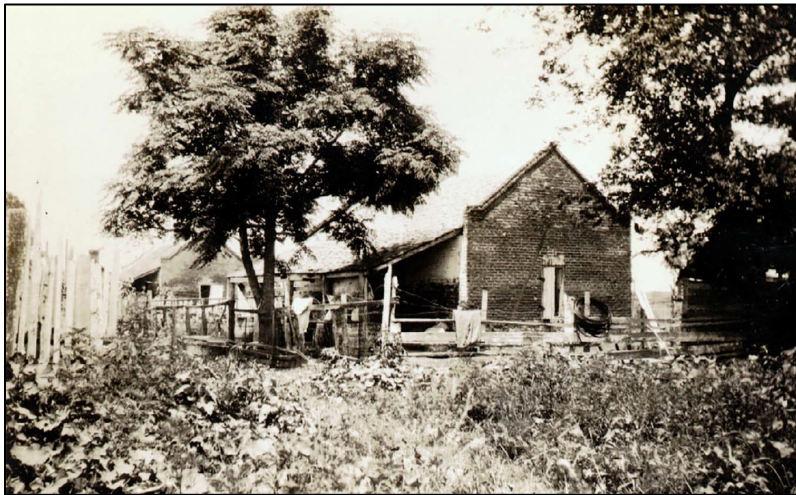
Fig 3.8. A compound-leaf tree shades the cabin west face within a wood and hog wire fenced informal garden landscape. This early view captures squash or sweet potato foliage and pole beans. Courtesy CGHRC.

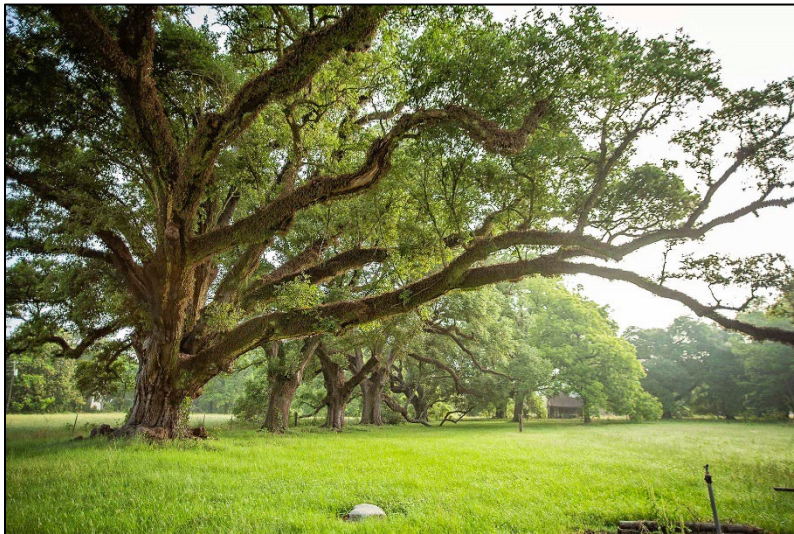
Fig 3.10. Near the Blacksmith Shop a row of large live oak trees mark the north park boundary, providing a visual edge. These large oak trees remain as witness trees. The sandstone and pipe may signal a former water trough location. Annabel Jones, courtesy CARI.

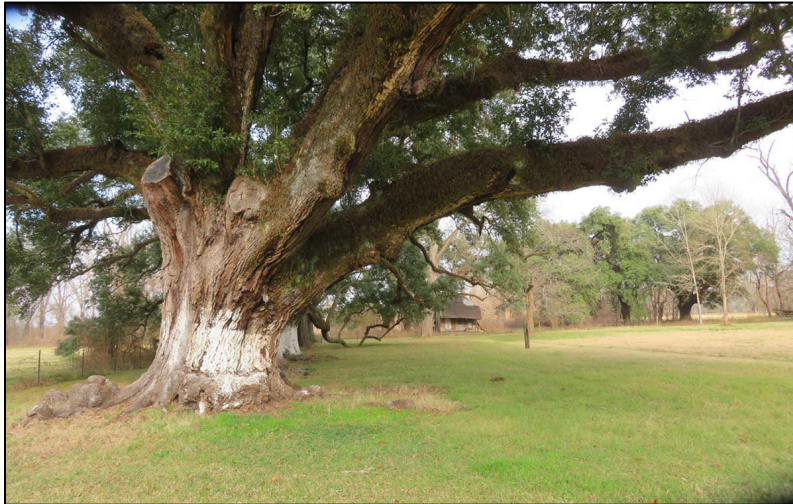
Fig 3.11. Traditional limewash on several live oak trunks dates to a summer camp activity in 2019. The practice protects trees from disease and excessive summer heat. The deteriorated Cook's Cabin, visible beyond the background tree row, is outside NPS holdings. Heritage Landscapes.

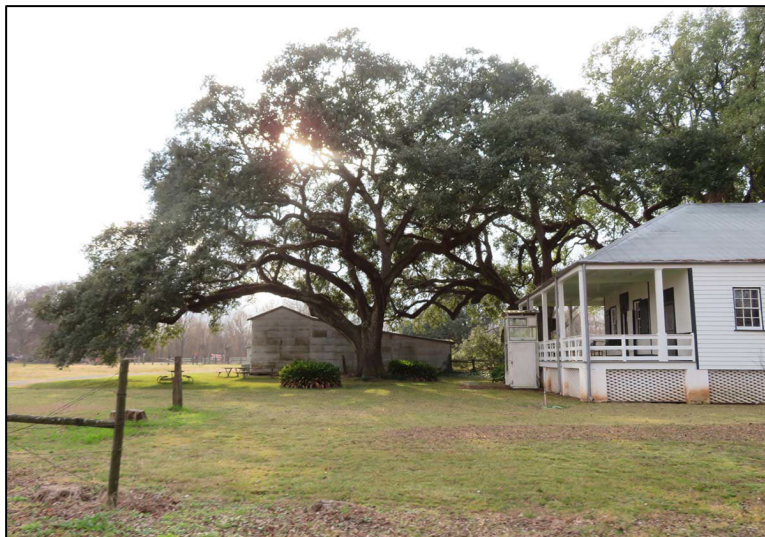
Fig 3.12. This view helps illustrate the massive scale of the oaks at the Overseer's House. The tree shades three picnic tables. The Cotton Picker Shed (background) restricts views to the Store. A new unpainted aluminum lift installed in 2020 (not pictured) blends into the landscape. Heritage Landscapes.

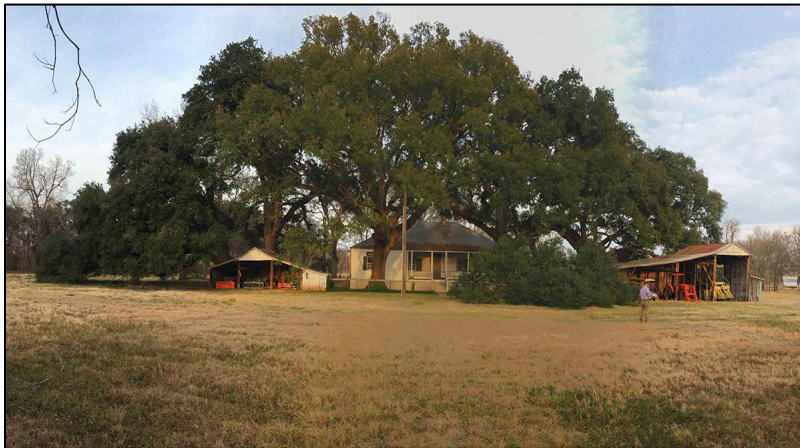
Fig 3.13. A row of large live oak and water oak tower over the Cotton Picker Shed (right) and Garage (left) and the Overseer's House (center). A low branch drops to the ground in front of the House limiting views through. Heritage Landscapes.

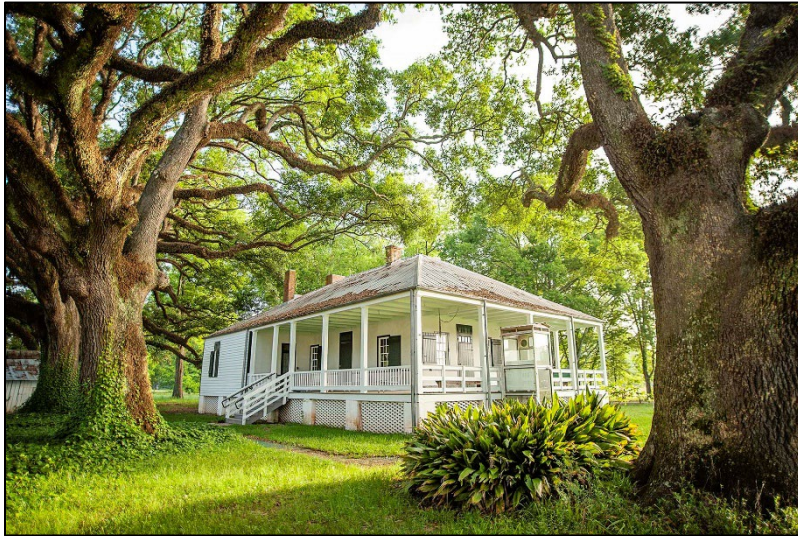
Fig 3.15. English ivy surrounds large oak trunks, offset from the Overseer's House by turf and narrow walk. In the foreground, clusters of cast iron plant grow beneath the spreading branches of oak trees as do resurrection fern.

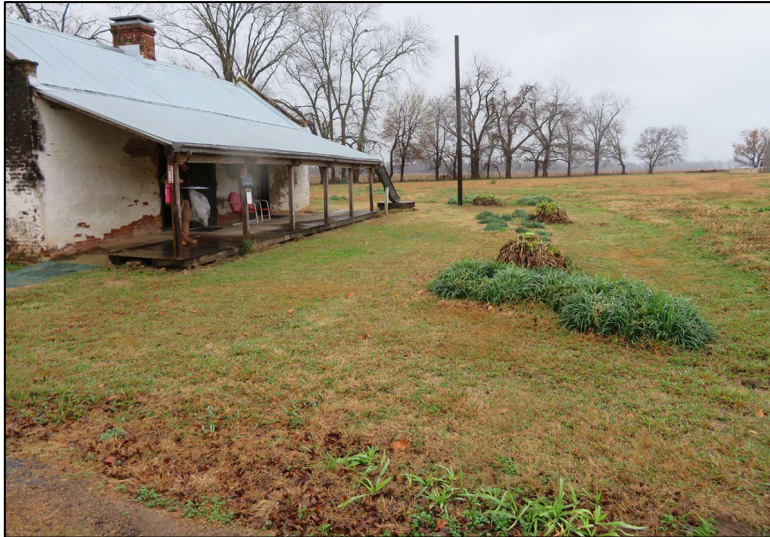
Fig 3.16. Perennial bulbs in the landscape of the Cabin 1 landscape remain, to include St. Joseph's Lily and daffodil foliage. These flowering bulbs persist former cabin gardens as remnants of residential landscapes. Heritage Landscapes.

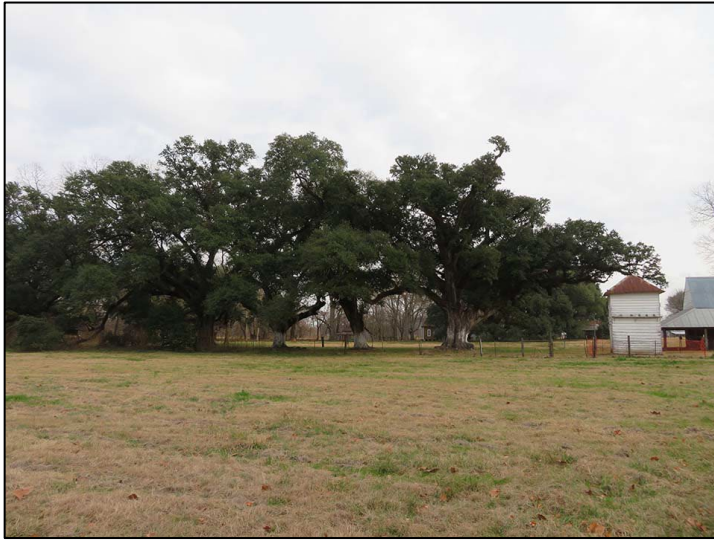
Fig 3.17. The character of an open groundplane continues, without pasture land use. Grand, historic live oak trees remain as edge-defining vegetation and display trunks with worn lime wash. Heritage Landscapes.

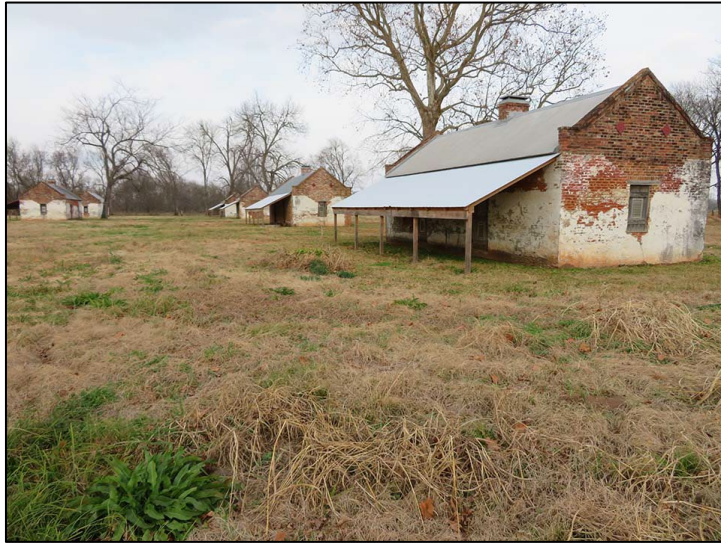
Fig 3.19. The current open landscape around Cabin 8 that may include some remnant St. Joseph's lily and daffodil foliage. Historic fences that enclosed domestic animals or gardens are missing. Heritage Landscapes.

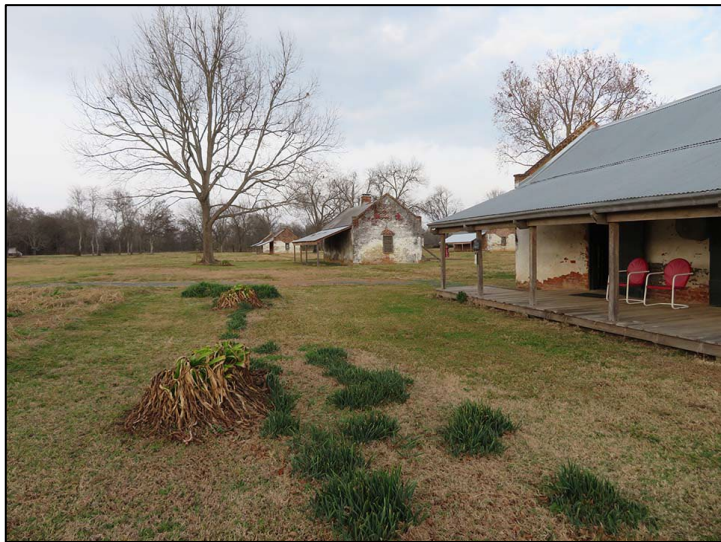
Fig 3.20. Naturalized groupings of daffodil and St. Joseph's lily remain within cabin landscapes. These plant material remnants express historic vegetation and are largely extant at Cabin 1. Heritage Landscapes.

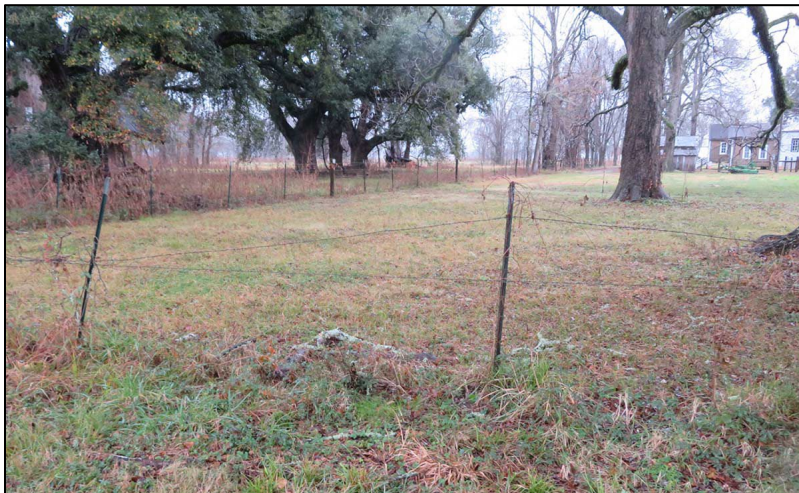
Fig 3.21. This view into the park property from the adjacent Big House yard shows a two-strand twisted wire fence marking the property boundary. Beyond, metal posts between wood posts line the property east edge near the Cooks' Cabin, outside of NPS property. A large pecan trunk is evident. 11/10/2019. Heritage Landscapes.

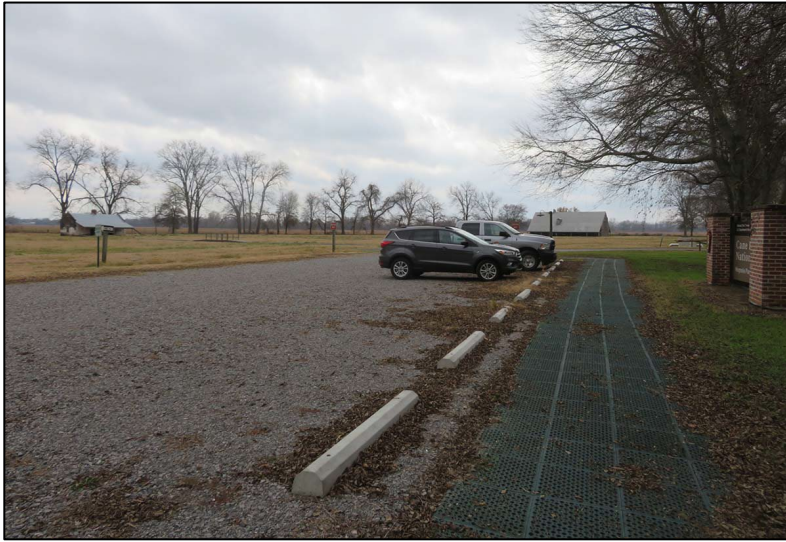
Fig 3.22. Wheel stops define 11 parking spaces in the gravel parking area with concrete paving at the handicapped space. A small traffic sign indicates a one-way traffic direction. Interlocking rubber mats improve access along the walks from parking area to Plantation Store. Heritage Landscapes.

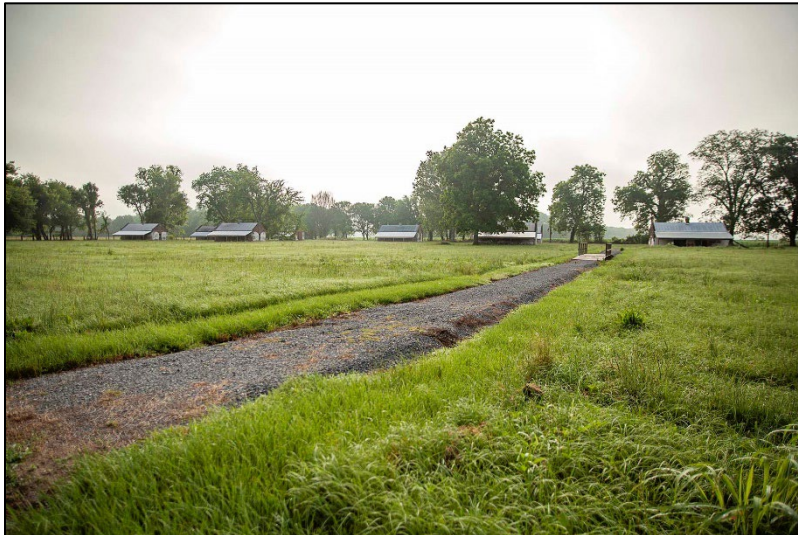
Fig 3.23. Along this gravel path between the parking area and Cabin 1, a wood foot bridge crosses a north-south drainage ditch remnant. Annabel Jones, courtesy CARI.

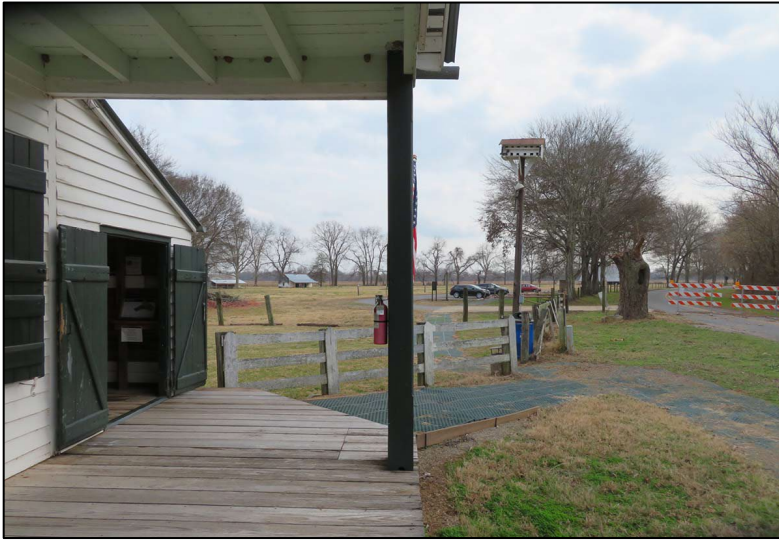
Fig 3.24. Green rubber trail matting defines the walk between the parking lot and Store with a ramp accommodating access to the elevated porch. The matting is largely visible in this area, though vegetation obscures the matting in other areas. Heritage Landscapes.

Rubber geogrid matting underlays segments of the primary walking path at Cabins 1 and 2. Added between 2014 and 2017, the mats somewhat improve accessibility and define visitor access paths. This non-contributing feature somewhat improves landscape accessibility though, where the green mat rises above the grade, detracts from historic character and creates tripping hazards.

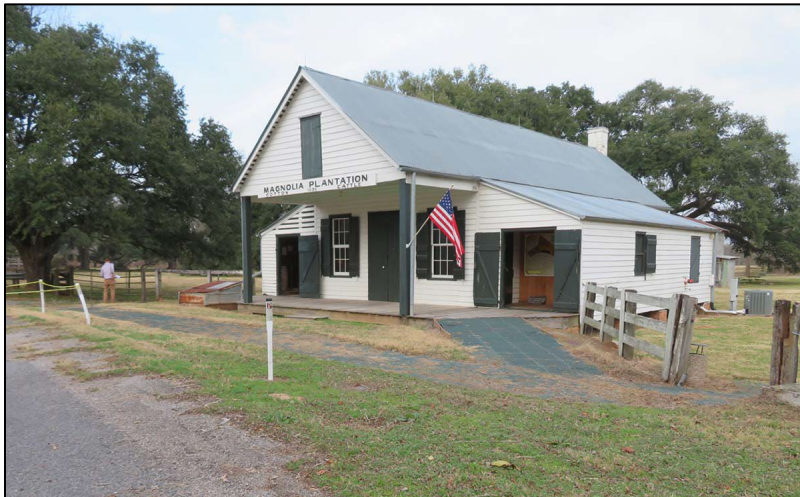
Fig 3.25. The Store serves as the visitor contact station for the park. North roof storm water is captured to fill the historic cistern, located to the north of the building. Heritage Landscapes.

The Plantation Store serves as a visitor contact station with direct walking trail and exterior American flag highly visible from the parking area (Figure 3.25). Collected rainwater from the north half of the roof is stored in an historic cistern northwest of the building. Downspouts direct rainwater from the southern roof face into lawn areas. To the east, the Overseer's House includes an added elevator lift to provide universal access to the porch and building interior (Figure 3.26). This ADA lift was replaced in Spring 2020 with an aluminum one that blends into the landscape more effectively. To the north, the Blacksmith Shop is open to visitors with tools and equipment on exhibit inside (Figure 3.27). Nearby the Pigeonnier is surrounded by temporary fencing to restrict visitor contact (Figure 3.27). At the south end of the property, the Gin Barn encloses the historic gin machinery and is open for visitors (Figures 3.28 and 3.29). Adjacent to the Overseer's House, the Stable is in use for maintenance storage as is the Garage (Figure 3.30). The Corn Crib stands as an interpretive element between the Blacksmith Shop and Plantation Store (Figure 3.31). The Cotton Picker Shed is used for maintenance equipment storage and display of a 1960s John Deere Cotton Picker, historically used on Magnolia Plantation, in the southernmost bay (Commonwealth Heritage Group, Inc 2019, 9-14). Cisterns within LCA 1, repaired by the NPS, remain present at the northwest corner of the Store and northeast corner of the Gin Barn (Keel and Raupp 1998, 3-7).

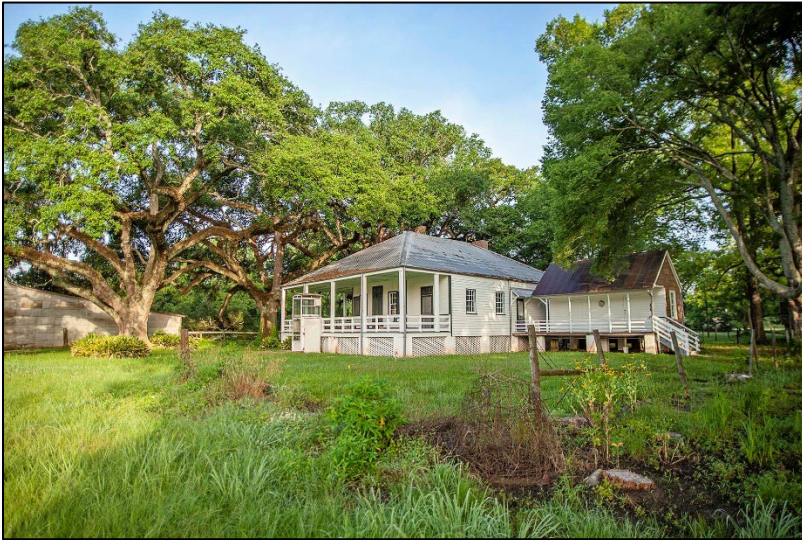
Fig 3.26. This view captures the setting of the Overseer's House with a rear addition and L-shaped fence in foreground. Live and water oak trees flank one side with a pecan tree seen on the other side. An ADA lift provides visitor access to the porch. Annabel Jones, CARI.

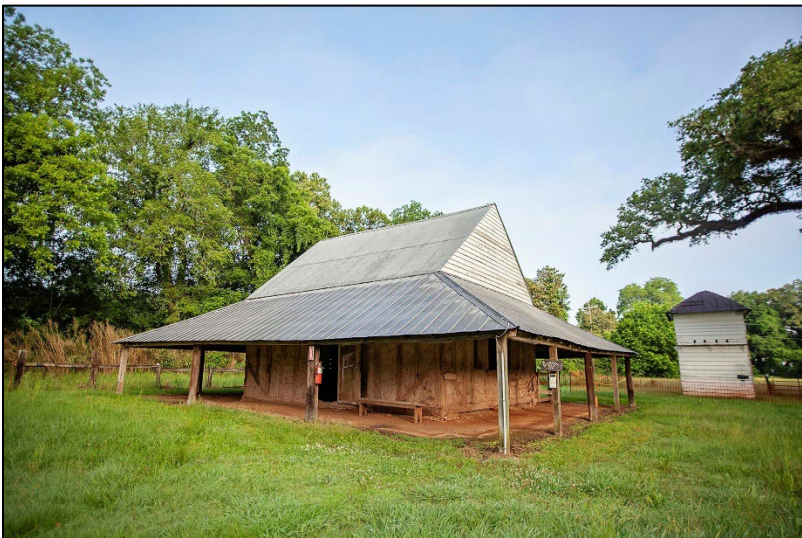
Fig 3.27. A broad roof overhang shades the Blacksmith Shop. A large live oak and the Pigeonnier provide context for the building. Temporary, plastic fencing controls visitor contact with the Pigeonnier. Annabel Jones, CARI.
