National Park Service Cultural Landscapes Inventory 2022

Magnolia Plantation

Cane River Creole National Historical Park

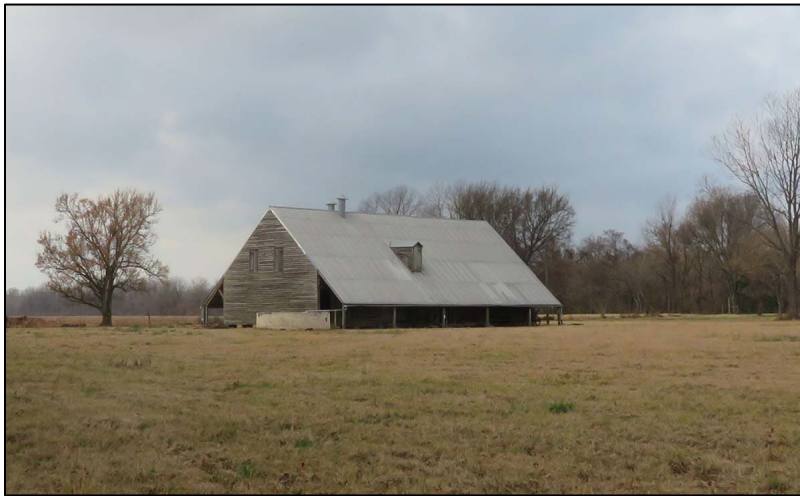
Fig 3.28. Expansive turf ground plane surrounds the isolated Gin Barn. The round concrete cistern tank beside the Gin Barn holds rainwater from the large roof. A mature pecan tree is located at the right. Heritage Landscapes.

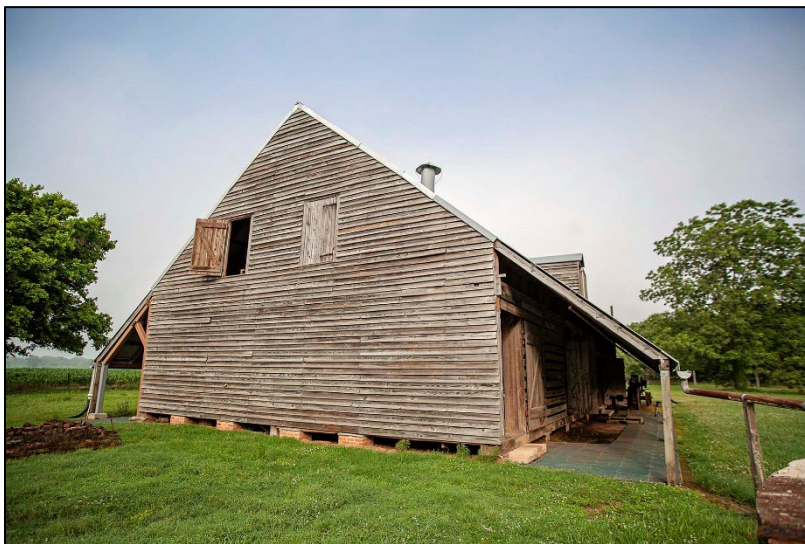
Fig 3.29. Rubber mat surfaces the ground plane below the Gin Barn roof overhang. Gutter leads to the cistern at the right edge of this photo. 2020 hurricanes damaged the structure. Annabel Jones, CARI.

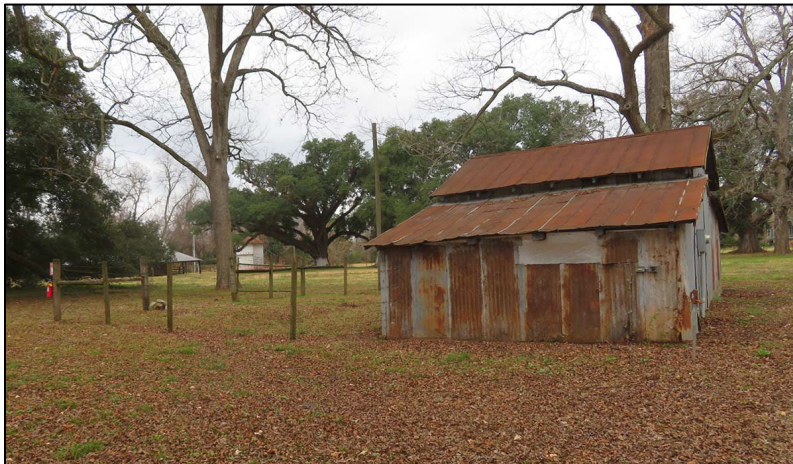
Fig 3.30. The sheet metal Stable building with corral, northeast of the Overseer's House, serves as maintenance storage in 2020. Two pecan trees trunks flank it. Heritage Landscapes.

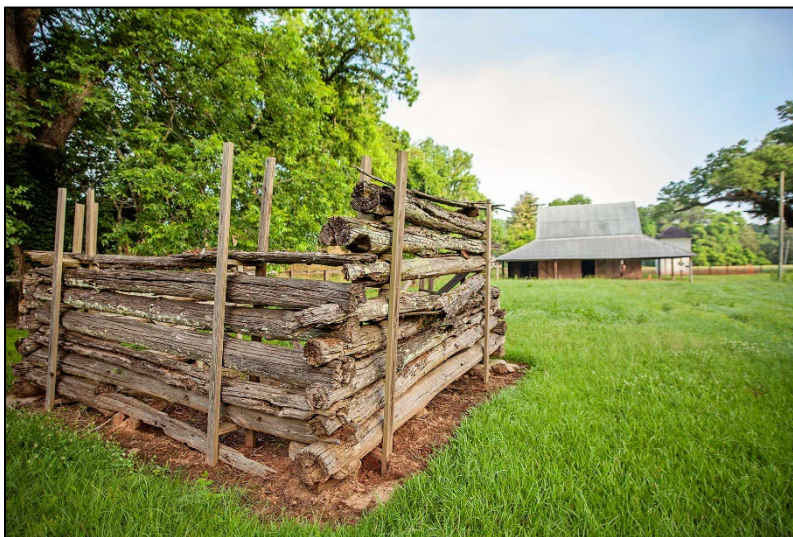
Fig 3.31. A three-sided wooden corn crib likely moved several times during the period of significance contributes to visitor understanding of the property's agricultural heritage. Annabel Jones, CARI.

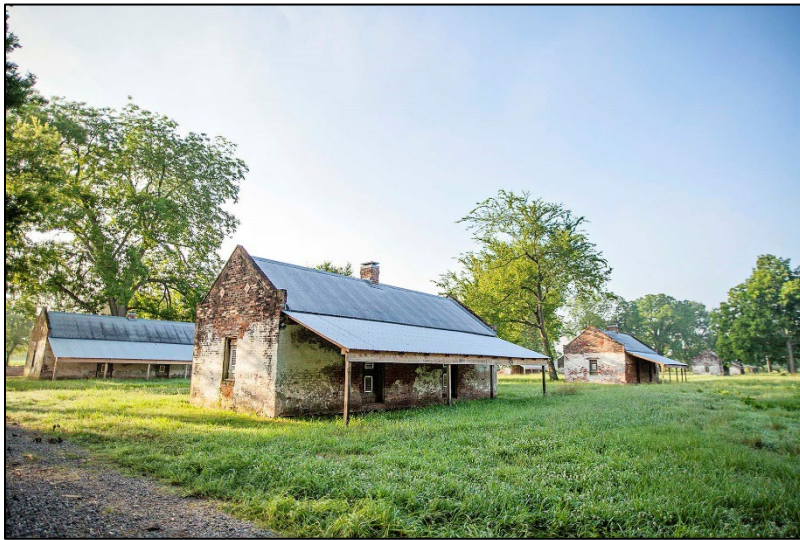
Fig 3.32. Organized in a grid pattern, Quarters buildings face west with rebuilt extended galvanized metal porch roofs to shade the structure from hot afternoon sun. Annabel Jones, courtesy CARI.

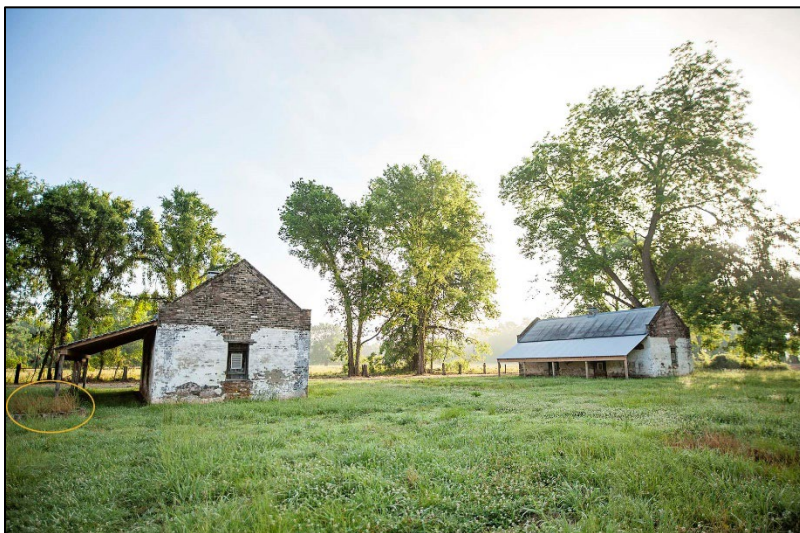
Fig 3.33. Porch roofs of corrugated metal were added to all cabins to replace missing historic roofs. They shade the west façade of each Quarters building. As shown in this photograph, most buildings do not have porch decking, but have a dirt floor surface. The concrete edge of a below-ground cistern is visible beside the building (yellow circle). 11/10/2019. Heritage Landscapes.

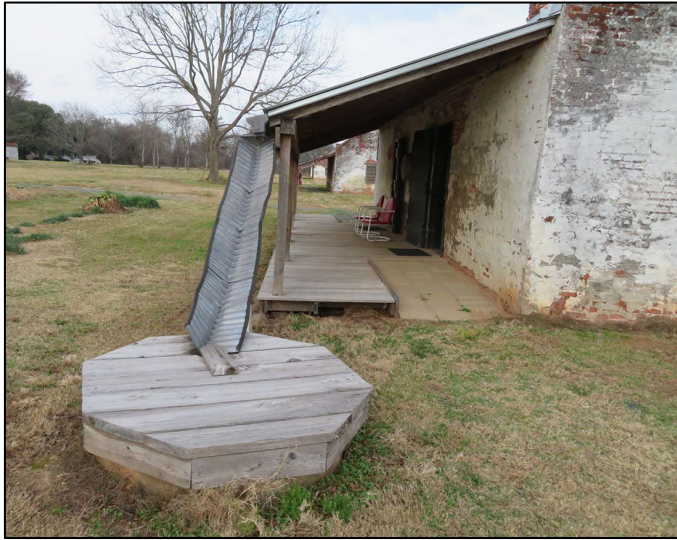
Fig 3.34. Gutters on the Cabin 1 porch convey rainwater to folded sheet of corrugated metal which spills into the historic cistern. 11/10/2019. Heritage Landscapes.

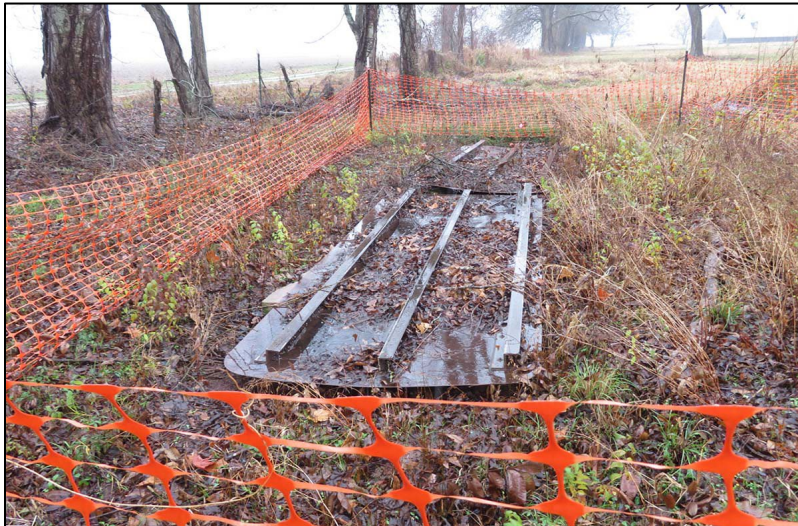
Fig 3.35. Safety fencing surrounds the covered dipping vat at the east boundary of LCA 2, alerting and protecting visitors from the trip and fall hazard and toxic soils. 11/10/2019. Heritage Landscapes.

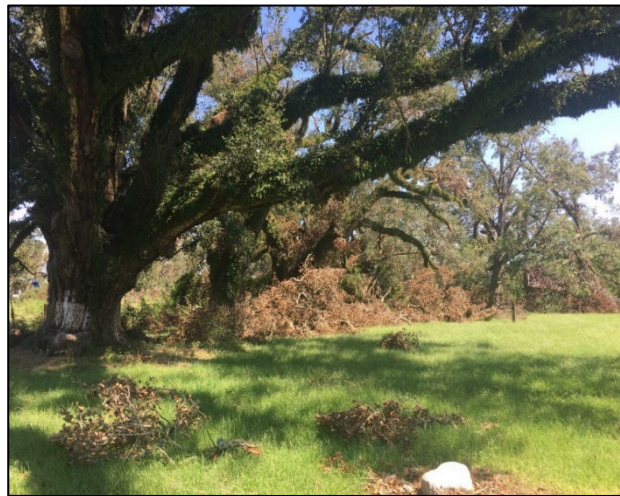
Fig 3.37. Live oak trees lost branches but were not uprooted. Courtesy CARI.

line vegetation would have defined views across the historic landscape, today large oaks serve as the primary spatial element dividing landscape features in the 2020 landscape. The combined effect of the live oak and water oak trees in front of the Overseer's House and along the north property boundary distinguish the lawn east of the Blacksmith Shop as a separate space (Figures 3.37-3.38).

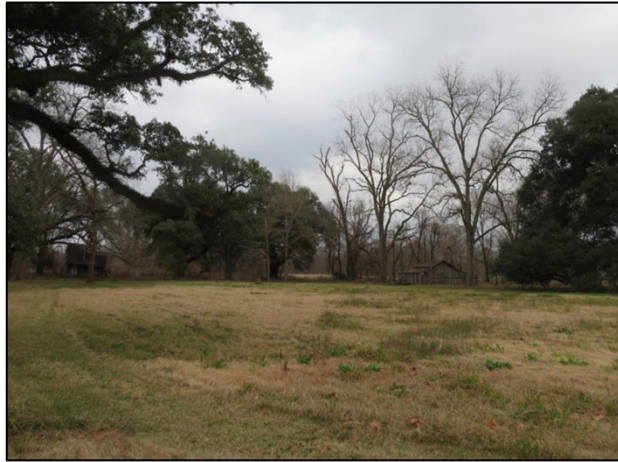
Fig 3.38. Oak and pecan trees around an expanse of mixed species turf creates a distinct visual space east of the blacksmith shop. The deteriorated Cook's Cabin is shaded by canopy to the left. Views extend north and east to fields beyond the property. Heritage Landscapes.

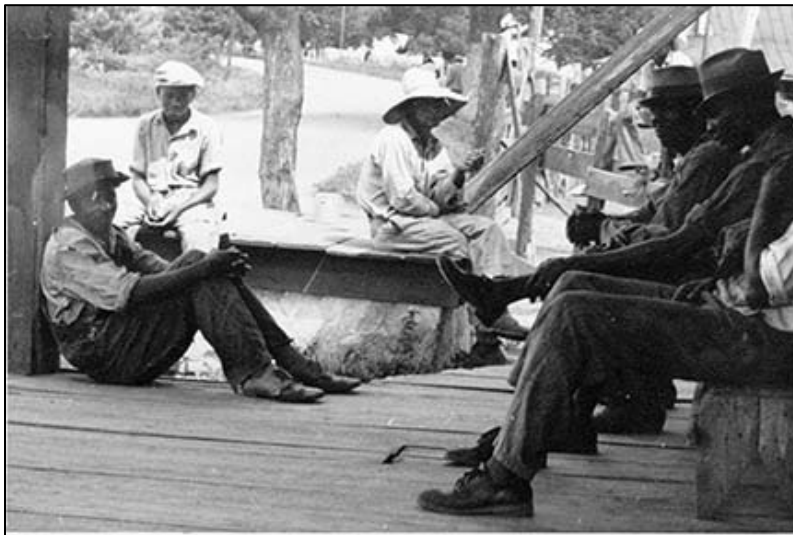
*Fig 3.40. During the 1940s, the Store on LA-119 functions as a major social and economic hub. The covered cistern located between the front porch and irregular board fences collects rainwater and serves as a bench and table.
Courtesy CARI.*

Portions of the fence between the Blacksmith Shop and the Store consist of posts and irregular planks that may have been supplemented with twisted or barbed wire (Figure 3.40). Fencing south of the Store and connected to the Mule Lot includes repurposed railroad ties for posts. The approximately five-foot posts and widely spaced planks compose the fence around the 1940s (Figure 3.44). East of the Store, a post and plank fence separate the back of the Store from a work yard with an outbuilding that appears to be an outhouse. The approximately four-foot-high fence consists of five boards facing the work yard (Figure 3.41). A metal vehicular gate just south of the Blacksmith Shop aligns with remnants of a historic land or road on the 1858 Walmsley plat.

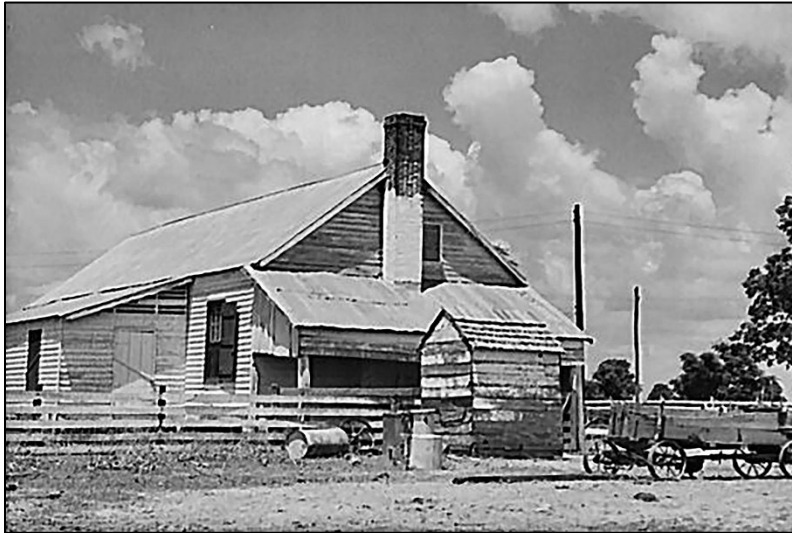
Fig 3.41. A fence and outbuilding, likely an outhouse, define a yard east of the Store in the early twentieth century. The flywheel and cylindrical tank may have been a part of a water pump system. Courtesy LOC.

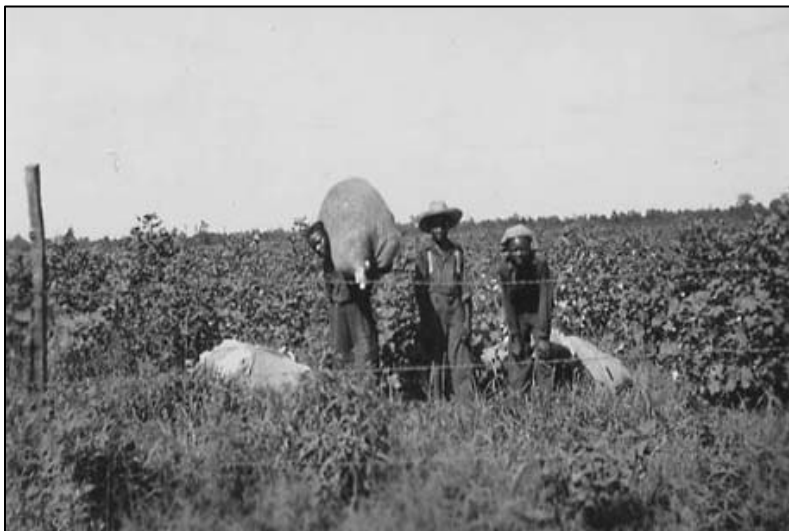
Fig 3.42. Simple split log poles and three strands of barbed wire make up a fence alongside a cotton field in the 1930s. Courtesy LSU.

Simple field fences, alone or together with rough field edge vegetation, confine livestock to pastures or exclude animals from planted areas. Some of these fences consist of three strands of barbed wire attached to irregularly-spaced narrow wooden posts (Figure 3.42). Farm workers would need to regularly inspect, repair, and replace the lines, some of which likely remained from 1886, when Matthew Hertzog purchased 3,960 feet of wire fence (Firth and Turner 2006, 116).

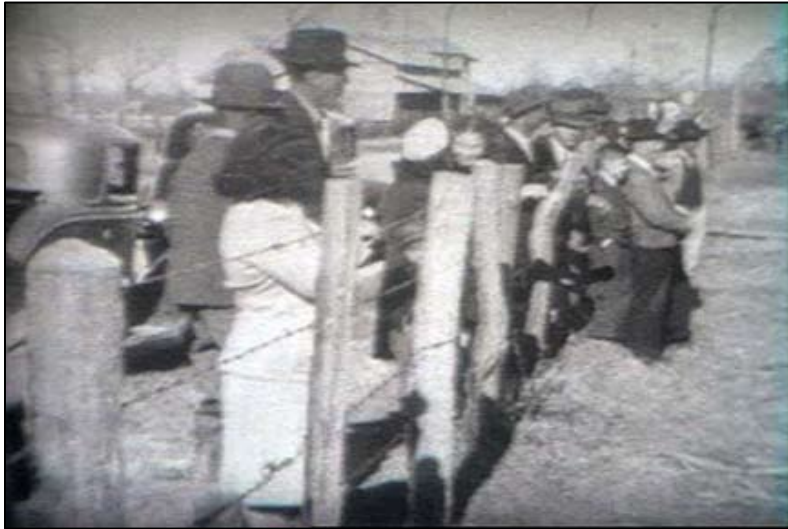
Fig 3.43. In the early twentieth century, a combination of branches, split and milled posts hold four barbwire strands to form the fenced roadside boundary near the Blacksmith Shop. The curved posts are from Osage orange. Courtesy CARI.

Fences demarcate the plantation boundary at River Road and define internal spaces of the Plantation Yards. To the north near the Blacksmith Shop and by the adjacent horse pasture, roadside fences consist of four strands of barbed wire with log fence posts spaced approximately six feet on center (Figure 3.43). Extending east from the Blacksmith Shop, an interior fence separated the pasture and row of live oak from the field north of the Blacksmith Shop. A photograph from the 1920s shows that higher branched tree limbs allow partial views between

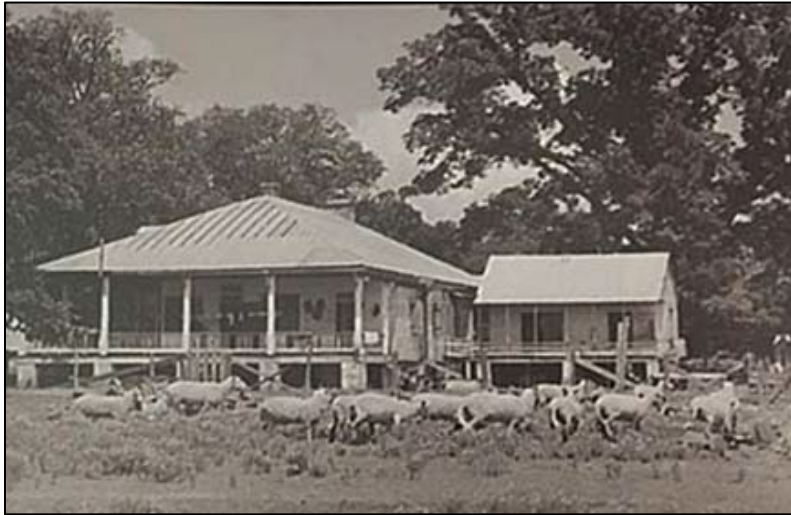
Fig 3.45. Sheep maintain the turf east of the Overseers House, circa 1940s. Wire fencing on posts on the south and east sides of the yard differs from the picket fence along the west side. The roof gutters and modifications to capture rainwater from both structures and feed the Overseers House cistern. Courtesy LOC.

The various fencing at the Overseer's House expresses a similar character to the boundary fence at the Main House, a more decorative fencing than elsewhere. Parallel detailing at these two homes may reflect the comparable higher social standing of the residents. A circa 1930s white-washed picket fence borders the west side of yard and perhaps the north side of this fenced yard (Figure 2.10). These 1930s picket fence sections of narrow, even spacing, were attached to four-foot-high posts. Each picket had an angle cut top that sloped in one consistent direction. In a location near the south end of the west fence, two pickets are cut level with the horizontal brace. On the south and east sides of the Overseer's House, fencing consists of hogwire stretched between posts, with angled braces, documented in a 1940s image (Figure 3.45).

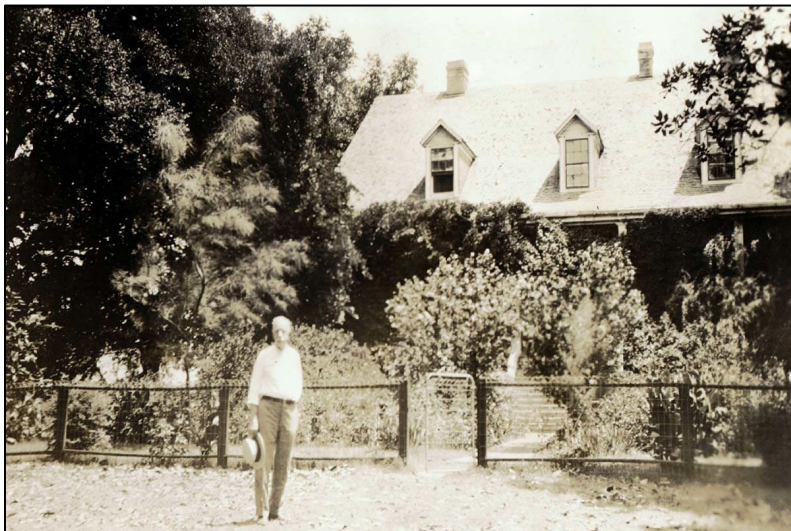
Fig 3.46. Ornamental wire fencing and a preassembled tube and wire gate at the Main House related to the Overseer's House regular picket fence. Both of these contrast with utilitarian fences of the Plantation Yards and garden or pen fences of the Quarters, circa 1940s. Courtesy CGHRC.

Aside from the picket fence around the Overseer's House, the utilitarian fences of the Plantation Yards contrast with the those of the Main House outside of the study area. At the Main House, an ornamental, woven wire fence with vertical and horizontal strands and a rounded top pattern surrounds the garden (Figure 3.46). Four-foot-high posts with top and bottom rail support the fence wire fabric with a matching steel tube gate with an ornamental top scroll. Together the fence and gate form a complementary ensemble that is unique to the Main House.

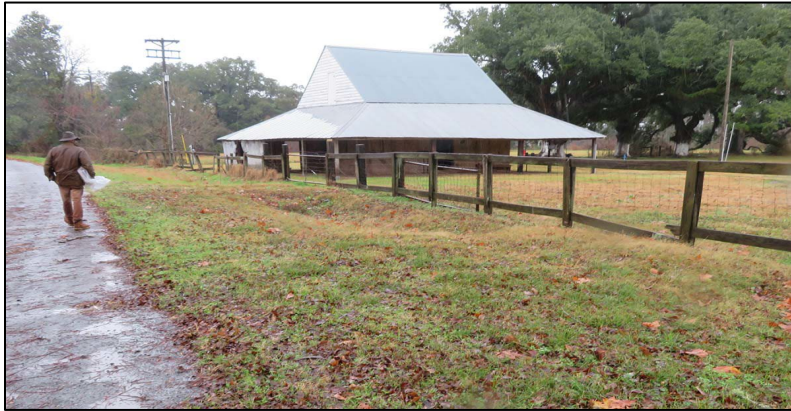
Fig 3.49. Wood posts with hog wire and unpainted wood top and bottom rails form a clear boundary with LA- 119 between the Blacksmith Shop and Store. Heritage Landscapes.

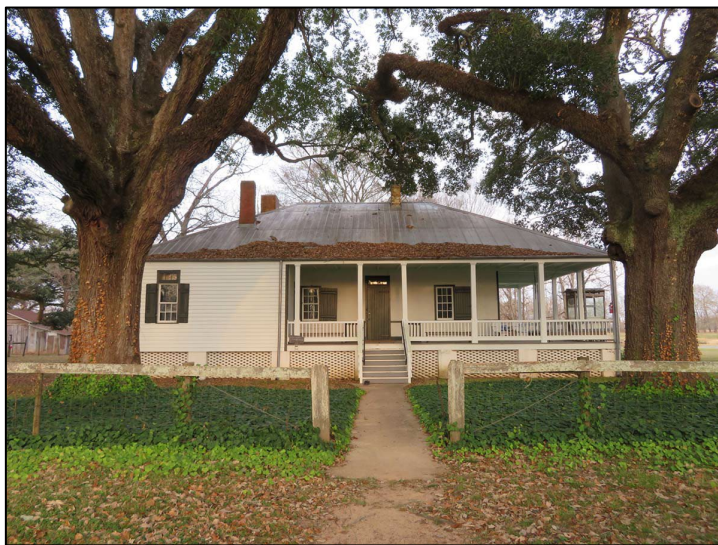
Fig 3.50. A hog wire fence with top and bottom wood boards defines the front edge of the Overseer's House garden. White wash or paint on the top rails and two large square posts flank the walk and relate to the white building. The round intermediate posts are unpainted. Heritage Landscapes.

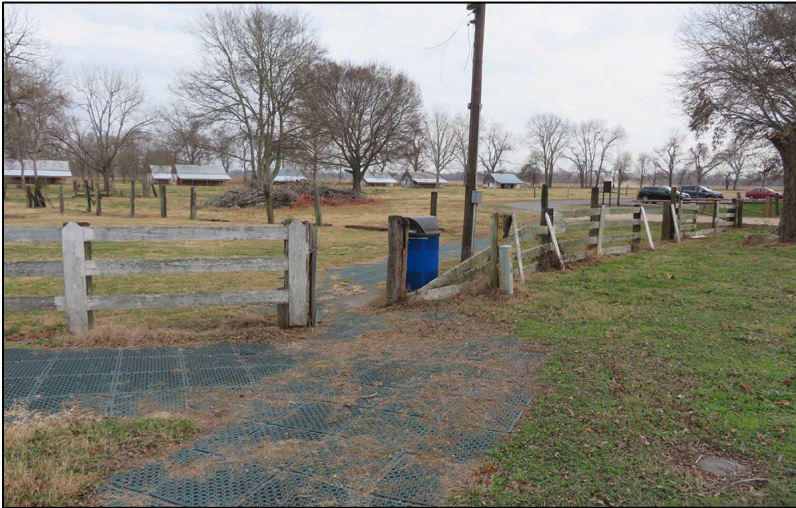
Fig 3.51. Whitewashed or painted board wood fences with round posts and face picket are in varied condition east of the Store, with some elements missing. Heritage Landscapes.

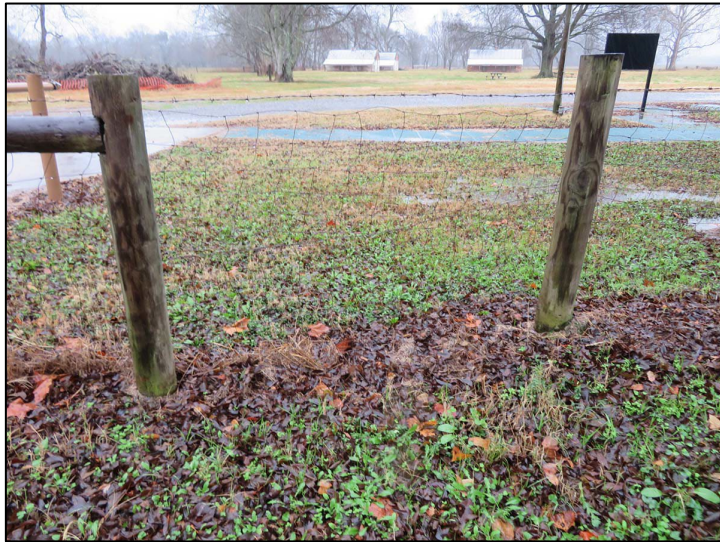
Fig 3.52. New wood posts support hog wire and a string of barbed wire west of the parking lot along LA-119. Hog wire fabric varies in size and material of various metals. Heritage Landscapes.

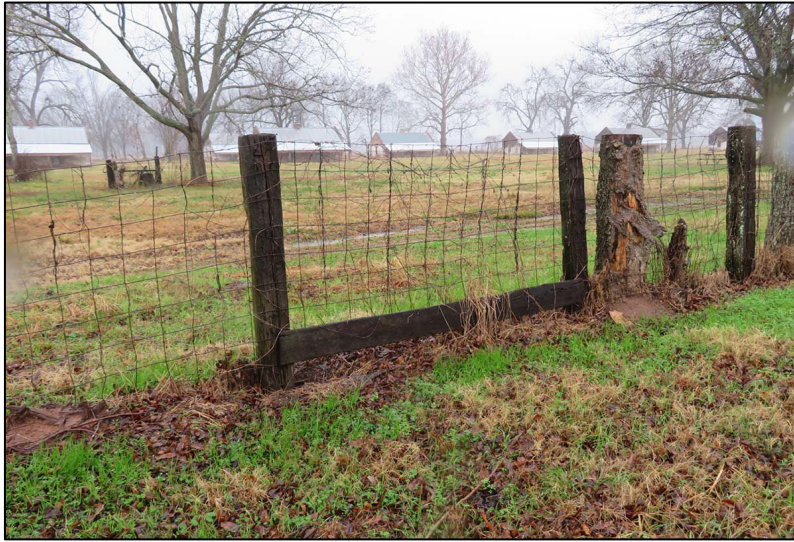
Fig 3.53. A remnant fence east of the Store is composed of hog wire with wood posts. Stumps of trees grown into the fence remain. A single lower fence board suggests the fence may have had top and bottom wood rails in the past. Heritage Landscapes.

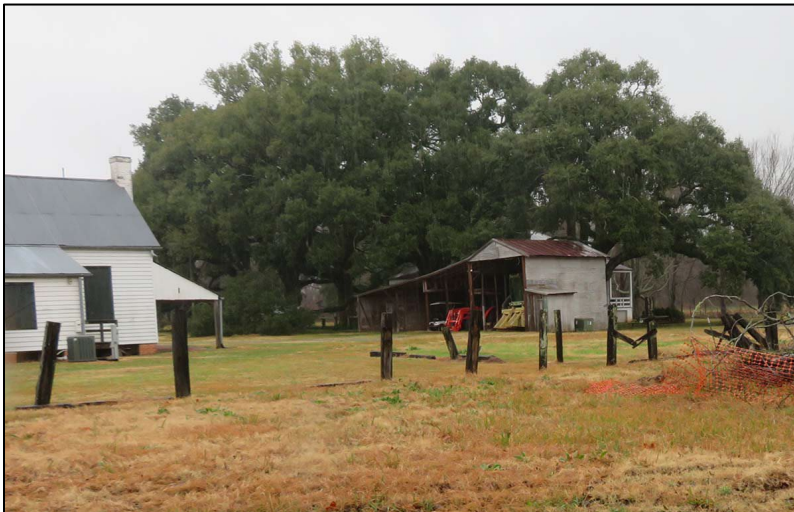
Fig 3.54. Standing wood railroad ties remain marking a former fence line and fence posts along the Mule Lot south of the store. Heritage Landscapes.

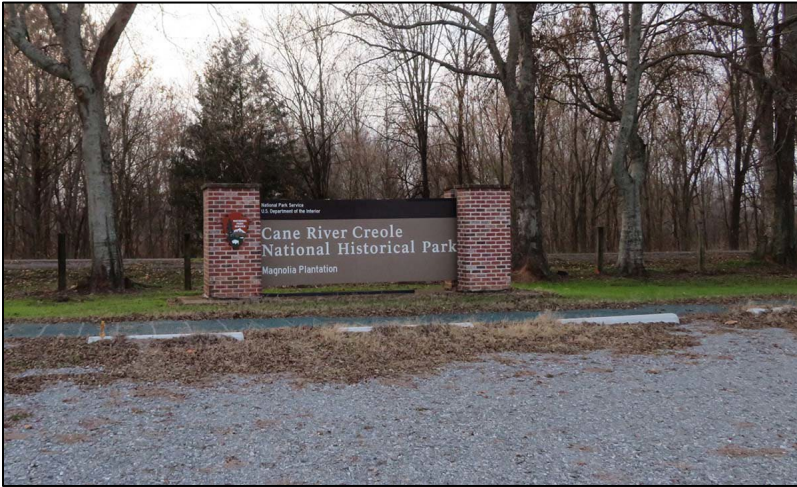
Fig 3.55. The primary park entrance sign with brick piers is relates to the on-site materials of the brick cabins in the Quarters. Heritage Landscapes.

Directional and interpretive signage occurs throughout the property to guide vehicle traffic, welcome visitors, and provide information including call-in numbers and QR codes for audio tours (Figures 3.55-3.57). A low-profile bicycle rack at the parking area supports multimodal visitor access. A recycle bin between the parking area and Store provides a needed service but

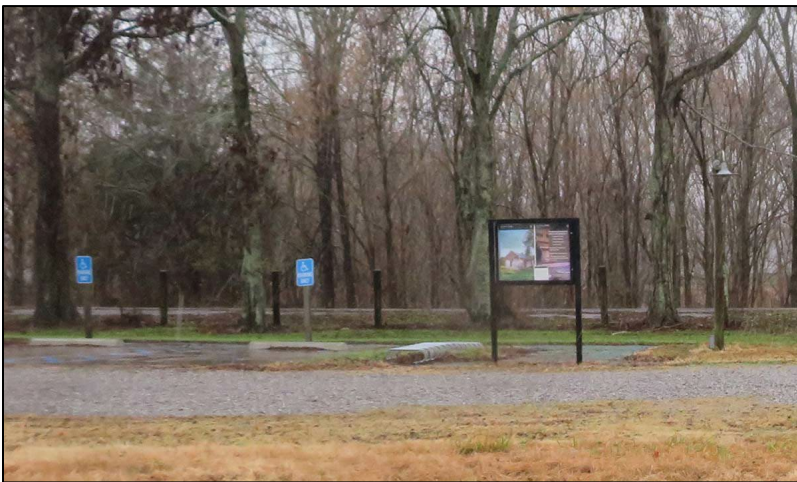
Fig 3.56. An interpretive kiosk at the parking lot welcomes visitors to the park; a low profile bike rack is to the left. A pedestrian-scaled light mounted on a wood pole illuminates the path. Heritage Landscapes.

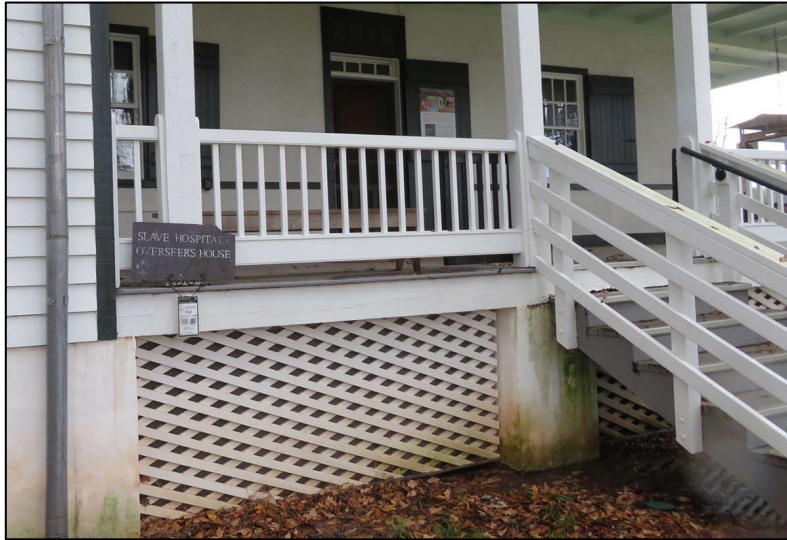
Fig 3.57 Traditional painted slate signs identify each plantation building, while a sign hanging below includes dial-in number and QR code to access an audio tour information. The location of this sign on the Overseer's House porch requires visitors to walk off the path to reach the sign. Heritage Landscapes.

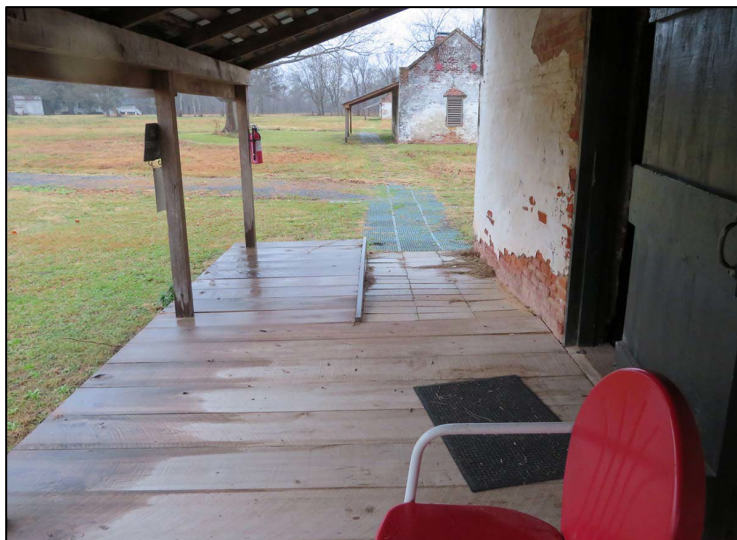
Fig 3.58. A paved ramp cuts into both ends of the Cabin 1 wood porch deck to reach the porch and furnished interior. The accessible path extends to Cabin 2 and connects to the gravel walk to the left, leading to the parking area. Heritage Landscapes.

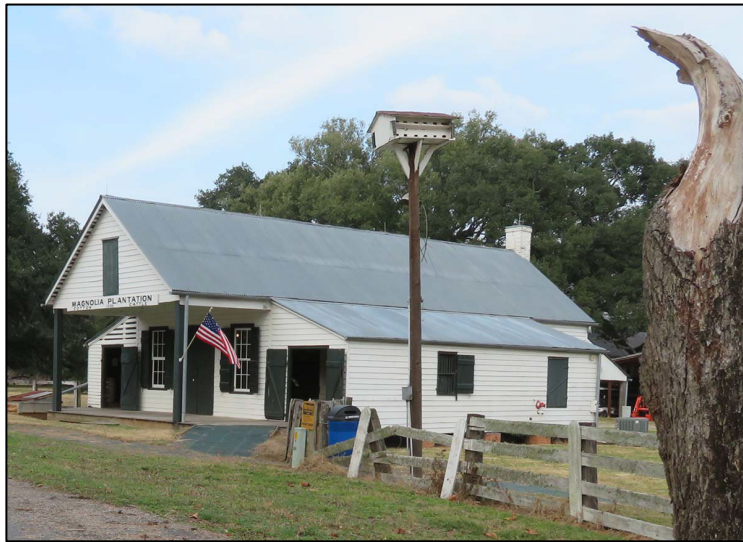
Fig 3.59. A purple martin bird house mounted to a repurposed wood utility pole stands south of the Store. The foreground trunk is a recently demised pecan, known as the "pitty pat tree." A blue recycle bin draws attention and detracts from the historic character. Heritage Landscapes.

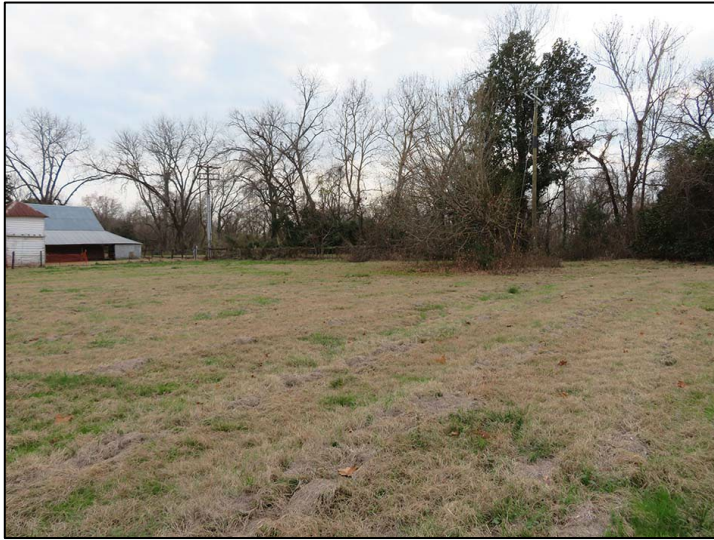
Fig 3.61. This contemporary repeat view illustrates remaining pastoral character in the grassy landscape and the missing fence north of the blacksmith shop. With historic rail fence no longer present, views across the landscape are more open. Heritage Landscapes.

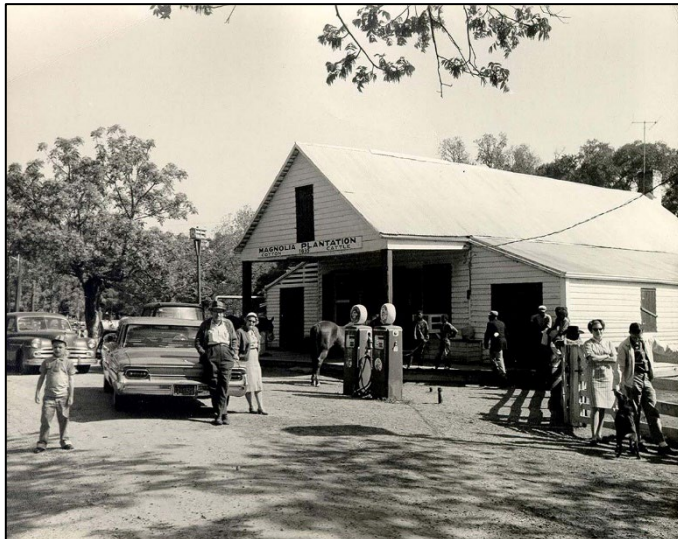
Fig 3.62. The storefront porch, fence, and drive organize the landscape west and south of the store. The groundplane appears to be primarily loose soil and gravel surface with shared pedestrian, vehicular, and equestrian use. Two gas pumps face the drive. A purple martin birdhouse is seen to the left of the store in this 1962 historic view. Courtesy CARI.

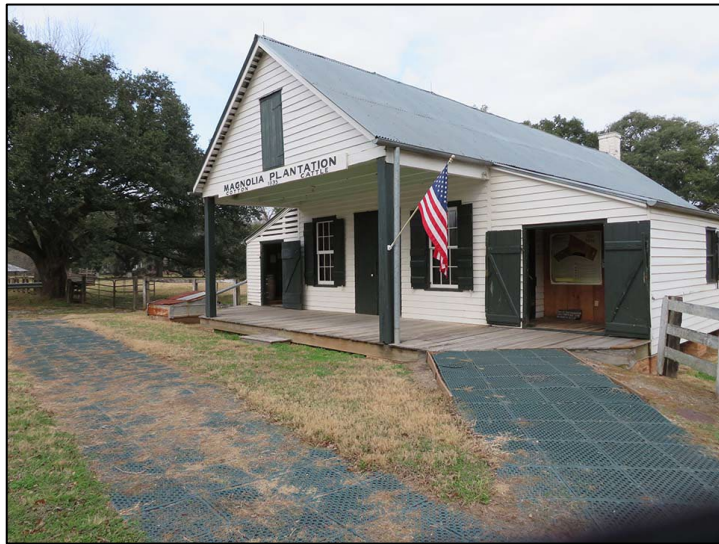
Fig 3.63. Trail mat reinforces the circulation surface with added ramp to facilitate porch access. The contrasting surface detracts from the open, undefined circulation seen in the earlier view. A low stone step is present in the historic location. Missing features include the gas pumps, purple martin birdhouse (relocated to the south), gravel paved frontage and wooden box bench. Heritage Landscapes.

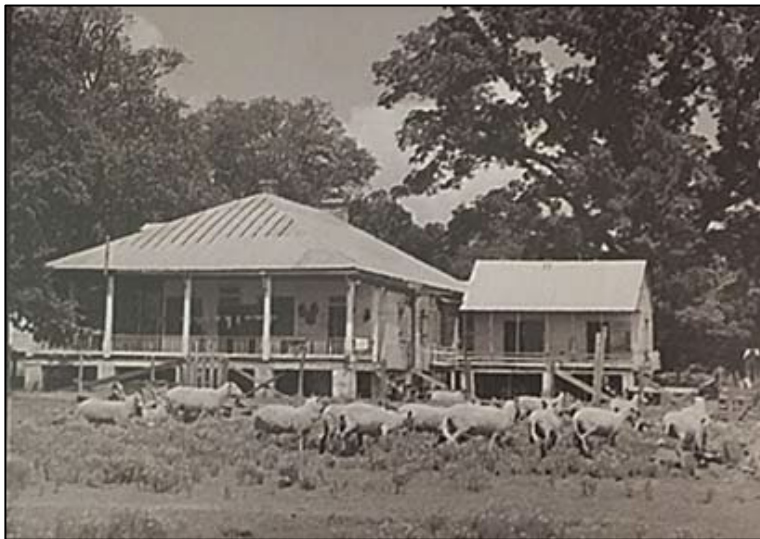
Fig 3.64. Overseer's House side view of south façade with sheep on a high lawn, not close cropped. Fences to right may be a paddock. Live oaks trees located left or west, and tree canopies to the right add scale, mass and shade. Courtesy LOC.

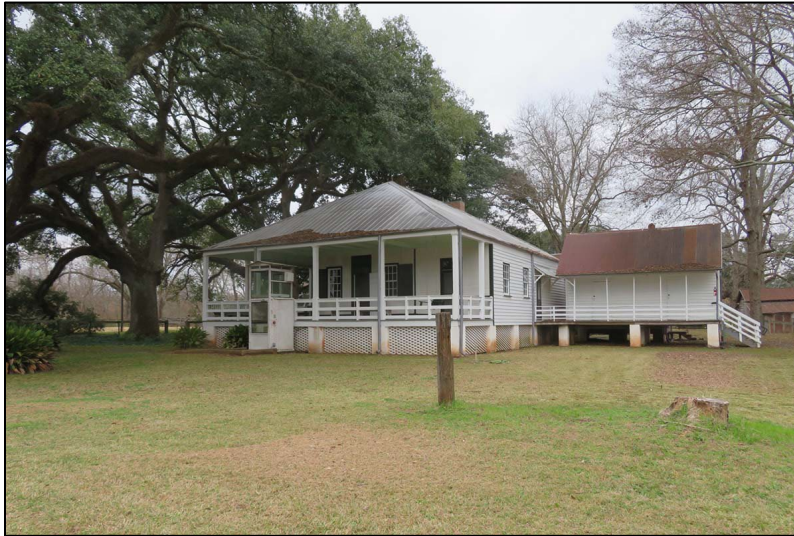
Fig 3.65. Although animal grazing no longer occurs around the Overseer's House, mown lawn conveys some character of the historic pasture grasses. Large canopy trees persist in the background of this repeat view. Single post is a remnant of a historic fence line present in the 1940s and a post and wire fence remnant remains behind the photographer of this image. Heritage Landscapes.

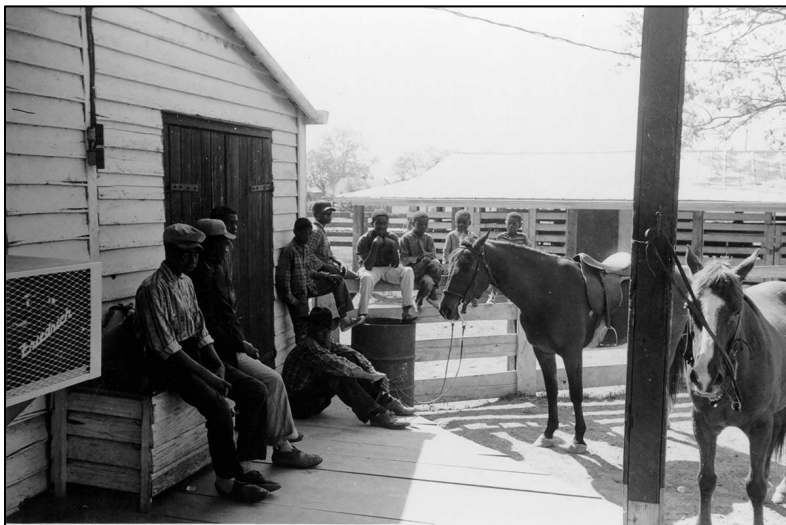
Fig 3.66. Fence, wood box, and steel barrel accommodate seating and a post-mounted hook ties off a horse in front to the store in this 1961 view. A broad three-rail fence encloses a Mule Pen with a Mule Barn beside the store. An electric line to the building is visible at the top of the image. An air-conditioning unit is installed in the foreground window. Courtesy CARI.

Fences serve as a character-defining feature of the historic landscape that give clues to historic land use. For example, wood rail fence indicated enclosures for horses or mules, as was present and remains south of the Store linking to the former Mule Lot (Figure 3.66).

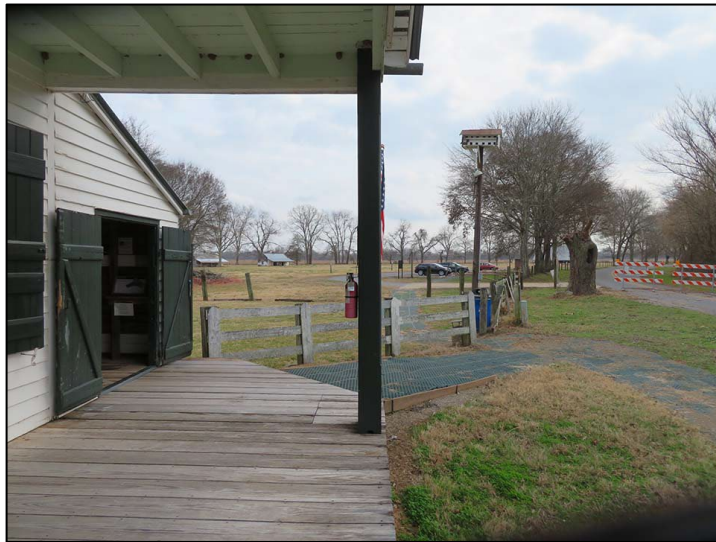
Fig 3.67. The purple martin house remains, now relocated so the south of the Store. A similar three-rail fence holds the edge of the historic animal enclosure. An added ramp provides improved accessibility to the porch. Missing features include the barrel, wood box, layered fences, Mule Pen and Mule Barn are longer present, extending views over the open landscape to the parking area. Heritage Landscapes.

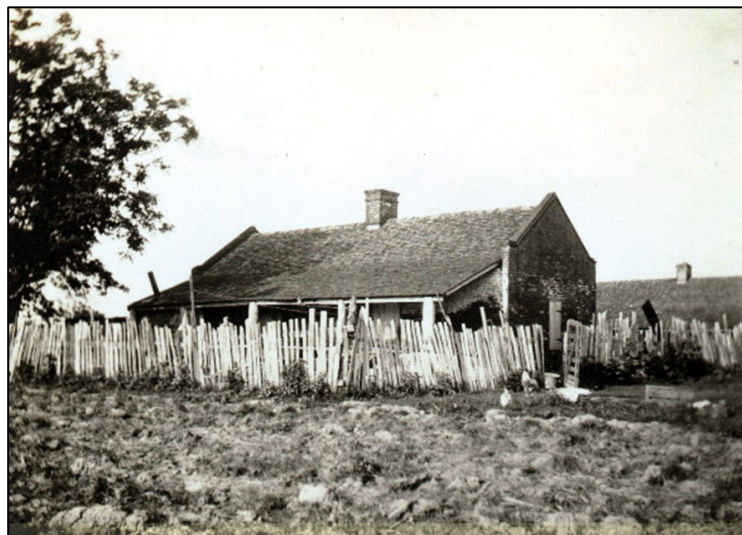
Fig 3.68 Closely spaced pickets with irregular heights enclose this cabin. Recently cultivated soils fill the foreground of this 1922 view. Courtesy CGHR

Fences which historically divided the individual residential landscapes do not remain in 2020. Historic ground views record the character of tall picket fences at several of the residences (Figure 3.68). In 1941, fences enclosed most of the individual cabin landscapes with additional smaller enclosures, likely for small livestock or vegetable gardens. Changes in fence locations by circa 1958 suggest changes to land use with greater subdivisions for livestock. Although no ground photography records details, a series of fences east of the cabins, seen on the 1950s aerial views, near the cattle dipping vat may have held cattle and other livestock before leading them through the vat. No internal fences are present in LCA 2 in 2020 though the east and west edges of the LCA 2 mown paths follow the outer 1958 fence alignments.

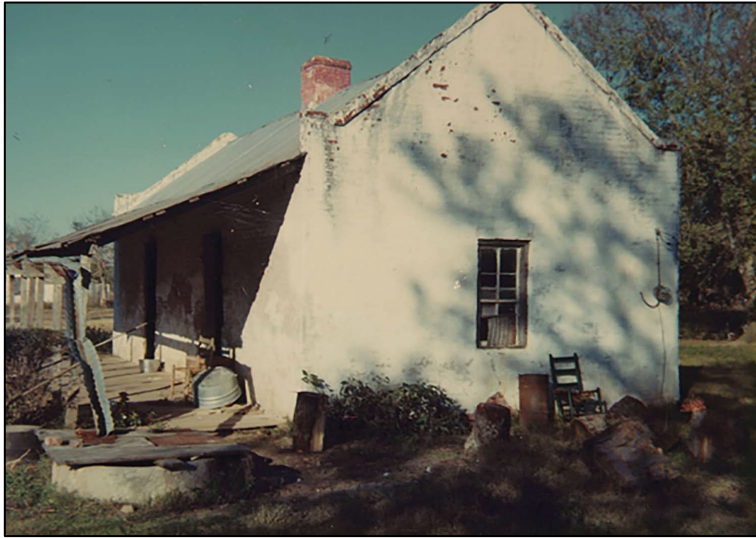
Fig 3.69. This 1960s color image depicting a freshly-painted Cabin 1 or 2 was the image used as the basis for the replica gutter, shown in the view below. Courtesy CARI.

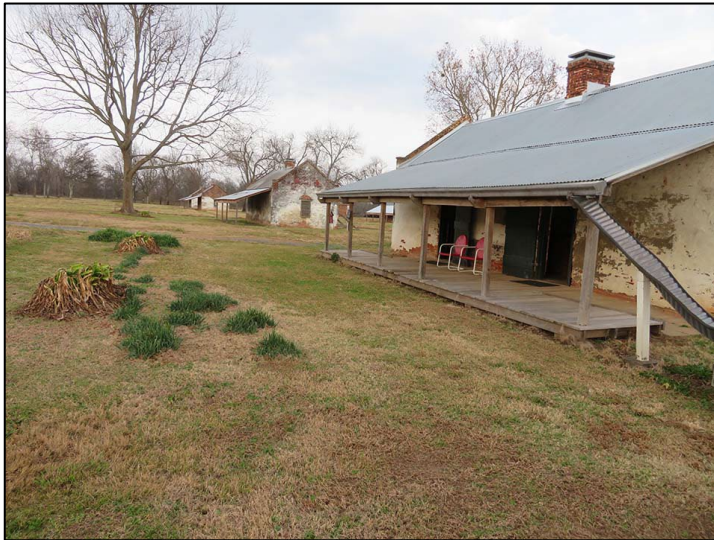
Fig 3.70. Fences, barrels, benches, and ladders are not present while red metal chairs on the porch and galvanized metal washtub hanging on the wall of Cabin 1 reference the presence of historic furnishings of the mid-twentieth century. The gutter extension to the cistern is a replica of a documented historic feature. Heritage Landscapes.
