National Park Service Cultural Landscapes Inventory 2022

Name of Landscape/Component Landscape
Name of Park
[Condition Reassessment 2022]

Hyde Farm

Chattahoochee River National Recreation Area

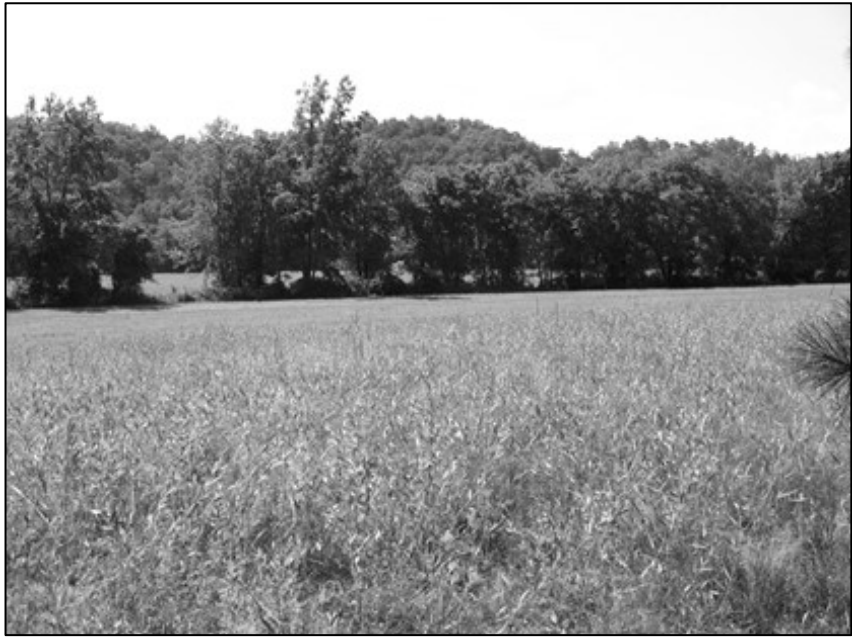
Fig 8. Floodplain field, 2010.

Fig 9. Floodplain field, 2022.

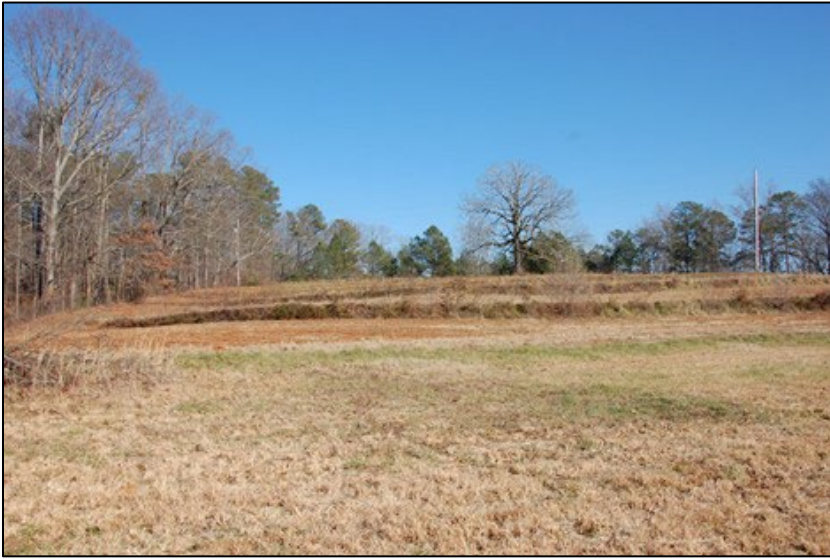
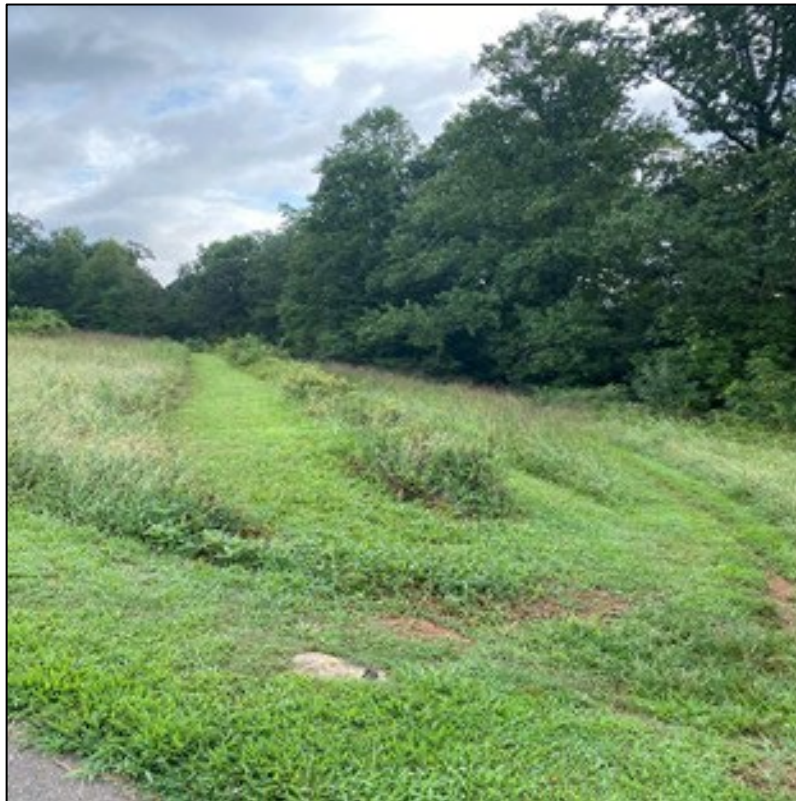
Fig 10. Upland terraces in winter 2010.

Fig 11. View of upland terraces west of entry drive in summer, 2022.

Fig 12. View of upland terraces east of entry drive in summer, 2022.

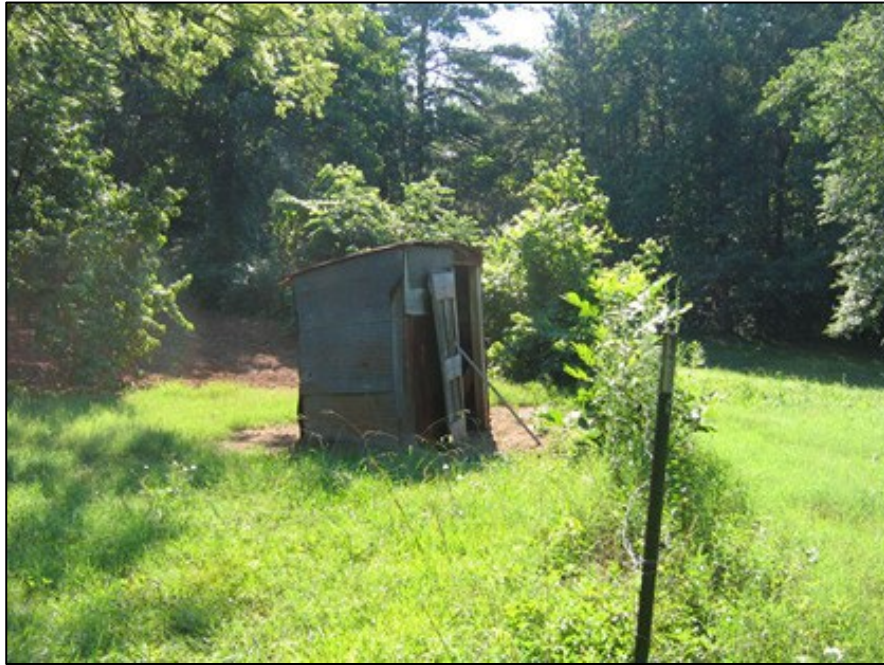
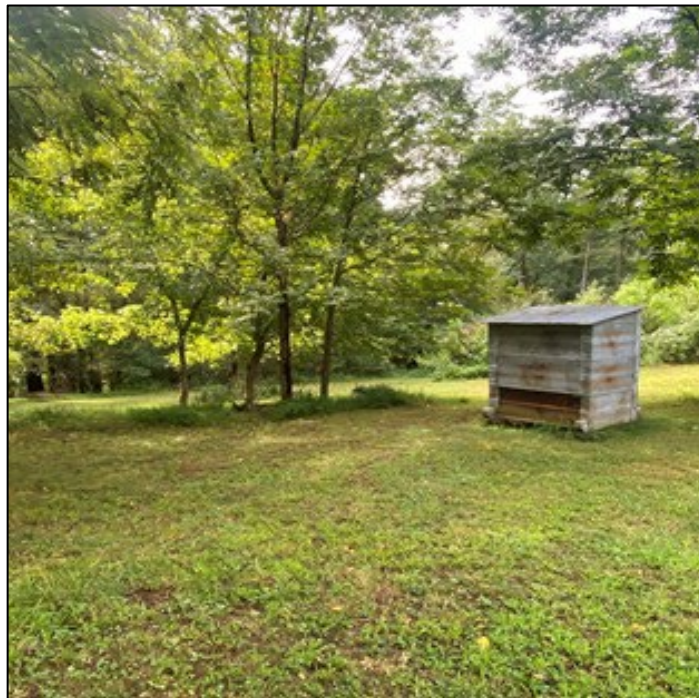
Fig 13. Privy.

Fig 14. Privy, 2022.

All buildings and structures on the site were restored or reconstructed in 2014 and 2015 by Cobb County. This involved the replacement of much of the original material fabric, including siding, roofing materials, structural elements and the stacked stoned foundations. While efforts were made to differentiate historic materials from new materials, weathering of those materials since 2014 has made it more difficult to discern historic siding from new. Regardless of these changes, which were not compatible with the CLR Treatment Recommendations, the buildings and structures of Hyde Farm maintain their locations, footprints, overall design and form, and their relation to each other. While their material integrity has been diminished, they remain contributing features to the cultural landscape.

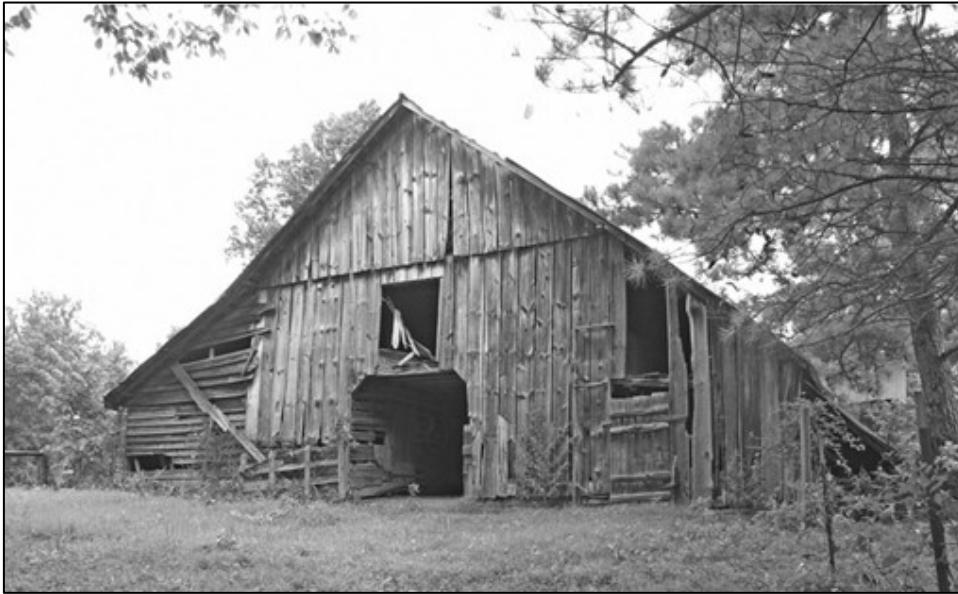
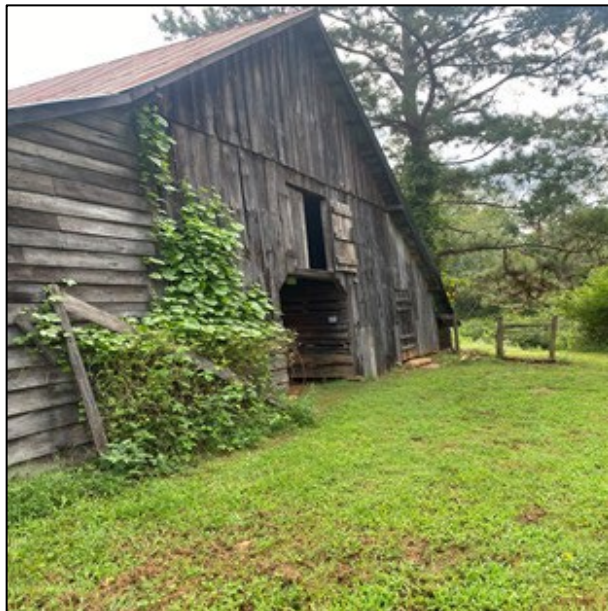
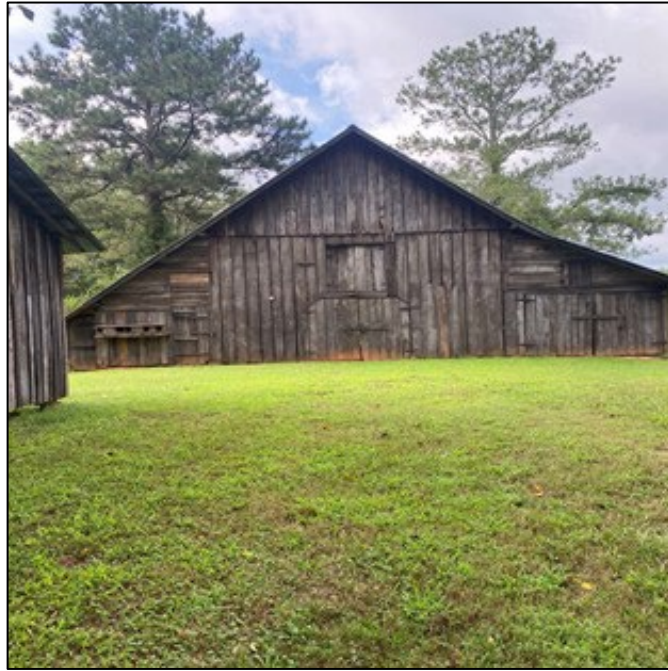
Fig 15. Barn.

Fig 16. Barn, 2022.

Fig 17. Barn, rear elevation, 2022.

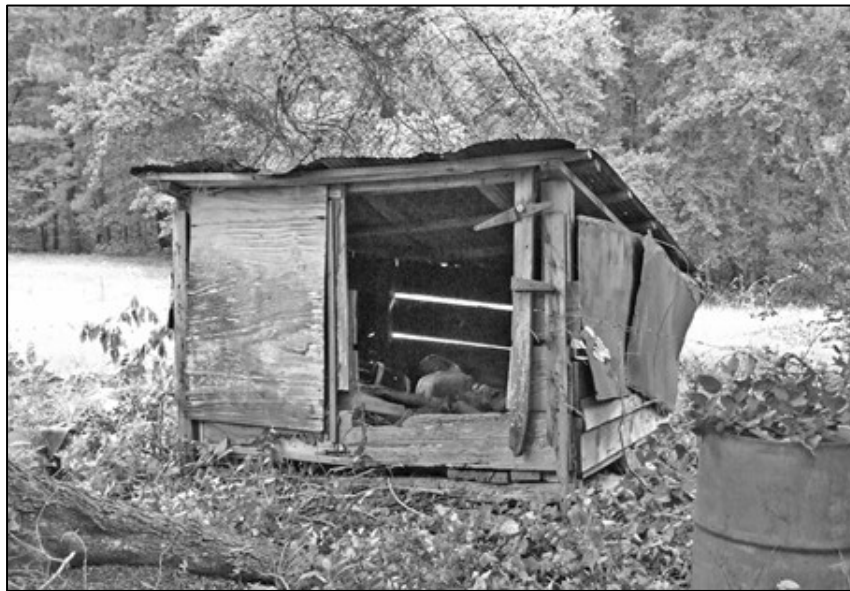
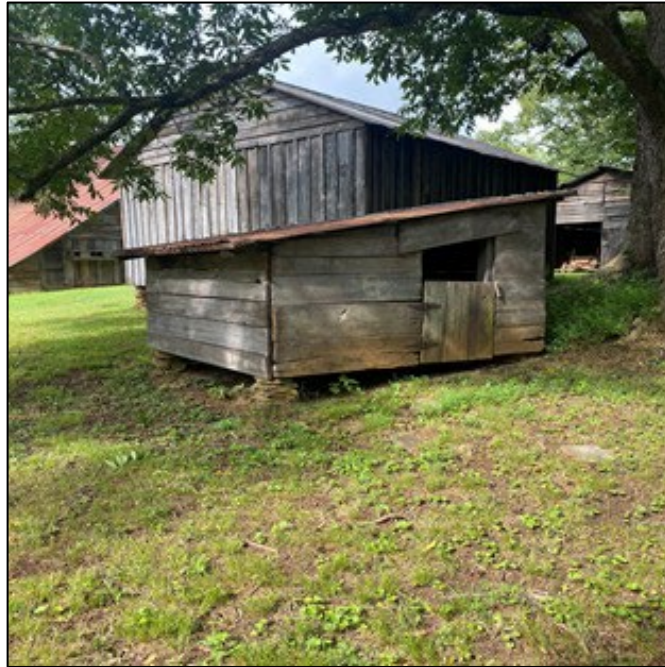
Fig 18. Hog shed, 2008.

Fig 19. Hog shed, 2022.

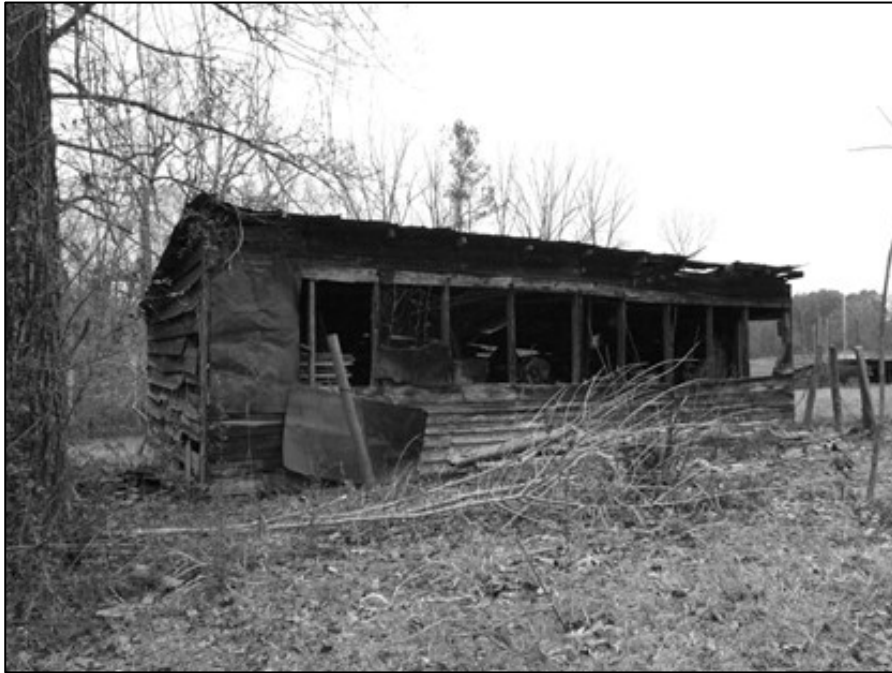
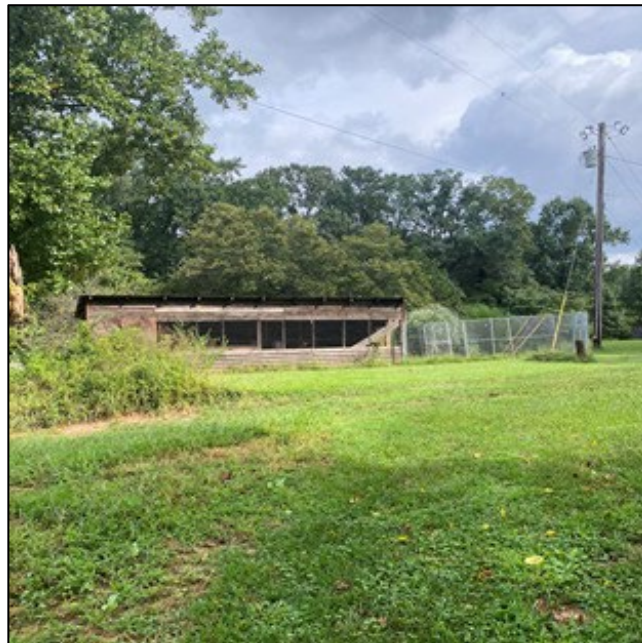
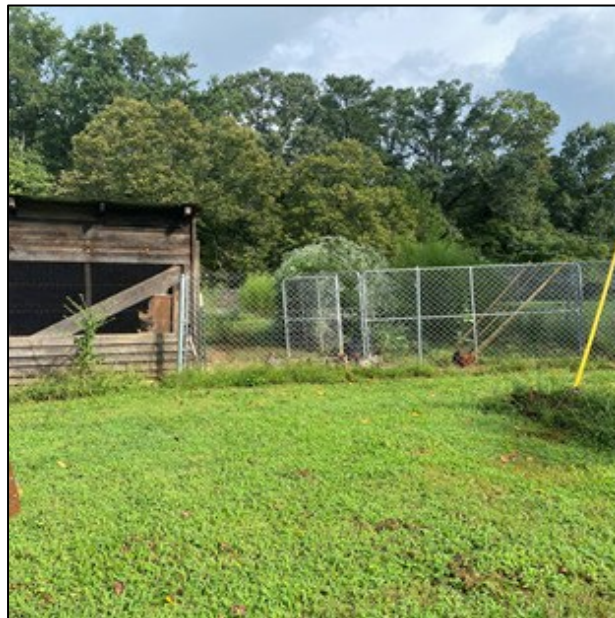
Fig 31. South Chicken House, 2008.

Fig 32. South Chicken House with chain link chicken enclosure, 2022.

Fig 50. Chain link fence chicken enclosure on South Chicken House, 2022.

Secretary of Interior's Standards. This treatment has therefore threatened historic integrity of the site and National Register eligibility. The construction of new features, including the chicken enclosure, the wood rail fence, and Boy Scout kiosk further damages integrity. The Cooperative Management Agreement (No. G534009001) between CHAT and Cobb County is set to lapse in 2022, which could negatively impact the landscape due to improper maintenance leading to further successional growth, the spread of invasives, and construction of incompatible features.

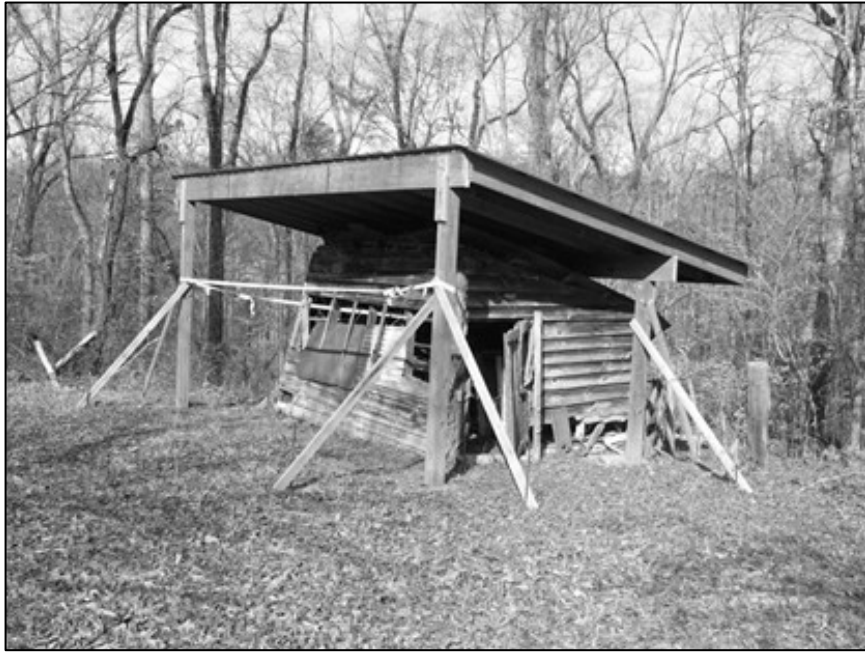
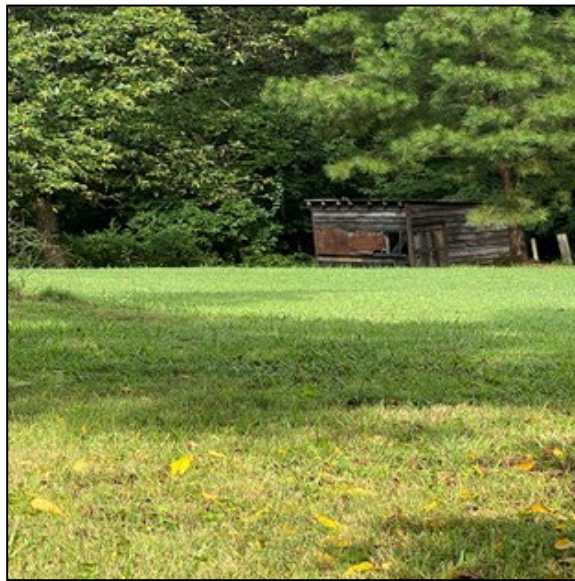
Fig 37. Goat house with stabilization shelter, 2009.

Fig 34. Goat house, 2022.

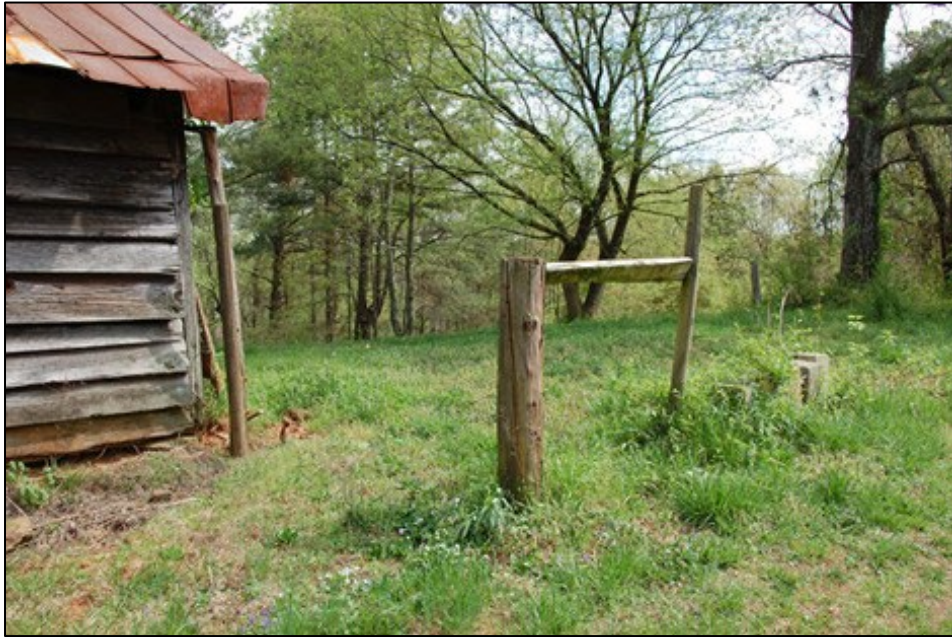
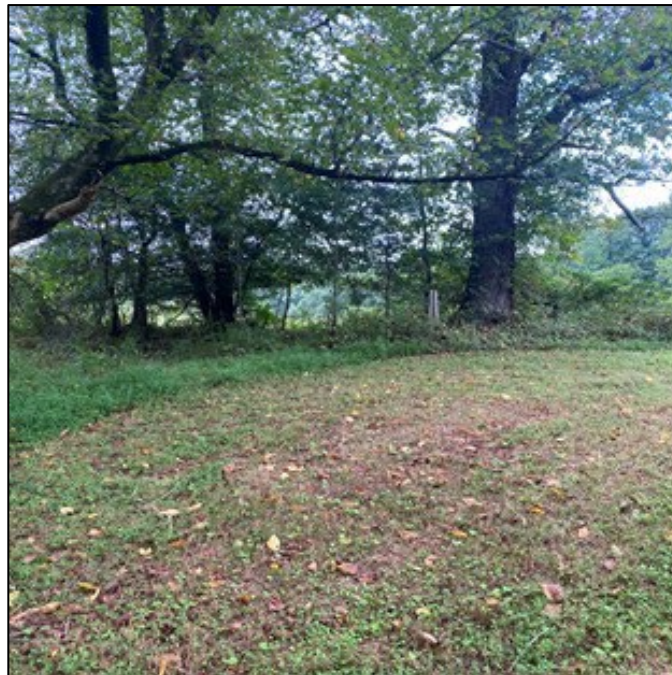
Fig 41. Barnyard fence, 2010.

Fig 42. Remnant post in barnyard, 2022.

does not replicate the historic fence or follow the original fenceline. The barnyard fence and hog pen fence remain missing. Hyde Farm is currently in poor condition.

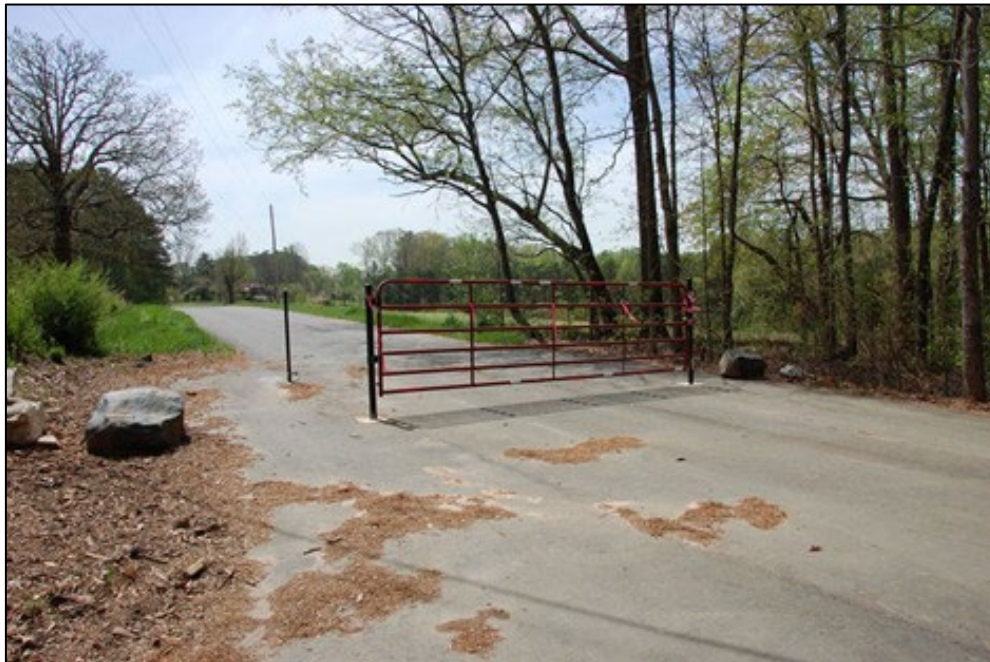
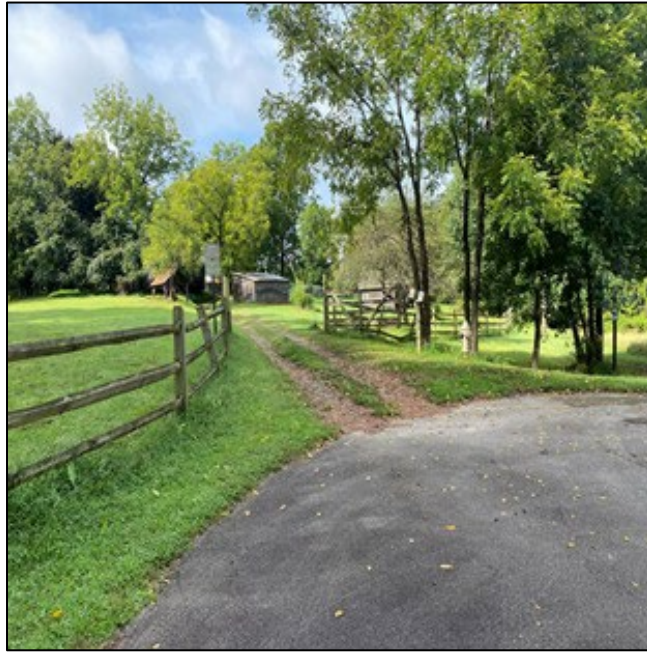
Fig 44. New Cobb County gate across Hyde Road, 2010.

Fig 49. New wood rail fence flanking Cobb County gate to farm core, 2022.

north boundary of Hyde Farm and a farm gate added in 2004 by TPL deters access to the entry drive. These gates and new fence added to the landscape since J. C. Hyde passed away are non-contributing and diminish integrity of location, workmanship, design, setting, and feeling. The CLR recommends the replacement of the recently removed fences. A wooden gate on the south edge of the pasture was also removed and has been preserved for replacement.

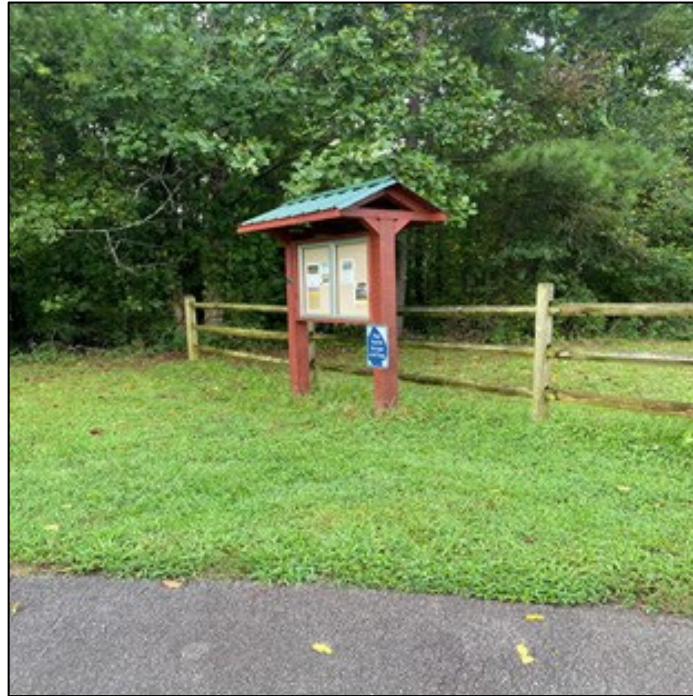
Fig 51. 2021 Eagle Scout Kiosk in 2022.

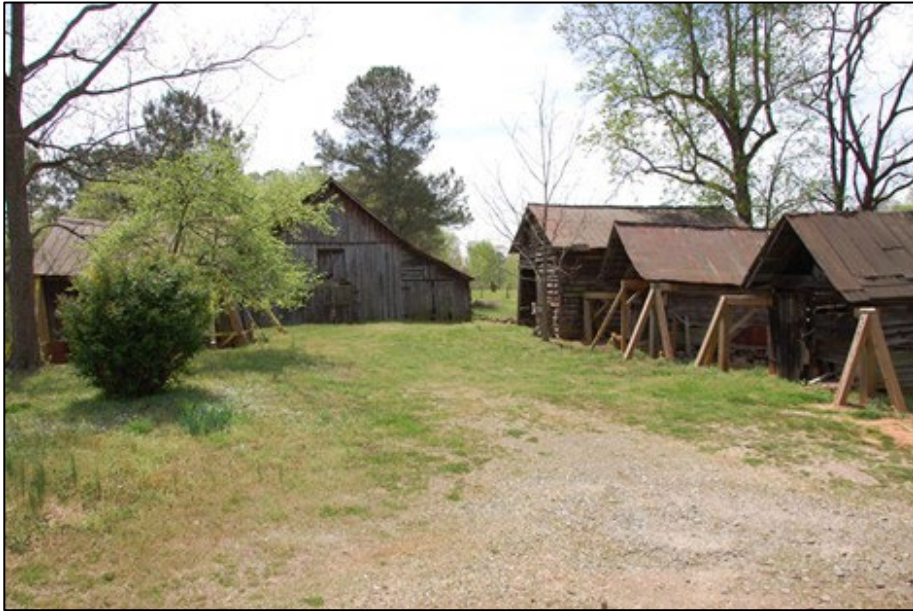
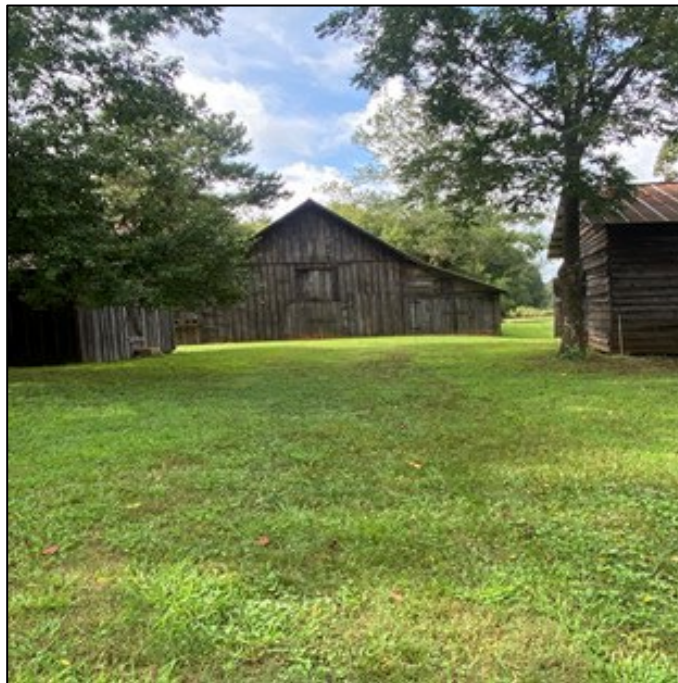
Fig 63. Spatial organization of the core farm. Work yard behind the Power-Hyde House enclosed by farm outbuildings.

Fig 64. Work yard behind house, 2022.

Behind the main house, the Corn Crib, Barn, Truck Shelter, Tool Shed, and Gear House form a U-shaped work yard. The fence line of a mule pasture and orchard contains several twentieth-century buildings added by the Hydes to the northwest. The fields at Hyde Farm extend north and south of the core farm and include other agricultural land in the back field and floodplains. The upland fields retain integrity with terraces and unchanged boundaries. The integrity of location, setting, design, feeling, association, material, and workmanship remain in the spatial organization of Hyde Farm.
