National Park Service
Cultural Landscapes Inventory
2009

Sope Creek Ruins
Chattahoochee River National Recreation Area

CULTURAL LANDSCAPE INVENTORY
CONDITION ASSESSMENT CONCURRENCE SHEET - 11 August 2009

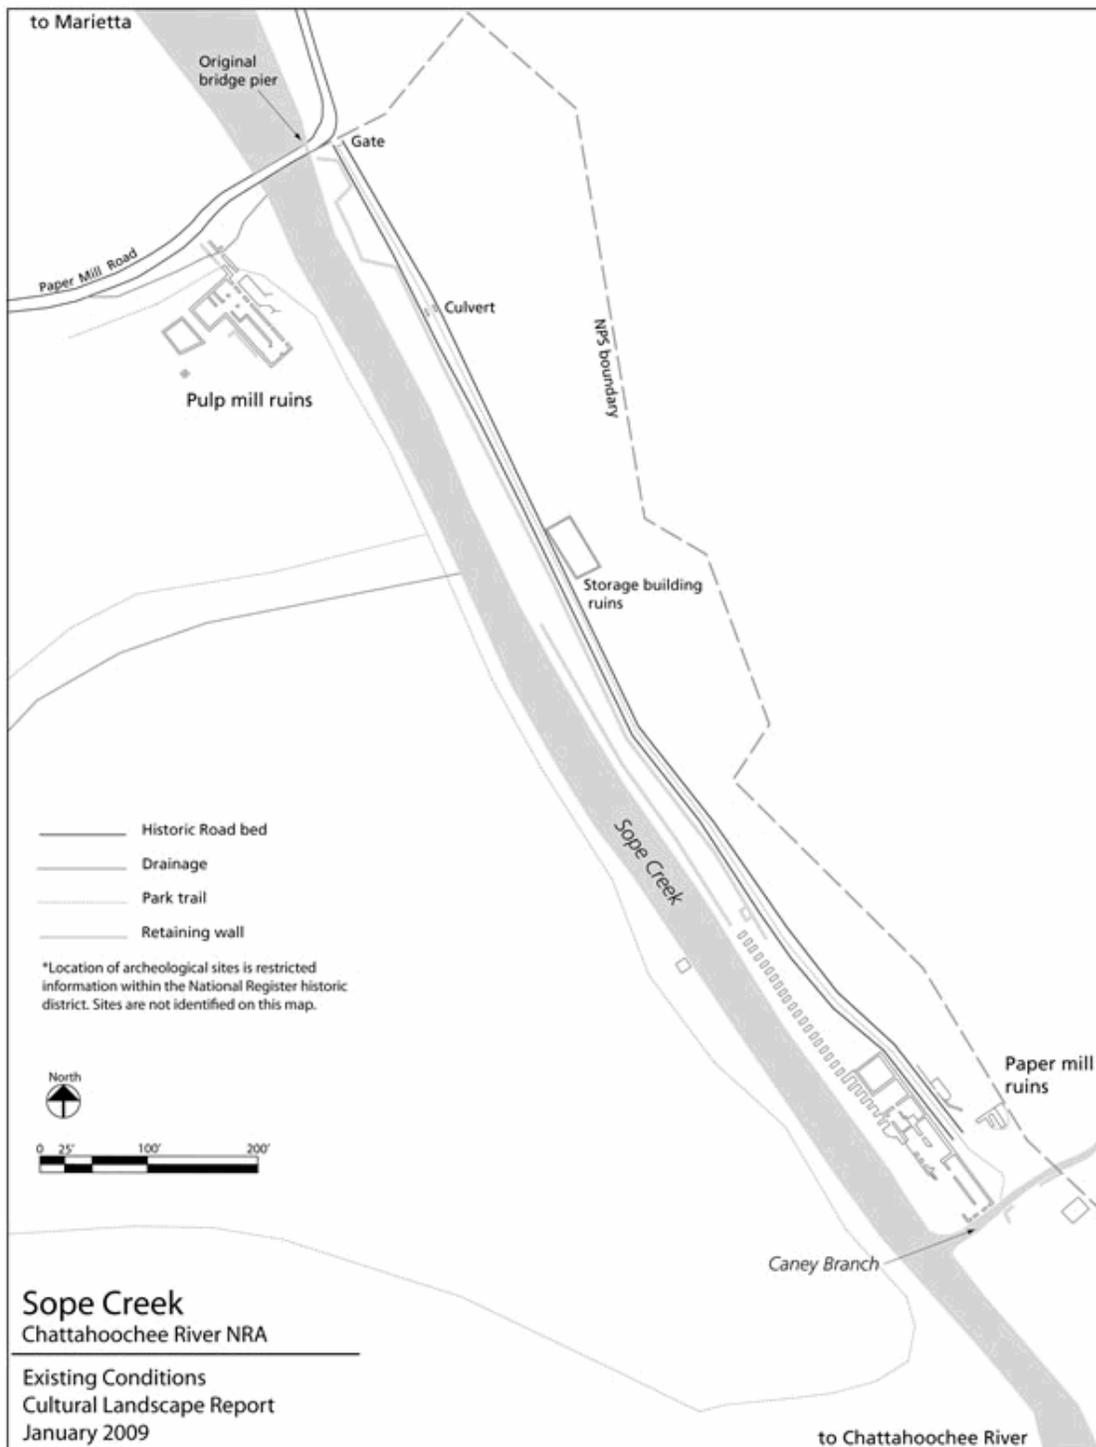
Sope Creek CLI Site Plan, 2009.

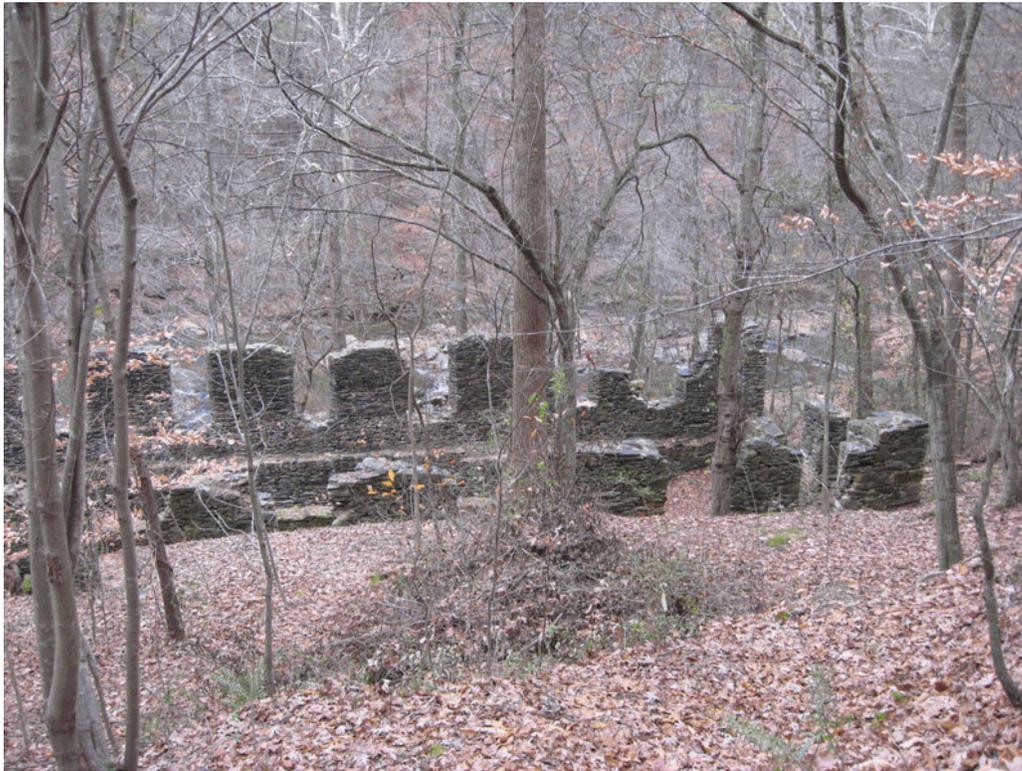
Slope leading down to west bank Pulp Mill, 2009. Sope Creek in background.

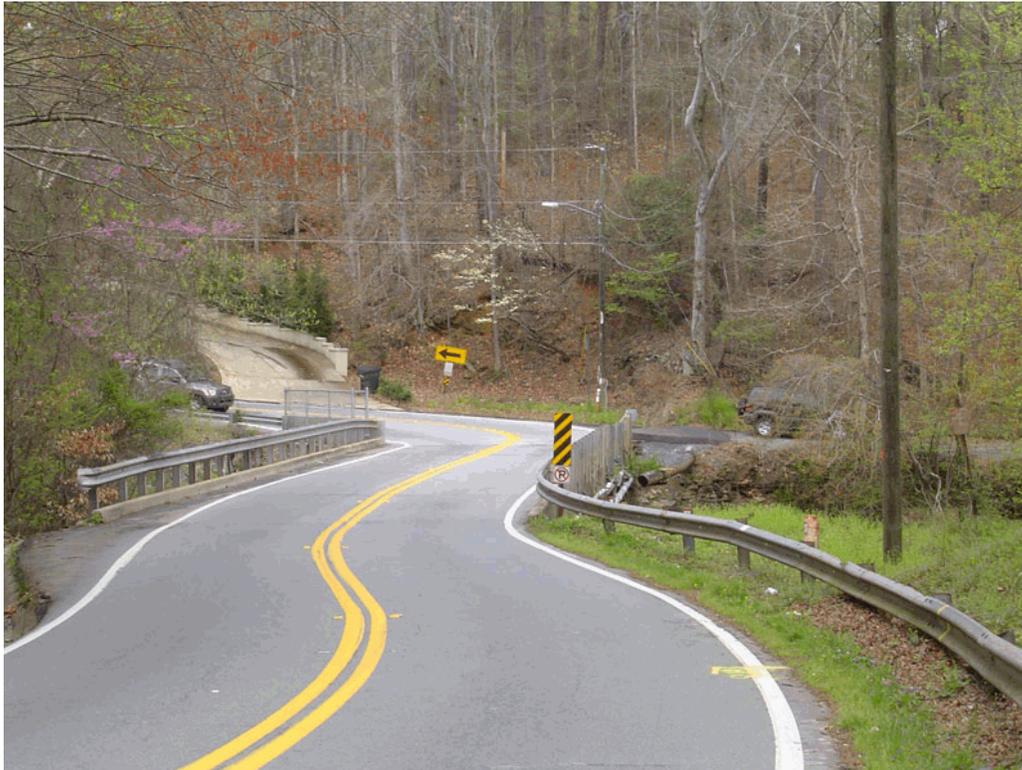
Paper Mill Road on the north boundary of the landscape dates to the nineteenth century. A covered bridge once spanned the creek but was destroyed by fire in 1964. A concrete superstructure replaced the original bridge on Paper Mill Road and the county road was paved with asphalt. The integrity of location and association remain, though the modernized road has diminished integrity of setting, feeling, design, materials, and workmanship. Paper Mill Road still connects the Sope Creek area to Marietta, the county seat and railroad depot. This route was used to transport paper products during the industrial era.

Paper Mill Road and bridge, northern landscape boundary, looking east, 2008.

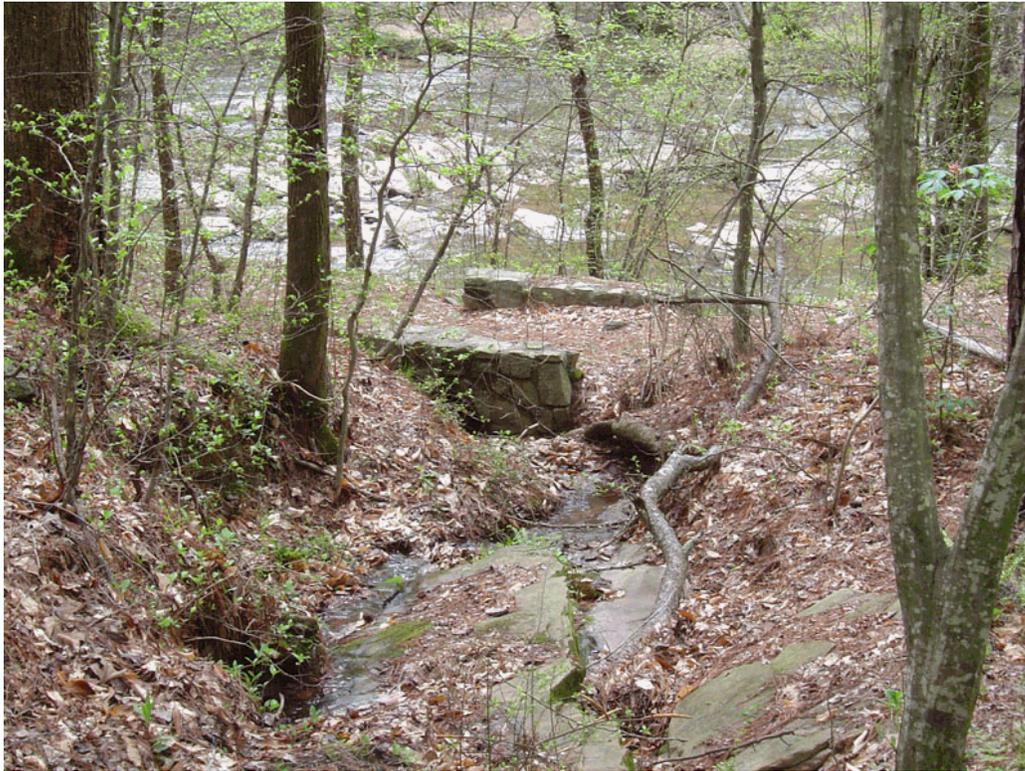
Modern stone culvert, east bank of Sope Creek, 2008.

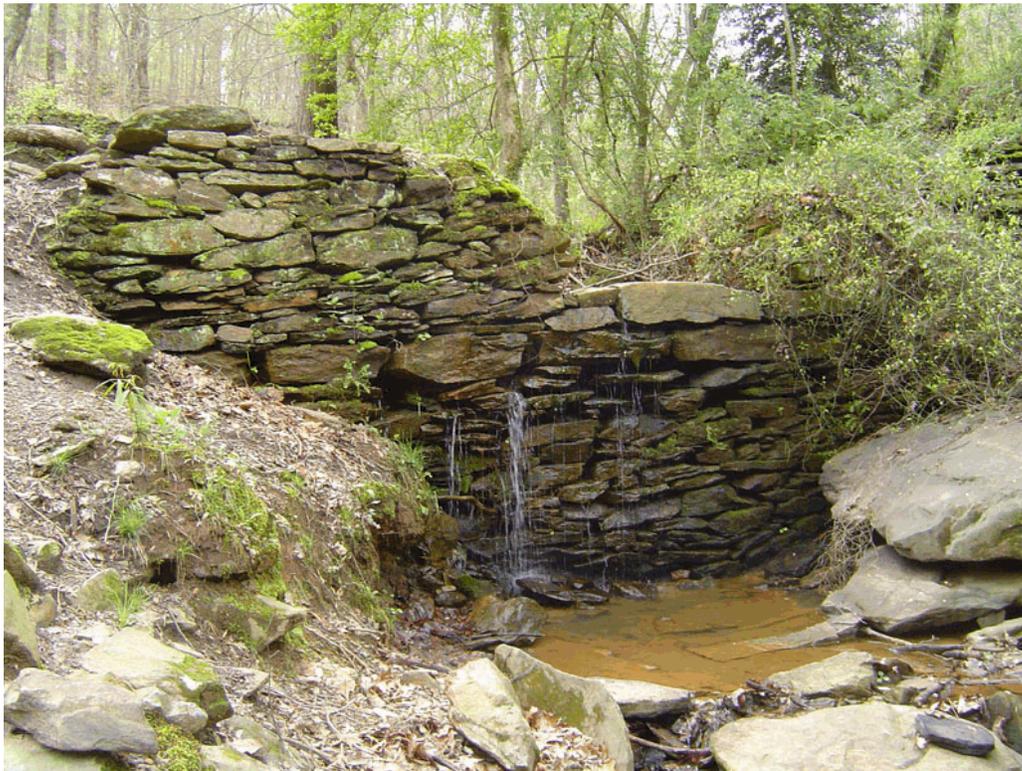
-A retaining wall to the north of the pulp mill foundation (26.2') parallels the creek. Due to the drainage pattern of Paper Mill Road on the slope above, the retaining wall has water seeping through the stones. The retaining wall has a notch of stones absent on the top, possibly suggesting the wall supported a raceway or machinery.

West bank retaining wall, north of pulp mill.

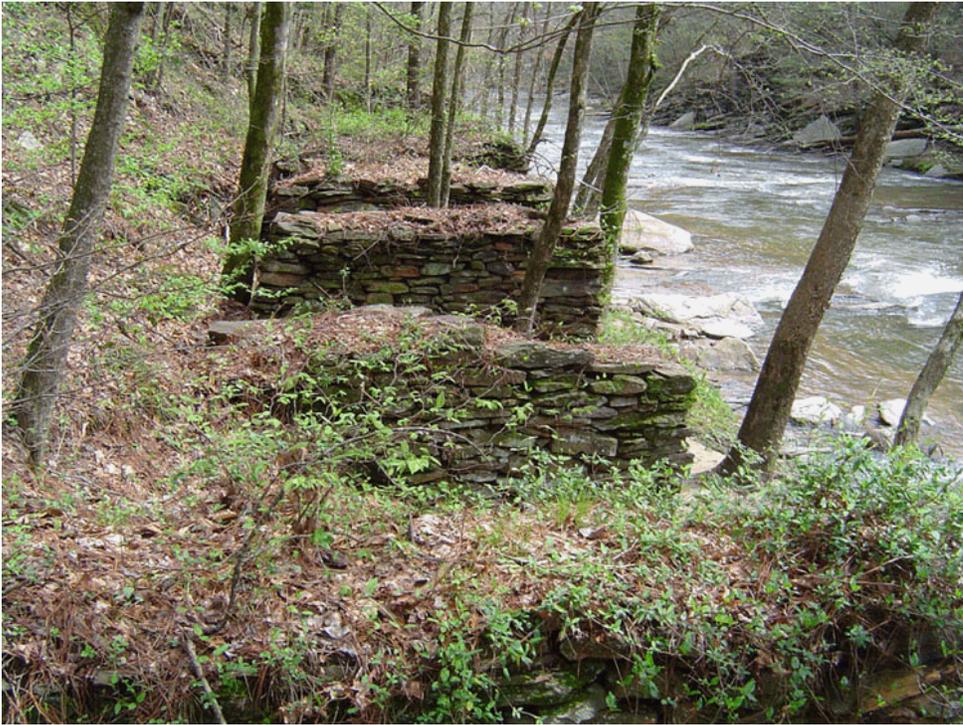
Raceway piers on east bank. Sope Creek in background.

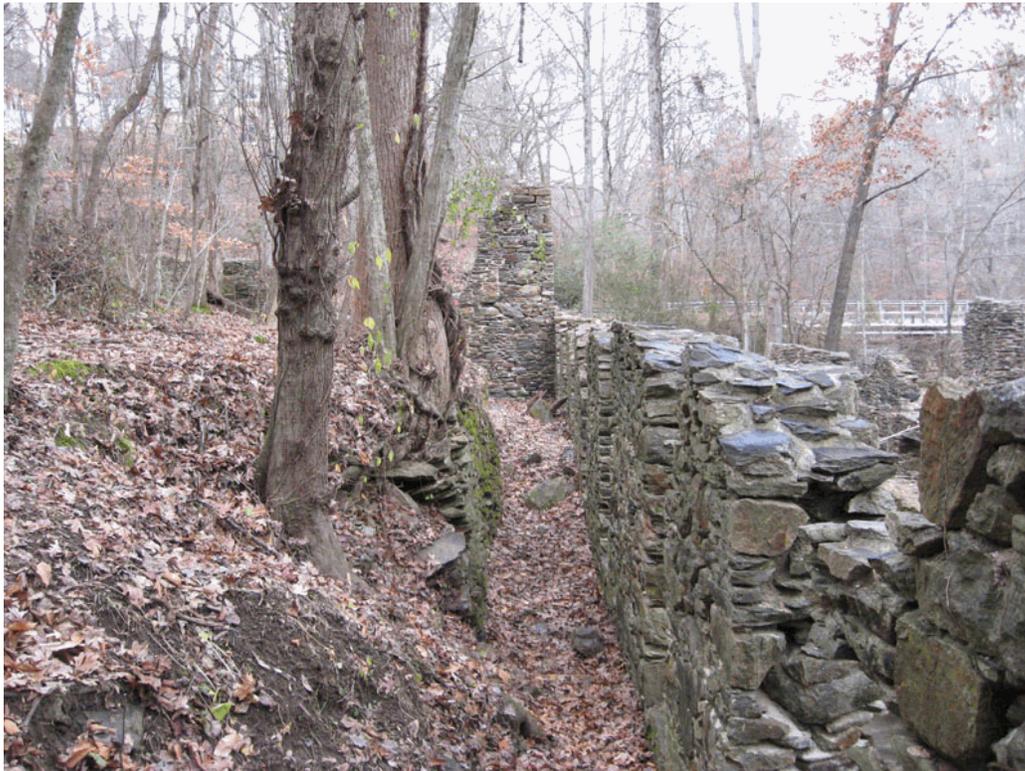
-The L-shaped pulp mill (118' x 61.7') survives in the original location with a foundation and walls of field stone rising over a full story on the east façade. The lintels of the pulp mill were stabilized in the 1980s by NPS staff and wooden barriers prevent visitors from entering the ruins from the north slope.

Retaining wall and pulp mill ruins.

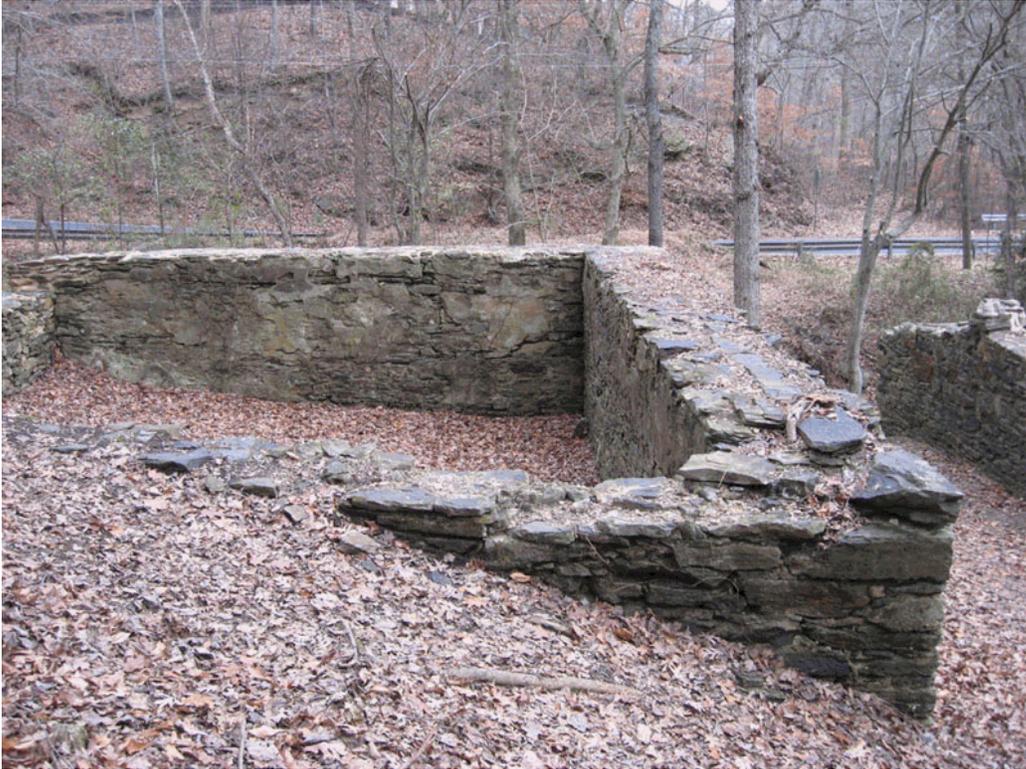
-A pulp mill annex (28.8' x 30' x 30.2' x 35.7') sits immediately west of the pulp mill and forms an irregular rectangle. The south east corner is an acute angle, though each side of the annex foundation is solid stone construction. Repairs were made to the mortar in 2007 following tree damage.

Sope Creek Pulp Mill Annex, 2008.

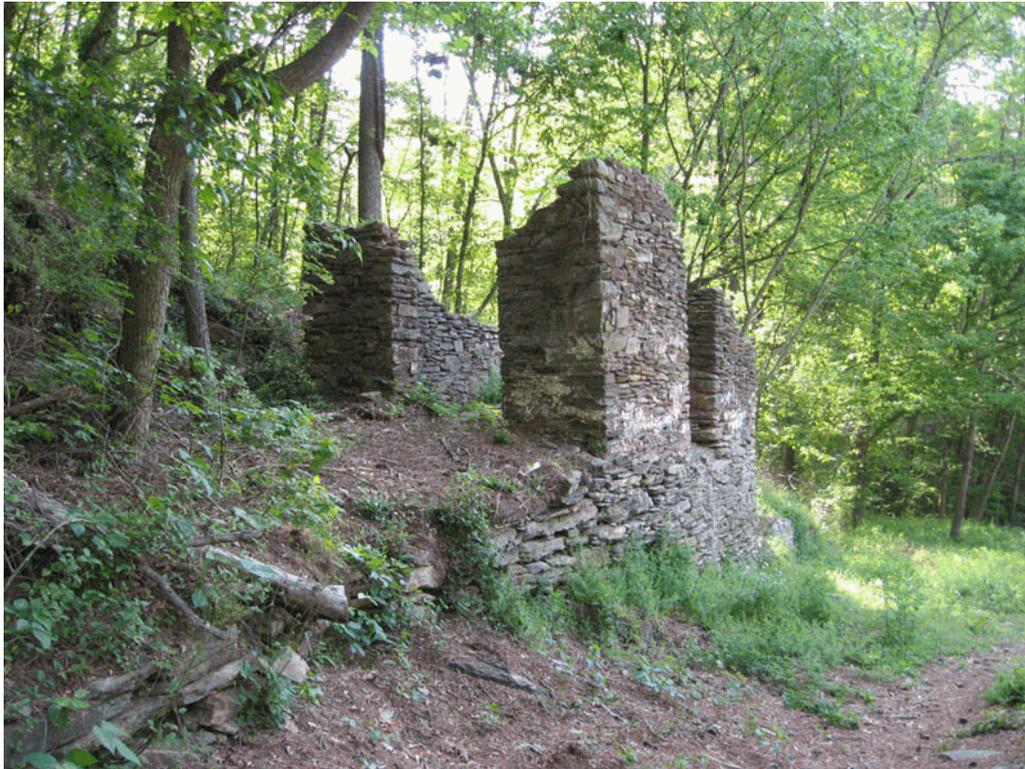
-A boiler room (9.1' x 24.2') is located directly across the trail/road bed east of the paper mill. The boiler room has a rounded wall on the south façade and a retaining wall (68.5') extending north and south of the building. The structure is heavily overgrown in the summer months, but remains in good condition.

Sope Creek Paper Mill Boiler Room, 2009.
