National Park Service
Cultural Landscapes Inventory
2007

Bromide Springs/Bromide Hill
Chickasaw NRA - Travertine District

Inventory Unit Summary & Site Plan

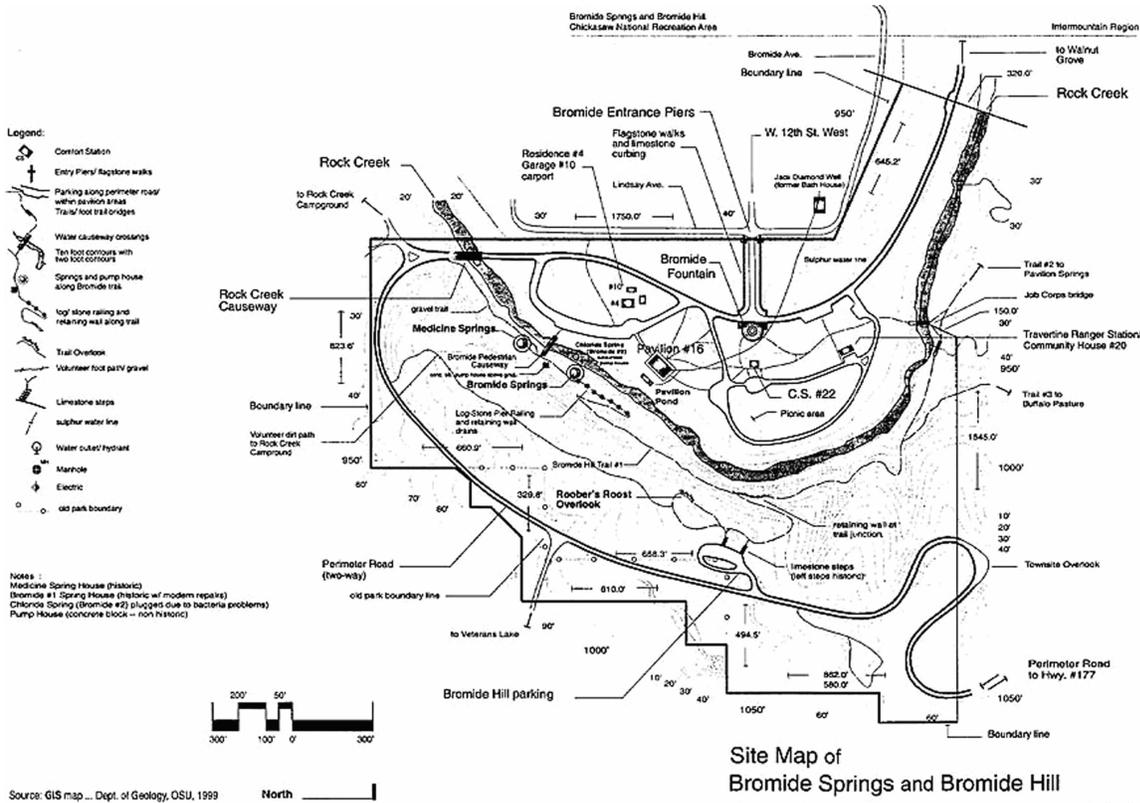
Site Plan

Site plan for Bromide Springs/Bromide Hill. Source: GIS base map obtained from Department of Geology, Oklahoma State University (1999), augmented by Iowa State University.

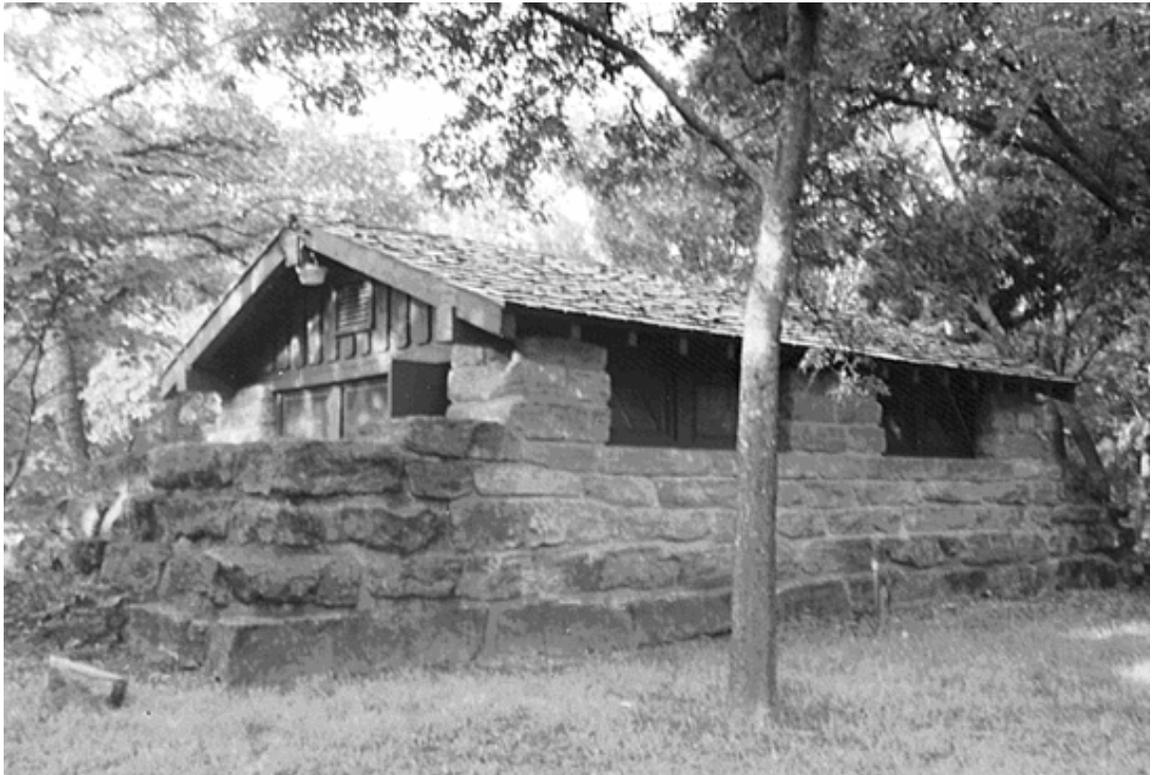
*Bromide Springs Comfort Station, circa 1997.
(CNRA archives, LCS photograph).*

One of the last buildings of CCC-era to be constructed at Bromide Springs was a rustic style comfort station. This comfort station replaced two existing concrete comfort stations. According to a construction report of 1934 these two buildings were of concrete, needed constant repairs and too small, poorly lighted and located too close to the main road. The rustic style comfort station was modeled after the comfort stations in Cold Spring Campground. Materials used in the construction were sawn wood timbers a rough, dark gray and brown limestone. The stone units were large and irregular in shape, and the masonry was also done in a fashion to enhance the random, natural feel of the structure.

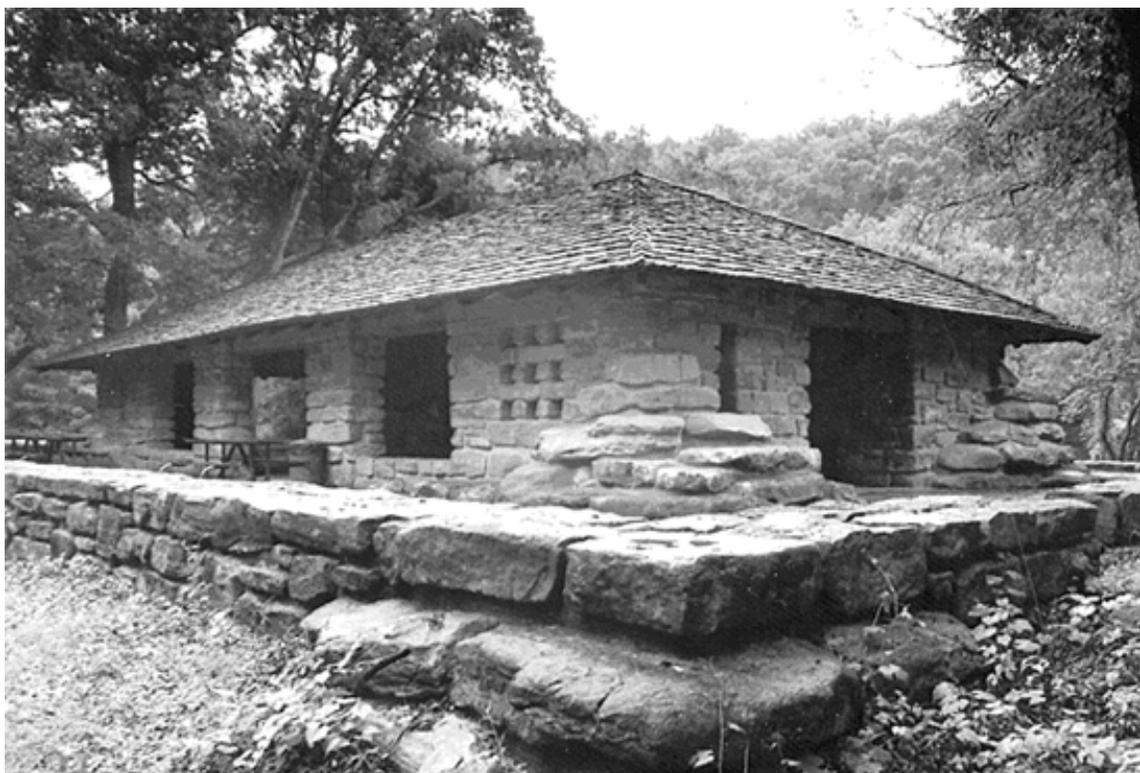
*Bromide Springs Pavilion, circa 1997.
(CNRA archives, LCS photograph)*

Bromide Springs Pavilion: As stated above, Bromide Springs Pavilion was the first CCC-era building to be constructed at Bromide Springs and exists today much as it did at the end of the period of significance. The structure is an NPS rustic design, utilizing boulders and large timbers in its construction. Changes include both changes in use and appearance.

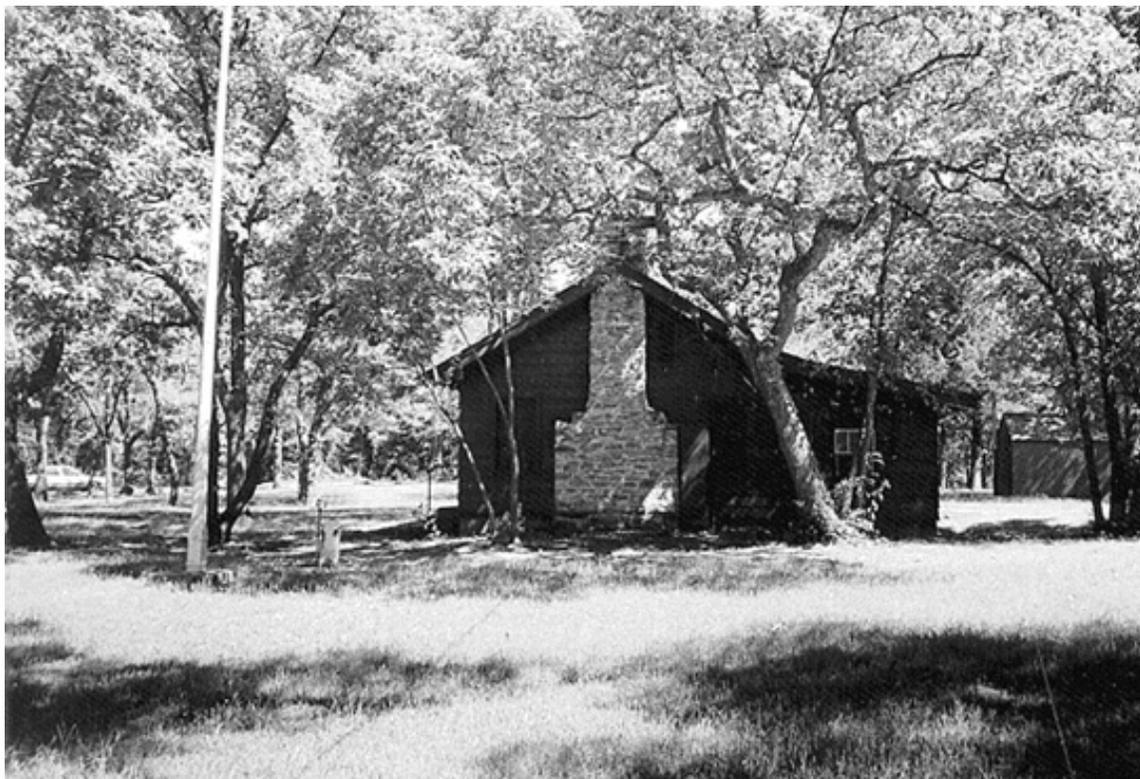
*Travertine Ranger Station, circa 1997.
(CNRA archives, LCS photograph)*

Travertine Ranger Station: Known earlier as both the Museum and as the Community House, the present-day Travertine Ranger Station is one of the extant buildings in the Bromide area that were constructed prior to the CCC-era work plan. Located in the eastern portion of the area, the Travertine Ranger Station is roughly 33 by 45 feet and is constructed of wood frame construction. The building sits on a concrete foundation and has a small porch on its south side. Like the other Community House in Cold Springs Campground, the Travertine Ranger Station was built by the Sulphur Chamber of Commerce in the 1920s. The building was slated for removal in 1940s Master Plan documents, but demolition never occurred. Today it is painted brown like most NPS structures, and blends into its surroundings, and it is used as ranger offices.

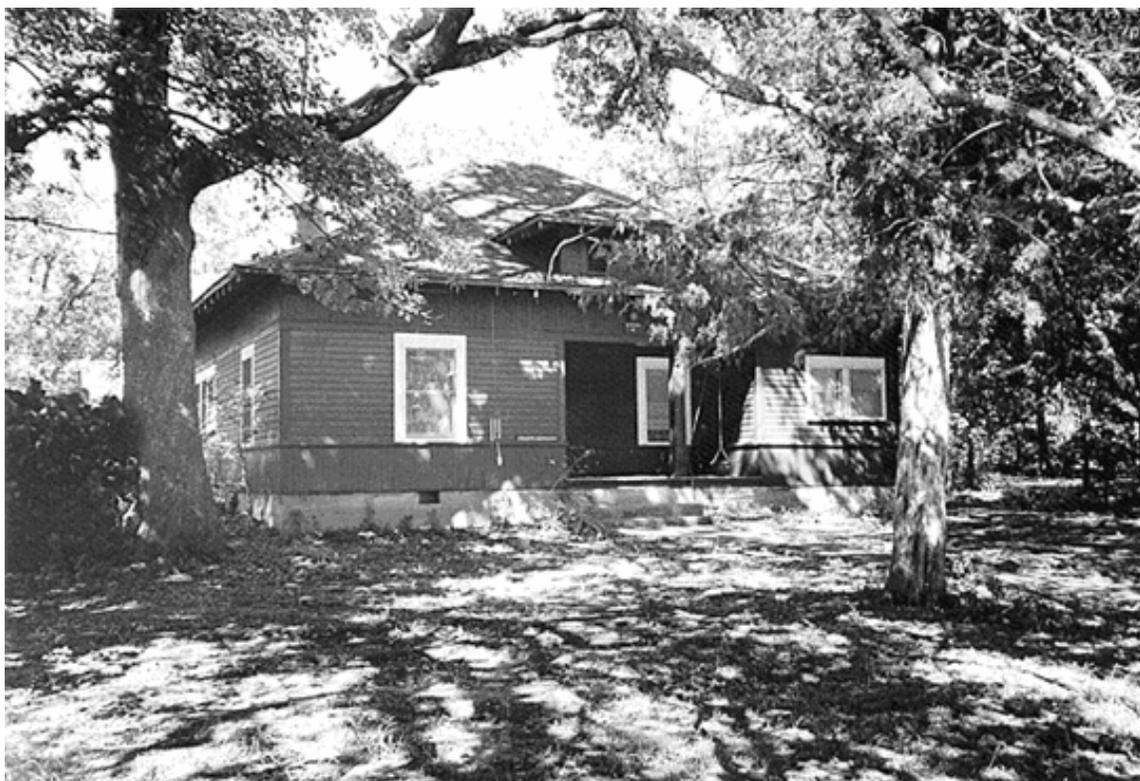
*Bromide Ranger Station (former residence), circa 1997.
(CNRA archives, LCS photograph)*

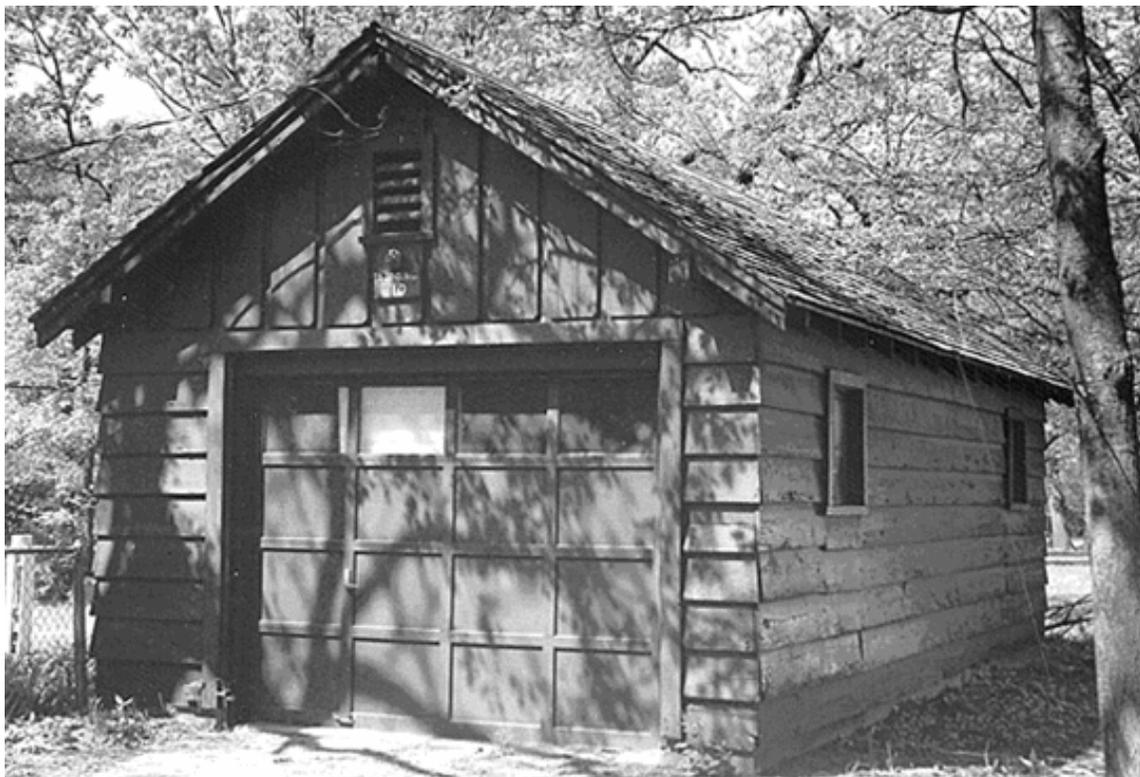
*Garage for Bromide Ranger Station, circa 1997.
(CNRA archives, LCS photograph)*

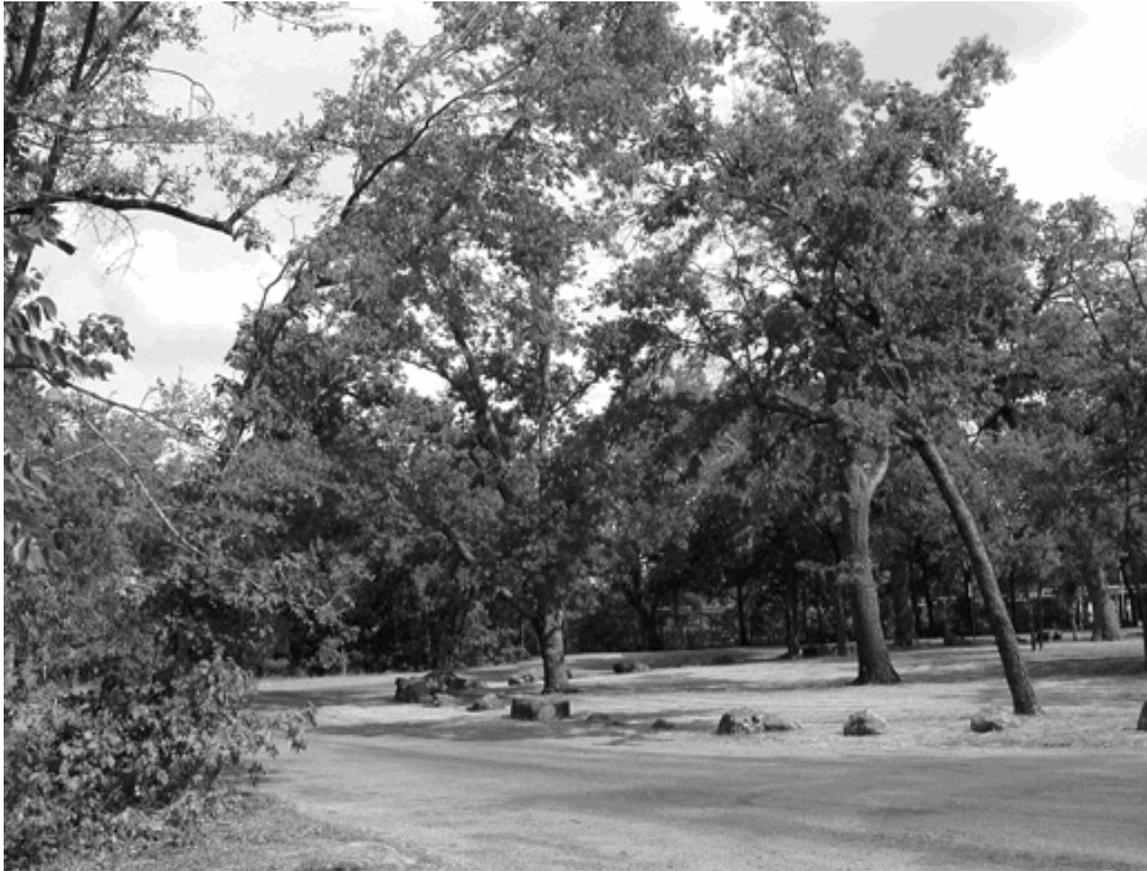
*Typical loop road in Bromide Springs area, 2001.
(Photograph by Iowa State University)*

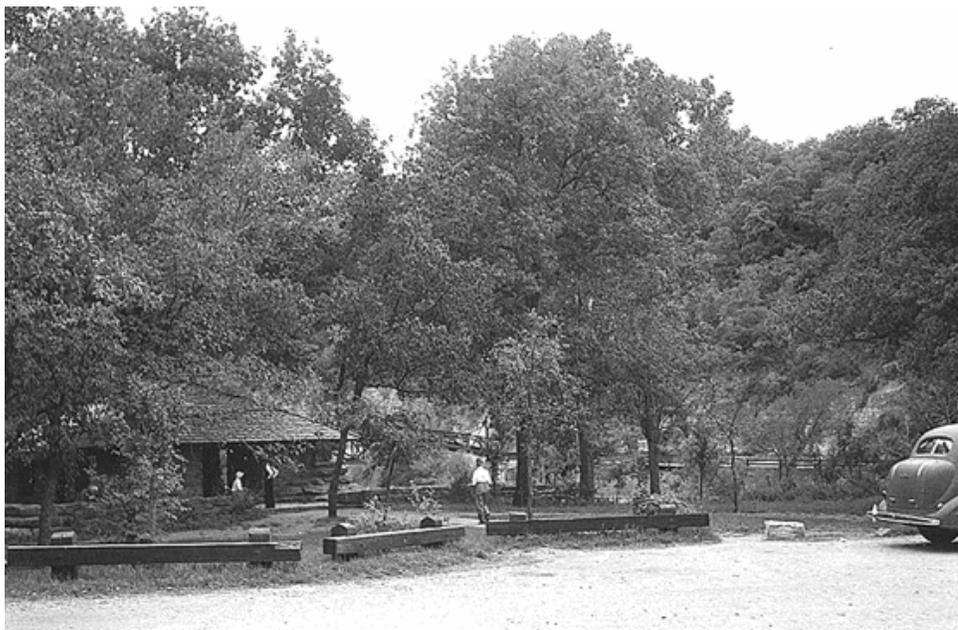
Parking area at Bromide Springs Pavilion, showing timber guard rails (no longer extant), 1937.

(CNRA archives, photograph 965)

occurred to these features as they have been repaired over the years. One of the most notable changes is the substitution of single, circular timber rails for double, square timber rails along the large stone and pier retaining wall (see earlier photograph in history section). Around 1990, stone swales were added to solve drainage and erosion problems.

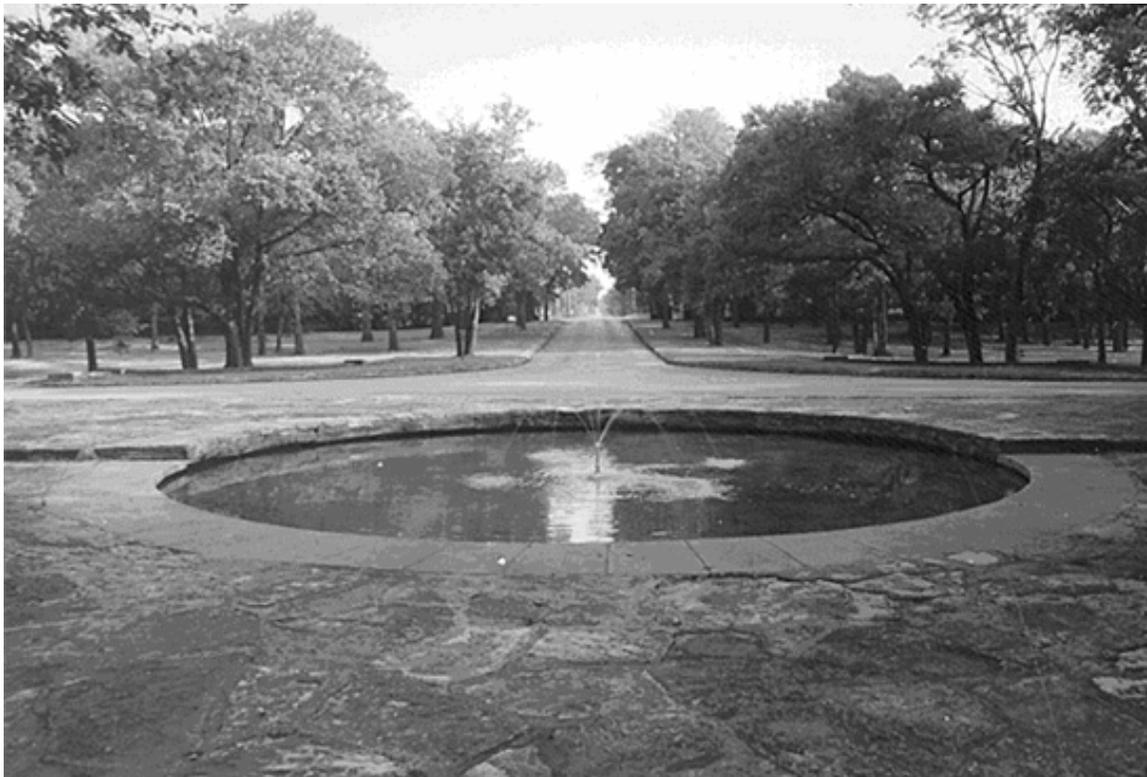
*12th Street Fountain, view looking north down 12th Street axis, circa 1997.
(CNRA archives, LCS photograph)*

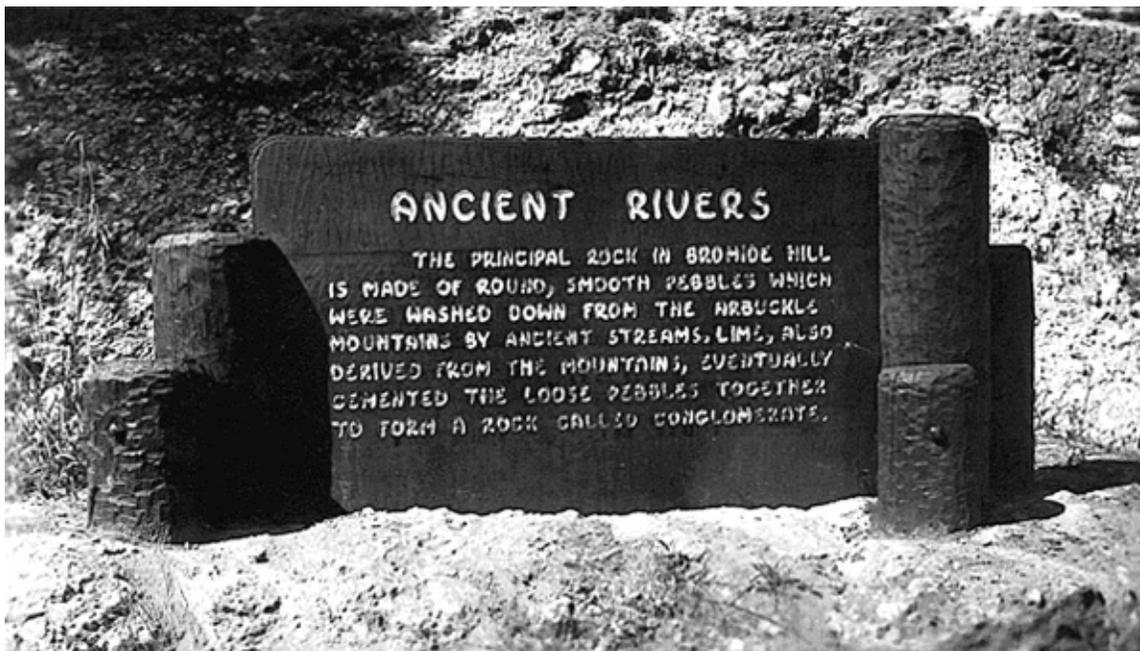
Original CCC interpretive sign along Bromide Hill Trail, circa 1936.

Compare to existing sign, shown in previous photograph.

(CNRA archives, photograph 25)

Interpretive Sign: Along Cliffside Trail and near a spring enclosure is an interpretive sign. As shown in historic photographs, the sign originally was a typical example of rustic signage found in the Platt District, which were large planks with carved letters, anchored at the ends with logs of varying heights and diameters. Today the sign, which appears to be a replacement, is missing its log anchoring ends. The text—describing “Ancient Rivers and Mountains” of the area— is incised with white letters, and is roughly 46 inches by 76 inches.

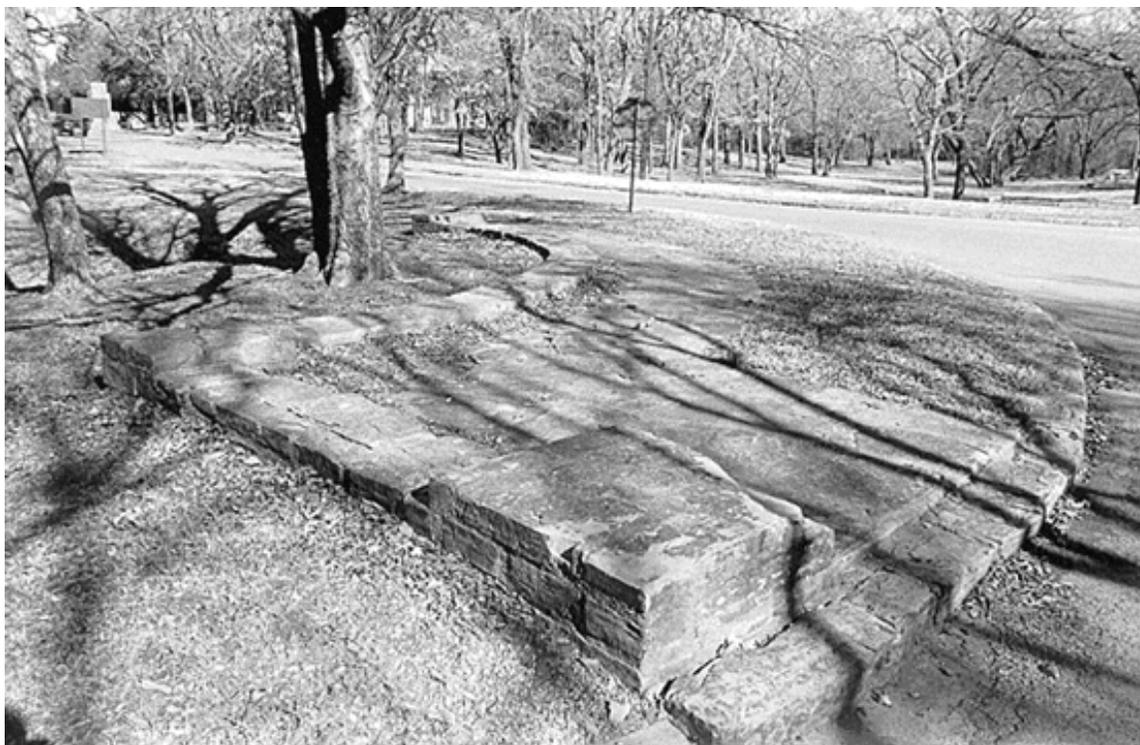
Flagstone walk and curbing of varied heights at the intersection of the perimeter road and 12th Street, circa 1997.

Note small raised stone edging columns at corners and entry road culvert in tree shadows.
(CNRA archives, LCS photograph)

Bromide Entry Piers: As noted above, the piers at Bromide entrance were constructed during the 4th enrollment period and provide a formal pedestrian entry to the park. Here, 12th street is lined with flagstone curbing. Placed across 12th Street from each other are two sets of large and small piers, constructed of Mississippi limestone. The large piers are 3 feet 6 inches square and stand 11 feet tall. Separated by a flagstone walkway are smaller piers (3 feet square and 4 feet tall). These features appear not to have changed much since the period of significance. The only major change to the area is the addition of the brown and white NPS sign, which was not located here historically.

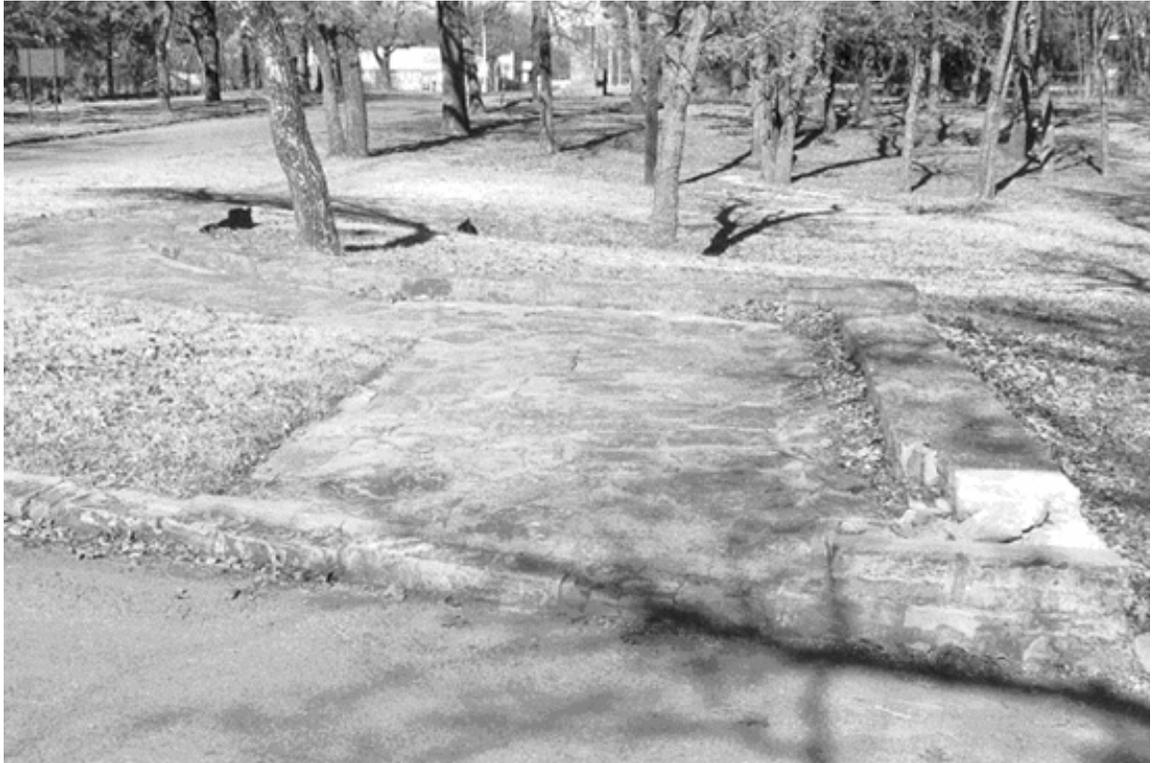
Flagstone walk and curbing of varied heights at the intersection of the perimeter road and 12th Street, circa 1997

Note entry road culvert in background.

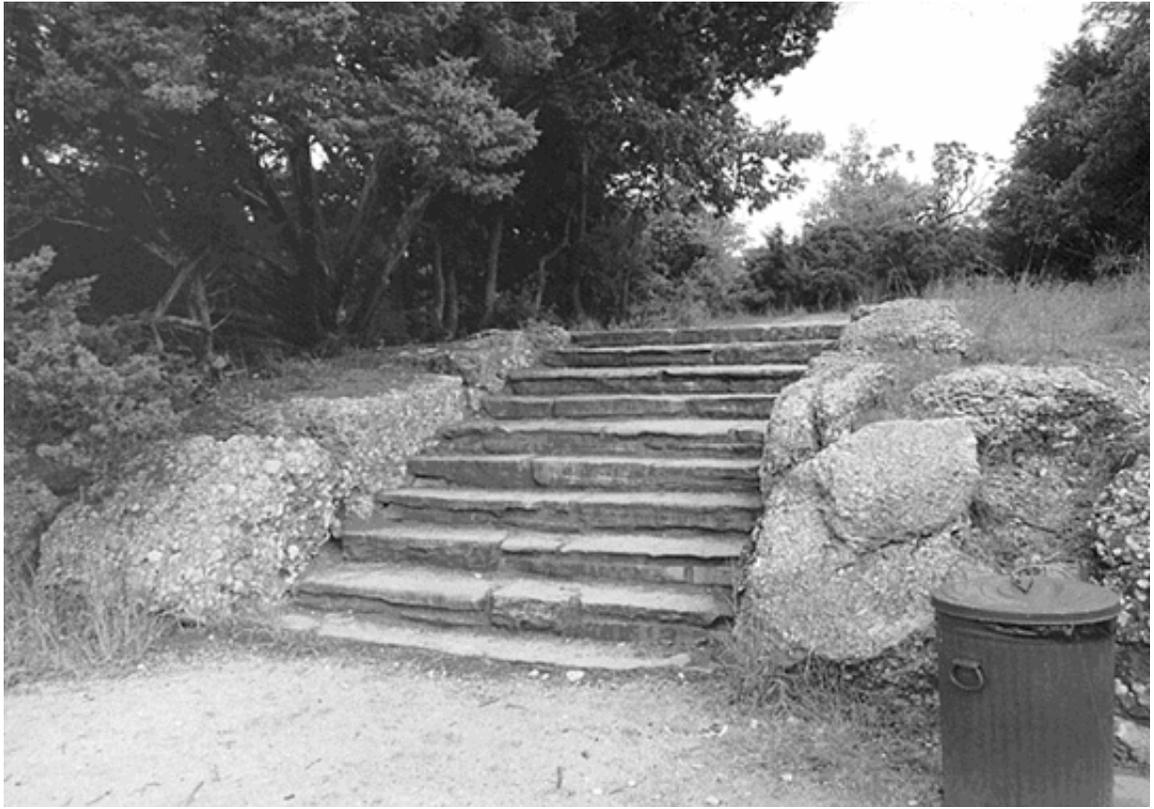
*Stone steps and conglomerate boulders at the Bromide Hill parking area, circa 1997.
(CNRA archives, LCS photograph)*

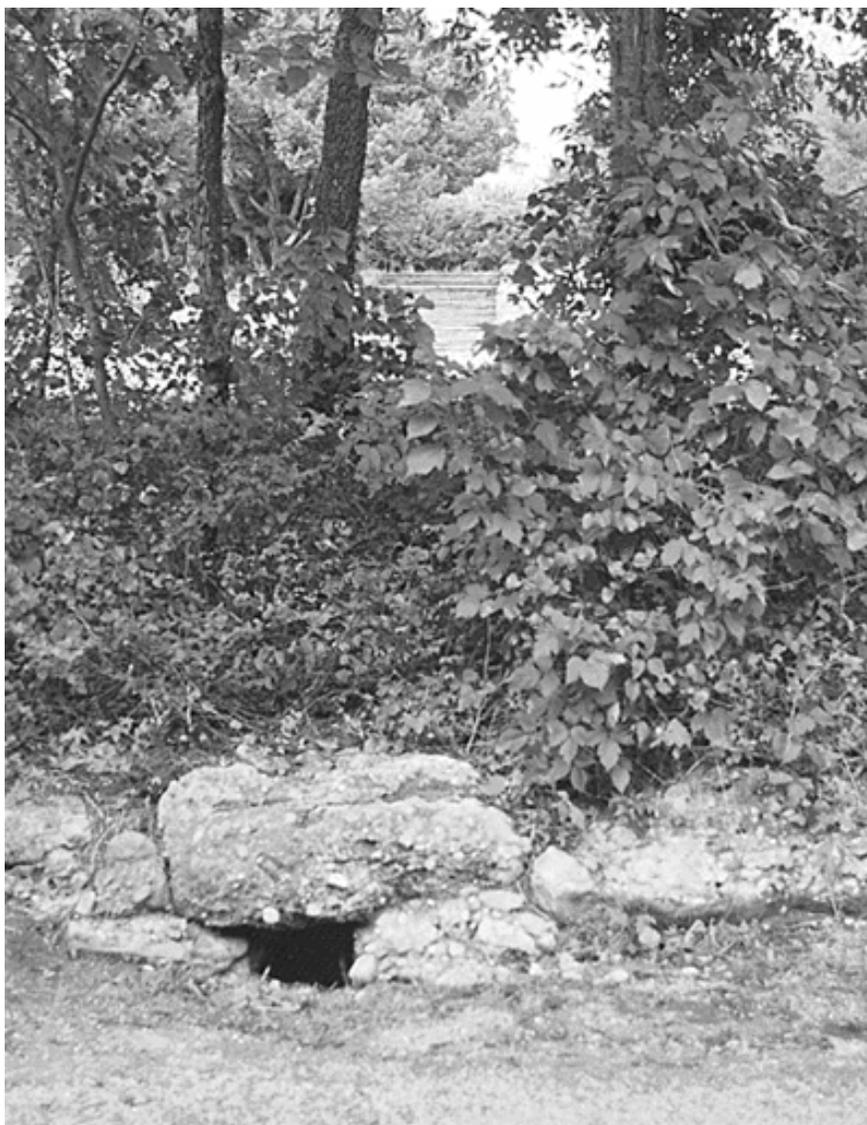
Stone culvert headwall in island between parking area and entry road, circa 1997.

Note steps in the distance.

(CNRA archives, LCS photograph)

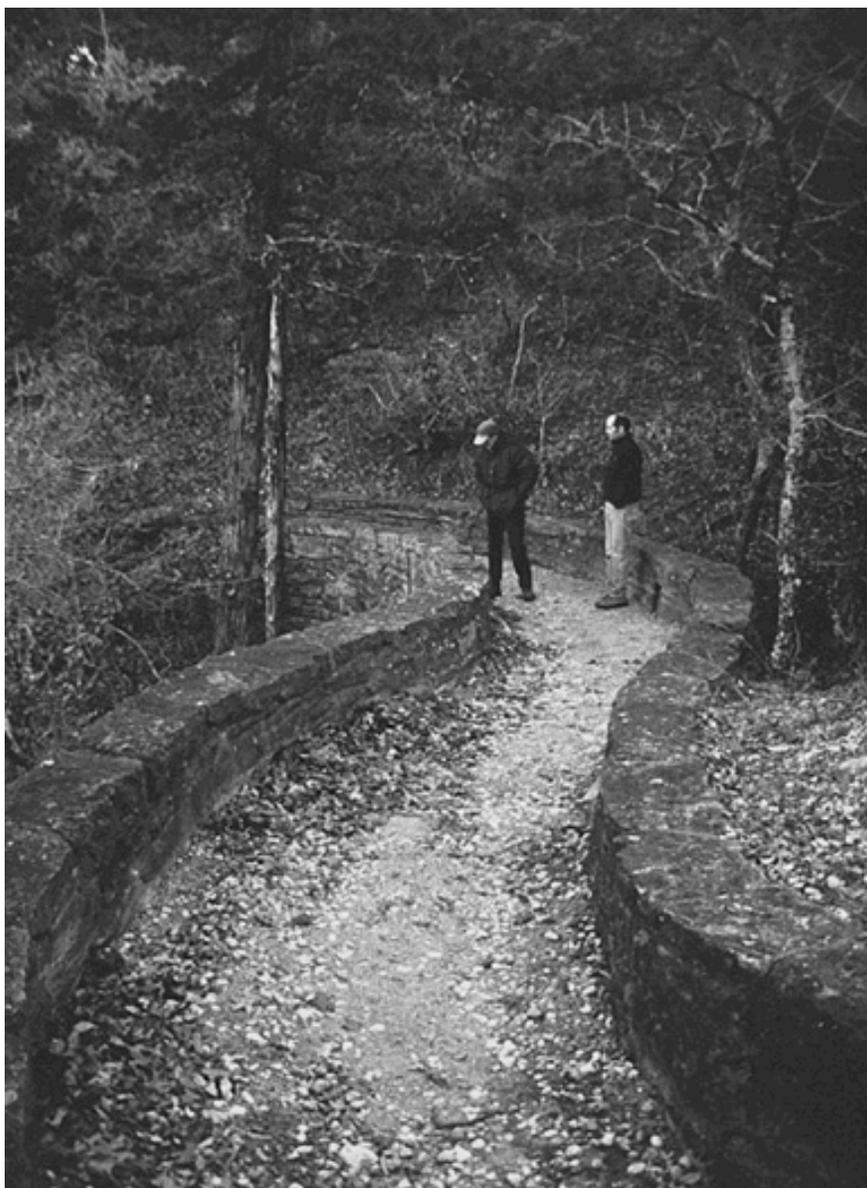
*Trail stone retaining walls along Bromide Hill Trail, 2000.
(Photograph by harlen Groe)*

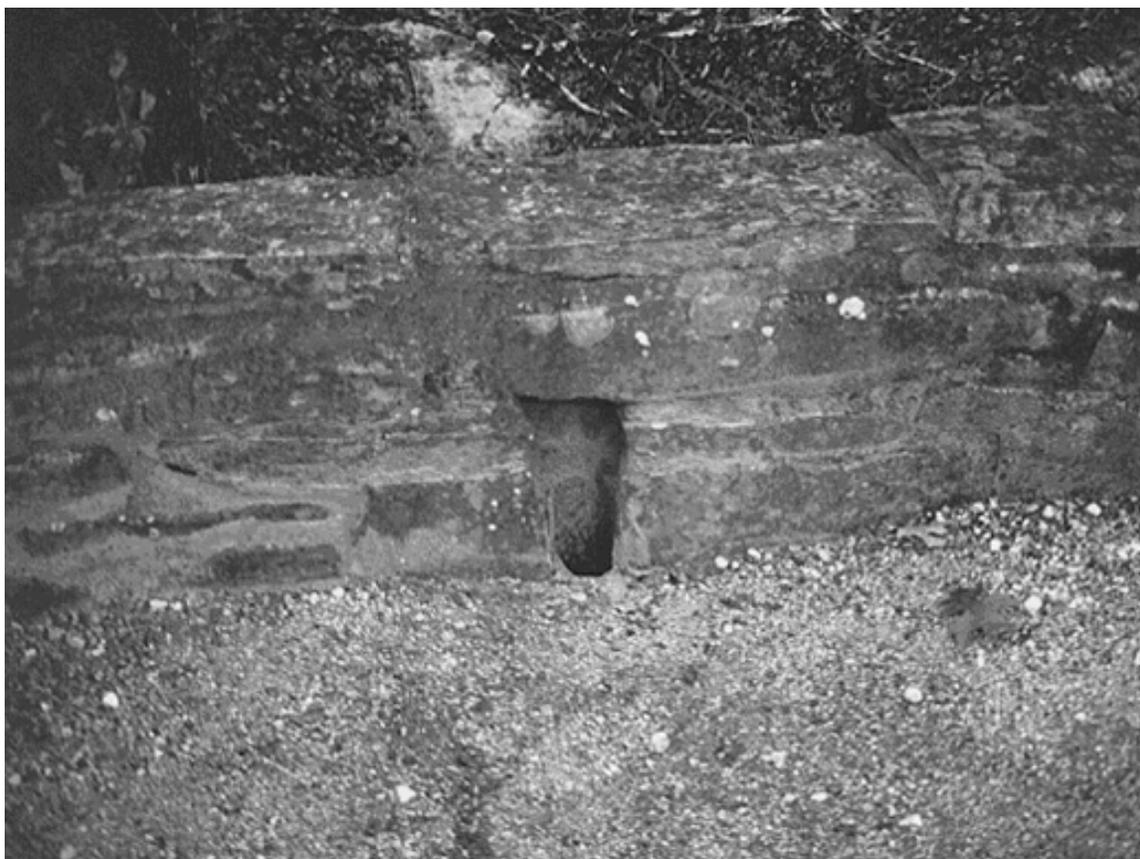
*Typical retaining wall with retaining wall drain along Bromide Hill Trail, 2000.
(Photograph by harlen Groe)*

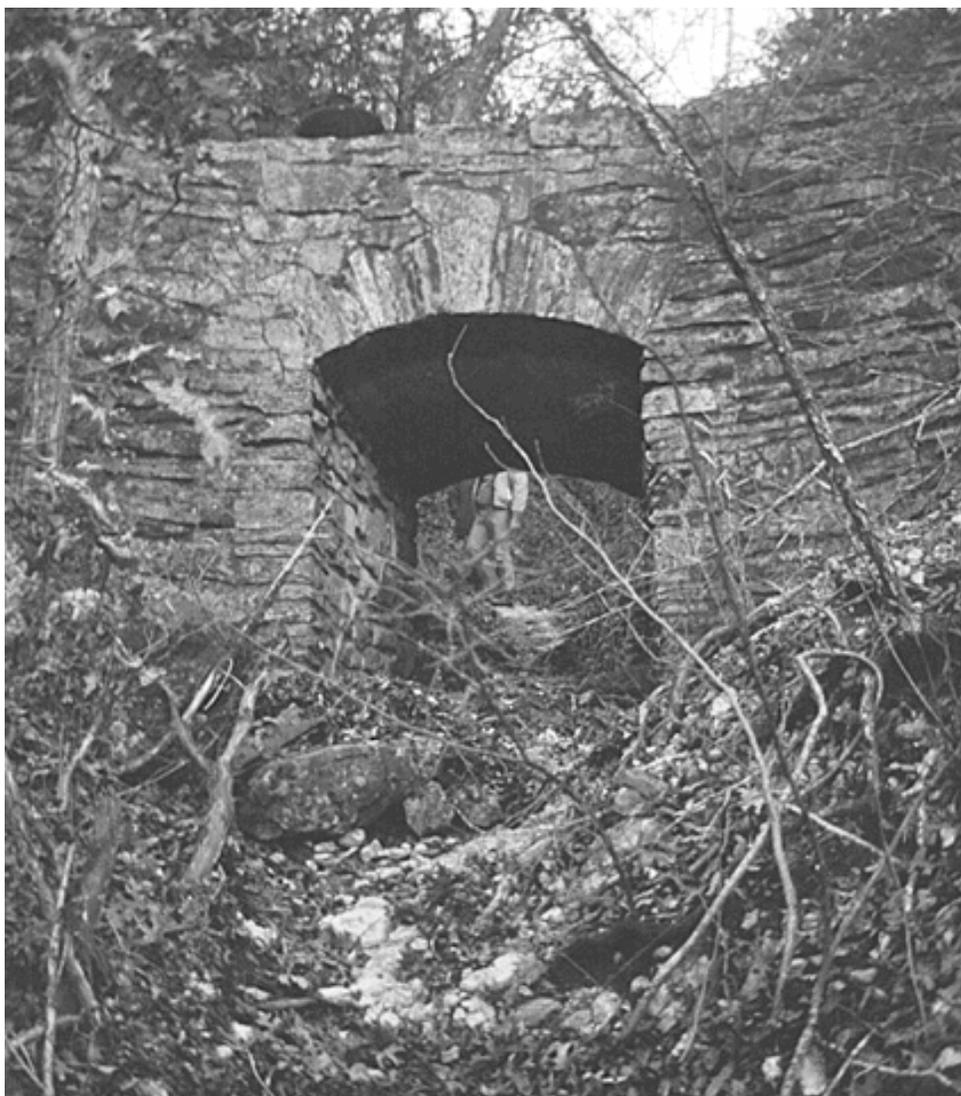
*Downslope side of bridge culvert along Bromide Hill Trail, 2000.
(Photograph by harlen Groe)*

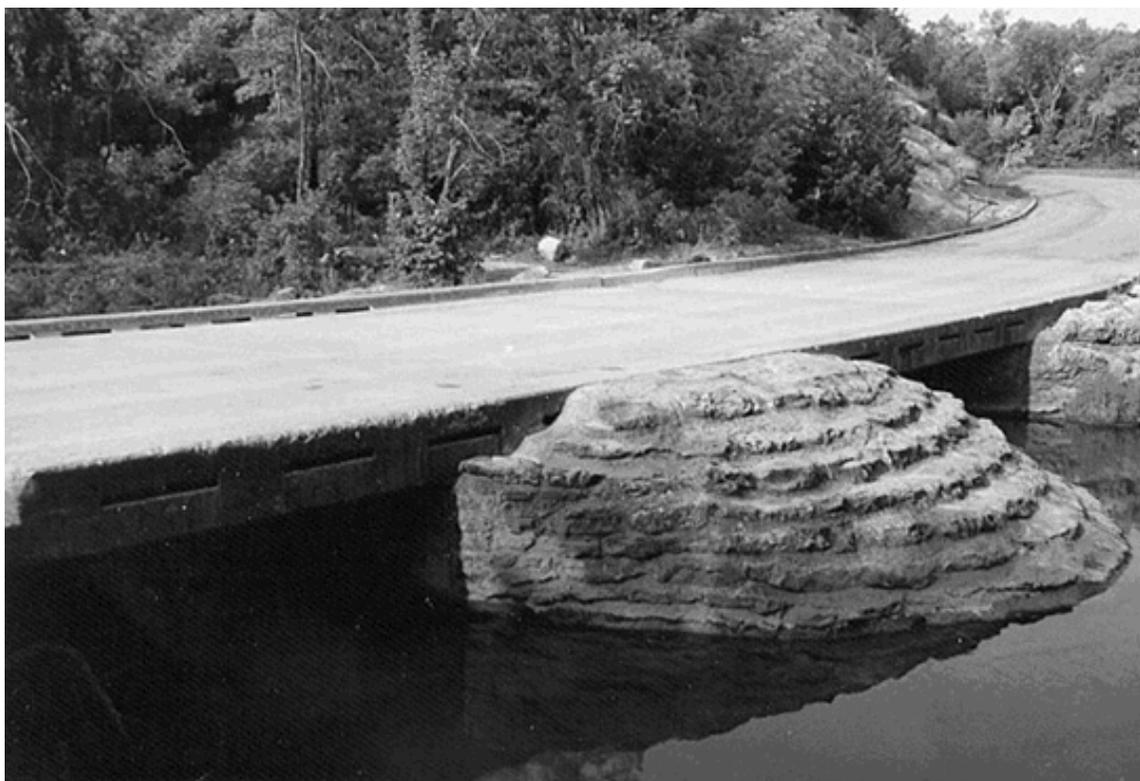
*Low water bridge across Rock Creek along perimeter road.
(CNRA archives, LCS photograph)*

Rock Creek Causeway: The Rock Creek Causeway along the perimeter road is located just west of Bromide springs. Some wear has occurred on the bridge, and in particular, the curbing. The essential layout remains the same, though periodic flooding prompts rebuilding. Built in 1937, the bridge has not changed significantly since then. The bridge is notable for its coursed stone piers.

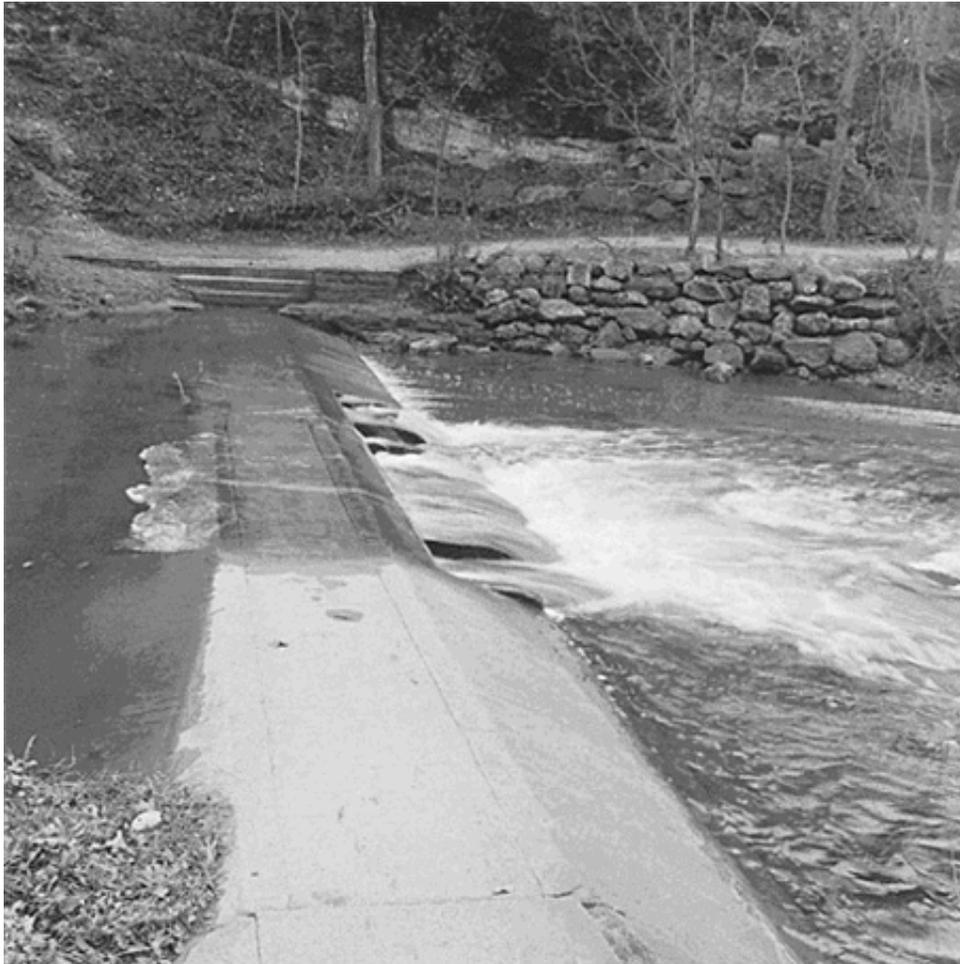
*Pedestrian crossing over Rock Creek between Bromide Springs and Bromide Hill Trail, circa 1997.
(CNRA archives, LCS photograph).*

Bromide Pedestrian Causeway: Bromide Trail is connected to the Bromide Springs area by a low water pedestrian crossing located at the base of Bromide Hill. The bridge is accessed from the parking area near the RV dumping station. The low-water crossing connecting is about three feet in width. Built of concrete, it was completed in the early 1930s.

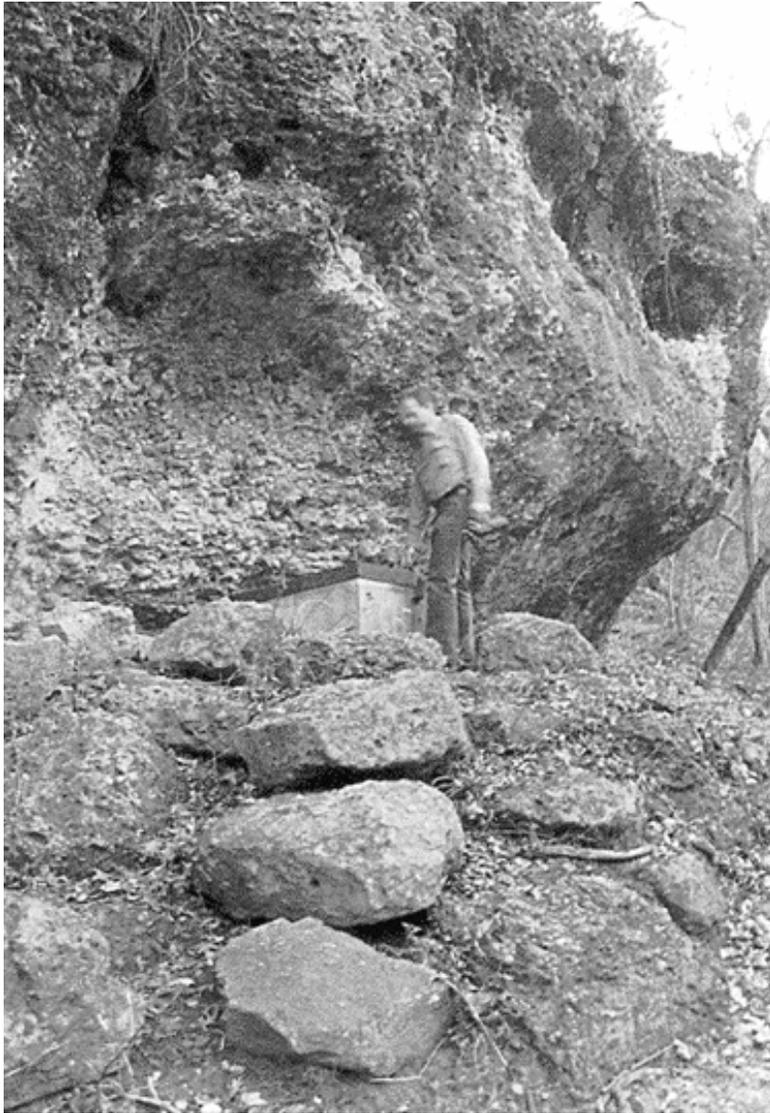
*Spring enclosure elevated above Bromide Hill Trail, circa 1997.
(CNRA archives, LCS photograph)*
