National Park Service  
Cultural Landscapes Inventory  
2008

Historic Designed Landscape  
Chiricahua National Monument

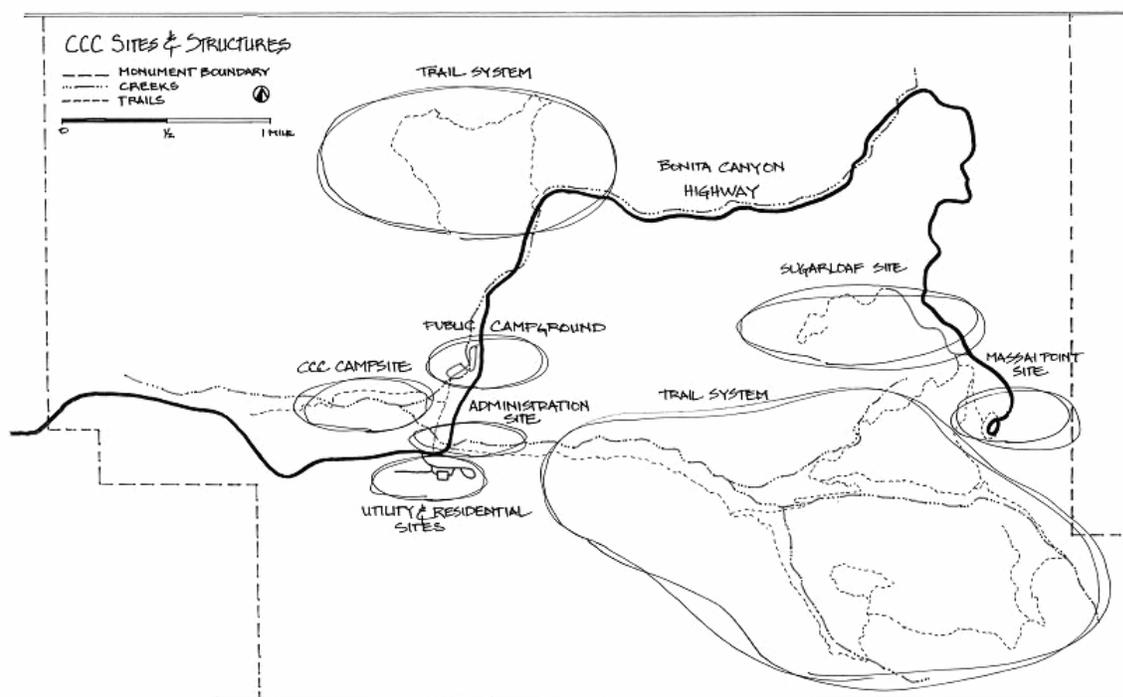
Map 2. Locations of sites and structures identified in Chiricahua National Monument Nomination.

*Map of CCC Sites and Structures within Chiricahua National Monument. Source: CHIR Historic Designed Landscape National Register Nomination, 2007.*

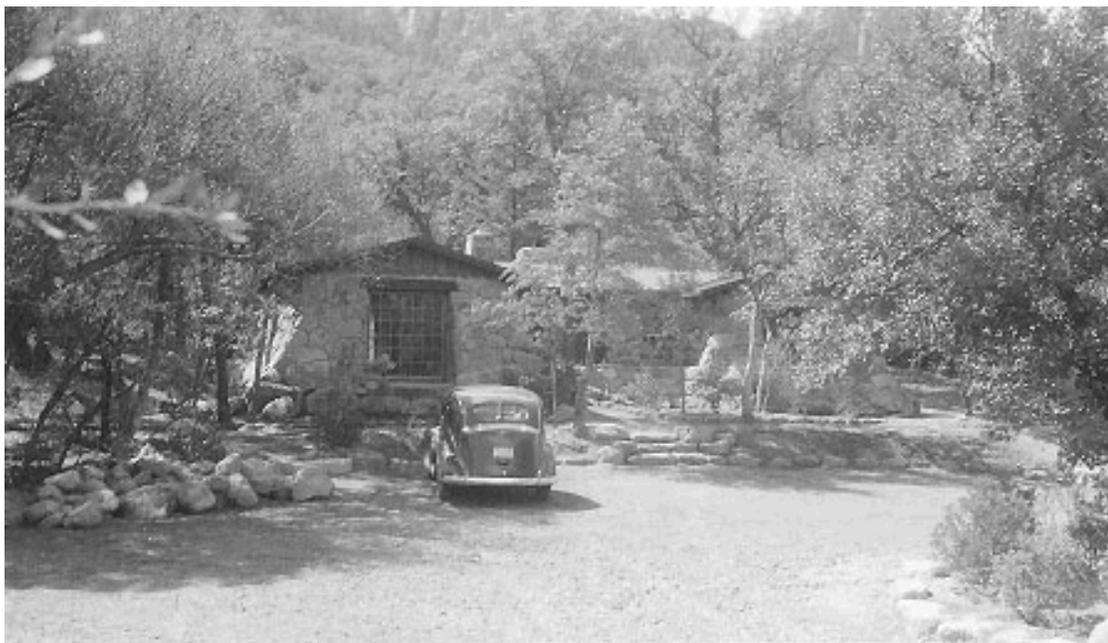
*Administration Building, paths and parking area, 1939. View looking south. Source: Chiricahua National Monument Archives.*

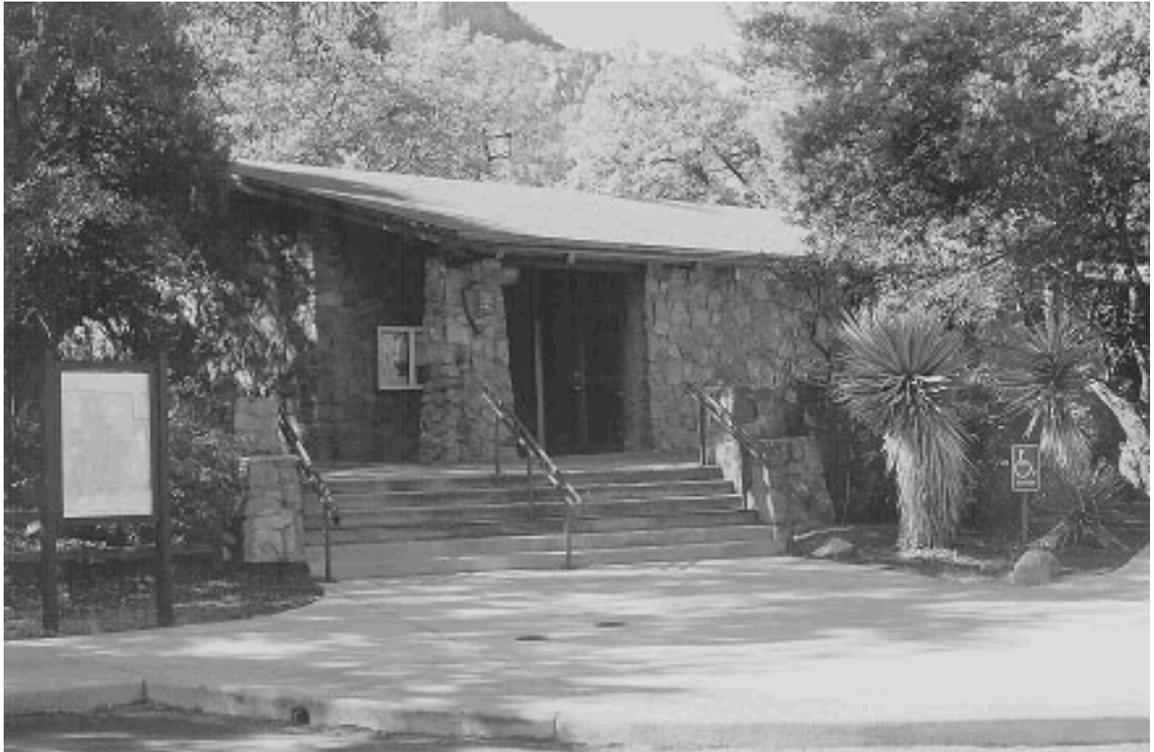
*Visitor's Center, 2002. Source: CHIR Historic Designed Landscape National Register Nomination, 2007.*

The Visitor Center/Administration Building was originally constructed as two buildings, a visitor center/administration building and a comfort station. The original CCC construct was of stone masonry. The foundation is a stone-veneered concrete. The walls are constructed of massive stones sometimes selected because of their ‘rustic’ nature (patinas, lichens, etc.). The drive and parking island in front of the Visitor Center was defined by rock curbs.

In 1967, the Mission 66 construction effort joined the two buildings into one with an enlarged exhibit/visitors area that retained much of the original flavor of the old CCC construction. During the course of this work the original stone curbing that defined the parking/driving lane was removed and replaced with a higher ashlar stone wall set in mortar that acts as a retaining wall. The split rail fence was an addition in coinciding with the Mission 66 effort.

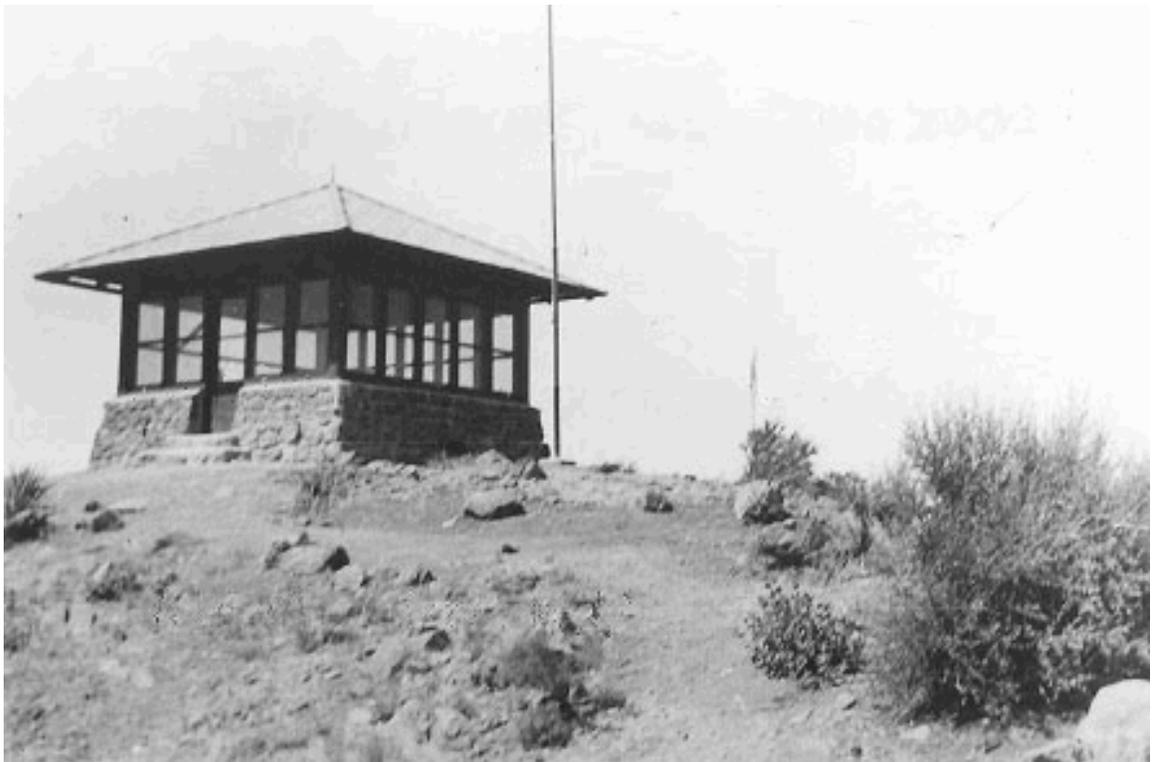
*Sugarloaf Lookout, view looking southwest, 1935. Source: CHIR Historic Designed Landscape National Register Nomination, 2007.*

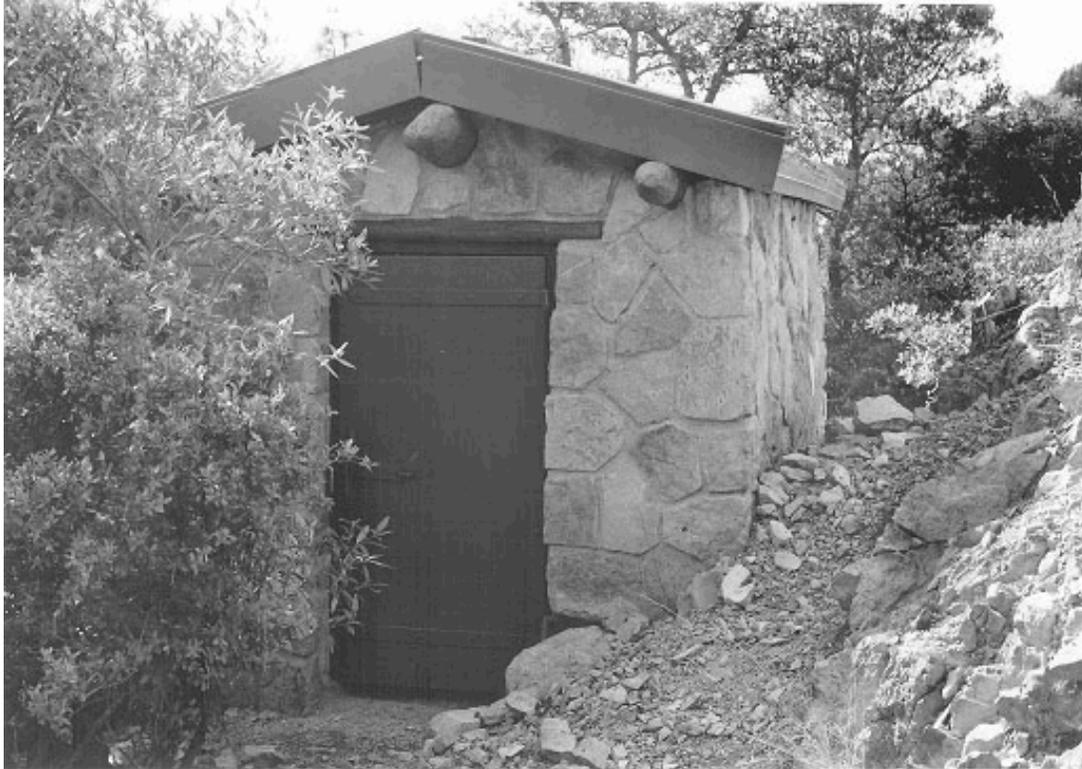
*Second Magazine Cap with steel door, vigas, and replaced roof, 2003. Source: CHIR Historic Designed Landscape National Register Nomination, 2007.*

The final area of consideration is the CCC camp at Bonita Creek which contain a few remaining structures. The structures that remain are rock foundations, two chimneys, a bear cage, a powder magazine, and a cap room. The bear cage is a stone masonry wall enclosing a natural opening in the hill north of the CCC camp. There are iron bars set in the wall creating a cage. The two chimneys remaining date from 1948-49 -- the dude ranch period-- and are therefore non-contributing. The building was unfortunately demolished by the National Park Service in the 1960s. The powder magazine and cap magazine is a cave excavated into the hillside on the north side of Rhyolite Canyon. There is a steel door with wood frame. The cap magazine is near the powder magazine and is constructed of stone masonry. The condition of the powder magazine is good. However, the cap magazine is in poor condition.

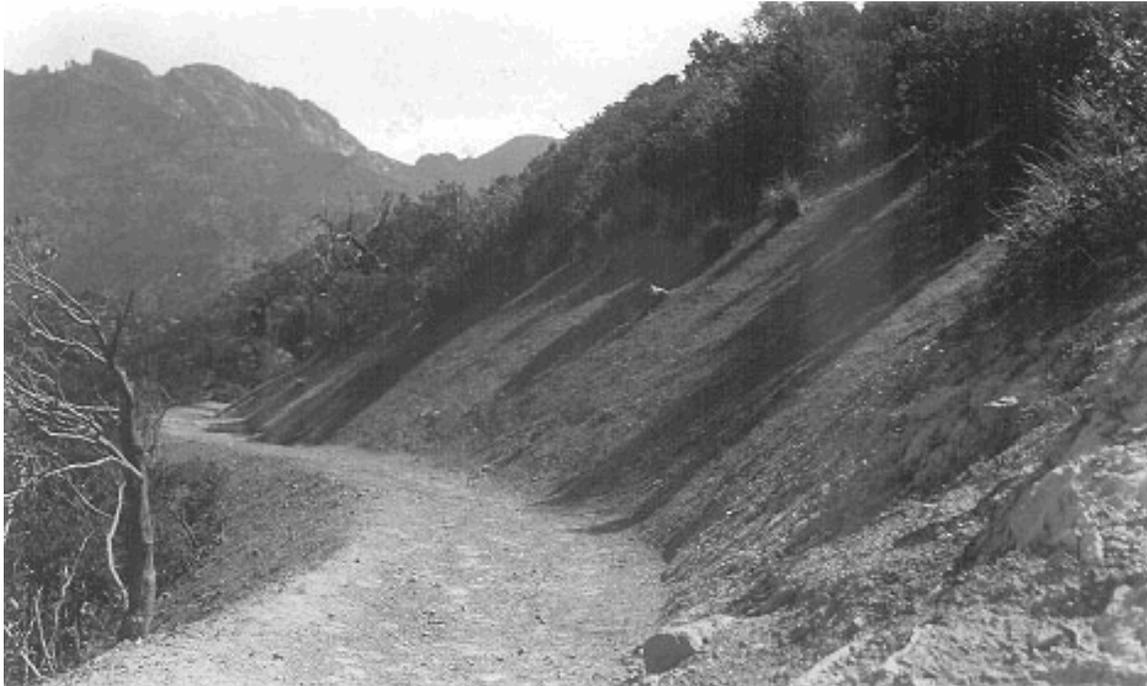
*Sugarloaf CCC Trail shortly after completion, 1935. Source: CHIR Historic Designed Landscape National Register Nomination, 2007.*

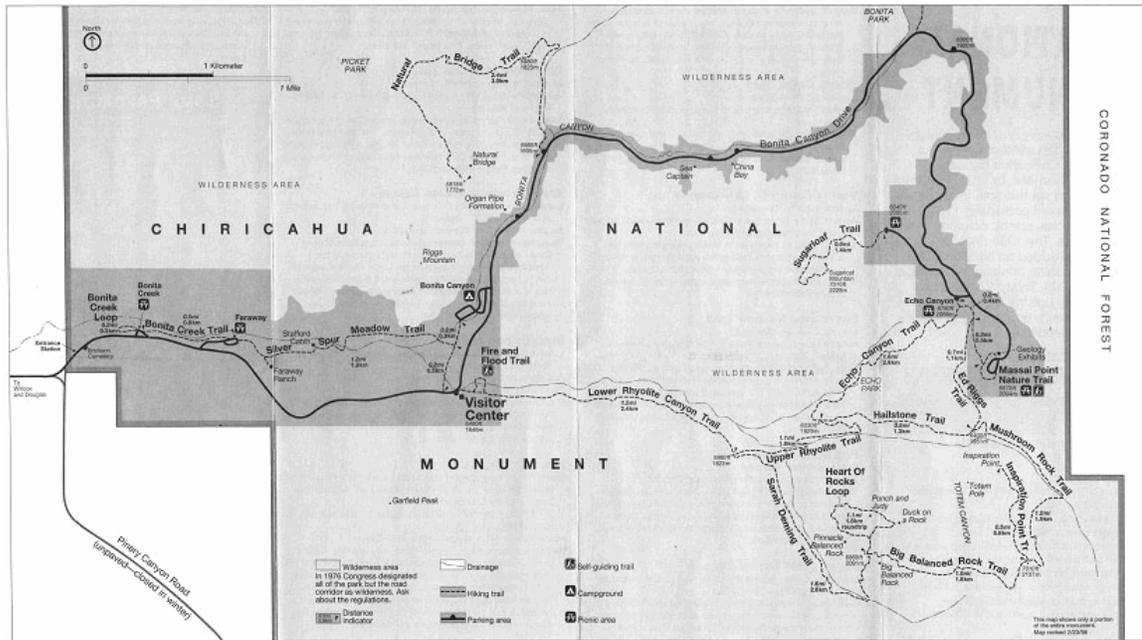
Map 3. Locations of and connections between Bonita Canyon Highway and the trail system in Chiricahua National Monument.

*Map of Bonita Canyon and Trails, 2007. Source: CHIR Historic Designed Landscape National Register Nomination, 2007.*

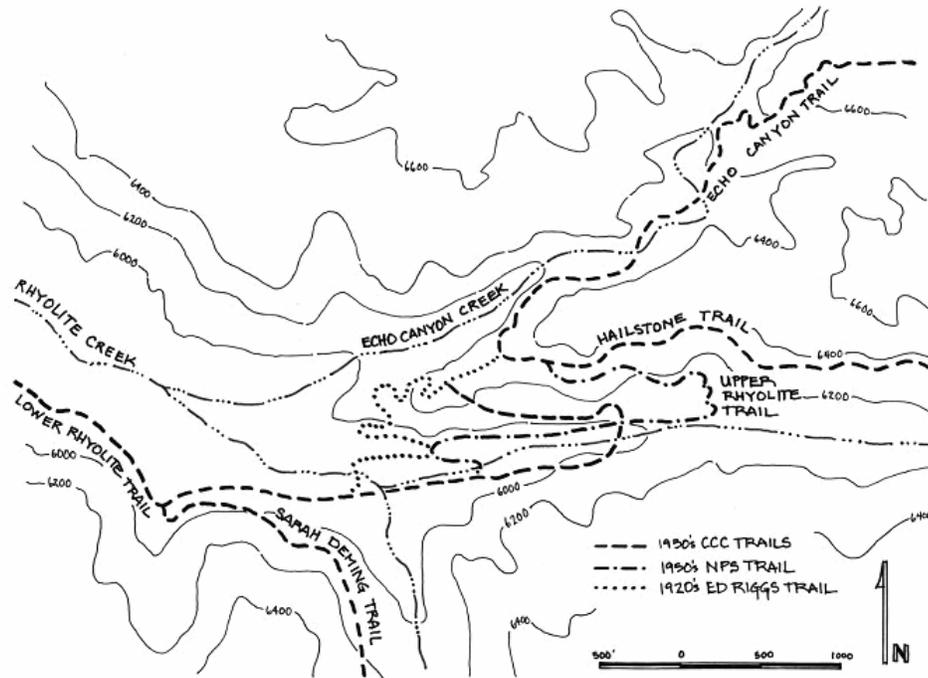
Map 4. Historic trails in Upper Rhyolite Canyon showing locations of early Ed Riggs trail, CCC-constructed trail, and present-day Upper Rhyolite trail built in the mid-1950s.

*Map showing historic trails. Source: CHIR Historic Designed Landscape National Register Nomination, 2007.*

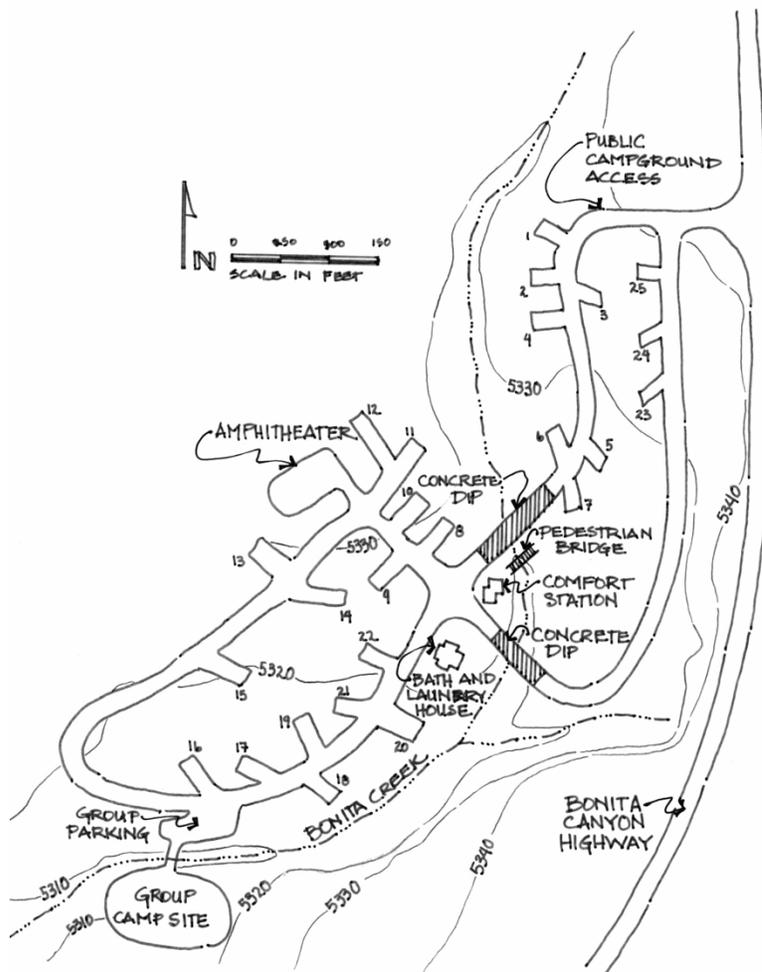
Map showing arrangement of public campground. Source: CHIR Historic Designed Landscape National Register Nomination, 2007.

At a smaller scale, the circulation within the Public Campground was laid out according to the "Meineke plan." Emilio Meineke, a US Forest Service plant pathologist, developed this plan in 1932 which was immediately adopted by the National Park Service for use in its own campgrounds (McClelland 1998: 277-278). The plan emphasizes a one-way automobile circulation and creates restrictions on locations available for automobile and camper parking. This circulation arrangement limits damage caused by automobile tires to soils and surrounding vegetation.

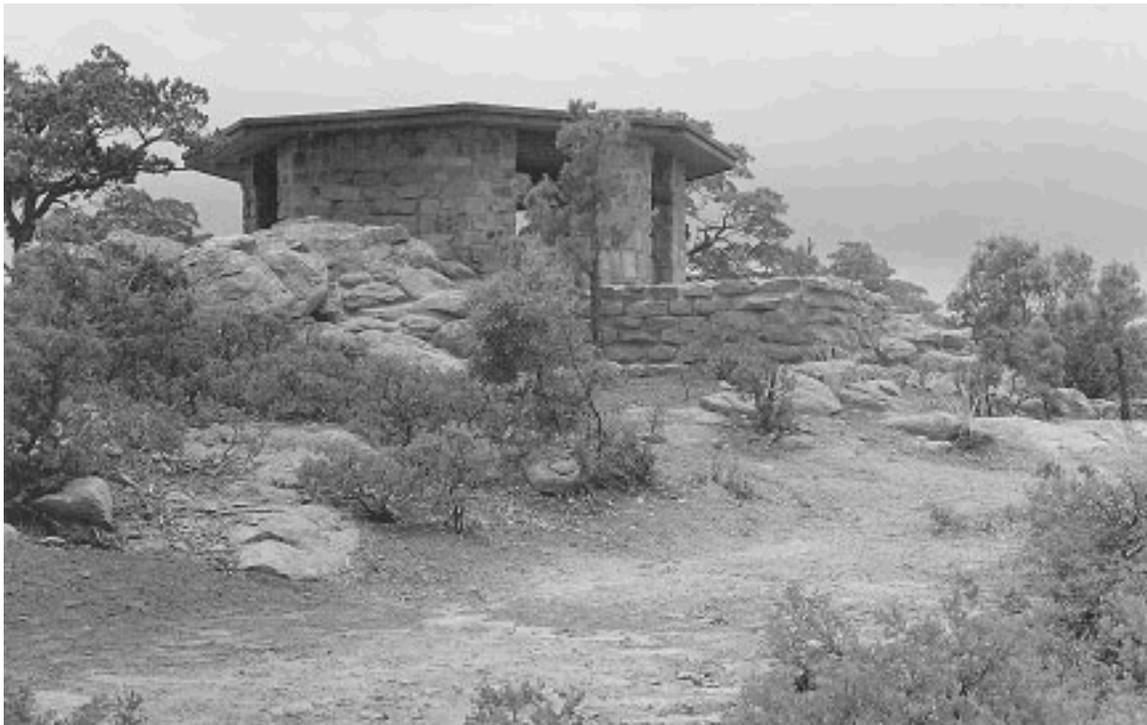
*Massai Point Orientation Station, following completion of construction and landscaping, 1940. Source: CHIR Historic Designed Landscape National Register Nomination, 2007.*

The second structure found at Massai Point is the exhibit building located on a knoll just north of the Massai Point parking area. This structure was designed by the noted architect Cecil Doty and is an octagonal building with a rectangular porch and entry door facing north. The building's porch and floor are native stone, but the building itself is coursed ashlar stone. The octagon's sides face significant landmarks and rock features, including Cochise head and Sugarloaf Mountain. The native stone on the south side of the exhibit buildings reveals coring for explosives. Perhaps it once suggested an exterior exhibit. With further exploration, the remnants of the barbecue pits from the opening day ceremonies can be located on this knoll.

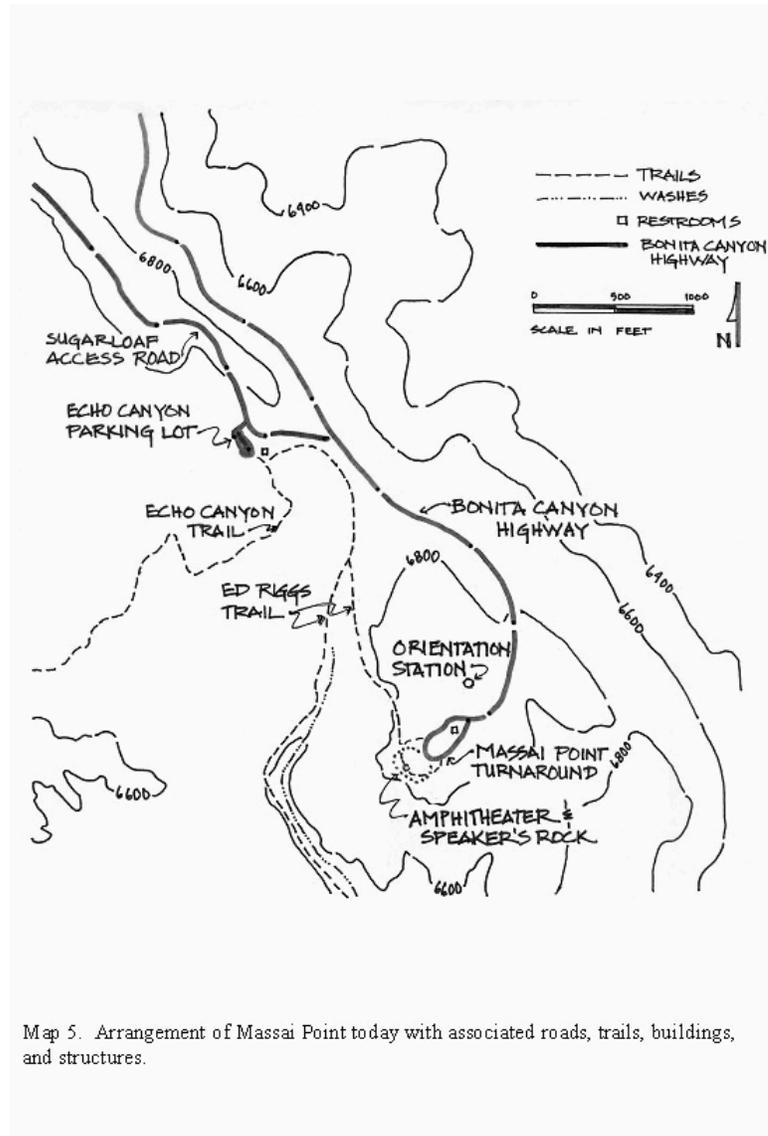
*Map showing arrangement of Massai Point. Source: CHIR Historic Designed Landscape National Register Nomination, 2007.*

The structures found at Massai Point contribute to the historical integrity of the monument. The Massai Point overlook is a roughly circular construct on top of a rock outcrop that is built of rubble. Surrounding the viewing area is a low wall approximately 3' tall with a surrounding bench. The trail out to the overlook is dirt with a railing embedded in the rock. Massai Point is all original CCC construction. The overlook affords the visitor an astounding view at the rock formations and distinct mountains. A lensless telescope is mounted in the overlook to identify prominent rock formations, mountains, and the Sugarloaf Mountain fire lookout. The construction of the lookout does not have the quality of craftsmanship observed in other structures. The construction material is rock rubble that has been stacked and mortared to create thin rock walls.

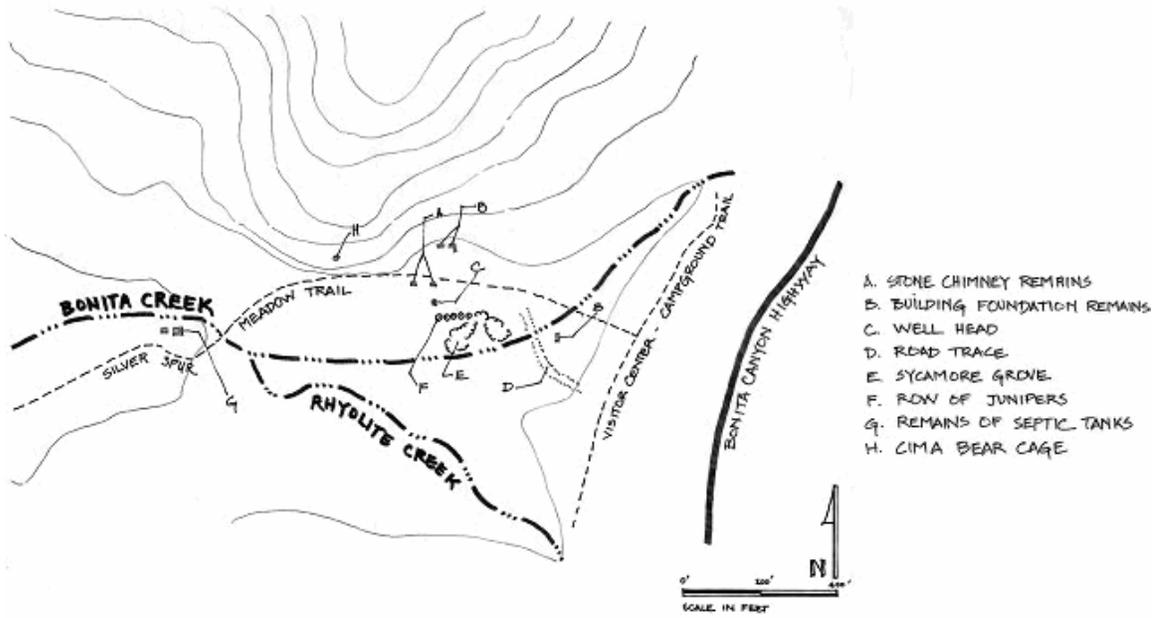
Map 14. Silver Spur Meadow today with remains of CCC structures.

*Map of Silver Spur Meadow. Source: CHIR Historic Designed Landscape National Register Nomination, 2007.*

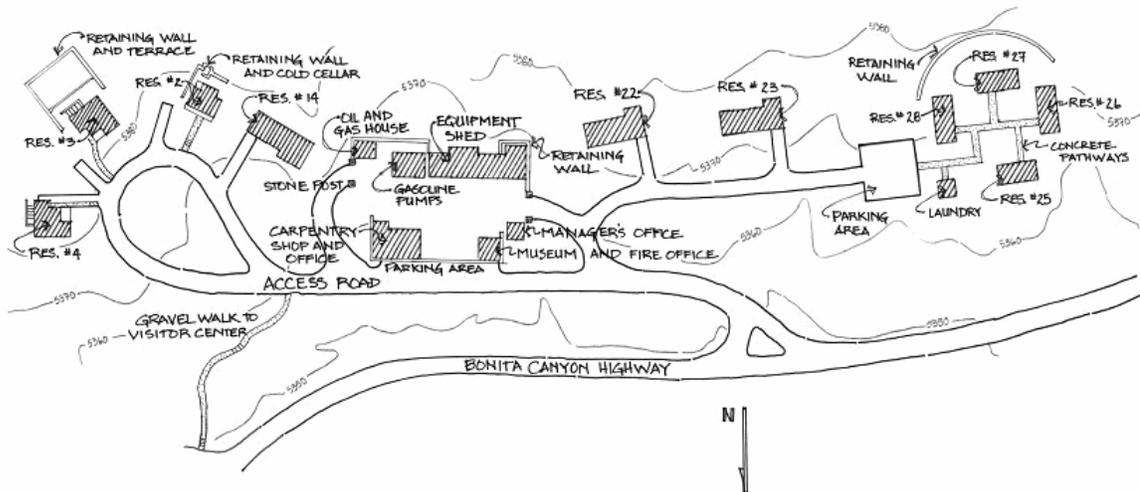
Map 15. Residential and Utility Areas with associated buildings, access roads, and structures as they exist today.

*Map of Residential and Utility areas. Source: CHIR Historic Designed Landscape National Register Nomination, 2007.*

Four staff residences are constructed above the Visitor Center/administration building. Three of these buildings are constructed in the Government Rustic style and the fourth in the Mission 66 style. Arranged around a vehicle round-about, the staff quarters have 3 to 5 rooms each with no parking garages. Stone curbing defines the roads and driveways. Typical stone

The maintenance complex comprises the gas and oil building, powerhouse, and laundry building. Set into the north-facing aspect of Rhyolite canyon, the maintenance complex is composed of structures that are constructed of ashlar stone in the rustic style. Doors and wiring have been upgraded but the exterior of the building possesses its original style. The CCC constructed an impressive retaining wall on the north side of the complex of ashlar stone laid with concrete mortar.

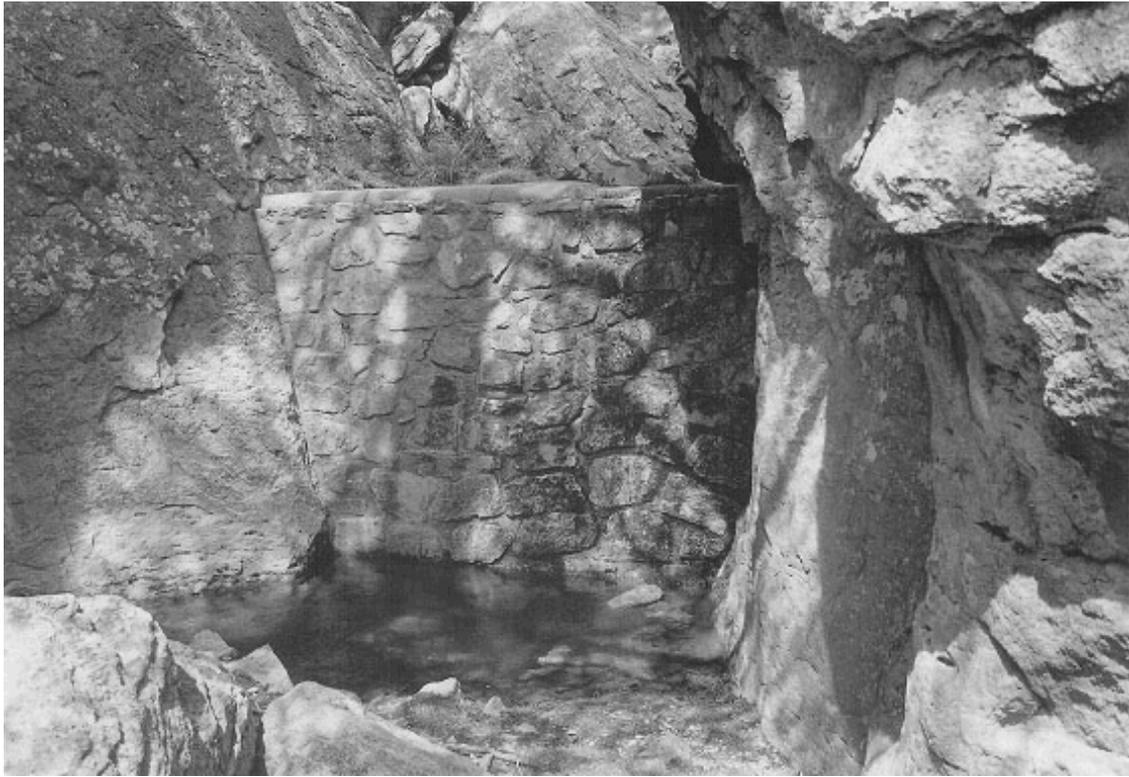
*Echo Canyon Dam, 1993. Source: CHIR Historic Designed Landscape National Register Nomination, 2007.*

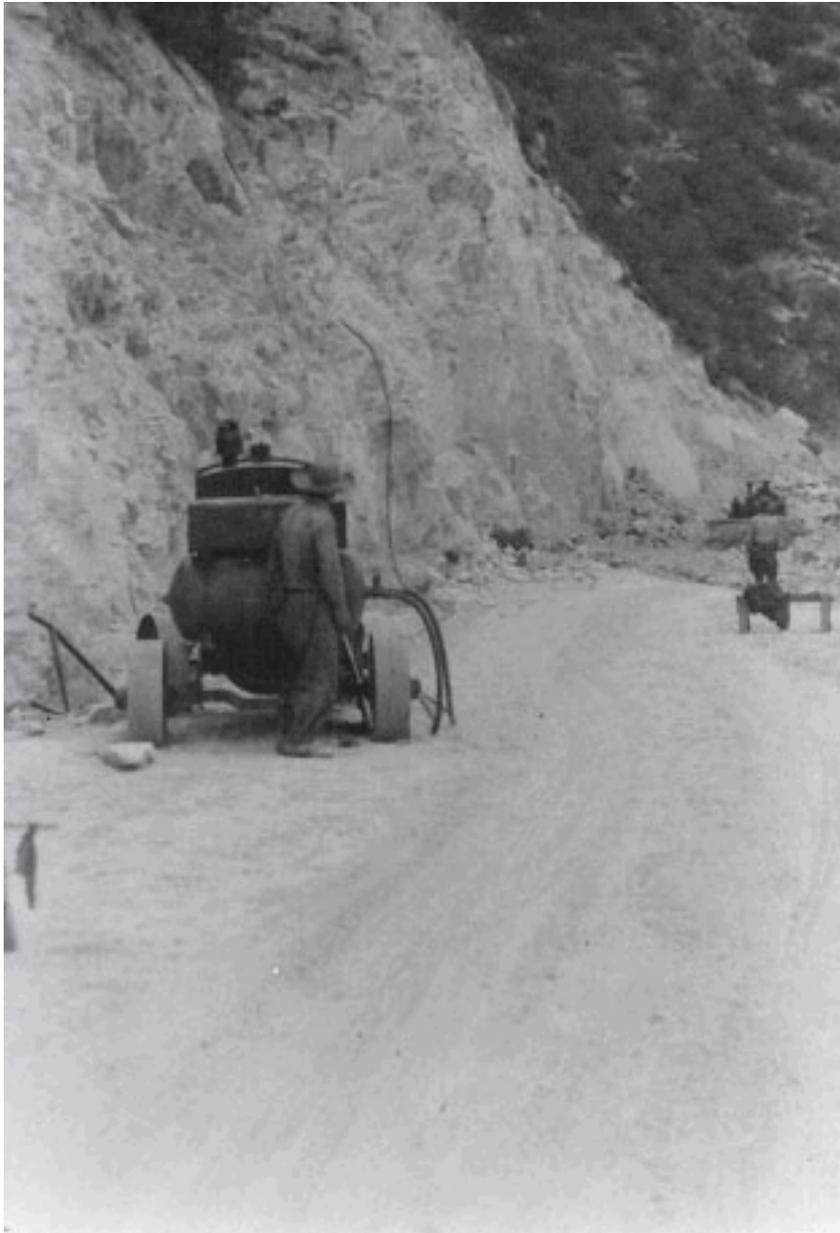
*Construction of Bonita Canyon Highway. Source: CHIR Historic Designed Landscape National Register Nomination, 2007.*

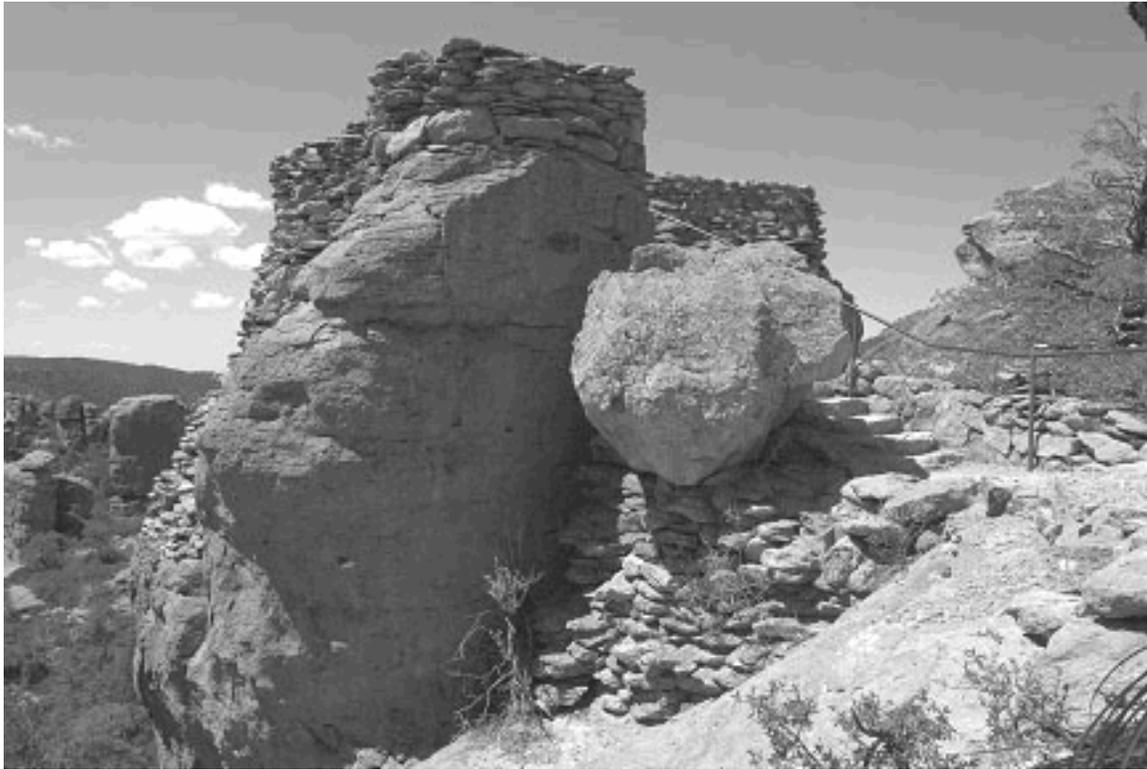
*Speakers Rock at Massai Point incorporates large boulders into base of rostrum and boundary of stairs. View looking northwest, March 2004. Source: CHIR Historic Designed Landscape National Register Nomination, 2007.*
