National Park Service  
Cultural Landscapes Inventory

Georgetown Area  
Chesapeake and Ohio Canal National Historical Park  
August 2018

## Inventory Unit Summary & Site Plan

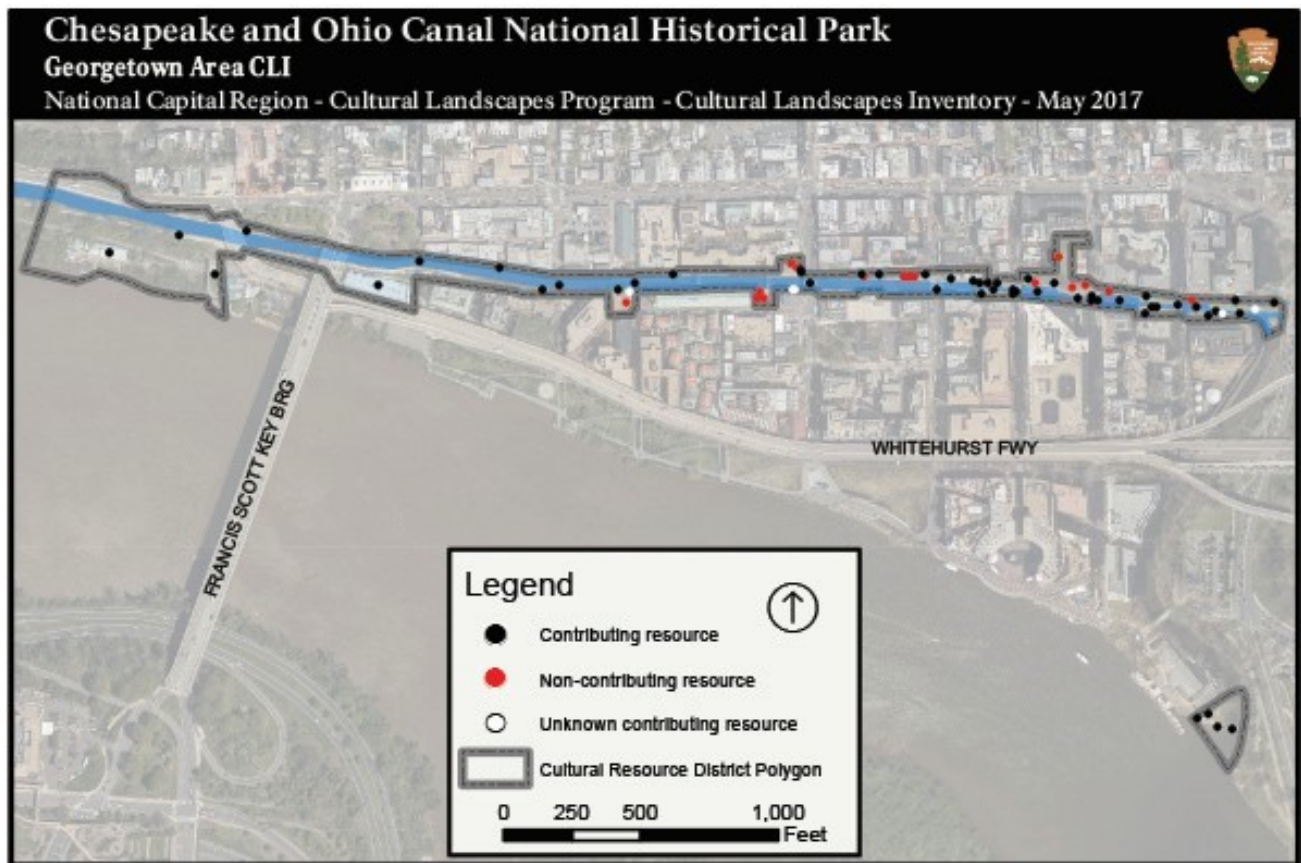
### Site Plan

*Site Plan. A larger, more legible map depicting the study area has been added to an appendix at the end of the document. Contributing resources are rendered in black and non-contributing resources are rendered in red (NCR CLP 2017).*

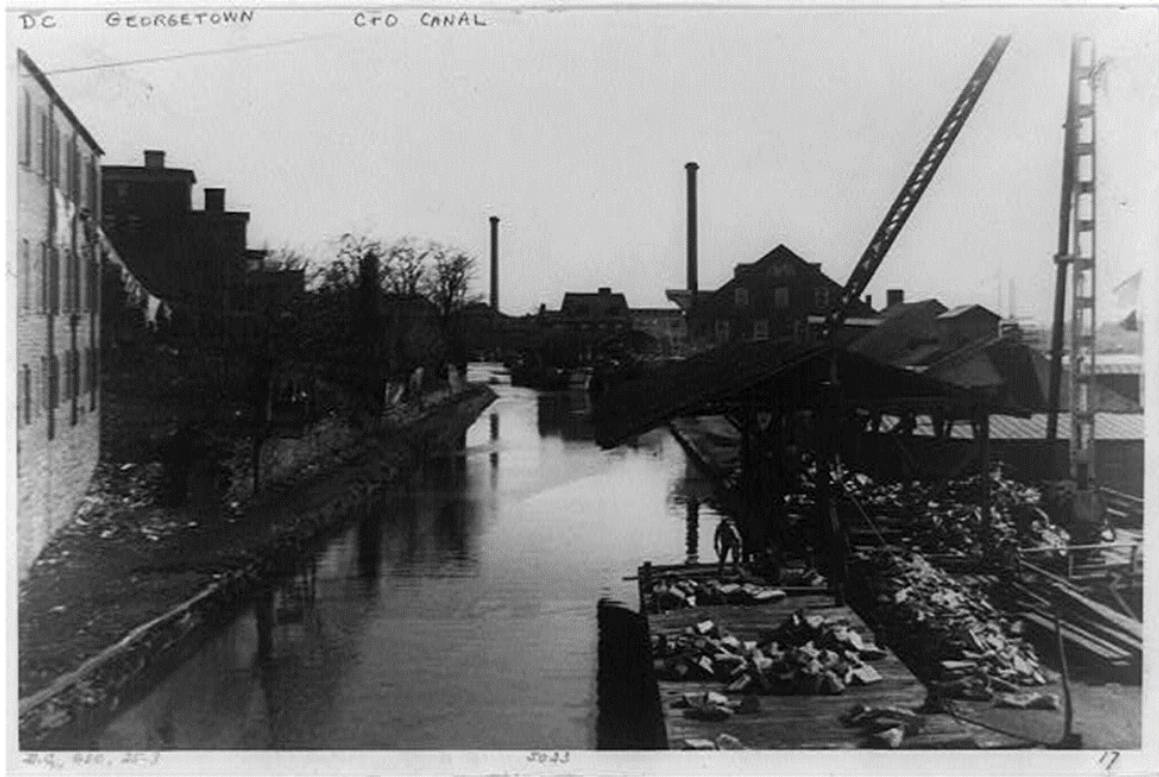
*This photograph shows the canal looking east towards 33rd Street. On the river side of the canal a worker is unloading goods from a barge. "C&O Canal and Wisconsin Avenue Bridge, Georgetown, Washington, D.C." 1890. From the Library of Congress (<https://www>*

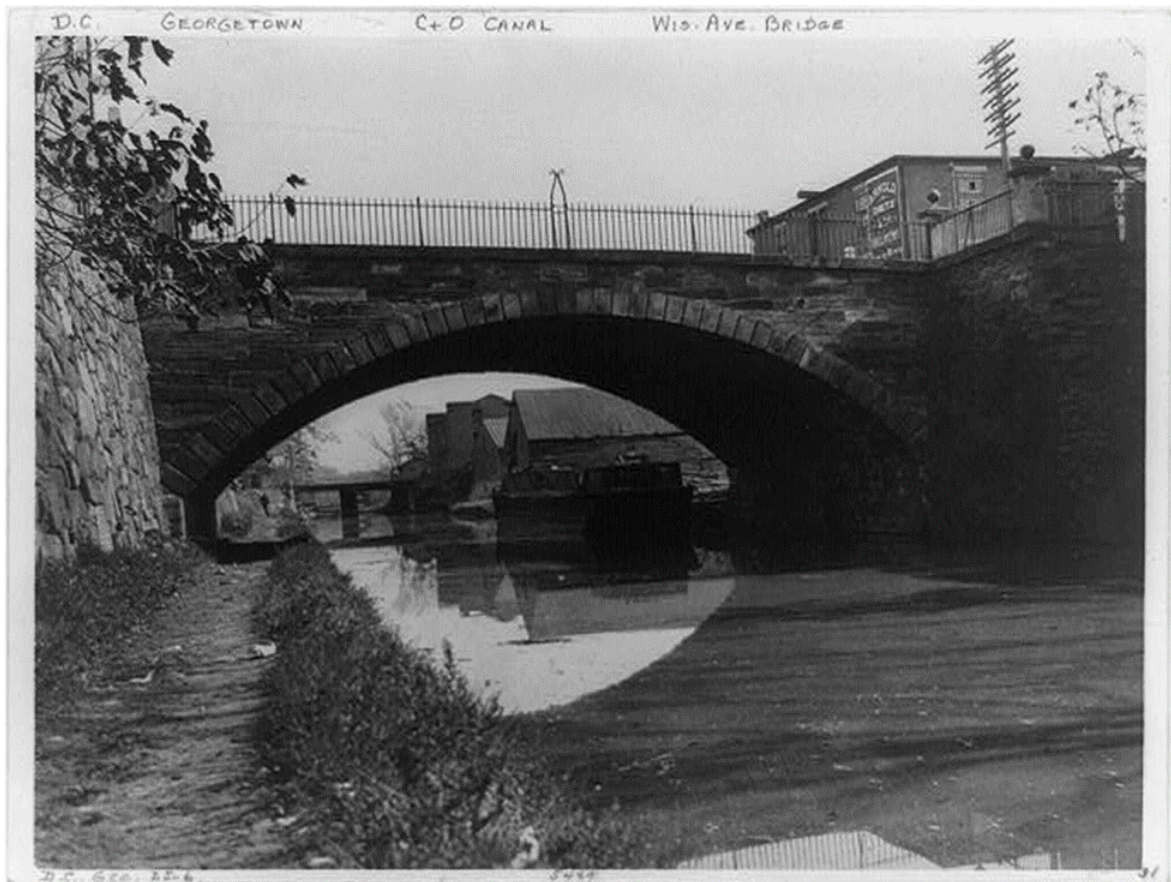
*This historic photograph of Wisconsin Avenue Bridge was taken looking east from the towpath level of the C&O Canal. "C&O Canal and Wisconsin Avenue Bridge, Georgetown, Washington, D.C." 1890. From the Library of Congress (<https://www.loc.gov/item/96502917>)*

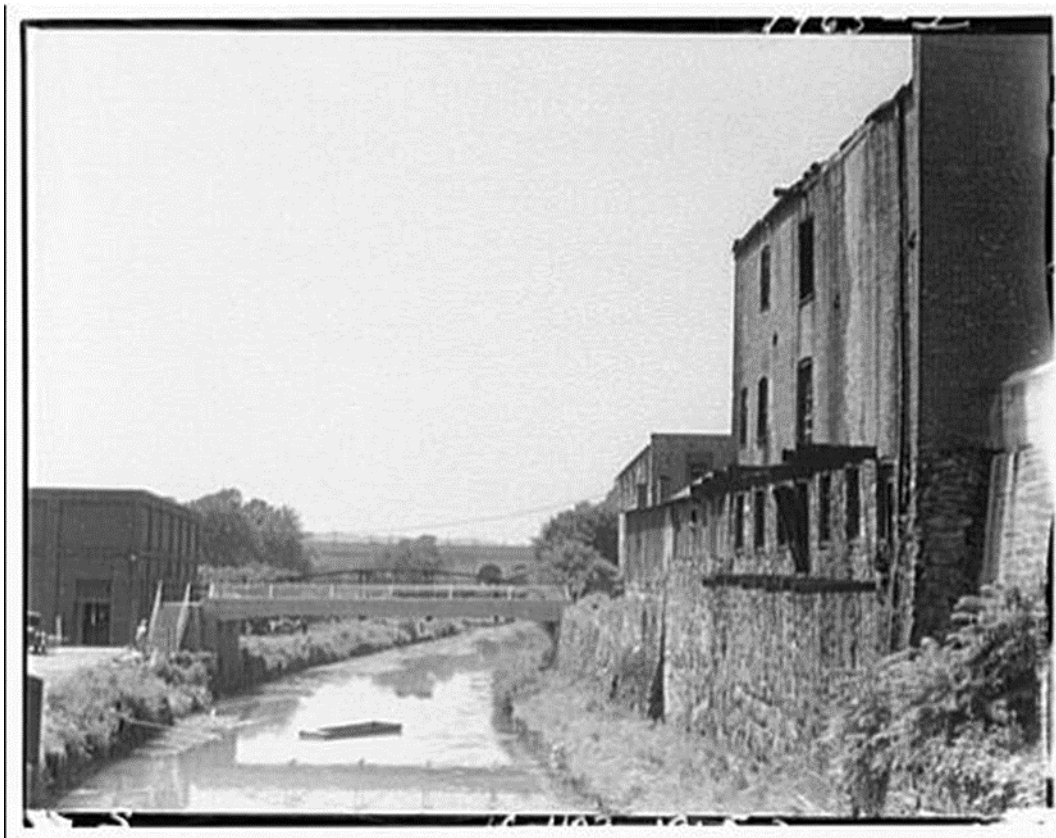
*The Potomac Street Bridge circa. 1920-1950. "Chesapeake and Ohio Canal (C&O Canal) Canal in Georgetown. C&O Canal View I." Theodor Horydczak, ca.1920-1950. From the Library of Congress (<https://www.loc.gov/item/thc1995004371/PP/>, accessed 2017).*

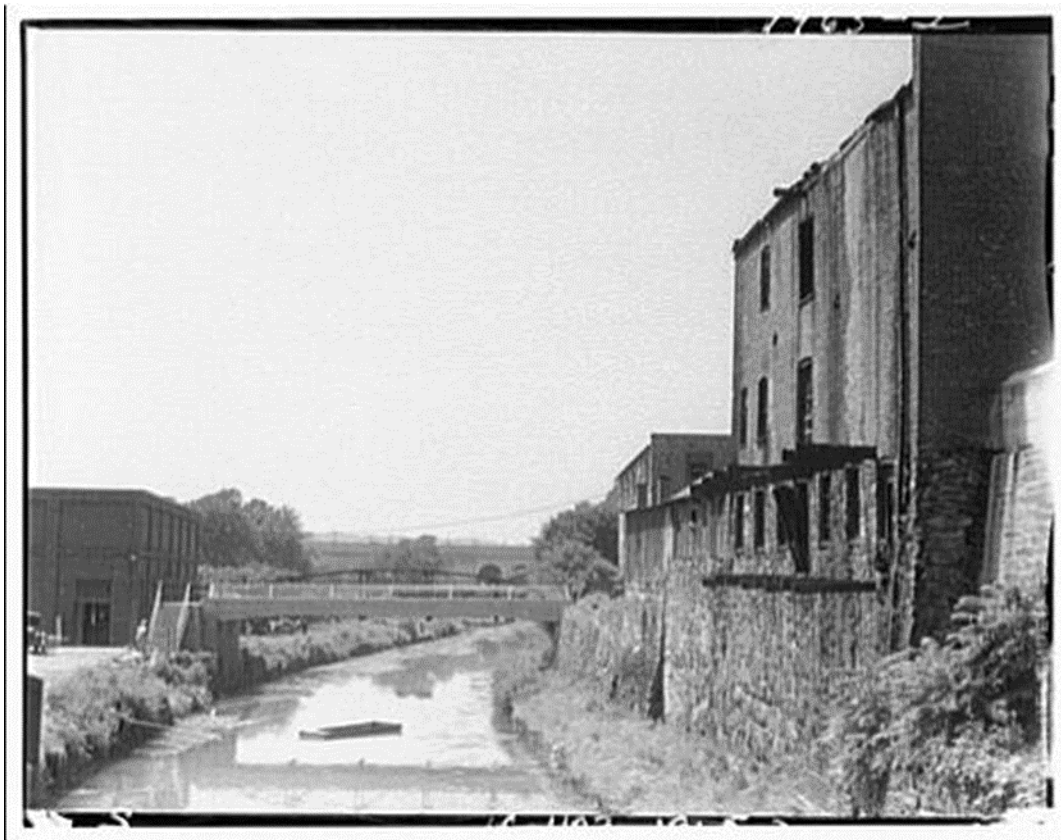
*The historic Wisconsin Avenue Bridge. There is minimal development on the berm and river side of the canal east of Wisconsin Avenue."Chesapeake and Ohio (C&O) Canal in Georgetown. View of C&O Canal with bridge." Theodor Horydczak, ca. 1920-1950. From the From the Library of Congress (<https://www.loc.gov/item/thc1995004374/PP/>, accessed 2017.)*

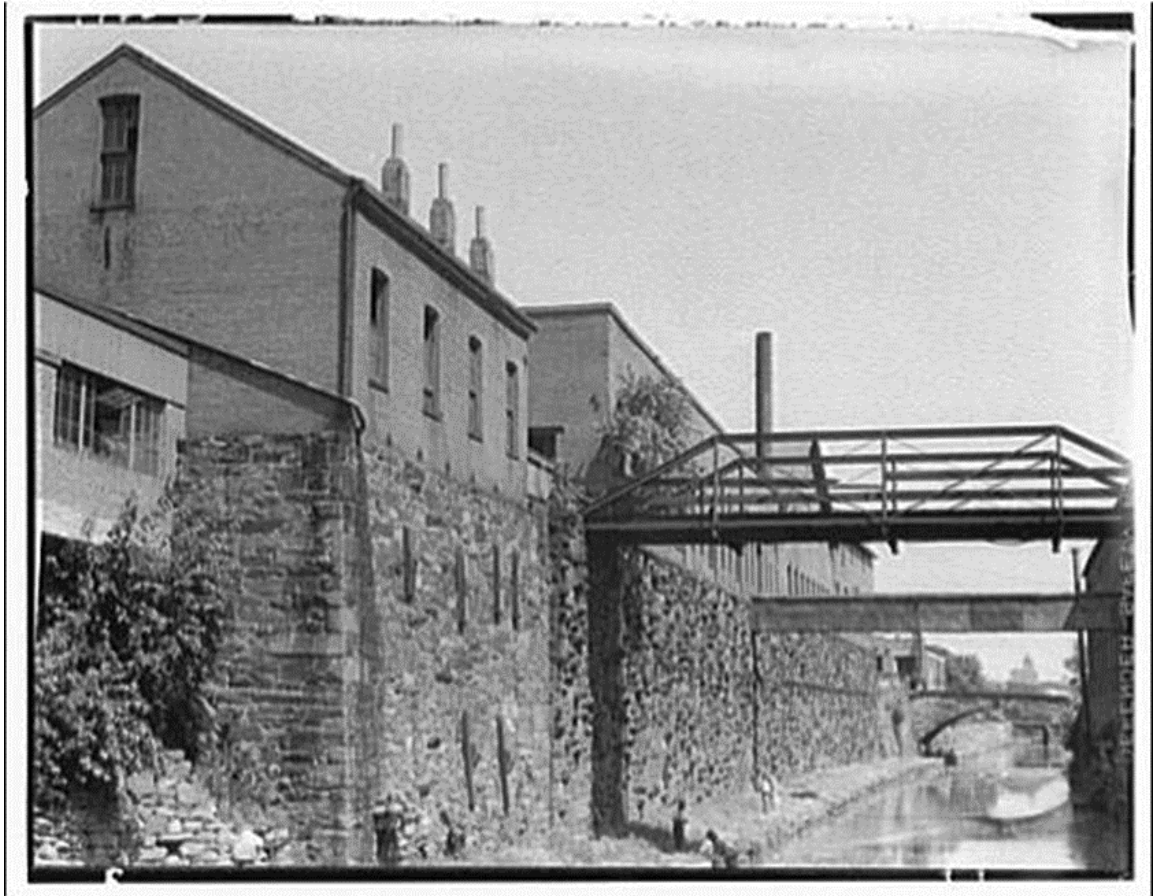
*The bridge closest to the viewer is the High Bridge, with the High Passageway in the mid ground, and Wisconsin Avenue Bridge in the background“Chesapeake and Ohio Canal (C&O Canal) in Georgetown. C&O Canal View II.” Theodor Horydczak, ca. 1920-1950. From*

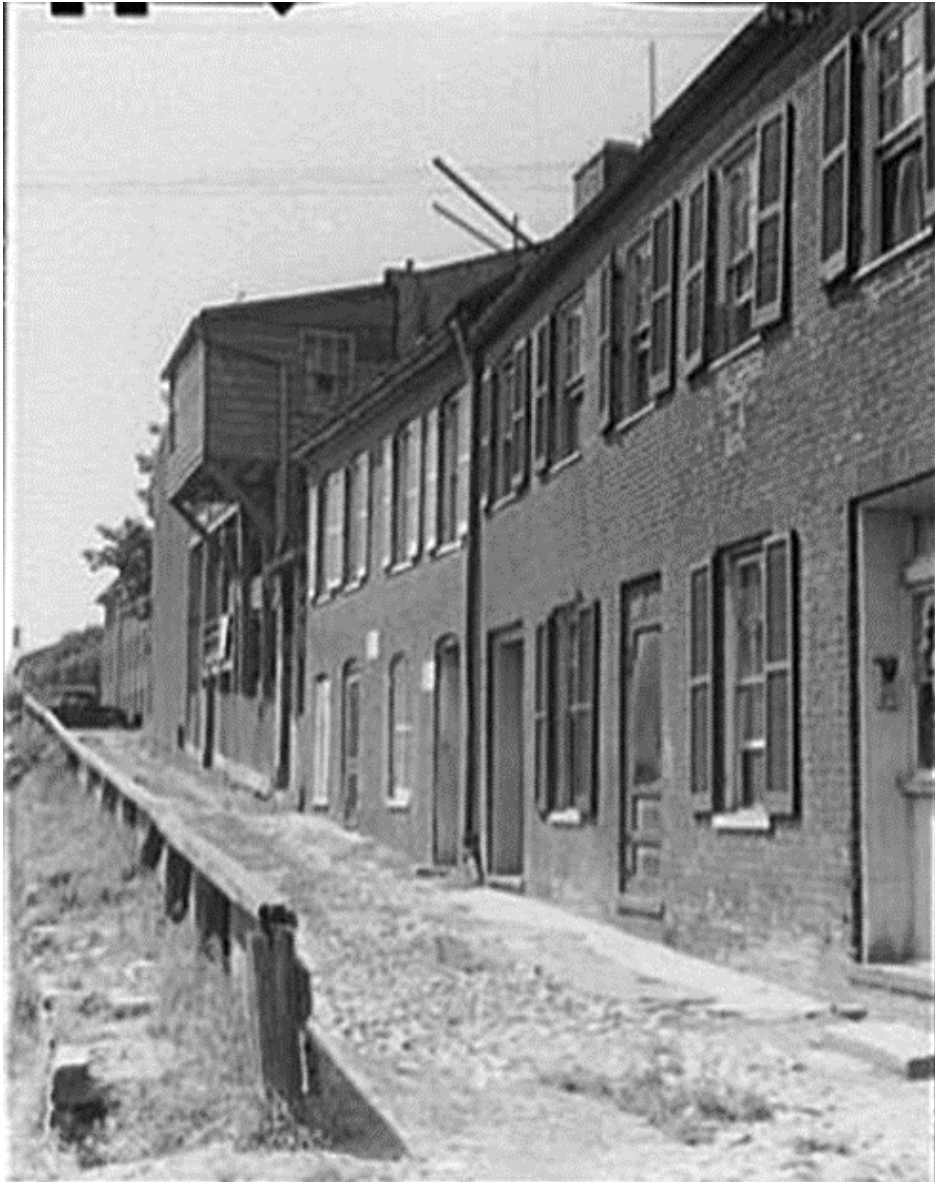
*In this photograph, a possible cobble stone path is present on the berm side of Chesapeake and Ohio Canal of Lock 4 "(C&O Canal) Canal in Georgetown. Path along C&O Canal." Theodor Horydczak, ca. 1920-1950. From the Library of Congress (<https://www.loc.gov>*

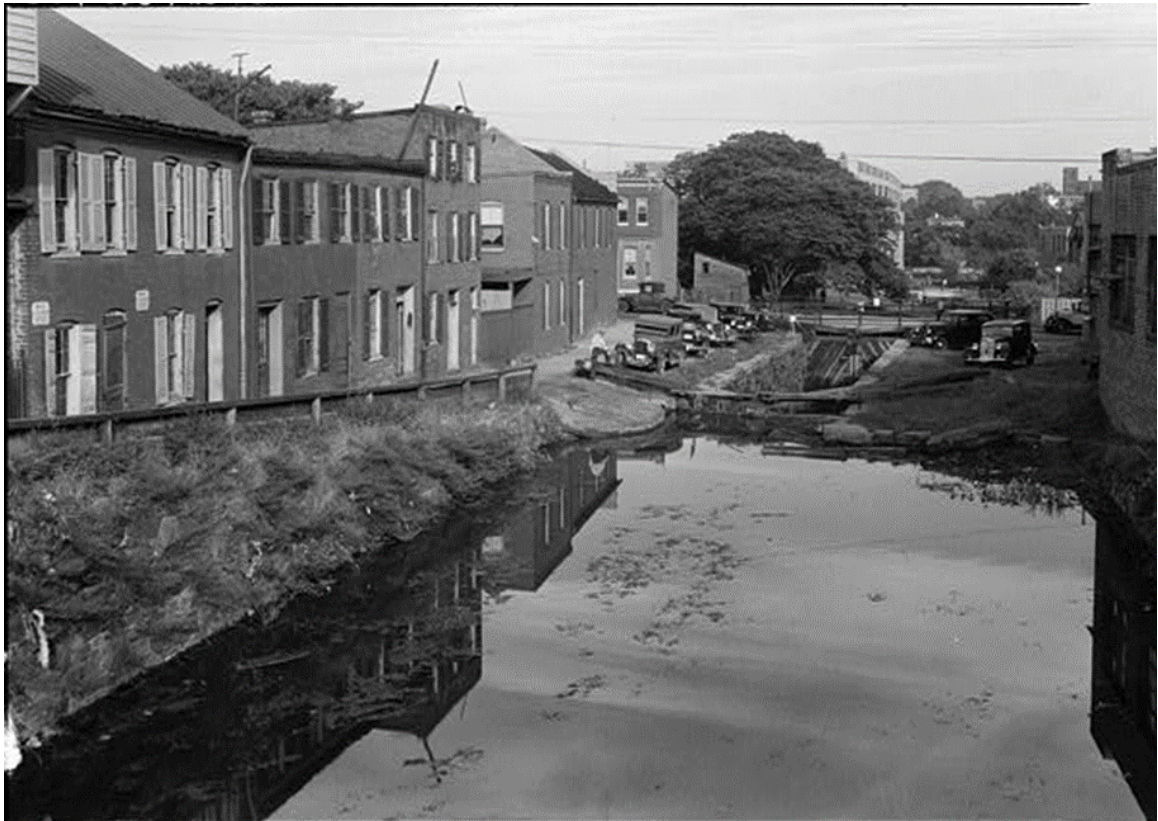
*“LOOKING EAST FROM THIRTY-FIRST STREET BRIDGE LOCK #4- Chesapeake and Ohio Canal, Georgetown Section, East & West parallel to M Street Northwest, Washington, District of Columbia, DC.” Historic American Buildings Survey (HABS DC-147) Albert S. Burns, 193*

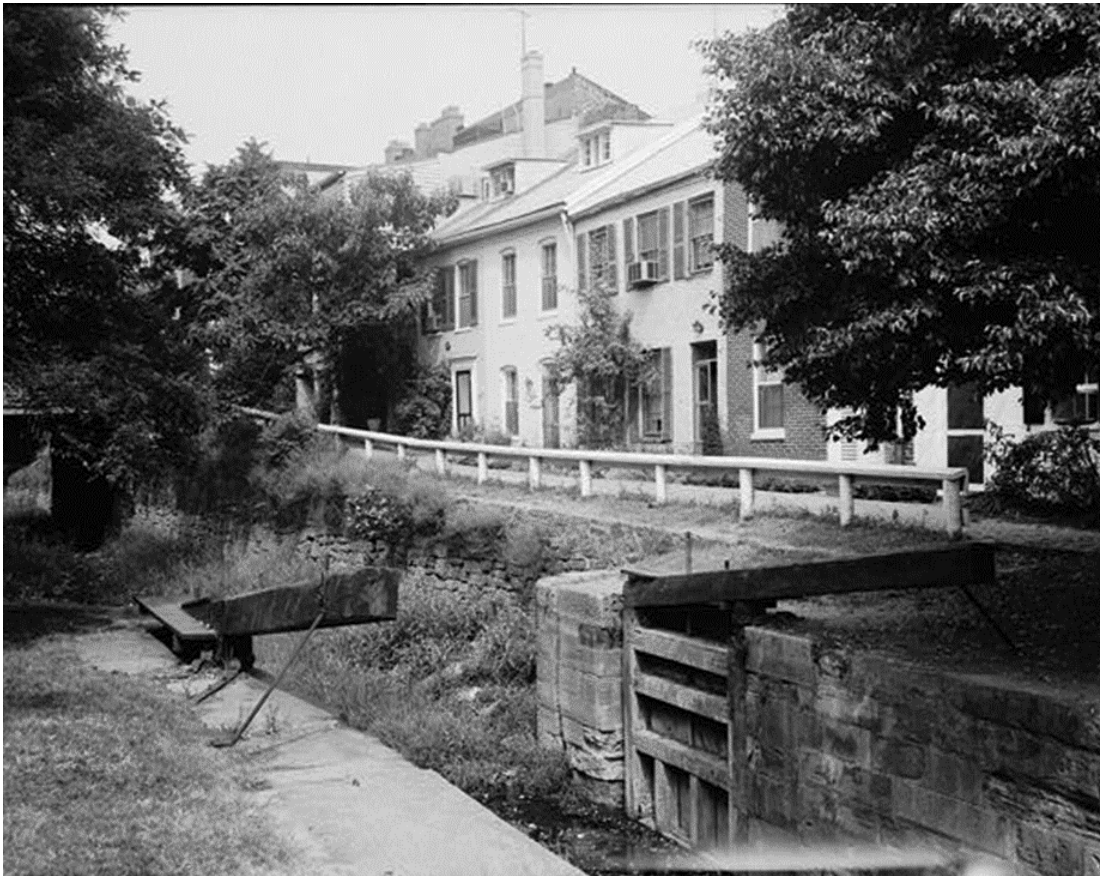
*In the 1948 planting plan, a new wooden fence with two rails and a cap was proposed at Lock No. 4. The 1967 photograph of Lock No. 4 consists of a single rail and capped fence. "LOCK NO#4 GATES, AND 'TOW PATH ROW' BUILDINGS- Chesapeake and Ohio Canal, Geo*

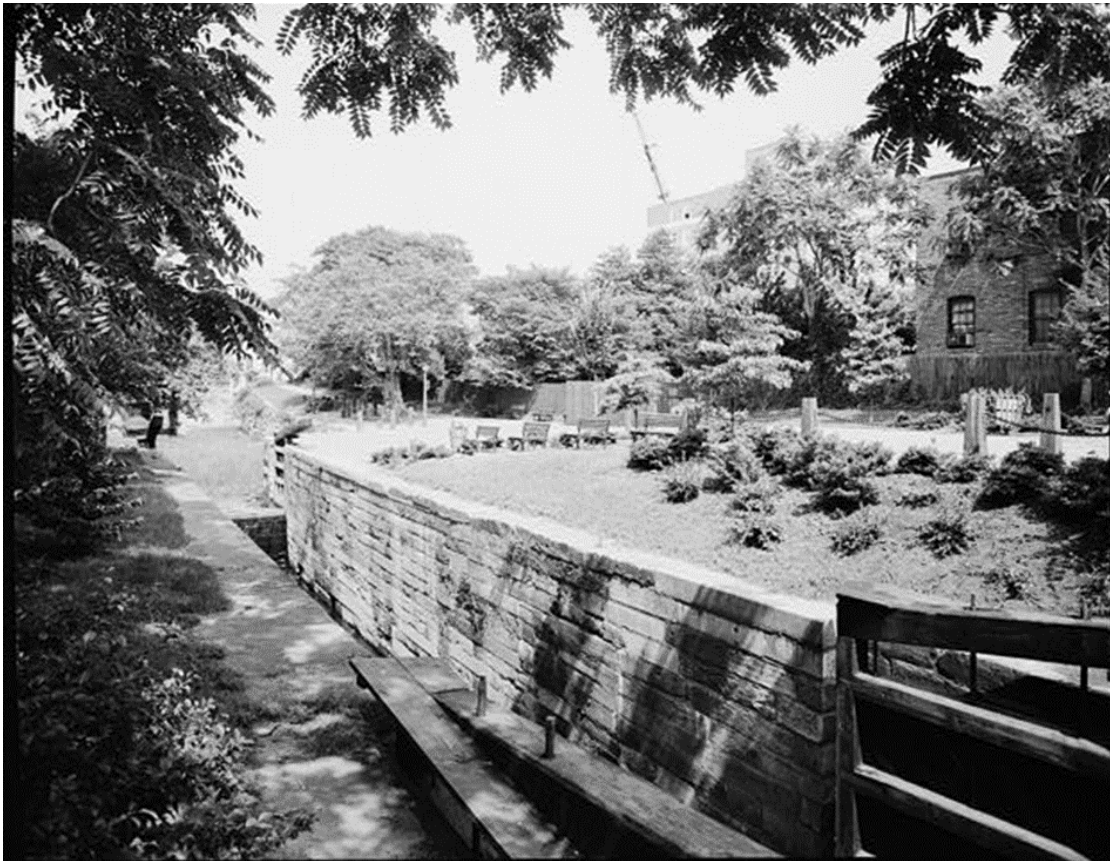
*The Lock No. 3 Plaza/Mule Yard, 1967 photograph looking west. “Lock #3-Chesapeake and Ohio Canal, Georgetown Section, East & West parallel to M Street Northwest, Washington, District of Columbia, DC.” George Eisenman, 1967. From the Library of Congress (<https://www.loc.gov/resource/hhh.dc0053.photos/?sp=1>, accessed 2017).*

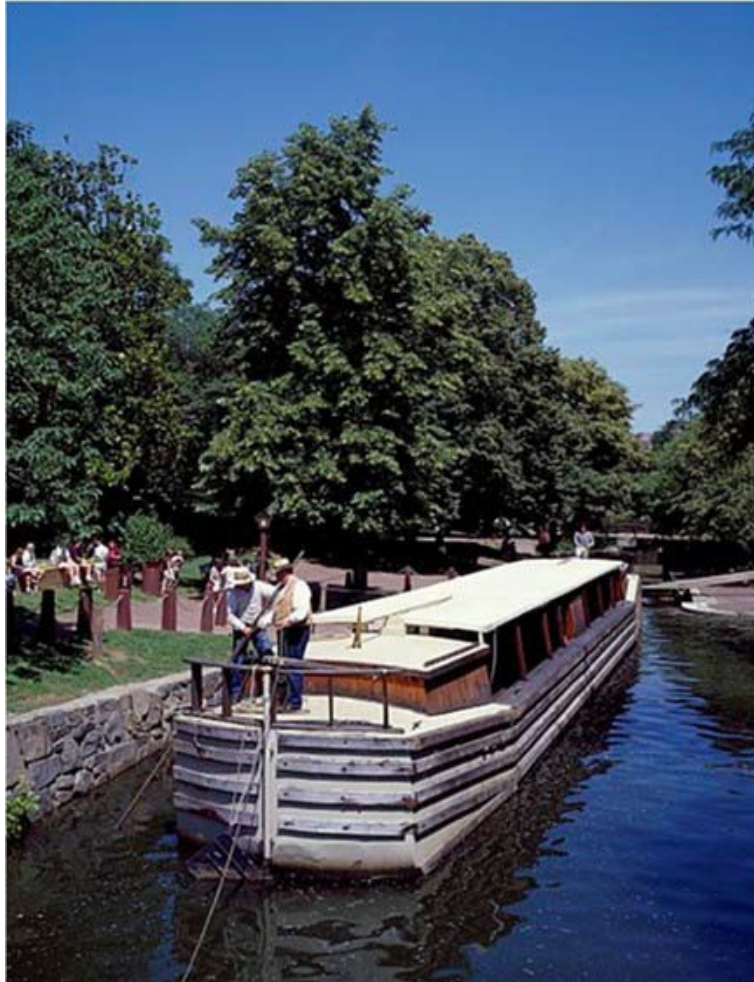
*Photograph of Lock No. 3 looking west. "Tourist barge on the old C&O Canal in the Georgetown section of Washington, D.C." Carol M. Highsmith, 1980. From the Library of Congress (<https://www.loc.gov/item/2011632165/>, accessed 2017.)*

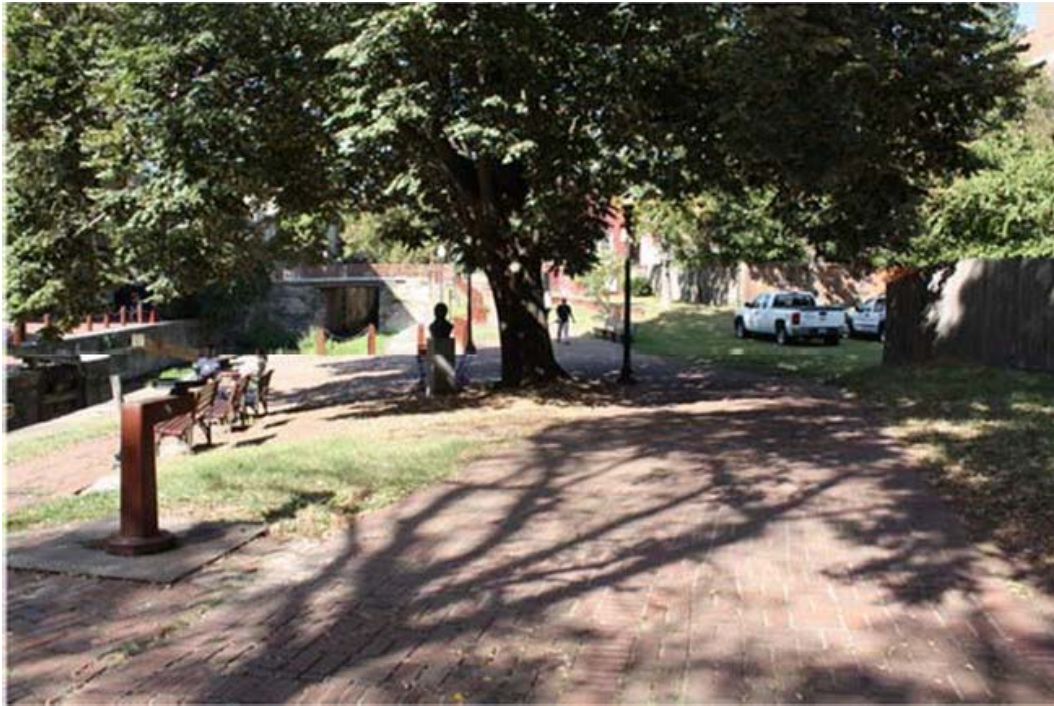
*Lock Three Plaza/ Mule Yard prior to the rehabilitation work on Lock 3 (NCR CLP 2016).*

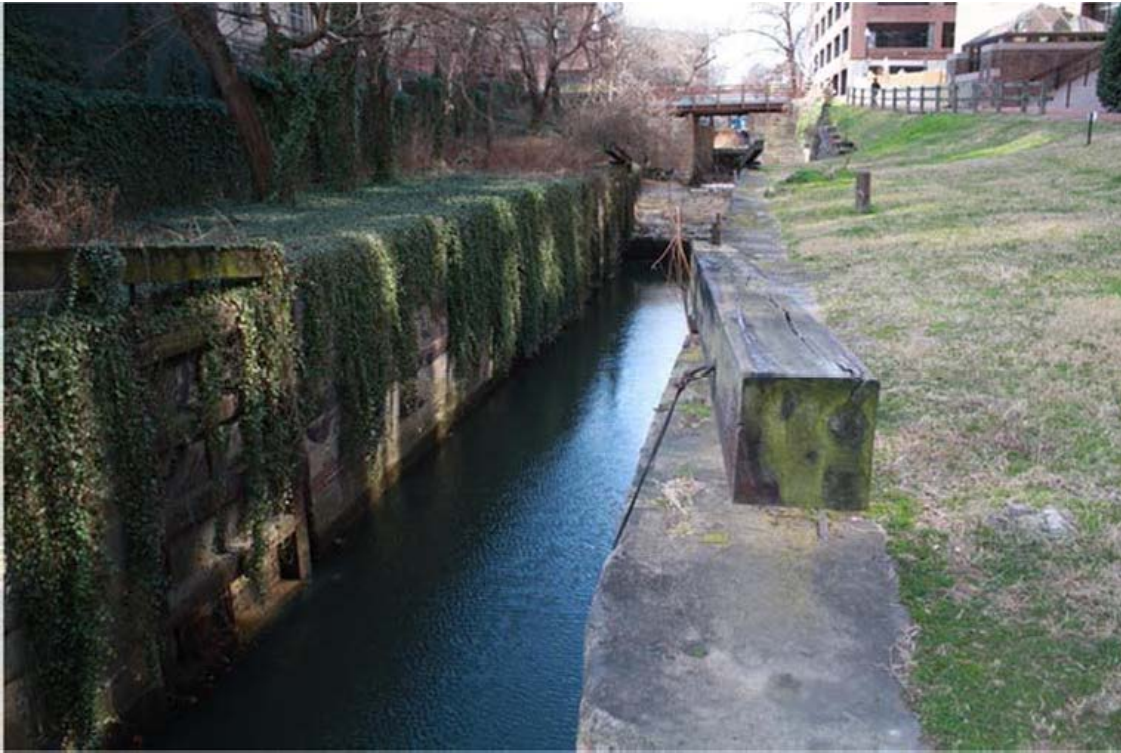
*Lock One. (NCR CLP 2016).*

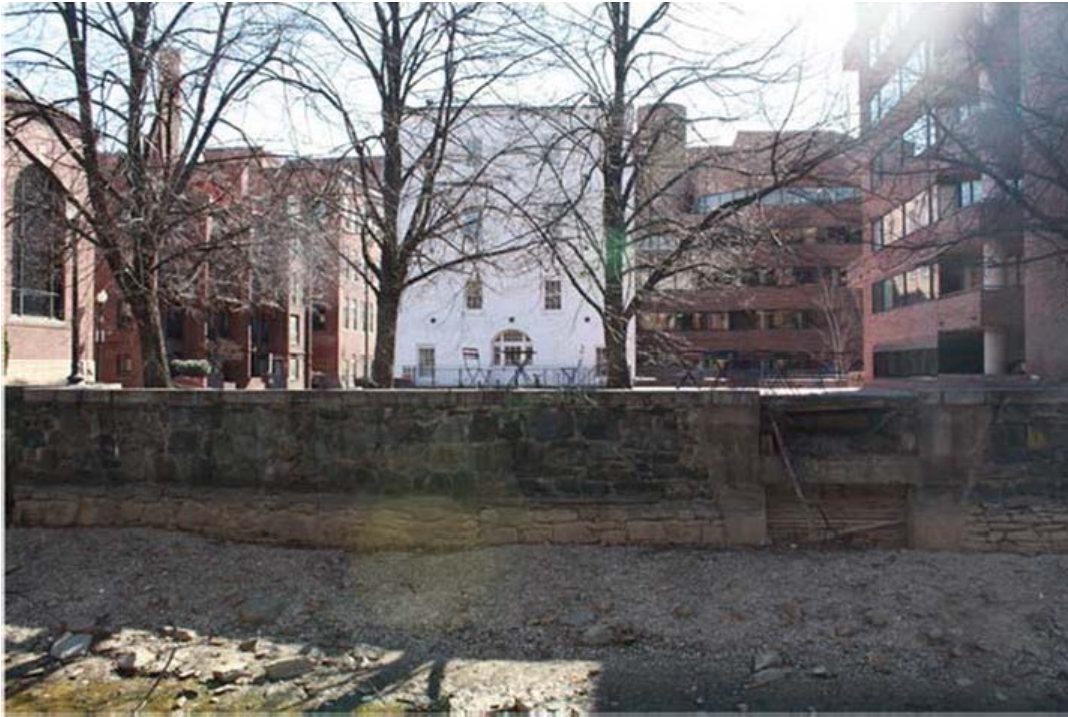
*The Fish Market Square, designed by Peter Vercelli. This photograph also captures the Dual Water Intake-Ruins of the Wilkins Rogers Milling Co., which supplied the former mill to the south with surplus canal water from 1839 to 1960. (NCR CLP 2017).*

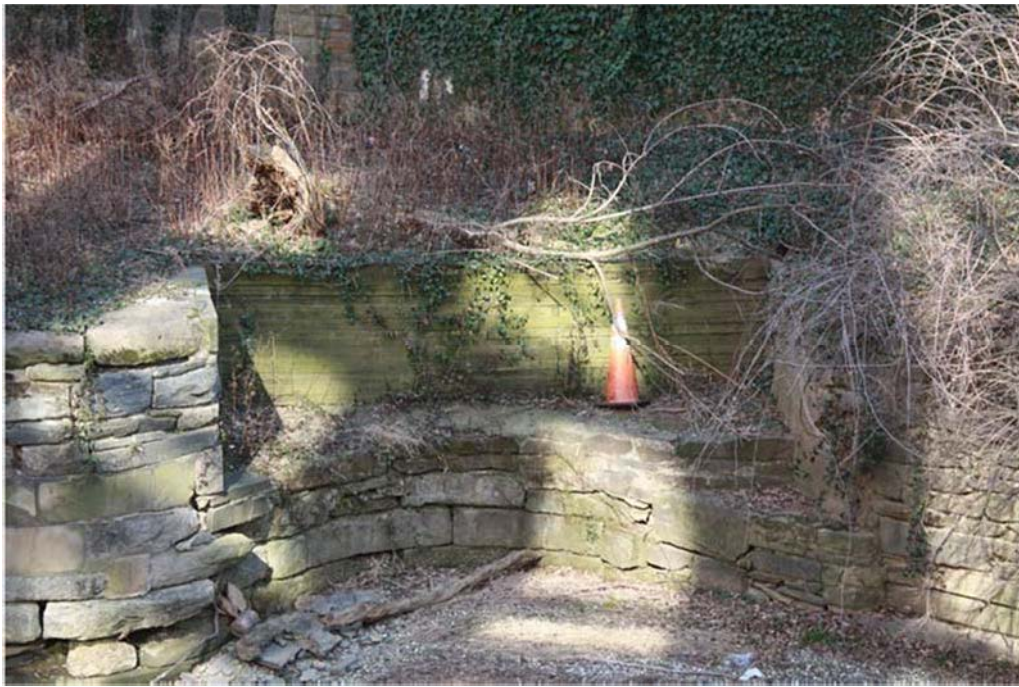
*The side pond inlet located on the south corner of the Lock No. 1 prism. (NCR CLP 2016)*

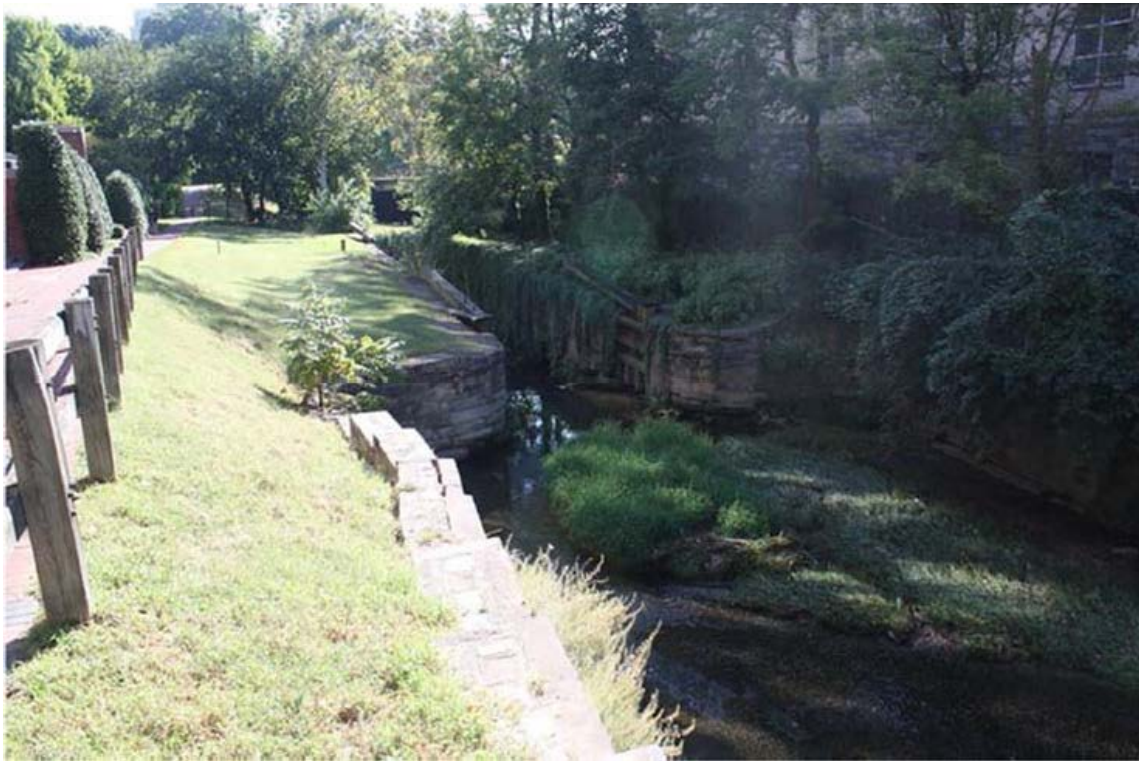
*Vegetation growing in Boat Basin No. 1. (NCR CLP 2016).*

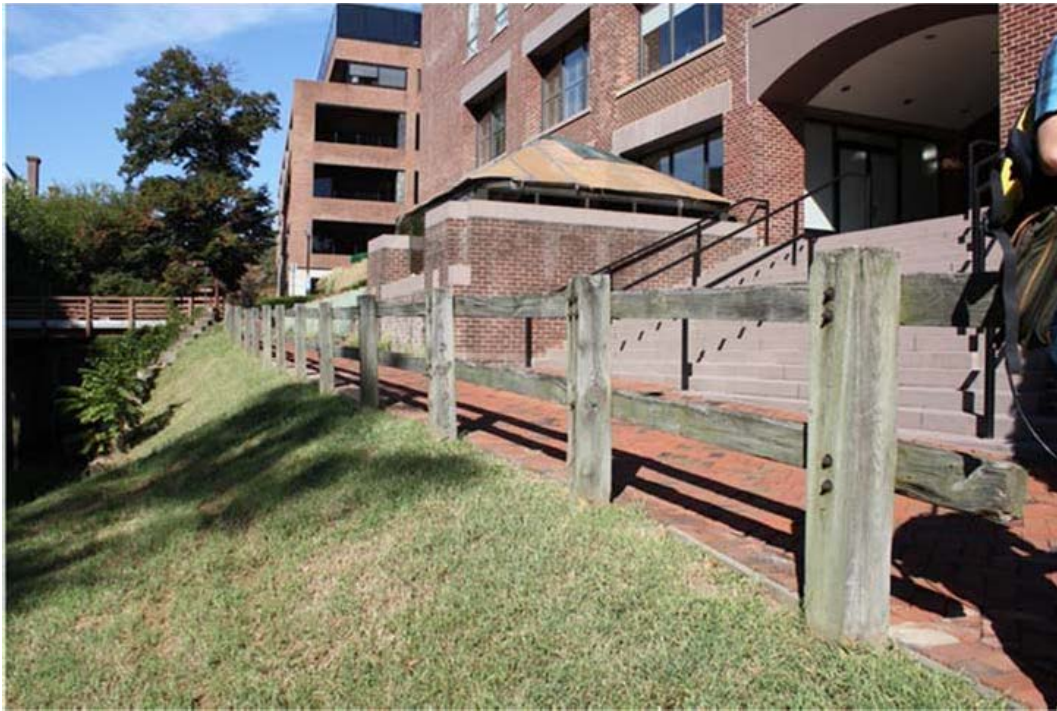
*The brick towpath on the berm side of the canal east of 29th Street. Historically, the towpath was on the river side of the canal east of Greene/29th Street (NCR CLP 2016).*

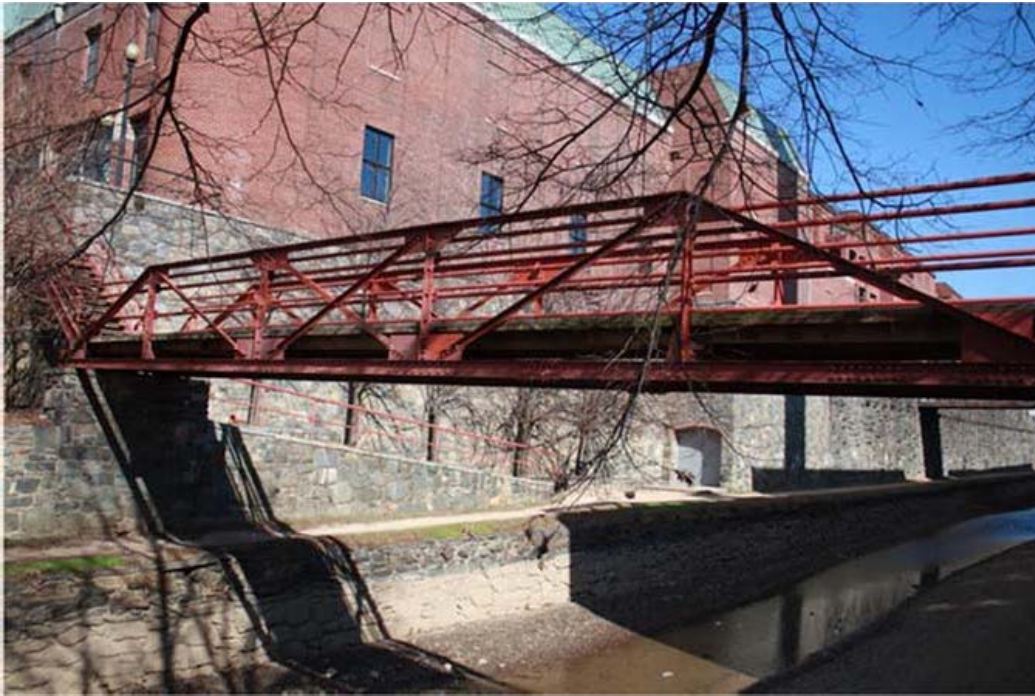
*The Potomac Street Bridge. Originally, the bridge was wooden and part of the set of bridge constructed in 1831. (NCR CLP 2017).*

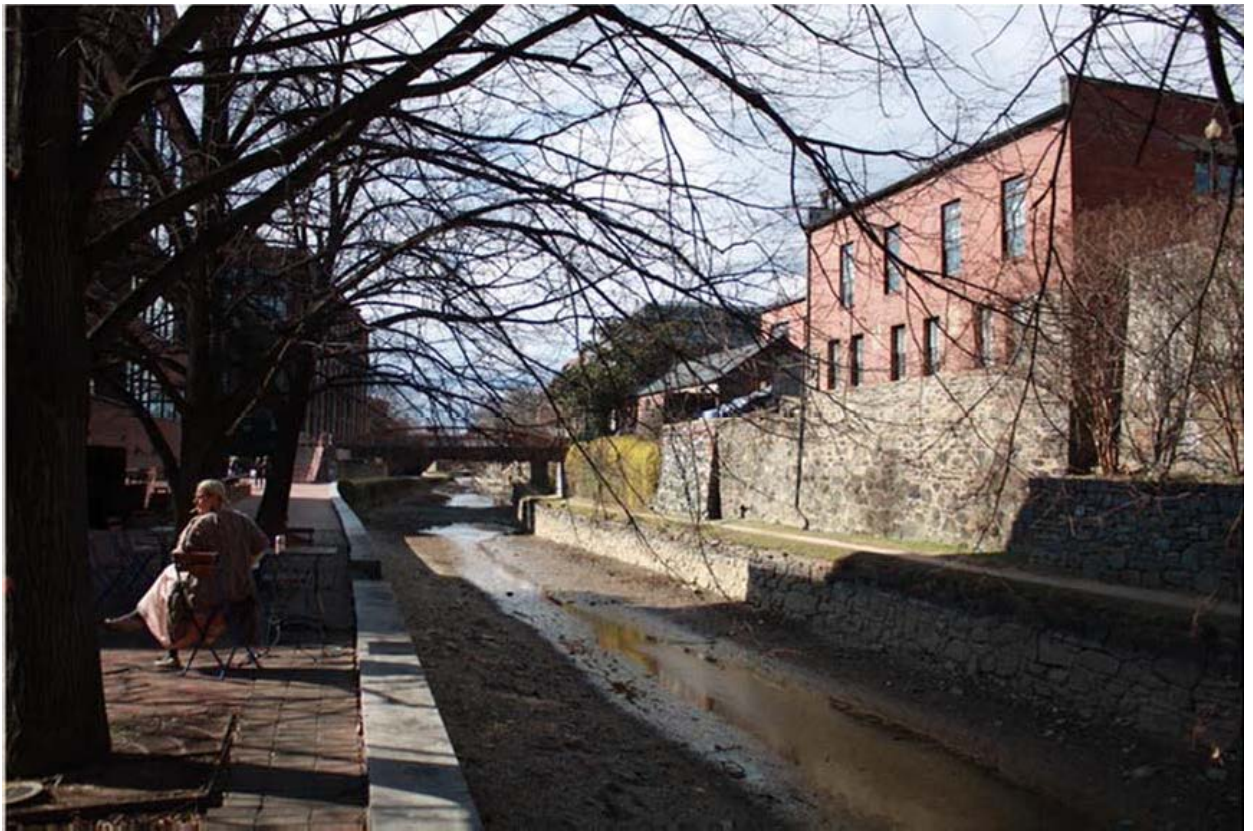
*River side of the canal looking west at Fish Market Square. The historic retaining wall composed of stack stone with mortar is on the right side of the image (NCR CLP 2017).*

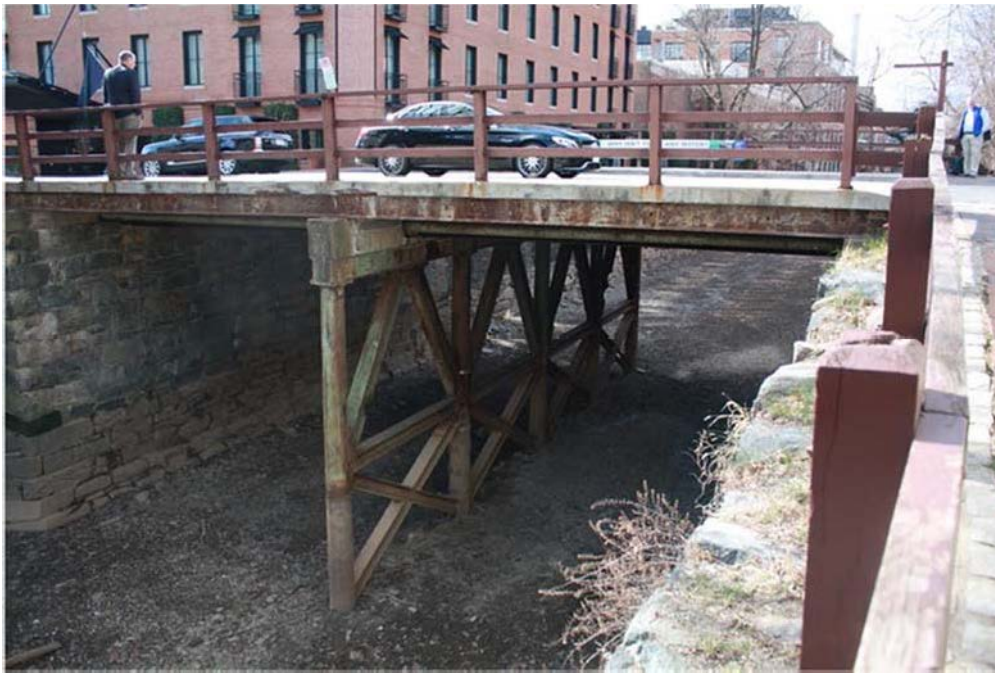
*31st Street Bridge (NCR CLP 2016).*

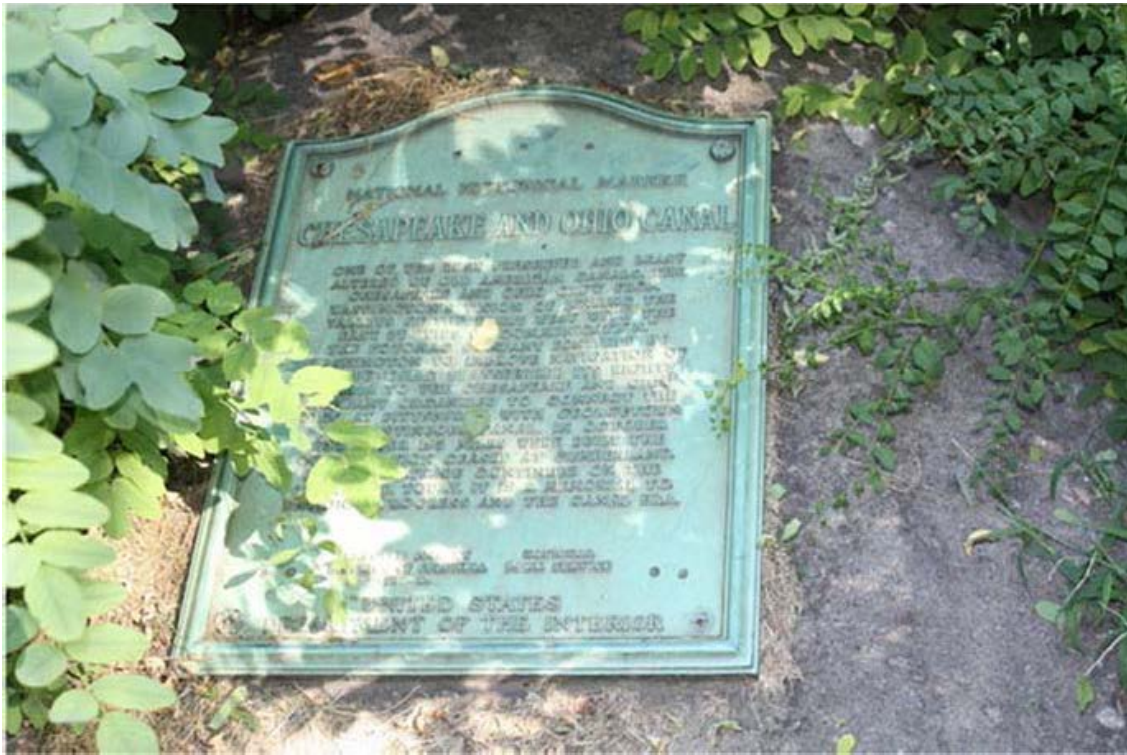
*The circa 1942 NHL marker (NCR CLP 2016).*

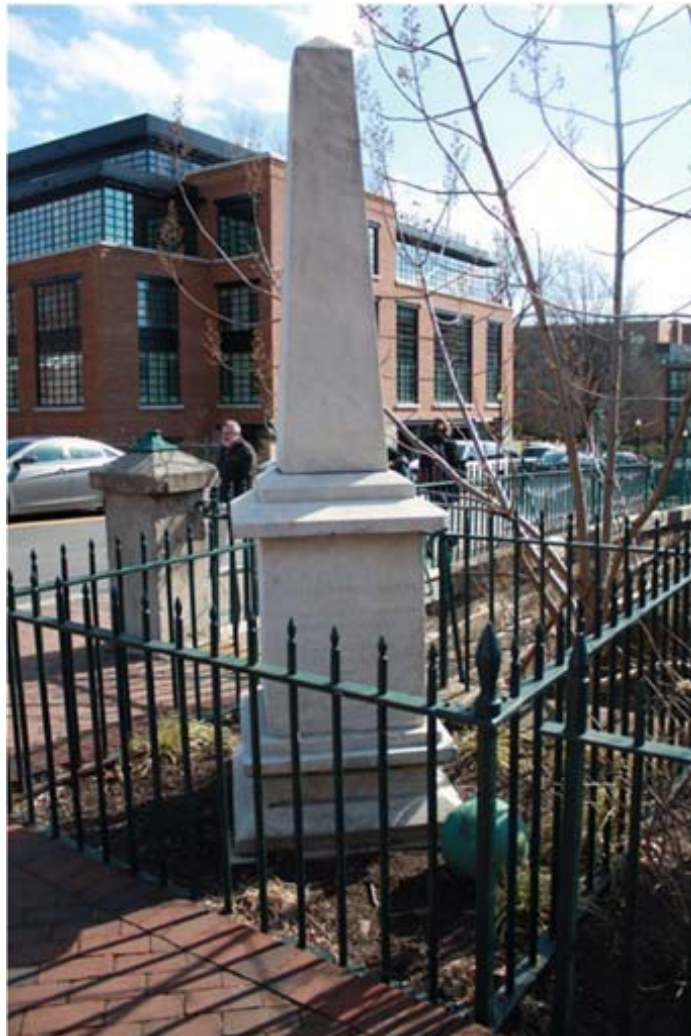
*Commemorative marble obelisk at the northeast corner of the Wisconsin Avenue Bridge. It is uncertain when the fence was placed around the obelisk. However, a fence is captured in the 1920s photograph. (NCR CLP 2017).*

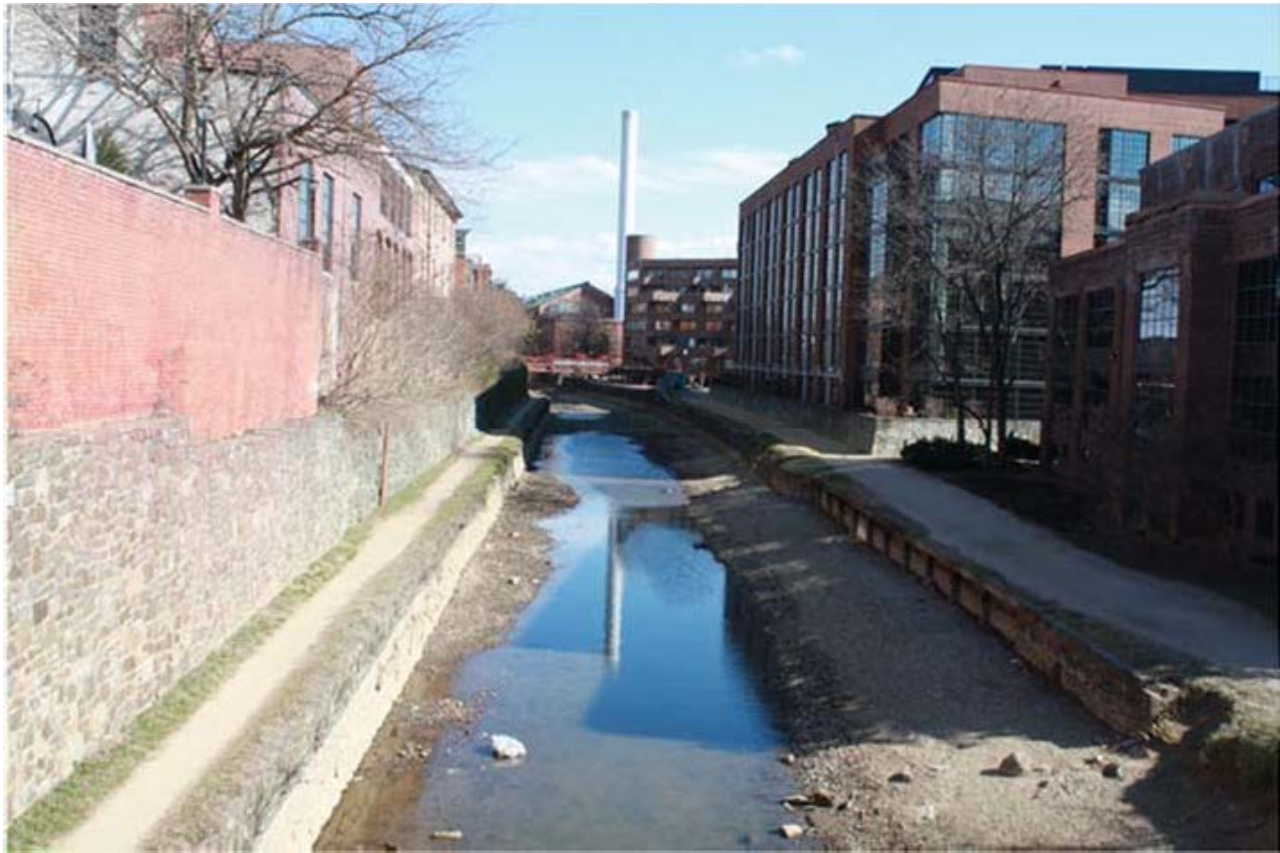
*This view west to Potomac Street illustrates how construction has encroached on the canal on both the river and berm side of the canal between 33rd and 34th Street. (NCR CLP 2017).*

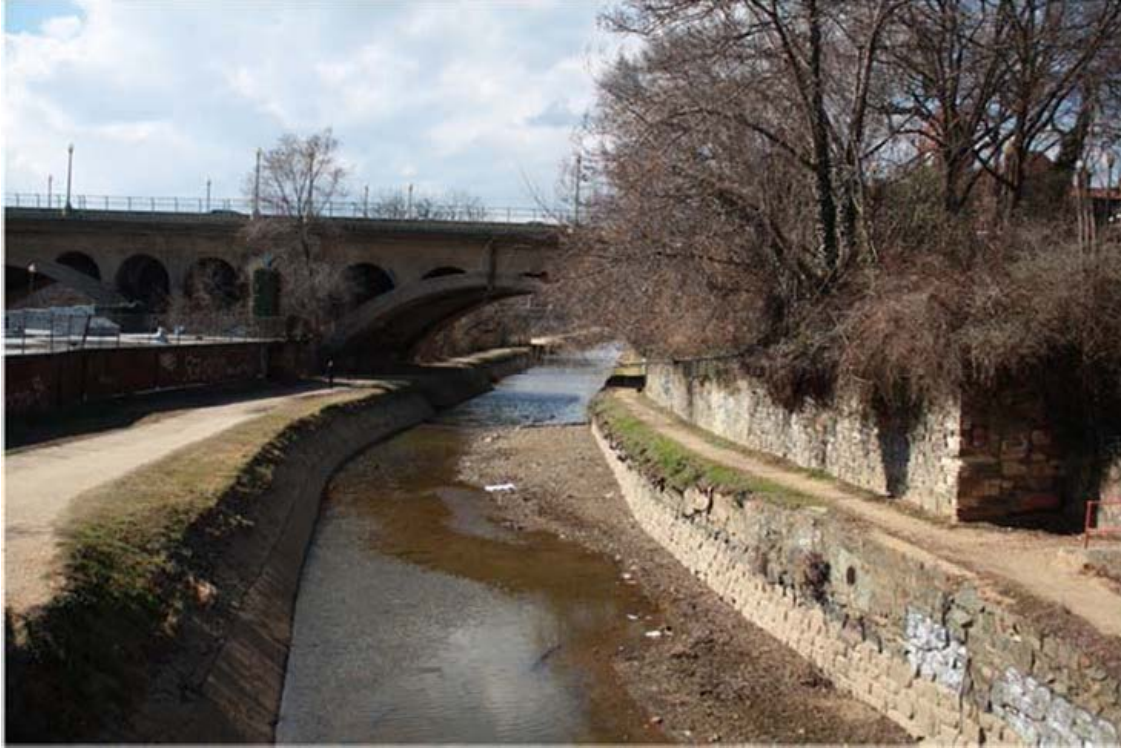
*The views along the canal west to the Key Bridge. (NCR CLP 2017).*
