# CENTRAL HIGH SCHOOL

## CULTURAL LANDSCAPE REPORT

# Central High School

**September 2009**

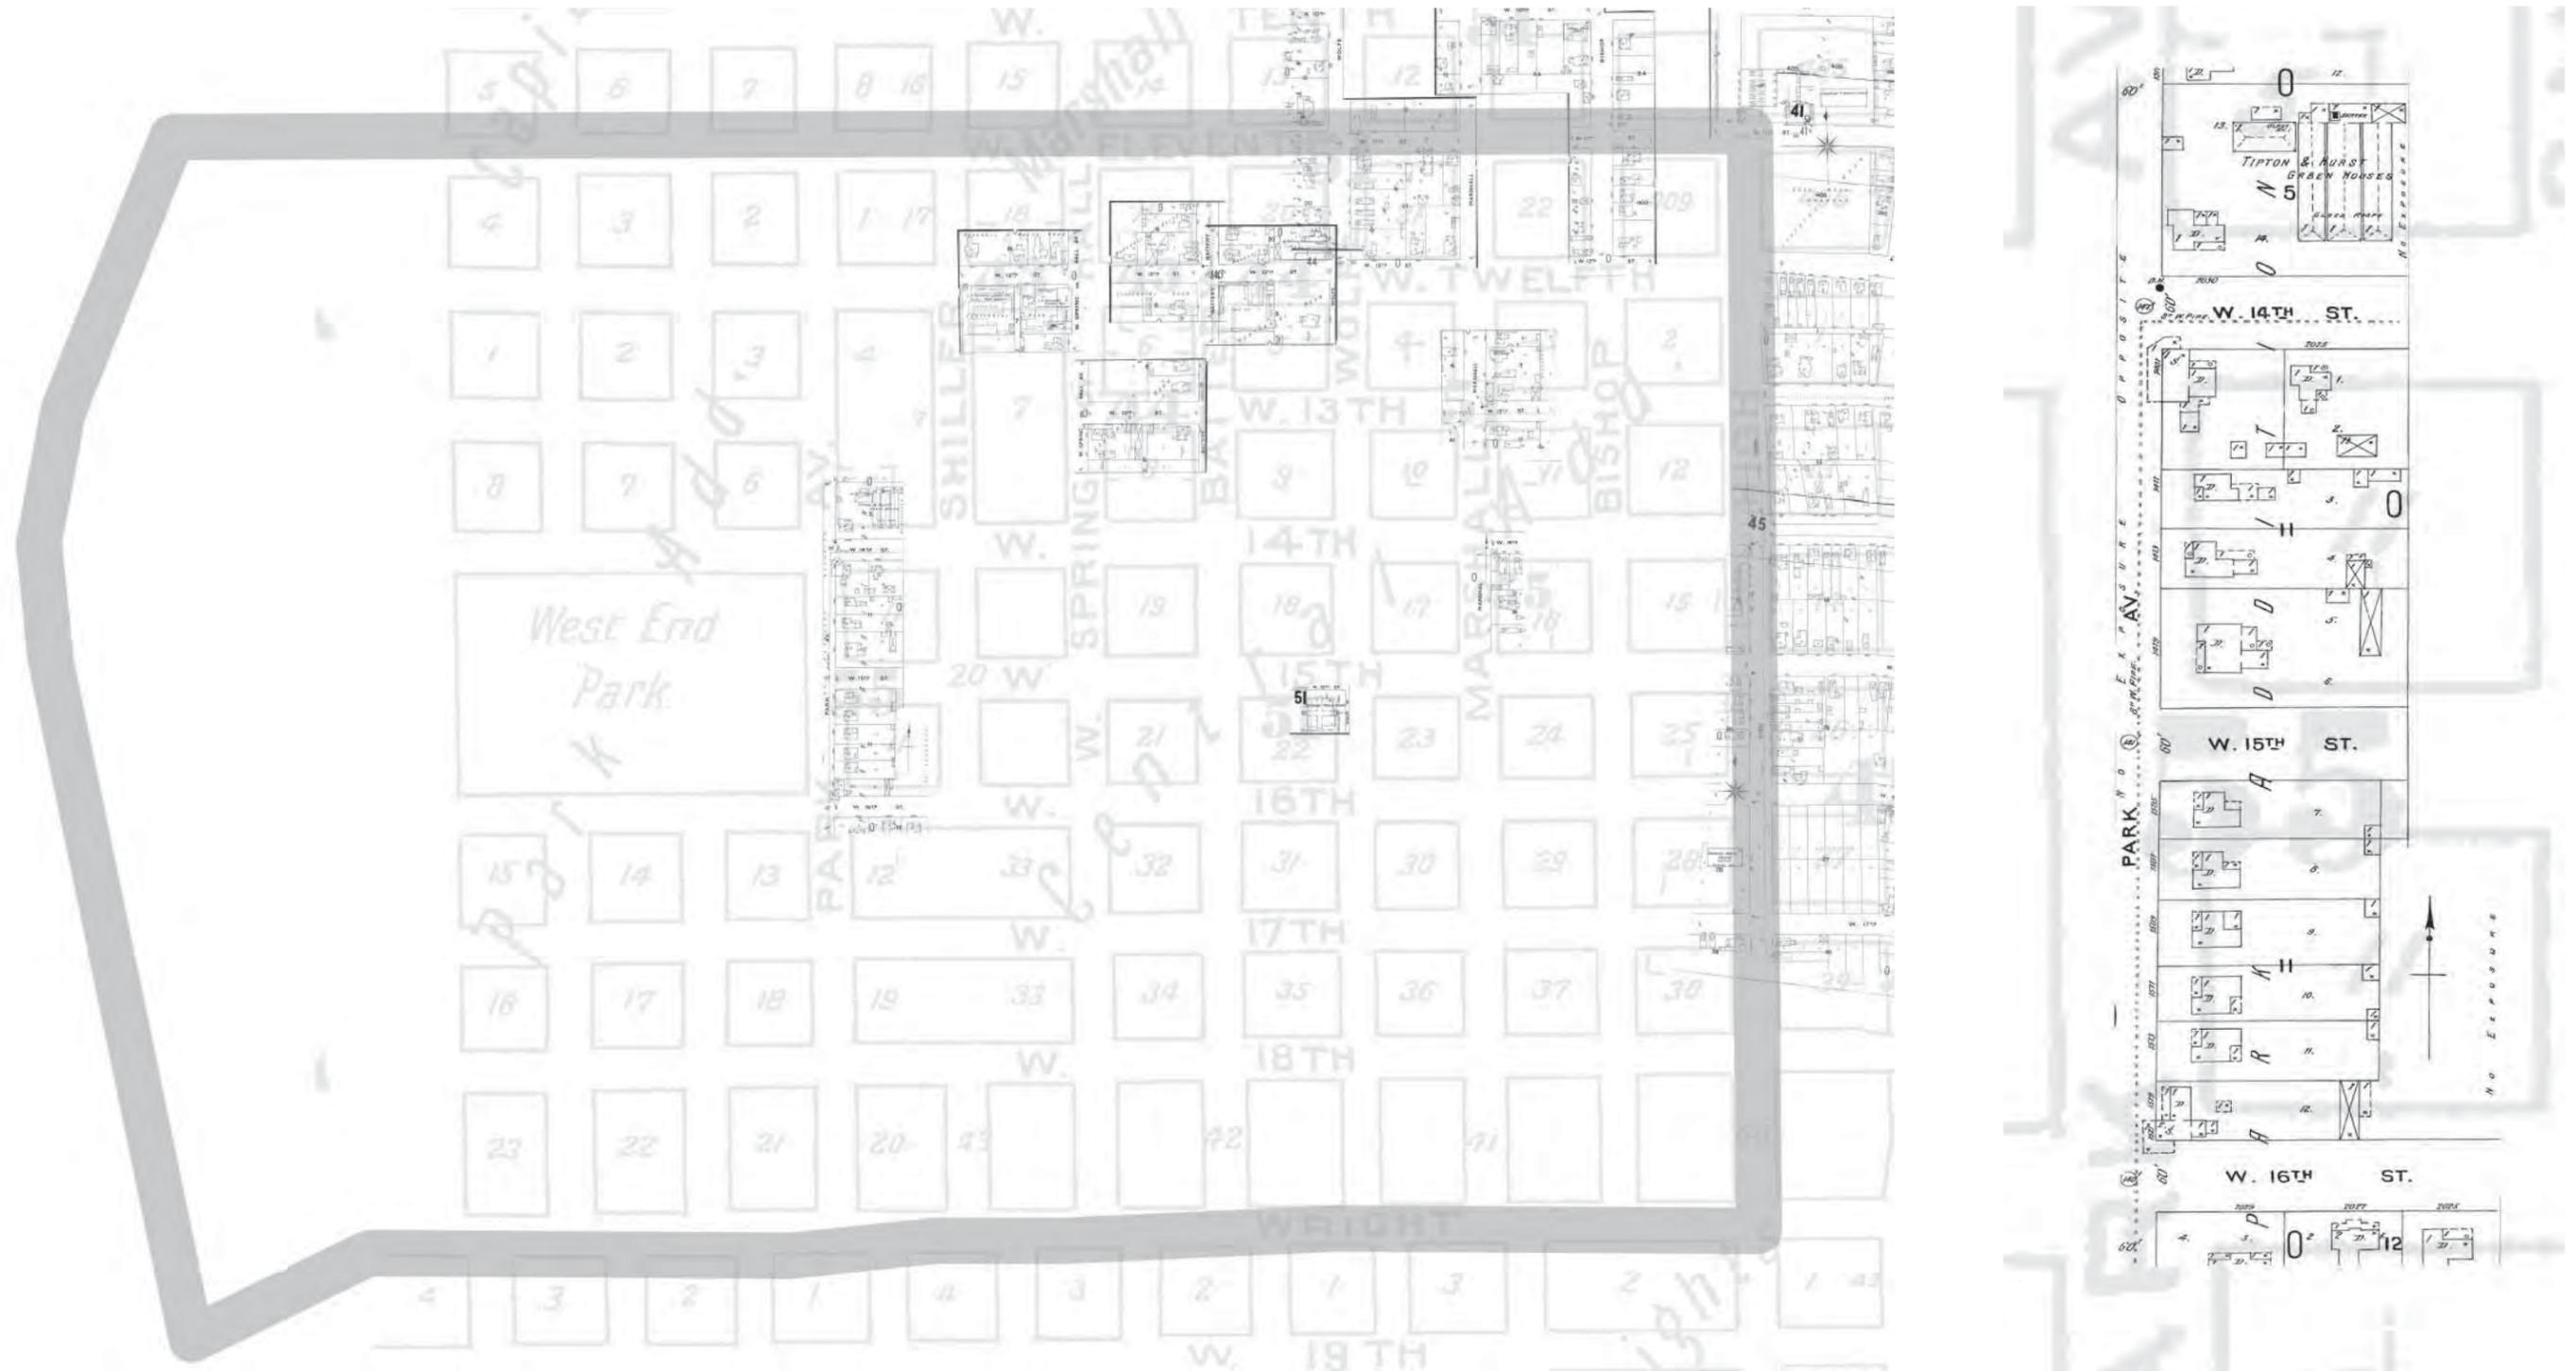
**Figure 2-3.** 1897 Sanborn Map, Little Rock, Arkansas. Full coverage of study area incomplete. Available sheets are indicated overlain on key. Detail of Historic Scene from Sheet 55. *Source:* "Digital Sanborn Maps 1867-1970," Proquest Information and Learning, <http://sanborn.umi.com> (accessed 8 January 2008).

Sanborn Map Company's fire insurance map coverage of the study area during the 19th century is limited. It was not until 1897 that portions of the West End were even depicted by the company (*Figure 2-3*). Most of the houses are described in the map as one-story, frame dwellings with front porches and a fairly uniform setback. Light industrial enterprises shown on these maps include the Tipton and Hurst Greenhouses (at W. Fourteenth Street—now Daisy Bates—and S. Park Street, now the site of the NHS Visitor Center), the J. H. Pritchard Lumber Company, and the L. H. Whitcomb Planing Mill on the south side of Twelfth Street between Schiller and Spring Streets.<sup>21</sup> Stores were distributed throughout the neighborhood, including on S. Park Street at W. Fourteenth Street and at Sixteenth Street. Several of these stores were built on the street right-of-way, with no setback. Institutions shown on the Sanborn maps include the Centennial School (1864, now demolished) at Fifteenth and Wolfe Streets, and the Ebenezer M. E. Church on Marshall Street south of W. Twelfth Street. This map also shows Fifteenth Street extending to S. Park Street, whereas today it ends at Schiller Street. At least some public utilities were available to residents of the study area by this time, because fire hydrants are shown at most intersections.<sup>22</sup>

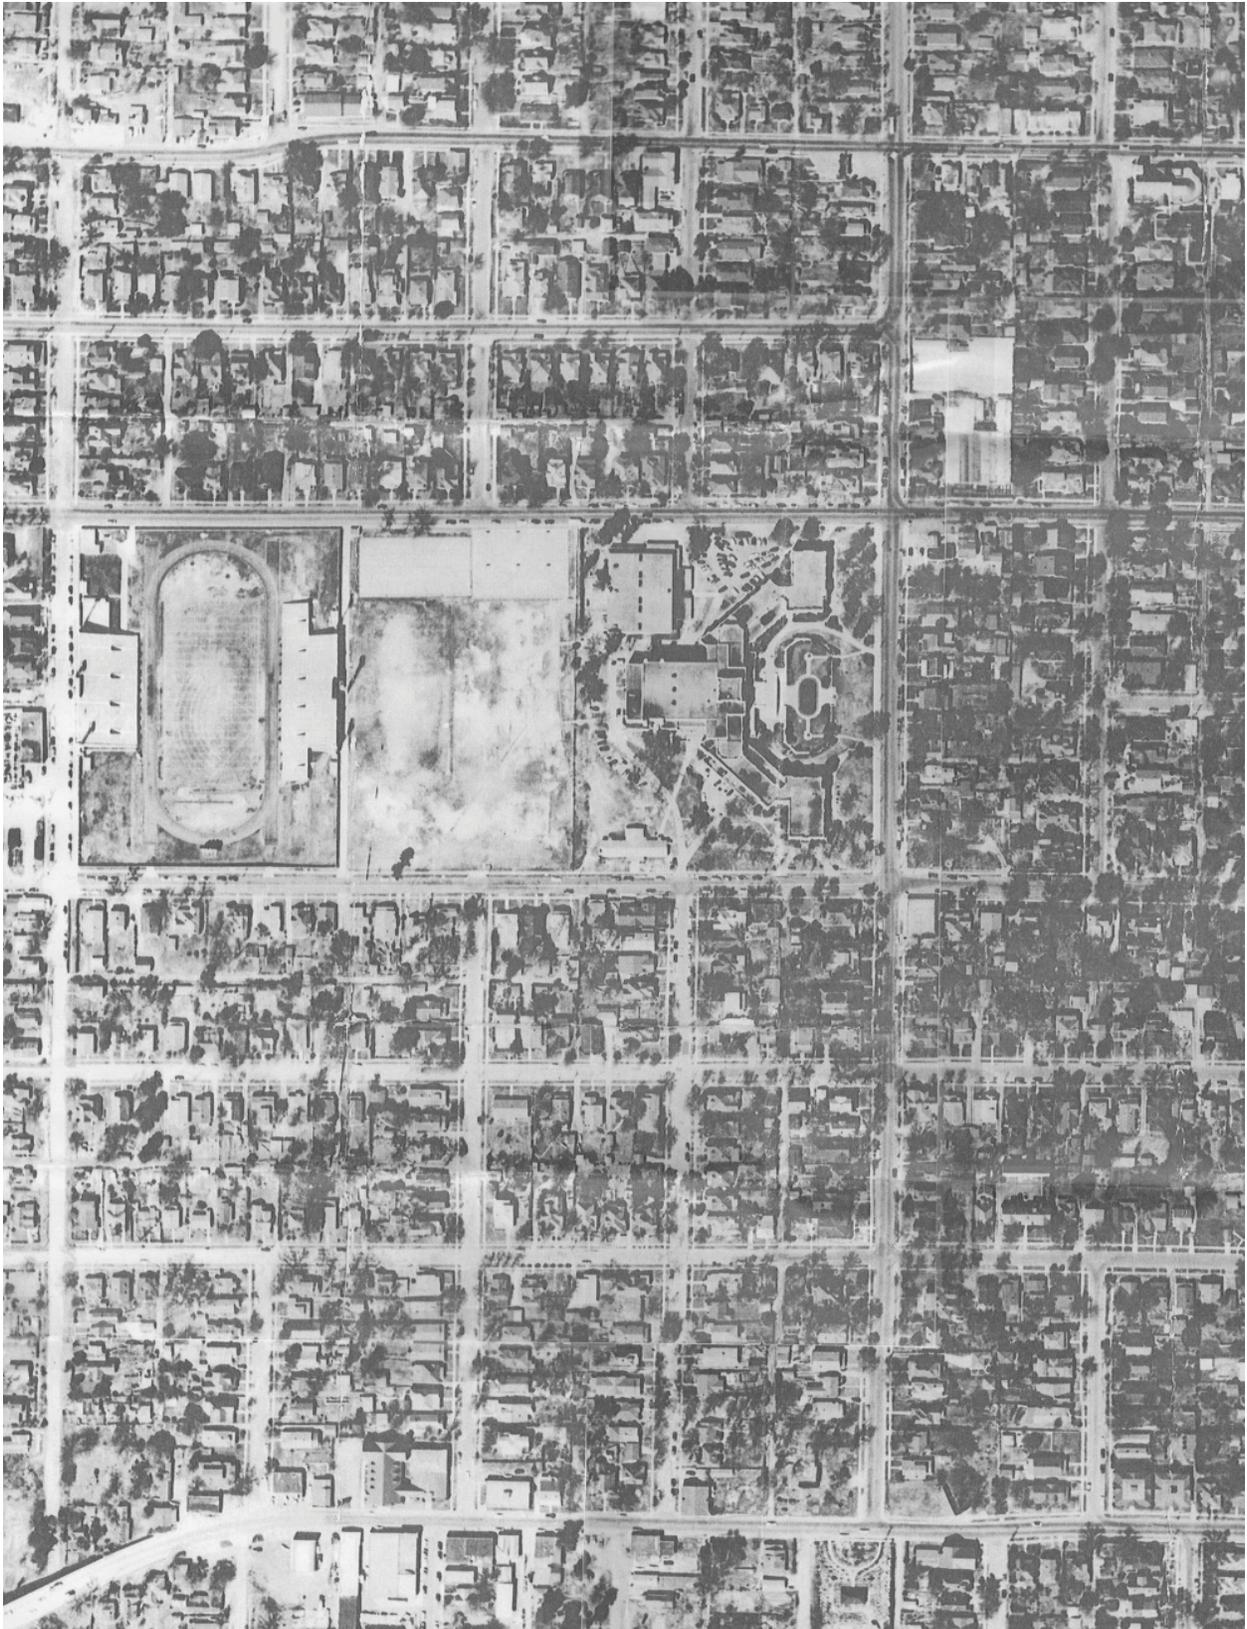
**Figure 2-7.** This aerial photograph shows the neighborhood around Central High School in 1957, at the time of the school integration crisis in Little Rock. *Source: "Command Report, Operation Arkansas, Part I, 24 September to 23 October, 1957 - Part II, 24 October to 30 November 1957." Little Rock Central High School National Historic Site Archives.*

Comparison of the Sanborn maps from 1897, 1913, and 1939-1950 suggests that while development within the study area for this report began slowly, major growth occurred after 1913 and the area was almost completely developed by 1950. An aerial photograph from 1957 confirms the dense urban neighborhood quality of the area surrounding the school at the time of the crisis of 1957-1959 (*Figure 2-7*).

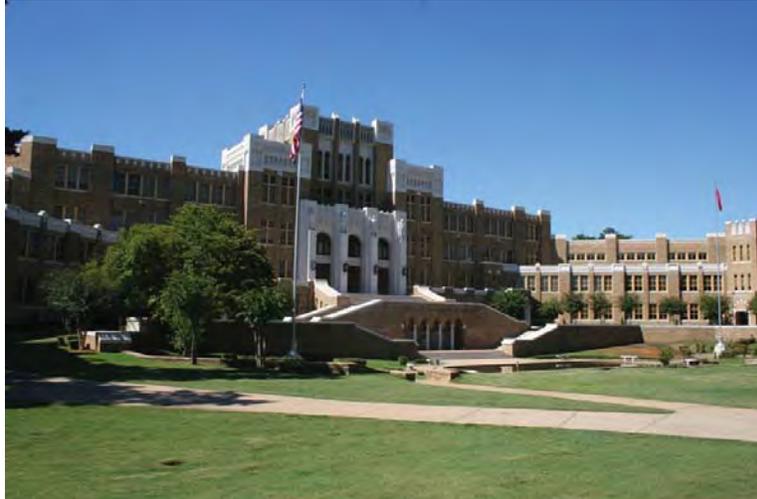
**Figure 2-32.** This section across S. Park Street shows the spatial relationship of the front space of the school as it contrasts with the more narrow spatial qualities of the neighborhood streets. *Source: John Milner Associates, Inc., 2008.*

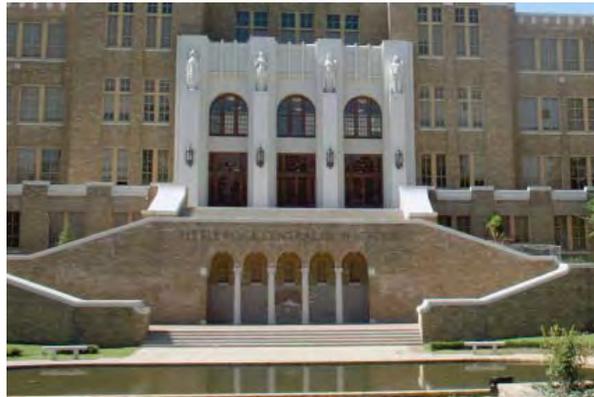
**Figure 2-33.** The front plaza of Central High School is the most significant feature of the Historic Scene character area (seen here looking northwest). *Source: John Milner Associates, Inc., 2007.*

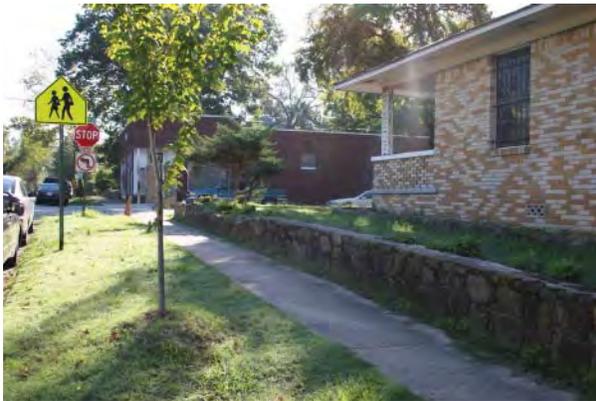
**Figure 2-41.** The brick house and mortared stone retaining wall at 1600 S. Park Street is depicted in photographs from 1957. *Source: John Milner Associates, Inc., 2007.*

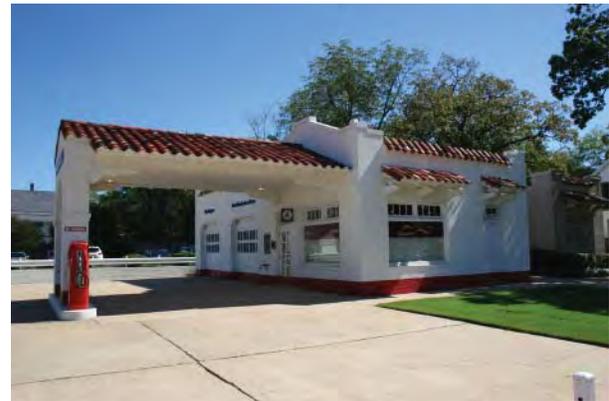
**Figure 2-42.** The Magnolia Mobil service station, where journalists phoned in their stories in 1957, was rehabilitated to its ca. 1950s appearance in 1997. *Source: John Milner Associates, Inc., 2007.*

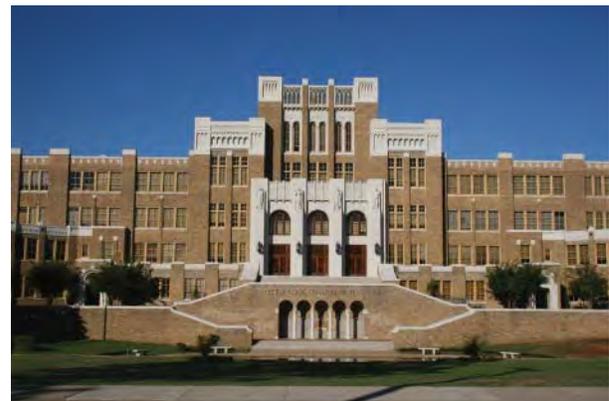
**Figure 2-44.** The front grounds of Central High School are organized symmetrically along a central axis leading from the front door. *Source: John Milner Associates, Inc., 2007.*

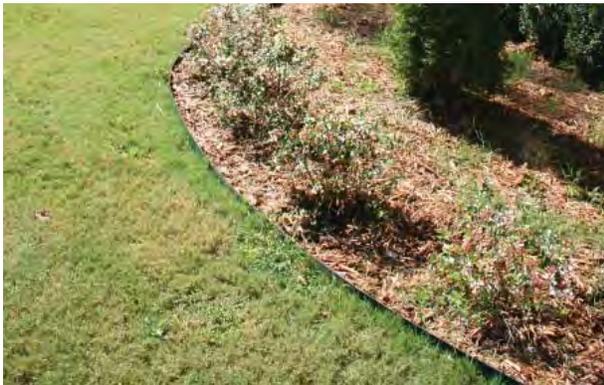
**Figure 2-54.** Metal edging inscribes curvilinear, mulched foundation plantings around the school. *Source: John Milner Associates, Inc., 2007.*

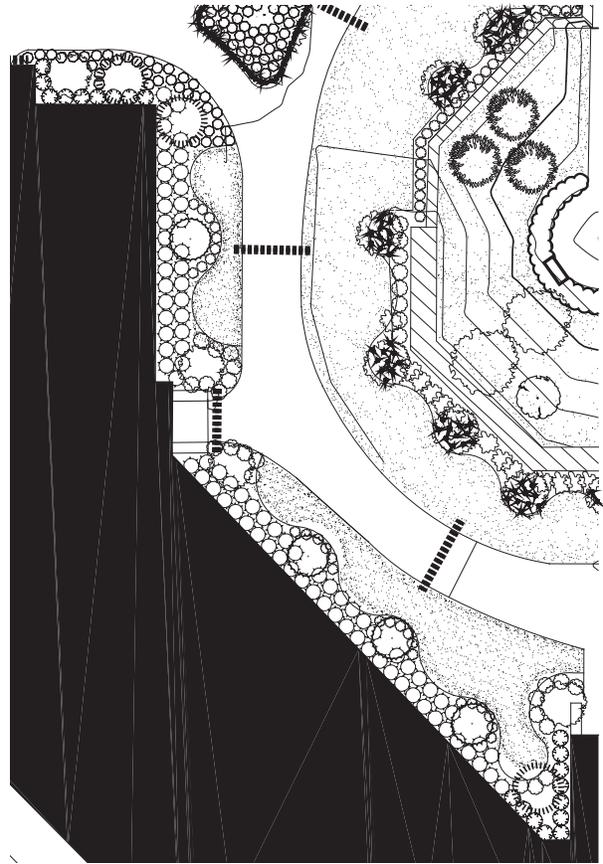
**Figure 2-55.** Detail of 2007 Landscape Plan. *Source: Frank R. Riggins, “Central High School Landscape,” Phases 1-2. Crafton, Tull, and Associates, Inc. (now Crafton, Tull, Sparks and Associates, Inc.), Little Rock, Arkansas, 2007 (AutoCAD drawing).*

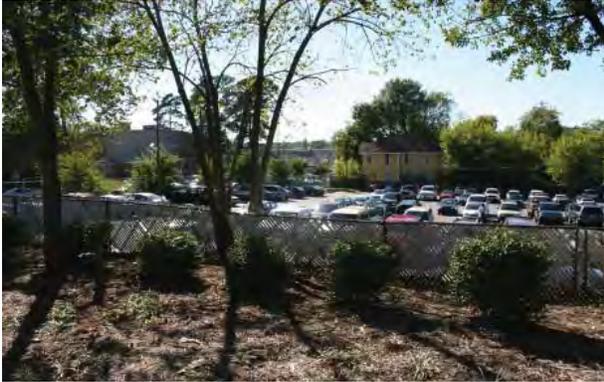
**Figure 2-73.** The southeastern corner of the Commemorative Garden is an open, grass knoll.  
*Source: John Milner Associates, Inc., 2007.*

**Utility and street light poles** are set in the tree lawn on the east side of S. Park Street. **Stop signs, parking signs and fire hydrants** are also features of the streetscape in this area (see *Figure 2-73 and 2-80*).

The NHS Visitor Center now stands on the site of the Tipton and Hurst Greenhouses, which were located at the intersection of W. Fourteenth Street and S. Park Street (see *Figure 2-5*). The simple street intersection paving that existed in 1957 was replaced in the early 2000s with a pattern of white and red stamped concrete (see *Figure 2-73*).

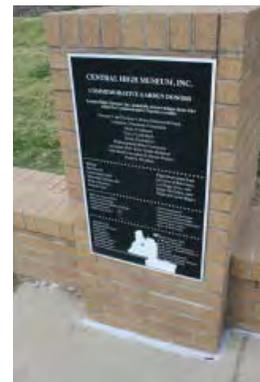
**Figure 2-84.** Brick bollards with inset path lights in the Commemorative Garden.  
*Source: John Milner Associates, Inc., 2007.*

Furnishings in the Commemorative Garden include: path lights mounted within **brick bollards** that are approximately three feet high and two feet square (*Figure 2-84*); cylindrical cast concrete trash receptacles centered in the paths of both entrances to the garden; and **nine symbolic benches** along the garden path with curved, cast concrete seats mounted on three buff-colored brick footings (see *Figure 2-76*).

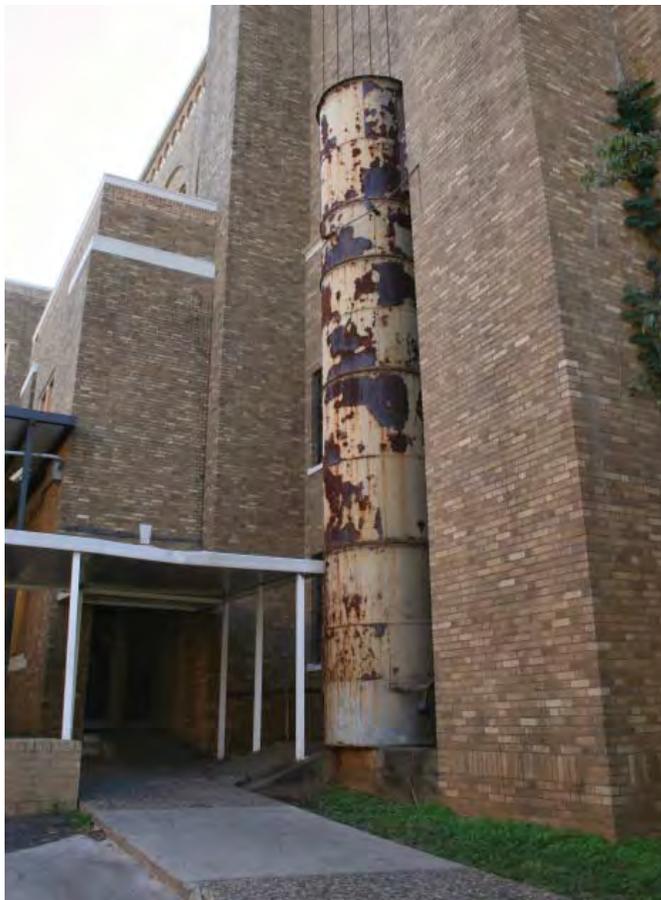
**Figure 2-86.** One of the features found at the back of the building is this spiral fire escape slide enclosed in metal sheeting, presumably original to the building. Its twin is located on the opposite corner on the same side of the building. *Source: John Milner Associates, Inc., 2007.*

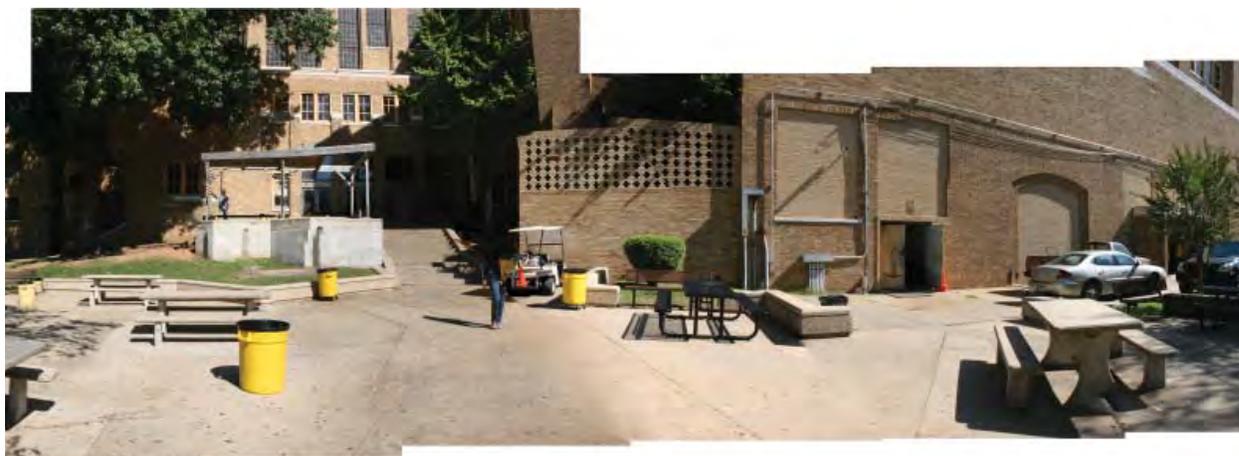
**Figure 2-87.** This panoramic photomontage illustrates the complex rear facade of the high school building and the variety of uses hosted there. Access to the lower level is through the garage doors to the right. *Source: John Milner Associates, Inc., 2007.*

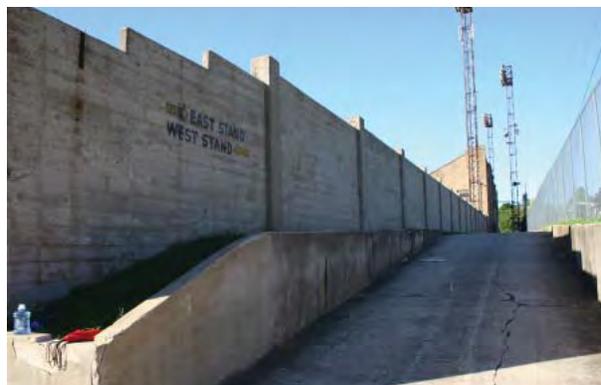
**Figure 2-88.** West grandstand of Quigley Stadium. *Source: John Milner Associates, Inc., 2007.*

**Quigley Stadium** is the dominant structure on the west end of the high school site (*Figure 2-88*). It is bounded by a 10-foot high poured concrete wall, and includes two grandstands on either side of the broad playing field and six 100-foot-tall athletic field lights (*Figure 2-89*). The two grandstands seat 15-20,000 fans and are made of concrete faced with buff-colored brick. A **small stucco building** attached to the southern side of the west grandstand houses the Little Rock School District Child Nutrition Office. The east grandstand is larger than the west grandstand and has a central seating area and additional seating in two wings. The perimeter wall is free-standing, constructed of poured concrete, and is set with a plaque commemorating the WPA and its 1936 construction date mounted on the southwest corner (*Figure 2-90*). On the east side, a concrete retaining wall also frames the service drive

Quigley Stadium is lit by six 100-foot-tall sets of **athletic field lights** mounted on vertical steel trusses (*Figure 2-88*). They may date to the original construction of Quigley Stadium and can be considered historic because they appear in photographs from 1957 (see *Figures 2-22 and 2-23*).

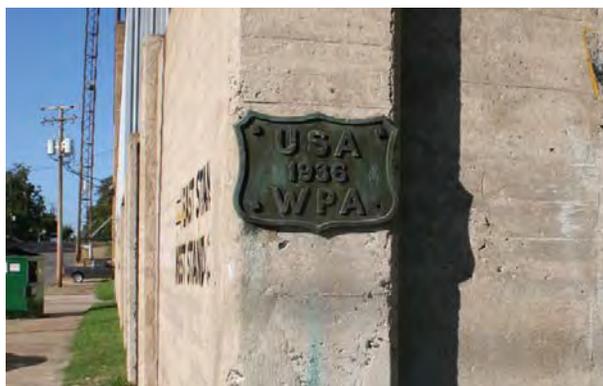
**Figure 2-89.** Looking north along the poured concrete wall surrounding Quigley Stadium. *Source: John Milner Associates, Inc., 2007.*

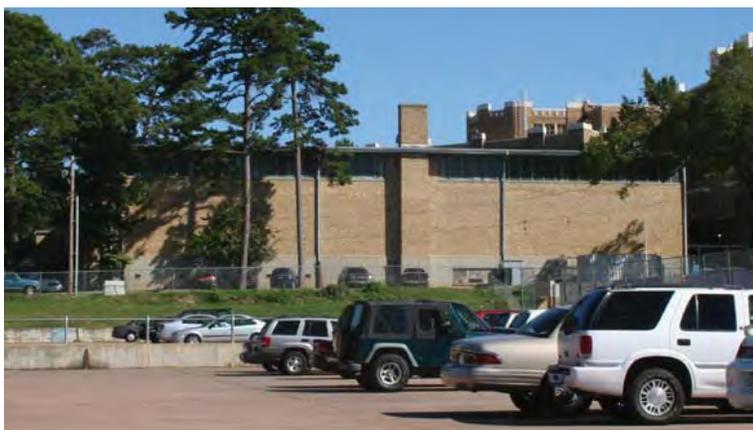
**Figure 2-91.** The Tiger Fieldhouse, northwest of the main high school building, seen here looking east. *Source: John Milner Associates, Inc., 2007.*

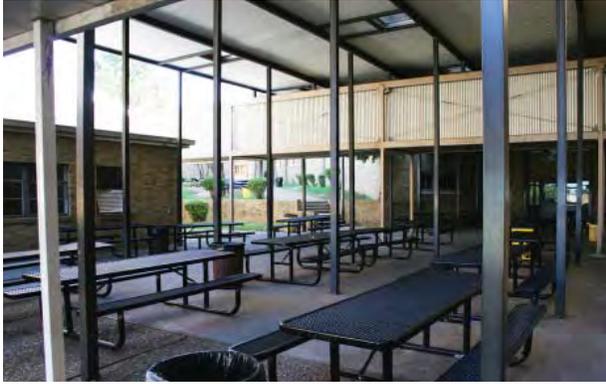
**Figure 2-92.** A modern overhead structure on the west side of the school. *Source: John Milner Associates, Inc., 2007.*

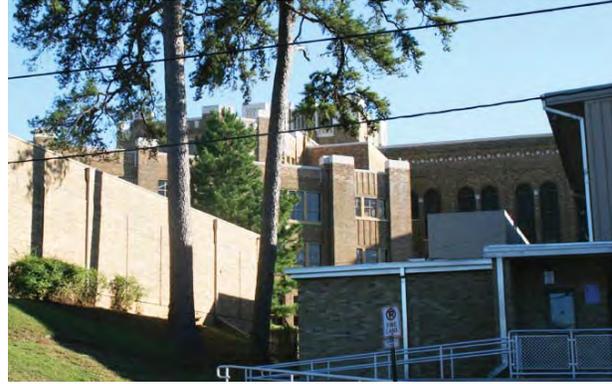
**Figure 2-93.** This ADA ramp provides access to the Tiger Fieldhouse. *Source: John Milner Associates, Inc., 2007.*

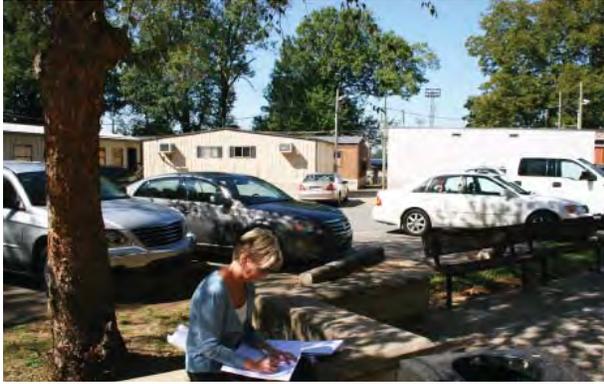
**Figure 2-98.** Portable classrooms grouped on the southwest of the main school building. *Source: John Milner Associates, Inc., 2007.*

**Views of and from within Central High School** are inhibited by perimeter walls and fencing as well as cluttered additions to the west side of the school (see *Figures 2-98 and 2-99*). **Views of the stadium wall** are imposing; the 10-foot high poured concrete walls surrounding the stadium, though historic, present a bare composition at the west end of the school site for surrounding neighbors (*Figure 2-115*). On the other hand, they create a sense of enclosure from within the stadium (*Figure 2-116*). Elsewhere on the school property, high, chain link fencing secures the school perimeter but also obscures views into and out of the schoolyard (*Figure 2-117*).

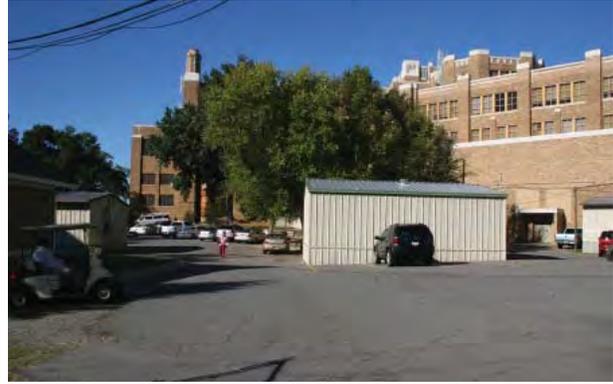
**Figure 2-99.** A storage unit in the center of the parking lot blocks views of the school. *Source: John Milner Associates, Inc., 2007.*

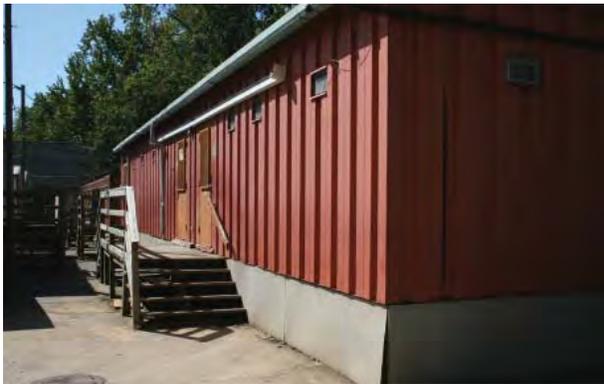
**Figure 2-100.** The portable classrooms are prefabricated structures of varying colors and styles. *Source: John Milner Associates, Inc., 2007.*

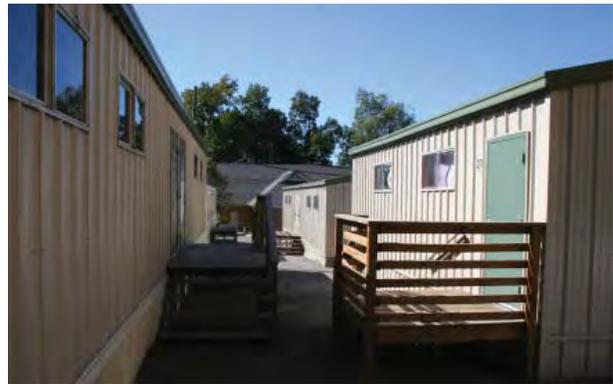
**Figure 2-101.** Wood stairs, handrails and landings access the portable classrooms. *Source: John Milner Associates, Inc., 2007.*

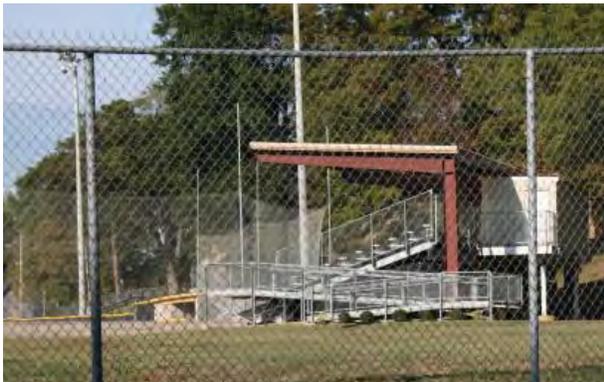
**Figure 2-102.** A baseball diamond and dugout were developed in the playing fields west of the school in 2003. *Source: John Milner Associates, Inc., 2007.*

A **baseball diamond and an associated dugout** were redeveloped on the south side of the middle third of the school property in 2003 (*Figure 2-102*).

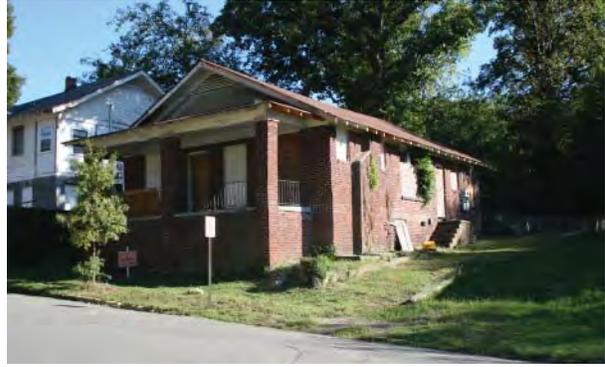
**Figure 2-104.** Boarded-up Craftsman bungalow on W. Sixteenth St. *Source: John Milner Associates, Inc., 2007.*

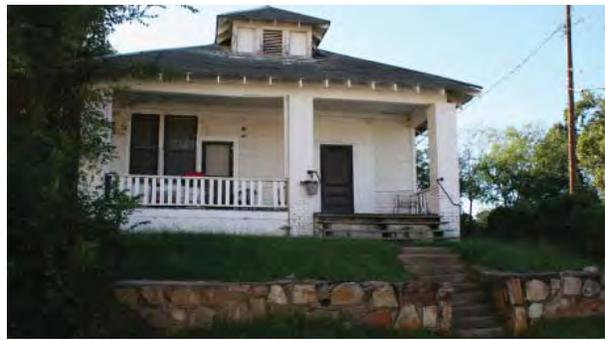
**Figure 2-108.** Craftsman house facing CHS on Jones Street; note stone retaining wall. *Source: John Milner Associates, Inc., 2007.*

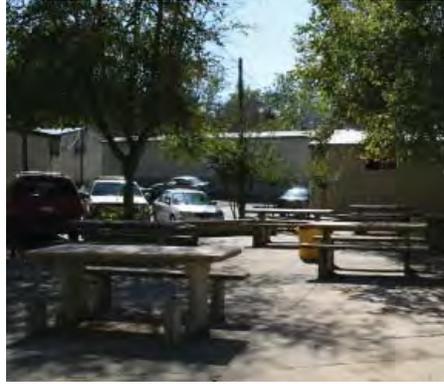
**Figure 2-119.** Views towards the neighborhood are also obstructed by the modular structures. *Source: John Milner Associates, Inc., 2007.*

**Views into the schoolyards** behind the school are blocked by building additions and their connecting structures and the prefabricated modular buildings on the south side (*Figure 2-118*). All of the prefabricated units positioned behind the school are obtrusive, non-contributing features negatively impacting views into and out of that area. One in particular blocks views of the rear of the school and an outdoor seating area that dates to the period of significance. It also blocks views from the other direction; without it, views would be available from the picnic tables into the residential neighborhood, looking across W. Sixteenth Street and down Dennison Street (*Figure 2-119*).

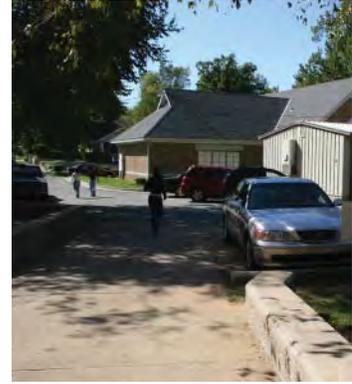
**Figure 2-120.** Site of demolished house on Jones Street, west of the high school. *Source: John Milner Associates, Inc., 2007.*

**Views of the streetscape** are threatened by deferred maintenance and demolition of residences surrounding the high school. The gaps left by demolished homes also contribute to the uneven quality of the streetscape and a gradual loss of historic character (*Figure 2-120*).

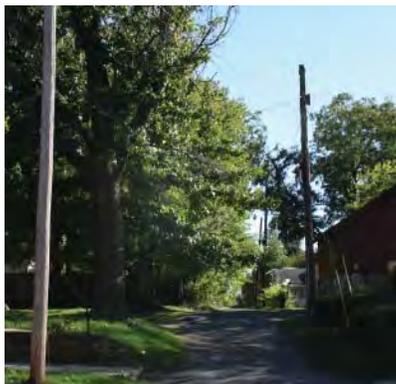
**Figure 2-123.** A warehouse west of Quigley Stadium is accessed from Jones Street. *Source: John Milner Associates, Inc., 2007.*

There is a **staff parking lot and loading area** on the south and west (rear) side of the school; this was a historical condition. This area is accessed off of W. Sixteenth Street, opposite Dennison Street. West of Quigley Stadium there is also a warehouse that takes deliveries, accessed from Jones Street (*Figure 2-123*).

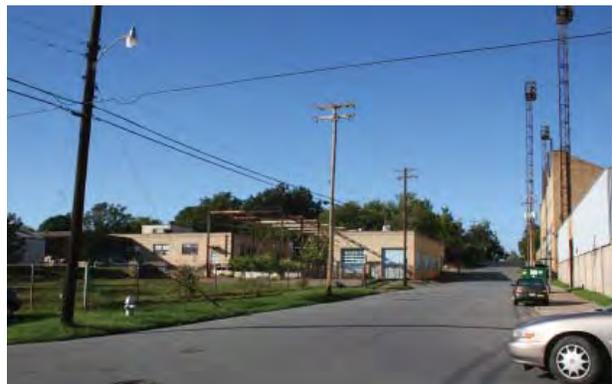
**Figure 2-124.** The parking lot on the north side of Daisy Bates, across from the high school. *Source: John Milner Associates, Inc., 2007.*

Daisy Bates (formerly W. Fourteenth Street) is the widest of the perimeter streets around Central High School, at 36 feet (see a full description in the Public Service Area Circulation section, above). It has a double yellow stripe and six inch concrete curbing to either side. Rice Street continues to the north off of this street. Notably, Dennison Street north of Daisy Bates, another secondary road, was removed with the addition of the school's north parking lot. This lot can be accessed from W. Thirteenth Street only, although pedestrians can exit the lot on to Daisy Bates (*Figure 2-124*).

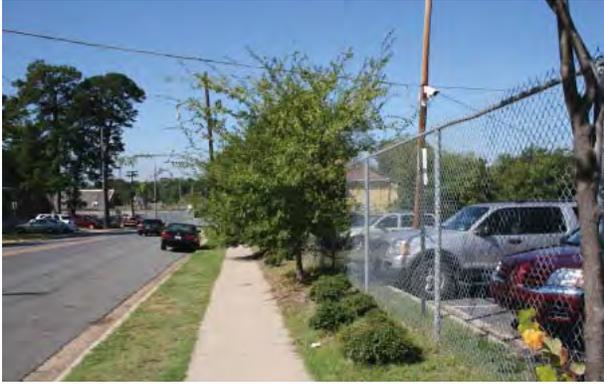
**Figure 2-125.** An accessible drop-off area, on the north side of the school. *Source: John Milner Associates Inc., 2007.*

A **universally accessible drop-off area** is located just off Daisy Bates, on the north side of the school. As one of the original circular driveways, it is now concrete and allows only one-way traffic (*Figure 2-125*). School buses pick up and drop off at the front entrance of the school on S. Park Street (see the Historic Scene Circulation section, above).

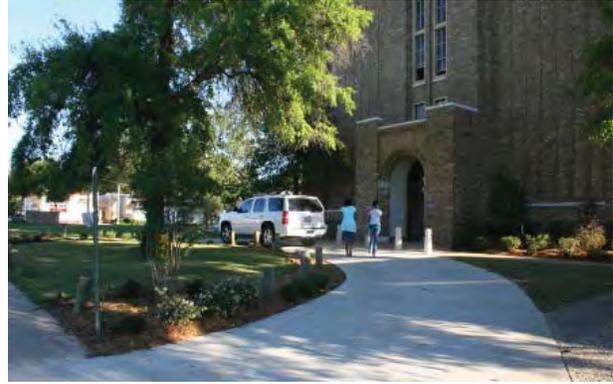
**Figure 2-126.** Cars parked in the unassigned areas behind the school. *Source: John Milner Associates Inc., 2007.*

Parking is allowed in designated areas on the south and west sides of the main school building but cars can also be found parked around dumpsters and in unassigned areas behind the school (*Figure 2-126*). Cars can also be seen parked behind the chain link security fencing on areas of mown turf at the school's south entrance (*Figure 2-127*).

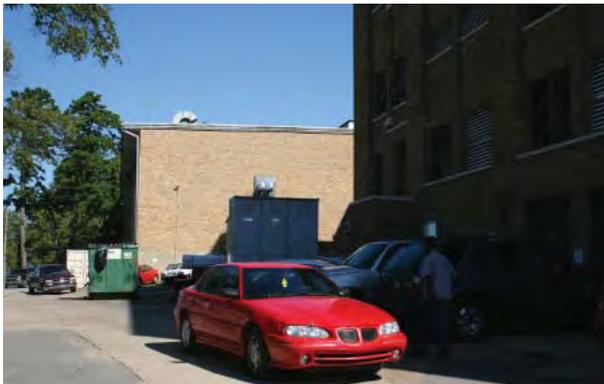
**Figure 2-127.** Cars parked behind a chain link fence on the south side of the school. *Source: John Milner Associates, Inc., 2007.*

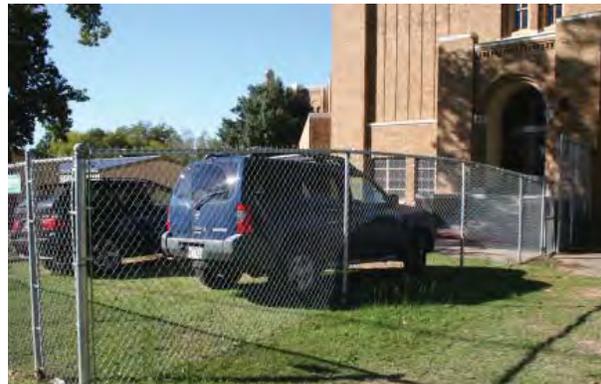
**Figure 2-128.** The parking lot west of the school and the surrounding chain-link fence. *Source: John Milner Associates, Inc., 2007.*

the tiers and its easternmost side is mitigated by three-foot high concrete retaining walls (*Figure 2-128*).

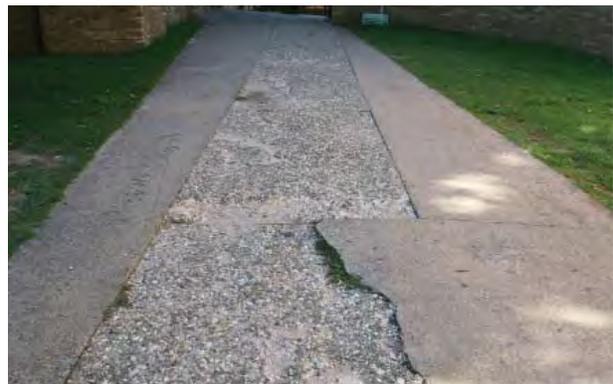
**Figure 2-129.** Paving in need of repair. *Source: John Milner Associates Inc., 2007.*

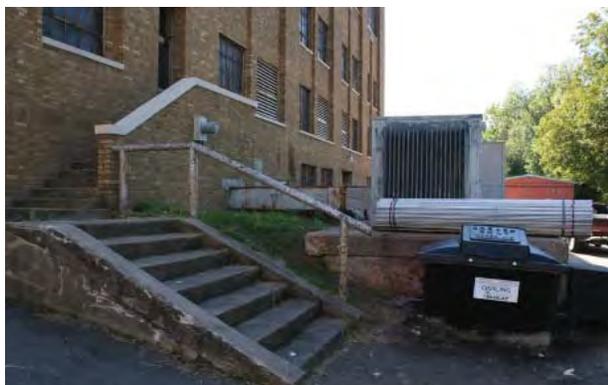
**Figure 2-130.** Damaged stair cheekwalls. *Source: John Milner Associates, Inc., 2007.*

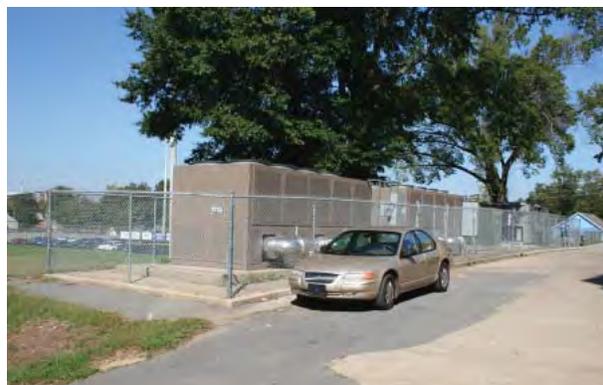
**Figure 2-131.** Pavement in drives is cracked and patched. *Source: John Milner Associates, Inc., 2007.*

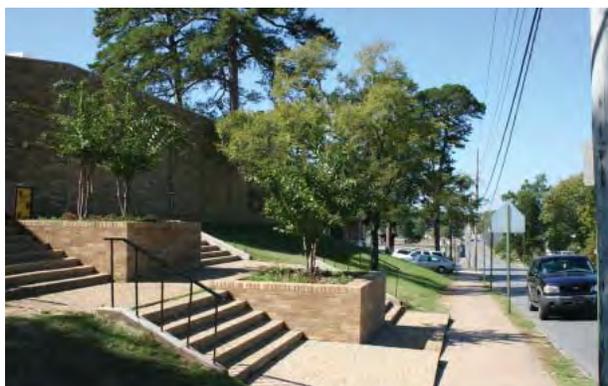
**Figure 2-132.** Trees between the library and field house. *Source: John Milner Associates Inc., 2007.*

West of the north wing of the school, there are a number of mature trees in the lawn between the Matthews Library and the Tiger Fieldhouse (*Figure 2-132*). There is a pair of pines between the library and fieldhouse (*Figure 2-133*), and a large pine between these buildings and the school. In that courtyard area, there are also crape myrtles and privet.

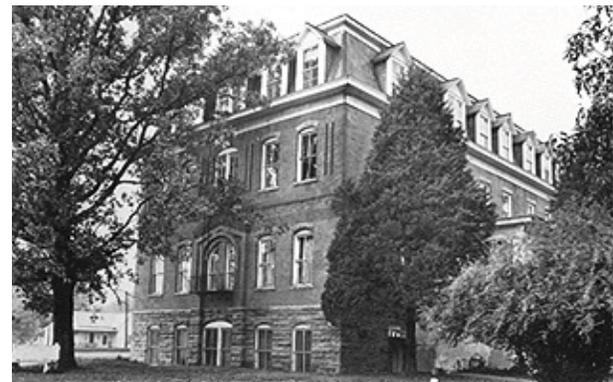
**Figure 2-156.** The campus of Arkansas Baptist College. *Source: "Forever HBCU" web site, [http://foreverhbcu.com/admin/schoolimages/Arkansa\\_Arkansa\\_arkansasbapcamp.jpg](http://foreverhbcu.com/admin/schoolimages/Arkansa_Arkansa_arkansasbapcamp.jpg) (accessed May 7, 2008).*

The Neighborhood Setting is also characterized by institutional campuses (see *Figure 2-156*). These usually consist of a loose arrangement of buildings within a large block, constructed to serve the program of the organization and less frequently in response to the overall neighborhood. In the case of the Arkansas Baptist College campus this is a condition that dates to the historic period of significance. The Arkansas Children's Hospital campus, however, is a new development that occupies blocks that were residential during 1957-57; the character of this northwestern part of the neighborhood has been significantly altered by changes in street circulation patterns, buildings that are very large in scale, and an increase in overall paved surfacing.

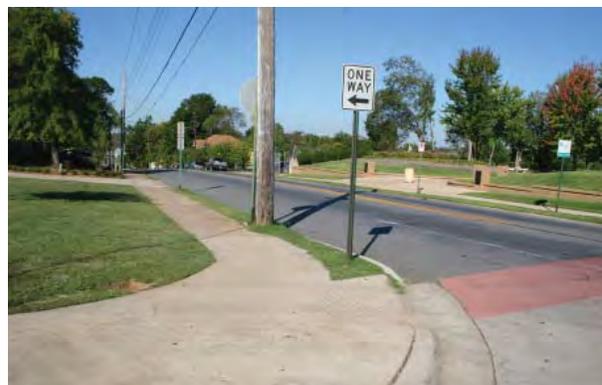
**Figure 2-164.** Residential driveways are frequently concrete two-tracks with a turf center. *Source: John Milner Associates, Inc., 2007.*

In addition to the **local and collector streets**, houses within the neighborhood are almost all accessible by **narrow, unpaved alleys** that bisect each block and are usually oriented north to south (see *Figure 2-122*). Alleys are frequently used to access parking at the rear of buildings. Otherwise, parking for residences is accessible via narrow driveways off of the local streets. **Residential driveways** vary are typically asphalt or concrete, or simple two-track concrete with a turf center (*Figure 2-164*).

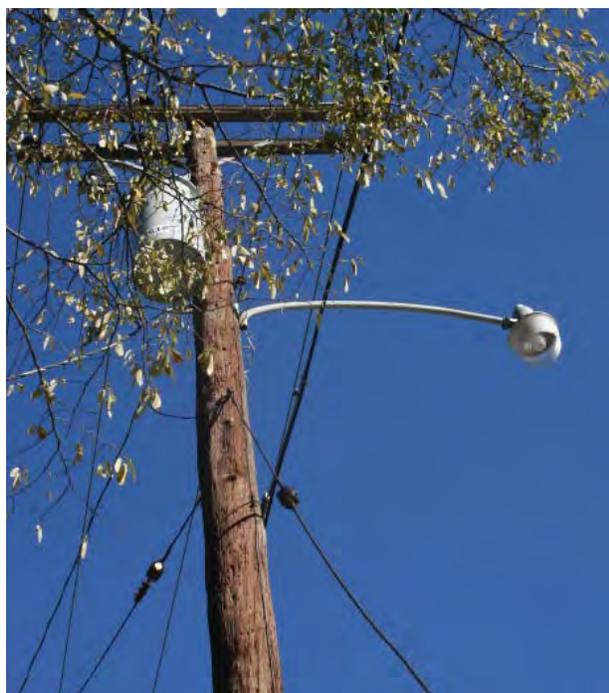
**Figure 2-165.** Street-side signage and utility poles in the neighborhood. *Source: John Milner Associates, Inc., 2007.*

Small-scale features within the Neighborhood Setting include **street identification signs, traffic and other regulational signage, fire hydrants, and utility poles** that line the streets within the right-of-way (*Figure 2-165*). Some of the utility poles also support street lighting (*Figure 2-166*).

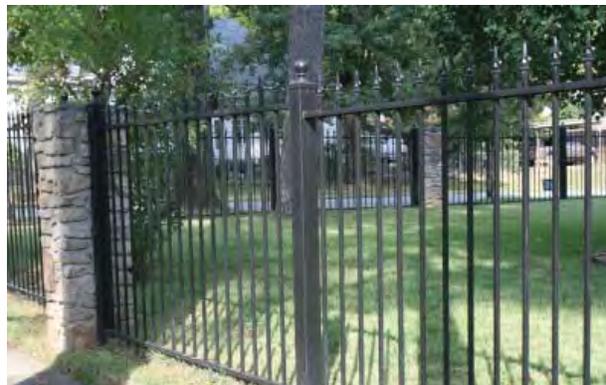
**Figure 2-168.** Metal fencing. *Source: John Milner Associates, Inc., 2007.*

An eclectic variety of **perimeter fencing** styles of varying transparencies can be found throughout the neighborhood including: ornamental metal (*Figure 2-168*), metal pickets featuring stone or brick columns (*Figure 2-169 and Figure 2-170*), chain link (*Figure 2-171*), wood pickets (*Figure 2-172*) and fully enclosed wood board privacy fences (*Figure 2-173*). Some fences enclosing back yards are visible from the street while other fences surround front yards.

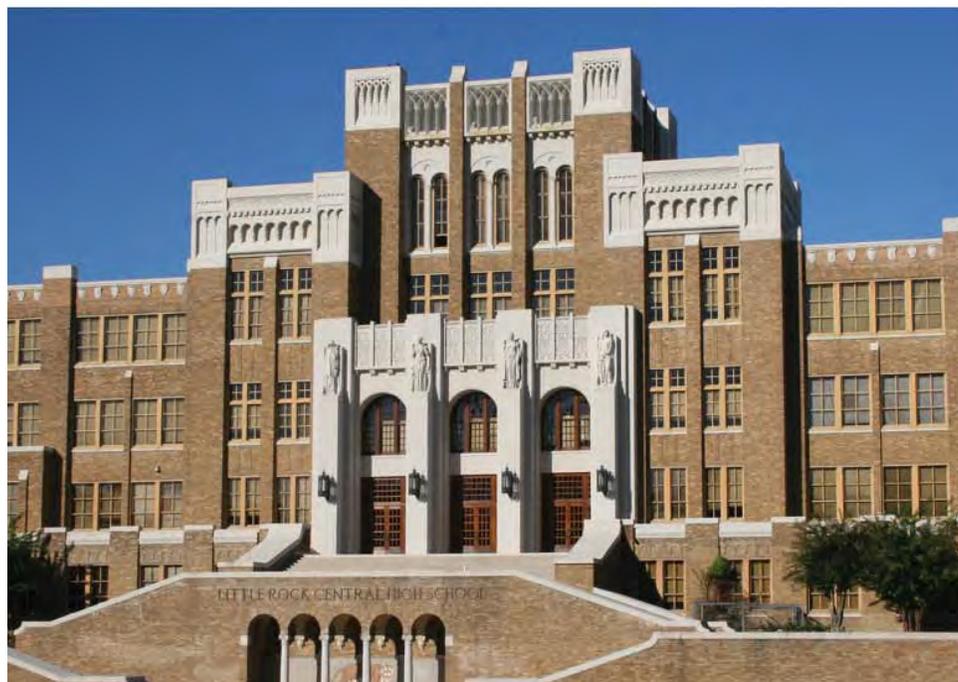
**Figure 2-174a.** This historic photograph depicts soldiers guarding the front of Central High School ca 1957-58. *Source: Central High Museum, Inc., COLL.B.12.I.183, no date, National Park Service, Little Rock Central High School National Historic Site.*

The façade of Little Rock Central High School is formidable (*Figures 2-174 through 2-178*). Grand in scale and with many classical details, it is a prominent landmark that is highly recognizable from historic photographs of the desegregation crisis. Views of this façade from many different points around the area (the front grounds of the school, as well as views from S. Park Street) are a valuable feature of the Historic Scene. Views of the school grounds and S. Park Street from within the school are also significant because students and faculty would

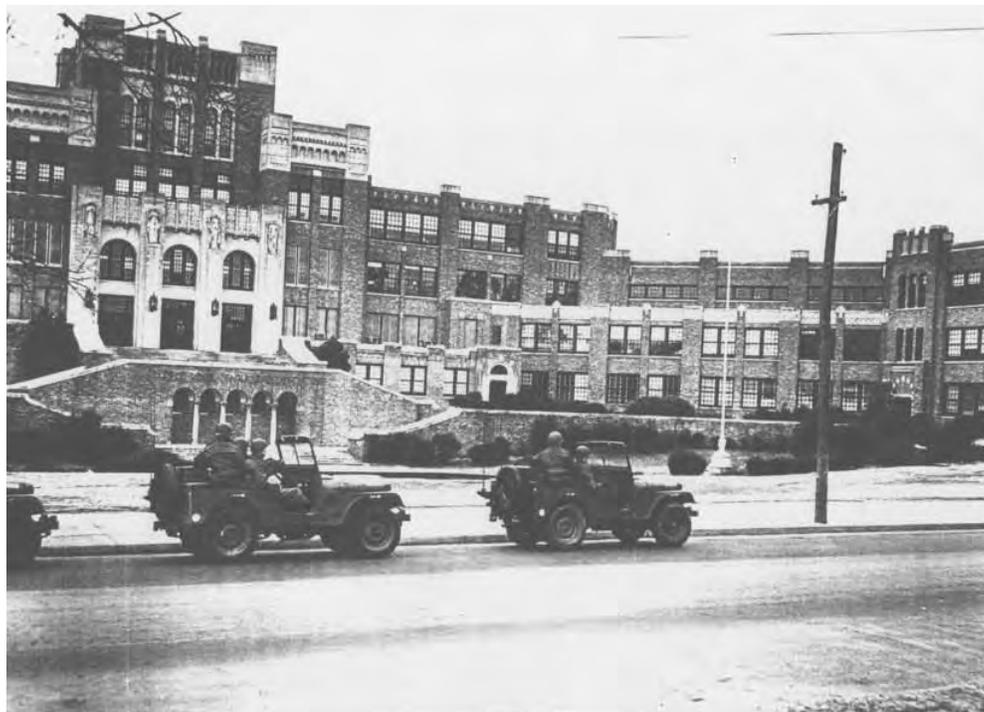
**Figure 2-175a.** This photograph from ca. 1957-58 shows the utility pole and overhead utility lines that defined the space of S. Park Street on its west side. *Source: Central High Museum, Inc., COLL.B.12.I.257, no date, National Park Service, Little Rock Central High School National Historic Site.*

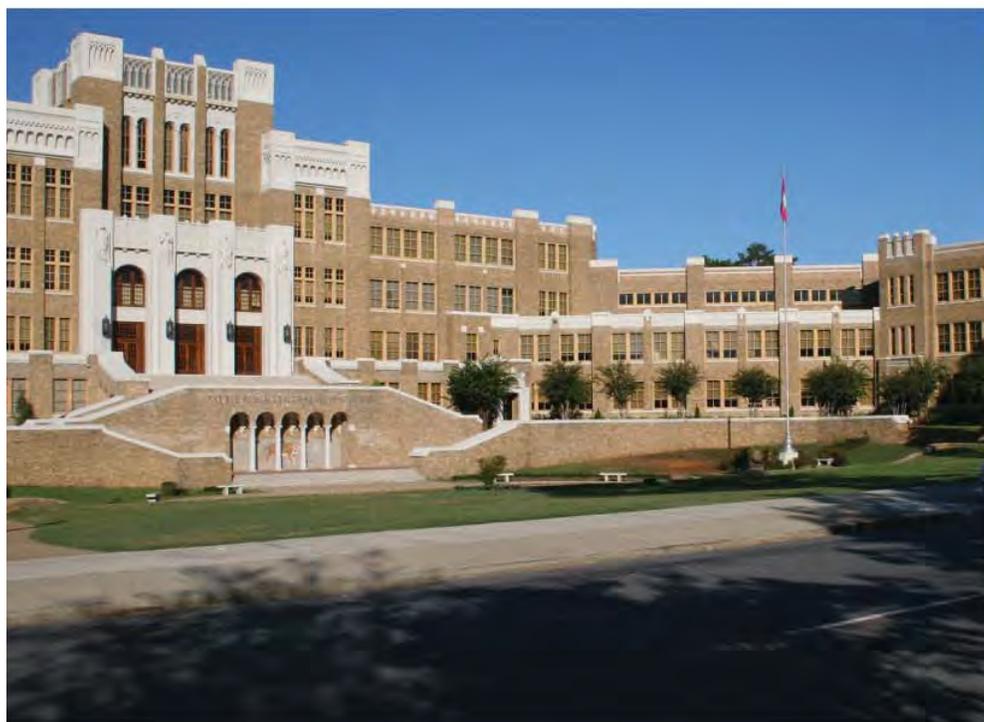
**Figure 2-175b.** In this recent view of the high school, many features are extant from the historic period. Missing, however, are the utility poles that once lined the west side of S. Park Street. *Source: John Milner Associates, Inc., 2007.*
