# CENTRAL HIGH SCHOOL

## CULTURAL LANDSCAPE REPORT

# Central High School

**September 2009**

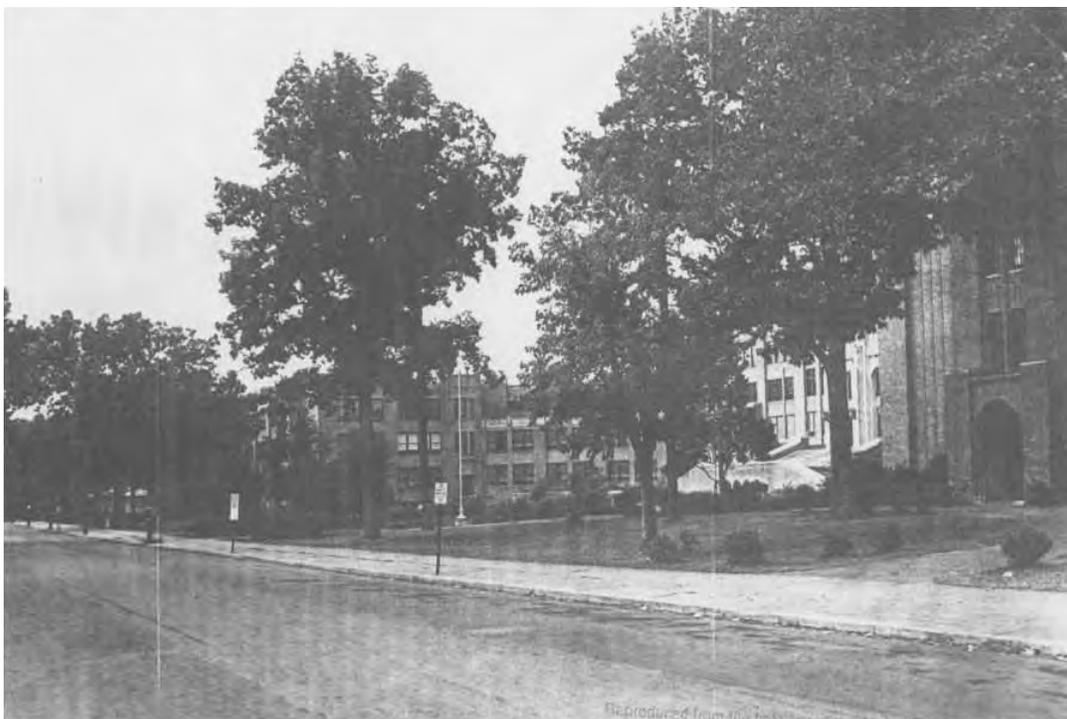
**Figure 2-177a.** This historic photograph depicts the shade trees and shrubs growing in the front school yard of Central High School ca. 1957-58. *Source: Central High Museum, Inc., COLL.B.12.I.13, no date, National Park Service, Little Rock Central High School National Historic Site.*

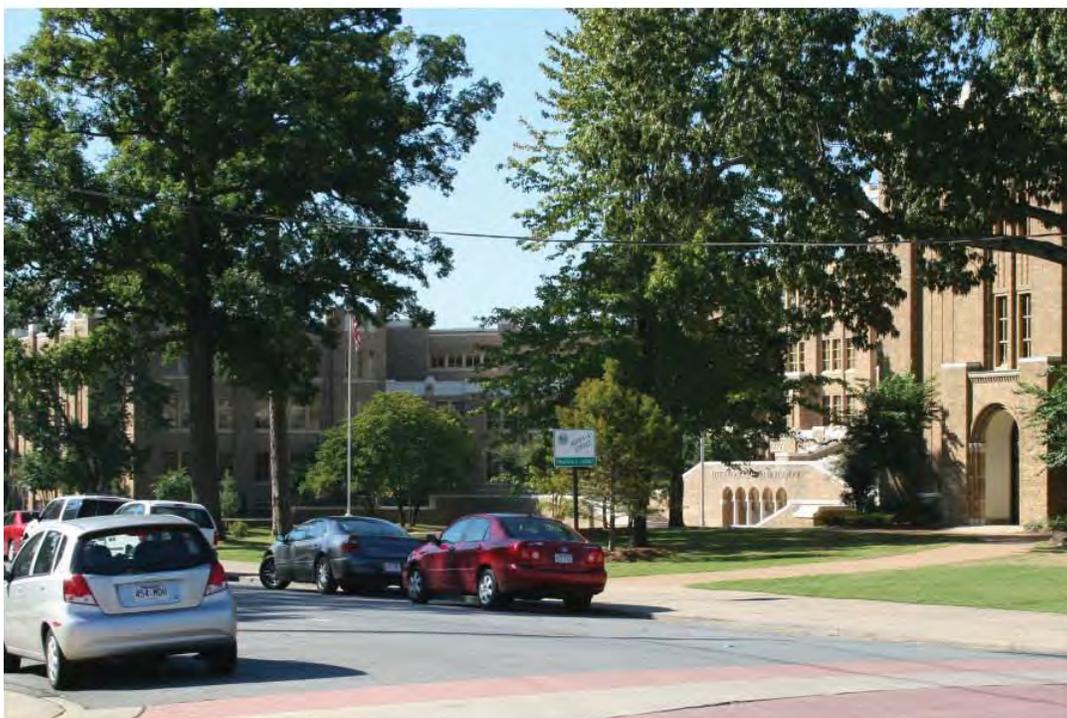
**Figure 2-177b.** Most of the trees that existed during the period of significance are existing today. However, the shrubs that lined the entrance walks are not extant and some smaller trees have been planted in the center island. *Source: John Milner Associates, Inc., 2007.*

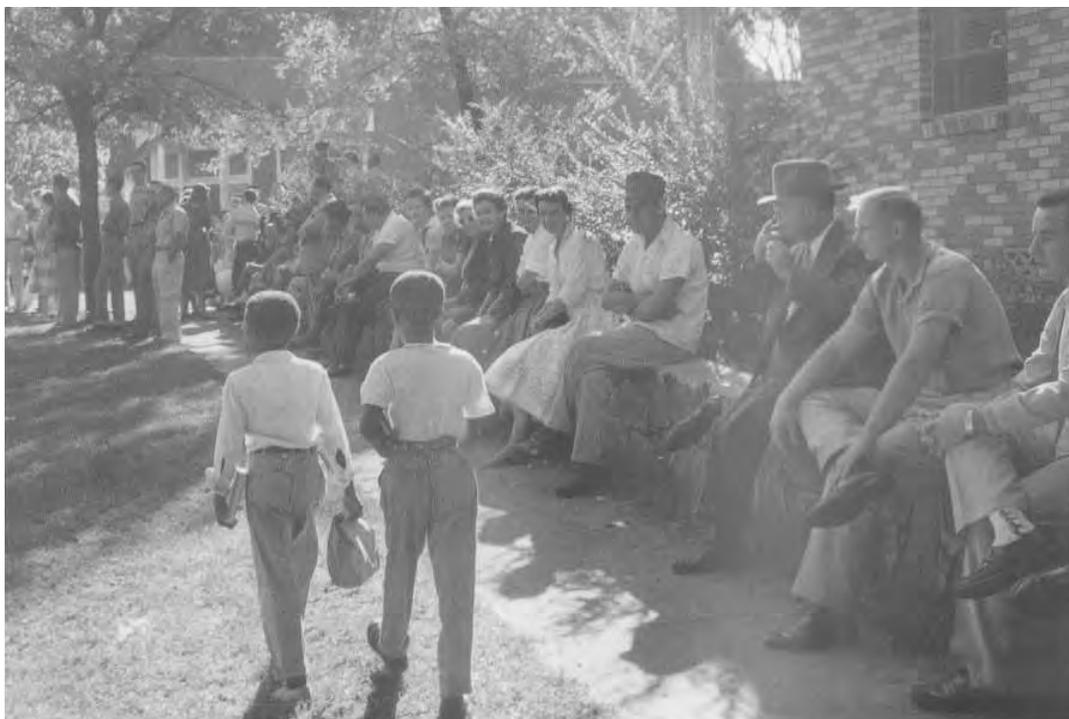
**Figure 2-180a.** During the desegregation crisis, onlookers perched on the stone retaining wall supporting the yard of this brick house on the corner of S. Park and W. Sixteenth Streets and across from Ponder's Drug Store. These children had to pass through the crowds to get to their school. *Source: Will Counts, A Life is More Than Just a Moment: The Desegregation of Little Rock's Central High. Indianapolis: Indiana University Press, 1999 (50th Anniversary Edition 2007), 4.*

W. Sixteenth Street was also the location of the brick house on the corner of S. Park and W. Sixteenth Street where onlookers lounged during the crisis across the street from Ponder's Drug Store. Both the house and the stone masonry wall that was there in 1957 appear to be in good condition (*Figure 2-180*).

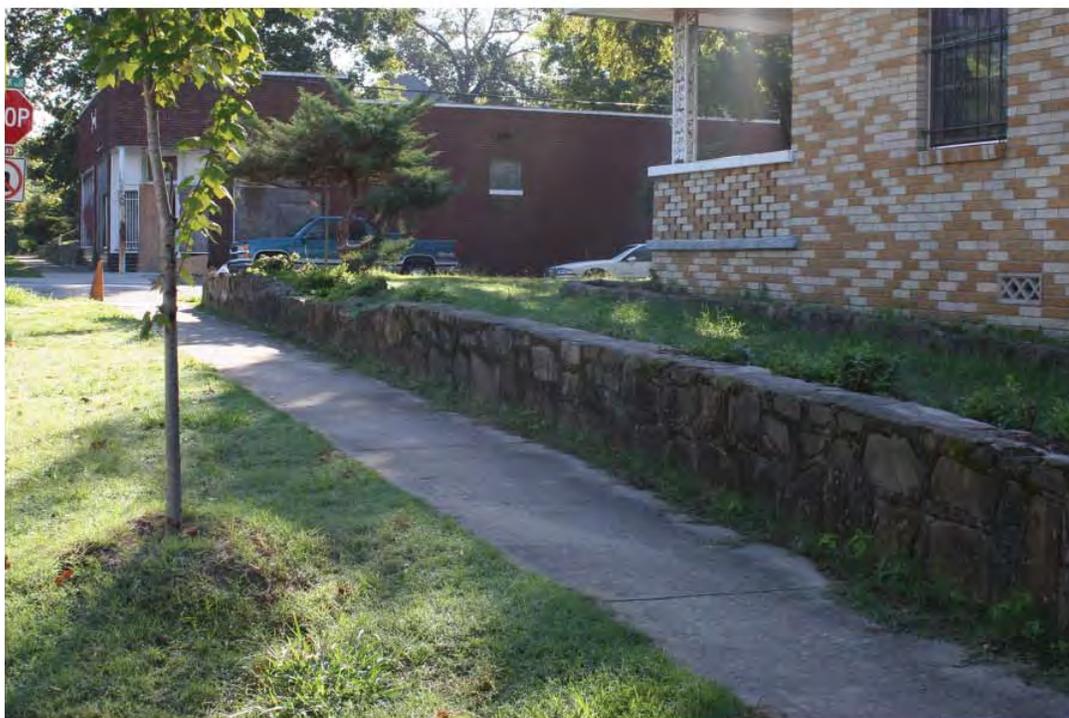
**Figure 2-180b.** Today, the house and stone wall appear to be in very much the same condition as they were in 1957-58. *Source: John Milner Associates, Inc., 2007.*

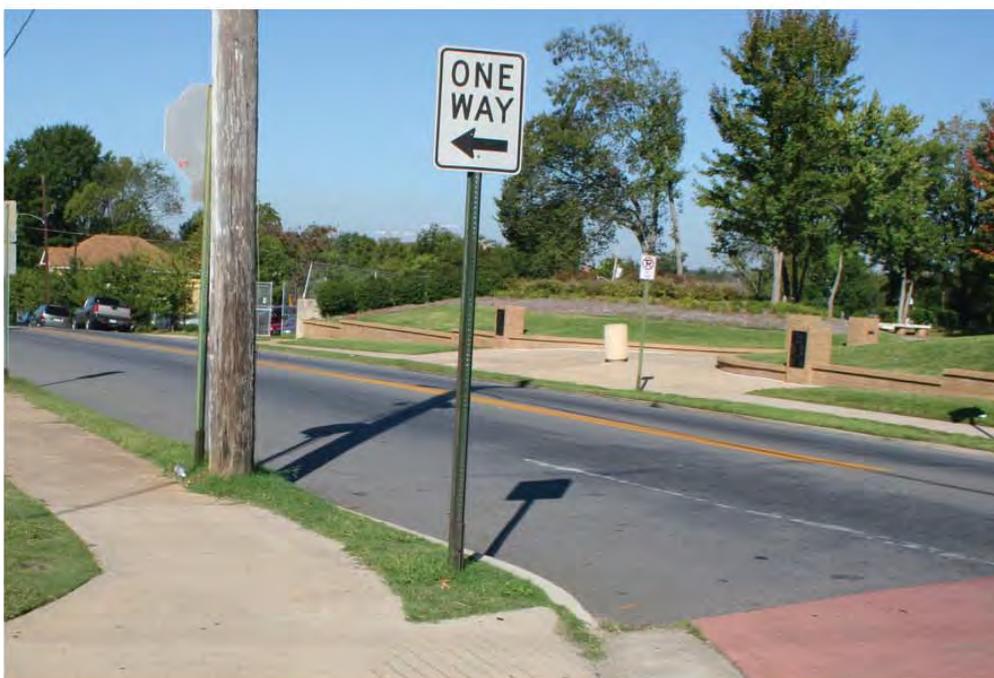
**Figure 2-181b.** The two houses depicted above have since been demolished. The lots were later acquired by CHMI, which constructed the Commemorative Garden where the houses had been located and then donated the garden to the NPS. *Source: John Milner Associates, Inc., 2007.*

There is very little historic integrity to the Public Services area, as the entire area has been redesigned to accommodate its administrative and new interpretive uses. The two residences and the greenhouses which occupied this area during the period of significance burned in the 1980s and the remains were removed. The residences that were at the northwest corner of then W. Fourteenth Street and S. Park Street in 1957 had already been demolished when Central High Museum, Inc. acquired the property (*Figure 2-181*).

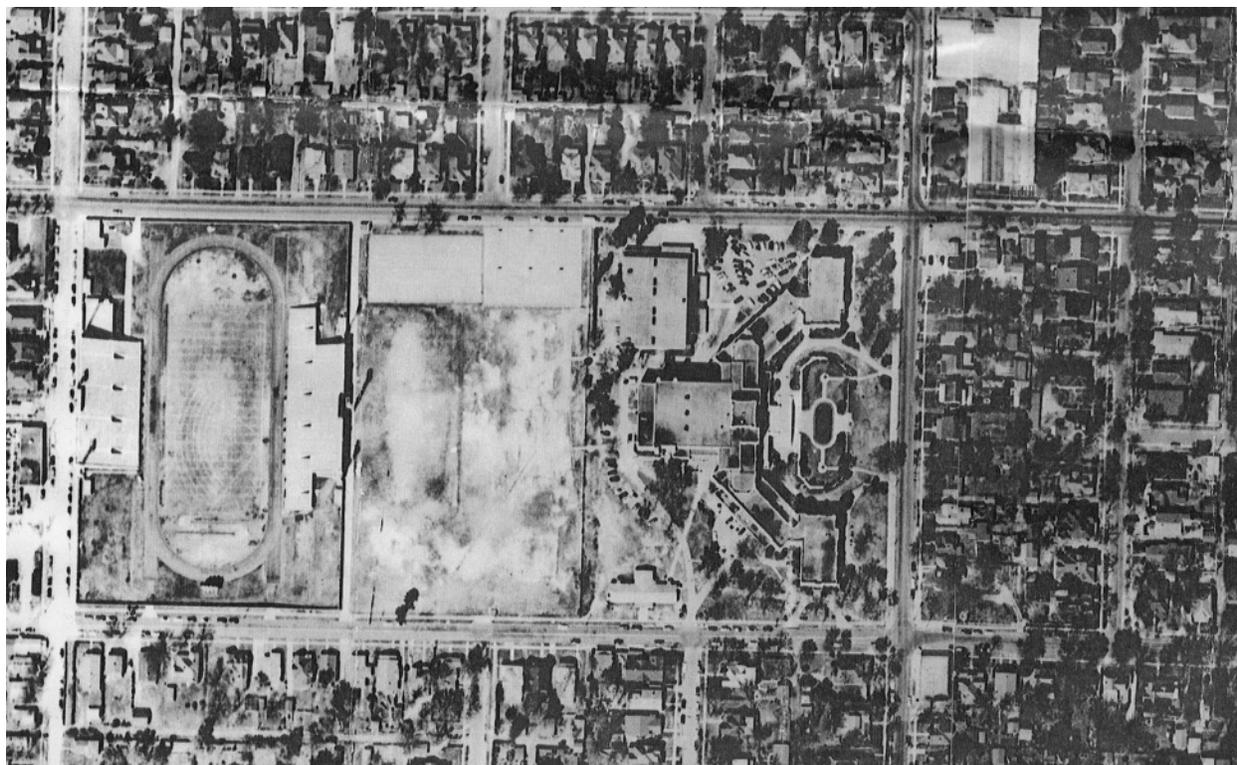
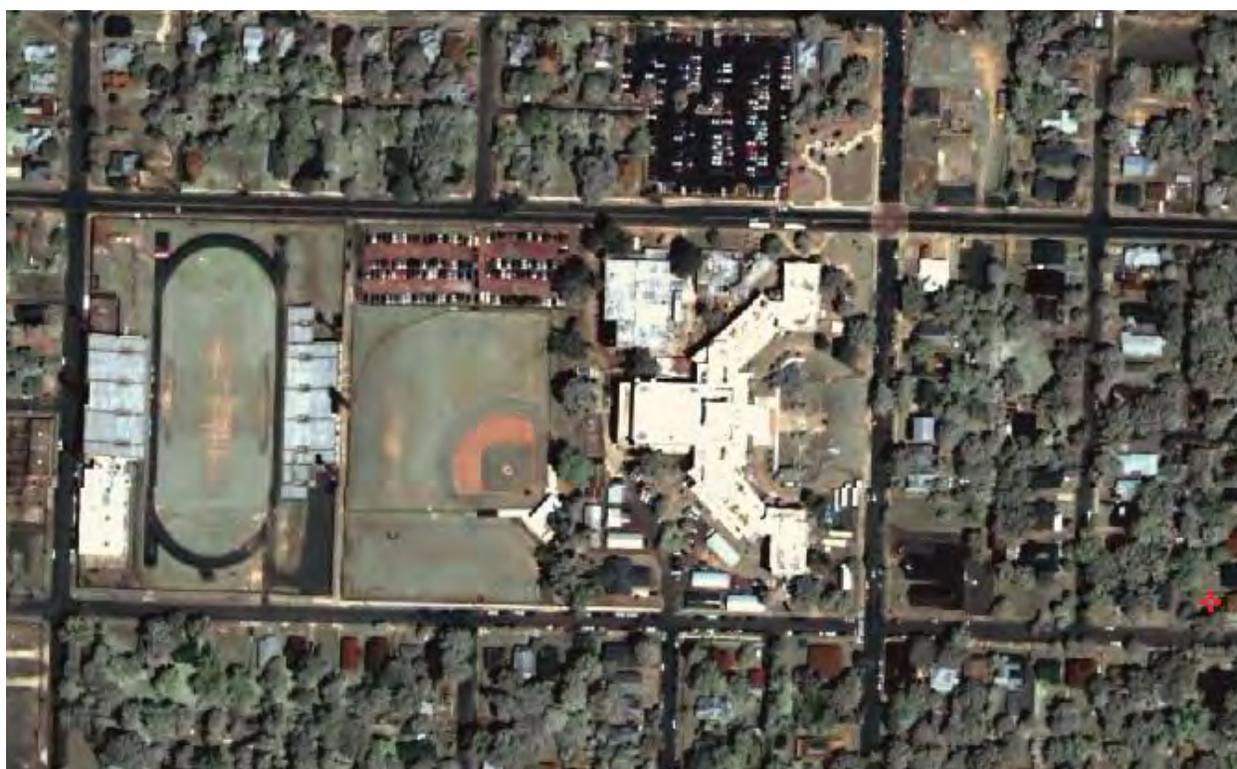
**Figure 2-182.** Comparison of the 1957 aerial, above, with the aerial shot in 2005. *Source: "Command Report, Operation Arkansas, Part I, 24 September to 23 October, 1957 - Part II, 24 October to 30 November 1957." Little Rock Central High School National Historic Site archives; 2005 aerial obtained from Little Rock Public Works Department, 2007.*

The Central High School Area possesses moderate integrity for the period of significance (*Figure 2-182*). Significant historic associations include the:

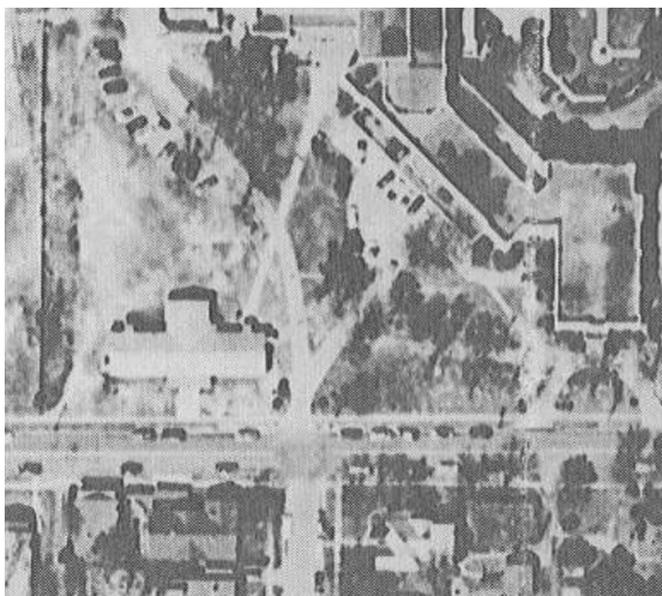
**Figure 2-183a.** Route taken from the lower level of Central High School by the Little Rock Nine via police convoy on September 23, 1957. It is not known from which of the two garage doors the group exited. *Source:* “*Command Report, Operation Arkansas, Part I, 24 September to 23 October, 1957 - Part II, 24 October to 30 November 1957.*” Little Rock Central High School National Historic Site Archives.

- National Guard and 101<sup>st</sup> Airborne encampment on athletic fields during period of significance;
- Drive-in side entrance of building where students were escorted off-campus in police cars and residence across the street on Dennison that witnessed the event (*Figure 2-183*);
- Playing fields and Quigley Stadium, which have changed little since the 1950s; and
- Location of Campus Inn, although the original building was replaced.

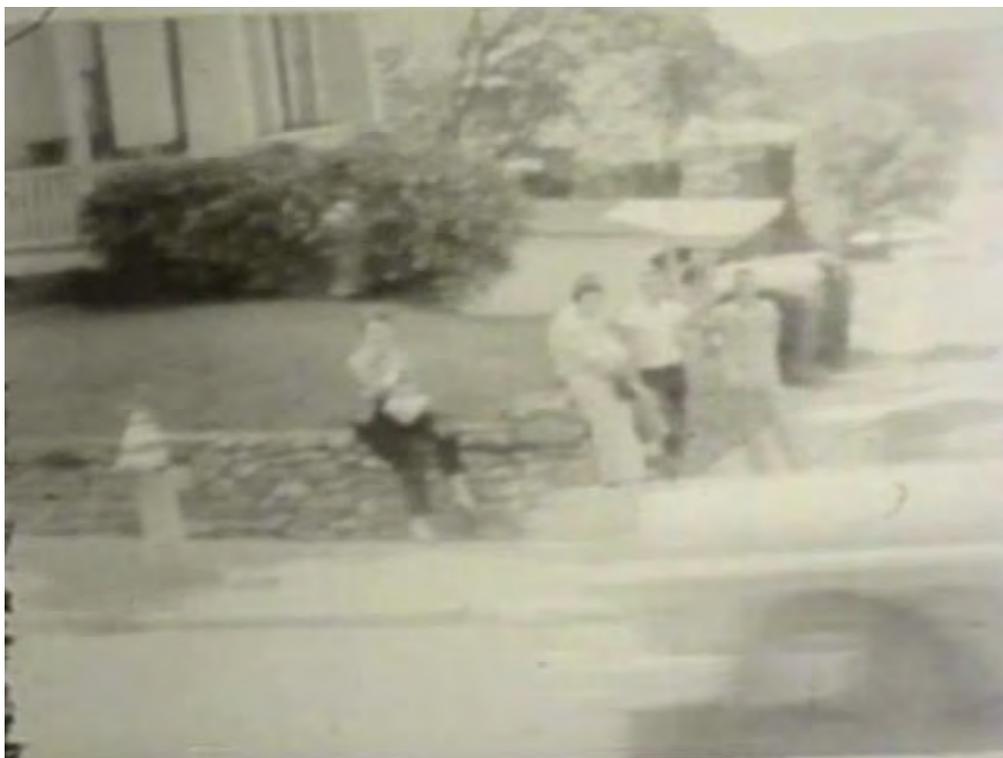
**Figure 2-184a.** Spectators seated on the stone retaining wall at 1600 Dennison Street watch police cars as the remove the Little Rock Nine to safety on September 23, 1957. *Source: "Home Movie Footage of the Little Rock Desegregation Crisis, 1957, 1958, 1959" obtained from Butler Center for Arkansas Studies, Central Arkansas Library System.*

- Surrounding streetscape, although its integrity has been compromised by the incremental demolition of residences along all three streets; and
- House across the street from the side entrance, at 1600 Dennison Street is extant and in good condition, except that its garage, evident in historic photographs, has since been removed (*Figure 2-184*).

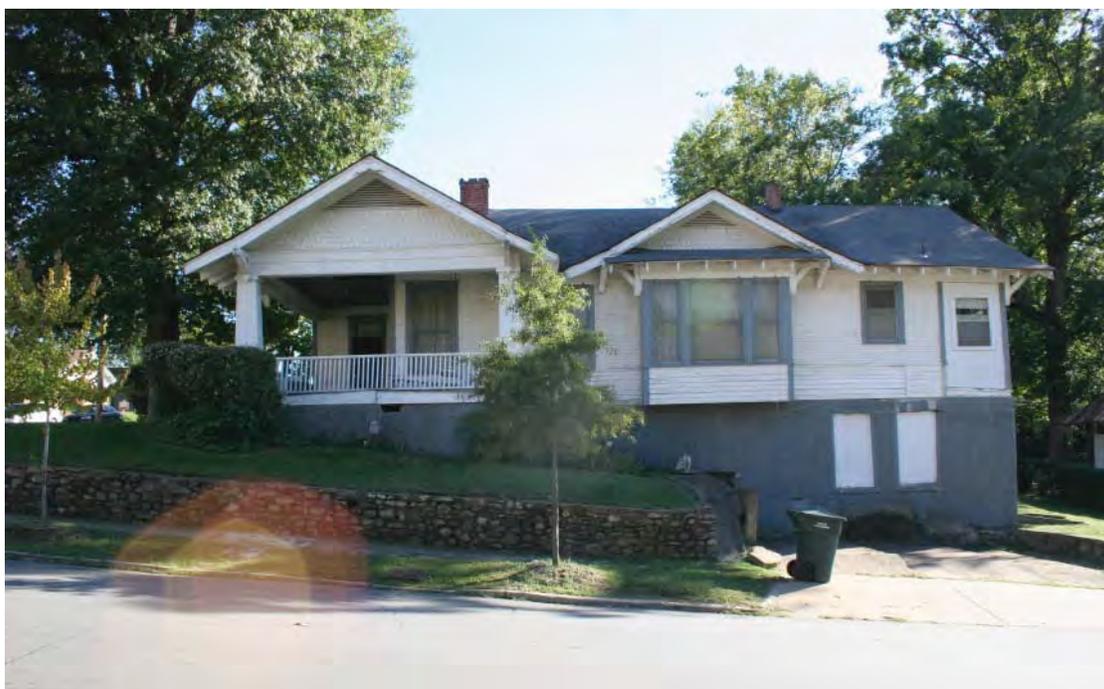
**Figure 2-184b.** The house and stone retaining wall at 1600 Dennison Street in 2007. *Source: JMA, 2007.*

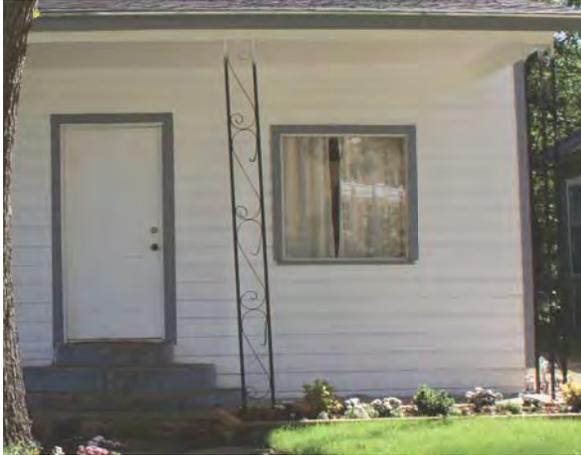
**Figure 3-1.** Bent metal porch supports at 1411 S. Park Street. *Source: John Milner Associates, Inc., 2007.*

- Replace other architectural details that are documented to date to the 1957-1959 period, including metal awnings, metal porch supports, or metal porch railings (*Figures 3-1 and 3-2*).

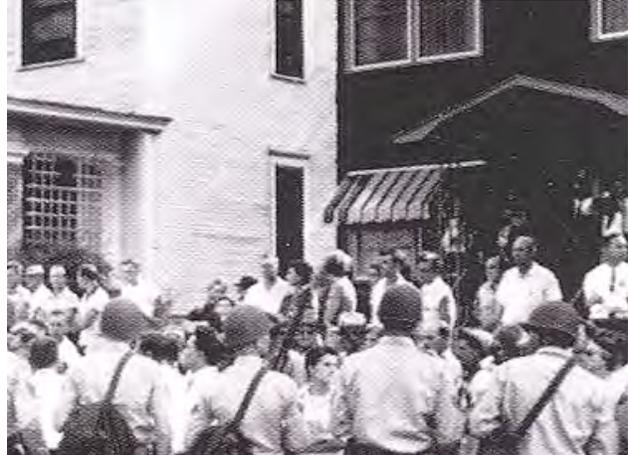
**Figure 3-2.** Metal awnings at 1501 S. Park Street. *Source: Central High Museum, Inc., Coll B-12.I.65, ca. September 1957, National Park Service, Little Rock Central High School National Historic Site (detail).*

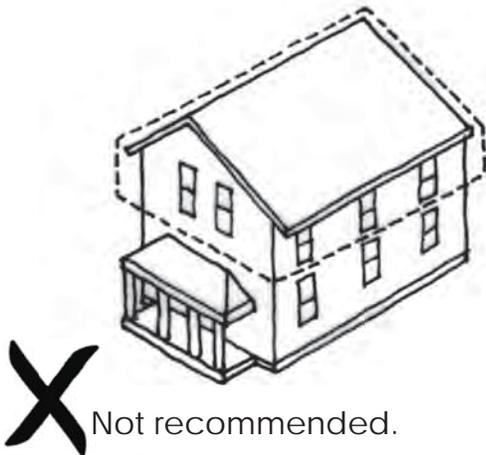
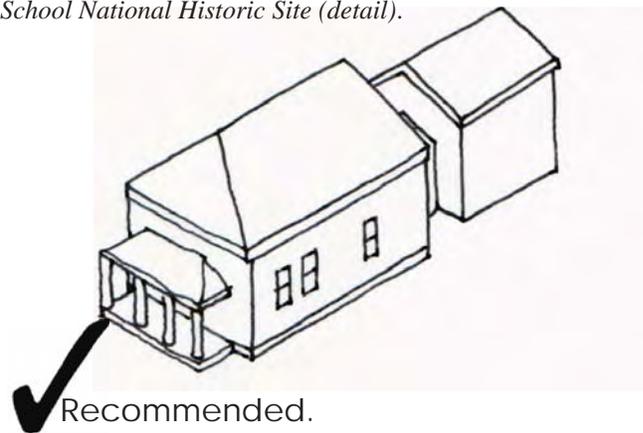
**Figure 3-3.** Place additions to existing buildings to the rear of the building, instead of “building up. Consider adding a connector to set off the historic part of the building and to make the addition more easily removable. *Source: JMA collection.*

- Preserve the façades of buildings and their relationship to the streetscape; site additions on rear façades rather than where they will be visible from the streetscape (*Figure 3-3*).

addition at the rear of the house and link it to the main structure with a narrow connector so that the original lines of the house are evident (see *Figure 3-3*).

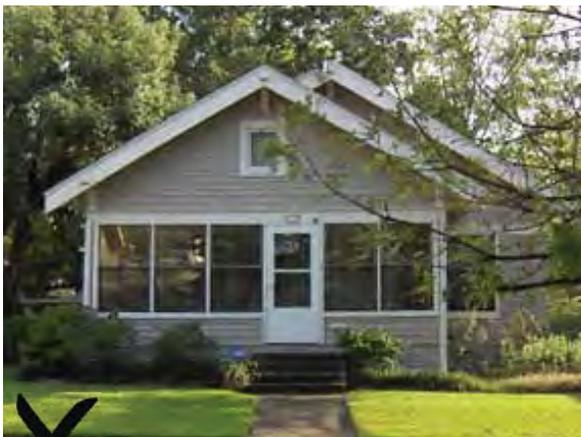
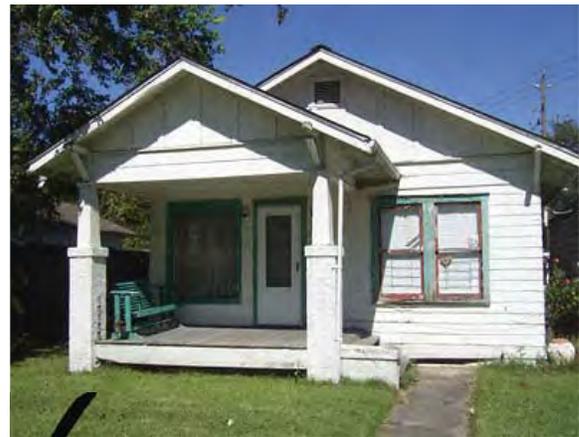
**Figure 3-4.** The front porch of the bungalow on the left has been enclosed with reflective glass, which affects its historic character. The open quality of the porch of the bungalow on the right is preferred. *Source: JMA collection.*

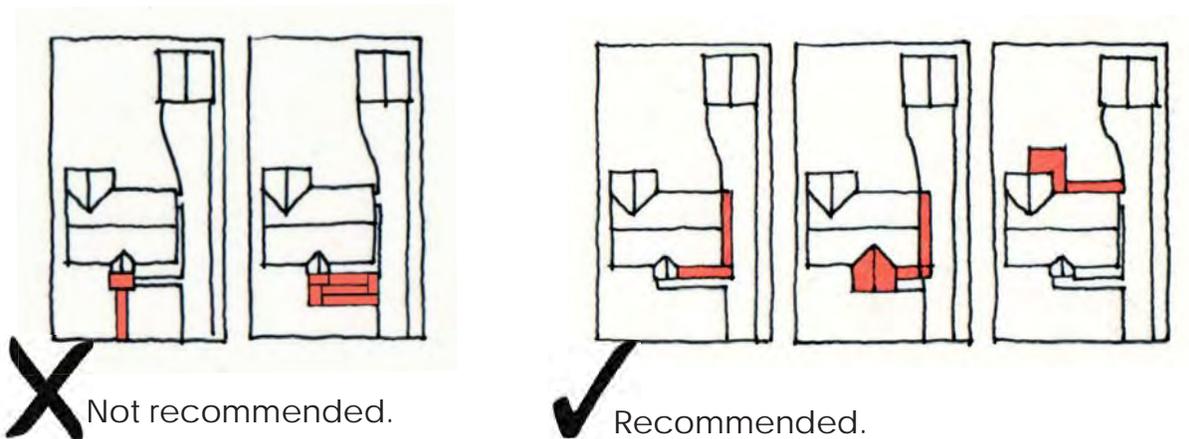
**Figure 3-5.** Instead of placing decks and ramps on the front of the building, consider placing them to the rear or side of the building to minimize impact to the historic streetscape. *Source: JMA collection.*

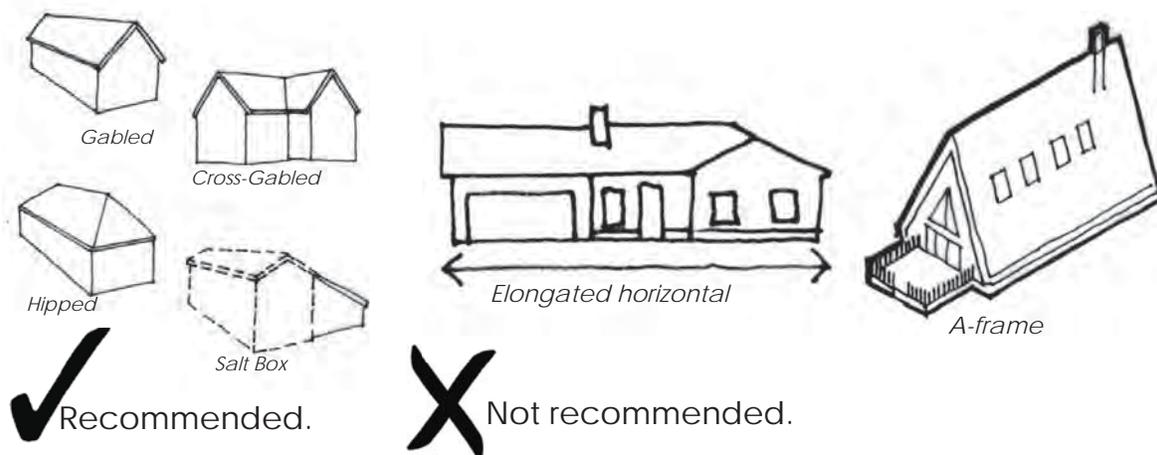
**Figure 3-9.** Design new buildings so that they reflect local historic building forms and shapes, whether gabled, cross-gabled, or hipped. Avoid forms such as elongated ranch styles and A-frames. *Source: JMA collection.*

- Building form - design new buildings so that they reflect locally-found historic building forms and shapes, whether boxy, as with American Foursquare residences or more complex, as with the Craftsman style homes. Provide roofs that reflect surrounding historic residences that are similarly pitched, hipped, cross-gabled, or oriented to the front or side, and detailed with chimneys, dormers, bracket, eave supports and similar features. Avoid forms such as A-frames, low ranch-style buildings or buildings with flat roofs (*Figure 3-9*).

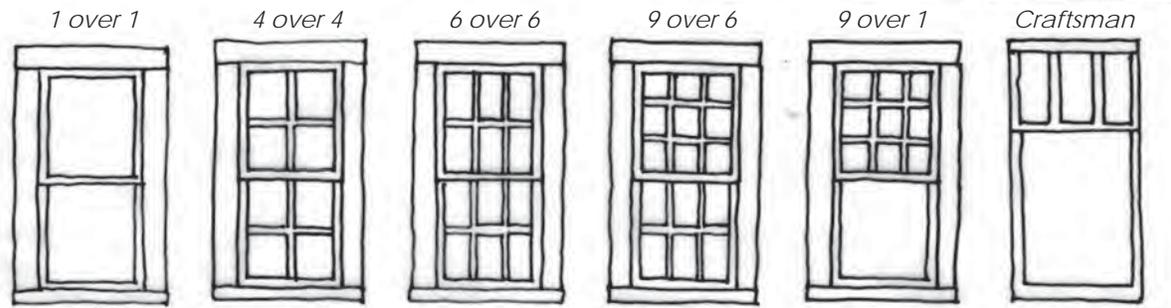
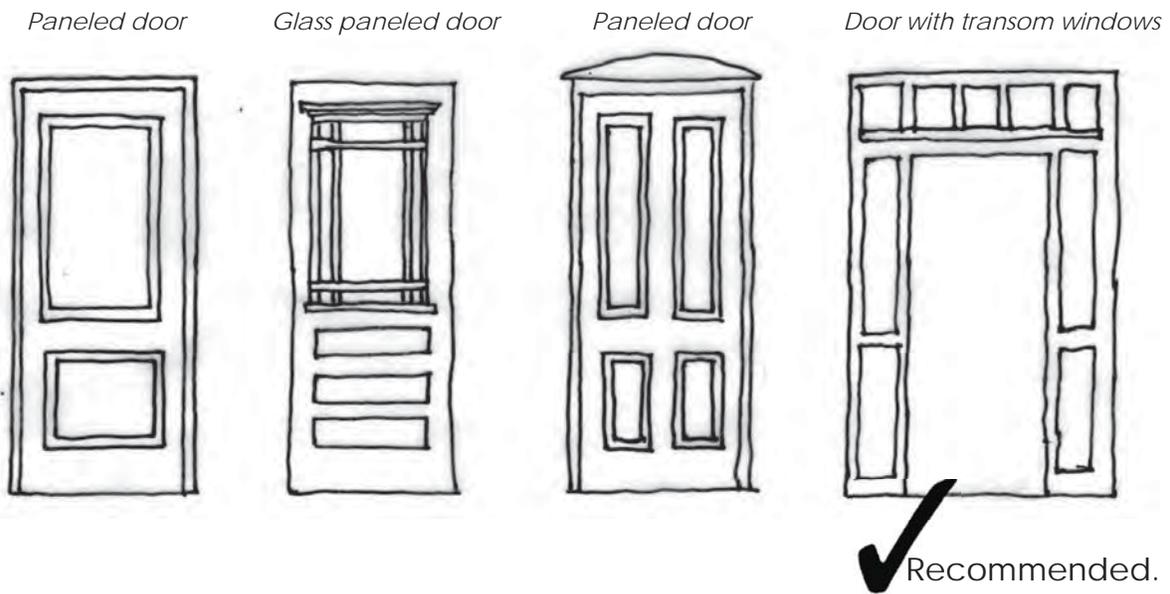
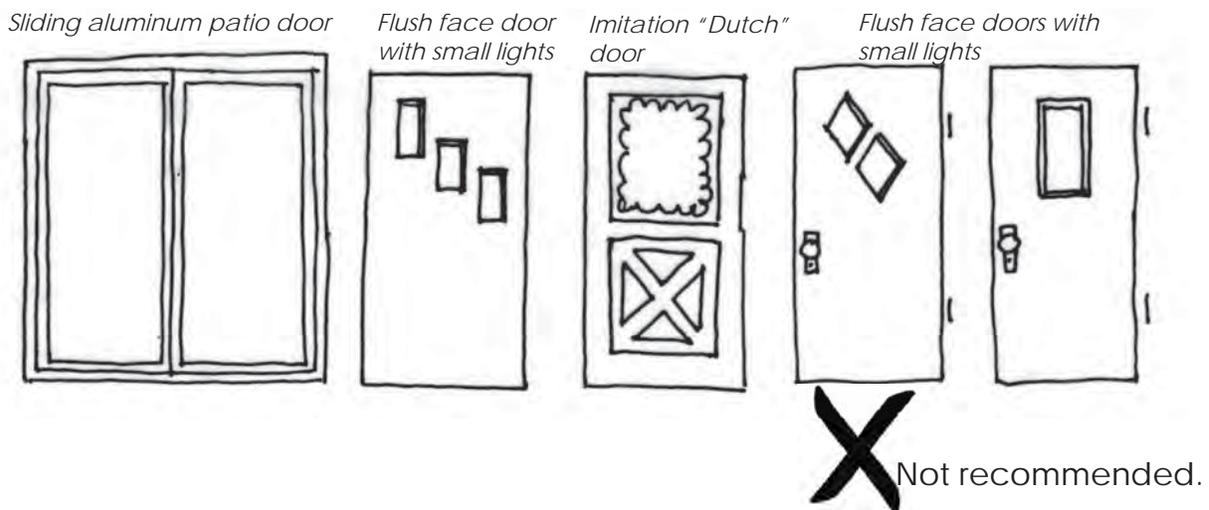
**Figure 3-14.** Windows and doors dating to the historic period tend to be more detailed than not. Most windows tend to be double-hung, most often with one-over-one or three-over-one lights. Doors are usually composed of a regular arrangement of recessed panels, often with upper windows and side lights. *Source: JMA collection.*

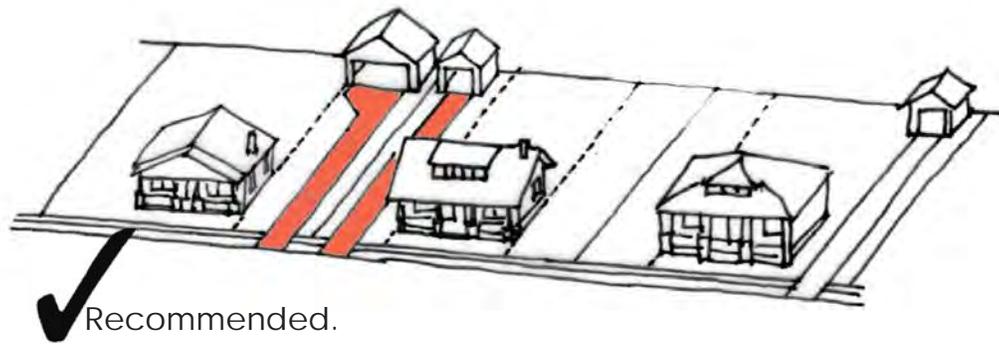
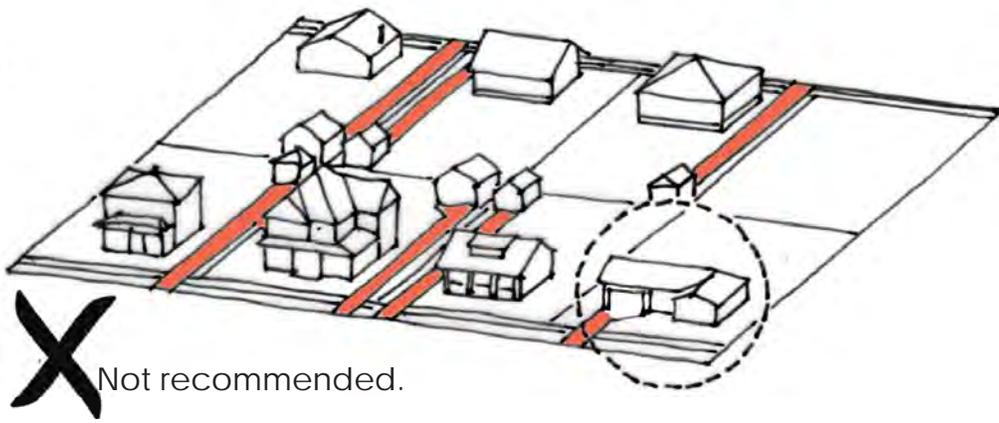
**Figure 3-16.** Continue use of residential driveways that provide access to garages placed to the rear of lots. Avoid placing garages in the side yard or attached to buildings with doors facing the streetscape. *Source: JMA collection.*

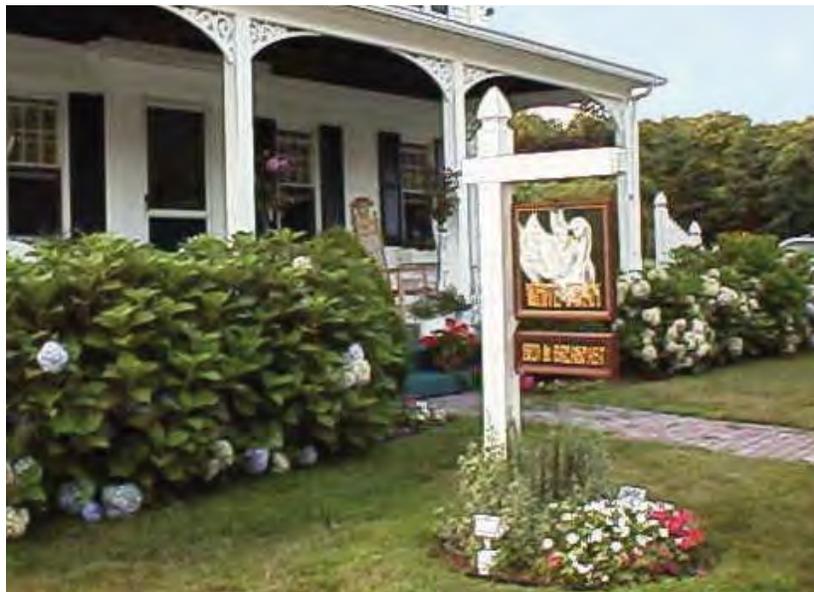
**Figure 3-17.** Small signs identifying compatible uses in historic residential areas are appropriate. *Source: JMA collection.*

- Design signs for compatible uses that are introduced into the residential area so that they are inconspicuous and residential in scale (*Figure 3-17*). Avoid using masonry or concrete monument signs or those that rotate, blink, or flash. Small signs of less than six square feet preferably set on a free-standing wood or black metal bracket or a smaller sign attached to the building next to the front door, may be appropriate. Incorporate regulations governing such signs as part of local historic district guidelines.

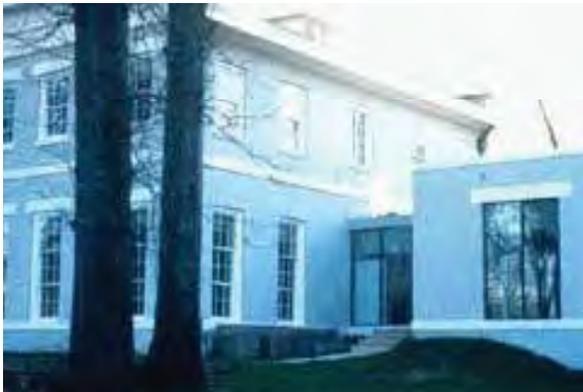
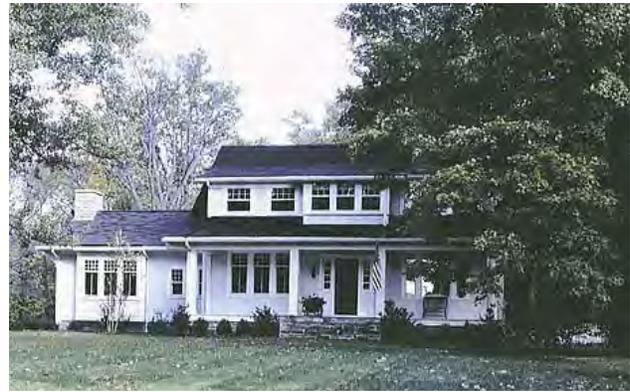
Add space with a modern “hyphen” connecting old and new, or by “telescoping”. The addition to the left expresses the original in the repetition of the horizontal lines of the lintels and water table. The addition to the right expresses the original design in its scale, window patterns, and roof line.

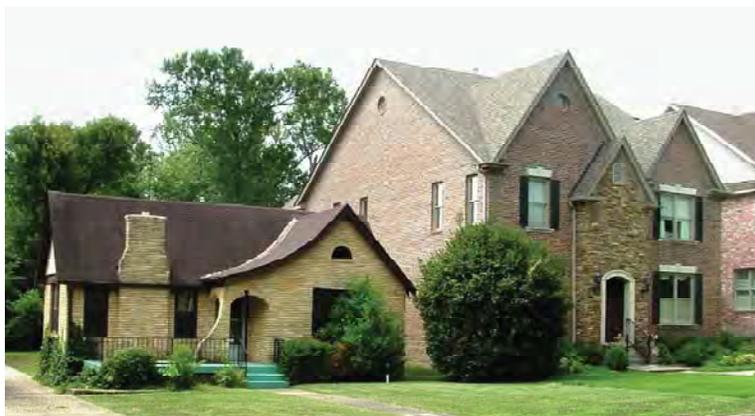
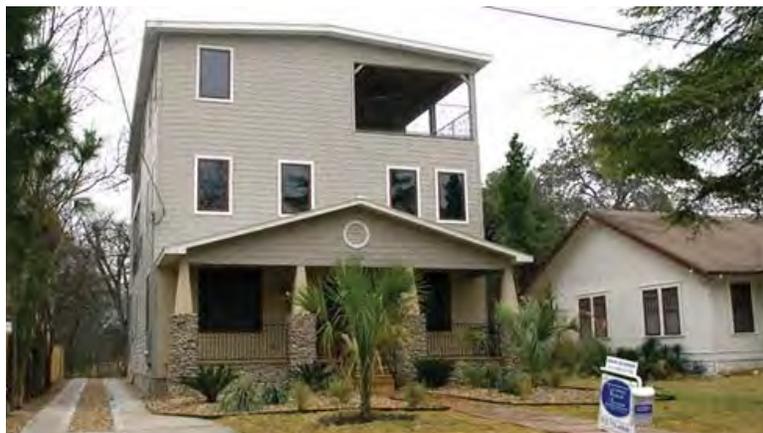
**Scale:** Design new buildings with respect towards the average height, width, and site placement of historic buildings in the surrounding neighborhood.

These new houses (top, right and bottom, left) do not fit in with the smaller scale of these historic neighborhoods.

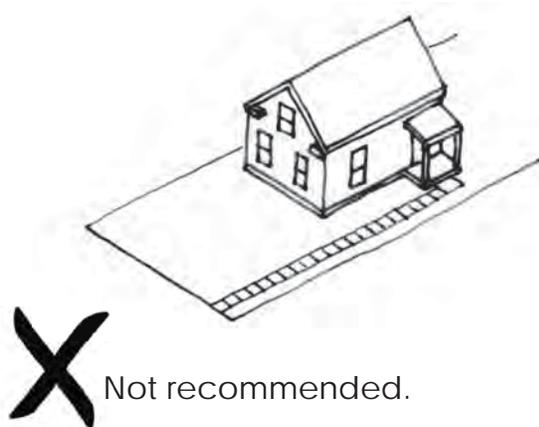
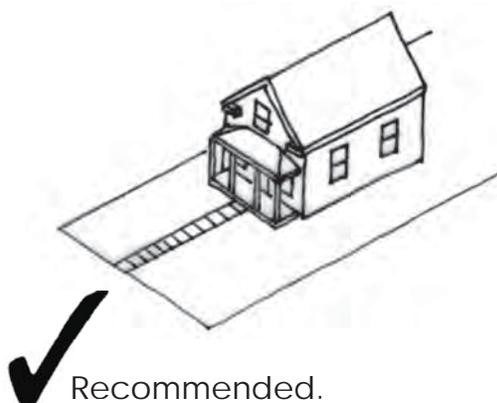
**Orientation:** For additions or new construction, orient the main entrance to the street in the local traditional manner instead of onto the side or rear yard of the lot.

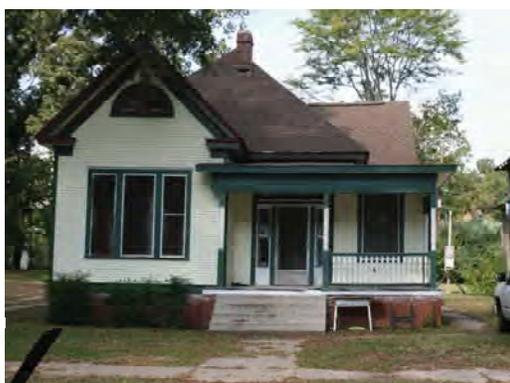
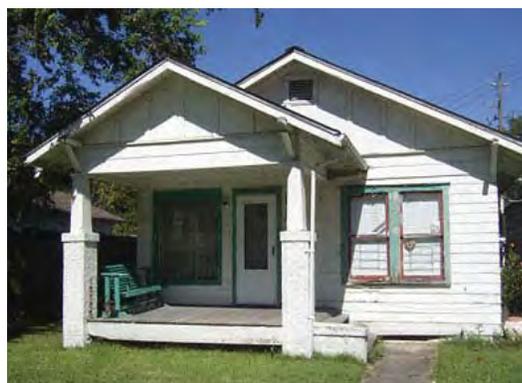
The open quality of the porches of these two houses is preferred to enclosure. If it is necessary to enclose a porch, consider wire screen or non-reflective glass.

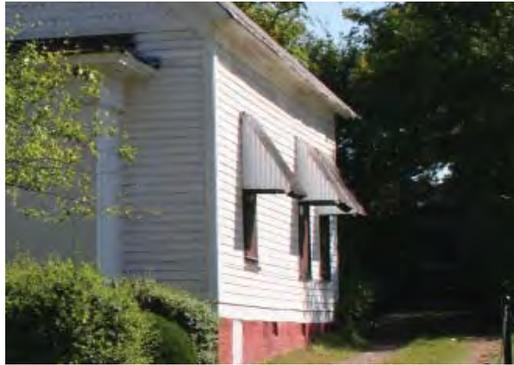
**Metal Awnings:** Striped metal awnings were popular in the 1950s and are still appropriate for this historic neighborhood.

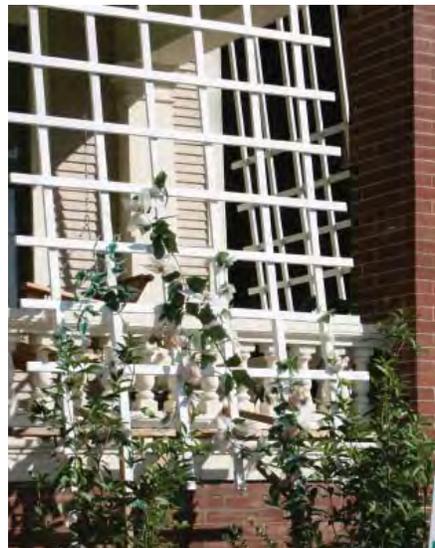
**Trellises:** Trellises built to support ornamental vines were common in the neighborhood in the 1950s and are appropriate today.

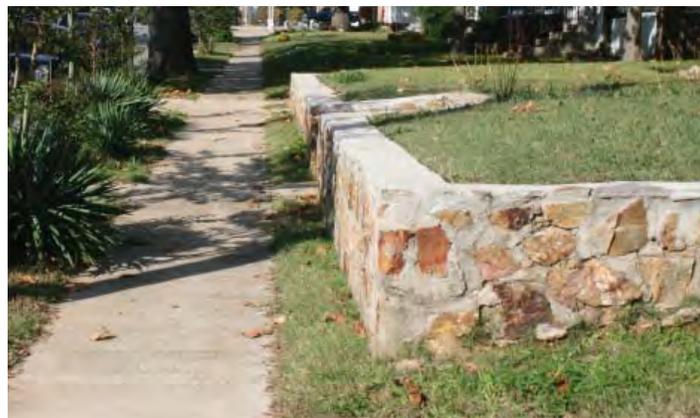
**Retaining Walls:** Preserve original rock retaining walls whenever possible.

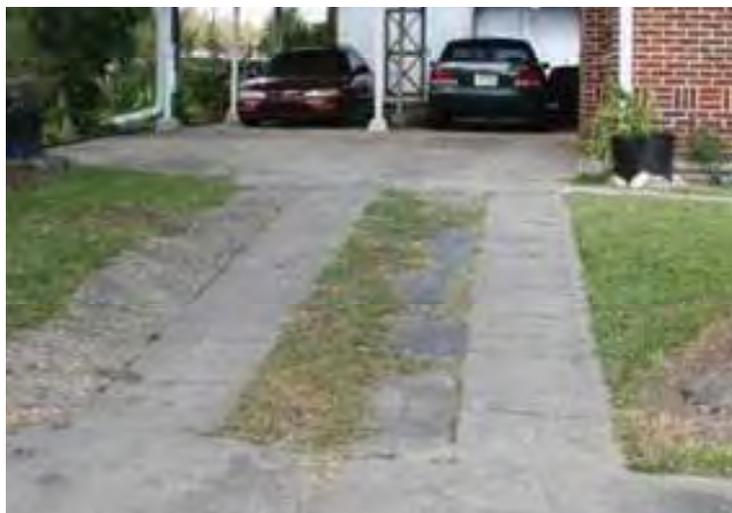
Two-track driveways were common during the historic period and are recommended today. The center aisle can be filled with turf, gravel, or stone paving.

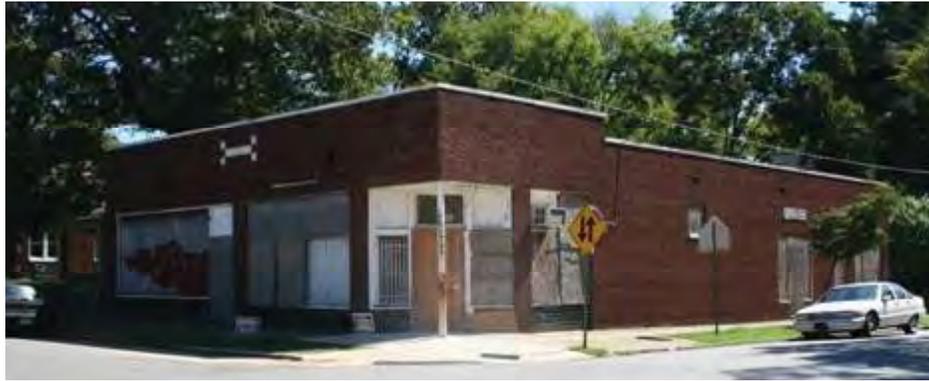
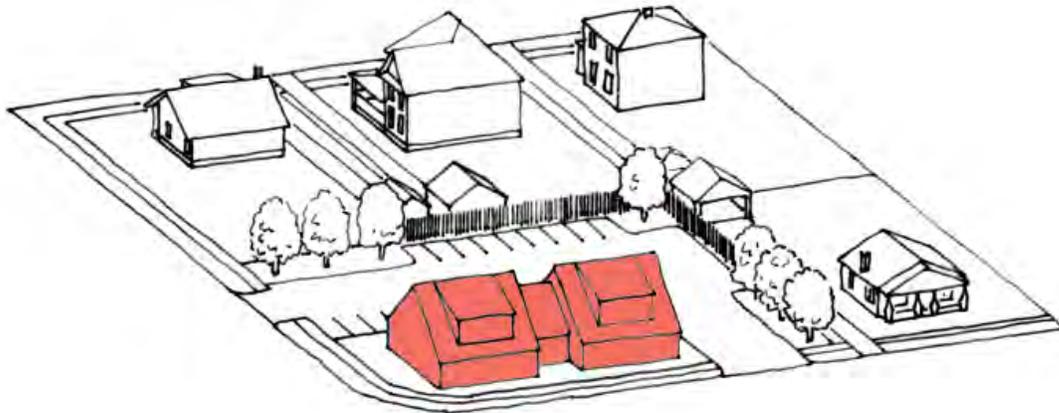
**Location, Orientation, and Parking:** For additions or new construction the entrance should be oriented to the street in the local traditional manner and not onto the side or rear yard of the lot. Locate parking lots to the side or rear of commercial buildings and provide access from alleys or secondary streets.

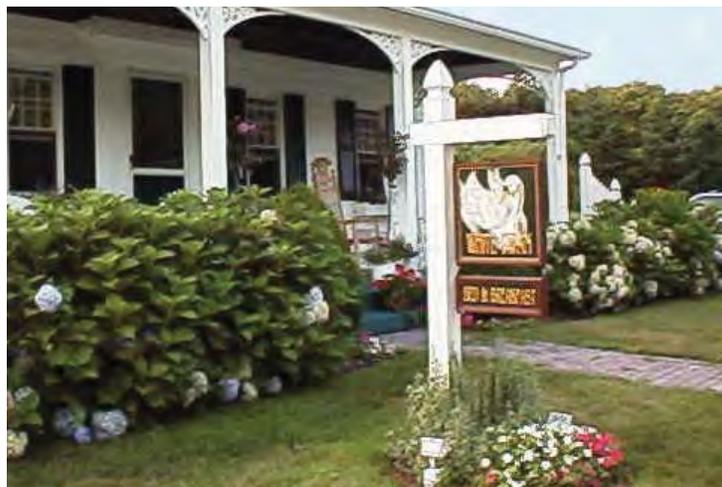
**Signage:** Small signs identifying compatible uses in historic residential areas are appropriate.
