National Register of Historic Places Registration Form

historic name: Rim Rock Drive Historic District
other names/site number: Scenic Rim Rock Road; 5ME5944

street & number: Colorado National Monument (N/A) not for publication
city, town: Grand Junction, Colorado (X) vicinity
state: CO code: 008 county: Mesa code: 077 zip code: 81521

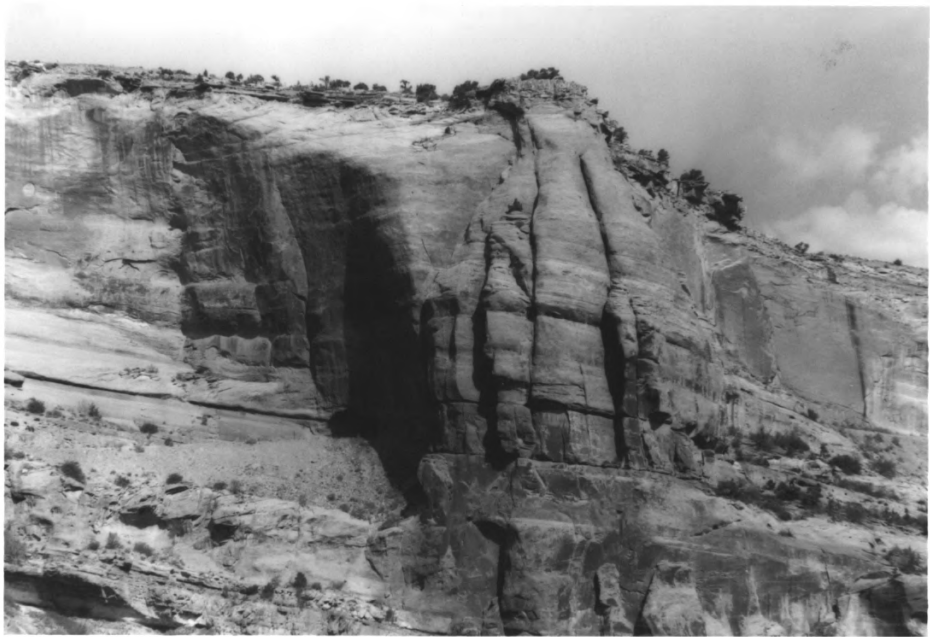
4 RIM ROCK DRIVE HISTORIC DISTRICT 4-24
COLORADO NATIONAL MONUMENT
MESA COUNTY, COLORADO

The topography of Colorado National Monument, the goal of creating a scenic highway, and reliance on manpower instead of heavy equipment dictated Rim Rock Drive's path and construction techniques. From the west entrance near Fruita, *Rim Rock Drive* climbs through Fruita Canyon. From an elevation of 4,690 feet on the valley floor, the road employs a series of long switchbacks and two tunnels to reach the top of the mesa at an elevation of 5,700 feet, somewhat north of the Saddlehorn area. (4, 16)

Tunnel No. 1, constructed 1936-37, is found at milepost 2.14. (4, 6, 7) This tunnel was blasted through the solid sandstone canyon wall using a pilot bore and is sixteen feet eight inches high, twenty-six feet six inches wide at its base, and 236 feet long. The tunnel has arched entrances without exterior portals and has, from its creation, been lined with gunite, which follows the unevenness of the excavated rock. Above the tunnel entrances are rock walls which extend for a great height. The roadway inside the tunnel is concrete paved, and has narrow concrete curbing flanking the twenty-four-foot wide pavement.

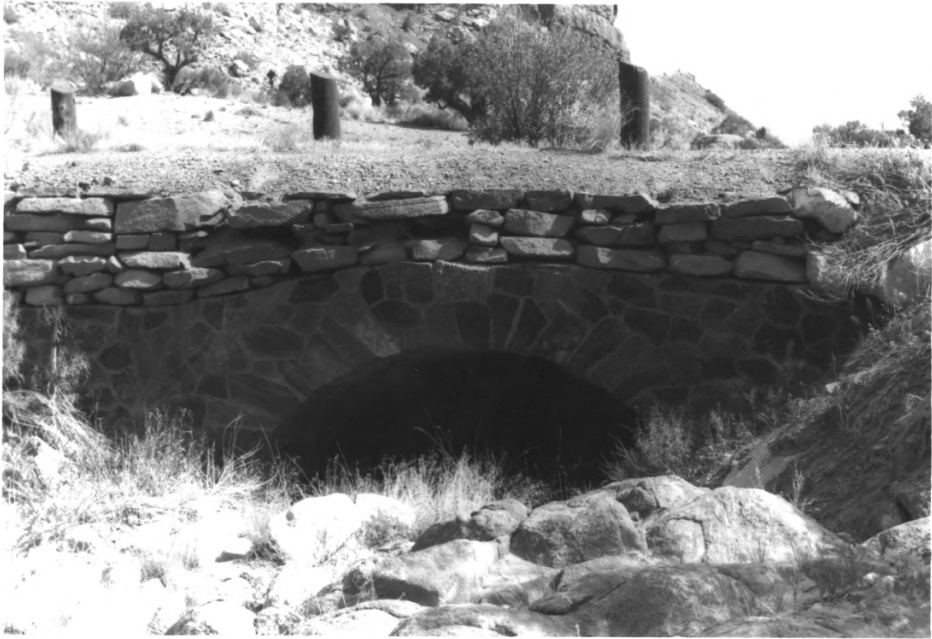
5 RIM ROCK DRIVE HISTORIC DISTRICT 2-25

At milepost 1.73 (5) is a culvert headwall composed of random rubble, mortared into place, forming a segmental arch with radiating rubble voussoirs above the culvert pipe. The top of the wall is unevenly leveled. Above the mortared wall is evenly coursed, dry laid sandstone, which is topped by gravel and dirt and the surface of the road. The mortar is red colored and was originally stained with local mud. The corresponding headwall on the other side of the road is similar in design, but lacks the layer of dry-laid rock above the mortared section.

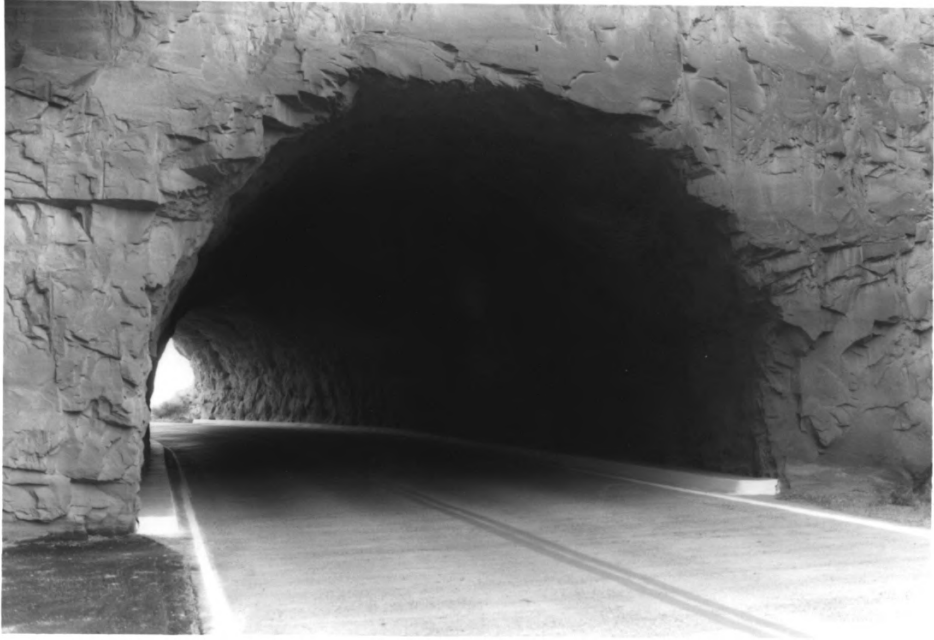
8 Rim Rock Drive Historic District 2-20

A short distance beyond *Tunnel No. 1*, at milepost 2.30, is *Tunnel No. 2*. (8, 10) The road between *Tunnels 1* and *2* was washed out by heavy rains in August 1968 and was subsequently rebuilt along the same plan. *Tunnel No. 2* was built 1936-37 and was blasted through solid sandstone using a pilot bore. Its excavation preceded that of *Tunnel No. 1*. *Tunnel No. 2* measures 185 feet long, sixteen feet eight inches high, and twenty-six feet six inches wide. The tunnel has arched entrances, no exterior portals, and has never been lined.

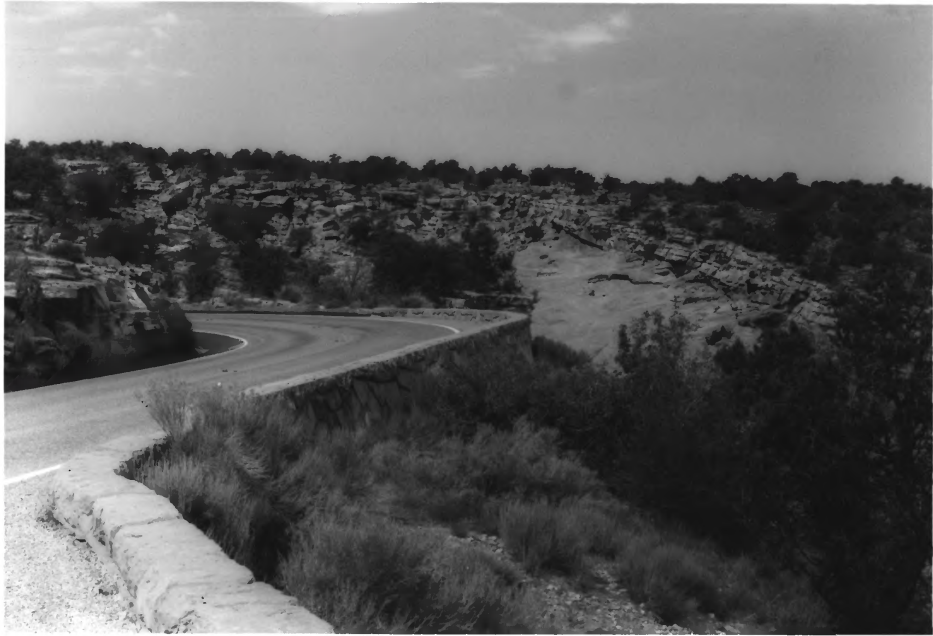
11 Rim Rock Drive Historic District 2-32
Colorado National Monument
Mesa County, Colorado

A polygonal masonry guard wall was constructed at milepost 2.52. (11) The guard wall is sixteen inches high and eighteen inches wide. This guard wall, which has an associated retaining wall below it, is of a design which is unique along the road, although other parks had similar walls constructed. New construction, utilizing rocks left over from 1930s quarrying, has been added on to the western end of this wall.

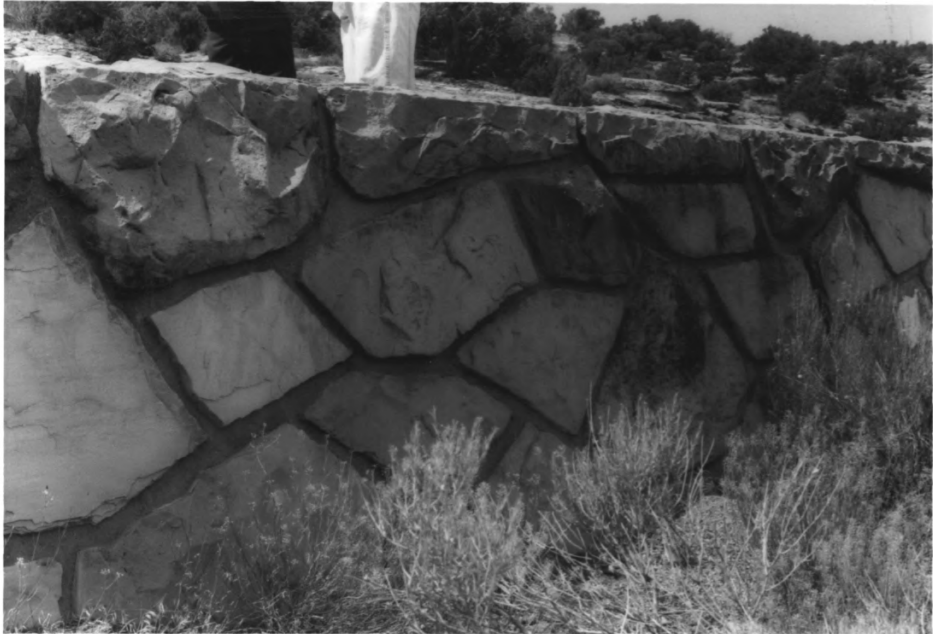
12 Rim Rock Drive Historic District 2-33

A polygonal masonry retaining wall with guard rail above is found at milepost 2.52. (12) The wall is composed of deeply mortared, polygonally shaped, quarried stones. The wall varies in height to as much as eight feet above the ground. The top layer of stones appears more roughly faced than lower layers and is level. The design of the wall is unique for the monument, although a similar wall built at Crater Lake National Park was presented in the 1938 National Park Service publication, Barriers, Walls, and Fences.

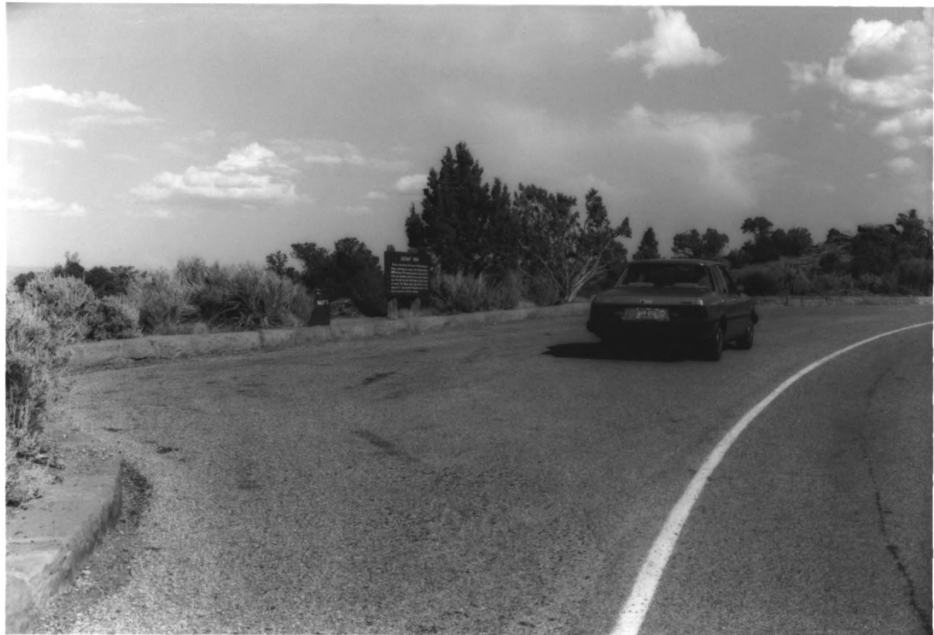
15 RIM ROCK DRIVE HISTORIC DISTRICT 3-22
COLORADO NATIONAL MONUMENT
MESA COUNTY, COLORADO

At milepost 3.46 (15), the first historic turnout is found. Distant View overlook is a turnout with rustic style curbing composed of large, quarry-faced sandstone slabs. The view from this turnout includes a magnificent view of the Grand Valley, the Book Cliffs, and Grand Mesa. Historic turnouts include the rustic style stonework exhibited by this overlook, which is displayed in such features as curbing, ledges, traffic islands, and sidewalks. For example, Highland View overlook at milepost 9.91 (28) features a rustic

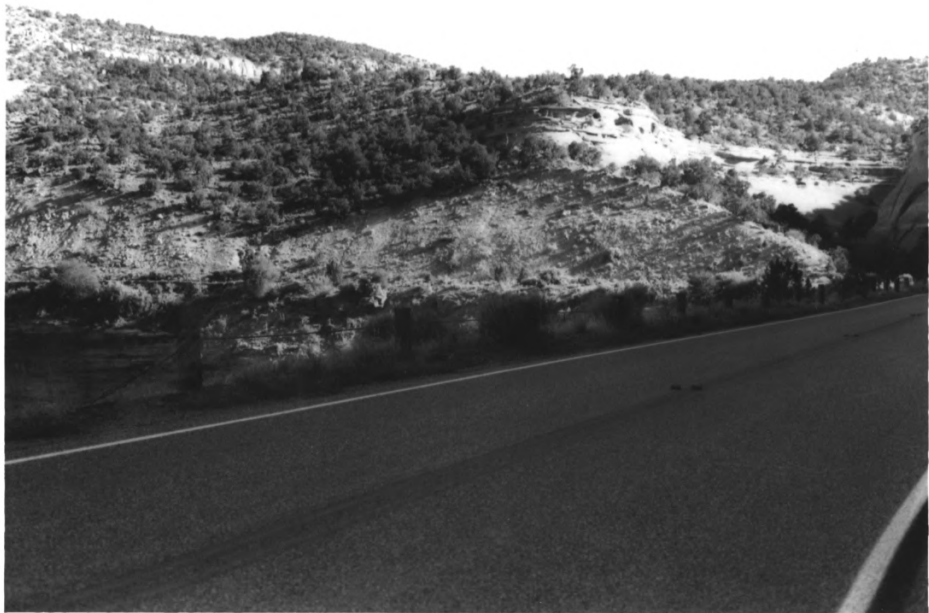
17 Rim Rock Drive Historic District 3-29
Colorado National Monument
Mesa County, Colorado

At milepost 4.80 (17) is a representative post and wire cable guard rail. The guard rail is composed of wood posts driven into the ground, attached with reflector disks, and strung with cable. Two guard rails of this type were observed along Rim Rock Drive. One of the more formally designed guard walls exists at milepost 6.15 (19). The parapet guard rail is composed of evenly coursed, quarry-faced ashlar. The wall is eighteen inches wide and varies in height from twenty-one to twenty-seven inches. This wall is unique along the road, although similar features were built in other parks.

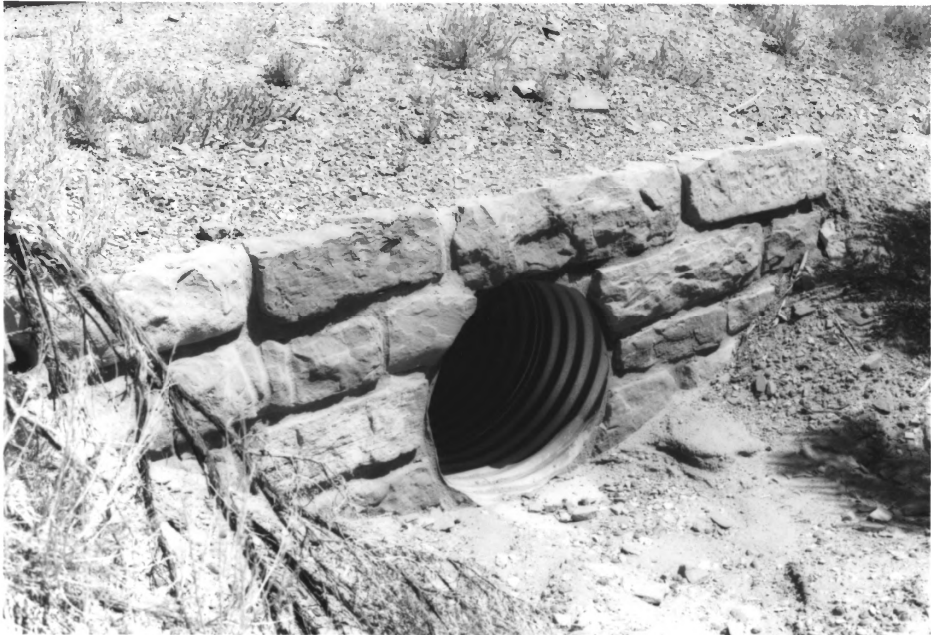
21

A culvert headwall has been rebuilt at milepost 7.03. (21) Originally the culvert wall had a rectangular opening. Now composed of evenly coursed, quarry-faced, mortared ashlar with metal culvert pipe visible from exterior.

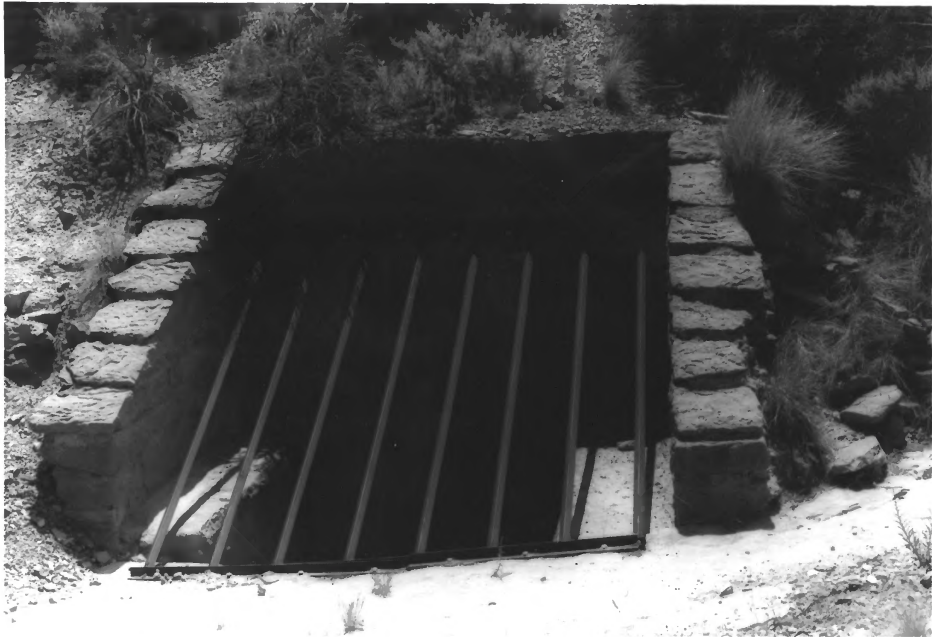
25 Rim Rock Drive Historic District 3-4

At milepost 8.43 (25) is a drop inlet with square concrete base opening surrounded on three sides by mortared walls of evenly coursed, quarry-faced ashlar. Side walls are tapered toward front. The hole in the rock is circular and the drop is fifteen to twenty feet. A grate has been placed over the opening for safety.

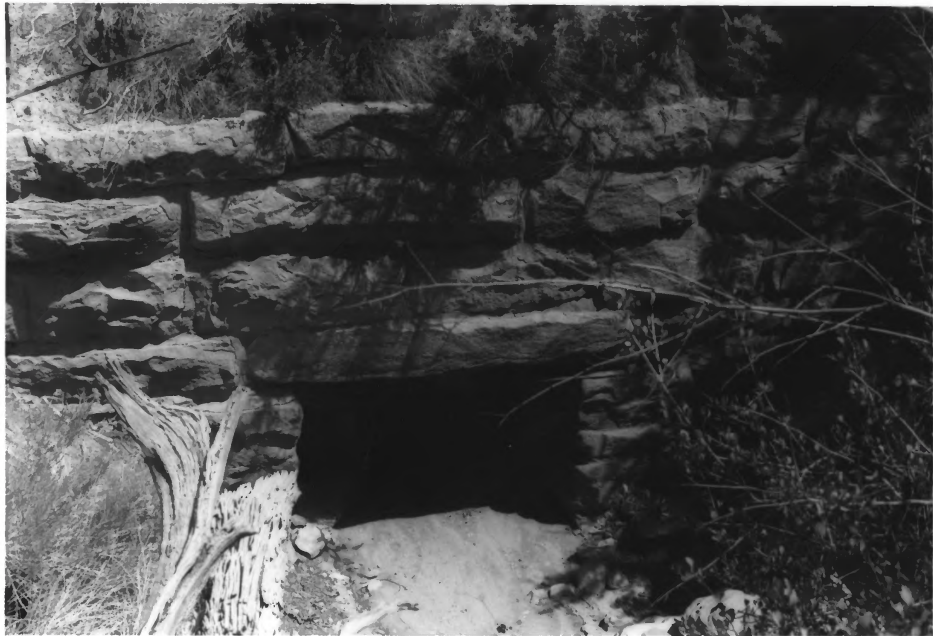
26 Rim Rock Drive Historic District 3-16

A stone culvert reflecting the rustic style favored by monument planners is at milepost 8.83. (26) The headwall is composed of large, roughly-quarried, rectangular slabs of sandstone, mortared into place and forming a rectangular opening with flat slab lintel atop metal bar. The top of the wall is roughly level. The culvert has been lined with gunite. The opposite wall of the culvert also has a large, flat, stone lintel and stone slab walls.

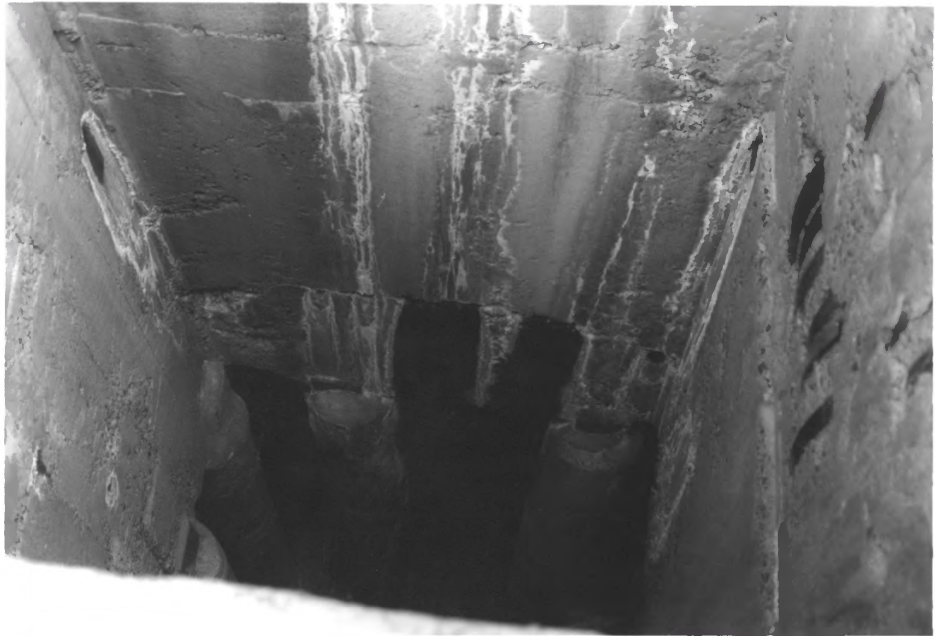
27 RIM ROCK DRIVE HISTORIC DISTRICT 3-6

At milepost 9.33 (27) is a drop inlet with square opening of concrete blocks, which are atop concrete pillars twelve feet tall. The drop is about thirty-five feet. The pillars are modern additions and the walls have been gunite lined.

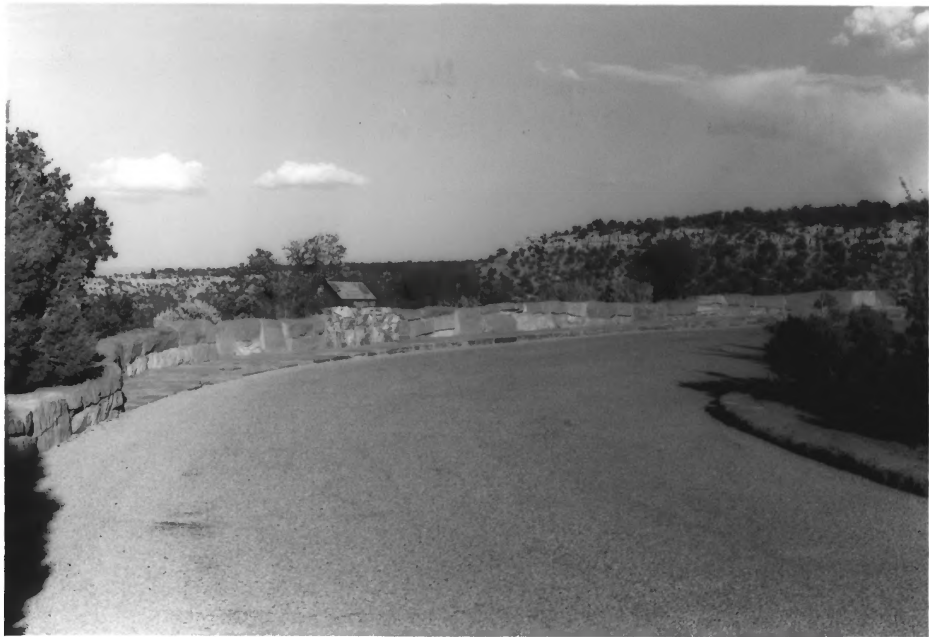
28 Rim Rock Drive Historic District 4-1

stone wall constructed of large, roughly faced stones; a sidewalk of flagstone; and a stone-edged traffic island. Red Canyon Overlook at milepost 16.05 (33) is an original turnout which features a more formal, evenly coursed ashlar ledge, stepped at intervals from two to three layers, and a traffic island with curbing composed of rippled sandstone.

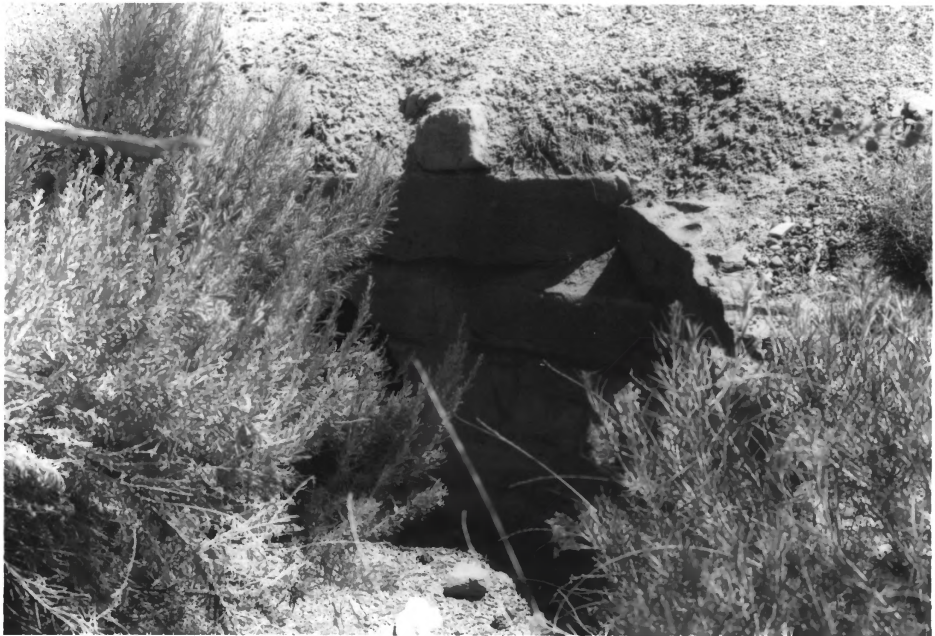
29 RIM ROCK DRIVE HISTORIC DISTRICT 3-7
COLORADO NATIONAL MONUMENT
MESA COUNTY, COLORADO

A rustic culvert headwall, constructed of coursed, large sandstone slabs, roughly-faced and shaped to form a circular arch around the culvert pipe was built at milepost 10.53 (29). The headwall has one wing to hold fill visible and may have another hidden under dirt and vegetation. The metal culvert pipe has been replaced.

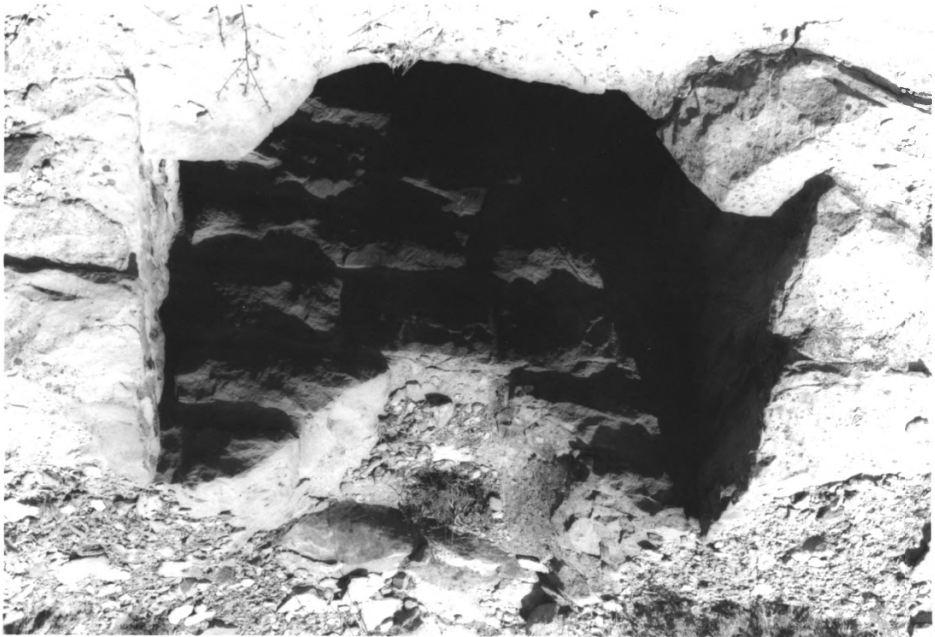
30 Rim Rock Drive Historic District 3-8
Colorado National Monument
Mesa County, Colorado

At milepost 11.63 (30) is a drop inlet with a rectangular opening faced on three sides with evenly coursed, mortared, quarry-faced stone. The vertical drop is ten to twelve feet.

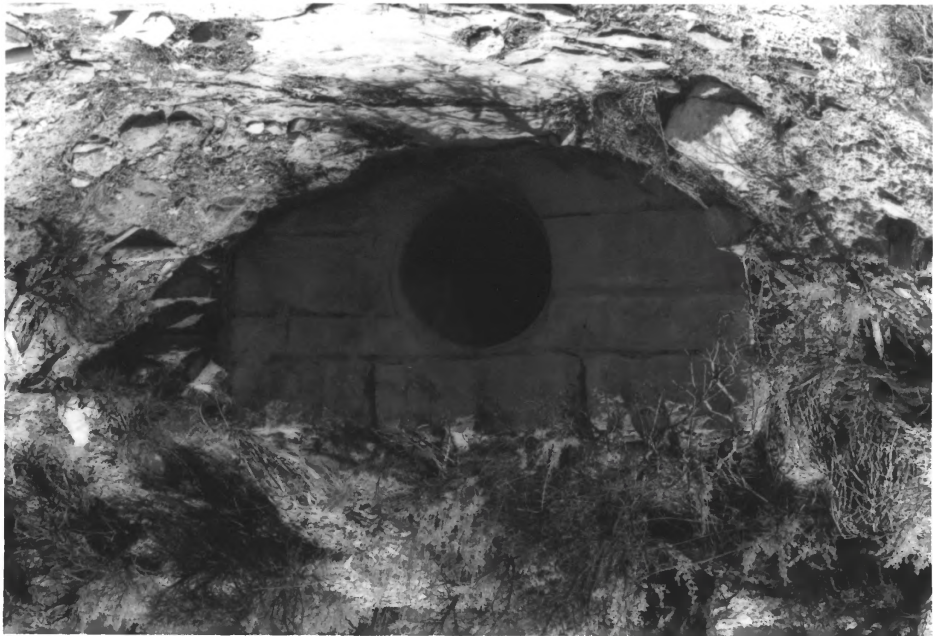
31 Rim Rock Drive Historic District 3-9
Colorado National Monument
Mesa County, Colorado

An unaltered, rustic culvert with headwall composed of roughly-faced, evenly coursed, large sandstone slabs shaped around a circular opening for the culvert pipe was built at milepost 11.98. (31) The wall is rectangular in shape, measuring approximately three feet high and five feet wide, and is one of the most frequently found designs along the road.

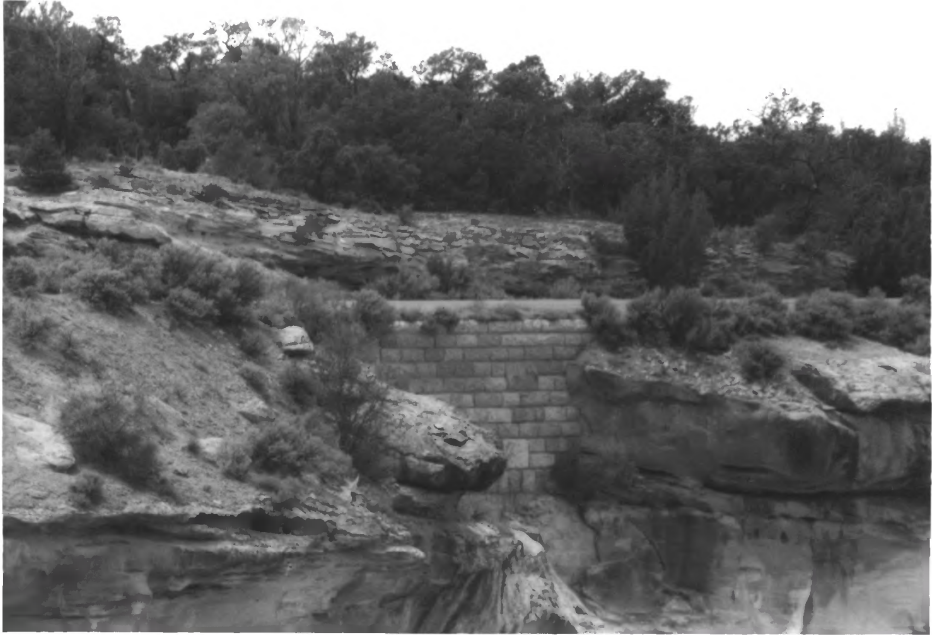
34 Rim Rock Drive Historic District 3-11
Colorado National Monument
Mesa County, Colorado

At milepost 18.23 (34) an evenly coursed ashlar retaining wall was built. The formality of this wall was of a type discouraged by monument planners, who favored more primitive-appearing constructions for the terrain.

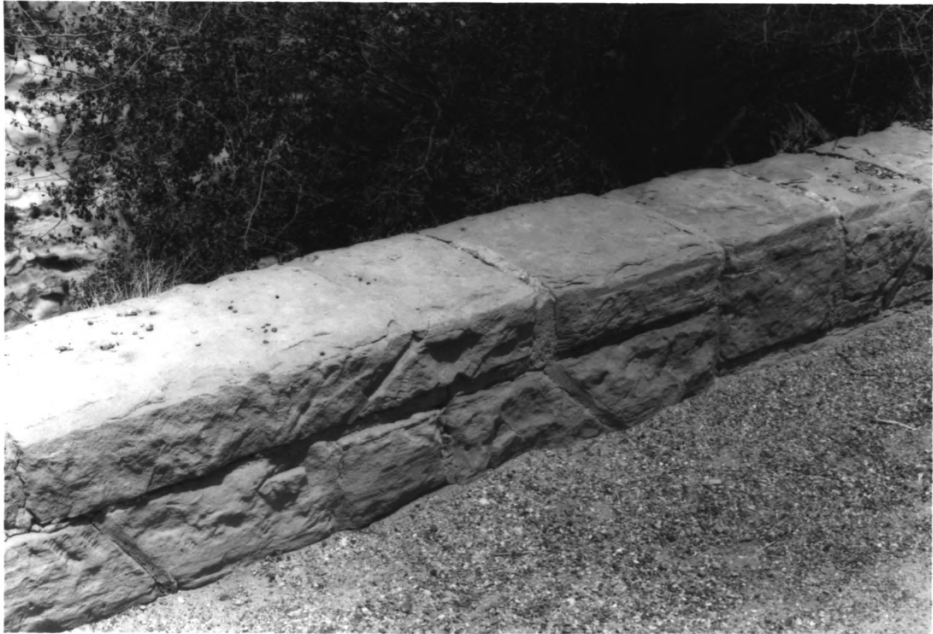
35 RIM ROCK DRIVE HISTORIC DISTRICT 3-12

At milepost 18.56 (35) is an unusual guard wall constructed of large, roughly quarried sandstone slabs with false masonry joints placed at angles to the horizontal axis. The purpose of the false joints is unknown, although they may have been created to lessen the appearance of rigid, straight lines of the real mortar joints. The false mortaring of this wall is unique along the road.

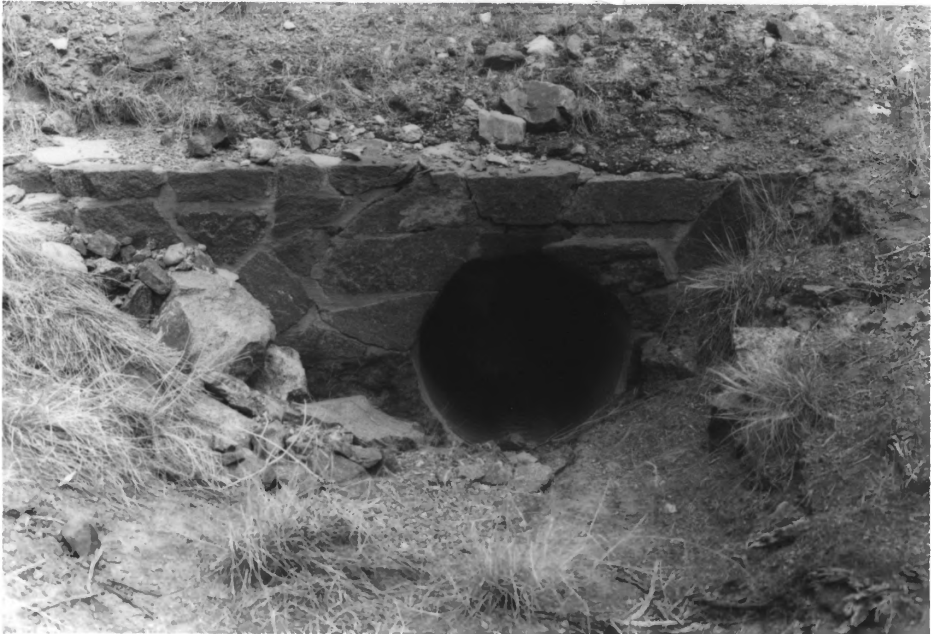
40 RIM ROCK DRIVE HISTORIC DISTRICT 3-15

At milepost 21.22 (40) is a culvert with a headwall composed of gneiss rubble forming a circular opening around a metal culvert pipe. The top of the wall is roughly level. This culvert represents the type constructed in the No Thoroughfare Canyon section during the latter part of the road project and reflects the change in rock type found along the roadway and the later construction date. The wall measures approximately two-and-a-half by five feet.
