CULTURAL LANDSCAPE REPORT FOR THE  
NELSON HOUSE GROUNDS  
COLONIAL NATIONAL HISTORICAL PARK  
VOLUME 2: TREATMENT

# CULTURAL LANDSCAPE REPORT FOR THE NELSON HOUSE GROUNDS

## COLONIAL NATIONAL HISTORICAL PARK VOLUME 2: TREATMENT

YORKTOWN, VIRGINIA

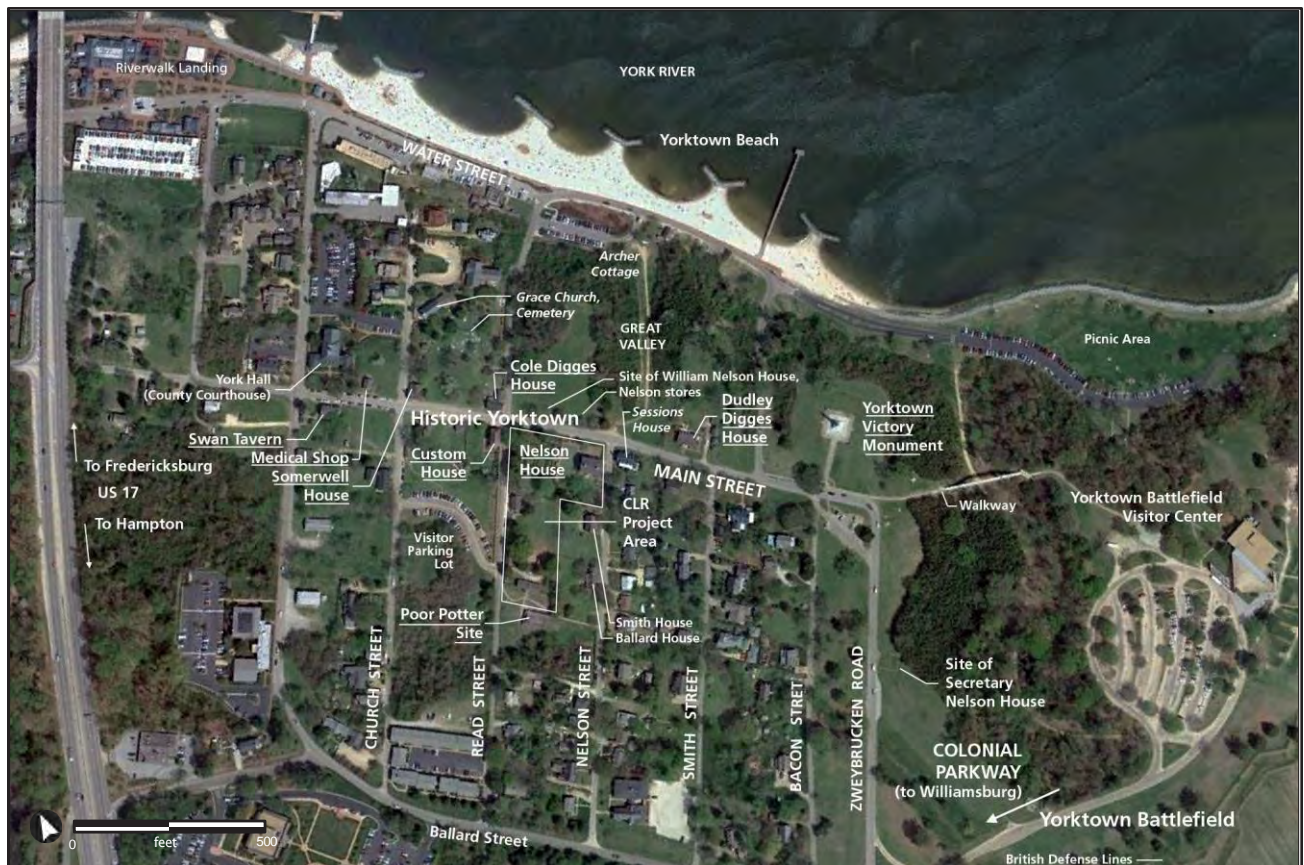
**Figure I.3 Aerial photograph of Yorktown showing the setting of the Nelson House and relationship to Yorktown Battlefield, Colonial Parkway, and historic buildings and sites within the village. Historic sites owned by the National Park Service and open to the public are underlined. Colonial buildings not owned by the park service are labeled in italics. (Commonwealth of Virginia photograph, 2010, annotated by SUNY ESF for the 2011 CLR.)**

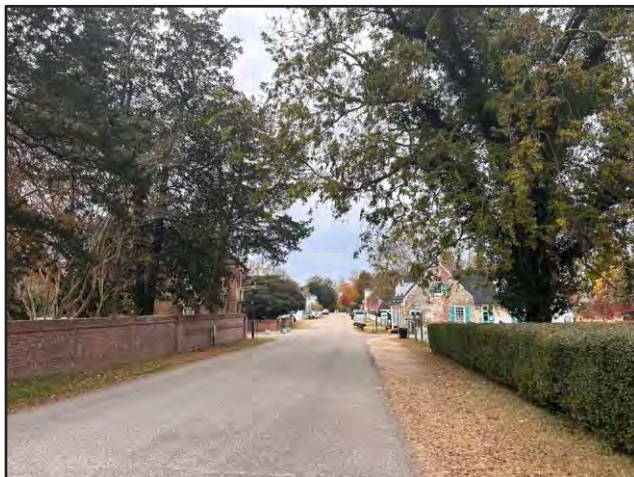
Figure 2.3 (below left). Looking west along Main Street from west end of the Nelson House grounds, November 2023. At right is the Cole Digges House. (Image by KZLA. Hereafter, all images by KZLA unless otherwise noted.)

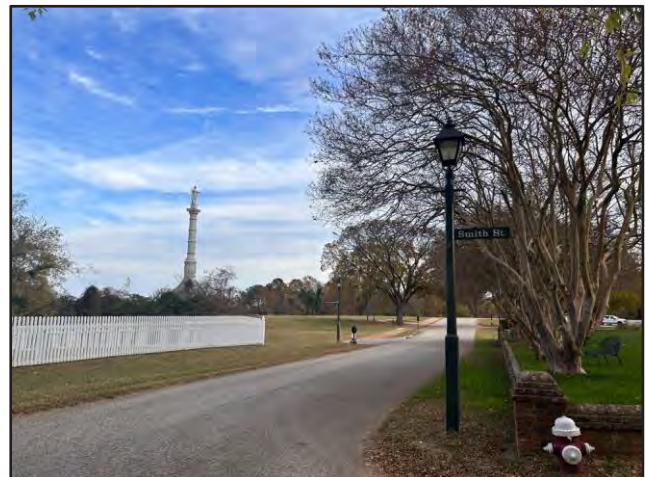
Figure 2.4 (below right). Looking east on Main Street from the Nelson House with the park's Monument to the Alliance and Victory in the distance, November 2023.

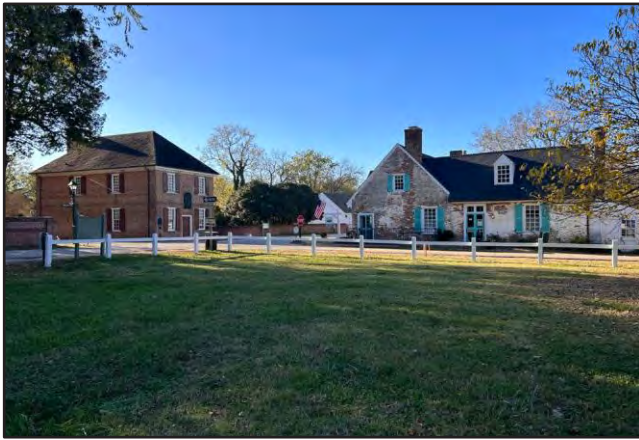
Custom House (Lot 43A), 410 Main Street

The Custom House, at the corner of Read and Main Streets, is a two-story brick building constructed as a warehouse c. 1720 by Richard Ambler. From this building, Ambler and his son collected custom duties for the port of Yorktown during the colonial period. The building is believed to be the oldest standing custom house in the country. The lot features a walled garden at the rear and a reconstructed summer kitchen that were built during the early twentieth century by the Daughters of the American Revolution (DAR) Comte de Grasse Chapter, which has owned the property since 1924. The building is open to the public as a museum and contains DAR chapter offices.

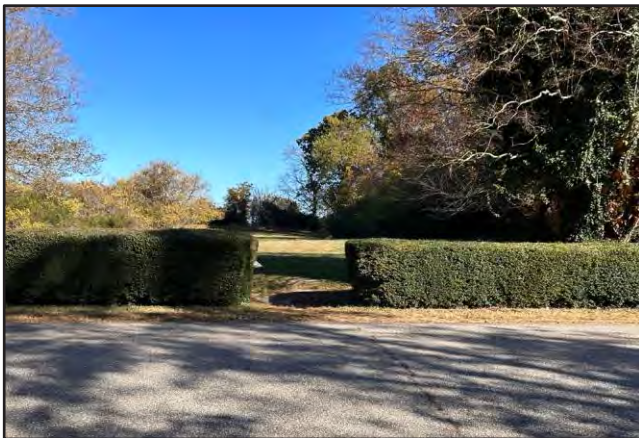
**Figure 2.5. The Custom House (left) and Cole Digges House (right), looking southwest with the site of the Cox House and Peninsular Bank and Trust Company in the foreground, January 2010. The trees at left are within the Nelson House grounds.**

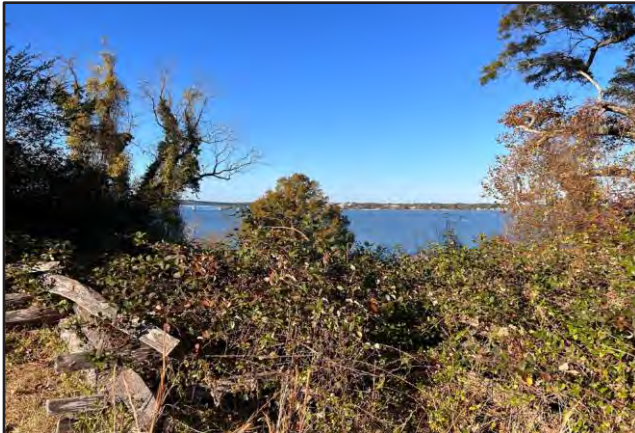
**Figure 2.6. The open lots north of Main Street, view north from the Nelson House with the York River in the distance, January 2010. At the far end of the field are Civil War earthworks. The clipped hedge dates to the York Hall estate.**

These five lots along the north side of Main Street were part of the York Hall estate and were acquired by the federal government in 1968. The lots comprise the foreground of the view from the Nelson House. At one time the York River would have been visible beyond these lots, but trees near Main Street and woods in the Great Valley and along Read Street obscure all of the view. Much of this land is maintained as lawn, with a low clipped privet hedge along Main Street that was established as part of the York Hall estate in the 1920s. During the colonial period, these lots were the location of the William Nelson house (lot 47A) built c. 1745, the Nelson stores (lot 46) built c. 1710, and the Cox House (lot 47) built c. 1720 on the site of an earlier house. A small temple-front bank building was constructed on the site of the Cox House c. 1923 where a white post and rail fence now exists. On lots 84 and 85, the Blows maintained a tennis court and gazebo. Only the gazebo foundation remains from these structures though it is not visible today.

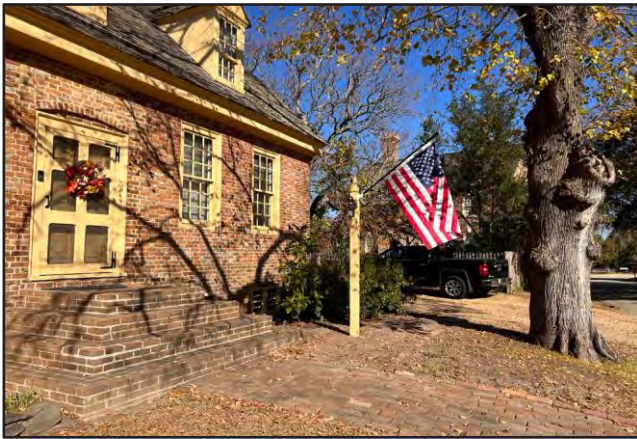
The Smith House is a Park-owned colonial house on a half-acre lot bordered on two sides by the Nelson House grounds, and to the south by the Ballard House. Built c. 1750, the restored house is a one-and-one-half story, four-bay brick building with exterior end chimneys, a wood shingled gable roof with dormers, and nine-over-nine sash windows. At the rear is a frame dairy with a pyramidal roof that was built by the park c. 1976. A shed has been added to the landscape along with a series of brick steps, walkways, patio, and gutters along the façade of the house, as well as perennial and shrub beds. A brick walkway leads from the

**Figure 2.11 (top).** The Smith House looking northwest from Nelson Street, 2023.

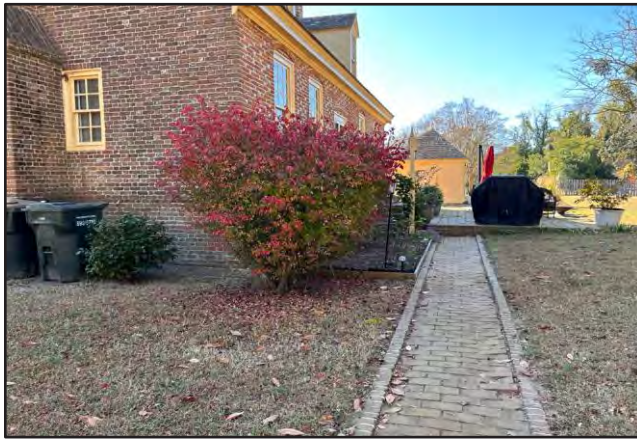
**Figure 2.12 (middle).** The rear of the Smith House looking south, 2023. The small yellow structure is the Smith dairy.

rear patio north to the lot boundary fence at the rear of the Nelson House, though no gate provides access between the lots. Along the boundary of the lot on the east and west sides are thirty-eight-inch high wood picket fences with sixty-two-inch tall fences on the north and south lot boundaries; all rebuilt in 2008. A low picket fence separates the gravel parking area from the rear yard with a double-hung gate for vehicular access.

The landscape, which is visible from the Nelson House, is an open lawn with two mature shade trees – a southern magnolia and a thornless honeylocust. The honeylocust has a burning bush planted next to its trunk with a movable, modern wooden bench. Shrub and perennials have been planted around the house and along some of the brick walks.

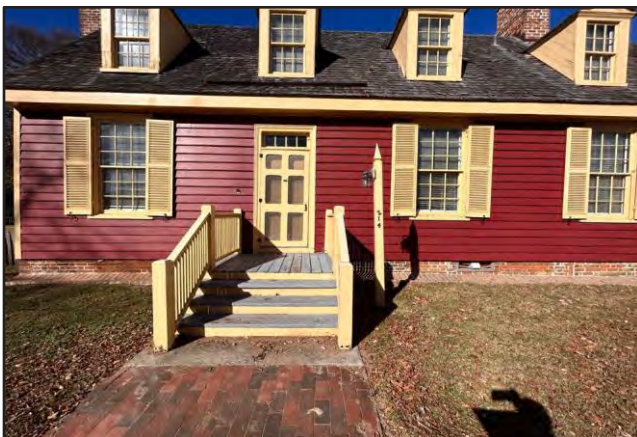
**Figure 2.13 (bottom).** The Ballard House from Nelson Street, 2023.

The Ballard House is a Park-owned colonial house on a half-acre lot bordered on one side by the Nelson House grounds. Initially built c. 1706, the restored house is a narrow one-and-one-half story, asymmetrical five-bay frame building with two chimneys, a wood shingled gable roof with dormers, clapboard siding, and nine-over-nine sash windows with louvers on the first floor. Brick gutters

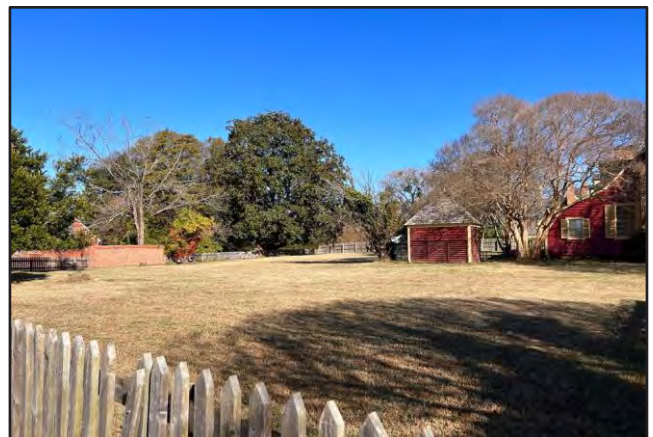
**Figure 2.14. (bottom right).** The rear of the Ballard House looking northwest from Nelson Street, 2023. The smoke house is at the center of the image.

At the rear is a smoke house with a pyramidal roof that was reconstructed by the park c. 1976 and is now used for storage. A brick patio is at the back of the house, connected to the street and to a gate in the side yard fence with the Smith House by brick walks, all of which are in poor condition with grass growing through the joints. The Ballard House served as a staff cottage for the York Hall estate and was acquired by the federal government in 1968 as part of Colonial National Historical Park. The house is a park staff residence (empty of residents in 2024) and is closed to the public. An interpretive wayside along Nelson Street provides an historical overview of the property. A paved walkway connect Nelson Street to the Poor Potter site just between the lot boundary and the fenceline.

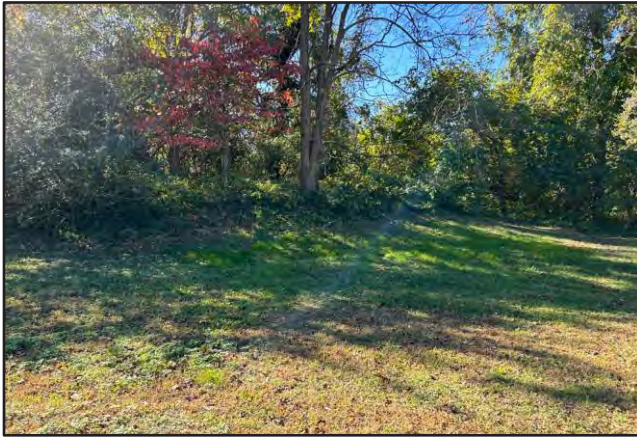
Lot 55, adjacent to the Ballard House, is a partly wooded Park-owned parcel that contains British earthwork remnants from the Siege of 1781. The lot was part of the York Hall estate and was purchased by the federal government in 1968 as part of Colonial National Historical Park. The earthworks, which also extend onto adjoining Lot 51A (Poor Potter Site), as well as east of Nelson Street. They had been partially cleared prior to the 2011 Cultural Landscape Report and were visible from the walk to the Poor Potter Site, but now have mostly grown over with little visibility to the landforms. A clipped privet hedge, established by the Blow

**Figure 2.15. (top) Remnant British earthworks south of the Poor Potter site.**

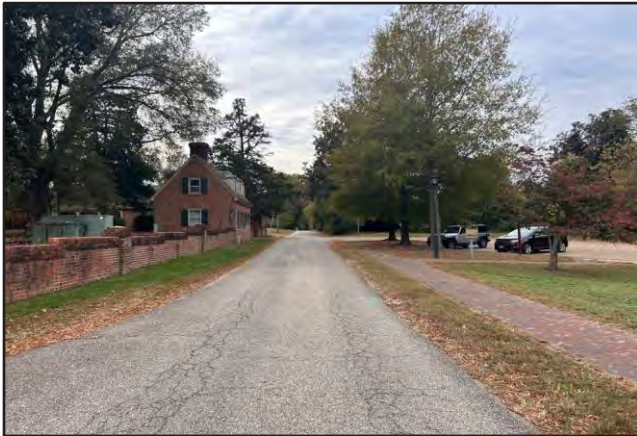
**Figure 2.16 (middle). Read Street looking south, 2023. The Church Street parking lot to the right and at left, the perimeter wall of the Nelson House grounds and garage/Ranger Station.**

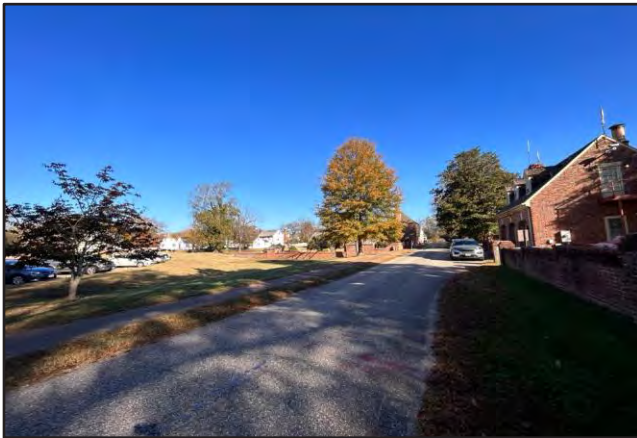
The two-acre landscape of the Nelson House grounds – on lots 48, 49, 50, and 52 – forms the largest and most prominent domestic property in Yorktown. From Main Street, the landscape is dominated by the Nelson House, located at the northeast corner of the grounds, and brick walls that extend along Main and Read streets. These walls, generally six to eight feet tall, consist of a retaining wall along the front court dating to c. 1870, and a mixed retaining- and free-standing wall with brick piers along the rest of the property that was built as part of the York Hall estate between c. 1916 and 1920. Incorporated into the perimeter wall along Read Street are two Colonial Revival-style York Hall estate outbuildings: the carriage house (garage) and Wisteria Cottage (gardener’s cottage). (Remnants of a low galvanized pipe and wire-mesh fence on top of the wall along Read Street categorized in the 2011 Cultural Landscape Report have been removed from the formal garden wall.)

**Figure 2.20. (top) The Nelson House looking southwest from Main Street showing the perimeter wall and boxwood hedge, 2023. The historic function of the circular feature at the corner of the wall is not known.**

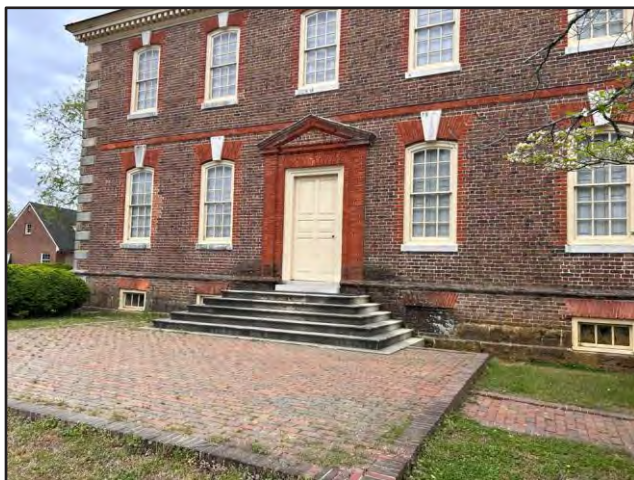
**Figure 2.24.** The front court looking southeast showing the brick terrace, granite steps, and lawn,

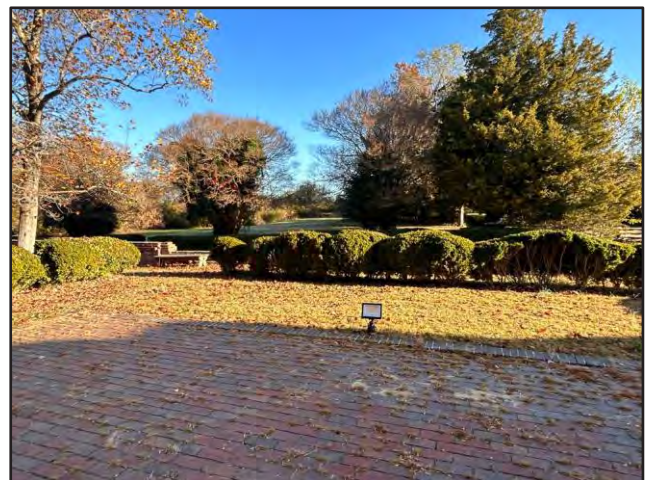
**Figure 2.25.** View from the front door of the Nelson House across the front court towards the northwest and the obscured view of the York River, 2023.

corner of the house presumably intended to deter visitor access to where a desire line leads to Nelson Street. There are no trees within the front court. The historic view from the front entrance toward the York River, which looks out across undeveloped land north of Main Street, is obscured by trees.

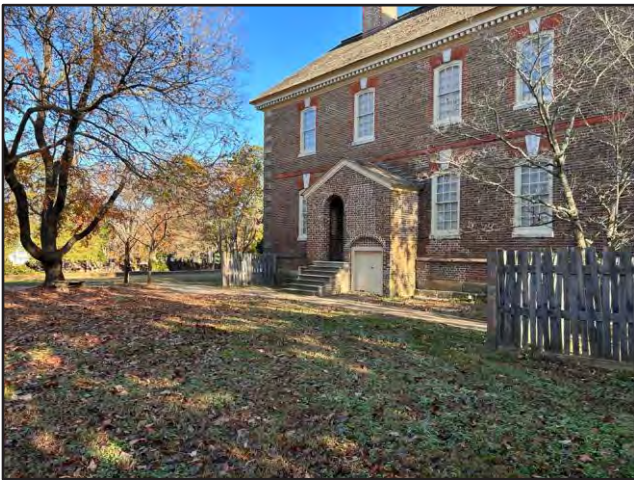
The back court is a small, colonial-period space that consists of the grounds between the Nelson House and Smith House lot characterized by lawn with wood paling (picket) fences and trees growing along the periphery. The space, formerly the location of the York Hall estate oval entrance drive, provides access to the site from Nelson Street for Park vehicles only. There is no gate or pavement for vehicles. One brick walk connects the terrace walkways to the rear entrance to the house, the basement door, and out towards Nelson Street (the walk ends before reaching the street). There is no pedestrian connection to the adjoining Smith House save for along Nelson Street.

The 2011 *Cultural Landscape Report* stated that in the York Hall era the landscape was raised so that a long window well was included in the rear court.<sup>6</sup> This may be reflected in the height of the granite block foundation of the building.

The perimeter fences contain openings along an NPS-era brick walk parallel to the Nelson House, and at a larger unpaved access for Park vehicles from Nelson Street. Portions of the paling fence have been removed in the since 2011 so that the opening to the south end of the terrace is more contiguous with the back court.

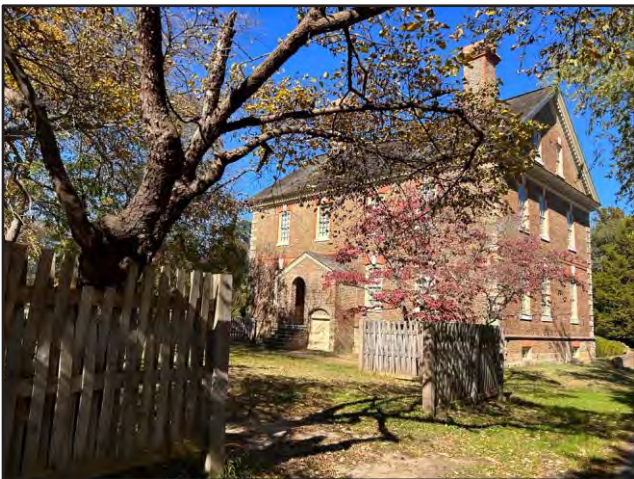
**Figure 2.26 (top).** The back court looking northwest from near Nelson Street, 2023.

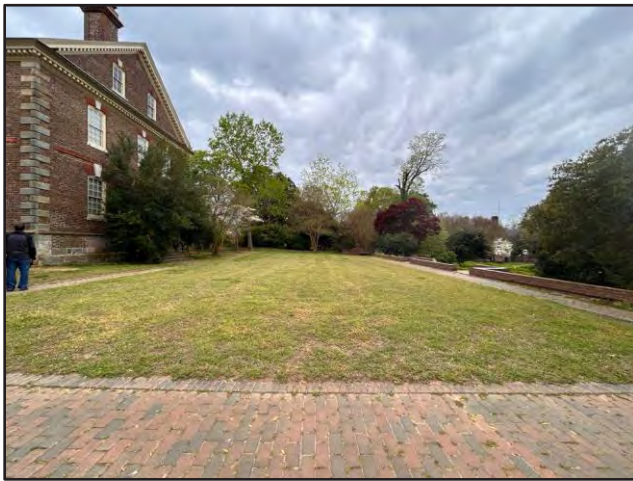
**Figure 2.28 (top).** The terrace looking south with the Nelson House at left and steps to the formal garden at right, 2024.

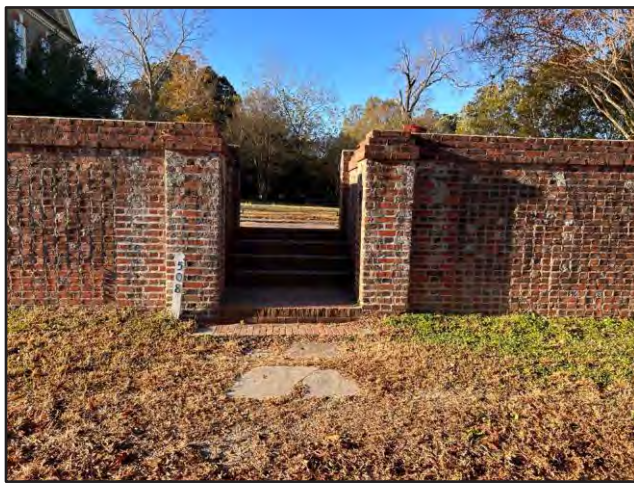
**Figure 2.29 (bottom).** The entrance to the terrace from Main Street, looking south, 2023.

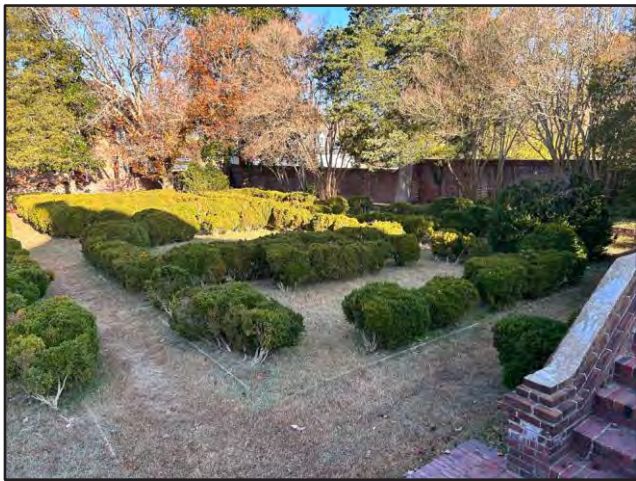
**Figure 2.30.** Looking southwest across the formal garden from the edge of the terrace, 2023.

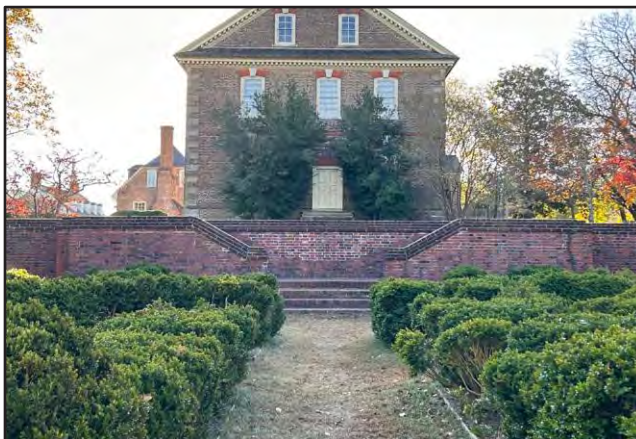
**Figure 2.32 (middle).** One of the main formal garden beds looking southwest showing missing center plantings and state of boxwood border, 2023.

The formal garden, occupying lot 48 at the corner of Main and Read Streets, is a Colonial Revival-style garden designed by Charles Gillette in 1922. The center of the foursquare garden is a quincunx plan consisting of a central circle and four surrounding rectangular panels, with an outer row of rectangles and individual common boxwood (*Buxus sempervirens*) shrubs at the corners. (Dwarf English boxwood (*Buxus sempervirens* ‘*Suffruticosa*’) was originally planted but had been replaced by the larger straight species common boxwood during the NPS management period.) The garden walks are mown turf with a mix of brick, wood, and/or no edging. The east–west central walk is on axis with the steps up to the terrace and the west entrance of the Nelson House. Most of the garden shrubs were replaced by the park service in the 1970s and 1980s. These include informally clipped boxwood hedges defining the beds, boxwood shrubs in the outer corner beds. Rose of Sharon shrubs were once located in the middle of the large center beds by the NPS, but these have been removed. The beds also once contained scattered perennials and flowering spring bulbs, including peonies, iris, and narcissus dating from the York Hall estate, and more recently planted canna and Yorktown onion (*allium*) during the beginning of the NPS era. Almost all of this has been lost, with just daffodils and iris visible in spring and the remainder of the beds have just grass filling their borders. There is a series of movable wood benches placed throughout the garden. In one select location, a bench is placed within the boxwood hedge which seems to invite visitors in, resulting in damage to the boxwood plants and loss of the structure of the hedge.

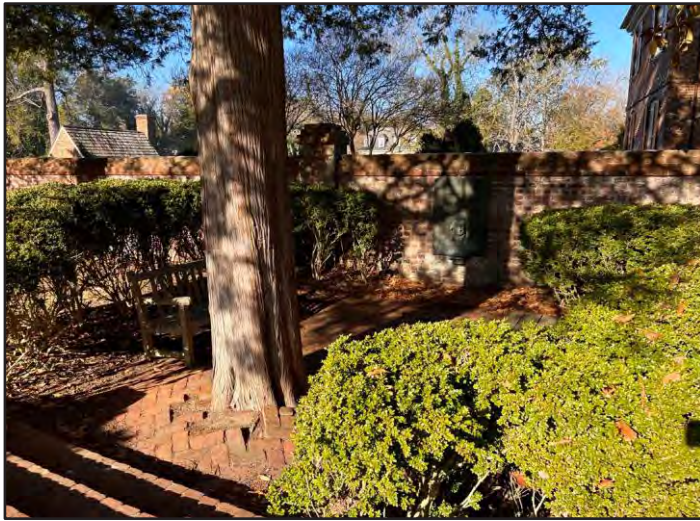
**Figure 2.33 (top left).** The circular brick patio at the west end of the east-west central garden walk, 2023. Just visible on the perimeter wall is the Cornwallis plaque.

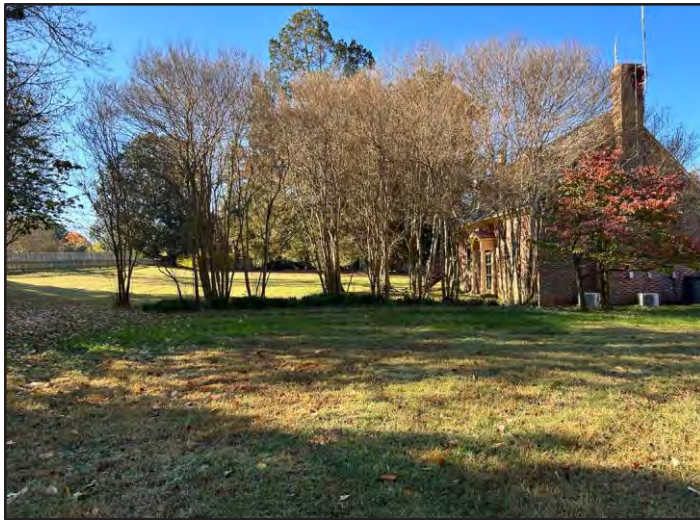
**Figure 2.34 (top right)** The northeast corner of the formal garden showing low brick retaining wall and mulched bed with trees, 2023.

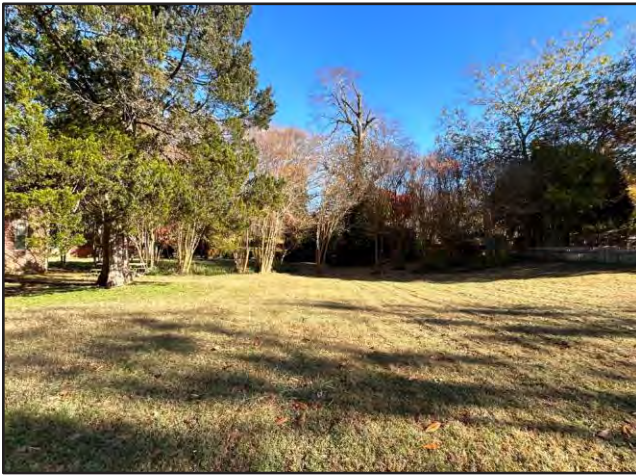
The York Hall garage, now known as the carriage house, was built c. 1916 and was designed by Griffin and Wynkoop. Today, it houses a Park ranger station and communications center. It is a three-bay, one-and-one-half story Colonial Revival-style brick building that faces inward toward the lawn. This façade has a residential character with a center entrance, classically-detailed entry porch,

and flanking six-over-six sash windows. Three dormer windows line the wood-shingle gabled roof.

**Figure 2.39 (bottom left).** The front of the carriage house (garage) looking northwest from the lawn, 2023. At left is the lattice brick wall added by the park to screen utilities. In the background is the National Park Service parking lot.

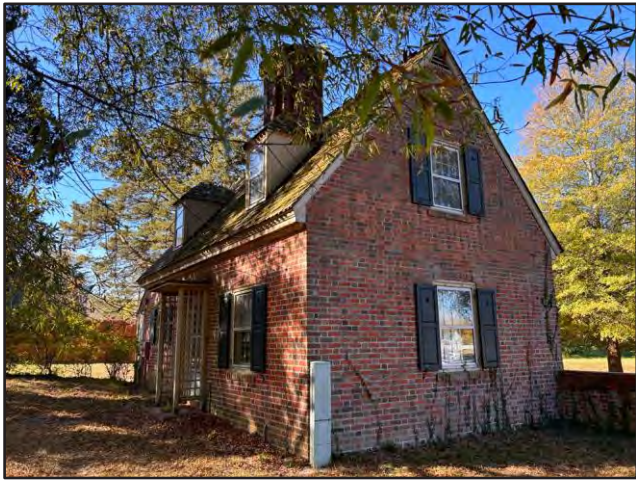
**Figure 2.41 (top).** The front of Wisteria Cottage looking southwest from the lawn, 2023.

Wisteria Cottage (215 Read Street), built c. 1916 as designed by Griffin and Wynkoop as the gardener’s cottage, is a three-bay one-and-one-half story Colonial Revival-style brick building that faces inward toward the lawn. This façade, shaded by a large willow oak, has a center door with a trellised entry porch and separate sidelight, and asymmetrical flanking casement and double-hung multi-paned windows with shutters. A wood-framed shed-roof enclosed porch dating to the York Hall estate period shelters the service entrance on the south side.

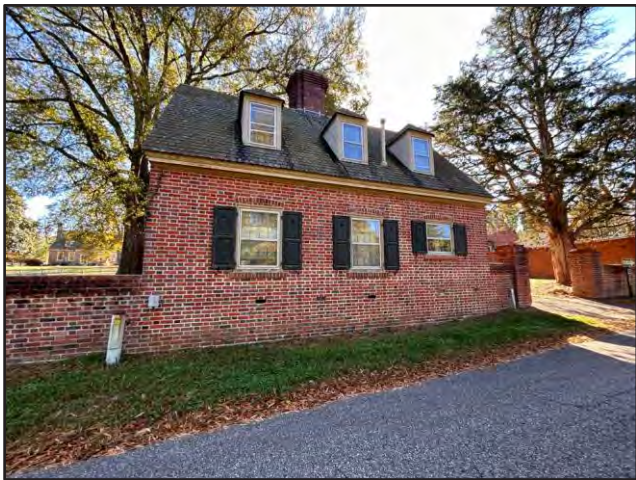
**Figure 2.42 (middle).** The Read Street side of Wisteria Cottage looking southeast.

The Read Street façade, which is integral with the perimeter brick wall, contains three windows and no doors. The wood-shingled gable roof has hipped-roof dormers and a large corbelled offset ridge chimney. There are presently no wisteria vines growing on the building. A stepping stone walkway leads from the back door towards the service yard through the break in the hedge.

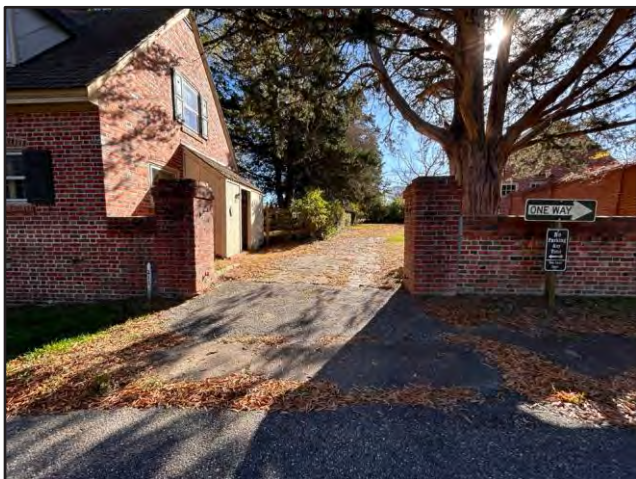
**Figure 2.43. (bottom).** The entrance to the service area looking east from Read Street with the stable at right and Wisteria Cottage at left, 2023.

The service area, developed as part of the York Hall estate beginning in 1916 and part of the Nelson House garden lots during the colonial era, occupies the south half of lot 50 and is screened from the lawn by shrubs and trees. The entrance to the service area is by a drive from Read Street flanked by brick pillars in the perimeter wall. The drive has an asphalt apron at the street, a concrete pavement (sawcut to look like blocks) at the cottage porch up to the start of the stable, and a gravel surface in front of the stable. A row of shrubs and trees, including a clipped privet hedge, crêpe myrtle, deutzia, rose, Southern magnolia, and red cedar, frames the north and east sides of the yard and screens it from the lawn. A desire line cuts through the hedge and connects to the rear entry of Wisteria Cottage, and another runs to the northeast around the hedge to the lawn.

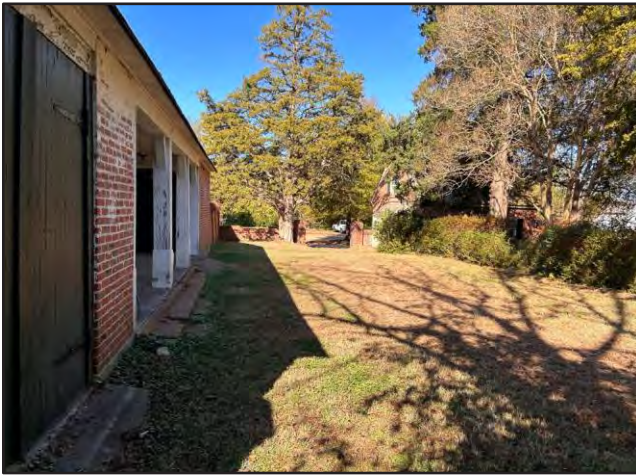
Built c. 1916 – and also designed by Griffin and Wynkoop, the stable is a one-story brick building that faces north toward the service drive and lawn. It features a wood-shingled roof with clipped gables, hay mow, and a center ventilating cupola with a pyramidal roof. The front

**Figure 2.44 (top).** The service drive and stable looking west, 2023.

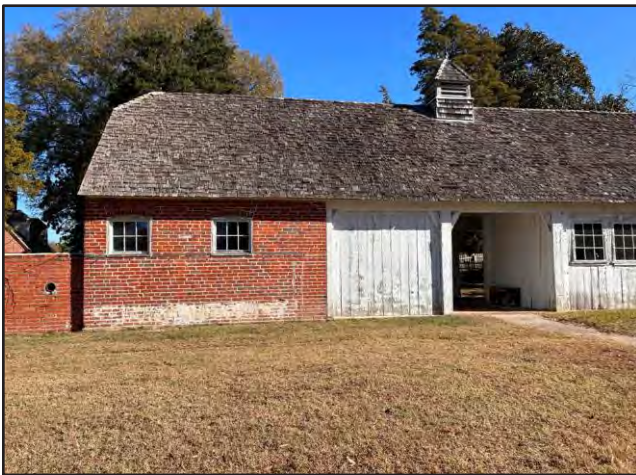
**Figure 2.45 (middle).** The stable looking north from the Poor Potter Site, 2023.

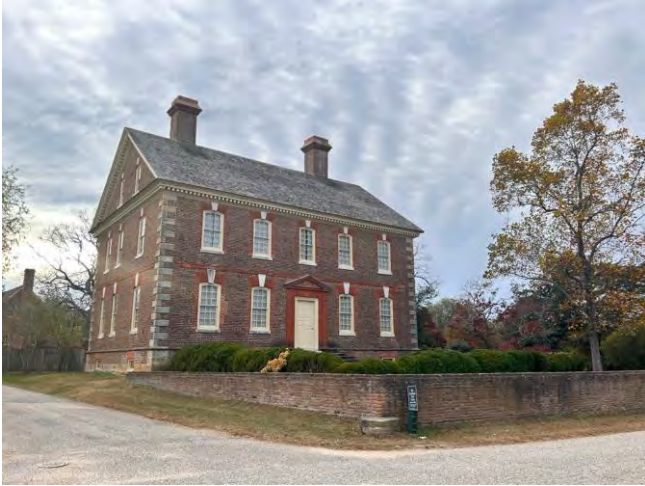
Table 3.2 Landscape Feature Inventory				
Nelson House Grounds, Colonial National Historical Park				
Feature Name	Feature ID Number	Evaluation Status	Evaluation	Existing Conditions Graphic Reference
Spatial organization				
SO-1. Front Court Space (c. 1730, c. 1976)	-	Contributing	The front court, bordered by the front of the Nelson House and perimeter wall along Main and Nelson Streets, is a defining spatial feature of the Revolutionary War and Civil War landscape. Created with the construction of the Nelson House, c. 1730, the front court during the Revolutionary War was most likely open to Main and Nelson Streets, with the kitchen-wash house partially framing the west side. The space may have been enclosed by a low plank fence and boxwood hedge. By the time of the Civil War, a large tree, probably a tuliptree, framed the west side, and growth of the boxwood hedge enclosed more of the space. C. 1870, a change in the surrounding grade led to the addition of a retaining wall that elevated the front court above Main Street. Throughout the York Hall estate period, the front court was a sheltered garden space enclosed by the perimeter wall and the boxwood hedge that had grown upwards of 15 feet tall. In 1976, the NPS completed rehabilitation of the front court that removed the high boxwood hedge and replanted a low boxwood hedge, thus reopening the space to the surrounding streets. Due to removal of the front court garden and high boxwood hedge, the space does not reflect the character of the York Hall estate period. The interior of the space, surrounded by the house and low boxwood hedge, is similar in character to the spatial character of the Revolutionary War and Civil War periods but dates to the NPS management period.

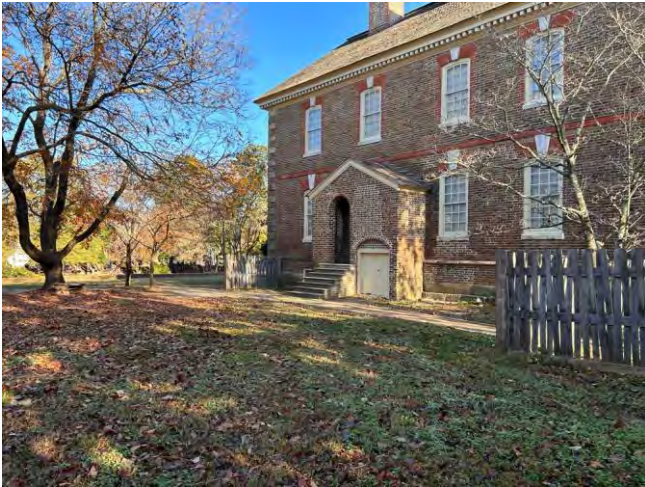
SO-2. Back Court Space (c. 1730, c. 1976)	-	Contributing	The back court space, the area defined by the Nelson House, terrace, Nelson Street, and Smith House lot, is a spatial feature of the Revolutionary War landscape. Due to lack of documentation, the details of the space – except for the wall of the house – are unknown. A mature boxwood hedge enclosed the south boundary along the Smith House lot during the 19th century and possibly dated to the 18th century. No documentation has been found on the Revolutionary War period definition on the west side, where the court transitioned to the garden and open lots and service area, or to Nelson Street on the east. The use of the back court space is also unknown, although it would have been a typical place for a colonial formal garden given its proximity to the house and separation from the service area. During the York Hall estate period, the back court space was transformed into a formal entrance area according to plans by Charles Gillette. His design included an oval drive with a turf island bordered by dwarf boxwood hedges, perimeter shrubs, a brick wall and gates along Nelson Street, and an entrance from the terrace marked by goddess statues on pedestals. The space also opened along a walkway to the formerly separate Smith House lot to the south. During the NPS rehabilitation of the grounds c. 1976, all of the York Hall estate features were removed except for several trees, and the space was simplified into an open lawn enclosed by wood fences and plantings on the west, south, and east sides. Although lacking its historic details, the back court presently reflects the overall rectangular spatial character of the Revolutionary War period through its restored enclosure at the Smith House lot but dates to the NPS management period.

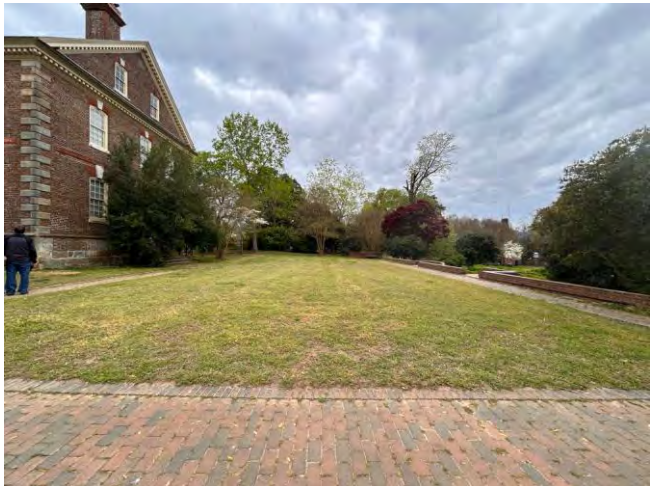
<p>SO-3. Terrace Space (1922)</p>	<p>-</p>	<p>Contributing</p>	<p>The terrace space is a defining feature of the York Hall landscape. It is also the presumed site of the first Nelson House built c. 1706, as well as the Revolutionary War-period service yard that was built with construction of the existing Nelson House c. 1730. The earth or marl-surfaced yard, accessed by a drive from Main Street, was defined by 6 closely spaced service buildings, three on the north side and three on the south side. These buildings were removed after the Civil War, with the kitchen-wash house the last standing until it was destroyed c. 1910, leaving all but the massive center chimney and foundation. As part of the initial development of the York Hall estate c. 1916, Charles Gillette designed a sloping terrace over the remains of the old service yard, with the grade along Main Street supported by the perimeter brick wall. Gillette designed marl paths and a mass of shrubs along the lower slope. As part of the construction of the formal garden in 1922, Gillette redesigned the terrace by raising it to a level grade supported by a brick wall along the east side of the garden and additional walls to the north along the lot 53 boundary. The new terrace consisted of an open lawn that overlooked the formal garden and was bordered by shrubs and trees along the north, east, and south sides. The space was further defined by brick and stone walkways along the perimeter. As part of the rehabilitation of the Nelson House grounds, the NPS retained the terrace space, but altered its details through lowering of the grade by approximately two feet, removal of perimeter shrubs, and redesign of the walkways. Despite these changes, the terrace space remains largely intact from the York Hall estate period. There is no above-ground evidence of the Revolutionary and Civil War-period yard. Geothermal wells were installed below the surface of the terrace, so the area has been explored archaeologically.</p>

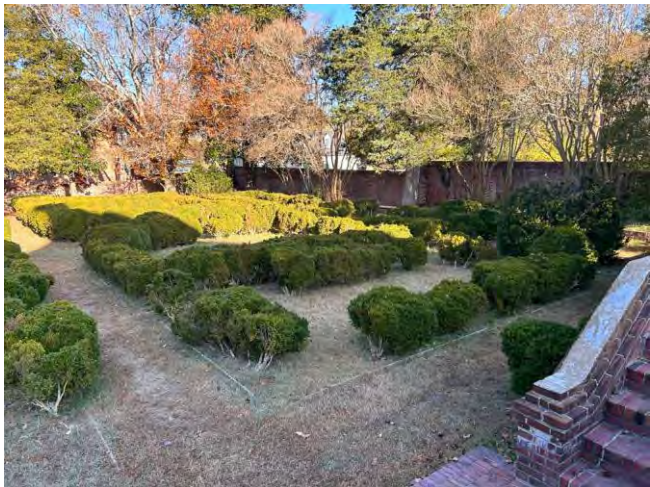
<p>SO-4. Formal Garden Space (1922)</p>	<p>-</p>	<p>Contributing</p>	<p>The formal garden space is a character-defining feature of the York Hall landscape. During the Revolutionary War and Civil War, lot 48 was a field within the Nelson House garden and open lots, and a well house along Main Street. The earlier house on lot 48 was removed by the time of the Revolution, and a second tenant house built in c. 1870 was removed by c. 1900. Fences historically lined Main and Read Streets, and the east side of the lot was bordered by the service buildings, located on an embankment. In the initial development of the York Hall estate beginning, c. 1916, the formal garden space was an open lawn enclosed by the perimeter wall along Main and Read streets, and dense tree and shrub plantings around the perimeter, with an opening to the lawn to the south. Redesign of the space as a formal, quincunx plan garden retained much of the pre-existing spatial character, except along the east side where a wall along the redesigned upper terrace created a distinct edge. After 1930, the space was modified by expansion of the shrub border along the south side around a swimming pool, now partially removed. After its acquisition of the property in 1968, the NPS retained the overall spatial character of the formal garden, although the perimeter plantings have been removed. The existing enclosed character contrasts with the open field that most likely existed during the Revolutionary and Civil Wars.</p>

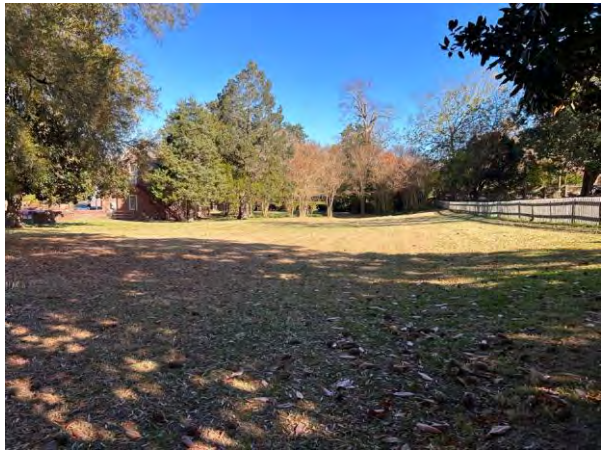
<p>SO-5. Lawn Space (c. 1922)</p>	<p>-</p>	<p>Contributing</p>	<p>The lawn is a character-defining spatial feature of the York Hall landscape. During the Revolutionary and Civil War periods, the space was comprised of three separate properties, including the rear yards of the Smith and Ballard lots and the Nelson House garden and open lots. The landscape was most likely an open field with a fence or hedge along the property boundaries. In the initial plans for the York Hall estate c. 1916, Charles Gillette planned an orchard for the site. In his redesign c. 1922 that included the formal garden, Gillette made this area into an open lawn that served as the central unifying space for the landscape, onto which the surrounding buildings faced. Reminiscent of the style of English landscape gardens, the lawn featured a broad swath of open turf framed by trees and shrubs bordering the perimeter buildings with stepping stone paths (see C-12) as connecting key features. Stepping stone pathways connected structures and spaces on the edges of the lawn, including Wisteria Cottage, the garage, Ballard House, and the formal garden. Following its acquisition of the York Hall estate in 1968, the NPS erected 4-foot-high wood fences to reestablish the colonial limits of the Nelson, Smith, and Ballard lots. While this fence disrupts some of the open spatial character of the lawn, overall, the space remains discernible.</p>

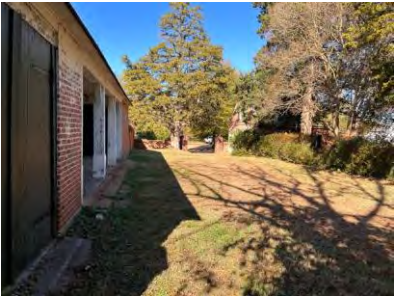
SO-6. Stable Courtyard (c. 1916)		Contributing	The stable courtyard, the space north of the stable building, is a character-defining spatial feature of the York Hall landscape. During the Revolutionary and Civil War periods, this area was part of the Nelson gardens and open lots, adjoining the lot 50 house along Reed Street. The stable courtyard dates to the initial development of the York Hall estate. Charles Gillette's c. 1915 plan of the landscape showed it as a rectangular area in front (north) of the stable, enclosed by trees and shrubs that screened the service area from the lawn, and set apart from the service yard south of the stable by serpentine brick walls. Circa 1945, the areas in front of these walls were separated from the courtyard by the addition of brick walls that defined two small service yards (see SO-8). Since 1968, the NPS has maintained the stable courtyard with few changes, except for removal and replacement of the screening vegetation (see V-12).

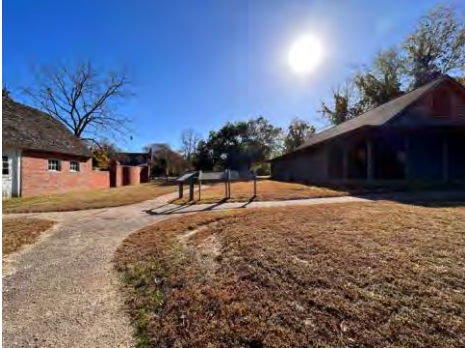
SO-8. Stable Yards (c. 1945)		Non-contributing	The two walled yards to the east and west of the stable do not contribute to the historic character of the landscape because they were built after the end of the York Hall estate historic period. During the Revolutionary and Civil War periods, this area was within the Nelson gardens and open lots. In the initial design of the original service yard (c. 1916) the areas to either side of the stable were part of the stable courtyard. In 1936, Gillette redesigned the original service yard into a tennis court. This work involved extending the serpentine walls to close off the openings for the two side service drives. The area east of the stable was designated as the new service yard. C. 1945, two new brick walls were erected in line with the north side (front) of the stable, creating small, enclosed service yards on both sides of the building. The east yard was used as a chicken yard and the west yard as a dog run. After 1968, the NPS made few changes to the yards aside from removal of a tree. Although additions made after the period of significance, these yards are compatible with the historic character of the York Hall landscape. Today the vegetation in the work yards is overgrown and some of the walls need to be supported structurally.

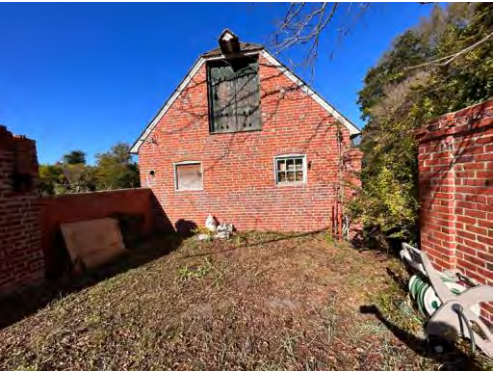
To either side of the stables are small yards enclosed by approximately 6-foot-high brick walls that were once planted with Virginia creeper vines and vinca, now just have grasses and weeds. The north wall enclosing the east yard is failing structurally and propped up for support. Both yards are enclosed on the south side by serpentine walls and have openings in the north wall adjacent to the building. The east yard extends onto lot 54 (Ballard House lot).

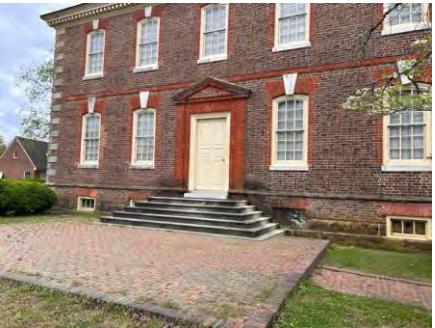
<p>C-2. Back Court Walkway (c. 1976)</p>	<p>155161</p>	<p>Non-contributing</p>	<p>The brick walkway that extends perpendicular to Nelson Street from the steps at the house to the terrace is a non-historic feature. The 5-and-a-half foot wide walkway, built of variegated red brick in running bond with soldier-course edges, was designed by Eugene George, AIA and constructed between 1974 and 1976 as part of the rehabilitation of the Nelson House by the NPS. The walkway provides access to the stairs at the back entrance of the house. At the eastern end of the walkway on Nelson Street, the walkway widens into a 9-foot by 12-foot brick pad that is a step lower than the walkway. (The walk does not connect to Nelson Street). No documentation exists on circulation in the back court during the Revolutionary War period. Although a contemporary feature, the back court walkway is compatible with the historic character of the landscape due to its materials and inconspicuous appearance. Some of these pads and walkways are in poor shape, heaving and creating tripping hazards.</p>

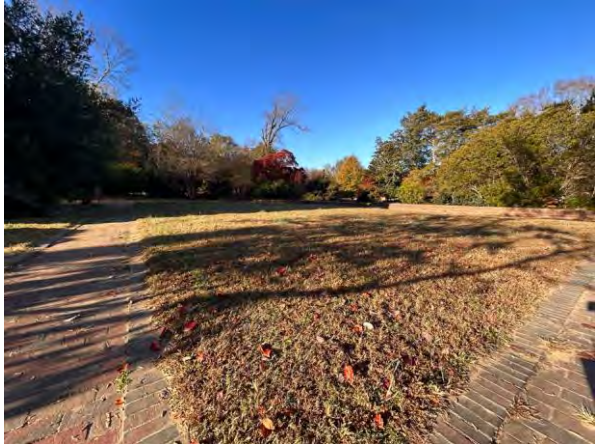
<p>C-3. Terrace Walkways (c. 1976)</p>	<p>155163</p>	<p>Non-contributing</p>	<p>The terrace walkways are a non-historic feature built c. 1976 as part of the rehabilitation of the Nelson House grounds by the NPS. During the Revolutionary War period, circulation at the site of the terrace consisted of an earth or marl-surfaced drive and yard. In the initial development of the York Hall estate, c. 1916, Gillette designed marl walkways edged with brick along the perimeter of the terrace to connect the house and entrance drive with the formal garden and lawn. In the redesign of the terrace in 1922, Gillette surfaced the walkways in brick, and, c. 1930, a stone walkway was added along the south and west sides of the terrace. C. 1976, as part of the rehabilitation of the Nelson House grounds, the NPS removed all walkways on the terrace and built new brick walkways that were similar in character. The new walkways, consisting of running bond with raised soldier-course edging, created a rectangular perimeter around the terrace lawn and connected with walkways to the front and back courts. A large brick pad was added near the back court, and a new landing was built at the Nelson House entrance as part of a new flight of steps. Although not historic, the terrace walkways are compatible with the historic character of the landscape because they are similar in design and materials to those that existed at the York Hall estate. Today, portions of the walkways are uneven and heaving, and have broken bricks and weeds.</p>

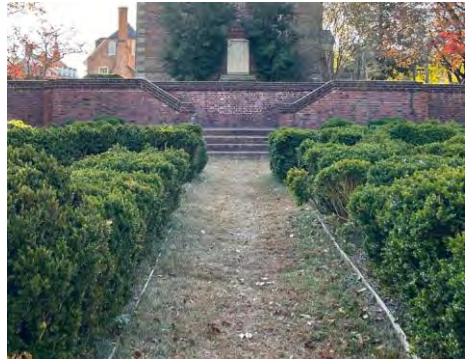
C-6. Formal Garden Brick Pads (1922)	155169	Contributing	The two herringbone-pattern brick pads in the formal garden, at the west and north termini of the primary axial walkways, are characteristic circulation features from the York Hall landscape. These pads were originally designed as bases for Chinese-style covered benches installed along the edge of the garden c. 1922. These benches were removed after 1930 and replaced with masonry benches in the same spot. Circa 1946, after the end of the period of significance, the north pad was extended toward the perimeter wall, and the west pad connected to a larger circular patio (see C-7). Although remnant, the two brick pads nonetheless reflect the original Gillette design of the formal garden. Today, the brick pad at north-south central walkway of the formal garden is heaved and both pads have grass and weeds growing in their joints.

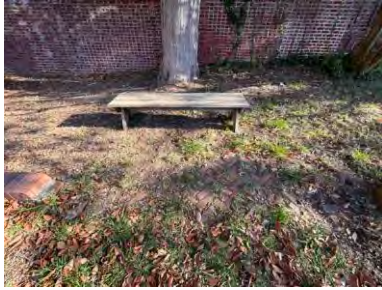
C-7. Formal Garden Circular Patio (c. 1946)	155171	Non-contributing	The circular brick patio in the west perimeter of the formal garden, built c. 1946, does not contribute to the historic character of the landscape because it was added after the end of the York Hall historic period and reflects a distinct shift toward informal outdoor living after World War II. The roughly 18-foot diameter patio, designed by Gillette, was built adjacent to an existing brick pad (see C-6) and around an existing red-cedar tree. The patio was enclosed by a boxwood hedge and featured a fireplace along the perimeter brick wall (see A-1). Although not historic, the patio does not detract from the historic character of the formal garden due to its inconspicuous appearance. However, the loss of the Chinese-style covered bench in this location, part of the original landscape design, does detract from the formal garden's historic character. C. 1975 the NPS relocated the Cornwallis plaque to the perimeter wall at this patio (see SSF-3). The patio is significantly heaved today around trunk and roots of the red cedar tree.

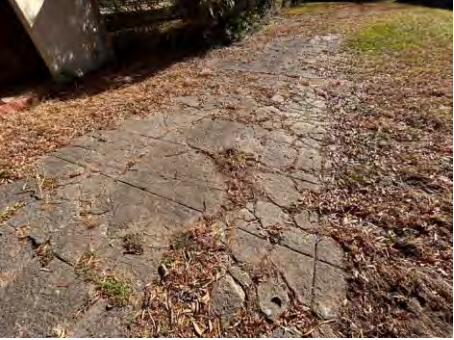
<p>C-11. Poor Potter Walkways (2006)</p>	<p>155179</p>	<p>Non-contributing</p>	<p>The Poor Potter walkways are non-historic features built in 2006 by the NPS to provide access to the new Poor Potter Site enclosure building from Read Street, Nelson Street, and the Nelson House grounds. The walkways were surfaced in Klingstone, a pavement that has the appearance of a traditional gravel surface, prior to 2011. Today, none of the gravel surface exists and the walkway has the appearance of asphalt. Because they are in a space that has lost historic integrity (the original service yard), the walkways do not detract from the historic character of the landscape. The walkways are steep and narrow and do not meet accessibility standards.</p>

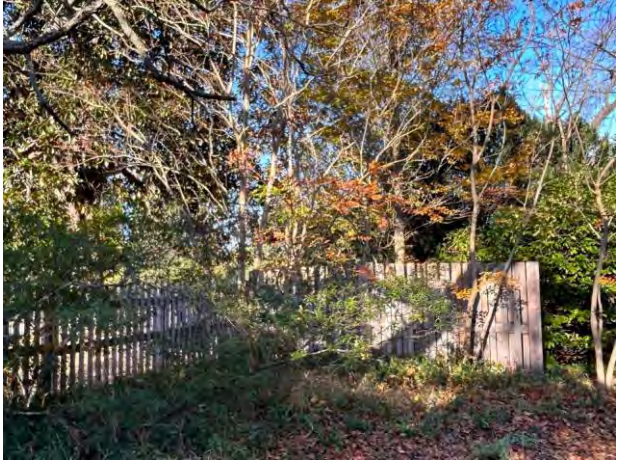
V-4. Terrace Trees & Shrubs (c. 1976)	155139	Non-contributing	The existing trees and shrubs are non-historic vegetation installed by the NPS (c. 1976) as part of the rehabilitation of the Nelson House grounds. During the York Hall estate period, the terrace had the same central lawn, but was flanked by dense shrub plantings along the north, east, and south sides. The existing trees and shrubs are sparser and consist of traditional Southern species including two groups of dogwoods at the walkways to the back and front courts, two pyramidal boxwoods flanking the western steps to the Nelson House, several crêpe myrtle, and assorted shrubs and a groundcover of periwinkle at the south end of the terrace. There are no plantings along the garden wall (west side). Although of contemporary origin, the existing trees and shrubs are compatible with the historic York Hall character of the landscape in species and overall placement.
