CULTURAL LANDSCAPE REPORT FOR THE  
NELSON HOUSE GROUNDS  
COLONIAL NATIONAL HISTORICAL PARK  
VOLUME 2: TREATMENT

# CULTURAL LANDSCAPE REPORT FOR THE NELSON HOUSE GROUNDS

## COLONIAL NATIONAL HISTORICAL PARK VOLUME 2: TREATMENT

YORKTOWN, VIRGINIA

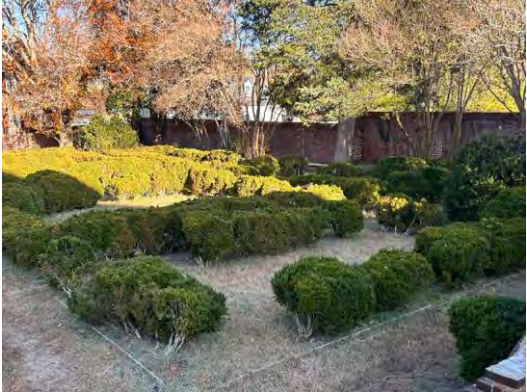
V-6. Formal Garden Specimen Boxwoods & Yews (c. 1985)	155143	Non-contributing, missing (yews)	The formal garden historically contained clipped tree boxwood in the same location of the boxwoods in the corner beds. Groups of four upright mounded yews were in the center of the beds until they were replaced with boxwood c. 1976 and rose of Sharon c. 1985. The English box in each of the outer four square corner beds, and the rose of Sharon (removed sometime after 2012) in the middle of the center beds, do not contribute to the historic character of the formal garden because they differ from the historic Gillette design. These shrubs detract from the historic character of the landscape because they are incompatible in form and appearance to the historic shrubs.

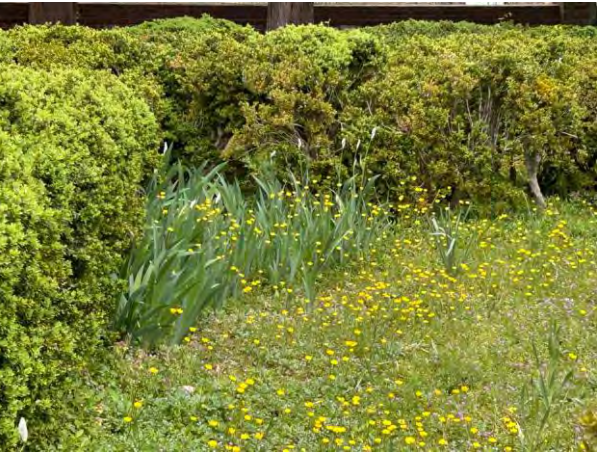
<p>V-8. Formal Garden Perimeter Plantings (c. 1922)</p>	<p>155147</p>	<p>Contributing</p>	<p>The trees and shrubs in the perimeter beds of the formal garden are a characteristic vegetation feature of the York Hall landscape, originally planted along the perimeter wall c. 1916 based on the design by Gillette. The layered planting design featured trees in the back and shrubs and groundcover in front, forming a backdrop for the view from the west terrace (see VV-2). Species included eastern red cedar, American beech, southern magnolia, aucuba, Chinese photinia, quince, sweet mockorange, and crêpe myrtle. A boxwood hedge lined the bed above low brick retaining walls. During the NPS management, the perimeter plantings were thinned and many of the small shrubs and groundcover were removed, leaving exposed mulch and soil. While most of the trees and the larger shrubs remain, the loss of the small shrubs and groundcover detracts from the historic character of the landscape.</p>

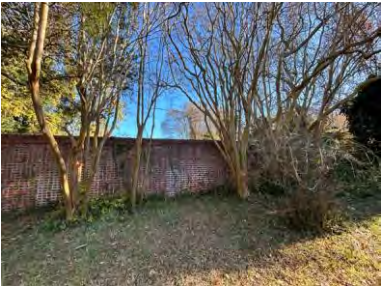
<p>V-9. Formal Garden South Entrance Plantings (c. 1922)</p>	<p>155147</p>	<p>Contributing</p>	<p>The plantings framing the south entrance to the formal garden are a characteristic vegetation feature of the York Hall landscape. As designed by Gillette in 1922, the south entrance plantings form a transition between the rectilinear lines of the formal garden and the informal character of the lawn. The two areas were divided by a low brick wall with urns flanking the opening. The plantings consisted of specimen trees and shrubs, including paired Burford hollies within the garden and littleleaf lindens south of the dividing wall, lined by a border of Japanese red maples. The outer plantings beneath the lindens featured mixed shrubs united by a groundcover of common periwinkle with an irregular, undulating bed edge that extended southwest to the carriage house and southeast toward the back court. Circa 1946, after the period of significance, these plantings were modified as part of the addition of a swimming pool and patio in the lawn of the south opening to the formal garden. The plantings were expanded to enclose the area south of the pool, leaving just a narrow path. The NPS removed the pool and most of the expanded plantings after 1968, except for a screen of crêpe myrtle (see V-10). Today, the plantings retain the one of the two lindens, the paired hollies, and a selection of the Japanese maples, as well as the groundcover and mixed shrubs in the east half. The loss of the groundcover and shrubs in the west half of the plantings detracts from the historic character of the formal garden.</p>

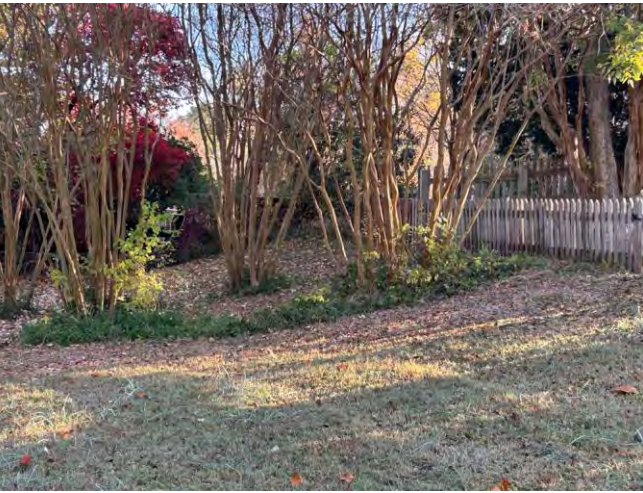
<p>V-10. Formal Garden South Entrance Hedge (c. 1922)</p>	<p>155149</p>	<p>Non-contributing</p>	<p>The hedge of crêpe myrtle south of the formal garden and near the carriage house (garage) is a non-historic feature. This hedge was planted c. 1946 after the historic period as a screen for the swimming pool at the south entrance to the formal garden. It was part of an expansion of the plantings at the south entrance to the formal garden. Following removal of the swimming pool, the NPS retained the hedge to screen views from the formal garden south to the lawn, which was intended as a service area. Today, the crêpe myrtle are underplanted by a groundcover, possibly liriopse. The hedge detracts from the historic character of the York Hall landscape by blocking the historic view from the formal garden to the lawn.</p>

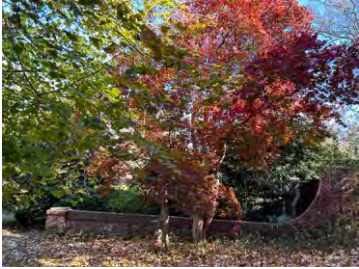
V-11. Lawn Specimen Trees (c. 1916, 1922)	155153	Contributing	The specimen trees in the lawn are a characteristic vegetation feature of the York Hall landscape. During the Revolutionary War period, the site of the lawn was most likely an open field. Some trees were planted during the initial development of the landscape by Gillette beginning around 1916. Gillette redesigned the area c. 1922 into an informal lawn in the style of an English landscape garden with scattered specimens and groves of trees along the periphery, including southern magnolia, eastern red cedar, and willow oak. Four of the specimen trees remain within the Nelson House grounds (two magnolias, red cedar, and the willow oak) and two are within the Smith and Ballard lot sections of the lawn (honeylocust and magnolia). Although several trees have been lost and at least one has been added (a red cedar near the carriage house), overall, the specimen trees reflect the informal design of the lawn in the York Hall landscape. The loss of the perimeter of understory shrubs bordering Read Street detracts from the historic character of the landscape.

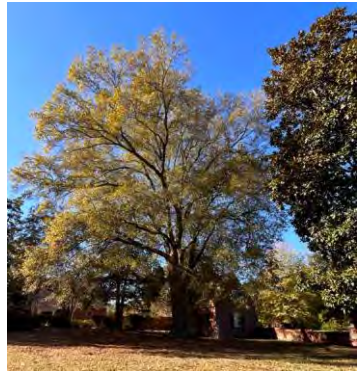
V-12. Stable Courtyard Screen (c. 1916)	155155	Contributing	The line of trees and shrubs along the north and east sides of the stable courtyard is a characteristic vegetation feature of the York Hall landscape. This screen, designed by Gillette, was planted between 1916 and 1922 to screen the service area from the lawn. The original plants included eastern red cedar, southern magnolia, crêpe myrtle, roses, and possibly deutzia. A clipped privet hedge lined the edges of the drive. A second planted area was in the area bordering the perimeter wall; this was partly removed with construction of the walled stable yards c. 1945. The NPS retained this screen including the clipped privet hedge, but some plants thinned or were removed, allowing views from the lawn. The plantings and hedge along the perimeter wall at Read Street have disappeared except for a red cedar tree. Despite these changes, the feature overall retains its historic character as a planted screen.

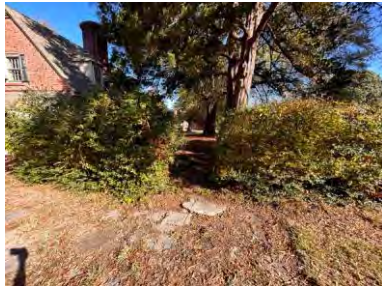
V-13. Stable Yards Vines & Groundcover (post-1945)	155157	Non-contributing	After the end of the York Hall estate historic period, vines and groundcover (primarily vinca and Virginia creeper) were added in the stable yards. While these may be remnants of plantings in the original stable courtyard, the existing extent most likely dates to after the yards ceased use upon NPS acquisition in 1968 and therefore were a non-historic feature. Since the stable walled yards are non-historic, the groundcover does not detract from the landscape's historic character. Today, some vinca remains, but the yards are mainly weeds kept short. The western yard had a volunteer tree-of-heaven growing within it.

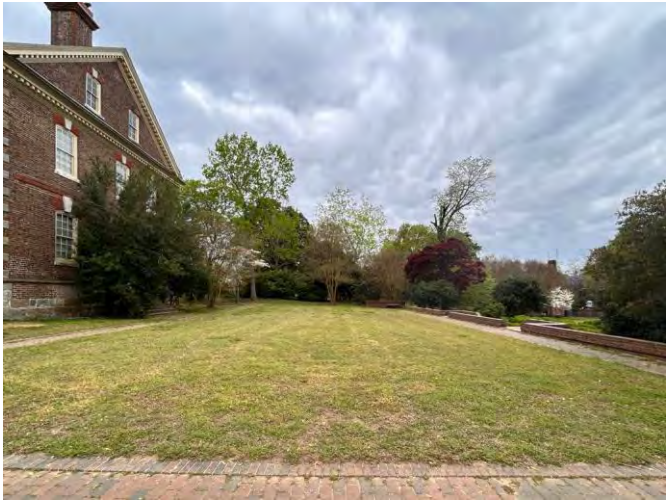
<p>V-15. Lafayette tree (c. 1824-c. 1922)</p>	<p>-</p>	<p>Missing</p>	<p>The Lafayette tree was a laurel which was reported to have stood in the front court (east of the walkway) during the visit and stay of the Marquis de Lafayette at the Nelson House in 1824. Reportedly, spectators to Lafayette’s visit used branches from the tree to make a crown for him. Blow felt it was significant enough to retain the tree during the early days of the York Hall Estate, however during the redesign of the front court, begun in 1921, the tree was removed to make way for the new private garden with fountain designed by Gillette. The Lafayette tree is a defining feature of the Civil War period and the York Hall landscape, potentially as for the Revolutionary War period.</p>

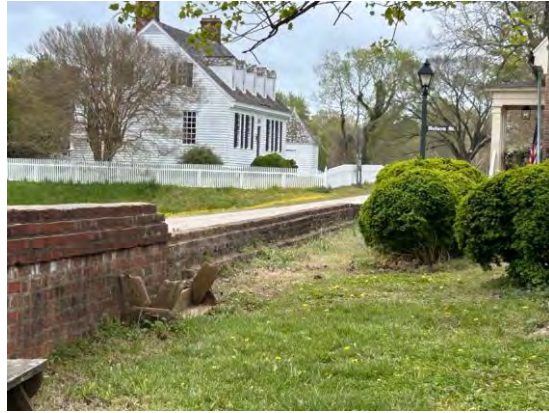
<p>BS-6. York Hall Perimeter Walls (c. 1916)</p>	<p>155191, LCSID #006879, Structure #34Y226H6 (Nelson House - Garden Wall [part])</p>	<p>Contributing</p>	<p>The perimeter brick walls along Main and Read Streets are character-defining structures of the York Hall landscape. These walls consist of brick retaining and freestanding walls constructed between roughly 1915 and 1922. (The connected brick retaining wall around the front court built c. 1870 is evaluated under the Front Court section, BS-5). The perimeter walls, measuring approximately 1,000 feet in length, are built of red brick in a mix of bonds and with a corbelled brick cap. The approximately 6-foot-tall section along Main Street steps down toward Read Street in three sections of header bond and contains an opening at the entrance walkway that leads to the terrace. The wall along Read Street is laid in a mix of common, stacked, and Flemish bond, and contains brick piers with corbelled caps between the sections. The wall curves inward at the carriage house (garage) and terminates at the walls in the north stable service yard. The walls along Nelson Street, which originally extended to the Ballard House, were removed by the park service c. 1975, and the wall along Main Street was lowered c. 1983 at the time the wall around the front court (BS-5) was lowered. Aside from these changes, the perimeter wall remains intact from the York Hall estate period (1914–1930).</p>

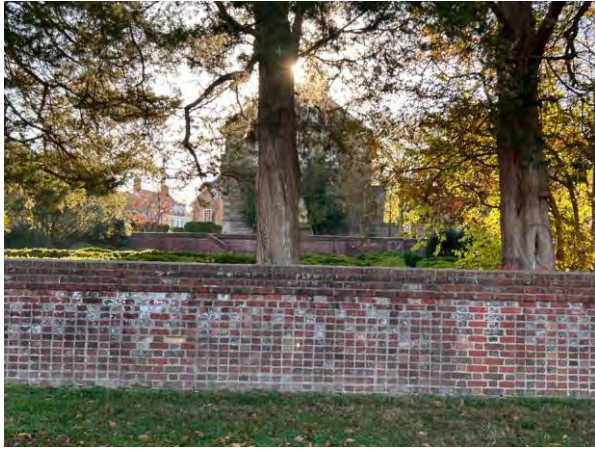
<p>BS-7. Formal Garden Walls &amp; Stairs (1922)</p>	<p>155193, LCSIS #006880, Structure #33Y226H3 (Formal Garden Walls)</p>	<p>Contributing</p>	<p>The brick walls along the east and south sides of the formal garden, including the stairs from the terrace, are a character-defining structure of the York Hall landscape. The east part of the wall, completed as part of the Gillette-designed formal garden in 1922, retains the raised grade of the terrace and serves as the formal entrance to the garden. It is a 6-and-a-half-foot high brick wall laid in Flemish bond with a corbelled brick cap and brick buttresses. The stairs consist of a double flight with a center herringbone-brick landing and a single flight to the level of the garden. The two sections of the south wall flank either side of the opening to the lawn and contain piers on the ends that were historically ornamented with urns. Much of the wall was covered in English ivy during Blow ownership. Alterations since the historic period include changes in mortar, lowering of the height of the east wall in response to lowering of the terrace grade c. 1976, and removal of the urns on the south wall. The existing concrete parging on the cap of the east wall dates to this period. The tall brick walls that frame the west and north sides of the formal garden (north and west sides) are part of the perimeter wall (see BS-6).</p>

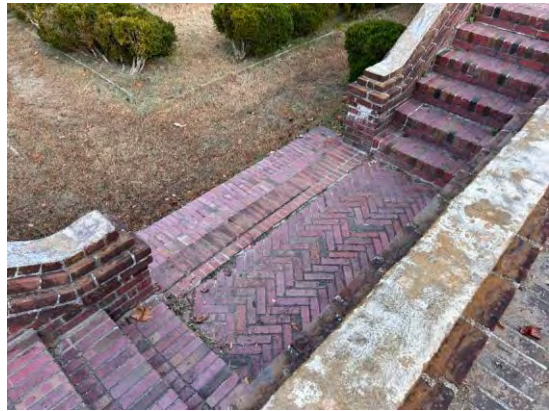
<p>BS-8. Formal Garden Perimeter Bed Walls (1922)</p>	<p>155195</p>	<p>Contributing</p>	<p>The perimeter bed walls in the formal garden are a character-defining structure of the York Hall landscape. Completed in 1922 according to the design of Gillette, these low brick walls retain the perimeter bed of shrubs and trees and extend around nearly the entire perimeter of the garden, except for the opening to the lawn on the south side. They vary from approximately 15 inches tall along the west and north sides to 3 feet at the northeast corner of the garden, and are laid in Flemish bond with a brick cap. There have been no changes to these walls since the historic period.</p>

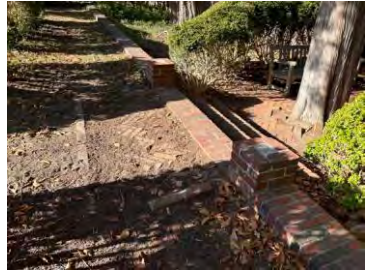
<p>BS-9. Formal Garden Tree Well (c. 1922)</p>	<p>155197</p>	<p>Contributing</p>	<p>A circular brick tree well in the perimeter bed at the northeast corner of the formal garden is a character-defining structure of the York Hall landscape. The well was built as part of the formal garden c. 1922 to protect an aged tree (species unknown). The well reflects Blow’s interest in preserving the old trees on the property. Aside from the notable loss of the tree at some point after 1930, there have been no documented changes to the well since the historic period.</p>	 
<p>BS-10. Serpentine Walls (c. 1916)</p>	<p>155199</p>	<p>Contributing</p>	<p>The serpentine walls to either side of the stable are distinctive structures of the York Hall landscape. Built c. 1916 along with the stable, the walls were designed to screen the original service yard (south of the stable) from the stable courtyard to the north. The walls are in a serpentine shape similar to those designed by Thomas Jefferson at the University of Virginia. Around 1936, after the end of the estate historic period, the service drive openings between the serpentine walls and the stable were closed off, and c. 1945, additional walls (see BS-11) were added to enclose small service yards. Although these later walls have altered the historic setting, the serpentine walls retain their historic character.</p>

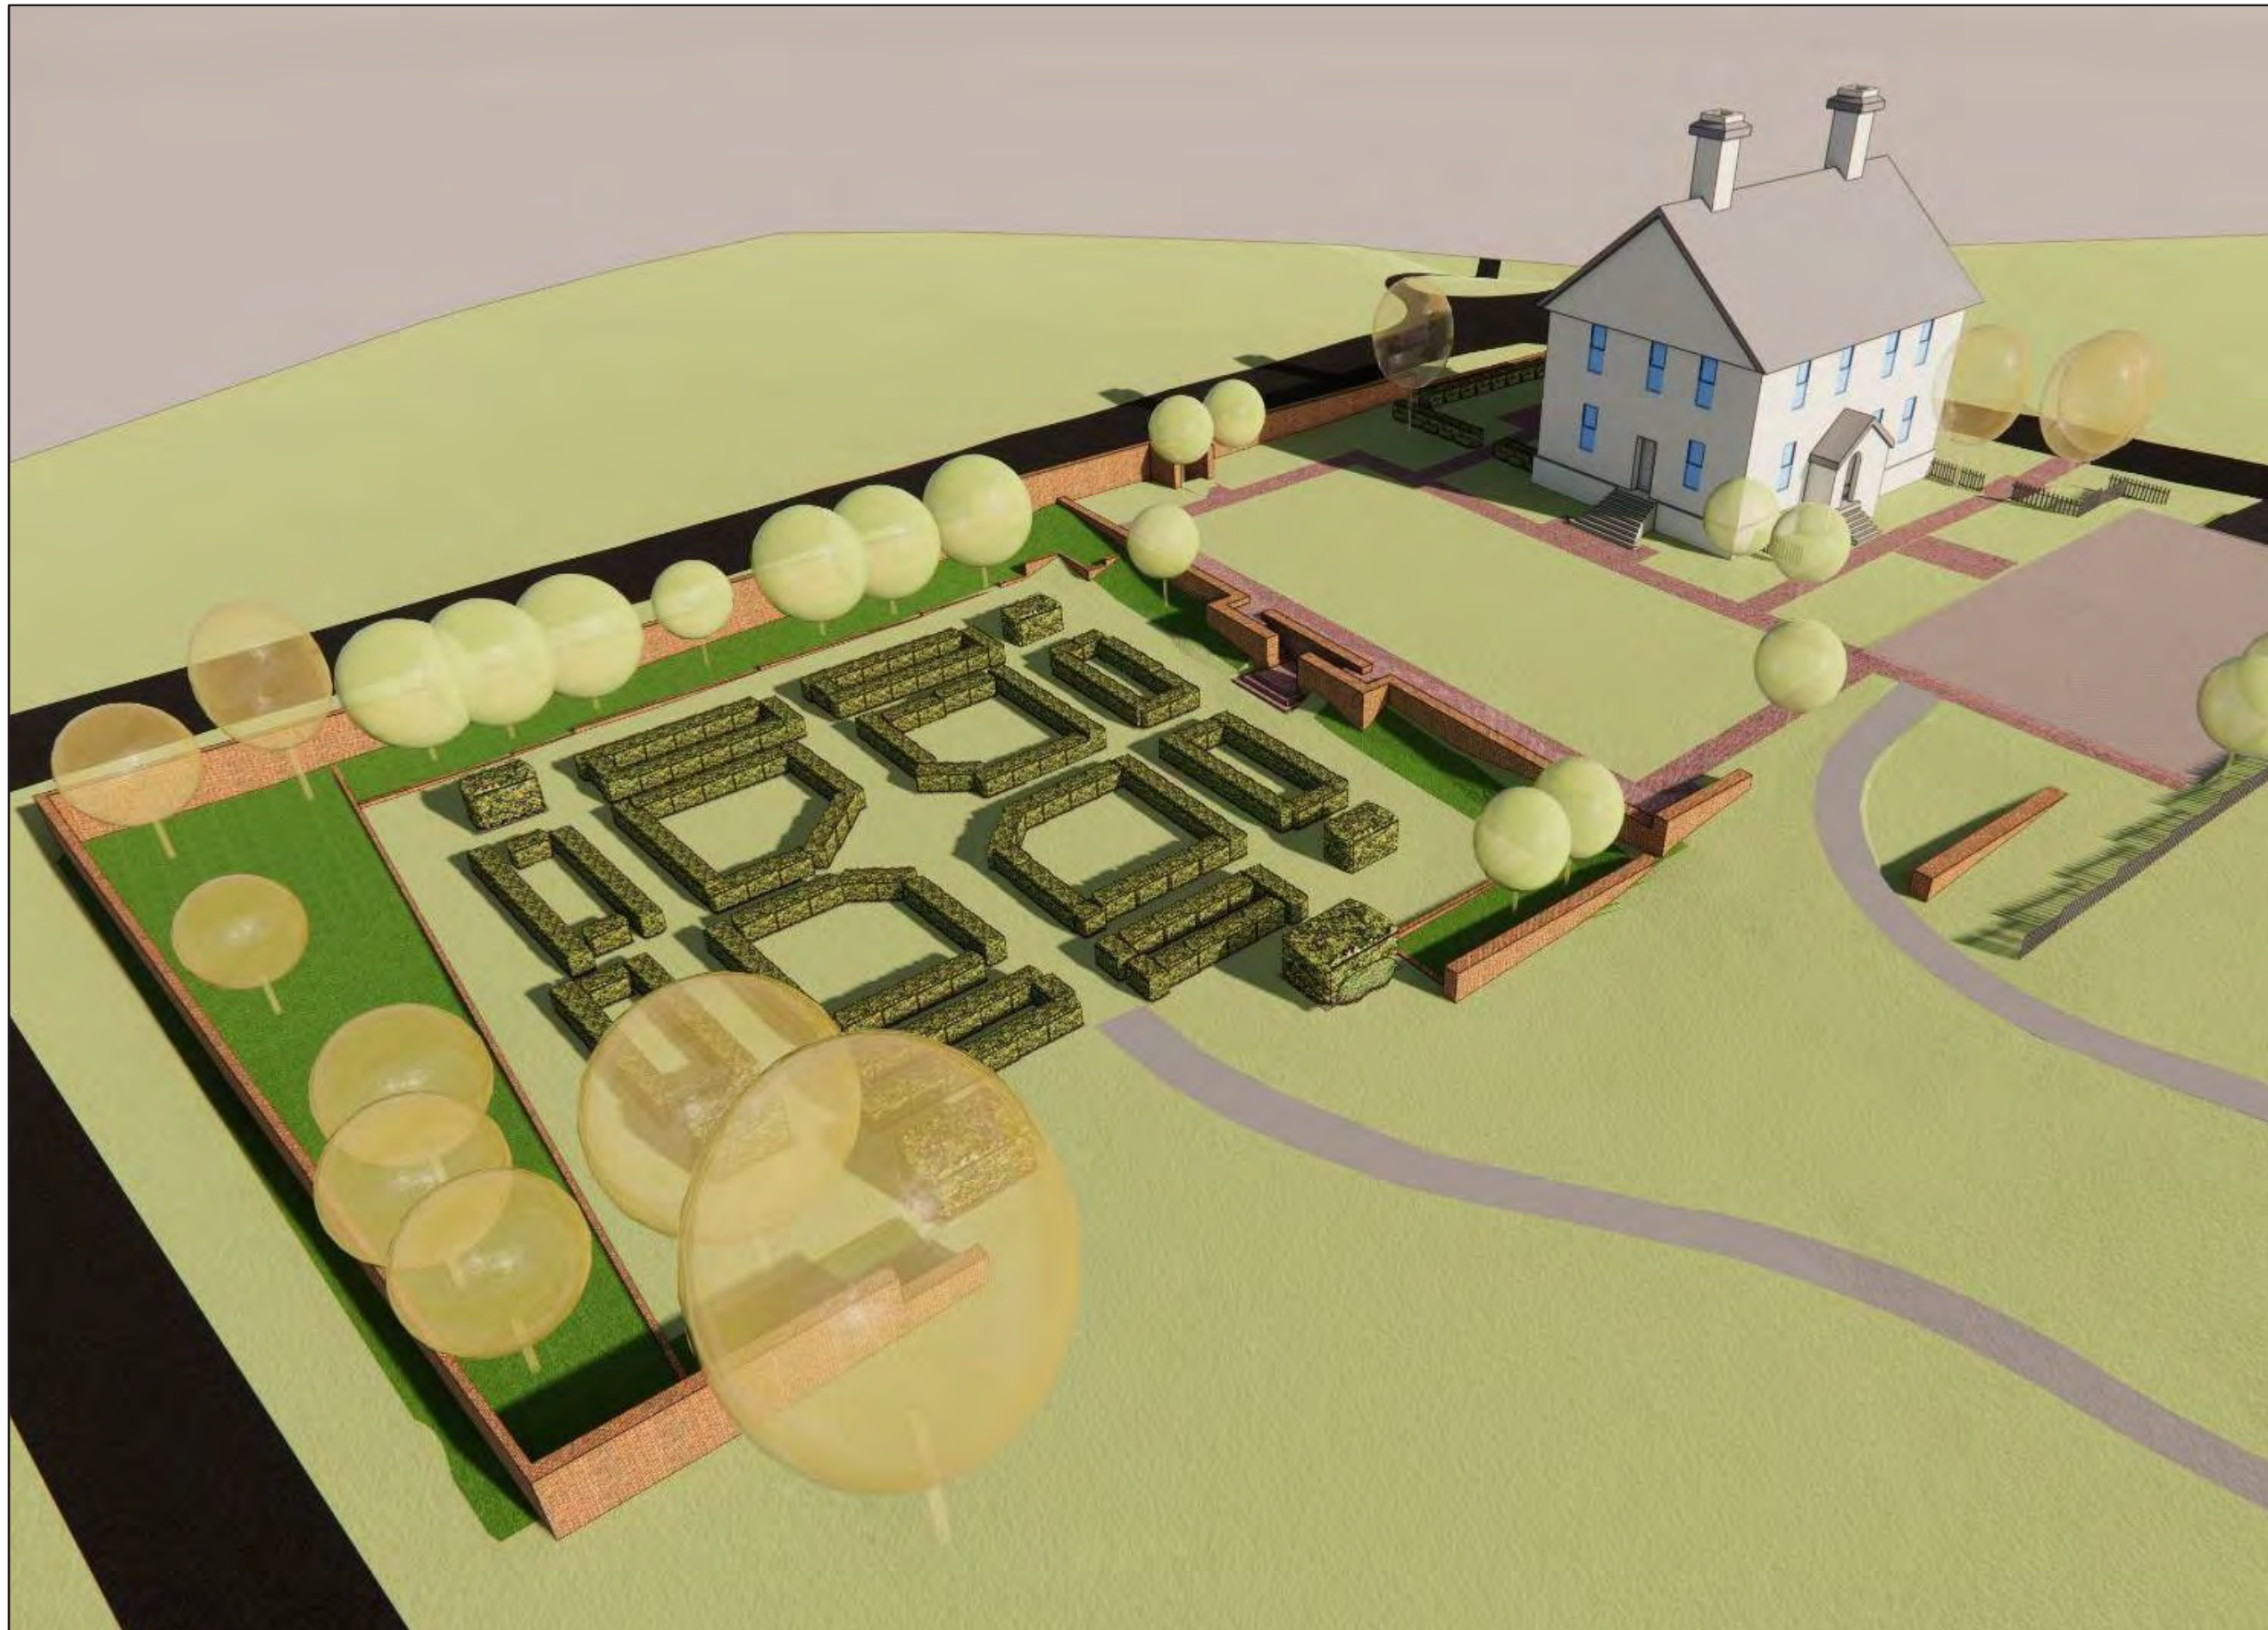
Figure 4.20 Graphic representation of re-grading and universal access between the back court and formal garden. (Prepared by Kyle Zick Landscape Architecture, Inc. with assistance from Intec Infra Technologies Pvt. Ltd.)

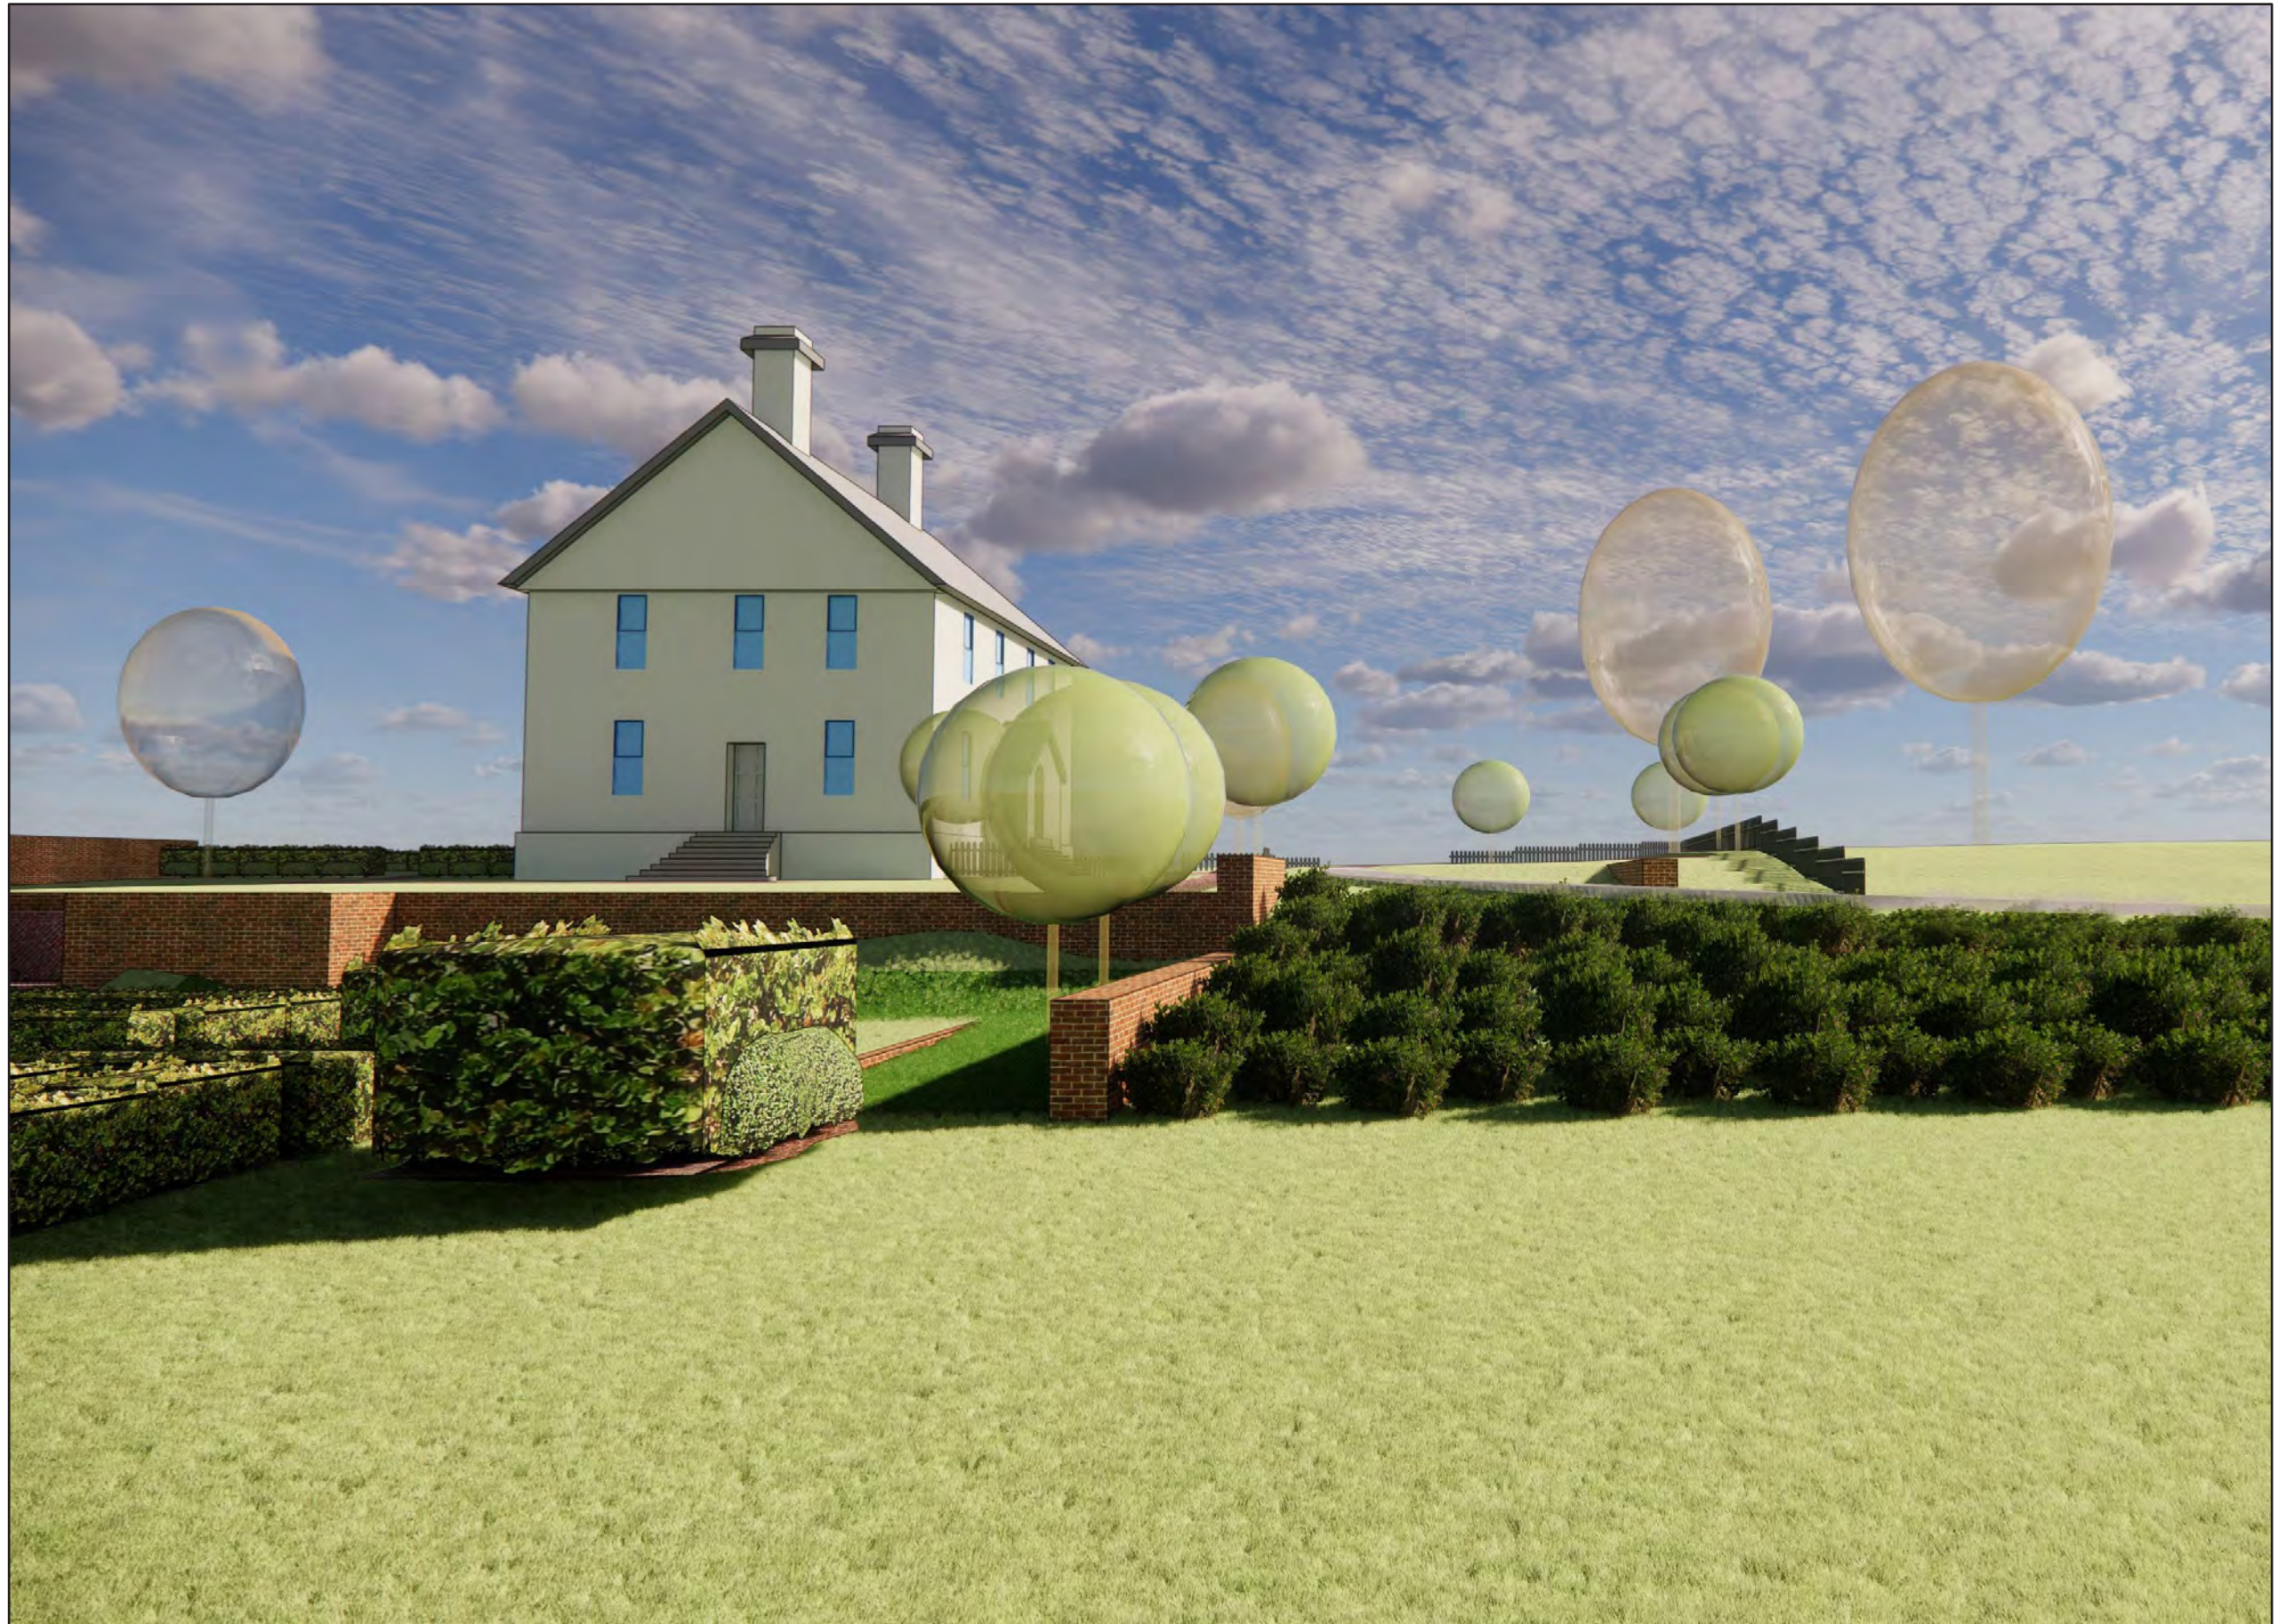
Figure 4.21 Graphic representation of re-grading and universal access between the back court and formal garden. (Prepared by Kyle Zick Landscape Architecture, Inc. with assistance from Intec Infra Technologies Pvt. Ltd.)

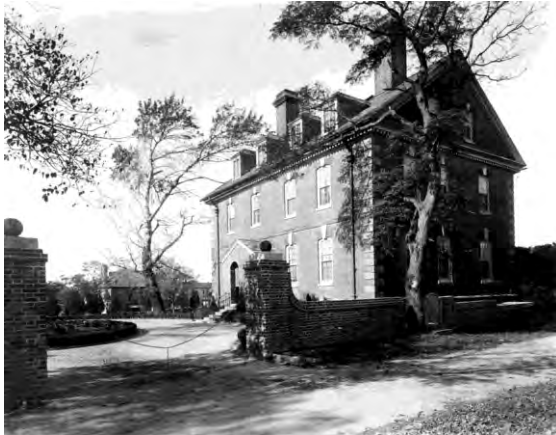
Circa 1918 view of fore (rear) court and Pearl (Nelson) Street with brick boundary wall.

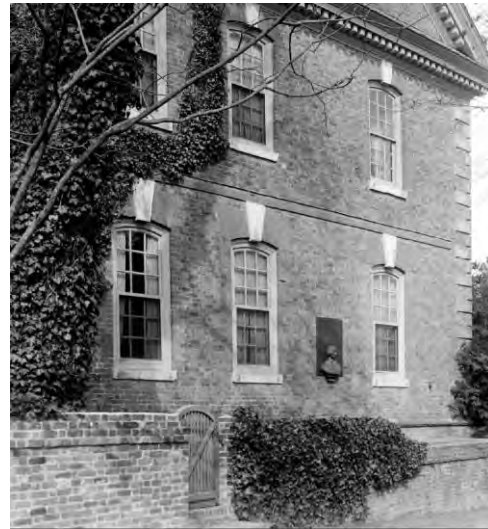
Circa 1931 view of Nelson Street facade with wood gate in brick boundary wall.
