# The Moore House

**The Site of the Surrender—Yorktown**

A National Park Service Historic Structures Report

Charles E. Peterson

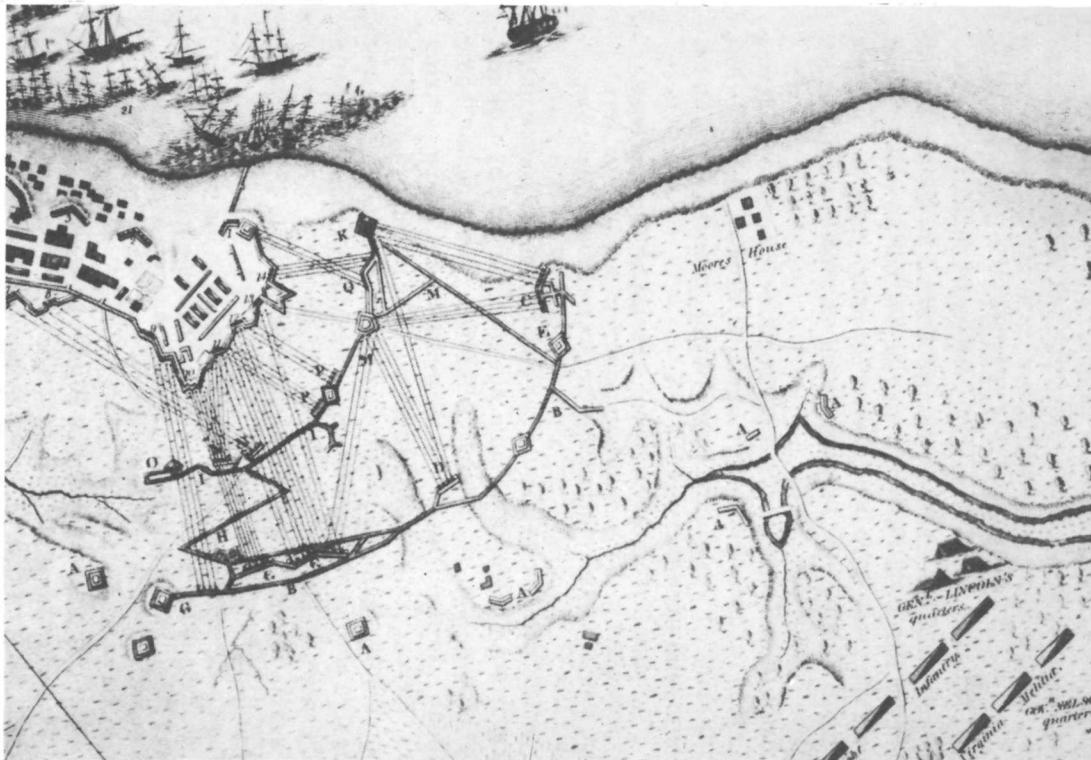
Plate No. 1: Portion of the "PLAN OF YORKTOWN IN VIRGINIA AND ADJACENT COUNTRY, Exhibiting the operations of the American, French, and English armies during the Siege of that place in October 1781. Surveyed from the 22nd to the 28th Octr. . . . Drawn by Jn. F. Renault with a Crow-pen and presented to the MARQUIS DE LA FAYETTE." This map is one of a considerable number prepared about this time. All of them vary in details such as the number and grouping of the buildings at the Moore House. The Revolutionary maps carry the first graphic representations of the Moore House.

No one has been able to dispute this date though the source of the information is not known. It is quite possible, judging by Colonial houses of known date in nearby Yorktown. The Sinclair home "Thorplands", farther down the Peninsula, has some striking similarities. The excavations of 1932 revealed the remains of probably one and possibly two earlier structures within a few feet of the present house. The first graphic representations of the Moore House appear on the military maps of 1781, et seq. (Plate No. 1)

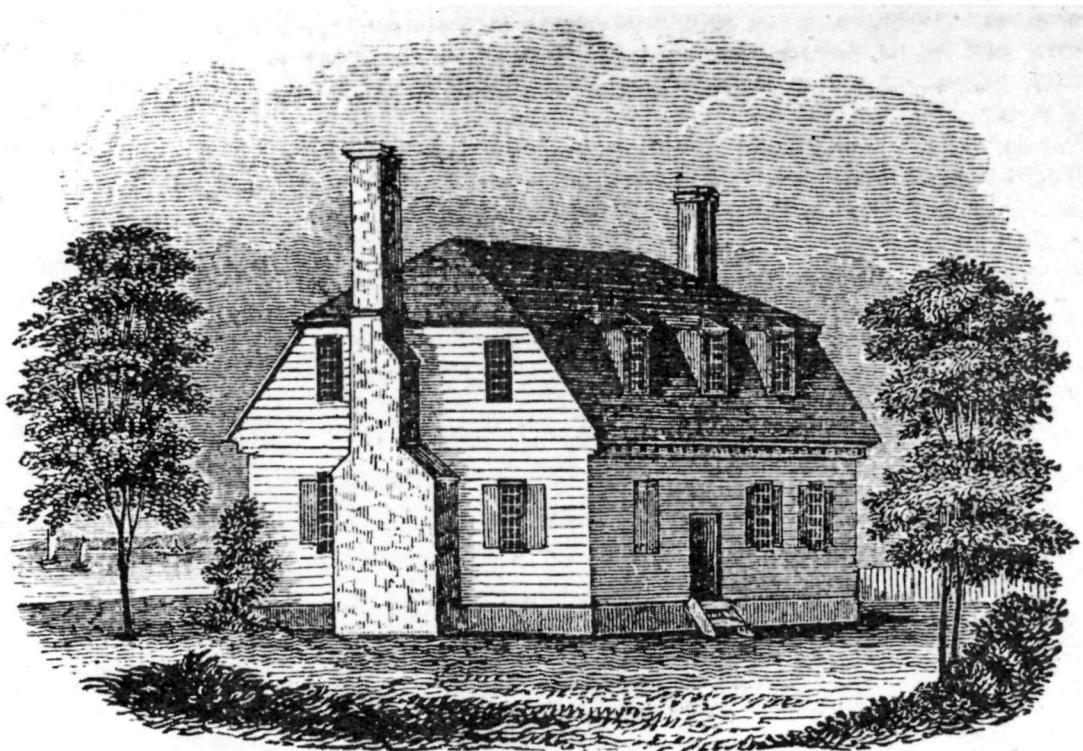
Plate No. 2: A photostat (enlarged) of the illustration (V 2 p. 530) in Henry Howe's "Historical Collections of Virginia," (1849). This is the earliest published view of the Moore House, brought to our attention by a loan of the volume from Mrs. A. Y. Burcher of Newport News, Virginia. This is the only information we have on the step arrangement at the rear door.

of interest ever after. Henry Howe published the first view in 1849 (Plate No. 2). In Lossing's "Pictorial Handbook of the Revolution" can be seen the earliest published front view known (Plate No. 3).

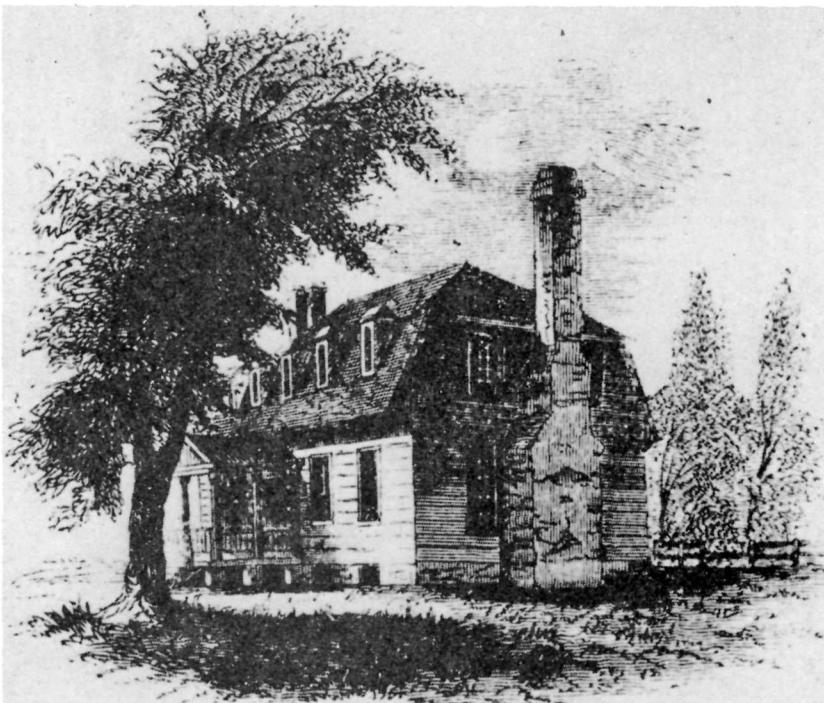
Plate No. 3: A photostat (enlarged) of the illustration in Vol. II, (p. 324) Benson Lossing's "Pictorial Field Book of the Revolution," (1850). Lossing made a tour of the places associated with the Revolutionary War, visiting Yorktown in 1848. This is the second earliest known pictorial representation of the Moore House. Brought to our attention by Mr. Thomas T. Waterman, then of the Williamsburg Restoration.

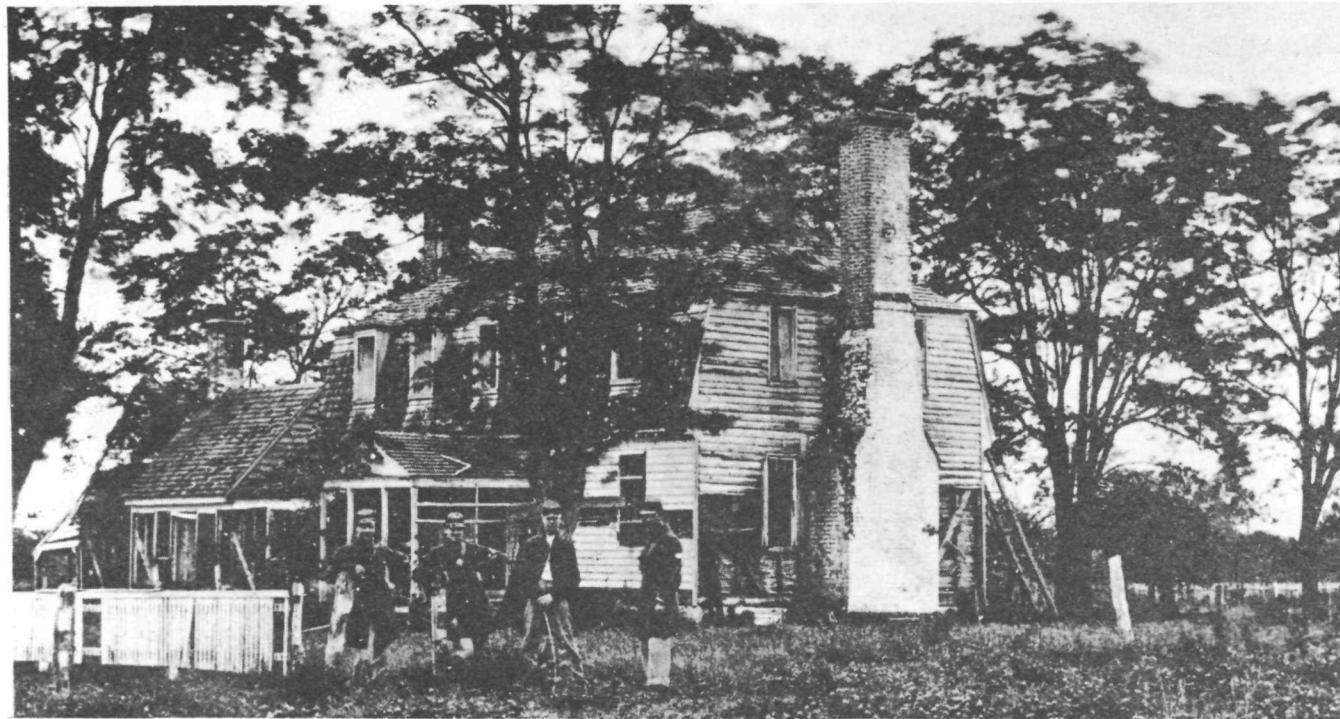
Plate No. 4: Enlargement of the photograph taken by Matthew Brady in 1862, located by the writer in the Library of Congress. The decision to restore a front porch was based on a study of this photograph. There have been at least four front porches on the House, (1) an 8' by 8' porch from which the brick pier bases survive; (2) the porch shown in this photograph; (3) the porch removed in 1931 which was built probably in 1881; (4) the present porch which is a conjectural restoration of (1). This view shows the chaos of the grounds during the War which may account for the disappearance of the outbuildings. The Civil War photographs show the East Wing for the first time. This is reproduced in Miller's Photographic History of the Civil War, Vol. I, p. 269

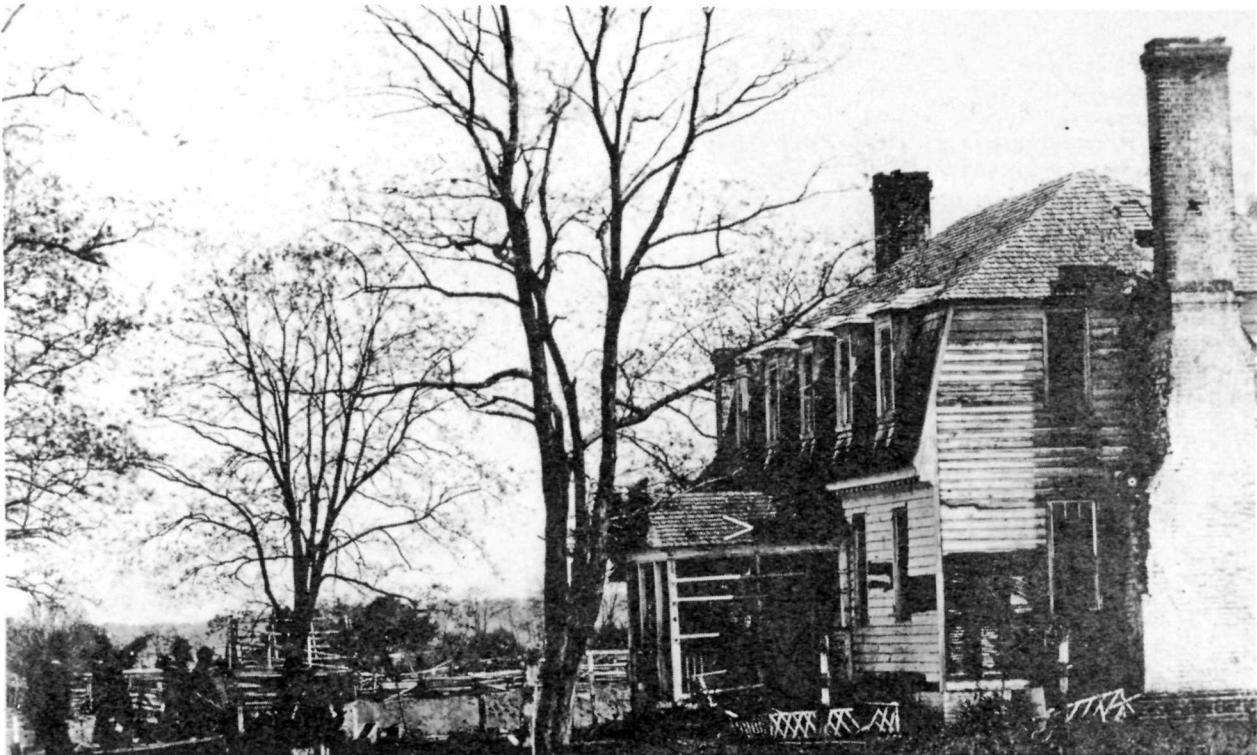
Plate No. 5: The Gardner print from a negative by Wood and Gibson, May 1862. Brought to our attention by Mr. Louis R. Fiske of Upper Darby, Pennsylvania, who sold it to the writer. This view shows beyond a doubt that the building was whitewashed at the time. It also shows the interesting "swirl" of the shingles on the hips of the roof and the dormers. The size and shape of the shutter hinges is clearly indicated. Unfortunately this hitherto unknown photograph did not show up until October 8, 1931, after the roof had been reshingled according to our plans. The first opportunity to correct the effect came with the Public Works program.

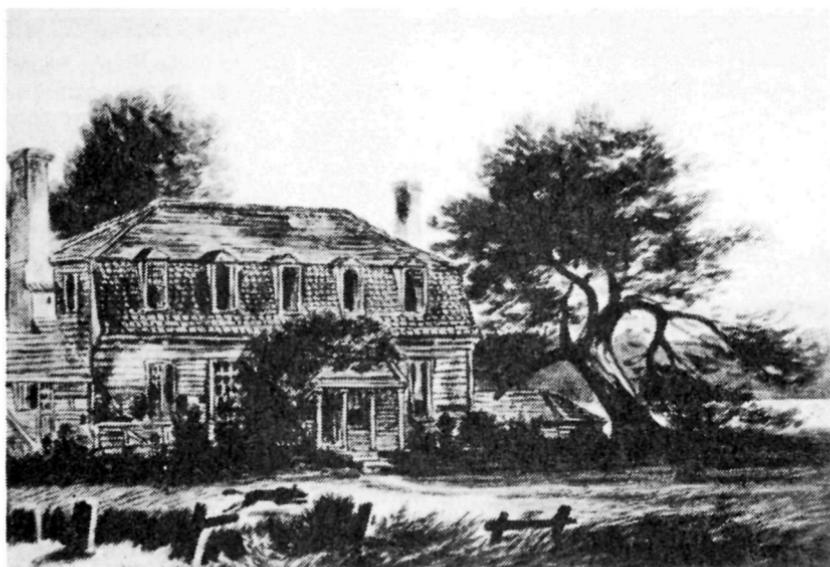
Plate No. 6: Photograph of the McIlvaine water color painted in 186–. This painting and the one following were secured through Mr. Charles Wall, Assistant Superintendent of Mt. Vernon. They are part of a set given to President Everett of Harvard. This photograph shows a tree very similar to the gnarled old catalpa just west of the House. Just beyond is an unidentified outbuilding, possibly an ice house covering a depression in the earth which has existed for years. The desolate appearance of the building indicates (as does the Sankey water color, Plate No. 8) that the building stood in an abandoned state between the Civil War and the Centennial Celebration. Obtained through the Branch of Research and Education, Historical Division.

Two excellent watercolors by McIlvaine were painted in 186–, one showing the front (Plate No. 6) and one the rear (Plate No. 7) of the building. The next picture known of the Moore House is a watercolor made by a Mr. S. H. Sankey in 1874 (Plate No. 8). The building is shown at large size as viewed from the northwest. At the time the picture was painted, apparently no appreciable change had occurred in the condition of the building since Brady’s photograph was taken. The

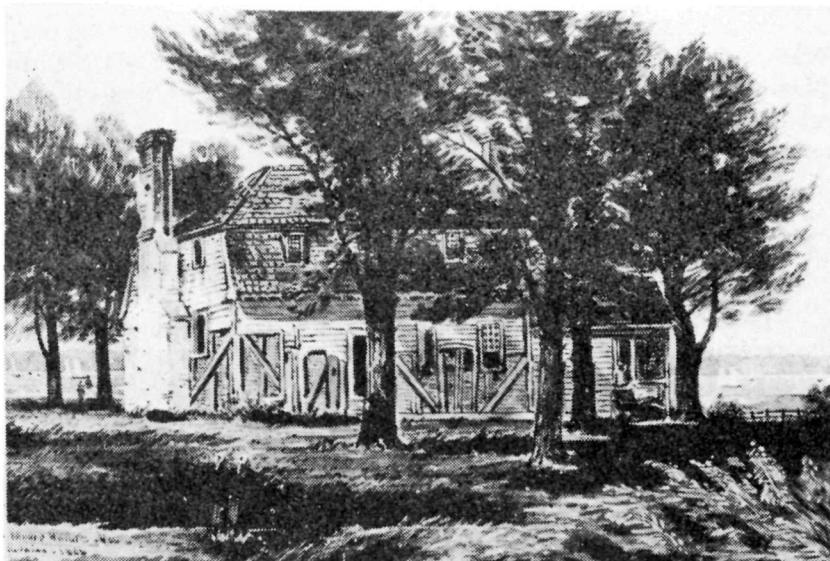
Plate No. 7: The second McIlvaine water color shows the rear of the House. A first glance at the original suggested red brick nogging between the framing members. Since the examination of the structure revealed no evidences of this it seems more likely to assume that it is just lath and plaster. Obtained through the Branch of Research and Education, Historical Division.

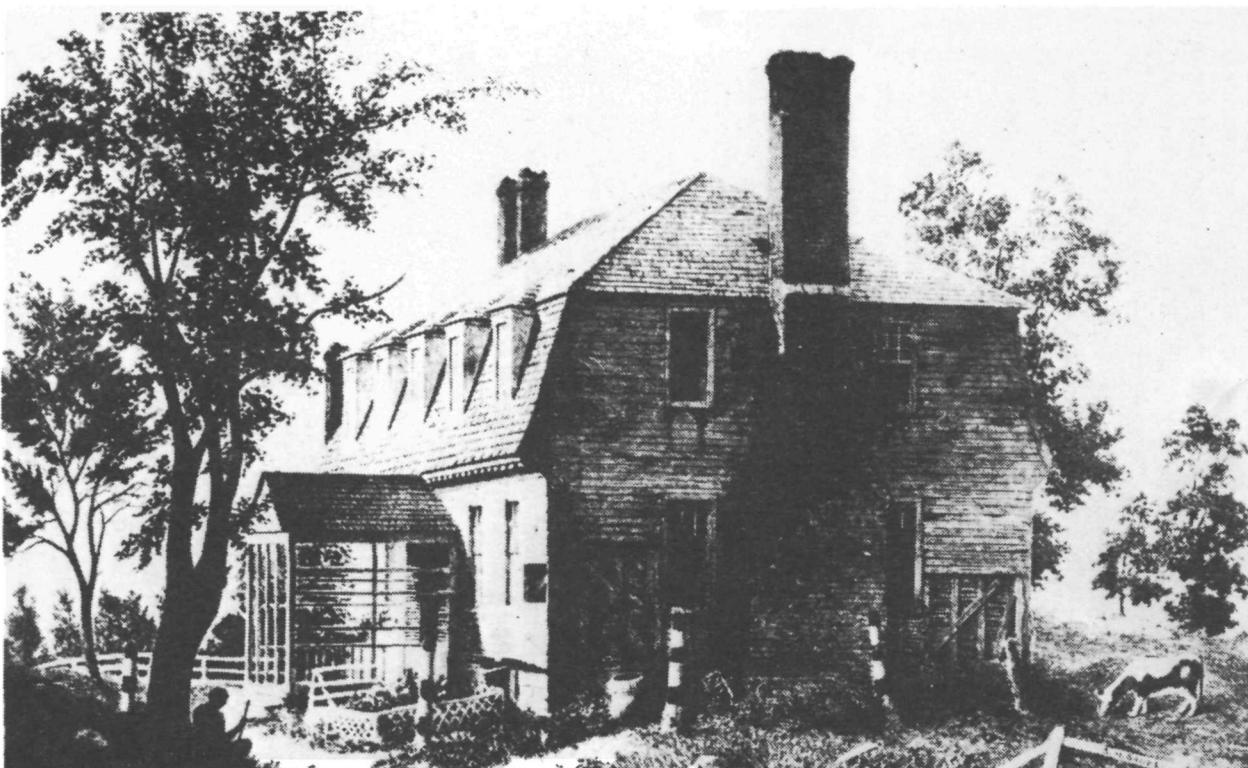
Plate No. 8: Photostat of the water color painted in 1874 by Mr. S. H. Sankey. The original is owned by Mr. Thomas J. Smith, 158 East 32nd Street, New York City. This was brought to our attention through Mr. Harold Shurtleff of the Williamsburg Restoration. The accuracy of certain details is remarkable. Compare, for instance, the muntins in the northwest first floor end window with those in the Brady photograph. The southwest second floor end window may have had a total of 18 lights as suggested. The thinness of the muntins shown in the Civil War photographs may indicate that they were replacements of the original 18th Century sash.

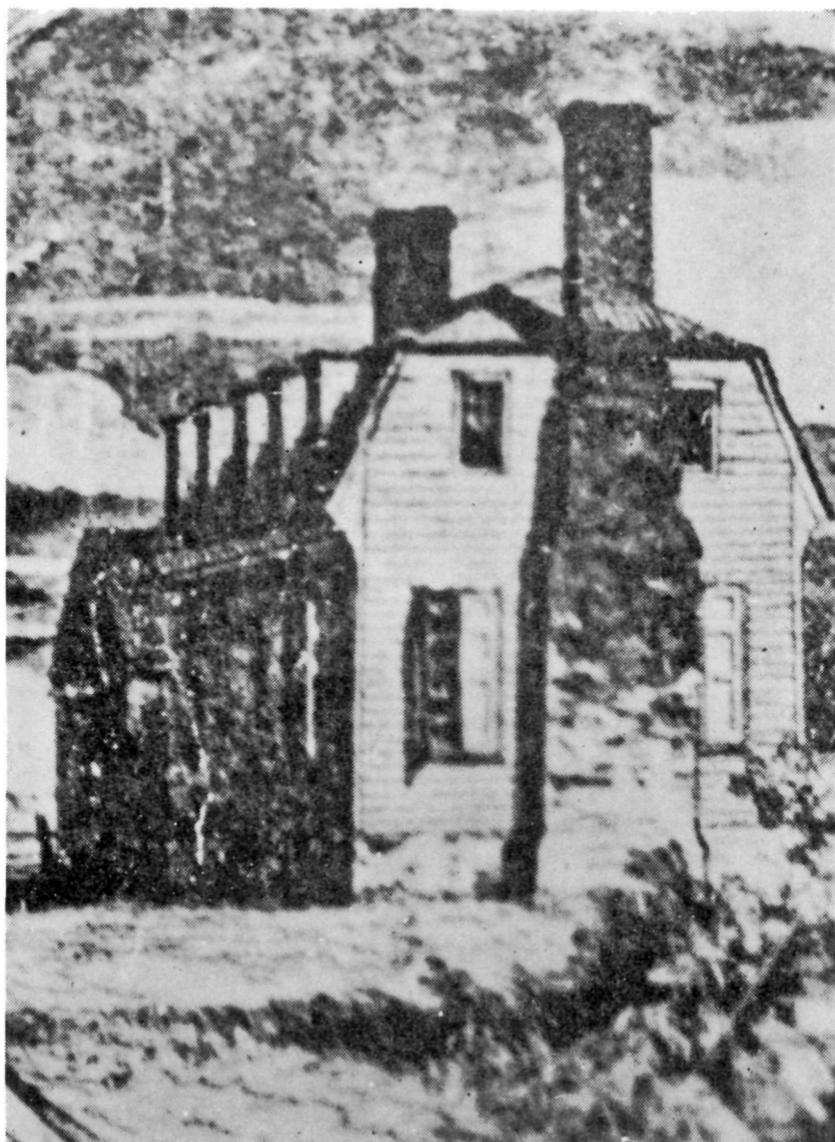
Plate No. 9: Drawing of the Moore House from a group including views of Williamsburg. These were mounted on a small sheet of cardboard said to have been the cover of a Yorktown Centennial program. It was loaned by Mrs. Catharine Shield. This view from the northwest shows solid panel shutters, and if these were not supplied from the artist's imagination, the sketch must have been drawn prior to the Civil War photographs. The building shown behind has not been identified. It may be the same one that appears in the Brady photograph.

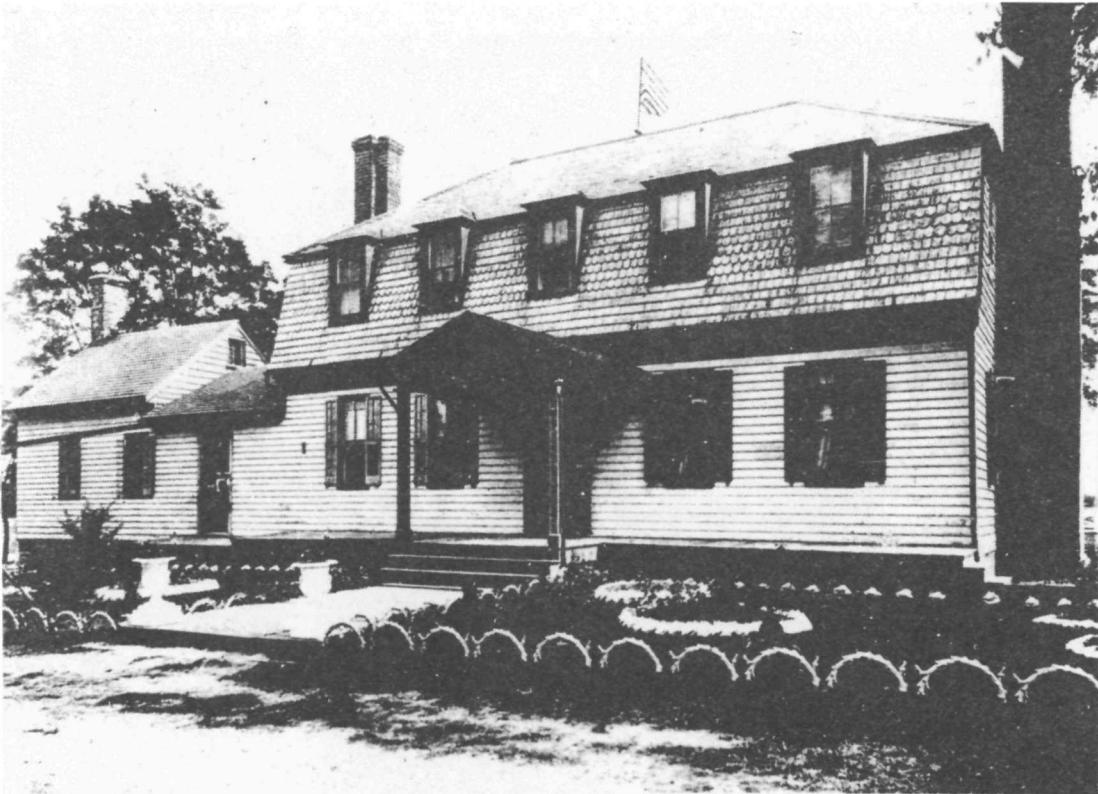
Plate No. 10: A photostat of a photograph inlaid between pages 22 and 23 in "A History of the Monument at Yorktown, erected by the United States Government to commemorate the close of the Revolutionary War, at Yorktown, October 19, 1781", Philadelphia, 1896. This was taken probably on the occasion of the Centennial in 1881.

In 1881, preparatory to the Yorktown Centennial, the structure was "restored" in a typical 19th Century manner. A photograph (Plate No. 10) taken at that time, reveals the extent of the work. The freedom with which this was carried out may be surmised from a contemporary account (Appendix No. 3). Mr. Wade, who was one of the carpenters during the 1881 work, recalls that a man named Thomas Hill from Haddenfield, New Jersey, was the Foreman on the work which was done under the auspices of the Centennial Association and was financed largely by contributions from the North. He also recalls that there were no doors, window sash, or shutters in the house when they began work there. The balustrade and some of the treads of the stairway were missing at the time and none of the old outbuildings remained.

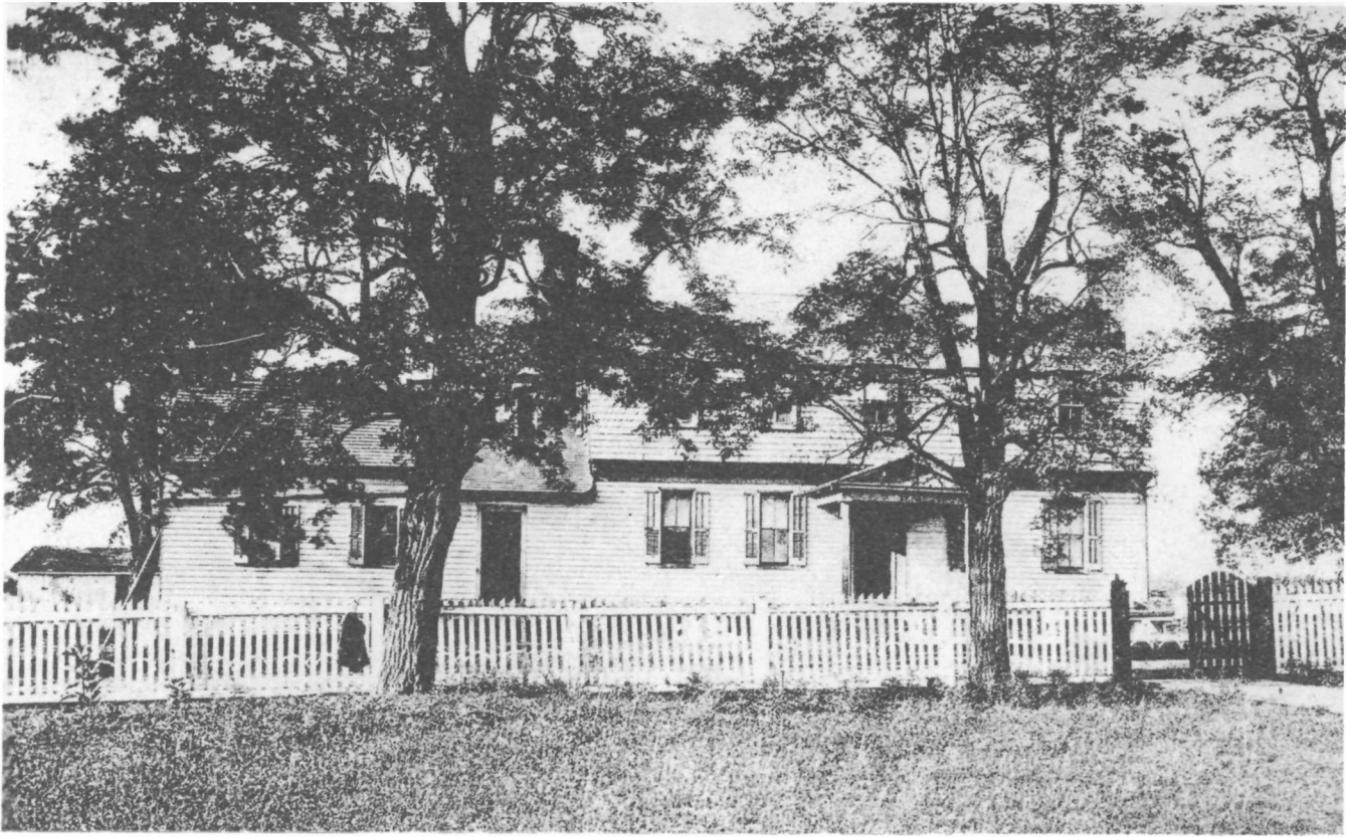
Plate No. 11: Photograph of the House (date unknown) some time after the Centennial, contributed to us by Mr. Walter Macomber of the Williamsburg Restoration. The cornices seem to be painted dark and it is believed that this is the olive green color found on the rear cornice when it was opened up in 1931.

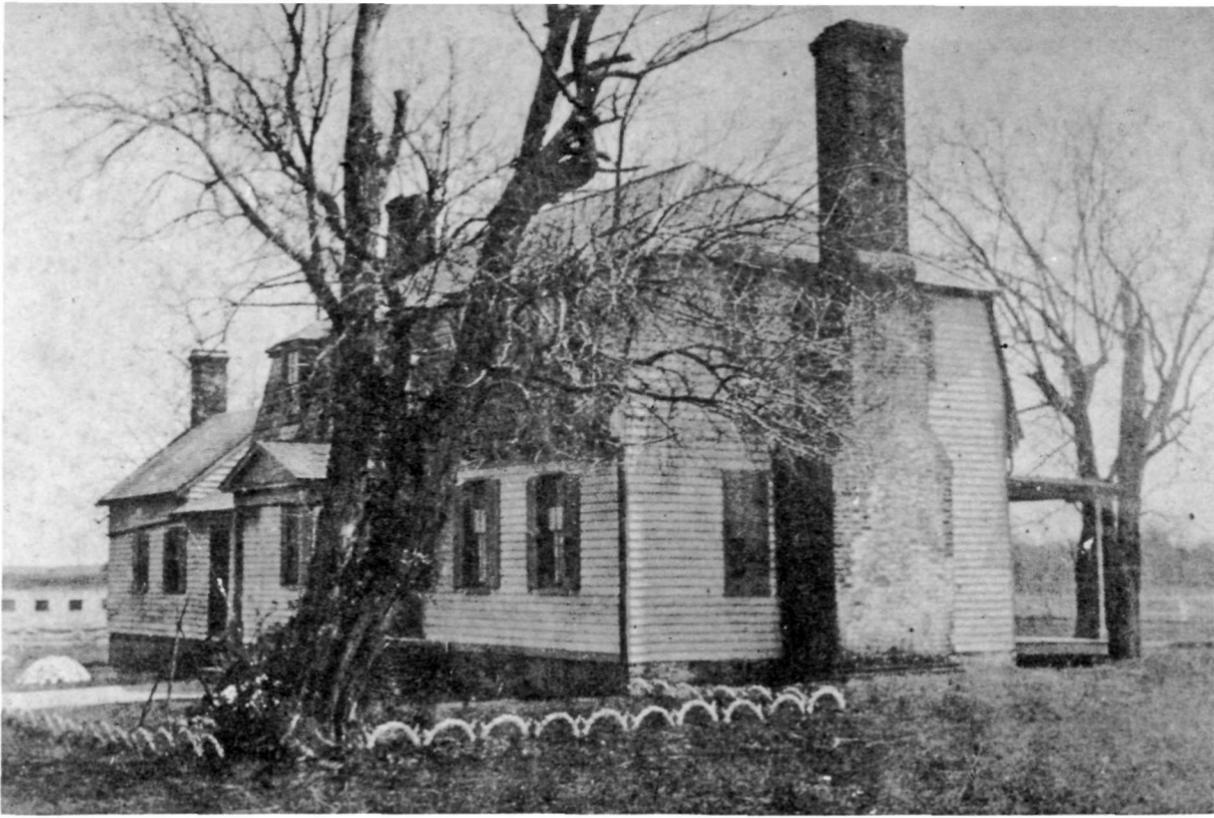
Plate No. 11-B: Photograph, somewhat enlarged, of a photographic print in the possession of Mr. Peyton Nelson of Williamsburg. Kindly loaned for reproduction by the owner. The exact date of this photograph is unknown. It seems to have been taken about the same time as 11-A. (Note the stacked rifles.)

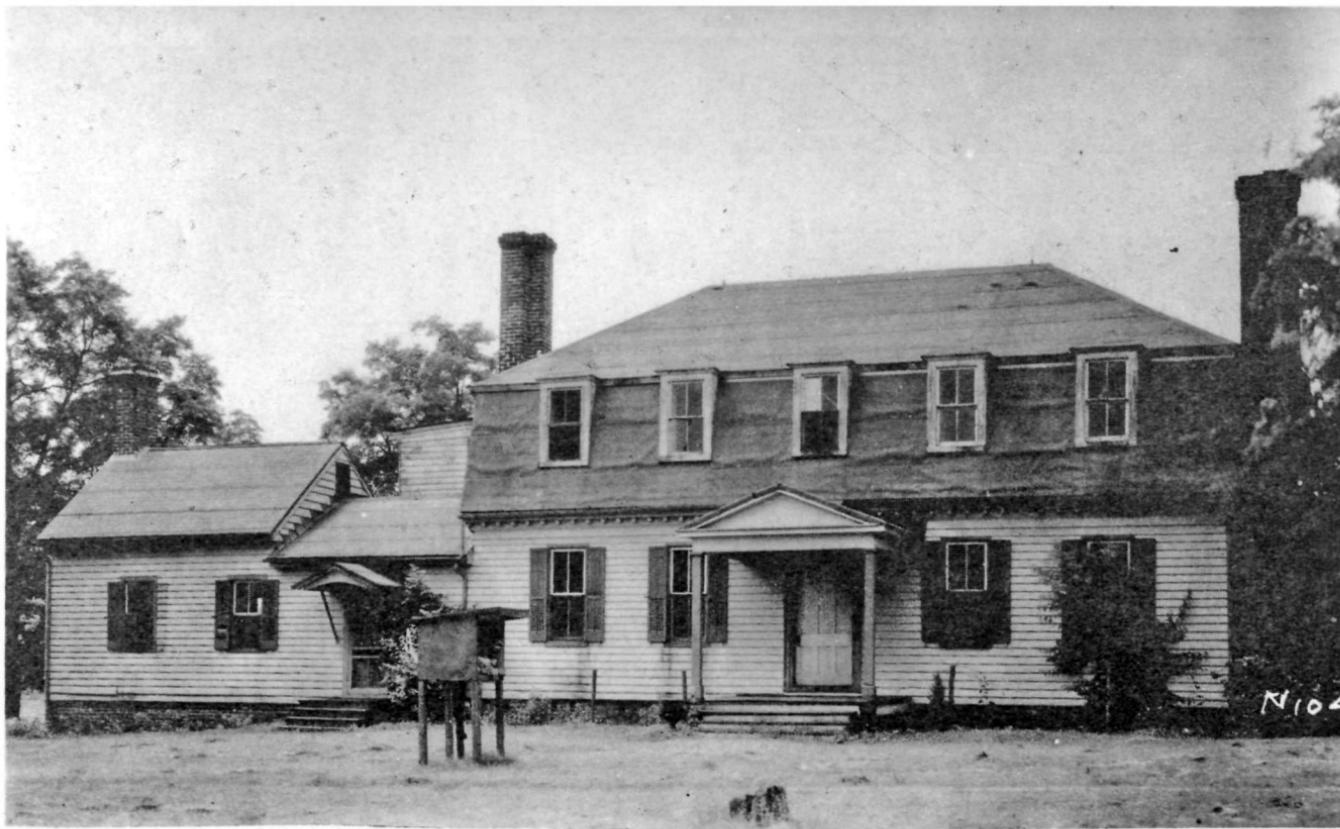
Plate No. 12: Front view of the House, July 1931, before the 1931 restoration work. Note the Victorian window sash, shutters, door and porch. The roll roofing was a protective measure supplied by the Williamsburg Holding Corporation. The hose connection, provided by some thoughtful agency, was connected with the Navy Mine Depot water supply.

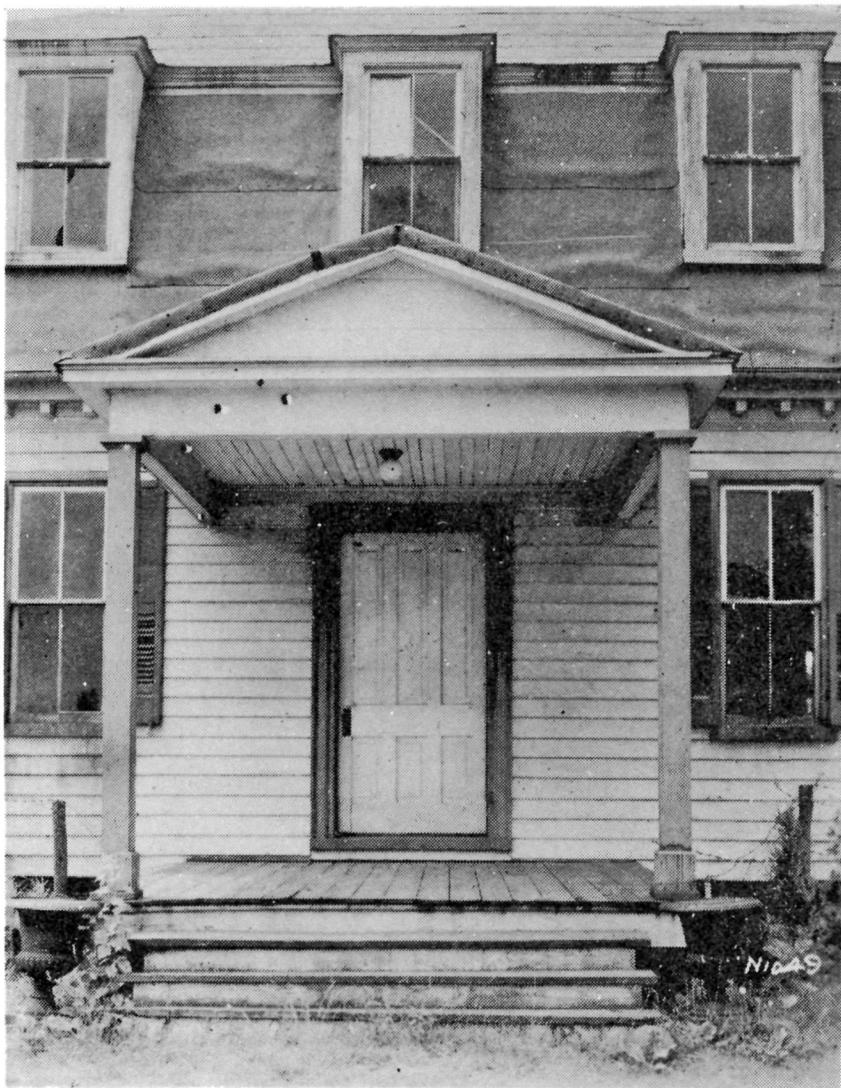
Plate No. 13: Porch detail, July 1931. This we believe to have been at least the third porch on this house. It was subsequently removed.

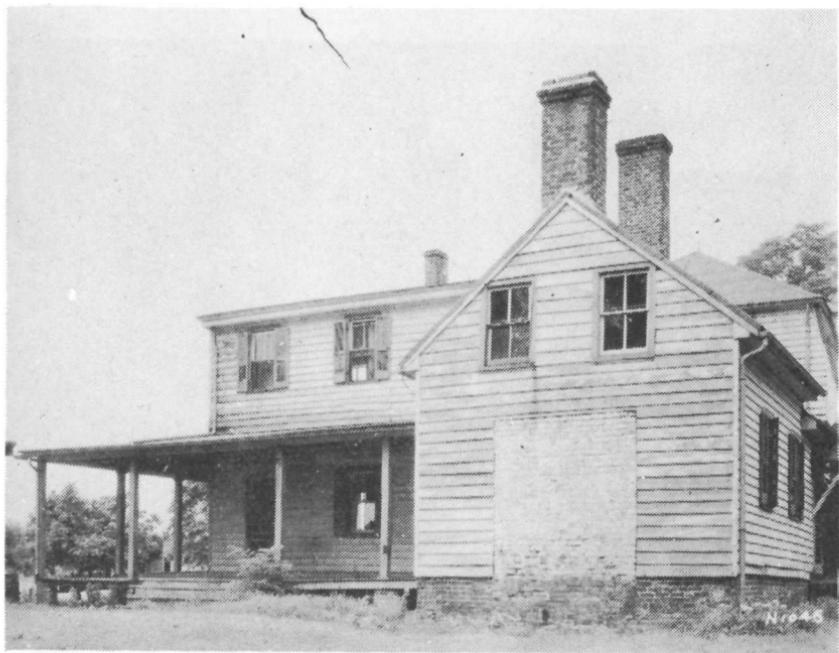
Plate No. 14: East wing detail, July 1931. This wing is thought to have been added somewhere between 1800 and the Civil War. Its foundations are of common bond, whereas those of the main structure are of Flemish.

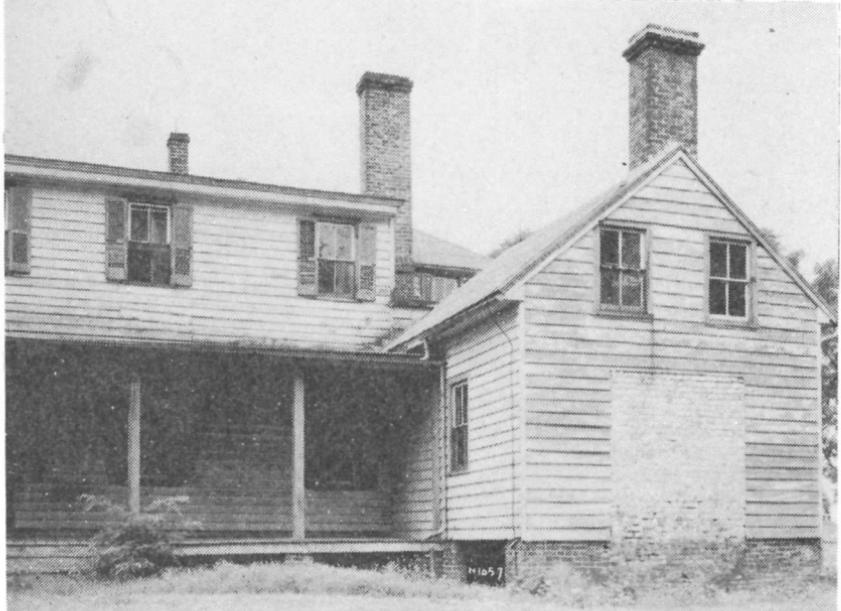
Plate No. 15: Details of East and Rear Wings, July 1931. Certain doorways had to be cut in the original framing of the house to allow access to the wings.

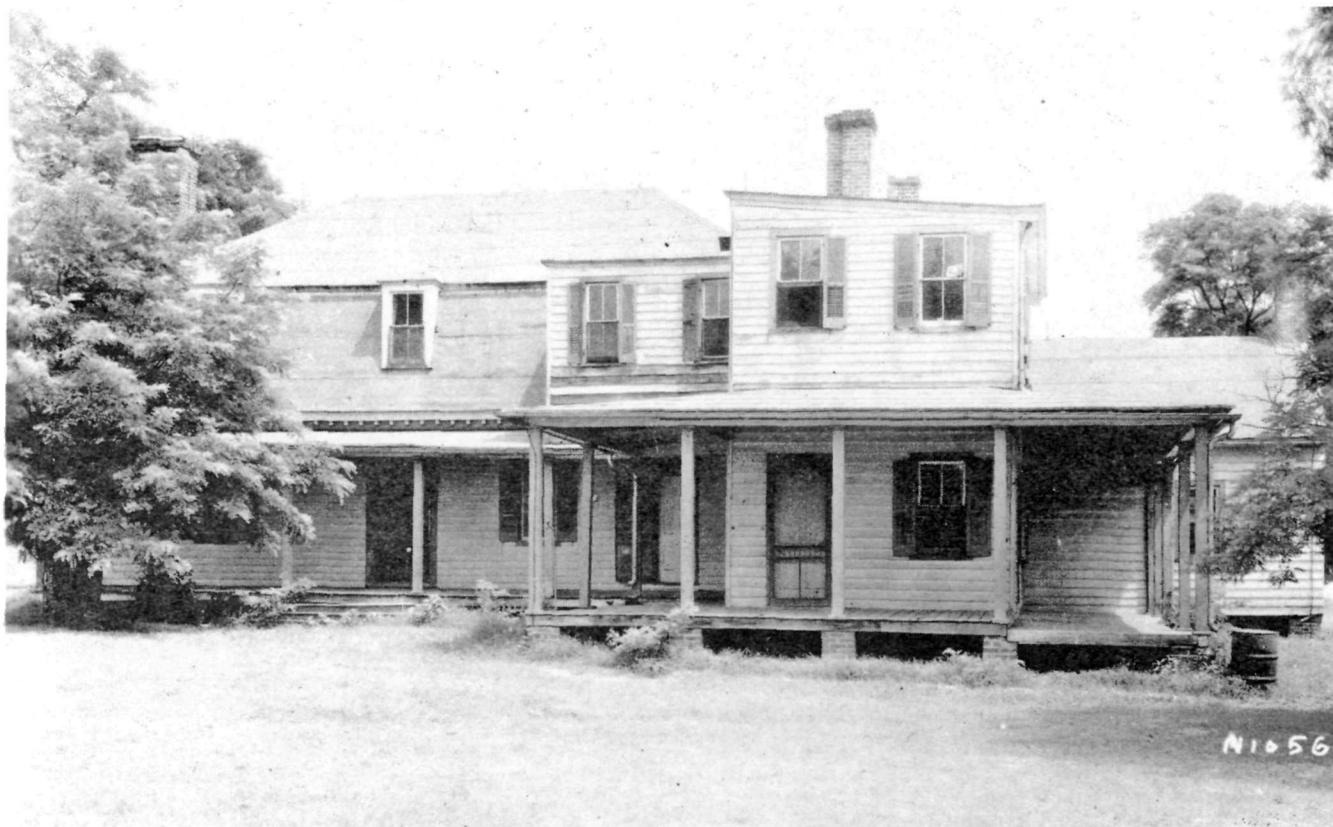
Plate No. 16: Rear View, July 1931. The rear wing was built at two different times: the lower floor was added for "the entertainment of distinguished visitors" in 1881, and the upper floor by John Cruikshank about 1886. A third dormer was torn away during the Cruikshank additions, but part of the framing remained in the walls.

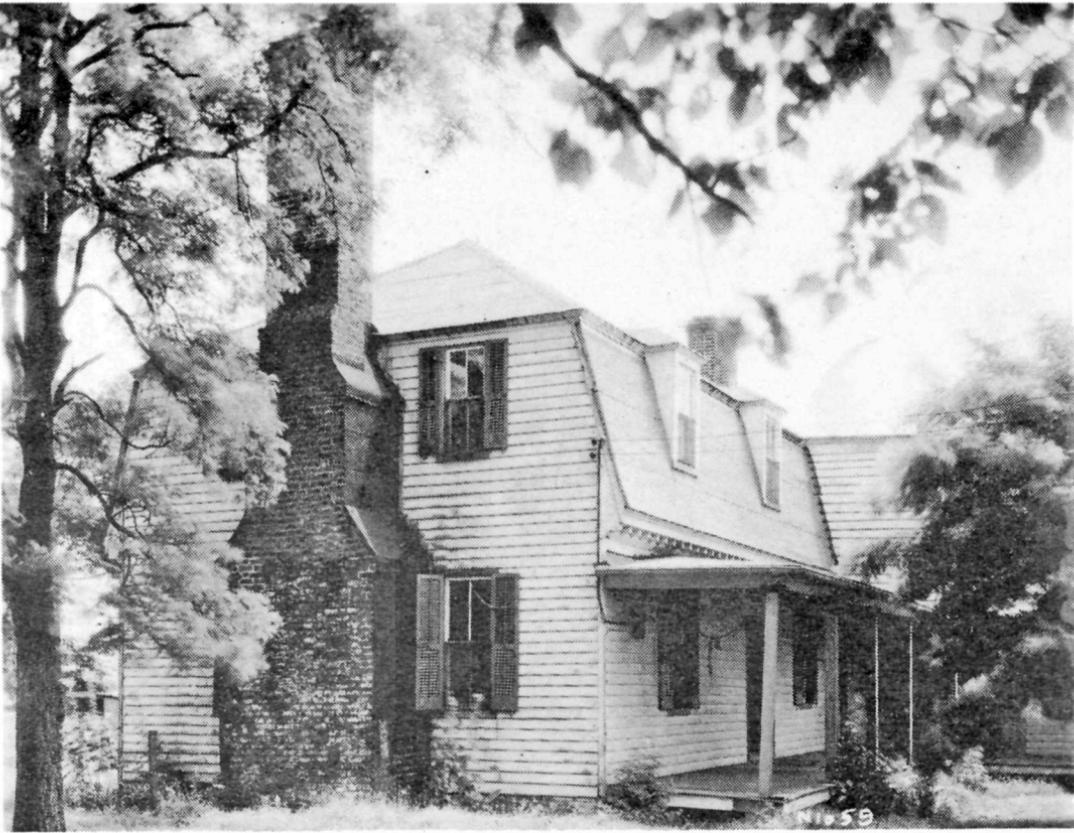
Plate No. 17: Southwest corner detail, July 1931. The rear cornice was largely buried under the Victorian porch roof. Original modillion blocks, when removed were found to be of poplar fixed in place with wrought nails.

2. The original cornice under the rear porch roof. Some of the poplar modillions had been replaced.

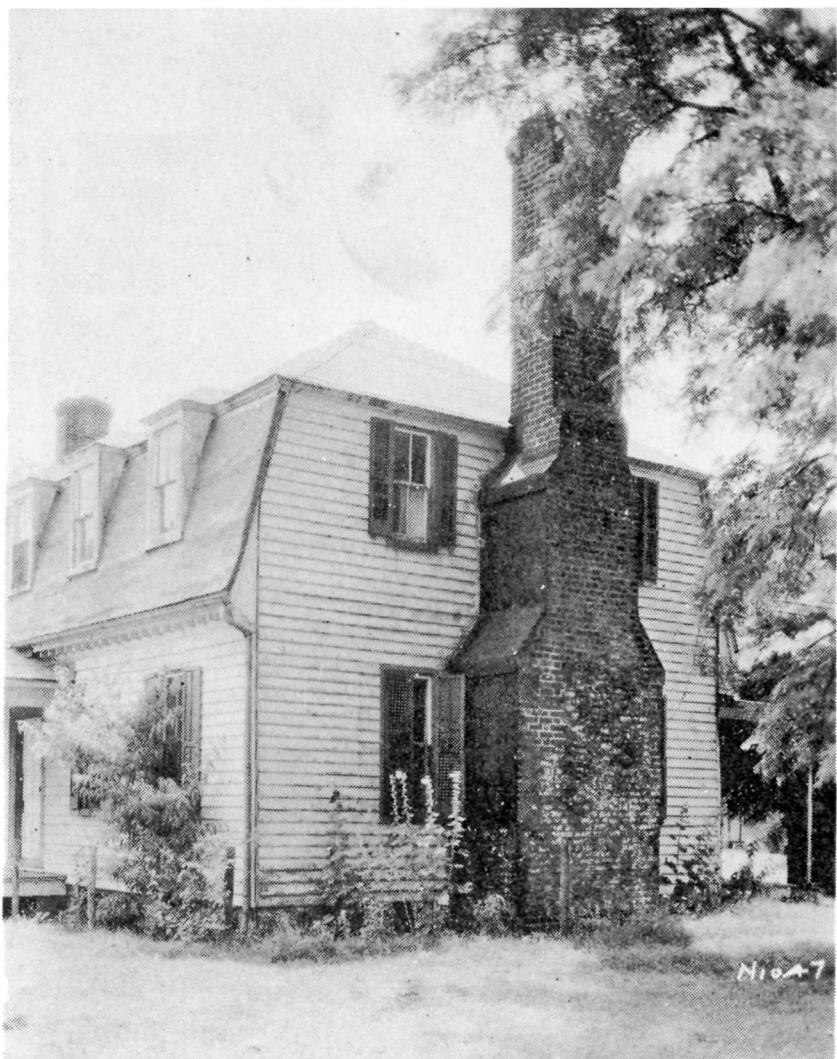
Plate No. 18: Northwest corner detail, July 1931. The tin flashing, patchy mortar and whitewash were subsequently removed from the brickwork.

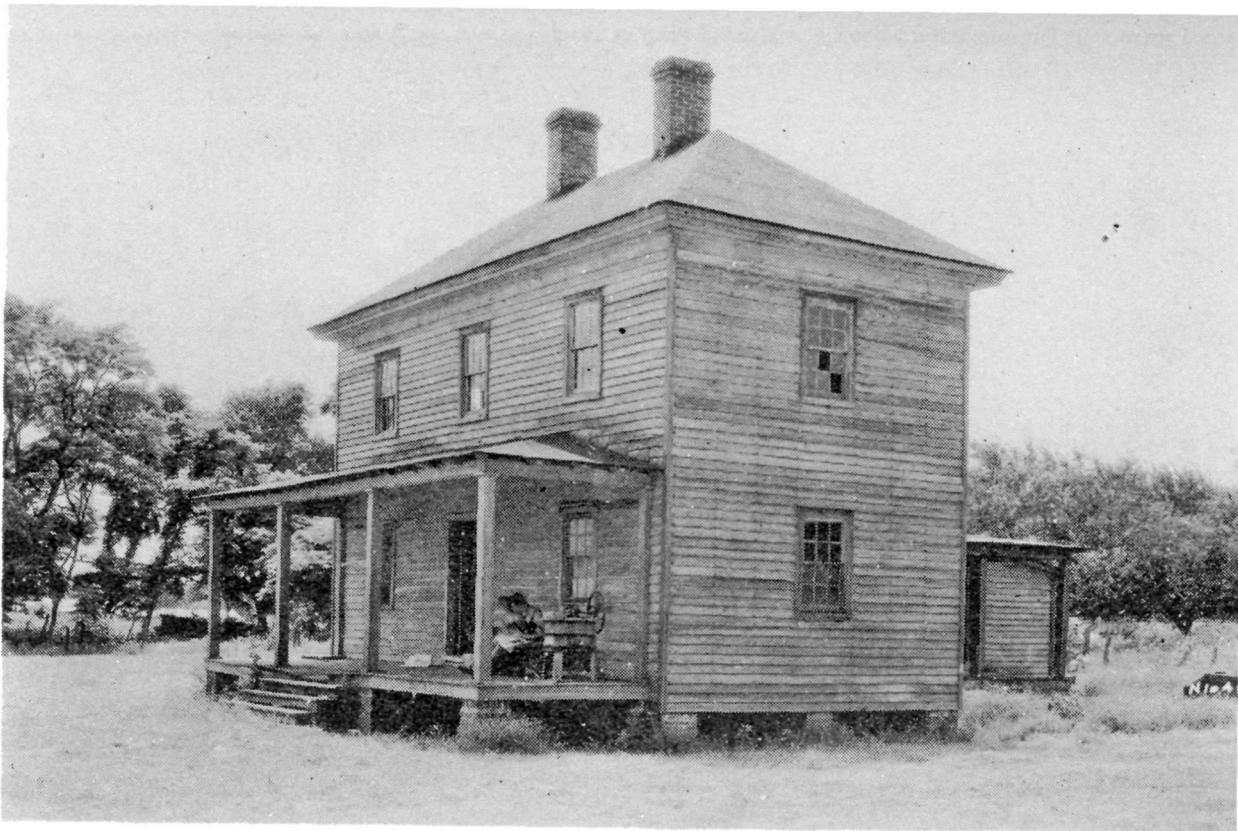
Plate No. 19: Largest of the outbuildings found on the property. Demolished just after photograph was taken in July 1931.

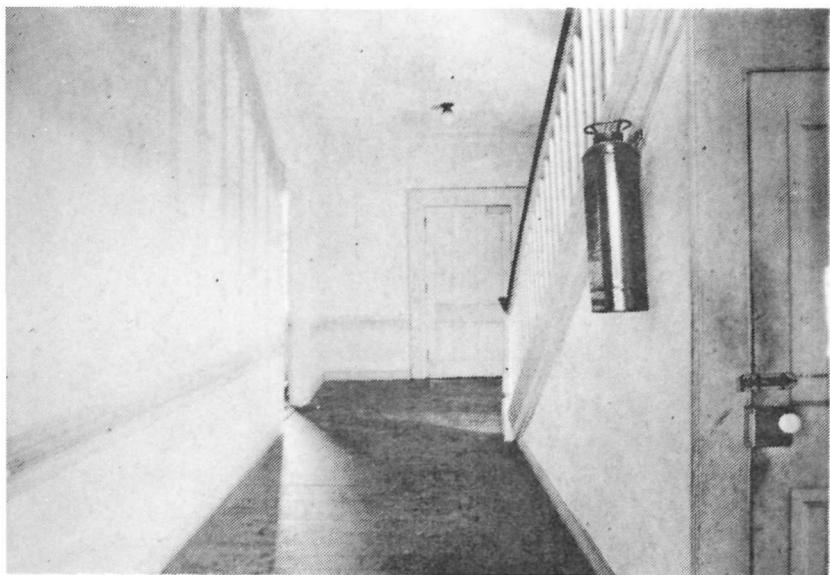
Plate No. 21: Central hall, July 1931. Note modern door and lighting fixture. Both were removed in 1931 and 1932.

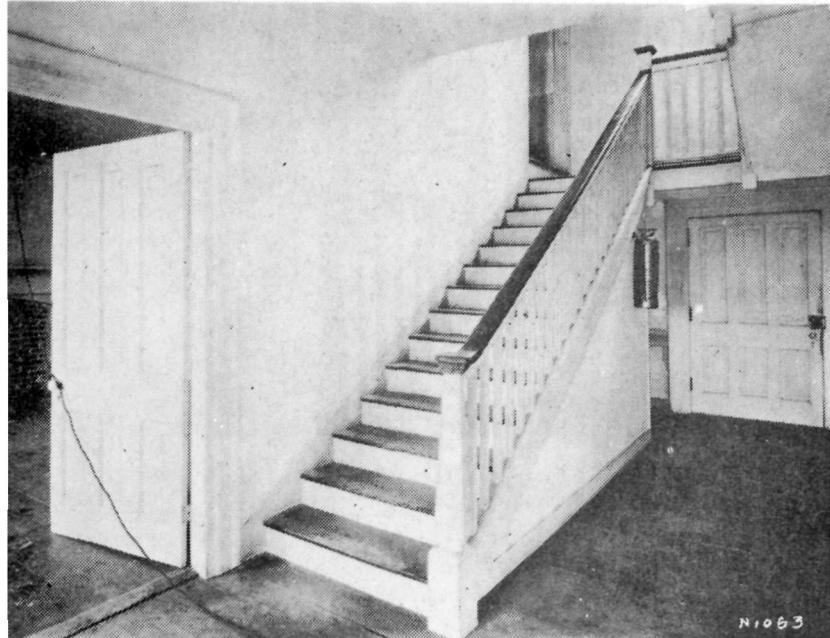
Plate No. 22: Main stairway, July 1931. The typical 19th Century balustrade was removed in 1933-34.

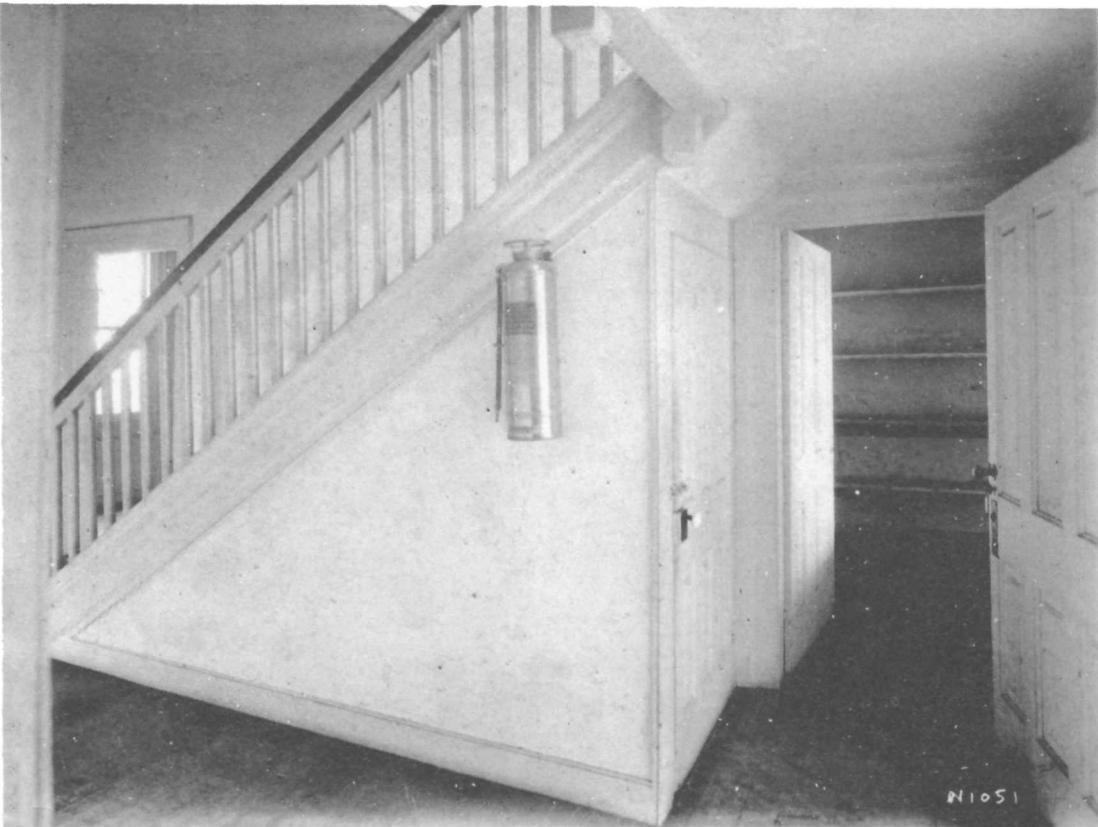
Plate No. 23: Door to cellar stairs, July 1931. The stairway had been cut through early floor joists showing that this space had been a closet originally. The room beyond seems to have been a closet for some time. Its partition walls are of uncertain date.

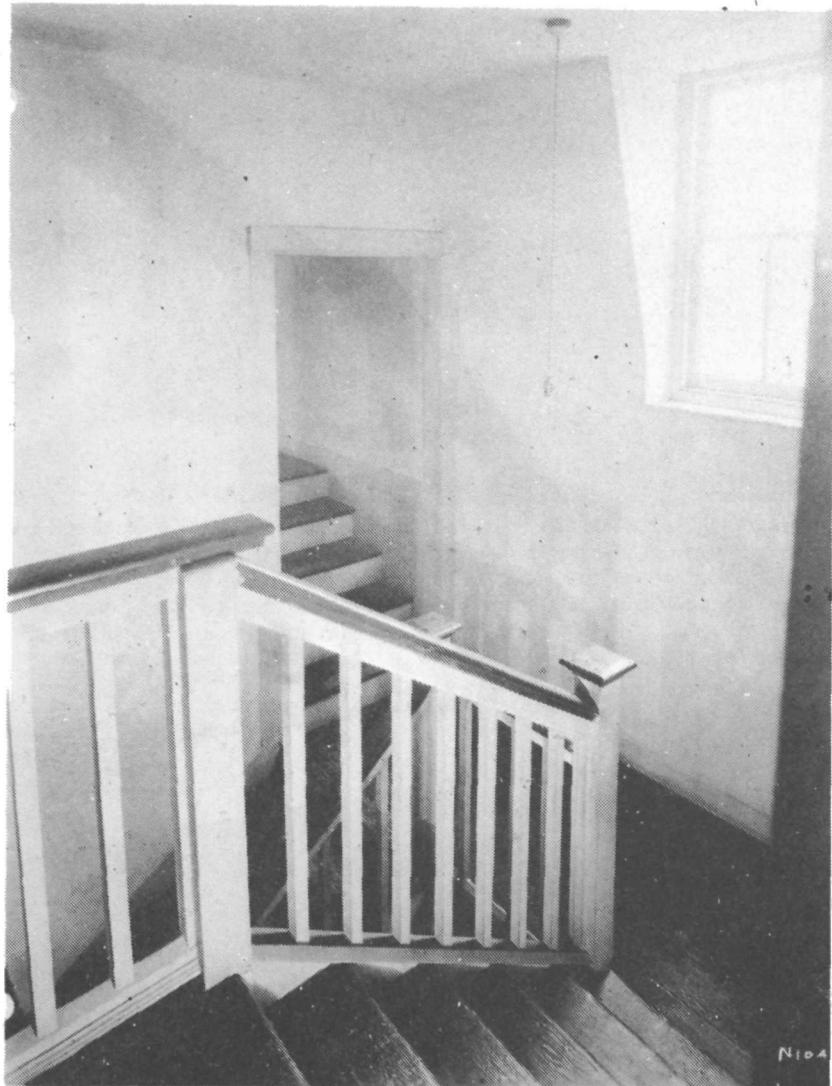
Plate No. 24: Stairway detail, July 1931. The left branch of the stairway was found to be of modern construction cut through old joists and was removed and sealed up in 1932.
