# The Moore House

**The Site of the Surrender—Yorktown**

A National Park Service Historic Structures Report

Charles E. Peterson

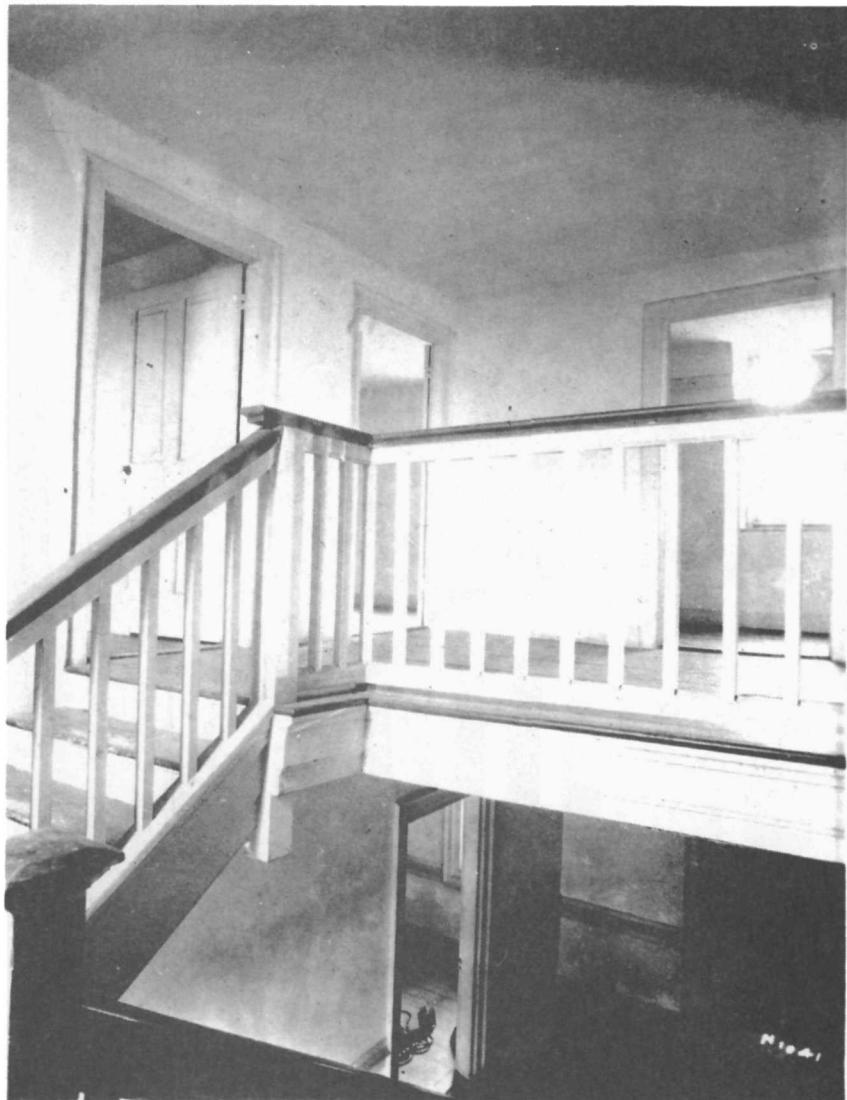
Plate No. 25: Stairway detail, July 1931. The modern stringer, rail, and balusters continued across the wall. They were thought to have been 1881 construction.

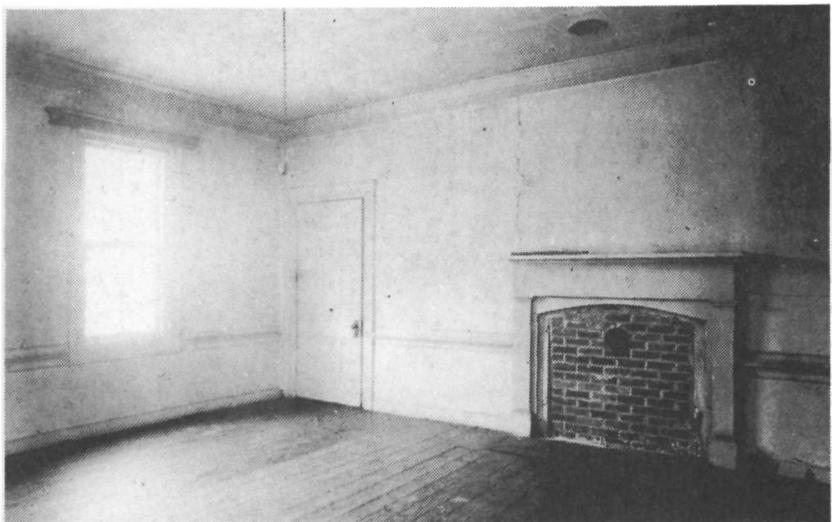
Plate No. 26: East Room view, July 1931. The mantel was obviously Victorian and replaced in 1932. The corner door led into the East wing. The cornice was replaced by one of simple Colonial design in 1933-4. On the back of one of the first floor mantels was found the pencil notation "Col. Peyton, Yorktown." This man was probably an officer in charge during the 1881 work.

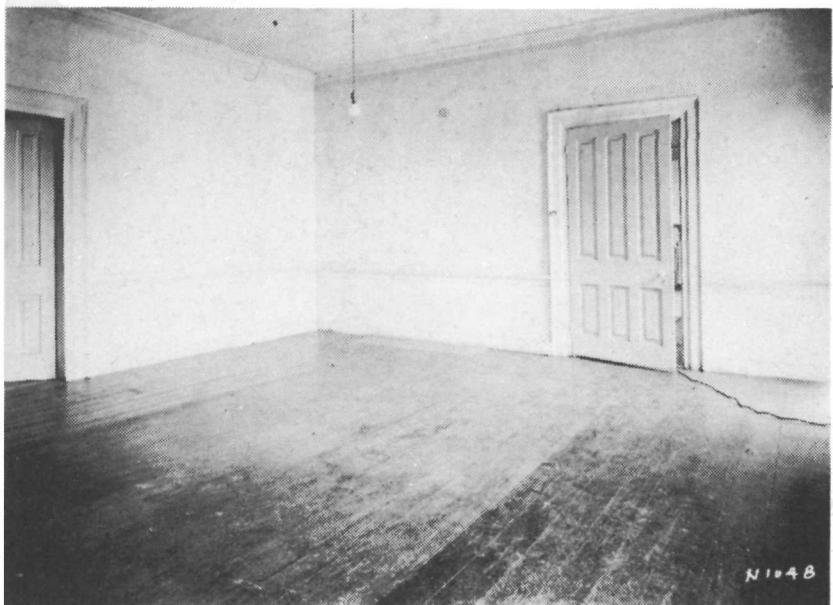
Plate No. 27: East Room view, July 1931. The interior doors throughout the house with their Victorian panels, mortise locks, and china knobs were replaced in 1932.

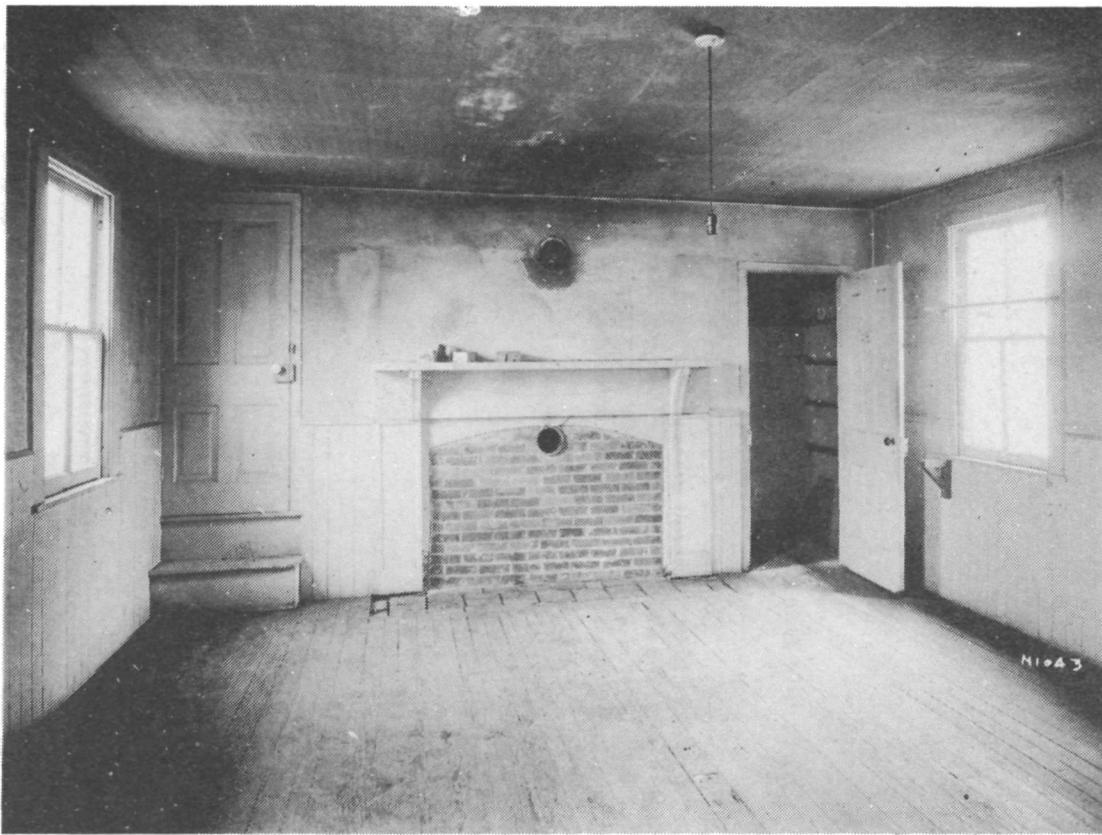
Plate No. 28: First floor room in the East wing, July 1931. Just before the removal of the entire wing.

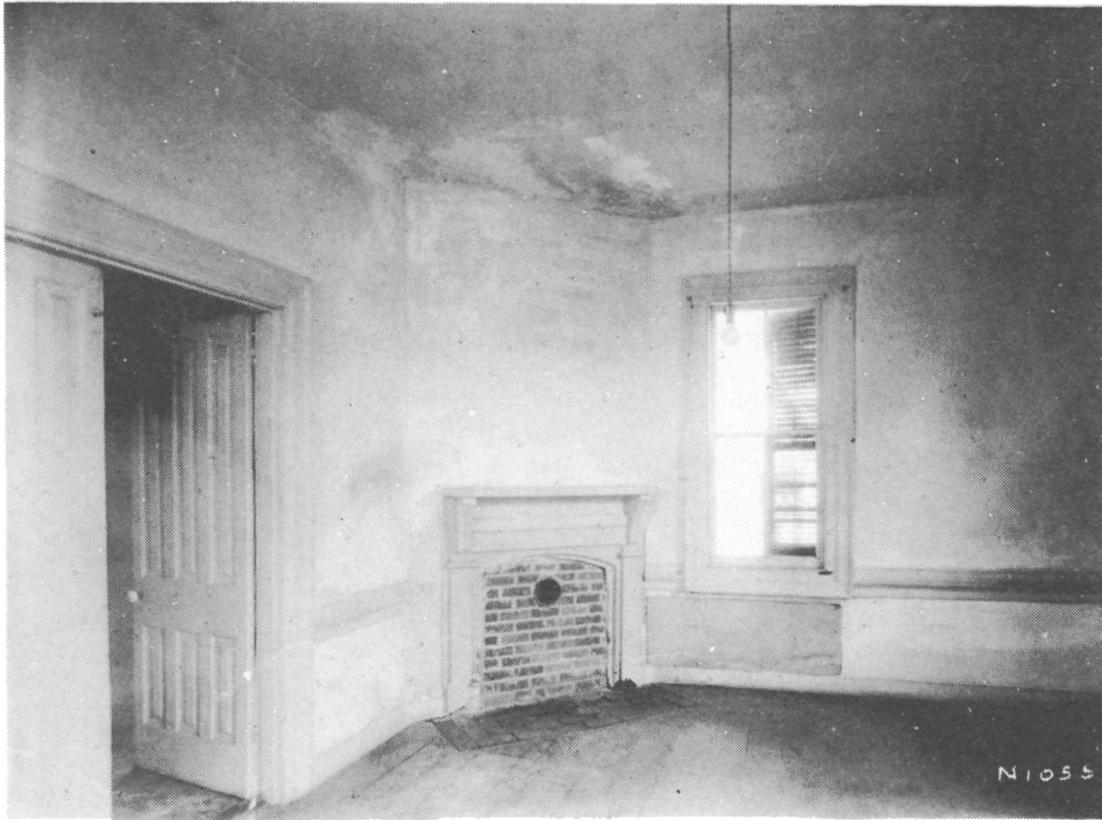
Plate No. 29: The "Surrender Room" fireplace, July 1931. The double door on the left was replaced by a single door in 1932 in accordance with the evidence in the framing and local precedent.

The framing of the double door leading from the "Surrender Room" to the rear room was investigated and it was found that a door of typical size, probably the original, had once existed there. This opening was reframed and new doors hung throughout the house, replacing those apparently installed in 1881. The doors in the interesting house of Mrs. Conway Shield of Yorktown were studied for precedent.

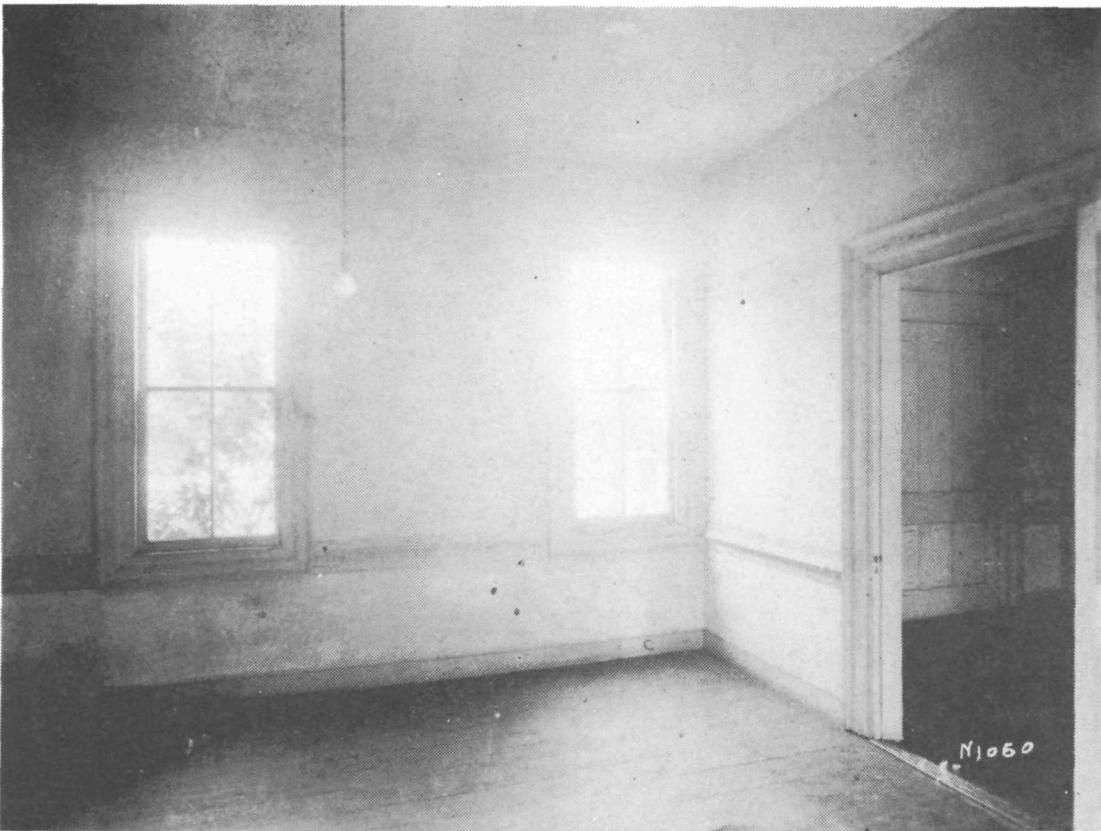
Plate No. 30: The "Surrender Room" in July 1931. The use of this room in Colonial times is not known. The writer suspects that the Committee of officers preparing the terms would have looked for a dining room table.

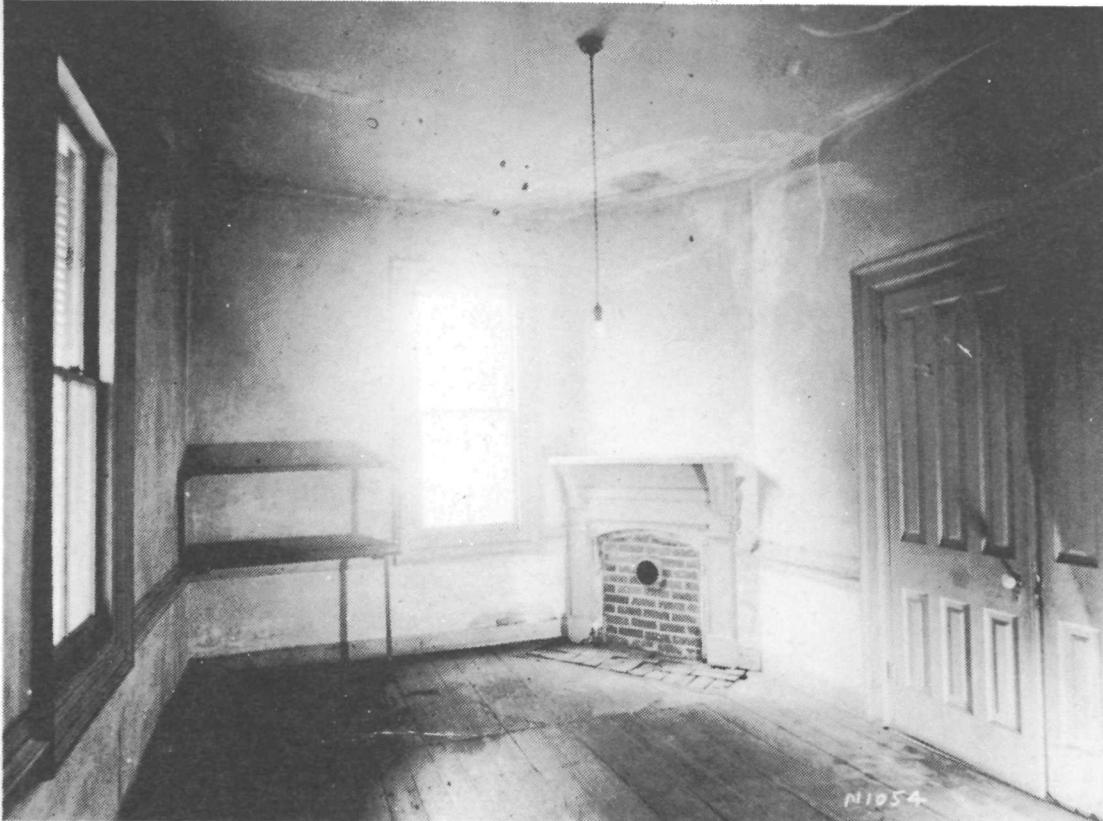
Plate No. 31: The room behind the "Surrender Room", July 1931. The interior door and window trim throughout the house are typical 18th Century in design and it is not known how much was replaced and added in 1881.

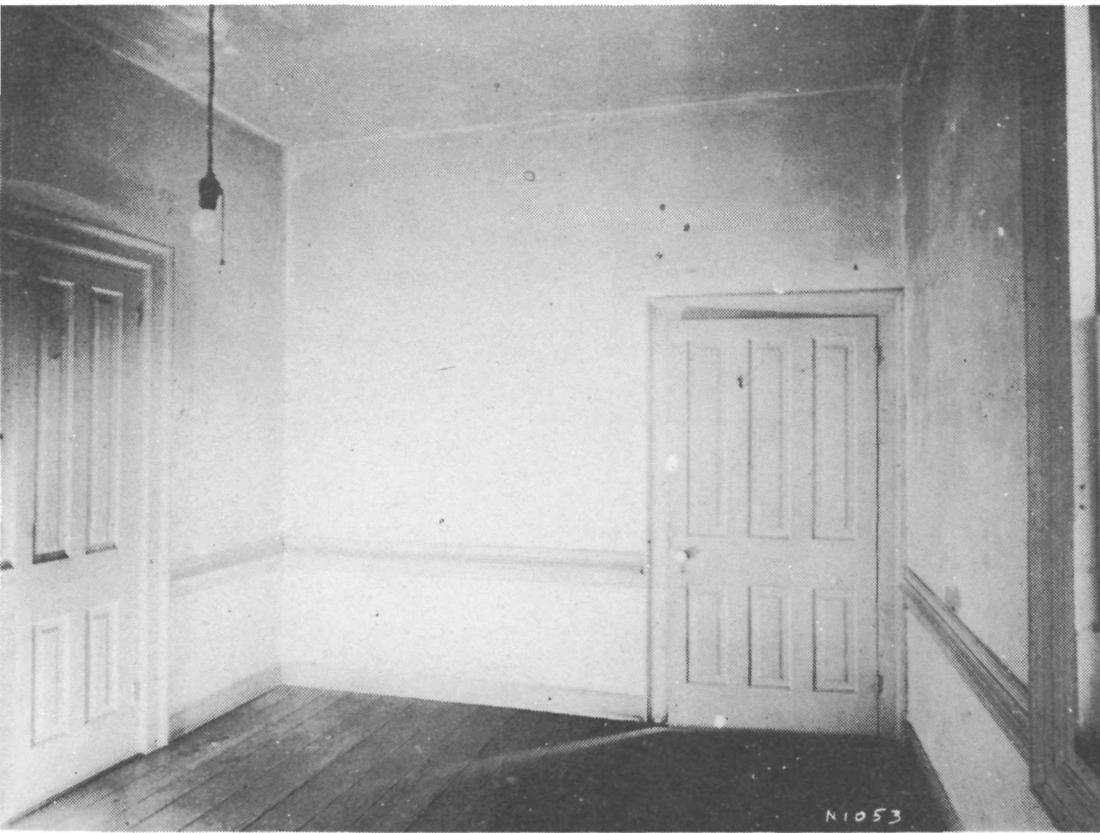
Plate No. 32: Room behind the "Surrender Room" July 1931. The chair rail shown in the picture ran throughout the three principal rooms of the first floor. The chair rail found in the building was not a typical Colonial detail and its age is uncertain.

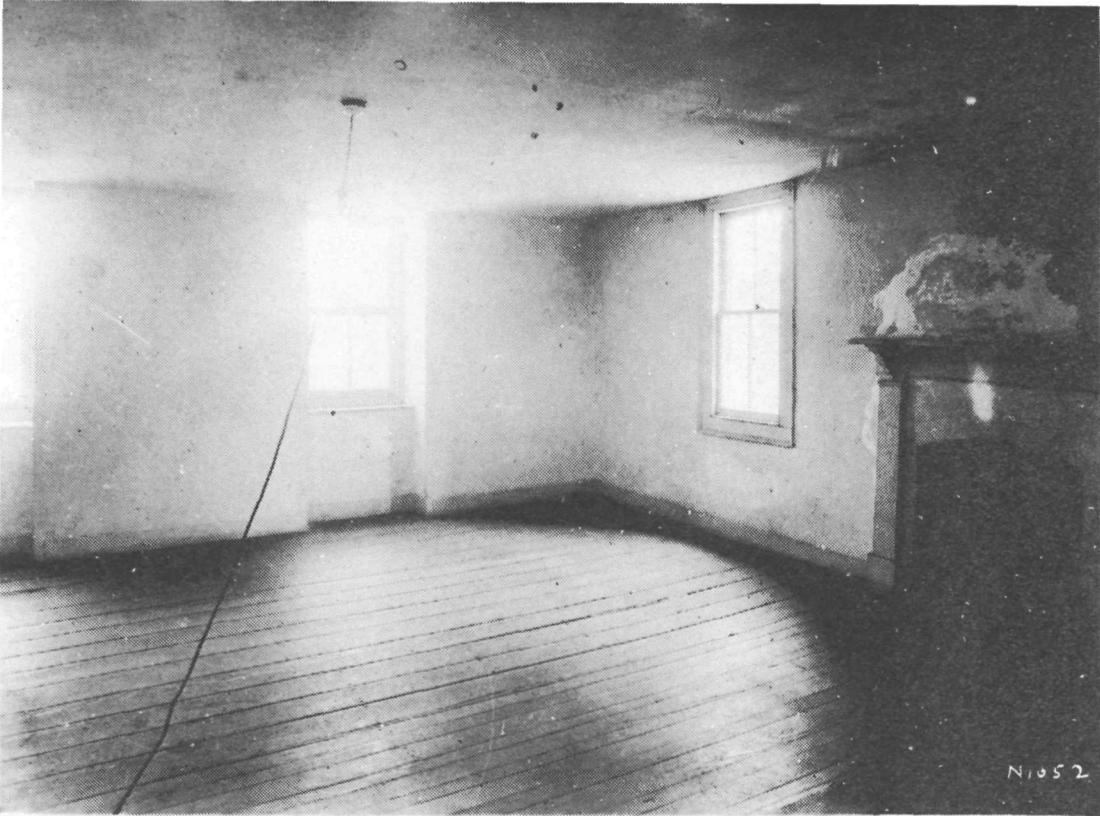
Plate No. 33: East Room, second floor, July 1931. All of the fireplaces were bricked up when the United States acquired the House. When the openings were cleared of the brick, detailed drawings were made of each condition in order to better approximate the proper size and shape of each.

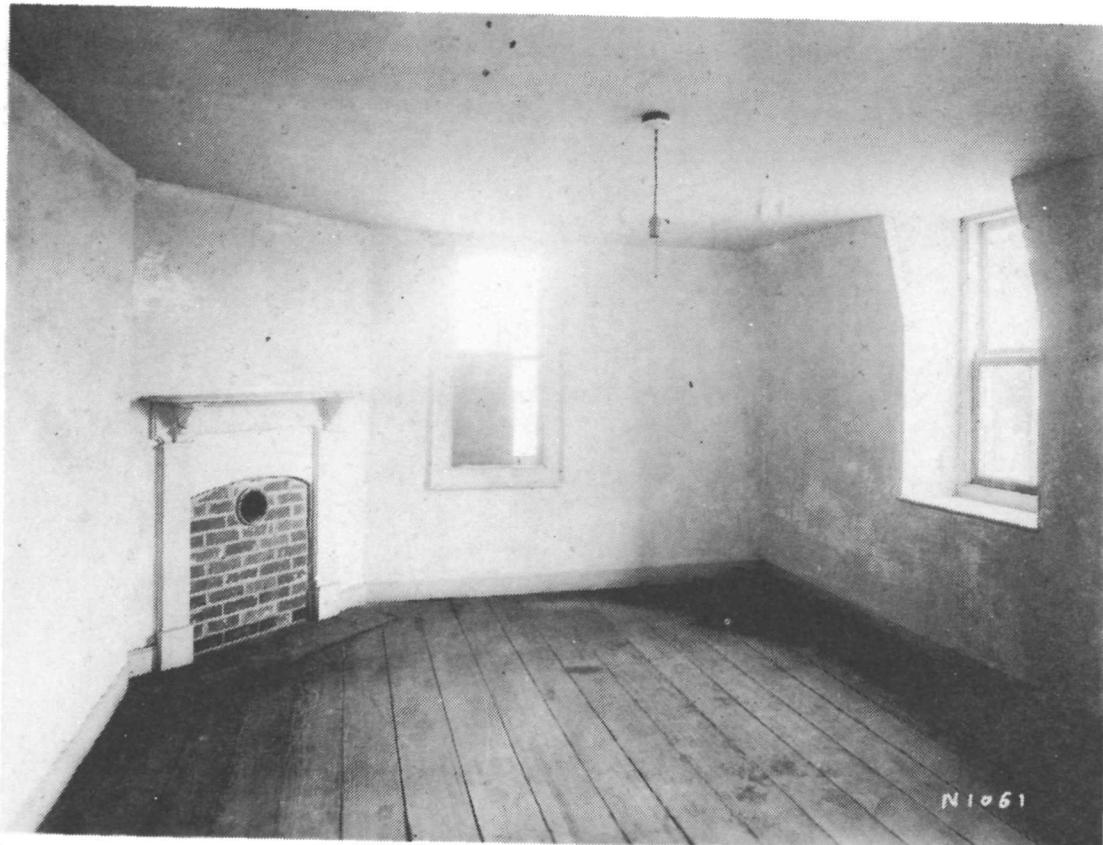
Plate No. 34: Northwest room, second floor, 1931. This room shares the end chimney with the room behind. Diagonal fireplaces like this are a common arrangement in early Virginia buildings.

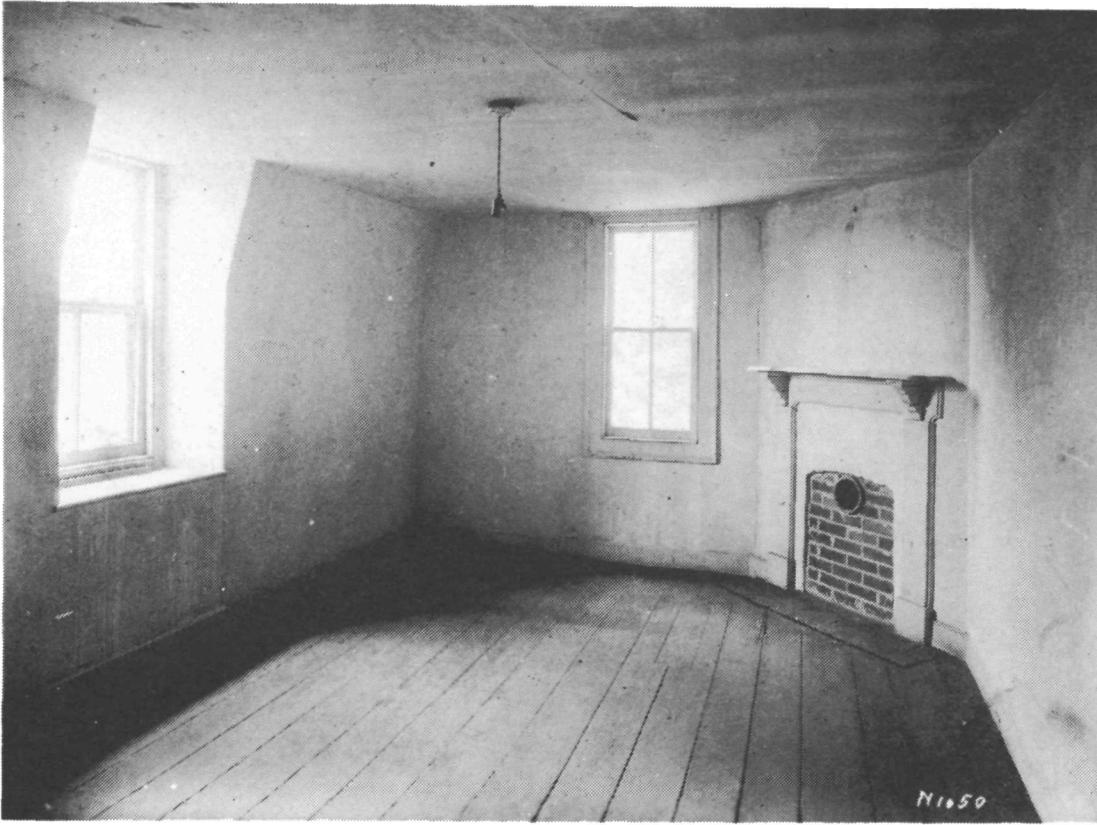
Plate No. 35: Southwest room, second floor, July 1931. While much of the original flooring remained in the building, it was patched with modern boards in many places. Antique flooring was used to correct the effect during the 1933-4 work.

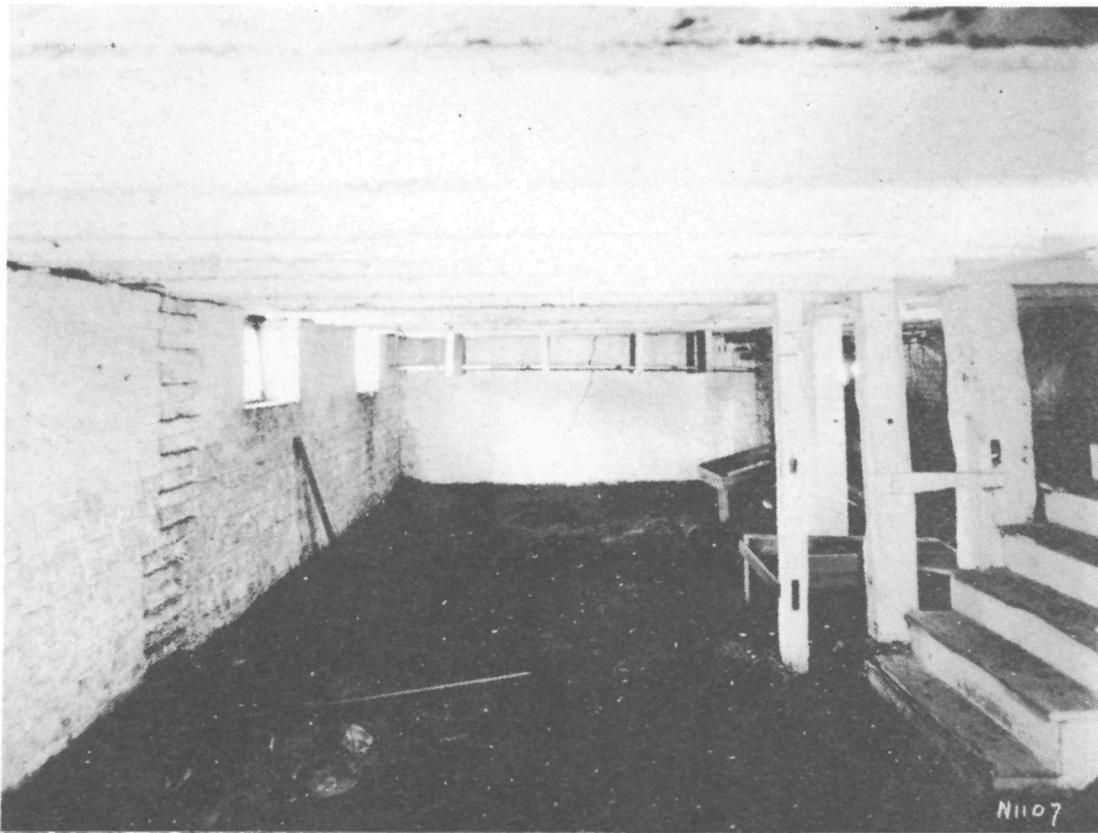
Plate No. 36: View looking east in the cellar. July, 1931. The stair shown on the right was modern and has been removed. Access was originally had through an outside entrance which has been restored.

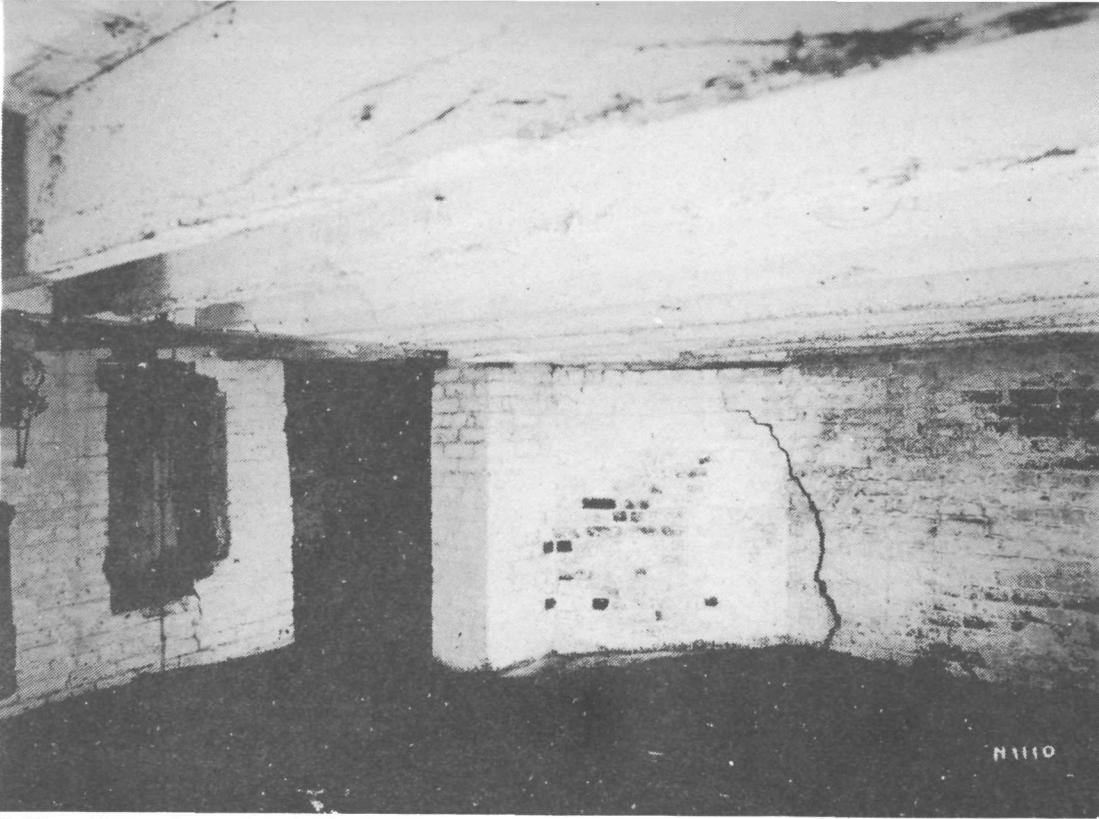
Plate No. 37: West chimney foundation, July 1935. The brick partitions on the left were modern and were removed after the first floor framing was repaired.

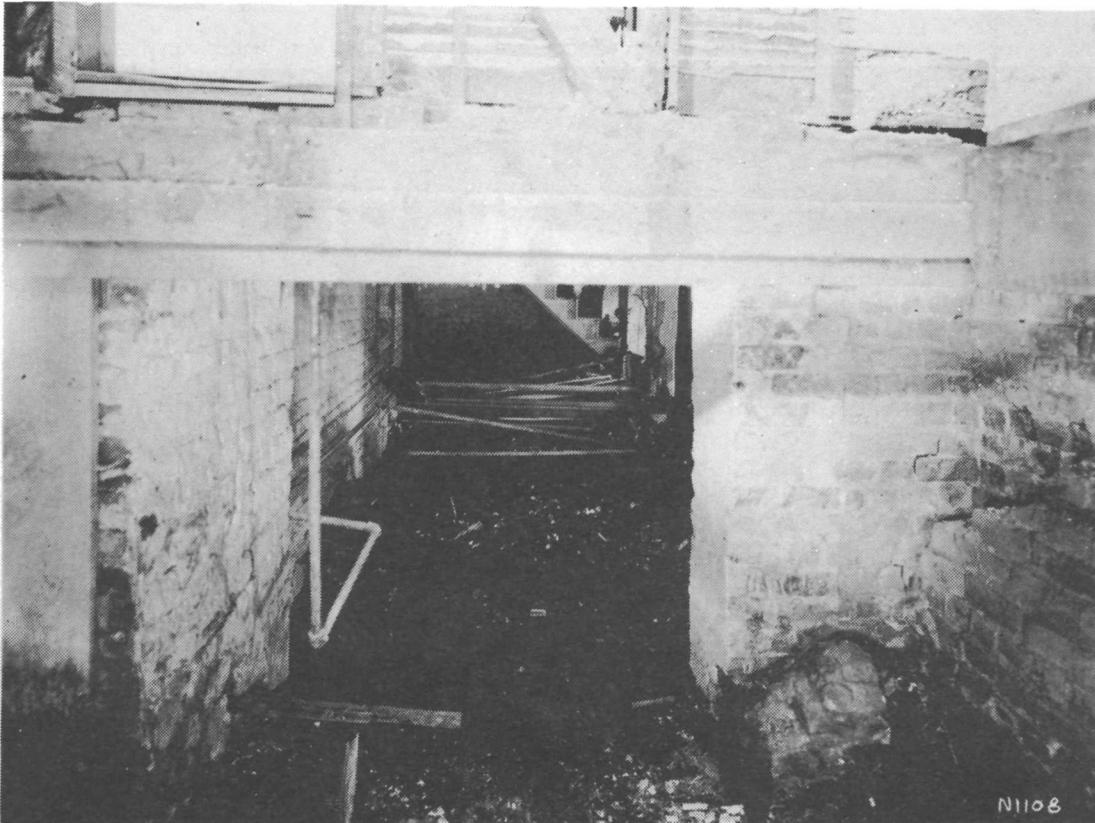
Plate No. 38: Remains of the original cellar entrance, July, 1931. On the right side can be seen the broken surfaces where the sidewall was torn away. On the left the wall had been largely rebuilt to meet new conditions in the rear wing. The oak nosing of the lowest brick step was sunk into the square holes to be seen on either side.

1. Shallow sinkings in the side walls of the cellar entrance formerly receiving the oak nosing of brick steps indicated the position and dimension of the three bottom steps.
2. No remains or indications of any cellar flooring were found.
3. No remains of any rear steps were found. However, certain brick walls unrelated to the house under restoration were uncovered. (These were completely uncovered in 1932—see Appendix No. 10.)
4. Four piers 17" by 17" of Colonial brick, same size as those in the original house, were found in the ground in front of the river or front entrance. These indicated the existence of an early porch of smaller dimension than and superceding the porch shown on the photographs of 1862. The original stumps of these piers, about three courses high, still remain in the ground.

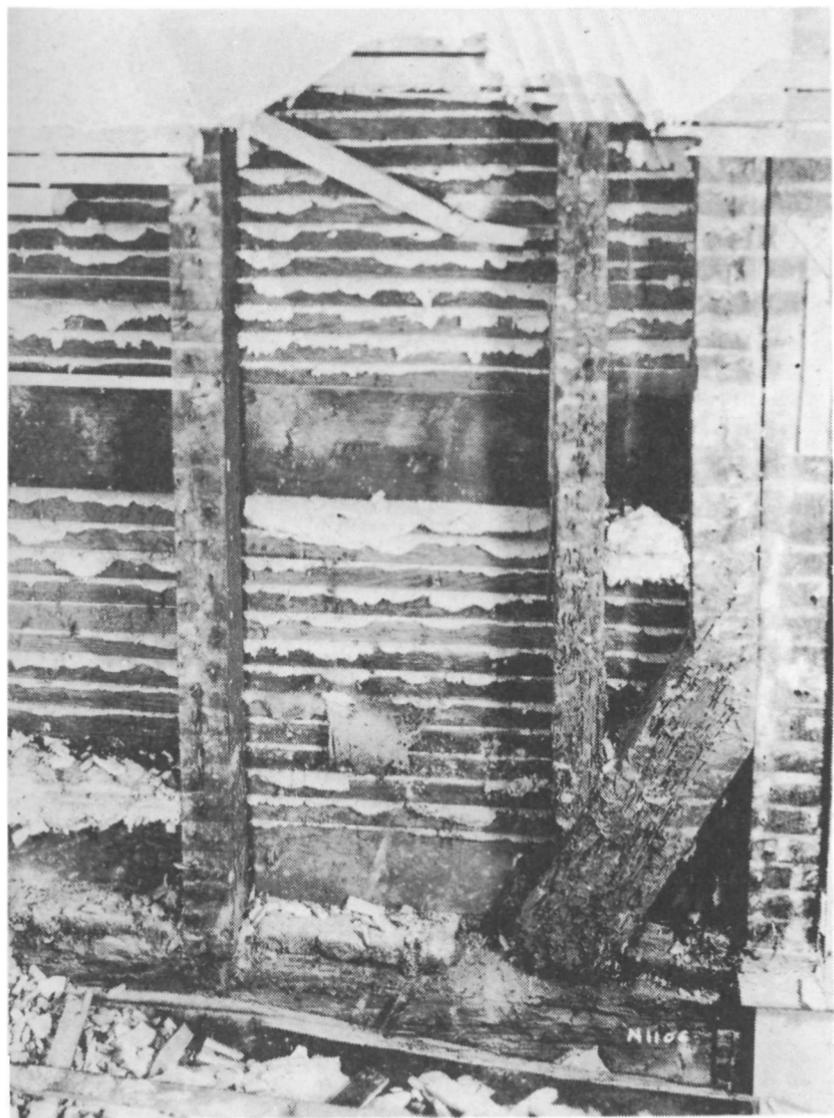
Plate No. 39: Detail of framing, southeast corner of the first floor, July 1931. The corner post and cross-brace were badly rotted and had been patched.

1. The sills were of hewn oak and in such good condition as to indicate their placement in 1881. The framing immediately above, probably the original, was in bad condition (Plate No. 39). The roof framing of poplar, mortised and pegged with the usual marking in Roman numerals, was in excellent condition (Plate No. 41).

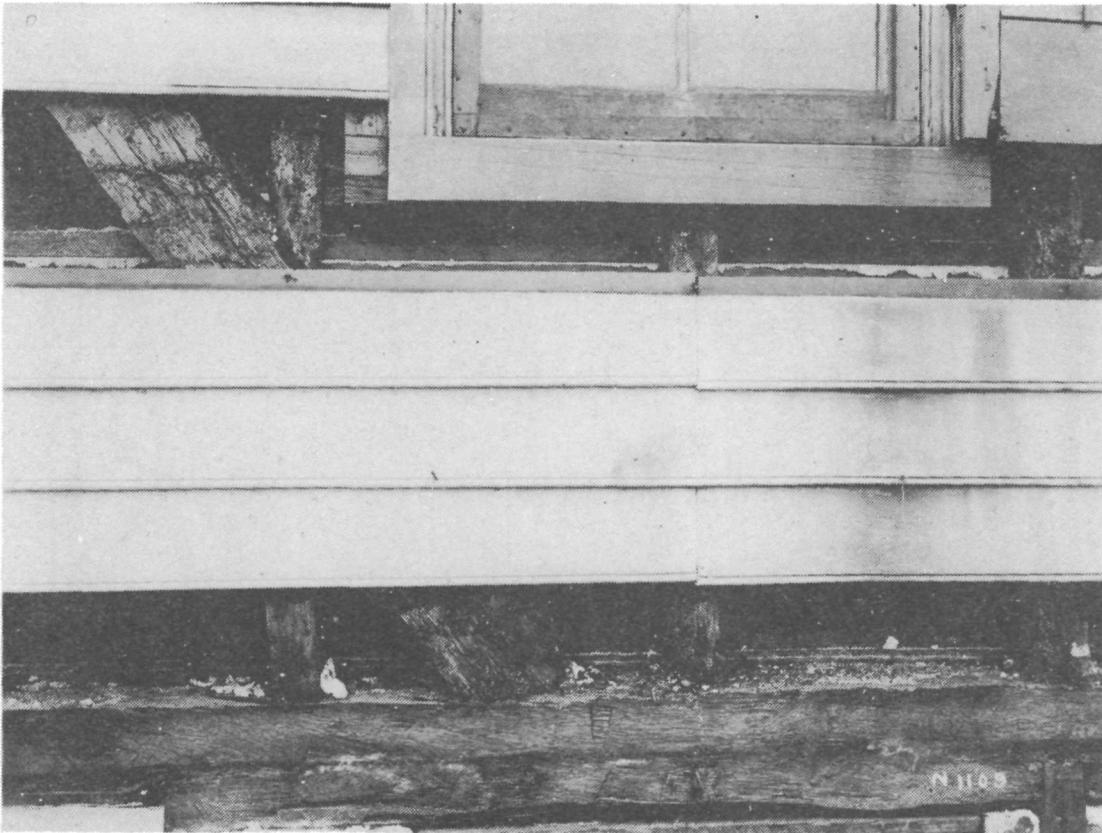
Plate No. 40: Framing detail, July 1931. When some of the weatherboarding was removed it was discovered that the tenons of the framing of the first floor windows had been cut and the frames dropped between four and five inches. We do not know the reason for this.

All of the first floor windows were raised to their original positions. The fifteen light window sash (1931) of the front dormers were changed to twelve light sash because of the sash remains to be noted in the Gardner photograph. The muntins of the Civil War period appear to be very thin and it hardly seems likely that they were in the original sash. The fifteen light sash (1931) were retained in the rear dormers because they are more typical of the period. The Sankey water color would indicate that the second floor end windows had eighteen light sash. The dormers might also have had them. Further evidence is needed here.

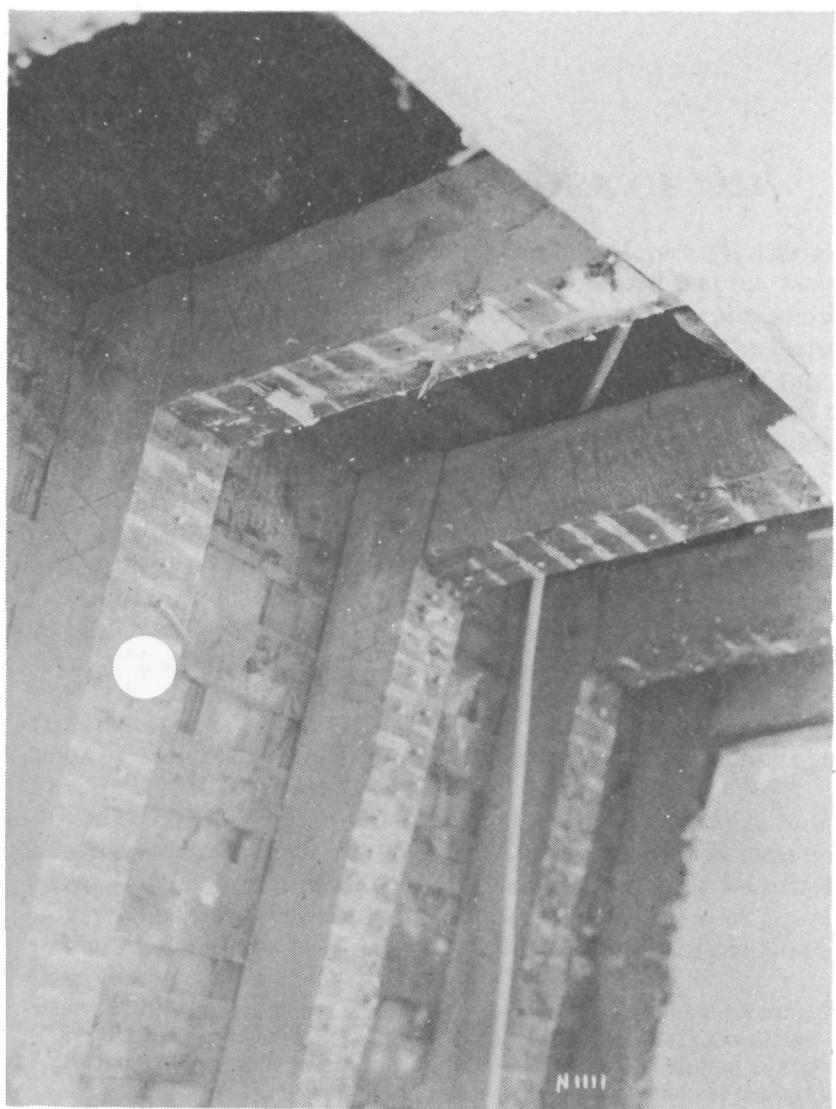
Plate No. 41: Roof framing detail, July 1931. The Roman numerals on the poplar rafters were marked there to assist the carpenters in assembling the framework of the house.

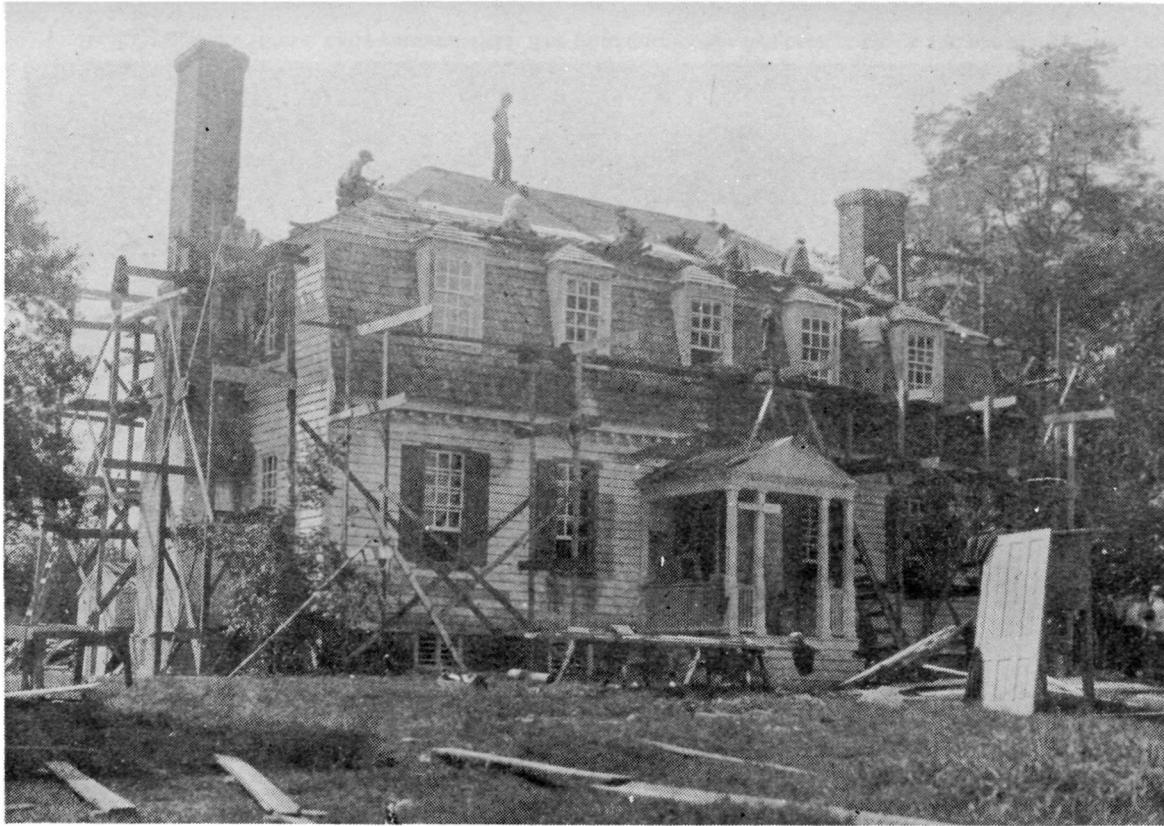
Plate No. 42: The first reconstruction program rushing towards completion for the Sesquicentennial, early autumn 1931.

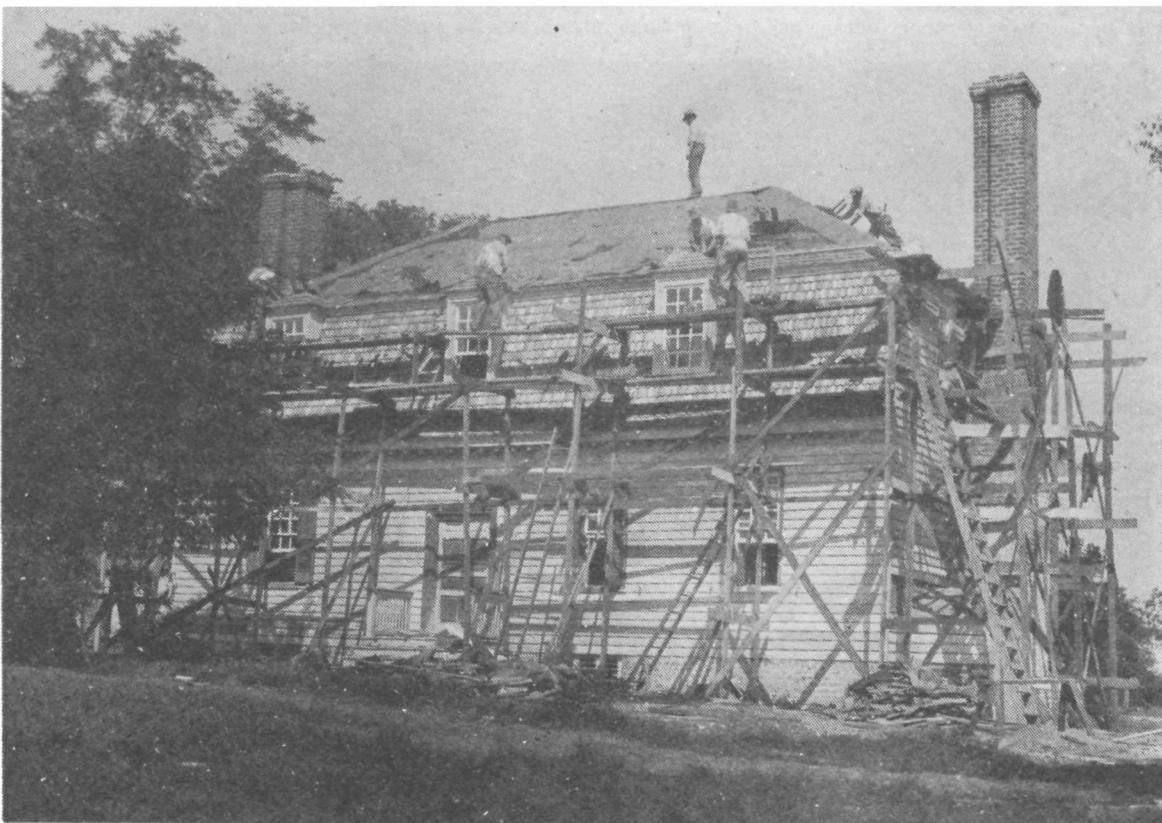
Plate No. 43: Rear view of the House, early autumn, 1931. The third dormer has just been put back and handsplit cypress shingles from Charleston, S.C. , put down.

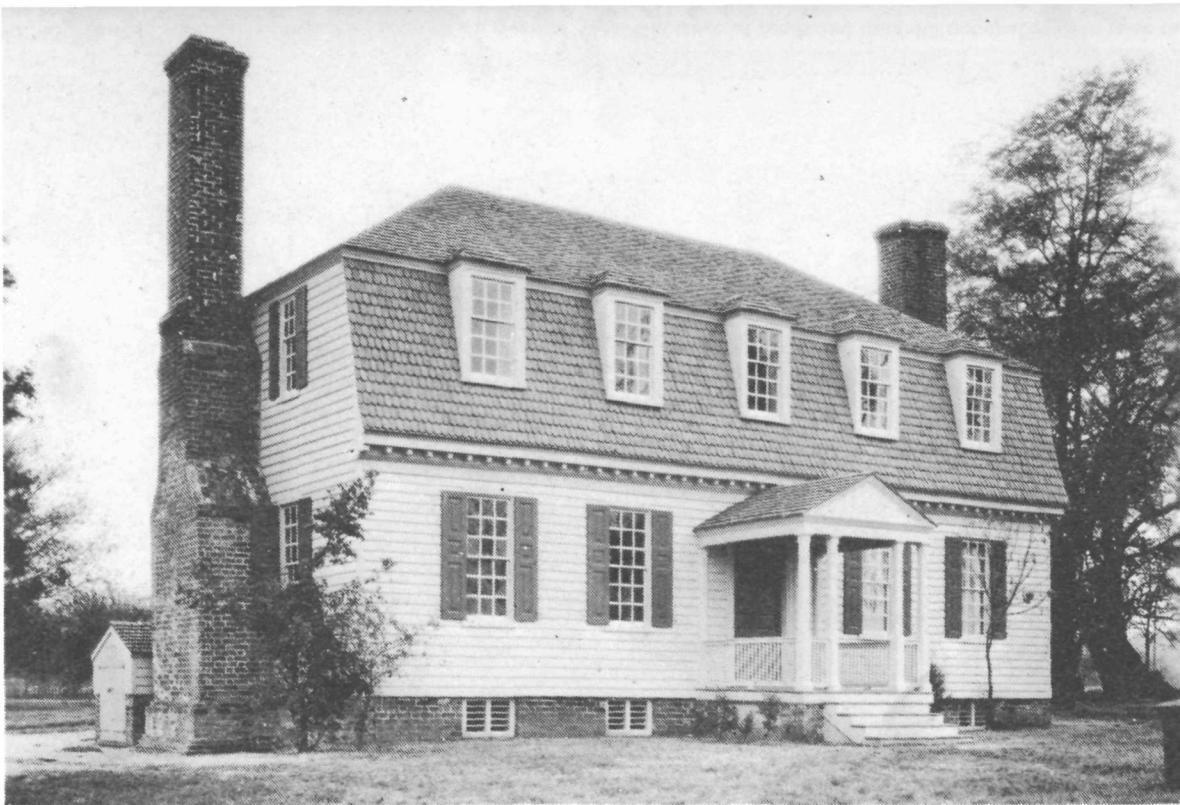
Plate No. 44: Front view of the house as put in shape for the Sesquicentennial Celebration, October 1931. The shutters are adopted from those formerly on the house of Miss Annie Galt of Williamsburg. The size of the window lights and the details of the sash are typical of the period in Tidewater Virginia.

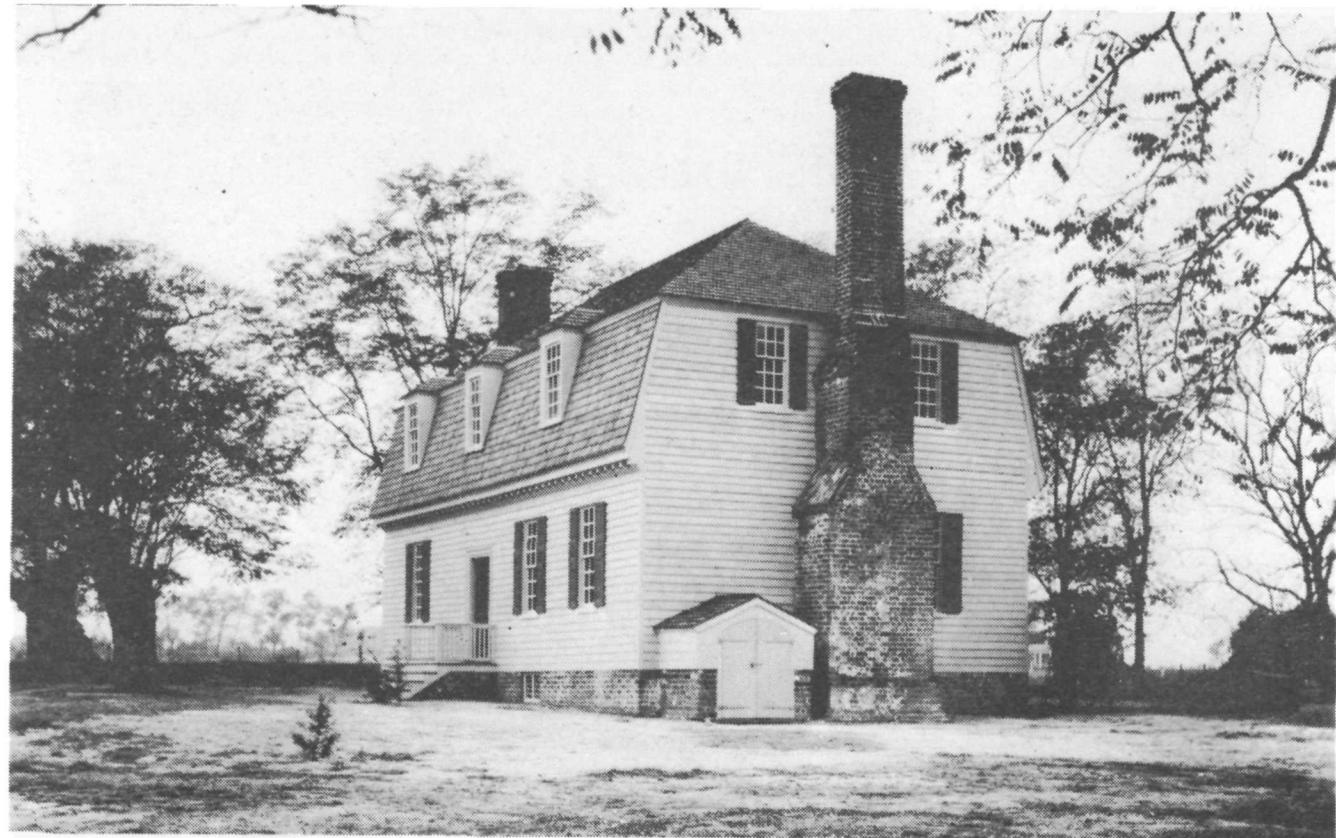
Plate No. 45: View of southeast corner after restoration work of 1931. Shortage of funds and time did not enable us to raise the window frames or complete the cleaning down of the chimney brick.

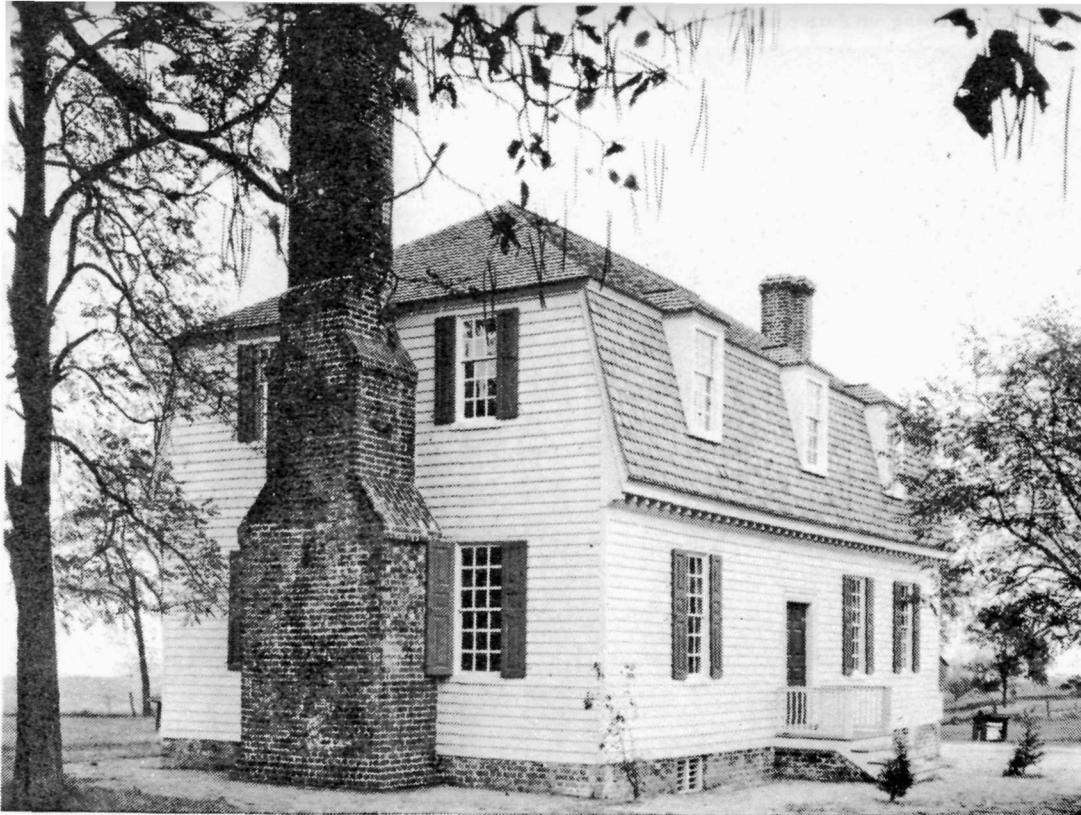
Plate No. 46: View of southwest corner after restoration work of 1931. The rear stoop was a conjectural design similar to those used in Williamsburg. The discovery of the illustration in Howe suggested the simpler arrangement which replaced this one in 1933-4.

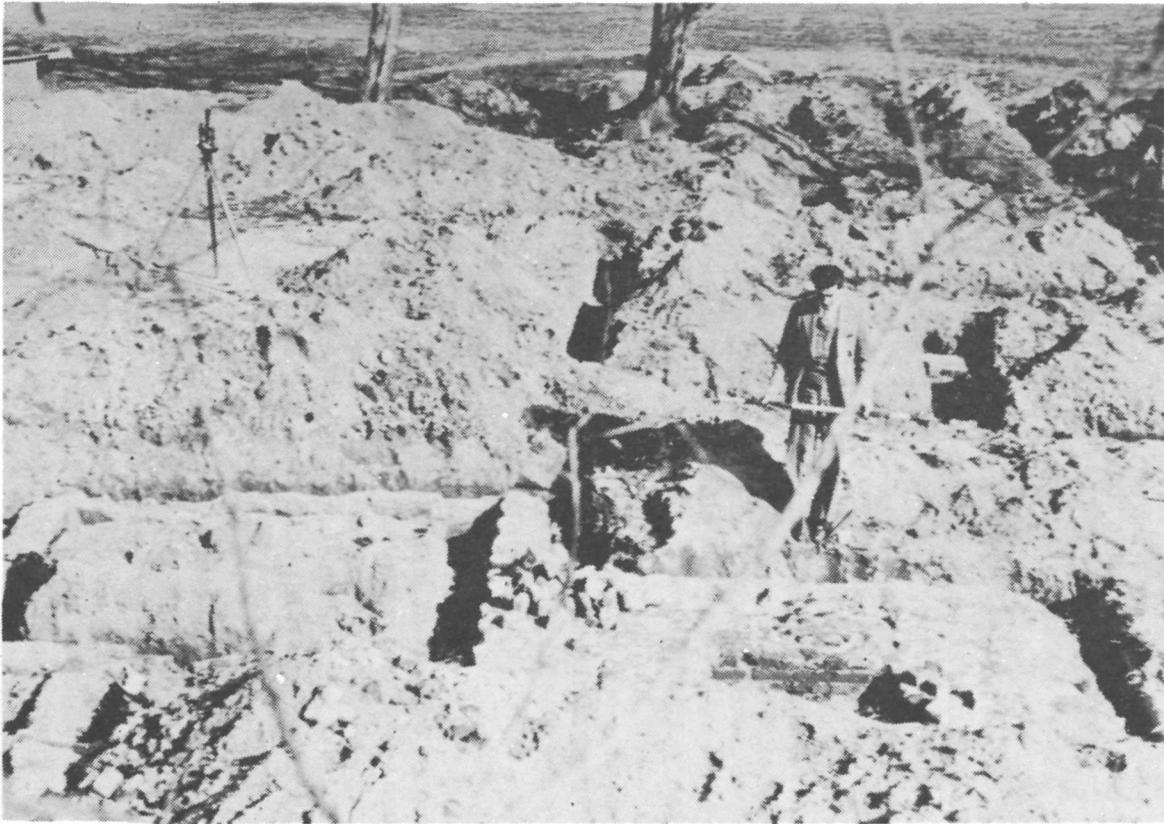
The remains of a structure approximately equal in size and shape to the present building were found just behind and not quite parallel to it (Plate No. 48). This was designated as Building No. 2. The foundations are of brick and marl, unusual in outline. Apparently the superstructure was of wood and there was no basement. In one corner there is a hollow rectangle of brick 5'5" by 7'10" of unknown use. It is believed that these fragments remain from a house of very early date since it is too close to the present structure to have stood at the same

Plate No. 48: Photograph of the excavation of "Building No. 2", 1932. The foundation is a shallow one of marl and brick and is thought to be the remains of a house earlier than the present structure (see Appendix).
