# The Moore House

**The Site of the Surrender—Yorktown**

A National Park Service Historic Structures Report

Charles E. Peterson

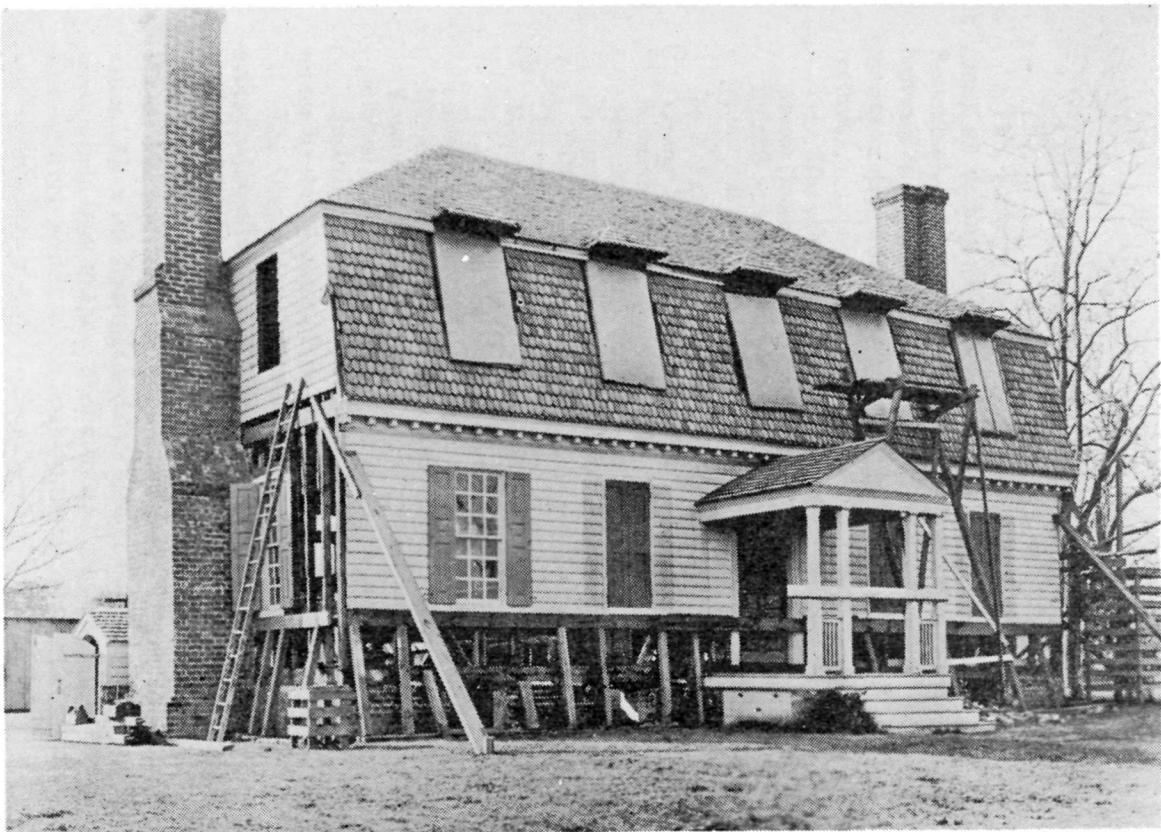
Plate No. 49: Beginning of the Public Works program October, 1933. The dormers were removed for rebuilding and the framing shored up for the removal of the first floor joists.

During this work program concrete footings were placed under the foundation walls, modern brick cellar partitions removed, defective sills, girders, joists and bracing replaced on the first and second floors, and the main stair rail and balusters replaced by an 18th Century design. The interior basement stairway was removed, a Colonial type door put in to replace the one found there and the space made into a closet. The key block of the first floor east room mantel was slightly changed. All of the plaster had been removed during the investigation of the house. This was replaced and the interiors painted in various colors in accordance with Georgian precedent. The rear stoop was replaced by the simple tread and stringer arrangement indicated in Howe's illustration. A brick gutter was run around the outside of the house. The shutters installed in 1931 were replaced by solid panel shutters of slightly different design as indicated in Plate No. 9. The roof was insulated and reshingled after the interesting manner shown so clearly in the "Gardner" photograph (unknown when the building was shingled in 1931).

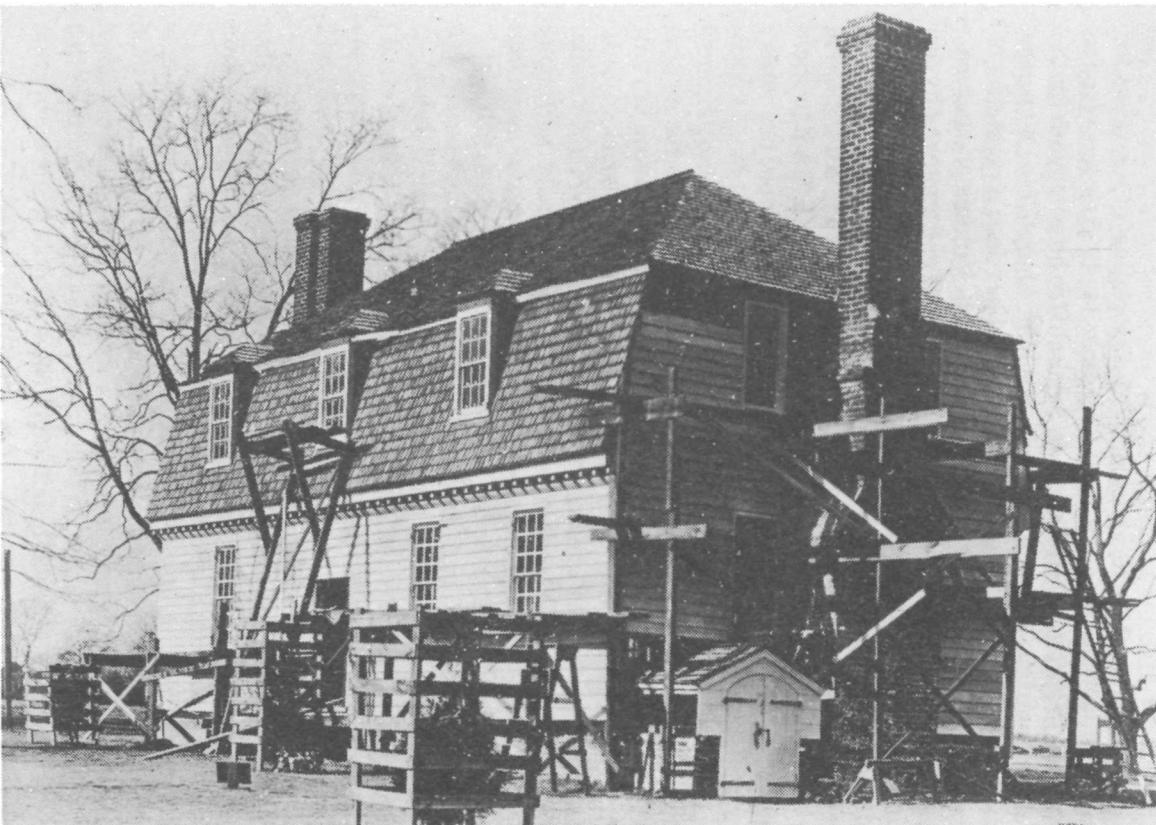
Plate No. 50: Rear view of the house during 1933–4 work. The first floor windows have been raised and the second floor windows resashed. A typical double ogee moulding was run all around the building where the roof plane breaks.

All of the first floor windows were raised to their original positions. The fifteen light window sash (1931) of the front dormers were changed to twelve light sash because of the sash remains to be noted in the Gardner photograph. The muntins of the Civil War period appear to be very thin and it hardly seems likely that they were in the original sash. The fifteen light sash (1931) were retained in the rear dormers because they are more typical of the period. The Sankey water color would indicate that the second floor end windows had eighteen light sash. The dormers might also have had them. Further evidence is needed here.

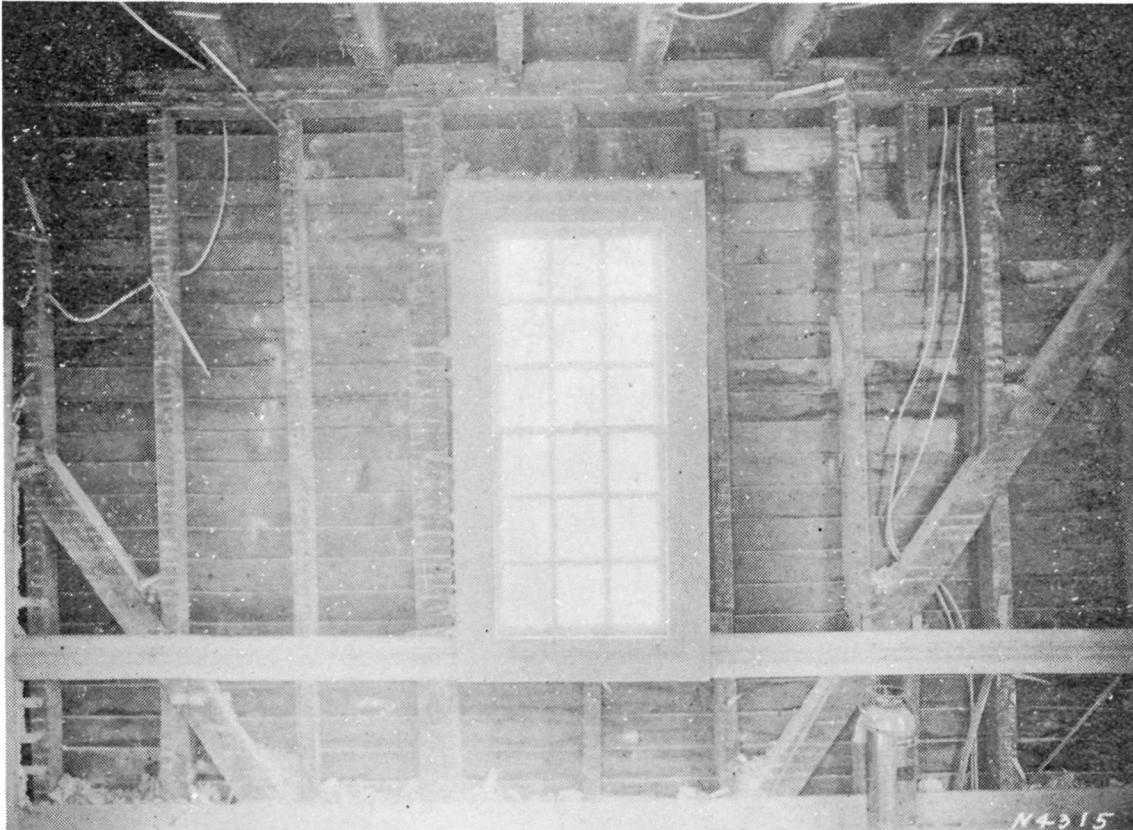
Plate No. 51: Framing detail, southwest first floor room, 1933. All the plaster in the building was removed at this time.

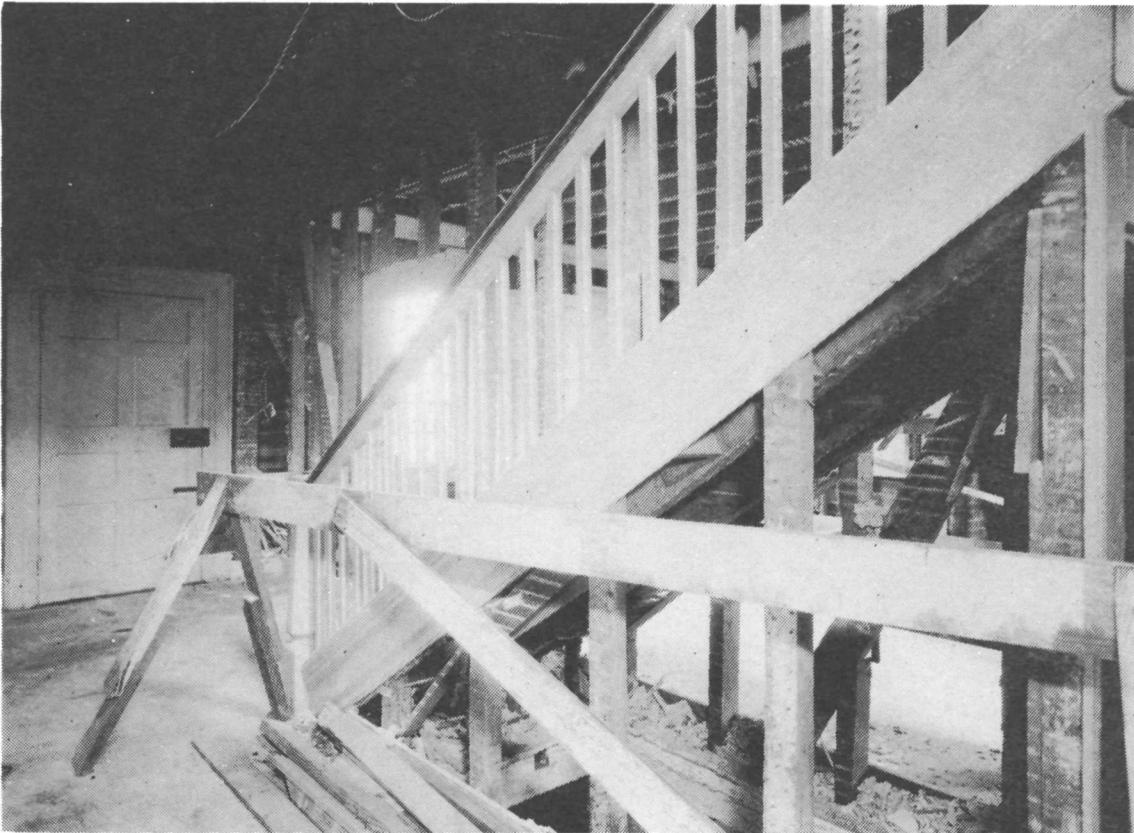
Plate No. 52: Stairway framing, 1933. Mortise hole of one of the joists originally supporting the closet floor under the stairs can be seen. The closet, including a new door, was restored in 1933–4.

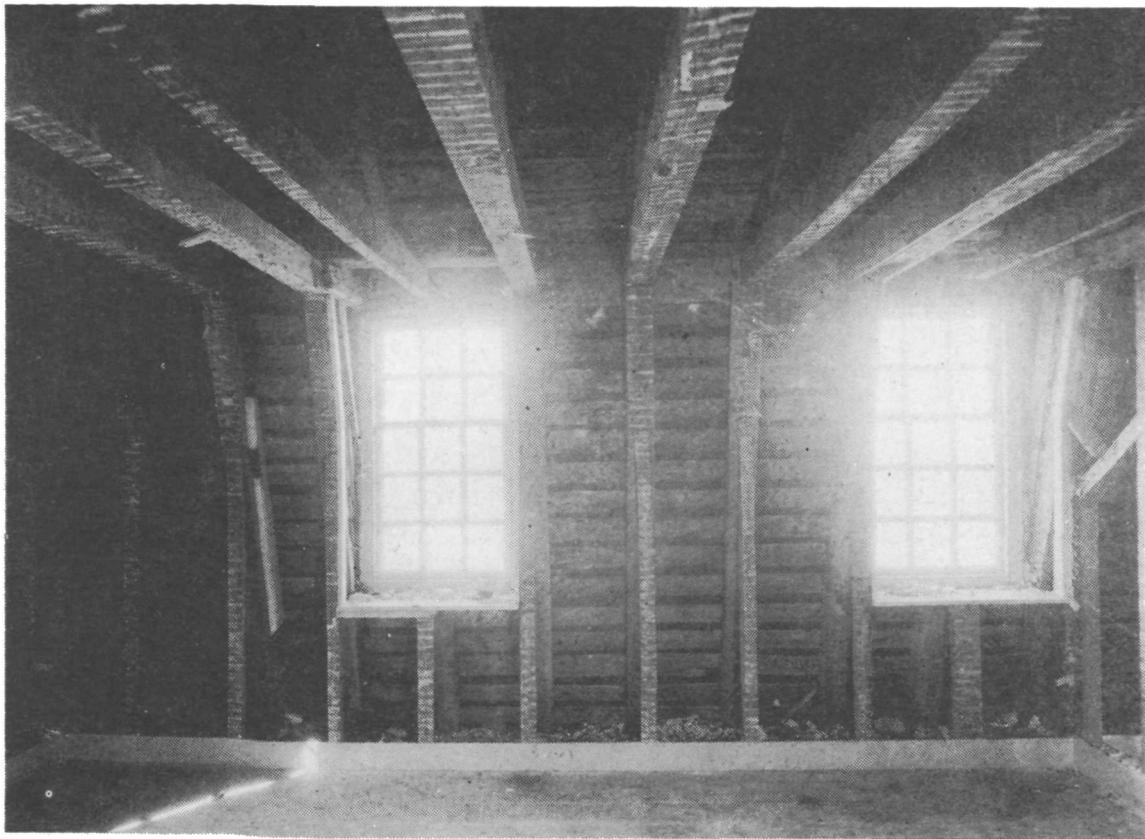
Plate No. 53: Upstairs framing, 1933, showing shingle nailing strips and the furring of the walls.

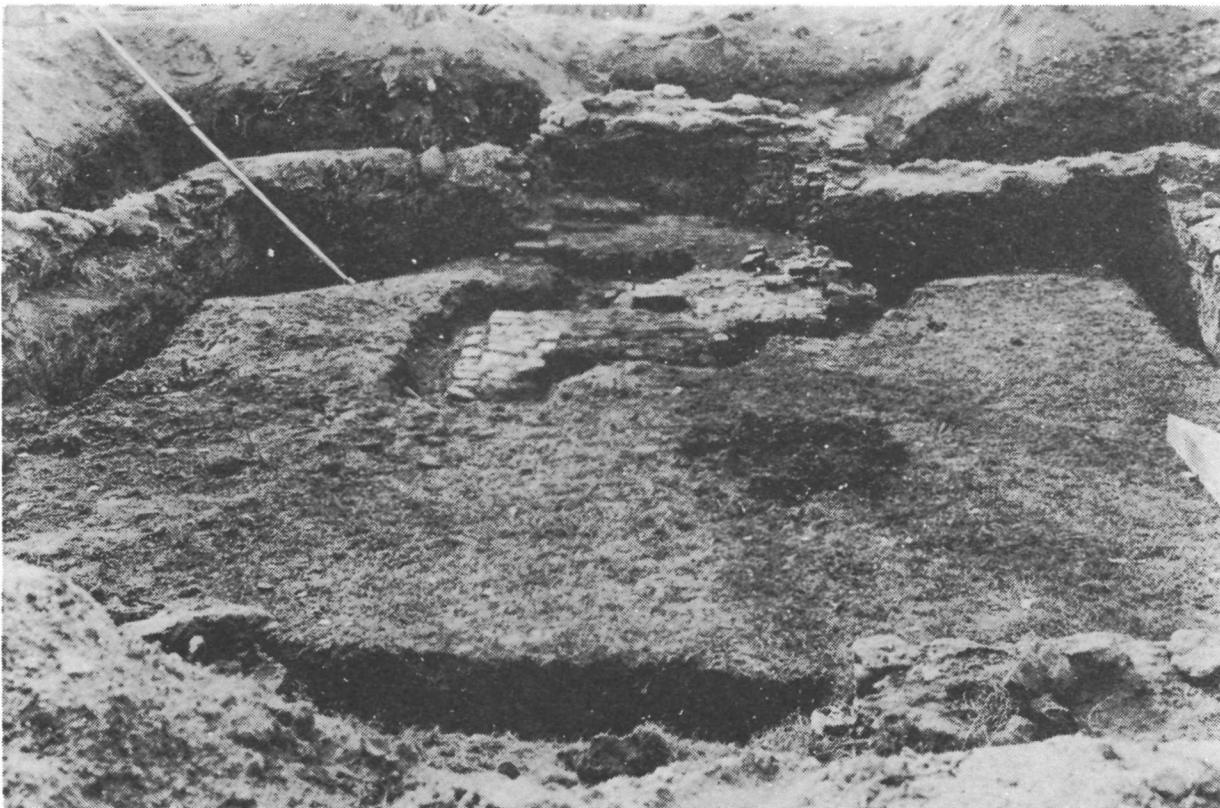
Plate No. 54: The remains of the building east of the main house measured 22'-4½" by 22'-7". For the most part they are of local marl. The fireplace lining and hearth were of typical handmade brick. The identity of this building is unknown. It was reconstructed as an outbuilding to the present house to hold the heating plant. These foundations were removed at that time.

Nearly four hundred dollars were spent on this exploratory work which was concluded in May. The foundations of Building No. 1 were left exposed for a time and then removed during the construction of the heating plant in 1934. The foundations of Building No. 2 were covered with earth and marked on the surface with dry-laid brick. For additional information refer to Appendix No. 7, and the drawings of the Historic American Buildings Survey.

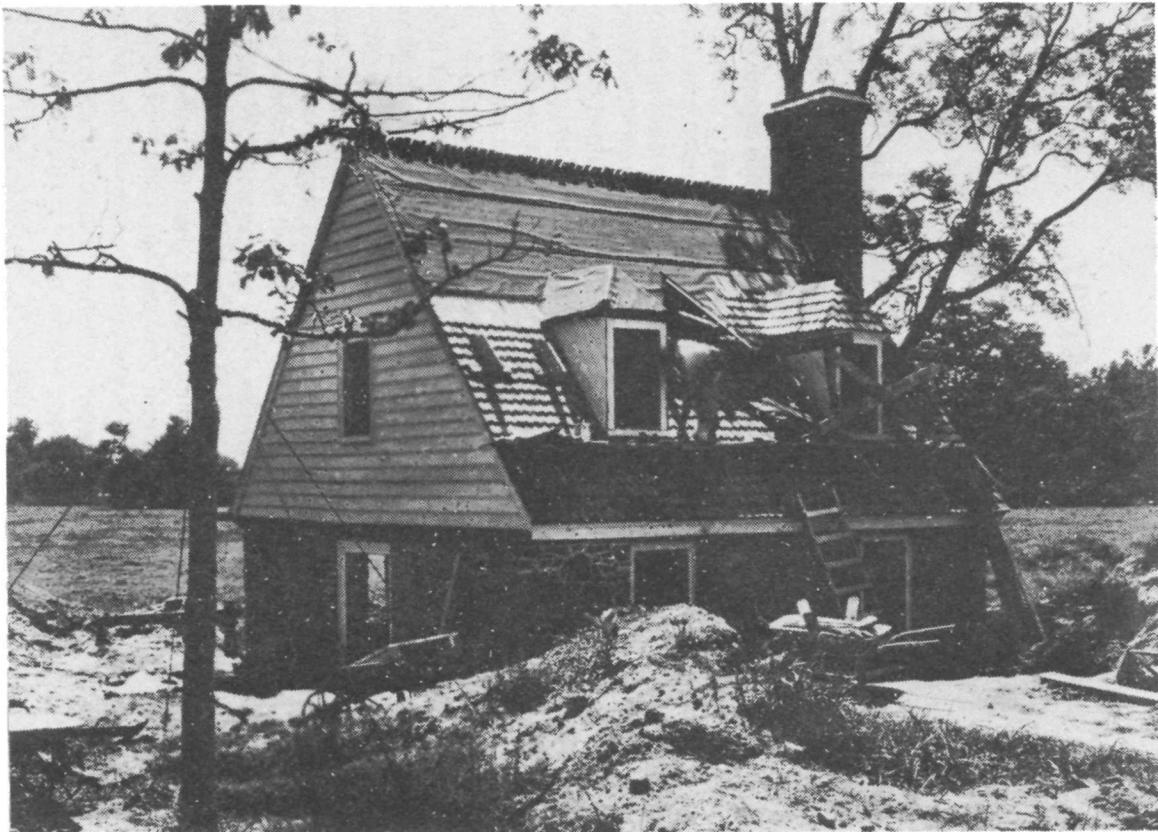
Plate No. 55: Shingling the roof of the heating building, 1934.

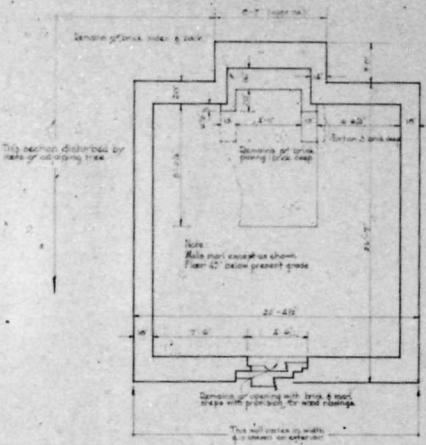
BUILDING NO. 2.

Scale 1/10"
