Assessment of Water Resources and Watershed Conditions in Congaree National Park, South Carolina

Natural Resource Report NPS/SECN/NRR—2010/267

Michael A. Mallin and Matthew R. McIver
Center for Marine Science
University of North Carolina Wilmington
Wilmington, NC 28409

December 2010

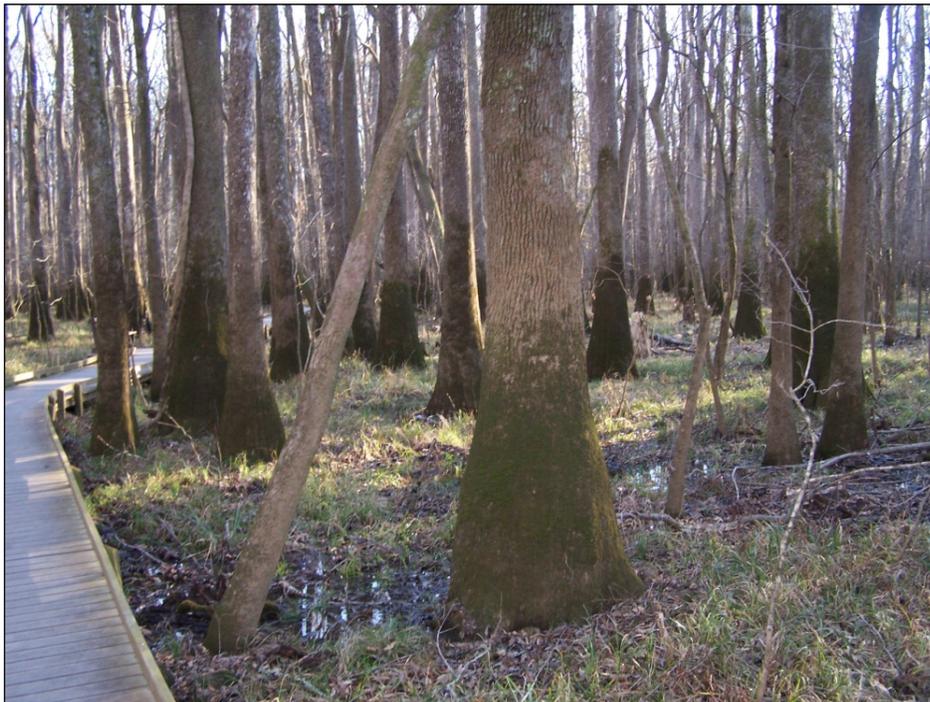
Plate 1. Boardwalk within Congaree Park showing flooding high water mark. Photo by M. Mallin.

Congaree National Park preserves the largest intact stand of old growth bottomland forest in the southeastern United States (Plate 1). The park, which contains approximately 24,230 acres (9,806 ha) of land, including approximately 11,000 acres of old-growth, is located in Richland County, on the South Carolina coastal plain, about 20 miles (32 km) southeast of the City of Columbia (Figure 1). It is most easily accessed from Columbia via S.C. 48 or from the east by exiting U.S. 601 to S.C. 48, from which Old Bluff Road can be accessed either from the east or west. The National Park Service road is entered from Old Bluff Road. The main portion of the park is located along and just above the floodplain of the Congaree River, and a smaller, more recently added section is the Bates Fork Tract (2,395 acres, or 969 ha), on the Wateree River to the east. The main portion of the park runs along the north bank of the Congaree River for about 10 miles (16 km), and varies in width from the river bank inland between, 1.8 to 3.5 miles, or 2.5 to 5 km (Knowles et al. 1996), while the Bates Fork Tract runs along the Wateree River for about four miles (6.4 km), and borders the Congaree River where it joins the Wateree River. This National Park is under the jurisdiction of the U.S. National Park Service (NPS), and there is a Park Office on-site (<http://www.nps.gov/cong>). The coordinates of the Harry Hampton Visitor's Center parking lot are N33.83031°, W80.82343° (WSG 84 datum). Presently the NPS maintains the Harry Hampton Visitor's Center and museum, the Old-Growth Bottomland Forest Research and Education Center (the Learning Center), a Maintenance Facility and Fire Building and a lower and upper boardwalk trail totaling 2.4 miles, or 3.9 km (Plate 1), and five other trails in the wooded areas (NPS 2004; NPS undated); with approximately 20 miles (32 km) of trails in CONG.

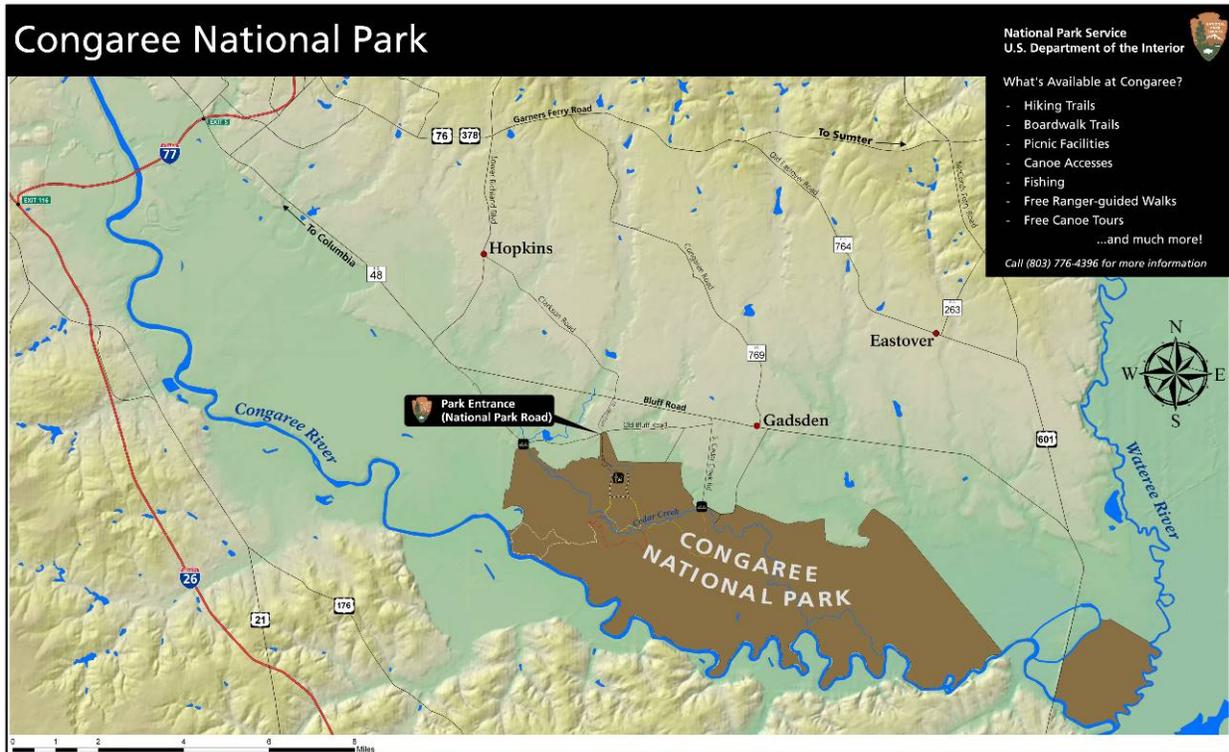
Figure 1. 2007 boundary of Congaree National Park, located east of Columbia, South Carolina.

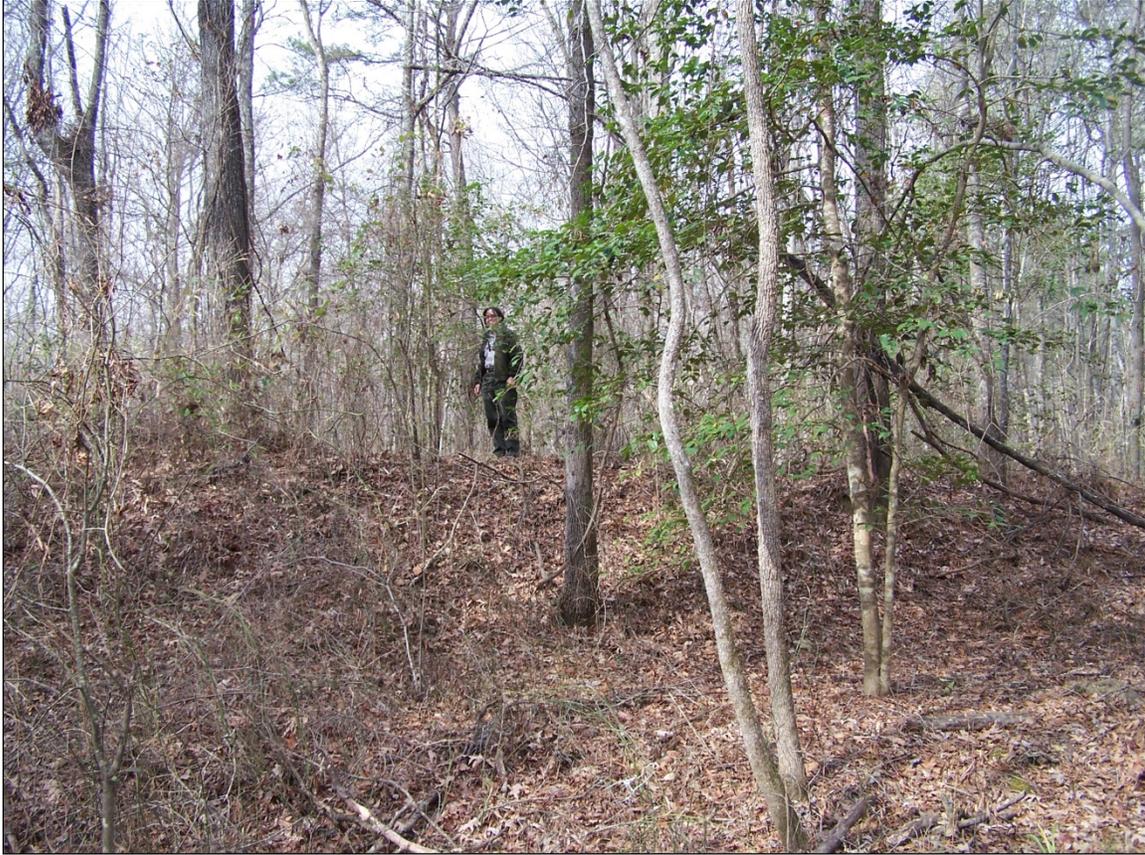
Plate 2. Dike formerly used to protect cattle and agricultural areas from flooding. Such dikes and cattle mounts are found in several locations in Congaree National Park. Photo by M. Mallin.

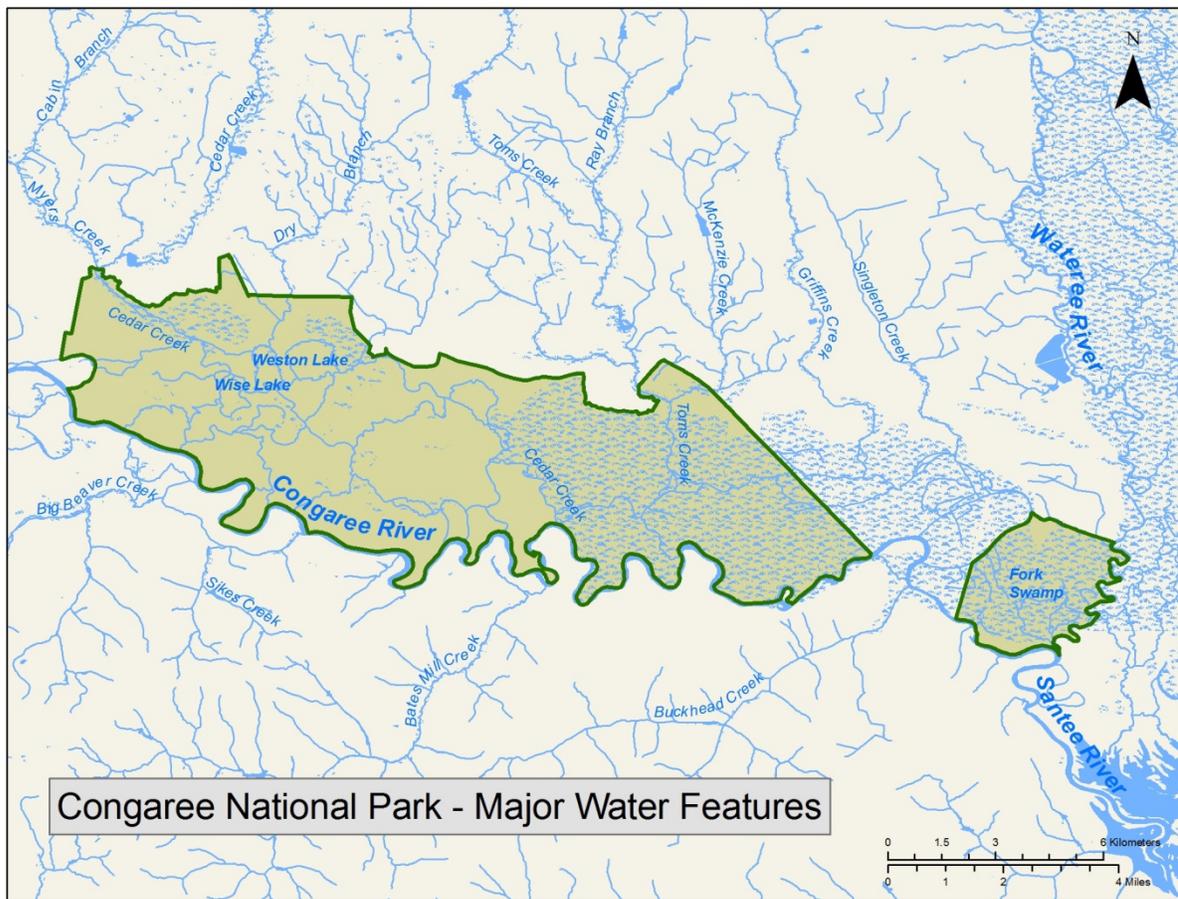
Figure 3. Streams, oxbow lakes, and other water features in and influencing Congaree National Park (note that the area referred to as Fork Swamp is now called the Bates Fork Tract).

The main section of CONG receives the inflow from several streams, including Cedar Creek, Dry Branch, Toms Creek and McKenzie Creek (Figure 3, Plate 4). Cedar Creek is the most prominent inflowing stream to the park, entering in the northwestern corner of the park. It is a 5th order stream that averages about 23 ft (7 m) in width as it enters the park and for much of its length; however, near where it enters Wise Lake it broadens to about 125 ft (38 m) in width (Maluk and Abrahamsen 1999). As mentioned above, this creek has been reclassified as “Outstanding National Resource Waters” by the South Carolina General Assembly. Woody snags are an important habitat in this stream (Smock et al. 1985), with about 22-27% of the bottom containing such material (Maluk and Abrahamsen 1999). Before entering the park it drains a catchment of approximately 35 miles² (90 km²); by the time it reaches Wise Lake in the middle of the park this drainage area increases to 71 miles² (184 km²), or (Maluk and Abrahamsen 1999). Upstream of the park Cedar Creek is fed by several tributaries, 2nd order Myers Creek, 3rd order Cabin Branch (which joins Myers Creek), and 3rd order Horsepen Branch (Table 2, Figure 3).

Dry Branch, a 3rd order stream, enters the midsection of the park from the north (Figure 3). To the east of this creek, 4th order Toms Creek (Plate 4) enters the park, with its 3rd order tributary McKenzie Creek also entering the park to the east of Toms Creek. Another tributary to Toms Creek, 2nd order Ray Branch, joins Toms Creek before it enters the park (Figure 3). Near its entrance to the park Toms Creek is 20-23 ft wide (6-7 m) wide and about 2.6 ft (0.8 m) deep (Table 2). Toms Creek drains a catchment of approximately 39 mi² (100 km²) (Maluk and Abrahamsen 1999). The floodplain area for both Cedar and Toms Creeks within the park extends beyond 50 m (164 ft) from the stream bank in either direction (Maluk and Abrahamsen 1999). Collectively, the creeks within the park meander considerably, joining and separating before entering the Congaree River (Figure 3). These are all blackwater creeks, which are characterized by darkly stained water from floodplain vegetation leachate, somewhat acidic waters, and elevated dissolved organic carbon content (Myer 1990). Just to the east of the main park is Running Creek/Running Lake (which enters present park lands and joins Toms Creek) and Griffins Creek and Singleton Creek lying in an area that may be a future park acquisition.

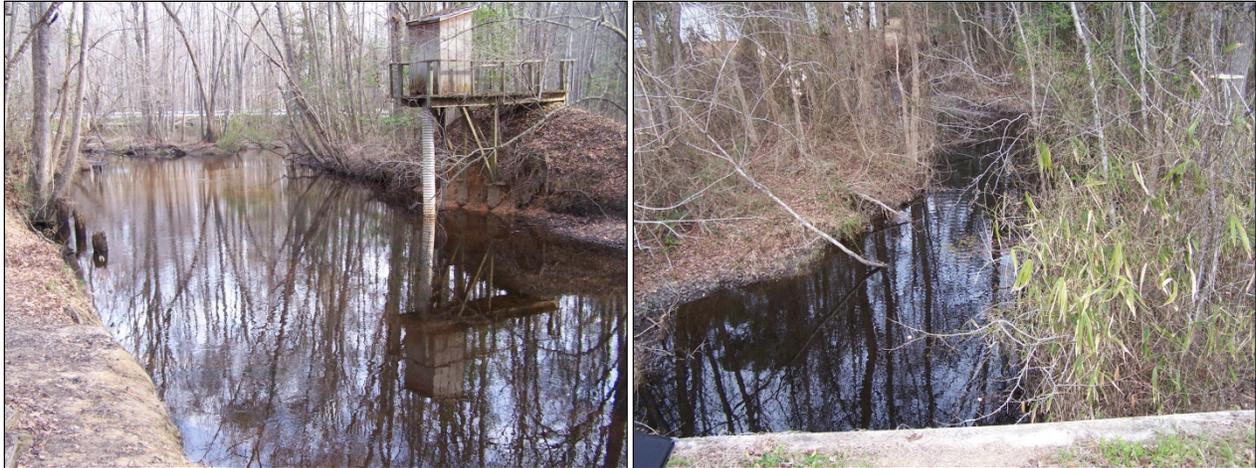
Plate 4. Cedar Creek (left) contains a canoe launch and trail and is designated an Outstanding National Resource Water by the State of South Carolina. Tom's Creek (right) is one of several creeks draining into the park from the northern border. It is listed as impaired waters by the SCDHEC for fecal coliform bacteria pollution and an impaired biological community.

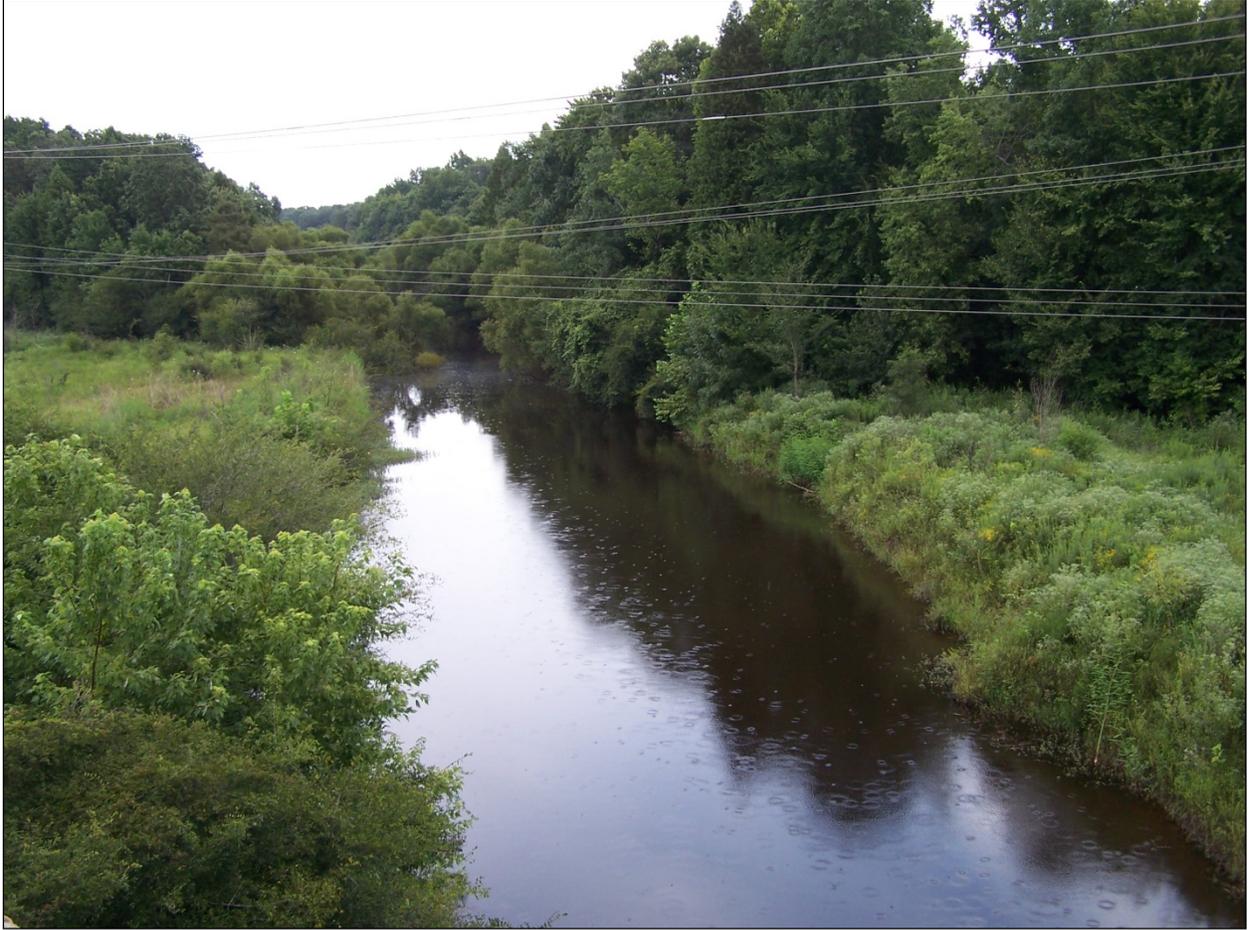
Plate 5. Bates Old River borders the Bates Fork Tract in Congaree National Park. Photo by M. Mallin.

Major creeks do not impact the Bates Fork Tract. However, the northwest border of the tract is formed by Bates Old River (also referred to as Old Dead River in some maps), which is an abandoned Congaree River channel cutoff in 1852 (Dr. David Shelley, NPS, personal communication; Figure 4, Plate 5).

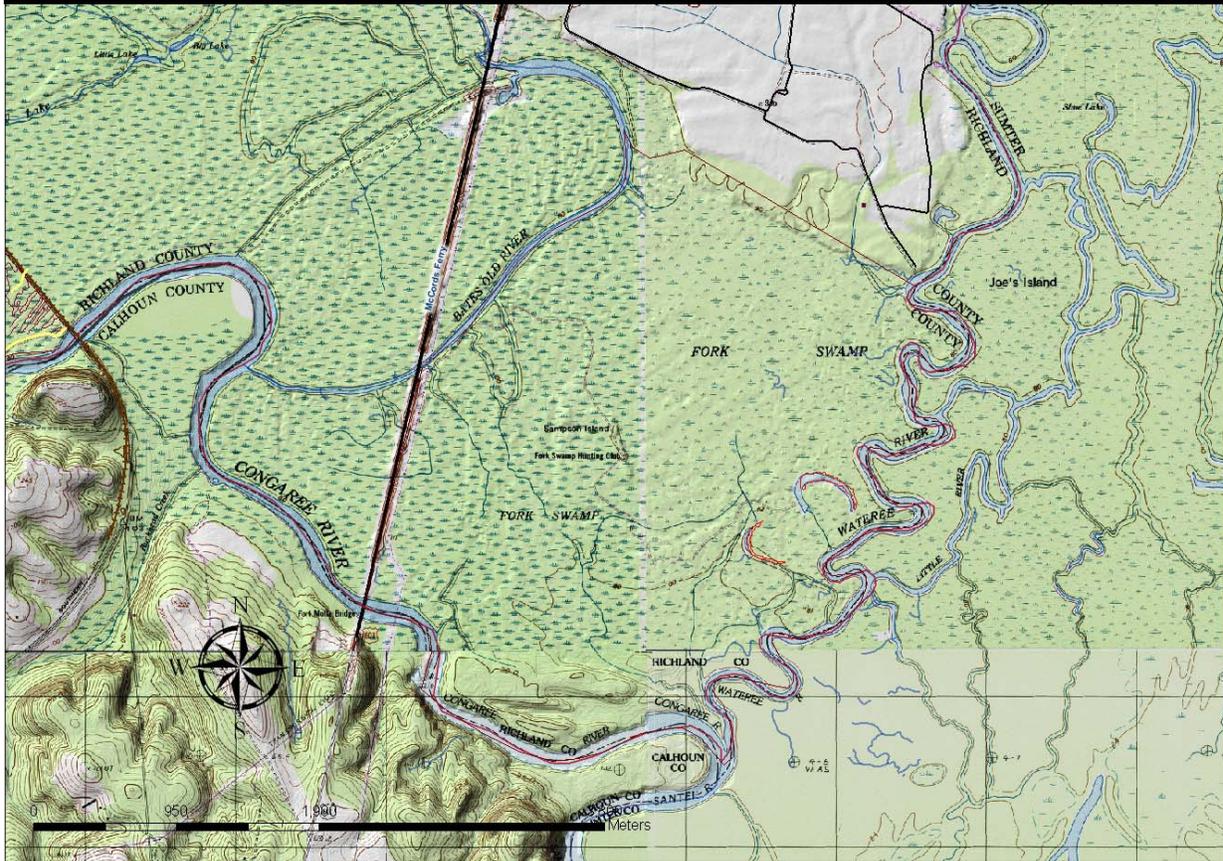
Figure 4. Bates Fork Tract (also called Fork Swamp) of Congaree National Park, with Bates Old River along the eastern border.

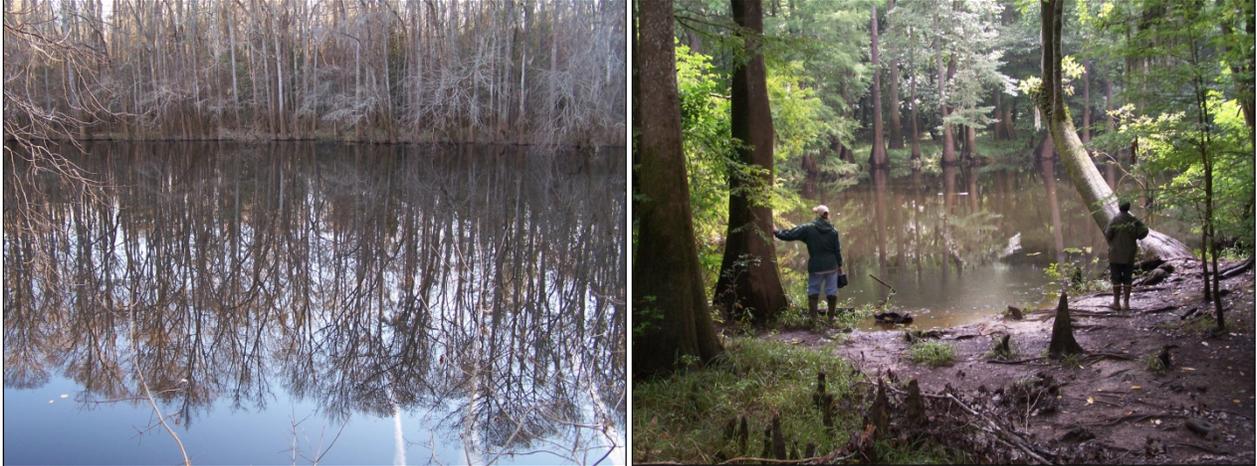
Plate 6. Weston Lake (left), accessible by the boardwalk, and Wise Lake (right) are two significant oxbow lakes within Congaree Park. Wise Lake is accessible via a road and trail.

Oxbow lakes are seen primarily in southeastern lowland areas of the U.S. They are formed when a meandering river channel loop is cut off. This straightens the channel and leaves behind an oxbow lake (Hupp 2000). There are two well known such lakes in the park, Wise and Weston Lakes, and other that are less accessible (Figures 3-5). Weston Lake is accessible to pedestrians via the raised boardwalk that extends from the Visitor's Center to the lake and returns to the Visitors Center (Figure 1). Wise Lake is accessible by a roadway (Sim's Trail) that becomes submerged during the periodic flooding that CONG experiences. Weston Lake is about 2.02 acres (0.82 ha) in size, whereas Wise Lake is about 5.54 acres (2.24 ha) in size (Ryan 2007). As are the creeks, these lakes are blackwater systems (Plate 6).

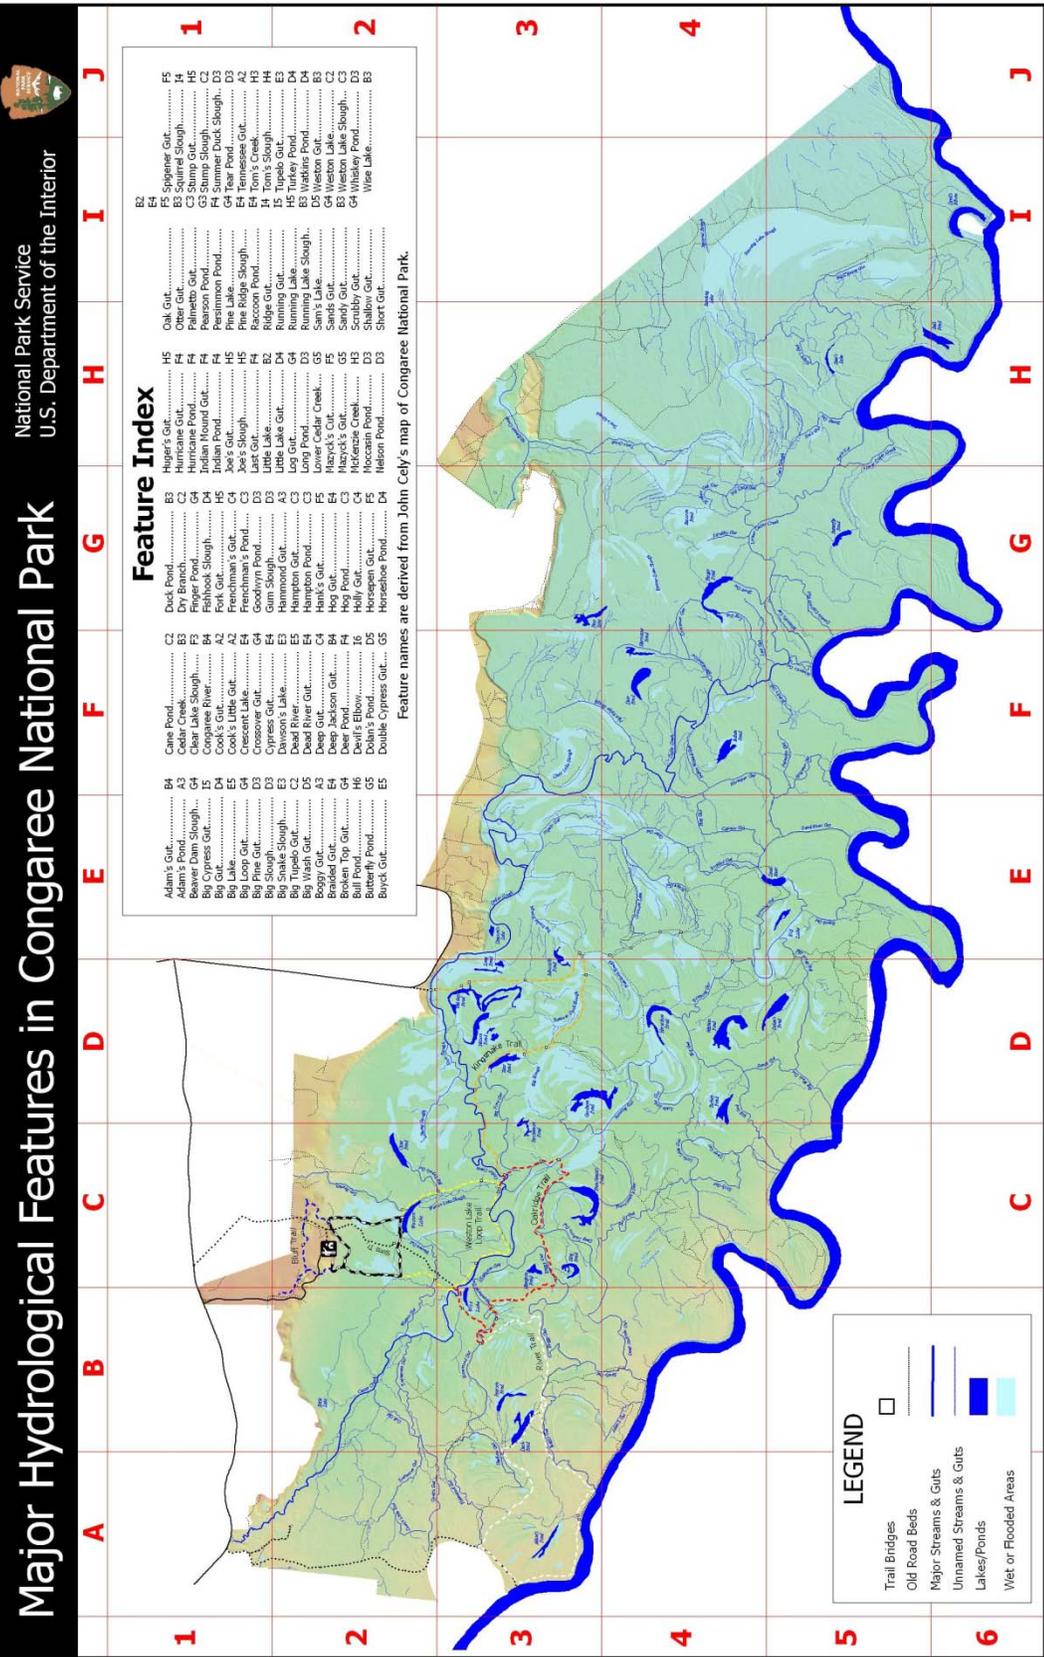
Figure 5. Oxbow lakes, ponds, and other named water features in a portion of Congaree National Park.

There are numerous water bodies scattered throughout the park (Cely, 2004). Besides Wise and Weston Lakes there are seven other named lakes and 25 named ponds (Figure 5). There are also 14 named sloughs, which are swampy areas that hold water for a period after flooding subsides, and are additional wildlife habitat (Maliszewski 2005). Because of the poor accessibility to most of the water features, the majority of lentic biotic (fish and invertebrate) surveys have been limited to Wise and Weston Lakes. There are at least two oxbow lakes in the Bates Fork tract, neither of which is presently accessible by vehicle, as well as Bates Old River (Plate 5).

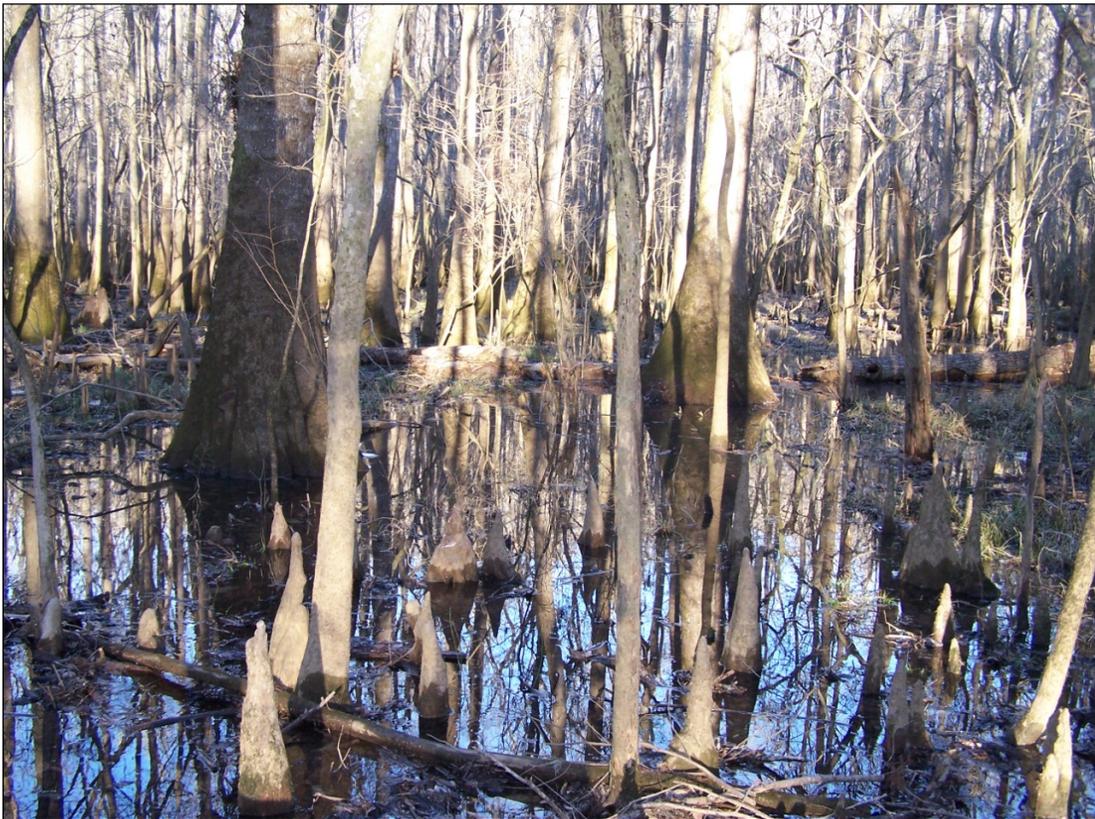
Plate 7. Typical wetland area within Congaree National Park. Photo by M. Mallin.

CONG consists largely of forested bottomland wetlands (Plates 1 and 7; Figures 3 and 4). Two estimates of total wetland coverage within the main portion of CONG include 20,269 acres (91.3% of the area) from the U.S. Fish and Wildlife Service National Wetlands Inventory, and 21,245 acres (95.7% of the area) from the U.S. Department of Agriculture Natural Resource Conservation Service (SCDNR 1995). The river surface and stream channels within the park are within the 90 and 100 ft (27.4 and 30.5 m) elevation contours. The park offices and visitor's center are located along a bluff at approximately the 120 ft (36.6 m) contour. Regular seasonal flooding typically reaches the 110 ft (33.5 m) contour (Plate 1). Approximately 90% of the main area of the park is flooded primarily from the Congaree River on average once per year, with lesser portions of the park flooded several times per year (Patterson et al. 1985). Besides the creeks, oxbow lakes and ponds mentioned above, other wet areas include guts, which are low areas usually containing standing water that become conduits for river water during flood periods (Plate 8). Sloughs, as mentioned, are swampy areas that hold water periodically. A complex web of various types of channels called scroll complex channels, batture channels, backswamp channels and crevasse channels distributes water and sediment throughout CONG; these have been classified by Shelly and Meitzen (2005) as cited in Shelly et al. (2008) with detailed information presented in Appendix A. In upland areas of the park there are seeps from the upper aquifer that create bog areas that support wetland vegetation, primarily an overstory of swamp tupelo *Nyssa biflora* and an understory of sedges dominated by *Carex* spp. (high species richness; 47 species within CONG), in non-flood periods (Gaddy et al. 2000).

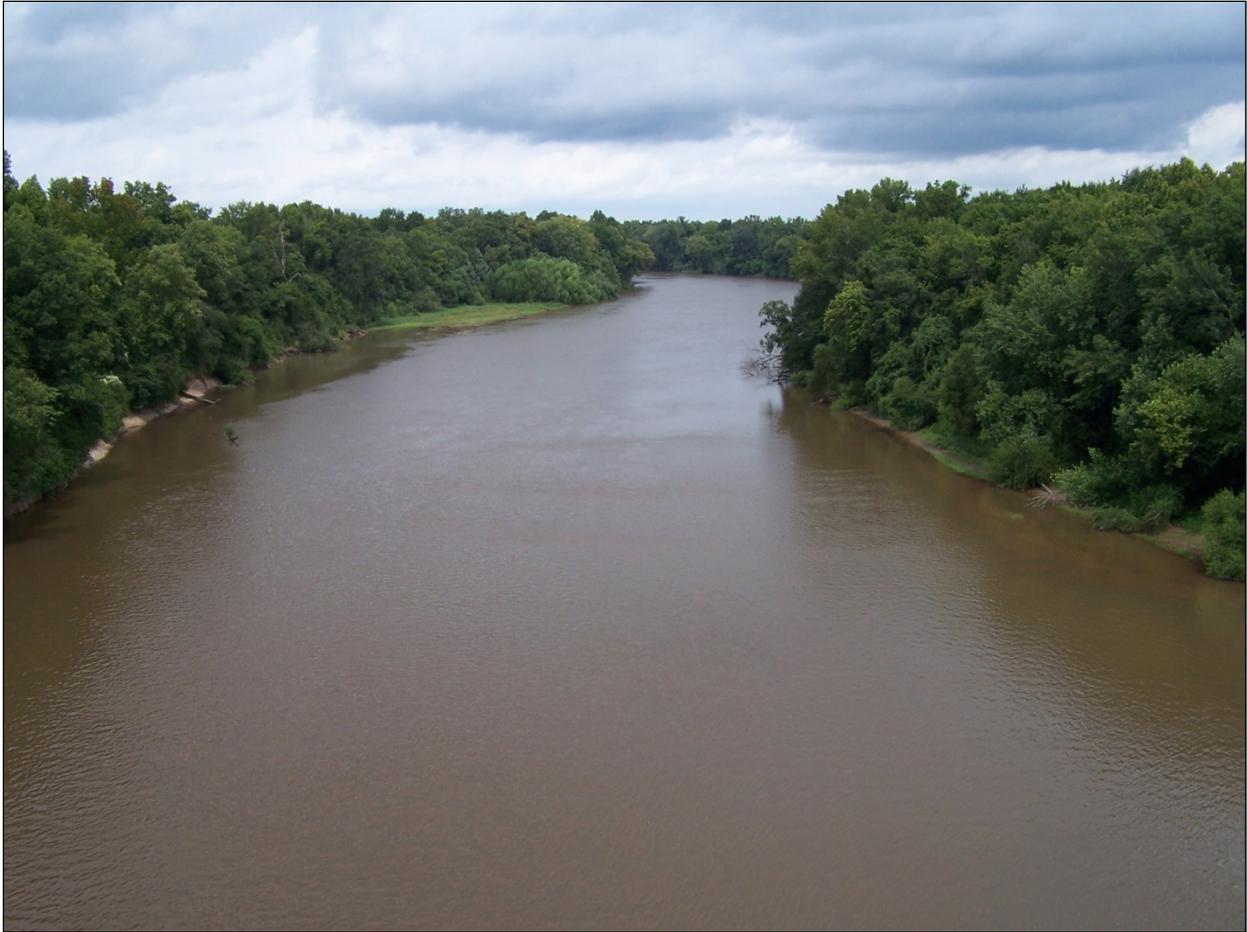
Plate 9. Mid-channel view of the Congaree River. Photo by M. Mallin.

Depending upon upstream rainfall, the Congaree River may contain large quantities of suspended sediments and be turbid at times (Plate 9). As will be discussed later in this report, at times this river-borne turbidity may impact the water quality of streams within CONG. During

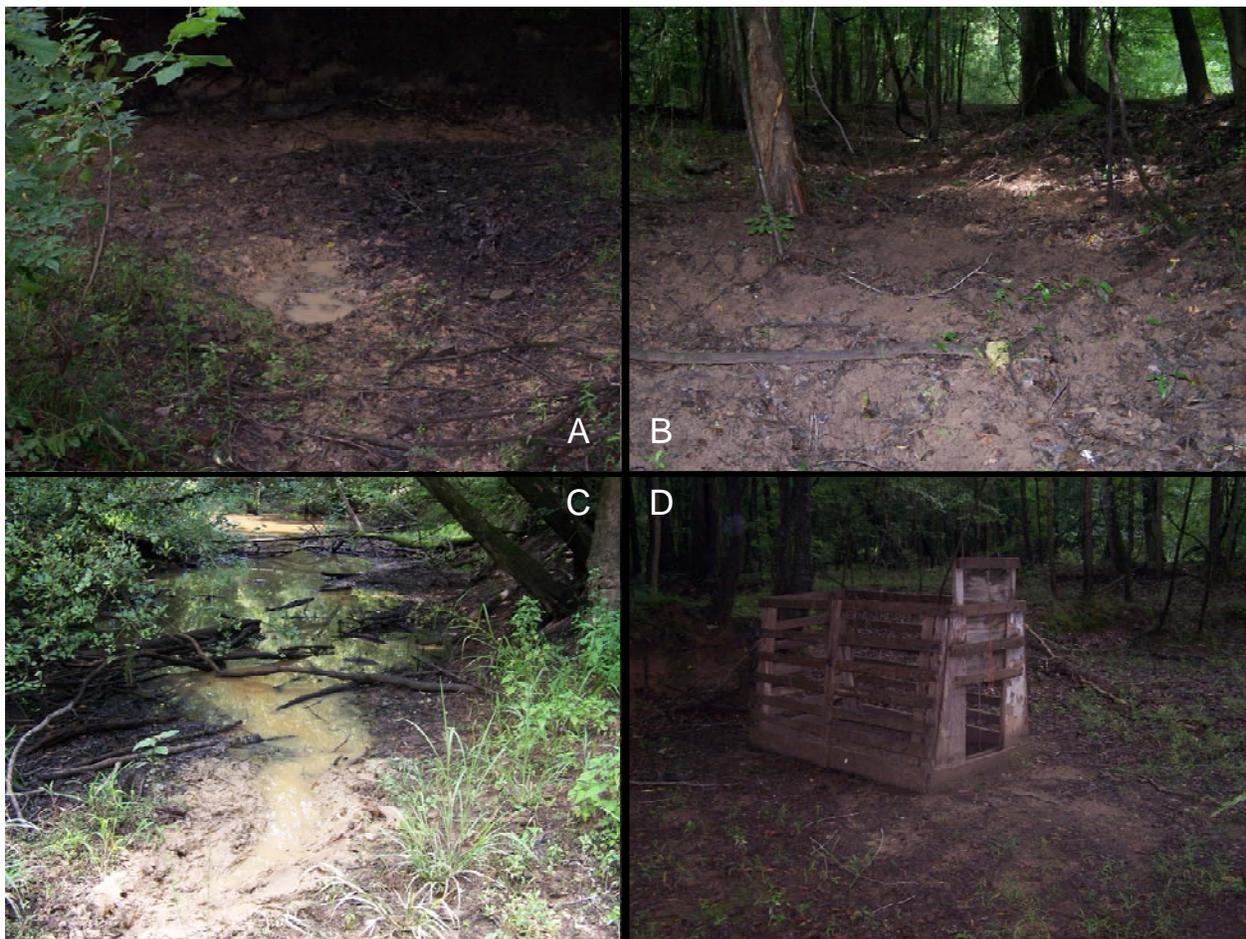
Plate 11. A – hog wallow, B – feral hog rooting area, C – feral hog rooting causes stream turbidity increases, D – USDA feral hog research program utilizes traps in Bates Fork Tract.

Feral hogs *Sus scrofa* were introduced as captive animals into America in 1539, and occur in approximately half of the states in the U.S. (Freibel 2007). There is a large and very active population of these animals within Congaree Park that has caused extensive damage through rooting and wallowing (Plate 11). The authors of this report saw evidence of rooting and wallowing in several areas of the park, including along the boardwalk trail to Weston Lake, in areas near Wise Lake, near water bodies along the eastern border road of the park, and especially within the Bates Fork Tract (Plate 11). In areas of heavy use the soil and vegetation is extensively turned over to depths of 4 to 12 in (10 to 30 cm), with the patches as large as 6.5 by 33 ft (2 m by 10 m) easily visible near trails (Plate 11A and B). While conducting mussel surveys Williams and Benson (2004) noted that feral hogs had uprooted hundreds of meters of streambank to depths of 6 to 12 in (15 to 30 cm) in search of food, killing vegetation and enhancing the potential for streambank erosion. Williams and Benson (2004) also found evidence that feral hogs fed on mussels along streams. We saw evidence that feral hog activity along water bodies (where clay was present) contributed to significantly elevated turbidity in the water (Plate 11C). A study by Freibell (2007) indicated that individuals maintained comparatively compact home ranges and spatial fidelity, suggesting an abundant resource base in CONG. While recording feral hogs within all types of habitats studies within the park, Freibell (2007) found evidence that the hogs particularly selected habitats for availability of oak mast, and suggested its prevalence within the park may be critical to hogs. A study of hog disturbance of plots within various habitats (performed primarily during drought conditions) found that average total disturbance in individual plots was 19% in cypress-tupelo forest, 9% in mixed bottomland hardwoods, 9% in seepage forest and <1% in uplands, showing a preference for wetter areas (USGS 2005). However, the study found that once widespread flooding recurred, differences in disturbance between uplands and wetlands were no longer statistically significant. Regarding long-term impacts, that report noted that severe rooting in the seepage forest plots remained visible for months to even years (USGS 2005). Presently, USDA is conducting disease research through a permit from NPS in CONG (Plate 11D). Feral hogs are trapped, euthanized, and tested for zoonotic diseases.

concern. The USGS (2005) study demonstrated that during drought periods these animals will concentrate their activities in wetland areas. The Williams and Benson (2004) study, along with our own observations, show that feral hog activities can degrade stream bank habitat and water quality. Additionally, we note that these large mammals produce feces that can contain bacteria, viruses, and protozoans that are pathogenic to humans (Hinton and Bale 1991) and their presence may be contributing to microbial water pollution within the park (see subsequent section titled *Human Health Issues*). Thus, NPS needs to continue and enhance programs designed to reduce the population of feral hogs within CONG. As noted by Freibel (2007), because these animals move freely across park borders management programs will need to involve neighboring property owners.

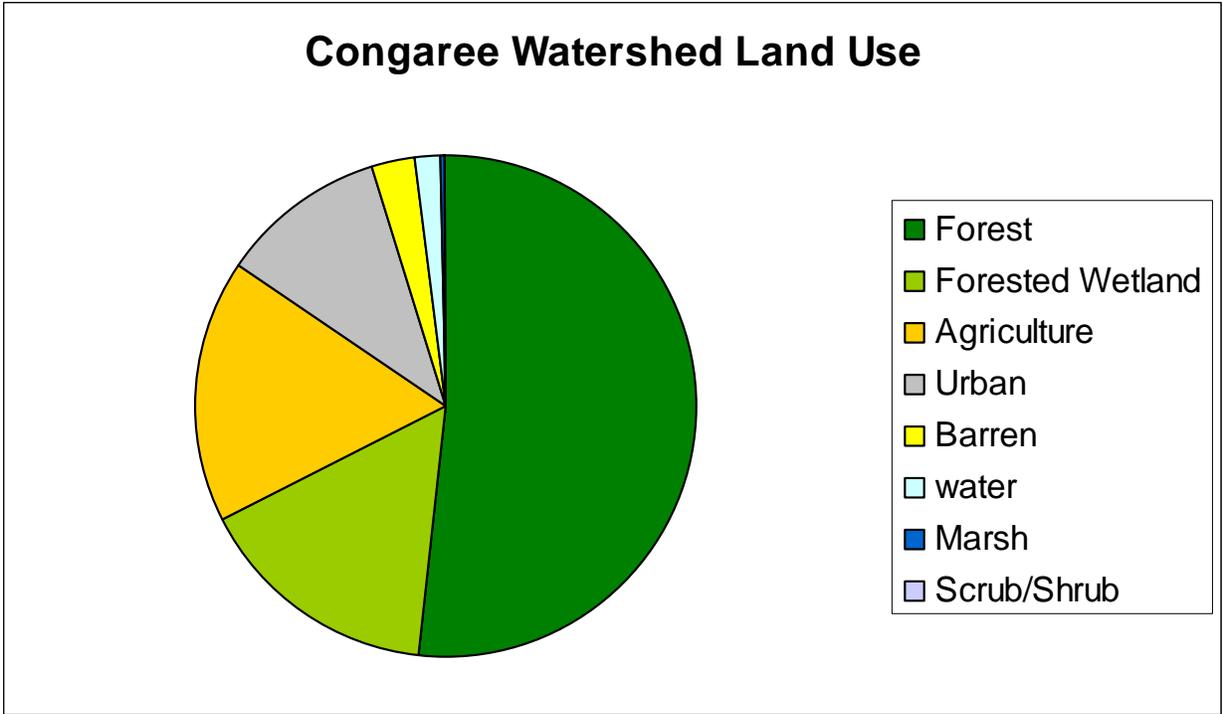
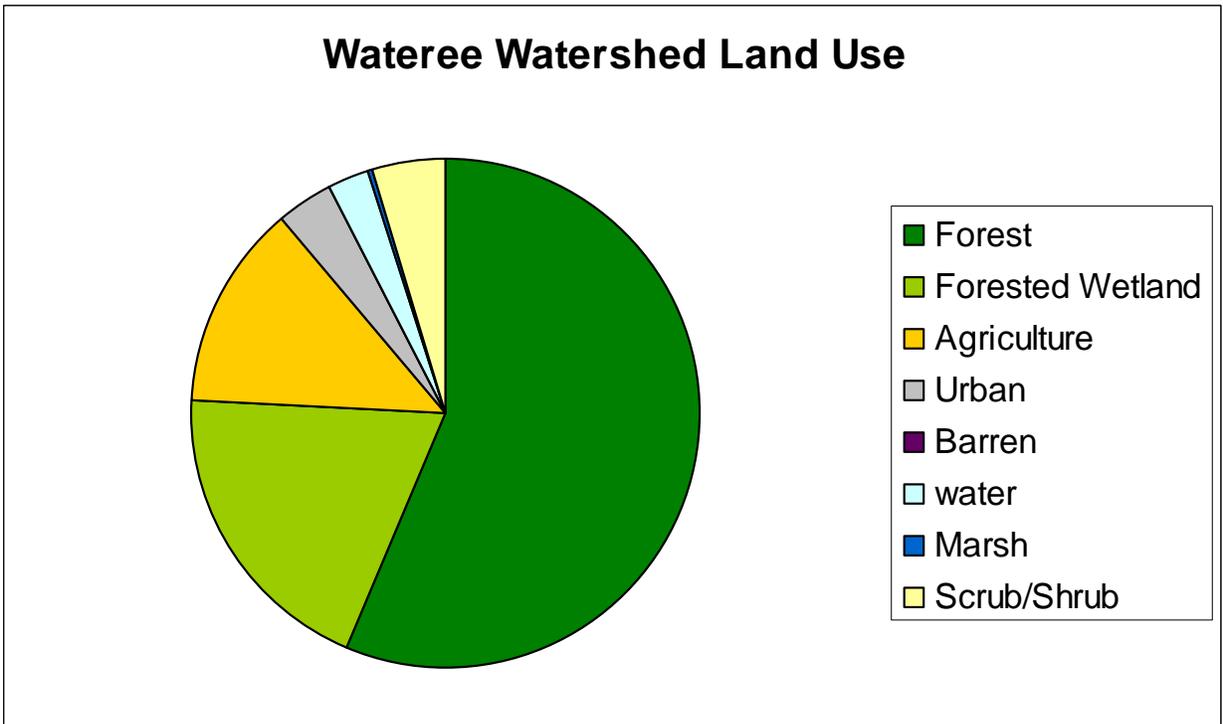
Figure 6. Land use within the Congaree and Wateree River Watersheds (SCDHEC 2004a; 2005).

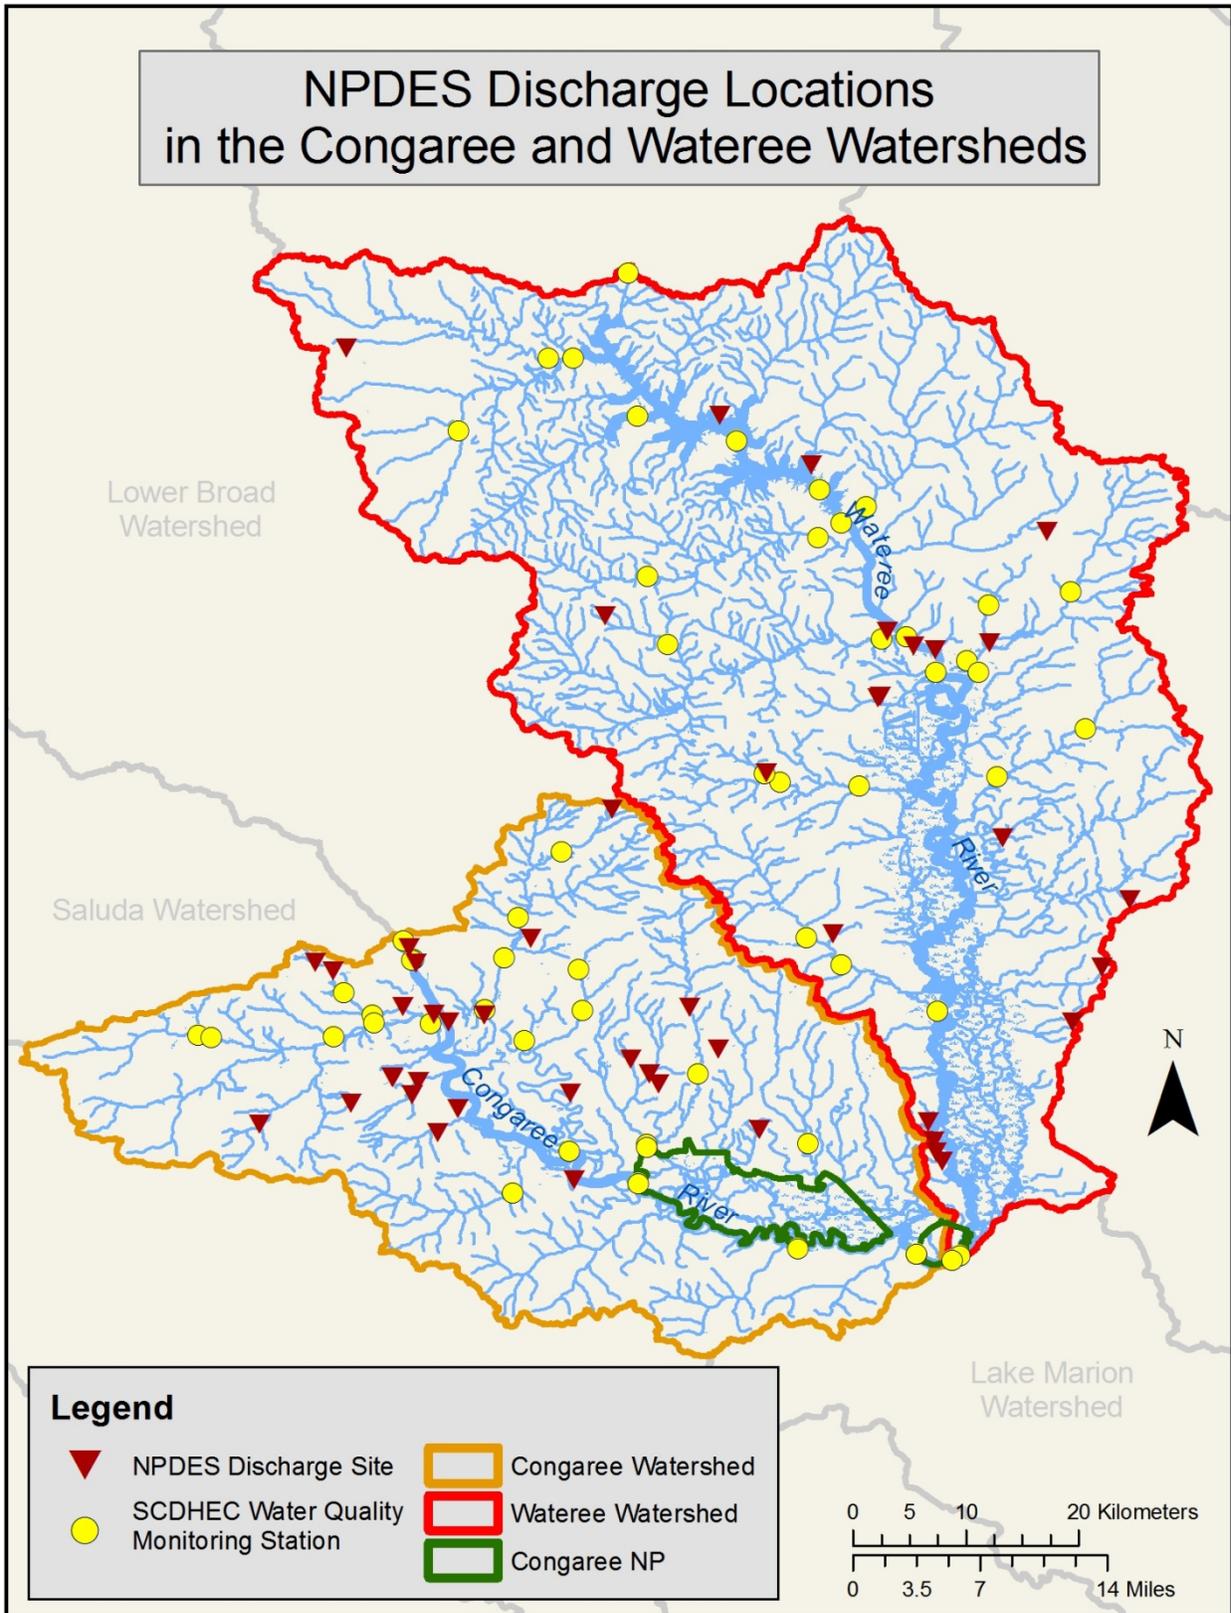
Figure 7. Location of NPDES dischargers and SCDHEC water sampling sites within or near Congaree National Park, SC.

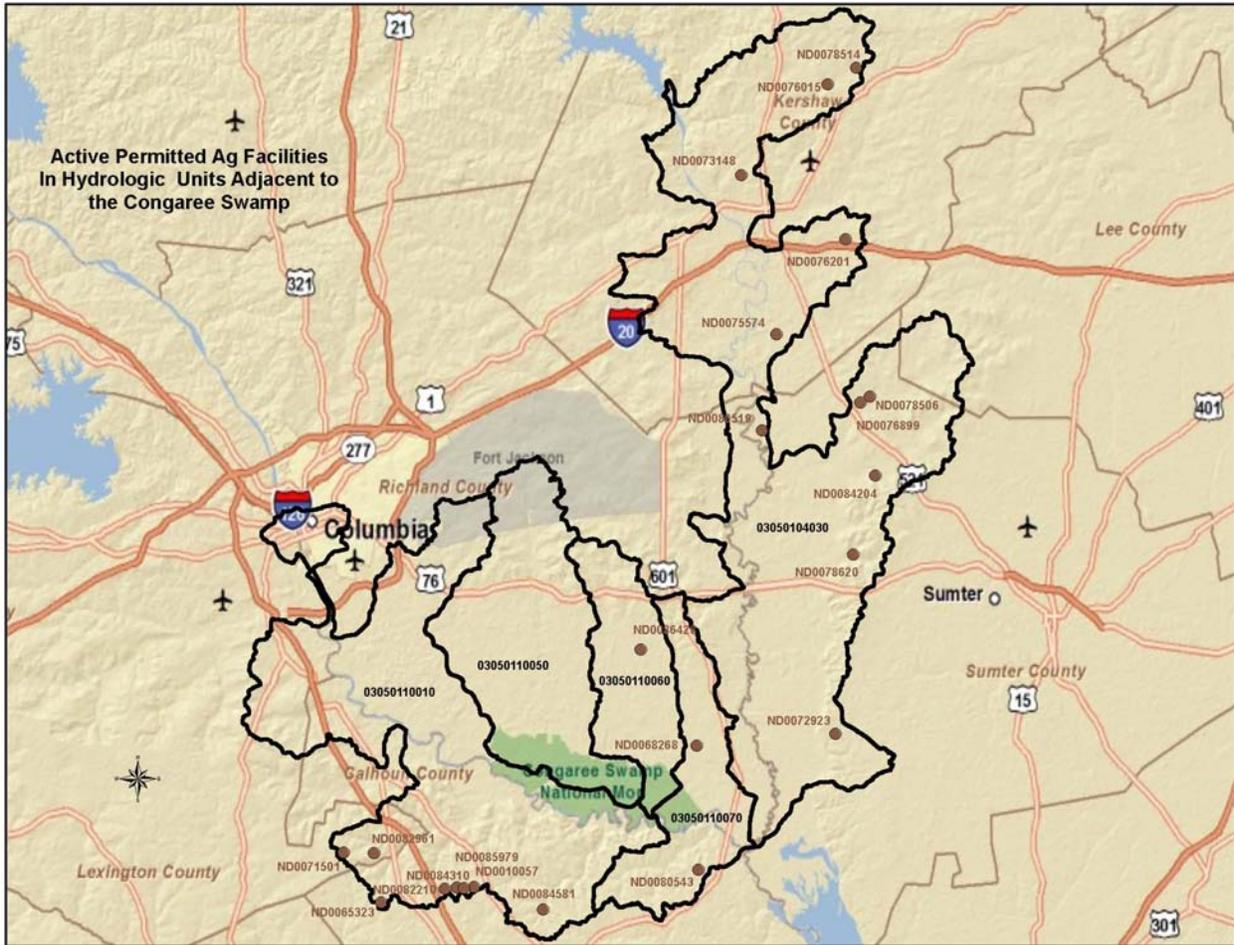
Figure 8. Location of permitted livestock production facilities (CAFOs) in watersheds impinging upon Congaree National Park (see Appendix C for map details).

Non-point source pollution consists of pollutants that are not piped off-site, but are diffused upon the landscape and subject to movement off site by stormwater runoff. Concentrated animal feeding operations (CAFOs) are large-scale livestock production facilities where dozens to hundreds (horse or cattle) or hundreds to thousands (swine) to hundreds of thousands and even millions (chicken and turkey) of animals are raised in close quarters and produce large amounts of manure. In these systems animal manure is spread out diffusely over the landscape either as liquid spray (swine waste) or dry litter (poultry waste), or semi-solid waste (cattle and hoes), this becoming non-point source pollution threats and subject to stormwater runoff carrying it into the nearest body of water. Thus, livestock waste runoff in some areas is a major water quality issue (Mallin 2000; Burkholder et al. 2007). There are several active permitted livestock facilities (located in the Congaree River, Wateree River, and Toms Creek watersheds (Figure 8). In Congaree hydrological subunit 03050110-010 none of these facilities are near the river or park and are likely not an issue, and no such facilities are located in the Cedar Creek watershed 03050110-050 (Figure 8). In Toms Creek hydrologic subunit 03050110-060 there is a stable facility (ND0086428) maintaining up to 100 horses. Runoff from such an area where horses defecate can pollute a stream with potentially pathogenic microbes. In Congaree River hydrological subunit 03050110-070 there are two poultry CAFOs (ND0080543 and ND0068268) holding between 80,000 and 100,000 birds each (Figure 8), and runoff from such facilities may be able to impact the easternmost portions of the park with fecal microbial or nutrient pollution. The Wateree River hydrological subunit 03050104-030 contains a number of permitted animal facilities, but only one is near the river itself (ND0080519) a poultry facility permitted for 80,000 birds. See Appendix C for information on all permitted CAFOs in the watersheds impinging on CONG.

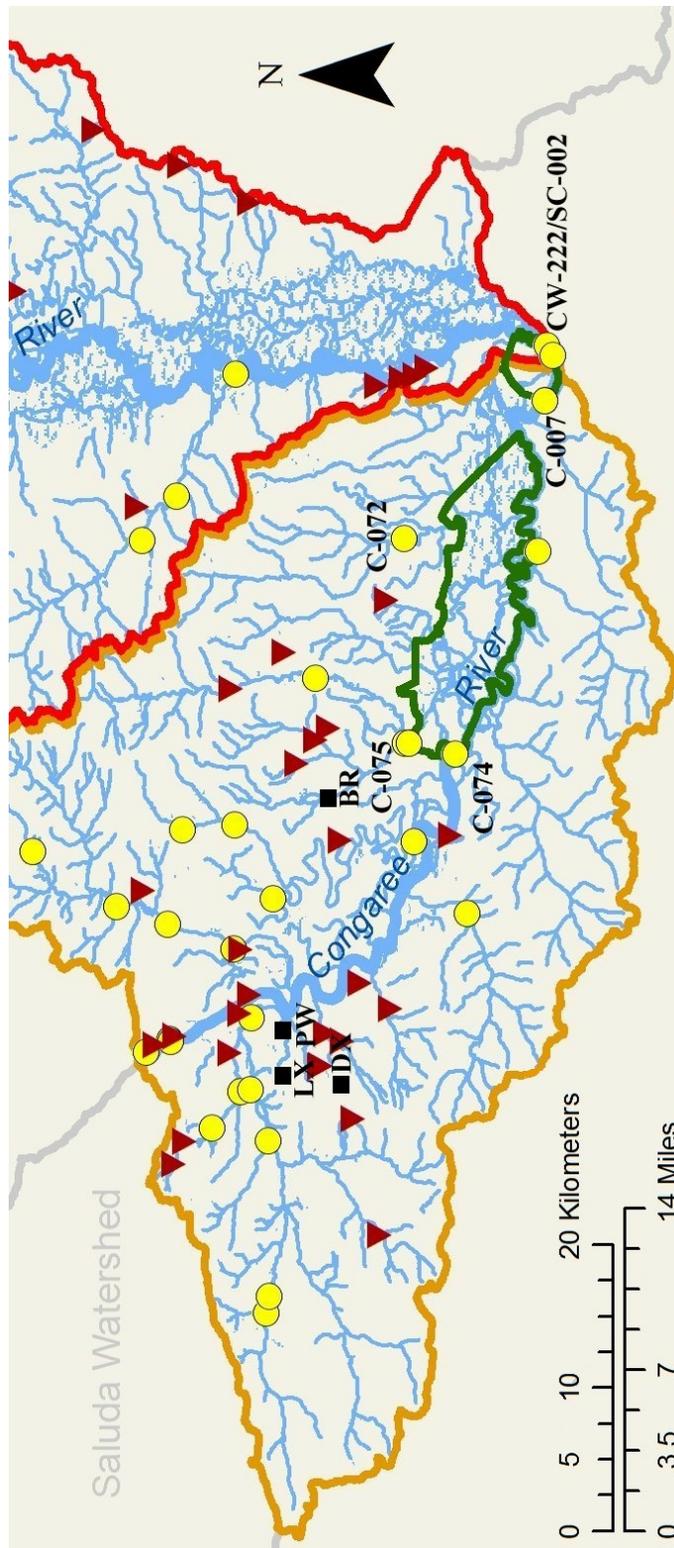
Figure 9. Location of SCDHEC active sampling sites near CONG (green border) that have data detailed on various Tables in this report, and Superfund sites that are on the EPA National Priorities List (black boxes). BR = SCRDI Bluff Road, DX = SCRDI Dixiana, LX = Lexington Landfill area, PW = Palmetto Recycling. As in Figure 7, yellow circles are SCDHEC sample sites and red triangles are NPDES locations.
