Assessment of Water Resources and Watershed Conditions in Congaree National Park, South Carolina

Natural Resource Report NPS/SECN/NRR—2010/267

Michael A. Mallin and Matthew R. McIver
Center for Marine Science
University of North Carolina Wilmington
Wilmington, NC 28409

December 2010

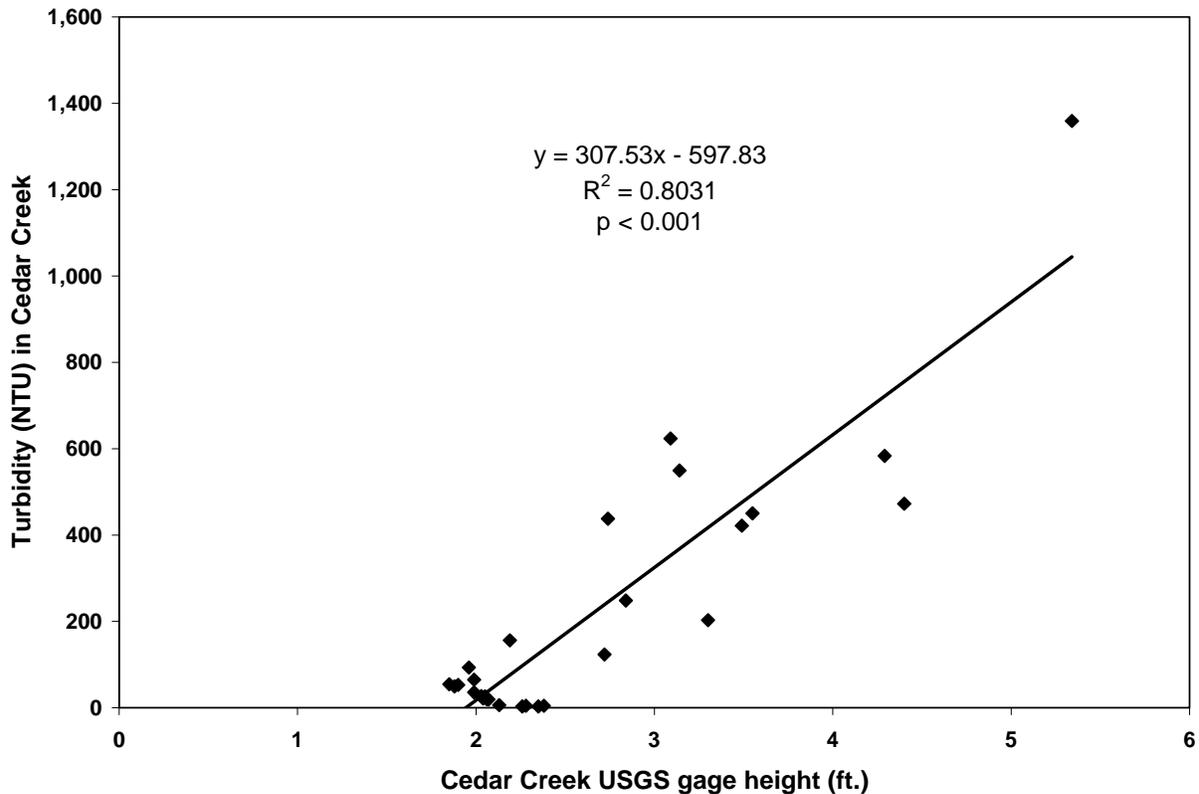
Figure 10. Regression equation predicting Cedar Creek turbidity at CONGccbr site using USGS-generated stream gage height in Cedar Creek Station 02169672, July 18 – August 14, 2008.

$$\text{Cedar Creek turbidity} = 222.6 (\text{gage height in ft. Congaree River}) + 26.9$$

However, elevated turbidity in Cedar Creek in May and early June 2007 was not significantly related to gage height in either stream ($p > 0.05$). Thus, at times elevated discharge in either Cedar Creek or the Congaree River may increase Cedar Creek turbidity to high concentrations. We note that these elevated turbidity measurements well exceed those seen in blackwater streams in southeastern North Carolina except during pollution incidents (Ensign and Mallin 2001; Mallin et al. 2006).
