National Park Service  
Cultural Landscapes Inventory  
2001

Castle Crest Wildflower Trail  
Crater Lake National Park

**Castle Crest Wildflower Trail  
Crater Lake National Park**

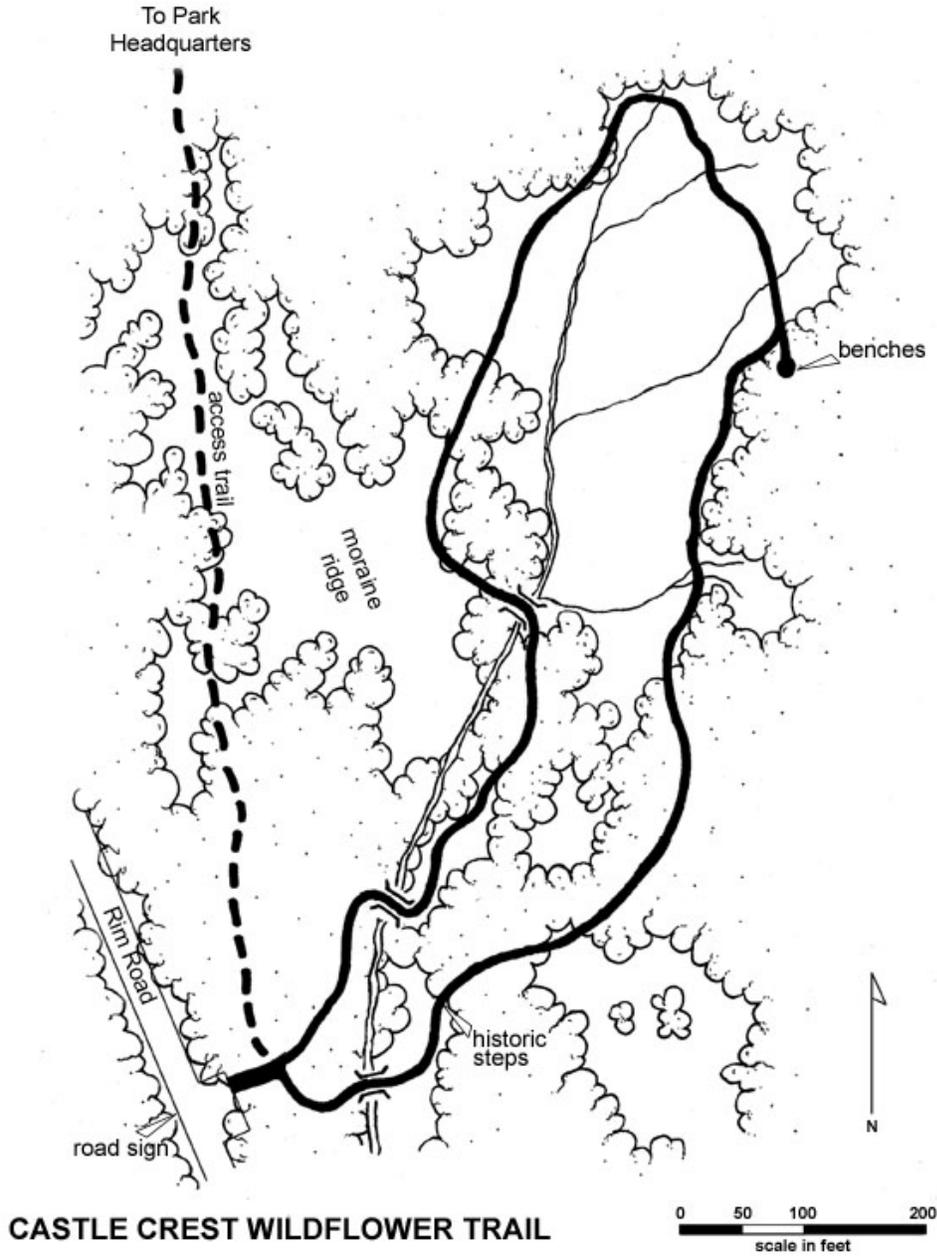
2001 site diagram showing the alignment of the Castle Crest Trail. (CCSO, 2001)

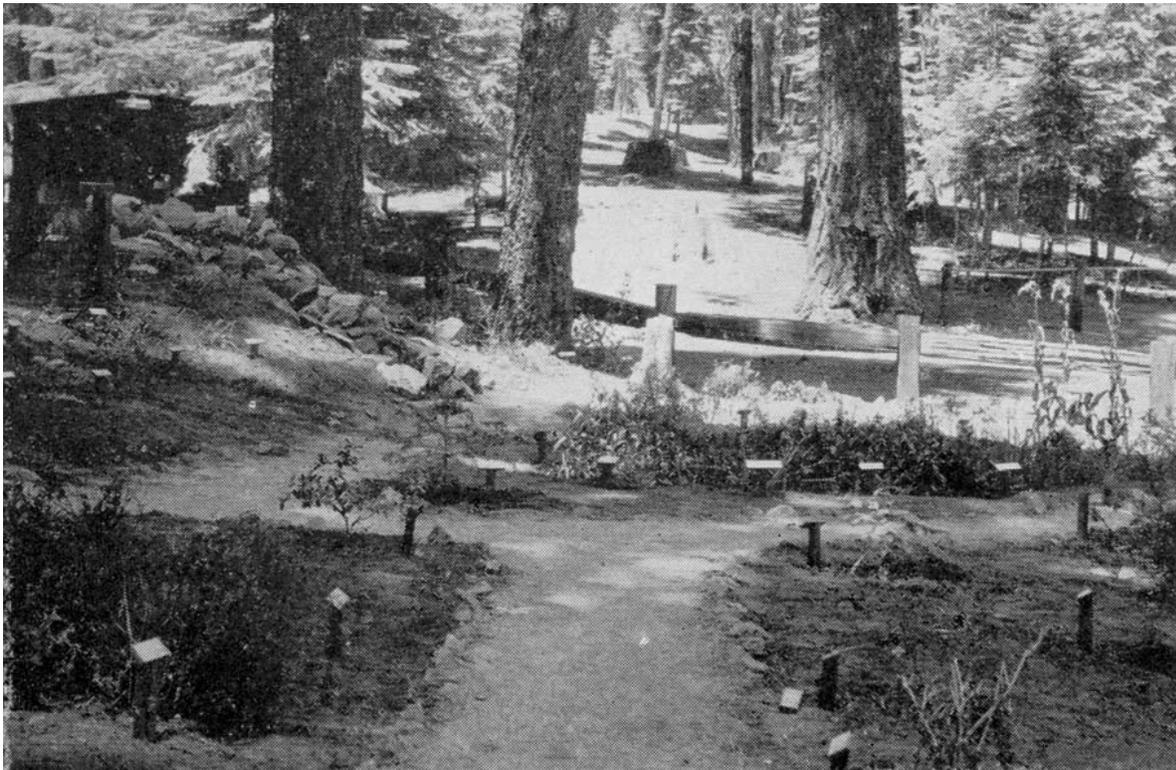
*Historic photograph of a completed wildflower garden at the Giant Forest Museum in 1929. The original labels in the Castle Crest Wildflower Trail would have looked similar. (Kelley, 1931)*

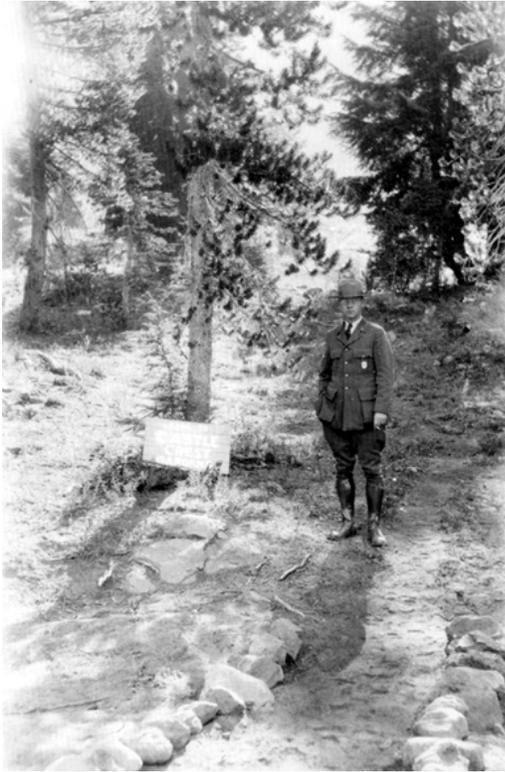
*Historic photograph of a naturalist at the original entrance to “Castle Crest Garden.” (CRLA archives, c. 1930)*

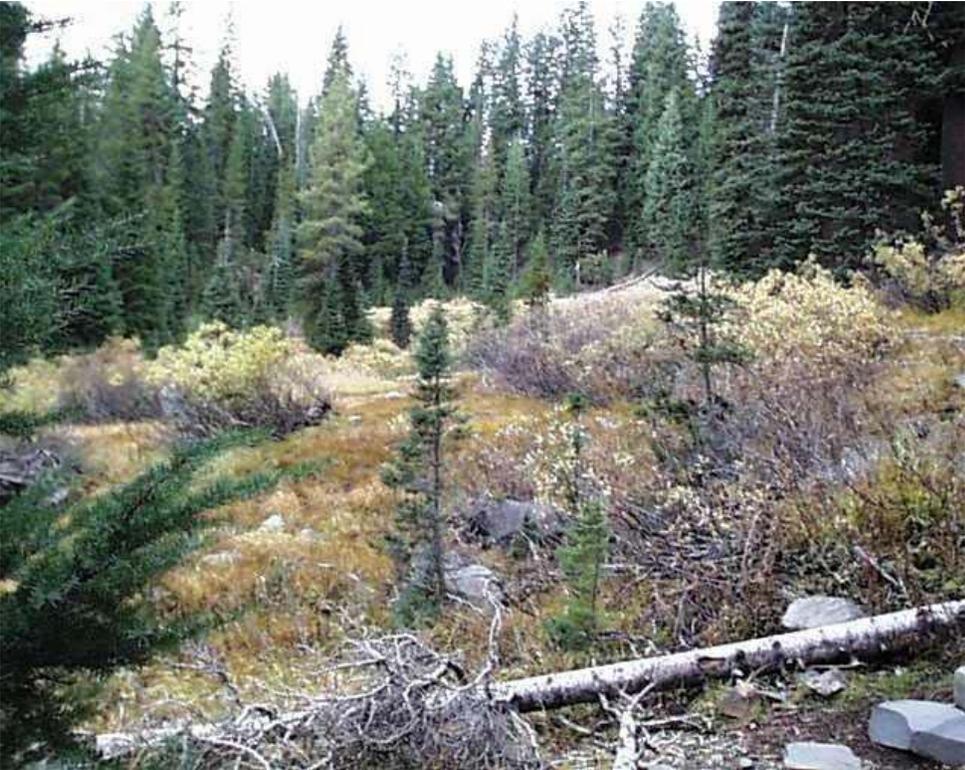
*Contemporary photograph of the Castle Crest meadow enclosed by mature forest. The trail skirts the edge of the meadow. (CCSO, 2001)*

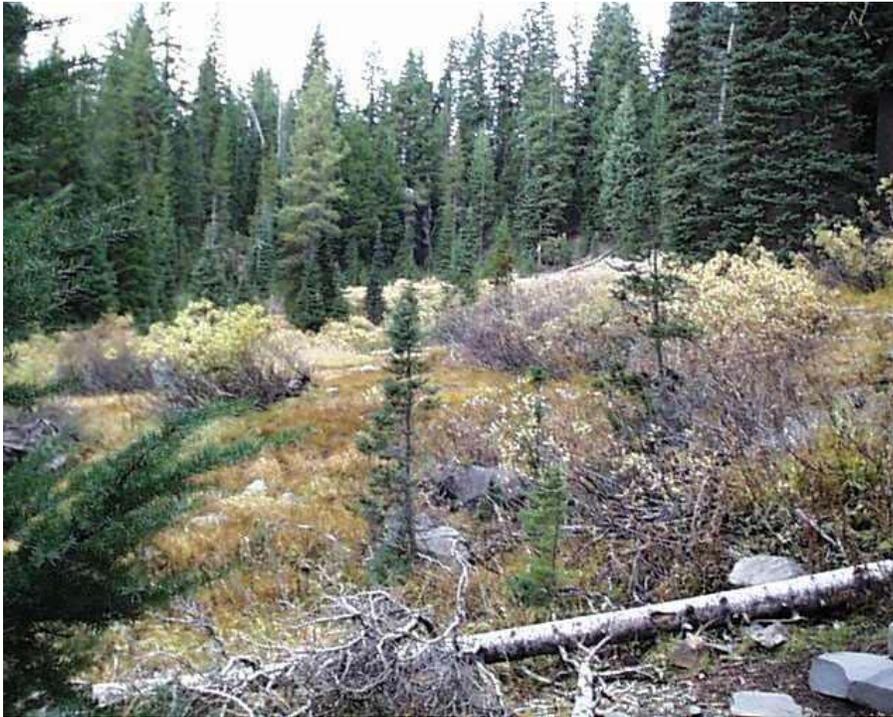
*Photograph of the Castle Crest meadow in autumn, 2001. Integrity of the meadow is threatened by early forest succession. (CCSO, 2001)*

A threat to vegetation as a landscape characteristic does exist. The slow encroachment of trees and other forest species into the meadow is changing the meadow wildflower species to forest species. The wildflower garden and nature trail were sited for the predominance of wildflowers within the Castle Crest meadow. Loss of these meadow wildflowers would effect the historic integrity of the landscape.

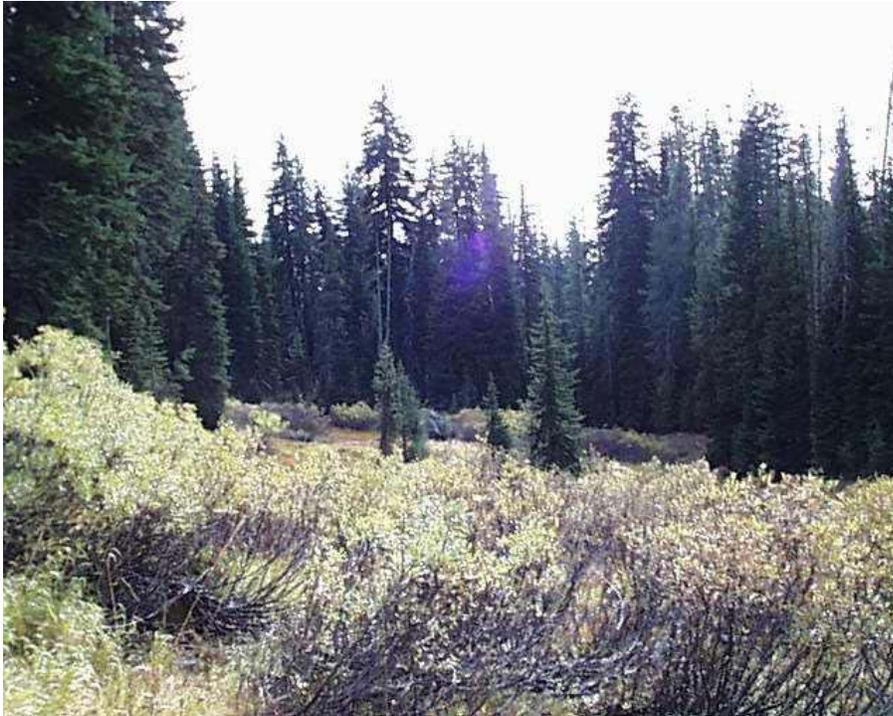
*Contemporary photograph of the Castle Crest meadow, showing the open expanse of the meadow, bordered by forest. Notice the young trees growing in the middle of the meadow. (CCSO, 2001)*

The integrity of the site is being threatened as trees are beginning to grow and mature within the meadow. Natural systems and features, however, currently do contribute to the integrity of the Castle Crest Wildflower Trail. Ecological and anthropological research in the region of Crater Lake indicate that the Castle Crest meadow was not anthropogenically created or maintained based on its elevation. The meadow was more likely the result of a naturally occurring, wet, spring-fed area with occasional natural fires. Fire suppression policies have been one factor that has encouraged forest succession within meadows throughout the region and likely a cause in this particular landscape (Interviews with Steve Mark and Jeff LaLande 2001).

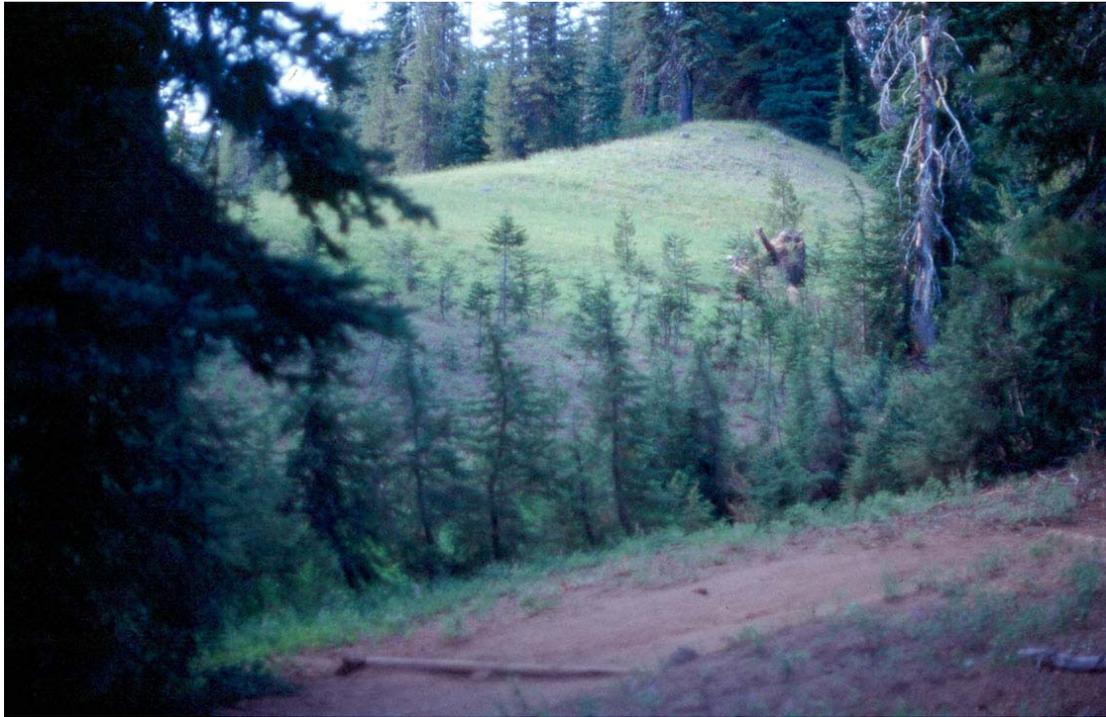
*Contemporary photograph of a moraine on the southern edge of the meadow. The moraine directs flow of the stream (hidden behind the row of young trees) through the Castle Crest meadow. (CCSO, 2001)*

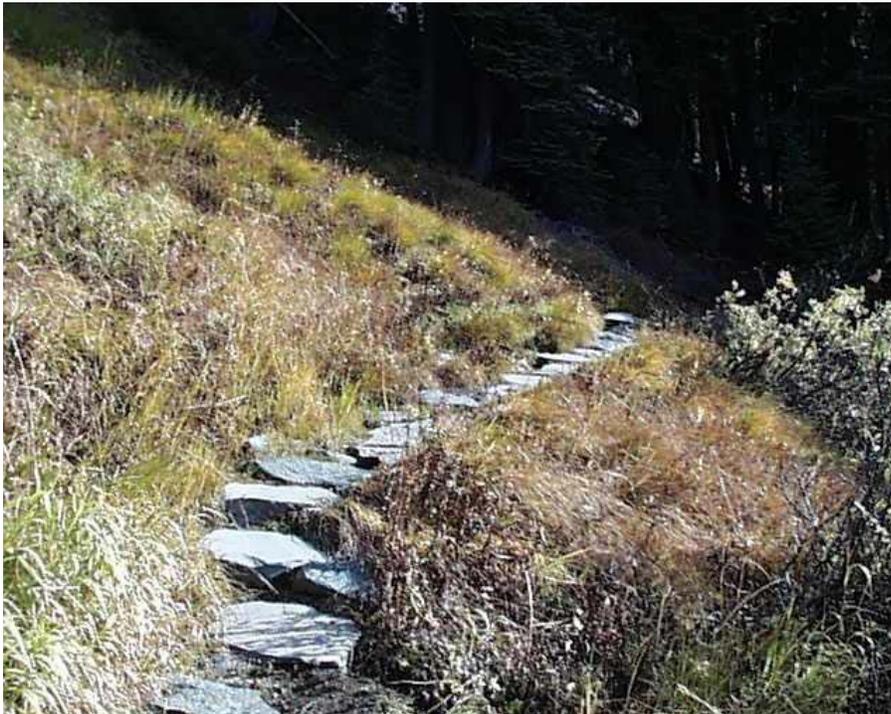
*Contemporary photograph of stepping stones used to traverse wet meadow. (CCSO, 2001)*

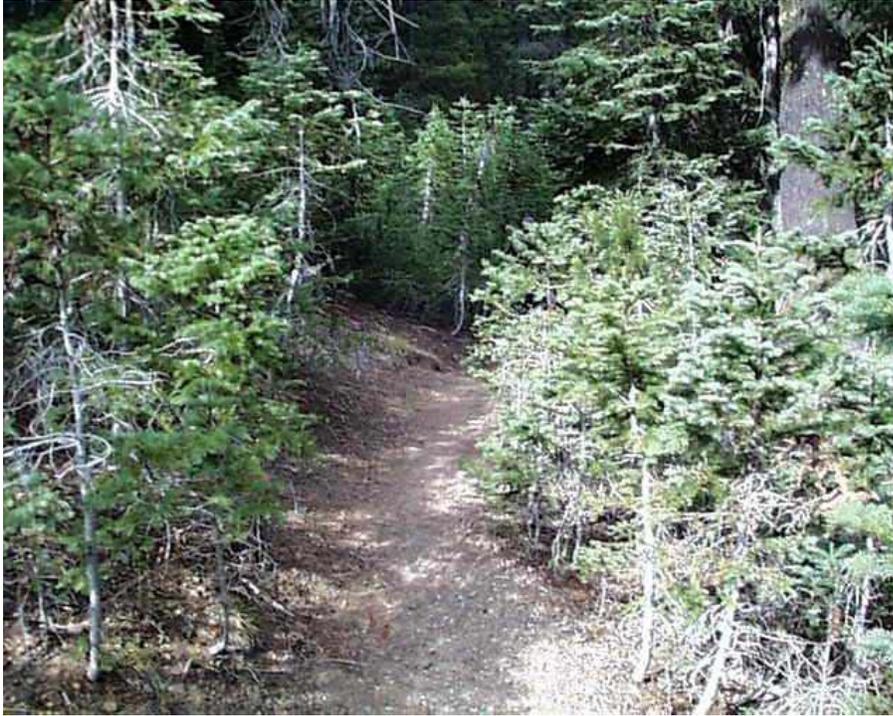
*Contemporary photograph of the trail winding through young trees. The trail tread here is mainly crushed pumice mixed with evergreen needles. (CCSO, 2001)*

Today, the trail continues to be approximately 3' wide, varying from 2'-5', with unclear edges. The trail tread consists of the native soils, predominately a mixture of sand, crushed pumice, and a scattering of jagged rocks (1"-8" in diameter). Where the trail passes through forest, the trail tread is composed of forest duff. Local flagstone is still used to pass over the meadow springs. These stones are approximately 18" wide. Field observations reveal that, although the trail has had minor realignments (such as one on the south side of the meadow where an older trail passes closer to the stream), the overall alignment of the trail is relatively unchanged. These aspects of the trail reflect the historic character of the trail and contribute to the Castle Crest Wildflower Trail's historic integrity.

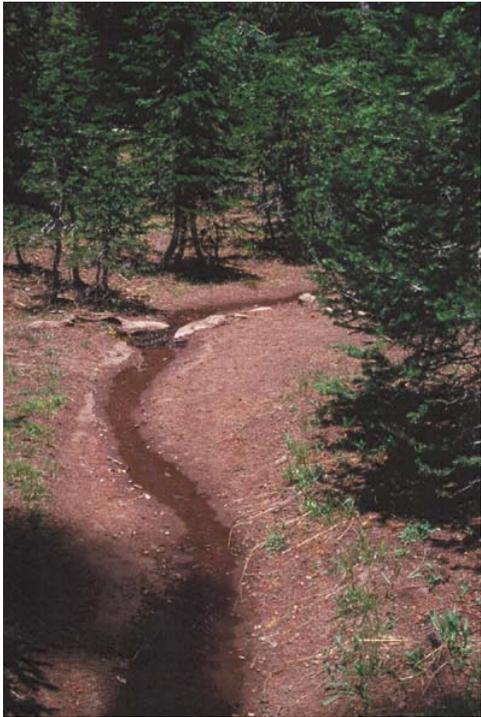
Photograph showing drainage problems along the access trail to Castle Crest meadow, c. 1990. Similar drainage issues affect the Castle Crest Wildflower Trail as well. (CCSO archives)

Stabilize trail tread by addressing drainage problems near bridges. Currently, the cross-section of the trail slopes down to the centerline in such a way that causes the trail to convey water during heavy rainfall. The areas with greater instability, heading in a counter clockwise direction around the meadow, include: (1) 20’ between the trailhead and the first bridge, (2) 10’ north of the first bridge, (3) 20’ on the southern side of the second bridge, and (4) 40’ on the north side of the third bridge. Add trail tread material (native soil) to sections to fill gullies and to regrade the tread slope to pitch 2% to one side. Dig a side ditch to collect and direct water to stream. Raise silt logs to trail tread grade.

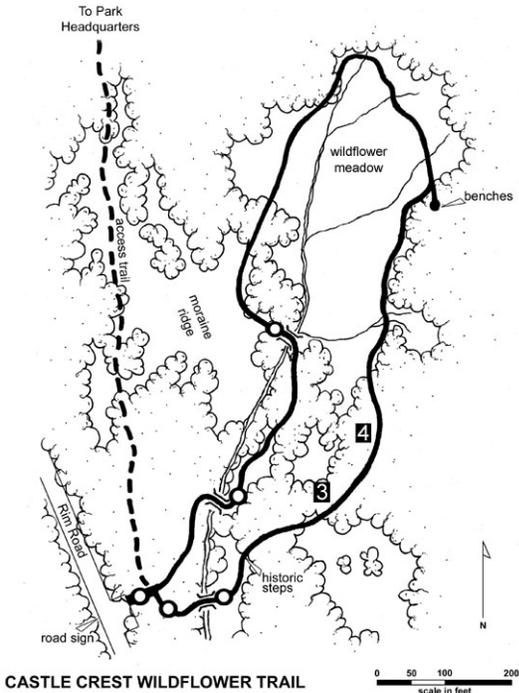
The trail grade currently ranges from 0-7%. The cross-section of the trail slopes inward to the centerline in such a way that causes the trail to convey water during heavy rainfall. Gullies have formed in the trail tread and are a threat to the trail's integrity. The areas of most danger, heading in a counter clockwise direction around the meadow, include: the large open area at the trailhead entrance, 20' between the trailhead and the first bridge, 10' north of the first bridge, 20' on the southern side of the second bridge, and 40' on the north side of the third bridge. These are all areas where the trail slopes down to meet the grade of the stream bank. Between the interpretive posts #3 and #4 is a section of trail where large rocks have tumbled down the slope over time and interfere with the trail tread. The trail tread needs some stabilization to ensure the landscape's integrity. See "Stabilization Measures" for more information.

2001 site diagram with white-centered dots marking locations of erosion problems on the trail. (CCSO, 2001)

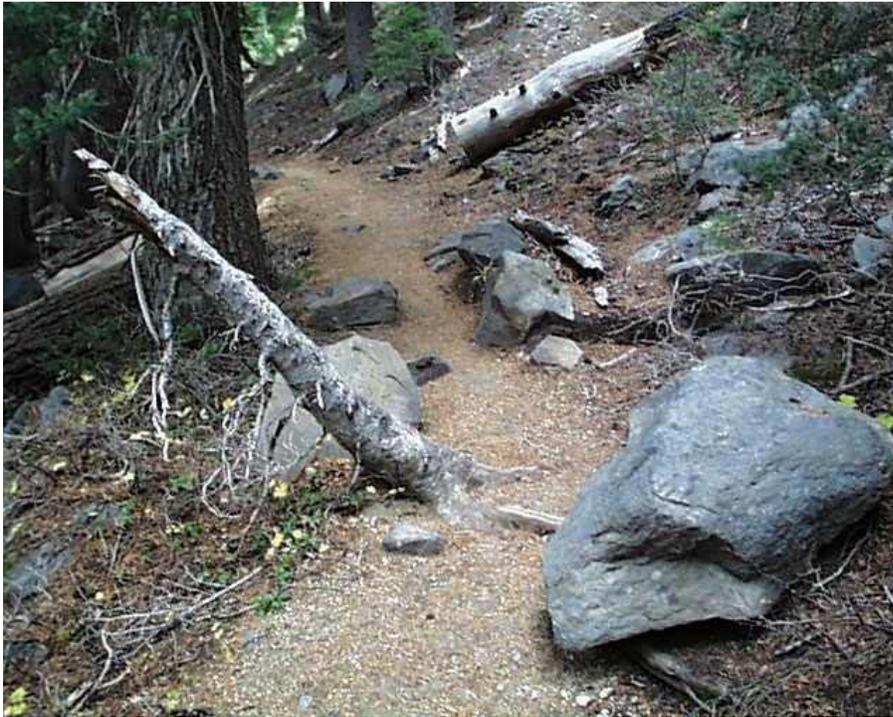
*Contemporary photograph of rocks and tree roots that interfere with a short segment of the trail. (CCSO, 2001)*

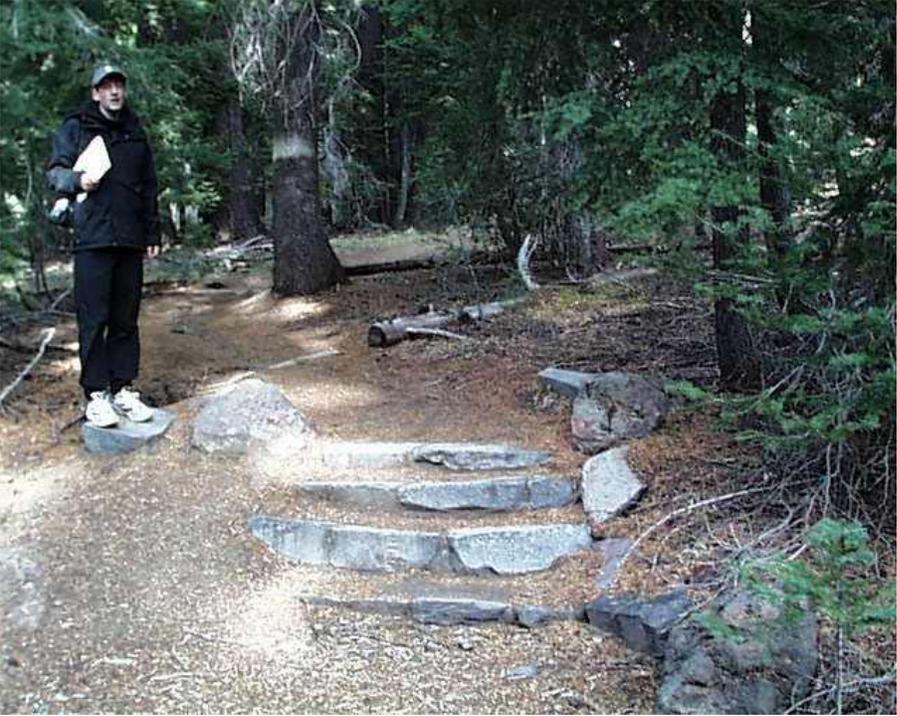
One small-scale feature along the Castle Crest Wildflower Trail is an original feature built during the period of significance. This feature is a set of stone steps located on the trail north of the #2 interpretive marker. These steps were built in the rustic style adopted by the National Park Service during the early years of park development. The four risers were constructed, consistent with rustic-style methods, of cut and mortared native stone from a nearby slope. These steps still exist, but they are becoming covered by forest duff.

*Contemporary photograph of cut and mortared stone steps on the Castle Crest Wildflower Trail. These steps were built in the rustic style popular during the site's period of significance. (CCSO, 2001)*

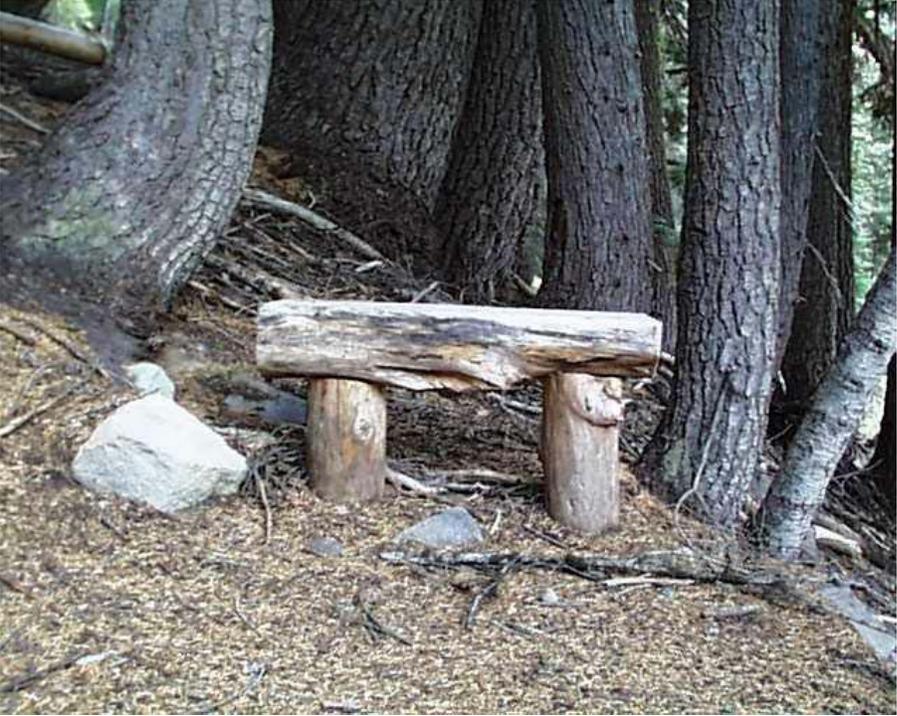
Five footbridges were built along the trail in 1929 (Superintendent's Annual Report 1929). These bridges were referred to as "log bridges" in one of the naturalist reports (Doerr, Park Naturalist Report 1938). Today, three recently constructed bridges exist. They were reconstructed in the rustic-style of historic footbridges built in Munson Valley during its early development (photograph of bridge in Munson Valley, c. 1930). Large logs were used for the curbs. Short pylons are placed on each end of the curbs. The tread of the bridges meets the tread of the trail. Located in the same locations as the original bridges, these three rustic bridge reconstructions are compatible features of the site, but non-contributing.

*Contemporary photograph of a rustic bridge reconstruction along the Castle Crest Wildflower Trail. (CCSO, 2001)*

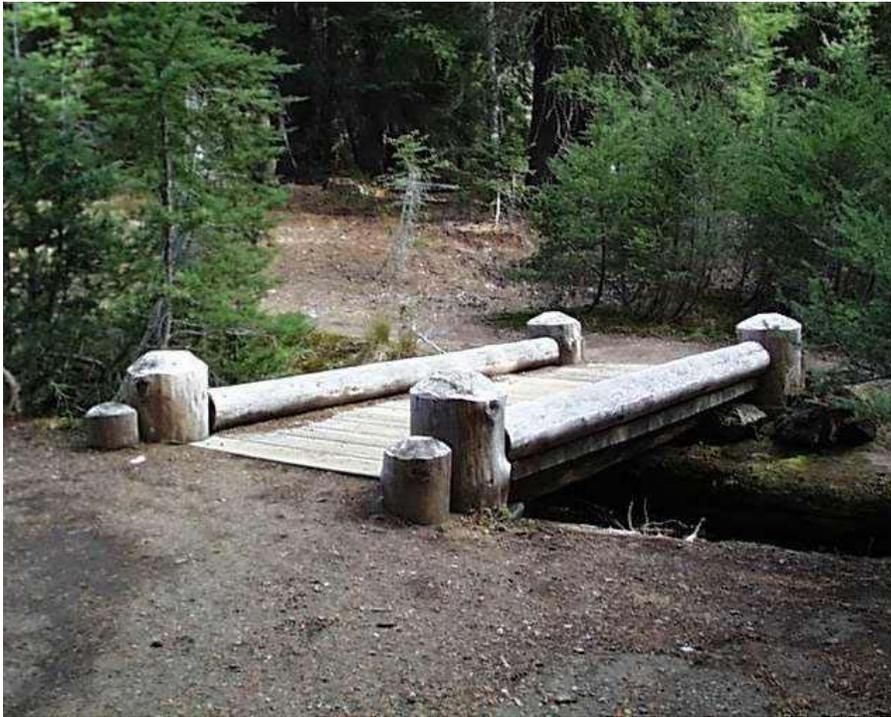
*Contemporary photograph of a footbridge reconstruction along the Castle Crest Wildflower Trail. (CCSO, 2001)*

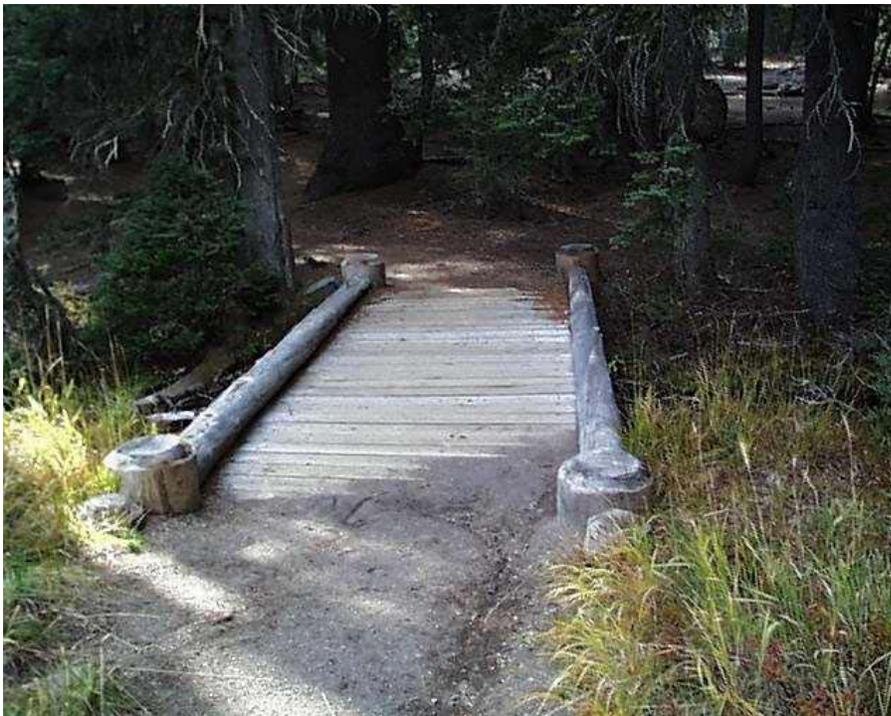
*Contemporary photograph of erosion occurring on the Castle Crest Wildflower Trail. Such erosion threatens all three bridges along the trail. (CCSO, 2001)*

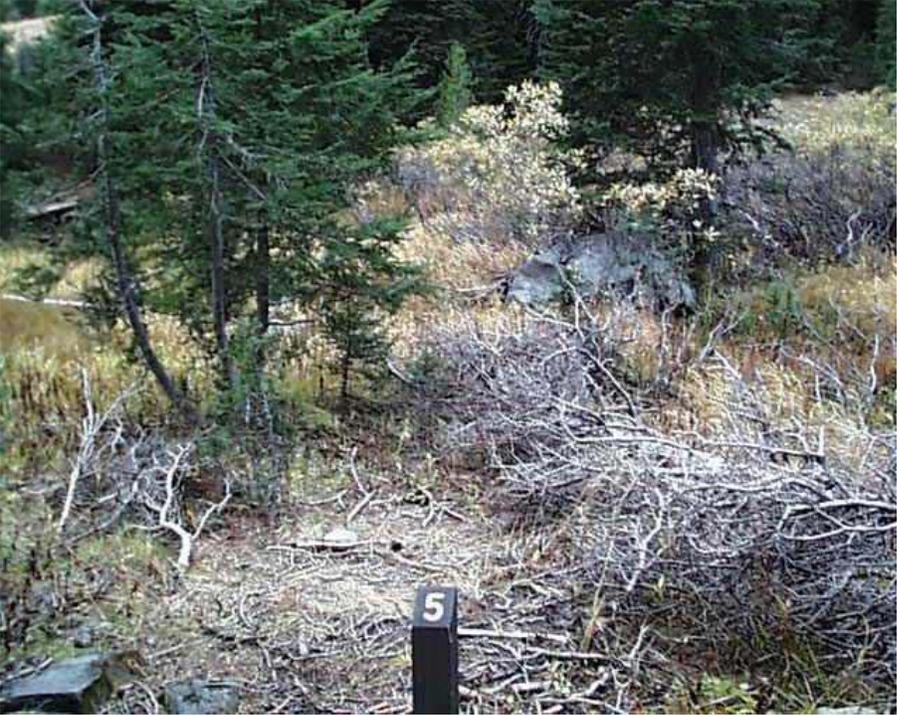
*Contemporary photograph of an interpretive post along the Castle Crest Wildflower Trail. (CCSO, 2001)*

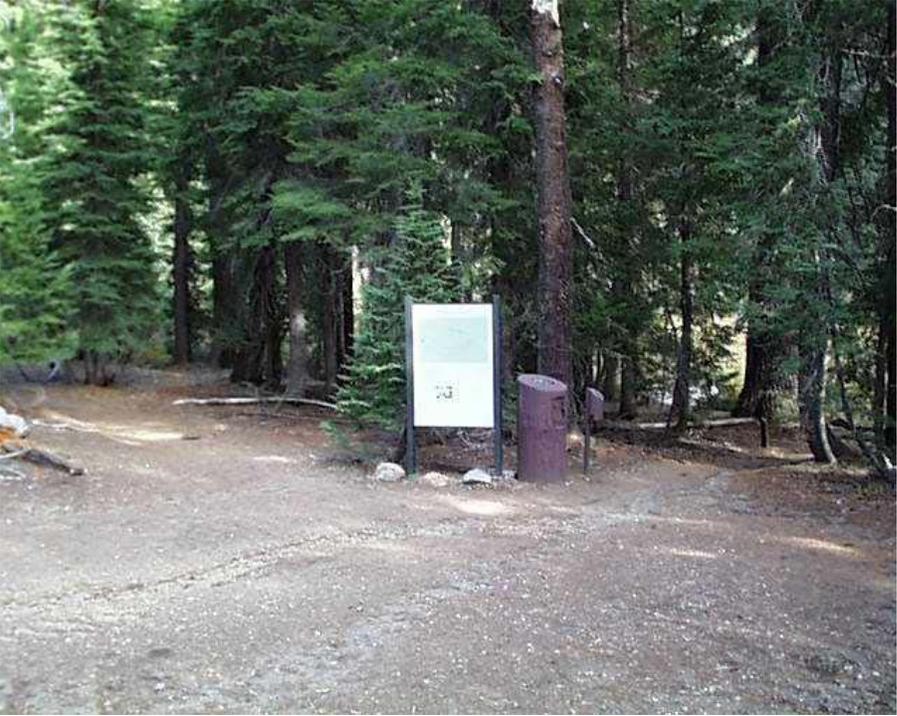
One temporary sign at the original entrance to the Castle Crest meadow was documented the 1930s photograph of a naturalist. The sign currently posted at the trailhead was designed and implemented in the mid-1980s as part of the "Parkwide Wayside Exhibit Plan" (1985). Currently, a sign is posted on Rim Road that resembles a sign specification drawn in 1952. These signs do not contribute to the site's historic integrity.

*Contemporary photograph of the sign at the trailhead to the Castle Crest Wildflower Trail. (CCSO, 2001)*

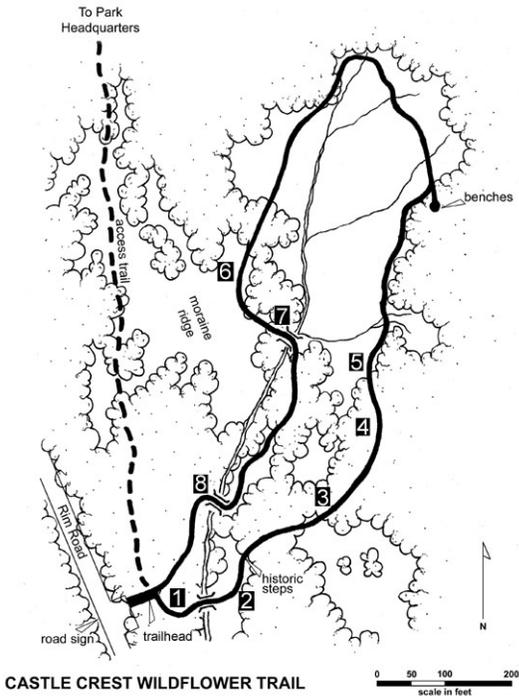
2001 site diagram showing locations of small-scale features along the Castle Crest Wildflower Trail. The numbered squares correspond to interpretive markers. (CCSO, 2001)

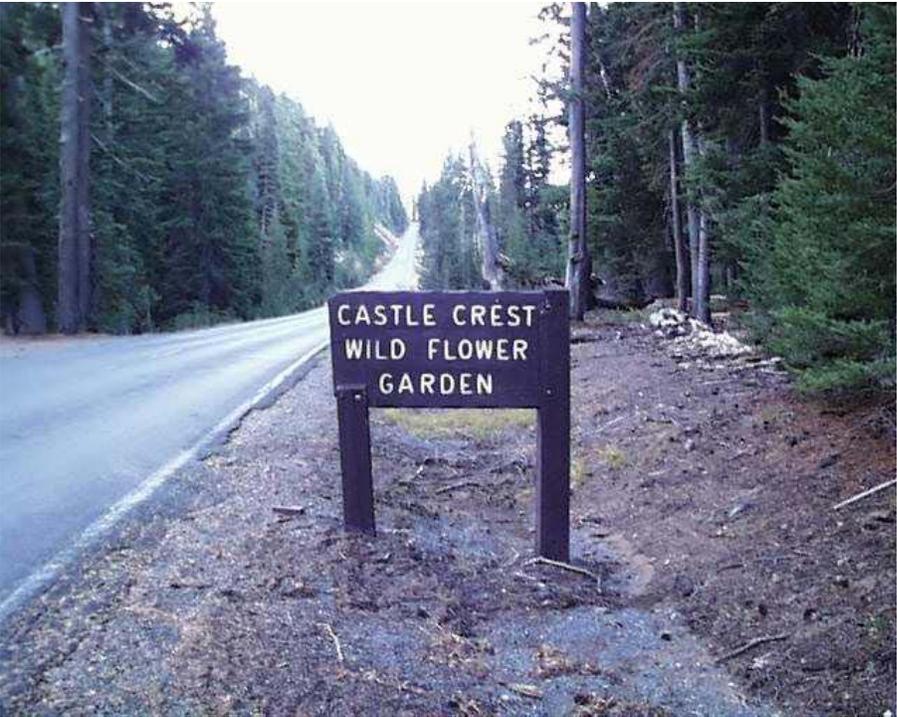
Contemporary photograph of the sign along Rim Road marking the parking lot at the trailhead. (CCSO, 2001)
