National Park Service  
Cultural Landscapes Inventory  
2011

Rim Drive Historic District  
Crater Lake National Park

## Rim Drive Historic District Crater Lake National Park

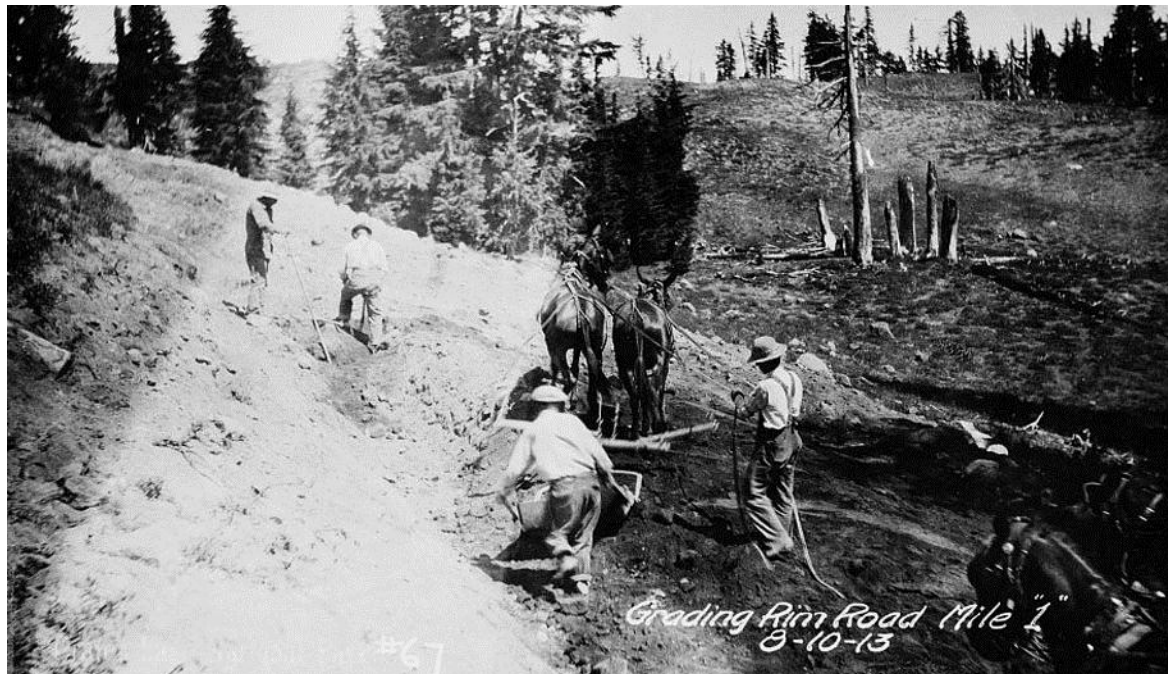
History #1: Grading the old Rim Road, 1913 (NARA, RG 77, DC).

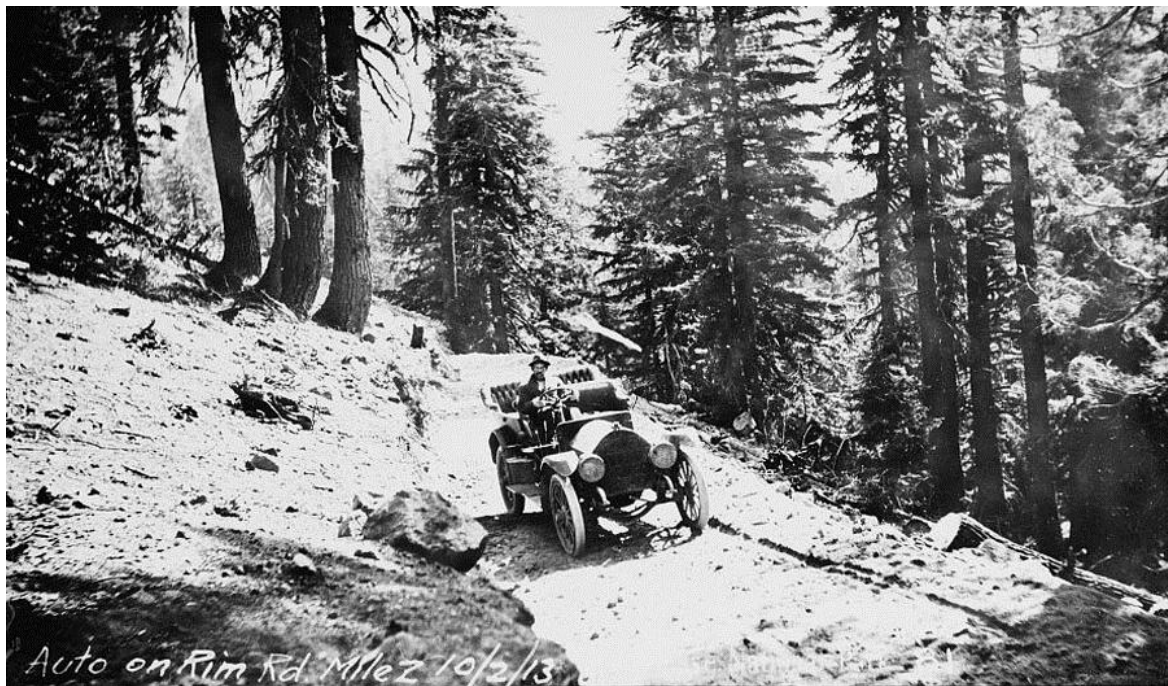
History #2: Automobile on newly graded section of the old Rim Road, 1913 (NARA, RG 77, DC).

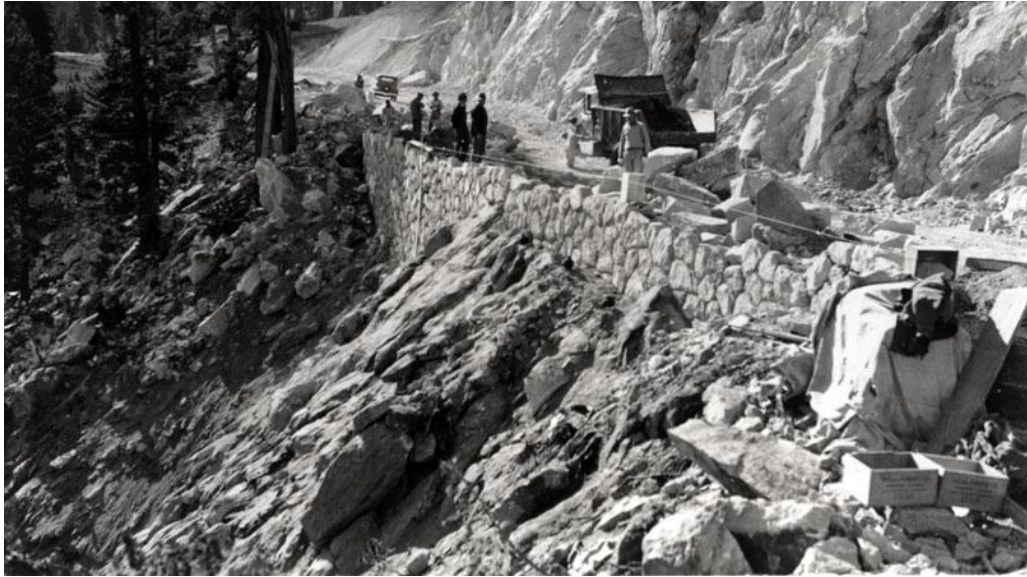
History #3: Construction of a stone masonry retaining wall at Scott Bluffs, 1934 (Doerner, NARA, RG 79, SB).

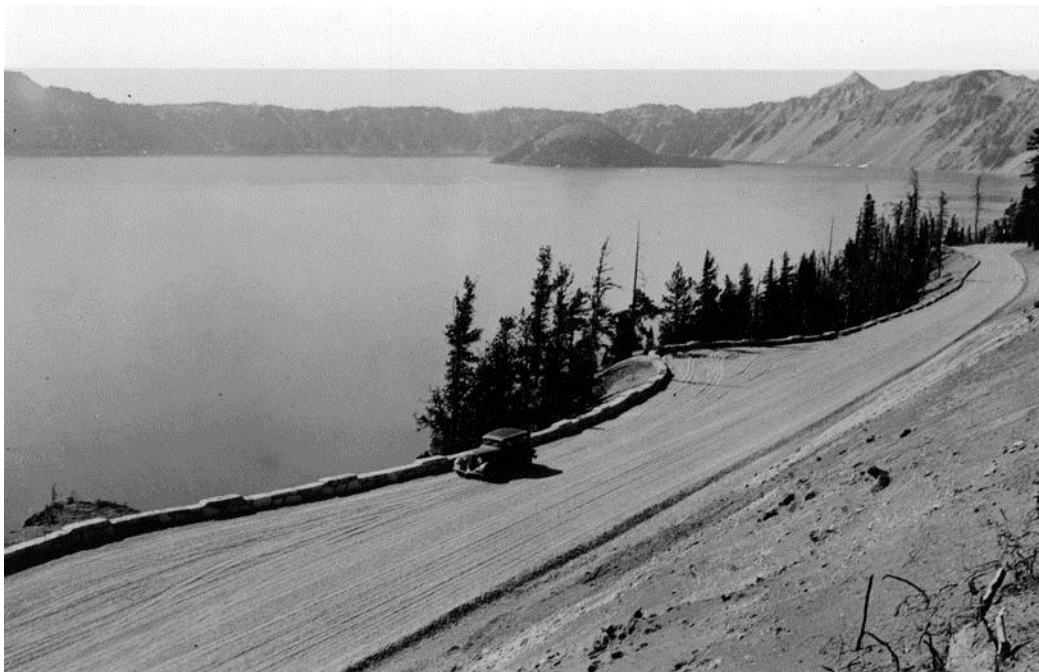
History #4: Parking area and associated guard wall near Cleetwood Cove in segment 7-B, 1936. Note the merlons and curvilinear form of the guard wall (Lange, NARA, RG 79, SB).

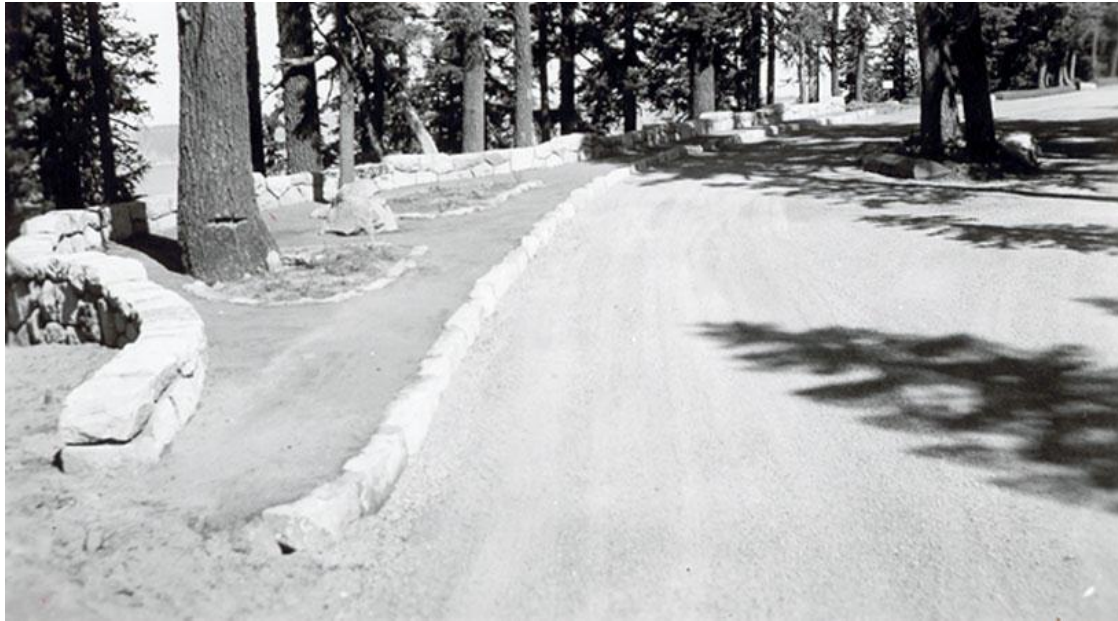
History #6: Parking area associated with the Kerr Notch observation station. Note curbing, guard walls and planting beds visible in photo, 1938 (Lange, CLNPMAC).

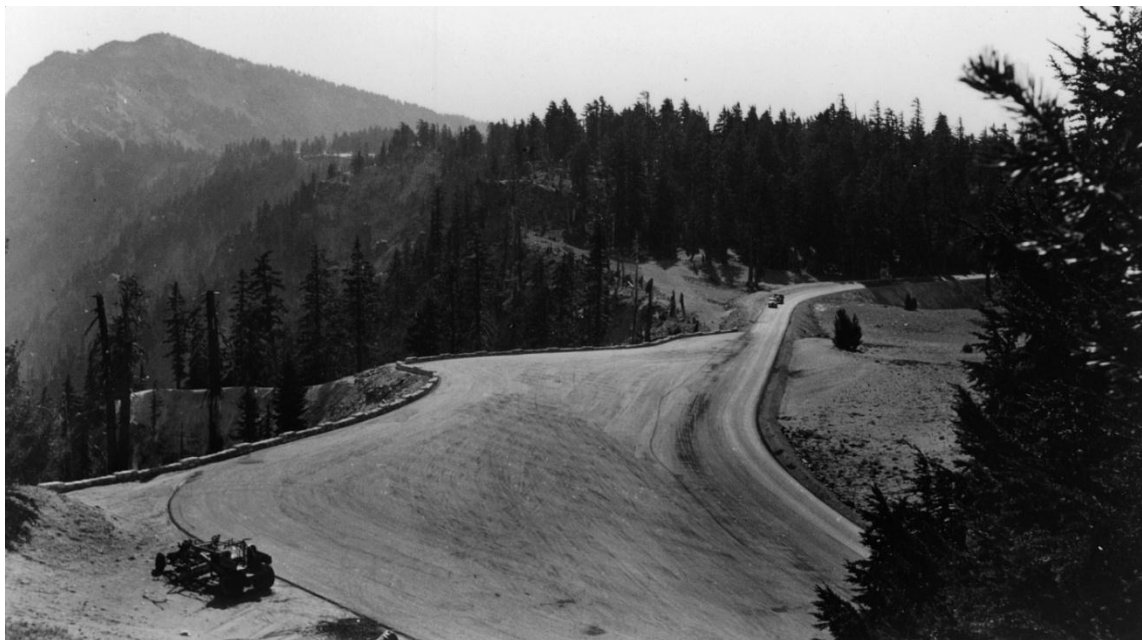
History #5: Parking area near Discovery Point. Note masonry guard wall with merlons, 1935 (Lange, NARA, RG 79, SB).

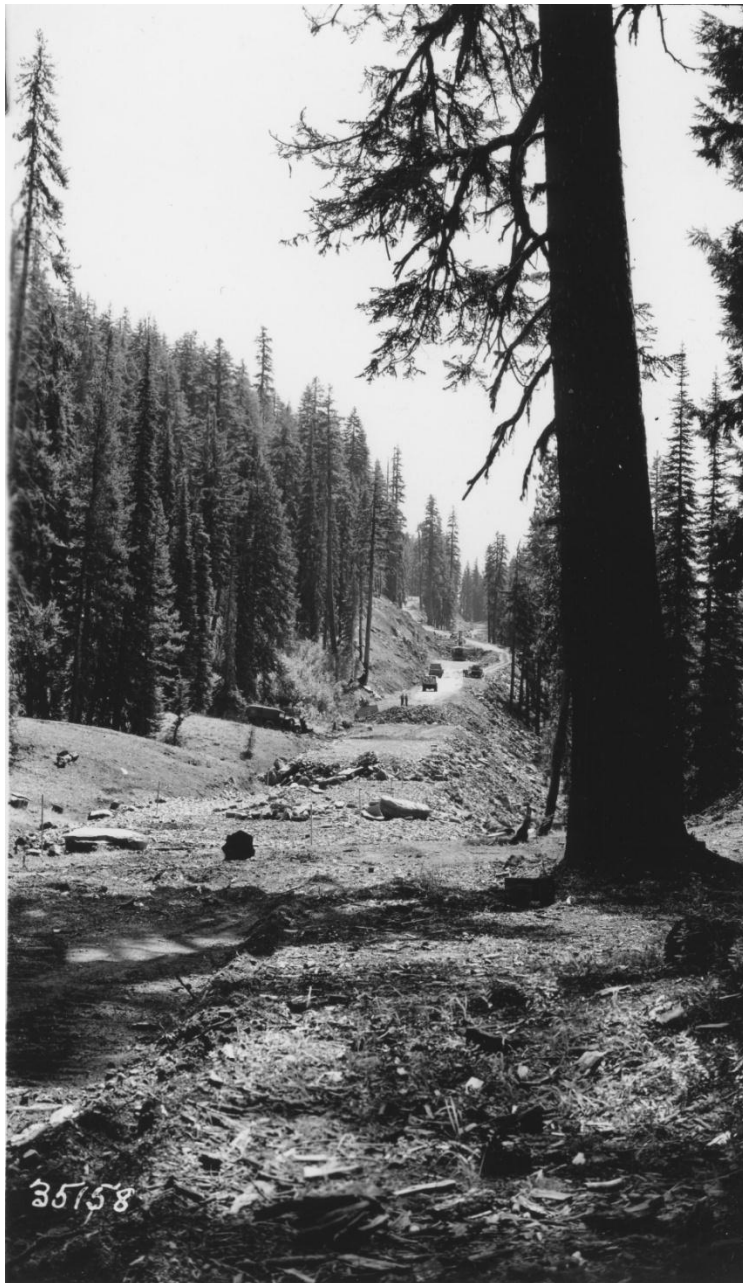
History #7: Rim Drive road construction east of the Castle Crest Wildflower Trail, 1939 (Struble, BPR).

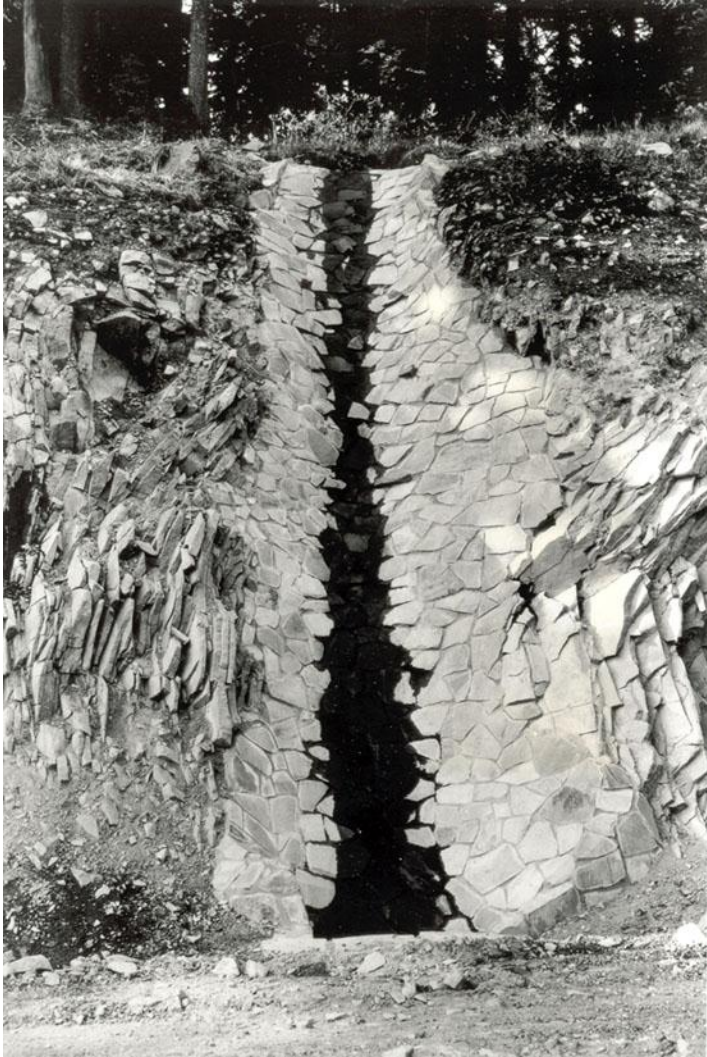
History #8: Stone masonry spillway located along segment 7-D2 (Lange, NARA, RG 79, SB).

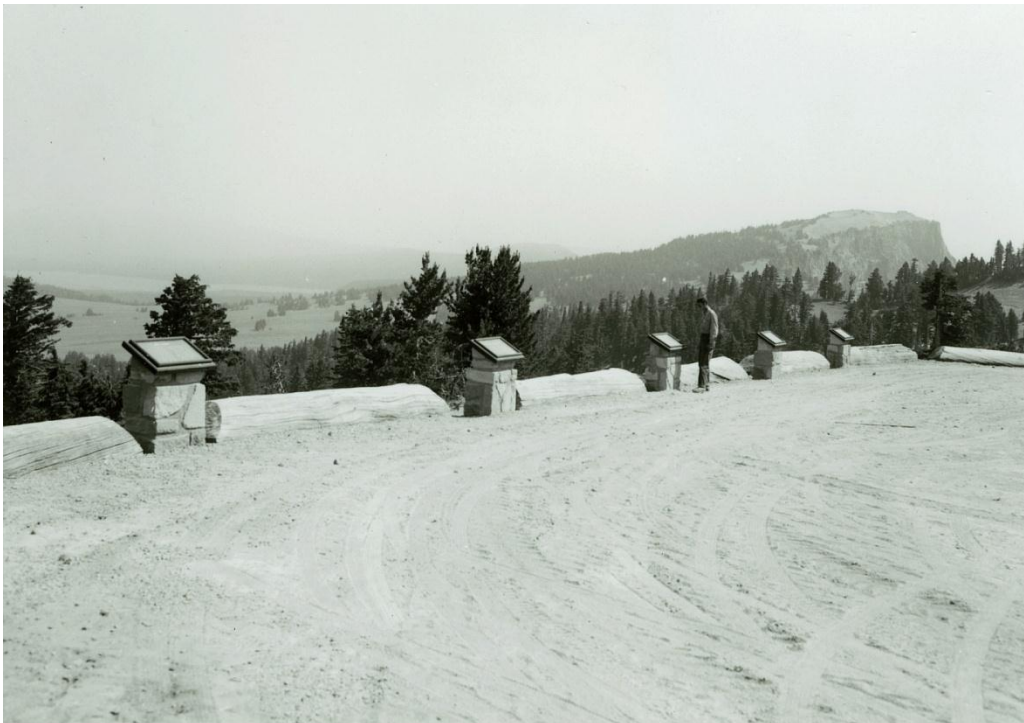
History # 10: The Diamond Lake substation with wayside exhibits located between log guardrails, 1959 (CLNPMAC).

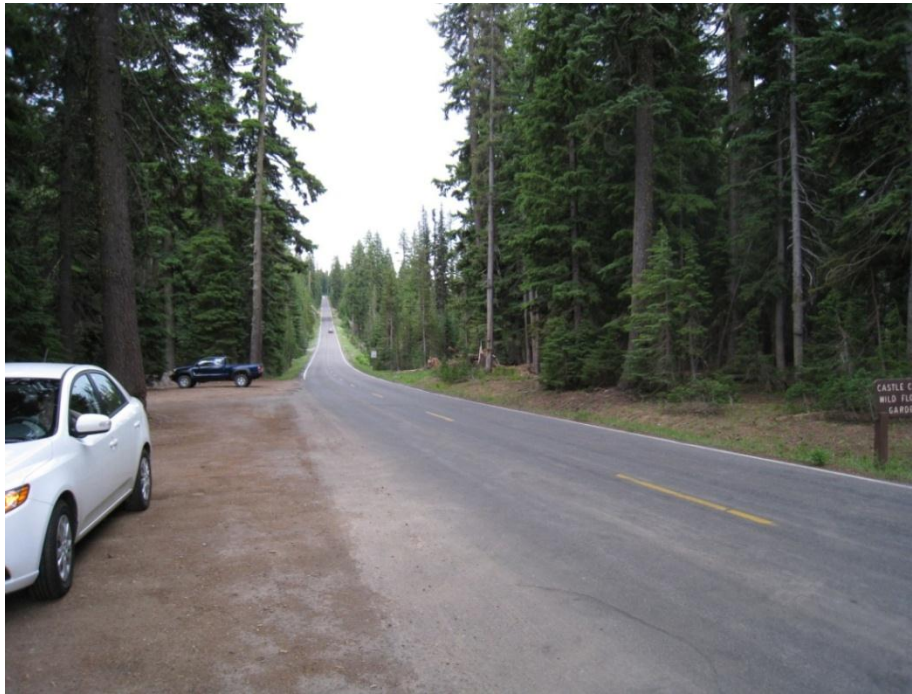
Natural Systems and Features #2: Rim Drive near Castle Crest Wildflower Trail. Note relatively dense subalpine forest along this segment of road (Gjesfjeld, PWR, 2010).

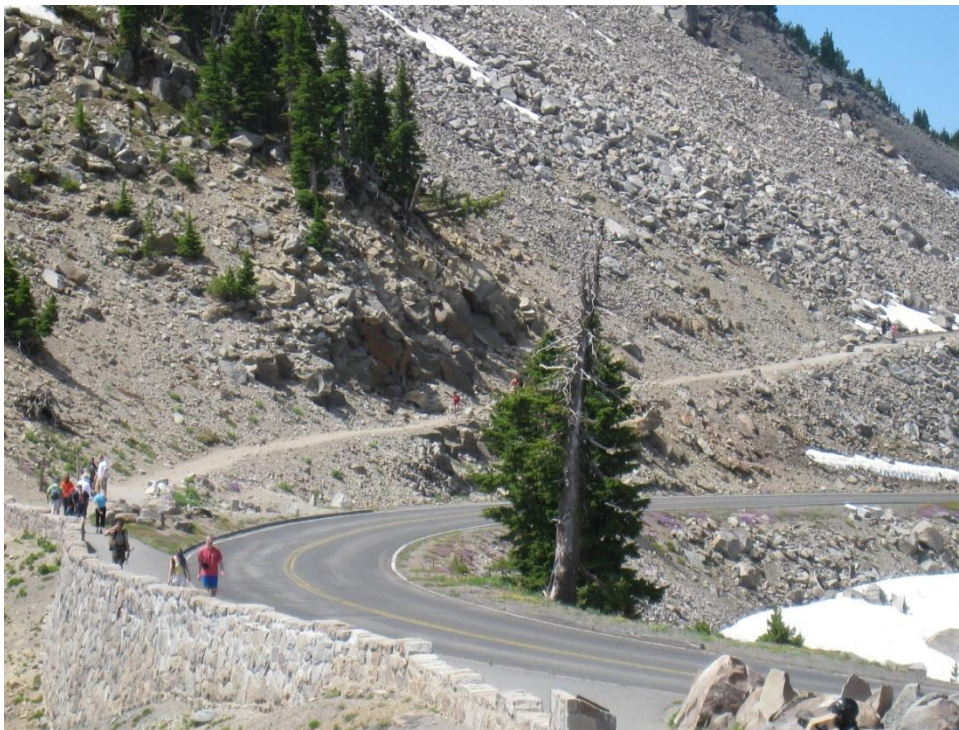
Natural Systems and Features 3: Trail to the Watchman overlook adjacent to Rim Drive. Along this road segment the environment is characterized by steep slopes, rock outcroppings and rocky scree laden slopes (Gjesfjeld, PWR, 2010).

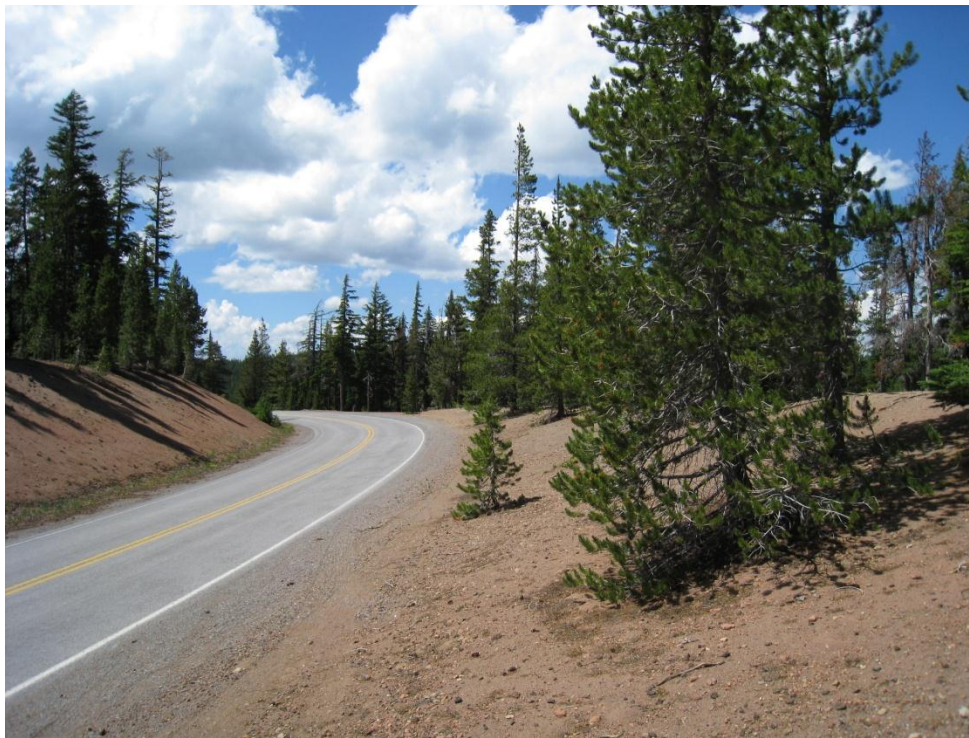
Vegetation #1: Example of daylighting along Rim Drive (Gjesfjeld, PWR, 2010).

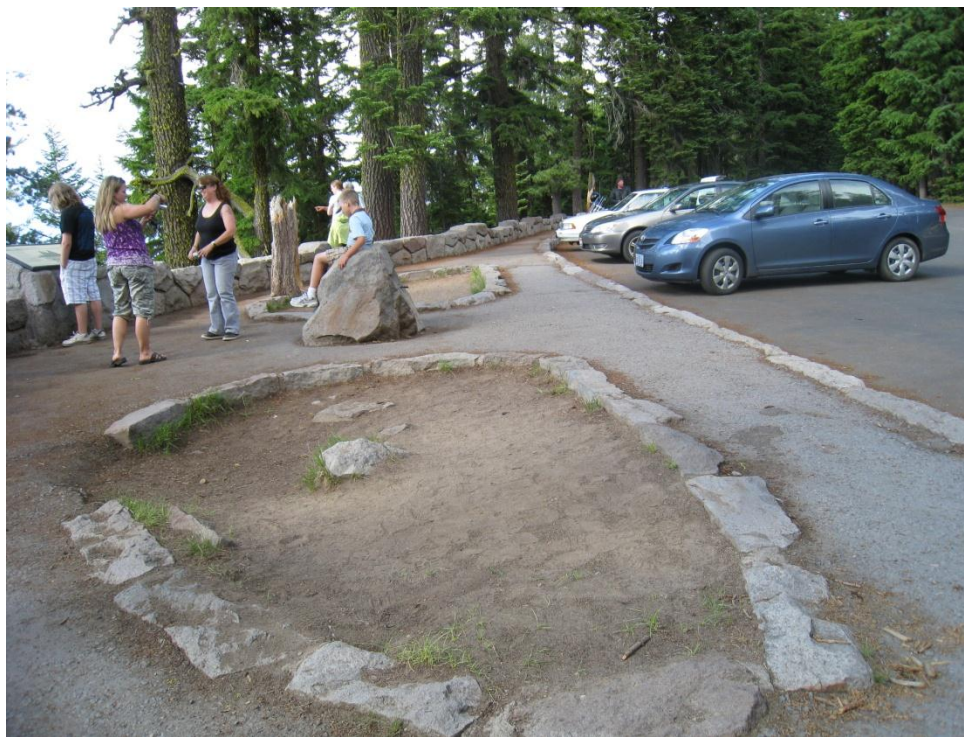
Vegetation #2: Small planting bed denuded of vegetation at Kerr Notch (Phantom Ship) (Gjesfjeld, PWR, 2010).

Today, the character of the vegetation associated with the naturalization of Rim Drive continues to reflect the original naturalistic design intent that was implemented during the period of significance. While some of the small planting beds have been negatively impacted by visitation, the planting beds associated with Cloudcap, Victor View, and Reflection Point continue to function in their original capacity. As a result, vegetation as a landscape characteristic contributes to the setting and feeling of Rim Drive Historic District.

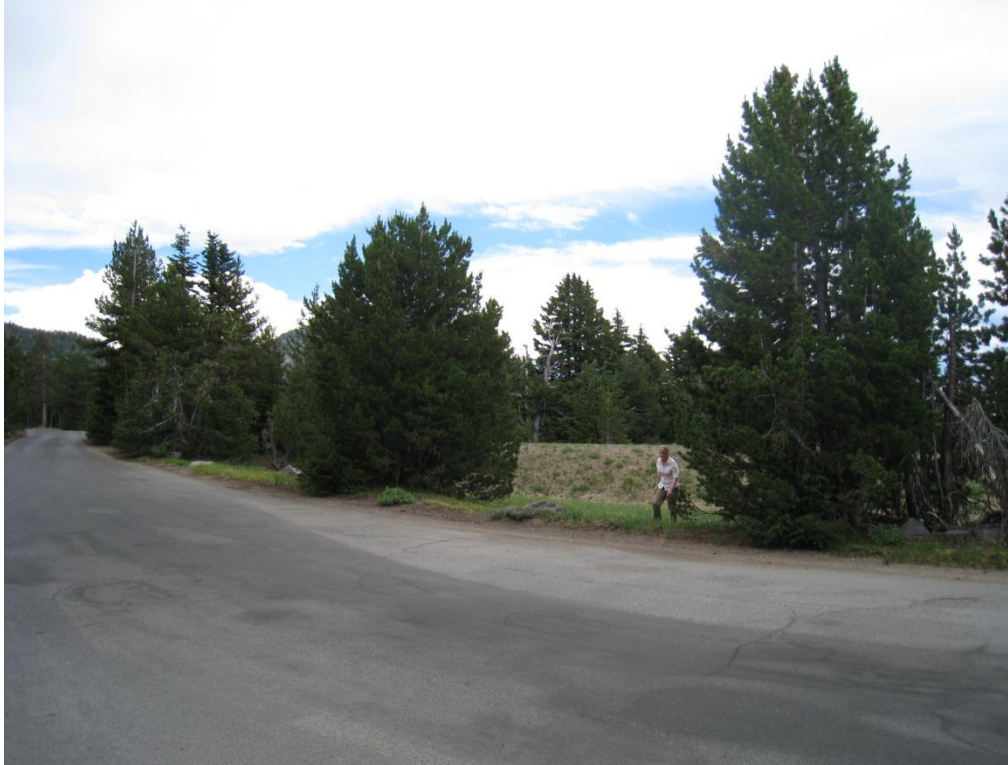
Vegetation #3: Island of vegetation separating Rim Drive from the Sentinel Rock (Victor View) substation (Gjesfjeld, PWR, 2010).

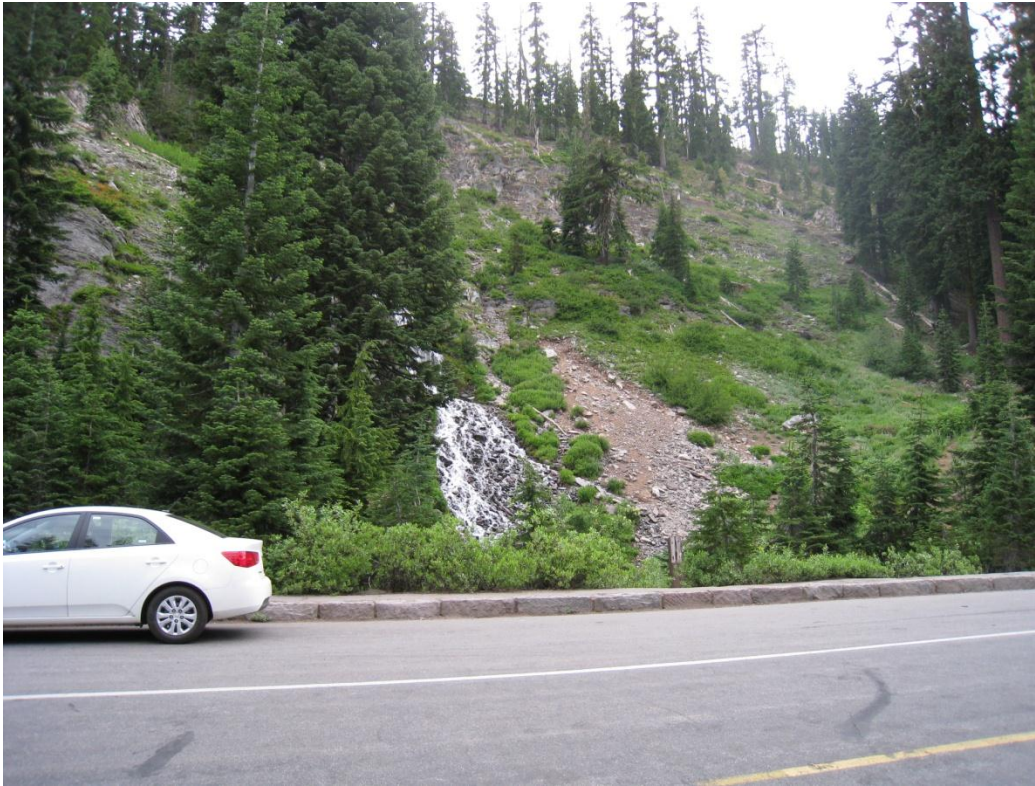
Circulation #9: View of Vidae Falls parking area and fill (Gjesfjeld, PWR, 2010).

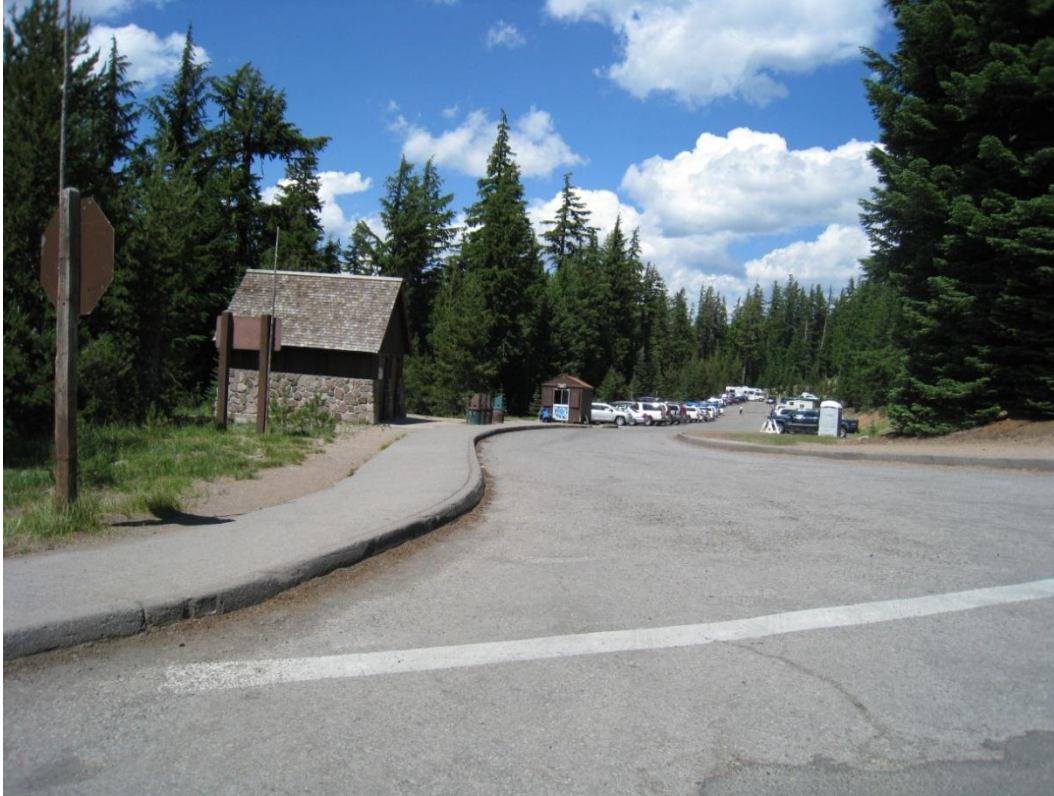
Circulation #19: View of parking area associated with Cleetwood Cove (Gjesfjeld, PWR, 2010).

Parking at the Cleetwood Cove trailhead initially consisted of simply widening the road shoulders, but this solution quickly became inadequate. A site plan completed in 1961 called for an elongated parking area across Rim Drive from the trailhead, oriented perpendicular to the road instead of parallel. With an adequate entranceway, the parking lot site would also be large enough to allow development of a picnic area with some thirty tables or even a campground. Grading the lot above Cleetwood Cove began in the

fall of 1961, but lack of water effectively limited development of other amenities to portable toilets and a few picnic tables. The only additional development at the site resulted from a spillage problem associated with fuel delivery to the tour boats. Consequently, construction of a gasoline transfer building situated between the parking lot and Rim Drive was undertaken in 1998.

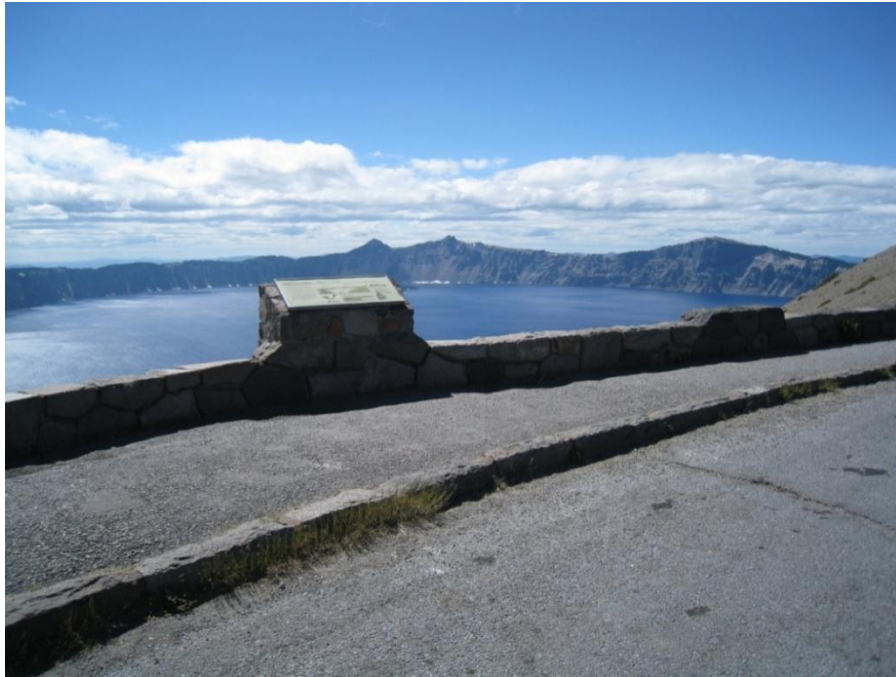
Buildings and Structures #1: View of Crater Lake from Cloudcap observation station. Note the interpretive sign, stone masonry wall and curbing in the foreground (Hartzler, PWR, 2008).

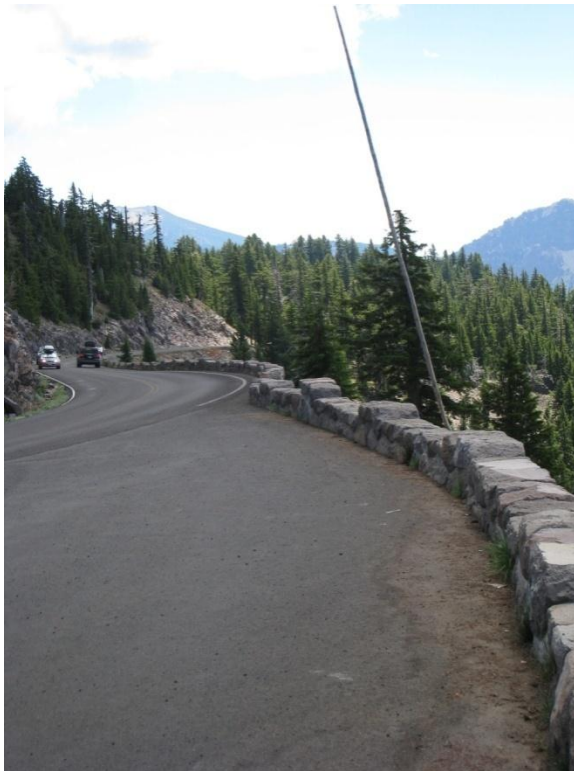
Buildings and Structures #2: Curvilinear stone masonry guard wall at Union Peak substation (Gjesfjeld, PWR, 2010).

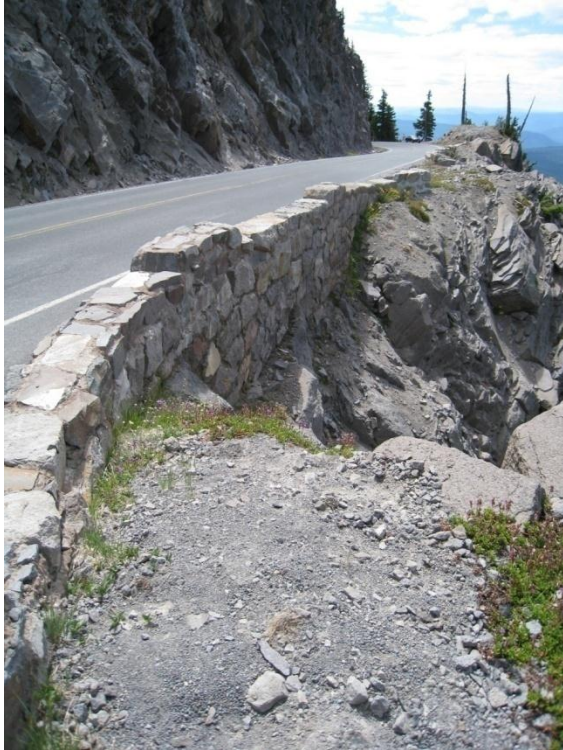
Buildings and Structures #3: Stone masonry retaining wall and guardrail along Rim Drive (Hartzler, PWR, 2008).

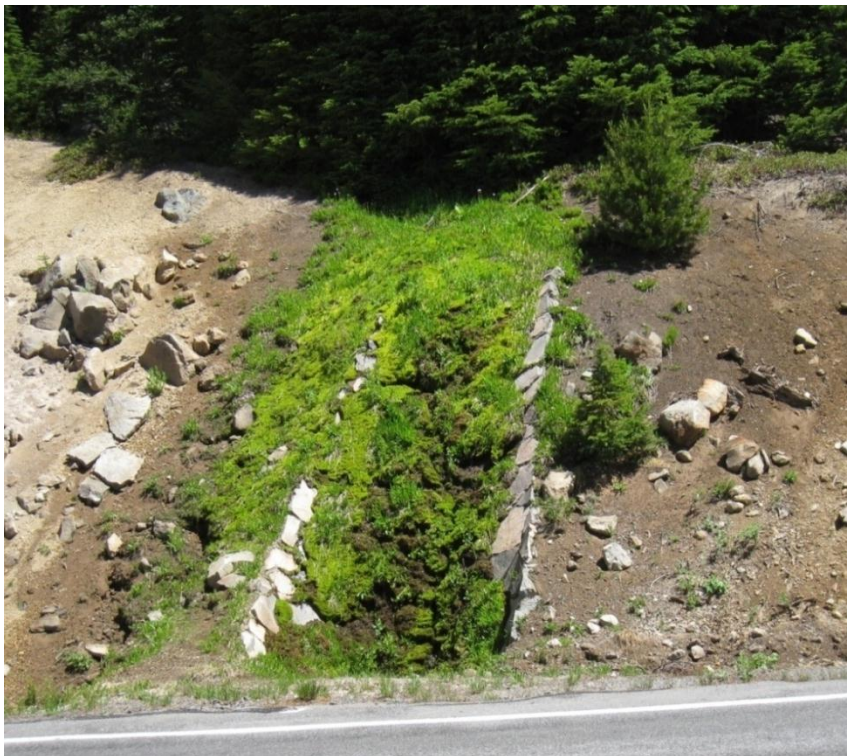
Buildings and Structures #4: Stone masonry spillway overgrown with moss and grass along Rim Drive segment 7-D (Gjesfjeld, PWR, 2010).

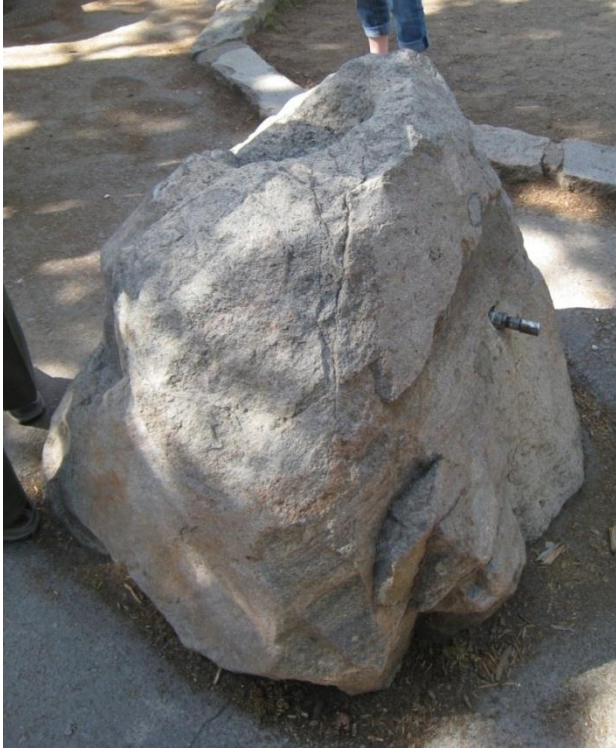
Buildings and Structures #5: Naturalistic stone drinking fountain at Kerr Notch observation station (Gjesfjeld, PWR, 2010).

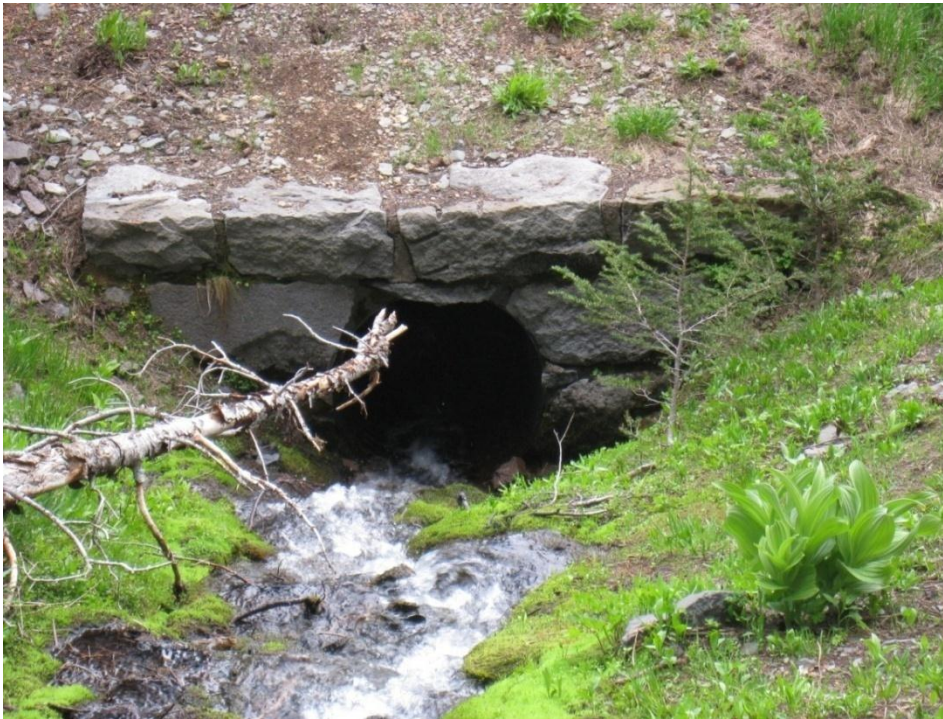
Buildings and Structures #6: Culvert with stone masonry headwall near Sun Creek Valley Vista (Gjesfjeld, PWR, 2010).

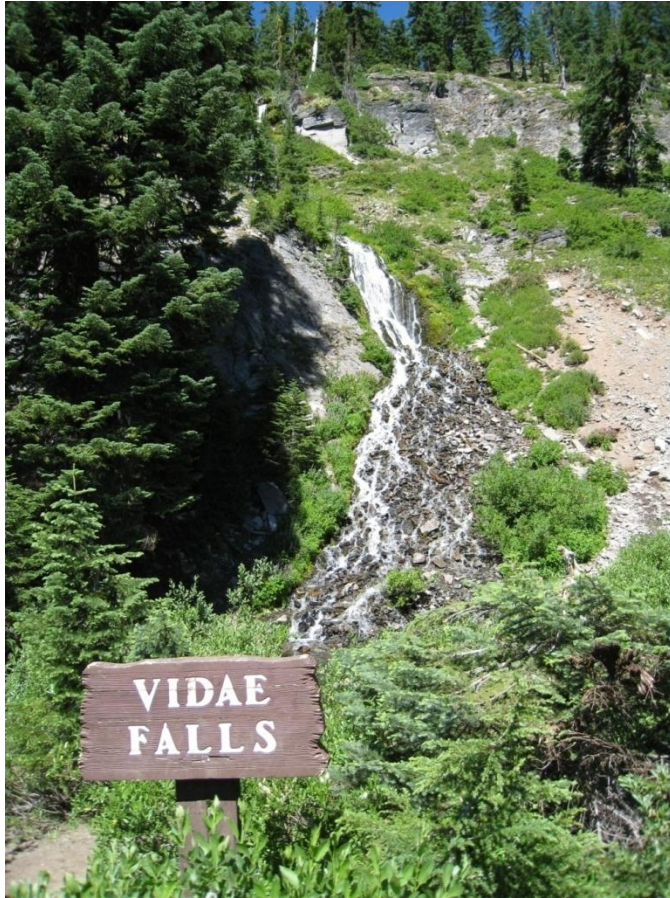
Buildings and Structures #6: View of historic hand-carved sign designed by Lange and produced by the CCC with Vidae Falls in the background (Hartzler, PWR, 2008).

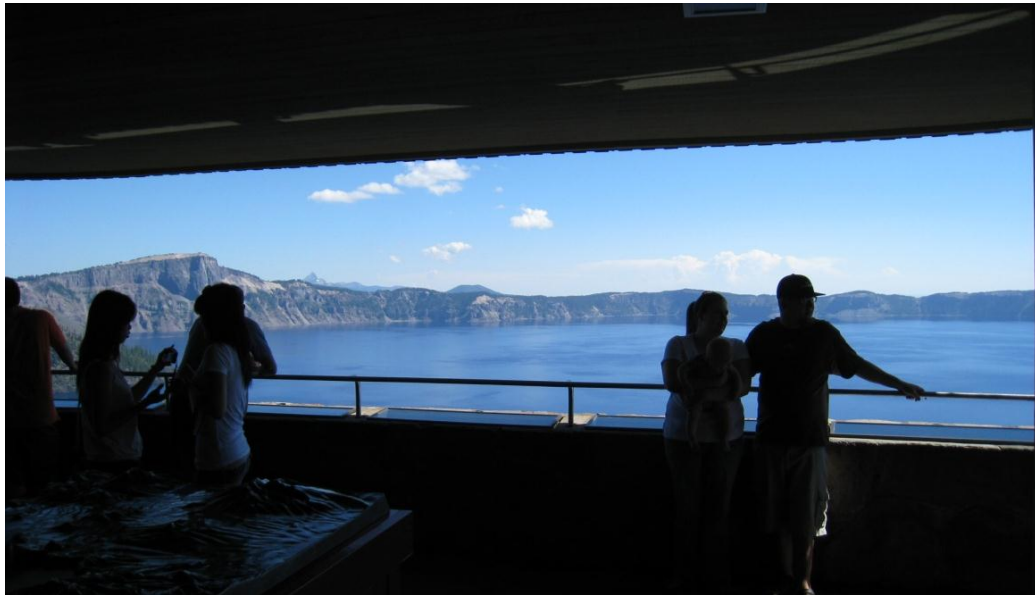
Views and Vistas #3: View from the Sinnott Memorial Overlook to the caldera. This vantage provides the most dramatic example of structured vista, in that the building's circular window with a low ceiling forces a horizontal perspective onto the lake (Gjesfjeld, PWR, 2010).
