CULTURAL LANDSCAPE RECOMMENDATIONS

PARK HEADQUARTERS AT MUNSON VALLEY
CRATER LAKE NATIONAL PARK

SUMMER 1991

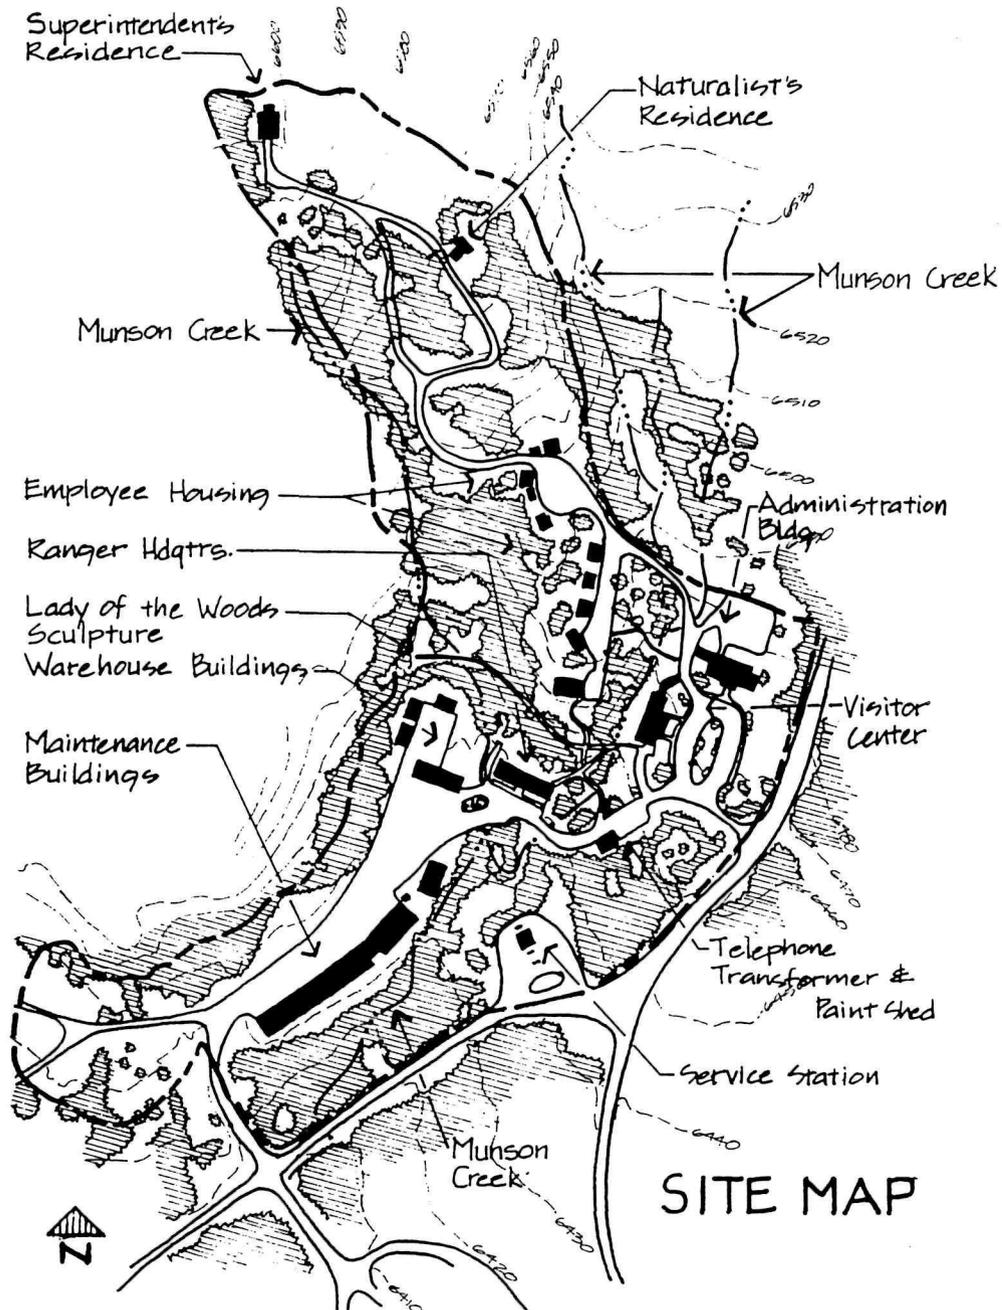
SITE MAP

Wood post signs and large boulders delineate and accent the entrance to the Visitor Center and maintenance area.

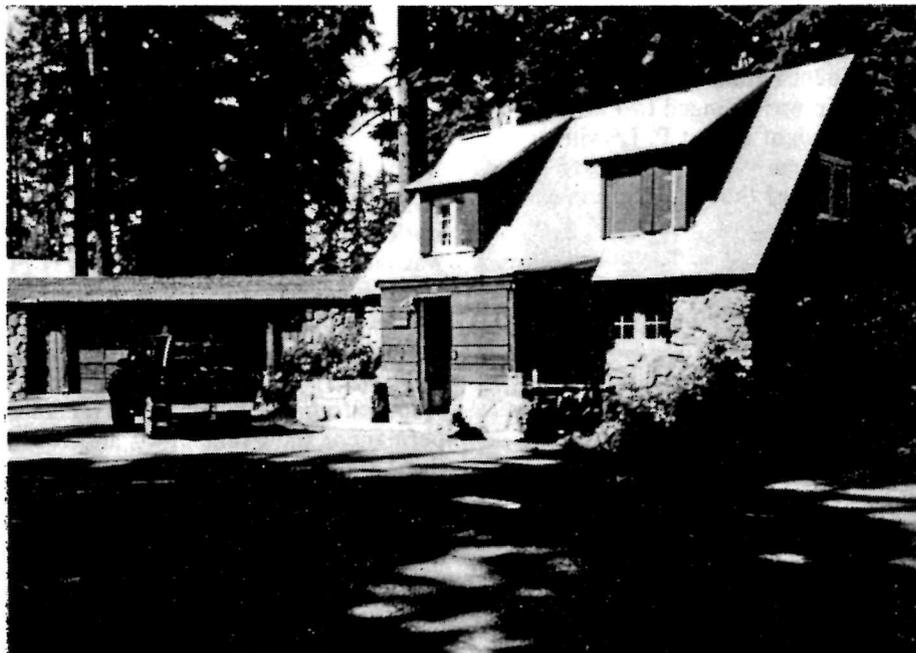
View south along spur road showing typical post WW II snow tunnel addition and widened road bed, 1990

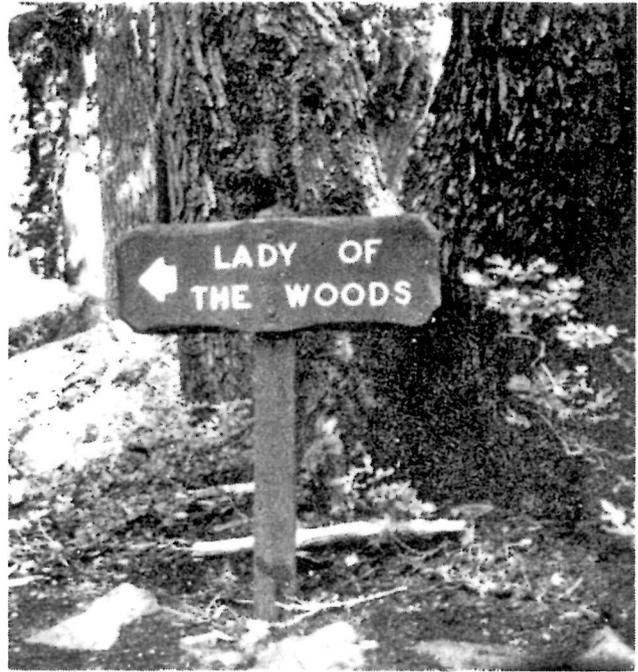
Mission 66 directional sign, routed wood painted brown with creme white lettering.

a. An overall sign for the site plan should be developed based on a hierarchy of style and type of information required. The plan should be consistent with the park-wide plan and should address the possibility of reestablishing Rustic style signs at the administrative complex.

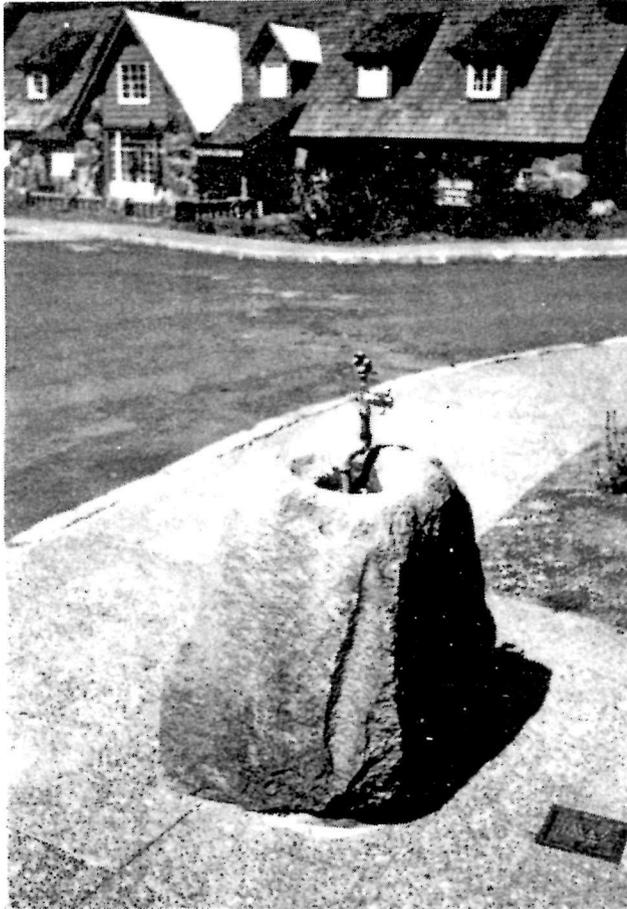
Drinking fountain in front of the Administration Building.

a. The condition of remnant stone features should be assessed in collaboration with the regional historical architect and historical landscape architect to determine an appropriate strategy for stabilization and maintenance, including cleaning and clearing of vegetation to enhance visibility as noted under the maintenance and management recommendations.

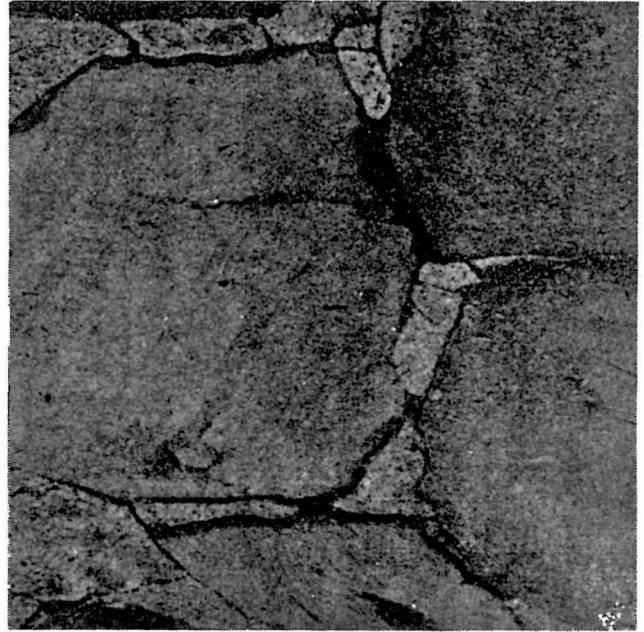
Flagstone paving detail.

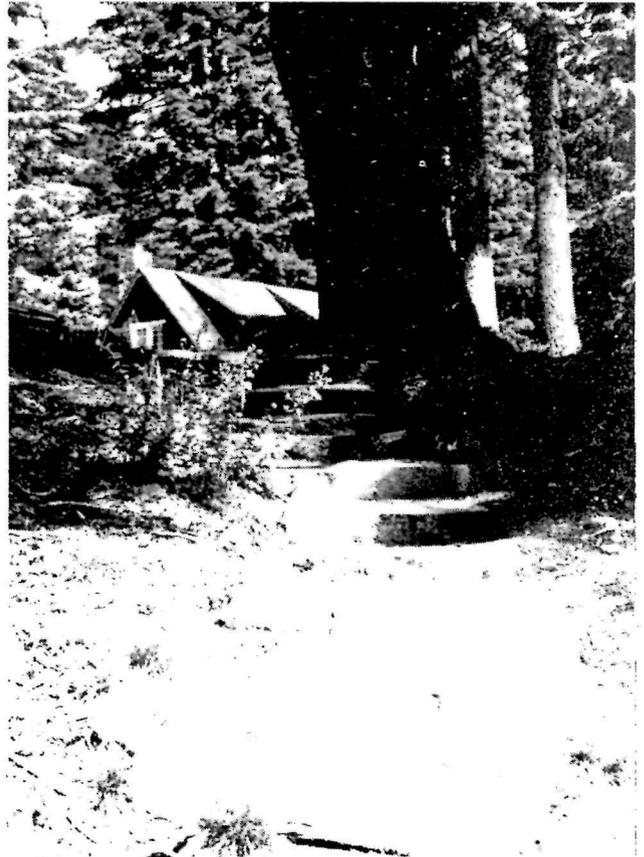
Stone steps to the lower group of employee residences.

1. Retain original circulation patterns.
2. The condition of all flagstone walkways, stone steps and the Munson Creek bridge should be assessed and an appropriate maintenance strategy for stabilization and preservation determined as noted under the maintenance and management recommendations..

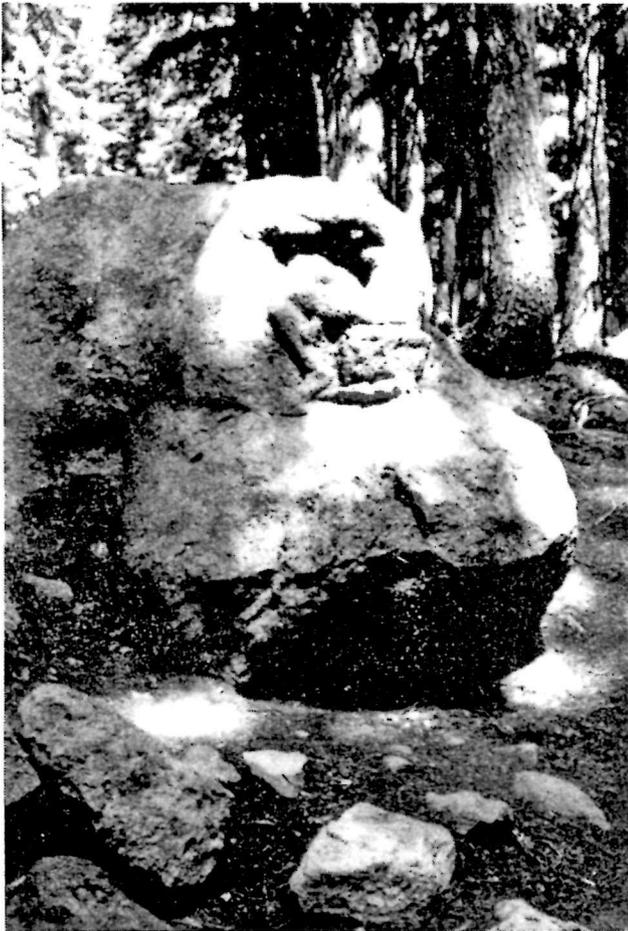
Carved by Earl Russell Bush in 1917, the sculpture stands approximately three feet high and is located 400 feet west of the Ranger Dormitory. A rustic wood sign identifies the site which can be reached by trail from the plaza area.

Lady of the Woods.

- a. Maintain adequate trail access to the sculpture.
- b. Replacement of the Mission 66 routed sign with a rustic wood sign should be considered.
- c. Routine cleaning of the sculpture should be included within the cyclic maintenance preservation program.

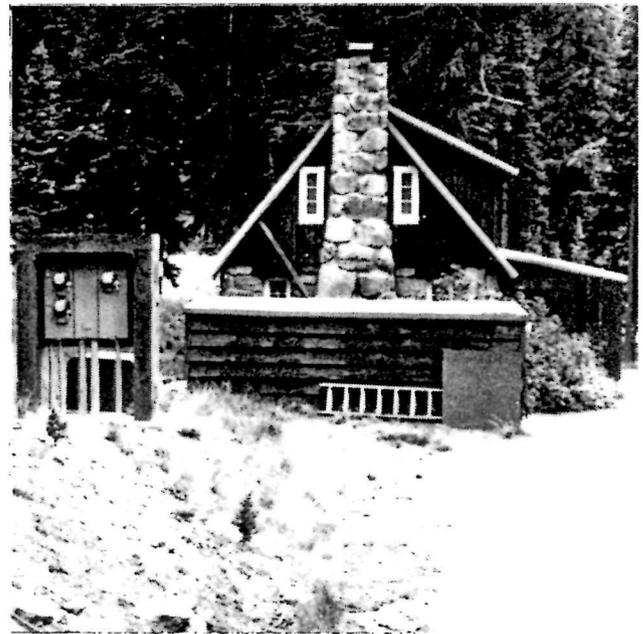
Utility box at the middle group of employee residences.

1. All historic structures on site within the historic district should be preserved and maintained under an approved cyclic maintenance preservation program. All significant structural resources should be incorporated into the Maintenance Management System, and the Inventory Condition Assessment Program (ICAP), including the Superintendent's Residence, Administration Building, and Ranger Dormitory.
2. Propane tanks sited in front of the employee residences are inappropriate and negatively impact the historic landscape. Burial, relocation or removal of the tanks is required.

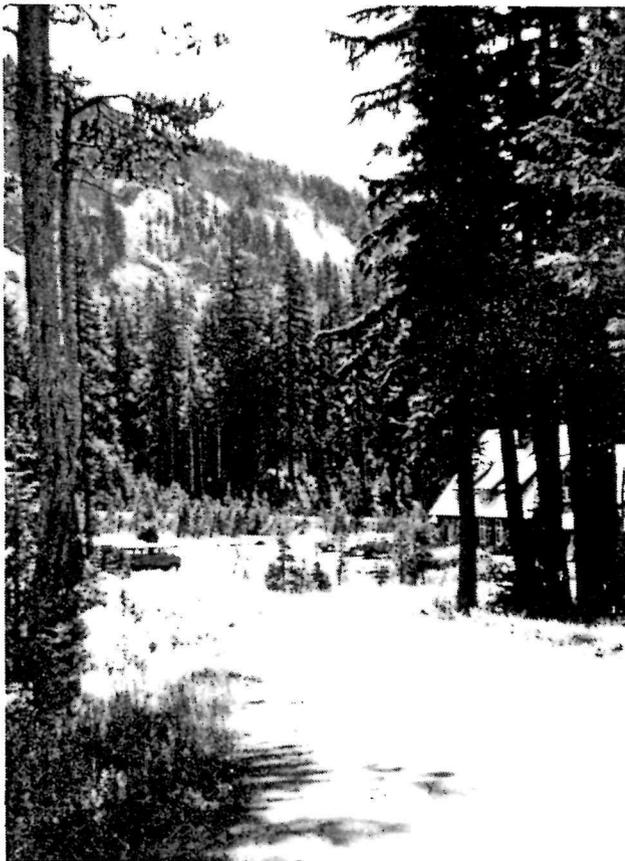
Parking lot north of the Administration building.

1. The administrative plaza should remain the main visitor arrival point. Visitor parking should remain concentrated in the plaza area. Employees should continue to use the parking lot north of the Administration Building.

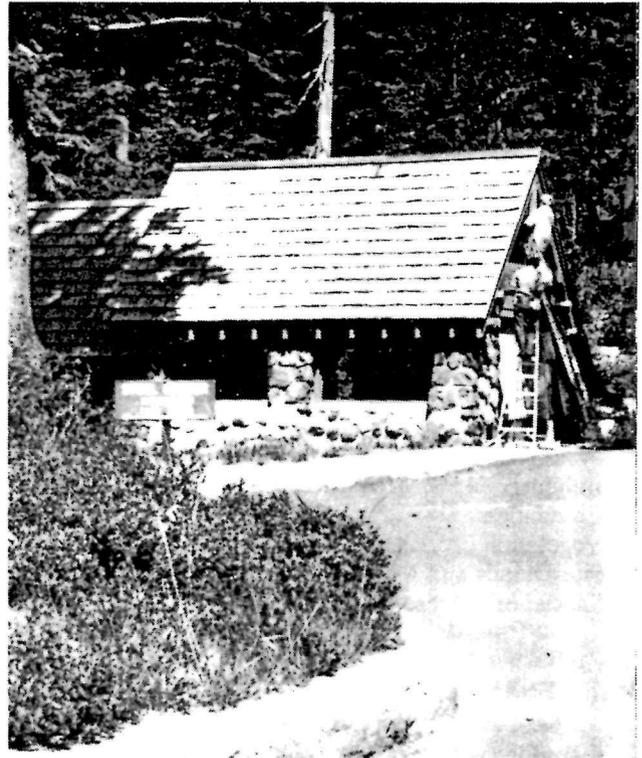
Remnant stone curbing around the ellipse and plaza area.

3. The condition of remnant stone curbing throughout the plaza area should be assessed to determine an

appropriate strategy for rehabilitation or replacement as noted under the maintenance and management recommendations.

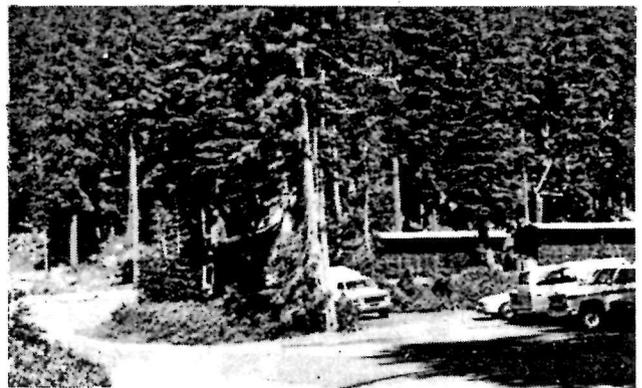
Planting "island" between the Messhall and Warehouse.

4. Reestablishment of stone curbing surrounding the planted "island" between the Mess Hall and Warehouse should be considered.

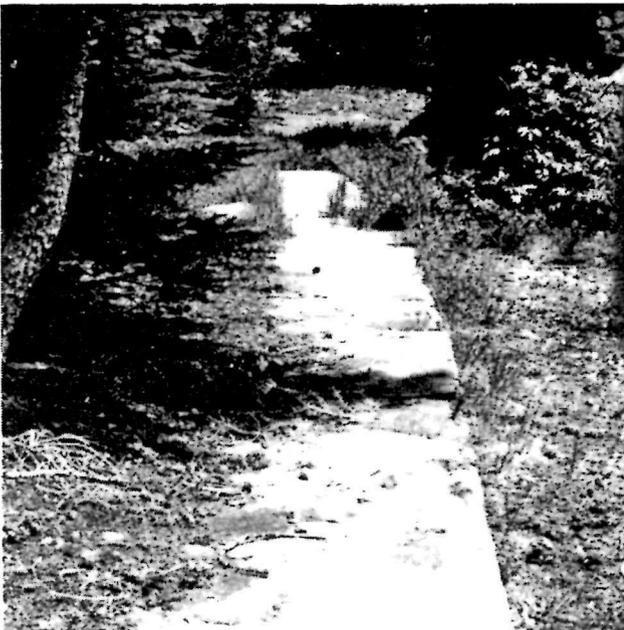
West flagstone walkway at the Superintendent's Residence.

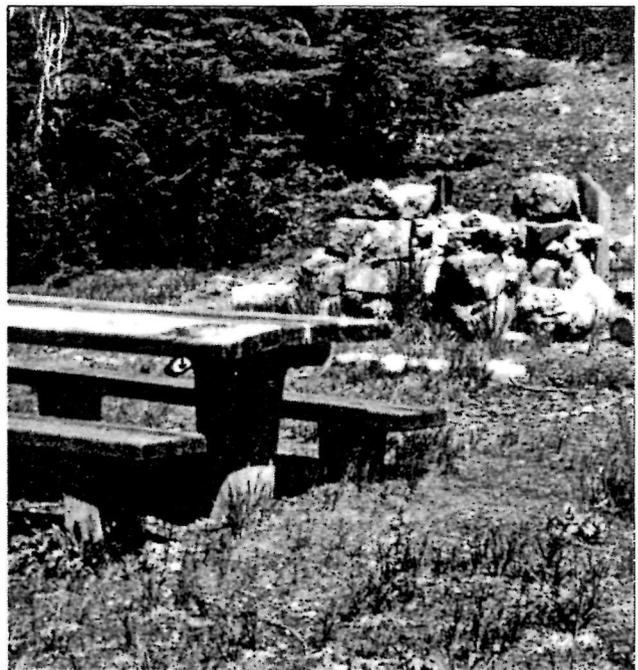
Picnic table and stone fireplace at the Superintendent's Residence.

1. Site furnishings (light fixtures, garbage cans, bike racks, signs and interpretive displays) should be visually compatible with the identified elements of the rustic style including scale, texture, and the general site character of Munson Valley. Furnishings should meet all applicable codes and regulations. Complementary design rather than replication is the preferred treatment for rehabilitation and/or replacement of site features.

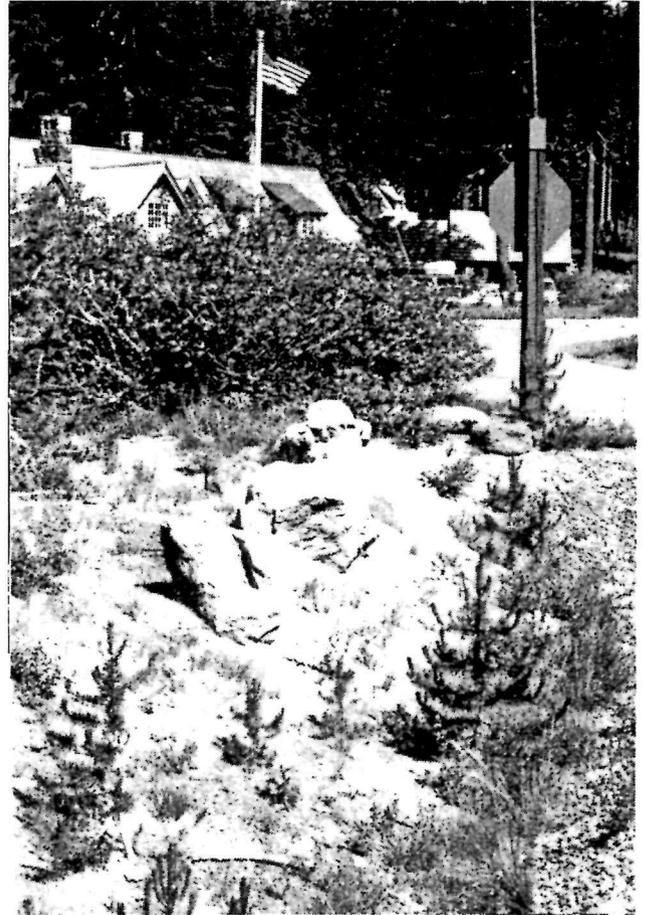
Extant boulders once used as a traffic control device for the old entrance to the plaza.

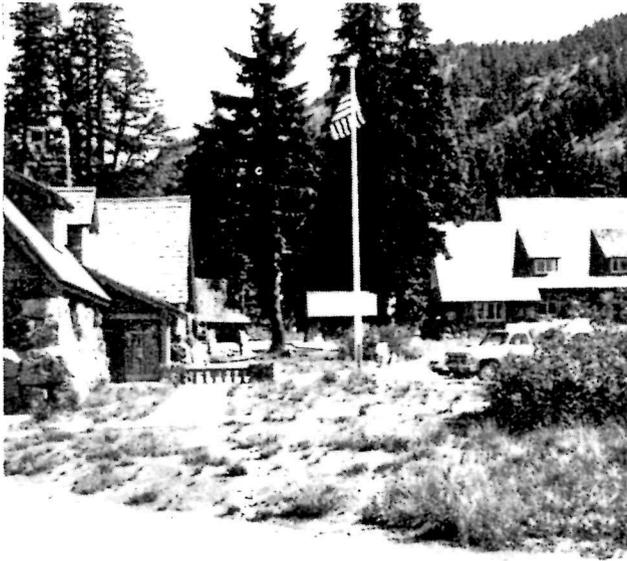
Remnant plant materials, 1990.

develop and implement a restoration planting plan. The plan should employ naturalistic design principles described in 1929-38 park documents, including tree placement to create shadows, and the general placement of native plant materials in natural groupings and associations. Prepare a preservation maintenance plan with recommendations for stabilization of remnant plant materials, routine and winter maintenance considerations.

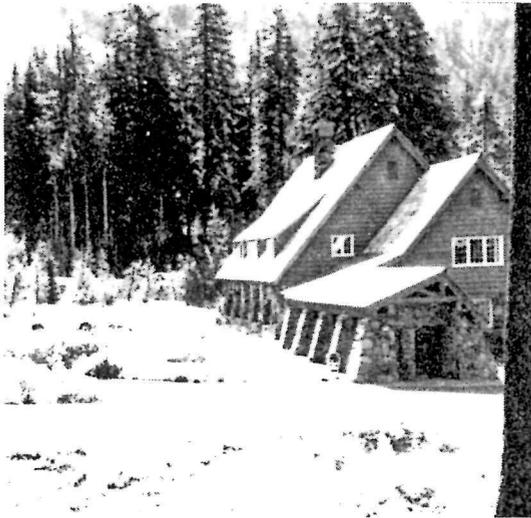
Administration Building; west view showing the snow tunnel and north parking lot.
