## CRATER LAKE

PNRO  
INVENTORYNational Park Service  
Pacific Northwest Region  
Cultural Resources DivisionWestin Building, Room 1920  
2001 Sixth Avenue  
Seattle, Washington 98121

1. SITE I.D. NO		5. ORIGINAL USE	7. CLASSIFICATION	9. RATING
2. NAME(S) OF STRUCTURE		Comfort Station		10. DATE
COMFORT STATION #72		6. PRESENT USE		1930
3. SITE ADDRESS (STREET & NO)		Transformer Station--PPL Vault #6	8. UTM ZONE	11. REGION
Rim Village			EASTING	10
Crater Lake National Park			NORTHING	
4. CITY/VICINITY	COUNTY	CITY	SCALE	
Crater Lake National Park, Klamath, Oregon			1:24 1:62.5	
			OTHER	QUAD NAME

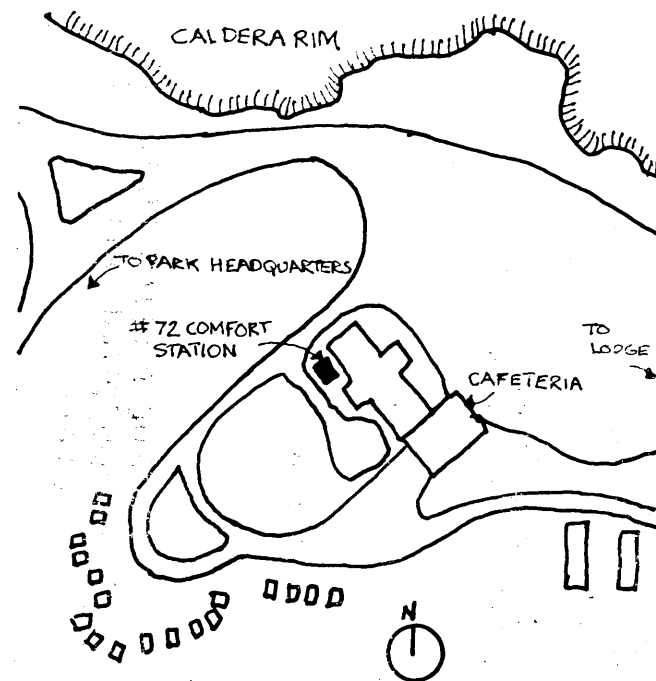
17. PHOTOS AND SKETCH MAP OF LOCATION

SOUTH ELEV.  
8-3-84

SOUTH EAVE DETAIL

S-EAST ELEV.  
8-3-84

EAST ELEV.  
8-3-84

NORTH ELEV.

WEST ELEV.
