# Rim Drive Rehabilitation Revegetation Project

## *2017 Annual Report*

# **Rim Drive Rehabilitation Revegetation Project**

## ***2017 Annual Report***

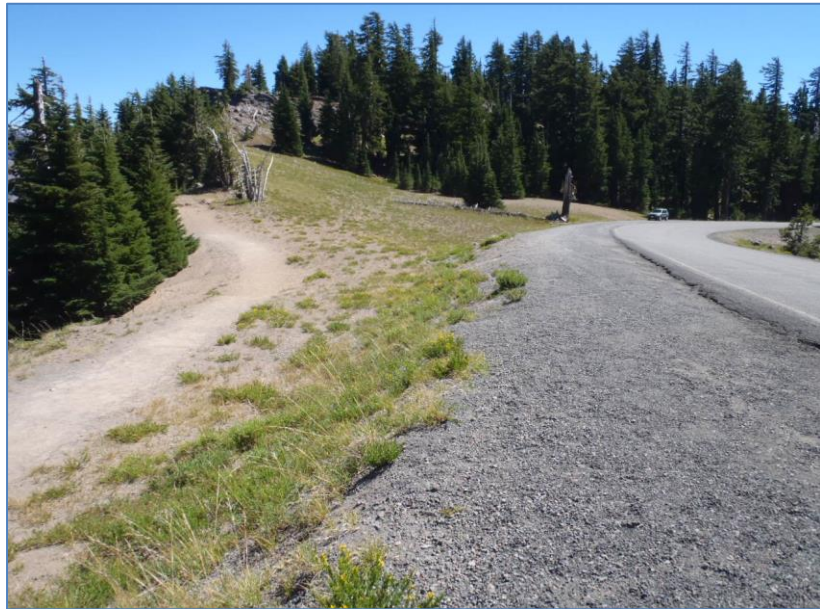
**Figure 1.** One of the pullouts (right) slated for obliteration and restoration along West Rim Drive. Photo by Jen Hooke.

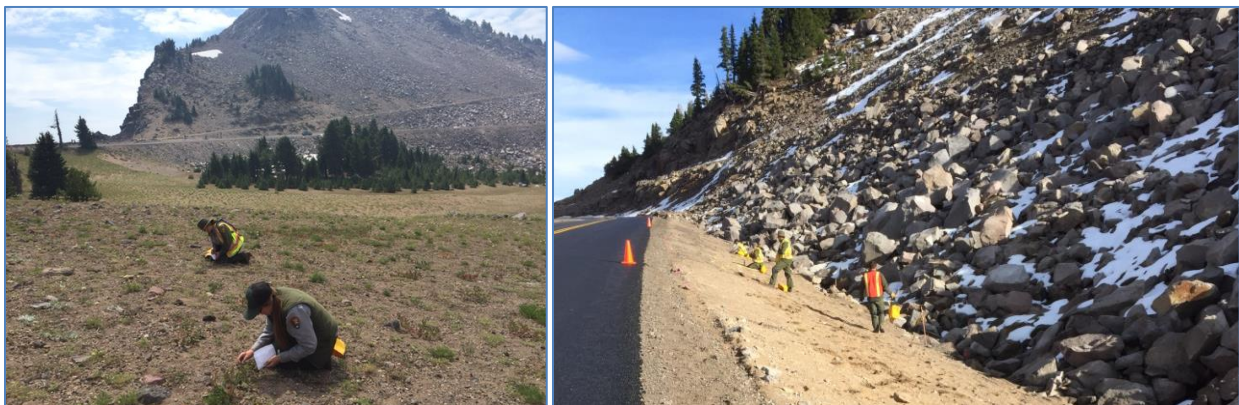
**Figure 2.** Collecting seed and conducting restoration outplantings for the Rim Drive Rehabilitation project. Photos by Carrie Wyler.

Restoration of areas disturbed by the Rim Drive Rehabilitation project (Figure 2) is necessary to jumpstart natural succession of vegetation communities and will help protect the rim environment from soil erosion and invasion by non-native plant species. Through using site-specific, native genotypes in revegetation efforts, the biodiversity and genetic integrity of the rim vegetation community is maintained. Additionally, as Rim Drive is a popular Park road, revegetation will yield aesthetic benefits to Park visitors by reducing the appearance of bare, disturbed ground throughout the project area. As of November 2017, road construction crews have completed deep patch operations on East Rim Drive; rehabilitated West Rim Drive from Rim Village north to North Junction; and completed the Rim Village parking area. Work on the Cleetwood parking lot and trailhead is ongoing and still not completed as of November 2017. One of nine pullouts along East Rim Drive has been obliterated, and four out of fifteen pullouts on West Rim Drive have been obliterated (two need additional soil contouring work prior to restoration). Much of the work in 2017 was hindered by a late snowmelt, multiple large fires, and early-season snow storms. Work in 2018 will focus on obliterating all remaining pullouts; completing the Cleetwood Cove parking lot and trailhead renovations; finishing renovation of the Watchman Overlook; starting rehabilitation of Roundtop Quarry and other staging areas; and finishing up other sites within the project area. The types of areas to be restored along with their restoration status are listed in Table 1.

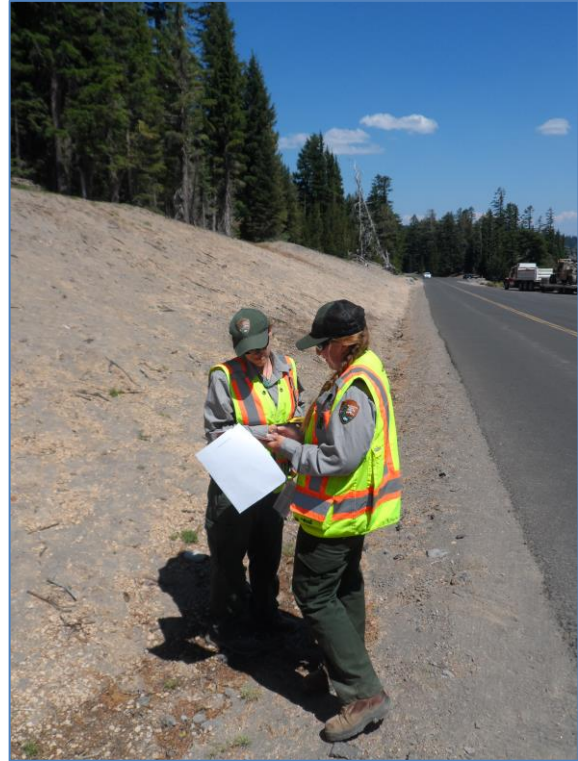
**Figure 3.** Developing revegetation prescriptions for disturbed areas. Photo by Scott Heisler.

Prior to construction, revegetation prescriptions were developed for each area slated for restoration starting in 2012 (Figure 3). These prescriptions serve as documentation of the pre-disturbance site features and plant species composition unique to each area. Prescriptions were developed by making visits to each site and recording the dominant plant species with an ocular estimate of each species' relative cover value. This documentation was established with the intent that it would inform revegetation efforts by providing a baseline from which to determine the number of plants and amount of seed to be used at each site. The specifics of this process are outlined in a project-specific Revegetation Plan (Gregory et al. 2015).

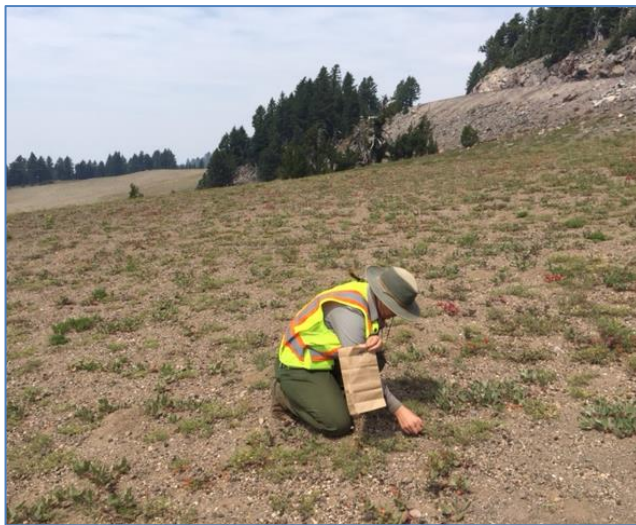
**Figure 5.** Collecting seed near the Watchman Overlook. Photo by Carrie Wyler.

When seeds were mature, they were collected, dried, and stored until shipment to the Corvallis PMC. Within each zone a single bag was used to collect all the seed from an individual species (Figure 5). In the field, bags were labelled with species code, collection date, and seed zone. After collection, seeds were transported to the seed drying and storage facility in the Stall Nine garage at Park headquarters (Figure 6). When seeds arrived at this facility, records were kept for each species with collection dates, specific collection location, and seed zone. Seeds were then dumped inside 30-gallon plastic storage totes secured with window screen at the top, allowing ventilation while reducing chances of

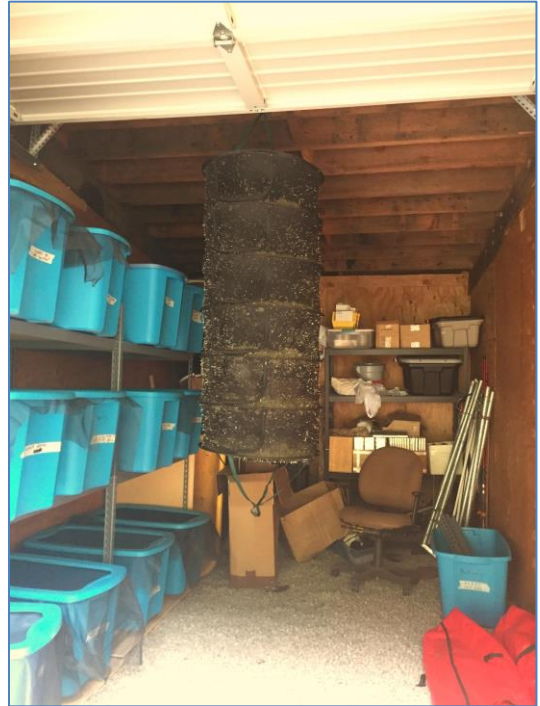
**Figure 6.** Seed drying and storage facility in the Stall Nine garage. Photo by Carrie Wyler.

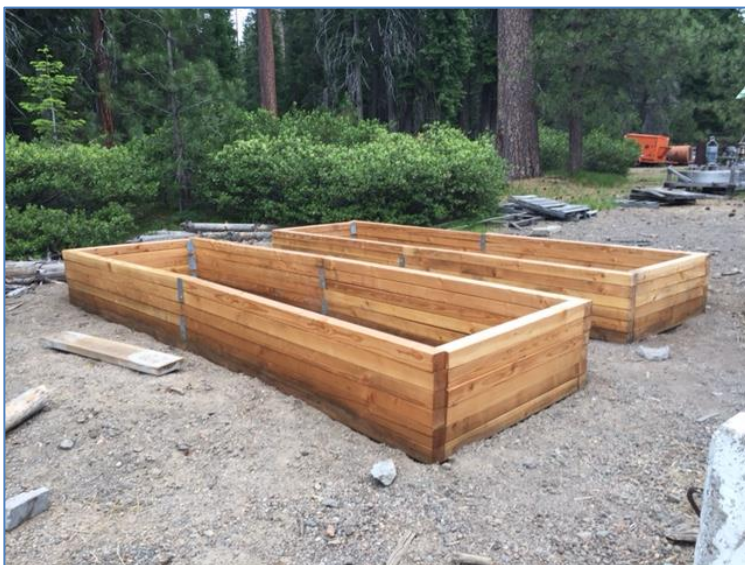
**Figure 7.** Seed increase beds at the South Yard. Photo by Carrie Wyler.

Due to the large area in need of restoration, and the difficulty in collecting adequate amounts of seed each year, in 2016 CRLA staff began the process of establishing seed increase beds from which 100% of the seed could be collected. Two seed increase beds (2'x4'x16') were constructed and positioned in the South Yard, which is at a lower elevation providing the opportunity to maximize on solar radiation and growing season length (Figure 7). In 2017, caged lids were constructed and added to the beds in order to prevent predation. The seed beds were filled with soil and planted with species from the North West Rim Drive seed zone.

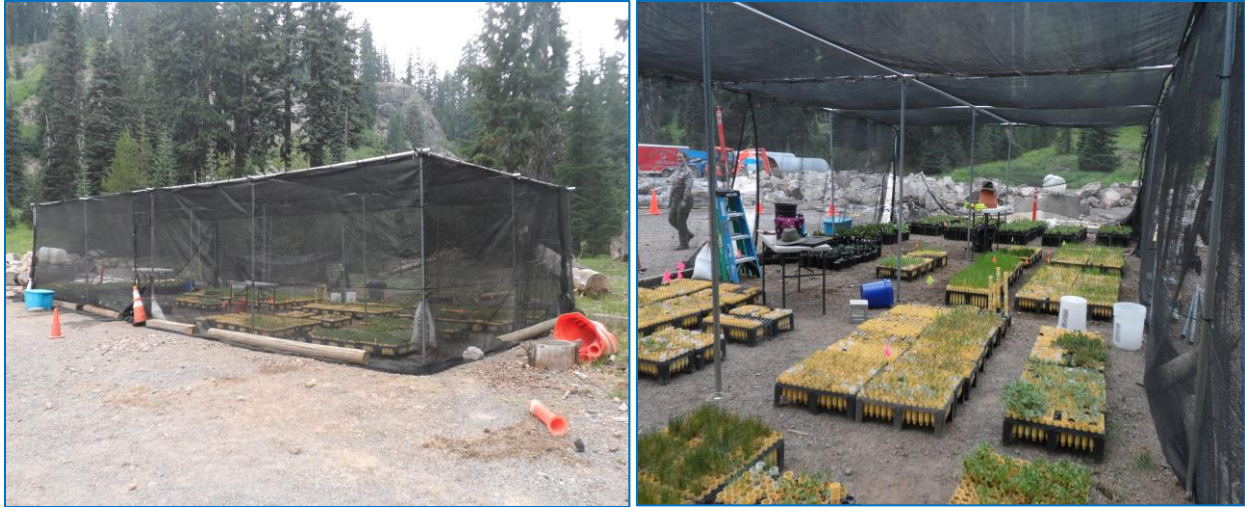
**Figure 8.** Improvements to CRLA’s Revegetation program during the 2016/2017 season: expanded 2017 shadehouse (left); shadehouse used to hold over plants from 2016 (right). Photos by Carrie Wyler.

In 2016, 15,318 native plants were grown at the Corvallis PMC and delivered to the Park. Due to early and abundant snowfall in October of 2016, many plants were unable to be planted and approximately 10,000 plants were overwintered at the Ballfield near Park headquarters. These plants then required care and maintenance throughout the 2017 field season. Once the snow melted out in June, plants were covered with a shade house (40'x 20'x10' – Figure 8). The plants were fertilized as

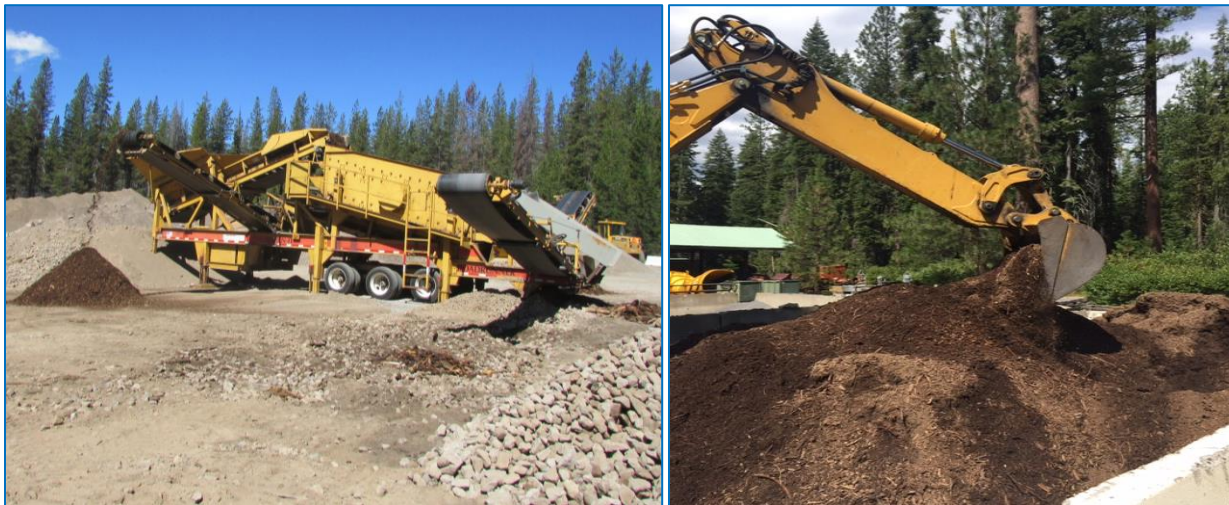
**Figure 11.** A screen plant was used to sort readily compostable materials (left) from partially composted woody debris to augment conditions at disturbed sites. Photo by Jen Hooke. Compost is routinely turned (right) to aid in decomposition. Photo by Carrie Wyler.

Beginning in 2016, Park-sourced mulch/compost and small coarse woody debris were acquired from Pole Bridge Creek Quarry for use in site preparation. With the aid of a large screen plant, partially composted woody debris was processed and sorted (Figure 11). Materials with particle size of < 5 cm were designated as compost and transported to the South Yard for further maturation and maintenance. Slightly larger materials (5 cm – 15 cm particle size), were retained and stored at the Ballfield adjacent to the shade house. Compost was routinely turned using heavy equipment for proper decomposition (Figure 11). The compost was, and will continue to be, used on restoration sites.

Compost temperature was monitored over the season and was found to be high enough to indicate active biota degrading the material. The compost was used to provide a source of natural fertilizer and mulch for newly planted seedlings. The compost also helped create local microclimates, retain soil moisture, and provide microfauna to help promote soil development and aid the establishment and growth of the seedlings. The woody materials were used to help stabilize recently disturbed and denuded sites from road construction while also helping create microclimates and seed pockets to further encourage the natural recovery of the areas. Larger woody debris (branches, logs, etc.) was

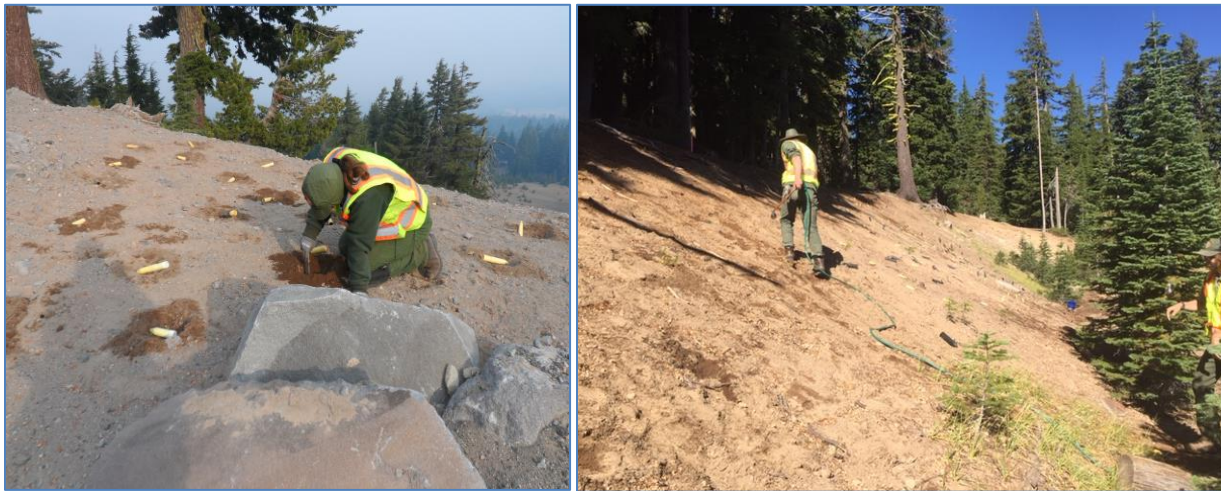
**Figure 13.** Planting along the Watchman grade and adding compost to planting holes (left). Watering newly planted and mulched plants from a truck-mounted water tank (right). Photos by Carrie Wyler.

A mix of plant species was planted in the disturbance areas in accordance with the prescriptions and actual availability of plant materials. After planting, compost was added and plants were watered (Figure 13). Site-specific seed mixes were prepared and hand-broadcast over planted areas, and over areas with slopes that were too steep to plant. After broadcasting seeds, the sites were scarified with hand rakes and compost was broadcast over the scarified areas. The plants were watered from a truck mounted tank (Figure 13) until they were covered with snowfall.

At restoration sites, holes were dug to a depth equal to or greater than the length of the planting tubes. Plants were carefully removed from the tubes by pressing on the sides of the tubes or tapping the rim of the tubes while they were inverted over the holes. After the plants had been removed, the roots were inspected for any signs of being root bound, having roots growing upward in the tube (“J”-rooting), or root girdling. If any of these were found, the roots were either trimmed or gently teased apart to encourage root growth and plant establishment. The plants were then placed in planting holes to ensure they were upright perpendicular to the pull of gravity (not relative to the local topography). Soil was then pushed back into the planting holes and tamped down gently to remove any air pockets in the soil. Plantings were installed so that the root collars of the plants were just at or slightly below the surface of the soil. Remaining soil or additional soil from the surrounding area was used to create a berm wall around the plants to facilitate water retention and help stabilize and protect plants. One or two handfuls of compost were then placed in the center of the rings around plants. After mulching, the plants were all watered at least once. A 200 gallon water tank was mounted in the bed of a truck on a wooden pallet and used in conjunction with an electric pump to facilitate watering of newly planted plugs.

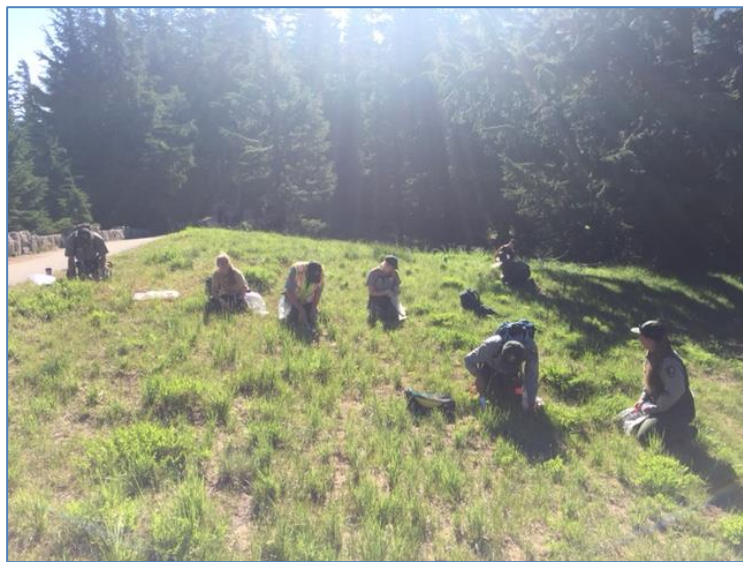
**Figure 15.** Controlling invasive plants near the Crater Lake Lodge. Photo by Carrie Wyler.

When invasive plants are encountered, data are recorded including scientific name, UTM coordinates (Zone 10, NAD83 datum), total number of plants present, area occupied by invasive plants, and treatment applied to population. Invasive plants are controlled via manual (Figure 15) or chemical methods as per the Park's Invasive Vegetation Management Plan Environmental Assessment

(DOI NPS 2017). All plant parts capable of reproduction are bagged and disposed of in the trash compactor at Park headquarters. Vegetative parts incapable of reproduction are left to desiccate on site unless they present logistical or aesthetic problems for Park visitors, employees, and partners.

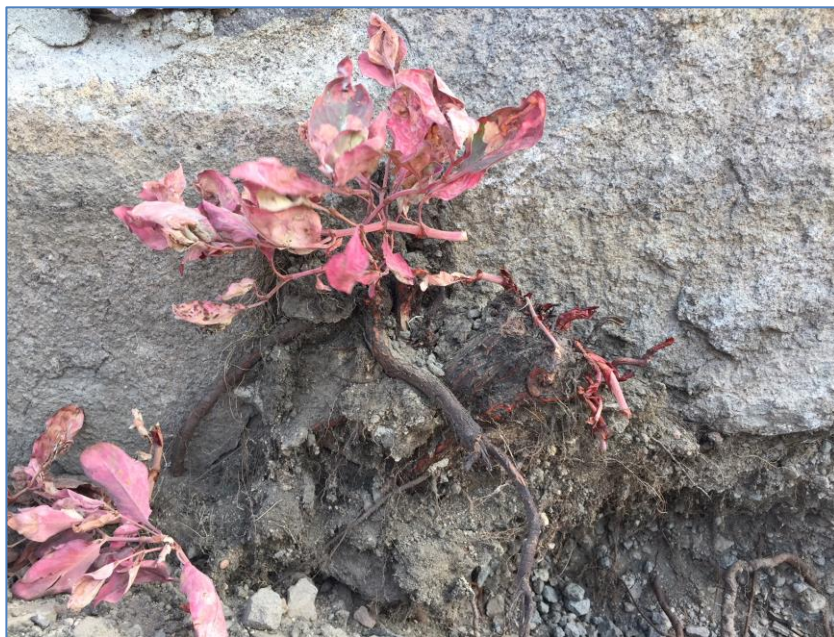
**Figure 16.** The almost woody root system of Davis' knotweed.  
Photo by Jen Hooke.

attempts at propagating Davis' knotweed (Figure 16) suggest root division/cuttings are viable means of propagating Davis' knotweed (Trindle and Fessner 2003); however, initial tests of this method by the Corvallis PMC were largely unsuccessful.

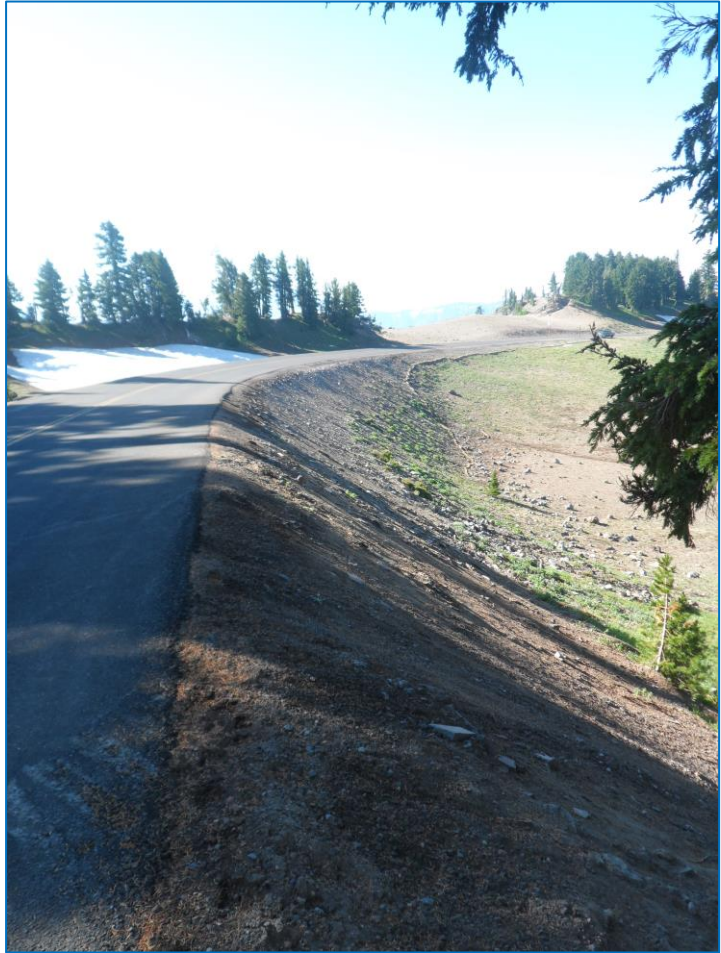
**Figure 17.** Deep patch operations along East Rim Drive created unanticipated disturbance of areas including this slope. Photo by Carrie Wyler.

After deep patch operations along East Rim Drive ceased in 2015, a much larger disturbance footprint was realized than initially anticipated (Figure 17). To mitigate for the increased levels of disturbance, it was agreed to use the seed increase services of the Meeker PMC to increase the abundance of plant materials available for restoration. In fall of 2015, 714 g of California brome and 2,218 g of squirreltail seed were sent to the Meeker PMC for seed increase. The seeds produced at the Meeker PMC will be collected, cleaned, and shipped to the Park in the fall of 2018 and 2019 for use in broadcast seed application for restoration. To maximize seed yield, it was agreed to combine squirreltail seeds from all seed zones for seed increase purposes. California brome seeds were combined from the three West Rim Drive seed zones, and also from the two East Rim Drive seed zones. Expected production totals from the Meeker PMC are displayed in Table 6.

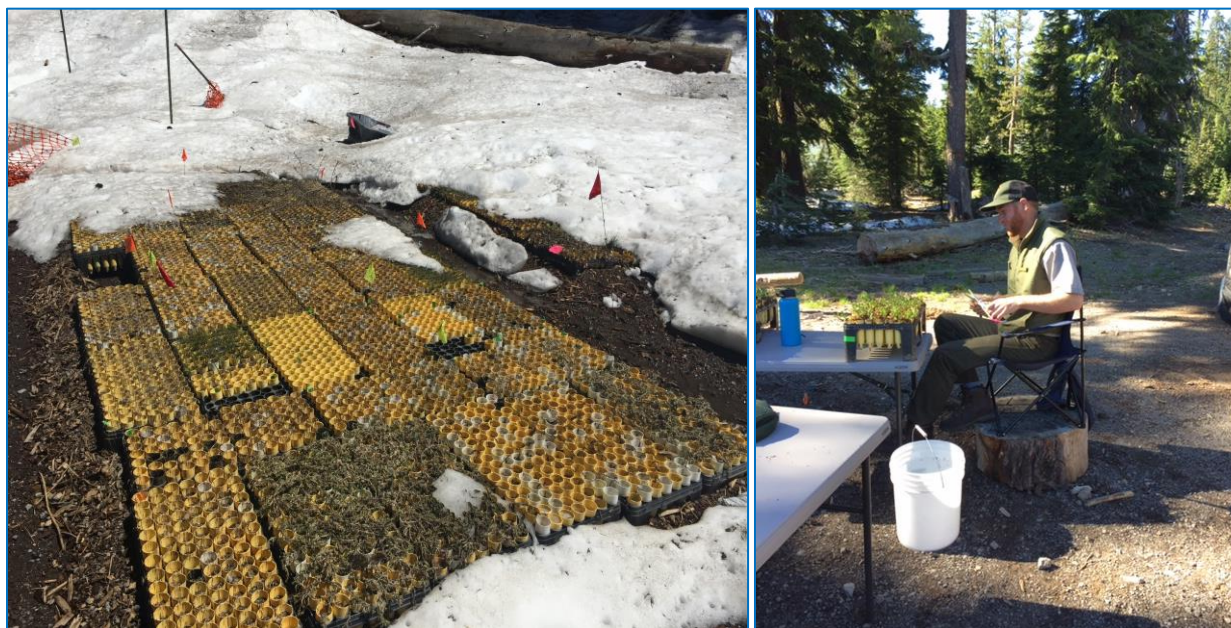
**Figure 18.** Overwintered plants melting out in June 2017 (left). Dividing plants at the South Yard (right). Photos by Carrie Wyler.

In 2016, over 15,000 native plants were grown at the Corvallis PMC and delivered to the Park. Due to early and abundant snowfall in October of 2016 and delays in the construction schedule, approximately 10,000 of these plants were unable to be planted and were overwintered at the Ballfield near park headquarters (Figure 18). These plants were then cared for by the Botany crew throughout the 2017 field season. When the majority of the plants had melted out in June, plants

without any green growth or with rotted roots were discarded. Certain species experienced substantially higher survivorship than others, with grasses, sedges and rushes having the greatest success, and species such as *Eriogonum marifolium* var. *marifolium*, *Penstemon davidsonii* var. *davidsonii*, *Lupinus lepidus* var. *lobbii*, *Ericameria greenei*, *Ericameria nauseosa* var. *speciosa*, and *Luetkea pectinata* experiencing high mortality. In order to make up for the loss of these species, approximately 1,500 of the grasses and rushes were divided (Figure 18). Among the divided plants there was an estimated 75% survival rate. These divisions helped to partially recoup the losses experienced from overwintering. Detailed reports of daily nursery activities and plant care are in Botany program files in the Nursery Activities binder.

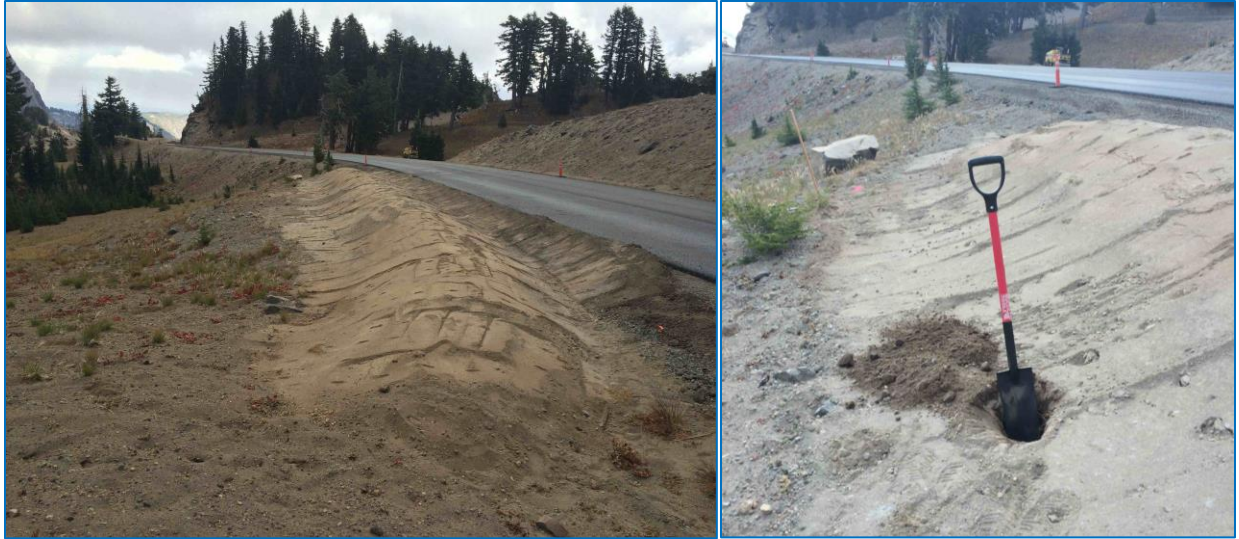
**Figure 19.** An obliterated pullout with insufficient site preparation, as the restored area looks more like a “worm” of placed topsoil rather than a natural landscape feature (left). Obliterated pullouts were inspected for signs of soil compaction (right). Photos by Ken Stella.

Due to very few of the disturbance areas being ready for restoration this season, there was very little site preparation that occurred in 2017. Two of the pullouts on West Rim Drive that were insufficiently obliterated in 2016 had still not been corrected (Figure 19). Other areas (e.g., Watchman Overlook, Cleetwood Cove Parking Lot) were not finished to the point of being able to prepare sites for restoration. The sites that were available for restoration were prepared prior to planting and/or seeding as per established methods.

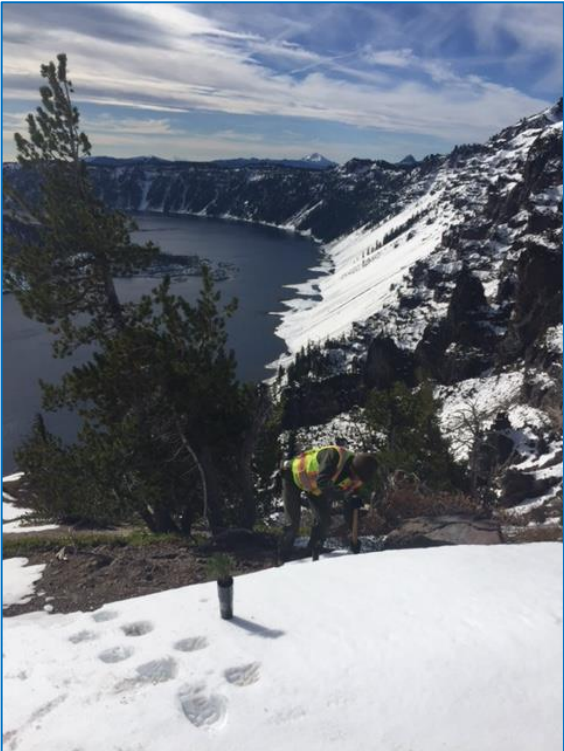
**Figure 20.** Early abundant snowfall in October 2017 shortened the restoration window. Photo by Carrie Wyler.

The Revegetation crew had planned to restore scheduled disturbance areas along West and East Rim Drives in the fall of 2017. Road construction plans for the 2017 season included finishing all obliterated pullouts along East and West Rim Drives. Accordingly, Park staff worked with the DSC Revegetation Specialists and the Corvallis PMC to have adequate plant materials (plants and seed) available for revegetation. The contractor assigned to the Rim Drive Rehabilitation project fell behind schedule, and as a result the only areas ready for restoration included unanticipated disturbance areas and two obliterated pullouts along West Rim Drive, one of which lacked adequate site preparation; and four small islands and an unplanned disturbed embankment at the Cleetwood Cove parking lot on East Rim Drive. A few early snow storms that hit in September and October (Figure 20) further compounded an already delayed construction schedule and resulted in not being able to revegetate areas that were scheduled for restoration.

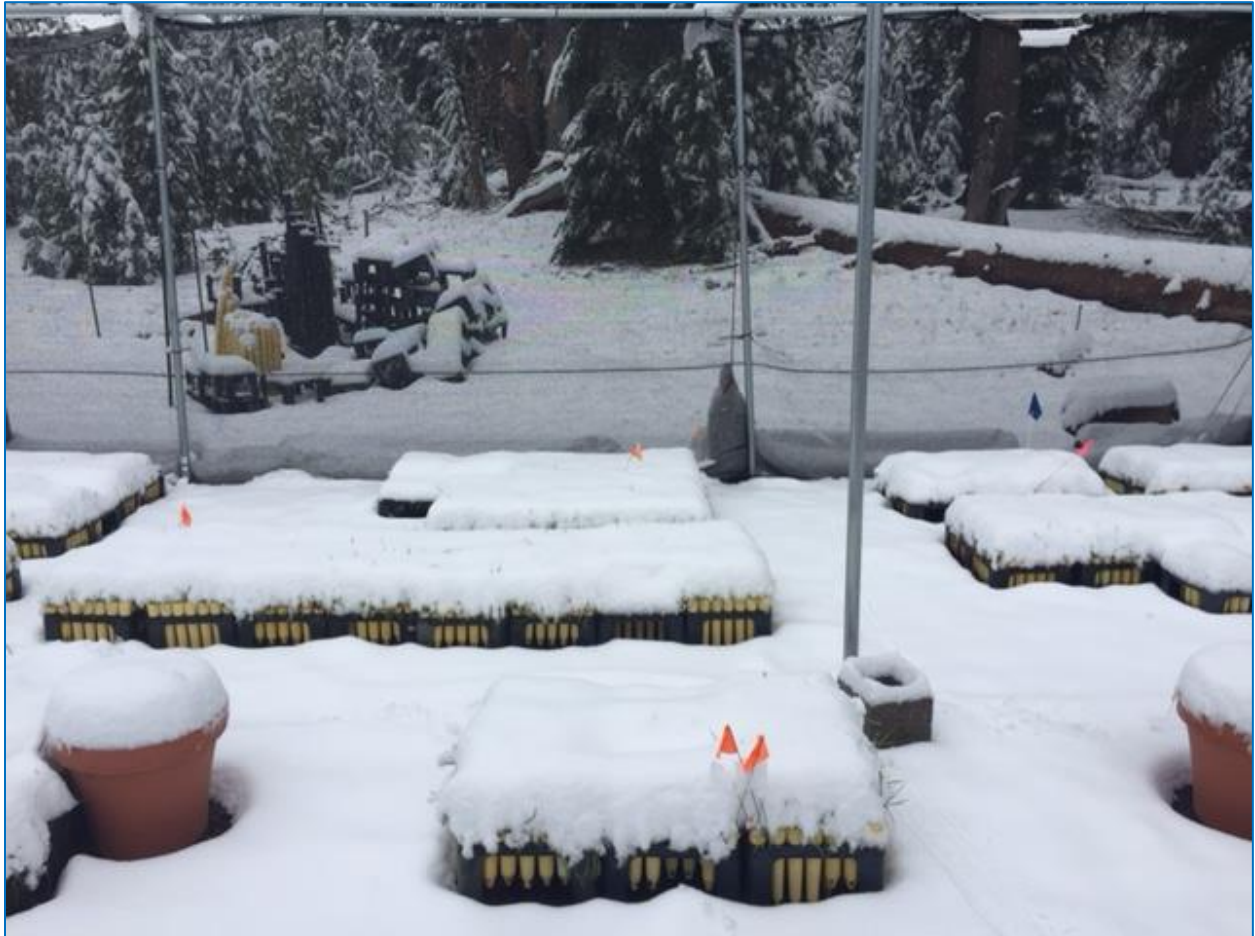
**Figure 21.** Plants covered by an early October 2017 snow storm. Photo by Carrie Wyler.

In 2017, 8,036 plants were not able to be planted and will be overwintered at the Ballfield (Table 9). Plants with less-than-optimal root development were planted first in seed zones where planting was possible. Plants exhibiting better root development and overall good health were selected for overwintering, with hopes of transplanting them into larger containers the following spring and planting them next fall. The overwintered plants were covered with two feet of snow during the last weeks of September (Figure 21), but were snow-free again after warm, dry weather in early October. They were finally covered with a persistent snowpack in early November.

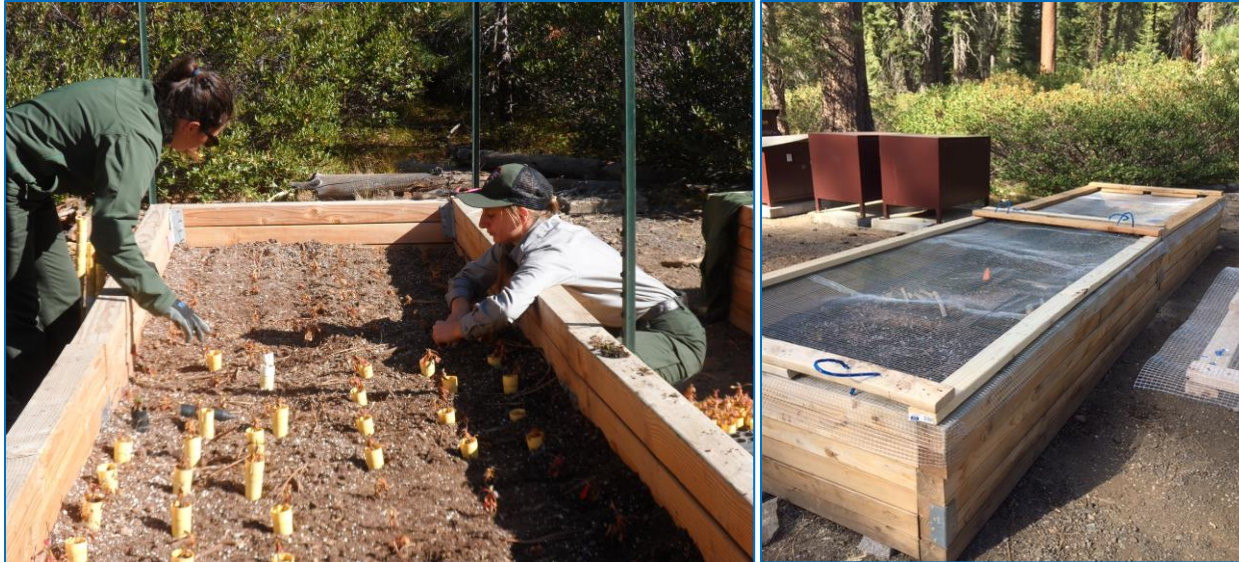
**Figure 22.** Planting seed increase beds at the Park’s South Yard with plants from Rim Drive (left). The seed increase bed on the right shows its caging lid to protect from animal predation. Photos by Tara Chizinski.

Due to the fact that a majority of the plants delivered in 2016 were still not able to be planted along Rim Drive, some plants were temporarily planted in the Park’s seed increase beds at the South Yard (Figure 22). Some plant species did not overwinter well in pots over the 2016/2017 winter. For that reason, three plant species were chosen to be planted in the seed increase beds based on difficulty of collecting their seed in the field and their chances of surviving the winter. The three plant species were *Eriogonum marifolium* var. *marifolium*, *Eriogonum pyrolifolium* var. *coryphaeum*, and *Penstemon davidsonii* var. *davidsonii* (Table 10).

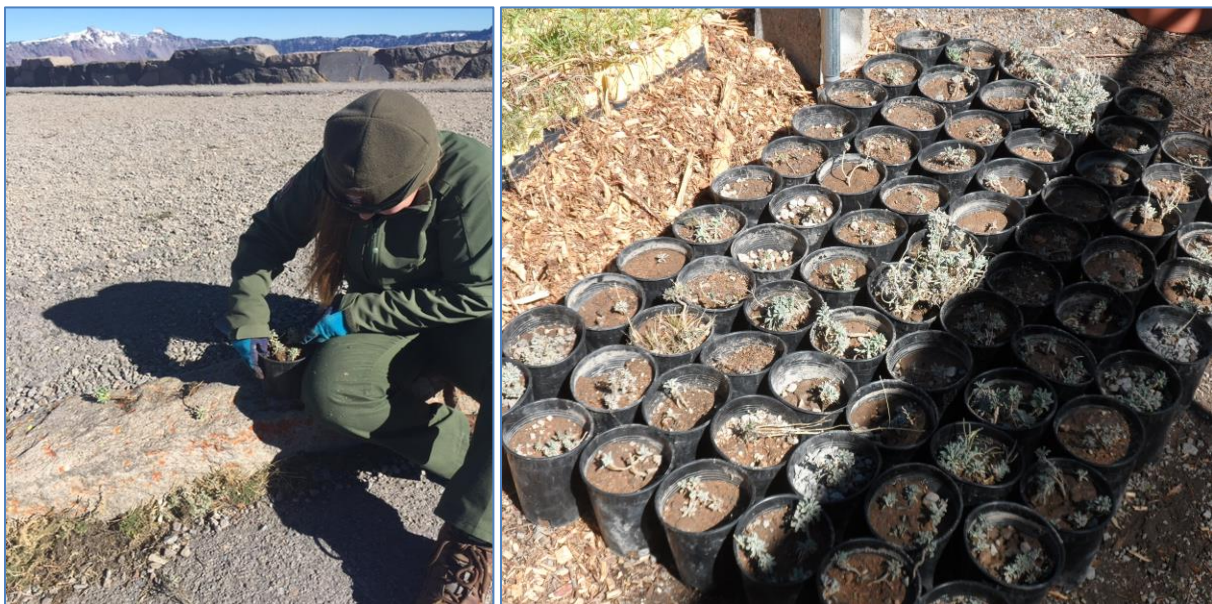
**Figure 24.** Salvaging *Boechea horizontalis* at Skell Head overlook (left). Crater Lake rockcress plants salvaged from the Skell Head overlook (right). Photos by Carrie Wyler.

During the 2017 season, 357 salvaged Crater Lake rockcress plants were replanted along the Watchman grade. Additionally, 75 pots with numerous Crater Lake rockcress plants were salvaged from the Skell Head Overlook wall and sidewalk (Figure 24). The wall is slated to be rebuilt and reinforced, and this construction will impact the plants growing in and near the wall. Salvaged plants were watered and cared for on a weekly basis at the Ballfield shade house. Salvaged plants were monitored in 2017 on 7/11, 8/9, and 9/27 for health, phenology, and survival.
