Rim Drive Rehabilitation Revegetation Project

2018 Annual Report

February 2019

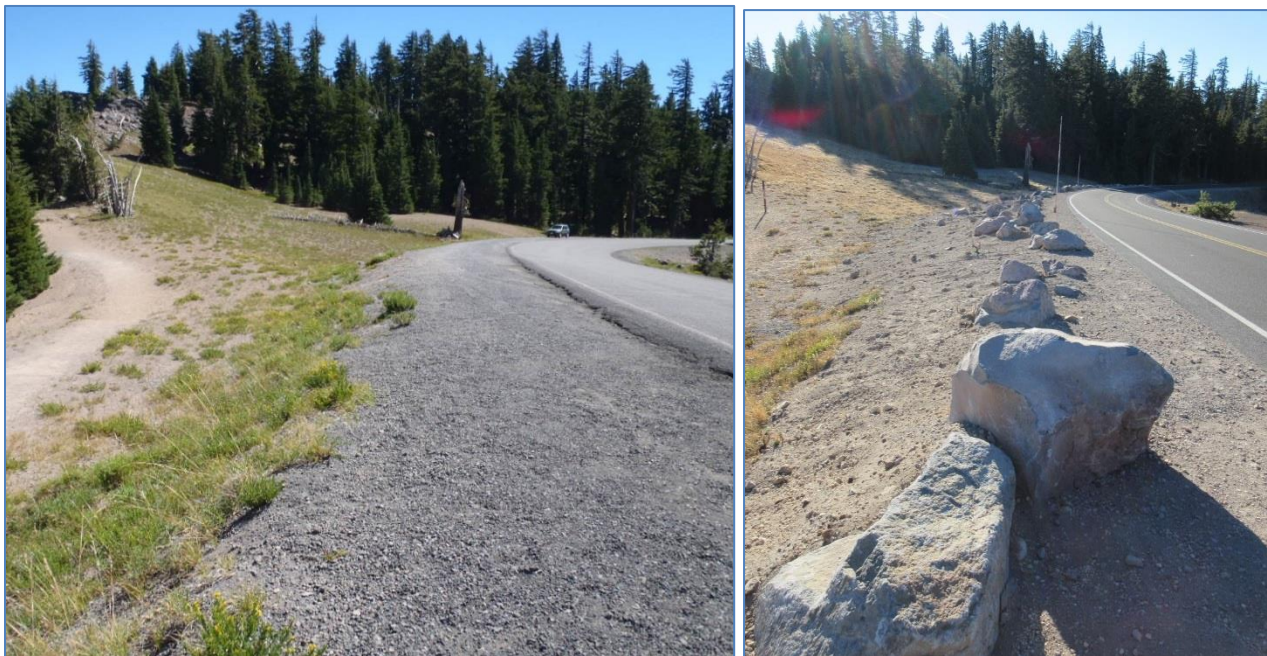
Figure 1. User-created pullout before (left; photo by Jen Hooke) and after (right; photo by Tara Chizinski) obliteration as part of the Rim Drive Rehabilitation project.

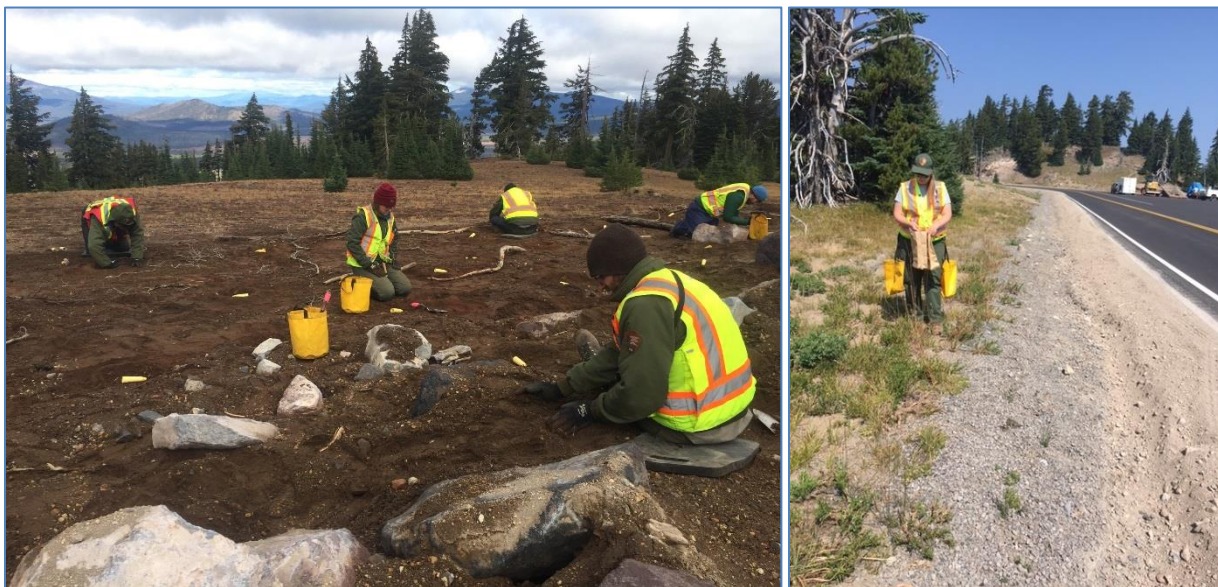
Figure 2. Conducting restoration outplantings (left) and collecting seed (right) for the Rim Drive Rehabilitation project. Photos by Carrie Wyler.

Restoration of areas disturbed by the Rim Drive Rehabilitation project (Figure 2) is necessary to jumpstart natural succession of vegetation communities and will help protect the rim environment from soil erosion and invasion by non-native plant species. Through using site-specific, native genotypes in revegetation efforts, the biodiversity and genetic integrity of the rim vegetation community is maintained.

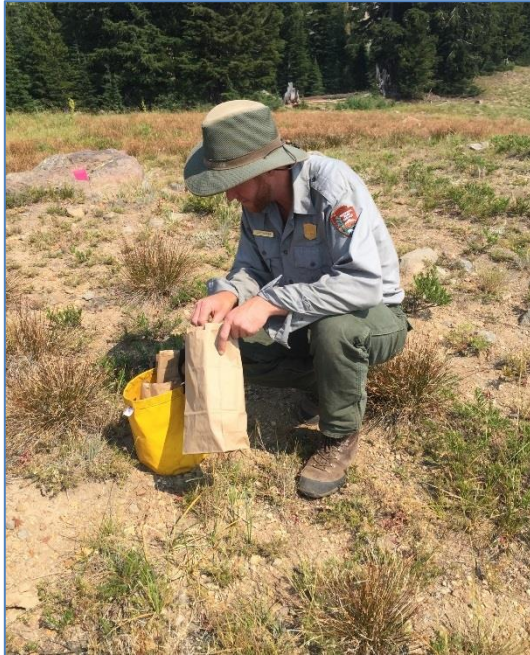
Figure 5. Collecting seed on West Rim Drive. Photo by Carrie Wyler.

When seeds were mature, they were collected, dried, and stored until shipment to the Corvallis PMC. Within each zone a single bag was used to collect all the seed from an individual species (Figure 5). In the field, bags were labelled with species code, collection date, and seed zone. After collection, seeds were transported to the seed drying and storage facility in the Stall Nine garage at Park

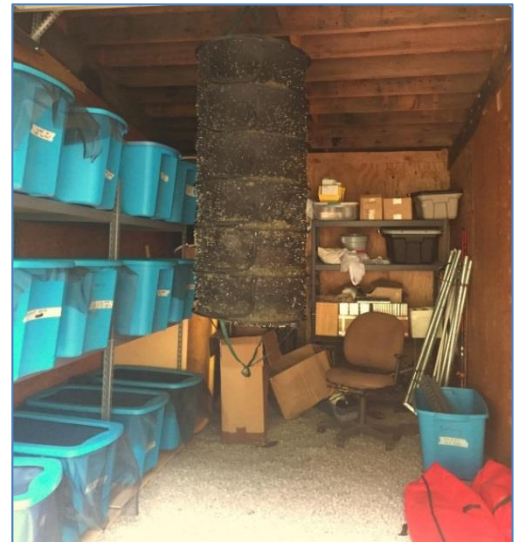
Figure 6. Seed drying and storage facility in the Stall Nine garage. Photo by Melody Frederic.

headquarters (Figure 6). When seeds arrived at this facility, records were kept for each species with collection dates, specific collection location, and seed zone. Seeds were then dumped inside 30-gallon plastic storage totes secured with window screen at the top, allowing ventilation while reducing chances of predation. Plant species that spilled very small seeds were first placed in smaller plastic bins before being stored within the larger 30-gallon tubs. The bins were labelled and organized on shelves by seed zone and species. Damp collections (especially lupines) were either shipped soon after collection (within a week), or set out in the sun during the day to speed the drying process.

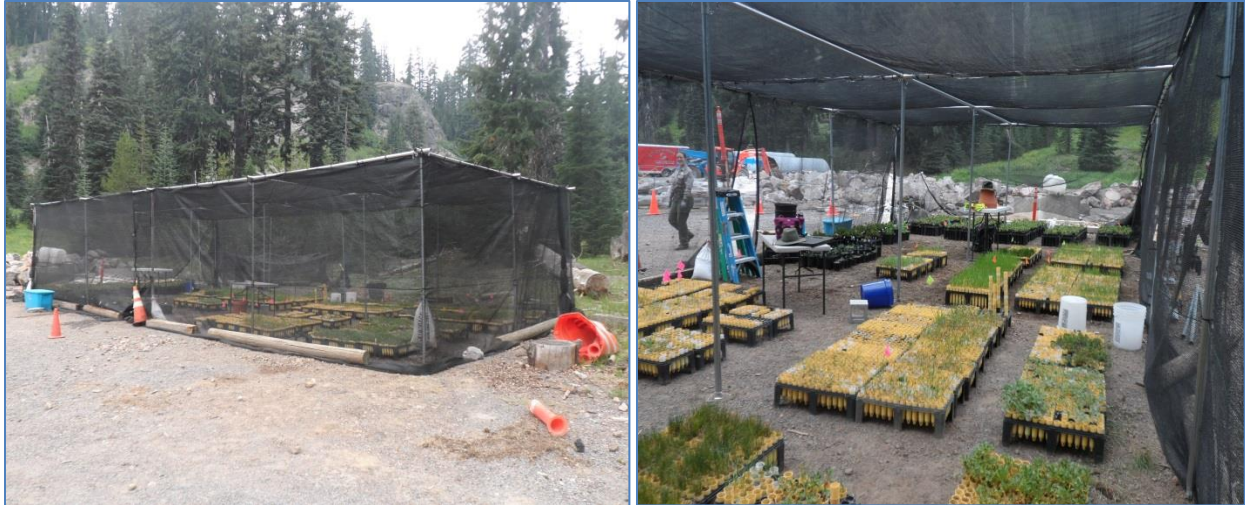
Figure 7. Shadehouse used to house plants held over from 2016/2017. Photos by Carrie Wyler.

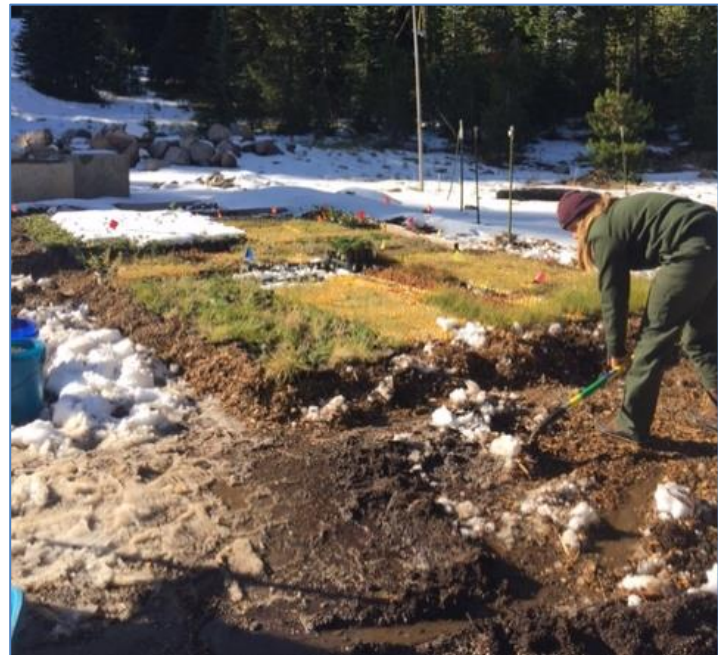
Figure 8. Plants being prepared for another overwintering period. Photo by Carrie Wyler.

As of November 2018, despite a successful planting season, many plants are being held over through another winter at the Ball Diamond. When ambient temperature dropped below freezing the containers were consolidated and mulch was stacked around the bases of herbaceous plants to prevent root freezing (Figure 8). These plants will need further care in the summer of 2019 including watering, fertilization, and transplanting into larger containers.

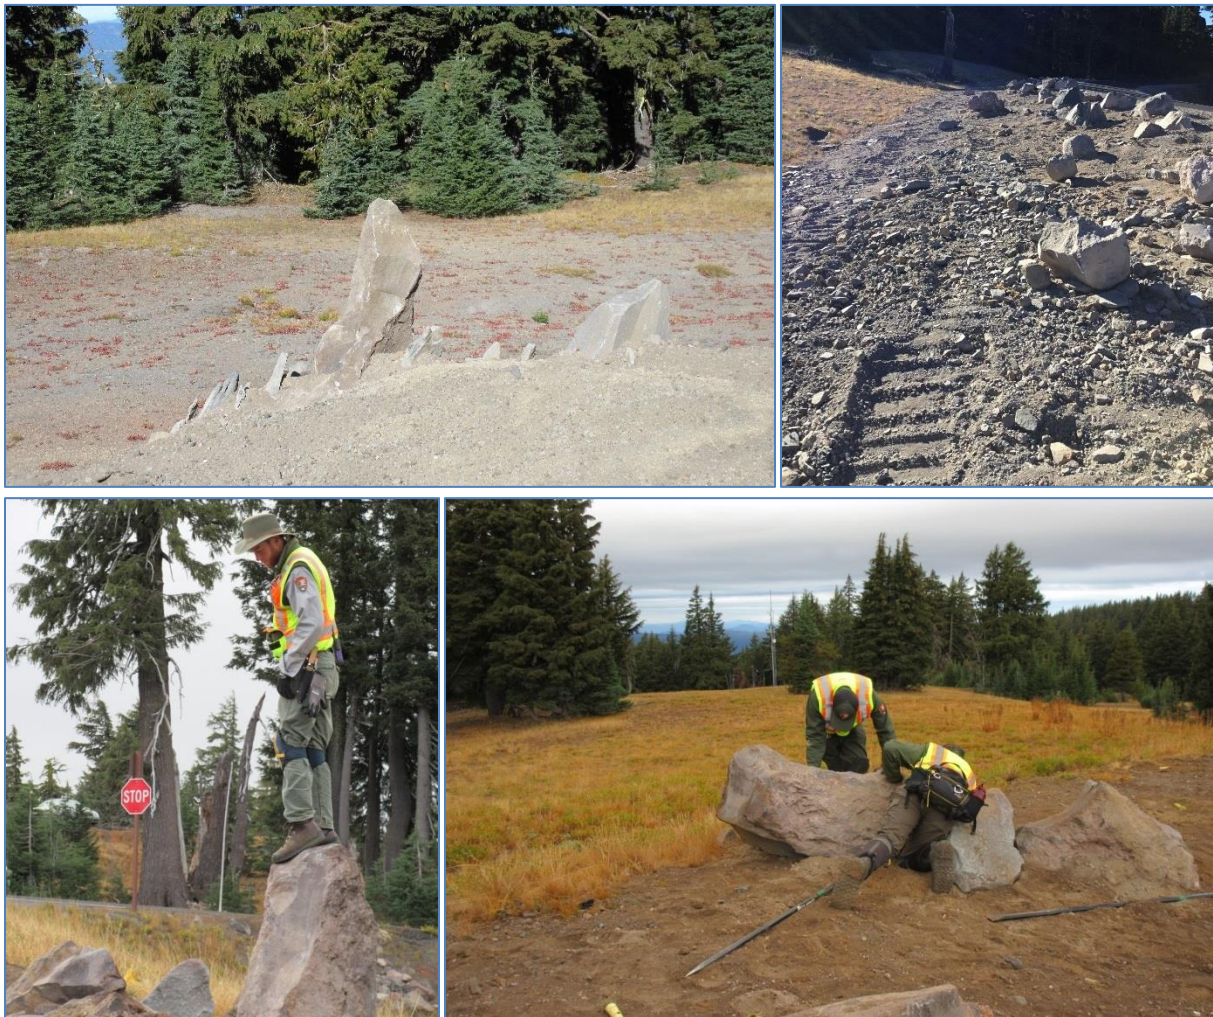
The road construction contractors were responsible for placing boulders on many restoration sites in order to prevent visitors from parking in these areas. Boulder placement was expected to look natural and not provide a distraction from the surrounding landscape. Where necessary, crews moved boulders and added some rocks in order to improve the aesthetics of the site and prevent cars from being parked on the edges of restoration areas (Figure 9).

Figure 9. Some sites had boulders placed that did not look natural (top left, bottom left) and/or were left with an excessive amount of gravel at the site (top right). The Botany crew adjusted sites as needed prior to planting/seeding. Photos by Tara Chizinski and Jen Hooke.

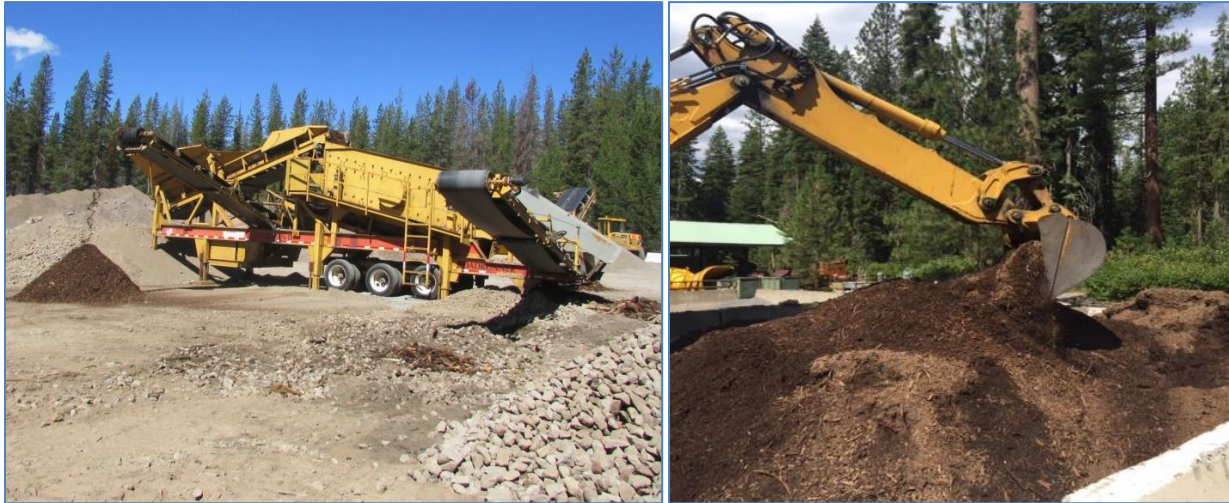
Figure 10. A screen plant was used to sort readily compostable materials (left) from partially composted woody debris to augment conditions at disturbed sites. Photo by Jen Hooke. Compost is routinely turned (right) to aid in decomposition. Photo by Carrie Wyler.

Compost temperature was monitored over the season and was found to be high enough to indicate active biota degrading the material. The compost was used to provide a source of natural fertilizer and mulch for newly planted seedlings. The compost also helped create local microclimates, retain soil moisture, and provide microfauna to help promote soil development and aid the establishment and growth of the seedlings. Woody materials were used to help stabilize recently disturbed and denuded sites from road construction while also helping create microclimates and seed pockets to further encourage the natural recovery of the areas. Larger woody debris (branches, logs, etc.) was obtained from the surrounding forest at disturbed sites and added to restoration sites as appropriate to assist with erosion control and site amelioration.

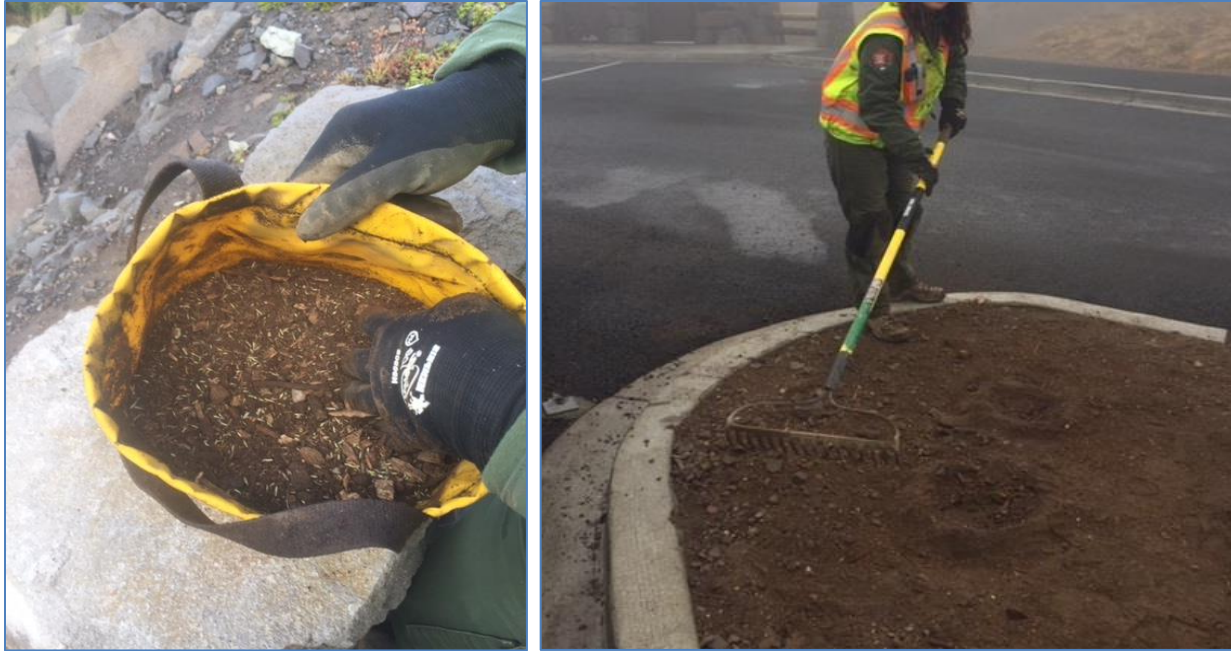
Figure 11. Site specific seed mix (left). Raking seed into a restoration site (right). Photos by Carrie Wyler.

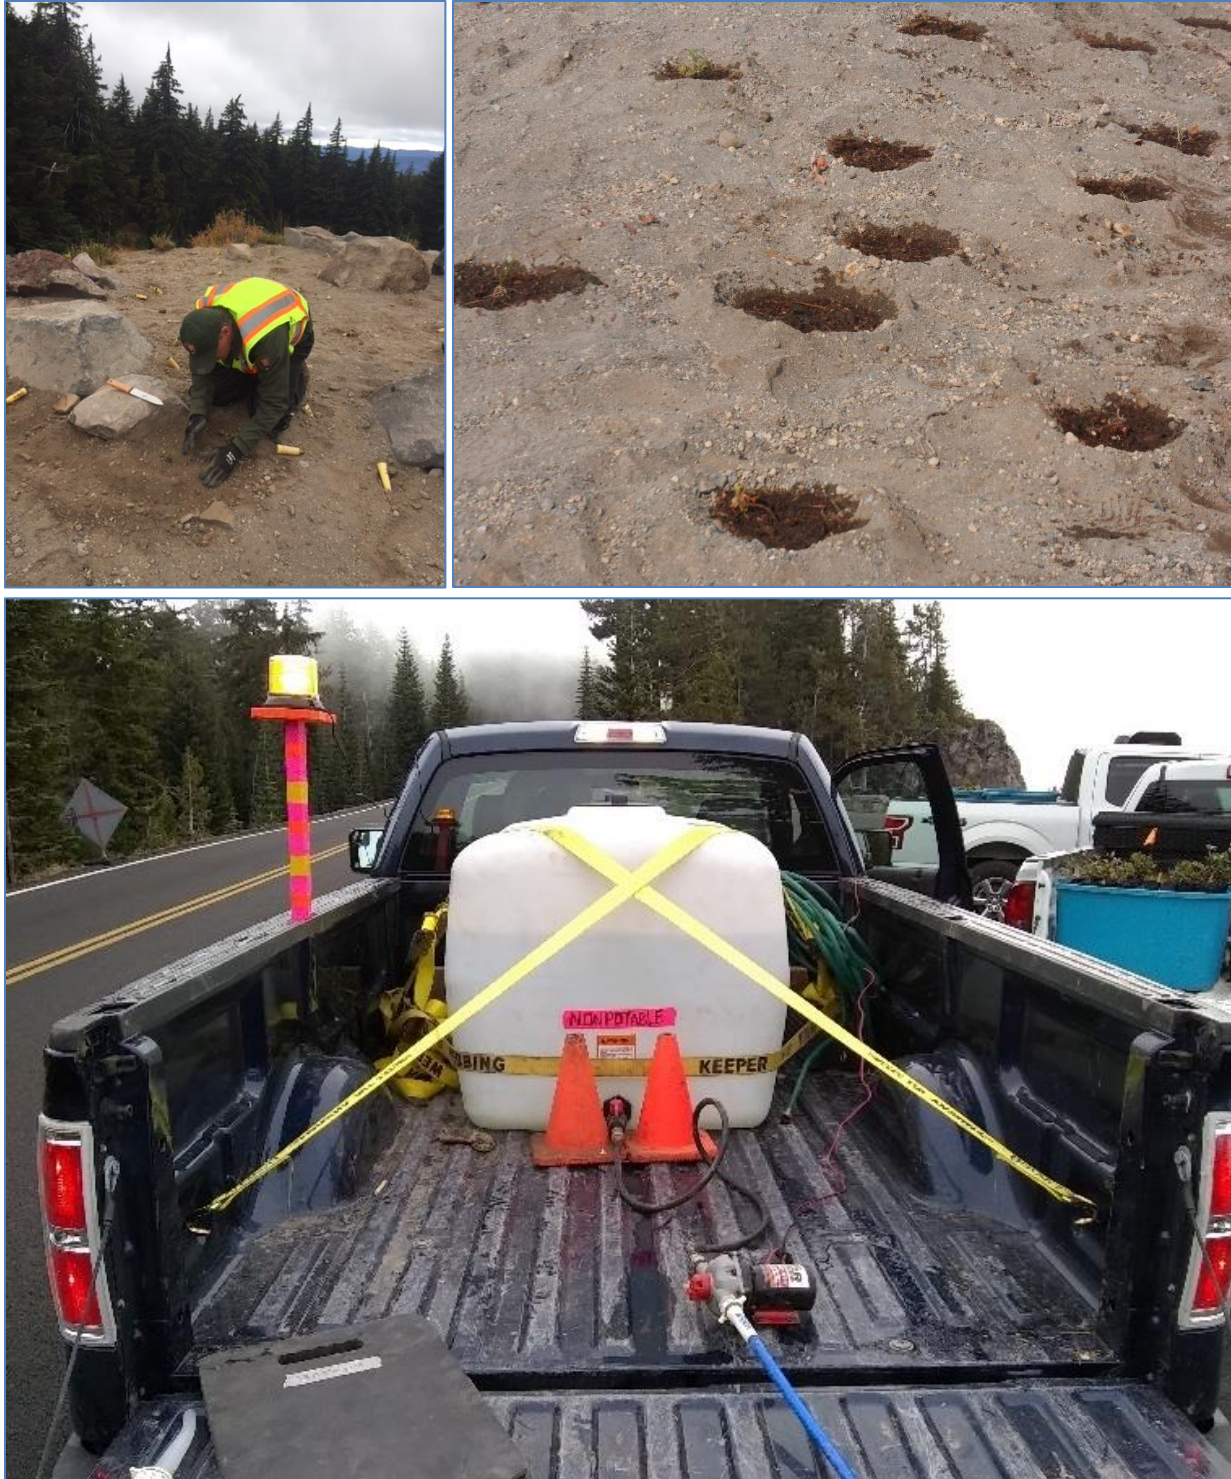
At restoration sites, holes were dug to a depth equal to or greater than the length of the planting tubes. Plants were carefully removed from the tubes by pressing on the sides of the tubes or tapping the rim of the tubes while they were inverted over the planting holes. After the plants had been removed, the roots were inspected for any signs of being root bound, having roots growing upward in the tube (“J”-rooting), or root girdling. If any of these were found, the roots were either trimmed or gently teased apart to encourage root growth and plant establishment. The plants were then placed in planting holes to ensure they were upright perpendicular to the pull of gravity (not relative to the local topography). Soil was then pushed back into the planting holes and tamped down gently to remove any air pockets in the soil. Plantings were installed so that the root collars of the plants were just at or slightly below the surface of the soil. Remaining soil or additional soil from the surrounding area was used to create a berm wall around the plants to facilitate water retention and help stabilize and protect plants. One or two handfuls of compost were then placed in the center of the rings around plants (Figure 12). After mulching, the plants were watered at least once. A 200 gallon water tank was mounted in the bed of a truck on a wooden pallet and used in conjunction with an electric pump to facilitate watering of newly planted plugs (Figure 12).

Figure 12. Upper left: Building a berm for a plant. Upper right: Recently installed plants with compost and soil berms to contain water. Photos by Tara Chizinski. Bottom: Truck-mounted water tank used to water newly planted and mulched plants. Photo by Carrie Wyler.

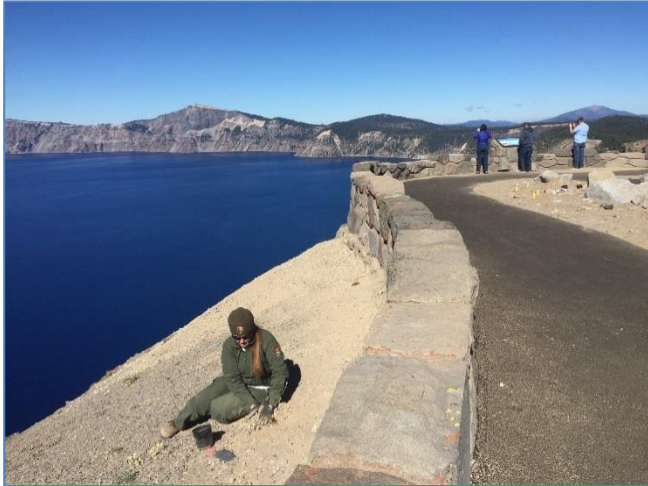
Figure 14. Transplanting a salvaged Crater Lake rockcress back at the Skell Head overlook after construction disturbance. Photo by Carrie Wyler.

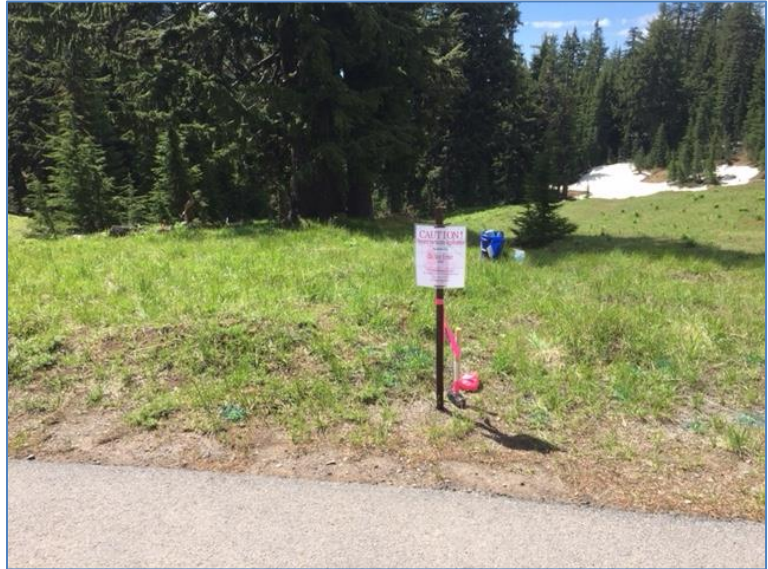
Figure 15. Area signed after herbicide treatment near the Crater Lake Lodge. Photo by Carrie Wyler.

When invasive plants are encountered, data are recorded including scientific name, UTM coordinates (Zone 10, NAD83 datum), total number of plants present, area occupied by invasive plants, and treatment applied to population. Invasive plants are controlled via manual or chemical methods (Figure 15) as per the Park's Invasive Vegetation Management Plan (DOI NPS 2017). All plant parts capable of reproduction are bagged and disposed of in the trash compactor at Park headquarters. Vegetative parts incapable of reproduction are left to desiccate on site unless they present logistical or aesthetic problems for Park visitors, employees, and partners.

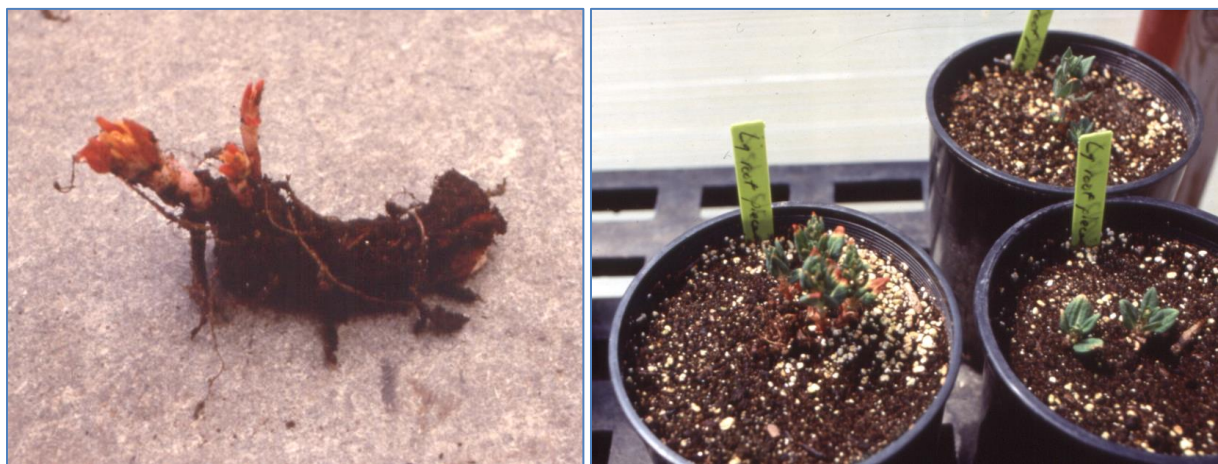
Figure 16. Sprouting root fragments of fleeceflower (left); pots of fleeceflowers emerging from root cuttings (right). Photos by Corvallis PMC.

In 2018, Botany staff collected seed from all species on the RDRR project's species collection list. Grasses, sedges, and buckwheat (*Eriogonum* sp.) species produced abundant seed that was easy to collect, and thus made up the bulk of 2018 seed collection. Species that were collected in lower quantities include lupine (*Lupinus* sp.) and paintbrush (*Castilleja* sp.), as predation from unknown insects and mammals significantly reduced the quantity and quality of available seed for these species. Additionally, phlox was collected in low quantities in 2018, as the seed matured much earlier than expected and the collection window was very short. Fleeceflower (*Aconogonon davisiae* var. *davisiae*) continued to pose a challenge for seed collection and plant propagation efforts. Fertilization appears to be very patchy in the field, and while fruit development can be detected for the first few months after fertilization, many developing seeds appear to be aborted weeks before any viable seed can be acquired. Previous attempts at propagating fleeceflower suggest root division/cuttings (Figure 16) are viable means of propagation (Trindle and Fessner 2003); however, initial tests of this method by the Corvallis PMC were largely unsuccessful. Crater Lake NP Botany staff are currently experimenting with this method, and attempting to propagate fleeceflower in 20 Jumbo cones.

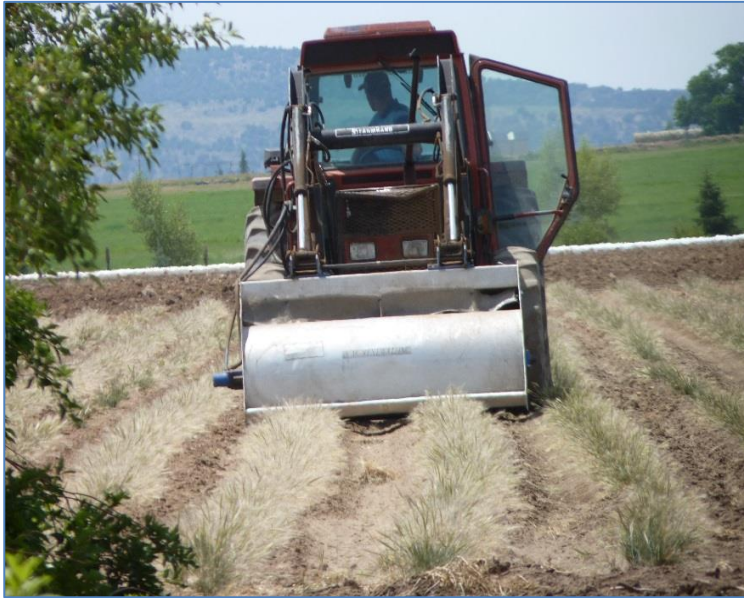
Figure 17. Squirreltail seed increase field at the Meeker PMC. Photo by Meeker PMC.

To mitigate for the increased levels of disturbance in this project, the seed increase services of the Meeker PMC were used to increase the abundance of plant materials available for restoration (Figure 17). In fall of 2015, 714 g of California brome (*Bromus carinatus* var. *carinatus*) and 2,218 g of squirreltail (*Elymus elymoides* ssp. *elymoides*) seed were sent to the Meeker PMC for seed increase. To maximize seed yield, it was agreed to combine squirreltail seeds from all seed zones for seed

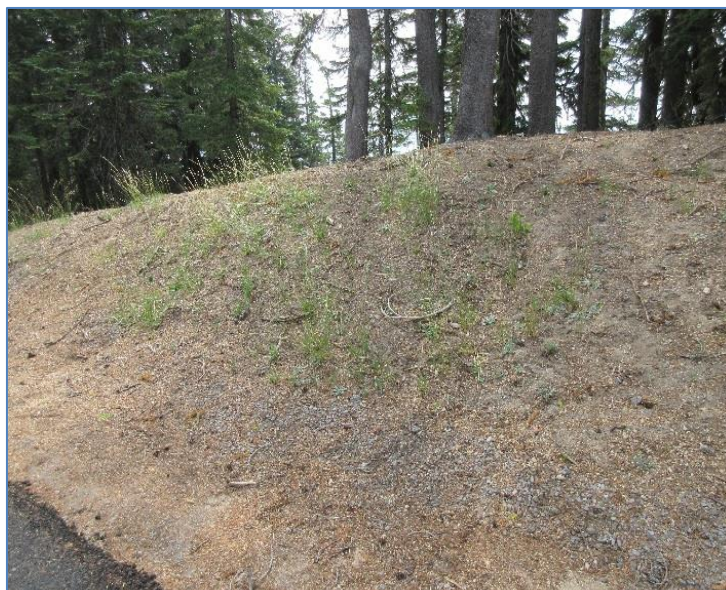
Figure 19. Example of a revegetation site with very good plant establishment after two years. Photo by Carrie Wyler.

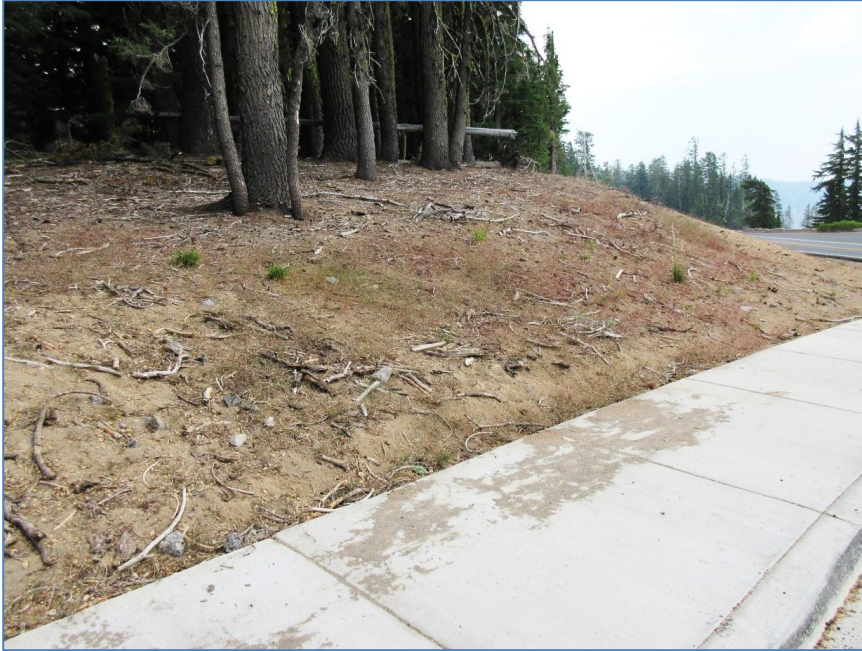
Figure 21. The pinkish hue of the plants in this photo reflects the abundance of spreading groundsmoke at this restoration site. Photo by Tara Chizinski.

Monitoring data also captured the colonization of most restoration sites that were revegetated during 2016-2017 in the North West Rim Drive, Northeast East Rim Drive, and Northwest East Rim Drive seed zones by the native plant spreading groundsmoke (*Gayophytum diffusum*). This species was not recorded during the drafting of restoration prescriptions and is serving the role of a pioneering species into revegetation sites (Figure 21). To date, no other native plant species has appeared at restoration sites that was not present pre-disturbance.

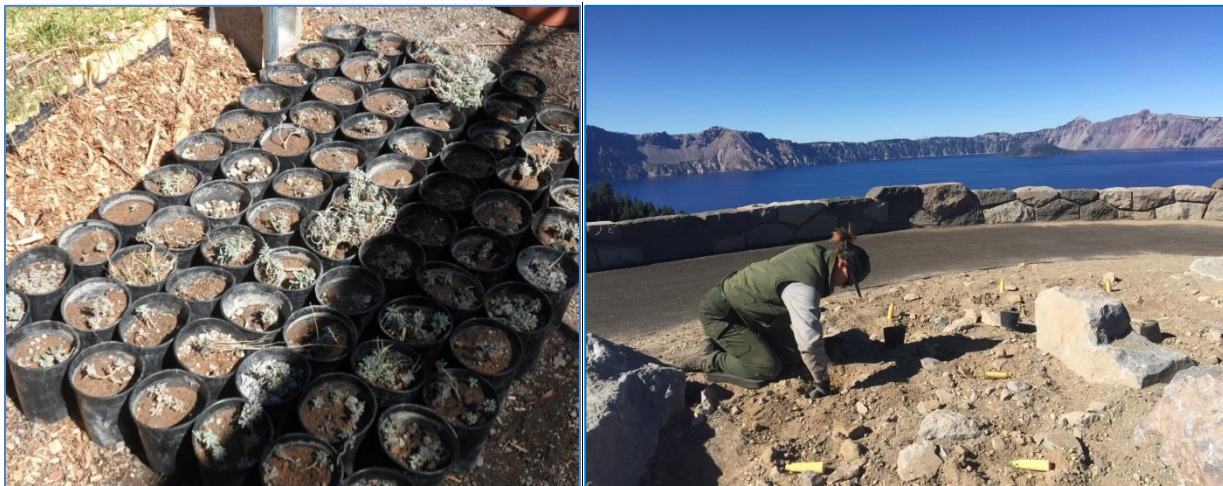
During the 2018 season, 63 salvaged Crater Lake rockcress plants were replanted at the Skell Head Overlook in the new planting islands and along the outside of the rock wall where they had been salvaged from (Figure 22). Their survival will be tracked over the coming years.

Figure 22. Crater Lake rockcress plants salvaged from the Skell Head overlook (left). Planting of salvaged *Boechera horizontalis* at Skell Head overlook (right). Photos by Carrie Wyler.
