Rim Drive Rehabilitation Revegetation Project

2019 Annual Report

Carolyn S. Wyler, Scott E. Heisler, Jennifer S. Hooke, Melody C. Frederic, Carson R.T. Ralls, and Benjamin D. Wright

April 2020

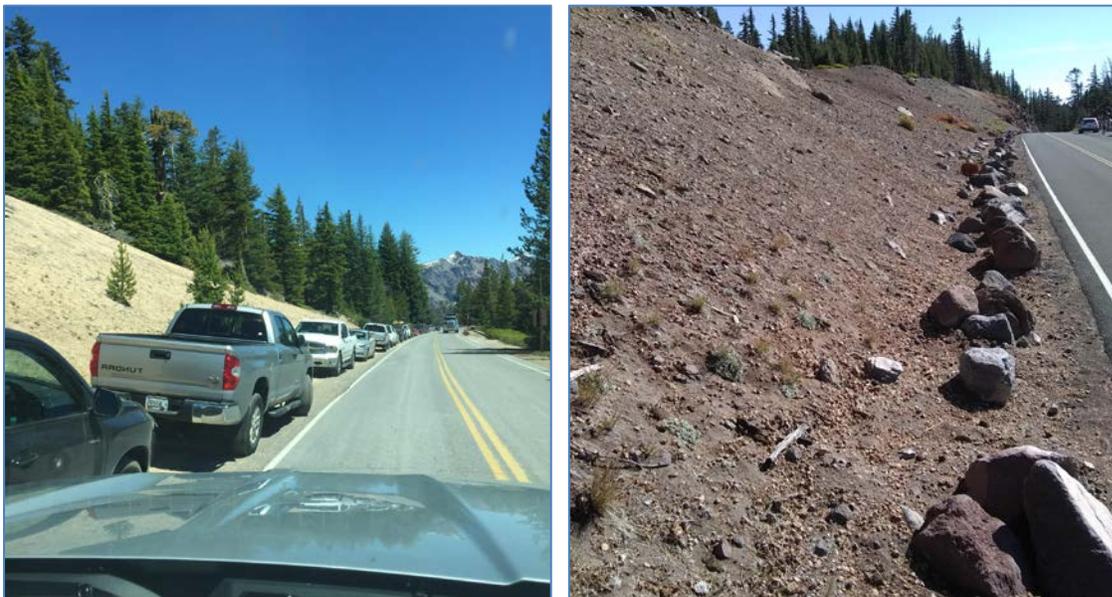
Figure 1. User-created pullouts before (left; photo by Carrie Wyler) and after (right; photo by Scott Heisler) obliteration as part of the Rim Drive Rehabilitation project.

Phase I of the Rim Drive Rehabilitation project was initiated in 2014 and focused on rockfall mitigation and road rehabilitation along Rim Drive. In 2014, intensive rockfall mitigation using heavy equipment and rock scaling occurred at Wizard Island Overlook, the Watchman, Sun Grade, Dutton Cliffs, and the Anderson Cut. In 2015 road rehabilitation work commenced that affected six miles of West Rim Drive, portions of East Rim Drive (e.g., North Junction to Cleetwood Cove; Skell Head; Grotto Cove), and the Rim Village parking lot. Major construction work on Phase I was completed in November 2018. Several new (i.e., unplanned) disturbance areas were established in 2016, 2017, and 2018 along West and East Rim Drives resulting from activities such as deep patch work, road realignment, and correcting drainage issues. In addition to impacting roadways and road shoulders, numerous pullouts, parking areas, and parking lots were modified. These modifications included obliterating unofficial pullouts (Figure 1), shrinking the footprint of excessively large parking areas, and installing landscaping islands in high visitor use areas.

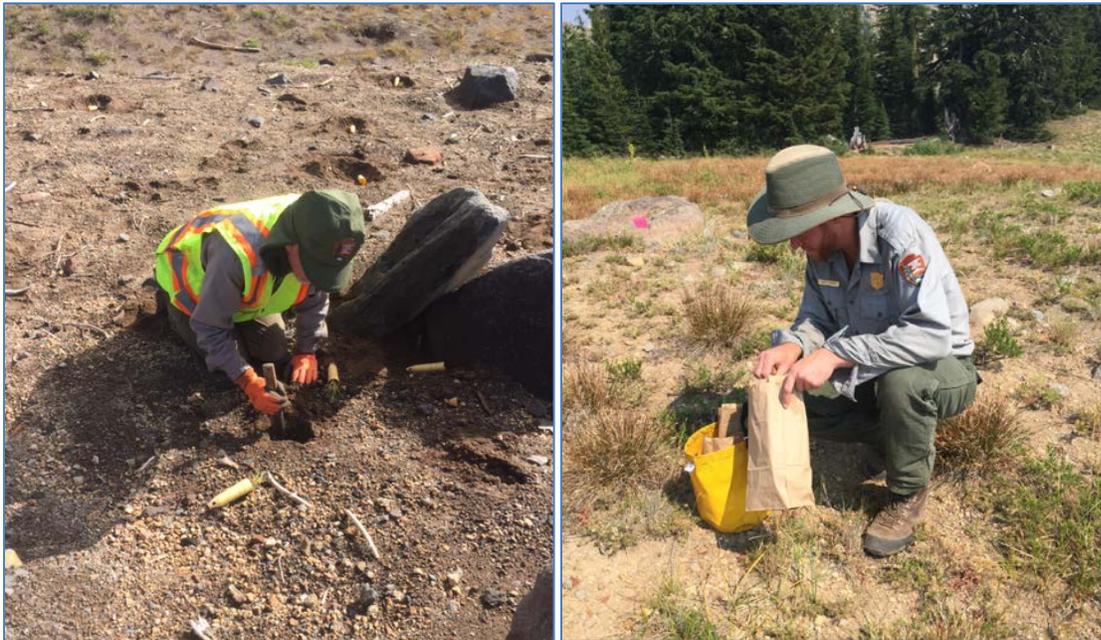
Figure 2. Conducting restoration outplantings (left) and collecting seed (right) for the Rim Drive Rehabilitation project. Photos by Carrie Wyler.

Restoration of areas disturbed by the Rim Drive Rehabilitation project (Figure 2) is necessary to jumpstart natural succession of vegetation communities and protect the rim environment from soil erosion and invasion by non-native plant species. Through using site-specific, native genotypes in revegetation efforts, the biodiversity and genetic integrity of the rim vegetation community is maintained.

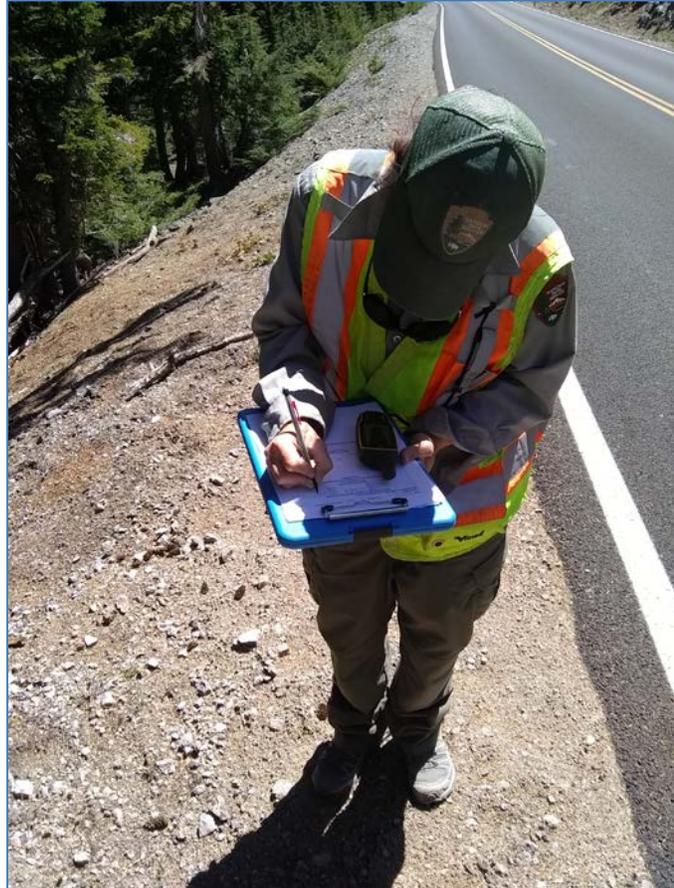
Figure 3. Monitoring plant phenology to track seed maturity. Photo by Scott Heisler.

The seed collection process commenced in 2019 by observing and documenting the phenology of each targeted species at each revegetation site within each seed zone (Figure 3). Notes were taken on plant phenology, seed maturity, and collection techniques; these observations helped refine seed collection protocols for each species (Beck et al. 2017). Maps were developed for all seed collection locations for species in each seed zone; these are stored on the Botany server.

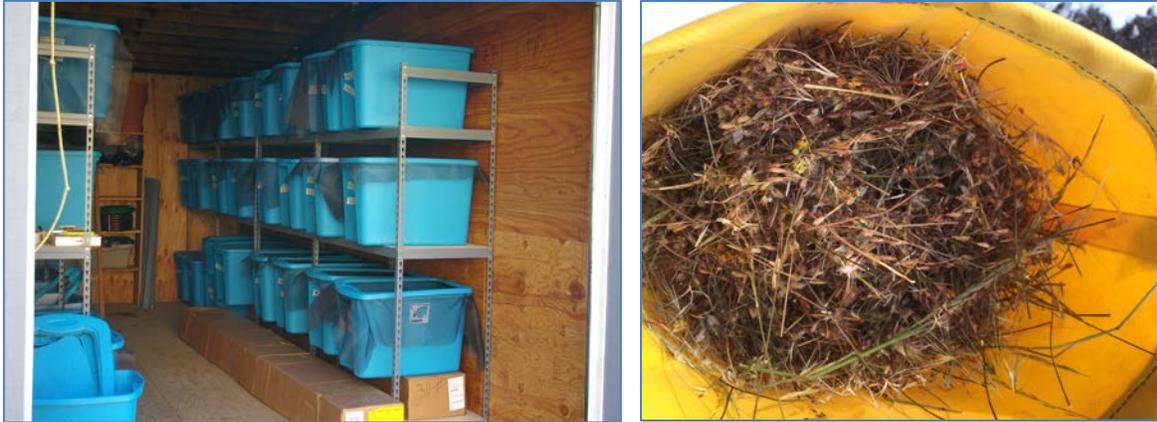
Figure 5. Seed drying and storage facility at Park headquarters (left). Parry's rush seed before cleaning (right). Photos by Carrie Wyler.

When seeds were mature, they were collected, dried, and stored until shipment to the Corvallis PMC. Within each zone a single bag was used to collect all the seed from an individual species (Figure 5). In the field, bags were labelled with species code, collection date, and seed zone. After collection, seeds were transported to the seed drying and storage facility in the Stall Nine garage at Park headquarters (Figure 5). When seeds arrived at this facility, records were kept for each species with collection dates, specific collection location, and seed zone. Seeds were then placed inside 30-gallon plastic storage totes secured with window screen at the top, allowing ventilation while reducing chances of predation. Plant species with very small seeds were first placed in smaller plastic bins before being stored within the larger 30-gallon tubs. The bins were labelled and organized on

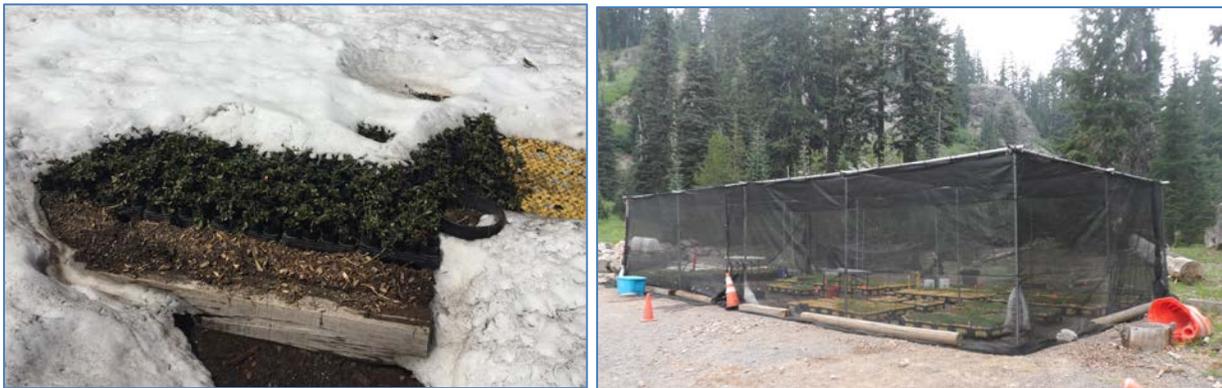
Figure 6. Overwintered plants emerging from the snow in the spring (left). Shadehouse at the Ball Diamond (right). Photos by Carrie Wyler.

Due to delays in the 2018 construction schedule, planting was not completed that fall and several thousand plants needed to be overwintered at the Ball Diamond nursery at Park headquarters. These plants required care and maintenance throughout the 2019 field season. Once the snow melted in June, plants were covered with a shade house (40'x 20'x10' – Figure 6).

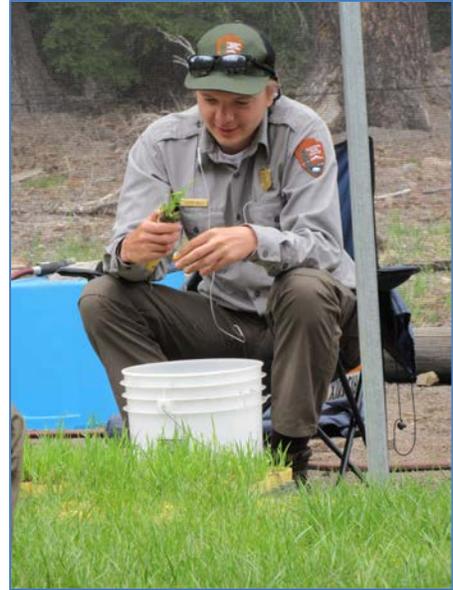
Figure 7. Conducting plant care in the Park’s shadehouse. Photo by Carrie Wyler.

The plants were fertilized with Peter’s 20-20-20 wettable fertilizer as prescribed by Corvallis PMC staff. Fertilization occurred approximately every 2 weeks at a rate of 1 tsp/gallon. Descriptions of fertilization procedures can be found in Botany program files in the “Nursery Activities” binder. Excess growth was manually trimmed with scissors or hedge clippers as needed. Any reproductive structures were removed to promote root development and prevent excess evapotranspiration, and dead growth was removed to discourage fungal growth. Undesired plant volunteers originating from Corvallis PMC in the planting tubes (e.g., moss, liverworts, and weeds) were removed before planting to minimize the risk of introducing non-native plant species to the Park (Figure 7). Any excessively root bound plants, including many grasses, sedges, spreading phlox (*Phlox diffusa*), and manzanita (*Arctostaphylos* sp.), were transplanted into larger containers or divided. The full details of which plants were transplanted can be found in the “Nursery Activities” Binder at Park headquarters.

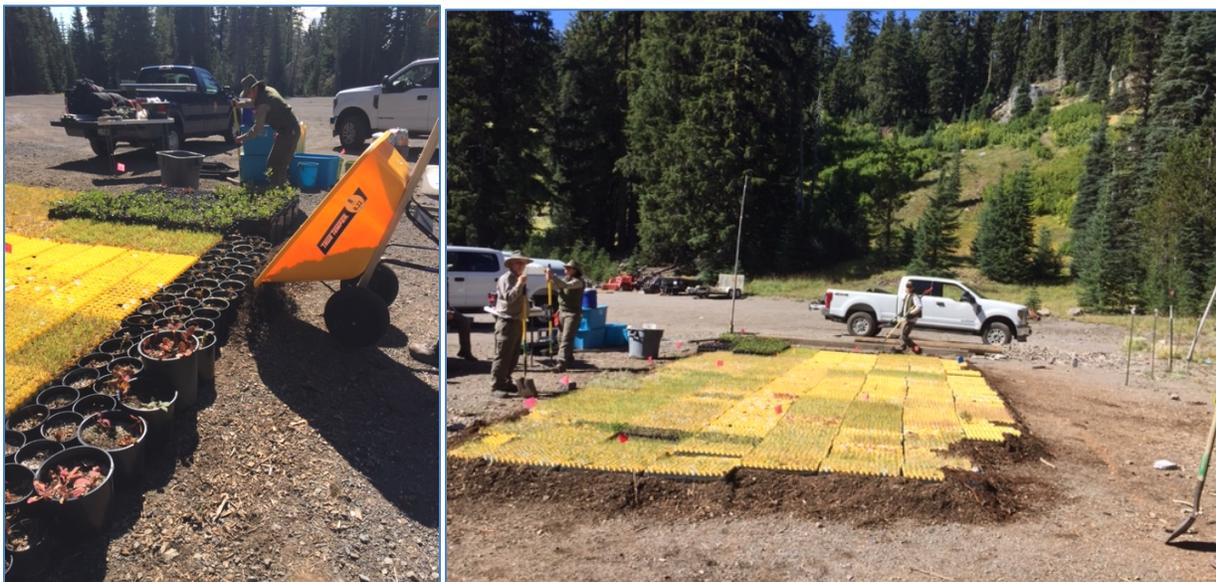
Figure 8. Distributing mulch around the edges of pots to insulate against frigid winter temperatures (left). Consolidated plants at the Park’s Ball Diamond prior to overwintering (right). Photos by Carrie Wyler.

Despite a successful planting season, many plants are being held over the 2019-20 winter at the Ball Diamond to fill in gaps as needed during the 2020 season. When ambient temperature dropped below freezing the containers were consolidated and mulch was stacked around the bases of herbaceous plants to prevent root freezing (Figure 8). These plants will need further care in the summer of 2020 including watering, fertilization, and transplanting into larger containers.

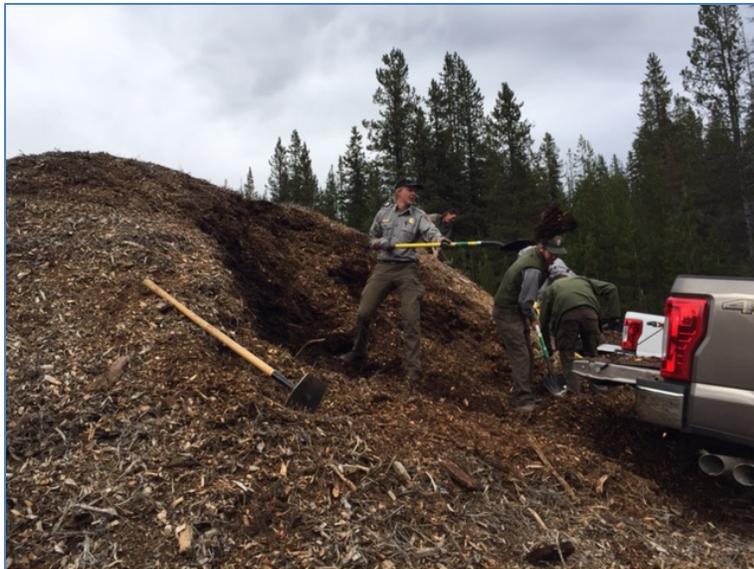
Figure 9. Compost being hauled from the Pole Bridge Quarry pile to the South Yard pile for use in restoration projects. Photo by Carrie Wyler.

Beginning in 2016, Park-sourced mulch/compost and small coarse woody debris were acquired from Pole Bridge Creek Quarry for use in site preparation. With the aid of a large screen plant, partially composted woody debris was processed and sorted. Materials with particle size of < 5 cm were designated as compost and transported to the South Yard for further maturation and maintenance. Slightly larger materials (5 cm – 15 cm particle size), were retained and stored at the Ball Diamond adjacent to the shade house. Compost was routinely turned using heavy equipment for proper decomposition. The compost was, and will continue to be, used on restoration sites (Figure 9).

Compost temperature was monitored over the season and was found to be high enough to indicate active biota degrading the material. The compost was used to provide a source of natural fertilizer and mulch for newly planted seedlings. The compost also helped create local microclimates, retain soil moisture, and provide microfauna to help promote soil development and aid the establishment and growth of the seedlings. Woody materials were used to help stabilize recently disturbed and denuded sites from road construction while also helping create microclimates and seed pockets to further encourage the

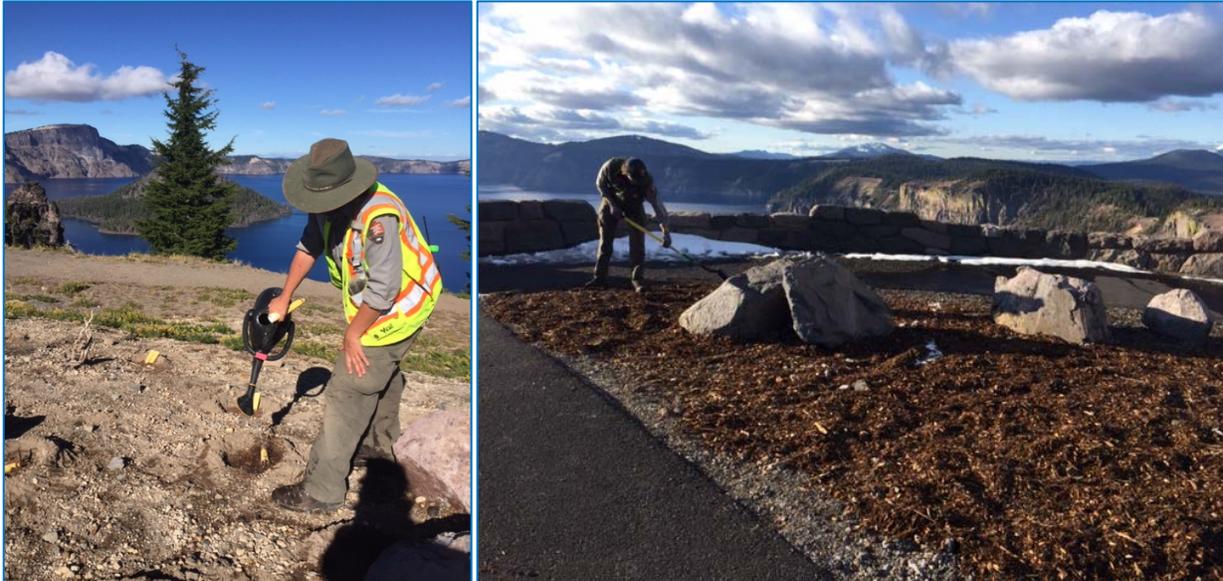
Figure 10. Watering plants after restoration planting (left). Raking seed in at Skell Head (right). Photos by Carrie Wyler.

watered (Figure 10). Site-specific seed mixes were prepared and hand-broadcast over planted areas, and over areas with slopes that were too steep to plant. After broadcasting seeds, the sites were scarified with hand rakes and compost was broadcast over the scarified areas (Figure 11).

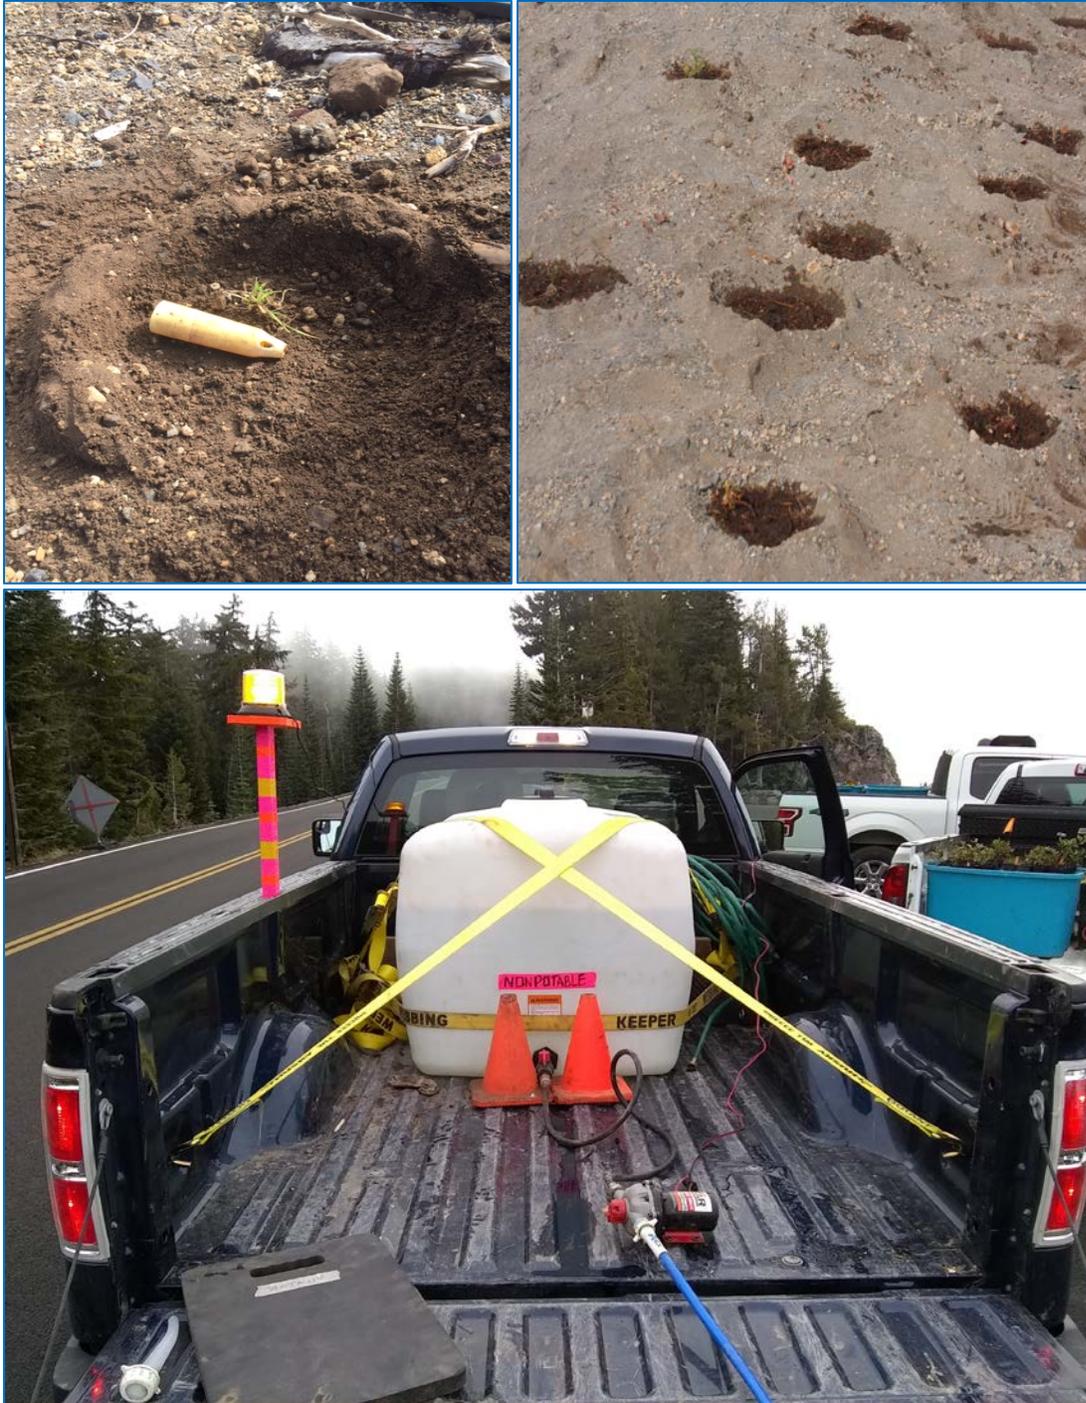
Figure 11. Upper left: Building a berm for a plant. Upper right: Recently installed plants with compost and soil berms to contain water. Bottom photo: The 200-gallon truck-mounted water tank. Photos by Carrie Wyler.

At restoration sites, holes were dug to a depth equal to or greater than the length of the planting tubes. Plants were carefully removed from the tubes by pressing on the sides of the tubes or tapping the rim of the tubes while they were inverted over the planting holes. After the plants had been removed, the roots were inspected for any signs of being root bound, having roots growing upward in the tube (“J”-rooting), or root girdling. If any of these were found, the roots were either trimmed or gently teased apart to encourage root growth and plant establishment. The plants were then placed in planting holes to ensure they were upright perpendicular to the pull of gravity (not relative to the local topography). Soil was then pushed back into the planting holes and tamped down gently to remove any air pockets in the soil. Plantings were installed so that the root collars of the plants were just at or slightly below the surface of the soil. Remaining soil or additional soil from the surrounding area was used to create a berm wall around the plants to facilitate water retention and help stabilize and protect plants. One or two handfuls of compost were then placed in the center of the rings around plants (Figure 11). After mulching, the plants were watered at least once. A 200-gallon water tank was mounted in the bed of a truck and used in conjunction with an electric pump to facilitate watering of newly planted plugs (Figure 11).

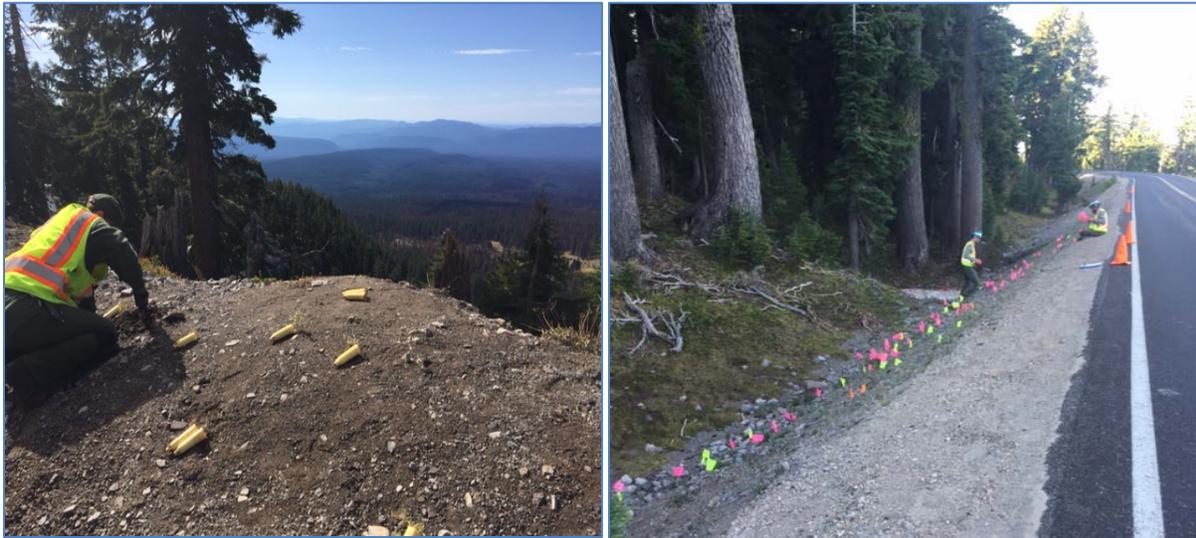
Figure 13. Planting Crater Lake rockcress along West Rim Drive (left). Monitoring Crater Lake rockcress at its reestablished population site (right). Photos by Carrie Wyler.

To mitigate impacts to the Park's special status plant species, baseline information was collected on pre-disturbance special status plant populations and seed was collected from rare plants for future propagation and revegetation. Wherever possible, special status plant species were protected from construction impacts. Rare plants were salvaged and cared for at a holdover facility and salvaged plants were transplanted back into their habitat post-disturbance. Additionally, supplemental

planting of propagated rare plants was conducted, and reestablished populations were monitored to inform management (Figure 13).

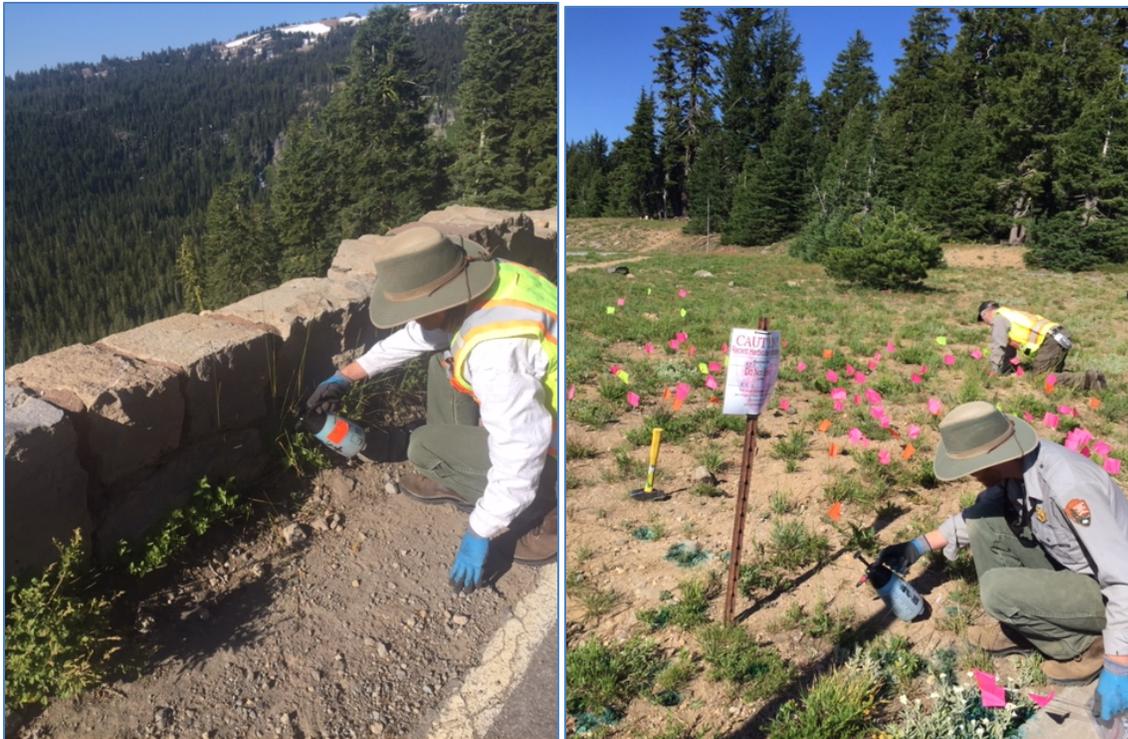
Figure 14. Controlling an invasive grass along East Rim Drive (left). Controlling sheep sorrel (*Rumex acetosella*) at Rim village (right). Photos by Carrie Wyler.

When invasive plants are encountered, data are recorded including scientific name, UTM coordinates (Zone 10, NAD83 datum), total number of plants present, area occupied by invasive plants, and treatment applied to population. Invasive plants are controlled via manual or chemical methods (Figure 14) as per the Park's Invasive Vegetation Management Plan (DOI NPS 2017). All plant parts capable of reproduction are bagged and disposed of in the trash compactor at Park headquarters. Vegetative parts incapable of reproduction are left to desiccate on site unless they present logistical or aesthetic problems for Park visitors, employees, and partners.

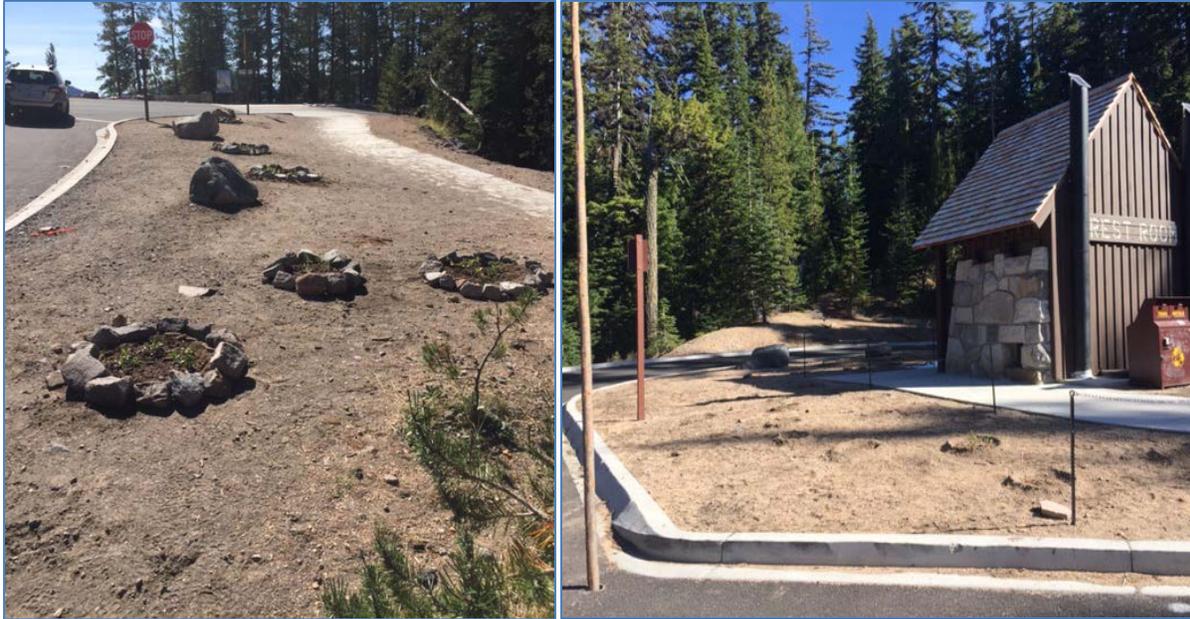
Figure 15. Plantings in groups of three with rock borders to mitigate trampling in heavily trafficked Cleetwood Cove parking lot areas (left). The area at the back of the Cleetwood Cove parking lot will be adjusted to allow for RVs to drive around the comfort station (right). Photos by Carrie Wyler.

Restoration work has begun at site NEERD3, which is the Cleetwood Cove parking lot. Construction work at the comfort stations and ticket booth sites was not completed until the fall of 2019. Landscaping islands and beds in the parking lot have been revegetated, but these areas are heavily trampled by visitors which presents challenges to restoration. These areas will need to be assessed yearly for traffic patterns and trampling and filled in with plants as problem areas arise. Additional barriers (fencing) may be needed to protect the newly established vegetation. Installation of fencing was not possible in the front of the parking lot due to a buried gas line's unknown location. To protect young vegetation until it is large enough to be visible by parking lot users, plants were placed in groups of three and circled with large rocks to form a barrier (Figure 15). The back of the parking lot will be worked on during Phase II of the RDR project. The area presently is not big enough for large recreational vehicles pass through and their back wheels often jump the curb and damage a revegetation site. This area has been sparsely planted in areas that would not be impacted by vehicle traffic (Figure 15). Site NEERD 3.1 is the east embankment of the Cleetwood Cove parking lot and will need to be addressed in future years. It has a steep slope of pumice soil that is continuously eroding and hindering restoration efforts.

- The east embankment at the Cleetwood Cove parking lot will continue to need slope stabilization and erosion control for revegetation efforts to be successful. This embankment was disturbed by contractors stacking cut logs on it when they were clearing trees to expand the parking lot. The embankment is steep and consists of loose pumice soil, which collapses when walked on. The site does not hold seed or water well, and it has been difficult to restore and revegetate. In 2019 large logs and rocks were put into place and areas were vertically mulched with little success. This area needs to be reassessed in 2020 to develop a

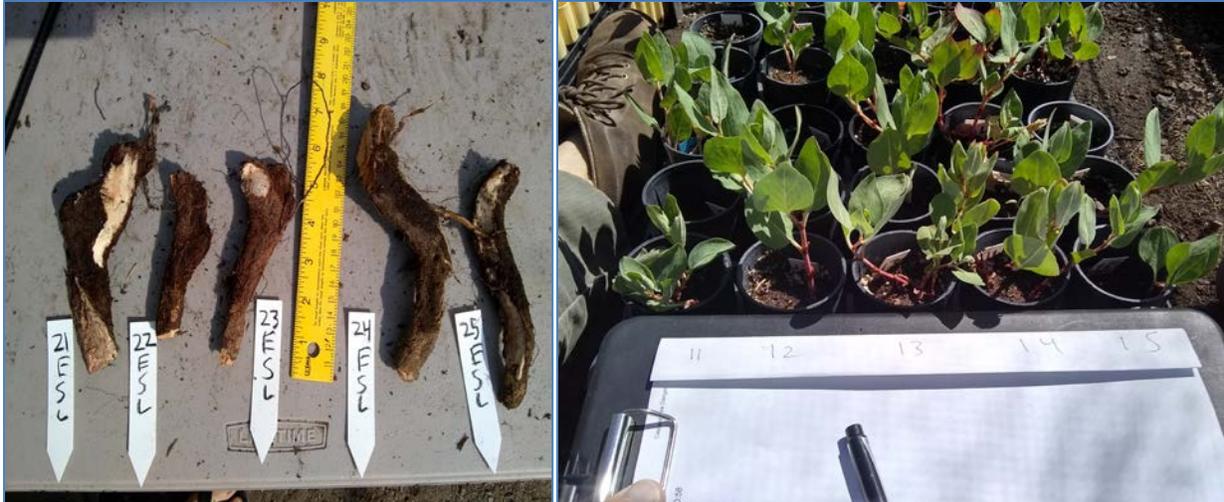
Figure 16. Root division cuttings of fleeceflower (left); pots of fleeceflowers emerging from root cuttings (right). Photos by Scott Heisler.

In 2019, Botany staff collected seed from all species on the RDRR project’s species collection list. Grasses and sedges produced abundant seed that was easy to collect, and thus made up the bulk of the 2019 seed collection. Species that were collected in lower quantities include lupine (*Lupinus* sp.) and pussypaws (*Calyptridium umbellatum*), as predation from unknown insects and mammals significantly reduced the quantity and quality of available seed. Additionally, spreading phlox was collected in low quantities in 2019, as the seed is difficult to collect, and the collection window was very short. Fleecflower continued to pose a challenge for seed collection and plant propagation efforts by seed. Fertilization appears to be very patchy in the field, and while fruit development can be detected for the first few months after fertilization, many developing seeds appear to be aborted weeks before any viable seed can be acquired. Previous attempts at propagating fleecflower suggest root division/cuttings are viable means of propagation (Trindle and Flessner 2003); however, initial tests of this method by the Corvallis PMC were largely unsuccessful. During the 2018 field season, several successful trials of propagating fleecflower from root divisions/cuttings were conducted by the Botany program. The success of these trials establishes this method as a viable option for producing this species for future revegetation needs at CRLA (Figure 16).

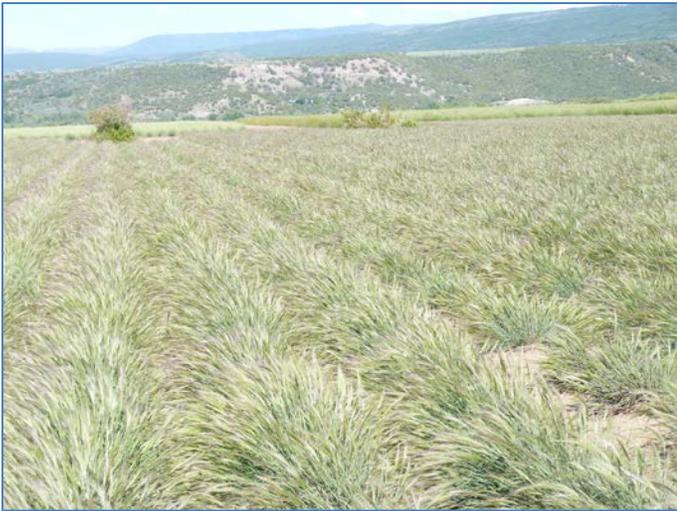
Figure 17. Bottlebrush squirreltail seed increase field (sown with CRLA seed) at the Meeker PMC in August 2019. Photo by Steve Parr.

To augment the amount of plant materials available for revegetation in both Phase I & II of this project, the seed increase services of the Meeker PMC were utilized. The Meeker PMC installed two seed increase fields for California brome (*Bromus carinatus* var. *carinatus*) and bottlebrush squirreltail (*Elymus elymoides* ssp. *elymoides*) from CRLA seed (Figure 17).

In fall of 2015, 714 g of California brome and 2,218 g of bottlebrush squirreltail seed were sent to the Meeker PMC for seed increase. To maximize seed yield, it was agreed to combine bottlebrush squirreltail seed from all seed zones for seed increase purposes. California brome seeds were combined from the three West Rim Drive seed zones, and from the two East Rim Drive seed zones. The seeds produced at the Meeker PMC were scheduled to be collected and cleaned in 2017, 2018 and 2019. Very little seed yield was available in 2017, as the fields established slowly. Due to the large quantity of seed received from the Corvallis PMC in 2018, no seed was requested from Meeker in 2018. Twenty pounds of bottlebrush squirreltail seed and 8.4 pounds of California brome seed were shipped to the Park in the fall of 2019 for use in broadcast seed application for finishing up revegetation work on Phase I restoration sites. Large quantities of seed will be needed for restoration at Roundtop quarry during Phase II of the Rim

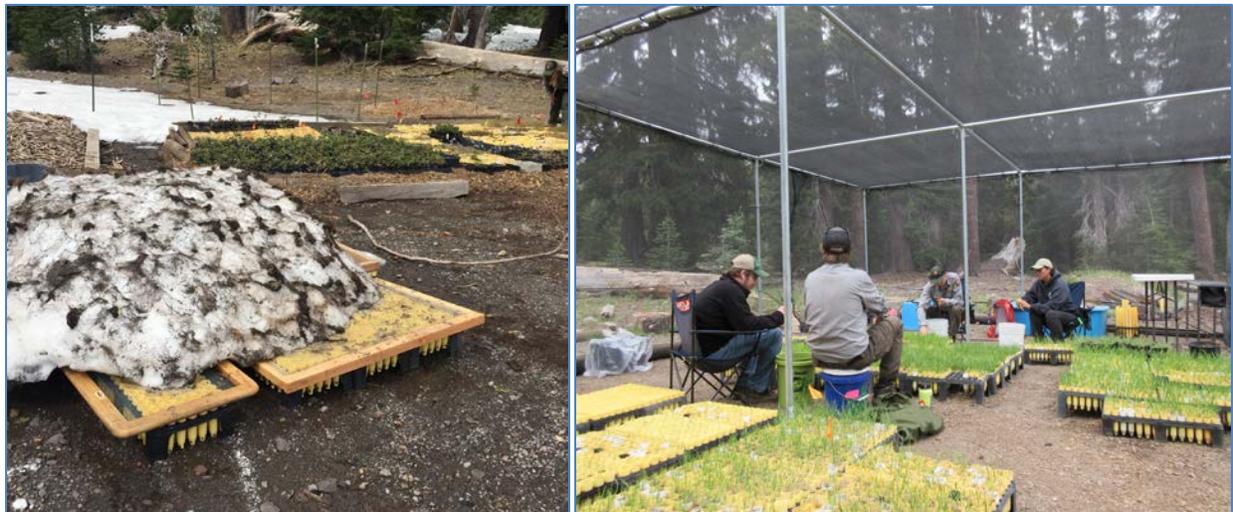
Figure 18. Overwintered plants emerging from the snow in June 2019 (left). Cleaning detritus, moss, and weeds out from overwintered potted plants (right). Photos by Carrie Wyler.

After the snow melted in 2019, plants that had been overwintered were assessed and inventoried. Plants without any green growth or with rotted roots were discarded. Certain plant species experienced substantially higher survivorship than others, with grasses, sedges and rushes having the greatest success, and species such as Sierra eriogonum (*Eriogonum marifolium* var. *marifolium*), Davidson’s penstemon (*Penstemon davidsonii* var. *davidsonii*), and Greene’s goldenweed (*Ericameria greenei*), experiencing high mortality. Many plants with well-developed roots were transplanted into larger containers while others with detritus, moss, liverwort, or volunteer plants were cleaned (Figure 18). Detailed reports of daily nursery activities are on file in the Botany office in the Nursery Activities binder.

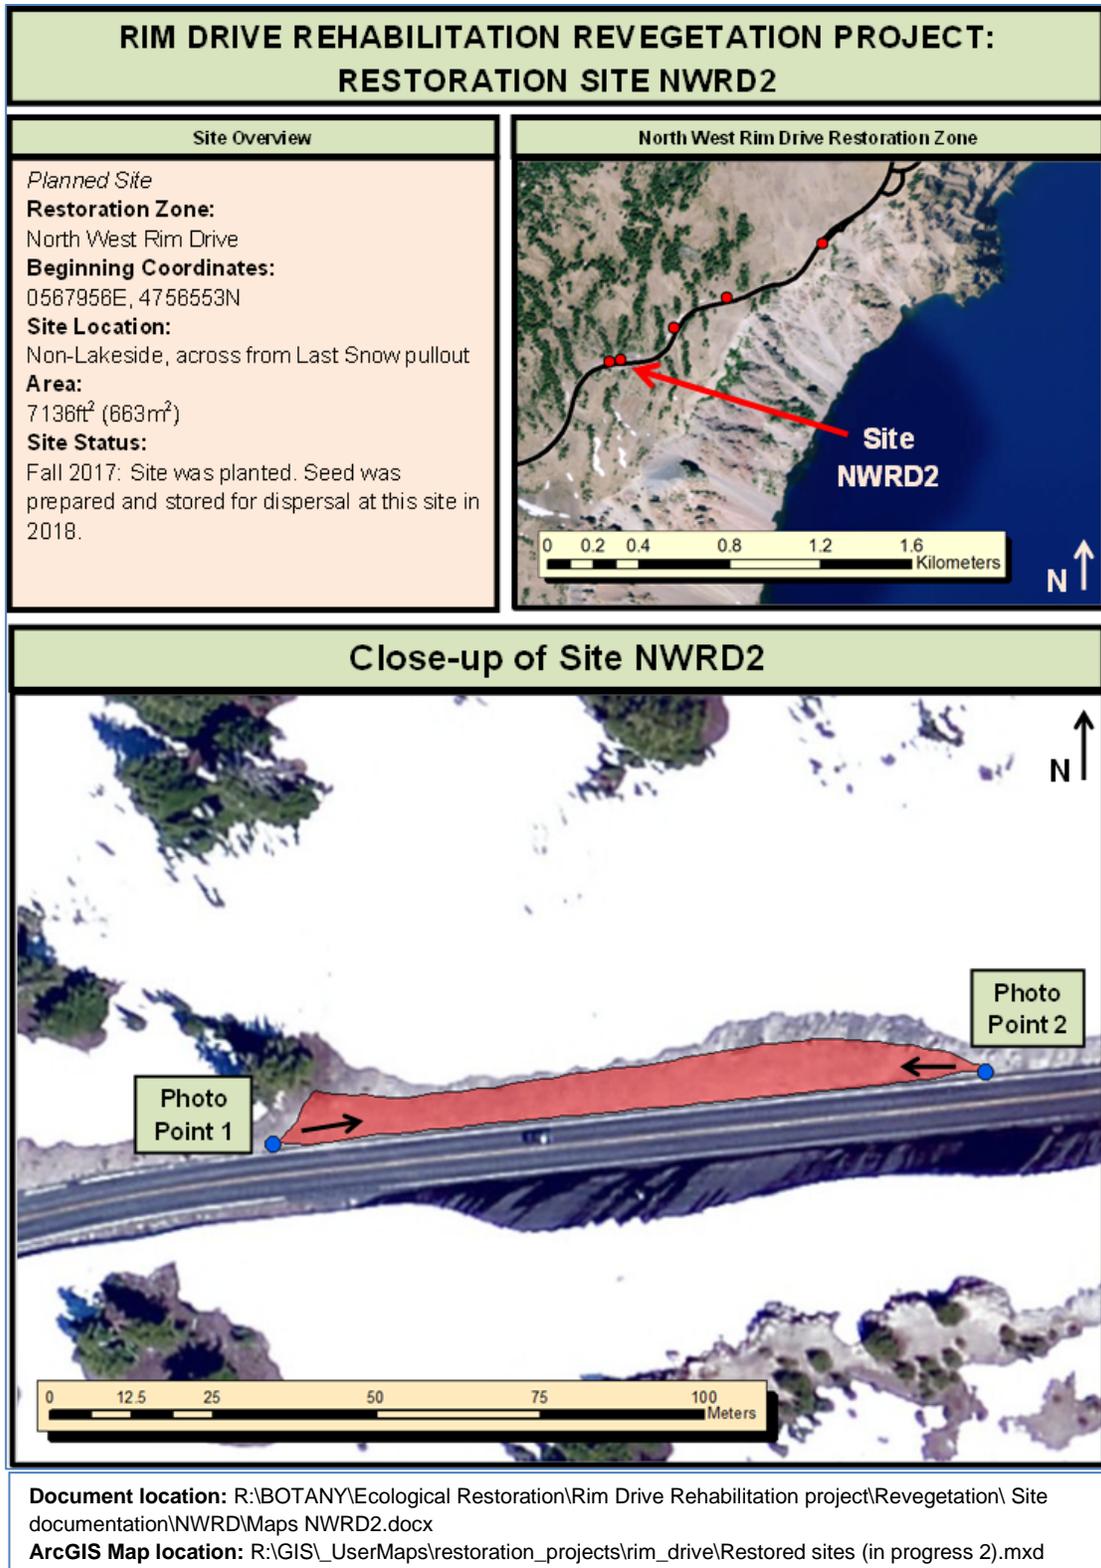
Figure 20. Example of a site overview map that was created in order to aid in site documentation and assist future staff in precisely locating and monitoring restoration sites. Map by Tara Chizinski.

Overview documents (Figure 20) were created for each restoration site, including a map of the site, description of the site location, and location of photo points. These documents show the precise area and location of sites and can be used in combination with monitoring forms as a way of tracking restoration progress from year to year at each specific site. Binders for each zone were created/updated and contain site maps and monitoring documentation for each restoration site. These binders are on file in the Botany office and available for reference by future staff. Overview maps and complete site documentation forms for all sites can be found on the Botany server.

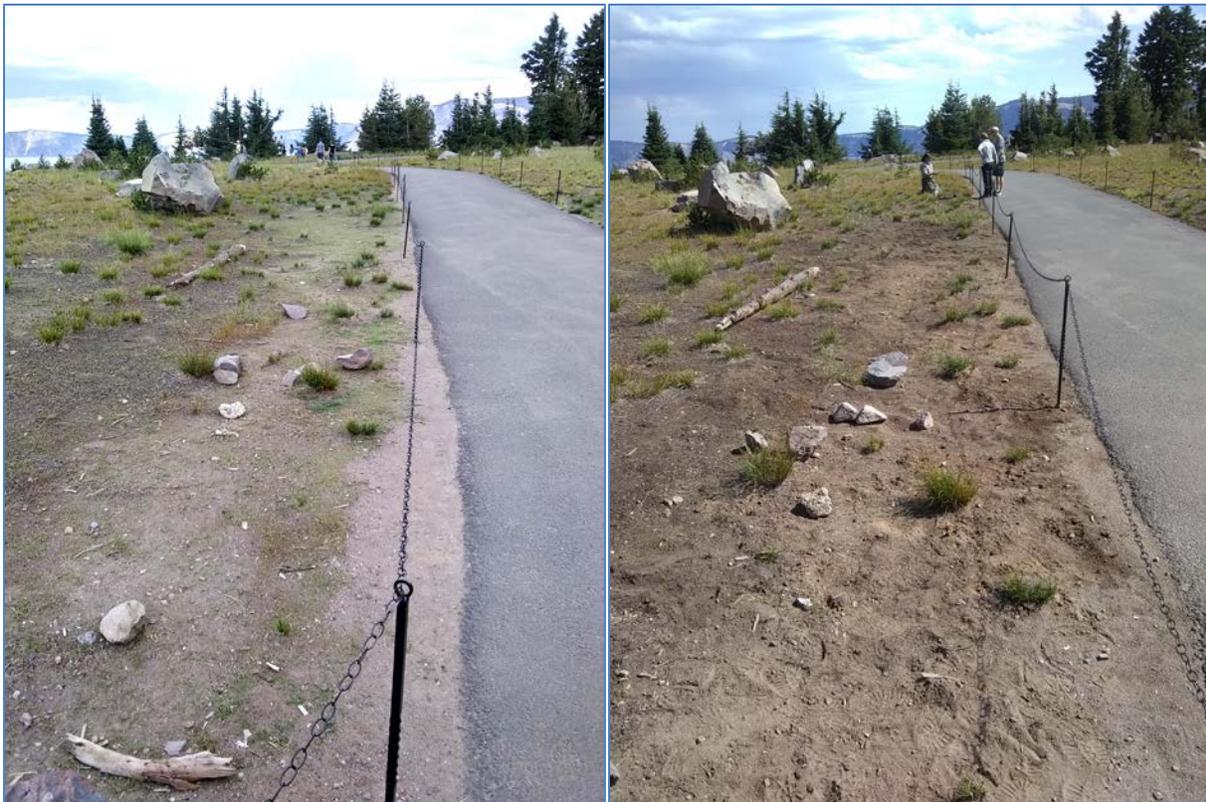
Figure 22. Red sandspurry (very low-growing green hue on the soil surface) prior to (left) and following manual removal (right) at Rim Village. Photos by Scott Heisler.

Common plantain, pineapple weed, and St. John's wort populations were treated in their entirety with all observed individuals removed. However, large invasive plant populations of yellow rocket, sheep sorrel, and white clover at Rim Village were treated as time allowed. The large population of sheep sorrel by the Crater Lake Lodge has been subject to a large control effort annually since 2013, often using volunteer groups. This site was first treated with herbicide in the fall of 2017 and was treated again in June-July 2018 and 2019. Sheep sorrel abundance was greatly reduced in 2018 and 2019, which may be attributable to the effectiveness of chemical treatment. Pineapple weed abundance

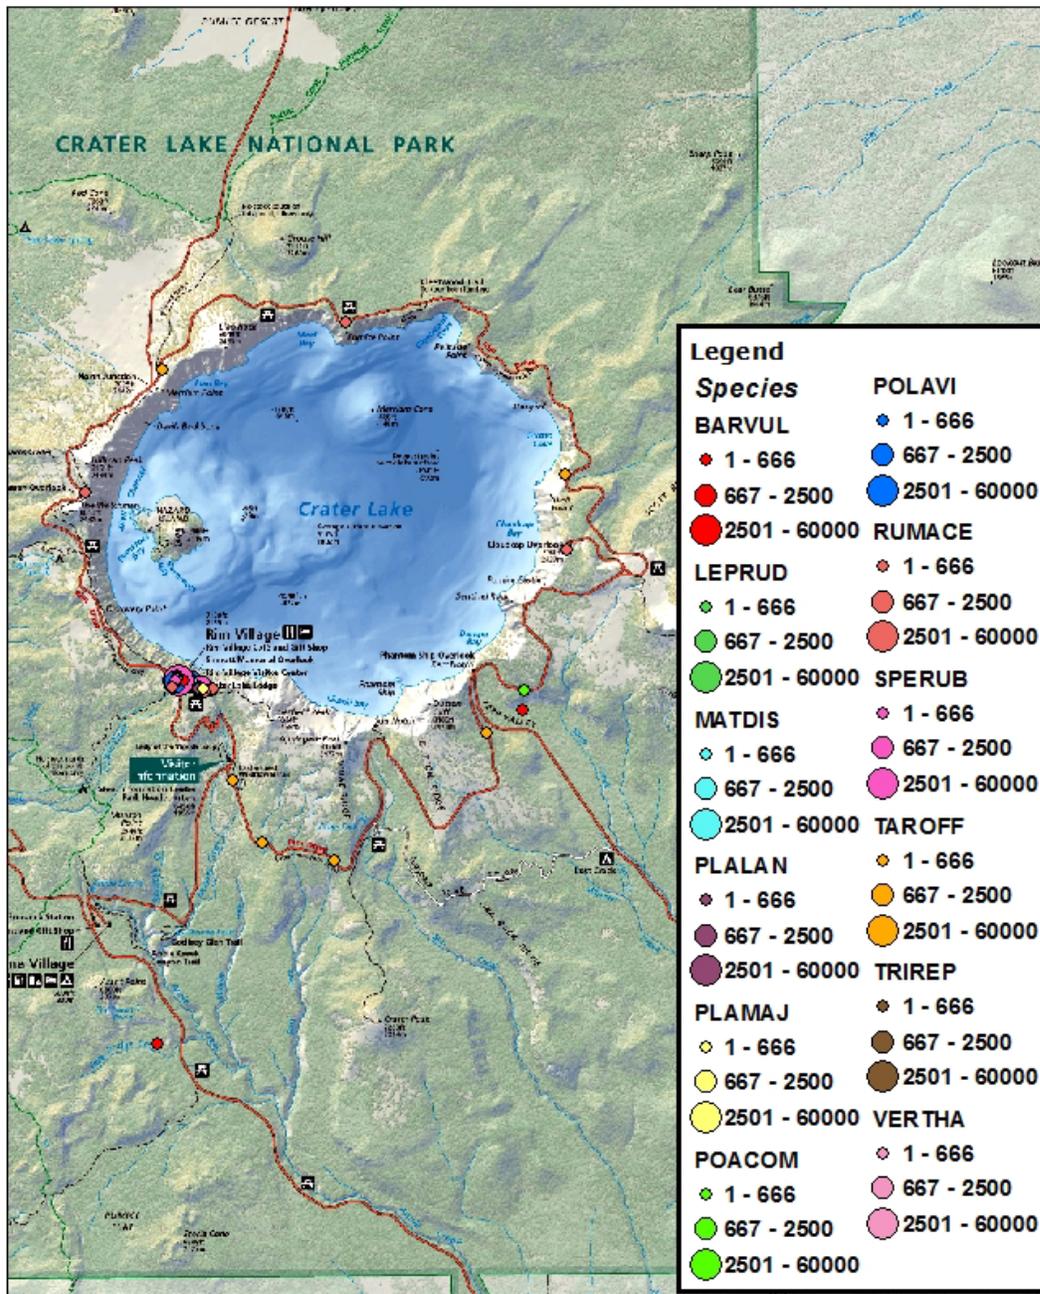
A total of 76,840 invasive plants were removed from project areas during the 2019 season. Invasive plants were encountered most frequently at Rim Village. Invasive plant abundances found this season are compared to 2017 and 2018 (Table 9). A map of invasive plant locations is displayed in Figure 23.
