Rim Drive Rehabilitation Revegetation Project

2021 Annual Report

Carolyn S. Wyler, Scott E. Heisler, and Jennifer S. Hooke

April 2022

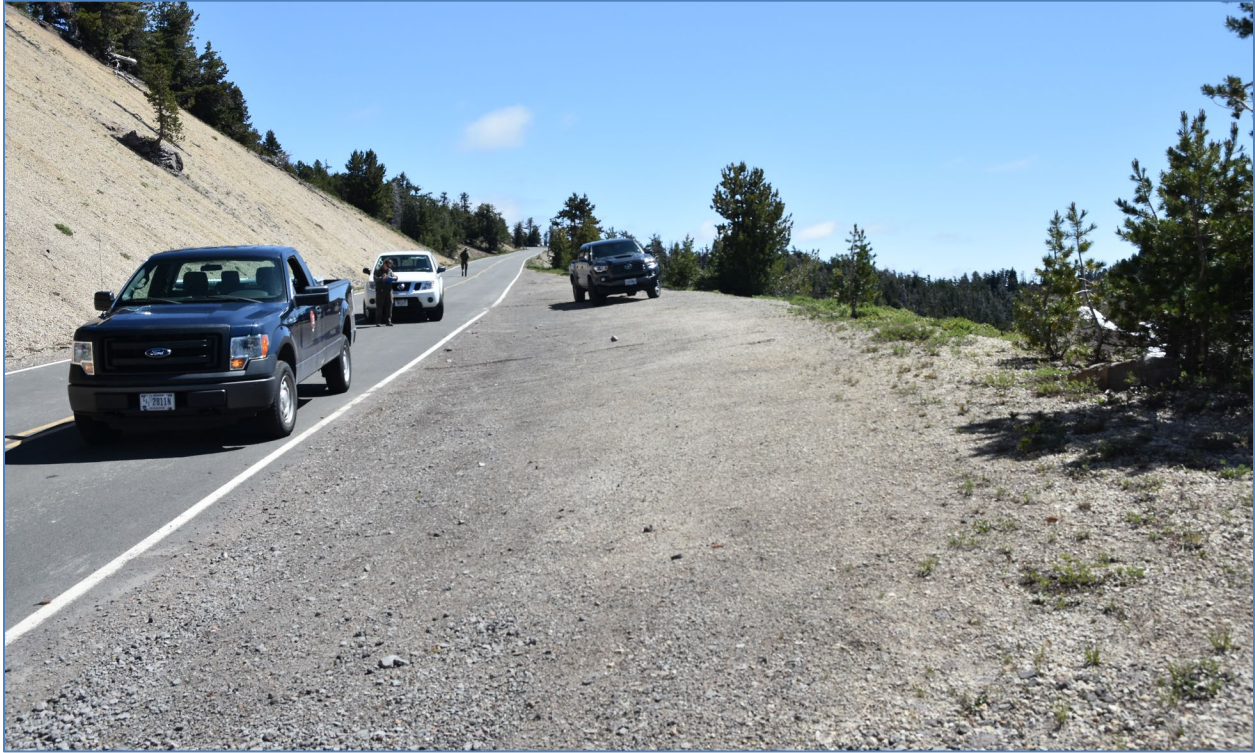
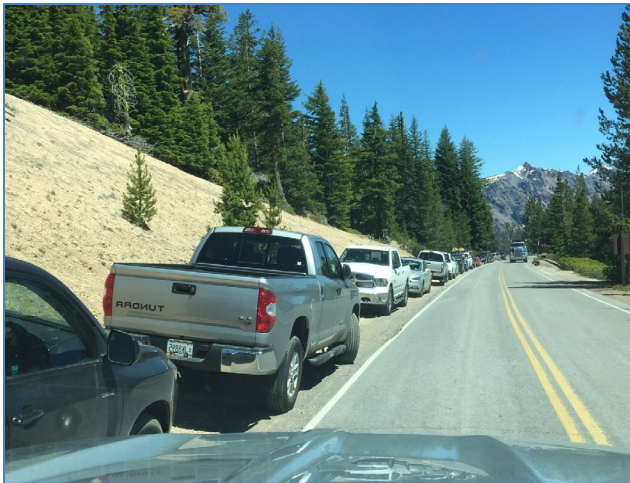
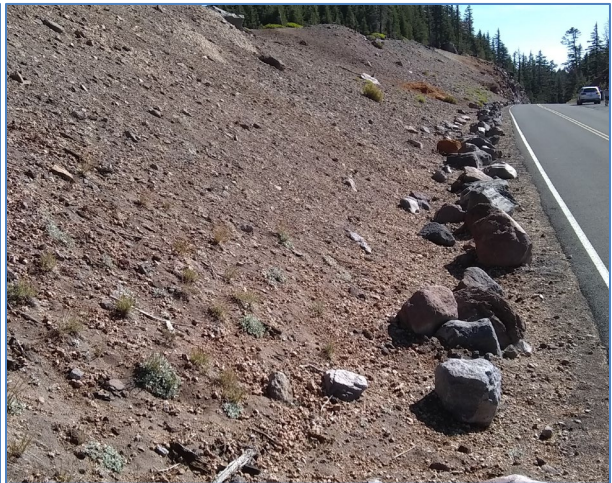
Figure 1. Top: Example of an excessively wide pullout within the project area. Photo by Jen Hooke. Bottom: User-created pullouts before (left; photo by Carrie Wyler) and after (right; photo by Scott Heisler) obliteration as part of the Rim Drive Rehabilitation project.

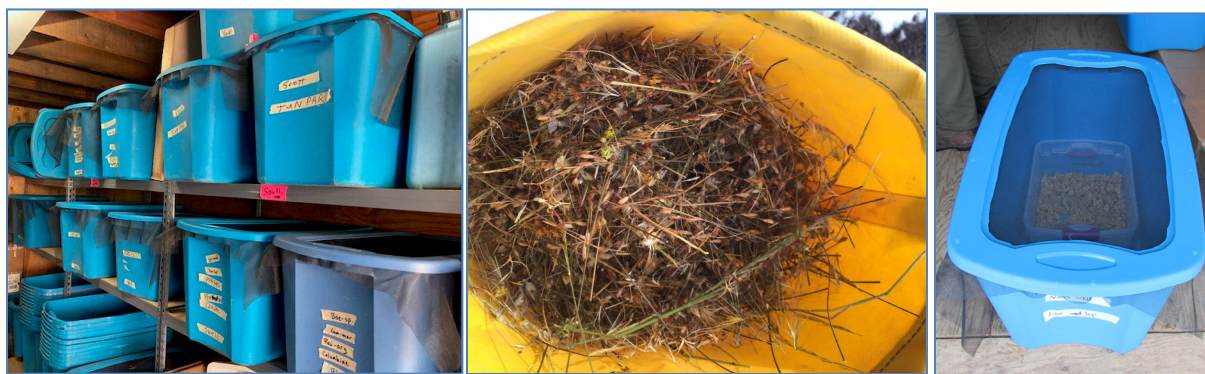
Figure 4. Seed drying and storage facility at Park headquarters (left). Collected seed before cleaning (middle). Seed drying in a container inside a drying bin with ventilated lid (right). Photos by Carrie Wyler.

When seeds were mature, they were collected, dried, and stored until shipment to the DGRC. Within each zone a single bag was used to collect all the seed from an individual species (Figure 4). In the field, bags were labelled with species code, collection date, and seed zone. After collection, seeds were transported to the seed drying and storage facility in the Stall Nine garage at Park headquarters (Figure 4). When seeds arrived at this facility, records were kept for each species with collection

dates, specific collection location, and seed zone. Seeds were then placed inside 30-gallon plastic storage totes secured with window screen at the top, allowing ventilation while reducing chances of predation. Plant species with very small seeds were first placed in smaller plastic bins before being stored within the larger 30-gallon tubs (Figure 4). The bins were labelled and organized on shelves by seed zone and species. Damp collections (especially lupines) were either shipped soon after collection (within a week) or set out in the sun to speed the drying process.

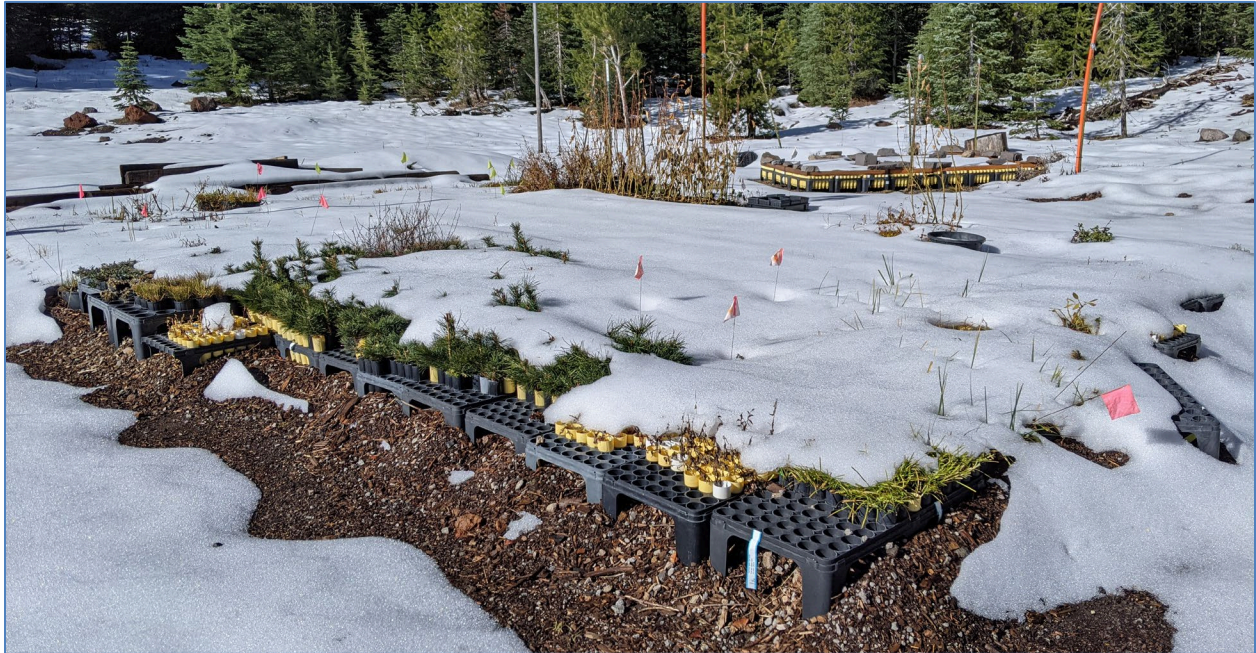
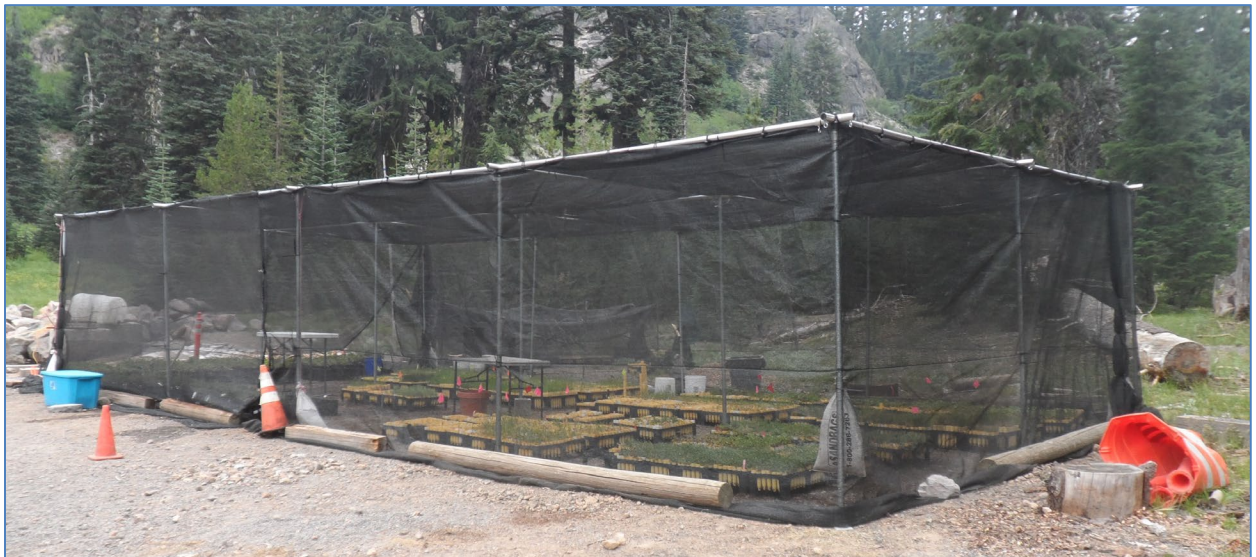
Figure 5. Overwintered plants under snow (top). Shadehouse at the Ball Diamond (bottom). Photos by Carrie Wyler.

Anticipating the need for established containerized plants for use in Phase II and the slow growth of native plants in the high elevation conditions at CRLA, an advance round of plant propagation was conducted at CRLA in fall 2020 and 2021. Approximately 130 plants were propagated in 2021 and are being overwintered at the Ball Diamond nursery at Park headquarters. These plants will require care and maintenance throughout future field seasons. Once the snow melts in June, plants are covered with a shade house (40’ x 20’ x 10’ – Figure 5).

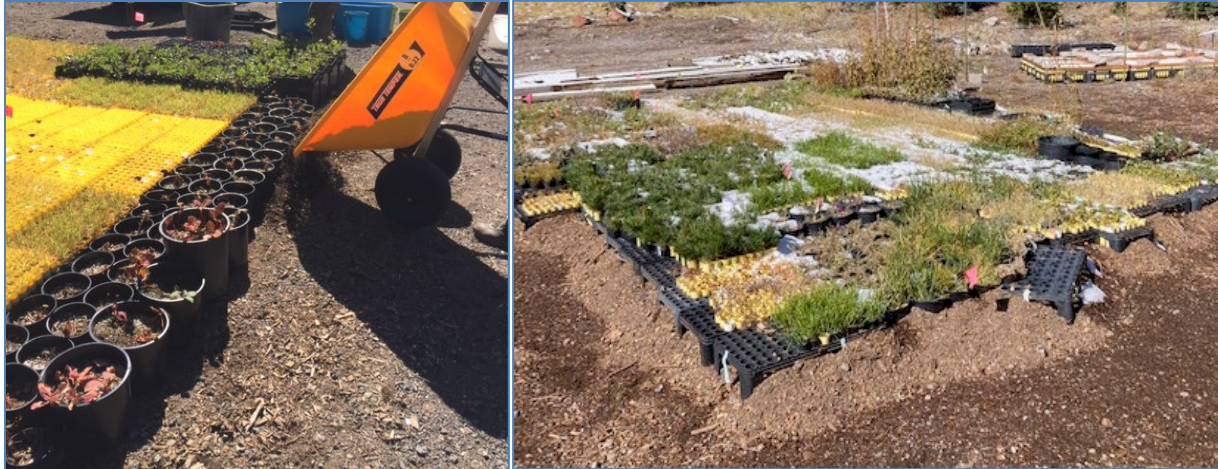
Figure 6. Distributing mulch around the edges of pots to insulate against frigid winter temperatures (left). Consolidated plants at the Park's Ball Diamond prior to overwintering (right). Photos by Carrie Wyler.

When ambient temperature dropped below freezing the containers were consolidated and mulch was stacked around the perimeter of consolidated containers to prevent root freezing (Figure 6). These plants will need further care in the summer of 2022 including watering, fertilization, and transplanting into larger containers.

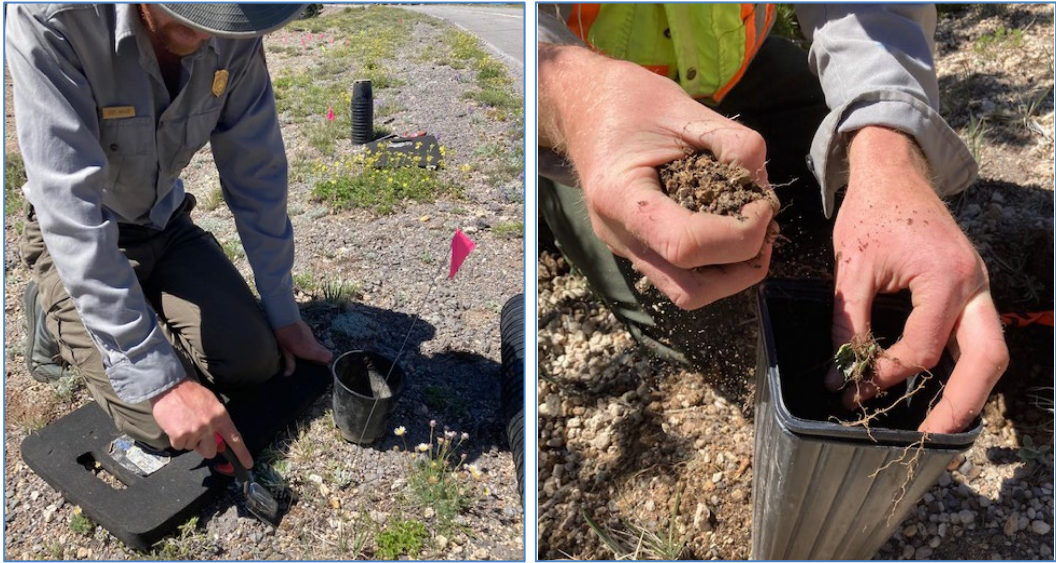
Figure 8. Salvaging Crater Lake rockcress from East Rim Drive roadside (left). Carefully transplanting roadside pumice moonwort into pots from projected disturbance areas (right). Photos by Carrie Wyler.

Due to the high probability of this project to disturb or eliminate plants in the road prism it was decided to salvage as many rare plant species that may be affected as practical. Plants were excavated with hand trowels and transplanted into pots using local soil to maintain local soil biological associations and soil composition (Figure 8). Plants were then transported to the Park’s native plant nursery at the Ball Diamond, where they were placed in a shadehouse. These plants will need to be cared for until they can be returned to their original locations where they will be planted just beyond the zone of regular roadside maintenance.

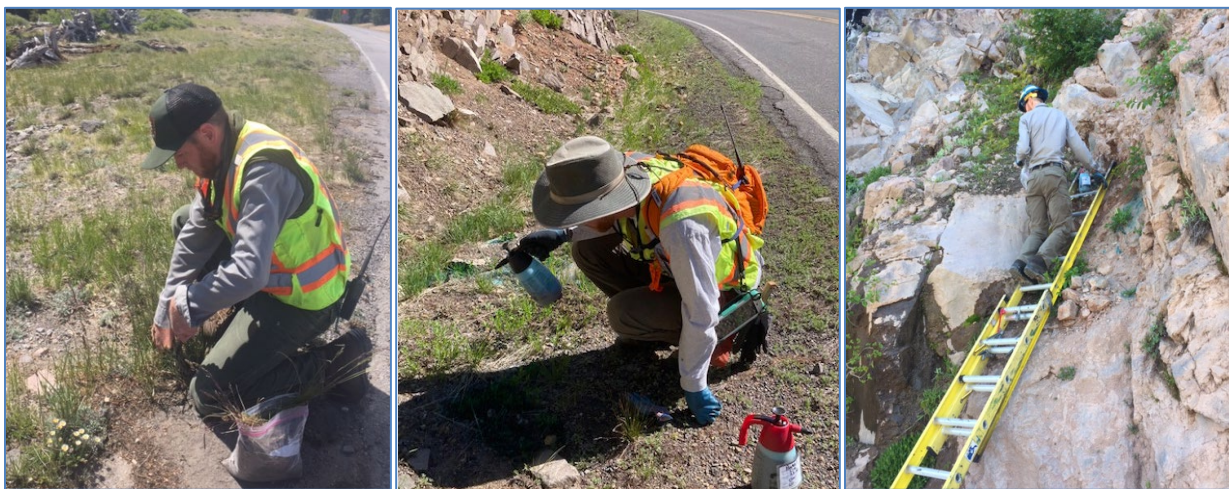
In 2021, most of the project area was surveyed for non-native, invasive plant species (Figure 10). Roadsides were surveyed throughout the season by foot. Project staging areas (Roundtop Quarry, the Ball Diamond, Pole Bridge Creek Quarry, and the junction of East Rim Drive and Pinnacles Road) were surveyed at least once by foot in their entirety, including access roads and around piles of materials.

Figure 10. Manually controlling an invasive grass near Skell Head overlook (left). Chemically controlling sheep sorrel (*Rumex acetosella*) on East Rim Drive (middle). Chemically treating common dandelion (*Taraxacum officinale*) on a cliffside along East Rim Drive (right). Photos by Carrie Wyler.

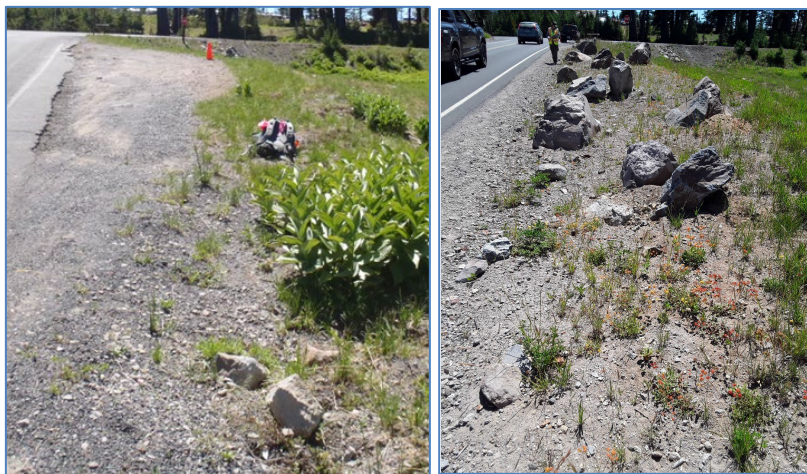
Figure 11. User-created pullout (restoration site SWRD1) before (left) and after (right) rehabilitation and revegetation efforts. Photos by Carrie Wyler.

As of November 2021, 62 restoration sites have been defined for Phase I and 29 restoration sites for Phase II of the RDRR project, each with a unique revegetation prescription based on pre-disturbance conditions (Table 2). Identification of Phase II restoration sites was guided by construction plan sets (95% design phase) and did not include disturbed sites at Roundtop Quarry or areas affected by deep patch or edge stabilization treatments. It is likely the number of sites will increase as impacts from those treatments become more apparent. When Phase I of the Rim Drive Rehabilitation project was completed, the actual area disturbed was found to be greater than three times what was planned (Wyler et al. 2020). The planned area of disturbance for Phase II of this project is anticipated to affect 21.2 acres. Full details of each site's prescription and planned versus actual disturbance areas can be found on the Botany file server. Similar documentation will be made for Phase II of the project to track disturbed areas (Figure 11).

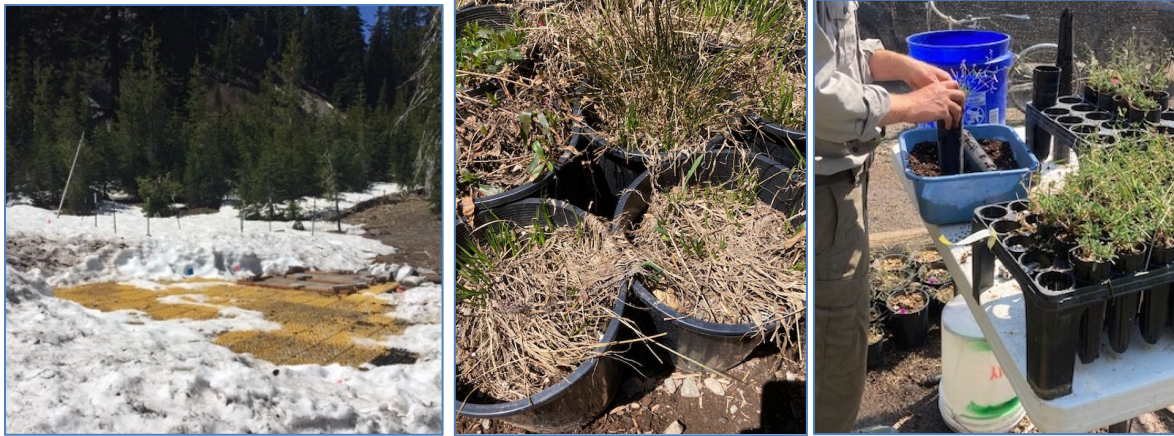
Figure 12. Overwintered plants emerging from the snow (left). Potted plants prior to detritus removal (middle). Plant care at the Park’s nursery (right). Photos by Carrie Wyler.

After the snow melted in 2021, plants that had been overwintered were assessed and inventoried. Plants without any green growth or with rotted roots were discarded. Plants with well-developed roots were transplanted into larger containers while others with detritus, moss, liverwort, or volunteer plants were cleaned (Figure 12).

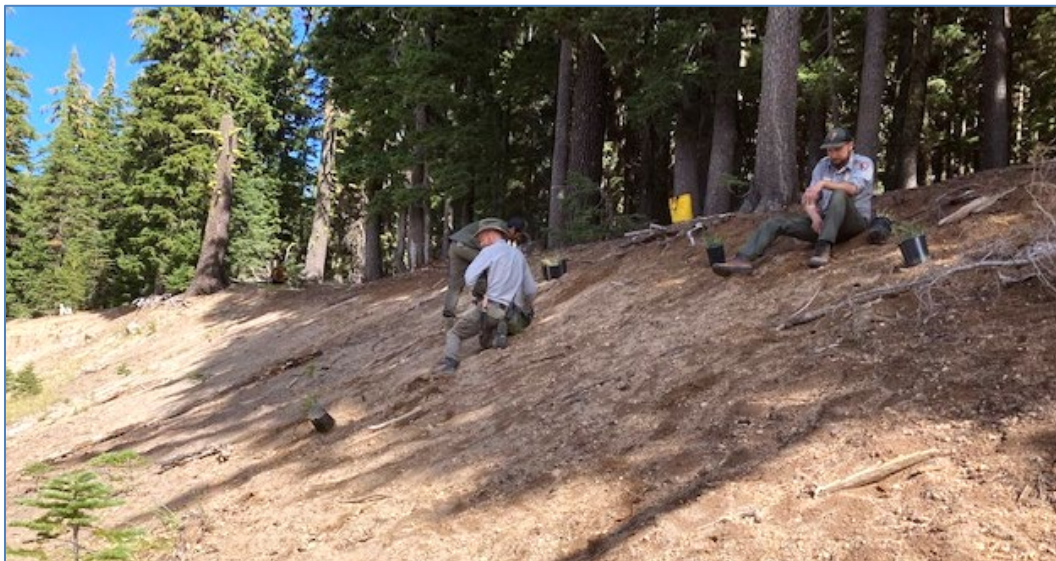
The eastern embankment of the Cleetwood Cove parking lot will continue to need slope stabilization and erosion control for revegetation efforts to be successful. This embankment was disturbed by contractors stacking cut logs on it when they were clearing trees to expand the parking lot. The embankment is steep and consists of loose pumice soil, which collapses when walked on. The site does not hold seed or water well, and it has been difficult to restore and revegetate. In 2019 large logs and rocks were put into place and areas were vertically mulched with little success. Every revegetation attempt creates more soil disturbance and erosion. In 2021, Botany staff planted 35 one-gallon pots of Hall’s sedge (*Carex halliana*) that was salvaged from a nearby area on East Rim Drive slated for upcoming disturbance (Figure 13). Hall’s sedge has a fibrous and rhizomatous root system, and it is hoped that it will create a root mat and hold back the sloughing soil. If found to be successful at stabilizing this slope after assessment in 2022, more will be planted on the embankment in the future.

Figure 13. Planting the steep and difficult to restore eastern embankment at Cleetwood Cove parking lot. Photo by Carrie Wyler.

- Site NEERD 3.1 is the eastern embankment of the Cleetwood Cove parking lot and will need to be addressed in future years. It has a steep slope of pumice soil that is continuously eroding and hindering restoration efforts. The area will need to be assessed for success from the 2021 plantings. If successful, more plants will need to be planted on the embankment; more Hall's sedge may be needed for this endeavor.

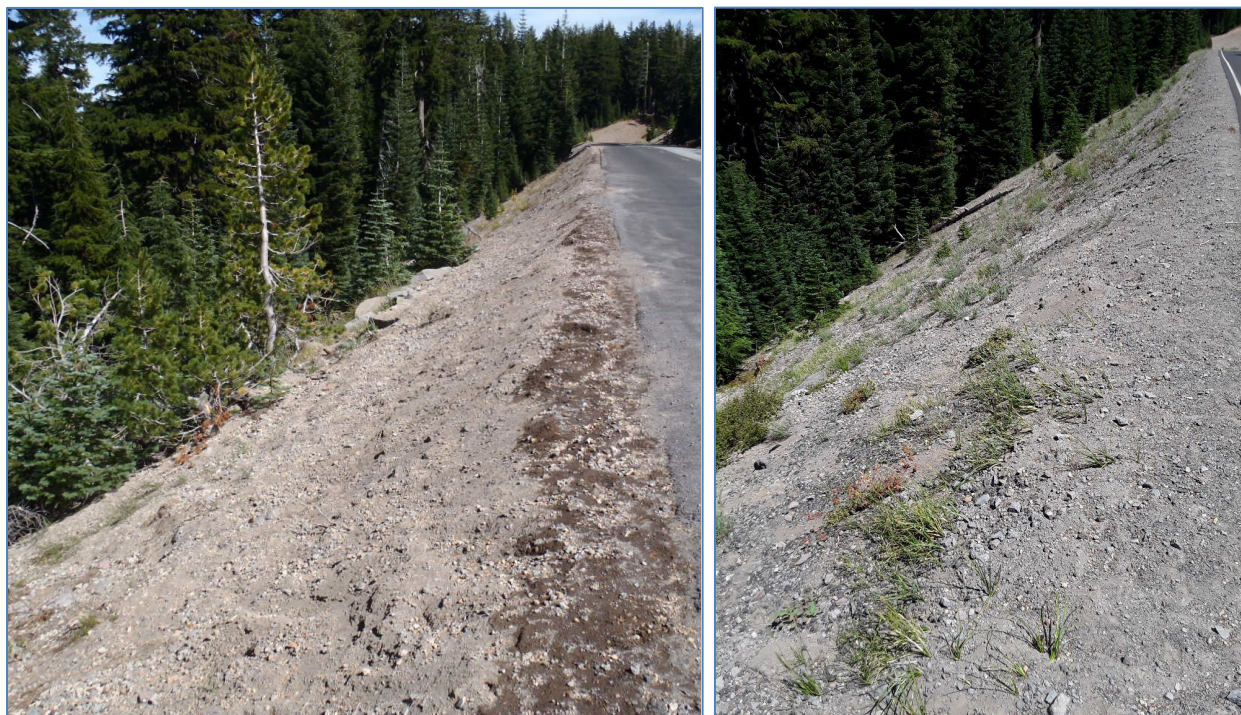
Yearly site documentation and monitoring has been completed for all sites that were restored as part of the Phase I RDRR project. For these sites, one-, two-, three-, and five-year post-restoration photo points were taken, and monitoring forms were completed as a means of assessing the success of revegetation efforts and determining additional site needs (Figure 14).

Figure 14. Site NWERD10 in 2016 (left) and in 2021 (right) showing vegetative recovery. Photos by Carrie Wyler.

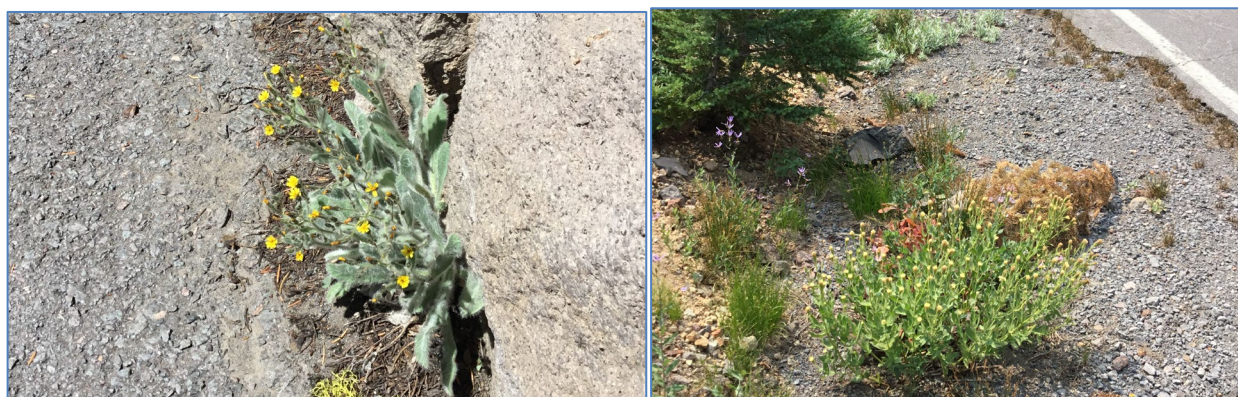
During the 2020 season, Phase II of the RDRR project was surveyed for special status plant species. Eleven rare plant populations were encountered in the project area that will need protections (e.g., installing orange fencing around a population buffer) during construction. Some of these rare plant populations will experience unavoidable impacts due to their occurrence in deep patch and edge stabilization treatment areas, in the road shoulder, in cracks between rock walls and pavement, or otherwise in the path of impact (Figure 15).

Figure 15. Some rare plants will experience unavoidable road construction impacts such as shaggy hawkweed (left) and Shasta arnica (right). Photos by Jen Hooke.

In these cases, rare plants will be salvaged ahead of construction and held over at the Ball Diamond nursery until they can be replanted. In 2021, 135 Crater Lake rockcress, 90 undescribed species of rockcress, and 10 pumice moonwort were salvaged from two different sites on East Rim Drive. Additional rare plant salvage will need to occur in future field seasons as the construction project progresses. Seed was also collected from rare plant species in the immediate path of construction impacts. Quantities of seed collected from rare plants in Phase II projected construction areas is displayed in Table 8. Spatial and population data are housed on the Botany file server.

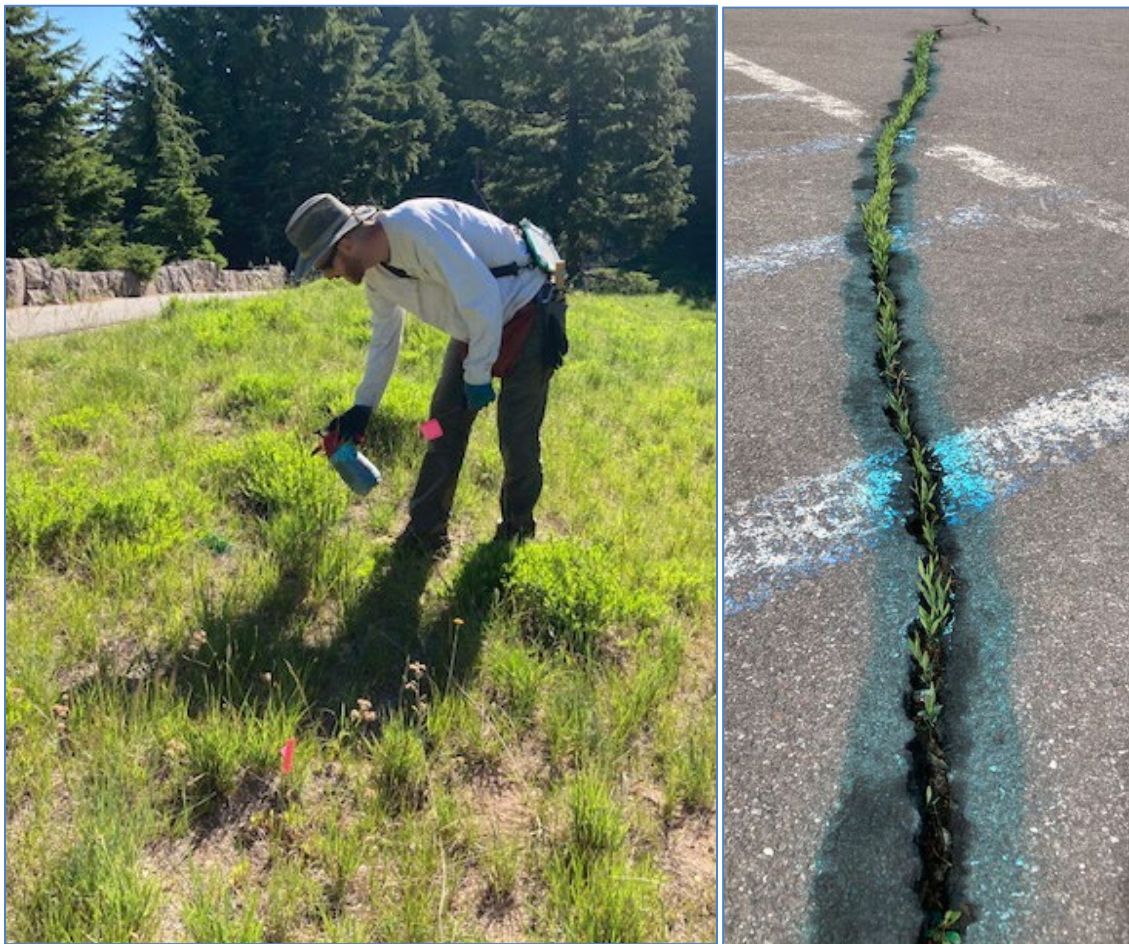
Large populations of common knotweed (*Polygonum aviculare* ssp. *depressum*), sheep sorrel, and red sand-spurrey (*Spergularia rubra*) at Rim Village were treated as time allowed. The large population of sheep sorrel by the Crater Lake Lodge has been subject to a large control effort annually since 2013, often using volunteer groups. This site was first treated with herbicide in the fall of 2017 and has been treated annually since. Sheep sorrel abundance was greatly reduced in 2018 and 2019, which may be attributable to the effectiveness of chemical treatment (Figure 19). In 2020 two new population areas were discovered which led to an increase in numbers from 2019, but numbers were again diminished during the 2021 field season. Common knotweed is another species that continues to increase greatly in number for unknown reasons, especially around the Lodge and in parking lot cracks (Figure 19). This is another difficult species to treat by manual means due to its deep root systems and tendency to occur in pavement cracks and crevices.

Figure 19. Chemically treating sheep sorrel at the Crater Lake Lodge meadow (left). Chemically treated common knotweed in a parking lot crack behind the Rim Village Café and Gifts building (right). Photos by Carrie Wyler.

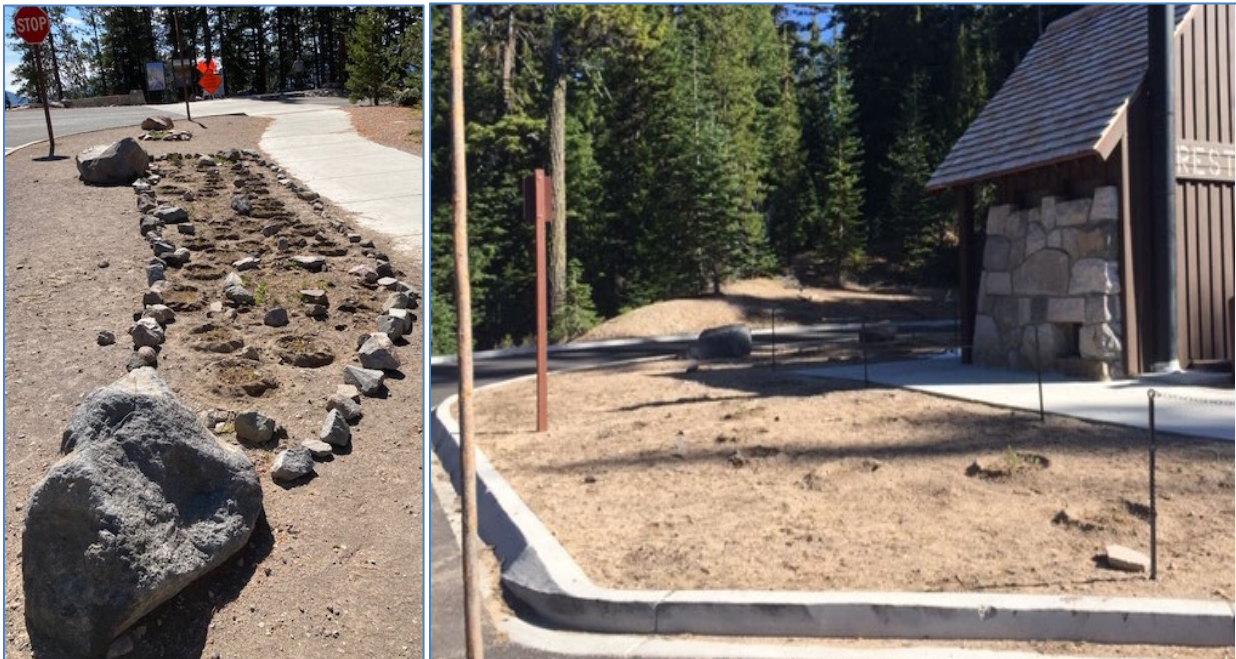
Monitoring results showed a clear pattern: restored sites that were protected from further impacts (e.g., vehicle damage, trampling) did markedly better than those that experienced additional and/or ongoing impacts. Fifty of the 62 restored sites are doing well, and vegetative recovery is progressing with no further action needed. The other 12 sites were either damaged by vehicle traffic, trampled by Park visitors, or have challenging site conditions (e.g., steep slopes, erosion, unstable soils) that make revegetation difficult. Supplemental planting and seeding in the future will continue to assist the recovery of restoration sites that are struggling, and some sites may need fencing and/or signage to protect them from further damage especially at the Watchman Overlook and Cleetwood Cove parking lot.

Figure 22. Plantings in groups with rock borders to mitigate trampling in heavily trafficked Cleetwood Cove parking lot areas (left). The area at the back of the Cleetwood Cove parking lot will be adjusted to allow for RVs to drive around the comfort station (right). Photos by Carrie Wyler.

- The back of the Cleetwood Cove parking lot will be worked on during Phase II of the RDRR project. The area presently is not big enough for large recreational vehicles to pass through and their back wheels often jump the curb and damage this revegetation site. This area has been sparsely planted in areas that would not be impacted by vehicle traffic (Figure 22). After construction work is completed, more plants will be added.
