Rim Drive Rehabilitation Revegetation Project

2022 Annual Report

April 2023

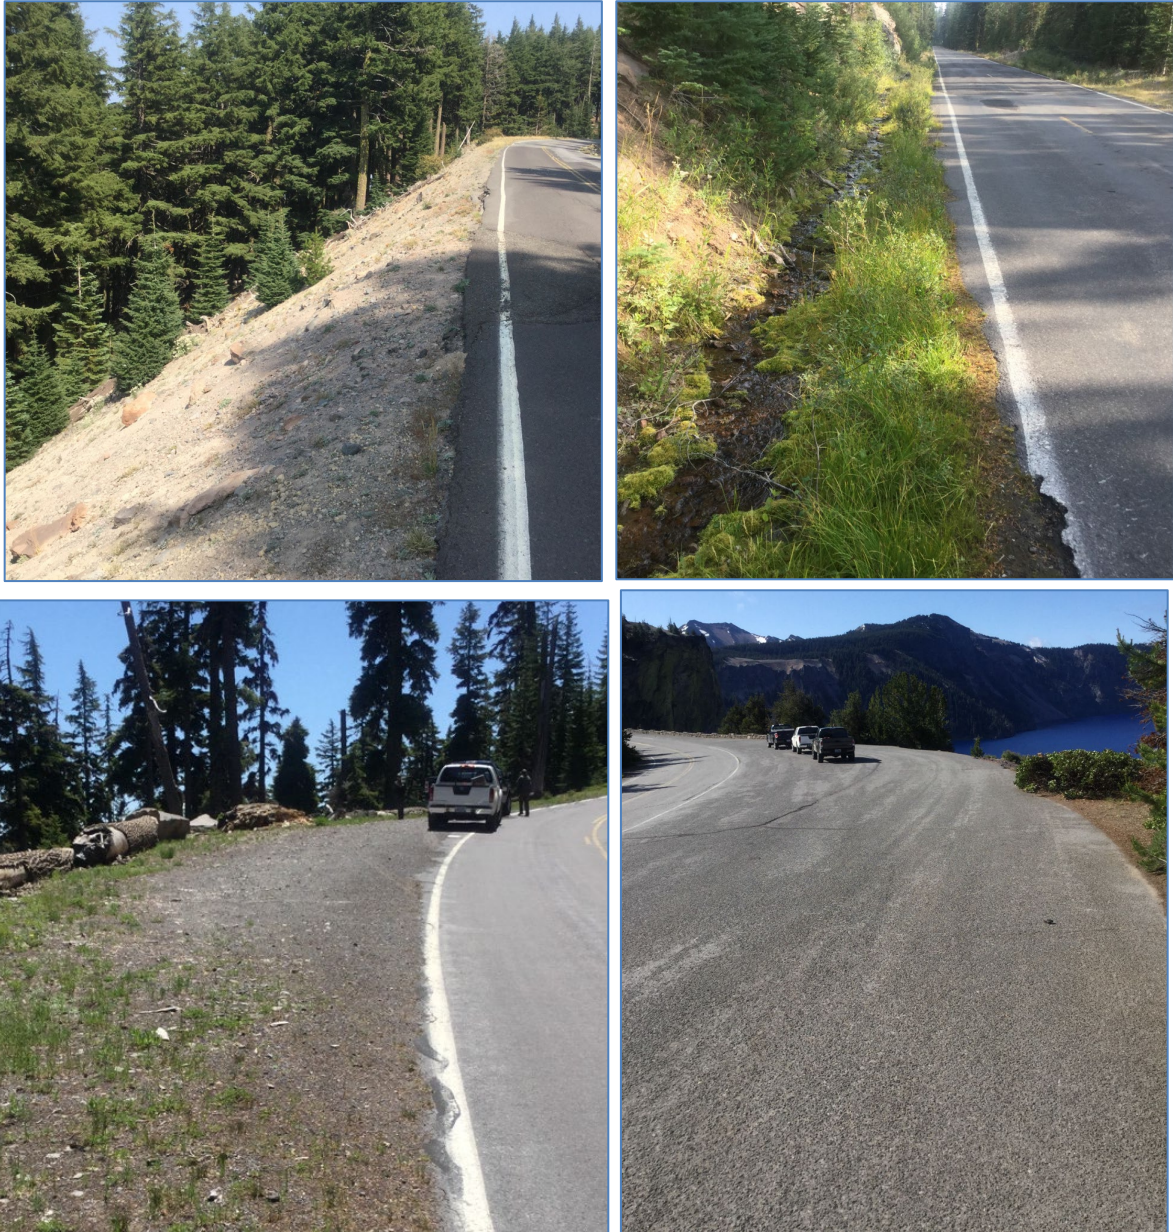
Figure 1. Top: Example of a deep patch area (left). Road stabilization section that will destroy a unique roadside riparian area as part of the Rim Drive Rehabilitation project (right). Bottom: User-created pullout (left). Example of an excessively wide pullout within the project area (right). Photos by Scott Heisler.

Additionally, road work will affect numerous rare and/or sensitive plant populations and areas with unique vegetation communities within the project area (Figure 1). Due to the substantial impacts occurring to soils and vegetation, FHWA funded efforts to restore affected areas through revegetation, special status plant species management, and invasive vegetation management. The Rim Drive Rehabilitation Revegetation (RDRR) project is tasked with:

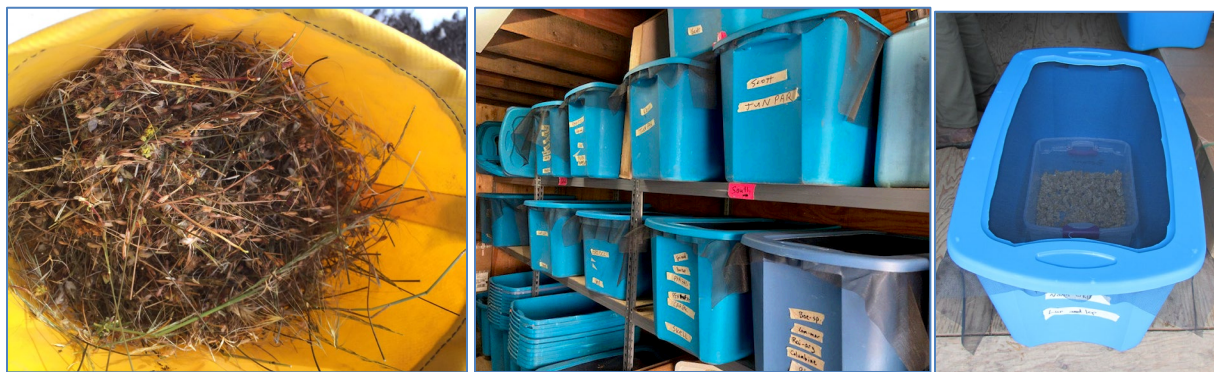
Figure 4. Collected seed before cleaning (left). Seed drying and storage facility at park headquarters (middle). Seed drying in a container inside a drying bin with ventilated lid (right). Photos by Carrie Wyler.

Prior to shipping seed to the DGRC, all seeds from a single species within a discrete seed zone were combined into doubled paper bags; each bag was labeled with species code and seed zone and taped shut. Records were kept of boxes shipped and their contents. Shipping seeds throughout the growing season was crucial due to the shortage of seed storage space at the park, and inadequate ventilation for effective drying of damp material.

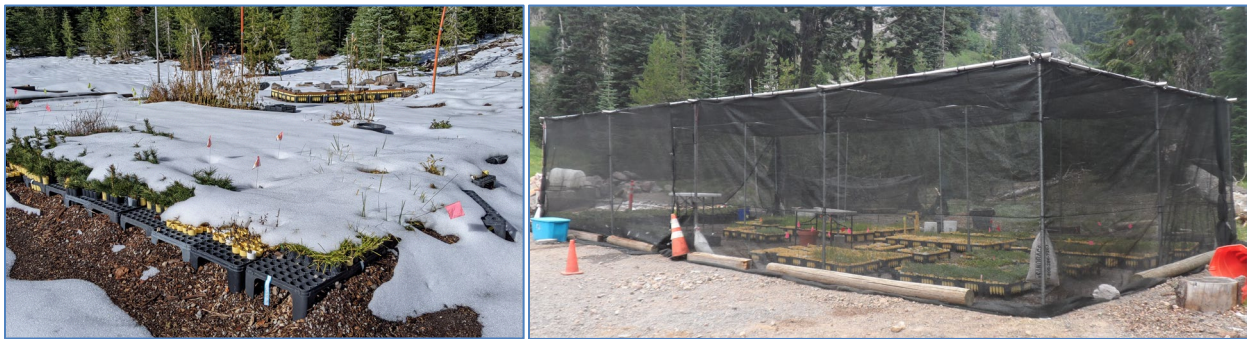
Figure 5. Overwintered plants under snow with mulch around the edges of pots to insulate against frigid winter temperatures (left). Shadehouse at the Ball Diamond (right). Photos by Carrie Wyler.

Anticipating the need for established containerized plants for use in Phase II and the slow growth of native plants in the high elevation conditions at CRLA, an advance round of plant propagation was conducted at CRLA in fall 2020 and 2021. Approximately 130 pots were seeded for propagation in 2021 and are being held over at the Ball Diamond nursery at park headquarters. No plants were propagated in 2022 due to the project implementation being moved back to 2023. In 2022, bush ocean spray (*Holodiscus microphyllus* var. *glabrescens*) and Sitka alder (*Alnus alnobetula* ssp. *sinuata*) were found to be rootbound and were transplanted from jumbo pots to one-gallon tree pots. All plants will require care and maintenance throughout future field seasons. Once the snow melts in June, plants are covered with a shade house (40' x 20' x 10' – Figure 5).

When ambient temperature dropped below freezing the containers were consolidated and mulch was stacked around the perimeter of consolidated containers to prevent root freezing (Figure 5). These plants will need further care in the summer of 2023 including watering, fertilization, and transplanting into larger containers.

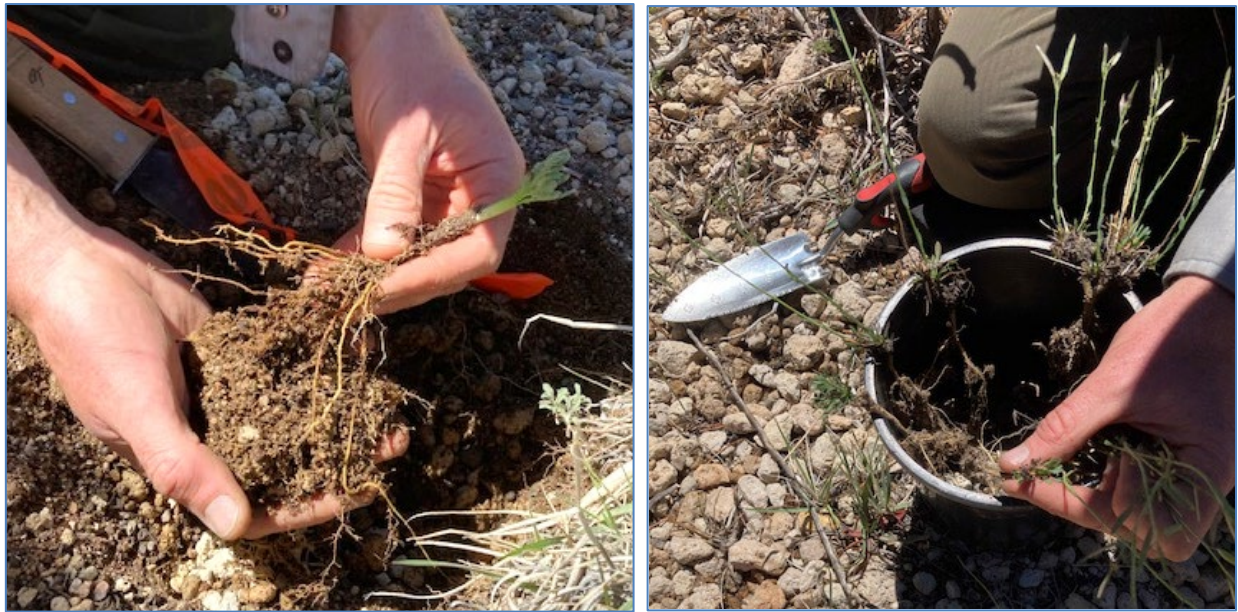
Figure 8. Salvaging pumice moonwort from East Rim Drive roadside (left). Carefully transplanting undescribed *Boechera* into pots from projected disturbance areas (right). Photos by Carrie Wyler.

Due to the high probability of this project to disturb or eliminate plants in the road prism it was decided to salvage as many rare plant species that may be affected as practical. Soon-to-be disturbed plants were excavated with hand trowels and transplanted into pots using local soil to maintain soil biological associations and soil composition (Figure 8). Plants were then transported to the park’s native plant nursery at the Ball Diamond, where they were placed in a shadehouse. These plants will be cared for until they are returned to their original locations post-construction where they will be planted just beyond the zone of regular roadside maintenance.

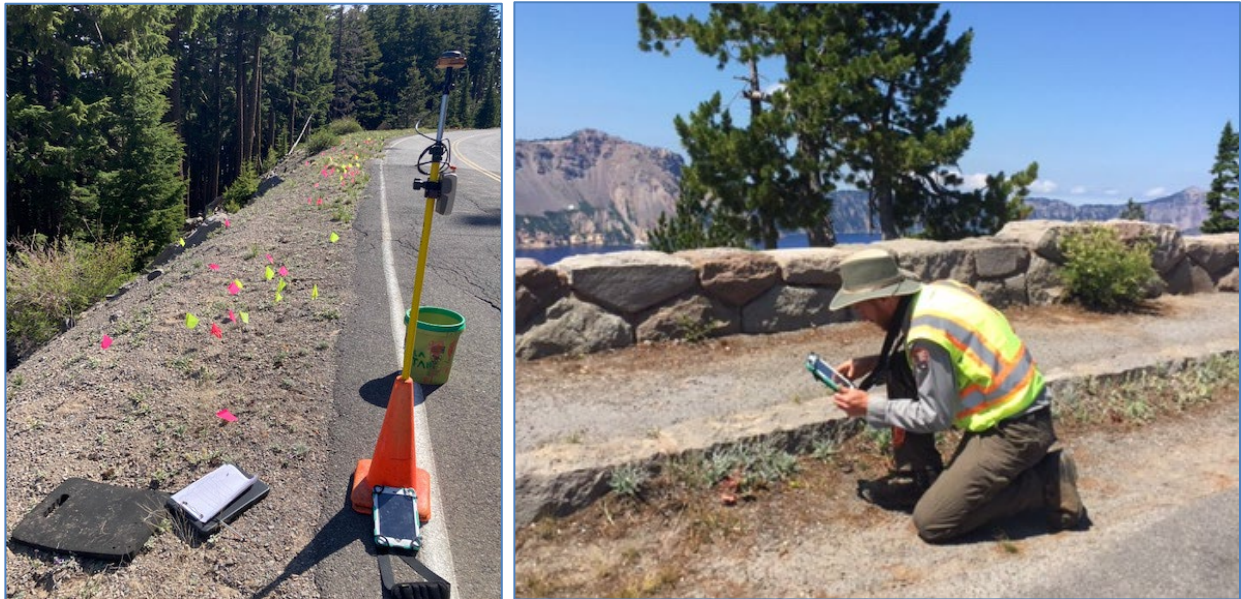
Figure 13. Some rare plants will experience unavoidable road construction impacts such as Crater Lake rockcress growing close to the road edge (left) and shaggy hawkweed growing in cracks between pavement and stone curbing (right). Photos by Carrie Wyler.

During the 2020 season, Phase II of the RDRR project was surveyed for special status plant species. Thirteen rare plant populations were encountered in the project area that will need protections during construction. Some of these rare plant populations will experience unavoidable impacts due to their occurrence in deep patch and edge stabilization treatment areas, within the road shoulder, in cracks between rock walls and pavement, or otherwise in the path of impact (Figure 13).

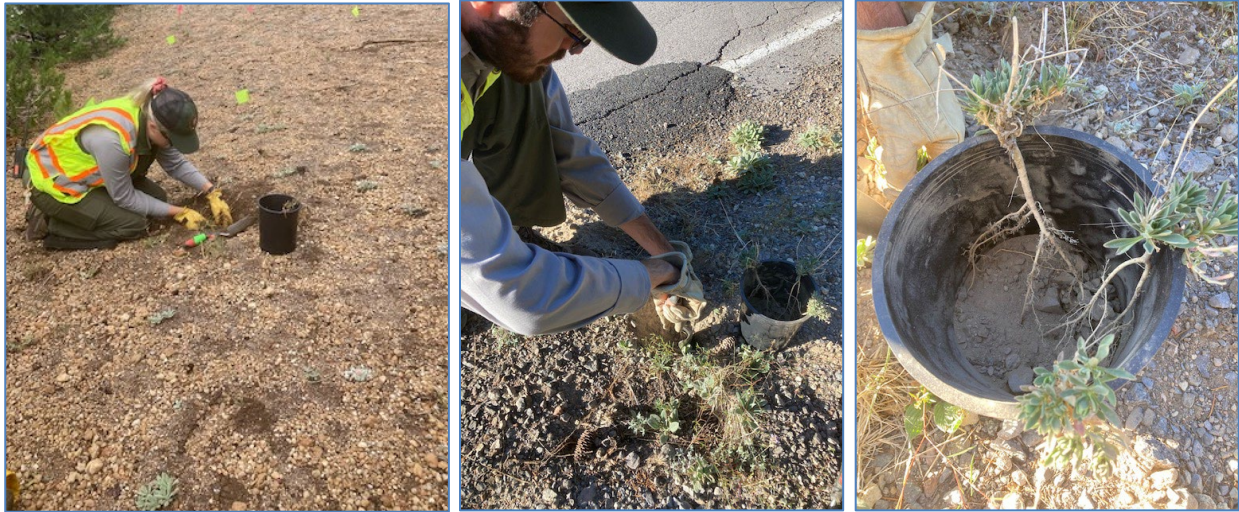
Figure 14. Salvaging pumice moonwort (left) and Crater Lake rockcress (middle) from East Rim Drive. Crater Lake rockcress being transplanted into a 1-gallon pot for hold over until construction is completed (right). Photos by Carrie Wyler.

In these cases, rare plants are salvaged ahead of construction and held over at the Ball Diamond nursery until they can be replanted. In 2021 and 2022, 766 rare plants were salvaged from six different sites on East Rim Drive (Figure 14). Quantities of salvaged plants are listed in Table 7.

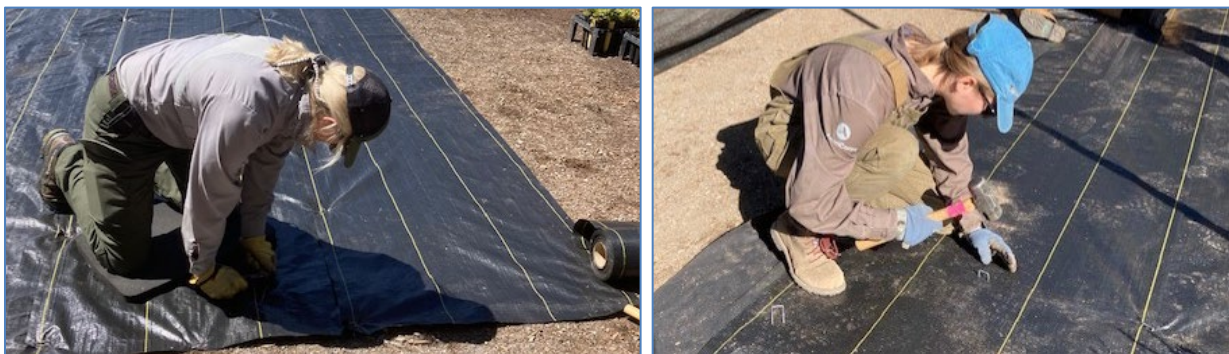
Figure 15. Installing weed barrier cloth at the park's native plant nursery. Photos by Carrie Wyler.

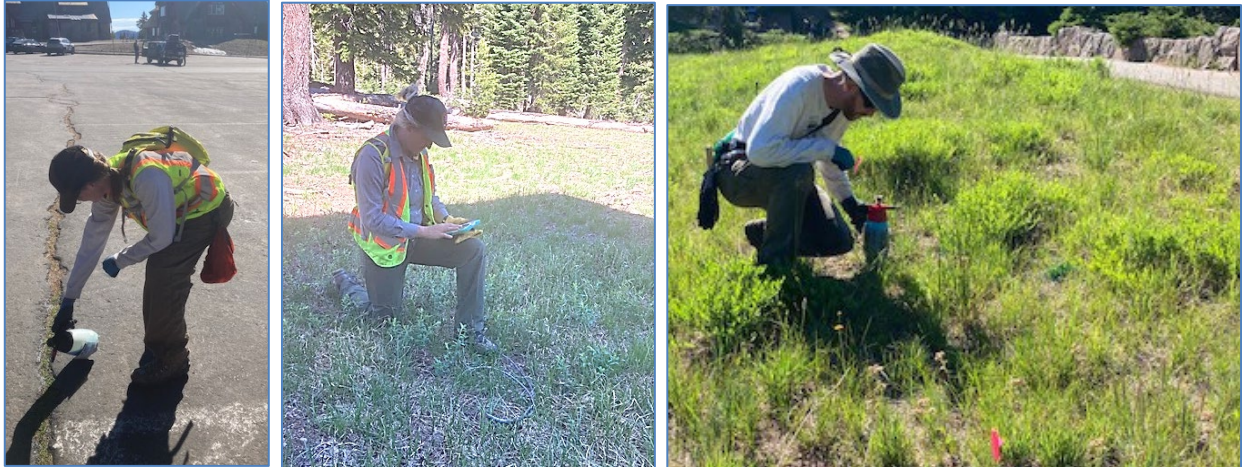
Figure 16. Chemically treating invasive species (left, right), collecting data on IVM treatments (middle). Photos by Carrie Wyler.

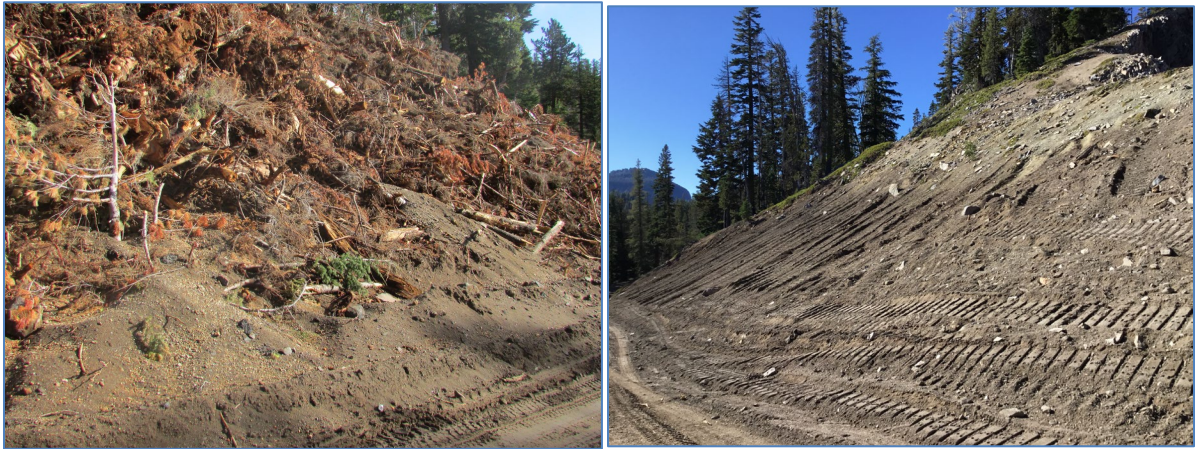
Figure 22. Slope disturbed at Roundtop Quarry by slash piling and ground disturbance in 2015 (left); same slope after removing slash and recontouring in 2018 (right). Photos by Jen Hooke.

- Restoration prescriptions will need to be developed for Roundtop Quarry. Its slopes were mechanically recontoured by the Phase I contractors leaving the disturbed areas completely devoid of vegetation (Figure 22). Once the park has determined the desired footprint for future use of this area, disturbed areas outside this footprint need to be revegetated and restored. Some of the seed produced by the Meeker PMC can be used at this site. Seed will need to be raked in with park compost and native debris distributed. The area will need to be mapped, documented, and monitored in Phase II for restoration progress and surveyed diligently for invasive plant species.

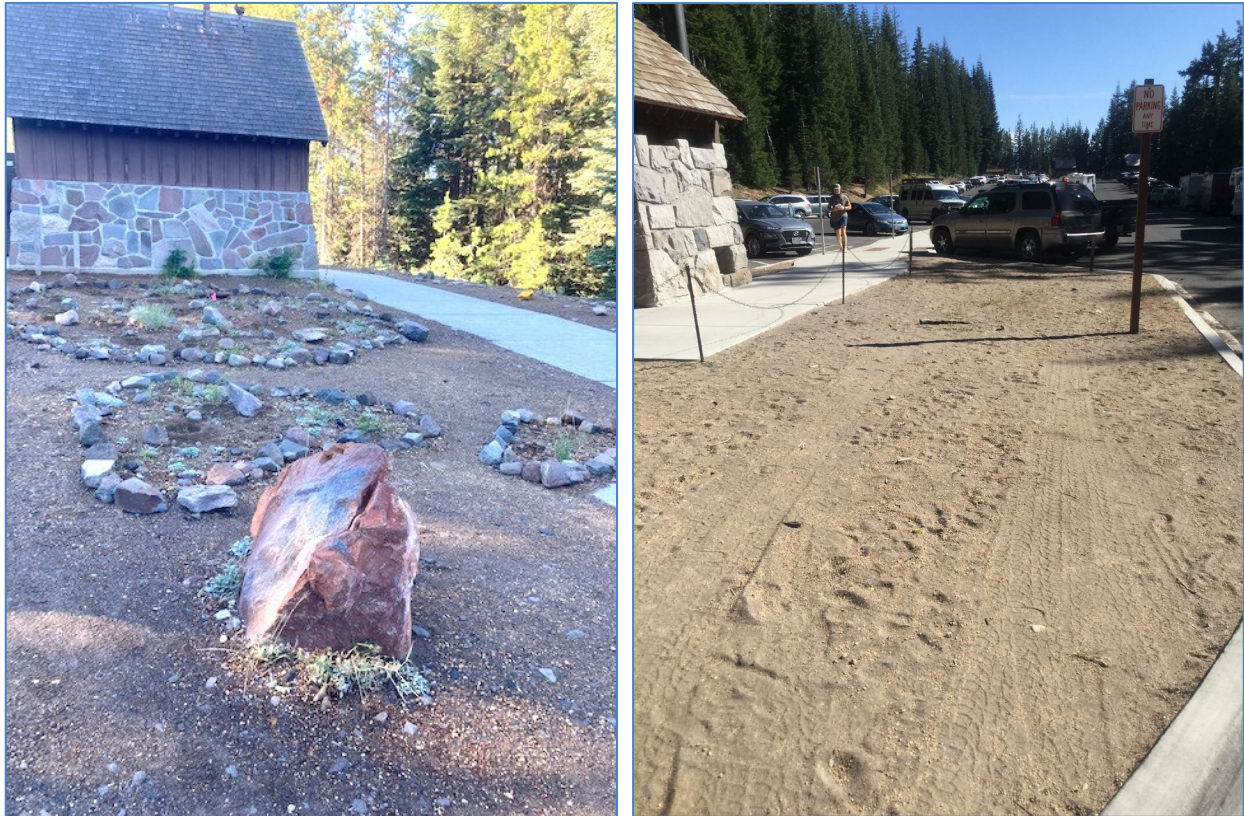
Figure 23. Plantings in groups with rock borders to mitigate trampling in heavily trafficked Cleetwood Cove parking lot areas (left). The area at the back of the Cleetwood Cove parking lot needs to be adjusted to allow for RVs to drive around the comfort station without damaging the landscaping island (right). Photos by Carrie Wyler.

- During 2019, 2020, and 2021 large rock rings were made around grouped plantings at the Cleetwood Cove parking lot, Glacial Scratches pullout areas, and Watchman Overlook. This technique has been deemed successful in deterring trampling if larger rocks are used and will be used in future restoration areas. Some areas may need more obvious exclusion methods such as fencing and signage. These sites need to be checked multiple times throughout the season as rock circles and fencing need maintenance.

- The back of the Cleetwood Cove parking lot will be worked on during Phase II of the RDRR project. The area presently is not big enough for large recreational vehicles to pass through and their back wheels often jump the curb and damage this revegetation site (Figure 23). This area has been sparsely planted in areas that would not be impacted by vehicle traffic. After construction work is completed, more plants should be added.

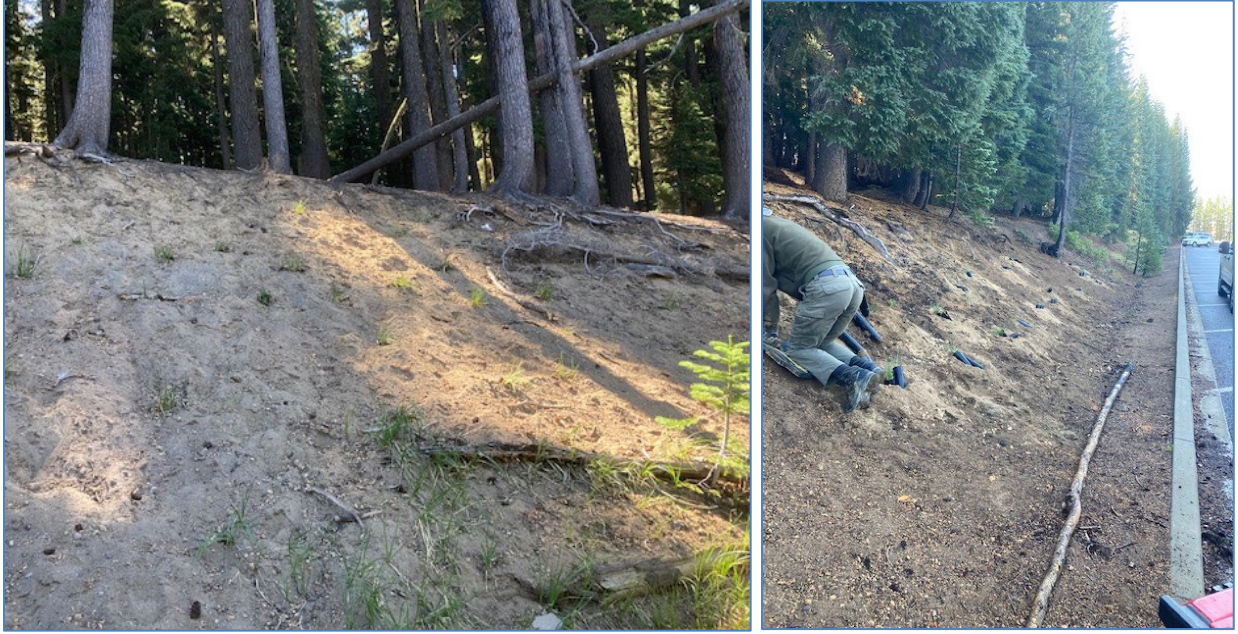
Figure 24. The steep slope of the embankment in the Cleetwood Cove parking lot with Hall's sedge taking hold (left). Planting more Hall's sedge on the embankment in 2022 (right). Photos by Carrie Wyler.

- Site NEERD 3.1 is the eastern embankment of the Cleetwood Cove parking lot and will continue to need maintenance in future years. It has a steep slope of pumice soil that is continuously eroding and hindering restoration efforts. This area was planted with Hall’s sedge in 2021 and 2022 after discovering that rhizomatous plants are the only plants that successfully establish themselves on the steep embankment (Figure 24). The area will need assessment after the 2022 plantings. If the plantings continue to be successful, more plants will need to be installed on the embankment; more Hall’s sedge may be needed for this endeavor as it does not propagate well from seed.
