Rim Trail Revegetation Project

2019 Annual Report

Scott E. Heisler, Carolyn S. Wyler, and Jennifer S. Hooke

April 2020

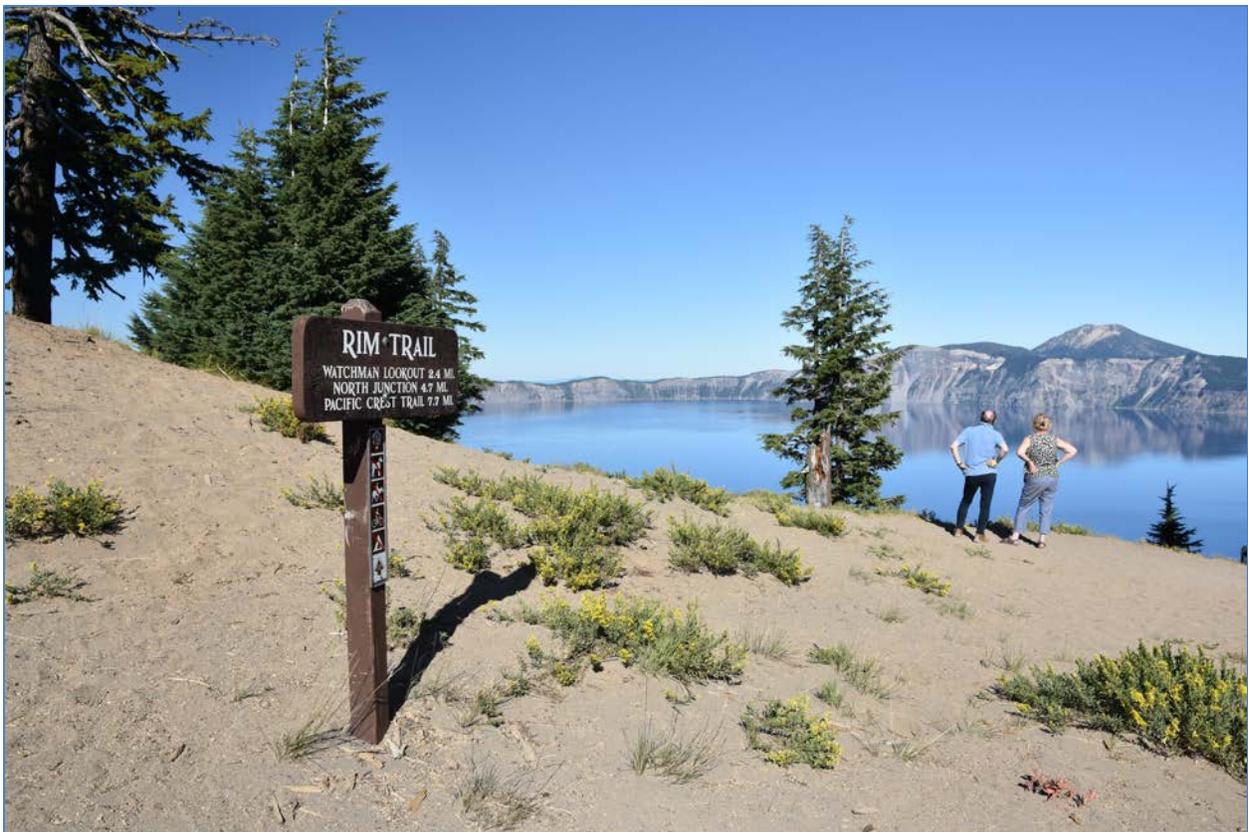
Excessively wide section of the Rim Trail encourages trampling and has almost eliminated vegetation cover.

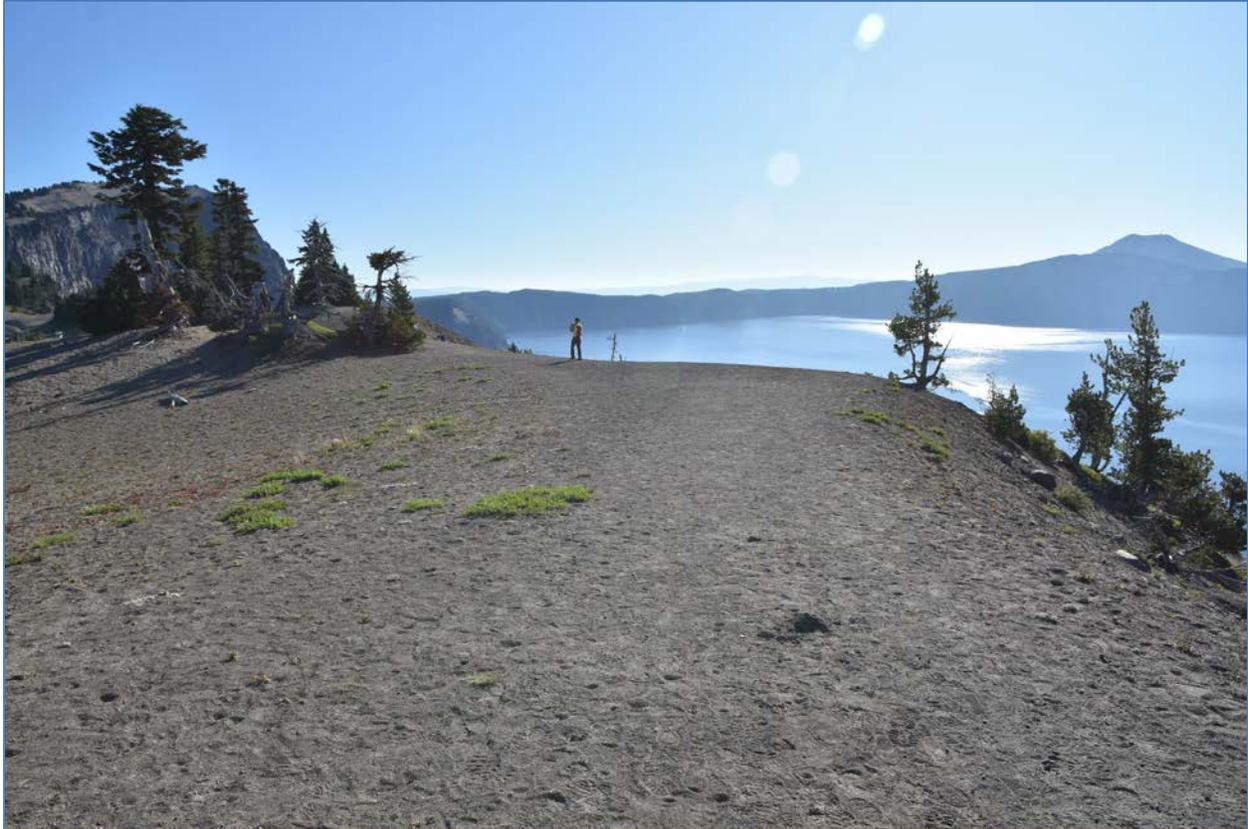
Sparse vegetation cover due to visitor trampling adjacent to the Rim Trail corridor.

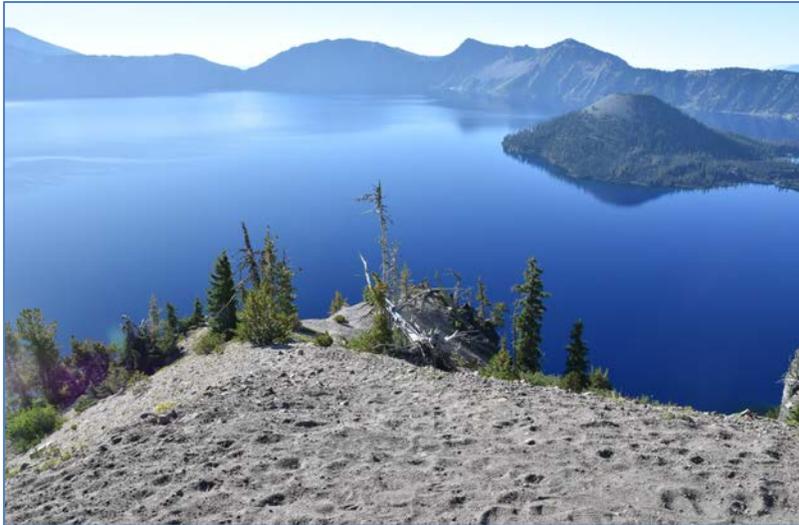
Figure 2. A social trail leads from the Rim Trail inside the Crater Lake caldera. Photo by Jen Hooke.

areas along West Rim Drive. In addition to detracting from the aesthetics of the trail, this damage compromises visitor safety by decreasing the stability of the trail and directing traffic into hazardous areas along the cliffs of the inner caldera (Figure 2).

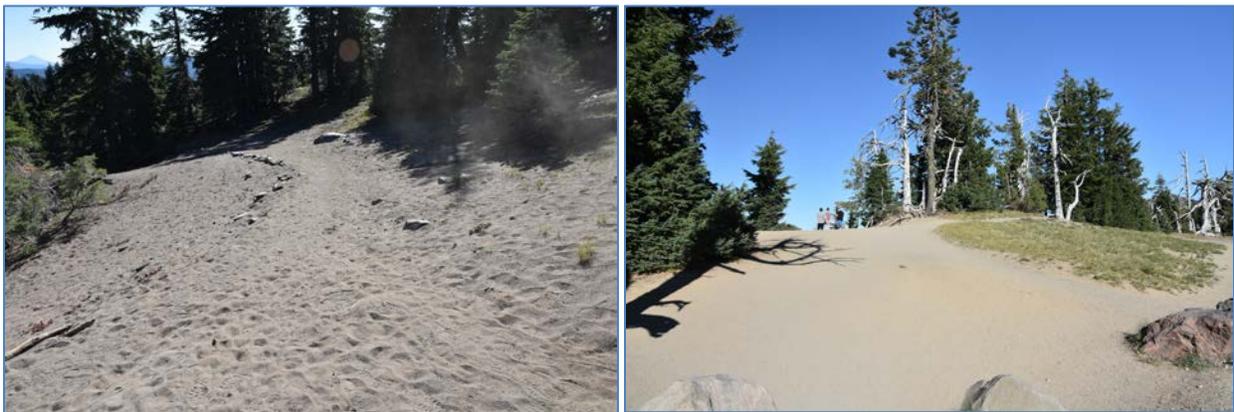
Figure 3. Excessively wide sections of the Rim Trail require work to address trail deficiencies (e.g., lack of trail demarcation, bloated width) prior to the commencement of revegetation work. Photo by Jen Hooke.

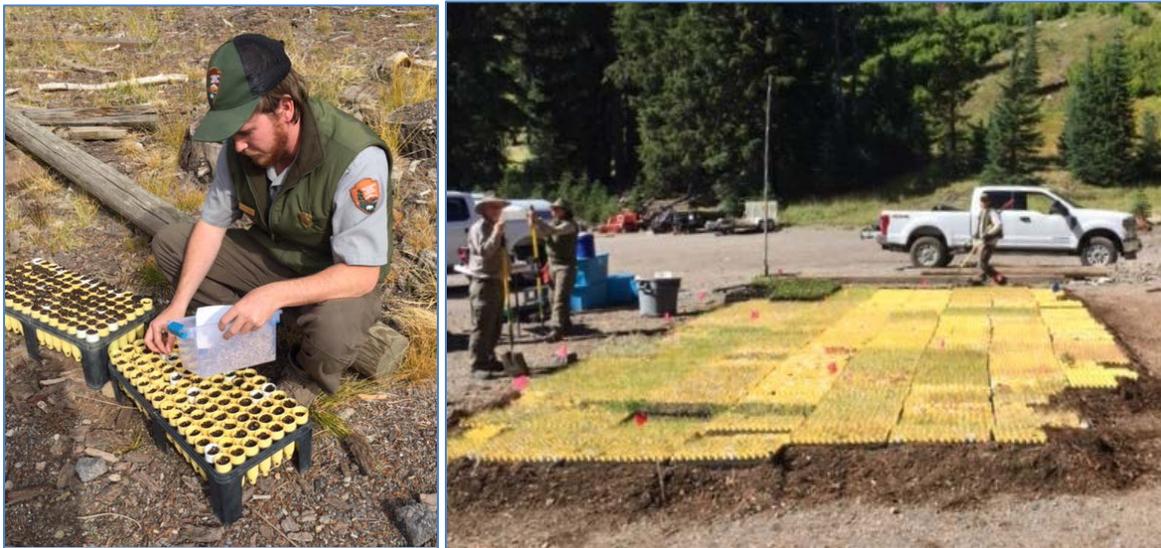
Figure 5. Seeding pots for plant propagation (left). Consolidating pots and surrounding them with mulch for overwintering (right). Photos by Carrie Wyler.

In October 2018 and 2019, Ray Leach “SC7 Cone-tainer” pots were placed in racks and then filled and settled to 0.5” below the top rim with Premier “PRO-MIX HP Mycorrhizae” soil. These pots were then seeded with native seeds collected from the restoration area during the 2018 and 2019 field seasons (Figure 5). A thin (~1/8”) layer of soil was then placed over the seeds, and the pots were watered to settle the contents. The seeded pots were placed under rodent-excluding screens in the Botany program’s space at the Ball Diamond at Park headquarters and left to overwinter under the snowpack to replicate natural germination conditions. Prior to overwintering, pots were placed in a tight group, and mulch was packed around the perimeter to protect roots from exposure to severe cold and desiccation (Figure 5). During the 2019 field season, the germinated plants were cared for according to the Botany program’s established native plant nursery protocols (on file on the Botany server).

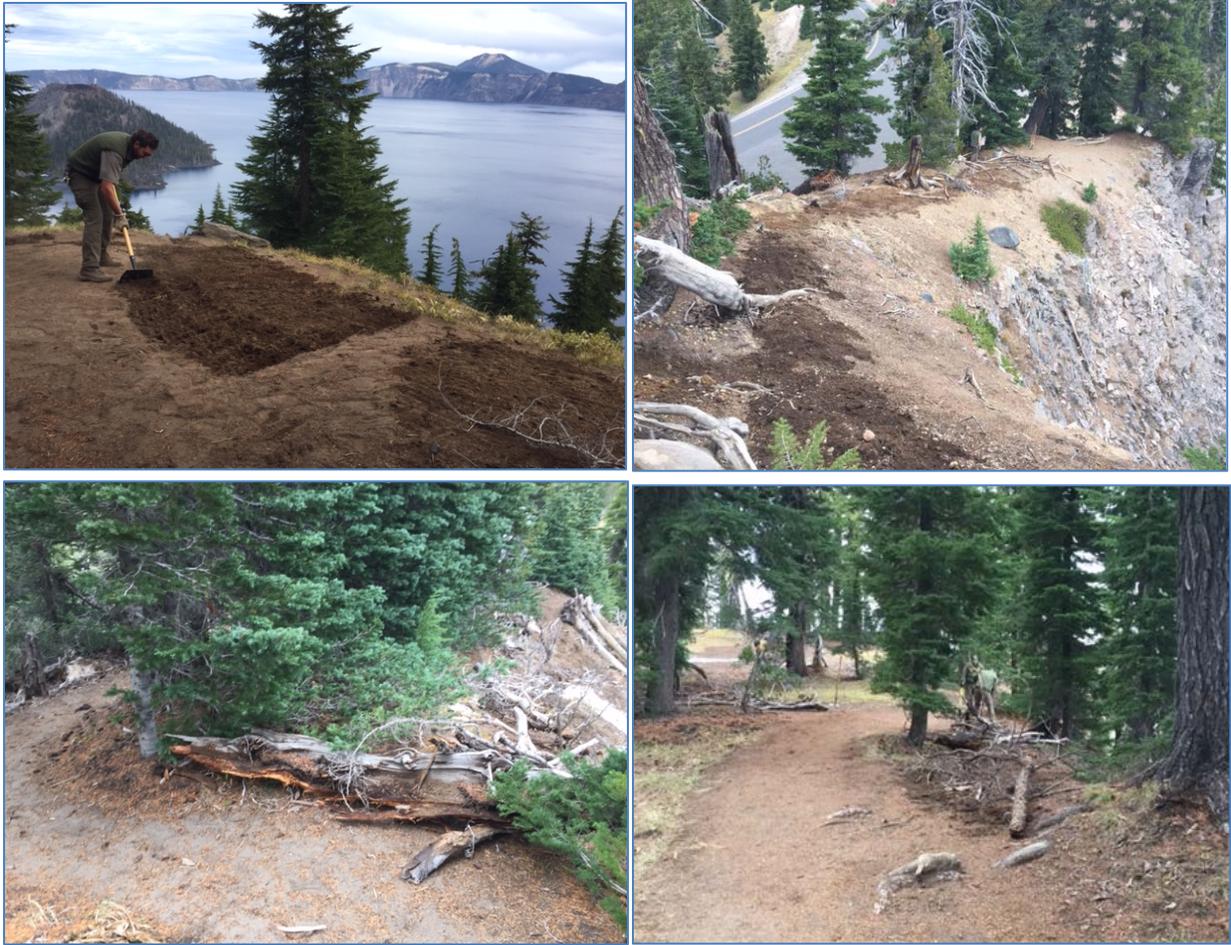
Figure 6. Botany crew member using a McLeod to decompact a large heavily trampled area (top left). Recontouring of a social trail slope that was created too close to the caldera rim (top right). Obstruction and disguising of visitor created social trails (bottom). Photos by Carrie Wyler.

Soil decompaction and tread removal were conducted by hand using a McLeod or pick mattock tool (Figure 6). Where social trail use had created level shelves on hillsides, these features were recontoured to match the hillside slope (Figure 6). Following decompaction, addition of duff sourced from adjacent areas and broadcast seeding of a limited quantity of grass seed was conducted to disguise the obliterated path, amend the barren soils, and jumpstart revegetation efforts. Access to the social trails was obstructed by the addition of large, coarse woody debris and rocks (Figure 6).

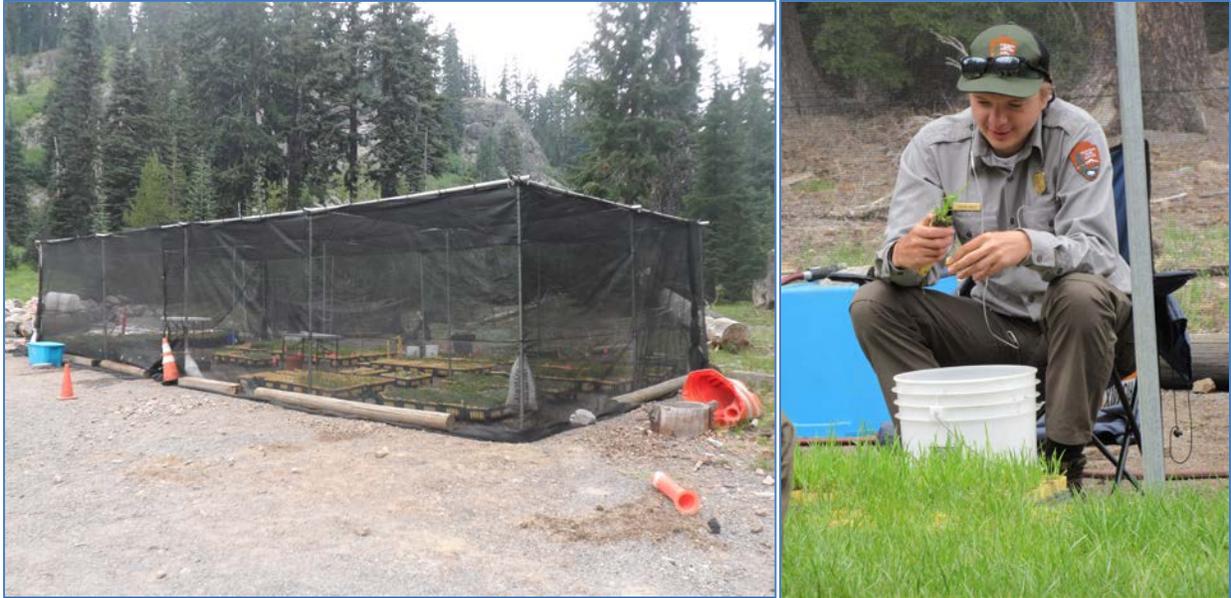
Figure 7. Shadehouse where plants are housed and cared for during the field season (left). Botany crew member conducting plant care (right). Photos by Carrie Wyler.

In total, 2,569 living containerized plants were propagated during the 2018 field season (Table 3). These plants experienced modest growth during the 2019 growing season at the CRLA Ball Diamond and were cared for during the field season (Figure 7). Over the fall and winter of 2019/2020 4,746 plants are being propagated by the DGRC (Table 4).

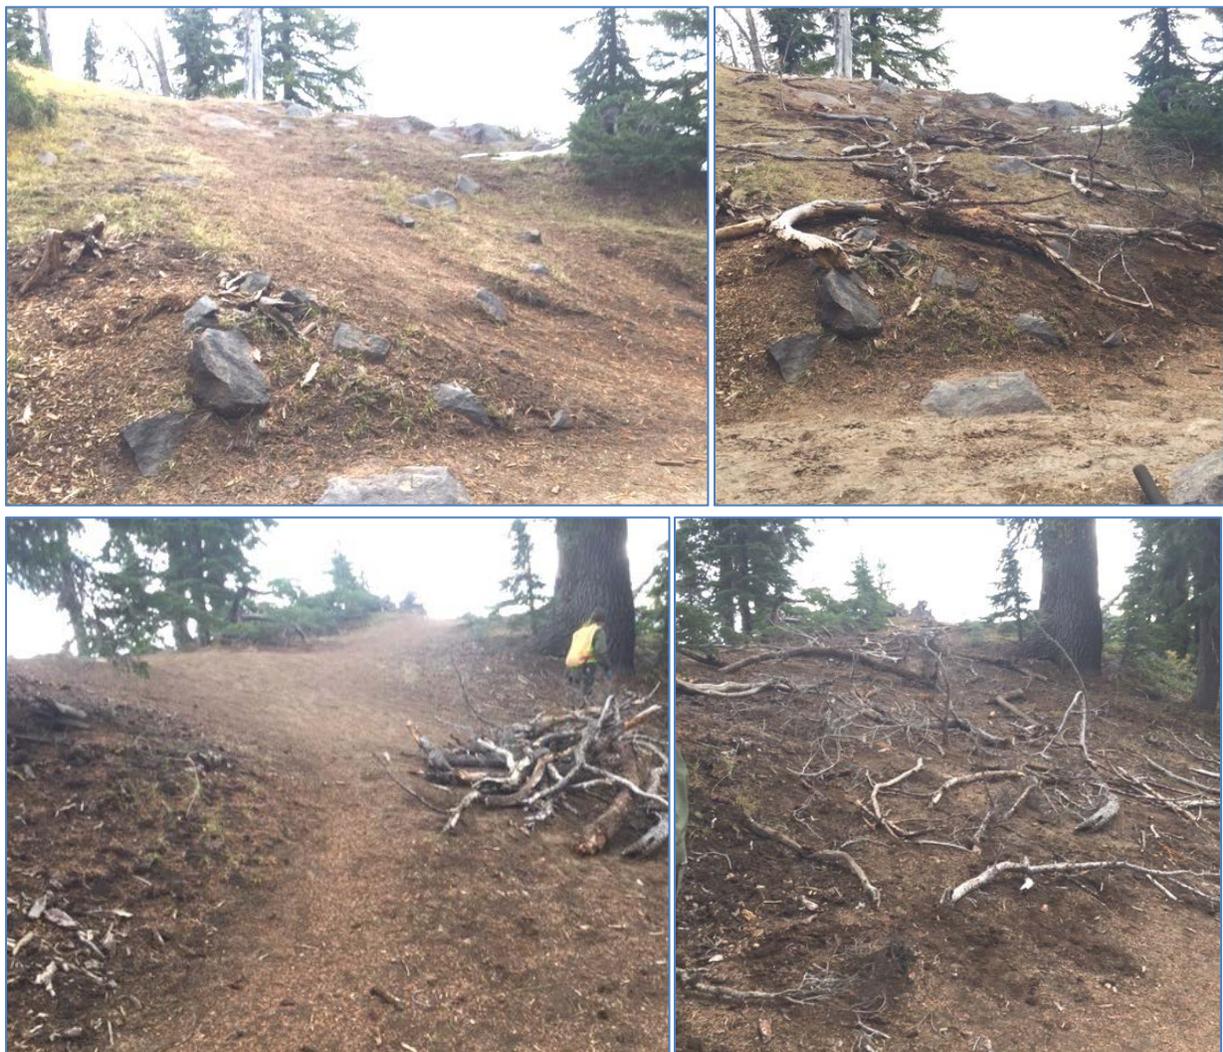
Figure 8. Before (left) and after (right) results of social trail obliteration work at two revegetation sites. Photos by Carrie Wyler.

Preliminary social trail obliteration was conducted at fifteen revegetation sites, encompassing approximately 0.7 acres of area in total (Figure 9). Approximately 1,530 g of bottlebrush squirreltail seed (*Elymus elymoides* ssp. *elymoides*) was broadcast seeded in these areas. Figure 8 demonstrates before and after pictures of two obliterated social trail sites.

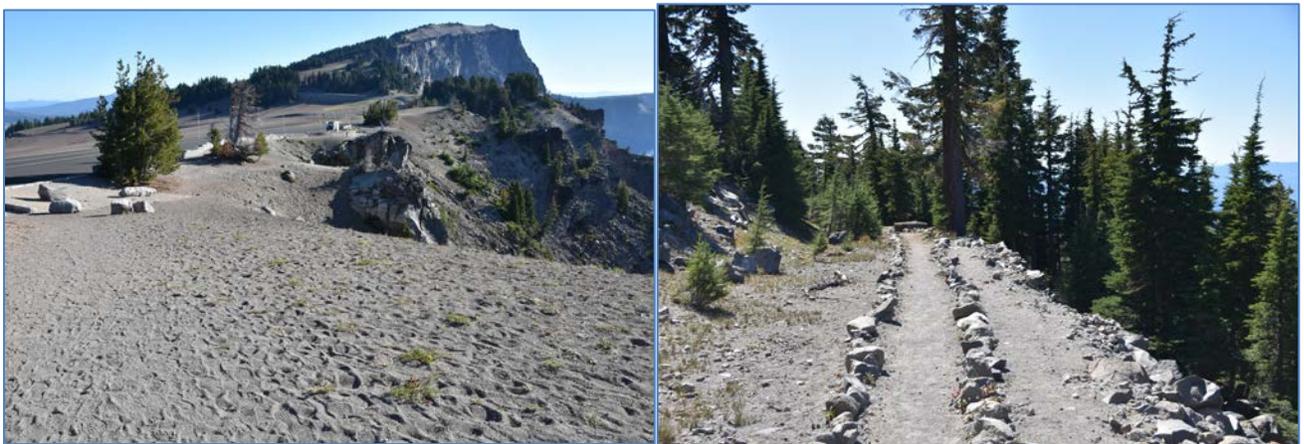
Figure 10. Large barren trampled fellfield terrain area containing the poorly defined Rim Trail (left). Example of an area that implements rocks to delineate the trail for a clear path (right) along the old Rim Road grade. Photos by Jen Hooke.

Certain sections of the Rim Trail have developed excessively wide tread which likely arose from a lack of clear trail delineation, an issue which is further exacerbated by expanses of barren pumice meadows resulting from trampling of trailside vegetation (Figure 9). These areas are common in the wind scoured pumice fellfield terrain at the northern end of the trail. To address this issue while maintaining the unique and spectacular viewshed afforded by these open expanses, it is suggested to conduct a trial of delineating the trail with stone edging combined with educational signage at access points. This method is currently in use on limited sections of the Rim Trail converted from the old Army Corps of Engineers Rim Road grade, and effectively confines most traffic to a narrow passage along the wide historic road grade (Figure 10). A trial would help assess the efficacy and aesthetics of this method in a natural (e.g., not an old roadbed) area. Implementation of this technique would need to be conducted by the CRLA Trails program.

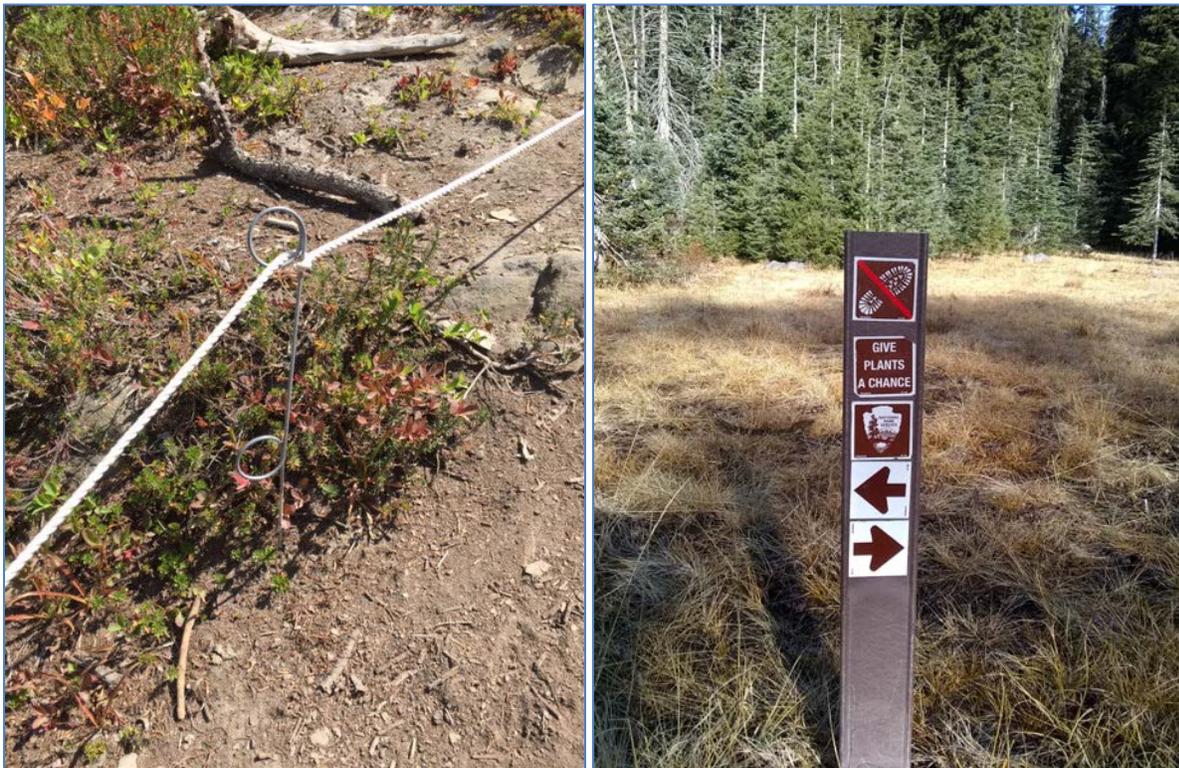
Figure 11. Low, easily movable, barrier fencing (left). Photo by Carrie Wyler. Carsonite sign directing visitors to the trail location (right). Photo by Scott Heisler.

Additional native seed collection is planned for the 2021 field season. Once the landscape repairs have been completed, all revegetation sites will be planted and seeded as per site prescriptions and available plant materials. Especially problematic areas may need additional barriers such as low fences and/or signs to encourage hikers to remain on trail corridors (Figure 11).
