Replace Rim Village Barriers Revegetation Project

2019 Annual Report

Scott E. Heisler, Jennifer S. Hooke, and Carolyn S. Wyler

April 2020

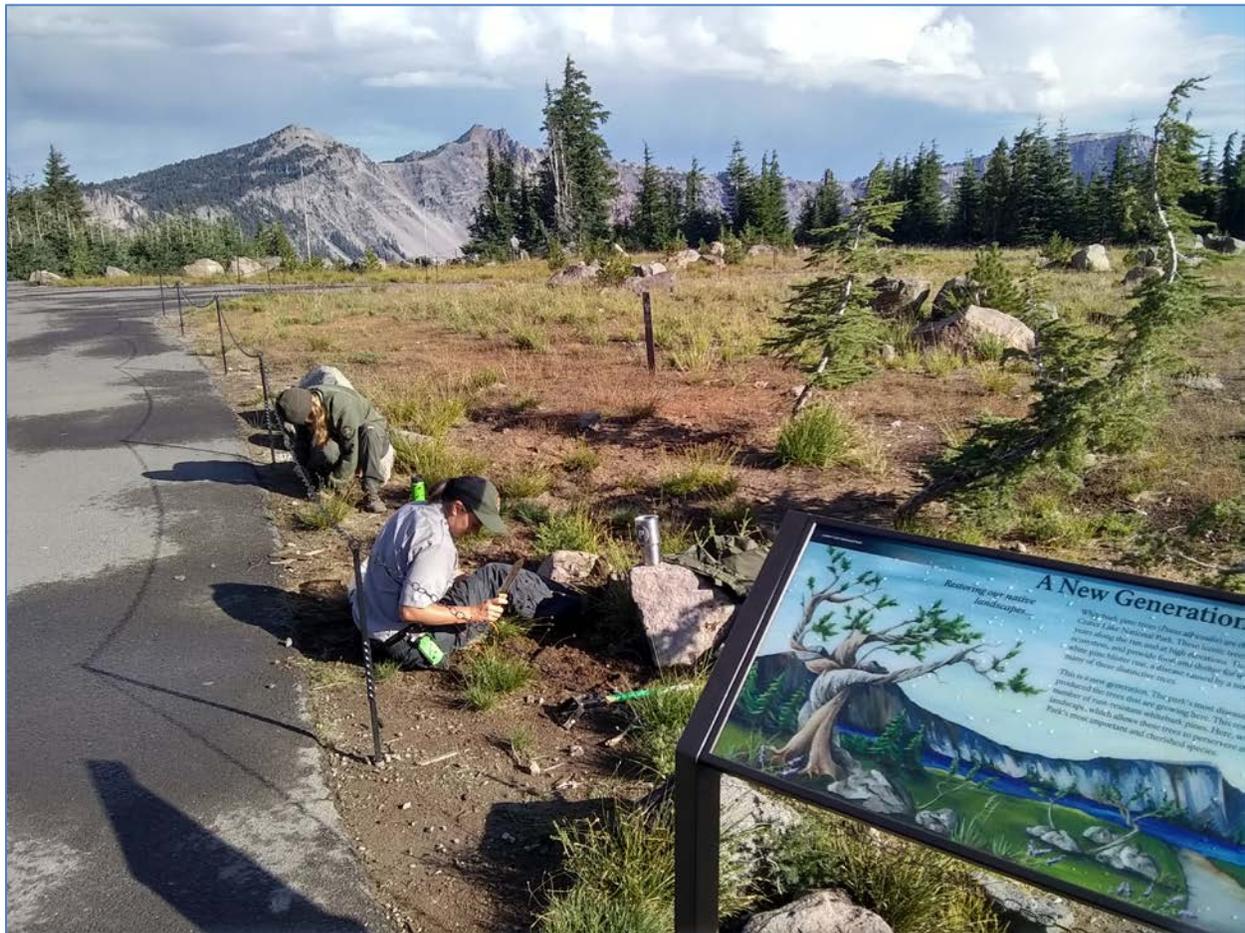
Botany crew members treating the invasive plant red sandspurry that is encroaching on native plant habitat in landscape beds at Rim Village.
Photo by Scott Heisler

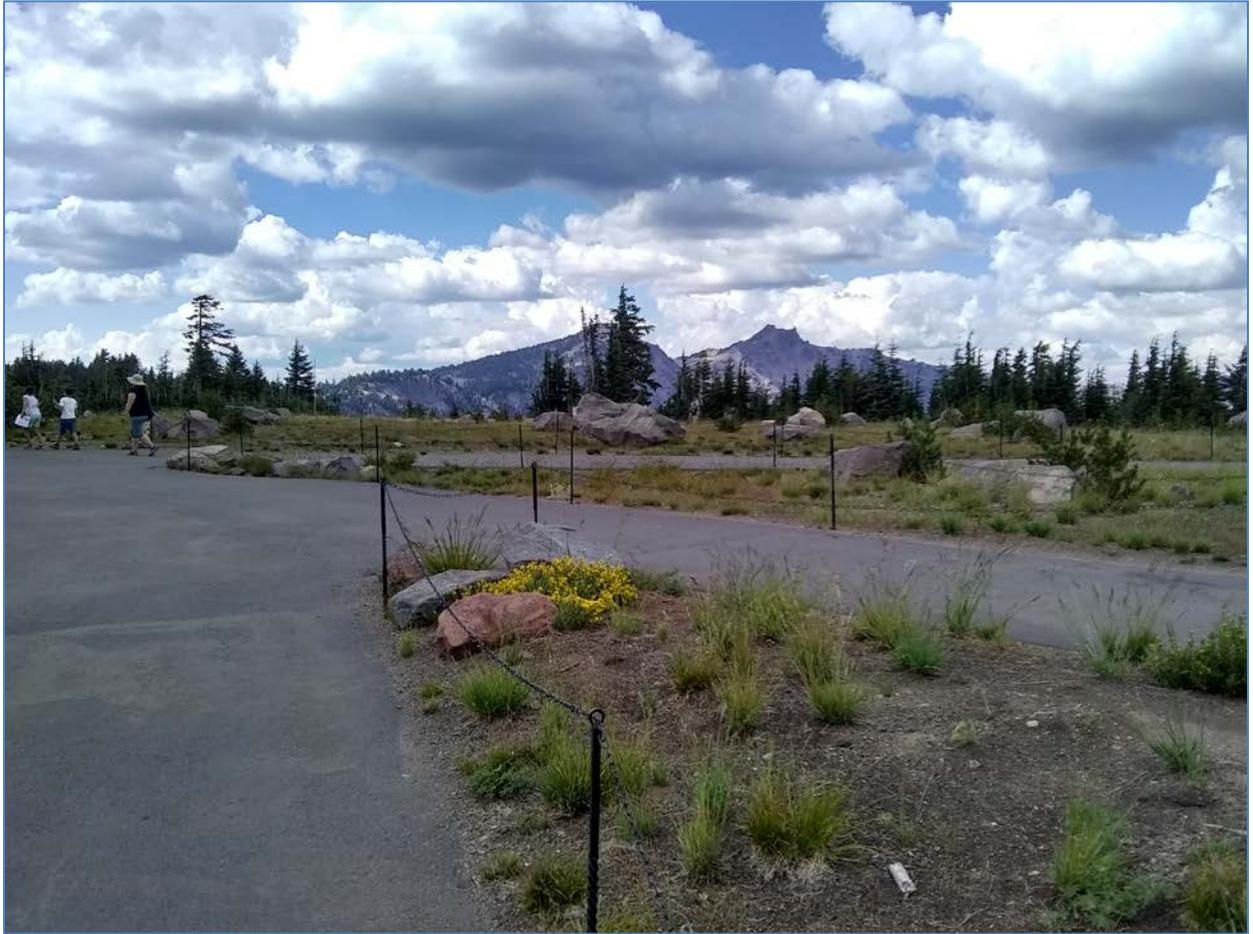
The new fencing design at Rim Village effectively protects the landscape from trampling.
Photo by Scott Heisler

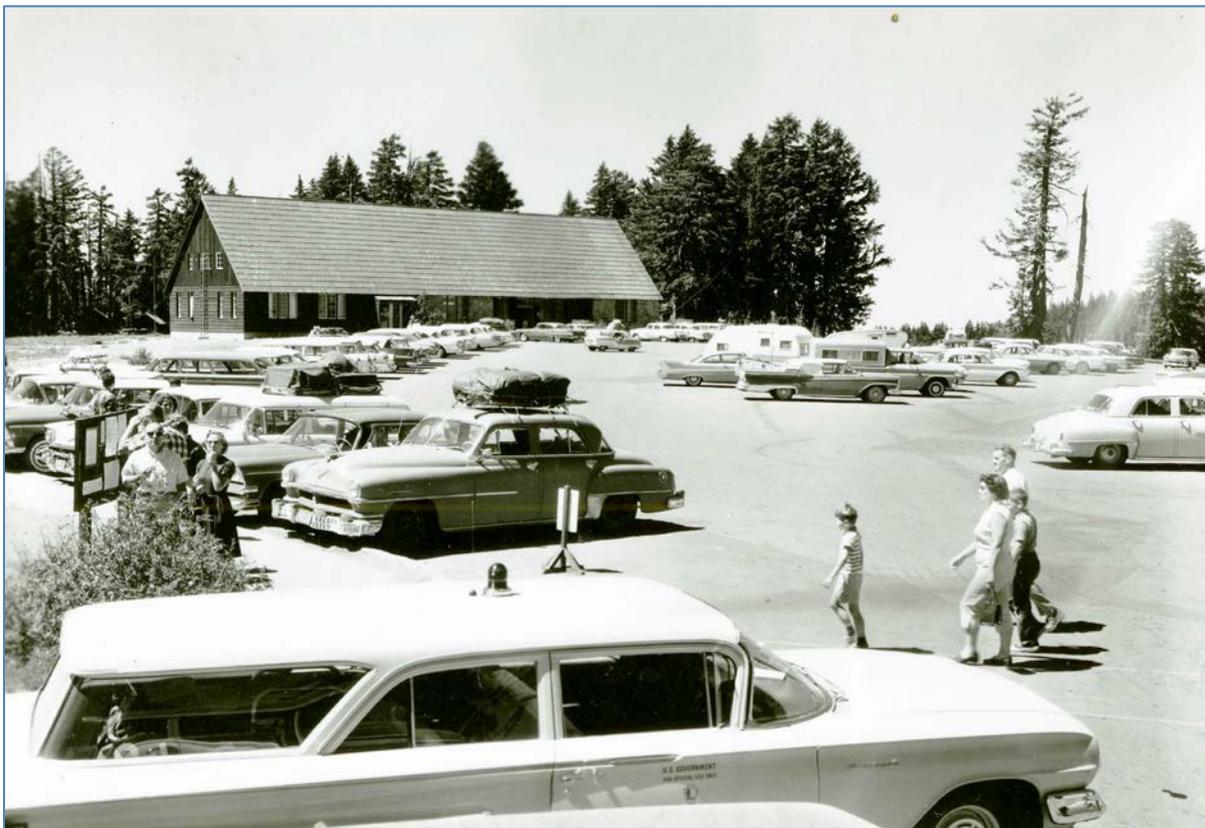
Figure 1. The former parking lot in front of the cafeteria building (now called the 1928 building) at the western end of Rim Village. Photo courtesy of the Crater Lake National Park Museum & Archives Collection.

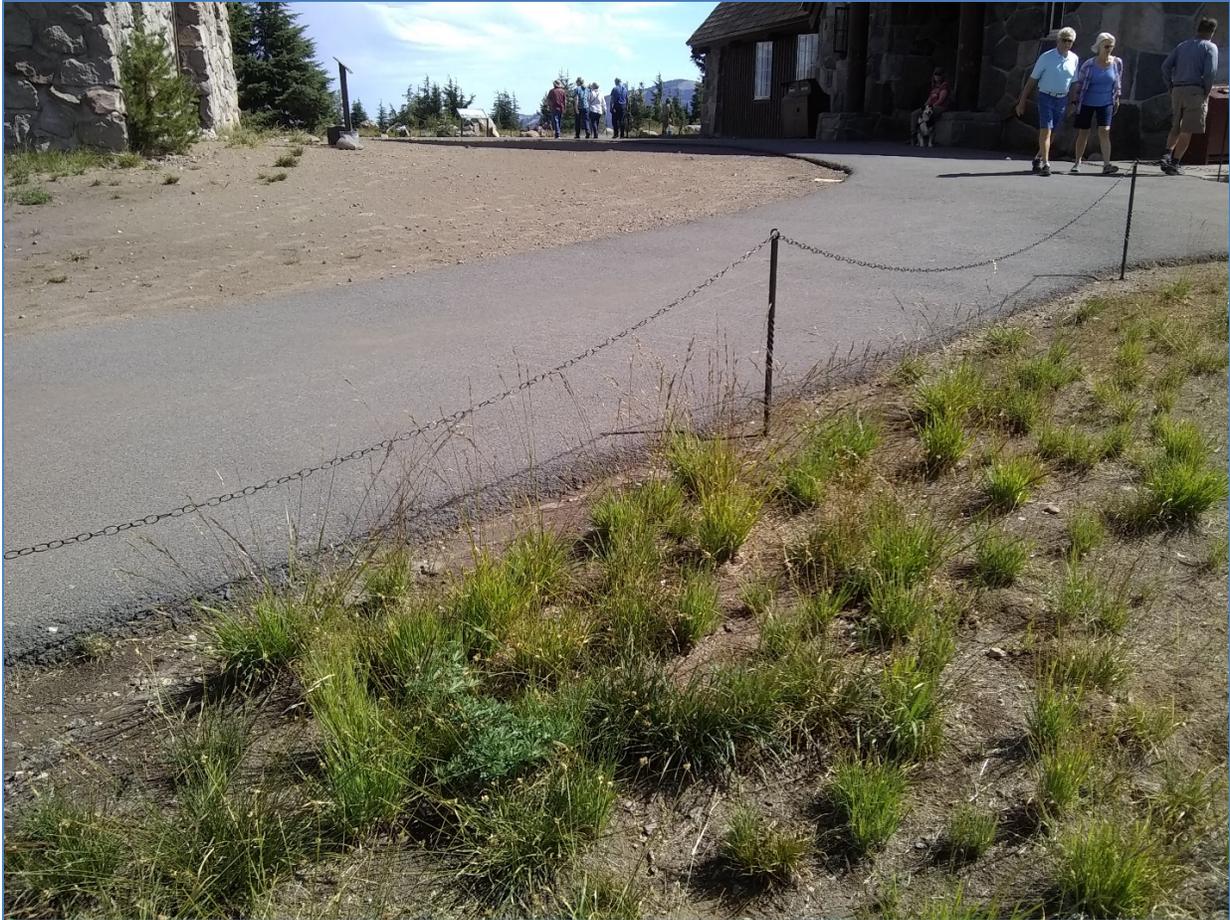
Figure 2. This image shows the effectiveness of fencing with vegetation growing abundantly on the fenced side of the path and vegetation completely denuded on the other side of the path where there is no barrier to foot traffic. Photo by Scott Heisler.

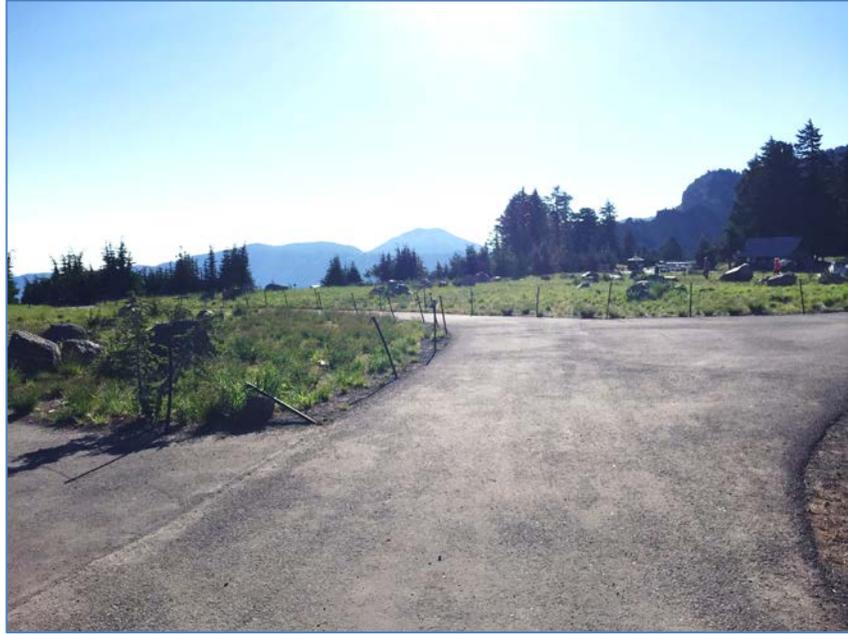
Figure 3. The old fencing design was prone to leaning and/or falling over, as it was lightweight and easily dislodged, and its rebar stake supports were difficult to install in the compacted ground. Photo by Carrie Wyler.

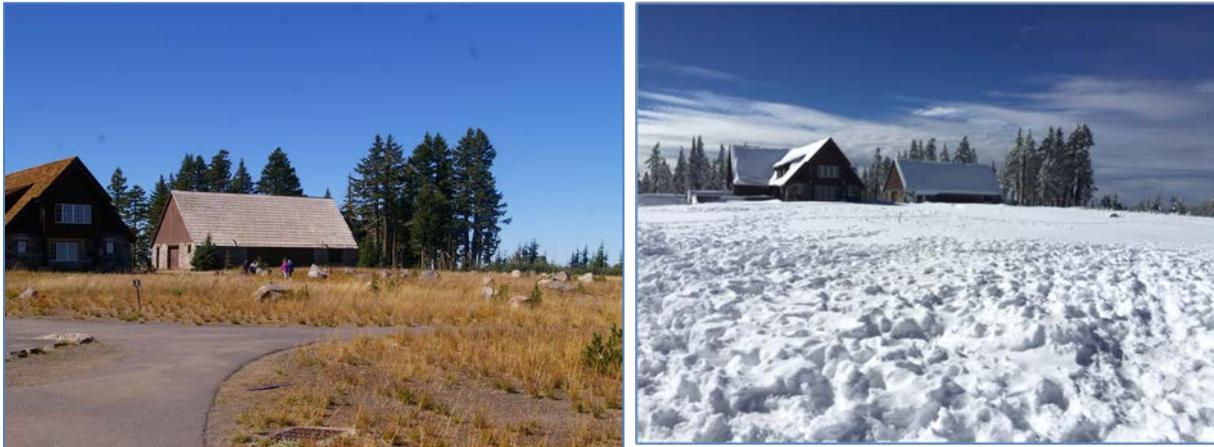
Figure 4. The former parking lot area in summer/fall (left) with walking paths delineated; and in winter/spring (right) when visitors travel freely across the area. Photos by Carrie Wyler.

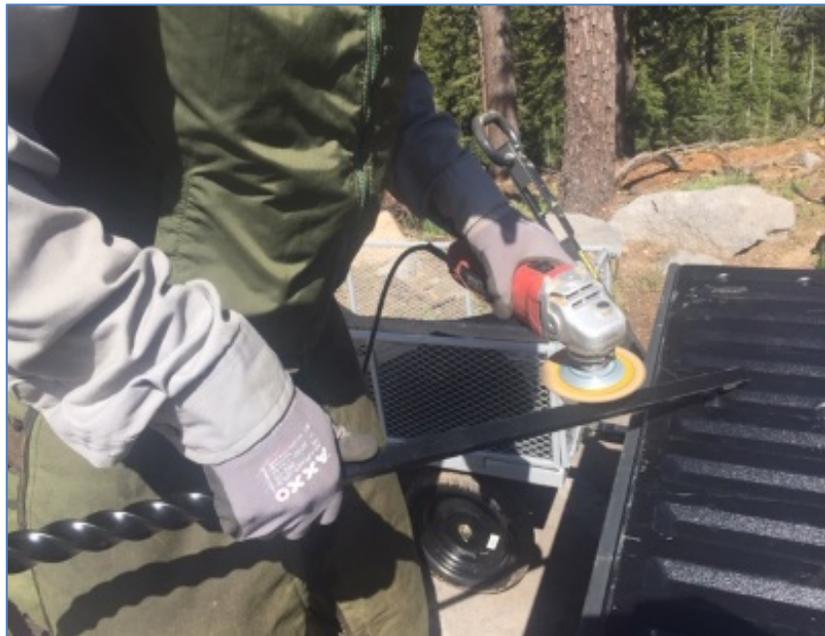
Figure 5. Grinding down the posts to achieve a better fit. Photo by Carrie Wyler.

During initial testing it was discovered that certain post and post receiver combinations had an excessively tight fit resulting from a manufacturing artifact on the opening of the receivers and variation in powder coating thickness on the posts. To streamline the yearly fencing installation/removal process, this issue was addressed by lightly grinding down the square posts along the length affected by the poor fit. This task was completed using an angle grinder, utilizing a “ferrous metals - grinding” wheel. For the procedure, posts were placed on a measuring board delineating the affected 16.5 inches, and approximately 1.25mm was ground off each of two adjacent corners (Figure 5). The ground-down area was then immediately painted with a double coat of flat black Krylon “Supermaxx Paint+Primer” spray paint to prevent rust from undermining the powder coating.

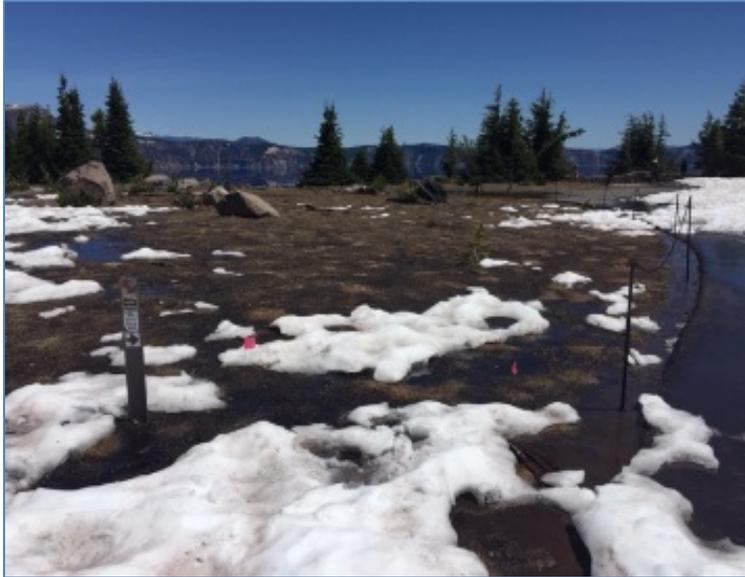
Figure 6. Redirecting foot traffic away from a partially fenced landscaping island. Photo by Carrie Wyler.

didn't pose a risk of causing visitors to fall into the posts. Uneven snowmelt resulted in some landscaping islands requiring partial fencing until the entire perimeter had melted. To limit visitor traffic into the partially fenced landscaping islands, bright pin-flags and Carsonite signs directing traffic were placed along the receding edge of the snowpack (Figure 6).

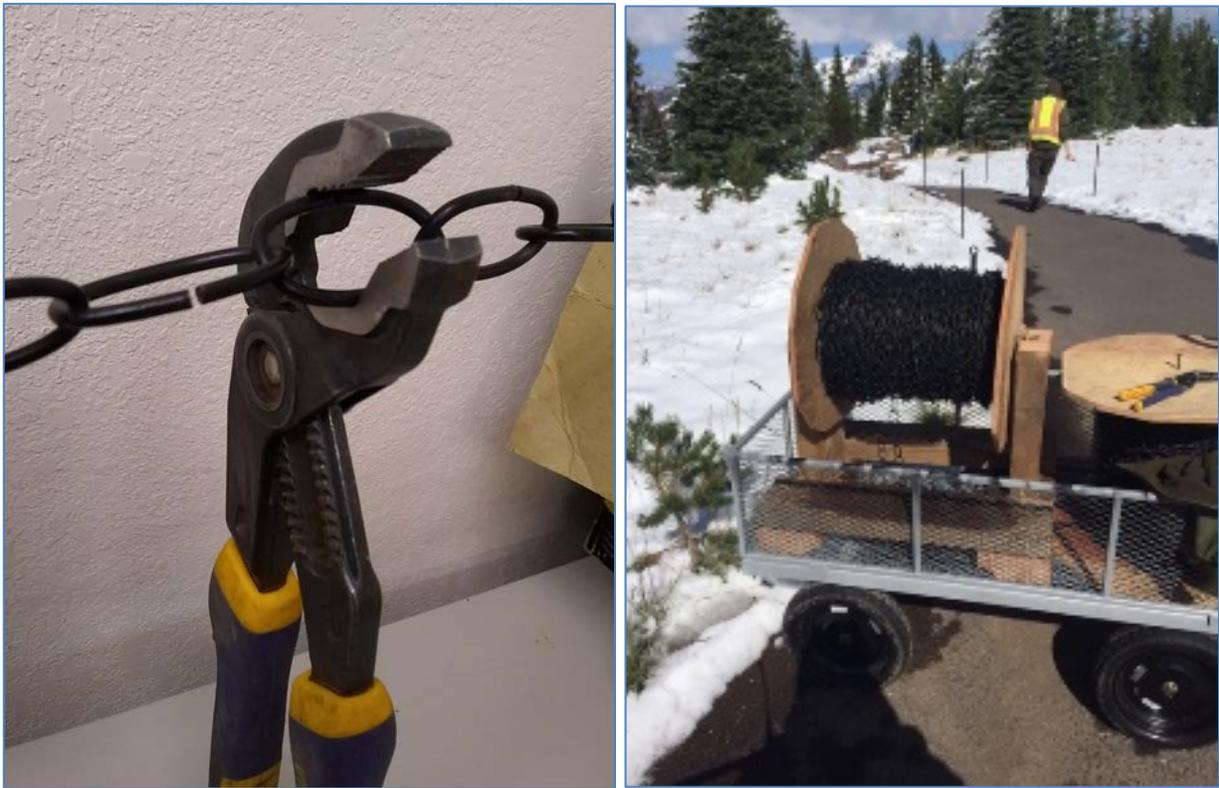
The chain used in the project proved to be more fragile than desired, with sections upwards of 6' disintegrating when subject to abnormally high weight stresses from visitor interaction with the chain. A commonly observed interaction of this type was visitors trying to sit on the chain. Rather than breaking at a single point, the non-welded links would uniformly bend open across an affected span of chain. When the weight stress was removed, the length of chain with bent links would disintegrate. Occasionally the links were not deformed to the point of failure. When this situation was observed, the gaps in the links were

Figure 7. Left: using pliers to pinch closed stretched fence chain links. Photo by Scott Heisler. Right: detail of the spool used for chain storage and transport. Photo by Carrie Wyler.

easily removed by pinching the link perpendicularly across the gap with a pair of tongue-and-groove pliers (Figure 7). To address the tendency of visitors to abuse the chain, additional slack was added to the chain in order to make it a less inviting sitting platform.

To facilitate winter storage and overall transport of the chain, six large wooden spools and a spool-holder were constructed. The spools were fabricated with 16" long 4"x4" lumber spindles, 20" diameter circles of 1/2" plywood as sides, and #2 gage nails acting as axles to spin on. The spool-holder was fabricated with a 20" square of 4"x6" lumber for the base, two 14" uprights of 4"x6" lumber, and four screws installed on the top of the uprights to hold the axles of the spools. The spool-holder was sized to fit in a utility cart for ease of use and transport (Figure 7).

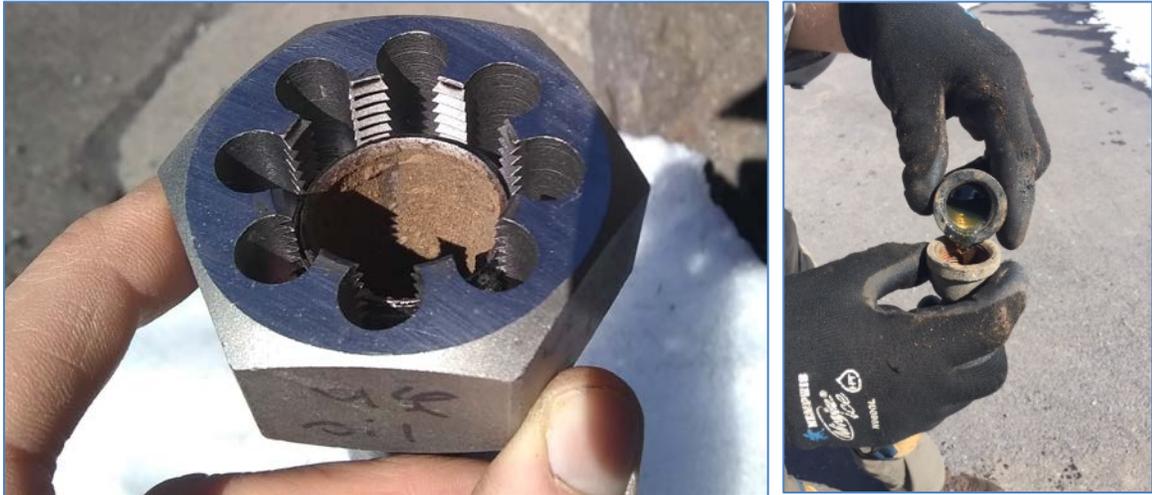
Figure 8. Chasing damaged threads on a post receiver with a pipe thread die (left). Oiling the threads on the caps (right). Photos by Scott Heisler.

To winterize the post receivers, a small amount of oil was used to coat the threads on the caps. Completely coating the threads was accomplished by pouring a small amount of oil in a cap, swirling it around to cover all the threads, and pouring the excess into the next cap to be coated (Figure 8). The caps were threaded hand-tight onto the post receivers. As the threads on the post receivers are a tapered diameter, the caps are only threaded on roughly 1/3" of the overall 1" length of threads on the receivers. Damage to threads on the post receivers was addressed by chasing the threads with a pipe thread die (Figure 8).

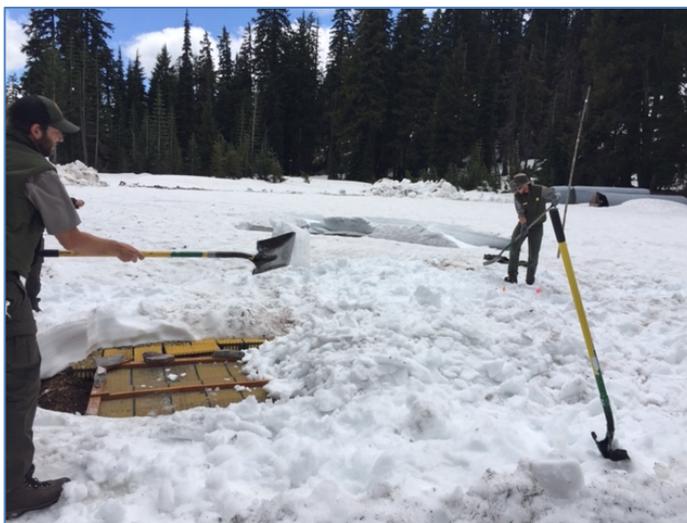
Figure 10. Removing snow from propagated plants to extend the growing season. Photo by Carrie Wyler.

All plant species used for propagation in fall 2018 produced satisfactory germination and survival rates, except for fireweed. It was decided to give the plants a second year of growth before outplanting, as they had not achieved satisfactory development by the end of the first field season. To mitigate the short growing season at CRLA, snow was shoveled off the plants in early June 2019 to lengthen the growing season (Figure 10). Whereas in 2018 the plants were temporarily transported to a warmer location in the Park (South Yard), in 2019 the plants remained at the Ball Diamond nursery for the duration of the growing season.

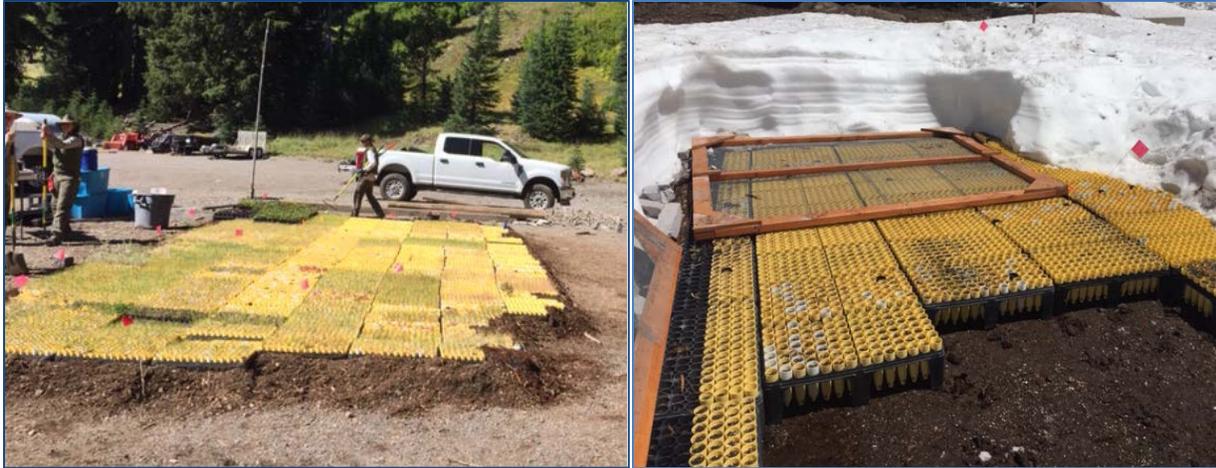
Figure 11. Bunched plants packed with mulch for overwintering (left). Seeded pots under rodent-excluding screens, melting out from the snowpack (right). Photos by Carrie Wyler

The seeded pots were then placed under rodent-excluding screens in the Botany program’s space at the Ball Diamond at Park headquarters and left to overwinter under the snowpack to replicate natural germination conditions. Prior to overwintering, pots were placed in a tight group, and mulch was packed around the perimeter to protect roots from exposure to severe cold and desiccation (Figure 11).

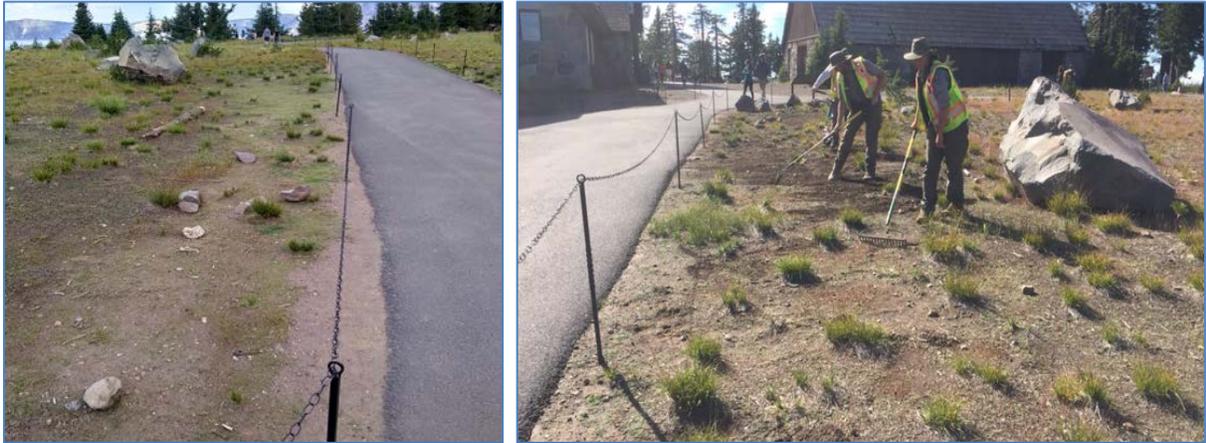
One population of a particularly resilient invasive plant species, red sandspurry (*Spergularia rubra*), required an intensive management effort during the 2019 field season. This species had formed near-monoculture mats along the denuded edges of several landscaping beds in the project area and was rapidly spreading to adjacent disturbed areas (Figure 12). To address this issue, approximately 60,000 plants, many bearing mature seed heads, were removed by hand pulling. This disturbed area was then broadcast seeded in fall 2019 (Figure 12), and the residual red sandspurry population will be treated with herbicide in early summer 2020.

Figure 12. Mats of red sandspurry (light green) along edges of the landscaping beds (left). The Botany crew raking native seed into the areas post-red sandspurry removal (right). Photos by Carrie Wyler.

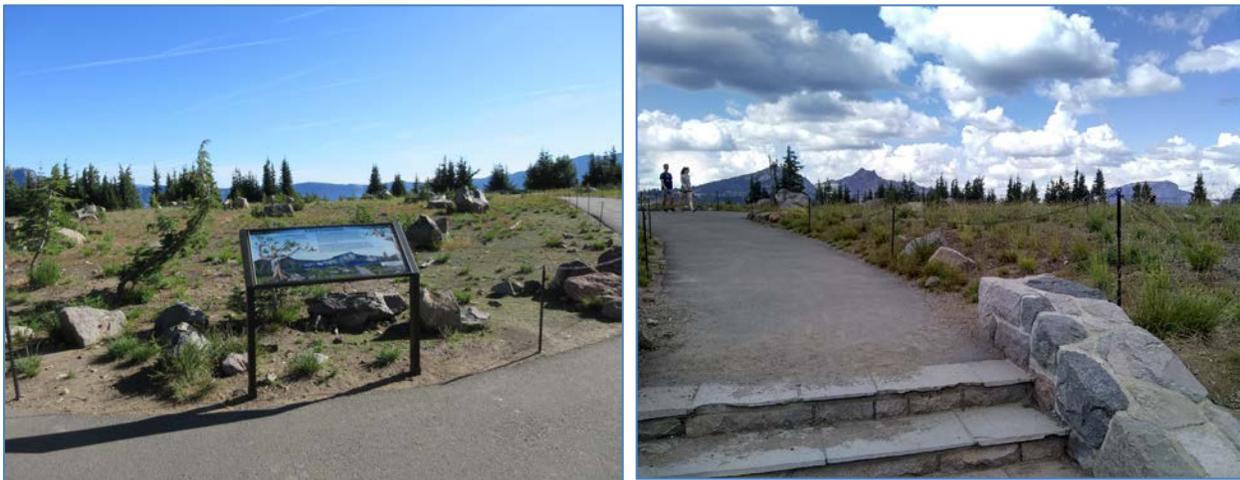
Figure 13. Interpretive sign in place (left). With fencing in place, the vegetation in the landscaping islands flourished (right). Photos by Scott Heisler.

During the 2019 season, the new fencing design proved to be an effective, reliable barrier in protecting the vegetation and whitebark pine plantings (Figure 13). The new fence design was assembled stepwise over the course of four weeks (June 17—July 11, 2019) as the snowpack receded. Assembly proceeded smoothly, encountering only minor issues involving excessively tight fitment with several post/post receiver combinations and damage to four post receivers due to snow removal operations alongside the Rim Village Café and Gifts building (Figure 14). The fitment issue was addressed by grinding the edges of all the posts needed for the full span of fencing. Critically damaged post receivers were replaced. Several additional posts and post receivers were destroyed over the course of the summer due to being struck by vehicle traffic on the walkways (Figure 14). The affected posts/post receivers were replaced.

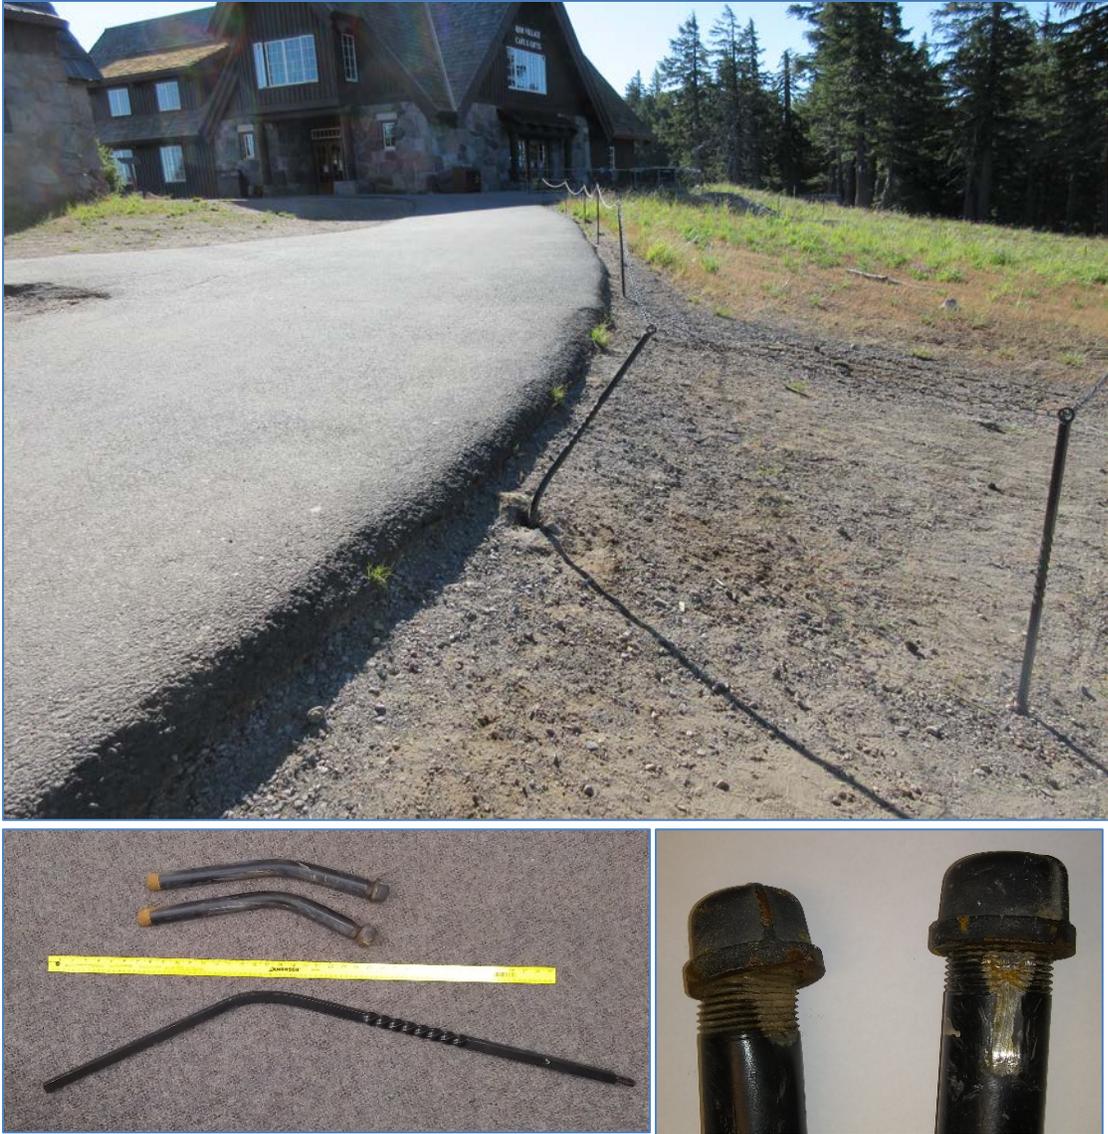
Figure 14. Damage to fence post by vehicle (top). Damage to post receivers (bottom). Photos by Scott Heisler.

Considering the damage to the fencing infrastructure sustained during 2019, it is recommended to maintain a dialog with the concessionaire via the CRLA Concessions Management Specialist. Snow removal personnel working in this area should be informed of the post receivers, established

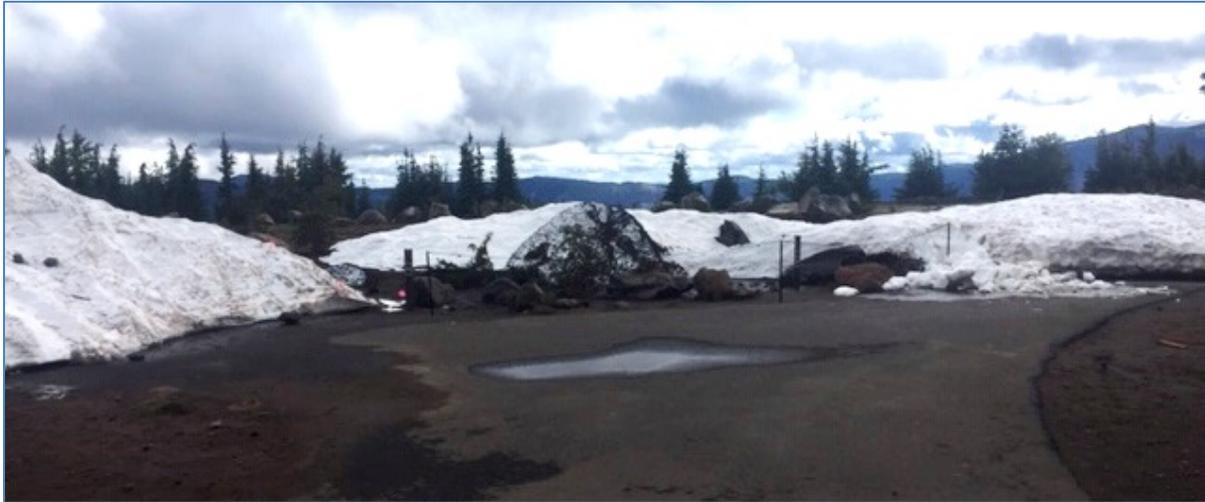
vegetation, and newly placed interpretive wayside post receivers. Additionally, it is recommended that snow should not be piled at the interpretive wayside location. The mound of snow created at this location is slow to melt and creates an obstacle that directs foot-traffic across the landscaping islands well into the summer season (Figure 16).

Figure 16. Snow piled at the wayside sign location that blocks foot paths. Photo by Carrie Wyler.
