**National Park Service
Cultural Landscape Inventory
2000**

**Superintendent's Residence
Crater Lake National Park**

CONDITION ASSESSMENT: **Fair**

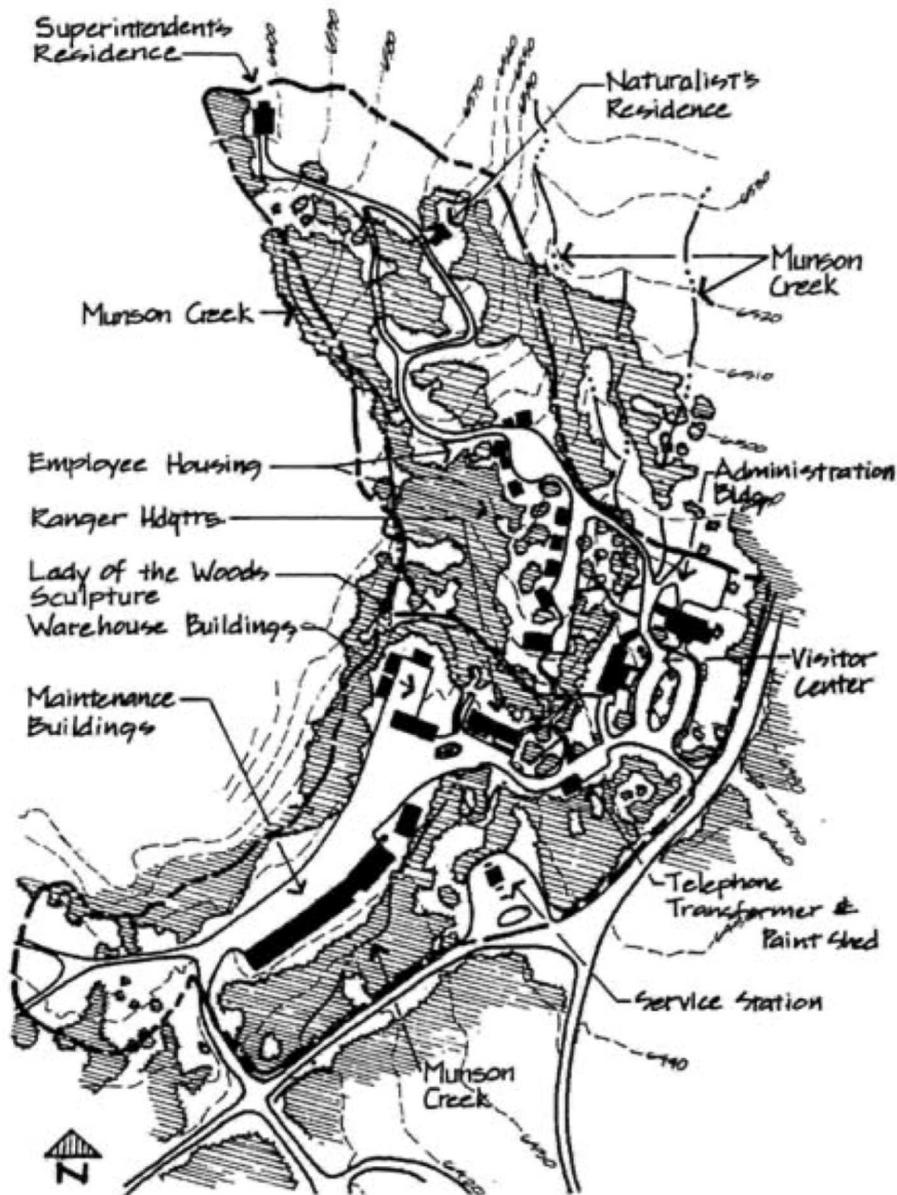
Site plan showing the existing conditions of the component landscape of the Superintendent's Residence. (CCSO, 2000.)

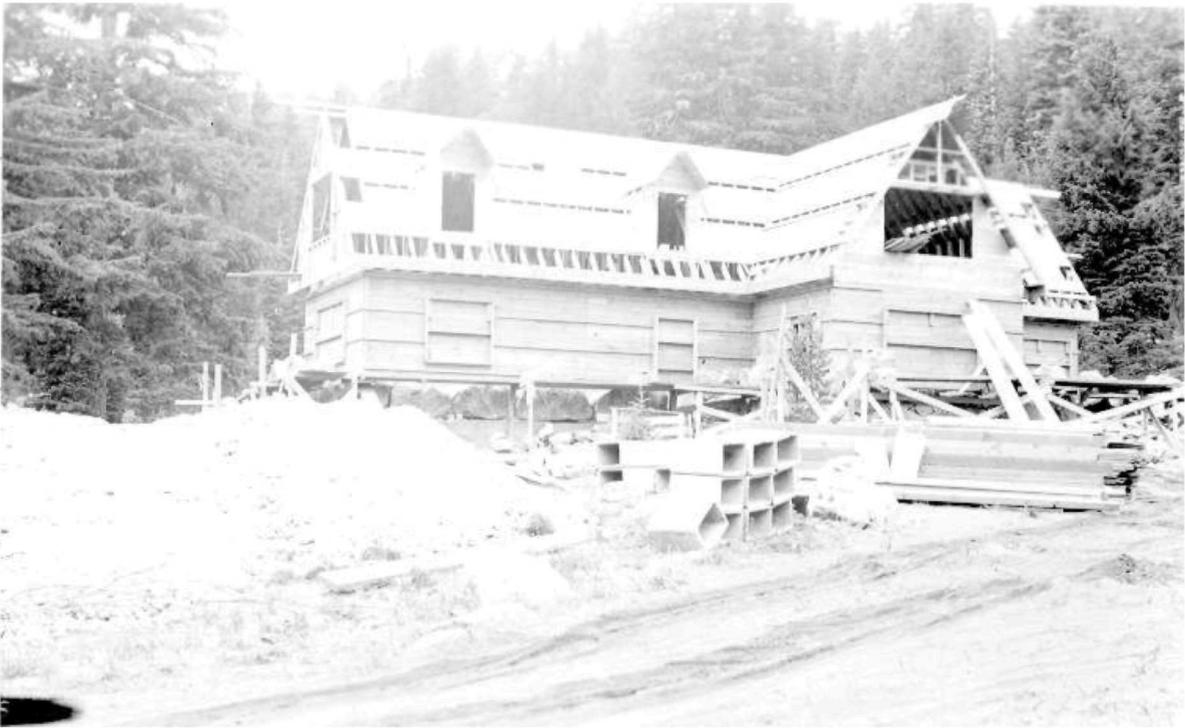
Historic photograph of the construction of the Superintendent's Residence at Munson Valley in 1932. Note the stonework being completed at the foundation of the building, and the crated coniferous tree at the front of the building. (CRLA/4363, 1932.)

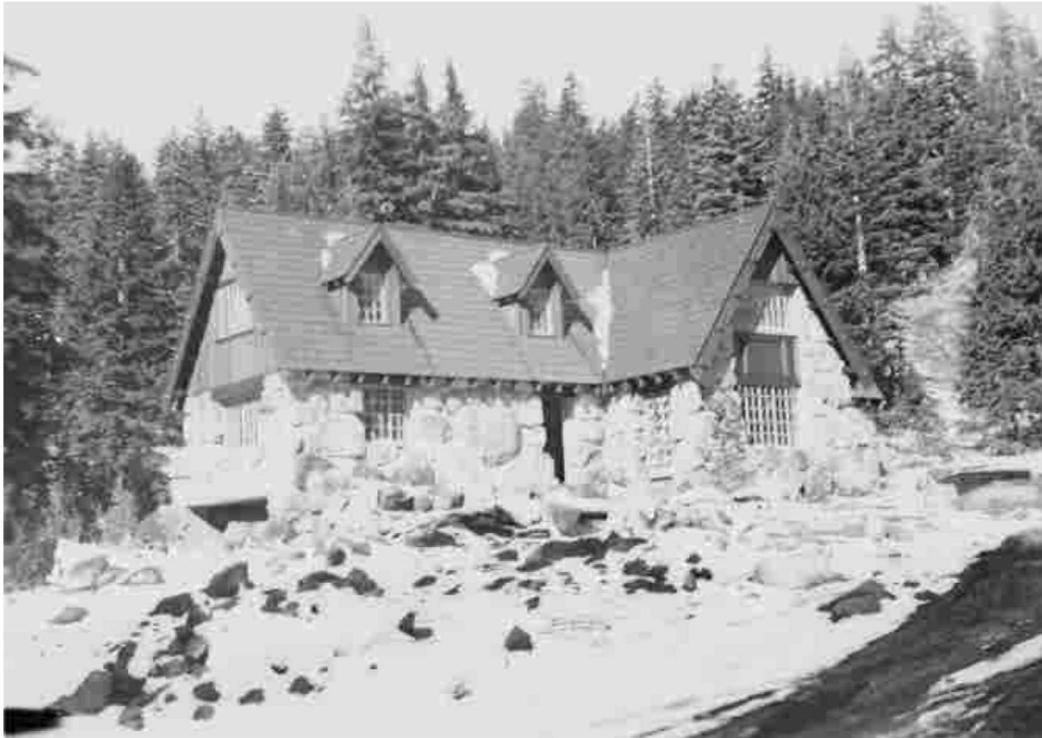
Historic photograph of completed Superintendent's Residence, 1932. (CRLA/75H, 1932.)

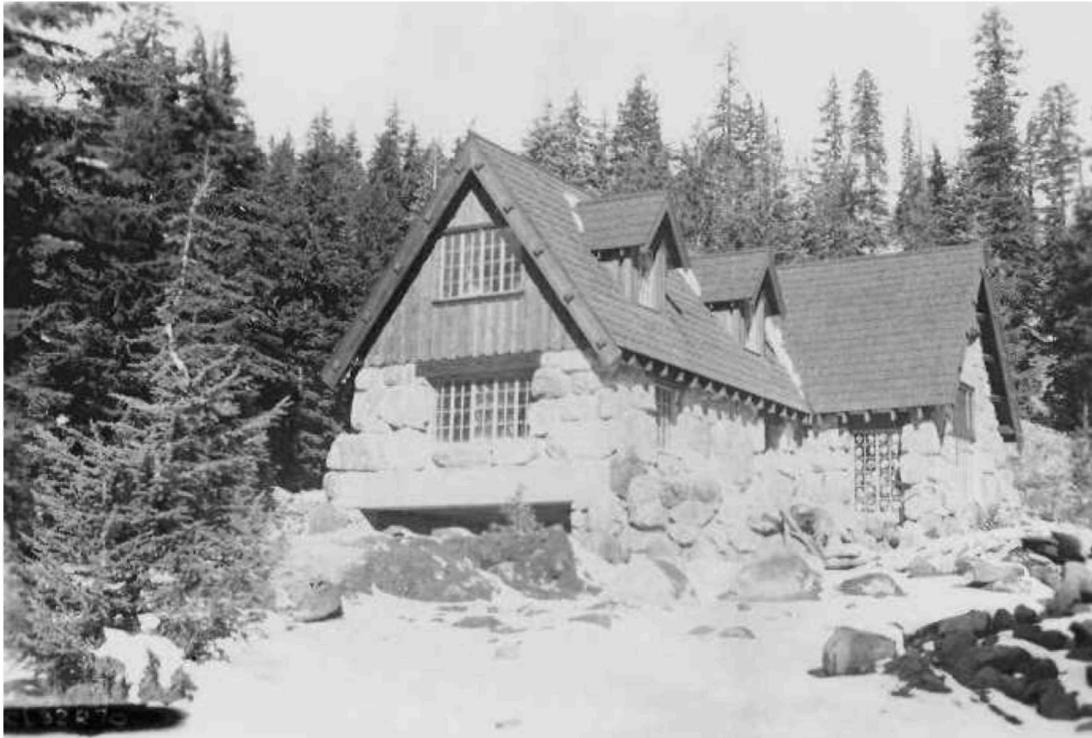
Historic photograph of the Superintendent's Residence, 1932. Note the coniferous trees planted along the sunken driveway. (CRLA/70H-4042, 1932.)

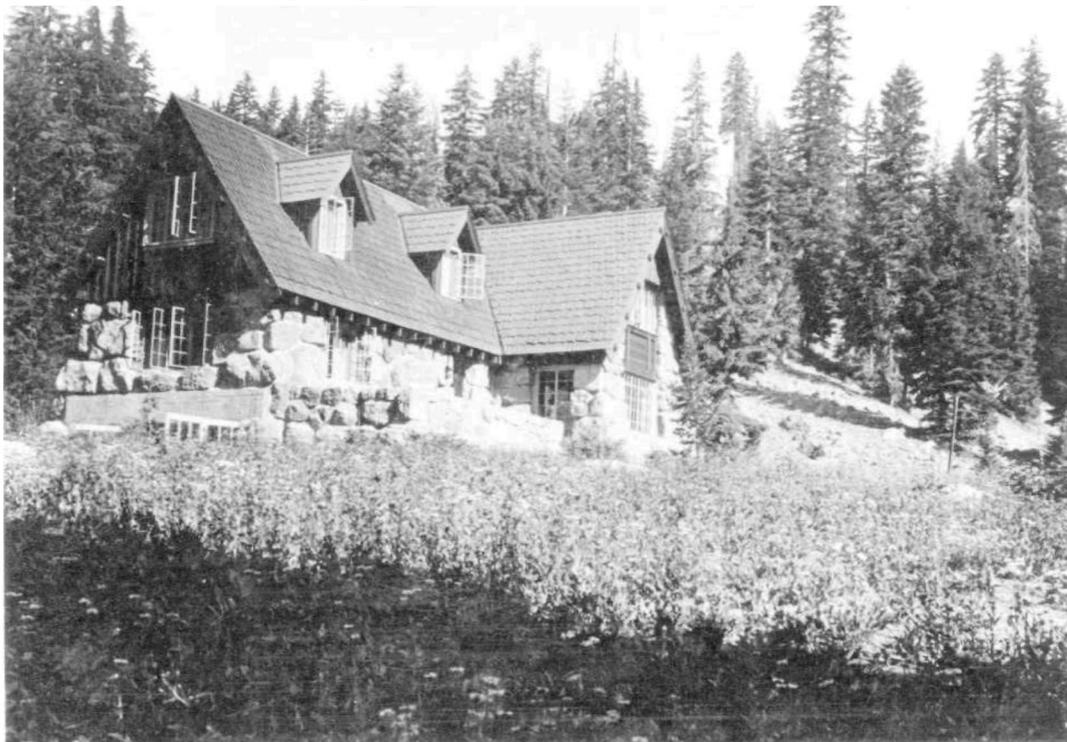
Historic photograph ca. 1935 of the Superintendent's Residence. Note the vegetation in the meadow, which grew as a result of Francis Lange's germination experiment. (CRLA/2639, ca. 1935.)

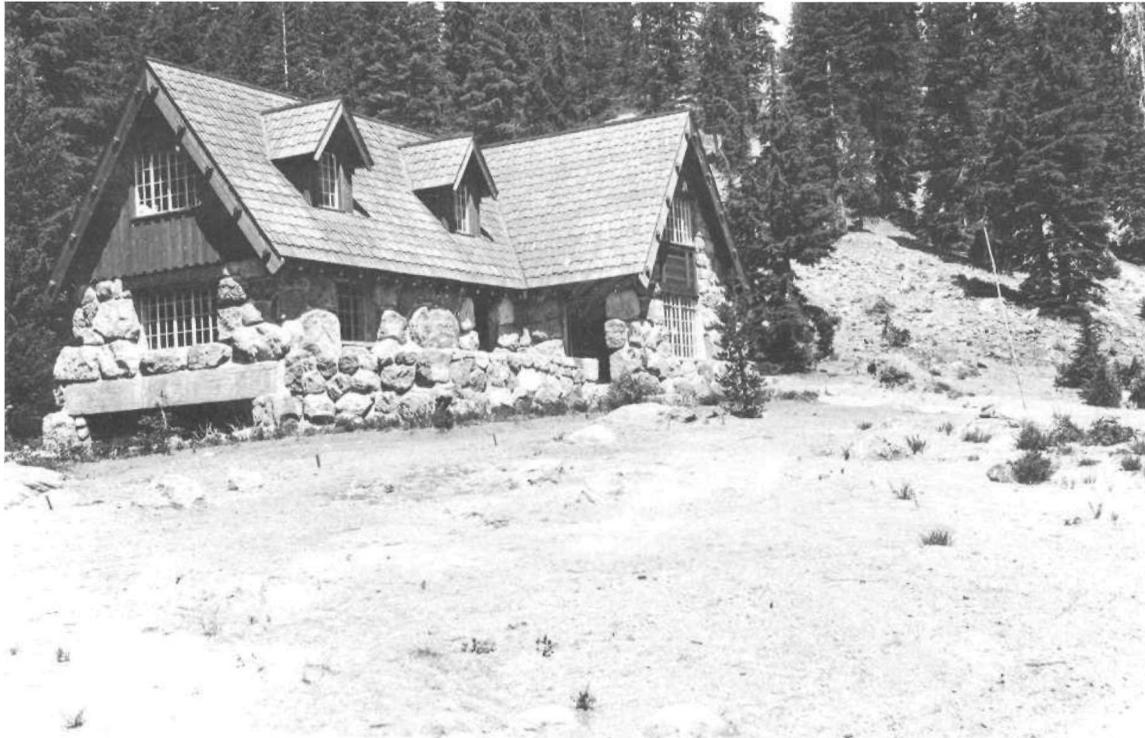
Historic photograph from 1934 of the Superintendent's Residence, prior to laying the flagstone walkway. Note the stakes near the building that outline the walkway. (CRLA/2637, 1934.)

By 1934 the superintendent's residence was being prepared for sodding. More than 150 loads of peat and top soil were placed about the residence, making it necessary to construct a walk around the building in order to complete the work (Report by Francis G. Lange, July 1, 1934). In September of 1934, because the site had a good ground cover of peat and top soil, park landscape architect Francis Lange recommended that no sodding be completed, as he wanted to observe whether dormant seeds within the top soil would propagate the following season (Report by Francis G. Lange, September, 1934).

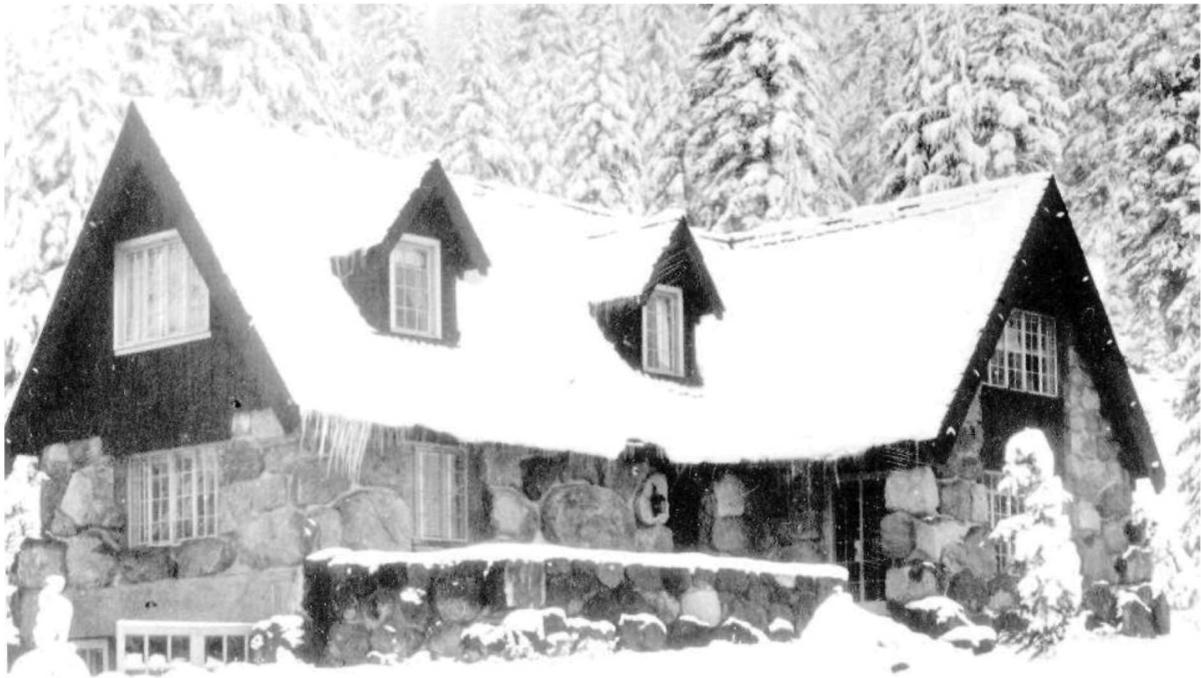
Historic photograph from the late-1940s of the Superintendent's Residence during the winter. Note the multi-light garage door at the lower left hand corner of the photograph. (CRLA/2538, late 1940s.)

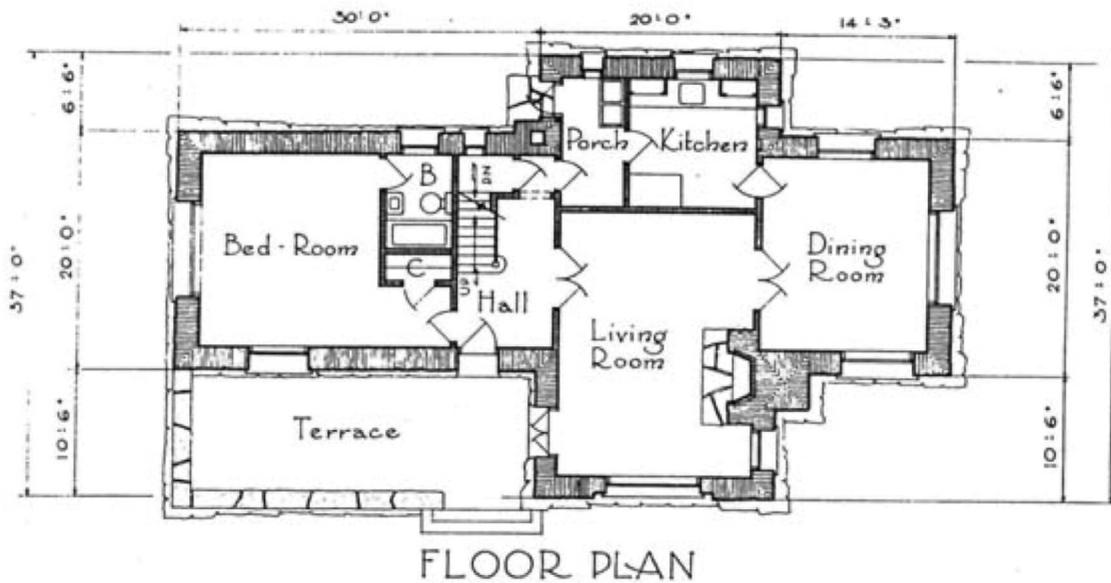
Historic drawing of the floorplan for the first story of the Superintendent's Residence. ("Park & Recreation Structures," Albert H. Good, 1938, 1990.)

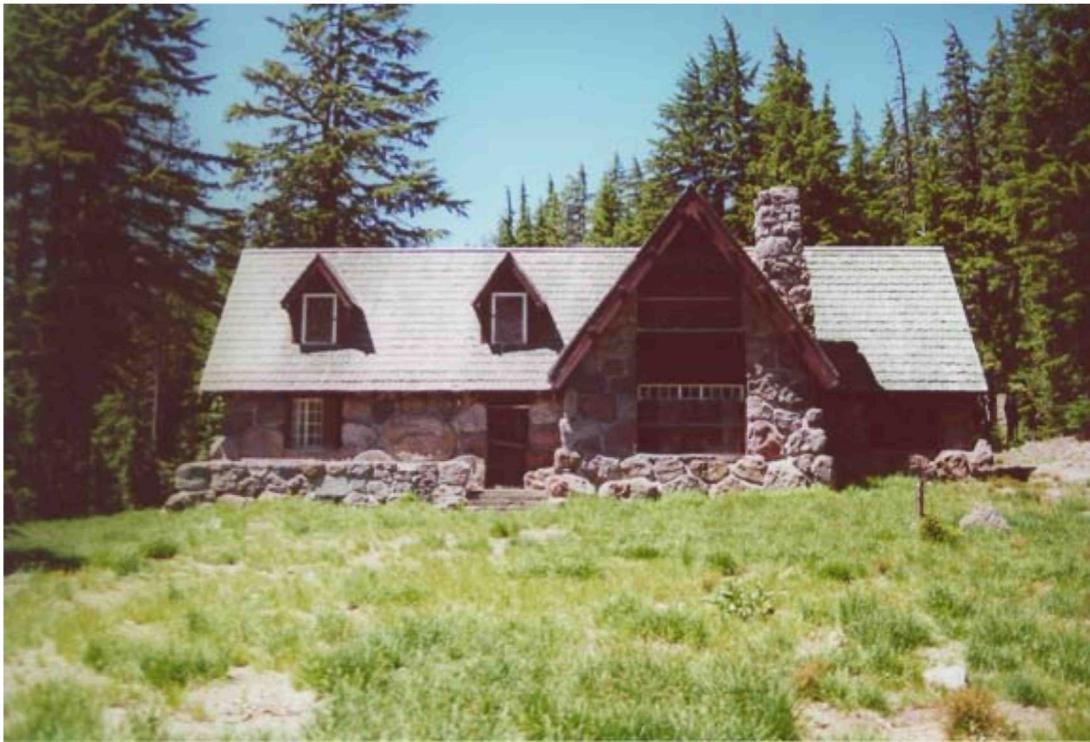
Contemporary photograph of the Superintendent's Residence. (CCSO, 2000.)

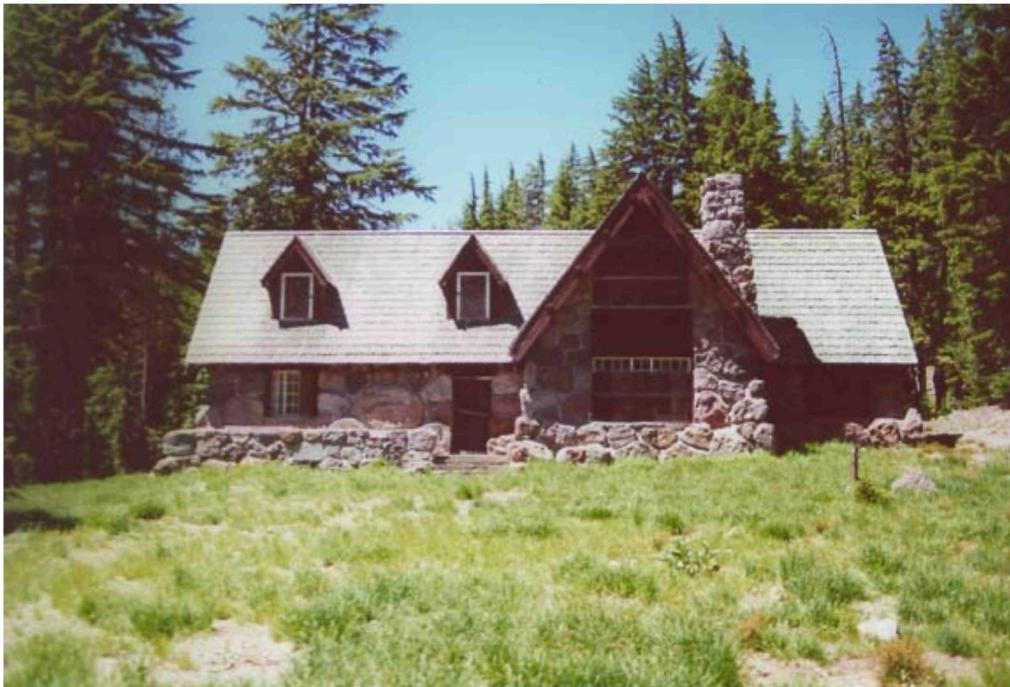
Buildings and structures are a landscape characteristic of the Superintendent's Residence site. The Superintendent's Residence is a one and one-half story stone and wood building built in the Rustic Style, with a garage and partial basement underneath. The ground floor is constructed of massive stone masonry with the second floor set within a steeply pitched roof. The plan is cruciform, with the long axis running north and south. The garage entry is on the basement's south side. A large flagstone terrace of native park stone is located on the southeast corner of the house. The shake roof is 16/12 pitch with gable ends at the four ends of the cruciform, and dormers on the east and west sides of the roof. A massive stone chimney rises to the ridge line on the north side of the living room. The upper gable ends are board and batten siding over wood frame construction. Windows are steel sash, and the main entry doors are heavy plank construction with special design hardware.

Contemporary photograph of the front façade (east elevation) of the Superintendent's Residence. Note the stone terrace at the left of the building face. (CCSO, 2000.)

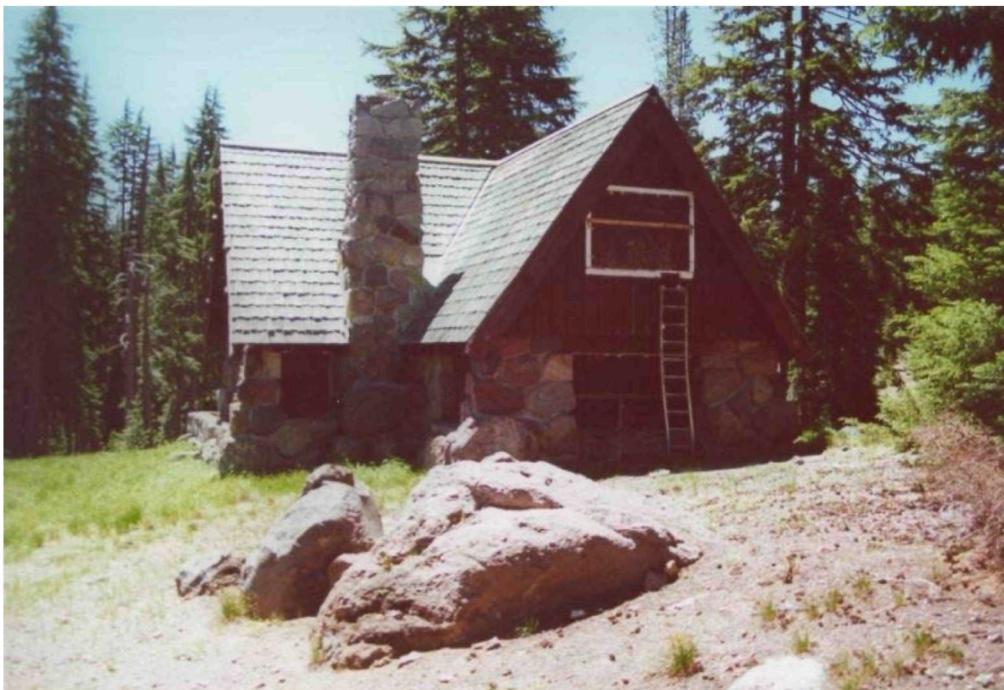
Contemporary photograph of the side façade (north elevation) of the Superintendent's Residence. Notice the large boulders in the foreground, that serve to blend the landscaped "yard" with the surrounding rugged terrain. (CCSO, 2000.)

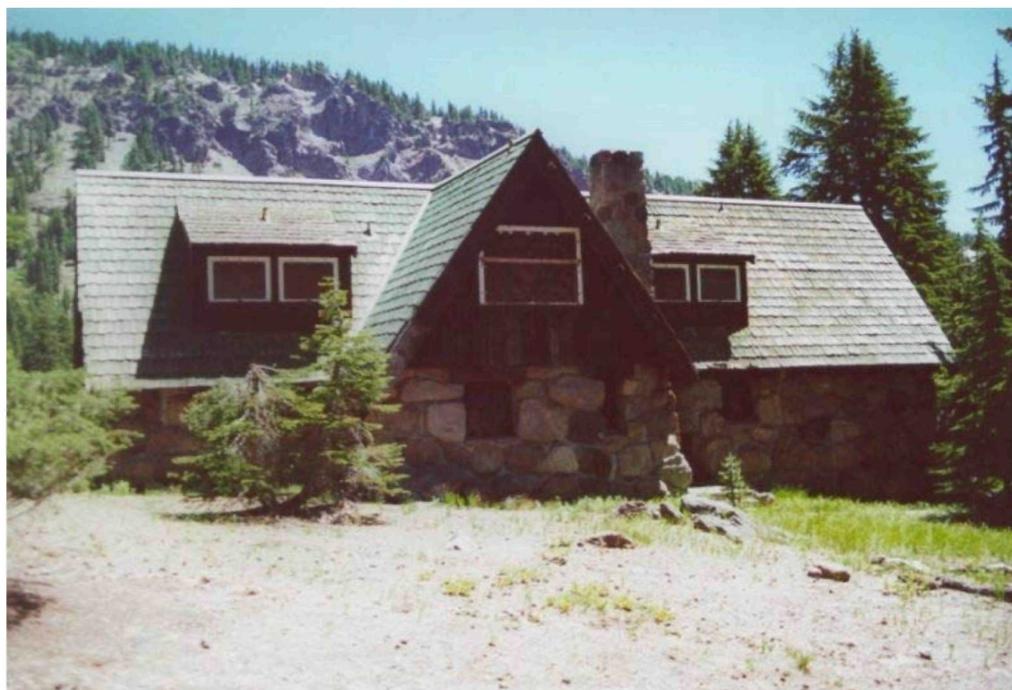
Contemporary photograph of the rear façade (west elevation) of the Superintendent's Residence. (CCSO, 2000.)

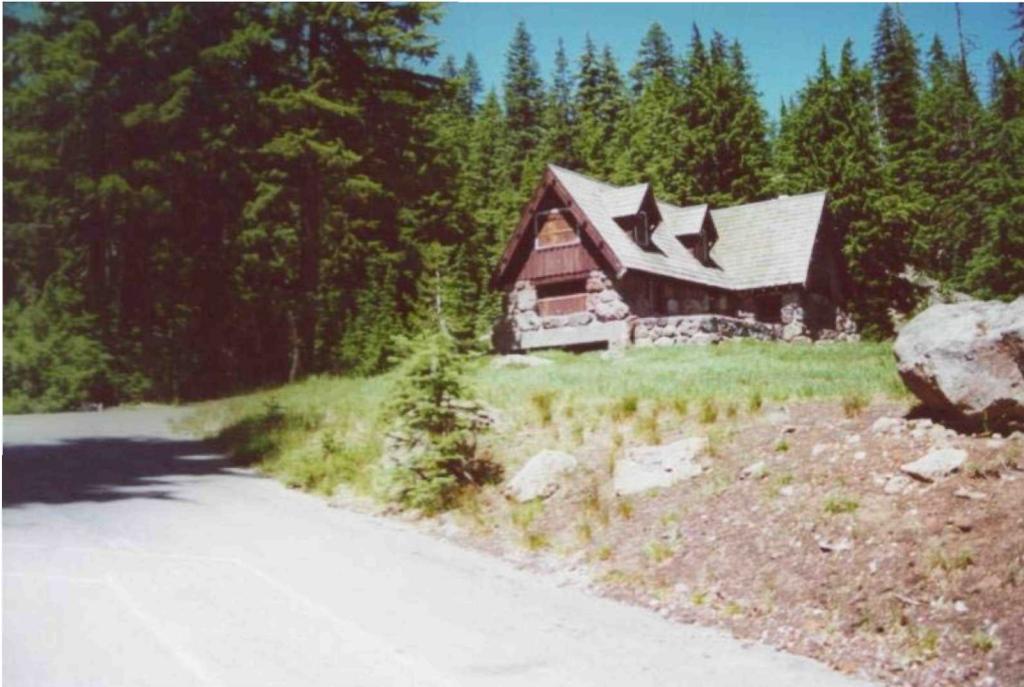
Within the component landscape of the Superintendent's Residence, the circulation is primarily pedestrian, and consists of two flagstone walkways that provide "formal" access and guide foot traffic from the parking area to the front and back entrances. The two walkways are in fair to poor condition. A paved driveway provides access to the sub-grade garage that is integral to the residence.

Contemporary photograph of the Superintendent's Residence, taken from the road that leads from the administrative complex. (CCSO, 2000.)

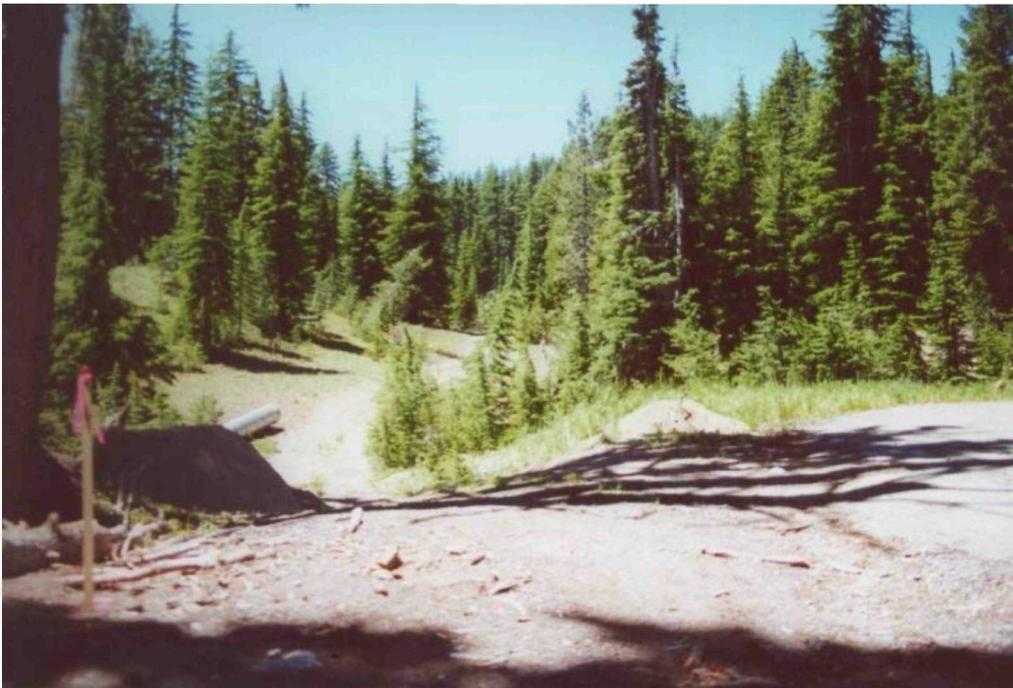
Contemporary photograph showing the terminus of the road to the Superintendent's Residence. Note the unpaved parking area at the lower center of the photograph, and the unpaved service road that leads up the hill behind the residence. (CCSO, 2000.)

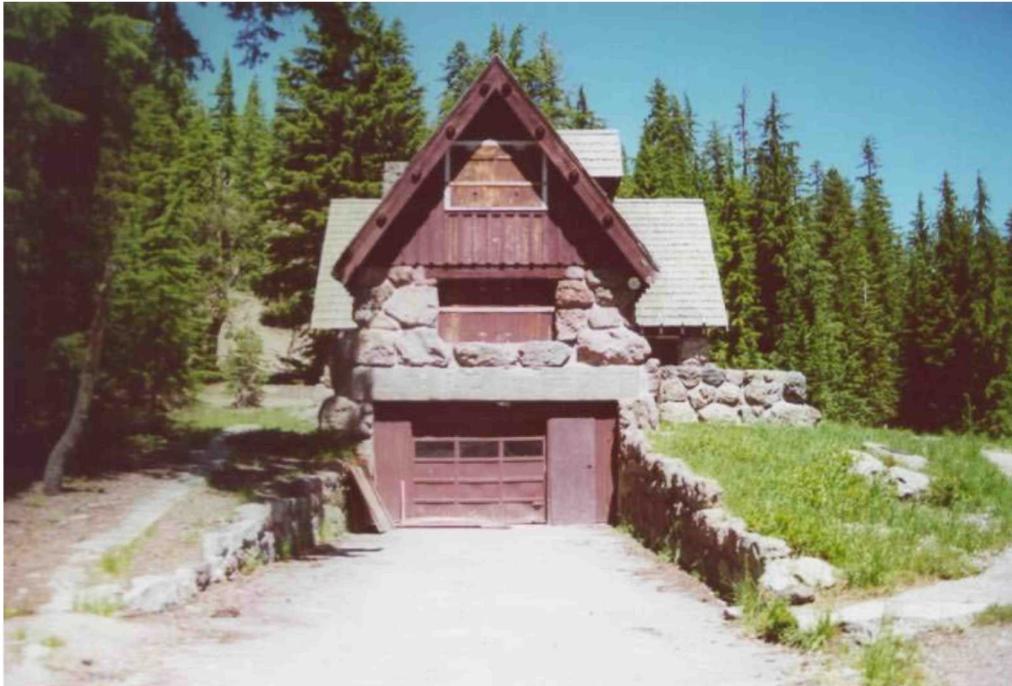
Contemporary photograph showing the pedestrian circulation within the Superintendent's Residence component landscape. Note the two flagstone walkways that lead off of the sunken driveway. (CCSO, 2000.)

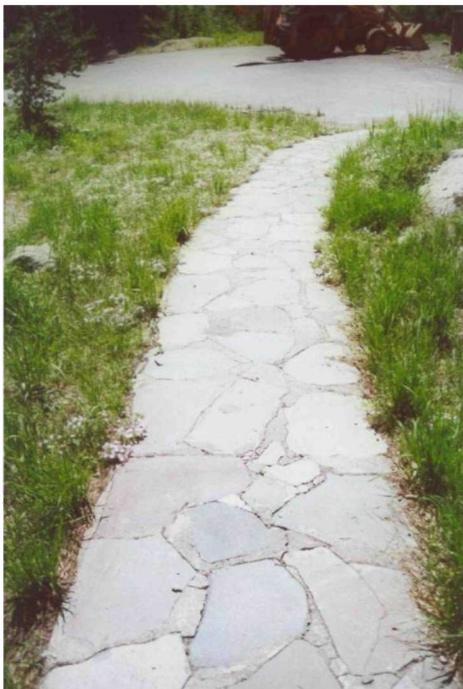
Contemporary photograph of the flagstone walkway that leads from the front porch of the Superintendent's Residence to the driveway. (CCSO, 2000.)

The flagstone walkways on the site are in need of tuckpointing, as some mortar bonds are failing. The same applies, although to a lesser extent, to the mortared stone retaining walls that line the driveway. These need remedial treatment of repair and tuckpointing.

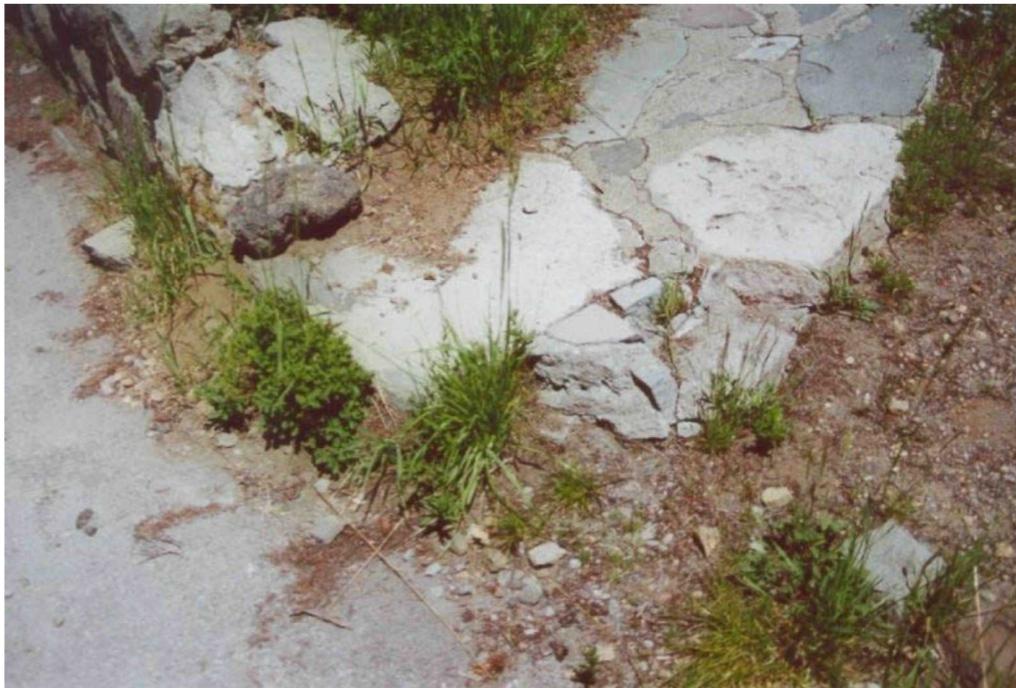
Contemporary photograph showing the condition of the flagstone walkway at the front of the residence. Impacts from severe weather conditions have eroded the mortar bonds, causing joints to fail. (CCSO, 2000.)

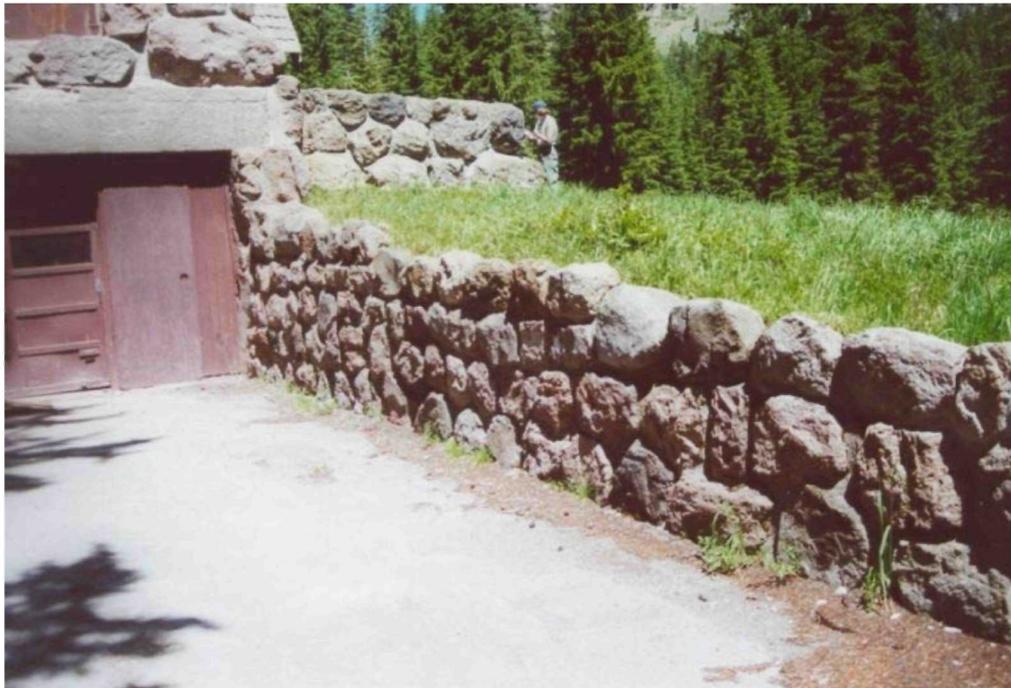
Small-scale features is a landscape characteristic of the cultural landscape of the Superintendent's Residence. Small scale-features include two rock and mortar retaining walls that line both sides of the garage driveway, which are in fair condition, and several boulders located within the residence yard. Non-contributing small-scale features include a picnic table, four benches, and a stone fireplace. These are all in poor condition and have not been included within the boundaries of the component landscape. Additionally, a fuel line to the residence's furnace is exposed along the driveway.

Contemporary photograph of one of the two rock and mortar walls that line the driveway to the garage of the Superintendent's Residence. (CCSO, 2000.)

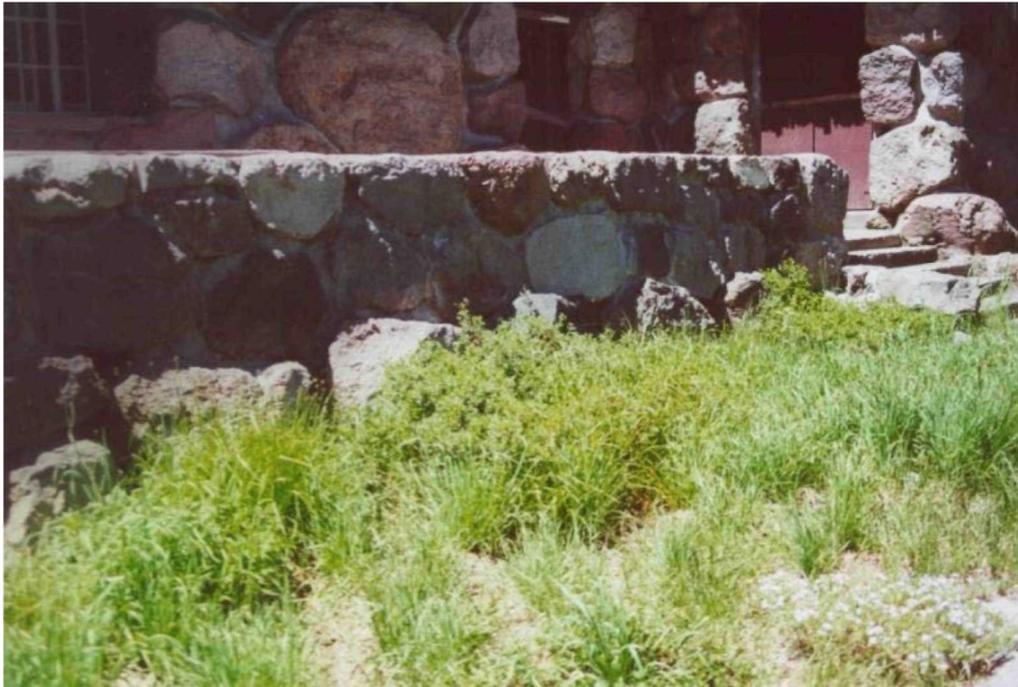
Contemporary photograph showing the foundation plantings near the front porch of the Superintendent's Residence. These Spiraea plants were transplanted in the early 1930s by CCC crews. (CCSO, 2000.)

The condition of the vegetation at the Superintendents Residence is fair. Regenerative pruning and supplementing the soil would improve the condition and longevity of historic foundation plantings. Weeding around specimen plants would increase plant vitality.

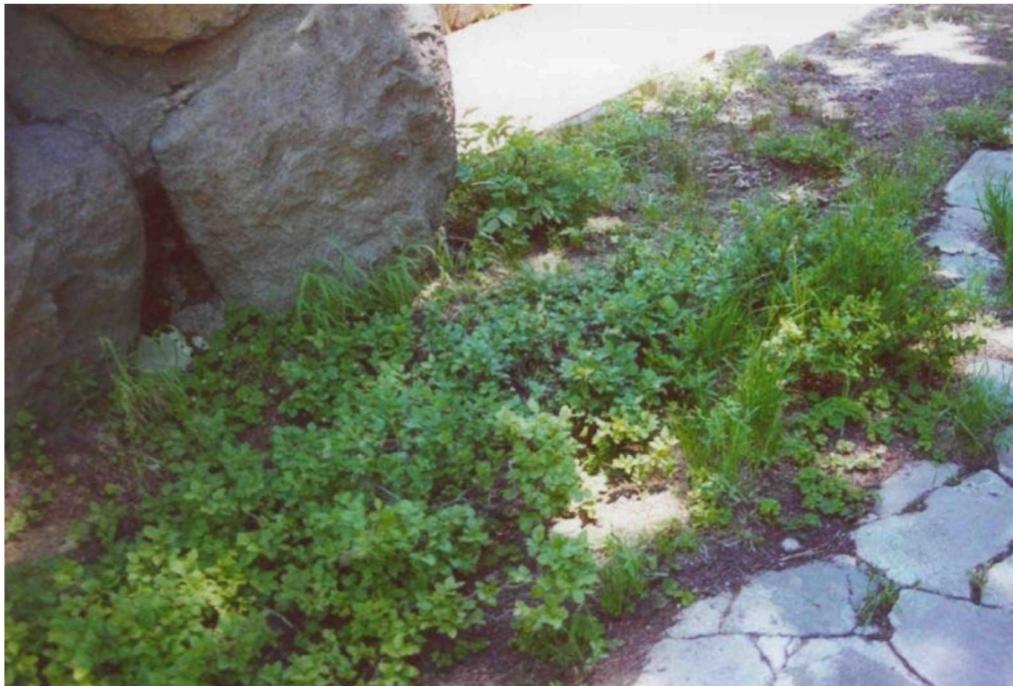
Contemporary photograph of historic Huckleberry foundation plantings near the driveway of the Superintendent's Residence. (CCSO, 2000.)

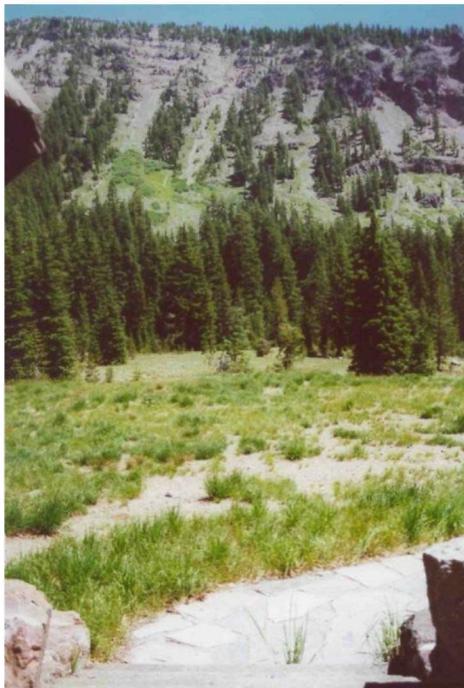
One important view remains as a landscape characteristic of the Superintendent's Residence: the view toward the slopes of Garfield Peak. However, the siting of a large microwave repeater upon Garfield Ridge has had a negative impact on this historic view. Another important view is the one near the road terminus to the northwest, toward the Superintendent's Residence. This view of the main and side facades of the building remains much as it did when the building was constructed.

Contemporary photograph of the view from the Superintendent's Residence front terrace toward Garfield Peak. (CCSO, 2000.)
