National Register of Historic Places
Inventory—Nomination Form

THE DUCK HOUSE
Description

(C.I.M.S. 1111)

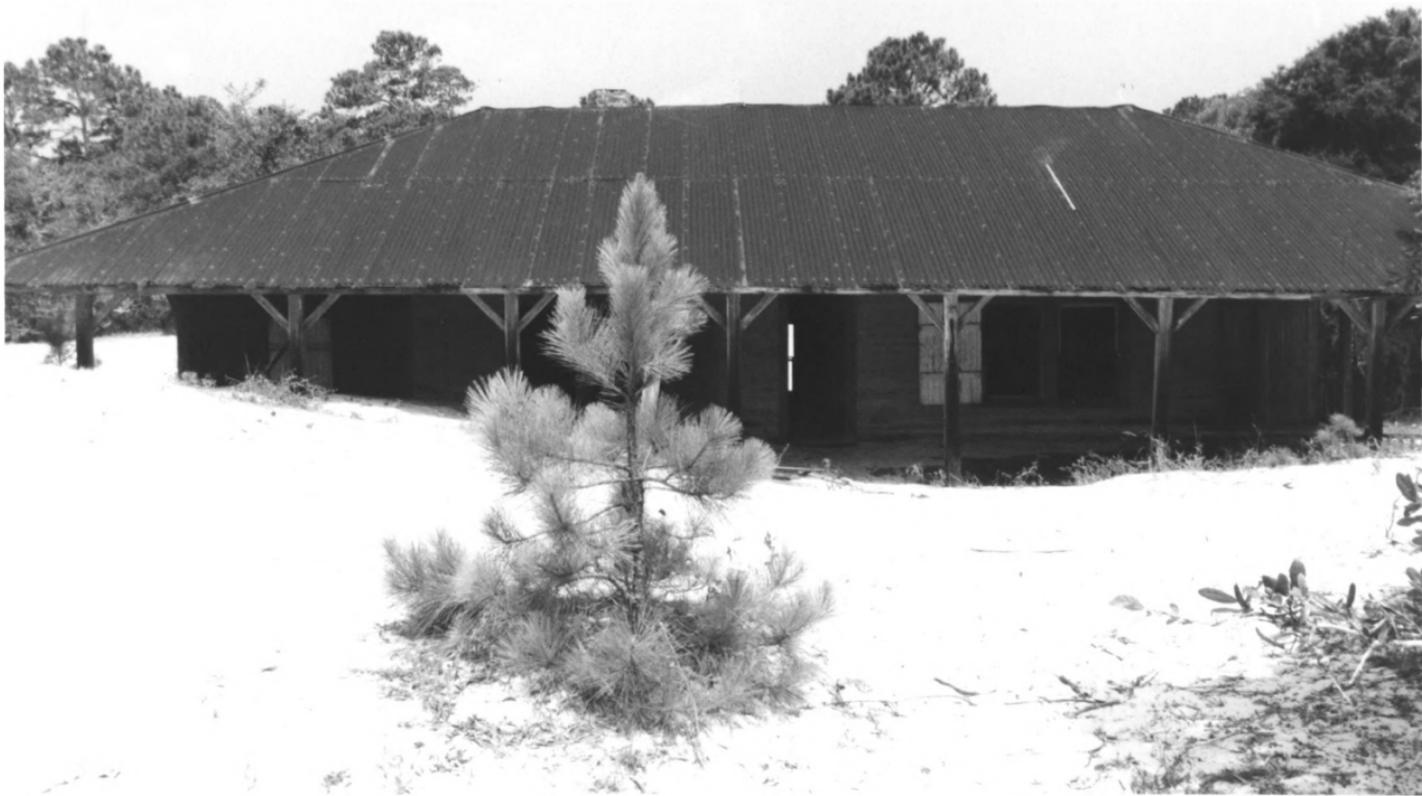
Duck House, east elevation, front
Cumberland Island Nat'l Seashore MRA
Cumberland Island, Georgia
Don Hooker, August 1983
Negative at NPS Regional Office, Atlanta

The building is "L" in plan with a wrap-around front porch. One of the side porches has been enclosed and the other is partially infilled. There is a small rear addition in the ell. Constructed on a pier foundation with diagonal braces, the building is in the path of encroaching sand dunes, and sand has covered part of the front porch floor.

A corrugated metal hipped roof forms a wide porch overhang which is supported by posts with diagonal bracket supports. Most of the porch railing is missing, as are the windows and doors. The exterior finish is horizontal clapboard sheathing on the main part of the building and rear addition, and vertical tongue and groove siding on the porch enclosures. Openings are framed with simple 1 x 4" surrounds. The inscription "Radio-Armoury" has been carved into the door surround of the small porch enclosure.

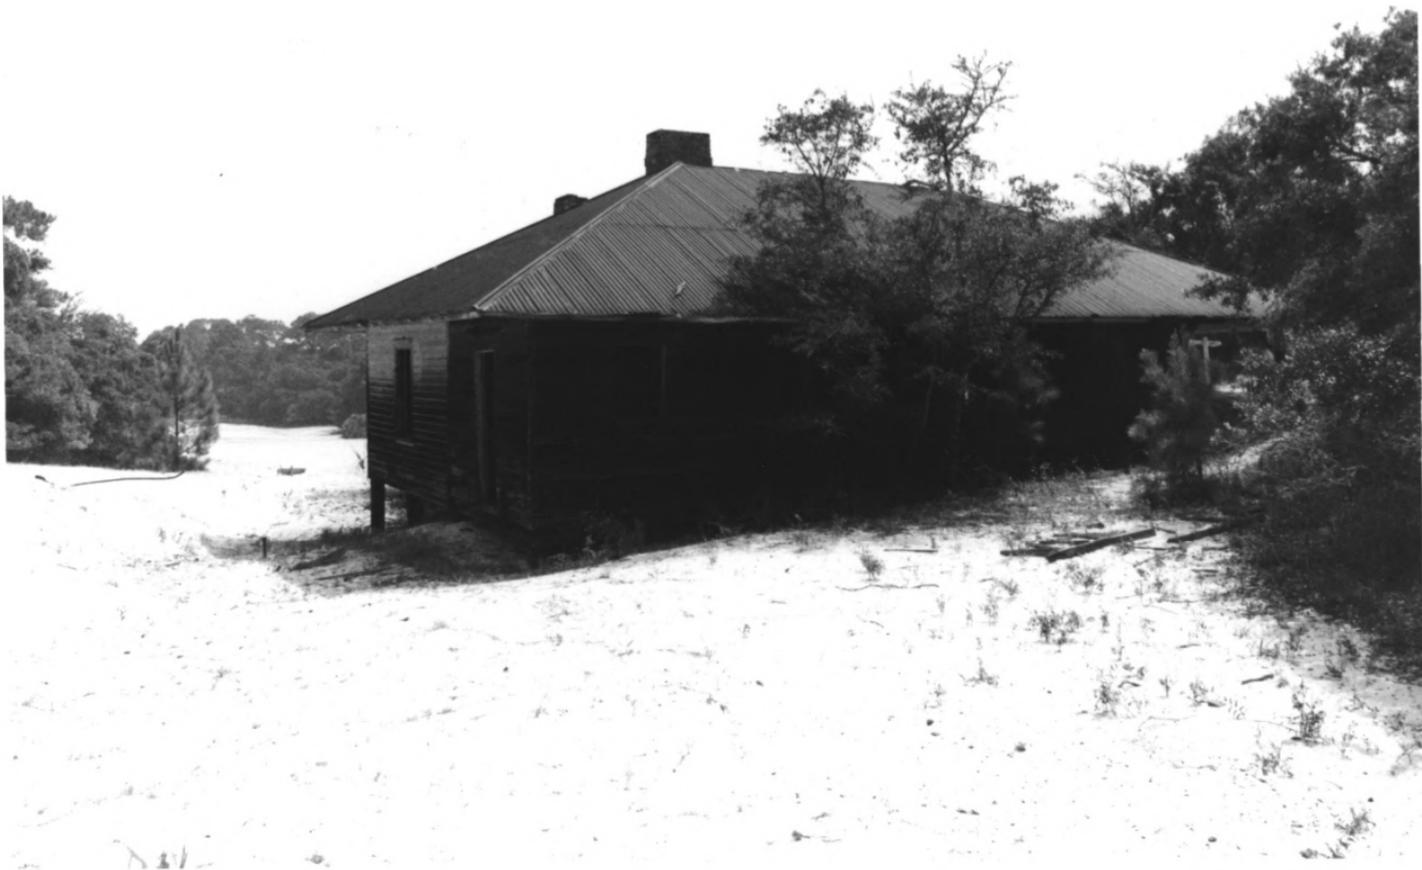
Duck House, south elevation, side
Cumberland Island Nat'l Seashore MRA
Cumberland Island, Georgia
Don Hooker, August 1983
Negative at NPS Regional Office, Atlanta

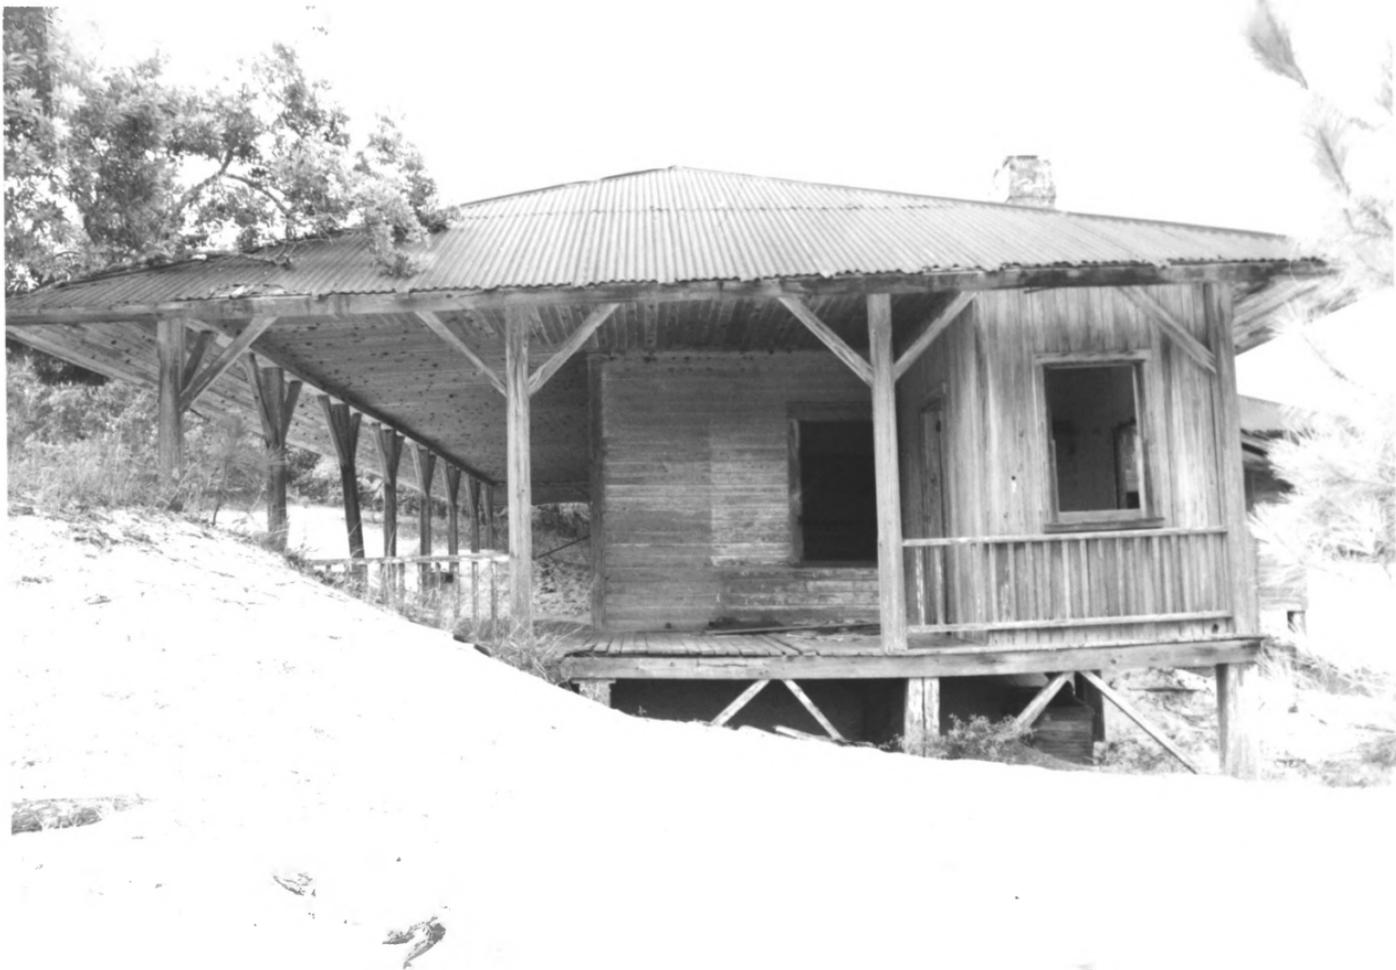
Duck House, north elevation, side
Cumberland Island Nat'l Seashore MRA
Cumberland Island, Georgia
Don Hooker, August 1983
Negative at NPS Regional Office, Atlanta

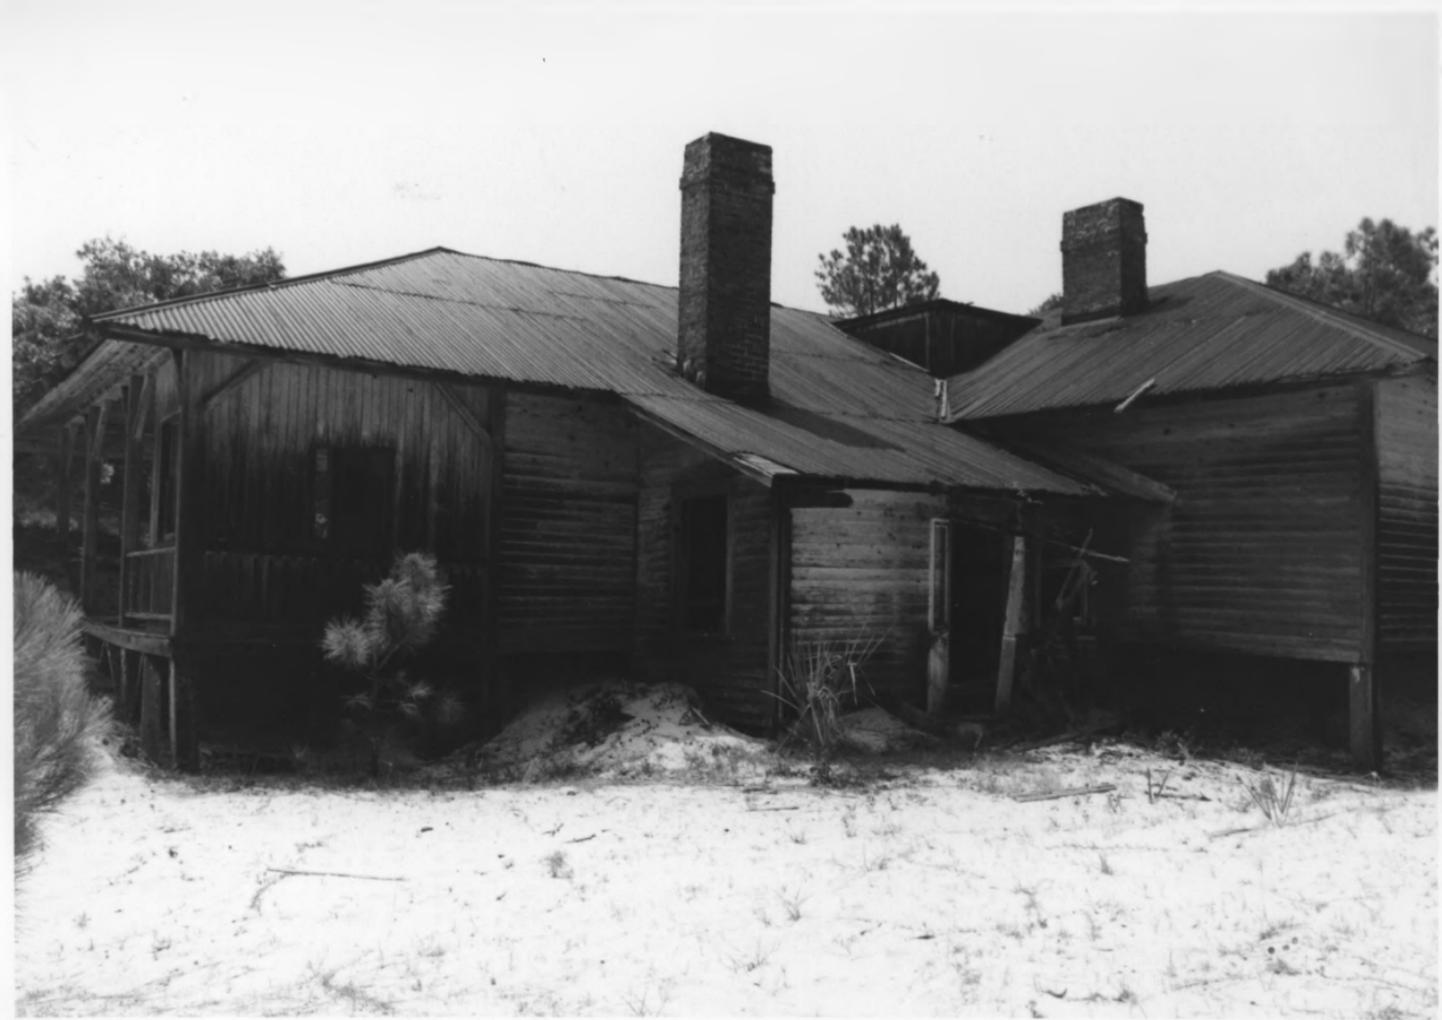
Duck House, west elevation, rear
Cumberland Island Nat'l Seashore MRA
Cumberland Island, Georgia
Don Hooker, August 1983
Negative at NPS Regional Office, Atlanta

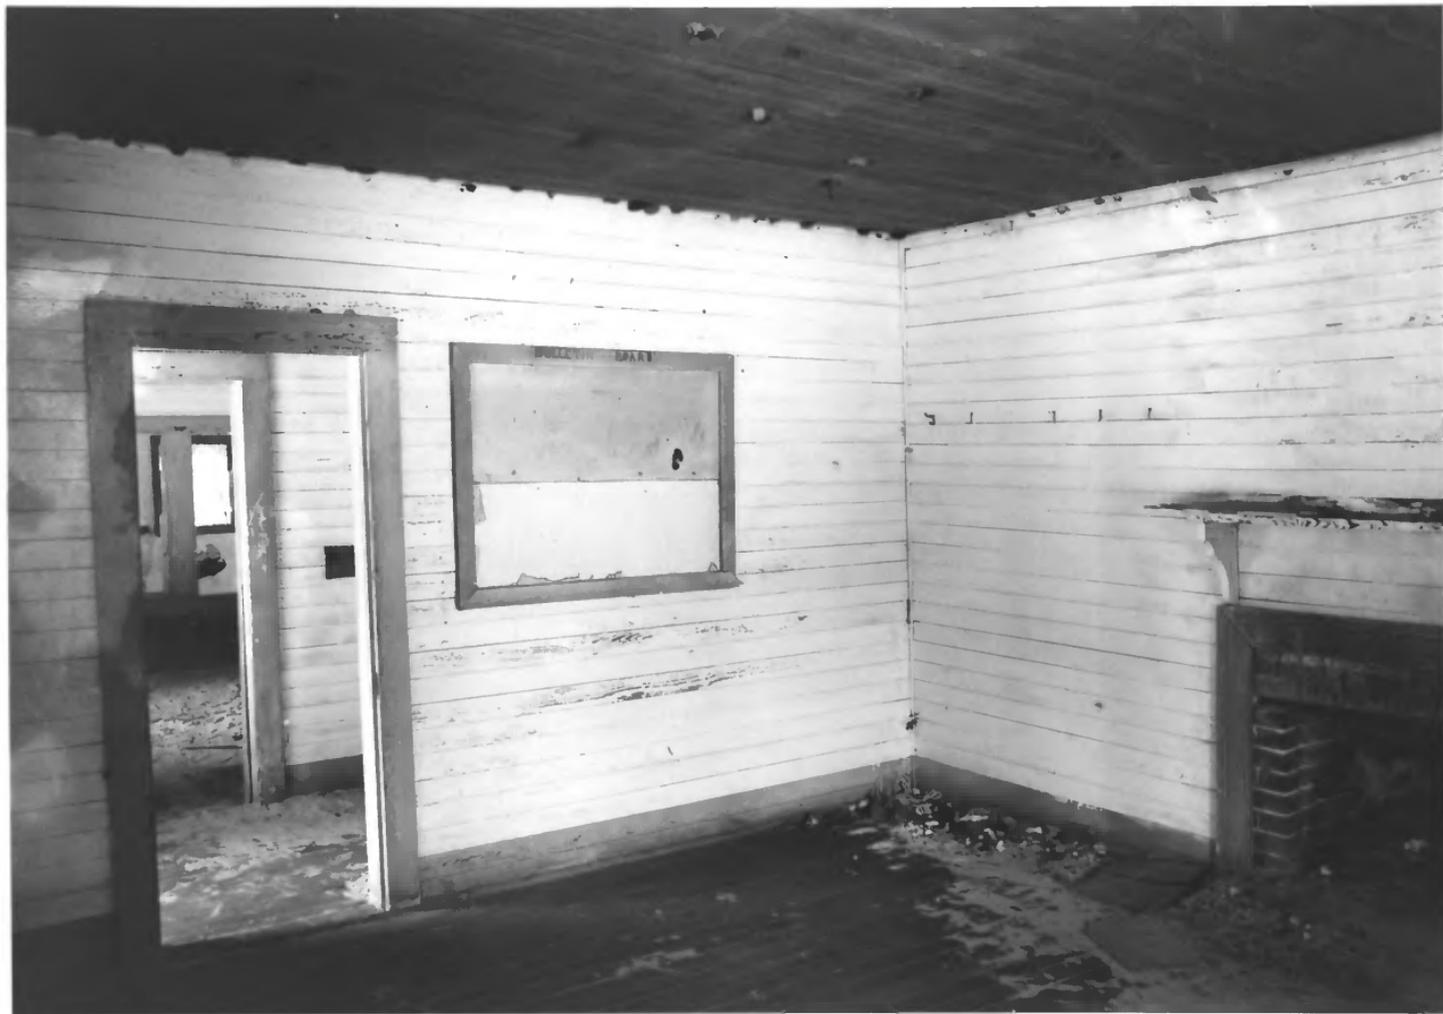
Duck House, north front room looking S.

The interior finish is of horizontal tongue and groove siding on walls and ceilings; floors are similar. Moldings are plain 1 x 4" surrounds. There are two fireplaces with simple molded firebox surrounds topped by a bracketed mantel shelf. A central hall is flanked by one room on the right and is two rooms deep on the left.

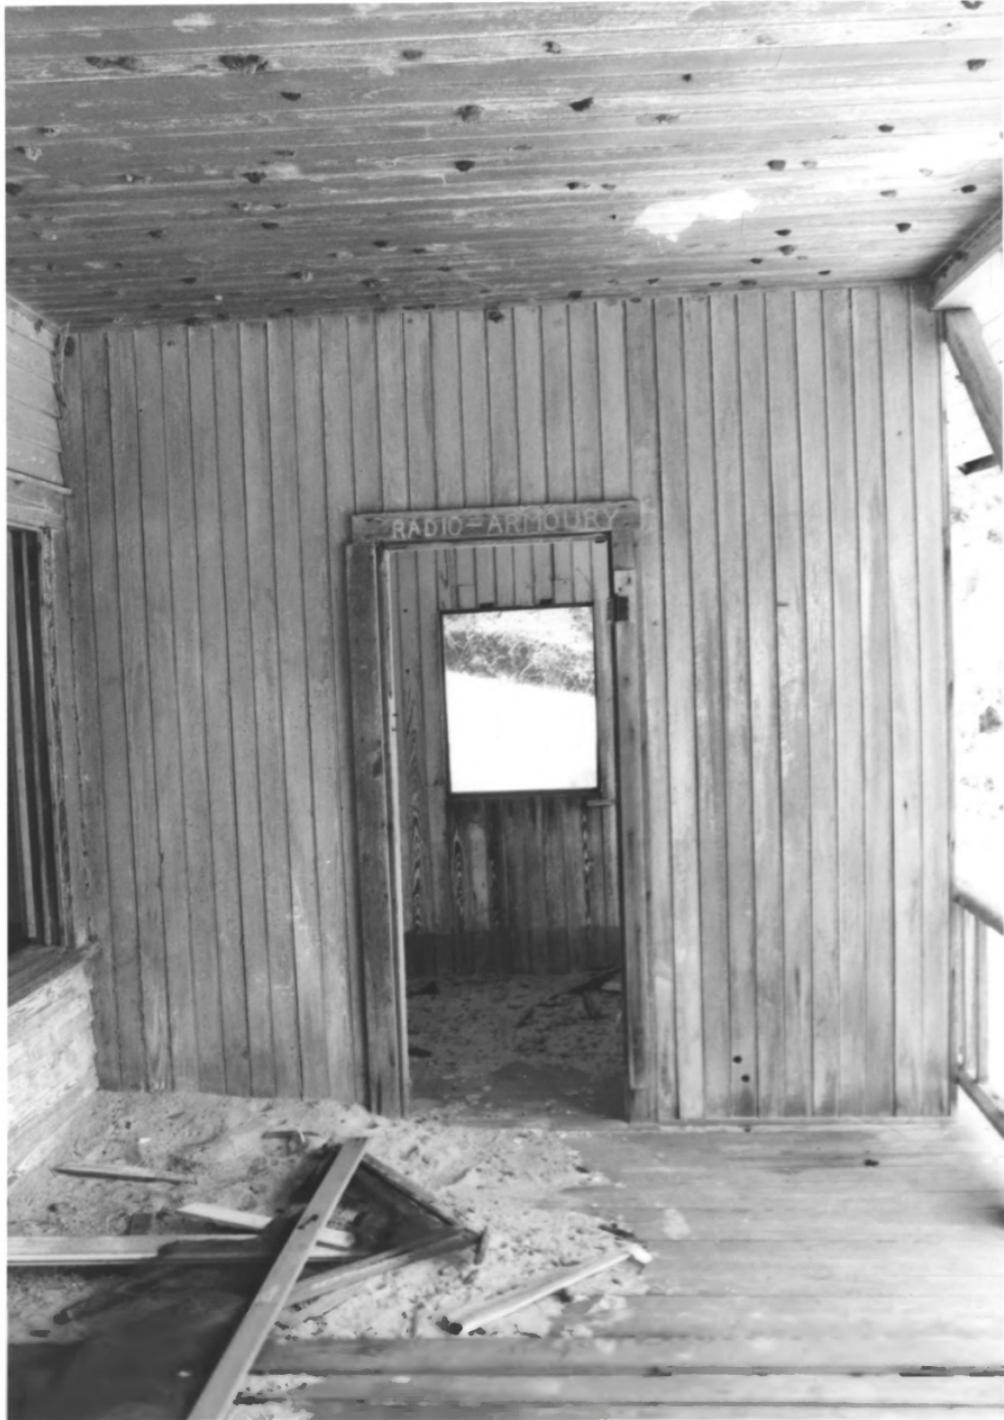
Duck House, door to N. elevation addition
Cumberland Island Nat'l Seashore MRA
Cumberland Island, Georgia
Don Hooker, August 1983
Negative at NPS Regional Office, Atlanta
