National Park Service  
Cultural Landscapes Inventory  
2012

Welton Farm (112-65)  
Cuyahoga Valley National Park

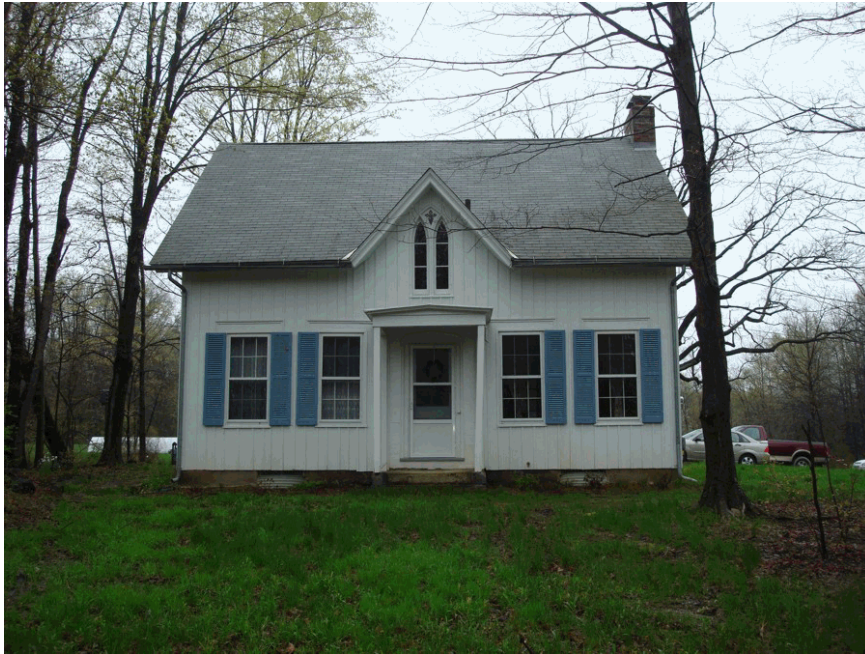
*Welton House, façade elevation (Jackson 2011)*

The Allen Welton House (HS-325) was constructed in 1854 and is a one-and-a-half story, wood frame house in the Gothic Revival Style. The core section of the house is five-bays wide by two-bays deep. The foundation is constructed of tooled, cut sandstone blocks with margins. The façade features a central entrance flanked by two pairs of windows. The steeply-pitched gable roof is parallel to the road and is intersected by a double lancet window with quatrefoil tracery. The house has wood board-and-batten siding and the windows are six-over-six, double-hung sash and have architrave trim and shutters. The front door frame has a flattened Gothic arch molding.

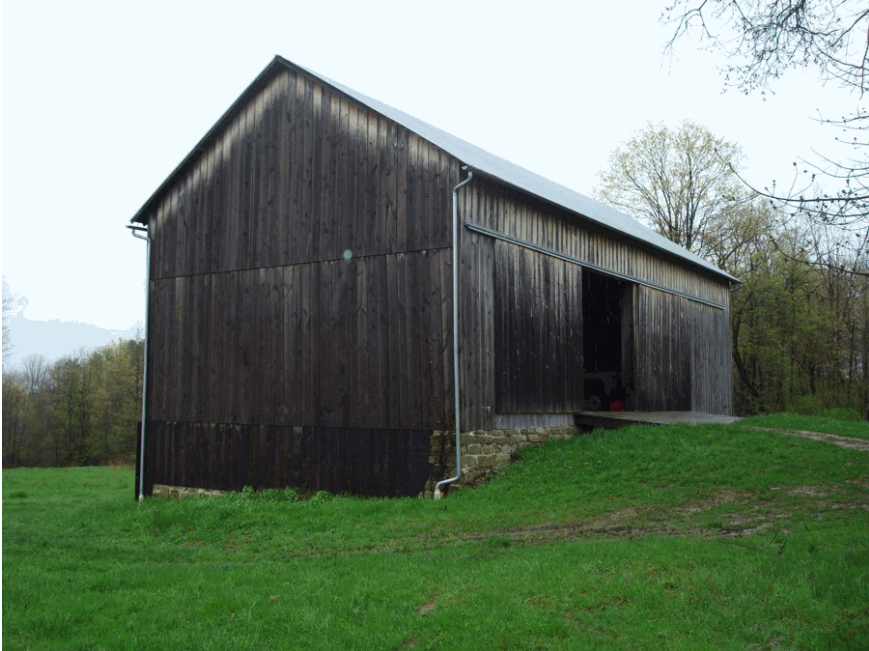
*Welton Barn, west elevation (Jackson 2011)*

The Welton Barn (HS-326) was constructed in 1852 and is a four-bay Raised Bank Barn. The barn is clad with vertical wood siding and the roof is covered with corrugated metal roofing material. The foundation is constructed of cut sandstone block and the interior framing is mortise and tenon. The Raised Bank Barn is a characteristic barn type for the Cuyahoga Valley. These barns are usually banked into a hill or have an earthen ramp located on the side to provide access to the second floor. Dairy cows were usually housed in the basement of the barn. This barn was rehabilitated by the National Park Service in the Fall of 2002.

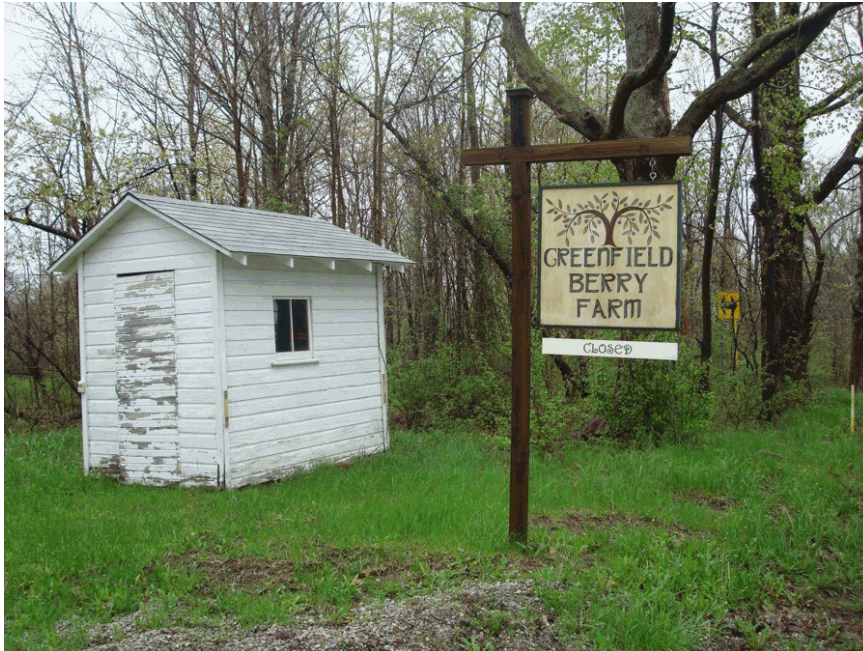
*Welton Milk House (Jackson 2011)*

The Welton Milk House (HS-327) is located near Major Road and is a gable-roofed, wood-framed building built around 1940. The milk house is clad with drop siding and the foundation is constructed of structural clay tile blocks. The structure is indicative of the function of the Welton Farm as a dairying operation and is an important element of the historic and cultural landscape. Although the National Register nomination considers the milk house a non-contributing resource, the structure should be treated as a contributing feature to the significance of the Welton farmstead and managed as a cultural resource. This feature was rehabilitated by the Countryside Initiative Program lessee.

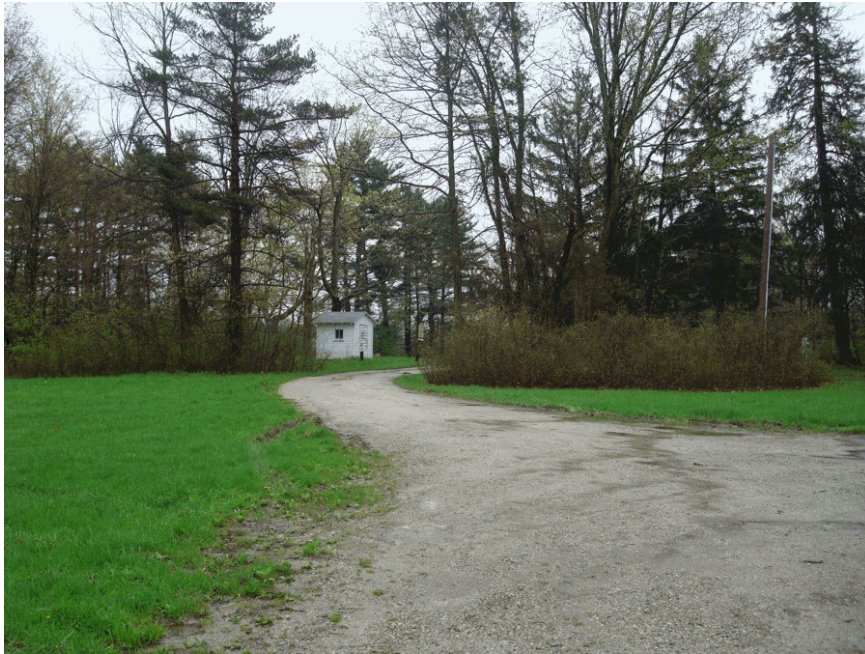
*Gravel drive leading towards Milk House (Jackson 2011)*

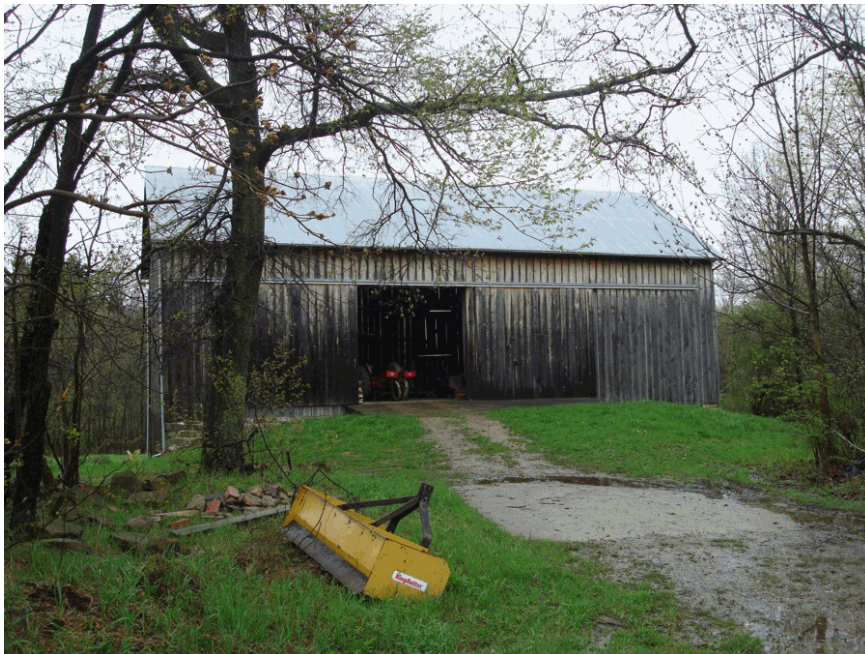
*Earthen ramp to gain access to second floor of the bank barn (Jackson 2011)*

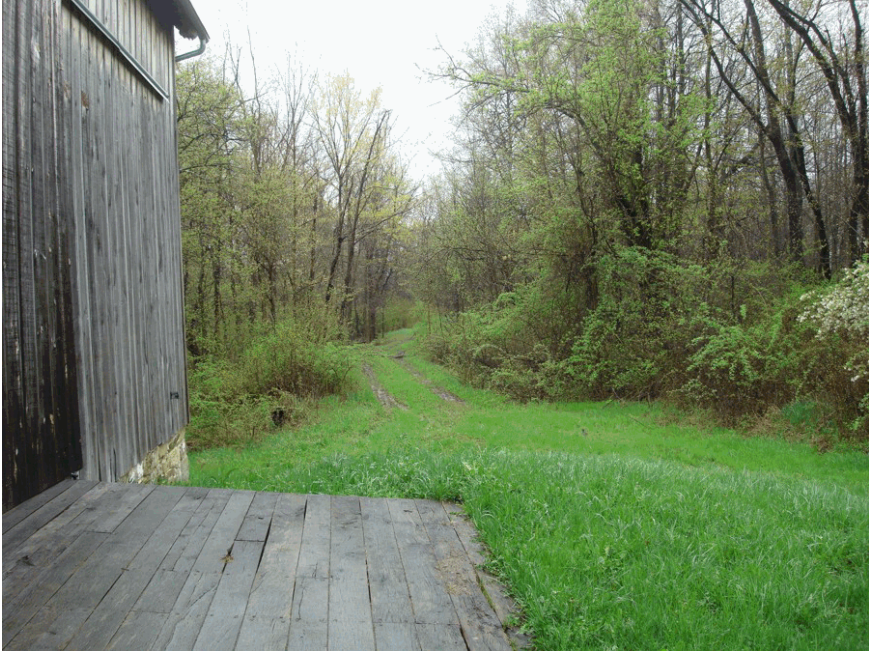
*Wheel path leading from the barn to the fields (Jackson 2011)*

In addition, a modern access road to the barn from the north side of the driveway by the garage was installed by the National Park Service in 2006. This road, compatible to the historic circulation of the site, is composed of dirt with gravel in low spots.

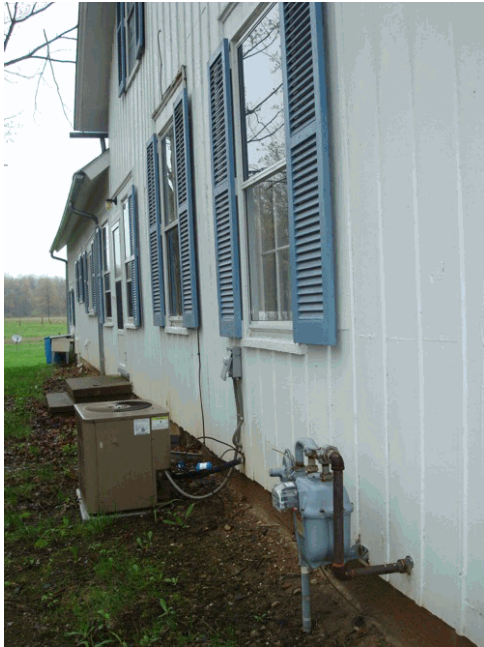
*Image of modern electrical and HVAC systems next to the house (Jackson 2011)*

Other small-scale features include a mailbox, signage for the farmstead, and power lines at the edge of the property. Next to the house, there are modern HVAC and electrical meter systems. A patio area, along with a fire pit, also appear next to the house. A satellite dish is visible in the open field.
