NATIONAL REGISTER OF HISTORIC PLACES
REGISTRATION FORM

historic name: **Albert Cofta Farmstead**

Albert Cofta Farm
Richfield Township
Summit County, Ohio

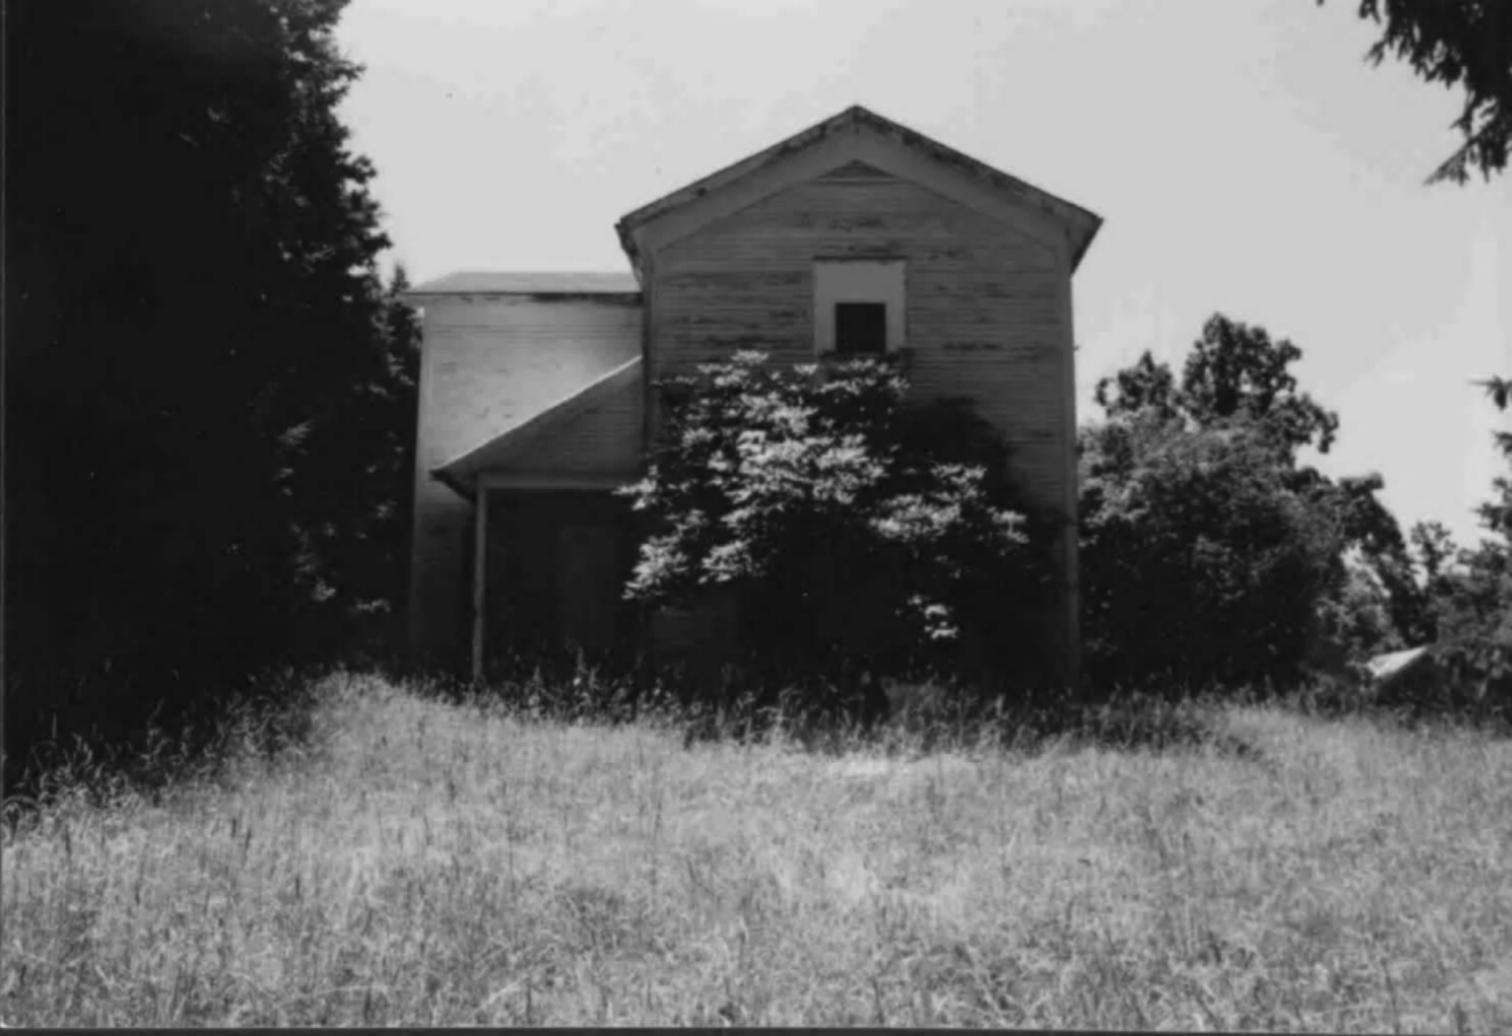
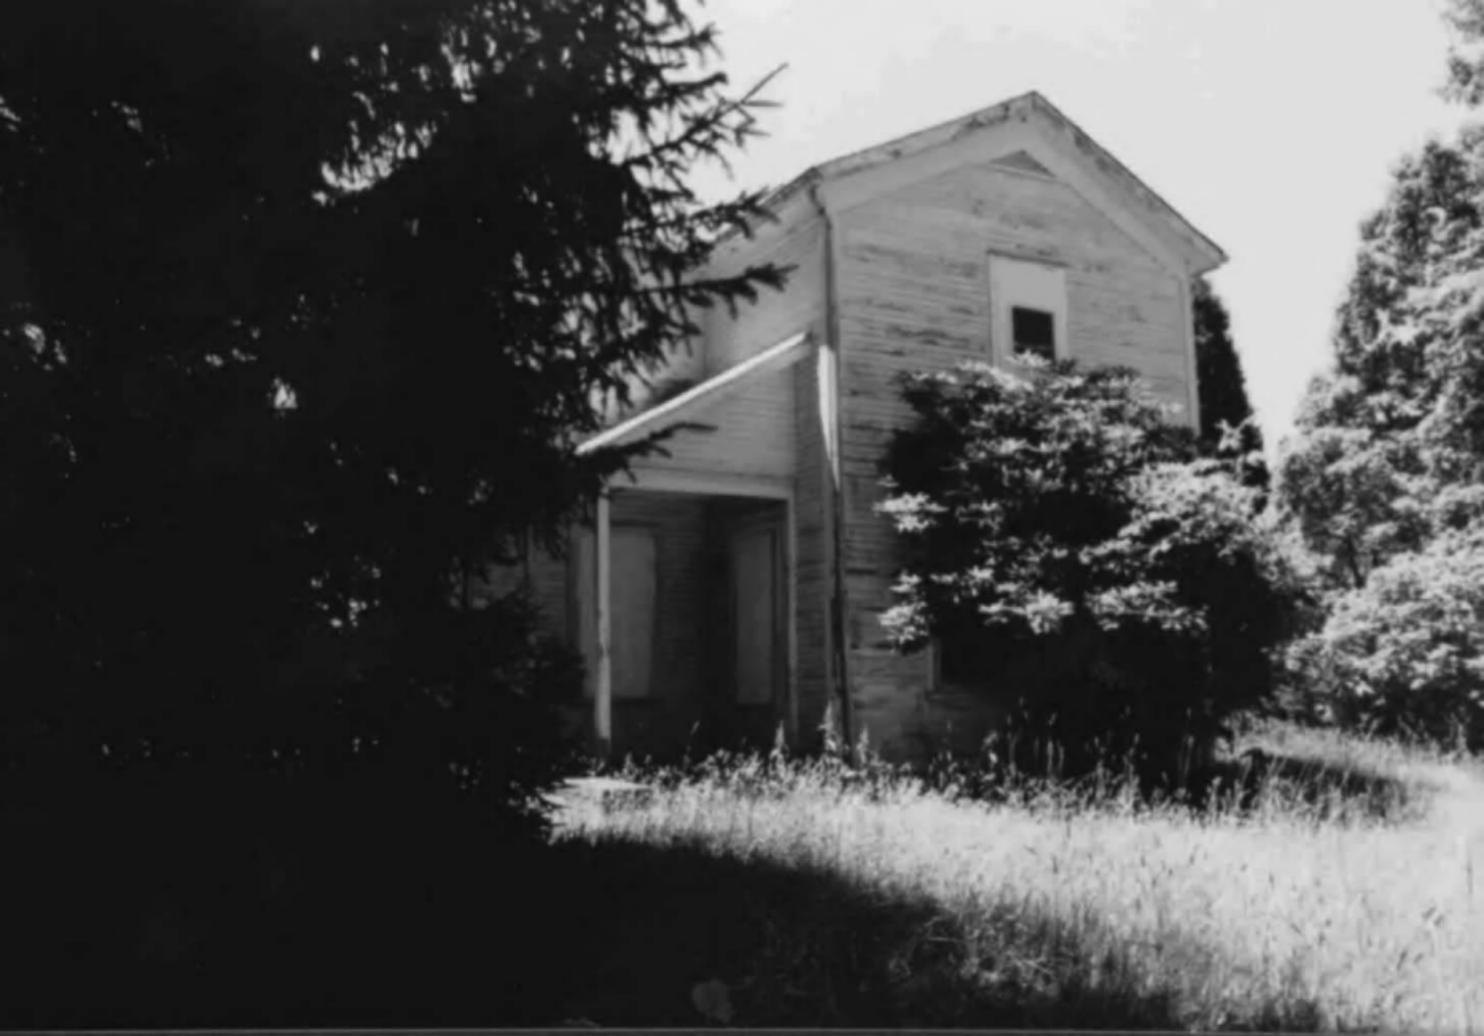
Built circa 1910, the Cofta House is a wooden-framed, two-story, Gabled Ell, Folk Victorian farm house (Photos 1-12). The building has an intersecting gabled roof with asphalt roll roofing and an interior brick chimney. All sides are covered with wooden drop lap siding. The northeast corner of the façade includes a shed-roofed porch with delicate turned porch supports and a concrete floor (Photos 1-2). A door adorns the north-facing façade. A large rhododendron bush partially hides the three one-over-one windows on the façade; all have double-hung sashes (Photos 1-2). The west elevation includes five, one-over-one double-hung windows, three on the first floor and two on the second (Photos 3-6). The east side features a bulkhead entrance to the full basement (Photo 14). The house has a cut sandstone foundation.

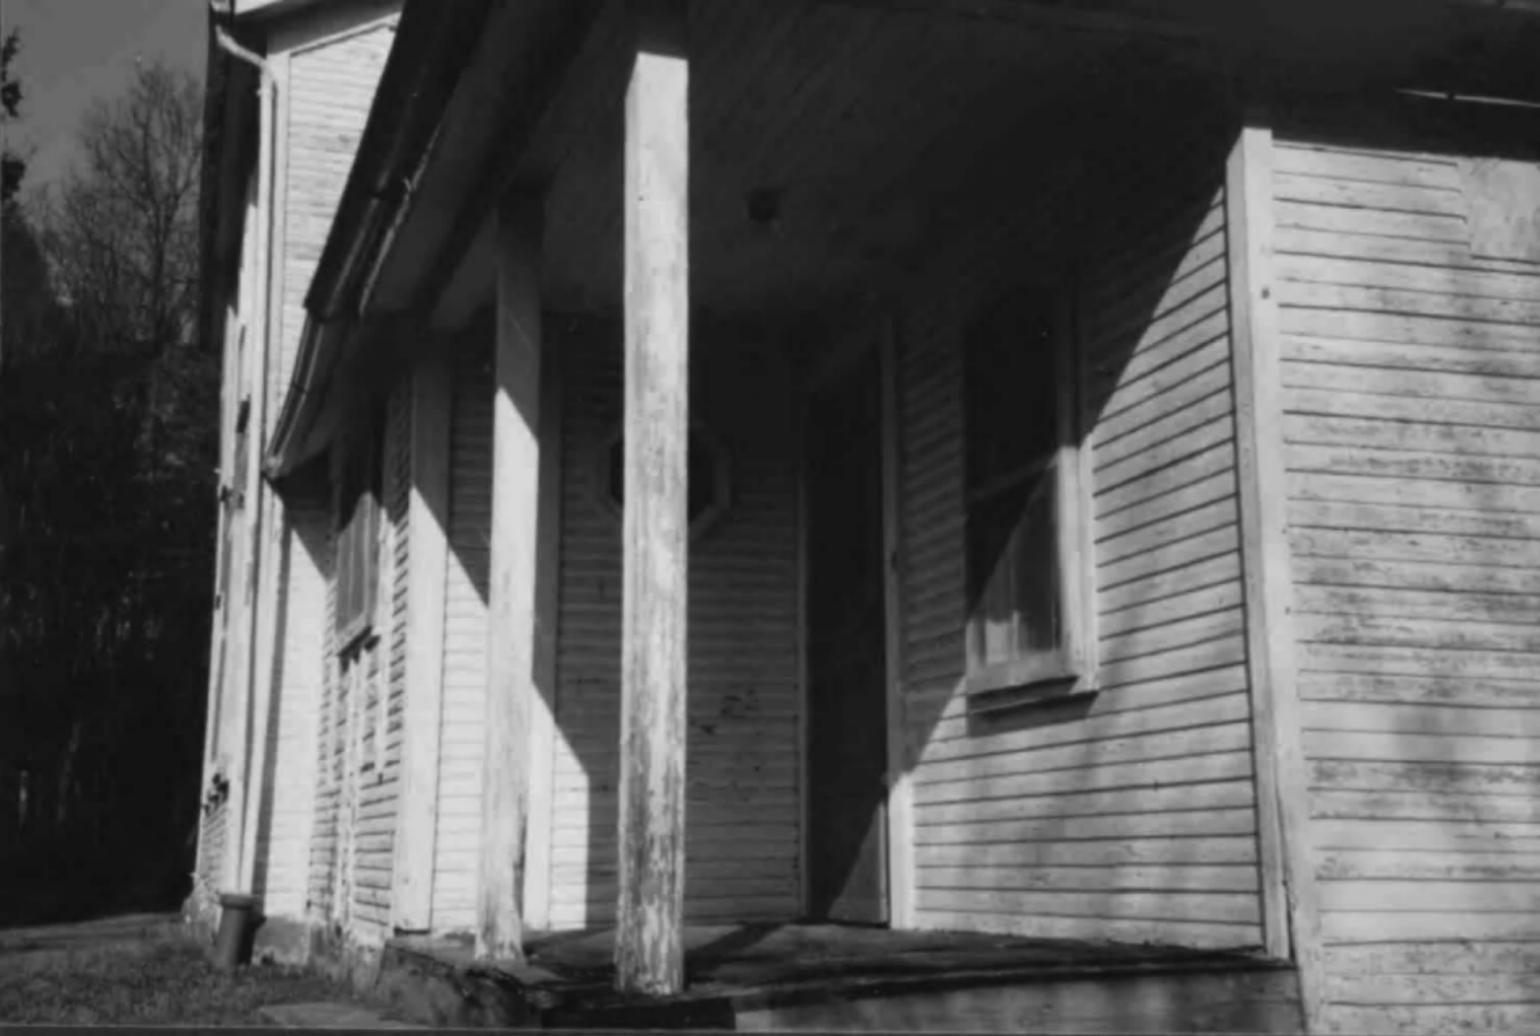
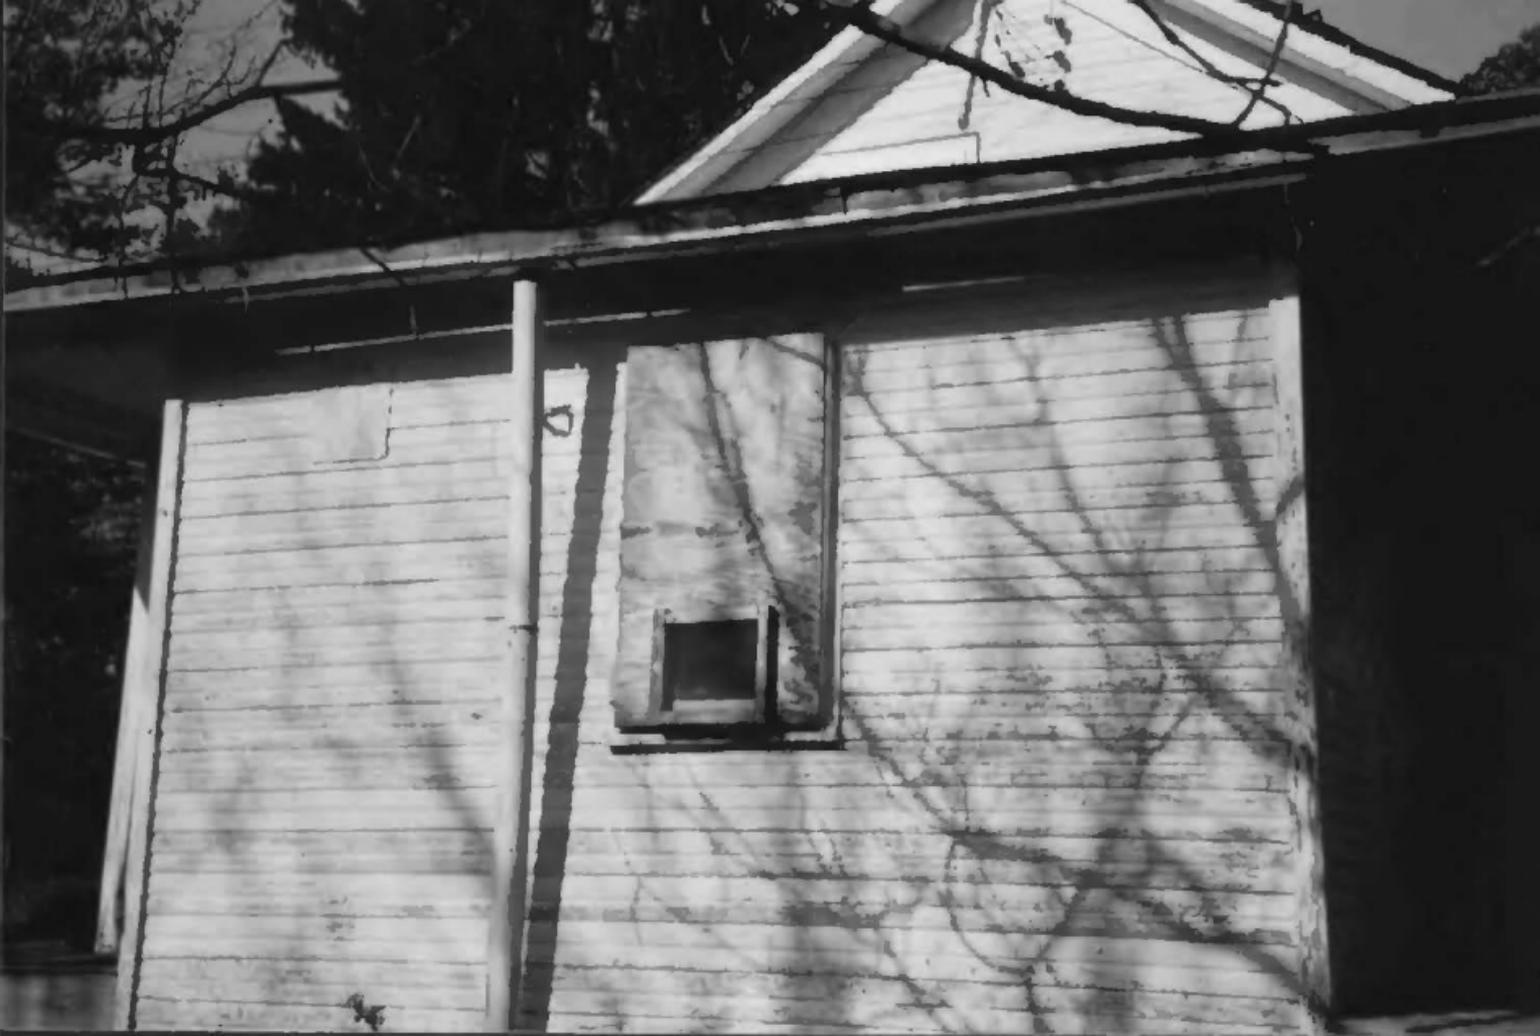
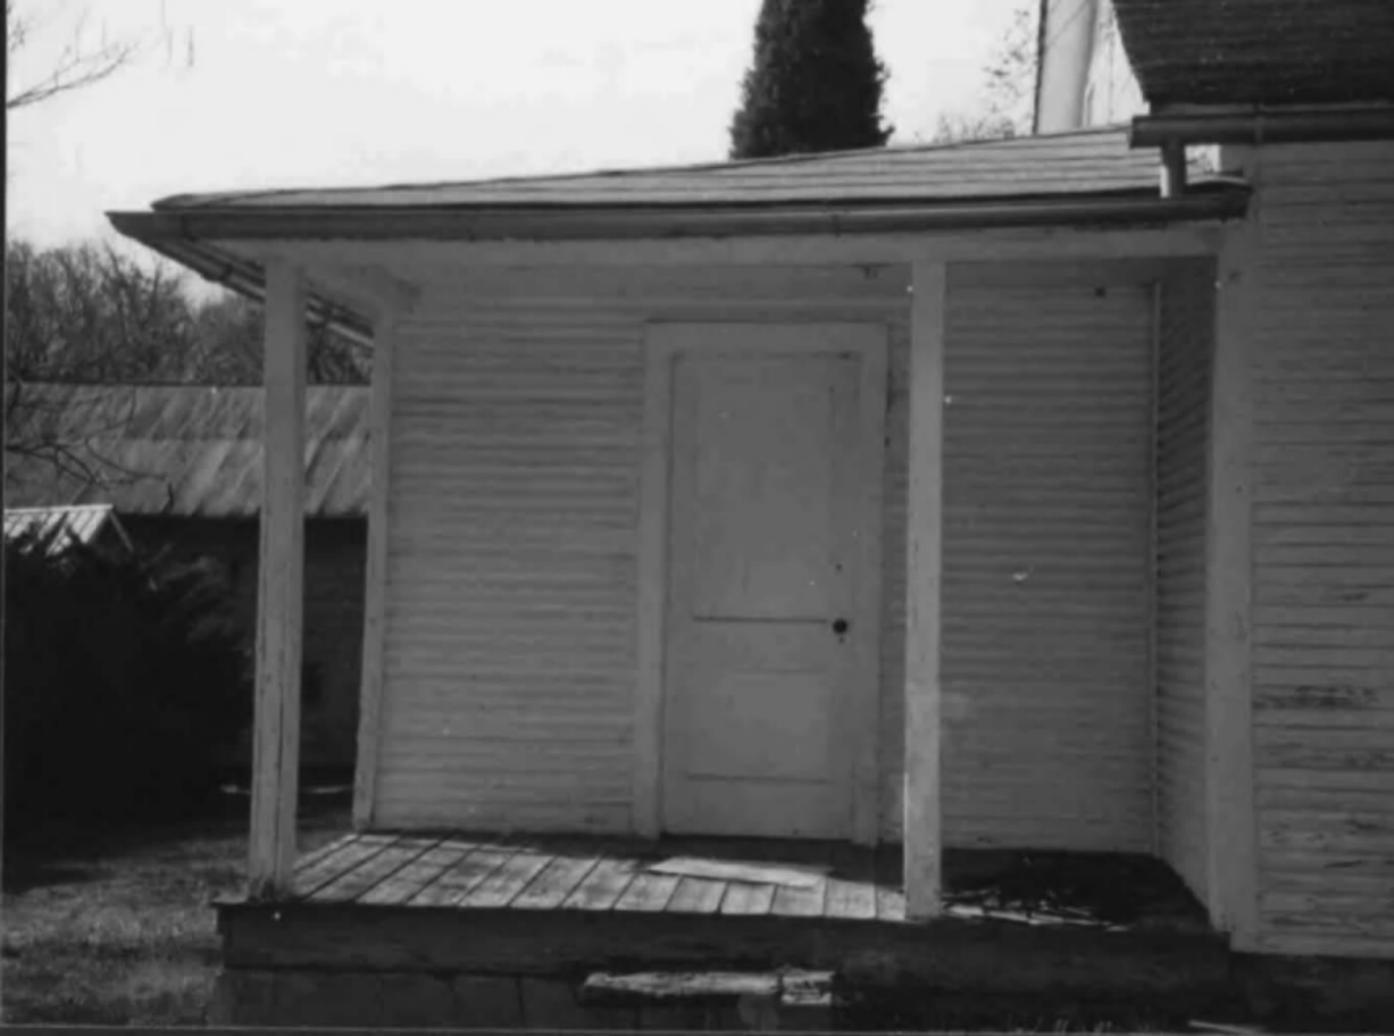
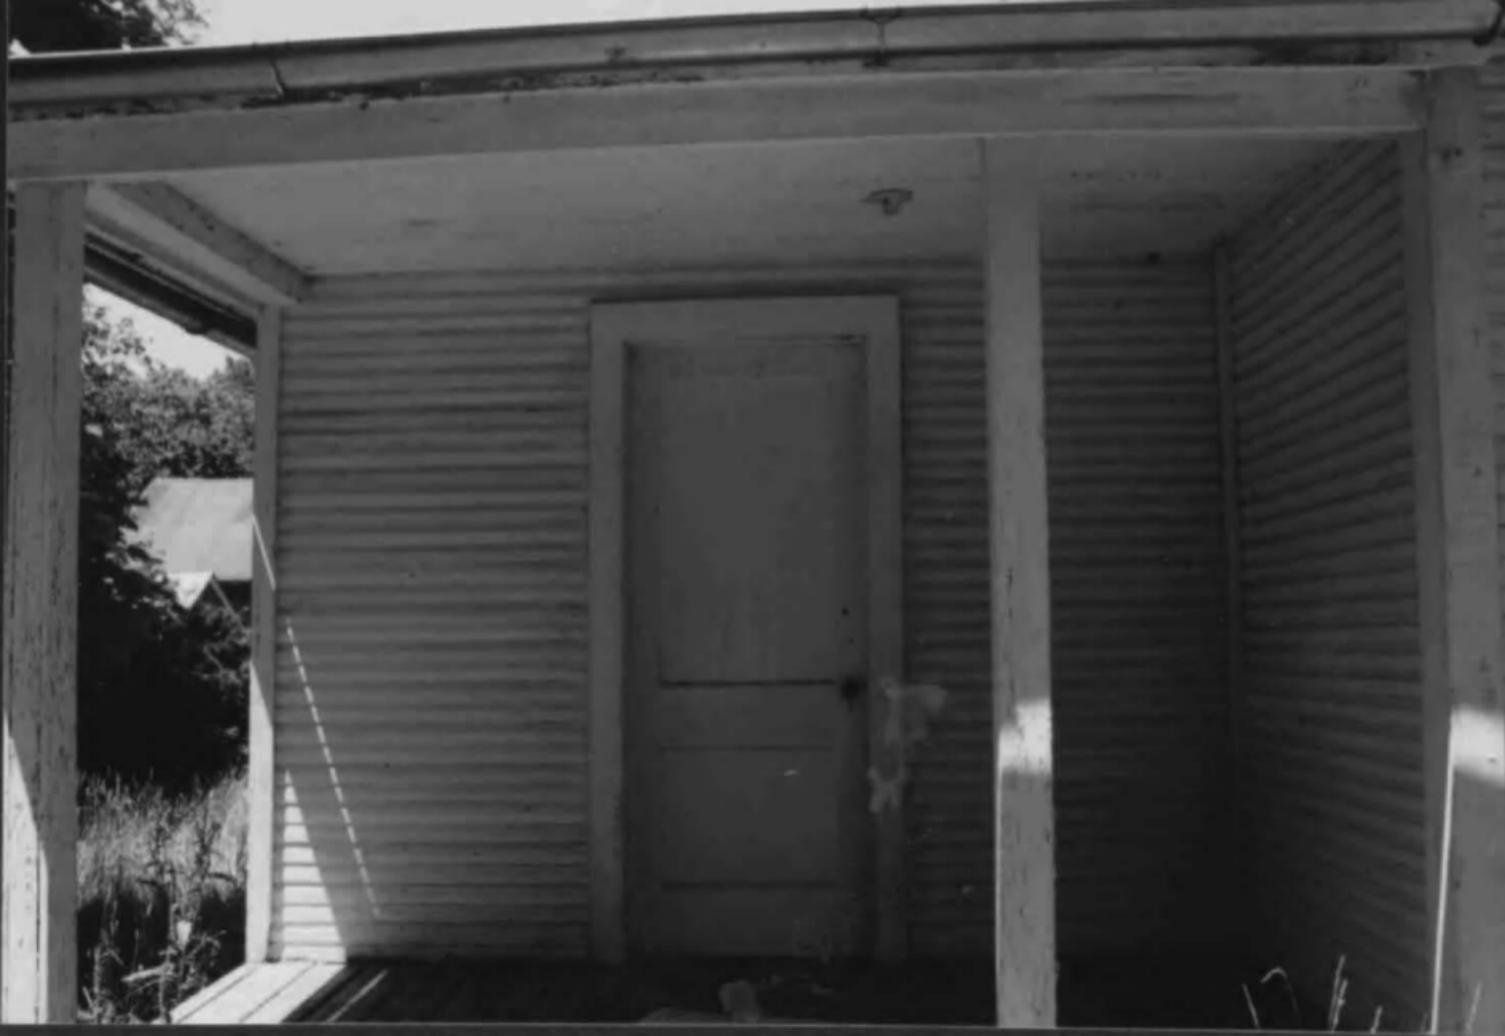
Two sections were later added to the south elevation of the main house (Photos 7-10). The first one-story addition has a gabled roof with asphalt roll roofing (Photo 15). There is an interior chimney along the east slope of the roof. The walls are covered with wooden drop lap siding. The west side includes a fixed, nine-light window, and the east side has a one-over-one, double-hung window. The south elevation has a small, fixed window within the gable end. This addition has a poured concrete foundation.

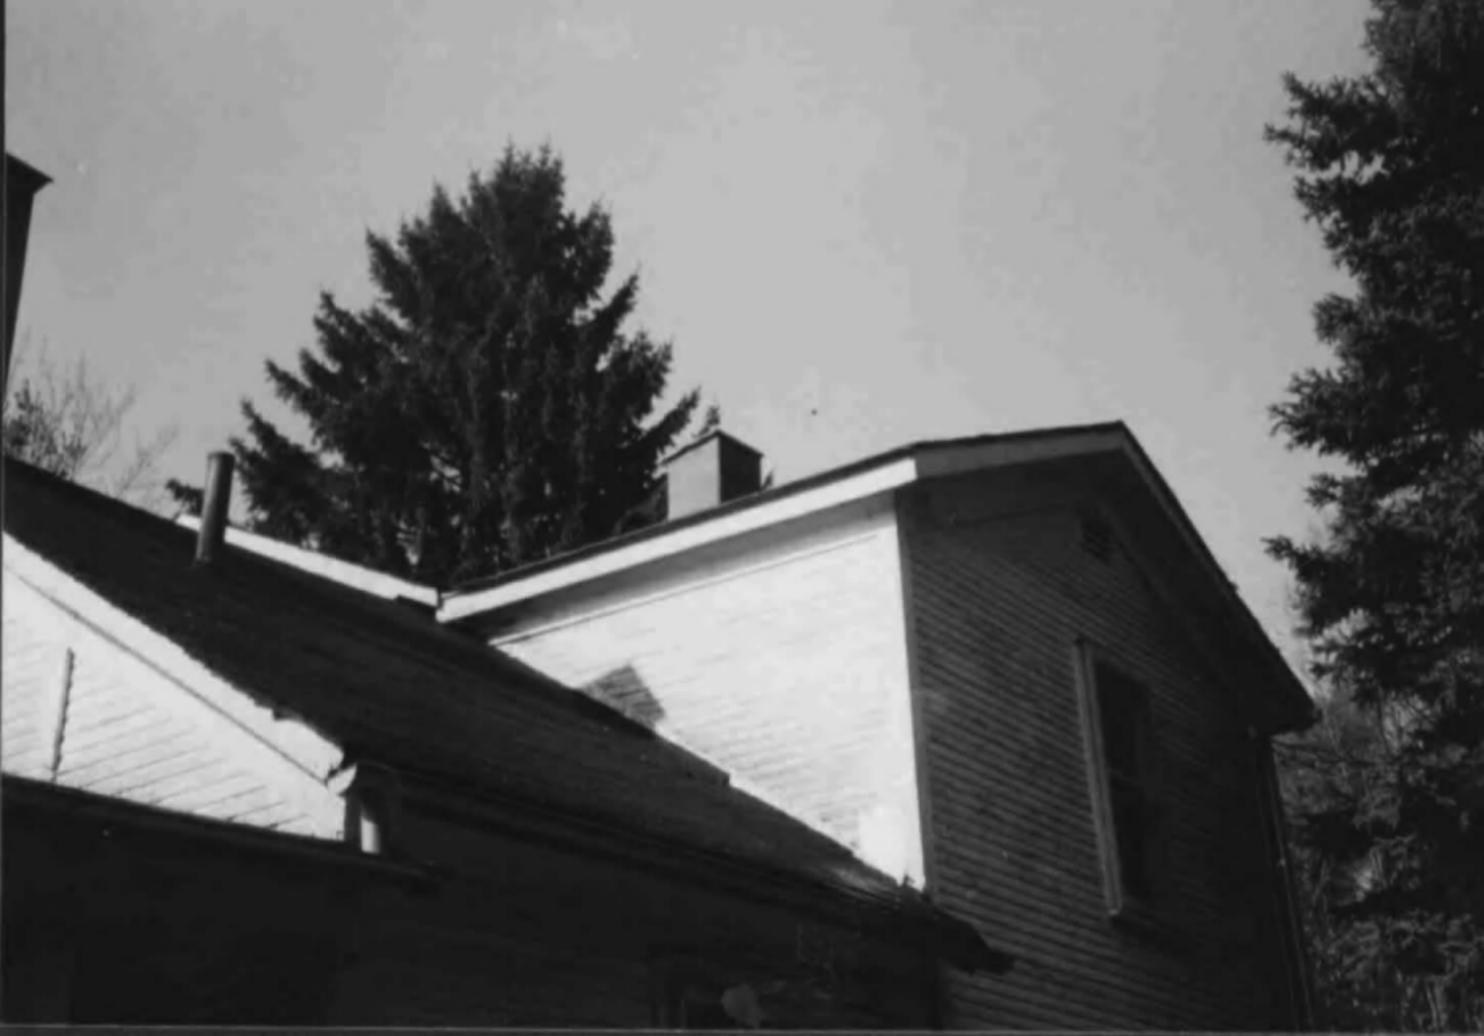
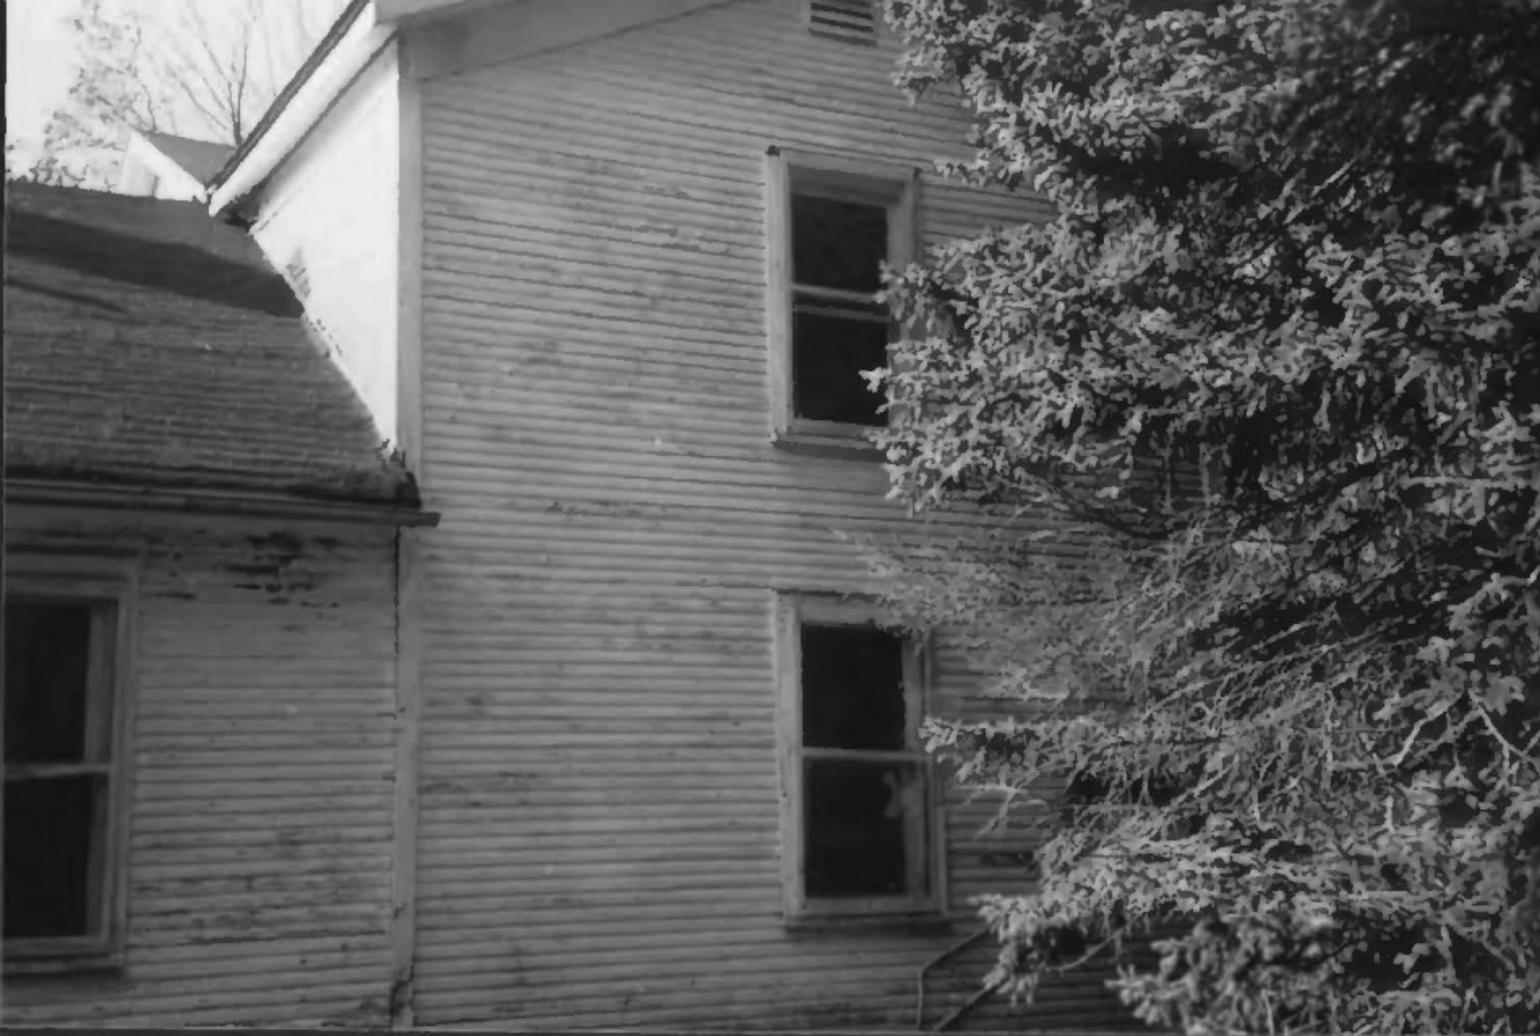
The east elevation also has a small porch and a door (Photos 11-16). A concrete block step is positioned along the east side of the porch (Photos 11-12). This step drops to a sandstone walkway (Photo 12) that leads to a well covered with a 4 x 6-foot stone slab cap (Photo 13). The sandstone walkway is considered as a contributing resource within the nomination. A 20 x 30-foot poured concrete slab covers the well opening. The well site is also considered a contributing resource of the Cofta Farmstead.

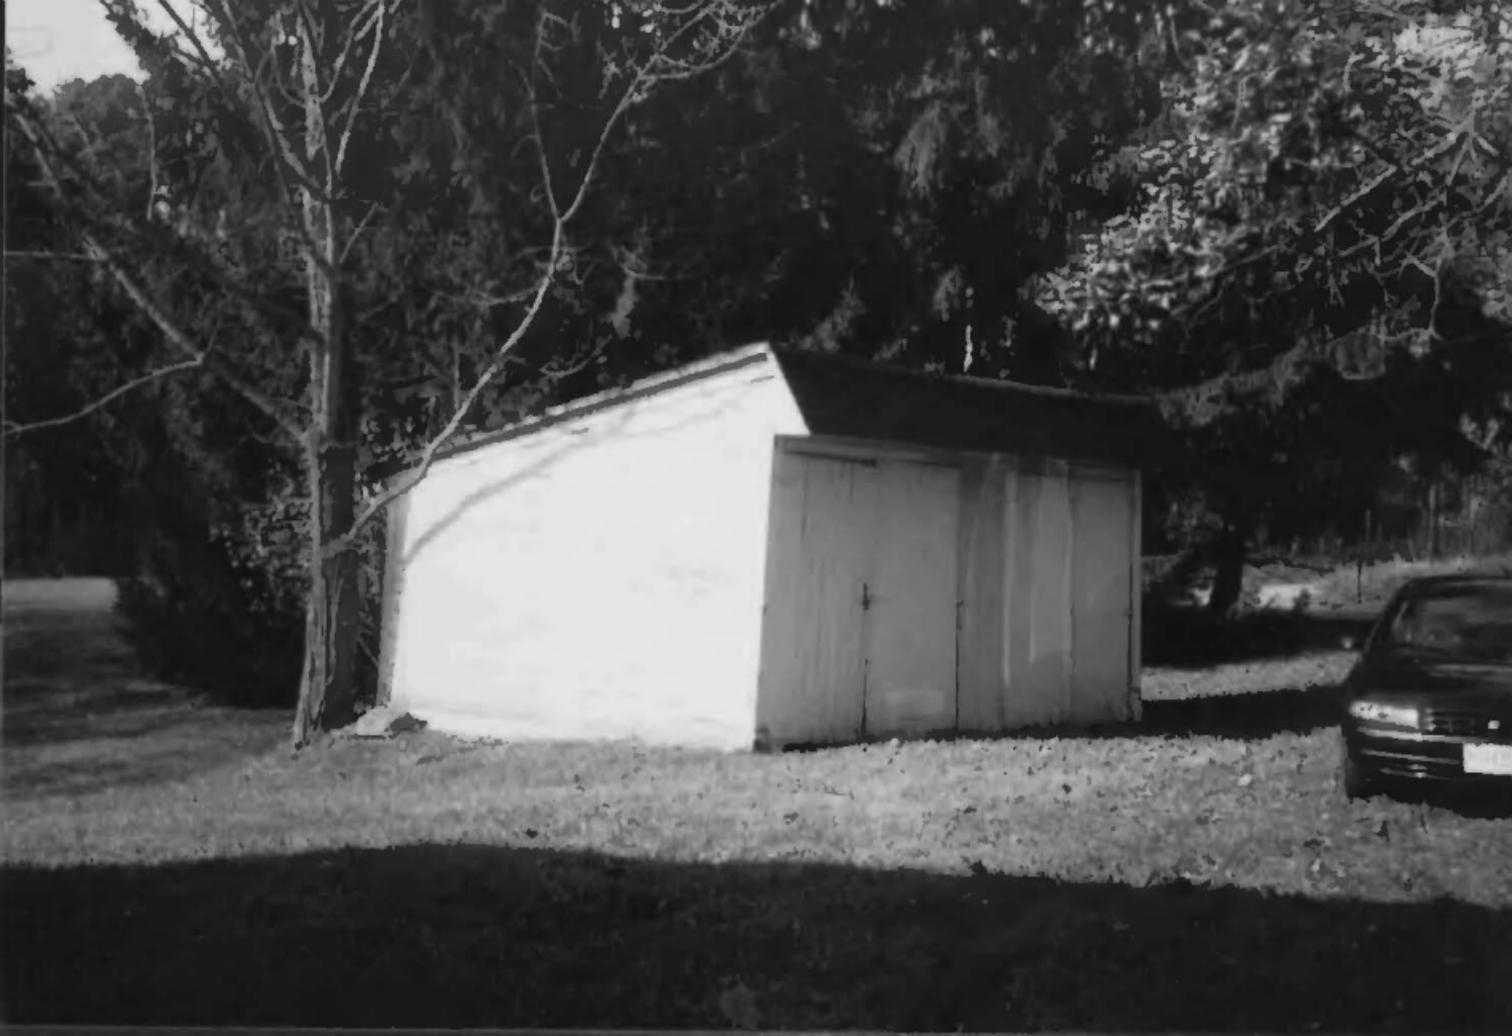
16 OF 28

The garage is positioned along the west side of the property's entrance drive, approximately thirty feet south of Brush Road (Photo 16). It is a wooden-framed structure with a shed roof and asphalt shingle roofing. There is a shed hood on the east side. An overhanging eave with exposed rafters is visible on the west side. The walls are covered with wooden drop lap siding. The north side includes one, two-over-two window with a double-hung sash. Two vertical board double-sliding doors are on the east elevation. The structure has a poured concrete foundation.

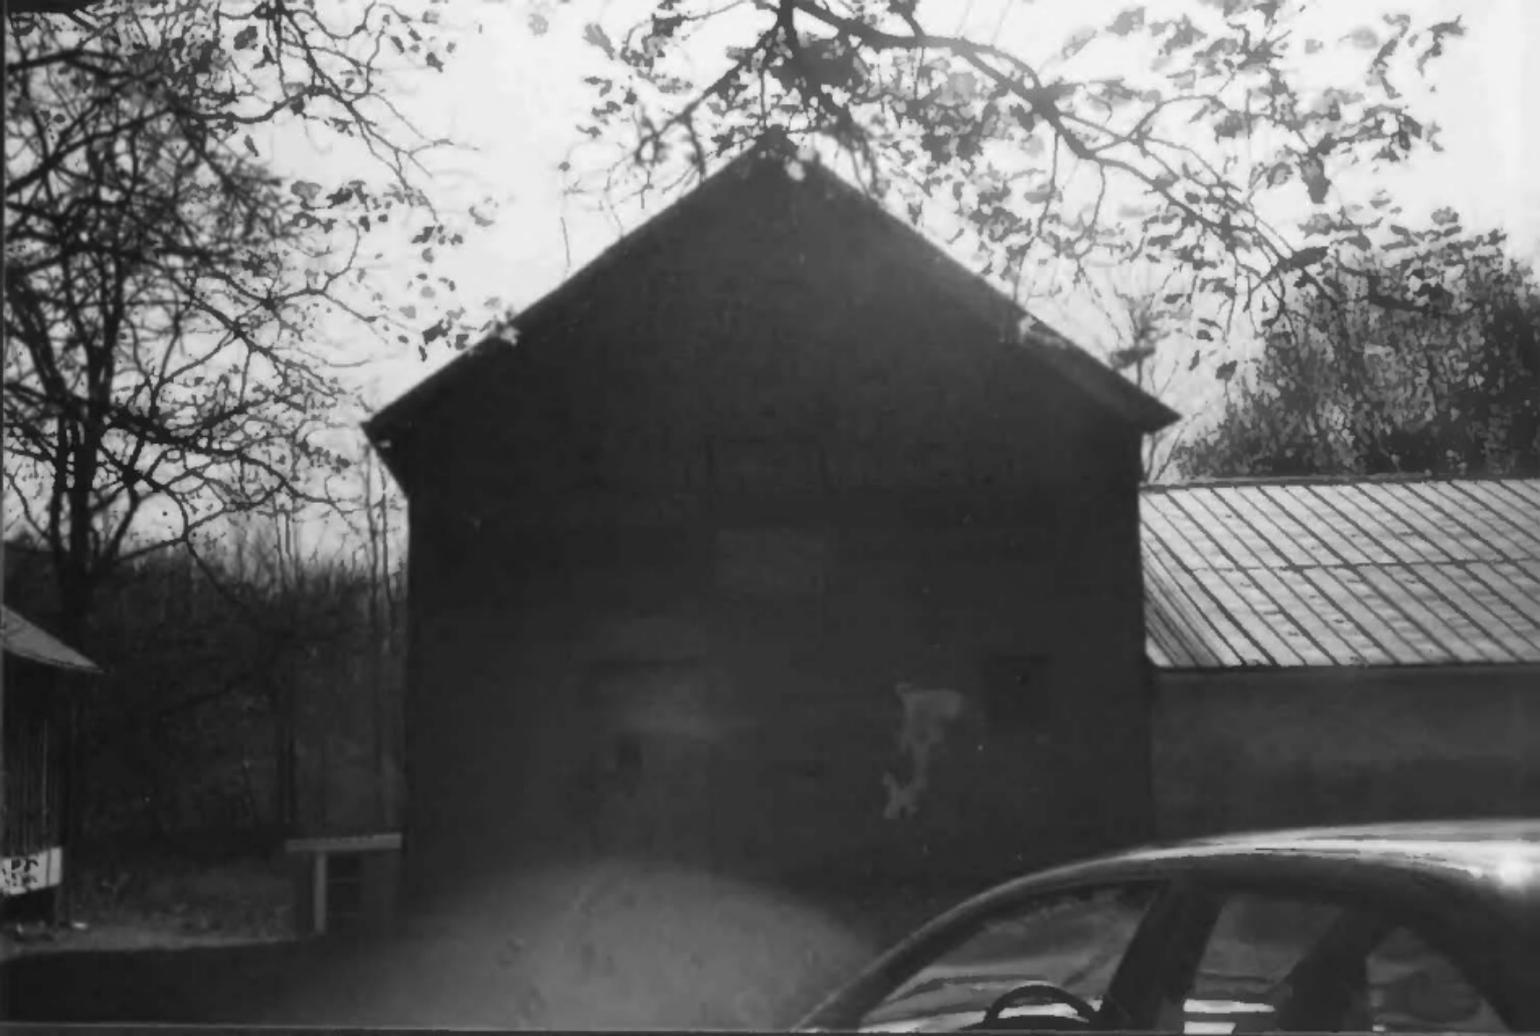
17 OF 28

The barn (built circa 1908, 1947 addition) is located approximately thirty feet west of the granary (Photos 17-21). The core section of the barn is a front-gabled, two-story, wood-framed building that was constructed into the bank that slopes on the south side. The barn's front-gabled roof is covered with sheet metal roofing material and has boxed rafter tails. The vertical board walls are covered with patterned asphalt roll siding (Insulbrick™), which is undoubtedly over fifty years old (Photo 20). The north side includes a pedestrian door, a hay loft door, and a small fixed window. The east side has three windows on the first level covered with meshed wire and a service door on the second level. A partial concrete-block basement wall is visible along the south side. It has a six-over-six window with a double-hung sash and a double-sliding vertical board door. The barn has a cut sandstone foundation. A short wall constructed of sandstone begins at the southeast corner of the barn and continues roughly five feet down the slope (Photo 18-19).

A concrete block addition was built onto the west side of the barn in circa 1947.¹ The one-story addition has a side-gabled (eave oriented) roof with corrugated metal roofing and exposed rafter tails (Photo 17). The north side includes a double-sliding vertical board door and a two-light

window with a hopper sash (Photo 17). The west side includes metal windows and wooden board and batten siding in the gable end. The addition has a concrete foundation.

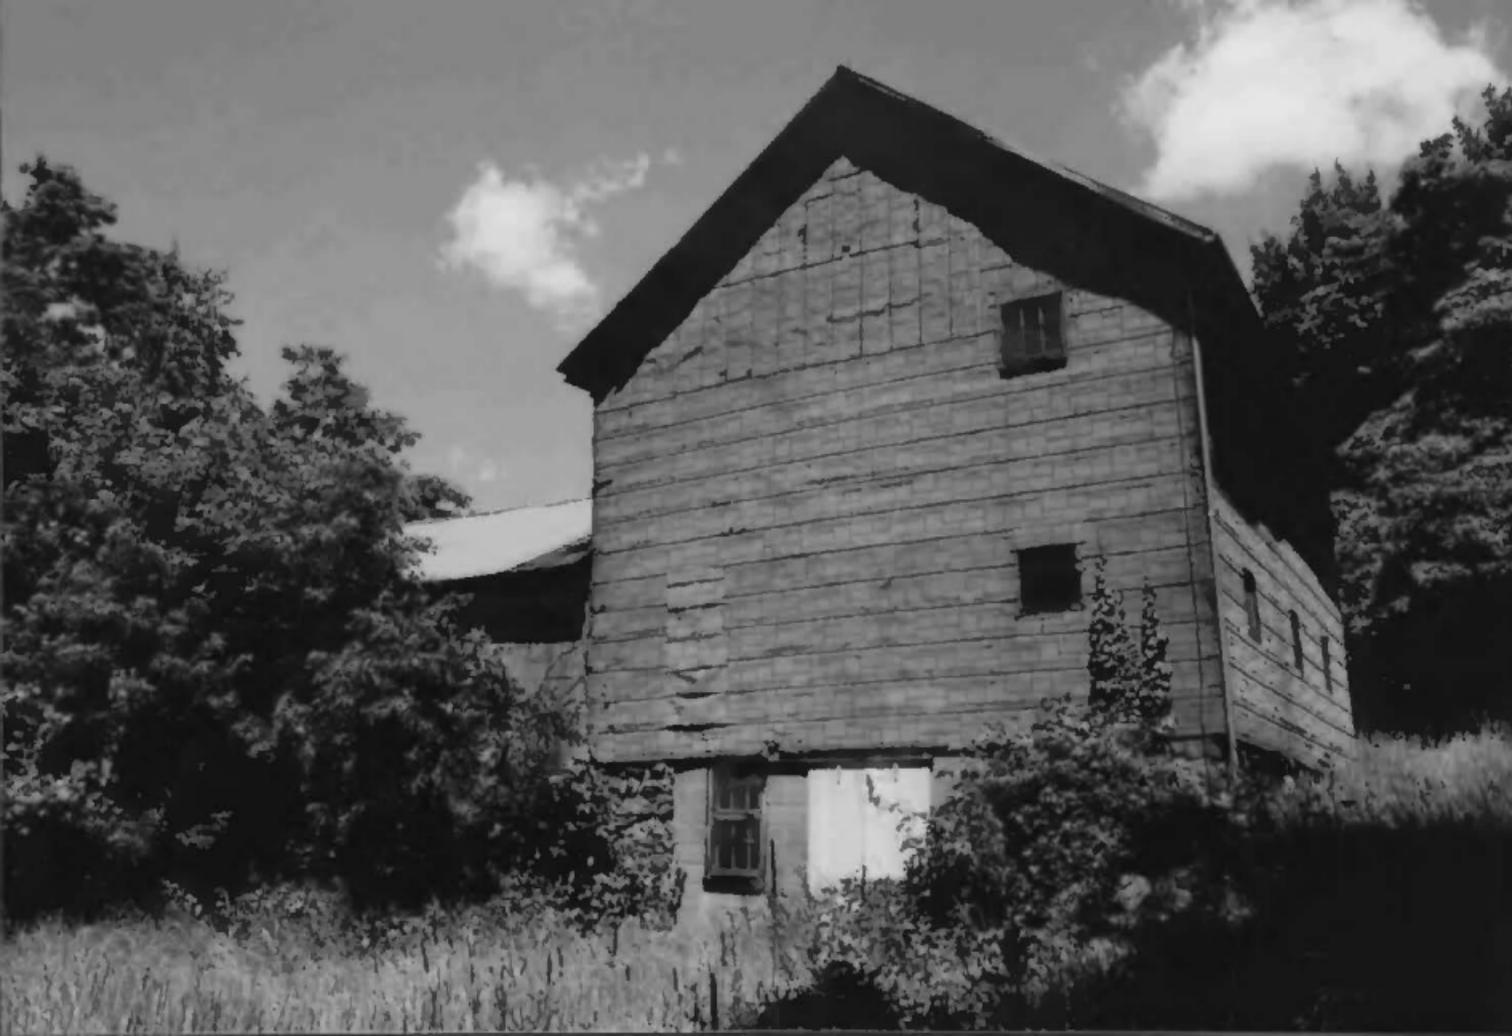
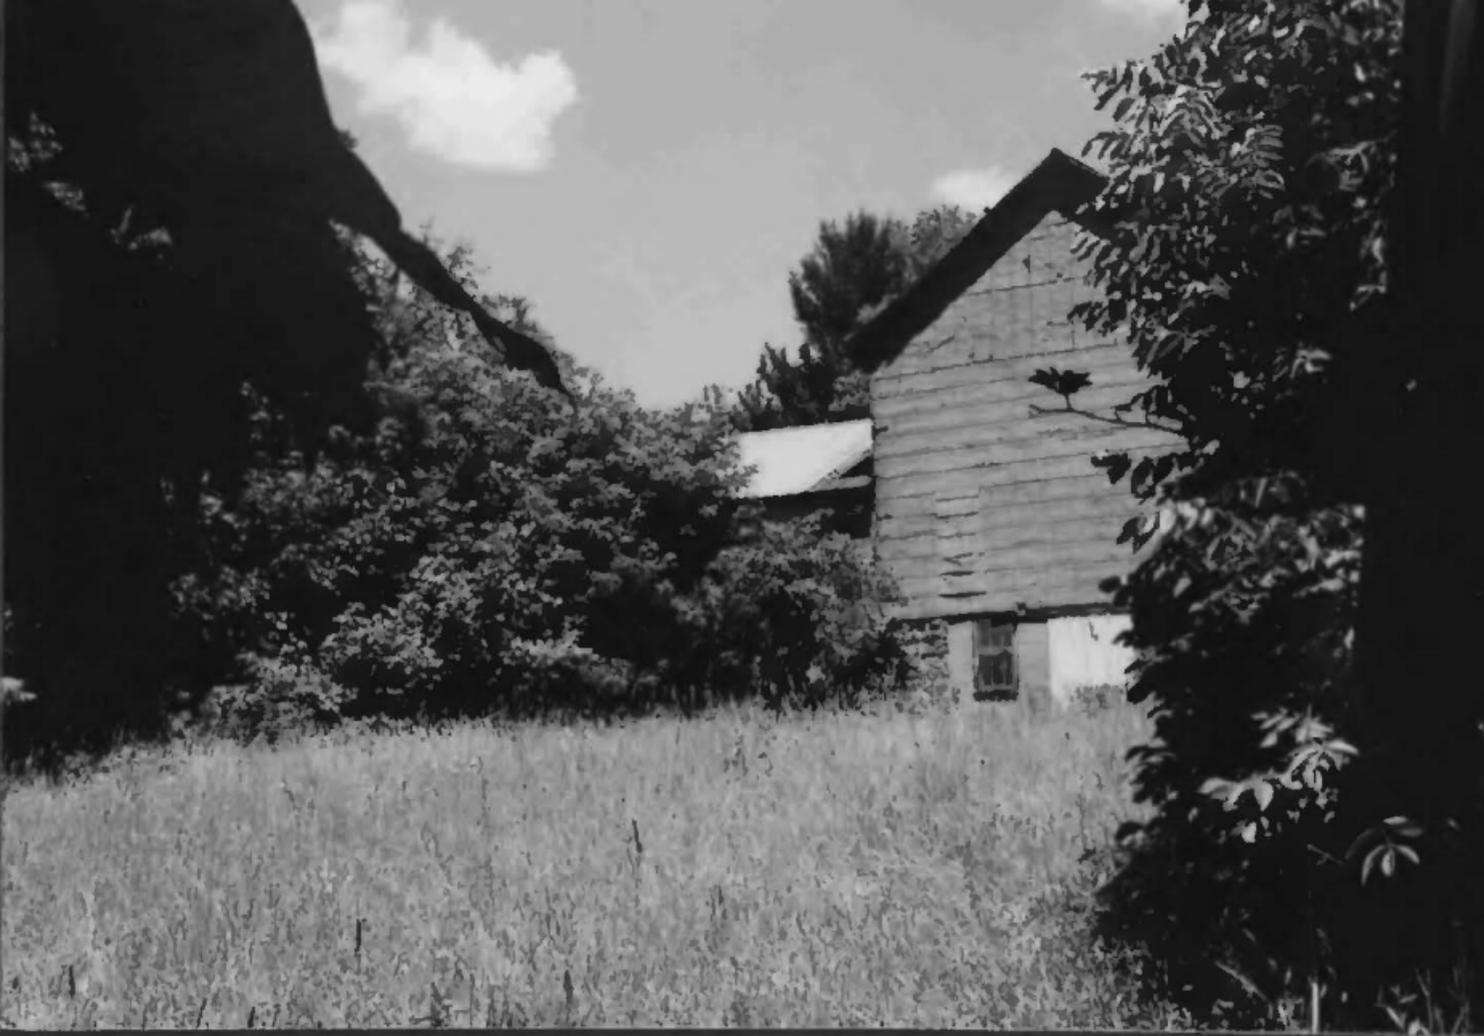
The foundation of the barn is cut sandstone block, and a large sliding-track door to the barn's basement is located on the north side. The second floor (threshing floor) held hay and livestock feed and the basement housed equipment and livestock, especially "milch" cows.
